DOT/FAA/W/92-1
DOT-VNTSC-FAA-92-6

1991 LLWAS Anemometer Test Program

Research and
Special Programs
Administration
John A. Volpe National
Transportation Systems Center
Cambridge, MA 02142-1093

Final Report
September 1992

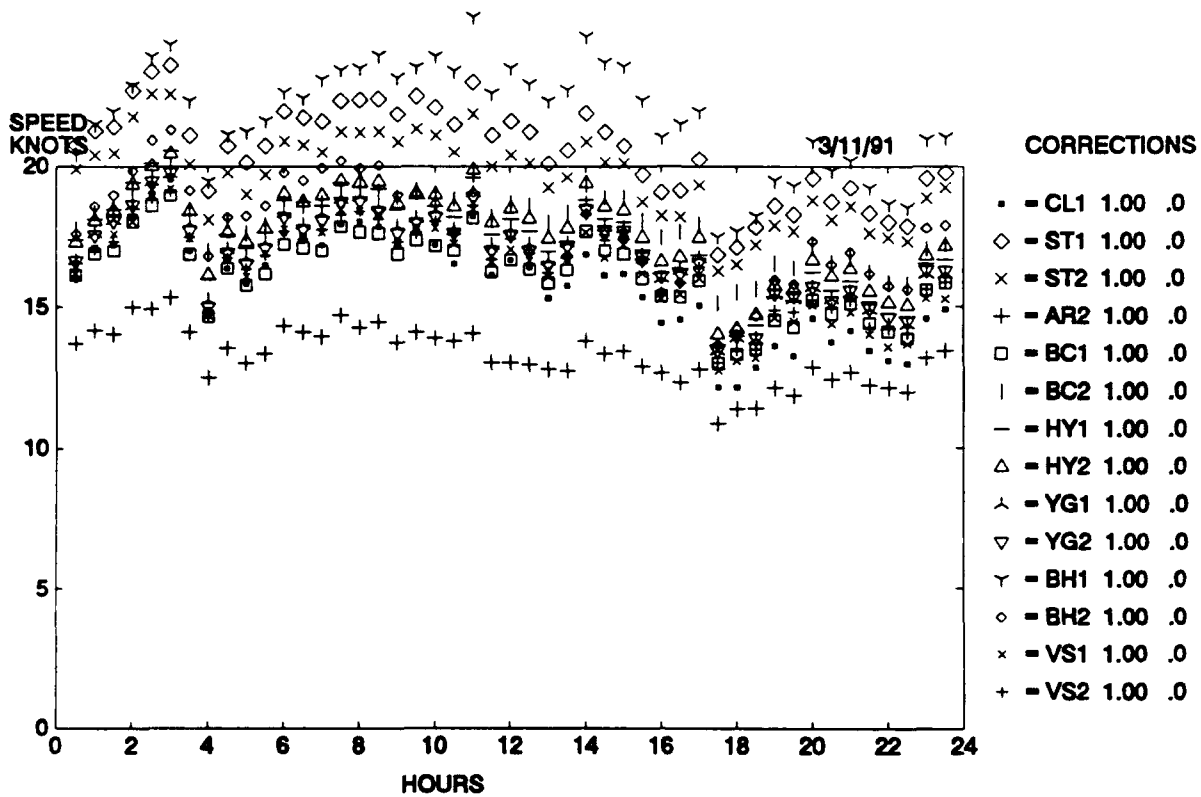
FIGURE 4-5. WIND SPEED DATA ON 3/11/91, UNCORRECTED

4.4.2.2 TIME PLOTS - The icing analysis is based on plots of wind speed vs. time. Figure 4-5 shows a sample plot for a number of sensors on the day before the 3/12/91 event. There is considerable scatter in the readings for the different sensors. Figure 4-6 shows how the agreement of the sensors is improved when the sensors have been corrected using the slopes and offsets obtained from scatter plots like Figure 4-4.

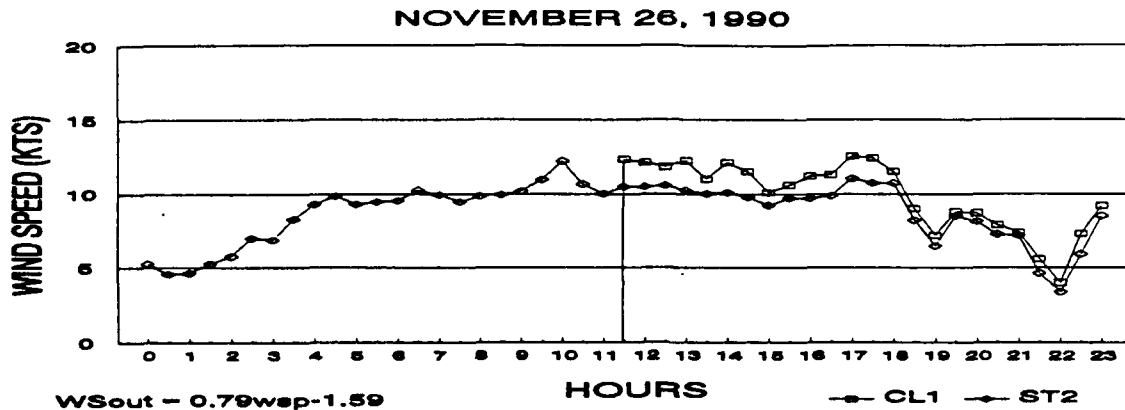
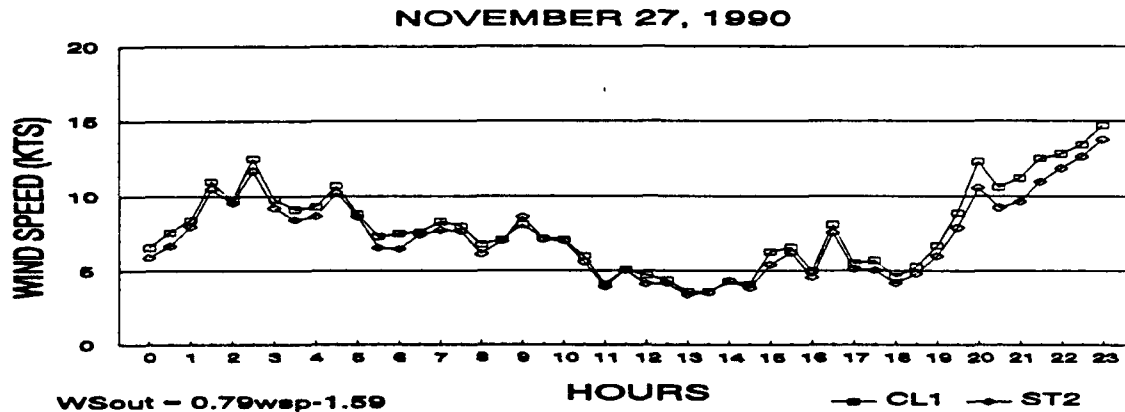
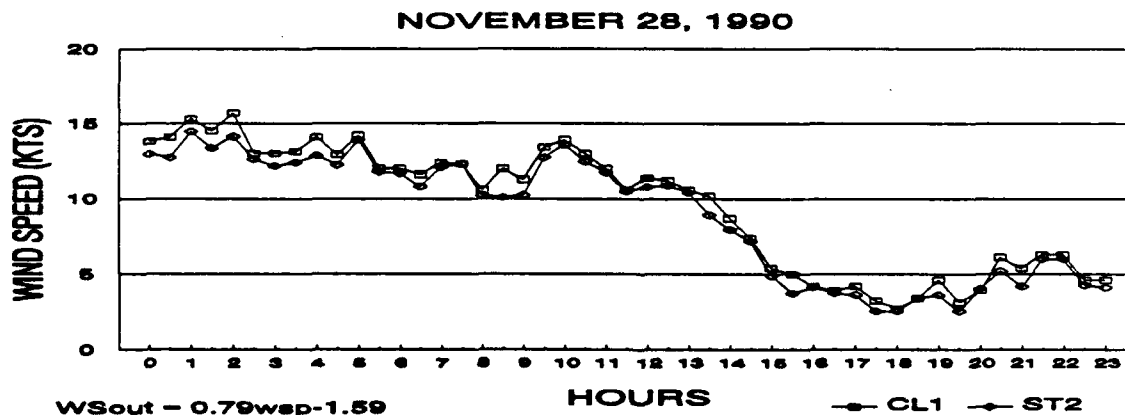
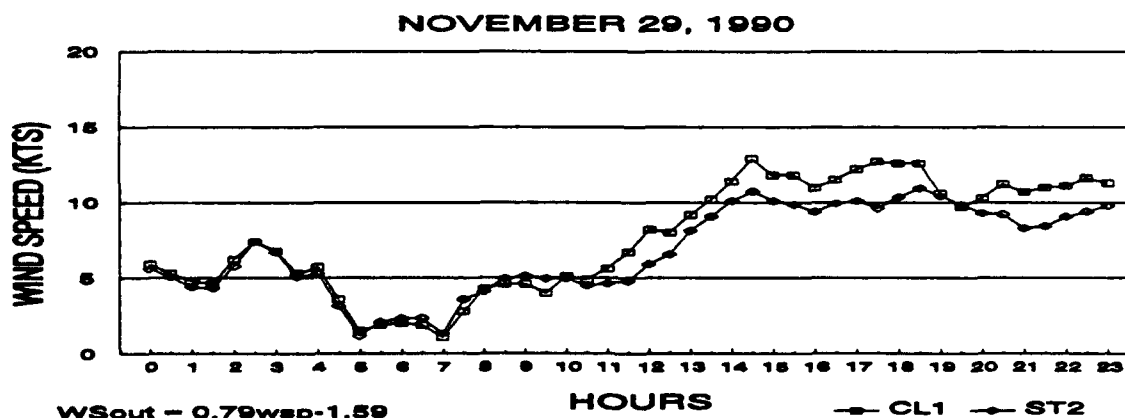
FIGURE 4-9. COMPARISON OF ST2 AND CL1 WIND SPEED ON 11/26-29/90

Figures 4-8 through 4-11 show wind speed plots for all the sensors operating during this event, which occurred very early in the test period. Figure 4-8 shows that the two Climatronics sensors tracked well through the event; CL2 was not in service after the event. Figure 4-9 shows agreement to within 1.5 knots between ST2 and CL1 through the event and for the following day. Larger disagreements were noted on the day before and the second day after the event when the wind direction was southerly. Figures 4-10 and 4-11 show variable agreement between the two Rosemount sensors and CL1; the errors are larger at low wind speeds, as would be expected for the pressure-sensing Rosemount units.

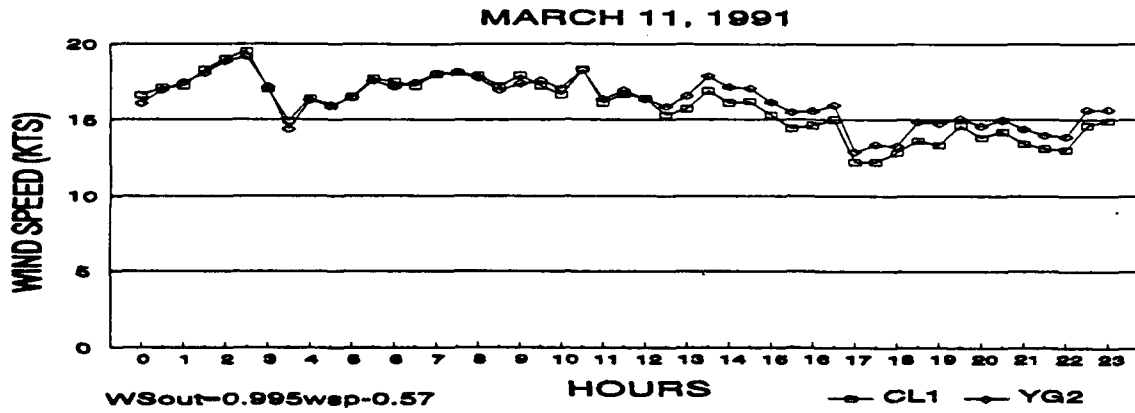
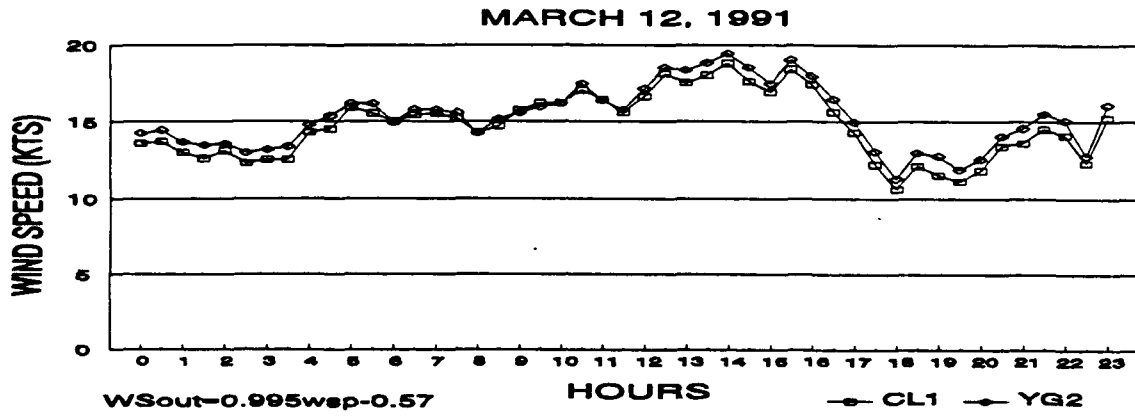
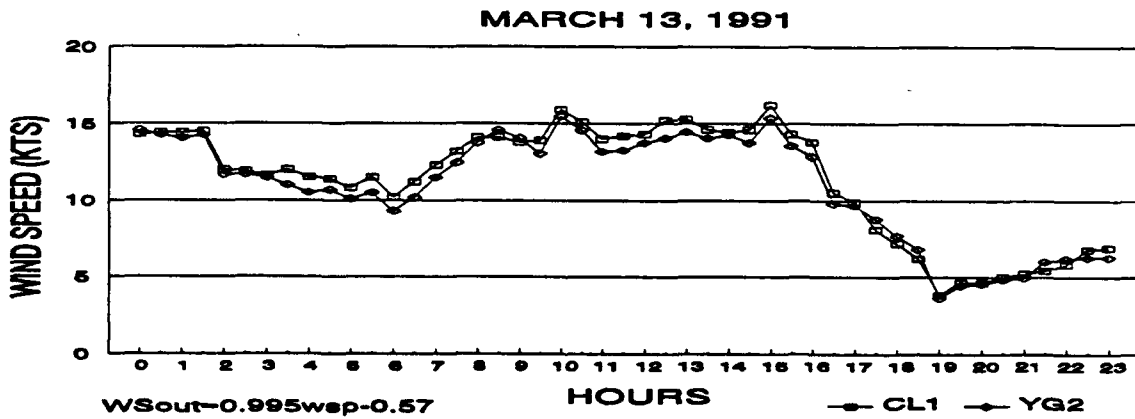
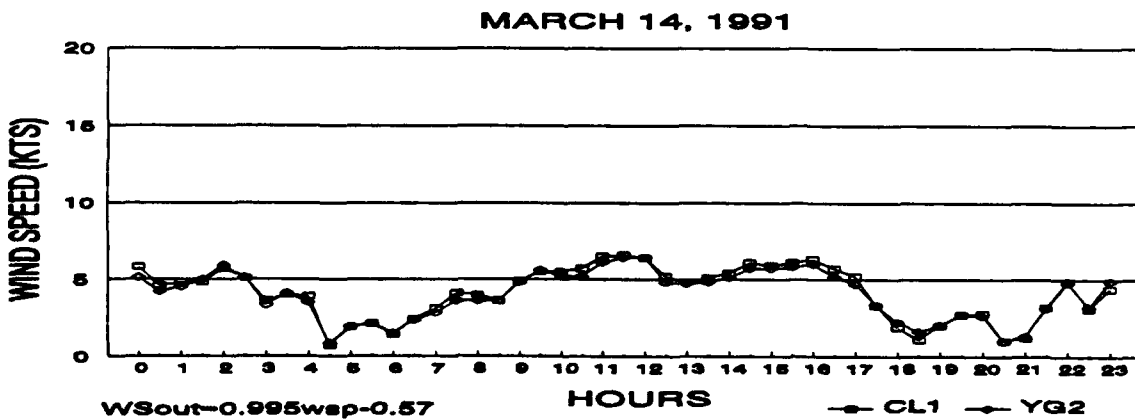
FIGURE 4-14. COMPARISON OF YG2 AND CL1 WIND SPEED ON 3/11-14/91

Figures 4-13 and 4-14 show wind speed plots for the two R. M. Young sensors (YG1 and YG2). In Figure 4-14, YG2 agrees well with CL1 throughout the event. In Figure 4-13, however, YG1 slowed down by 1.5-2 knots during 0400-0500 hours and during 0600-1030 hours. The maximum speed reduction was reached by 0430 and 0700 hours. The second speed reduction period corresponded to the observer's report (see Table 4-2.) of light freezing rain, icing indications from the Rosemount icing sensor, and a temperature near freezing (33 degrees). Neither the observer nor the Rosemount icing sensor indicated any icing during the first speed reduction period.

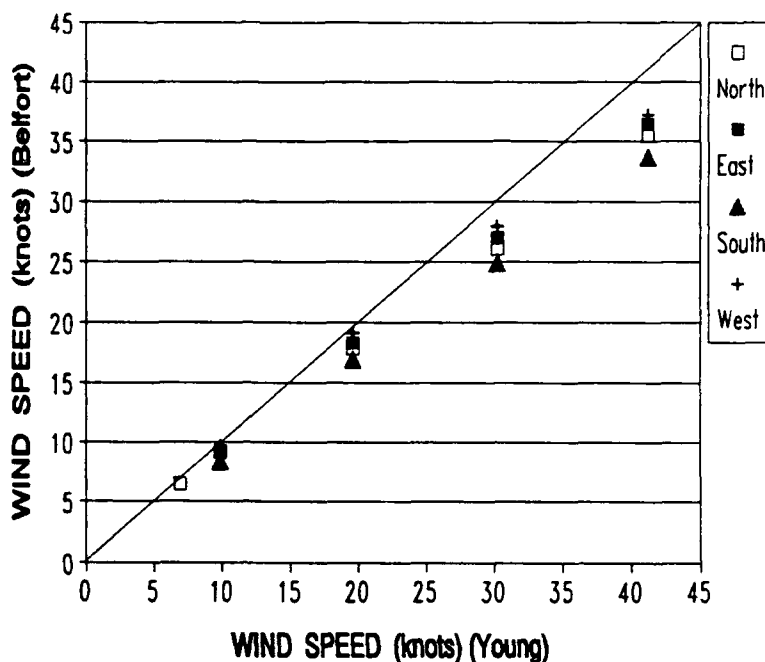
FIGURE 5-5. BELFORT HOT-WIRE CALIBRATION (S/N 10066)

Figure 5-5 shows the calibration of one Belfort hot-wire unit. Although the unit was seriously out of calibration, the response appeared to be linear.

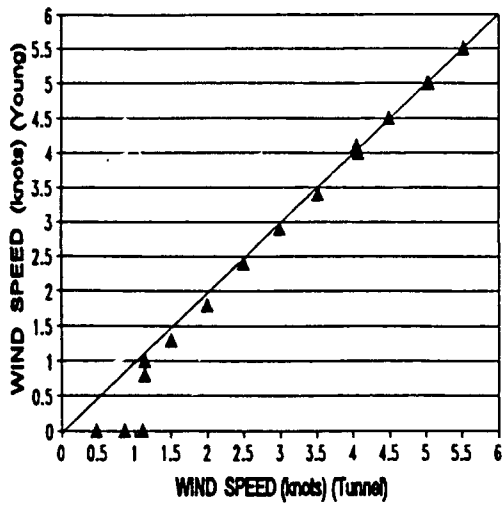
**FIGURE 5.9 R. M. YOUNG:
LOW SPEED**

The R. M. Young anemometer was indeed the most sensitive and had the lowest starting threshold. Climatronics, Vaisala, and Belfort (cup) had starting thresholds in close proximity to each other. The Hydro Tech anemometer had the highest starting threshold at about 3 knots. Note that this higher starting threshold results in significant measurement errors at wind speeds up to five knots. The second Hydro Tech anemometer was also tested for suspected problems. The starting threshold on the second Hydro Tech was somewhere between 5.5 and 7 knots, probably due to a bad bearing.
