DOT HS 813 724

**Special Crash Investigations:  
Remote Move-Over-Law Crash  
Investigation;  
Vehicle: 2016 Chevrolet Silverado  
2500;  
Location: Washington;  
Crash Date: May 2021**

**Special Crash Investigations**  
**Remote Move-Over-Law Crash Investigation**  
**Case No. DS22005**  
**Vehicle: 2016 Chevrolet Silverado 2500**  
**Location: Washington**  
**Crash Date: May 2021**

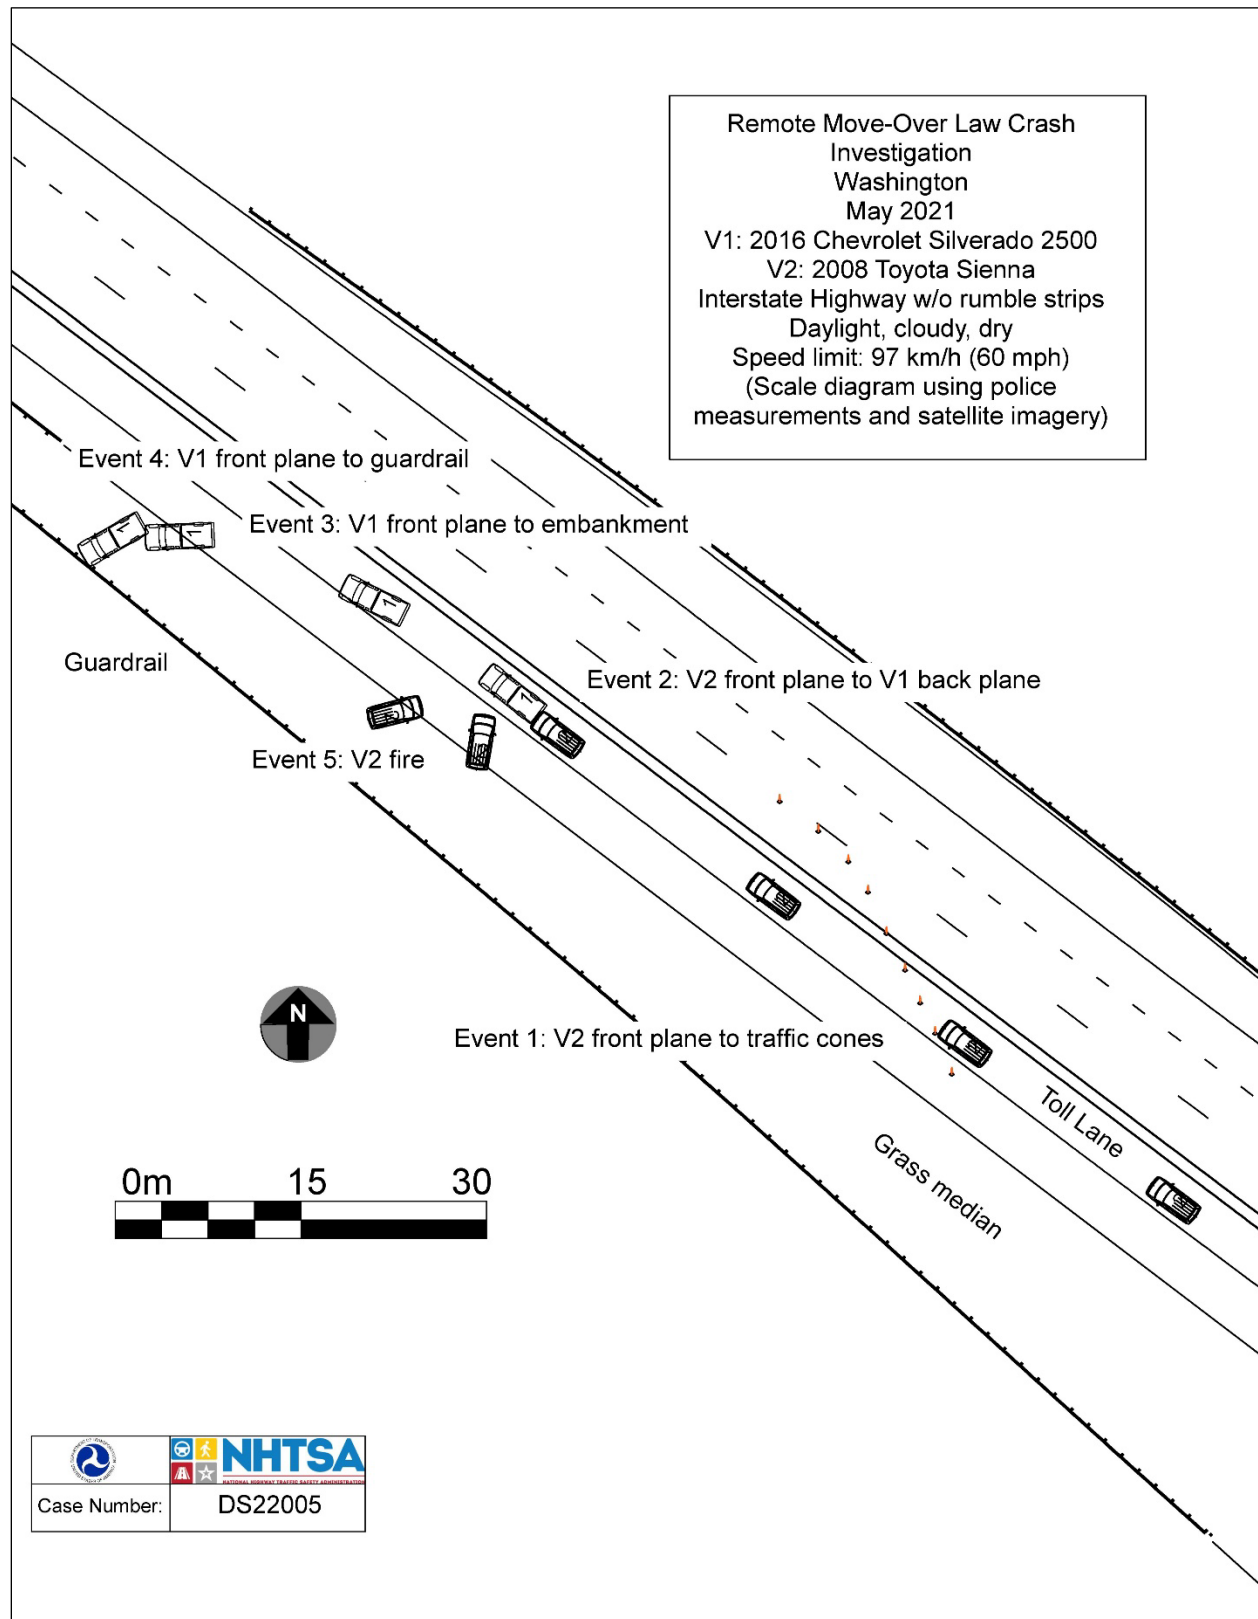
## Crash Diagram

The front plane of the Toyota struck one or more traffic cones marking the lane closure (Event 1). It continued traveling northbound for approximately 40 m (131 ft) until its front plane struck the back plane of the Chevrolet (Event 2). The damage flow to both vehicles and scrape marks in the pavement at the point of impact (Figure 4) suggested the front end of the Toyota under-rode the back plane of the Chevrolet. Impact pushed the Chevrolet forward and left where it departed the left roadway edge. Its front plane struck the grassy upward sloping embankment in the center median (Event 3) and a wood and metal guardrail (Event 4) where it came to rest facing west with its front plane in contact with the guardrail. The Toyota traveled off the left road edge and came to rest facing east in the center median. The Toyota's post-crash engine compartment fire (Event 5) was extinguished by the first police officer to arrive on-scene.
