# **RECYCLING PORTLAND CEMENT CONCRETE PAVEMENTS IN OKLAHOMA**

**Final Report**

**Tim Borg, P.E.  
Project Manager**

**State of Oklahoma  
Department of Transportation  
Research & Development Division**

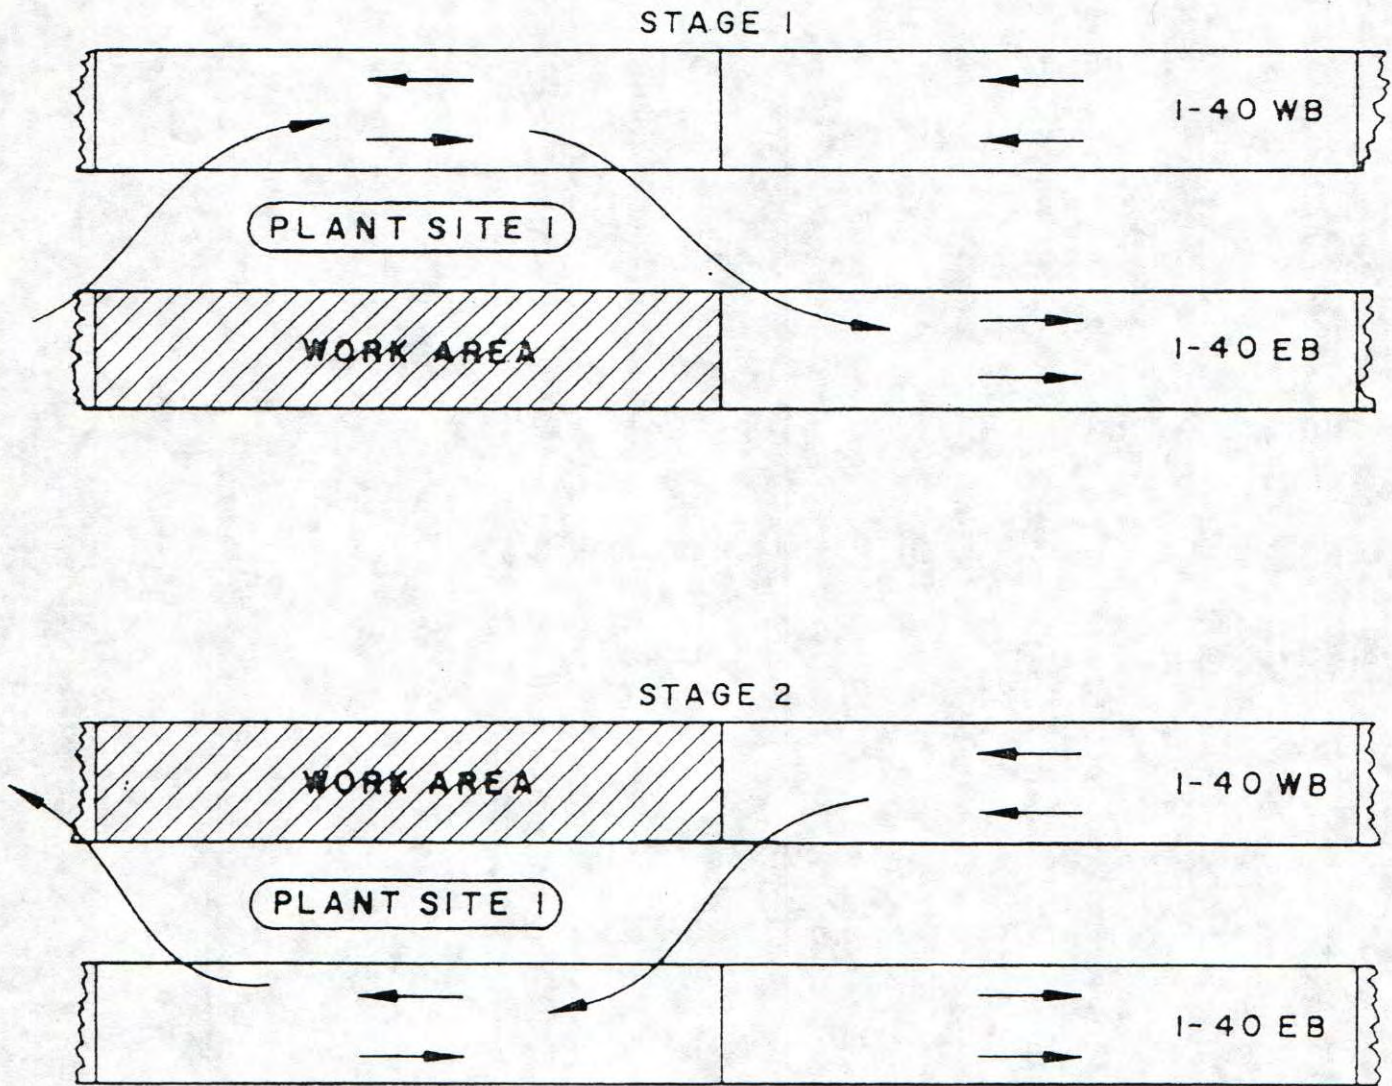
Figure 5. Staging of the West Half of the Project.

midday by the delivery of materials to the concrete batch plant. At the first plant site, where the median was not nearly as wide as the second site, delivery trucks frequently stopped on the two-way, two lane detour trying to gain access to the plant. At one point, the Research Division project manager observed a massive traffic jam consisting of: dump trucks returning on the detour to the batch plant for more loads of concrete, and large trucks delivering semi-trailer loads of sand, bulk Portland cement, bulk fly ash and coarse aggregate.

The traffic jam observed that day at the first plant was not an isolated, infrequent event. Apparently, the contractor made no attempt to coordinate the delivery of materials or to avoid the afternoon rush hour.

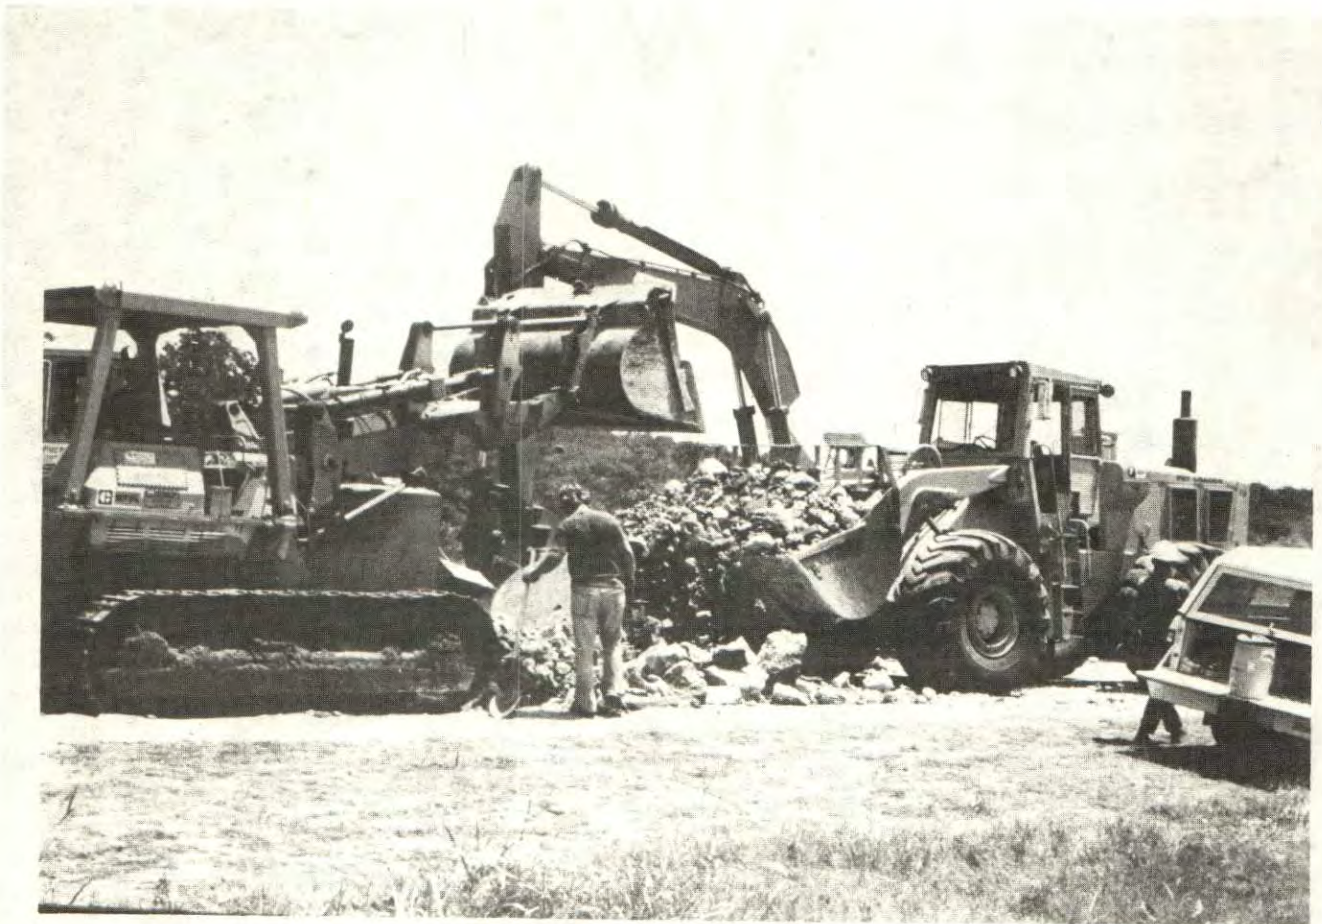
Figure 7. Loading the Rubble

With the pavement broken, a crawler loader lifted the rubble into the waiting bucket of a wheeled loader. The more maneuverable wheel loader then placed the rubble into the dump beds of waiting haul trucks. To reduce the amount of soil asphalt being picked up by the loader, the crawler made two passes on the rubble with a ripper to dislodge the matrix. A more efficient production resulted when a back-hoe used a ripper tooth (called a "rhino horn") in place of a bucket. The back-hoe worked between the loaders providing a continuous supply of loosened rubble. The back-hoe also could move broken pavement away from the soil cement shoulder with less damage to the shoulders than the crawler could alone.
