# STATE HIGHWAY 9 WILDLIFE CROSSINGS MONITORING – YEAR 2 PROGRESS REPORT

*December 2015 through April 2017*

March 2018

Report to the Colorado Department of Transportation  
Applied Research and Innovation Branch

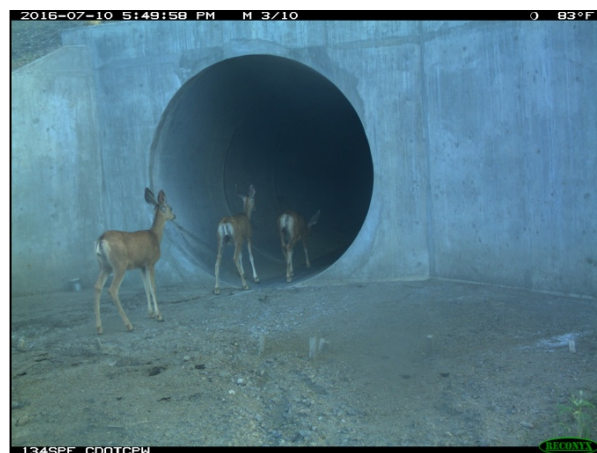
Figure 14. Unusual movement by a group of three mule deer making a success movement through the BVR Pipe Culvert.

Wildlife activity at these small culvert locations occurred primarily during the non-winter months. Mule deer were documented at all three sites and a success movement was made on one occasion by a group of three deer through the BVR Pipe Culvert after much investigation and multiple attempts (Fig. 14). White-tailed deer visited the Culbreath Box Culvert site, although no attempts to pass through the culvert were observed.

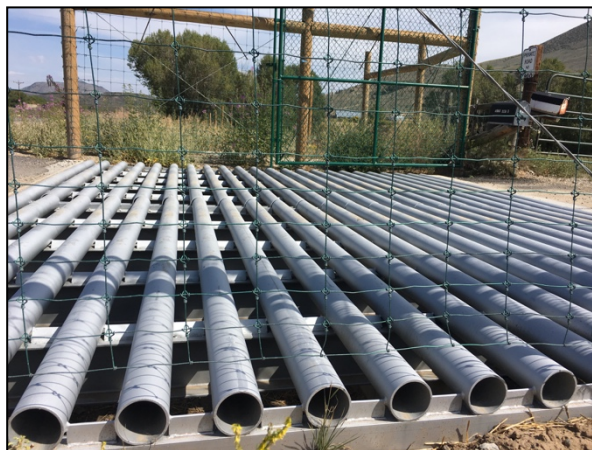
*Figure 16. Round bar deer guard design installed at select locations during Phase 2 construction.*

Snow plow damage has occurred at several of the flat bar guard locations. The round bar guards appear less susceptible to this type of damage. In addition, the flat bar design was more likely to get snow packed in between the bars during plowing, resulting in a continuous surface which can be more easily breached, as the photographic data displayed.

- **Deer guards.** Deer breaches observed in Phase 1 were hypothesized to be the result of 1) deer being able to easily walk on the flat bars, and 2) snow getting trapped between the flat bars and creating a packed surface for deer to walk across. As a result, CDOT developed a round bar guard design that was installed at three locations in Phase 2 and was used to replace the flat bar guards at two locations in Phase 1. Beginning in fall

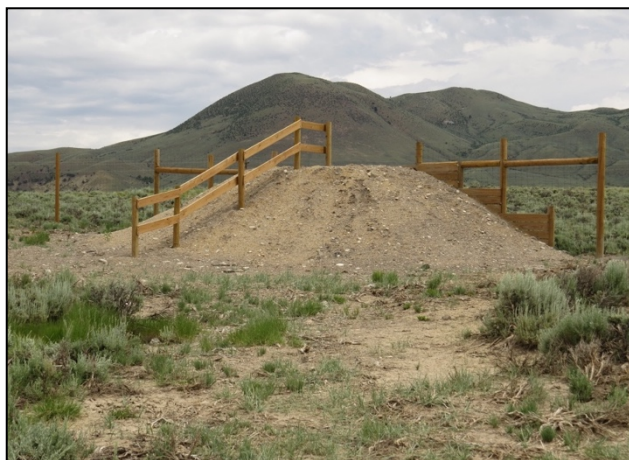
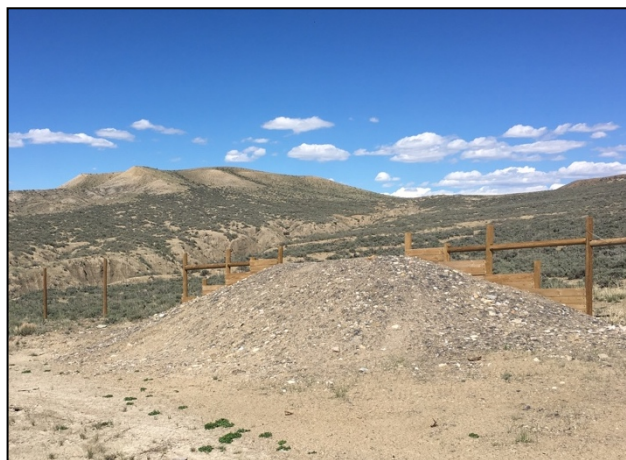
*Figure 17.* Examples of escape ramp with 2:1 slope and rail fence (left) and 3:1 slope with no rail fence (right).

To date, twelve escape ramps have been monitored for varying lengths of time. In the Phase 1 (north) segment, all ramps were constructed with a 2:1 slope and perpendicular rail fence, except for the North Overpass Escape Ramp, on which rail fence was not constructed. Based on preliminary observations and recommendations by the research team, during Phase 2 construction all ramps were constructed with a 3:1 slope instead of a 2:1 slope (Fig. 17). In general, ramps were constructed with perpendicular rail fence, except for select locations where rail fence was omitted per the request of the researchers, who wanted to test the effectiveness of ramps with and without perpendicular rail fence. In addition, two new 3:1 slope escape ramps were constructed in the Phase 1 segment near existing 2:1 slope ramps. These two ramps are also situated at lower topographic positions relative to the roadway, while the 2:1 slope ramps are at

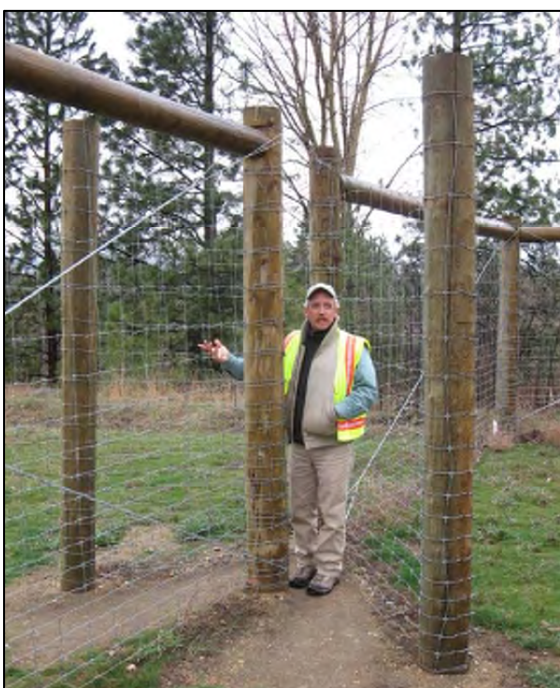
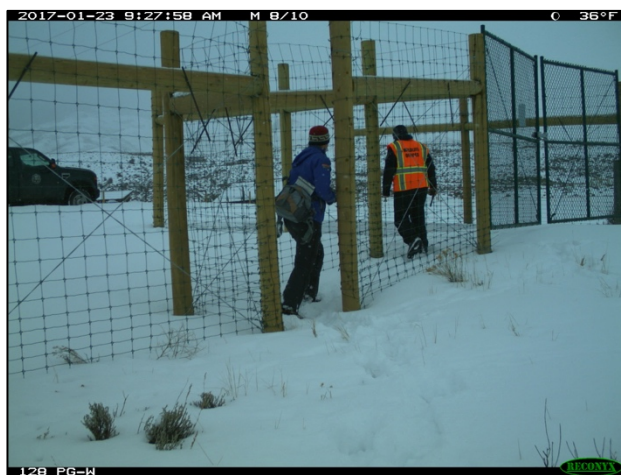
*Figure 18. a) Y-shaped pedestrian gate design used in Montana (left, photo credit: M. Huijser); b) modified right-angle design used by CDOT (above).*

The purpose of the pedestrian walk-through gates is to allow people to cross through the fence line without use of a gate or ladder. The design of the gate should allow people to walk through a series of sharp angles in the fencing while precluding wildlife, in particular ungulates. The pedestrian walk-through gates used for the SH 9 project are derived from the Y-shape design used by the Montana Department of Transportation (Fig. 18a). Because the wildlife fence follows the CDOT right-of-way, the Y-shape would have infringed on the adjacent lands. To preclude issues with landowners, CDOT created a modified right-angle design (Fig. 18b).
