Project 3.16: CT Bridge Girder Sections with Precast Decks and FRP Girder-Deck Shear Connectors

Final Report April 2024

Department of Civil and Environmental Engineering
University of Maine

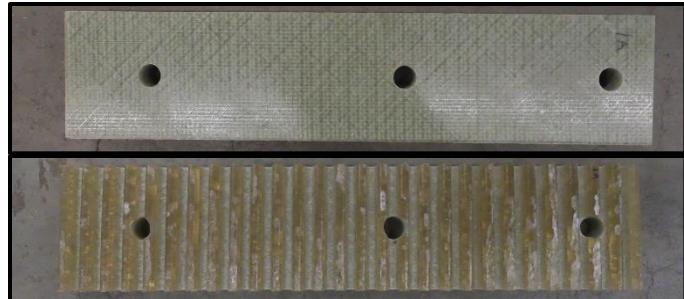
Figure 2-3: Plate 1A Back (Top), Ridges (Bottom)

Once the FRP plates were cut to final dimension, the specimens were assembled in their molds and all gaps filled with silicone. The shear-plates were arranged such that 22 in. of ridges would be cast into the concrete per shear-plate. The specimens were then sent to American Concrete, a local precaster, for pouring using a standard concrete mix frequently specified by the Maine Department of Transportation for structures. Of the five specimens, three were meant to be tested in fatigue with the remaining two remaining un-fatigued for control. The shear-plates were given the designation code "XY", where "X" denotes the shear block number and "Y" is denoted either A or B to differentiate the plates on either side. Figure 2-3 shows the back side and ridges of plate 1A. Included in Appendix A is the shear-plate ridge quality.

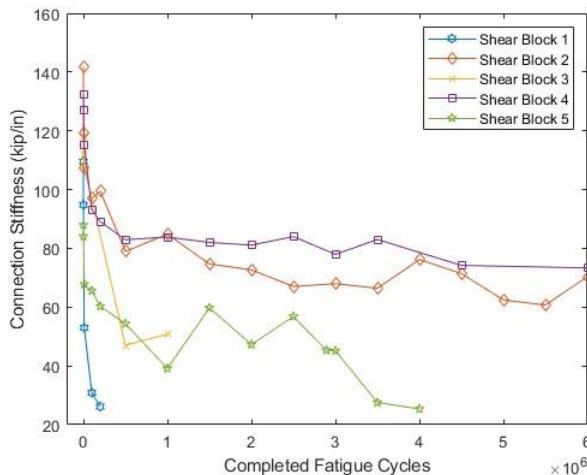
Figure 2-5: Stiffness Testing

The results of the periodic stiffness tests performed during fatigue testing are shown in Figure 2-5. To measure the connection stiffness, the displacement values used are the average slip values measured by the sensors against the starting displacements of the stiffness test. This is unlike the accumulated slip values used elsewhere where the slip is relative to the initial displacements of fatigue cycle 1. A linear-least squares fit of the load-slip curve was used to determine the slope of the periodic stiffness test curves, and therefore the periodic stiffnesses.

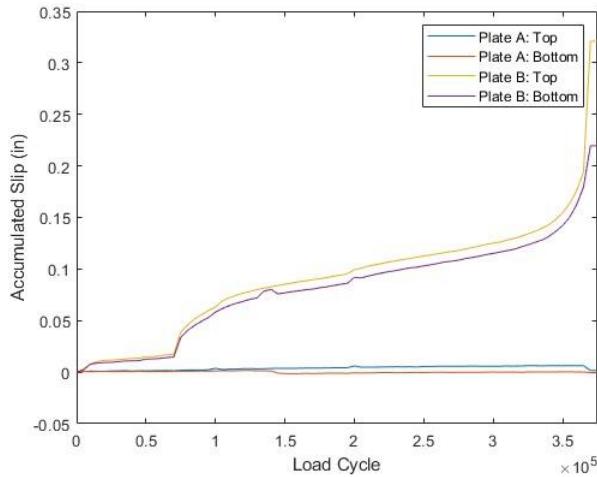
Figure 2-8: Shear Block 1 Accumulated Slip Vs Load

Accumulated slip is the difference in initial slip between each load cycle and the first load cycle. Slip is the relative displacement of the shear-plate to the concrete block. Therefore, increasing accumulated slip values means the shear-plate is displacing relative to the concrete block because of each cycle, and is not an indication of intracycle slip increasing. Constant slip values indicate the connection is enduring the applied loads. Figure 2-8 shows the failed shear-plate's accumulated slip increasing throughout testing with rapid increases around 75,000 and 350,000

The rapid increases of accumulated slip in Figure 2-8 suggest damage occurring, as opposed to gradual increases indicating general wear in the connection. As it will be seen with future shear blocks, the first increase in slip to 0.01 in. is nearly double the maximum slip of the shear blocks that completed fatigue testing. This may have been caused by the FRP nut cracking since the nut restrains the plate from moving but does not carry the shear loads. Therefore, it could incur damage resulting in an increase in slip without the shear block completely failing. Furthermore, it likely is not a result of the concrete ridges shearing, as they are better explained by the second exponential increase in slip. Assuming the shear-plate was no longer restrained as intended, the ridges between the shear-plate and concrete had opportunity for partial contact. This may have deteriorated the ridges, sequentially shearing them off faster as less were available to carry the fatigue loads.

A probable root cause for the premature failure is a missing cross brace between the shear-plates of shear block 1. The cross brace is a steel threaded rod that is intended to prevent unintended eccentric loads from horizontally loading the shear-plates, causing the shear-plates to pry on the other shear connection elements. This prying could fatigue load these components in a way they were not designed for. Figure 2-9 shows a shear block with a cross brace and shear block 1 without its cross brace. Lastly, the low ridge quality of shear block 1, given in Appendix A, may have contributed to the premature failure by further reducing the contact of the ridges.

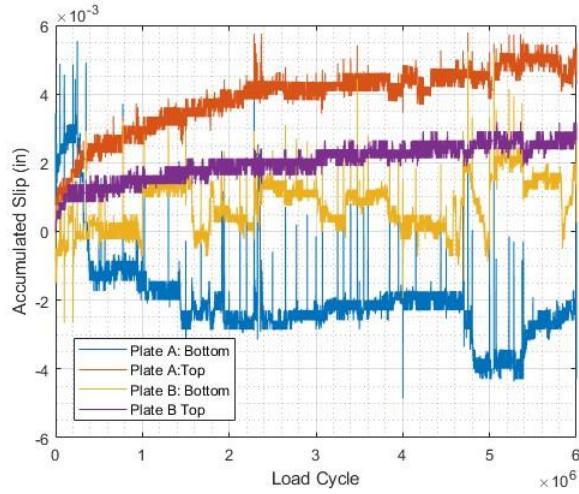
Figure 2-10: Shear block 2 Accumulated Slip Vs Load Cycle

Shear block 2 completed its six million fatigue cycles without failing. Figure shows the accumulated slip as a function of load cycle. The accumulated slip increasing indicates the connection displaced from its initial position at the start of fatigue testing. An initial increase during the first million cycles, followed by a gradual increase, as shown in Figure 2-10 are typical of previous shear block testing. However, the negative slips in the bottom of plate A are not expected behavior. A negative slip indicates the linear position sensor read smaller displacements over the course of testing.

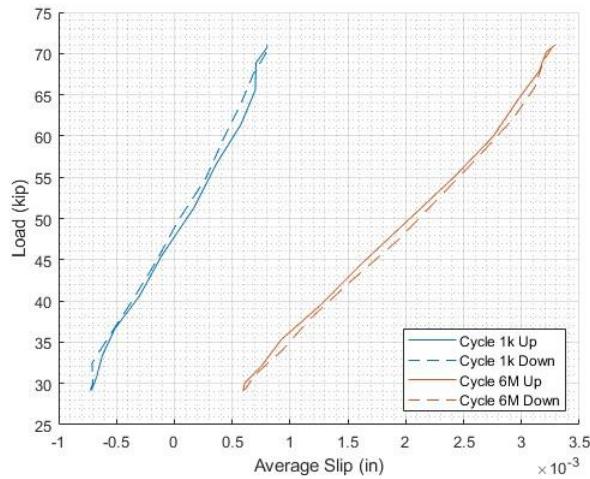
Figure 2-11: Shear Block 2 Average Slip Vs Load

Figure 2-11 presents the average slip from the four sensors recorded during the 1,000th and 6,000,000th load cycles, showing the effects of load and duration on the recorded slip. The horizontal shift from left to right from the curve at 1,000 cycles to 6,000,000 shows the accumulation of permeant slip during testing. A clockwise rotation in the later curve indicates a decrease in the connection's stiffness, leading to a larger slip at the same load. Lastly, it can be observed from the minimal difference between the loading and unloading branches that there is little hysteresis in the system in either load cycle. This implies that only a small amount of intracycle damage was accumulated.

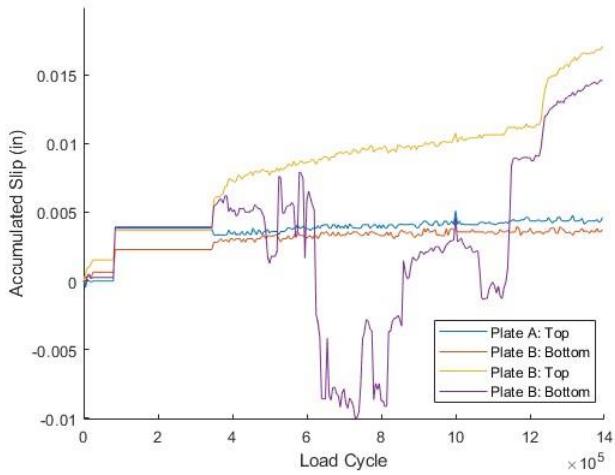
Figure 2-14: Shear Block 3 Accumulated Slip Vs Load Cycle

Figure 2-14 shows the accumulated slip as a function of load cycle for shear block 3. Increase in accumulated slip indicate displacement in the connection relative to its initial position. The flat lines in the data are a result of missing or corrupted data. During the missing data cycles, the accumulated slip appears to gradually increase as expected. After the missing data ends, the slips recorded in plate A remain relatively constant while plate B continues to increase. The erratic jumps in slip recorded at the bottom of plate B appear to be random, indicating the data from the bottom of plate B may be false readings.

Shear block 3 likely failed due to a load spike caused by a malfunction of the Instron controller. Despite the premature failure however, it is possible that the shear block would have failed prematurely during fatigue testing. Both the accumulated slip and stiffness of shear block 3 exceeded those of the specimens that completed 6 million fatigue cycles. Figure 2-114 shows the accumulated slip in shear-plate B near failure reached 0.015 in., three time that of shear block 2. Additionally, the stiffness of shear block 3 was already half that of shear blocks 2 and 4 at one million fatigue cycles as shown in Figure 2-5. Notably, a bend occurred in shear-plate A, which is unique to this shear block. This may be a result of combined bending and buckling in the plate. As plate B failed, the cross braced was pulled with it, applying a lateral bending force on plate A. Additionally, as the plate bent it was compressed as well, increasing the moment, and potentially buckling the plate as well.

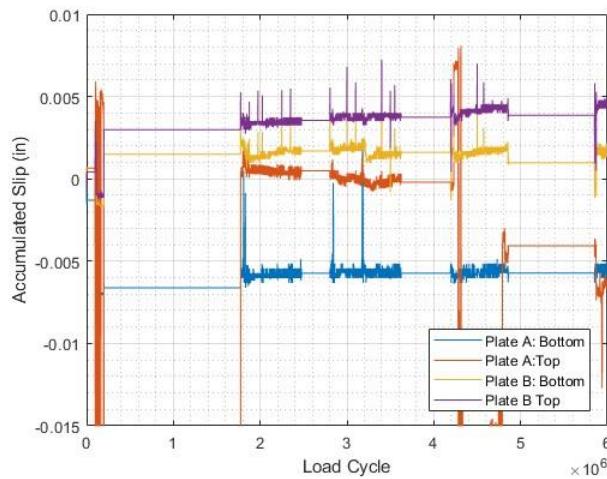
Figure 2-15: Shear Block 4 Slip Data

Shear block 4 completed six million fatigue cycles. Figure 2-15 shows the accumulated slips of the shear block as a function of completed cycles, where increases in accumulated slips indicate an increase in displacement between shear-plates and concrete. This shear block has several locations of corrupt data shown as flat lines. The sensor corresponding to the top of shear-plate A spikes in magnitude several times. Due to spikes in slip from the sensor at the top of plate A, the Y-axis of the plot has been cropped to better show the magnitudes of the remaining sensors' slip data.

The slip recorded by the sensor corresponding with plate A's top spiked in magnitude several times throughout fatigue testing. Since the other sensors did not record similar behavior, it is likely that unusable data was produced by the sensor. Therefore, this sensor was ignored when calculating the stiffness presented in Figure and the average slips presented in Figure 2-16. Much of the recorded data were corrupt, as seen by the horizontal lines in Figure 2-15. However, shear block 4 still shares the trends and magnitudes of accumulated and average slip with shear block 2 which also completed fatigue testing.

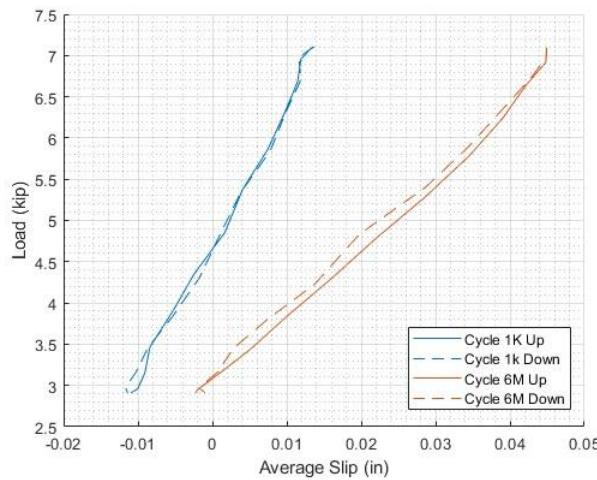
Figure 2-16: Shear Block 4 Average Slip Vs Load

Figure 2-16 shows the load-slip response of shear block 4 at 1,000 and 6,000,000 completed fatigue cycles. Since the sensor corresponding to plate A's top had noticeably larger magnitudes than the other sensors, and displayed erratic data trends, it was removed from the calculated average slip. The figure shows how the load-slip response of the shear block changed over the course of testing. This reveals accumulated slip through a horizontal shift in the curve, and a decrease in stiffness through a clockwise rotation.

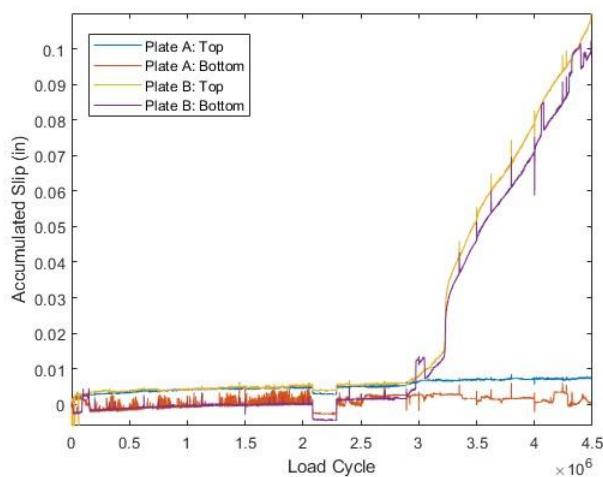
Figure 2-18: Shear Block 5 Accumulated Slip Vs Load Cycle

Shear block 5 completed 4.5 million cycles before the side of plate B unexpectedly failed as shown in Figure 2-17. Like shear blocks 1 and 3, the concrete ridges, bottom FRP nut, and Gbar shear connector had failed. Figure 2-18 shows the accumulated slips between the shear-plate and concrete block of the shear block over the test duration. These accumulated slips remained relatively constant for the first three million load cycles. After this, the slip in plate B began to increase rapidly, failing with 0.1 in. of accumulated slip. Figure 2-19 shows the average slip-load response of the shear block at 1,000 cycles and at 4.5 million complete cycles. Since the horizontal displacement between the curves is the difference in accumulated slip between the two cycles, the X-axis scale is relatively large for showing the slips within each load cycle. Additionally, the distance between these two curves is about 0.055 in. and not 0.1 in. since these curves average the slips of both sides of the shear block together.

Fatigue testing of shear block 5 was paused for four weeks during actuator maintenance after nearly 2.9 million fatigue cycles had been applied. During this time care was taken to minimize disturbance to the specimen, although it needed to be removed from the load frame to prevent damage. After completion of maintenance and restarting the test, block 5 failed around 1.7 million additional fatigue cycles later. When fatigue testing of shear block 5 resumed the accumulated slip in Figure 2-1 increased and the stiffness in Figure 2-5 decreased. This correlation suggests that the specimen's premature failure may have been impacted by the pause in testing, despite of the care implemented to minimize disturbance to the block during this pause. It is possible that the specimen could have been inappropriately moved or struck, causing damage. However, such damage is not likely considering no damage has occurred to date because of movement. Furthermore, an invasive procedure has previously been performed to remove shear-plates from shear blocks prior to testing in [7] without causing any issues. Therefore, it cannot be concluded that damage incurred during the pause caused a premature failure.

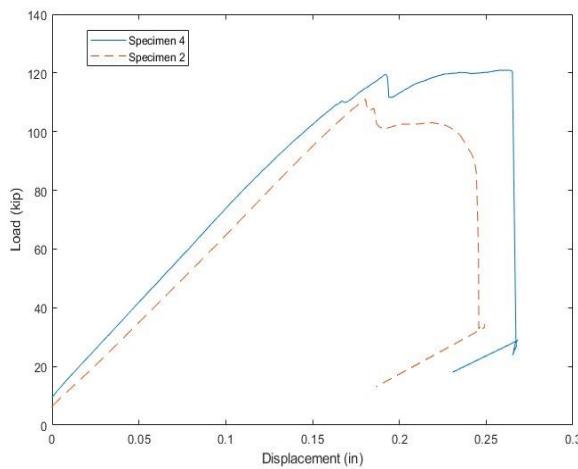
Figure 2-22: Strength Testing

Figure 2-22 shows the force displacement data recorded from the Instron during the strength testing of shear blocks 2 and 4. The curves are approximately linear until the first load drop, indicating elastic deformation in the shear blocks. After the peak, the load plateaus before rapidly dropping, and the failure was generally brittle.

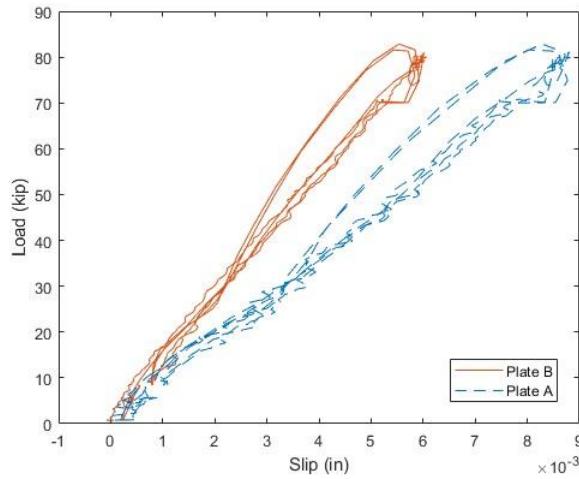
Figure 2-23: Shear Block 2 Pre-Failure Stiffness Testing

Figure 2-23 shows the resulting load-slip plot for shear block 2. The slip data are an average of the slip in each of the four DIC marker pairs. The corresponding load-slips curves behaved linearly while loading, but form “humps” while unloading. These may be a result of the actuator overshooting the intended loading, requiring operator intervention to manually unload the shear block each time. This is unexpected as shear block 2 was tested using the same programming that stiffness and strength tested shear block 4 already. Lastly, the figure shows that plate A has a lower stiffness than Plate B. This matches the general slip trends between Plate A and Plate B previously shown in Figure 2-10.
