COLORADO
Department of Transportation

CDOT Office of Applied Research

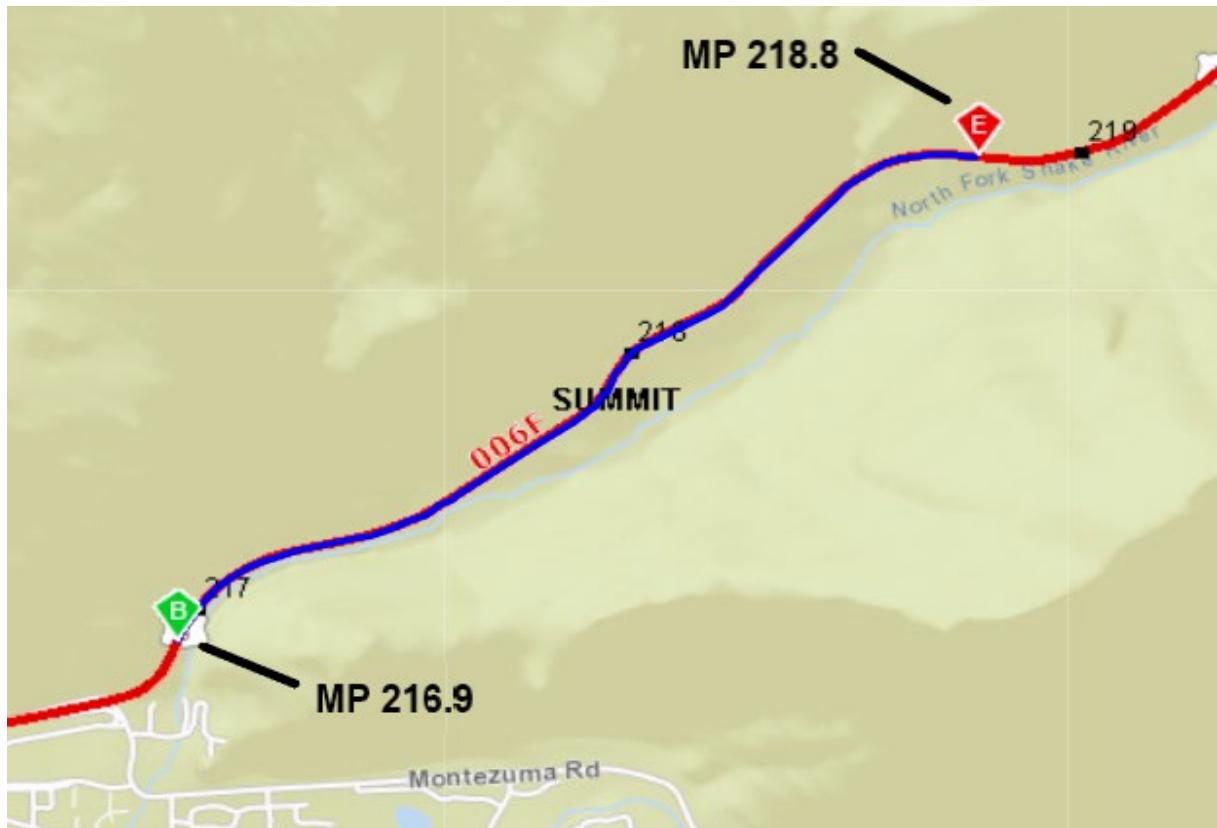
Figure 4-6: WB Commercial Vehicle Crashes, US6 MP 216.75-221.25, 2013-2022

The commercial vehicle crashes occurred at MP 216.90 and MP 218.80 (**Figure 4-6**). Both of these locations are characterized by being preceded by curves (**Figure 4-7** and **Figure 4-8**). For

There are no discernable patterns to the two recorded commercial vehicle crashes on the study corridor. Given that the truck escape ramp is located at MP 218.80, it could be reasonably concluded that at least one of these crashes could have utilized the escape ramp. Although it is impossible to identify a pattern with only one crash, given that the driver was unfamiliar with the area, the failure to utilize the runaway truck ramp might point to inadequacies in the advance notice given to truck operators in the westbound direction of the presence and location of the ramp.

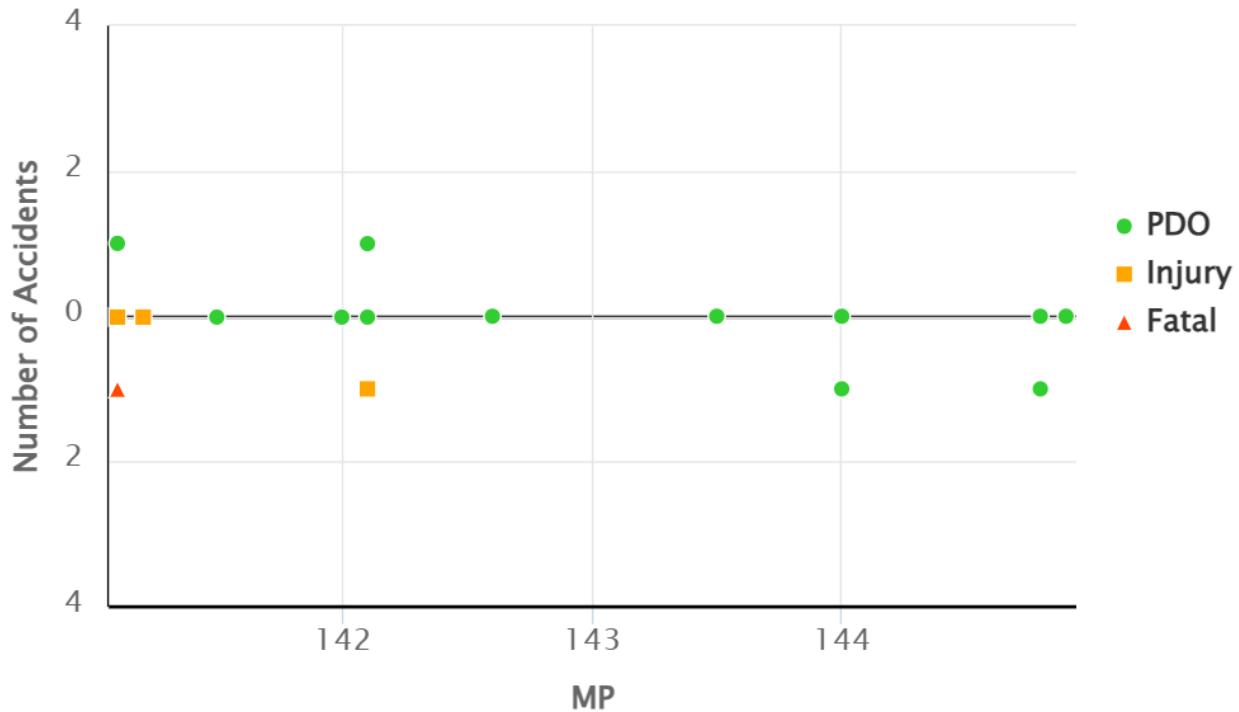
Figure 4-13: Truck Crash Locations, WB US40 MP 145-141

There were 16 recorded commercial vehicle crashes on westbound US-40 between MP 145 and MP 141 in the 10-year study period. This included 1 Fatal crash, with 1 fatality, 3 Injury level crashes, with 3 people injured and 12 Property Damage Only (PDO) crashes. **Figure 4-13** shows the location of crashes involving commercial vehicles (trucks) on the westbound study corridor.

Figure 4-13 shows that most crashes occurred prior to or at the truck escape ramp (MP 142). However, it also indicates that there were severe (injury+fatal), crashes recorded beyond the escape ramp near or at MP 141. **Figure 4-14** shows that there are two curves immediately following the one at MP 142. The first that drivers would encounter is less severe (MP 141.5), while the second is another sharp curve (MP 141.25) (see **Figure 4-15**). Both curves are also on a downgrade.

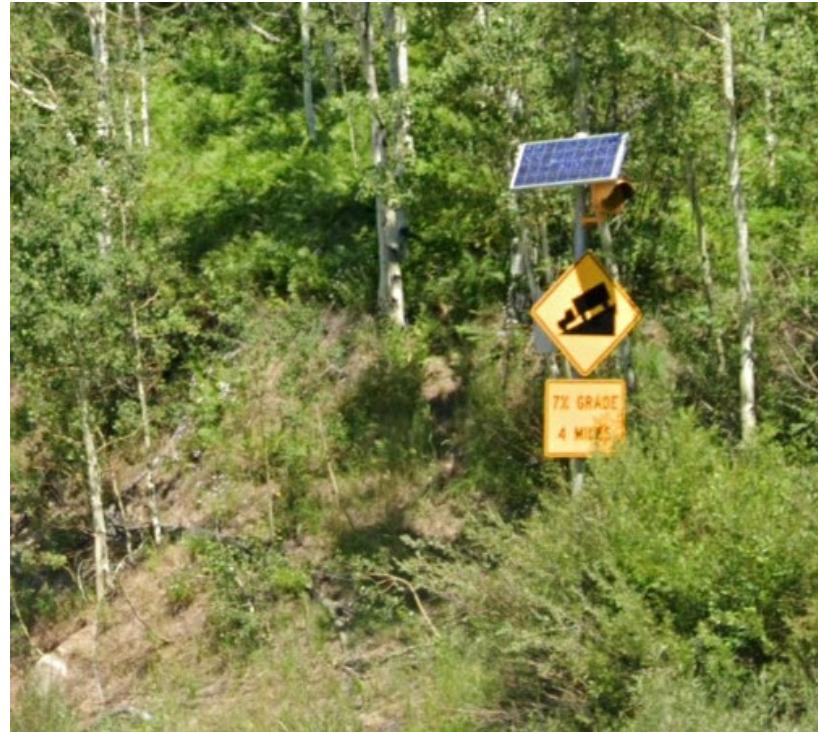
Figure 4-21: Steep Grade Warning, MP 143.02

Trucks are warned of a steep 7% grade from MP 143.02, approximately, for 4 miles (Figure 4-21).

Imagery indicates that these signs may be prone to becoming obstructed by foliage seasonally (**Figure 4-21** and **Figure 4-26**). As such, CDOT is advised to perform regular maintenance to ensure adequate visibility of signage, particularly to benefit the out-of-town and nighttime truck operator.

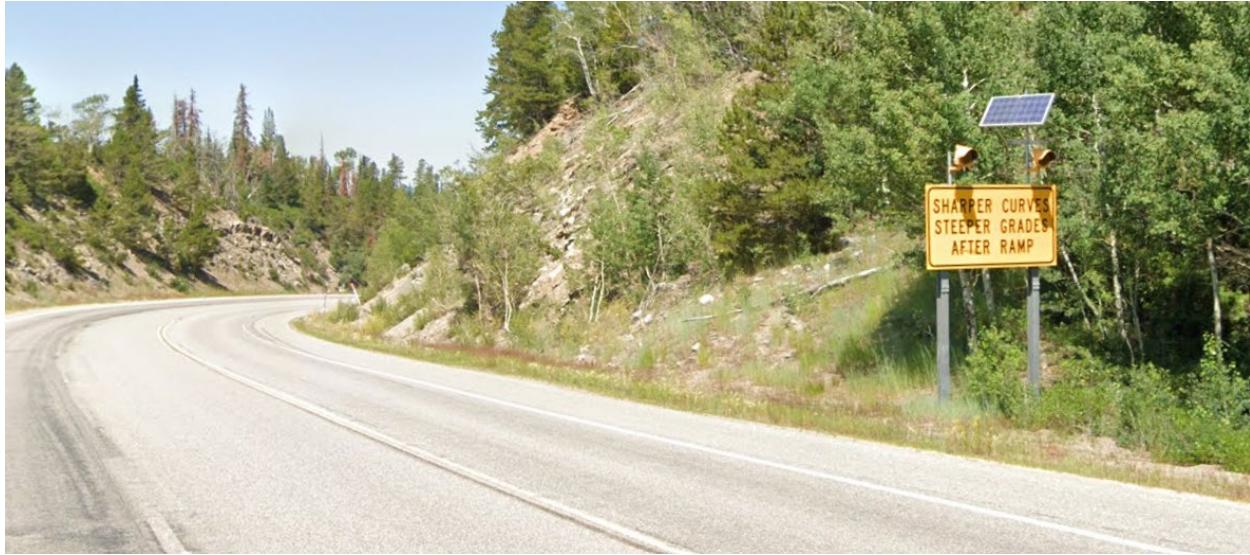
Figure 4-23: Curve & Grade Warning, MP 142.80

When all of these crashes are considered as a whole, it is clear that driver inexperience and unfamiliarity with the area, which can be exacerbated by poorly lit conditions, are contributing to the run-off-the-road truck crashes on the study corridor. The geometry and alignment of the corridor appears to be a major contributing factor also. Furthermore, it must be considered why run-off-the-road crashes occur beyond the escape ramp, when several of the crashes which occurred could have potentially utilized the ramp. Particularly, as there is an advance warning sign that curves and grades are sharper beyond the ramp (**Figure 4-23**).

As outlined earlier, there is a warning sign aimed at truck drivers in advance of the escape ramp, at approximately MP 142.80, which indicates that alignment and grade become even less favorable beyond the ramp (Figure 4-23).

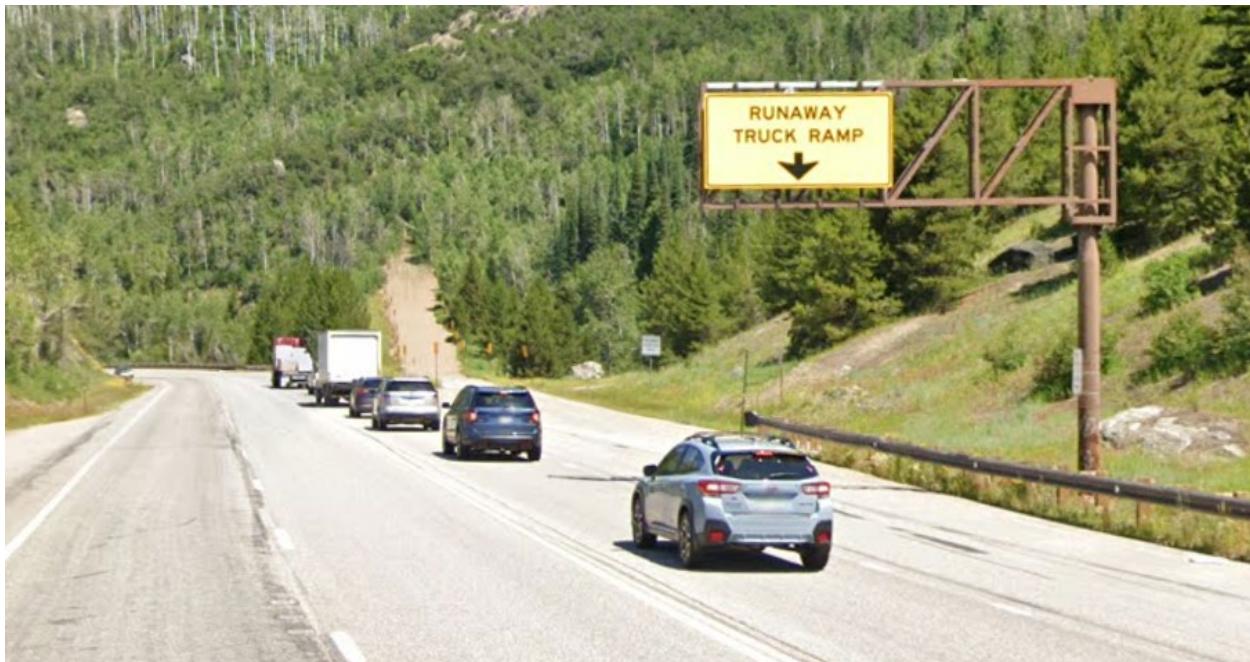
Figure 4-25: Truck Escape Ramp Entrance Sign, MP 142.25

The entrance sign for the truck escape ramp does not itself have flashing beacons (**Figure 4-25**).

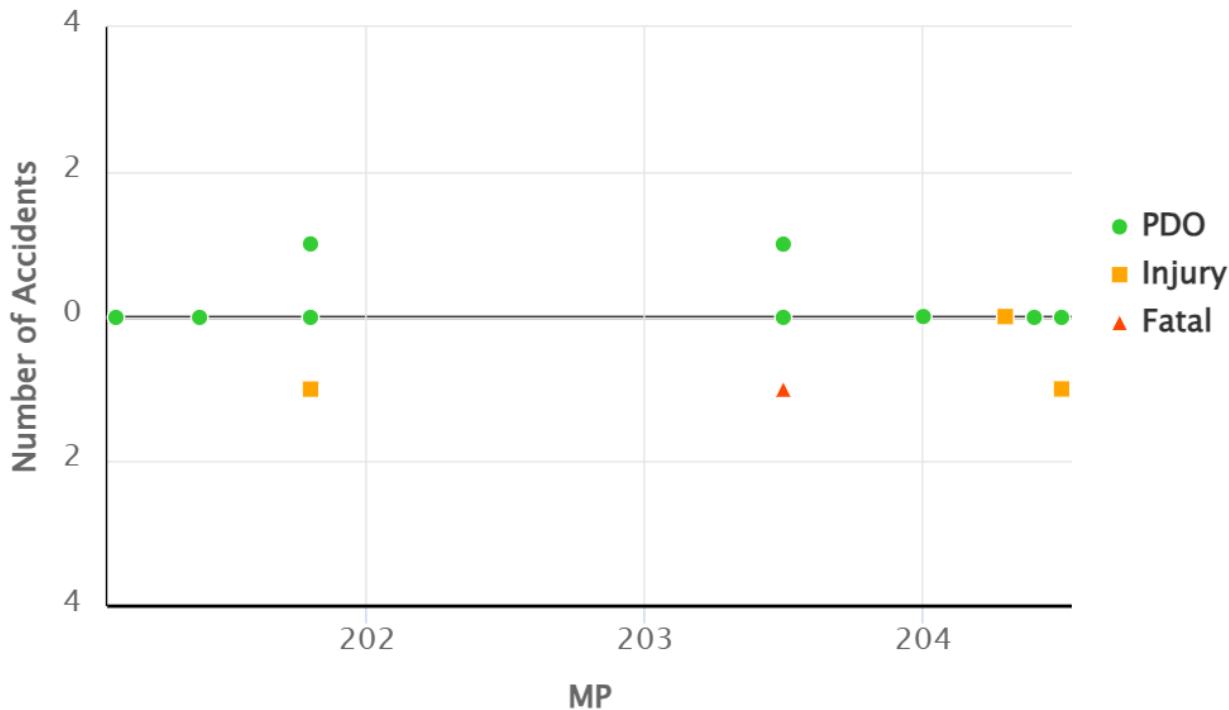
Figure 4-33: EB Commercial Vehicle Crash Locations, US 50

Figure 4-33 shows the location of commercial vehicle crashes within the study segment. Apart from 1 injury crash which occurred at MP 201.80, most severe (injury+fatal) commercial vehicle crashes occurred within $\frac{1}{2}$ mile either side of the truck escape ramp.

- The fatal crash occurred on 9/19/2020 at MP 203.50 and was an Overturning crash. The crash records show that the crash resulted from brake failure combined with the driver's inability to negotiate a curve. The crash occurred under dark conditions. Records show that the driver was also unfamiliar with the area. The crash records also indicate that the driver struck the guardrail before overturning, which is reflective of the Guardrail pattern seen on the study corridor. In this case the driver ran off the road before the truck could reach the escape ramp, approximately $\frac{1}{2}$ mile further down the corridor.

- The injury level crash at MP 204.30 was an Overturning crash which occurred on adverse road conditions during winter weather, the driver was preoccupied, and records indicate the driver lost control on a curve.

- The injury crash at MP 204.50 was a run-off-the-road collision with a sign, occurring in wet and dark conditions, the driver was unfamiliar with the area, and crash records indicate that the driver failed to manipulate the curve.

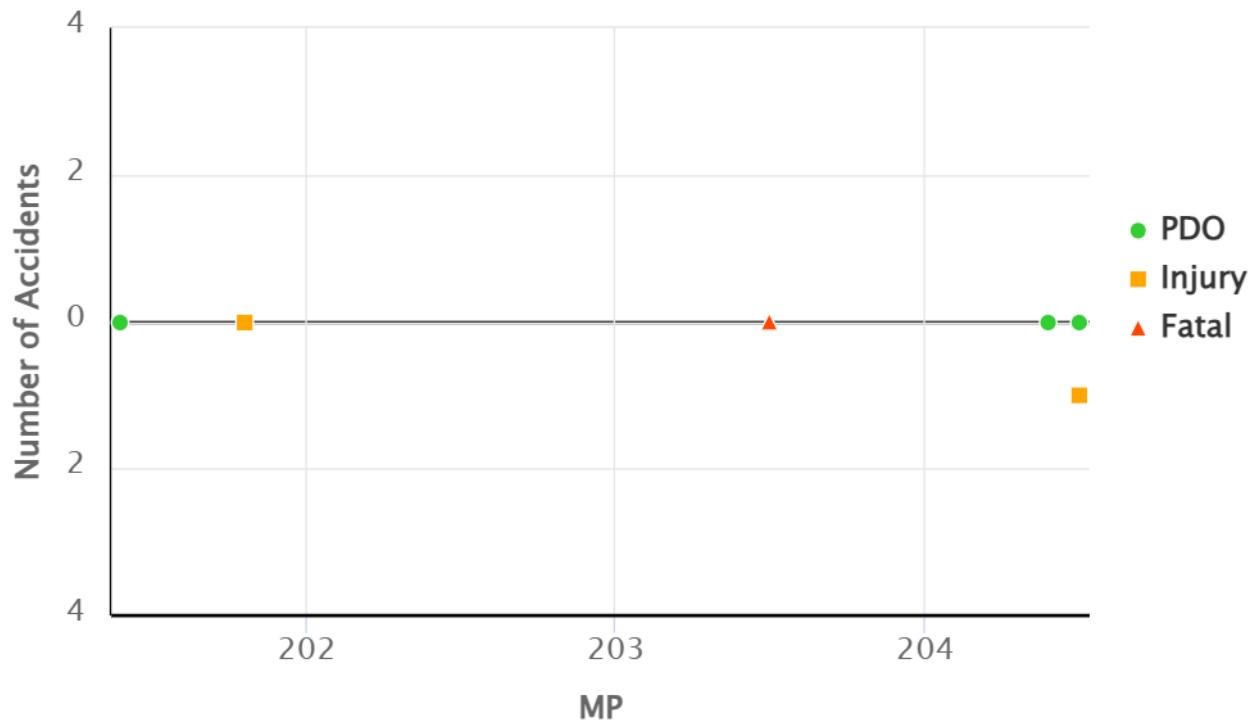
Figure 4-38: EB Off-Road Commercial Vehicle Crash Locations

Records show that just under half of truck crashes were off-road crashes (6 of 13). **Figure 4-38** shows that off-road crashes did not occur at the location of the truck escape ramp but rather appear to show a cluster beyond it at the curve near the town of Monarch at MP 204.50.

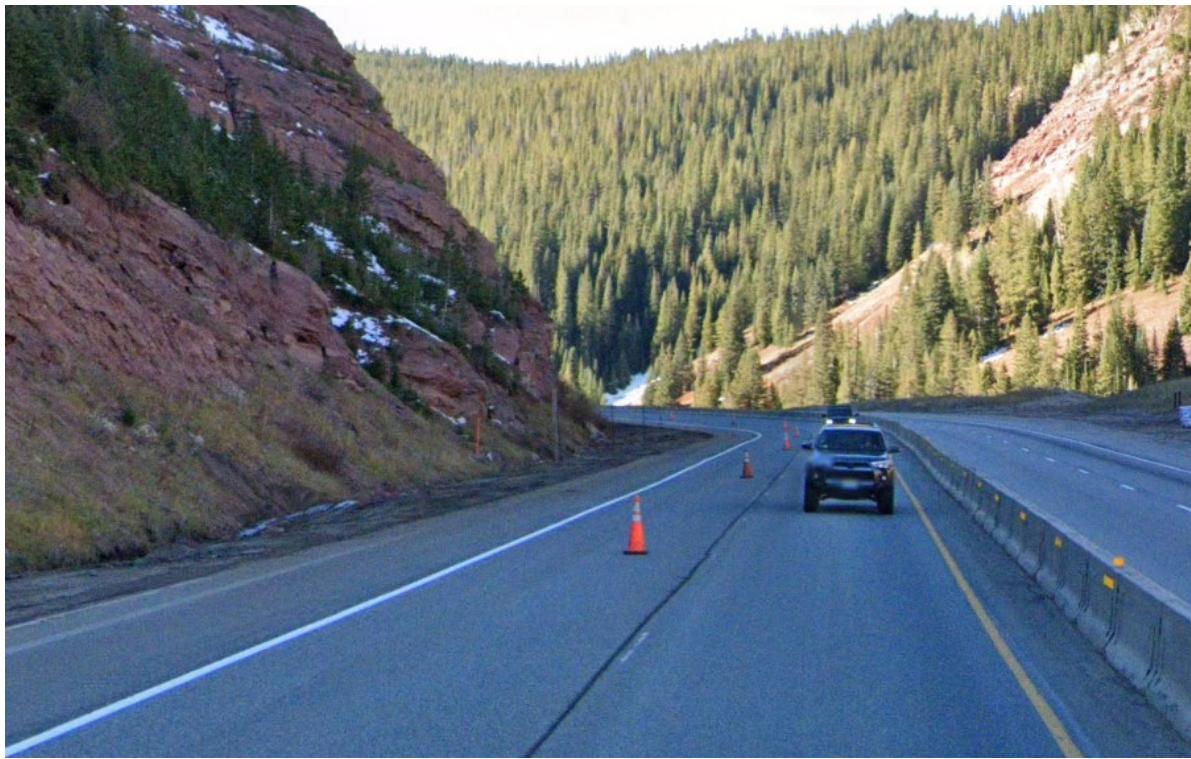
Figure 4-49: WB I-70 near MP 186 (facing East), Sharp Curve on Grade, Oct. 2023

crashes were recorded near MP 186, just following a sharp right curve on grade (**Figure 4-49**). The upper escape ramp is located near MP 185.72. Most of the injury level truck crashes occurred around the upper truck escape ramp. This might be reflective of the more pronounced curve in advance of the upper ramp, compared to the less severe curve prior to the lower ramp (see **Figure 4-42**).

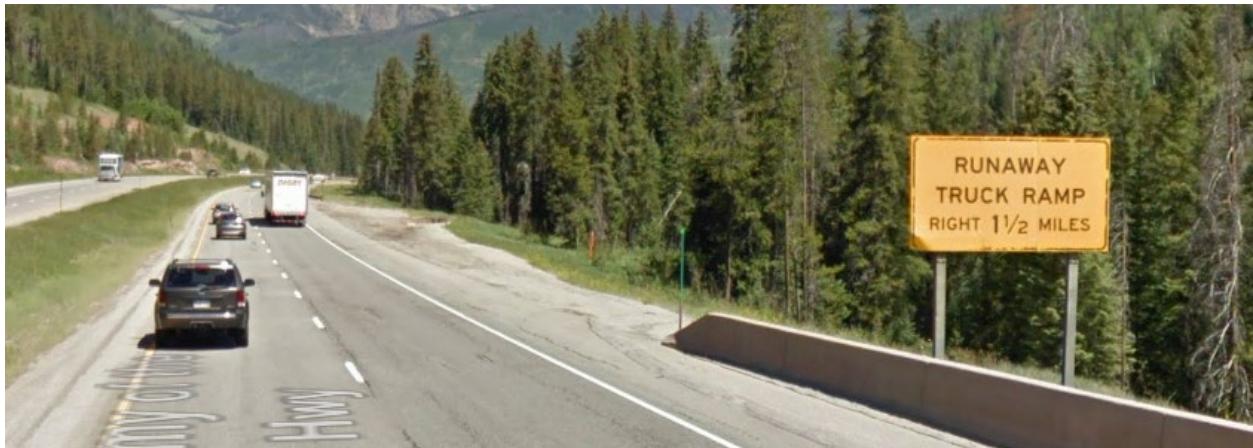
Figure 4-50: WB I-70 MP 183.72 Escape Ramp Advance Warning (Bold), Jun. 2018

There is an advance warning sign for the Lower escape ramp near MP 183.72 indicating it is located 1.5 miles downstream, but the text indicating the distance has been faded since sometime between June 2018 (**Figure 4-50**) and December 2018 (**Figure 4-51**). There is a 1-mile advance warning near MP 183.24 and another warning near MP 182.66 indicating the ramp is 2,000 feet downstream. The Lower ramp is located at approximately MP 182.36.

The failure to utilize the runaway truck ramp in a couple of instances listed above might point to inadequacies in the advance notice given to truck operators in the westbound direction of the presence and location of the ramps. It is recommended that CDOT replace the text on the advance warning signs related to the distance to the truck escape ramps on the westbound corridor to ensure it is bold and clearly legible. Additionally, CDOT should repair the supplementary distance plaque on the grade warning sign near MP 184.15 so that it faces drivers straight on.

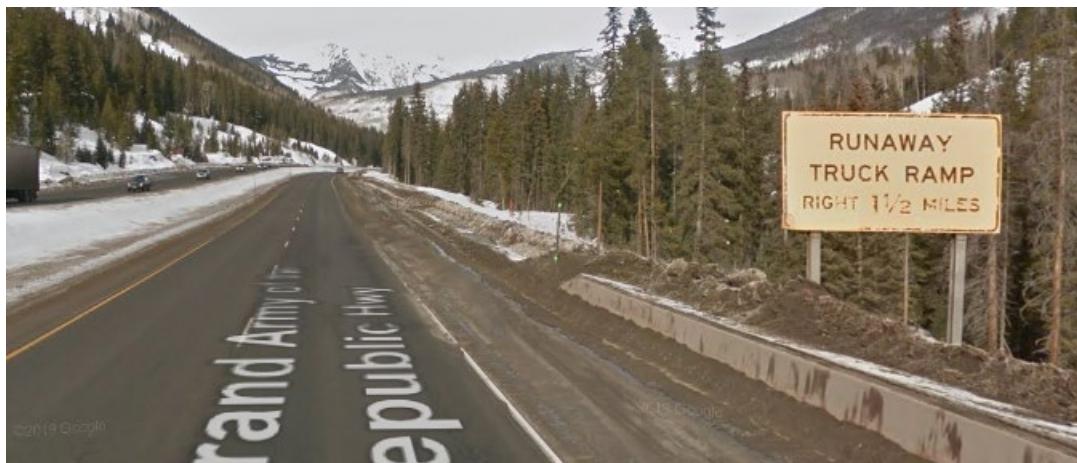
Figure 4-51: WB I-70 MP 183.72 Escape Ramp Advance Warning (Faded), Dec. 2018

2. On 3/17/21 near MP 183.80 a truck suffered brake failure and continued for approximately 1,000 feet before driving off the right side of the road due to slow moving traffic in front. It continued on the right shoulder for 575 feet before overturning down an embankment. Driver inexperience was a factor. This was an Injury level crash occurring on a wet road at a curve-on-grade. There is an advance warning sign for the Lower truck escape ramp near MP 183.72, however, as stated in the narrative the driver was inexperienced and may not have known how best to navigate the traffic ahead to access the escape ramp a mere 1.5 miles downstream. At the same time, a review of Google Streetview imagery shows that the text on the advance warning sign near MP 183.72 appears to have become faded between June 2018 and December 2018 and is currently faded (see **Figure 4-50**, **Figure 4-51** and **Figure 4-52**). This makes it difficult for drivers to determine exactly the distance to the ramp. This crash having occurred in 2021 was in the time frame when the sign was faded. This is an incidence in which the Lower escape

ramp could have potentially been used but a combination of driver inexperience and inadequate signing may have contributed to it not having been.

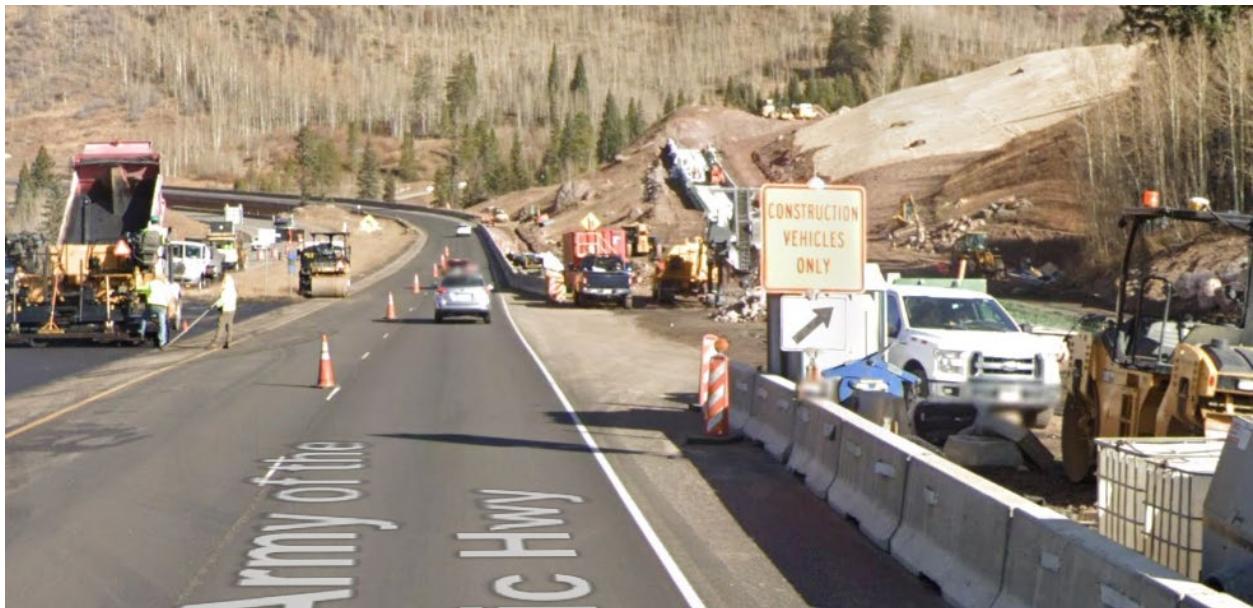
Figure 4-55: Lower Truck Escape Ramp, Reconstruction Oct. 2021

Figure 4-55 shows that in late 2021 reconstruction and reconfiguration of the Lower escape ramp took place, perhaps due to the occasions of trucks departing the arrester beds when utilizing the ramp.

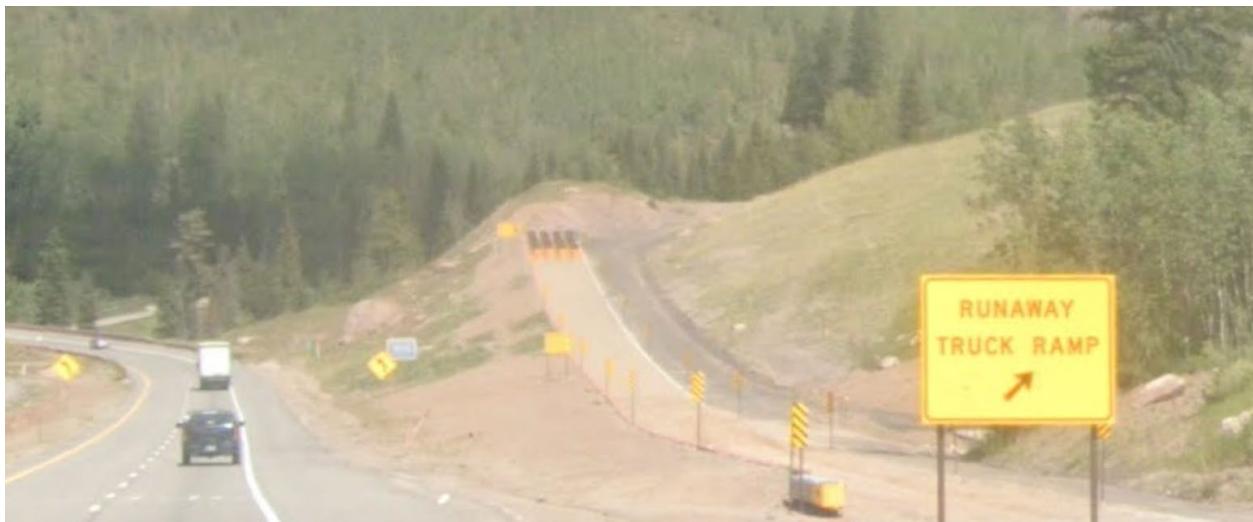
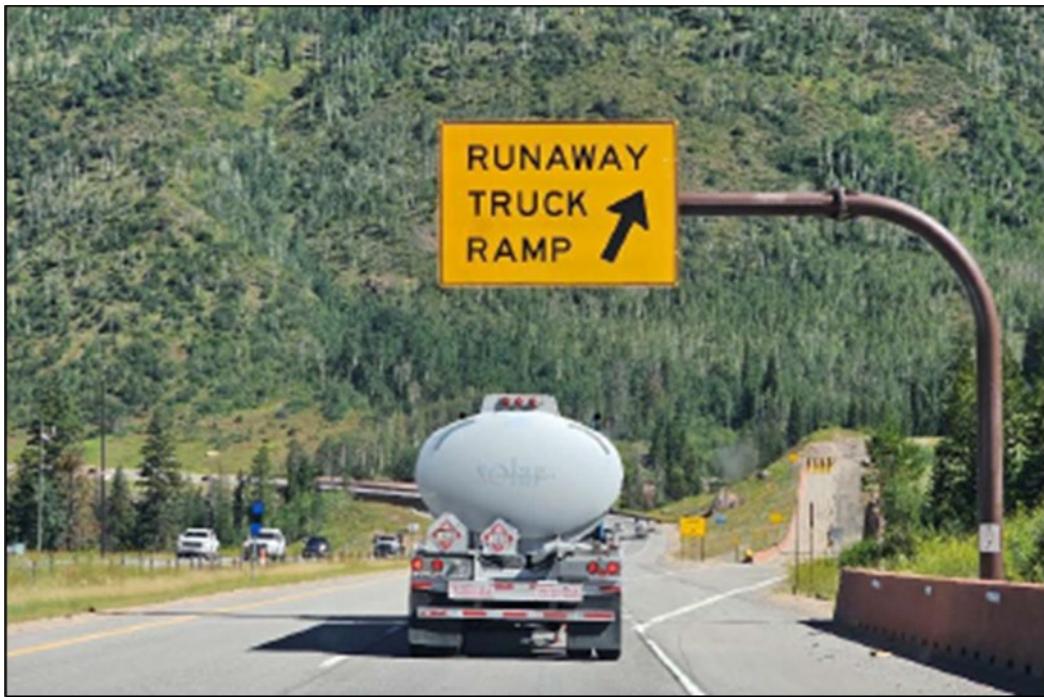
Comparison with **Figure 4-56** and **Figure 4-57** show the Lower escape ramp is now straightened so that drivers do not need to navigate a curve, and also impact attenuator barrels are present at the end of the ramp.

Figure 4-56: Lower Truck Escape Ramp, Aug. 2022

Figure 4-57: Lower Truck Escape Ramp, Aug. 2024

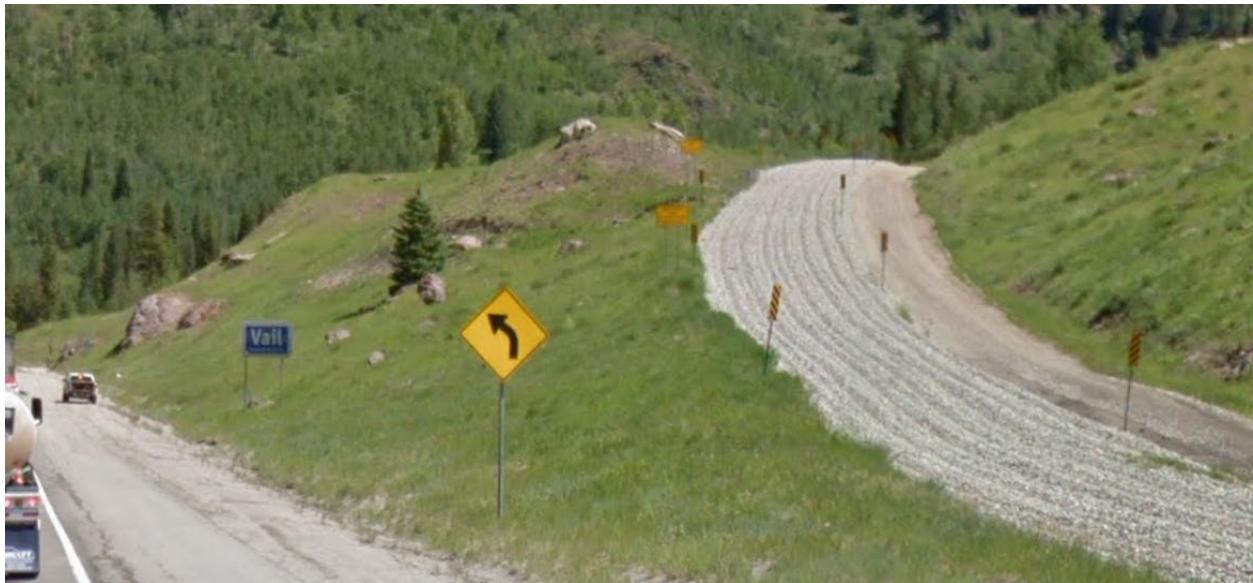
Figure 4-58: Trees and Shrubs to Left of Curved Lower Escape Ramp, Jun. 2018

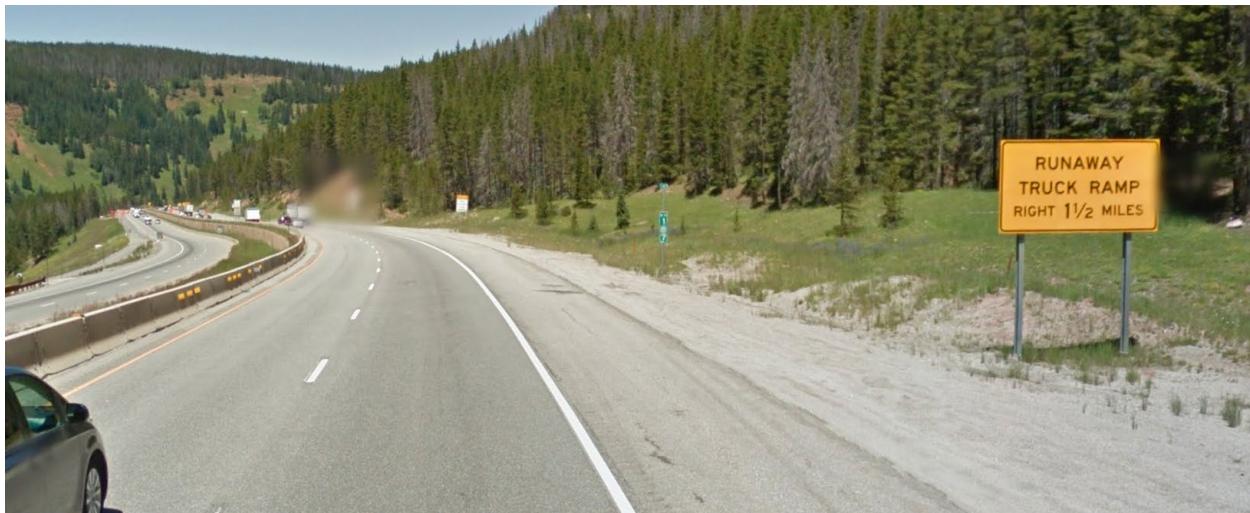
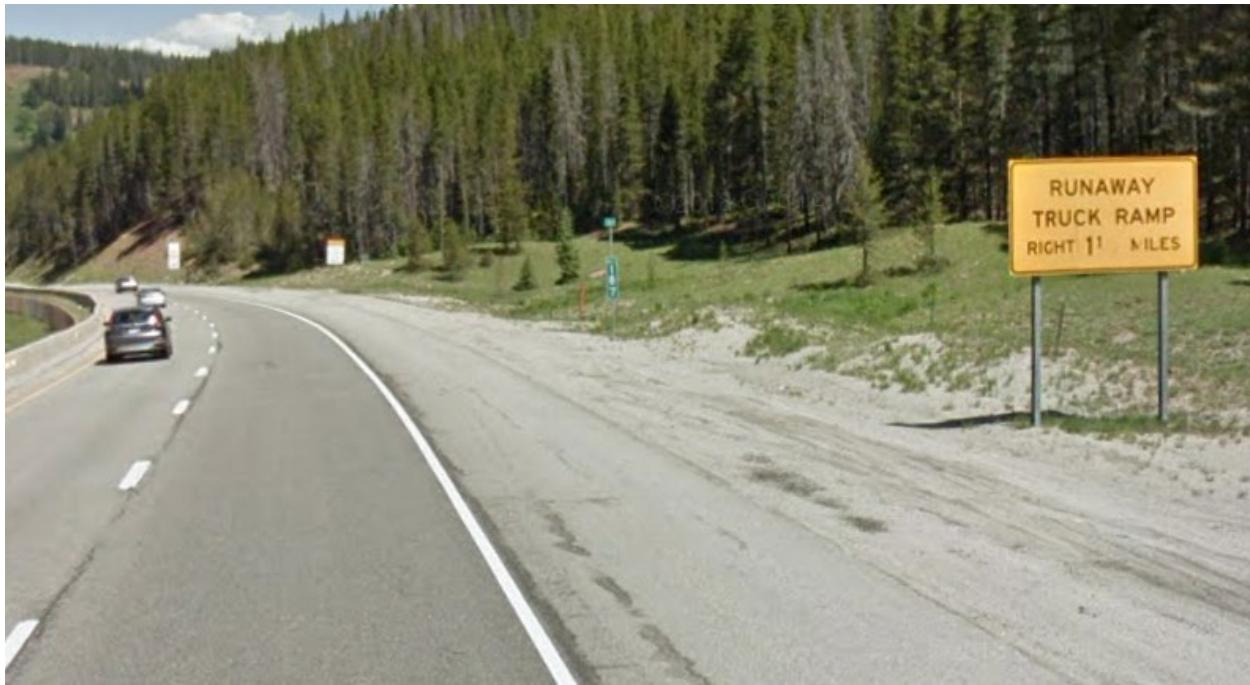
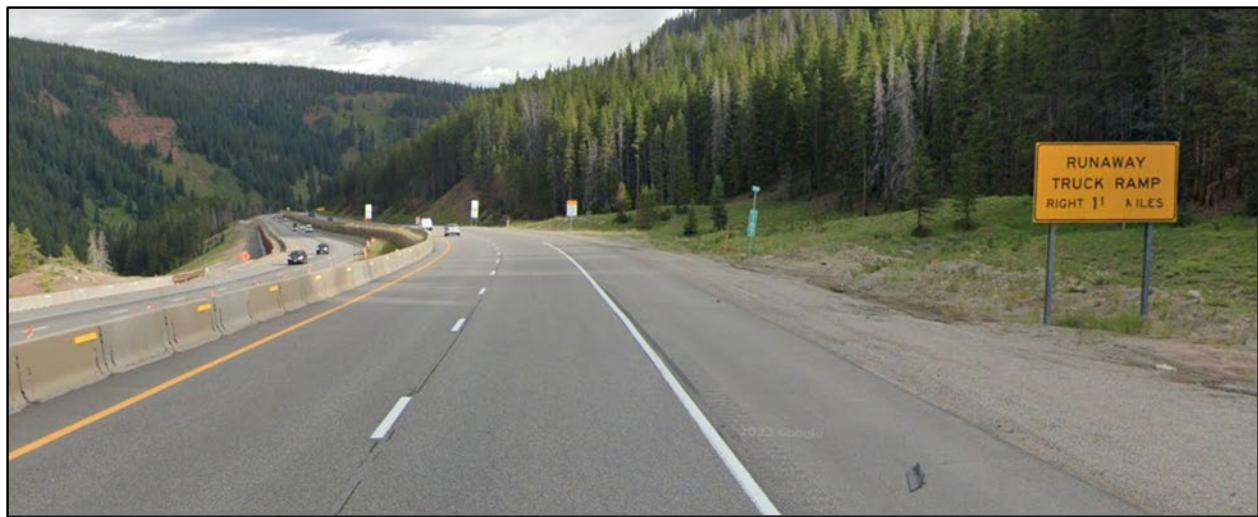
Imagery indicates that the advance warning sign for the Upper ramp near MP 187.11 has had the mileage faded since sometime after July 2015 (**Figure 4-62, Figure 4-63** and **Figure 4-64**). This would not be of assistance to the inexperienced or unfamiliar truck operator.

Figure 4-63: Upper Escape Ramp Advance Warning MP 187.11 (Faded), Jun. 2018

Figure 4-64: Upper Escape Ramp Advance Warning MP 187.11 (Faded), Aug. 2023

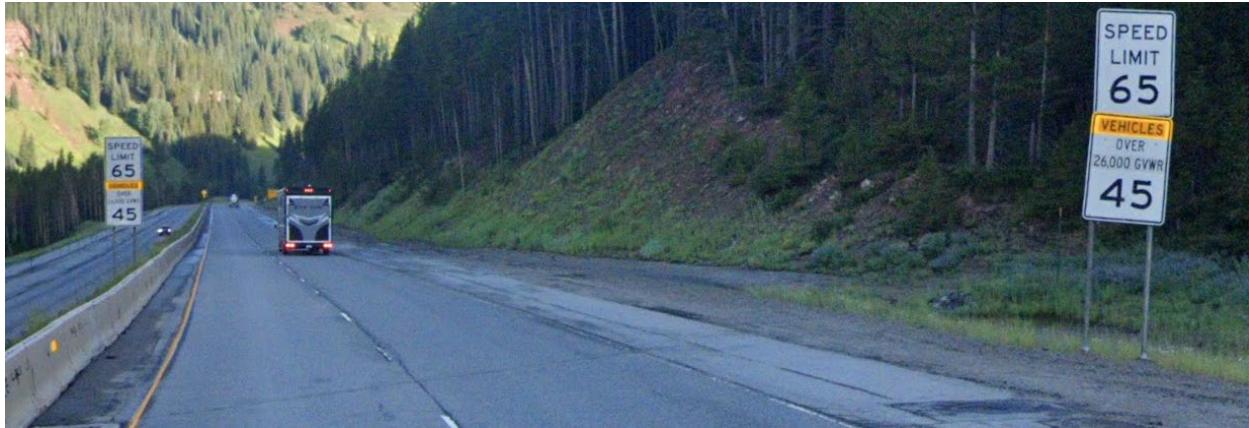
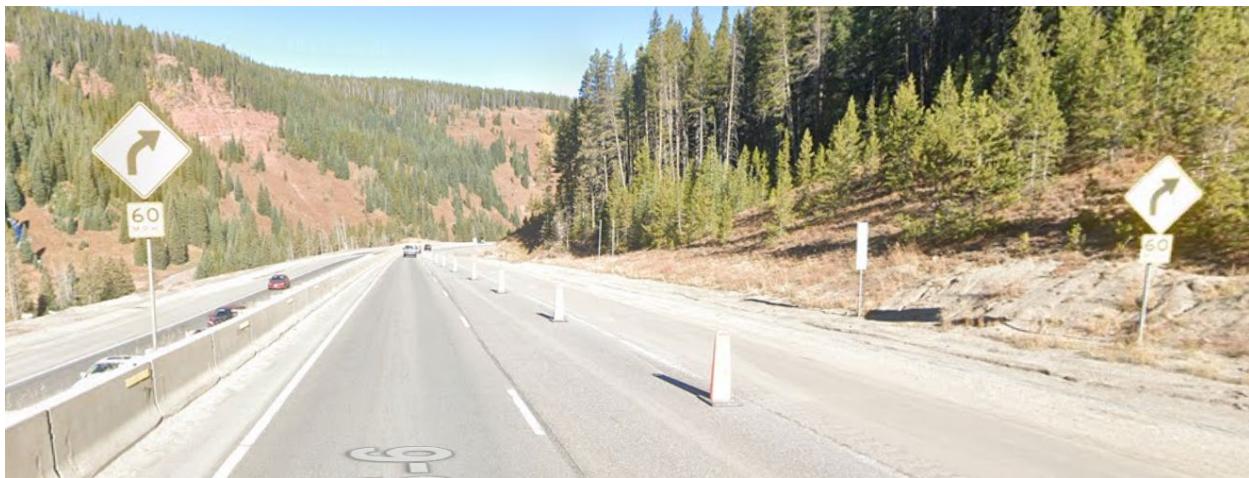
Near MP 188.99, MP 186.98 and MP 184.29, there are gated lower truck speed limits of 45 mph. However, at MP 188.00 and MP 186.60 there are curve warning signs with an advisory 60 mph speed limit which may be conflicting and confusing especially for inexperienced or out of town truck operators (Figure 4-65 and Figure 4-66 for example).

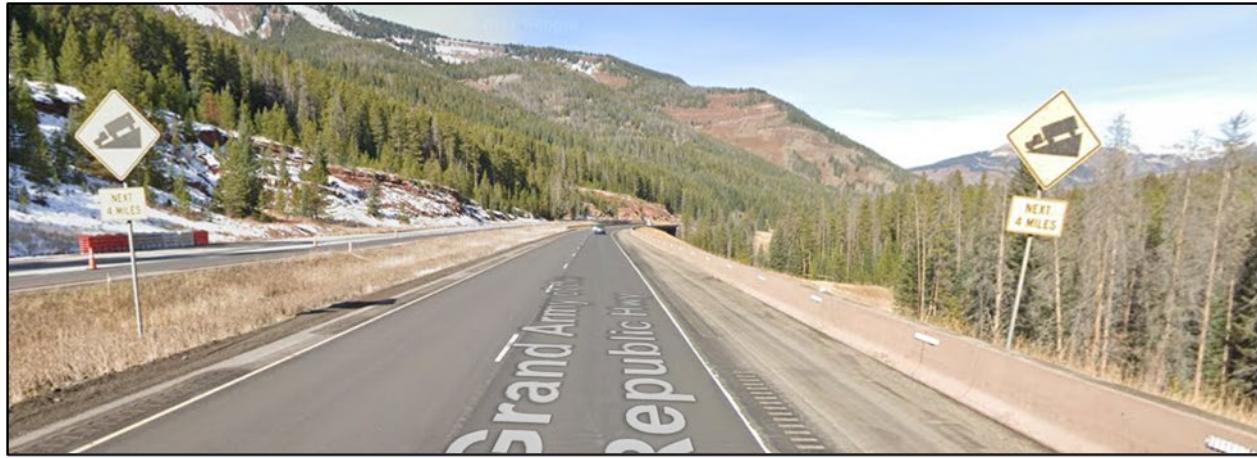
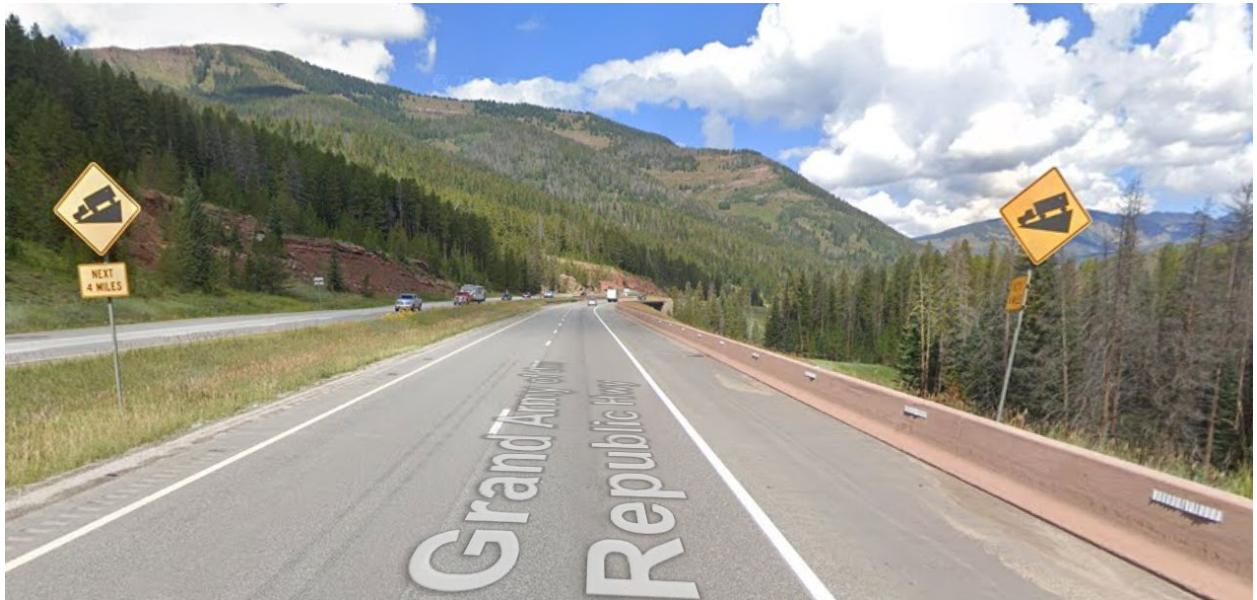
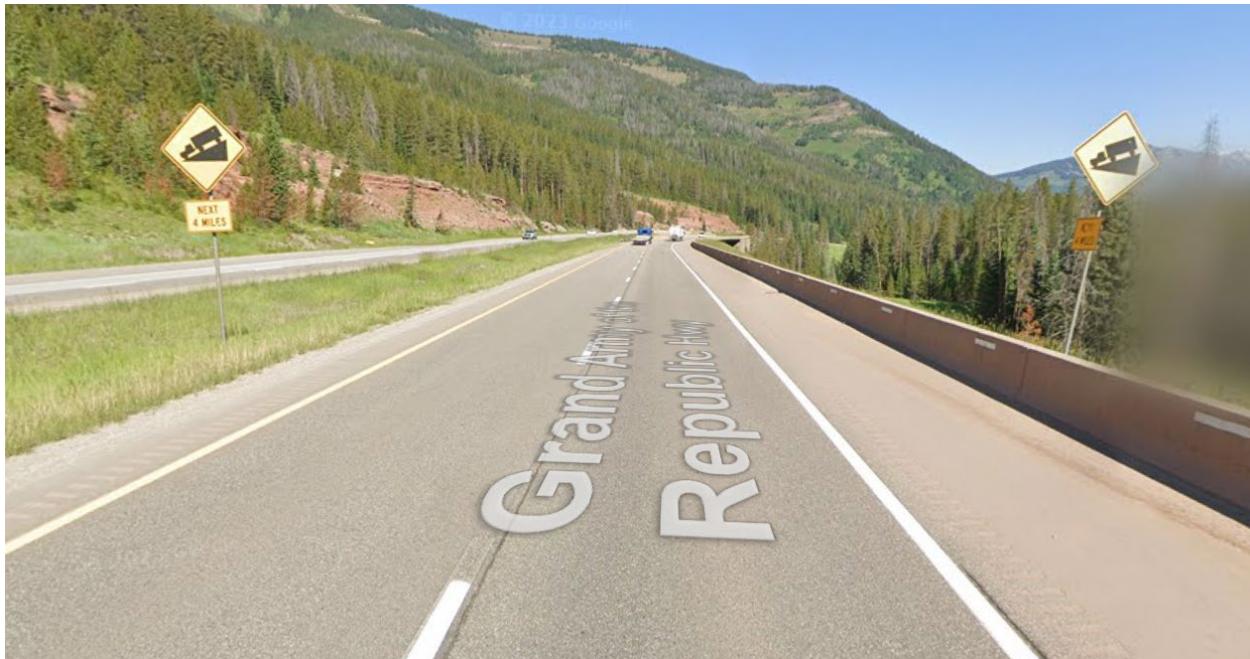
As outlined previously there are several grade warnings for trucks on the study corridor. However, imagery shows that the one located near MP 184.15, following the Upper ramp and in advance of the Lower ramp, has a supplemental “Next 4 Miles” plaque which appears to be twisted away from the oncoming driver since sometime between October 2021 and August 2022 (**Figure 4-67**, **Figure 4-68** and **Figure 4-69**).

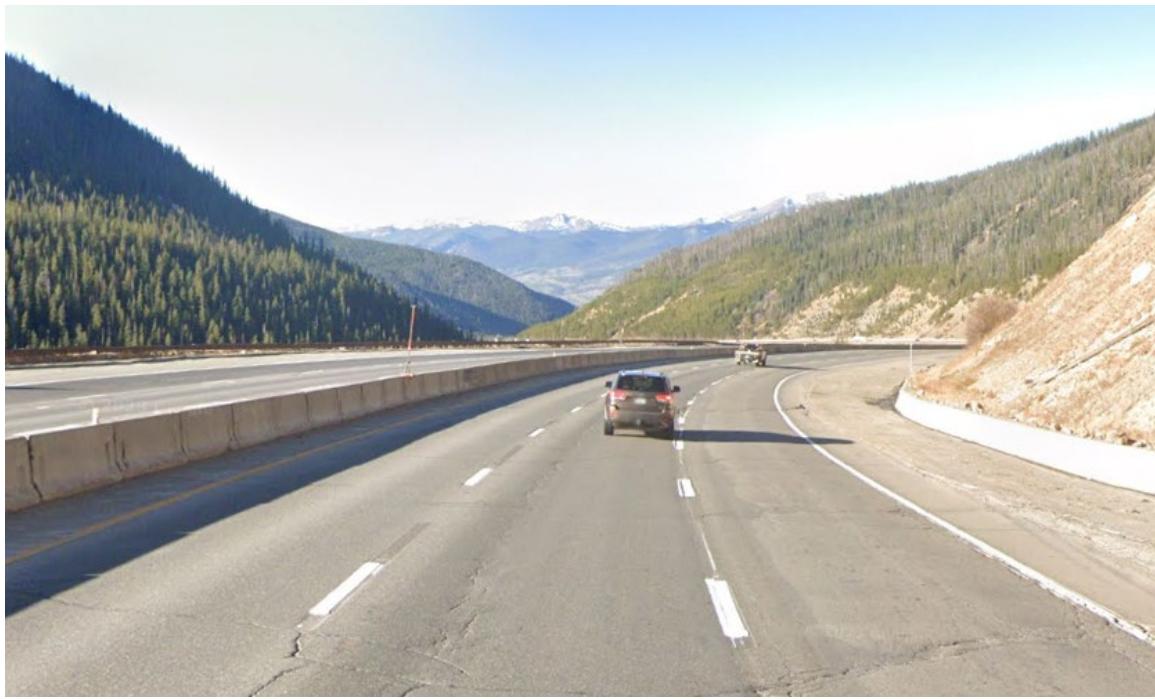
Figure 4-76: Sharp Curve near I-70 WB MP 212

Regarding Sideswipe same direction crashes, these were mostly seen to occur in adverse winter road conditions (11 of 16). A review of data shows that 4 cases involved drivers changing lanes. However, a stronger trend was detected when narratives were consulted, with 6 incidents involving the sliding, rotating, or jackknifing of the trailer due to icy/adverse road conditions, and subsequent collision with the side of another vehicle. **Figure 4-75** shows that there is a slight clustering of Sideswipe same direction crashes near MP 212. Imagery indicates that this location is in the vicinity of a sharp curve-on-grade. Adverse road conditions of snow/icy might cause commercial vehicle trailers to slide as they navigate the bend (**Figure 4-76**). As was recommended as part of Pedestrian section in the full version of the report, CDOT is advised to erect gated Slippery Conditions warning signs (*MUTCD W8-5*) with supplementary “ICE” plaques (*MUTCD W8-5aP*) in advance of MP 212.

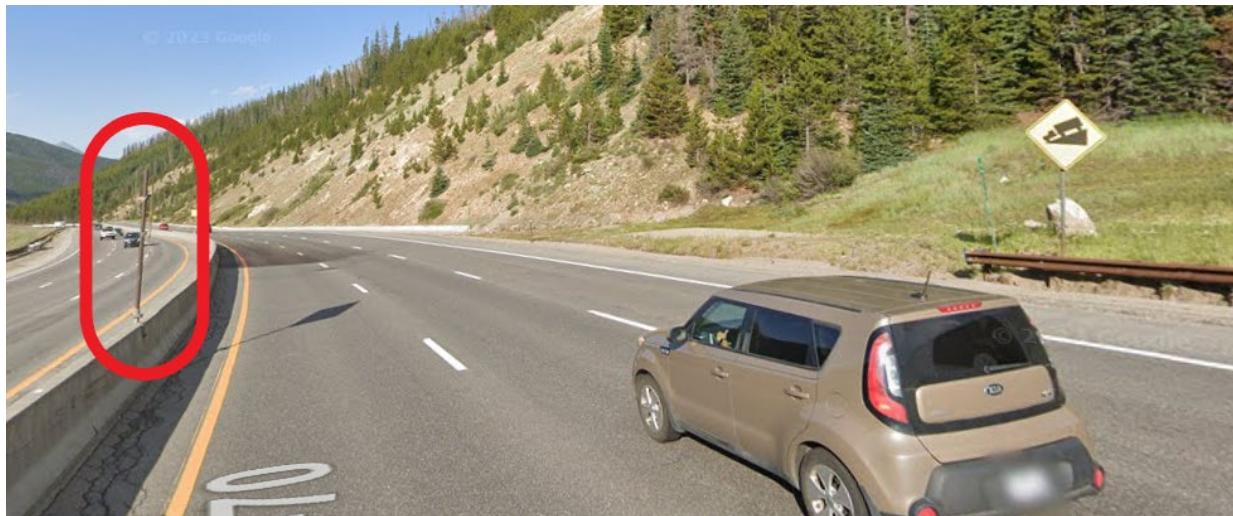
Figure 4-86: W7-1 Sign Twisted, WB I-70 MP 211.57, Aug. 2023 (facing West)

These signs are also supplemented with gated steep grades warning signs for trucks (MUTCD W7-1) near MP 211.57 and MP 208.65. However, Streetview imagery indicates that one of the signs at the former location is twisted away from oncoming traffic since sometime following 12/2018 and at least August 2023 (see **Figure 4-85** through **Figure 4-87**). If not already addressed, CDOT is advised to repair this sign so that it faces oncoming westbound traffic.

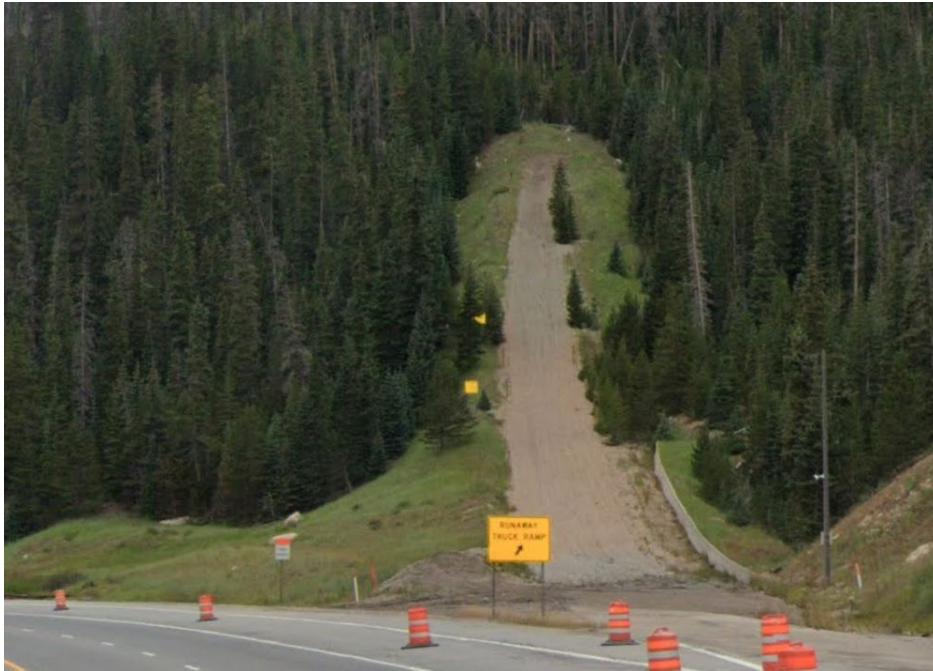
Figure 4-92: Upper Escape Ramp, Aug. 2022

A comparison of both ramps by way of available imagery indicates that the arrester bed of the Upper ramp is not as long as that of the Lower ramp. In addition, the bed of the Upper ramp appears to be encroached upon by trees, while the Lower bed appears to be clear (see **Figure 4-92** and **Figure 4-93**). This might possibly make the Upper ramp less inviting to a truck operator in need, posing the possibility of an overshoot or collision with trees.

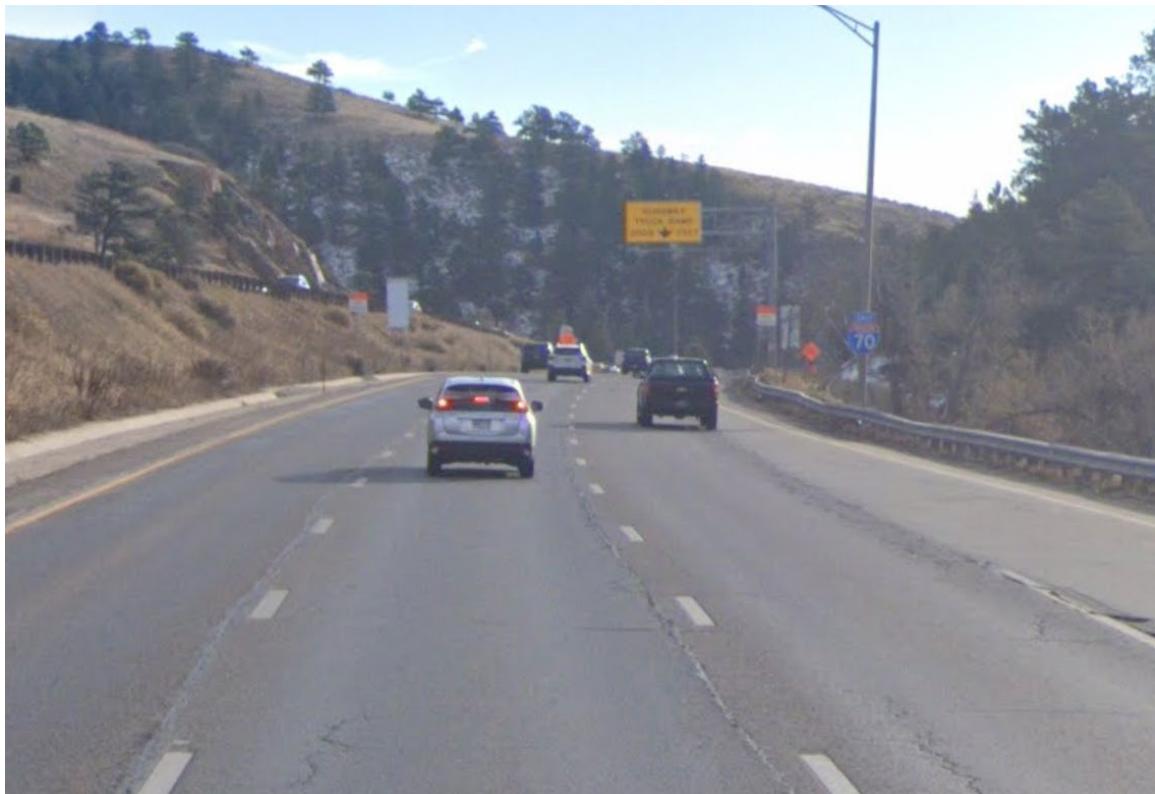
Figure 4-103: View Approaching MP 256.20 Eastbound

The locations of Rear-End collisions are seen in **Figure 4-102**. While there is no pattern relating to one specific location, a review of the locations where some clustering is seen (MP 253.90-254.50, MP 256.20-256.80, and MP 257.90-258.40), shows that crashes appear to occur where there are changes in curvature on grade, and where potential for hidden traffic queues might occur (example **Figure 4-103** and **Figure 4-104**). A review of crash records showed that 3 cases involved the driver being unable to stop in time for traffic.

A similar pattern regarding rear-end collisions and potentially hidden traffic queues has been discussed in the full version of this report as part of the general eastbound section. It was recommended that gated warning signs for traffic queues be installed on eastbound I-70 in advance of MP 254.50. Gated warning signs for traffic queues could also be included prior to MP 256 and MP 258.
