COLORADO
Department of Transportation

CDOT Office of Applied Research

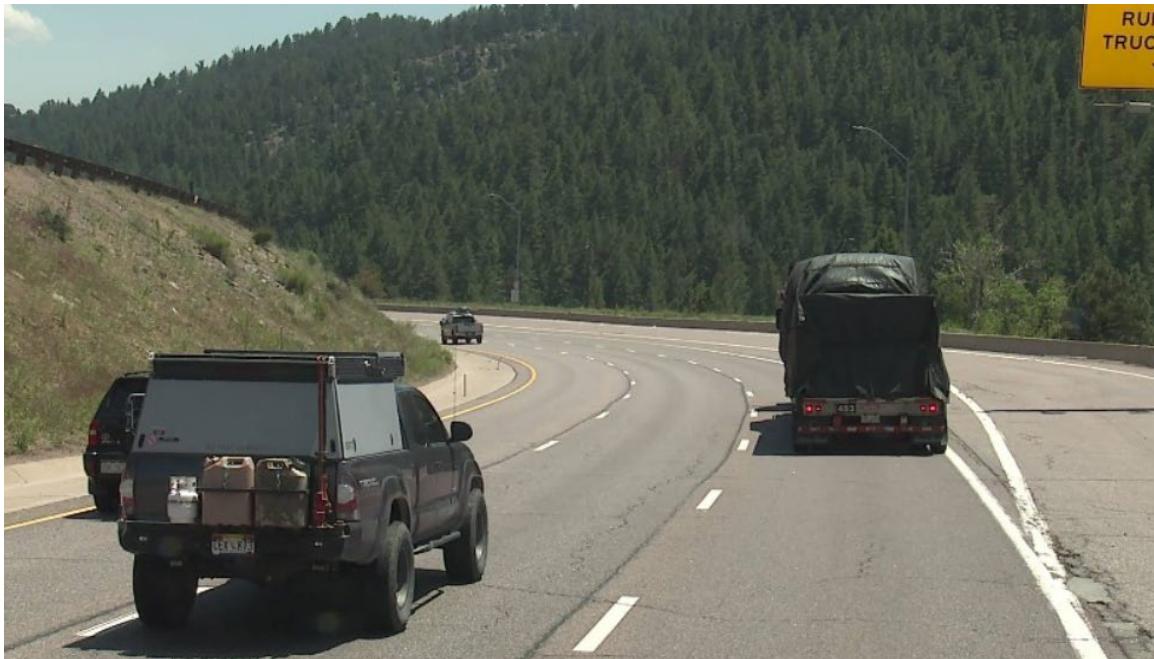
Figure 4-104: Approaching MP 256.68 Eastbound

The locations of Rear-End collisions are seen in **Figure 4-102**. While there is no pattern relating to one specific location, a review of the locations where some clustering is seen (MP 253.90-254.50, MP 256.20-256.80, and MP 257.90-258.40), shows that crashes appear to occur where there are changes in curvature on grade, and where potential for hidden traffic queues might occur (example **Figure 4-103** and **Figure 4-104**). A review of crash records showed that 3 cases involved the driver being unable to stop in time for traffic.

A similar pattern regarding rear-end collisions and potentially hidden traffic queues has been discussed in the full version of this report as part of the general eastbound section. It was recommended that gated warning signs for traffic queues be installed on eastbound I-70 in advance of MP 254.50. Gated warning signs for traffic queues could also be included prior to MP 256 and MP 258.

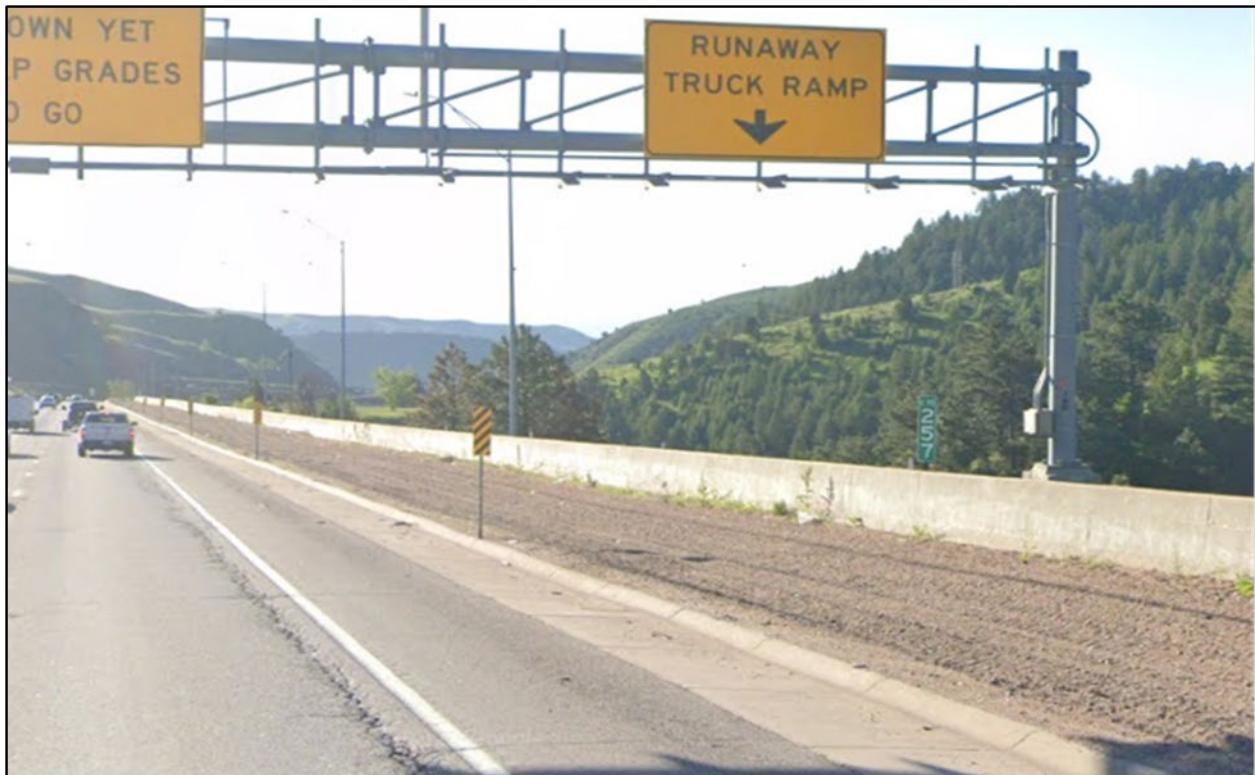
Figure 4-105: Object Markers on Right Side near MP 257, June 2023

As part of the “COLLISIONS WITH SIGNS” section in the full version of this report discussing eastbound crashes involving all vehicle types, it was outlined that there were two passenger vehicle crashes with signs at this same location. It is likely that these collisions involved the object markers which during the study period delineated the arrester bed from the right shoulder of the traveled way, as seen in **Figure 4-105**. This configuration allowed the potential for not only passenger vehicles to accidentally and dangerously traverse the boundary and enter the escape ramp, but also for trucks on the ramp to re-enter the roadway.

It might be deduced that brake or other mechanical failure precipitated use of the escape ramp as no adverse weather conditions were present at the time. As has been described previously, the sign which the truck struck after entering the escape ramp was likely one of the object markers seen in **Figure 4-105**.

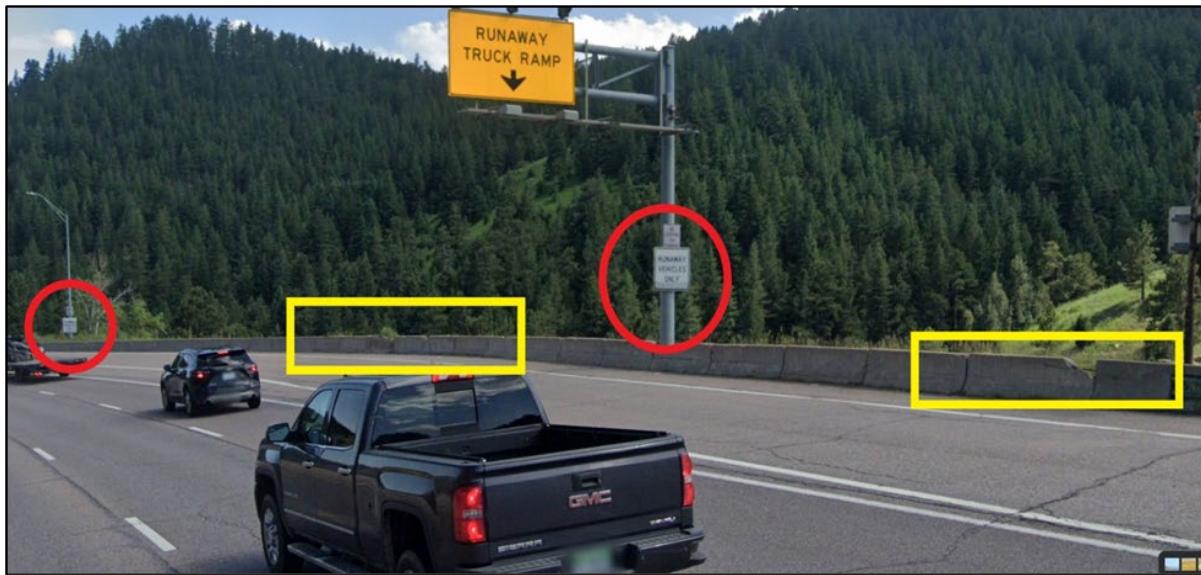
Figure 4-106: EB I-70 MP 256.70, Regulatory Signs & Barrier, June 2023

Google Streetview imagery indicates that there are several “EMERGENCY VEHICLE ONLY” regulatory signs on the approach to the arrester bed along the right side of the exclusive truck lane which provides entrance to the escape ramp. Imagery also indicates that, during the study period, the barrier wall on the right side which lined the entrance leading to the arrester bed had been struck and was damaged (**Figure 4-106** and **Figure 4-107**). This crash record in particular serves to demonstrate that trucks which do not approach the escape ramp entrance appropriately do have the potential to strike the barrier wall and other structures.

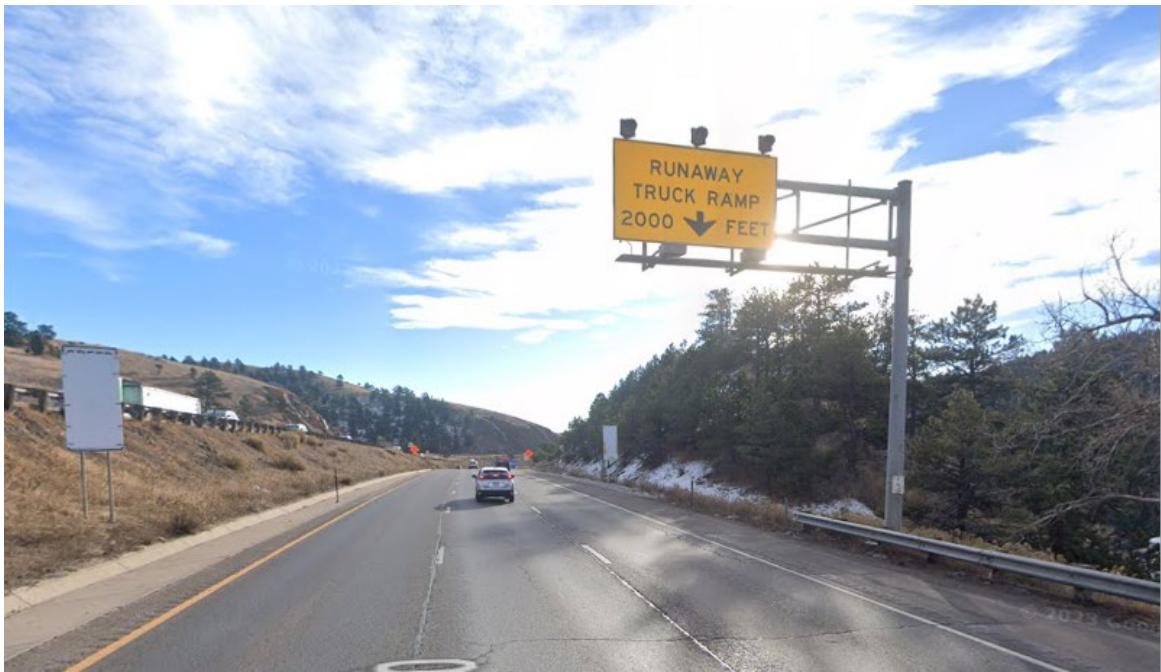
Figure 4-108: Escape Ramp Warning Sign, MP 256.31

In its current configuration, a clear view of the escape ramp arrester bed is hidden behind a corner, such that a truck operator must commit to using the ramp and the dedicated access lane prior to getting a visual of the ramp itself. For the inexperienced driver, or the out-of-town driver, this might be intimidating. **Figure 4-108** shows the view near MP 256.31 which indicates the ramp is 2,000 feet ahead and drivers should enter the right most lane. As can be seen, drivers must still navigate a right curve and the ramp is not yet visible. Compounding this, **Figure 4-109** shows that the beginning of the exclusive ramp access lane begins on a curve, where the ramp is still not visible. If a driver has not committed at this stage and waits until the ramp become visible after rounding the corner (**Figure 4-110**), this could present a situation necessitating a sudden movement to the right, but also unsafe mounting of the ramp, and as has been described by this crash record, collisions with the barrier wall on the right.

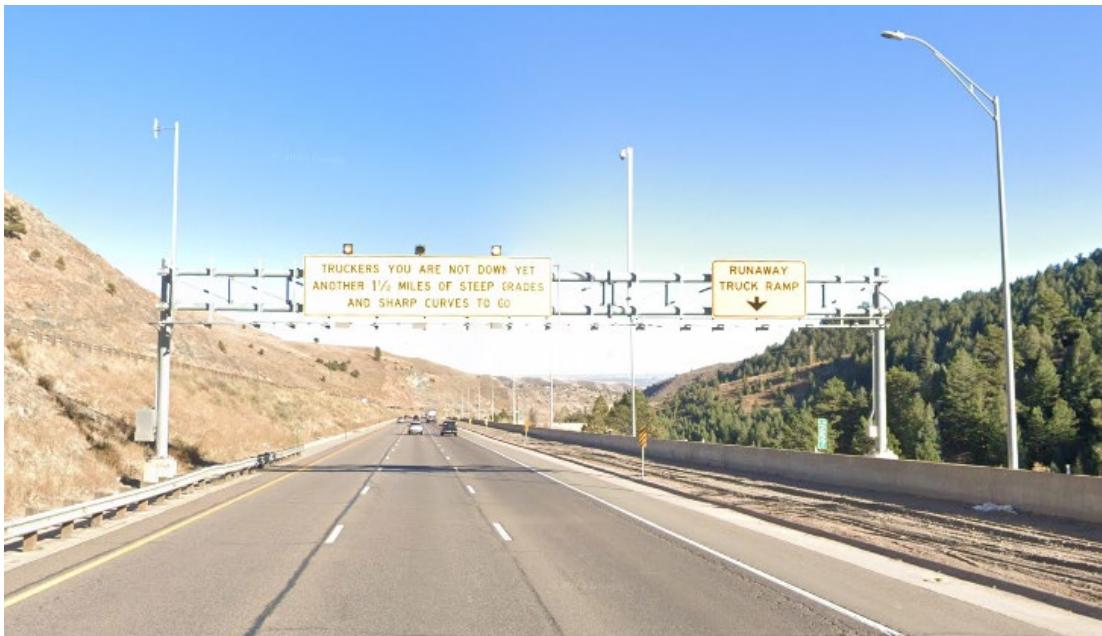
Figure 4-112: MP 256.98, 'TRUCK RAMP' Sign, Oct. 2021

Furthermore, Streetview imagery suggests that the overhead sign indicating the escape ramp position relative to the 3 through lanes was not present prior to 2020 (**Figure 4-111** and **Figure 4-112**). This may have caused further ambivalence for truck operators who were already lacking a clear head-on view of the ramp access leading up to this point.

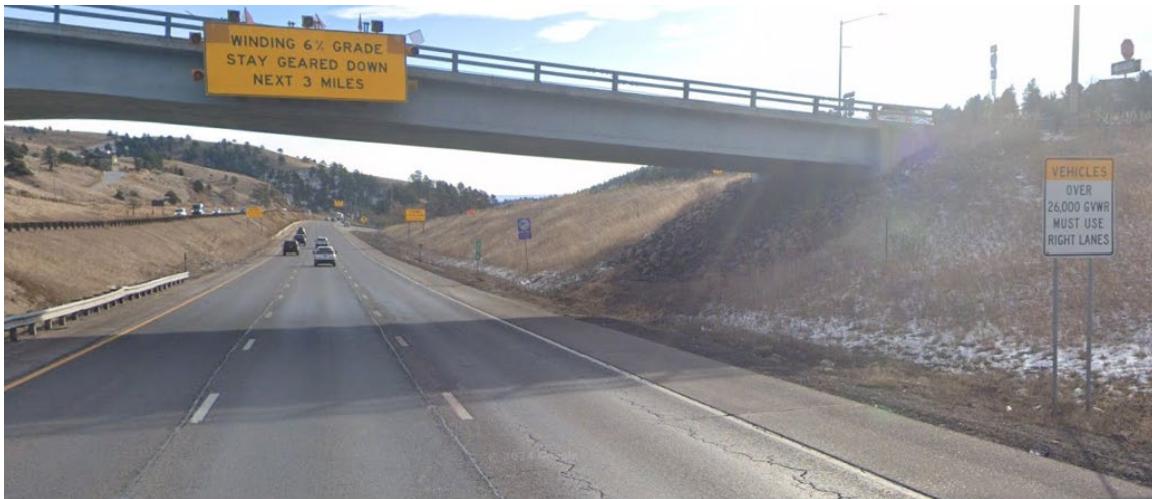
Figure 4-113: Grade & Curve Warning Sign, MP 255.96

A review of Google Streetview imagery indicates that there are several warning signs for truck operators referring to steep grades and sharp curves for 5 miles, 4 miles, 3 miles and 1.5 miles ahead, located near MP 253.73, MP 254.46, MP 255.96, and MP 256.98, respectively. The latter two signs are both large overhead mounted signs supplemented by flashing beacons (example **Figure 4-113**).

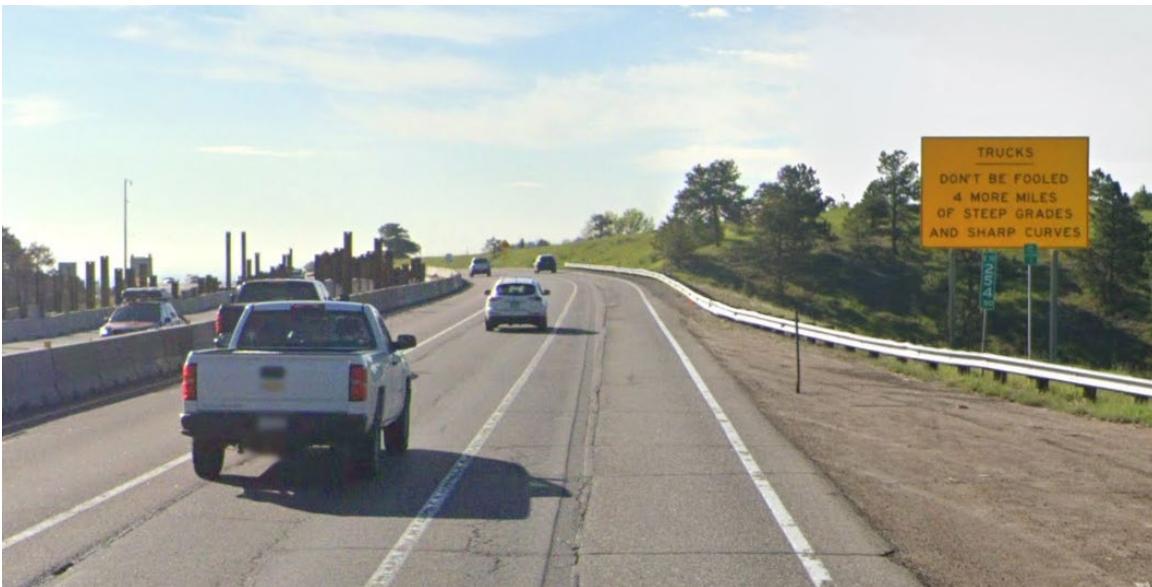
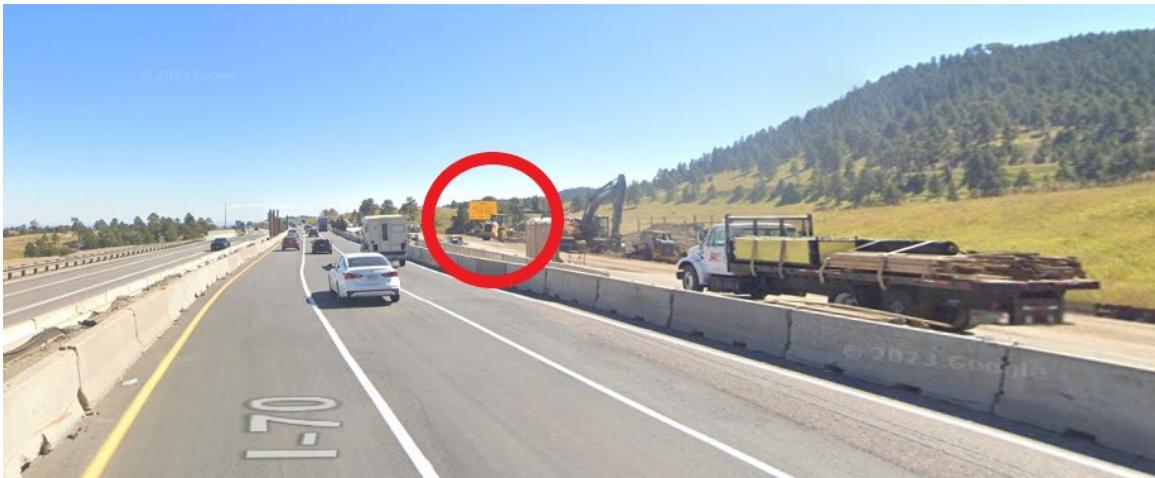
Imagery suggests that construction works might have obstructed the view of the warning signs near MP 254.46 (Figure 4-114 and Figure 4-115). CDOT should review any ongoing construction works and if possible, make adjustments to maximize visibility of signs for truck operators.

Figure 4-114: Truck Warning Sign, MP 254.46, May 2023

Figure 4-115: Truck Warning Sign, MP 254.46, Sept. 2023

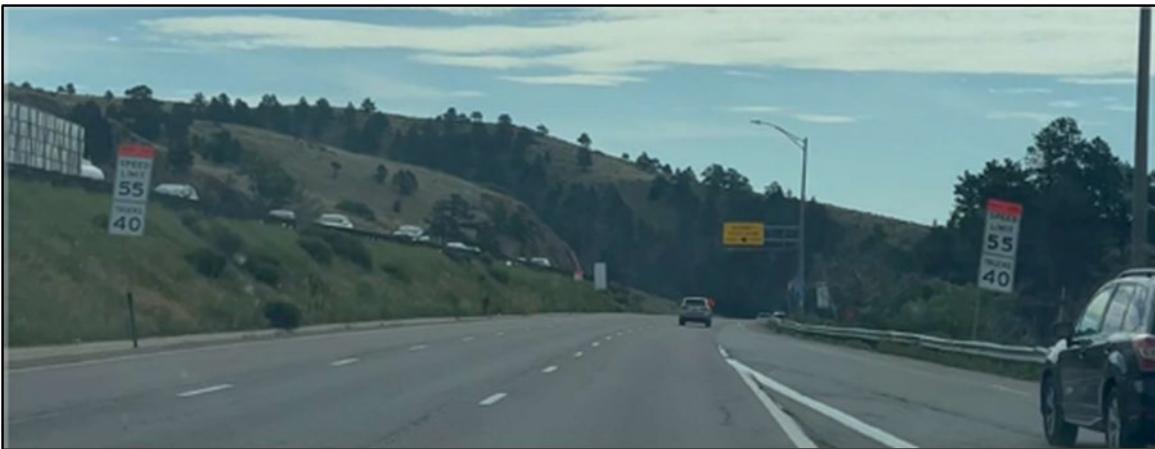
Figure 4-116: Lower Truck Speed Limits, MP 256.32, Aug. 2024

There is a lower speed limit of 45 mph in effect through the study corridor for commercial vehicles, as indicated by gated dual speed limit signs at several locations, for example near MP 256.32 (**Figure 4-116**).

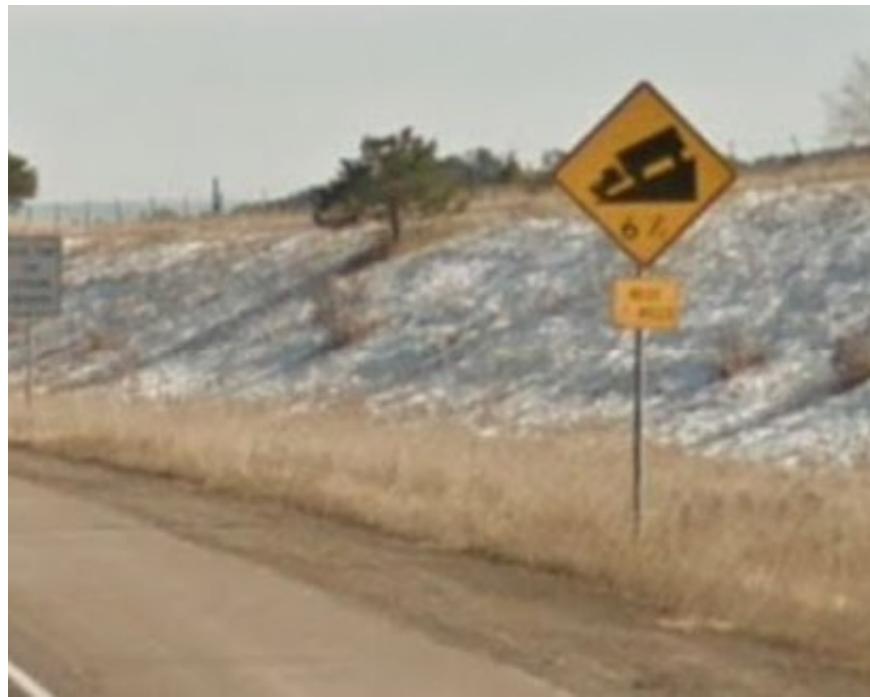
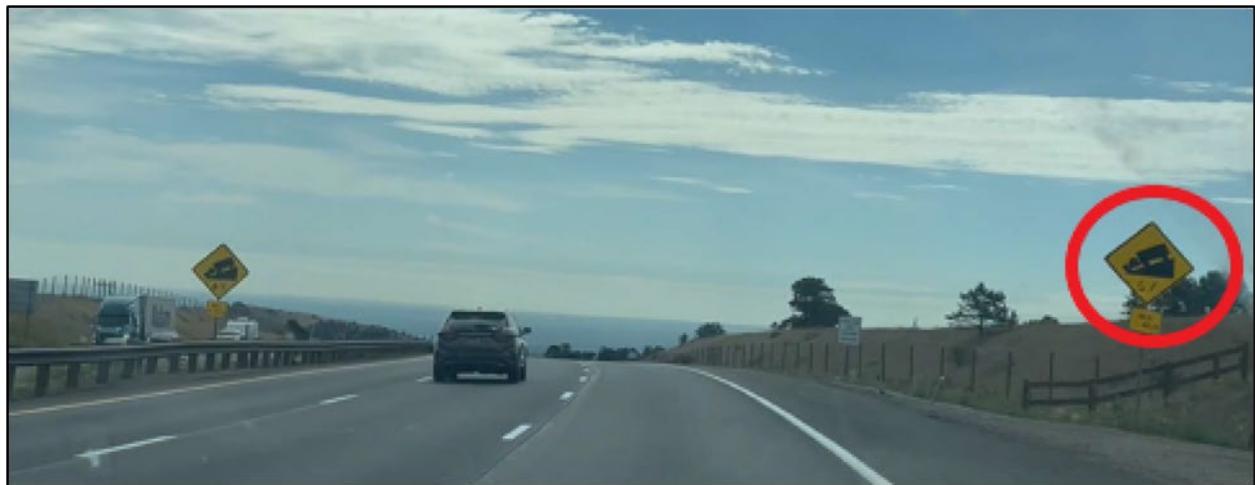
There are also steep downgrade warning signs (*MUTCD W1-7*) for trucks at two locations through the study corridor. However, imagery indicates that in the case of the gated warnings near MP 254.62, the last time the “6%” text was legible on the right-side sign was in 2018 (**Figure 4-117** and **Figure 4-118**). Additionally, the mileage/distance does not appear to be clear. CDOT should repair or replace the text on signs to ensure adequate visibility.

Figure 4-117: Grade Warning, MP 254.62, Nov. 2018

Figure 4-118: Grade Warning, MP 254.62, Aug. 2024

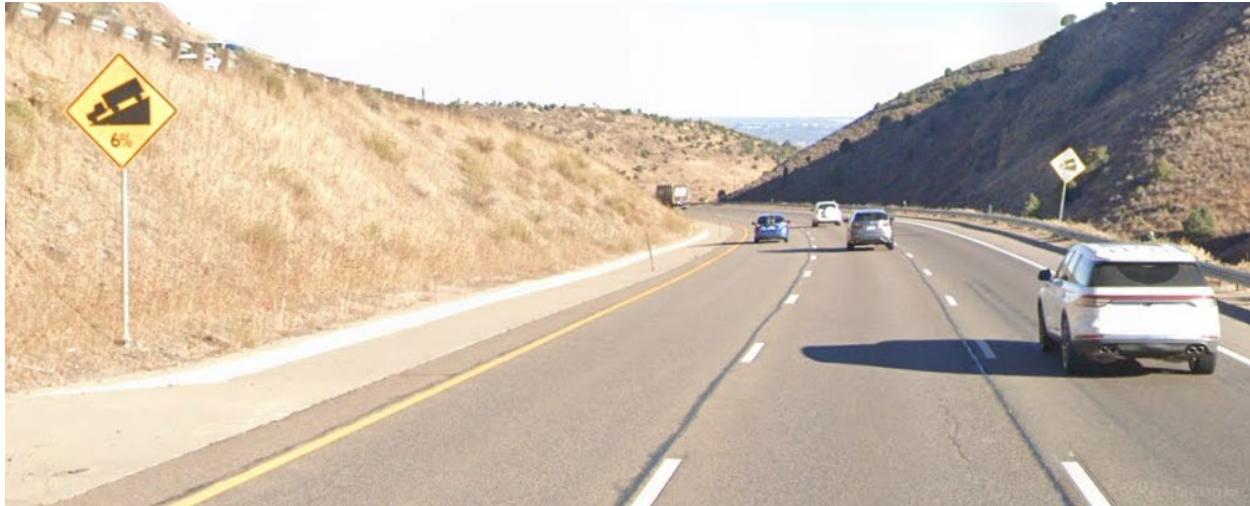
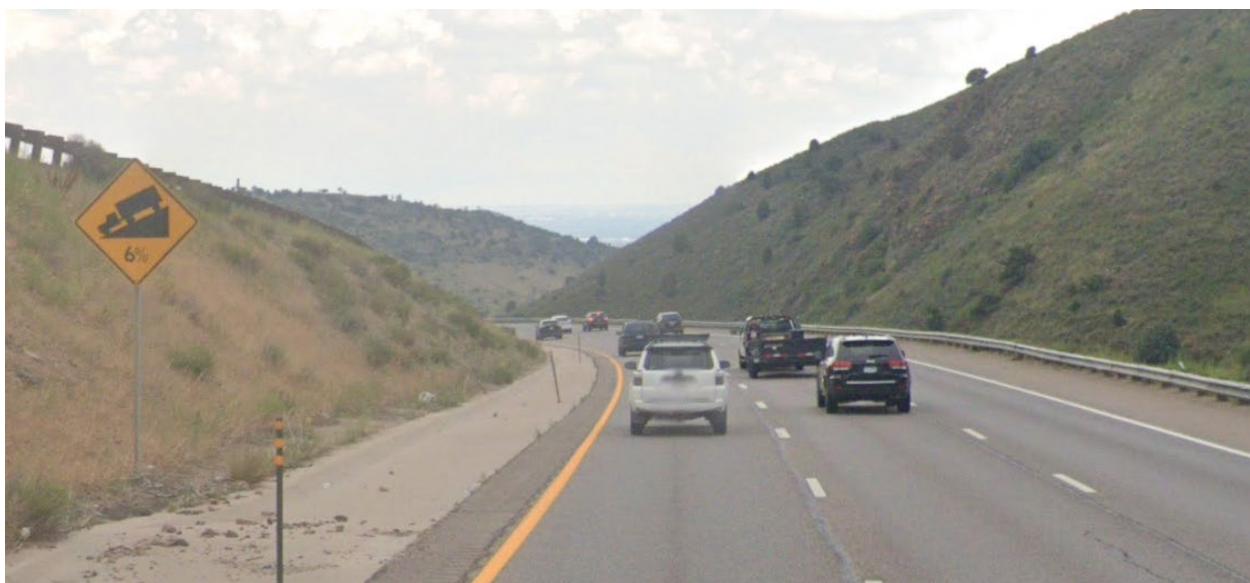
It also appears that in the case of the signs near MP 257.71, signs were staggered and gated up to late 2021 (**Figure 4-119**). However, imagery from mid-2022 indicates the right-side sign is missing (**Figure 4-120**). CDOT should replace the right sign to reinstate a gated warning.

Figure 4-119: Staggered Gated Grade Warnings, MP 257.71, Oct. 2021

Figure 4-120: No Right-Side Warning, MP 257.71, Jun. 2022

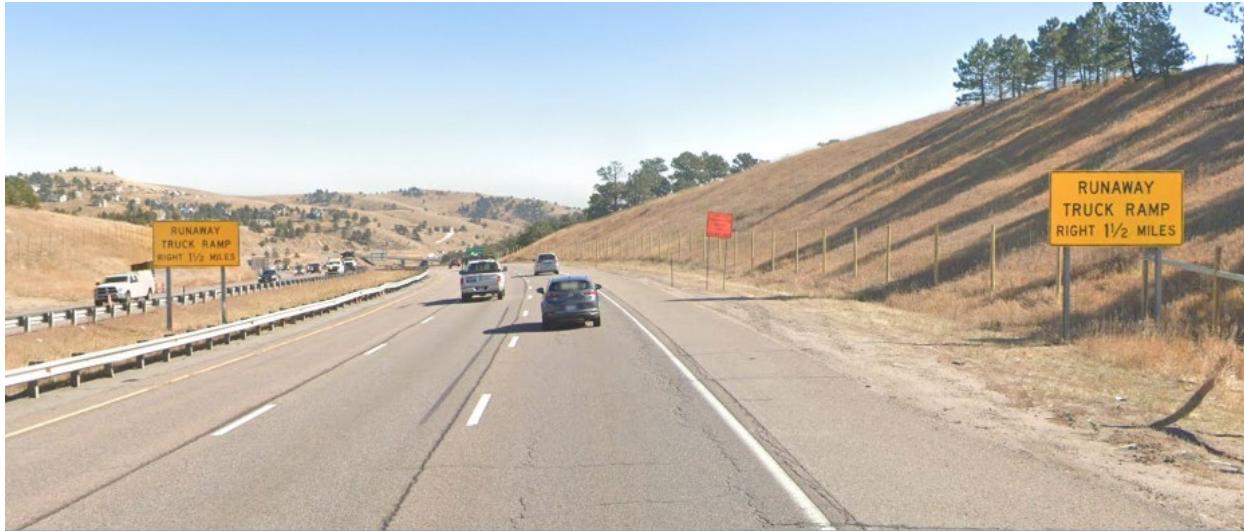
Figure 4-121: Initial Escape Ramp Warning, MP 255.32

Regarding the truck escape ramp itself, Streetview imagery indicates the initial warning is located near MP 255.32 approximately 1.5 miles ahead of the ramp, by way of large gated roadside warning signs (**Figure 4-121**). There is another set of similar gated roadside warning signs near MP 256.05 indicating the ramp is $\frac{3}{4}$ mile ahead. The next warning sign comes approximately 2,000 feet in advance of the ramp, near MP 256.31. This sign is a large overhead mounted sign with flashing beacons (**Figure 4-122**).

In summary, there are some sign repairs and/or replacement issues regarding warnings to truck operators which might require addressing by CDOT. The inclusion of additional warning signs for the escape ramp, possibly 2.5 to 3 miles in advance of the ramp, to account for cases of runaway trucks prior to MP 255.32, has also been recommended.

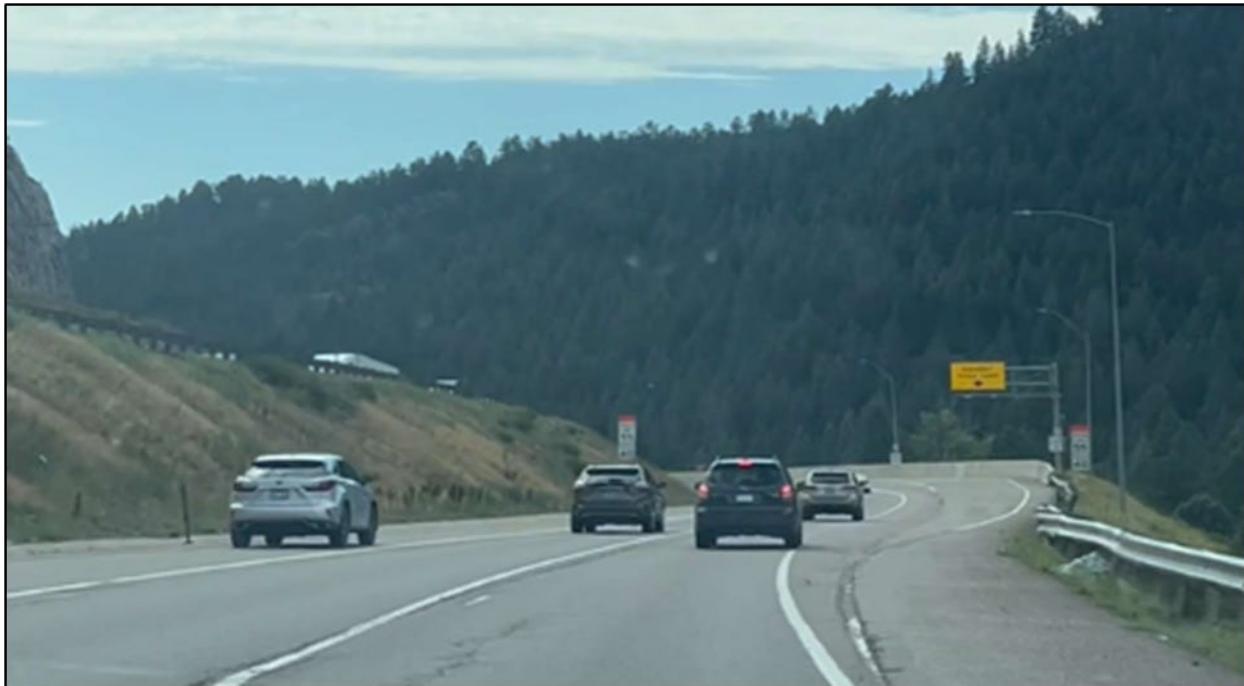
Figure 4-123: Start of Exclusive Truck Lane, MP 256.61, Aug. 2024

As outlined previously, the exclusive truck lane for ramp access begins near MP 256.61 on a curve (**Figure 4-123**). (Despite some recent modifications in 2024 to the escape ramp, the entrance continues to be on curve). The entrance sign for the ramp is located near MP 256.70 and has flashing beacons, and is also located on a curve, without a view of the ramp itself (**Figure 4-124**). Following the curve, the ramp becomes visible, with an overhead sign, which as described previously, was added sometime around late 2021 (**Figure 4-111** and **Figure 4-112**).

It is thought that the current configuration of the ramp, (access lane located on a curve and prior to truck operators having a clear view of the ramp), might have been causing, and may continue to cause truckers to elect not to use the ramp, or as in the case of the unsuccessful ramp use, electing to use the ramp too late, resulting in quick maneuvers to the right and possible collision with the barrier wall. As we understand, a construction project will move the ramp entry downstream providing a straight entry to the access lane and ramp itself and a clear view of the ramp for truckers.

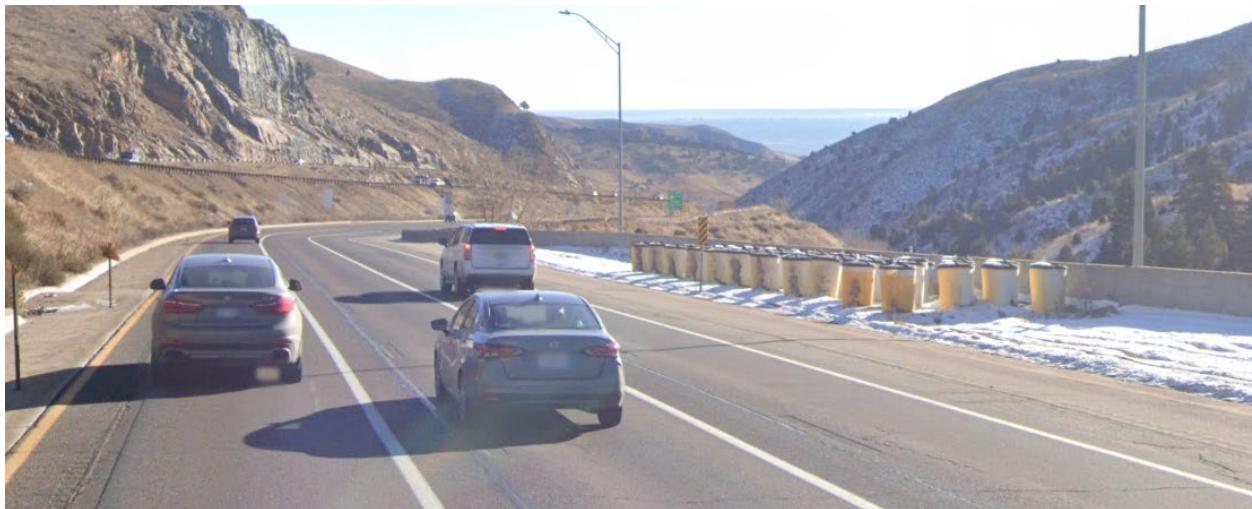
Figure 4-125: Impact Attenuators at end of Escape Ramp

It has been described previously how the flat arrester bed was lined with object markers on the left and a shallow curb, delineating it from the traveled way, within the study period. There are impact attenuator barrels located at the end of the ramp, which is located near MP 257.26 (Figure 4-125).

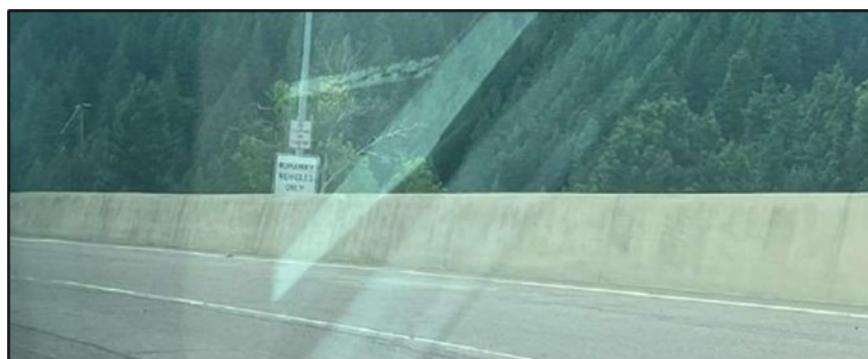
Figure 4-127: Escape Ramp Approach, Barrier Replaced, Aug. 2024

Moreover, as we understand it, replacement of the outside barrier wall, (which appears damaged in imagery from the study period), with a more substantial alternative is to be provided. It is also understood that barriers, such as the existing shallow curb, and object markers, will not be included as part of the reconfiguration to permit entry to the arrester bed by trucks at any point. This would also remove potentially dangerous curb mounting by trucks and/or passenger vehicles.

Figure 4-127 shows that the barrier on the approach to and lining the escape ramp has been replaced with a taller, more robust, continuous (rather than segmented) structure. As such barrier damage has been addressed.

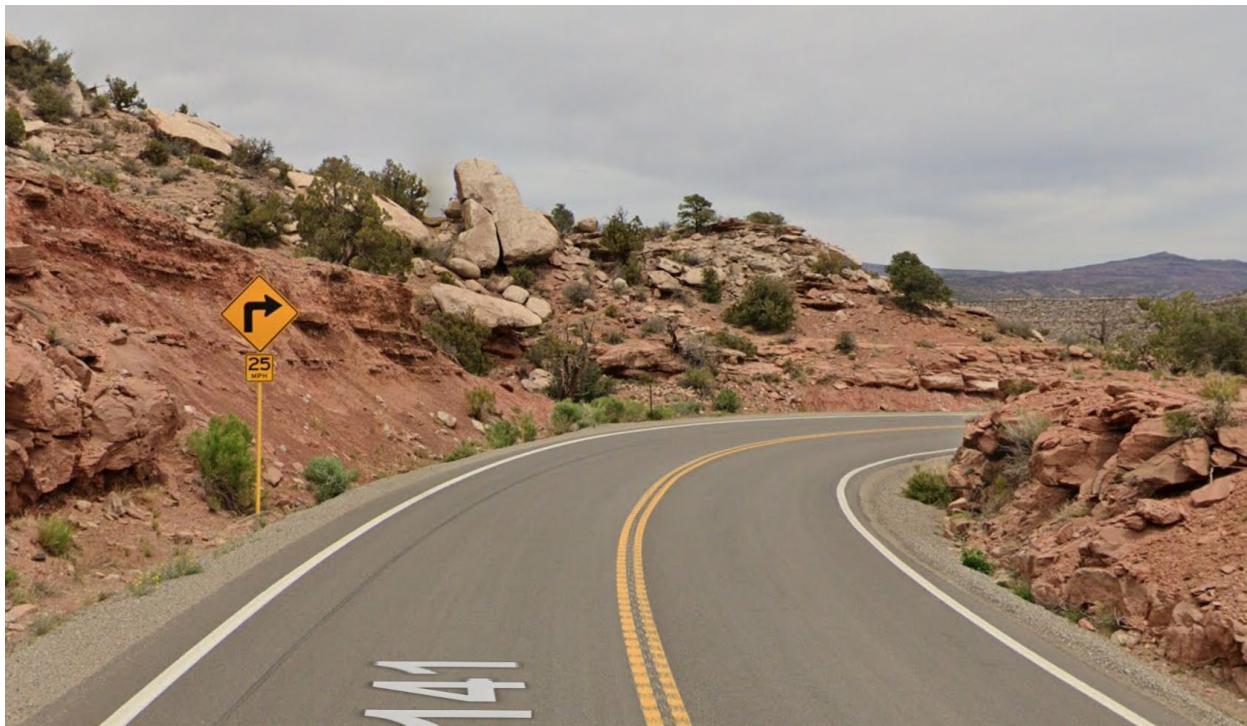
Figure 4-133: Northbound Approach to Curve at MP 19.30

Without a history of use, or without crashes in the vicinity of the ramp with characteristics indicating the driver might have benefitted from the use of the ramp, it is not possible to make a determination on the performance of the truck escape ramp. If anything, it appears that the major problem appears to have been near MP 19.30 regarding run-off-the-road crashes. However, the location is not suitable for a truck escape ramp in the northbound direction, as **Figure 4-133** shows the curve is bordered by steep rocky terrain and narrow shoulders. Furthermore, crashes occurring here tend to be 'off-left' (i.e. vehicles cross over into the southbound lanes), as such an escape ramp on the northbound side on the apex of a hairpin curve would not make sense. Because the problem seems to be at the curve itself rather than in the lead up to the curve, placement of an escape ramp immediately before the curve is not intuitive either. Rather, effort should be placed into raising increased awareness around the presence of and location of the switchback curves, combined with emphasis on advisory speeds and potential risk of running off the road.

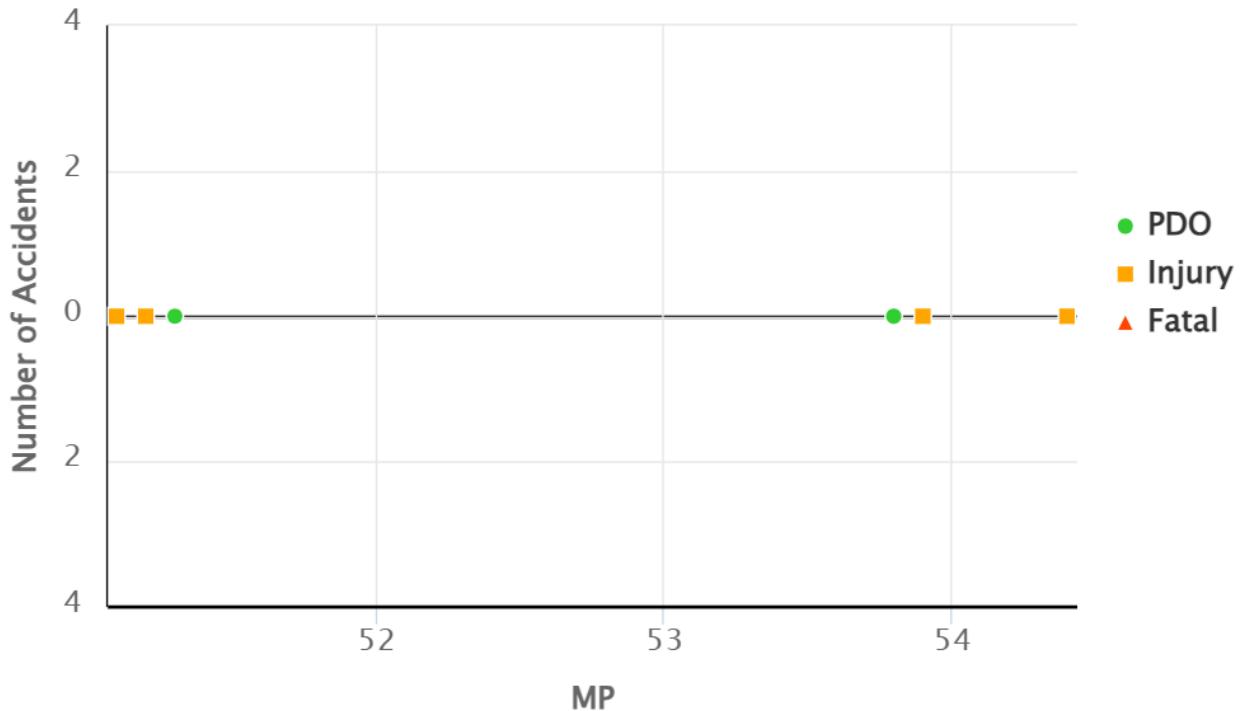
Figure 4-138: Truck Crash Locations, SB US550 MP 54.50-51

Figure 4-138 shows that truck crashes were not recorded at the truck escape ramp (MP 52.50) but did occur at the hairpin bend near MP 54, and the hairpin bend near MP 51. Crash records show that truck crashes tended to be predominantly high severity when they did occur (4 of 6 crashes were injury level).

As witnessed in **Figure 4-138**, three crashes occurred prior to the escape ramp near the hairpin curve at MP 54 (1 PDO, 2 Injury). A review of crash history records shows that all 3 were Overturning crashes, not surprising, as the guard rail does not appear until the curve near MP 51. Two of these three crashes occurred under dawn/dusk conditions. As part of the section addressing “DAWN/DUSK” crashes in the full version of this report, it was recommended that the frequency of reflective delineator buttons be increased, or that delineator posts covered in reflective material be erected, in addition to the installation of reflective chevrons through the curve, and the wrapping of existing sign supports with reflective material or backing. One of the records refers to “rounding the bend,” while another indicates the truck operator “lost control.” Finally, 2 of the 3 crashes involved driver inexperience.

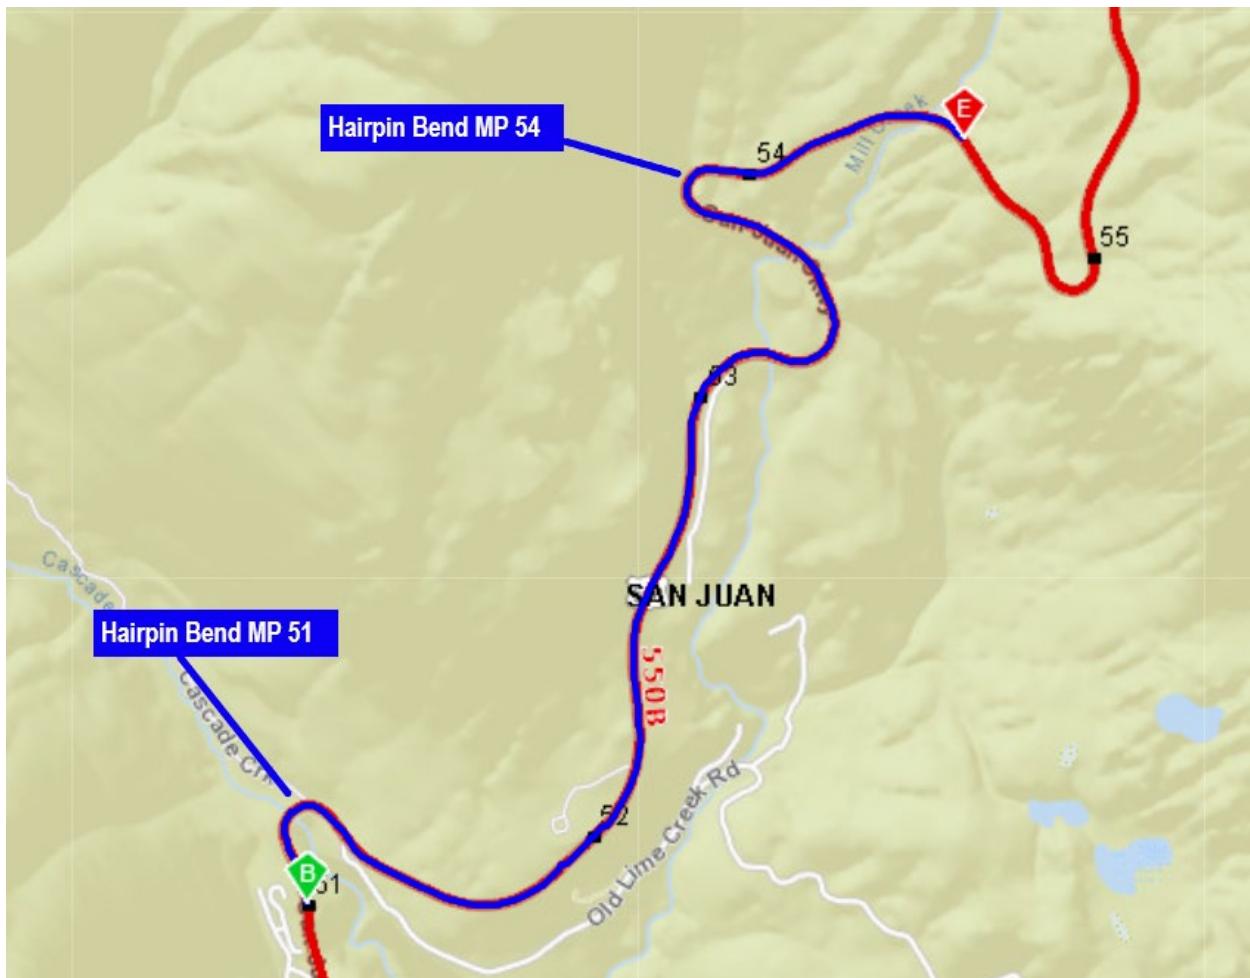
Figure 4-139: Hairpin Bends with Truck Crashes, US550

Figure 4-139 shows the first hairpin bend, approximately 2 miles in advance of the escape ramp, and the second hairpin bend approximately 1.5 miles beyond the escape ramp. Both severe curves are on a downgrade.

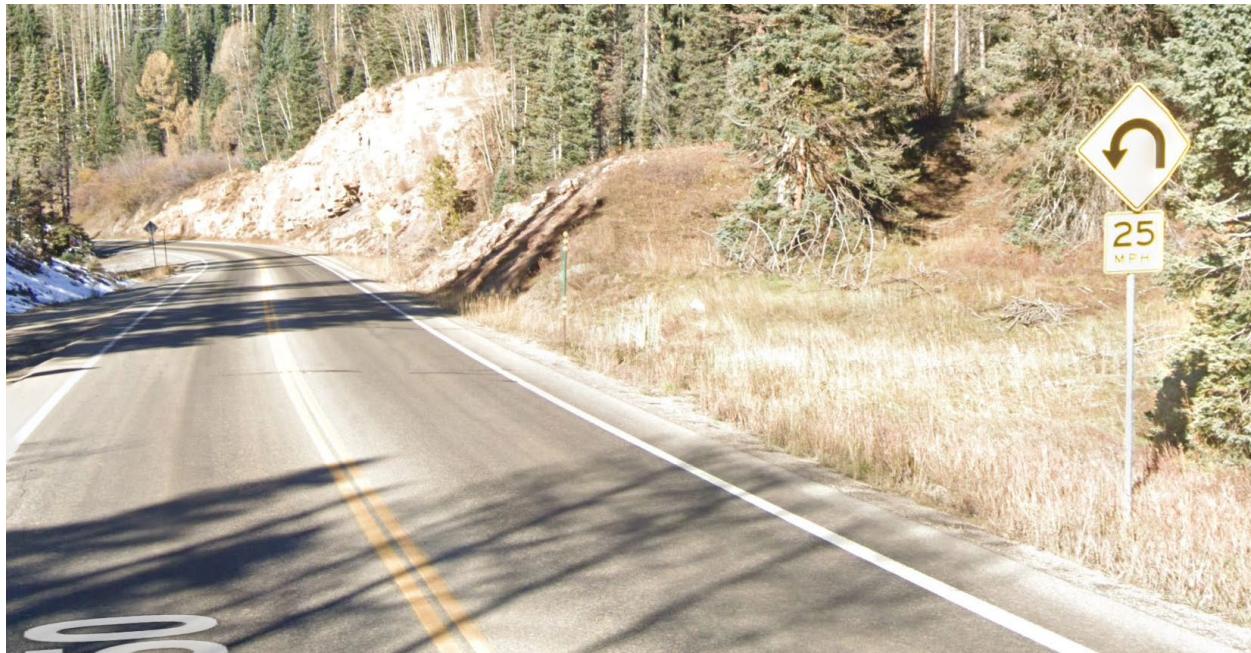
Figure 4-140: Advance Warning Approaching Hairpin Bend near MP 54 US550 SB

This points to a situation when the abrupt changes in alignment on a mountainous downgrade are creating challenging conditions for truck operators inexperienced in this driving environment, resulting in severe run-off-the-road crashes. As shown in **Figure 4-140** there is an advance warning sign for the hairpin curve with an advisory 25 mph speed limit. It is recommended that a system of enhanced warning signage be adopted to mitigate severe run-off-the-road truck crashes near MP 54 aimed at truck operators inexperienced in the mountainous environment. The addition of flashing beacons to the existing warning sign would be recommended, as seen for other warning signs on this corridor, and as seen on the Wolf Creek Pass corridor on SH-160. Additionally, the Region should consider the erection of an overturning warning sign with advisory speed and flashing beacon in advance of the current curve warning sign (see example **Figure 4-2**).

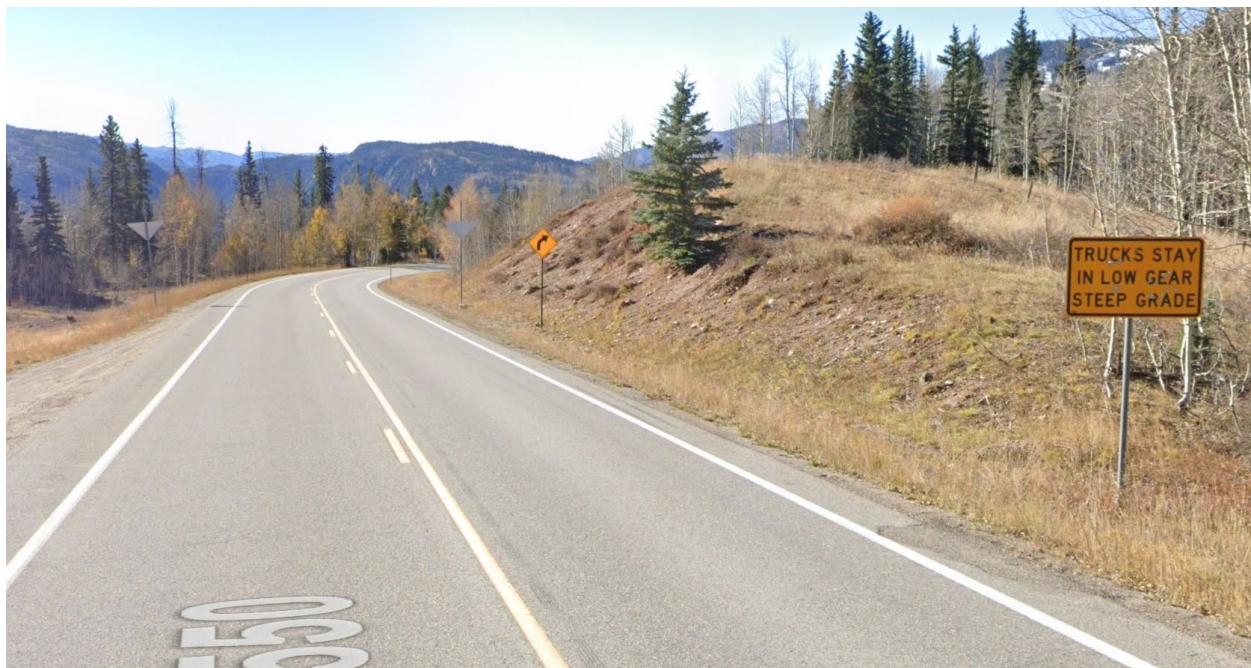
Figure 4-141: Curve & Grade Warning Signs, MP 52.30 (Approx.) US550 SB

Figure 4-141, **Figure 4-142** and **Figure 4-143**, show the advanced warning signs (in place at the time of the crashes) regarding alignment on the approach to the hairpin curve at MP 51. Despite what appears to be sufficient signage, crashes were still recorded.

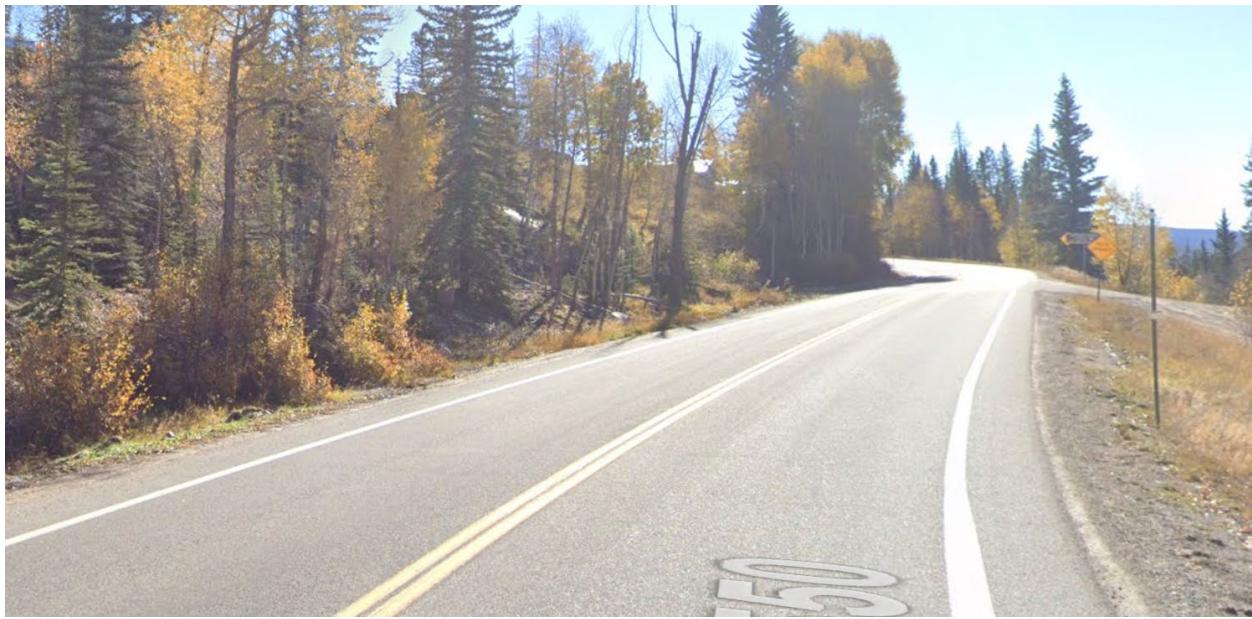
Figure 4-147: No Signs Present, US550 MP 51.40 SB (facing North), Oct. 2021

A review of available imagery indicates that sometime after October 2021 additional warning signage was erected on westbound US-550 near MP 51.40 in advance of the hairpin bend. When **Figure 4-147** is contrasted with **Figure 4-148**, it is apparent that two additional signs have been erected. Recent imagery from 2024 (**Figure 4-149**) shows that these signs include a combined hairpin curve and advisory speed warning sign, which is solar powered and outlined with LED lights, and a keep left arrow sign. Additional warning signage serves to raise conspicuity of the hairpin curve and alert drivers of the need to slow down.

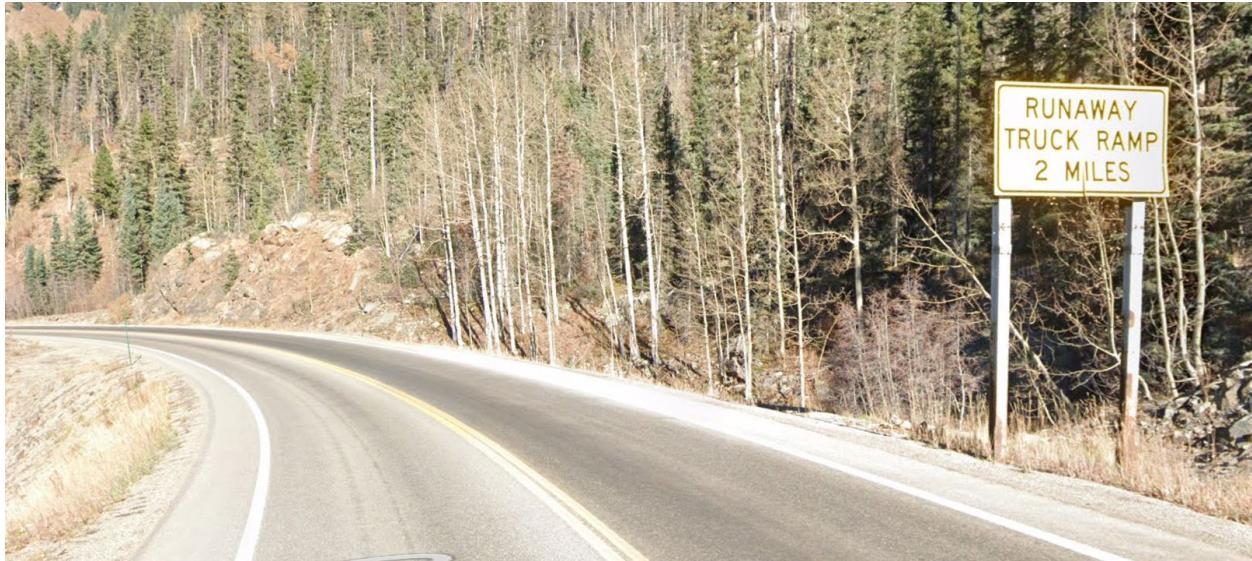
Figure 4-150: 1st Escape Ramp Sign, US550 MP 54.49 SB

Imagery indicates the first sign for the escape ramp occurs at approximately MP 54.49, 2 miles in advance of the escape ramp (**Figure 4-150**). The second warning sign occurs 1 mile downstream and 1 mile in advance of the escape ramp near MP 53.60 (**Figure 4-151**). The final warning sign for the escape ramp is near MP 52.86, warning the ramp entrance is 1,500 feet ahead, this sign, unlike the previous two, appears to be illuminated (**Figure 4-152**).

With two crashes which might have benefitted from use of the escape ramp, this emphasizes that reconsideration of the current warning and guidance signage along the corridor for truck operators should be made, moreover because the entrance to the ramp itself, being curved, is not particularly inviting for drivers. The previous recommendations made in this section would benefit run-off-the-road truck crashes westbound, especially for the unfamiliar/inexperienced driver. That is, a signing, detection and warning system similar to that employed at the Wolf Creek Pass (SH-160) would be appropriate. This would involve enhancing advance warning signs with flashing beacons and blank-outs, activated by detected runaway trucks, providing real-time feedback to truck operators, and implementation of diagrammatic “story” signs which outline in detail the location of severe curves and the truck escape ramp for truck operators, relative to their position, enabling them to make better informed decisions and adjust driving style appropriately. See **Figure 4-1**, **Figure 4-2** and **Figure 4-3** for example on Wolf Creek Pass.
