COLORADO
Department of Transportation

CDOT Office of Applied Research

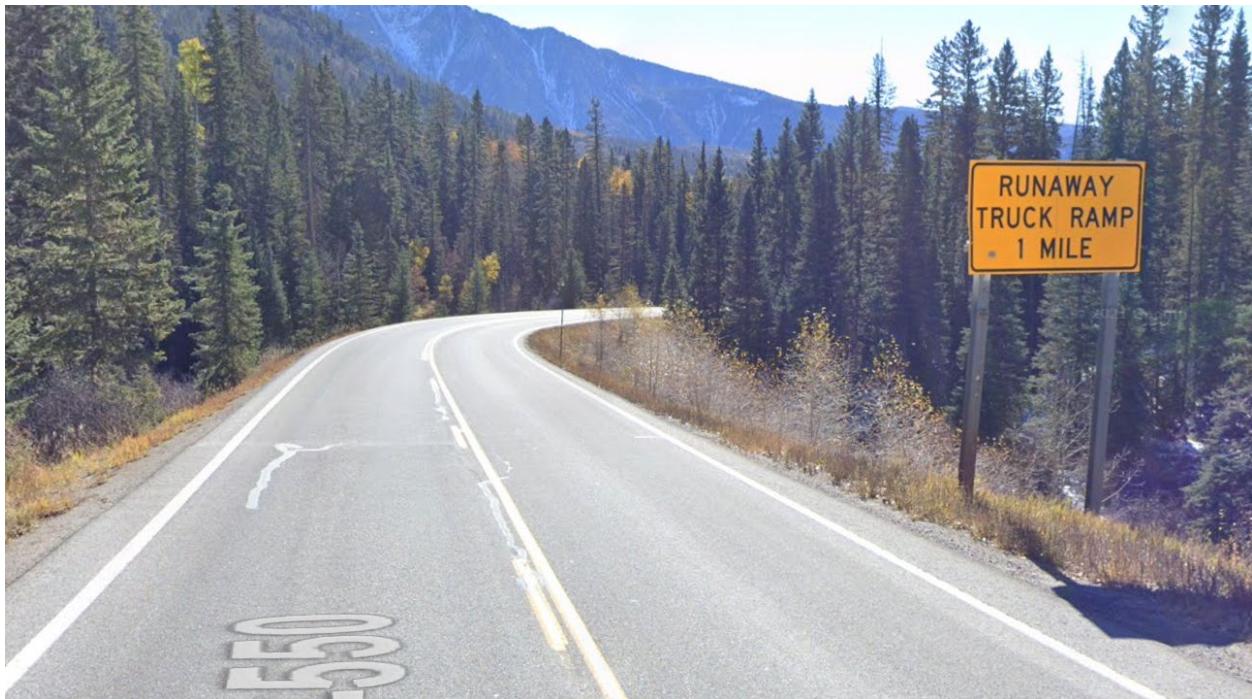
Figure 4-151: 2nd Escape Ramp Sign, US550 MP 53.60 SB

Imagery indicates the first sign for the escape ramp occurs at approximately MP 54.49, 2 miles in advance of the escape ramp (**Figure 4-150**). The second warning sign occurs 1 mile downstream and 1 mile in advance of the escape ramp near MP 53.60 (**Figure 4-151**). The final warning sign for the escape ramp is near MP 52.86, warning the ramp entrance is 1,500 feet ahead, this sign, unlike the previous two, appears to be illuminated (**Figure 4-152**).

With two crashes which might have benefitted from use of the escape ramp, this emphasizes that reconsideration of the current warning and guidance signage along the corridor for truck operators should be made, moreover because the entrance to the ramp itself, being curved, is not particularly inviting for drivers. The previous recommendations made in this section would benefit run-off-the-road truck crashes westbound, especially for the unfamiliar/inexperienced driver. That is, a signing, detection and warning system similar to that employed at the Wolf Creek Pass (SH-160) would be appropriate. This would involve enhancing advance warning signs with flashing beacons and blank-outs, activated by detected runaway trucks, providing real-time feedback to truck operators, and implementation of diagrammatic “story” signs which outline in detail the location of severe curves and the truck escape ramp for truck operators, relative to their position, enabling them to make better informed decisions and adjust driving style appropriately. See **Figure 4-1**, **Figure 4-2** and **Figure 4-3** for example on Wolf Creek Pass.

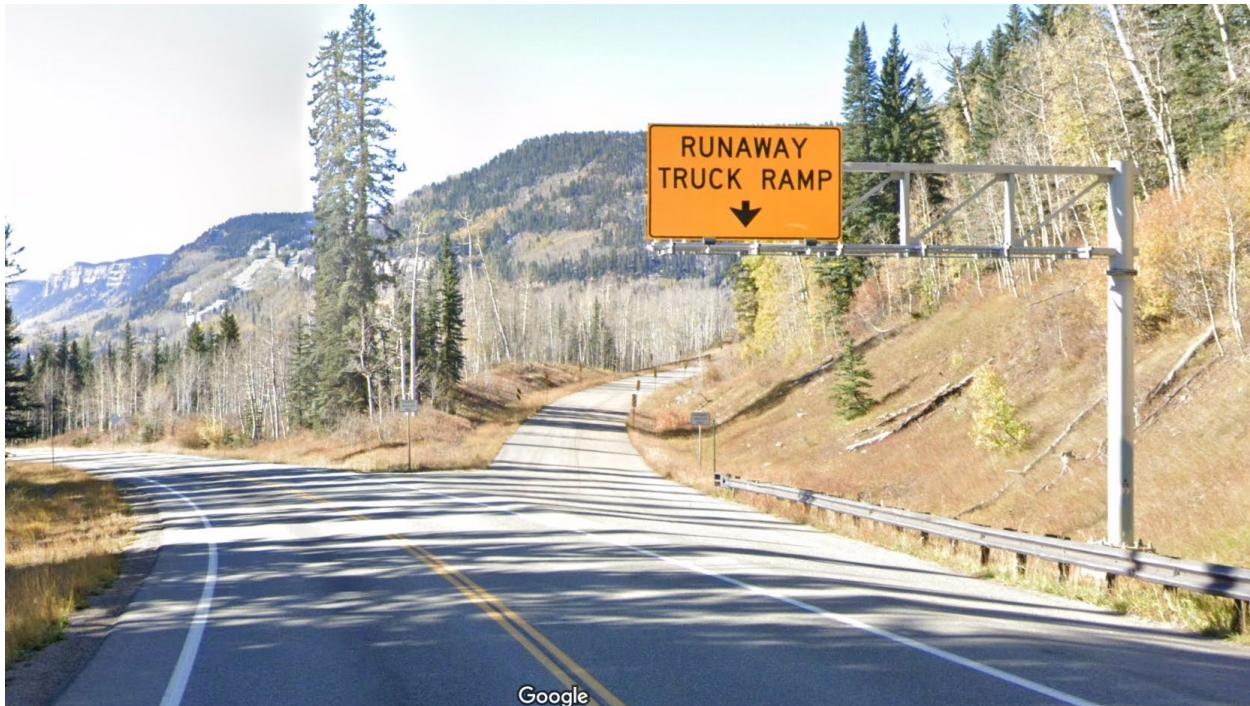
Figure 4-153: Truck Escape Ramp Entrance, US550 MP 52.50 SB

Figure 4-153 shows the entrance to the escape ramp near MP 52.50, the sign appears to be illuminated from below. This figure also shows that the ramp itself curves away from the mainline and out of the field of vision for approaching truck operators. This may cause operators to elect to not use the ramp out of fear of an unsuccessful attempt, which may result in rolling over the embankment.

There were no recorded uses of the escape ramp at MP 52.50, but one crash showed circumstances in which the ramp would have been of benefit. It involved brake failure, but why the driver did not or could not utilize the ramp was not included. When records for truck crashes back to 2007 were analyzed, they showed the same locational pattern. One additional brake failure crash was found in which the escape ramp might have been utilized but was not. Notably that the escape ramp curves away from the mainline and field of vision of truck operators, which may cause drivers to elect to not use the ramp due to a fear of unsuccessful access and overturning.

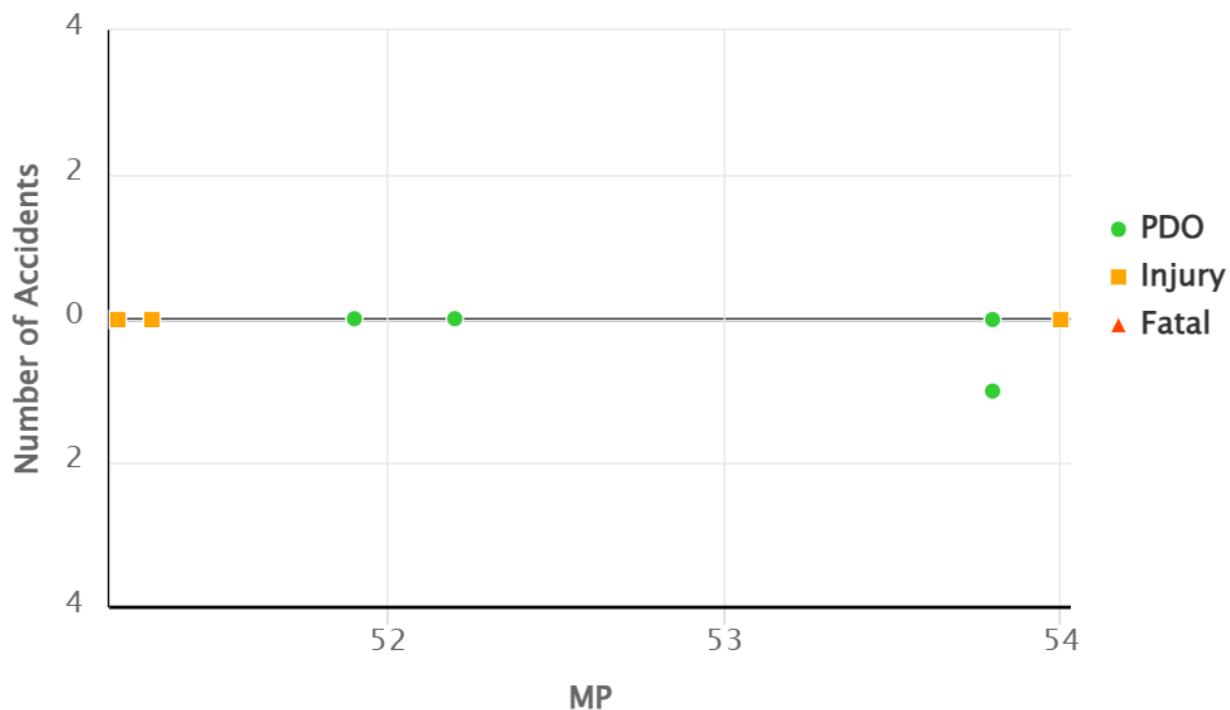
Figure 4-154: SB Truck Crashes, 2007-12, Straight Line Diagram

Figure 4-154 shows that southbound truck crashes in the 2007 through 2012 period show the same locational pattern as those in the more recent 10-year study period. That is, most crashes occurred near one of the hairpin bends, at either MP 51 or MP 54.

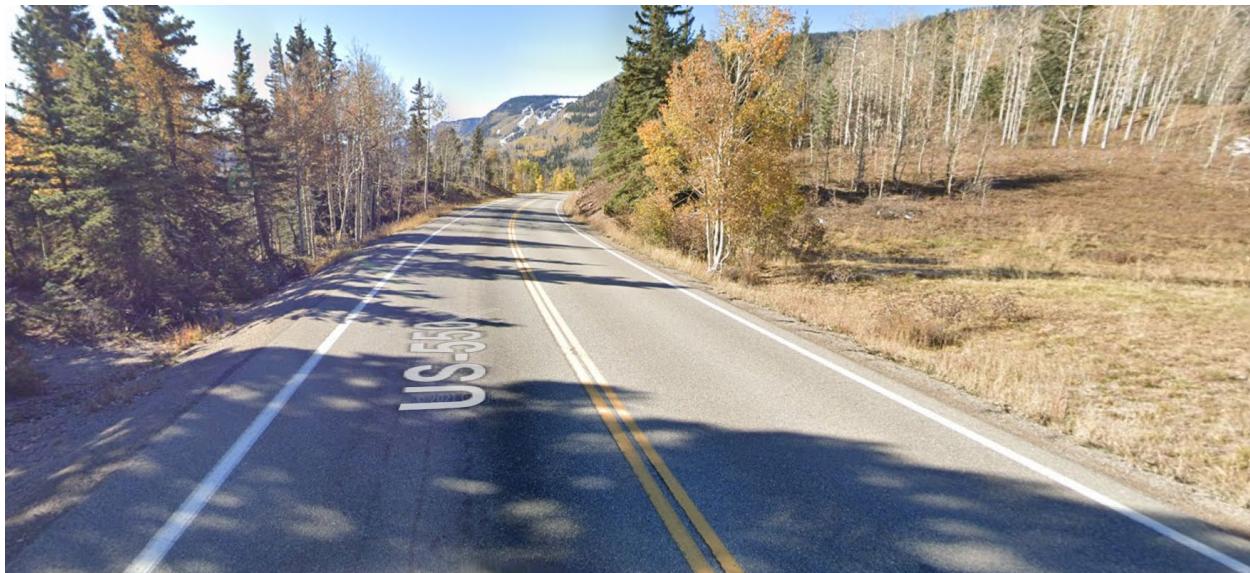
Figure 4-155: US550 MP 52.20 SB

There are no records in this period either of the truck escape ramp having been used. While initially it may appear that 2 crashes, one at MP 51.90 and one at MP 52.20, might have been candidates for use of the escape ramp, a review of the crash records rules this out. The former was a crash with a parked motor vehicle. The crash record for the latter shows that this was a guard rail crash, however there is no guard rail present, nor has there been historically, at MP 52.20 (**Figure 4-155**). It might be the case that this crash location was incorrectly recorded, and rather occurred at MP 51.20, where there is guard rail.
