DOT HS 813 734

**Special Crash Investigations:
On-Site Ambulance Crash
Investigation;
Vehicle: 2019 Ford E-350 Type III
Ambulance;
Location: Georgia;
Date: November 2022**

Special Crash Investigations
On-Site Ambulance Crash Investigation
Case Number: CR22017
Vehicle: 2019 Ford E-350 Type III Ambulance
Location: Georgia
Crash Date: November 2022

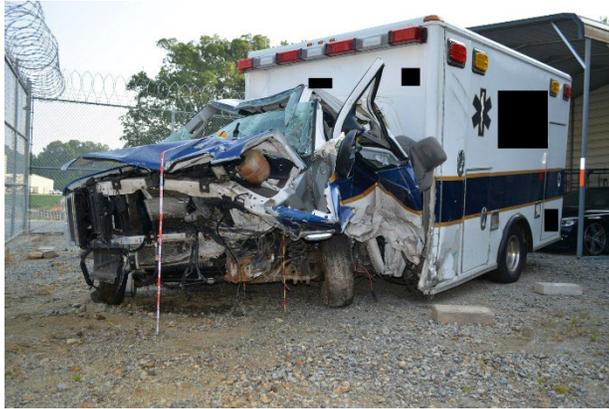
Figure 1. Front left oblique view of the ambulance

This report documents the on-site investigation of the fatal frontal off-set crash of a 2019 Ford E-350 configured as a Type-III ambulance (Figure 1), a 1996 Ford Mustang, and a 2002 Dodge Ram 1500 pickup truck. The crash was identified by the National Highway Traffic Safety Administration's Office of Emergency Medical Services in November 2022 via news media sources. The notification was forwarded to the Special Crash Investigations (SCI) group and assigned for on-site investigation by the SCI team at Crash Research & Analysis Inc. the same month. The SCI team contacted the police department to obtain a police crash report and determine cooperation for an investigation. However, due to pending litigation resulting from the crash and the open police investigation, the authorization to inspect the vehicles did not occur until June 2023.

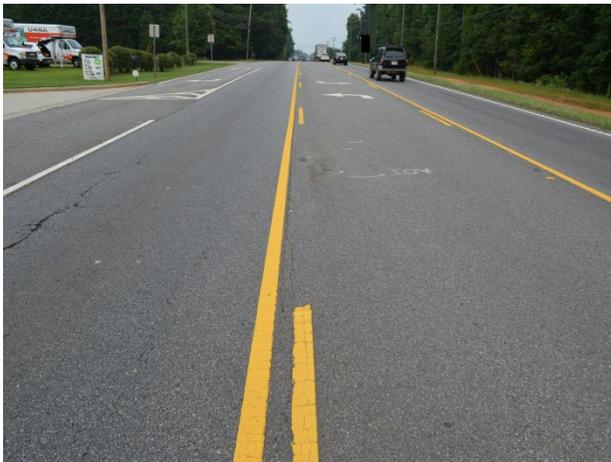
Figure 2. Looking east at the crash area

The crash occurred at 6:51 a.m. on a four-lane east-west undivided roadway. At the time of the crash the National Weather Service reported conditions as fair with a temperature of 1.1°C (34°F), 73 percent humidity, and northwesterly winds of 12.8 km/h (8 mph). The roadway was straight, constructed of bituminous asphalt (Figures 2 and 3) and had one eastbound lane, two westbound lanes, and a common center two-way left turn lane. The right-most westbound lane was for traffic turning into a business located on the north side of the road.

All travel lanes were 3.4 m (11.0 ft) wide. There was a positive 3 percent grade in the eastbound direction. The posted speed limit was 89 km/h (55 mph). The crash was recorded by security cameras located on the north side of a business. The footage and photos of the crash have been uploaded to the Crash Data Acquisition Network. A crash diagram is attached to this report.

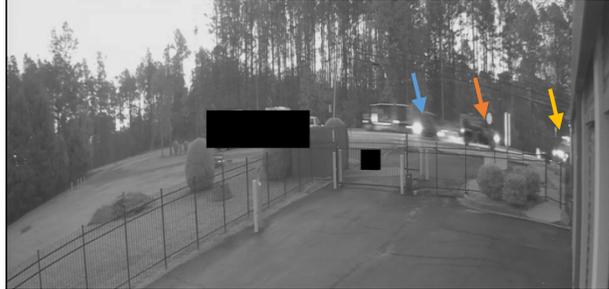
The ambulance was traveling east in the center two-way left turn lane with its emergency lights and sirens activated and was en route to an emergency scene at an EDR-reported speed of 107 km/h (66.5 mph) 5 seconds prior to algorithm enabled (AE). The Mustang was traveling west following a tanker truck and was being followed by the Dodge Ram. The tanker truck slowed and steered to the right giving way to the ambulance traveling up the hill. The Mustang steered left around the tanker truck and crossed into the center two-way left turn lane (Figures 4 and 5).

Figure 4. Looking south from camera 2 viewing the pre-crash positions of the vehicle. Blue arrow shows the Mustang, red arrow shows the box truck, and the yellow arrow shows the ambulance entering the frame.

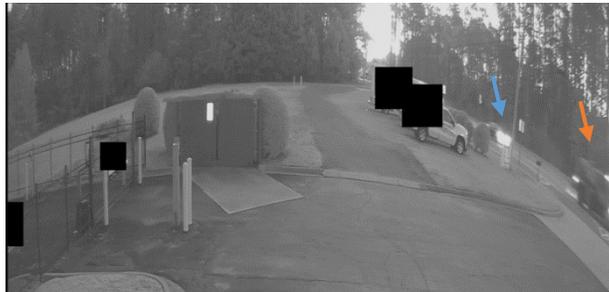
Figure 5. Looking east from camera 1 viewing the Mustang (blue arrow) and box truck (red arrow)

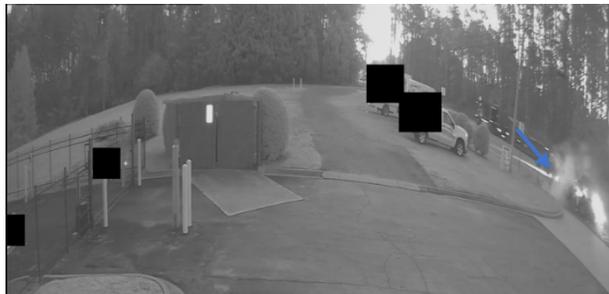
The redirected Mustang rotated approximately 180° counterclockwise. The Dodge Ram then struck the right side of the Mustang. The Mustang came to final rest against the Ram in the west right-turn lane (Event 3, Figures 8 and 9).

Figure 9. Looking east from camera 1 and viewing Event 3 (blue arrow)

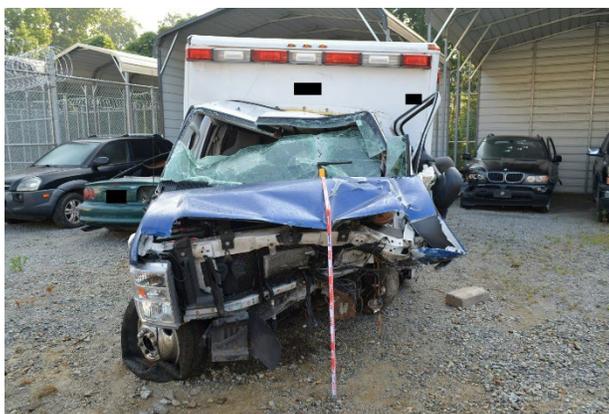
Figure 10. Viewing the front of the ambulance

The 2019 Ford E-350 type III ambulance (Figure 10) was identified by the Vehicle Identification Number (VIN) 1FDWE3FS0KDxxxxxx. The 2-door van-based vehicle was manufactured as an incomplete unit in 2019 and was then fitted to a previously used ambulance compartment in May 2019 as evidenced by the secondary manufacturers label. Due to the impact with the Mustang, the left front corner/door was crushed, and the primary manufacturer's label could not be documented. Constructed on a 370 cm (145.6 in) wheelbase, the ambulance had a 6.8-liter, V10 gasoline engine linked to an automatic transmission. The ambulance did not have any crash avoidance equipment. At the time of the SCI inspection, the ambulance had Maxxis Bravo Commercial LT225/75R16 tires on the front axle left rear and right rear inside tire positions and a Firestone TransForce HT2 LT225/75R16 tire on the right rear outer tire position. All tires were mounted on original equipment manufacturer aluminum alloy wheels with stainless steel hubs. All tire tread depths measured 5 mm (6/32 in) or greater. The ambulance gross vehicle weight rating (GVWR) label could not be documented due to damage to the driver's door. The search of the VIN revealed the GVWR of the ambulance chassis (excluding the ambulance box) ranged from 4,536 to 6,350 kg (10,001–14,000 lb).

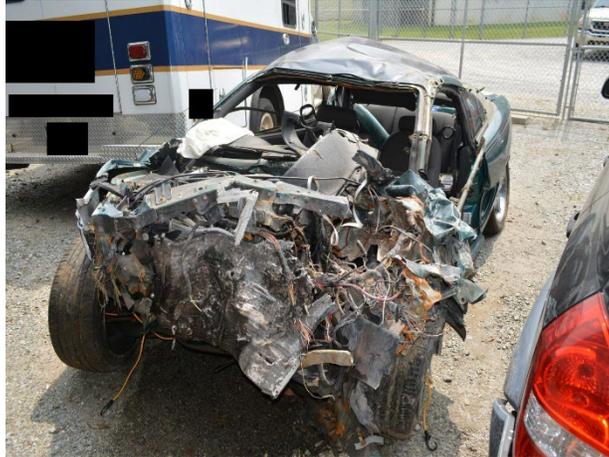
Figure 17. Left front oblique view of the Mustang

The 1996 Ford Mustang GT was a 2-door coupe (Figure 17) manufactured in August 1995 and identified by the VIN 1FALP42X9TFxxxxxx. The vehicle had a 257 cm (101.2 in) wheelbase powered by a 4.6-liter, V8-cylinder gasoline engine linked to a 5-speed manual transmission with rear-wheel drive. The service brakes were power-assisted four-wheel disc systems. Steering was a hydraulic rack-and-pinion system. The Mustang did not have any crash avoidance features.

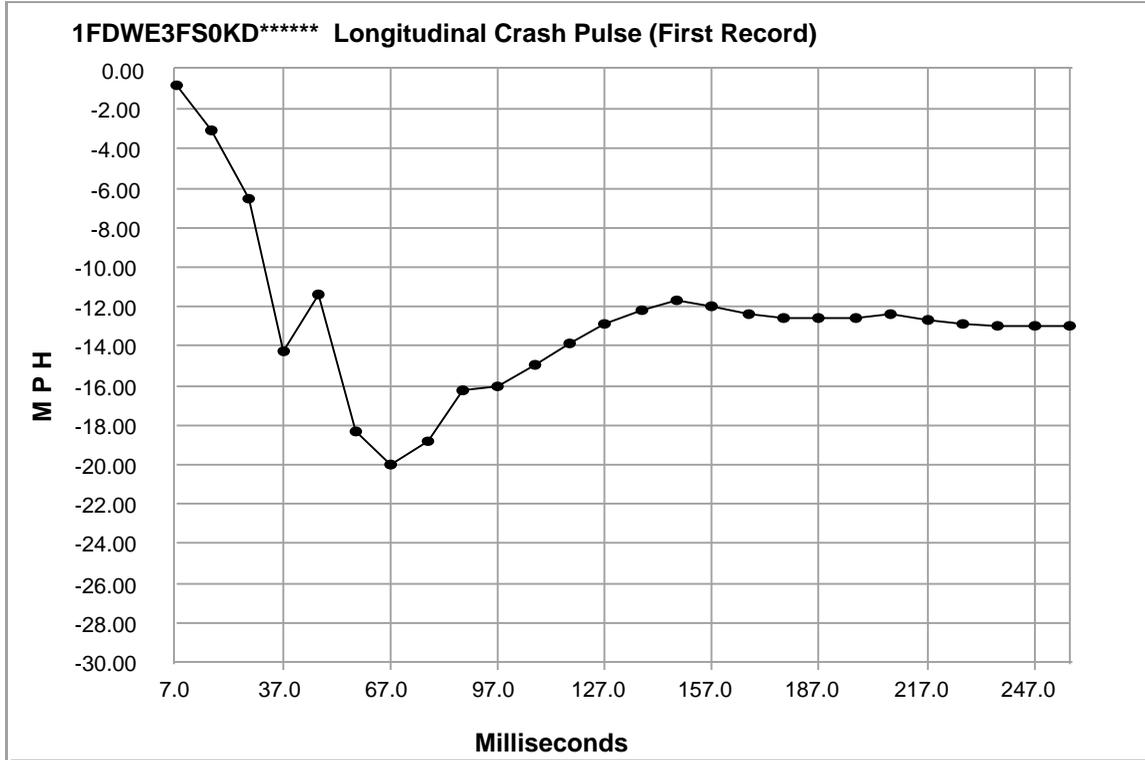
Longitudinal Crash Pulse (First Record)

Time (msec)	Delta-V, longitudinal (MPH)	Delta-V, longitudinal (km/h)
7.0	-0.79	-1.28
17.0	-3.06	-4.93
27.0	-6.58	-10.59
37.0	-14.28	-22.98
47.0	-11.35	-18.27
57.0	-18.31	-29.47
67.0	-20.04	-32.25
77.0	-18.79	-30.24
87.0	-16.25	-26.16
97.0	-16.02	-25.78
107.0	-14.92	-24.02
117.0	-13.84	-22.27
127.0	-12.86	-20.69
137.0	-12.23	-19.68
147.0	-11.69	-18.81
157.0	-11.94	-19.22
167.0	-12.33	-19.85
177.0	-12.56	-20.21
187.0	-12.61	-20.30
197.0	-12.55	-20.19
207.0	-12.42	-19.99
217.0	-12.70	-20.43
227.0	-12.91	-20.78
237.0	-12.97	-20.88
247.0	-12.92	-20.80
257.0	-12.98	-20.90

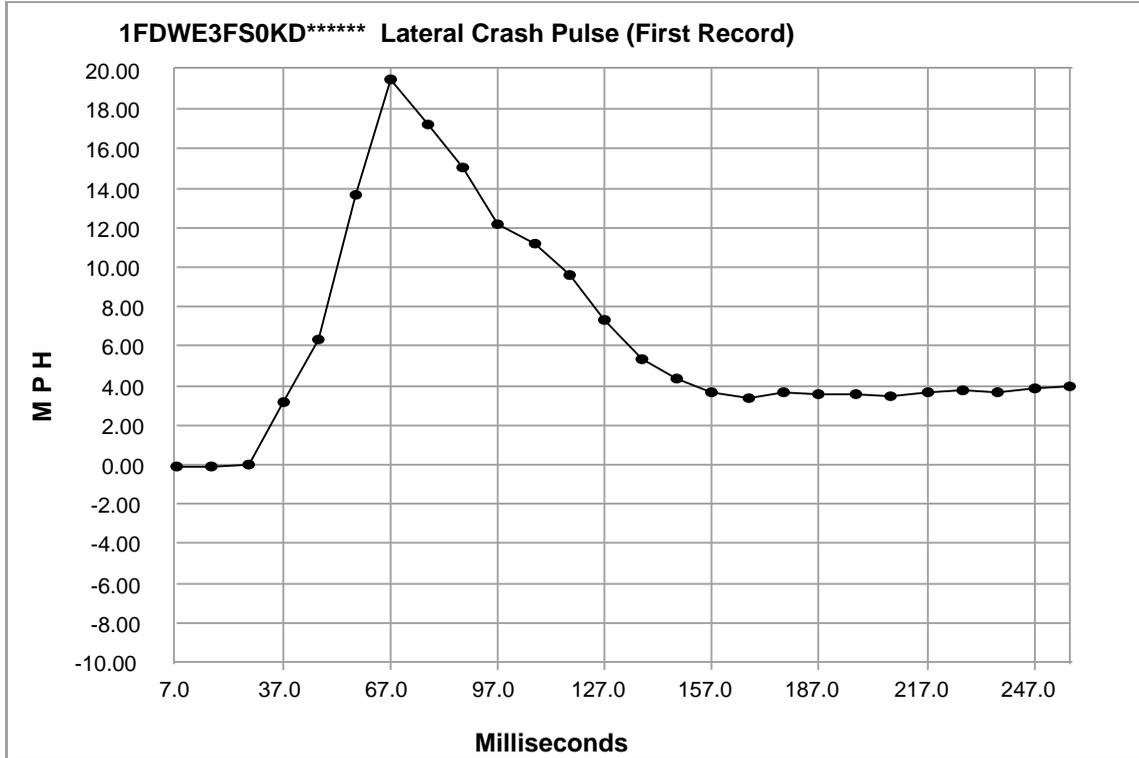
Lateral Crash Pulse (First Record)

Time (msec)	Delta-V, lateral (MPH)	Delta-V, lateral (km/h)
7.0	-0.07	-0.11
17.0	-0.08	-0.13
27.0	-0.01	-0.02
37.0	3.20	5.16
47.0	6.29	10.13
57.0	13.65	21.96
67.0	19.55	31.46
77.0	17.27	27.79
87.0	15.01	24.15
97.0	12.14	19.54
107.0	11.24	18.09
117.0	9.56	15.39
127.0	7.30	11.75
137.0	5.31	8.54
147.0	4.33	6.97
157.0	3.67	5.90
167.0	3.38	5.43
177.0	3.67	5.91
187.0	3.53	5.68
197.0	3.55	5.72
207.0	3.48	5.59
217.0	3.62	5.82
227.0	3.80	6.12
237.0	3.69	5.94
247.0	3.81	6.14
257.0	3.97	6.40

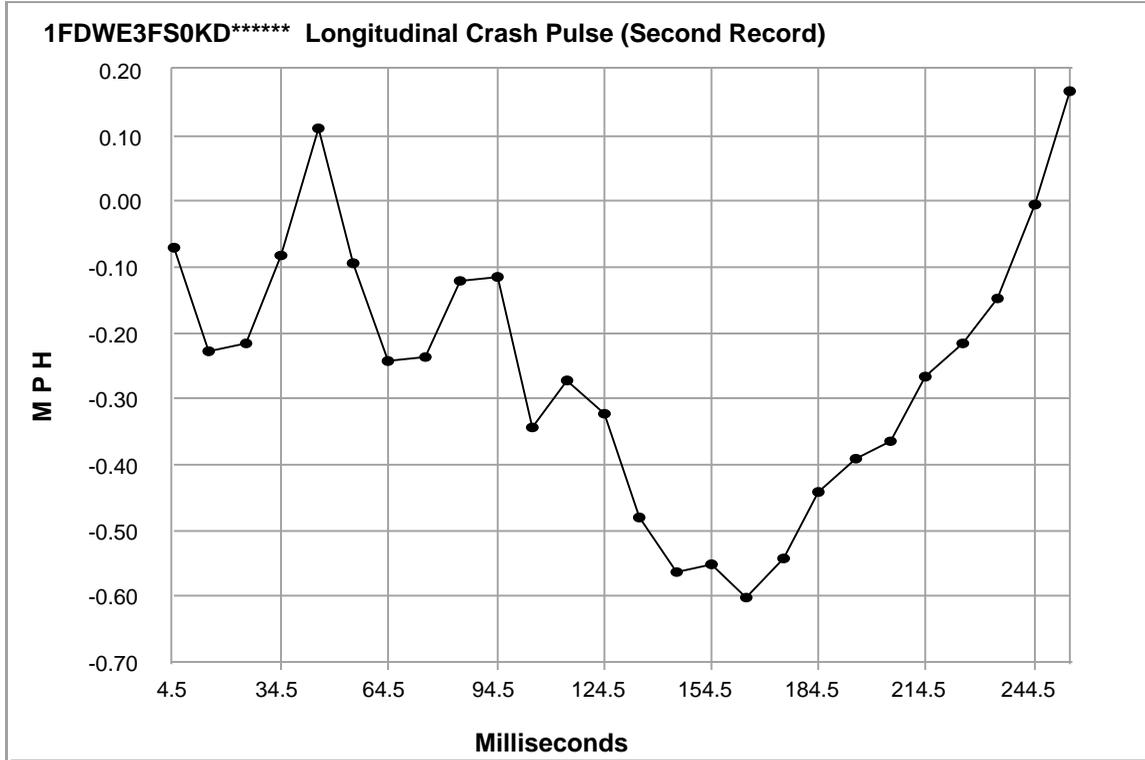
Longitudinal Crash Pulse (Second Record)

Time (msec)	Delta-V, longitudinal (MPH)	Delta-V, longitudinal (km/h)
4.5	-0.07	-0.11
14.5	-0.23	-0.37
24.5	-0.21	-0.35
34.5	-0.08	-0.13
44.5	0.11	0.18
54.5	-0.10	-0.15
64.5	-0.24	-0.39
74.5	-0.24	-0.38
84.5	-0.12	-0.19
94.5	-0.11	-0.18
104.5	-0.34	-0.55
114.5	-0.27	-0.44
124.5	-0.32	-0.52
134.5	-0.48	-0.77
144.5	-0.56	-0.91
154.5	-0.55	-0.89
164.5	-0.60	-0.97
174.5	-0.54	-0.87
184.5	-0.44	-0.71
194.5	-0.39	-0.63
204.5	-0.37	-0.59
214.5	-0.27	-0.43
224.5	-0.21	-0.35
234.5	-0.15	-0.24
244.5	-0.01	-0.01
254.5	0.17	0.27

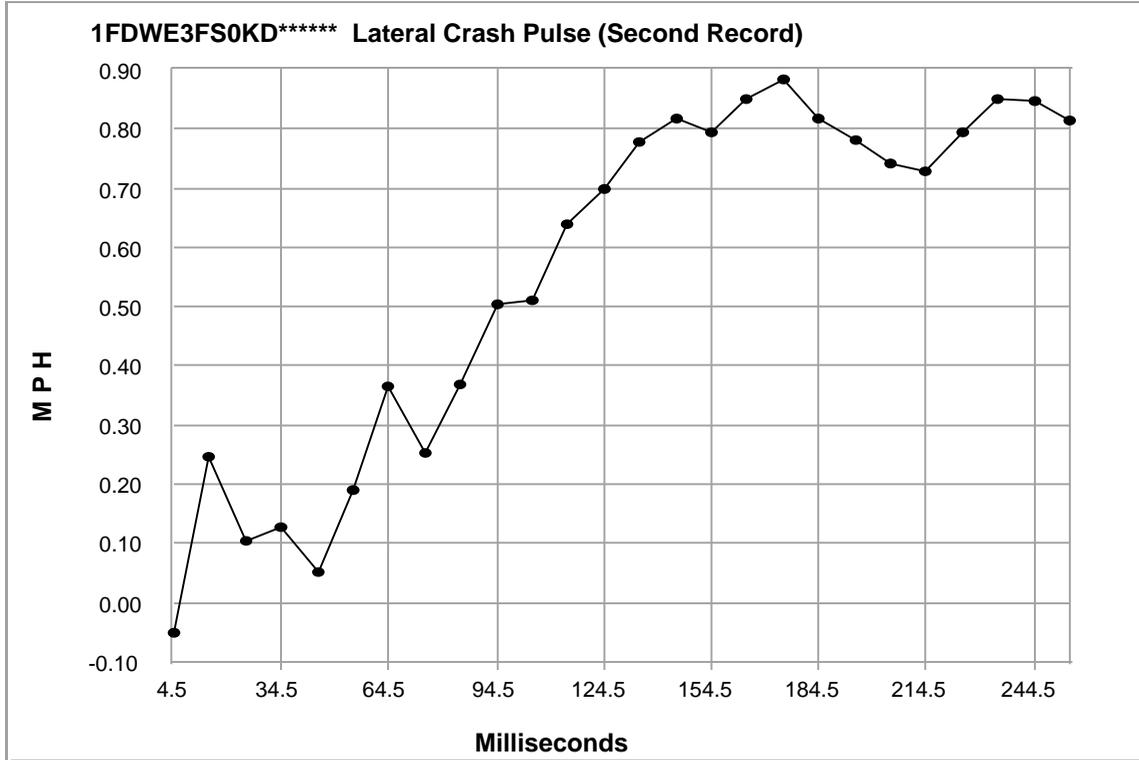
Lateral Crash Pulse (Second Record)

Time (msec)	Delta-V, lateral (MPH)	Delta-V, lateral (km/h)
4.5	-0.05	-0.08
14.5	0.25	0.40
24.5	0.10	0.17
34.5	0.13	0.20
44.5	0.05	0.08
54.5	0.19	0.31
64.5	0.37	0.59
74.5	0.25	0.41
84.5	0.37	0.59
94.5	0.51	0.81
104.5	0.51	0.82
114.5	0.64	1.03
124.5	0.70	1.12
134.5	0.78	1.25
144.5	0.82	1.32
154.5	0.79	1.28
164.5	0.85	1.37
174.5	0.88	1.42
184.5	0.82	1.31
194.5	0.78	1.26
204.5	0.74	1.19
214.5	0.73	1.17
224.5	0.80	1.28
234.5	0.85	1.37
244.5	0.85	1.36
254.5	0.81	1.31
