FIELD PERFORMANCE EVALUATION OF SELF-LEVELLING SEALANTS DOW CORNING 888-SL AND 890-SL

Gary G. Williams, P.E.
Research Project Manager

April, 1995

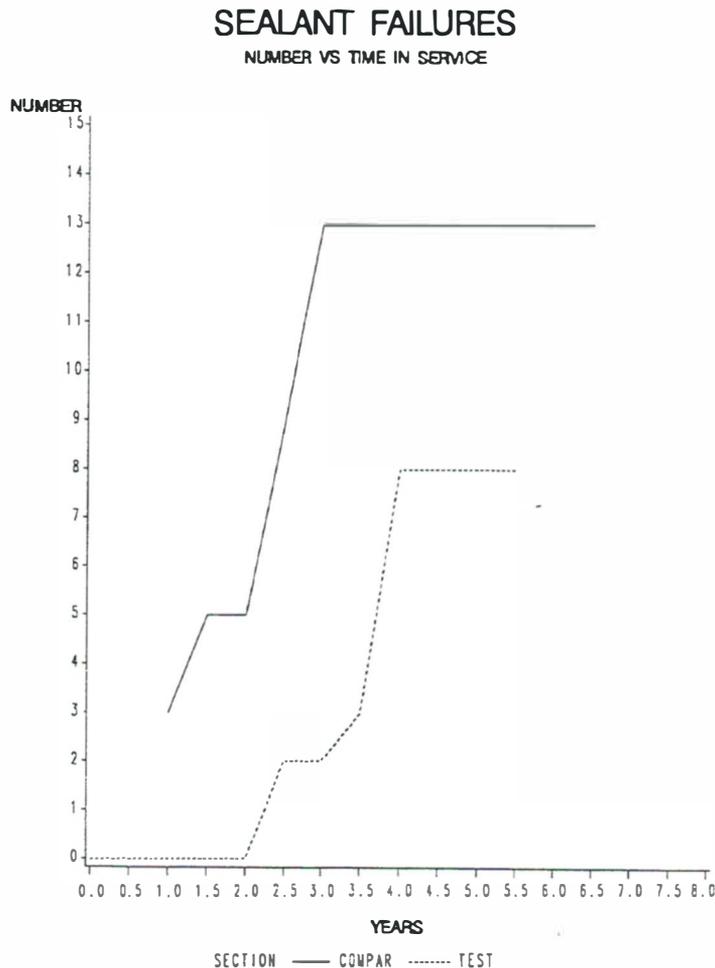
Figure 5. Failures vs. Time, Test Section and Comparison Section 1.

On the date of the final survey of this location (5-11-94) eight sealant failures had occurred. Of these, two were cohesion failures. The cohesion failures had the appearance of holes (approximately 1/4 inch diameter) through the sealant down to the backer rod. Six adhesion failures were also observed. All were located in the outside edge line joint. Adhesion failures were one inch and two inches long. The adhesion failures began to appear when the sealant had been in service for 3.5 years. Two of the adhesion failures were located where thermoplastic striping crossed the sealed joint.

By the end of the evaluation period, 13 failures were observed in this section. Nine of these were adhesion failures. Six of the failures were located in the outside edge line joint. The remainder were randomly located in the transverse joints on the shoulders. There were also four cohesion failures, which appeared as (1/4 - 3/8 inch diameter) holes through the sealant. The holes extended down to the backer rod.

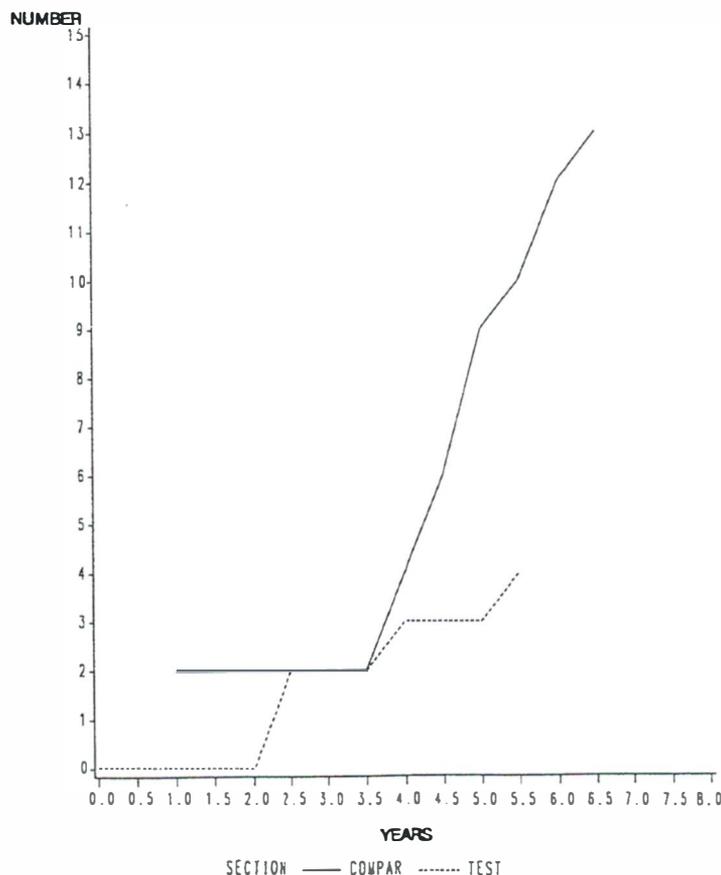
Figure 6. Failures vs. Time. Test Section and Comparison Section 2.

This section was last surveyed on May 11, 1994. At that time, four failures were observed (Two adhesion and two cohesion failures). All failures were located in the outside edge line joint.

Of 13 failures observed during the last survey, 10 were adhesion failures. The majority of the adhesion failures were located in the edge line joints. Nine of these failures were located in the outside edge line joint, with one in the inside joint. Lengths of adhesion failures ranged from one inch (2.54 cm) to one foot (30.48 cm).

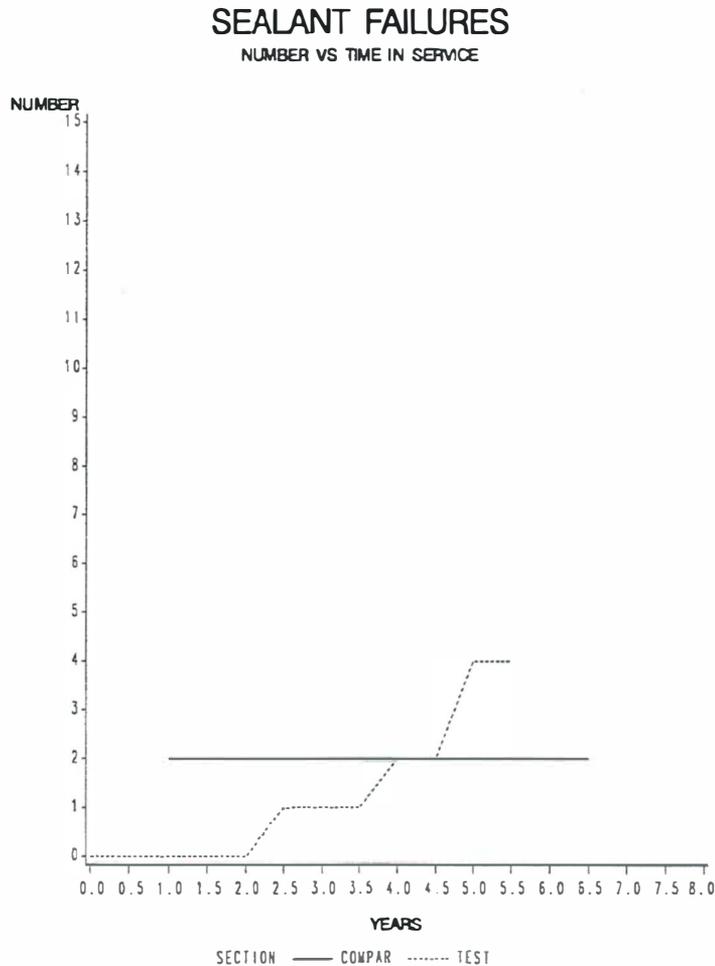
Figure 7. Failures vs. Time, Test and Comparison Sections 3.

Four failures had occurred in this section by the date of the final survey (May 11, 1994). Three of these were adhesion failures of the sealant in the edge line joint. All were approximately two inches long. In one localized area, there were three holes (each approximately 1/4 inch diameter) within one foot of each other.

Only two cohesion failures were noted in this section by the time of the final survey (May 11, 1994). These had the appearance of holes (approximately 1/2 inch diameter) through the sealant, down to the backer rod. Both failures were located in intersections of edge line joints and transverse joints in shoulders.

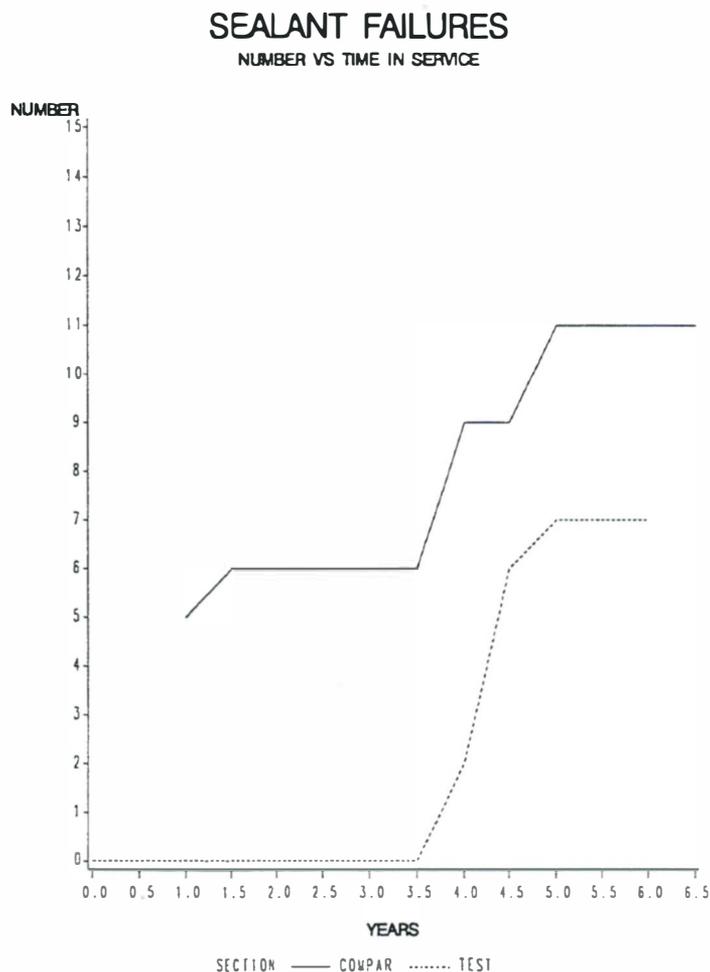
Figure 10. Failures vs. Time, Test Section and Comparison Section 1.

At the time of the final survey on this project (June 3, 1994), this section had seven adhesion failures (no other types of failure observed). Lengths of failures ranged from one inch to six inches. Four of these had failed on both sides of the sealant. This allowed the sealant to drop down into the joint in the failed area (Figure 13). All of the failures in this section were in locations where thermoplastic striping crossed a sealed joint (Figure 14). The failures were first observed when the sealant had been in service three and one half years.

Eleven failures had occurred in this section by the time of the final survey. Five of these were cohesion failures, appearing as 3/8 inch (0.9525 cm) diameter holes through the sealant). All of the failures of this type occurred at the intersection of transverse joints and longitudinal edge line joint. One failure was a three-inch-long cohesion failure that had the appearance of a split in the sealant. The other three were adhesion failures occurring where thermoplastic striping crossed joints (Figure 15).

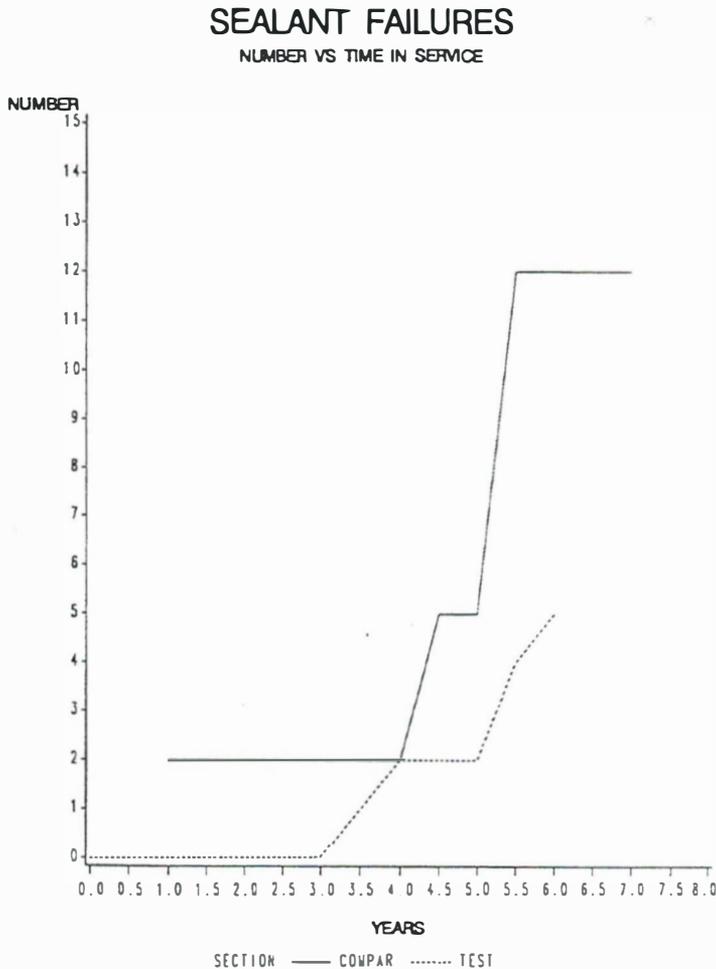
Figure 11. Failures vs. Time, Test Section and Comparison Section 2.

During the final survey (May 11, 1994), five failures were located in this section. Four of these were cohesion failures appearing as "holes" (approximately 1/2 inch diameter). The one adhesion failure was located where thermoplastic striping crossed a transverse joint.

The final survey noted twelve failures in this section. Nine of these were adhesion failures occurring where thermoplastic striping crossed transverse joints. The remaining failures were an adhesion failure (not located at a stripe) and two 1/2 inch diameter holes (cohesion failures) through the sealant.

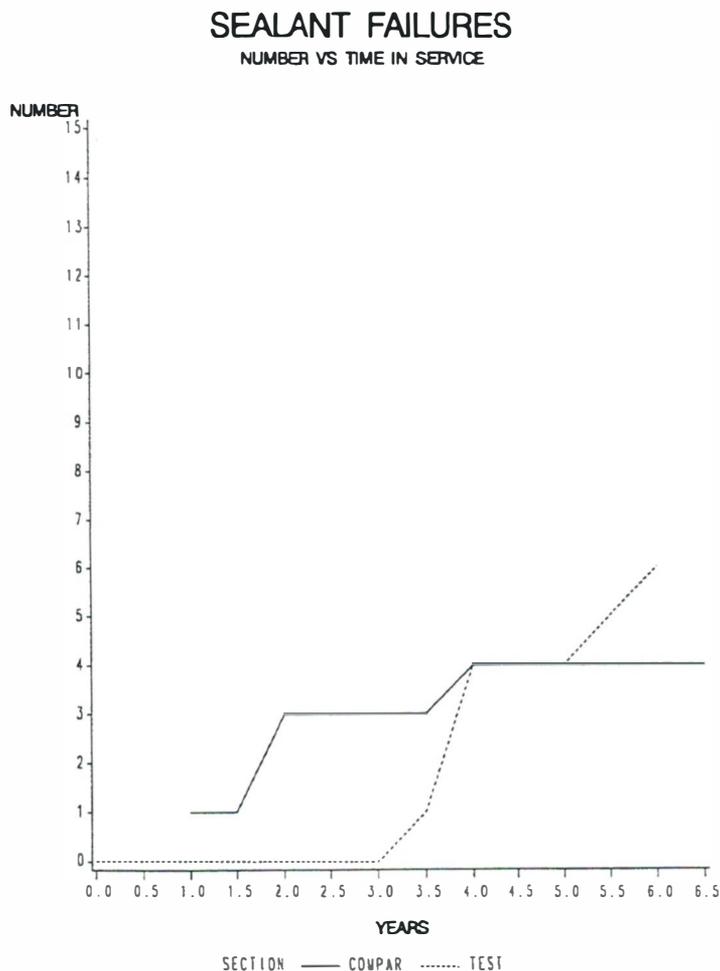
Figure 12. Failures vs. Time, Test Section and Comparison Section 3.

During the final survey (May 11, 1994), a total of six failures were noted in this section. Of these, four were cohesion failures appearing as 3/8 inch (0.9525 cm) diameter holes through the sealant. The holes extended down to the backer rod (Figure 16). The remaining two were adhesion failures. One was located where thermoplastic striping crossed a transverse joint. The other was located in the outside wheel path.

All four of the failures in this section were cohesion type, appearing as 3/8 inch (0.9525 cm) diameter holes. The holes extended down to the backer rod. Three of the failures were located at intersections of transverse and longitudinal joints. The remaining failure was located where thermoplastic striping crossed a transverse joint.

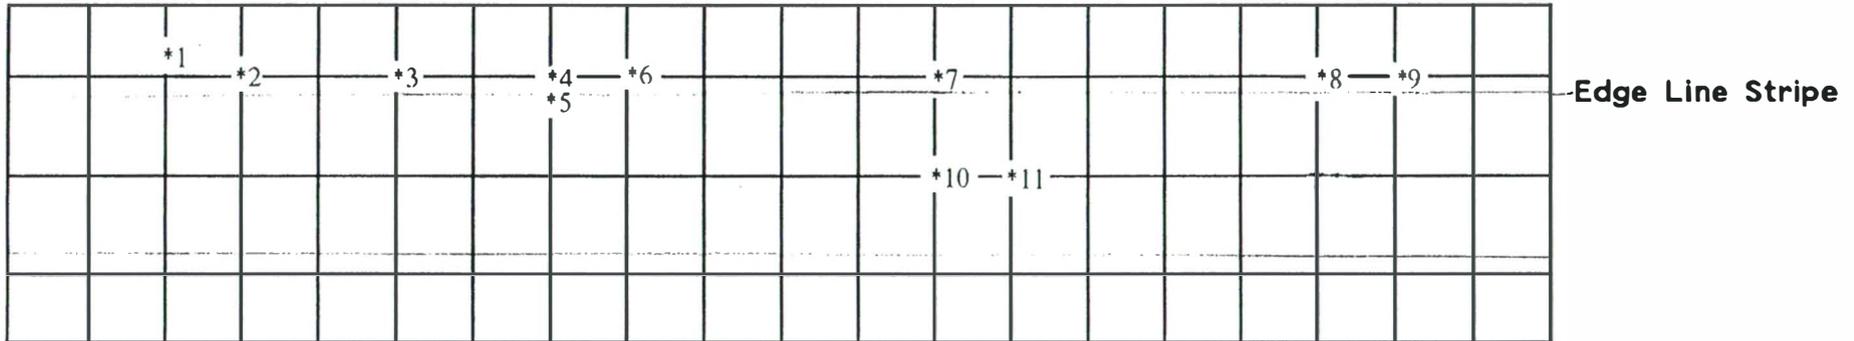
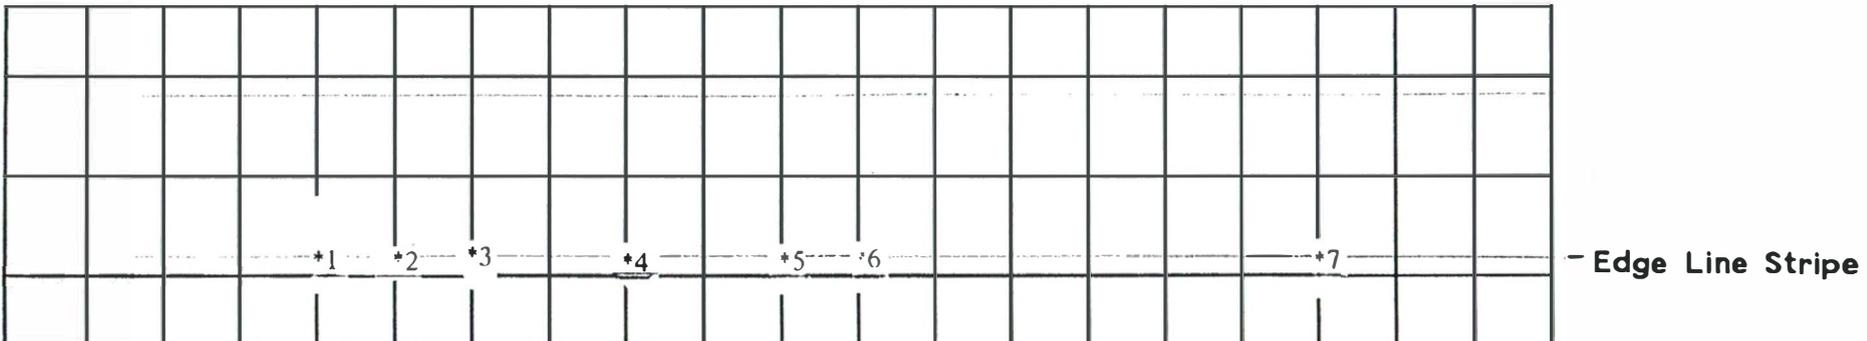
Test Section 1.

Begins at north end of approach slab, 116th St. Overpass Bridge, extends 20 slabs north.

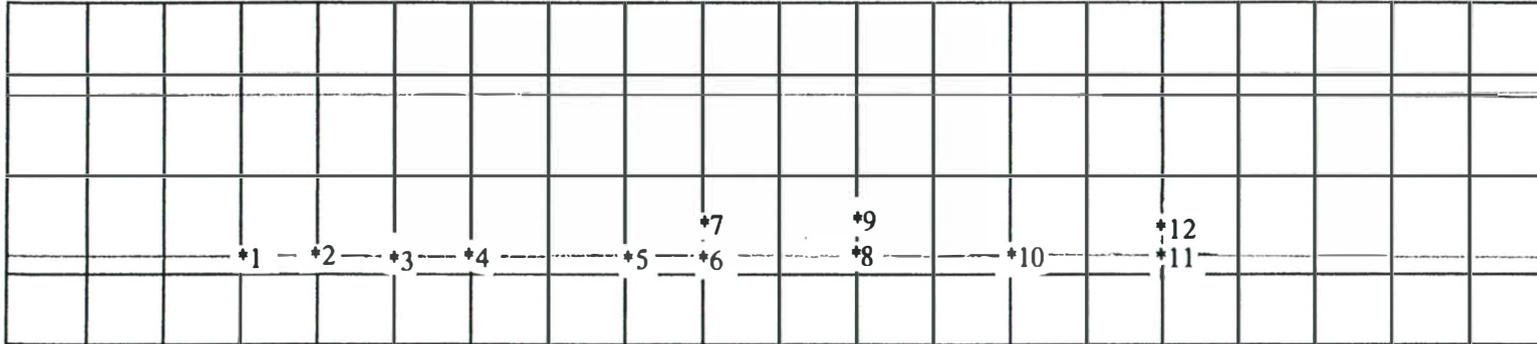
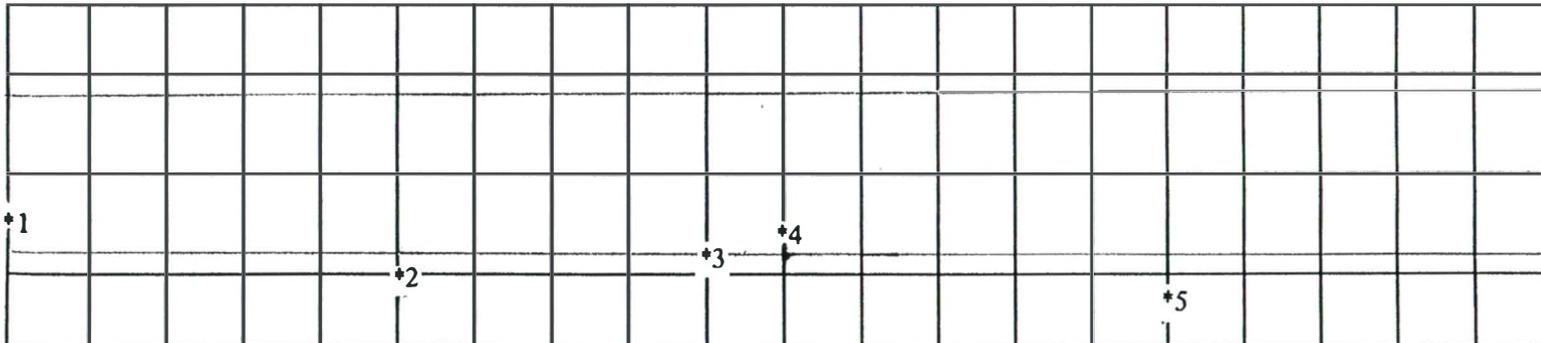
Test Section 2.

Consists of 20 slabs adjacent to main line. On exit ramp to 106th St.

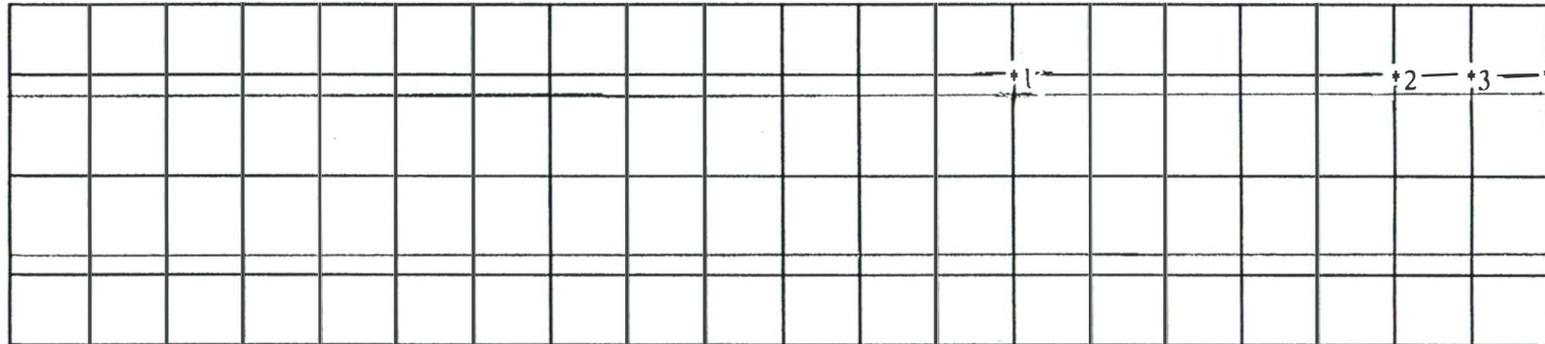
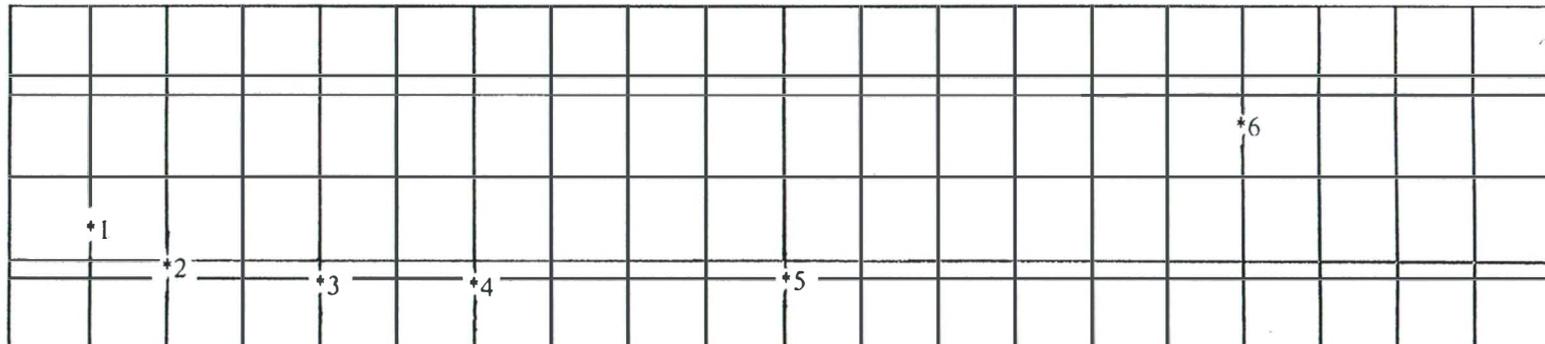
Test Section 3.

Located in 106th St. Entrance Ramp. Begins at first slab adjacent to main line, extends 20 slabs south (into ramp).
