Bridge Deck Thermography Verification and Policy

WisDOT ID no. 0092-23-04

September 2024

TECHNICAL REPORT DOCUMENTATION PAGE

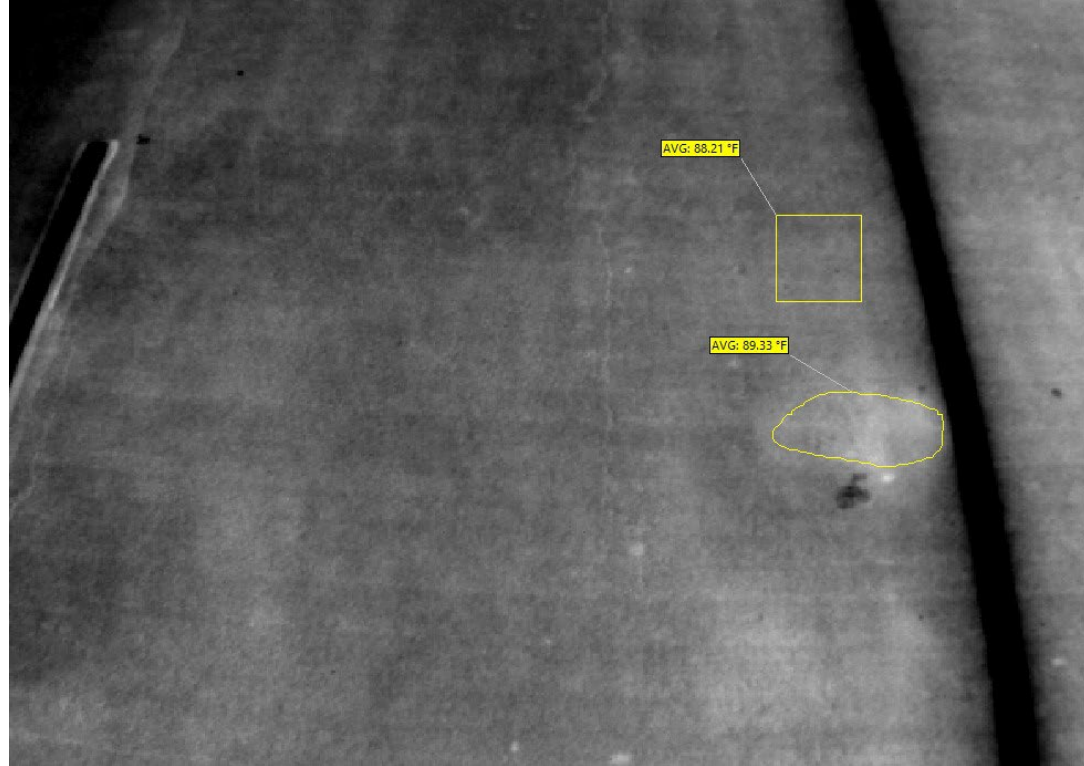
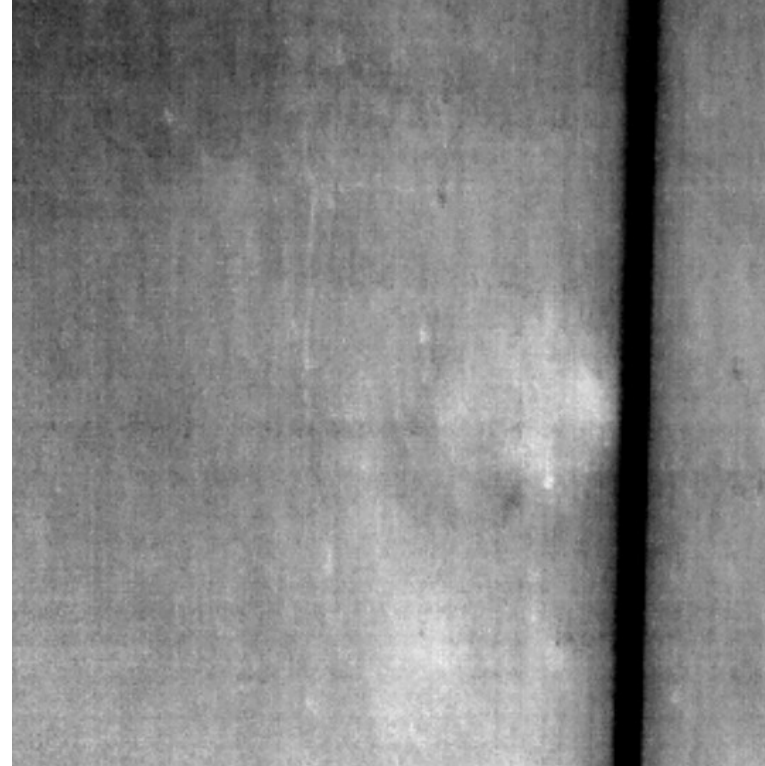
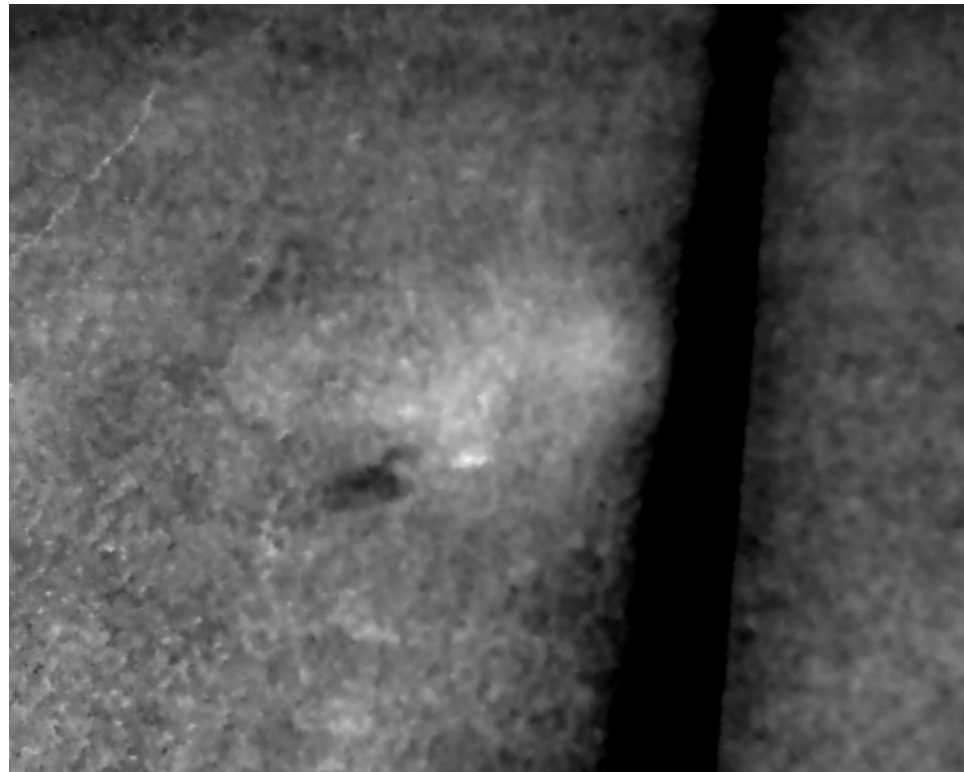
Infrared Thermography Method Comparison Images – Defect 1

Vehicle Mounted IR Camera

Drone IR Camera (collection height: 25 ft)

Drone IR Camera (collection height: 200 ft)

Handheld IR Camera

Fixed Wing – Aerial IR Camera (collection altitude: 1000 ft)

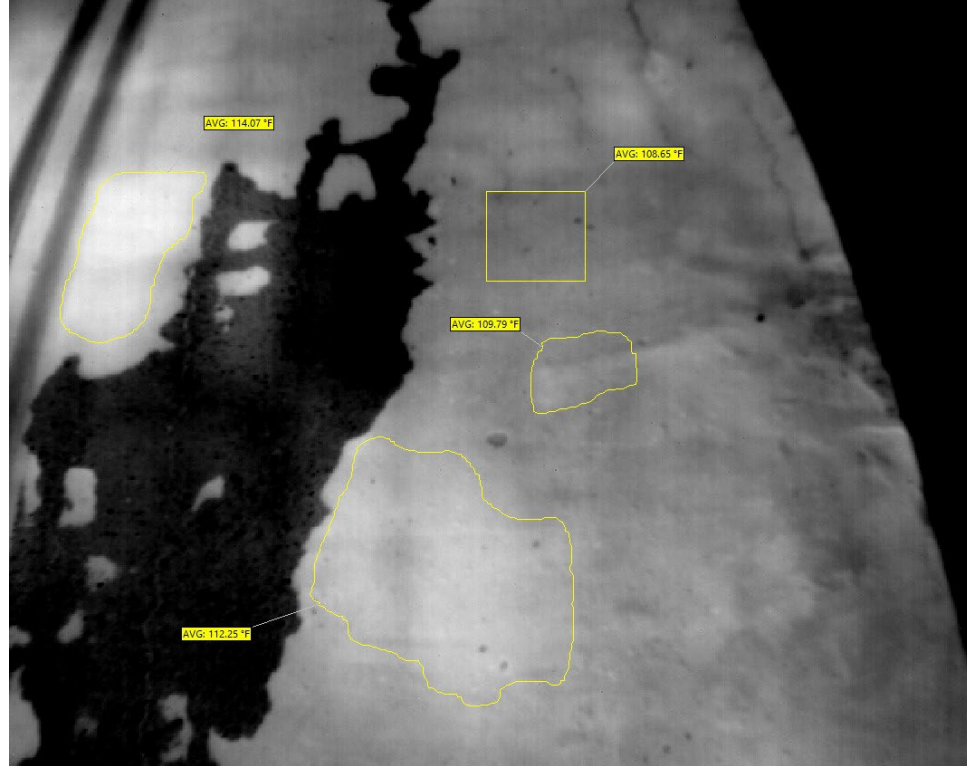
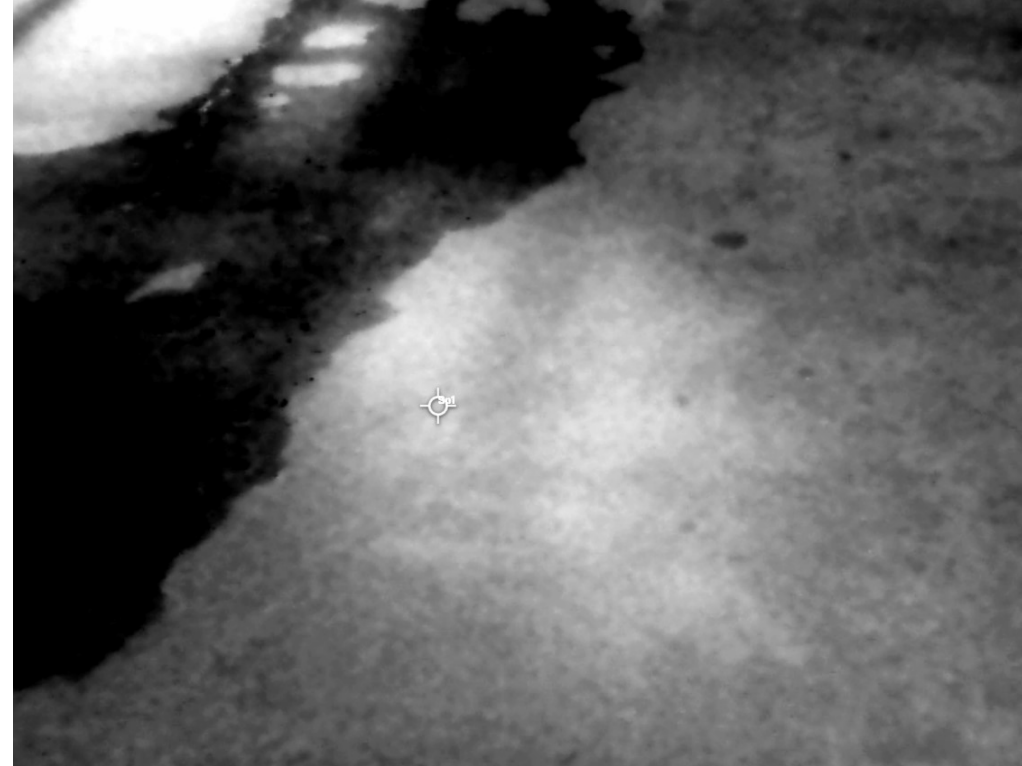
Infrared Thermography Method Comparison Images – Defect 1, 2 and 3

Vehicle Mounted IR Camera

Handheld IR Camera

Fixed Wing – Aerial IR Camera (collection altitude: 1000 ft)

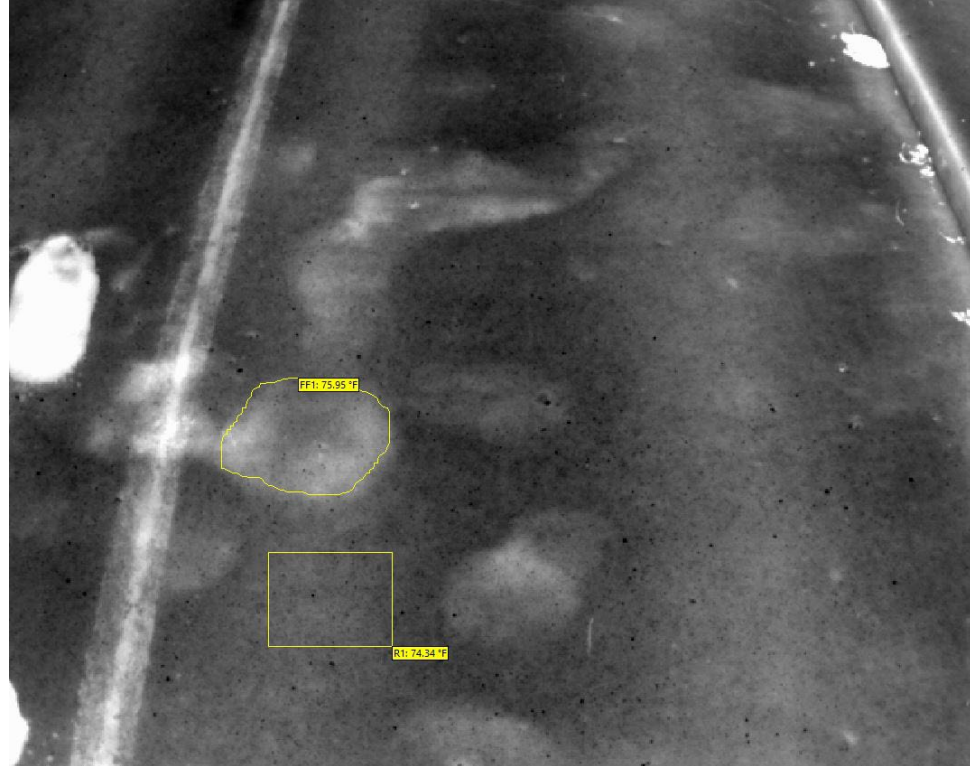
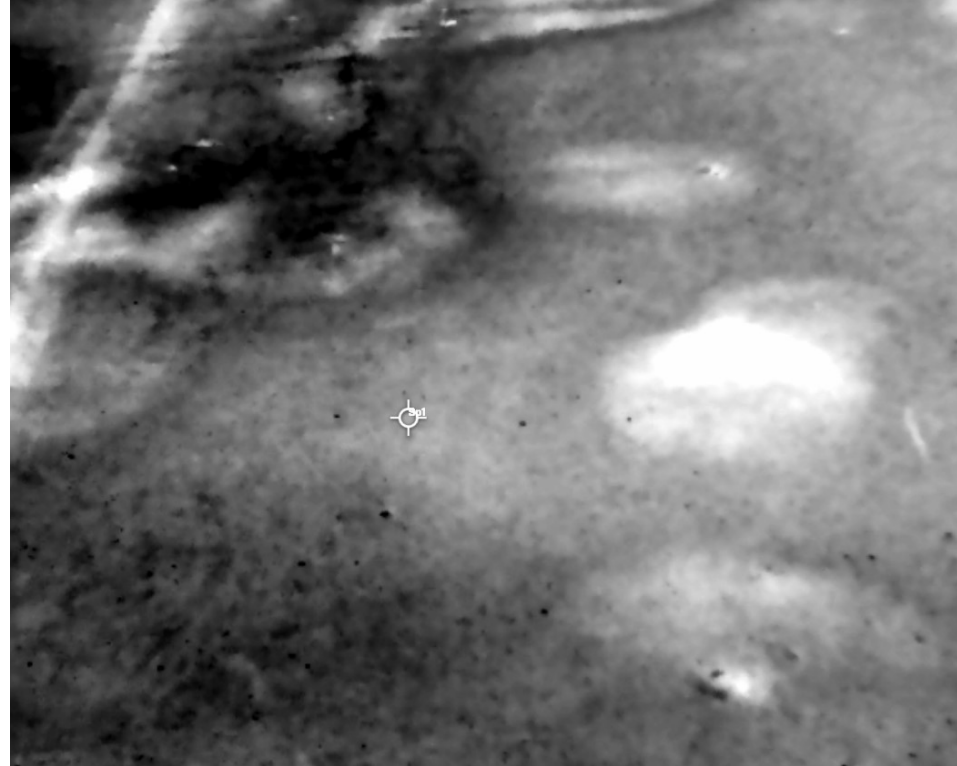
Infrared Thermography Method Comparison Images – Defect 1

Vehicle Mounted IR Camera

Handheld IR Camera

Drone IR Camera (collection height: 50 ft)

Drone IR Camera (collection height: 110 ft)

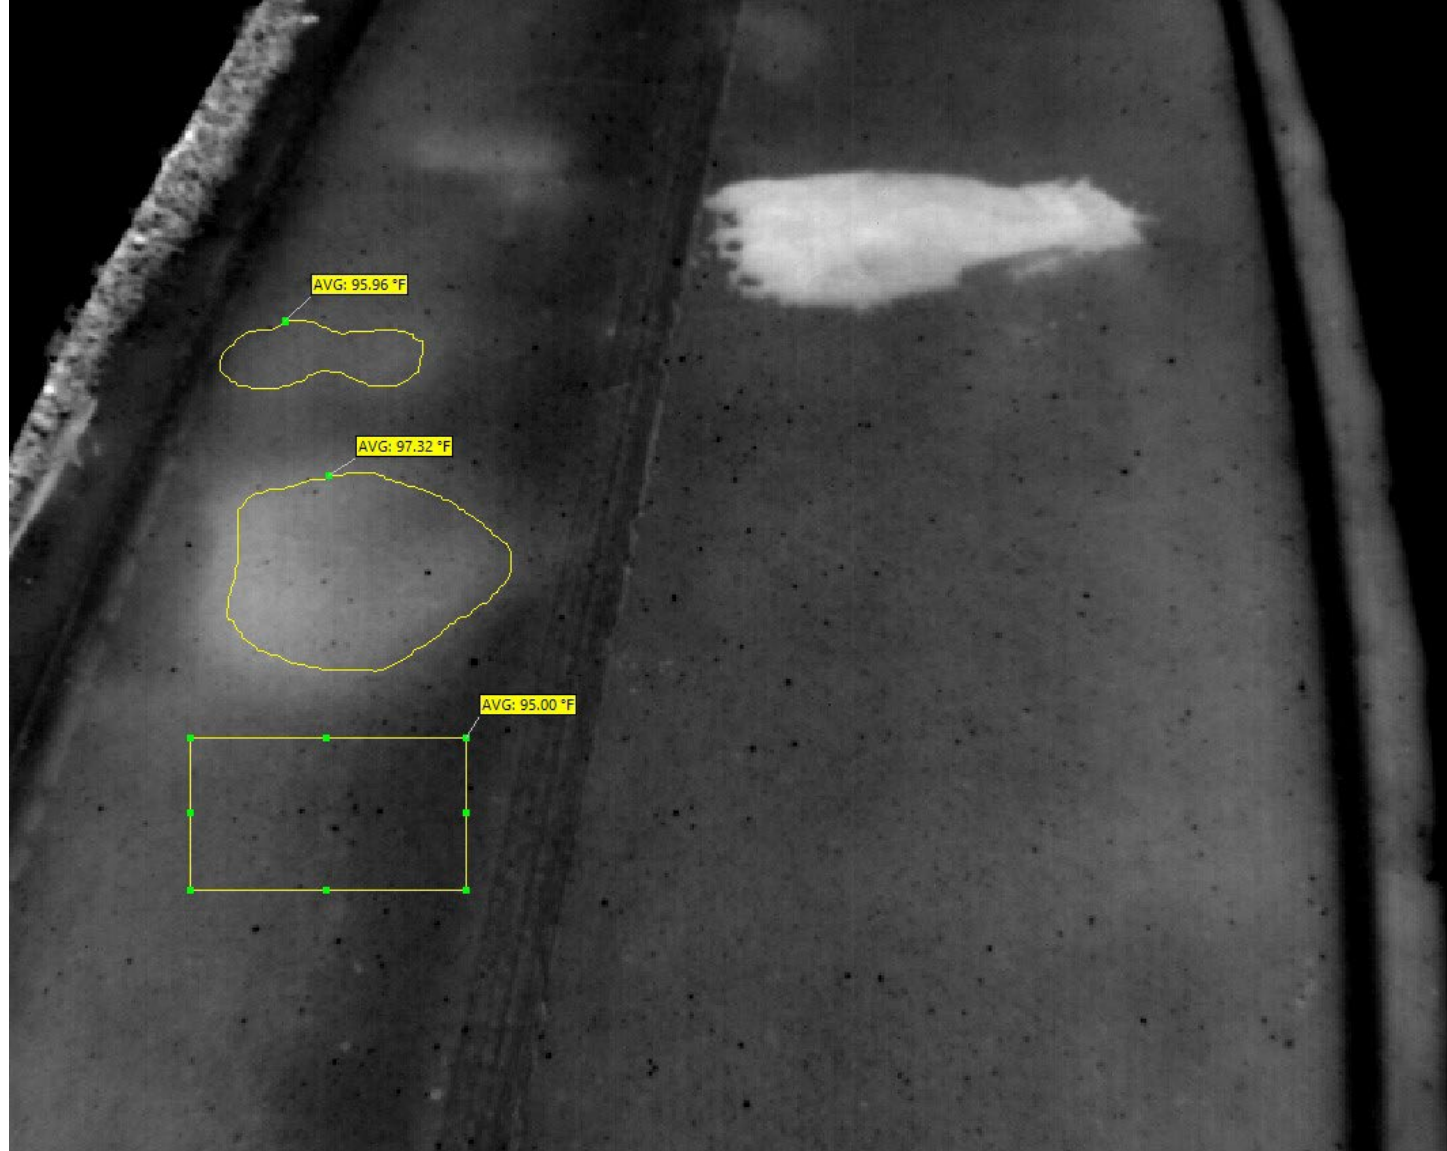
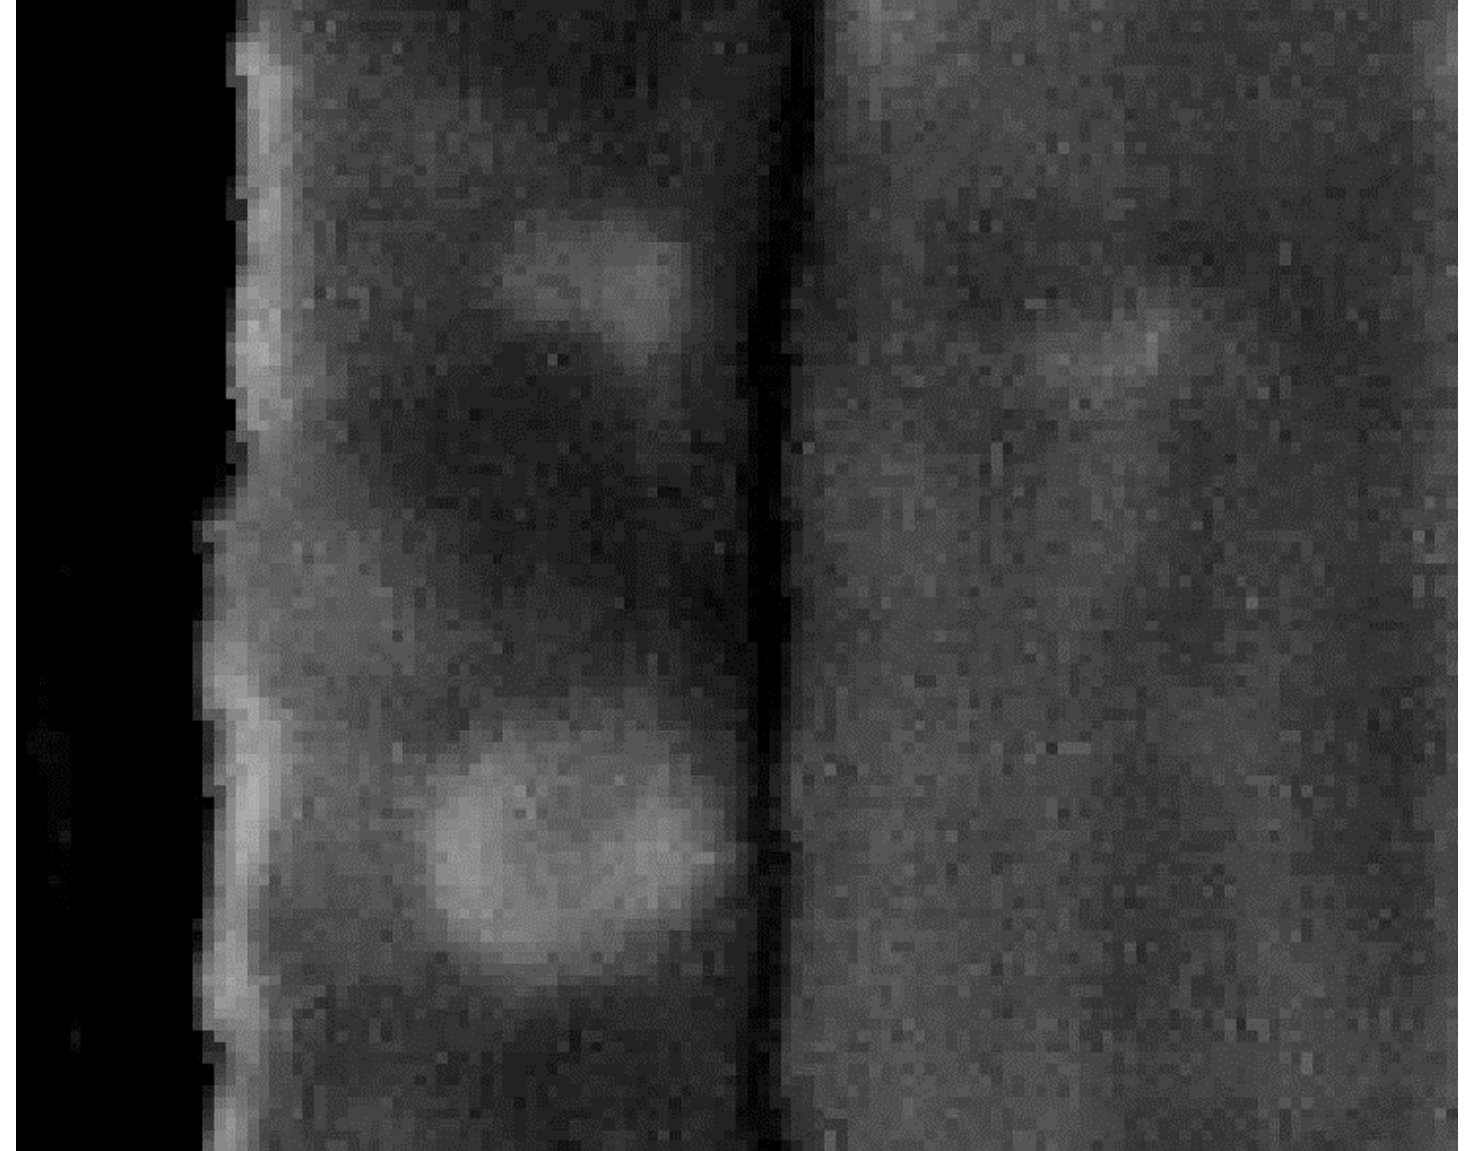
Infrared Thermography Method Comparison Images – Defects 1 and 2

Vehicle Mounted IR Camera

Fixed Wing – Aerial IR Camera (collection altitude: 1000 ft)

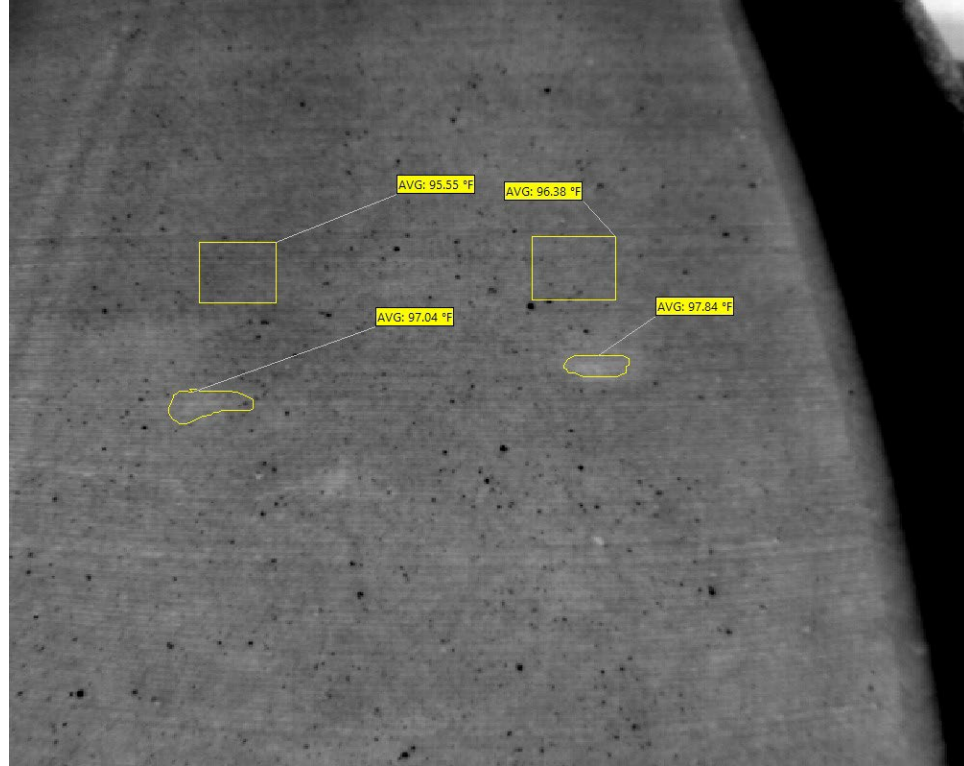
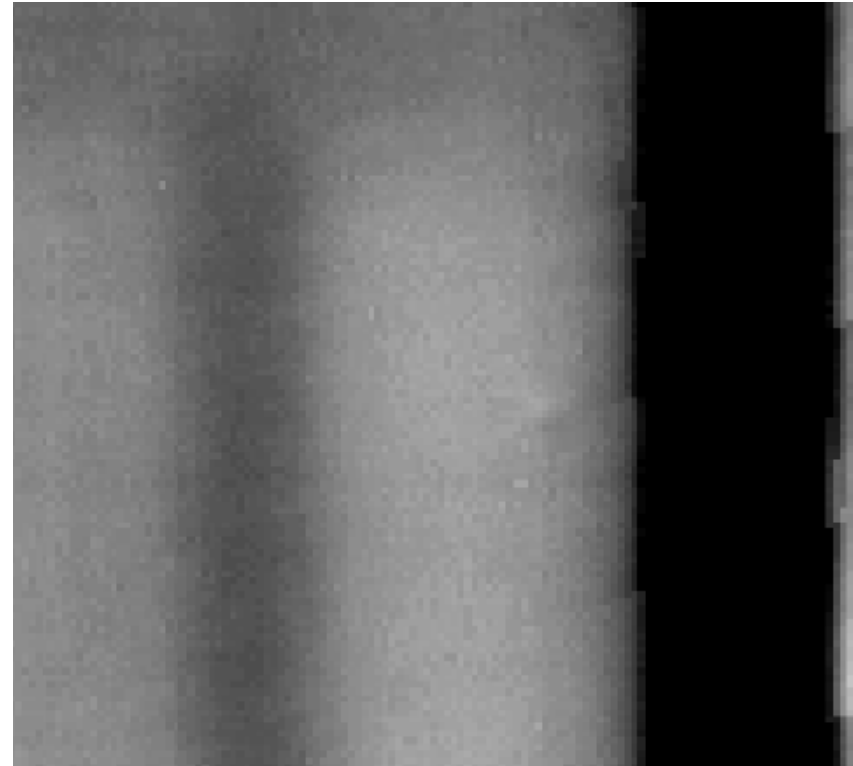
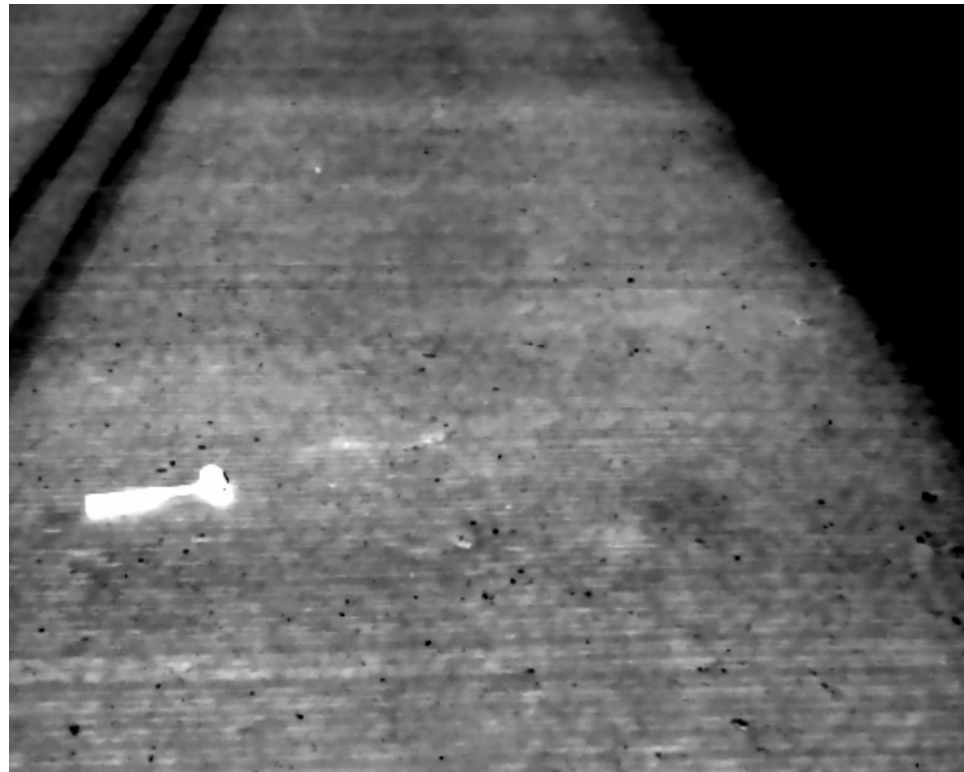
Infrared Thermography Method Comparison Images – Defects 2 and 3

Vehicle Mounted IR Camera

Fixed Wing – Aerial IR Camera (collection altitude: 1000 ft)

Handheld IR Camera (hammer indicating one of the defects)

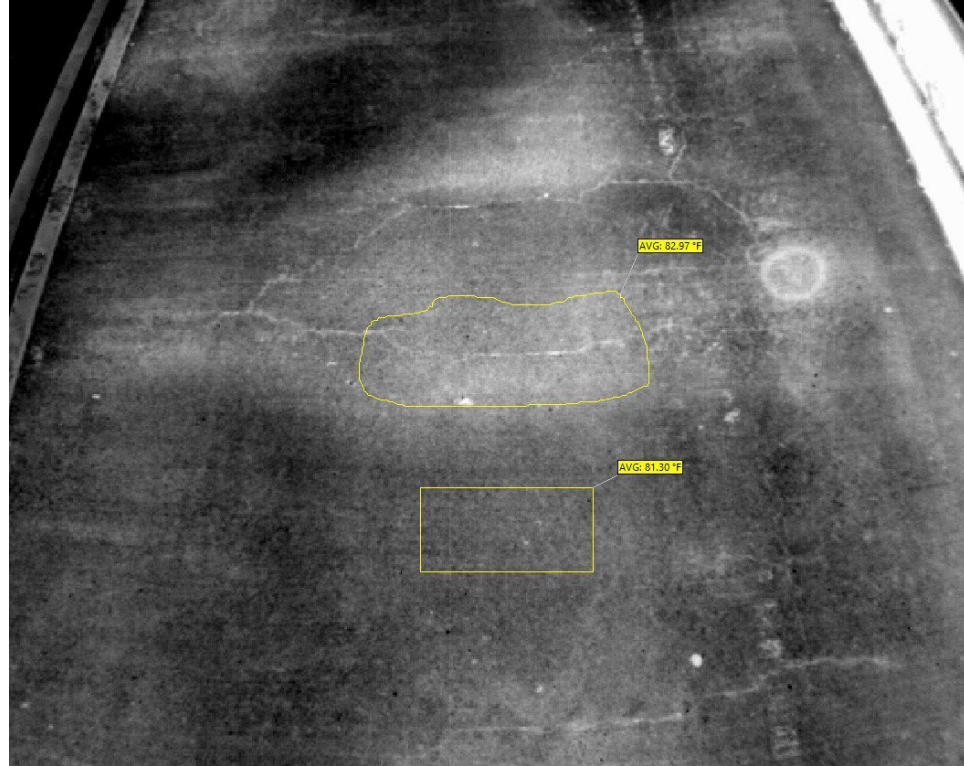
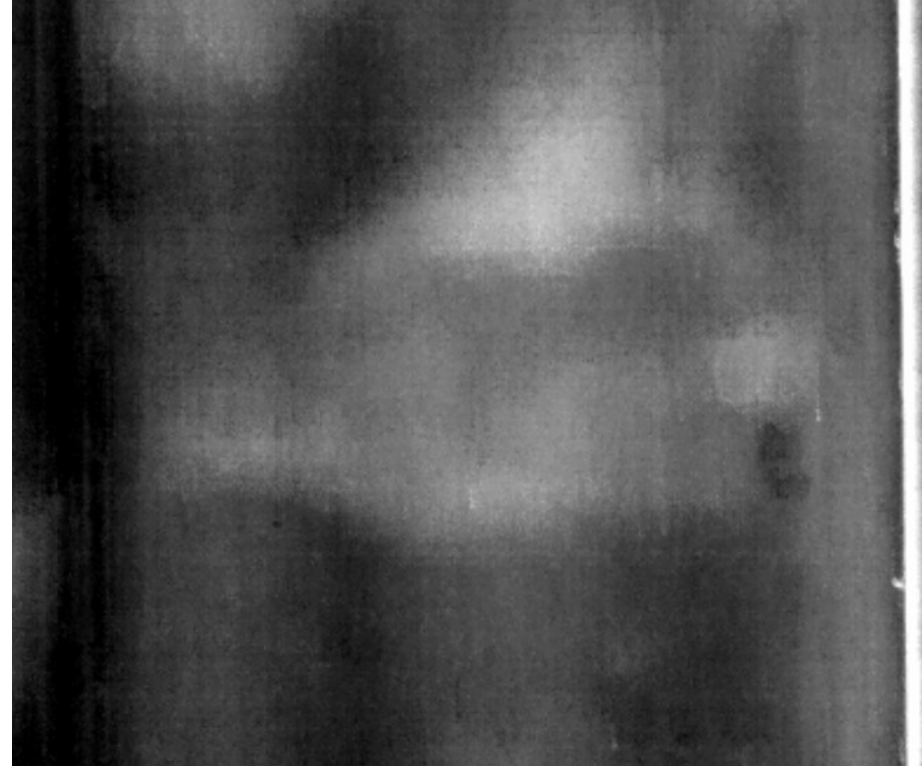
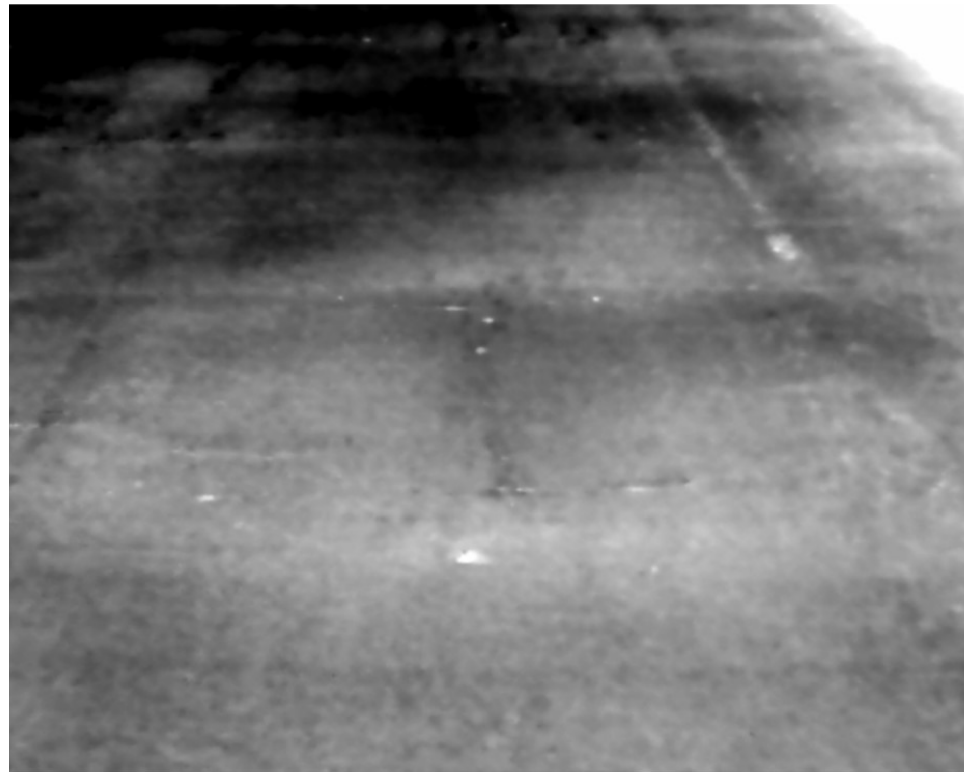
Infrared Thermography Method Comparison Images – Defect 2

Vehicle Mounted IR Camera

Drone IR Camera (collection height: 30 ft)

Drone IR Camera (collection height: 400 ft)

Handheld IR Camera

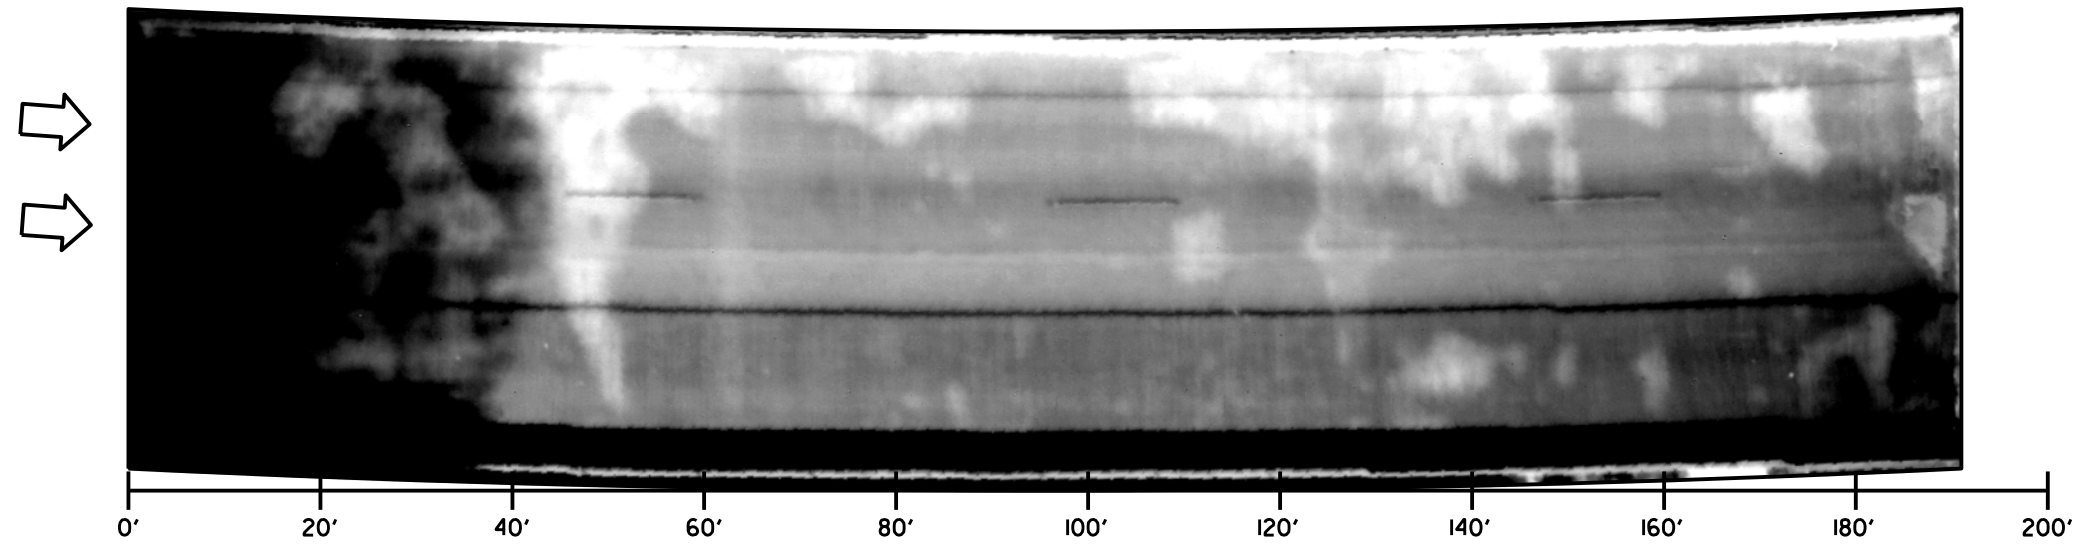
B670152

AERIAL INFRARED THERMOGRAPHIC OVERVIEW

SURFACE TYPE: CONCRETE OVERLAY
INFRARED INSPECTION DATE: 9/29/22, 1:11 PM

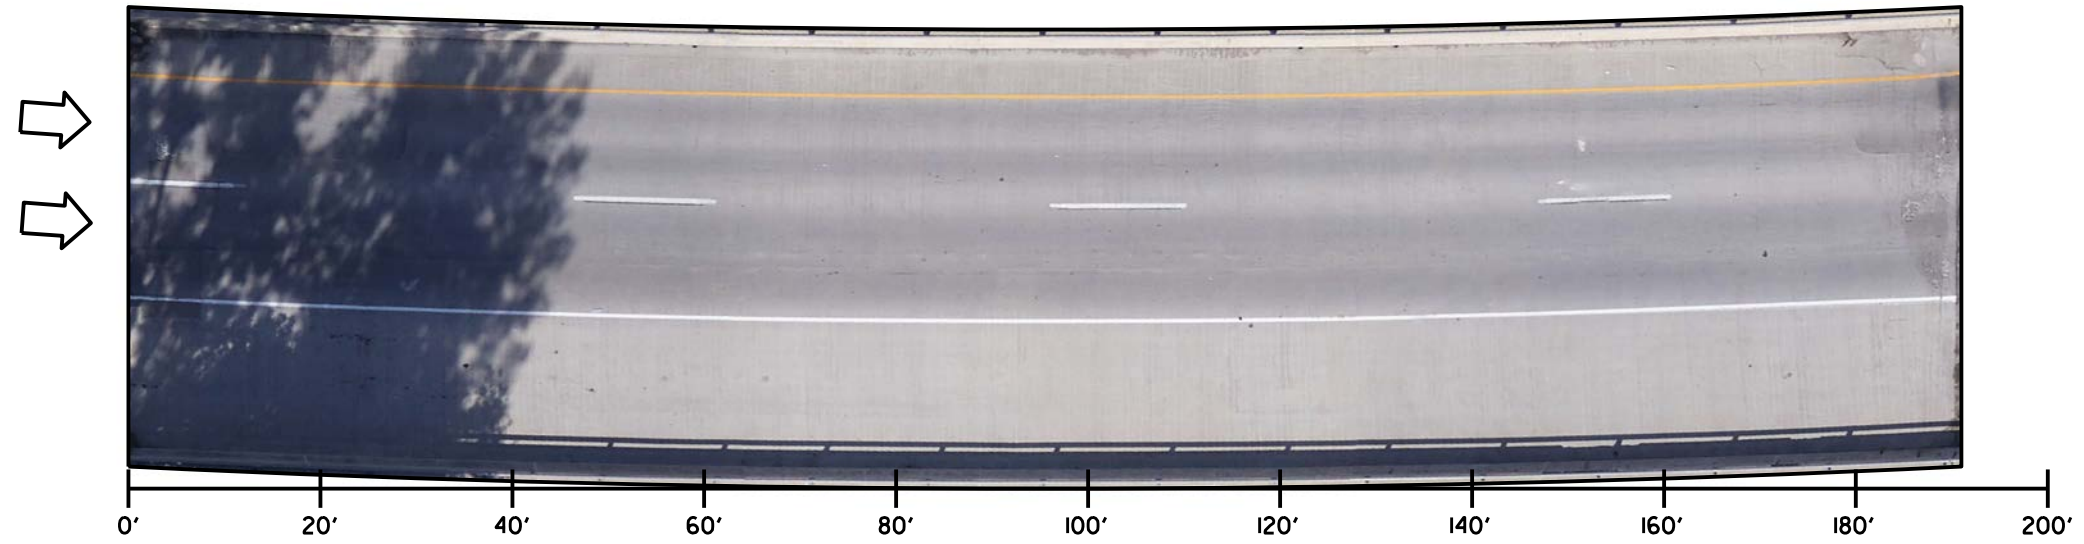
B670152
AERIAL RGB OVERVIEW

SURFACE TYPE: CONCRETE OVERLAY
INFRARED INSPECTION DATE: 9/29/22, 1:11 PM

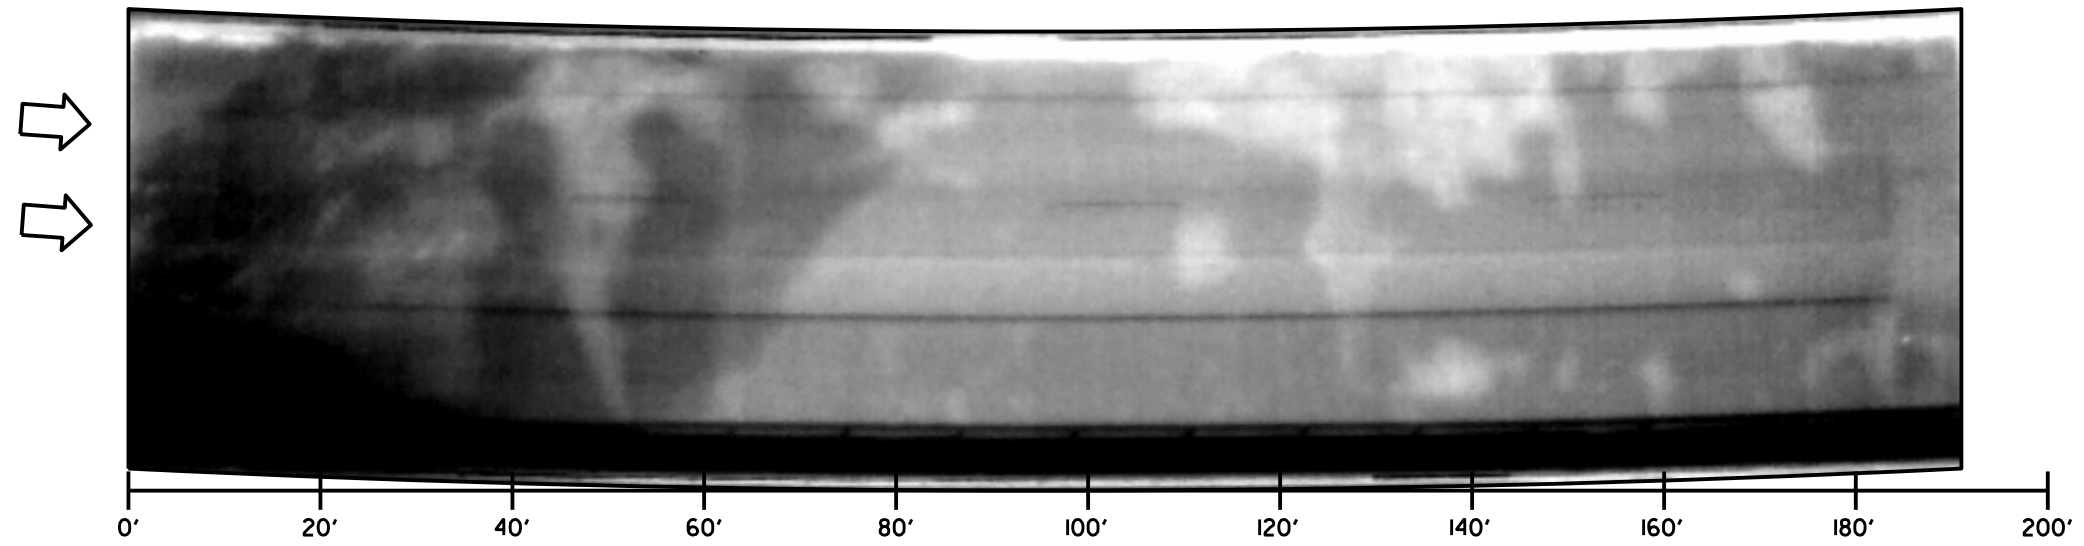
B670152
DRONE INFRARED THERMOGRAPHIC OVERVIEW

SURFACE TYPE: CONCRETE OVERLAY
INFRARED INSPECTION DATE: 10/17/23, 2:50 PM
