Bridge Deck Thermography Verification and Policy

WisDOT ID no. 0092-23-04

September 2024

TECHNICAL REPORT DOCUMENTATION PAGE

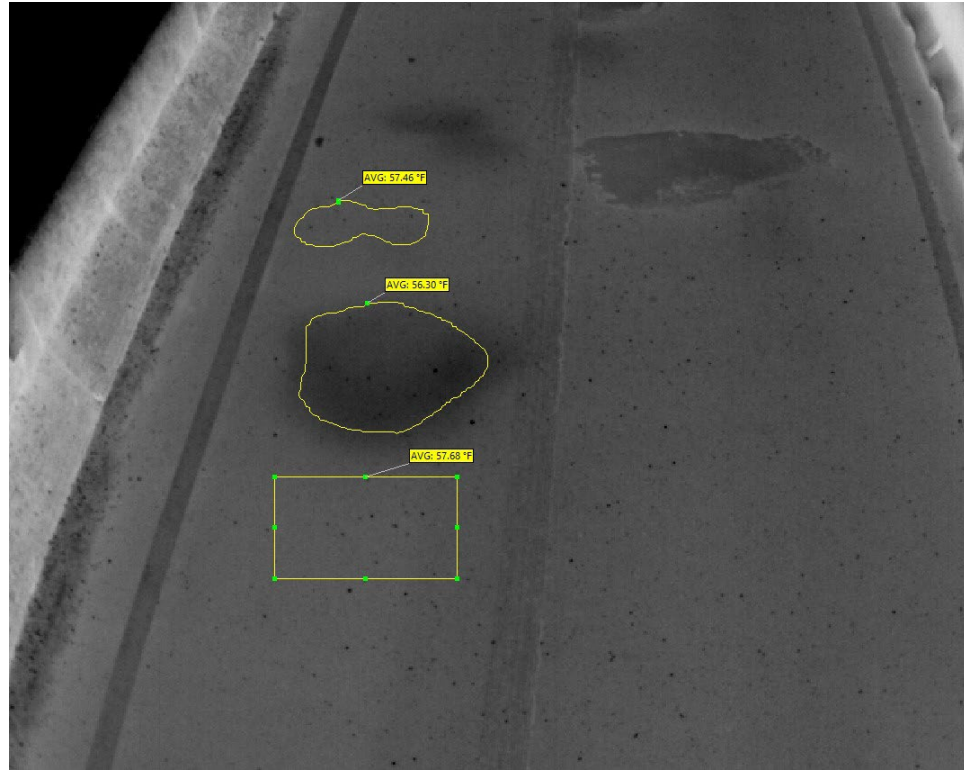
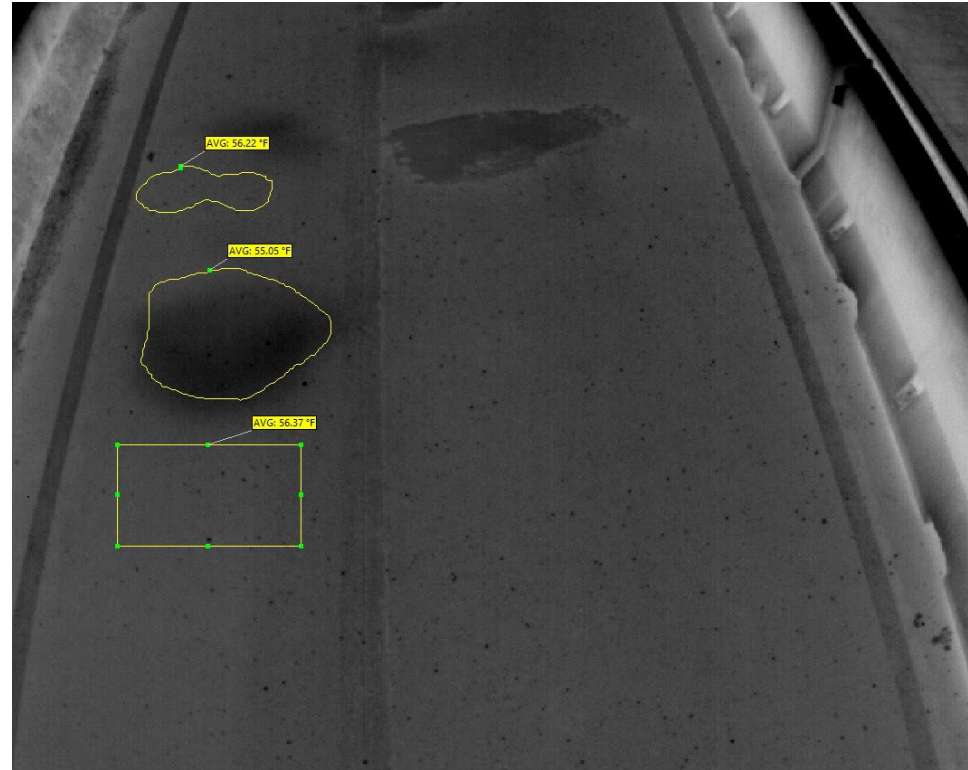
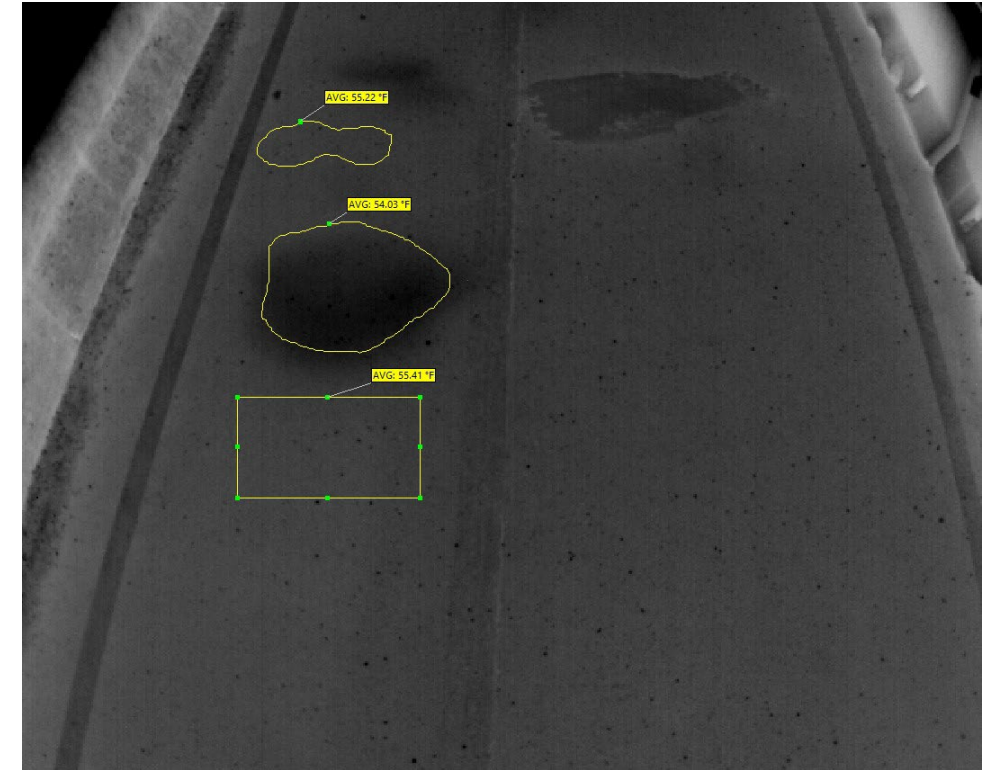
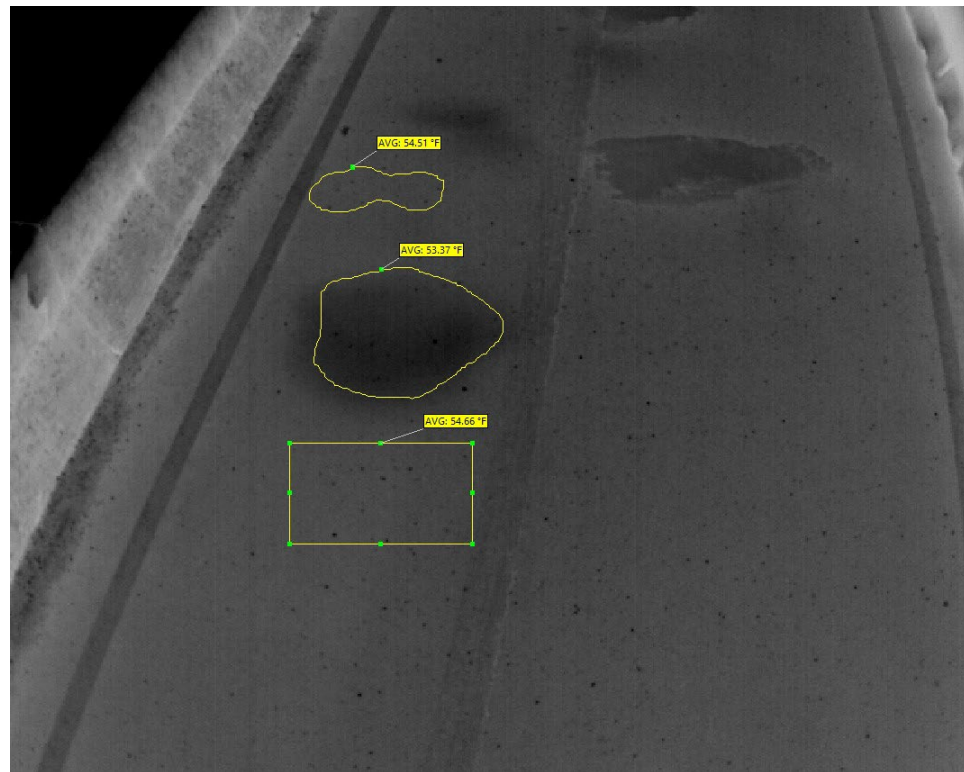
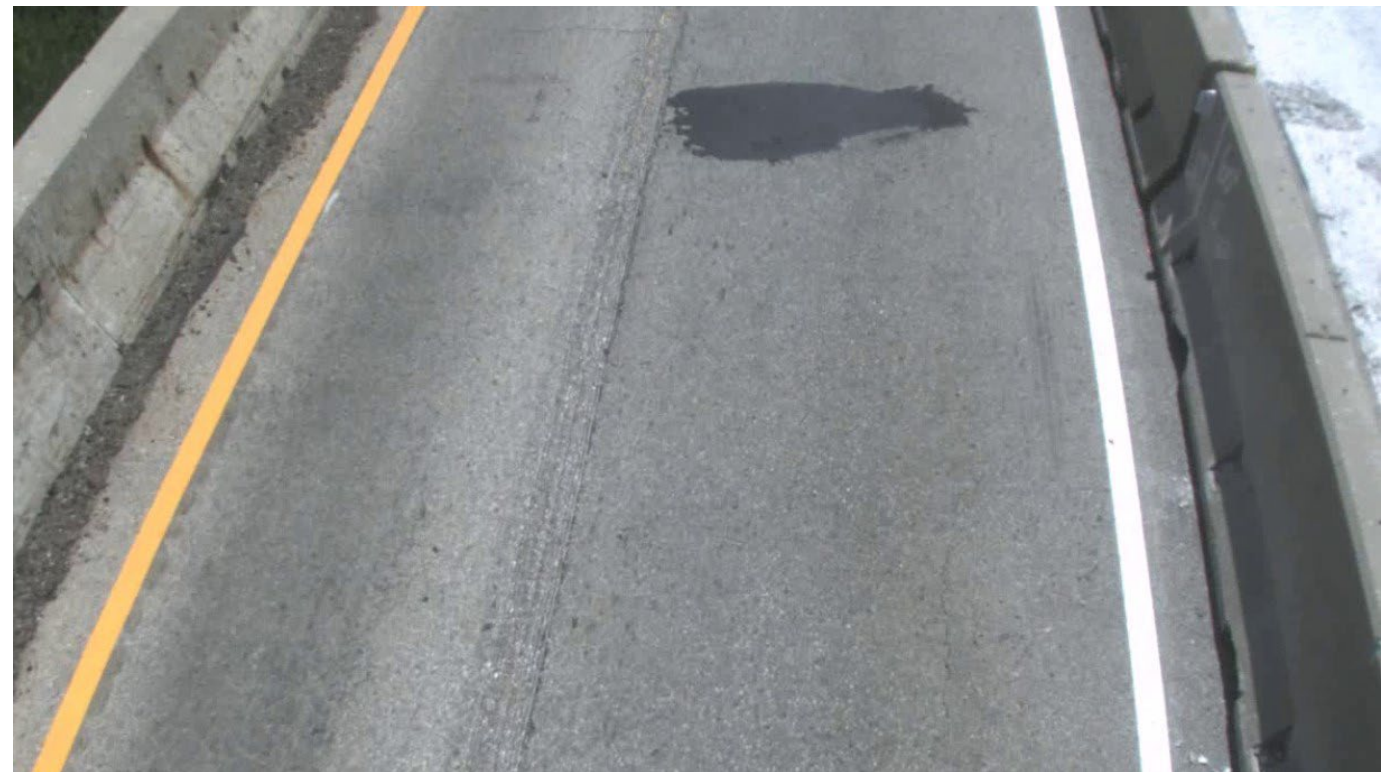
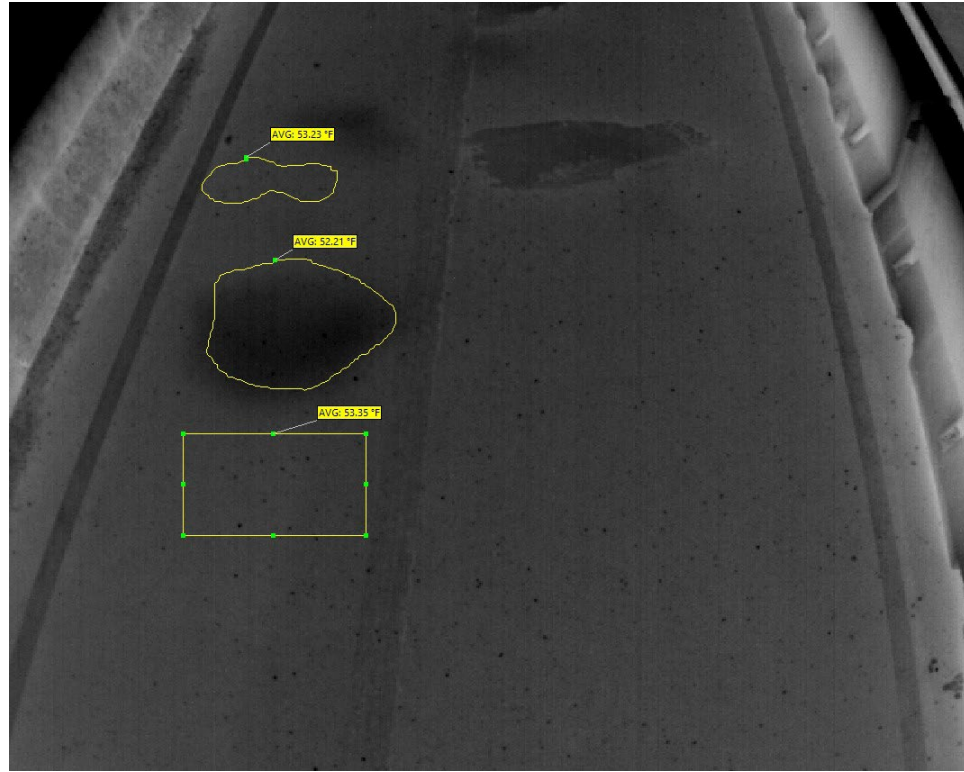
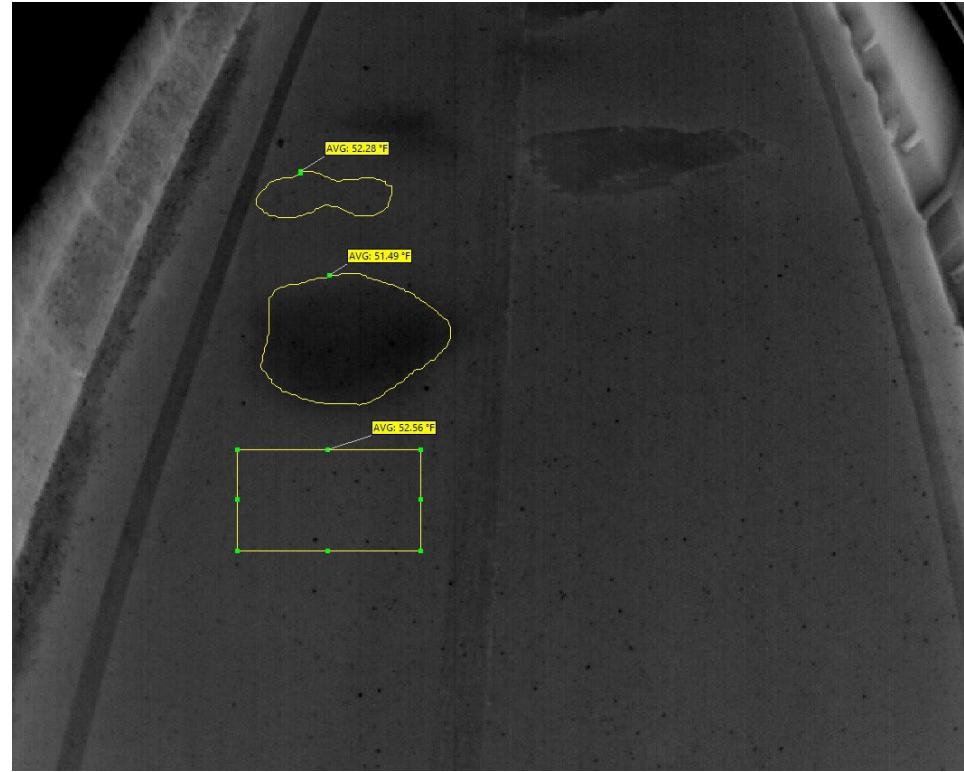
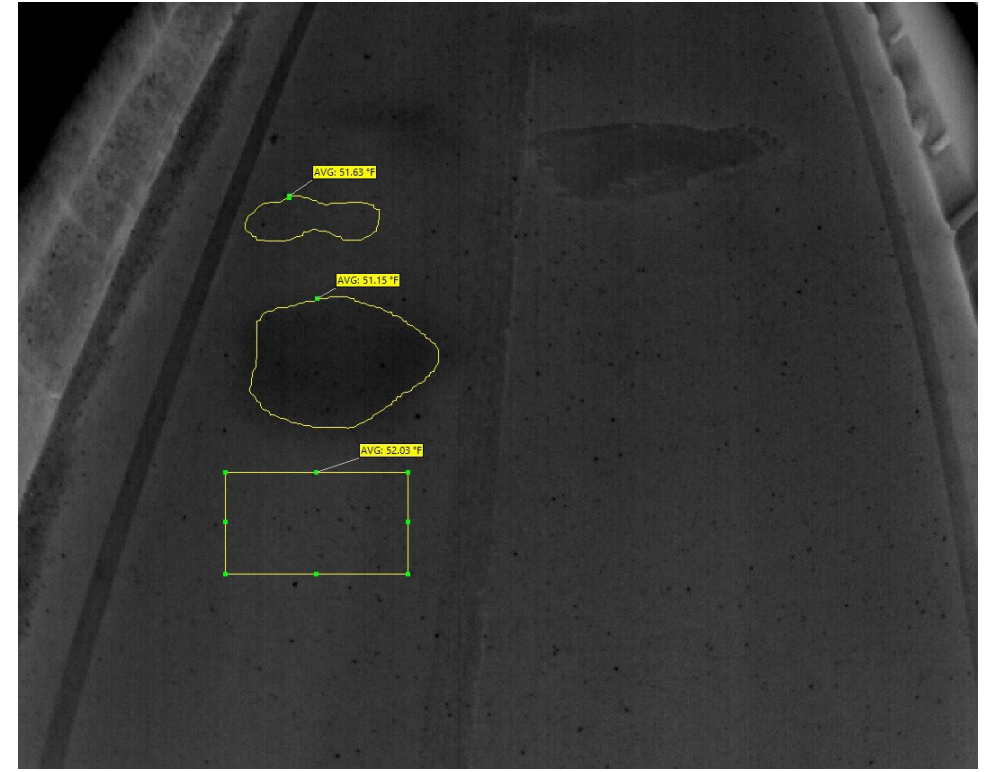
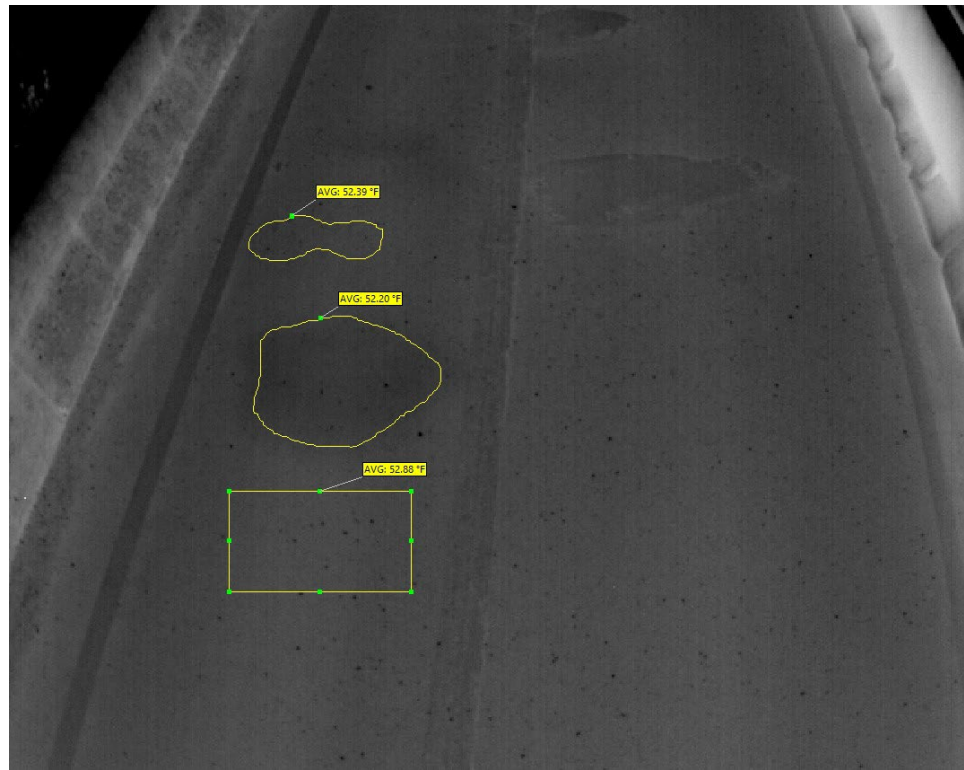
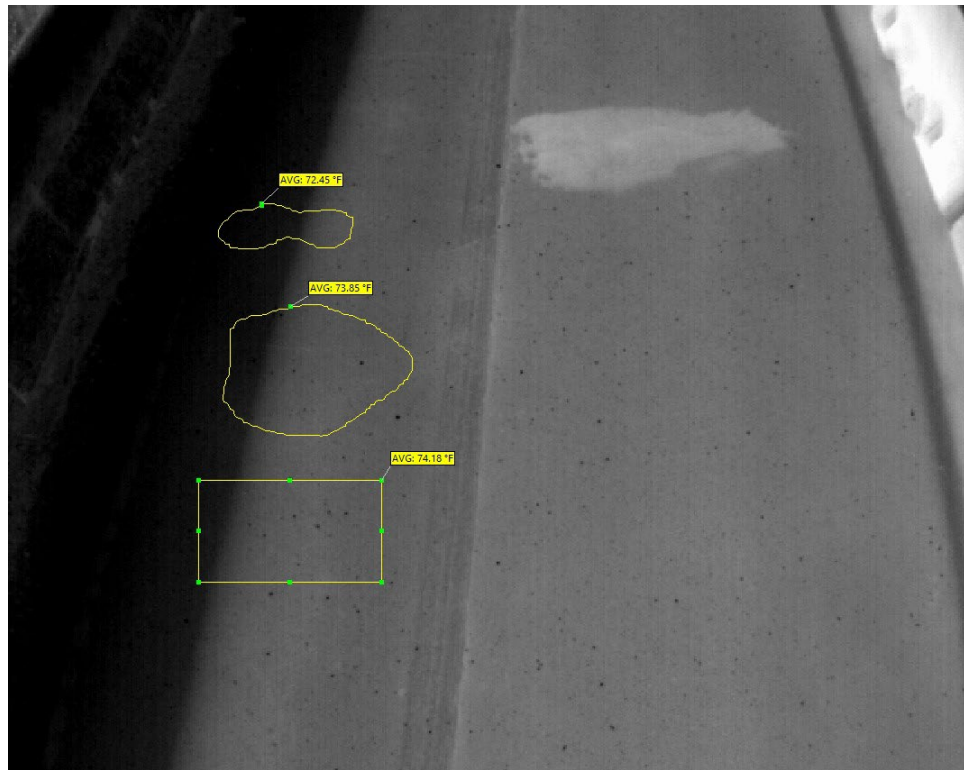
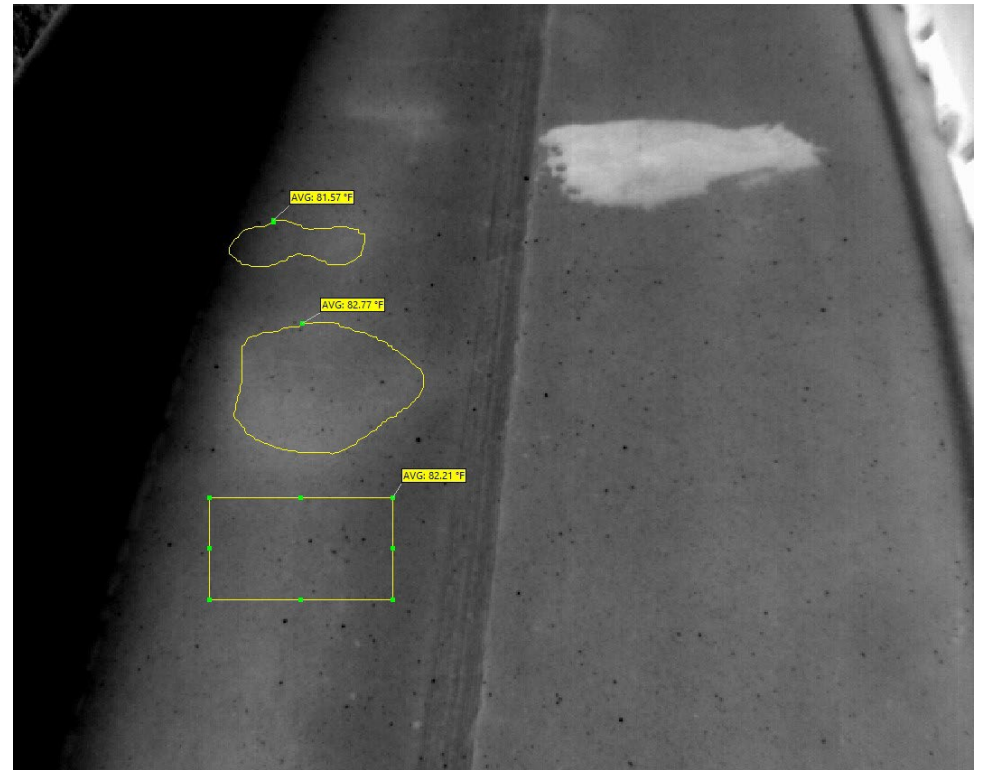
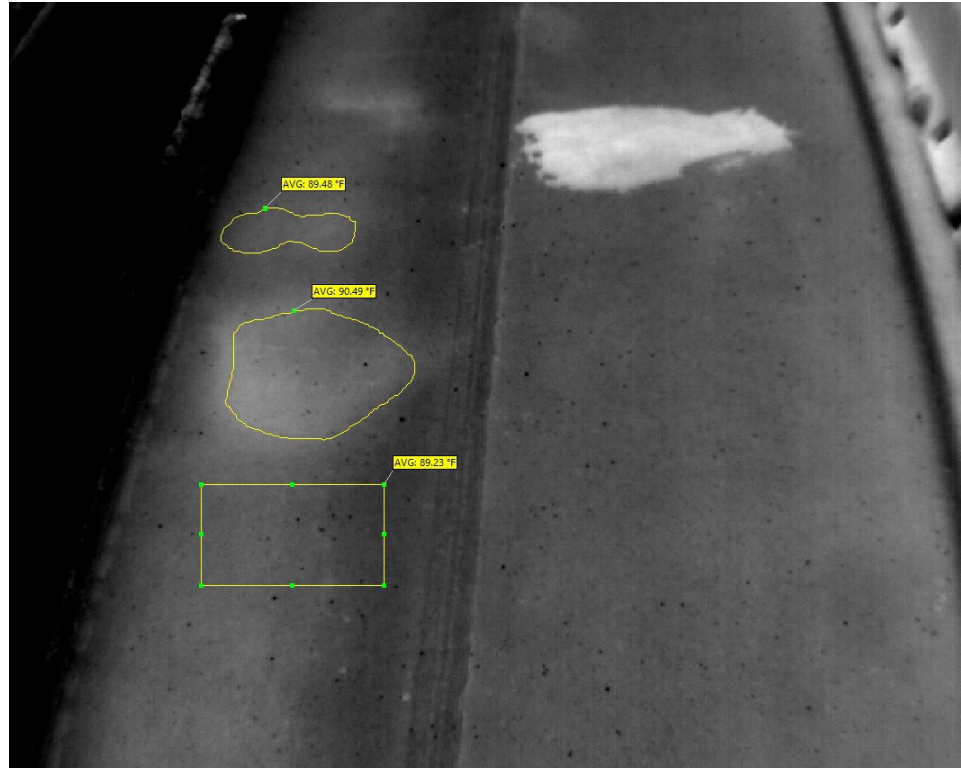
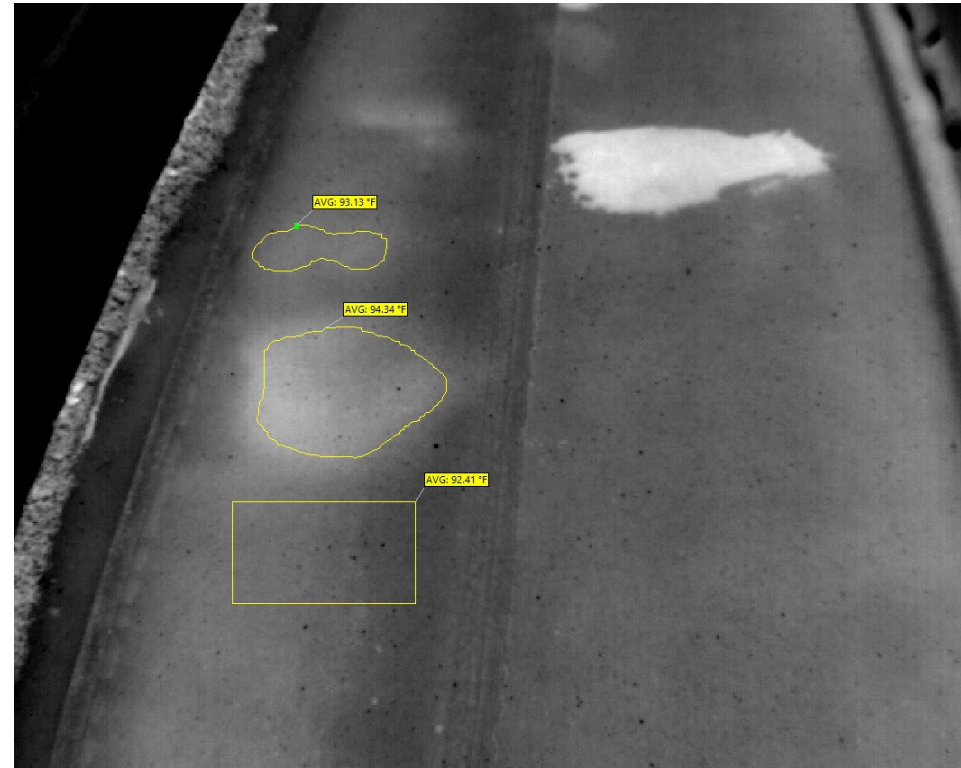
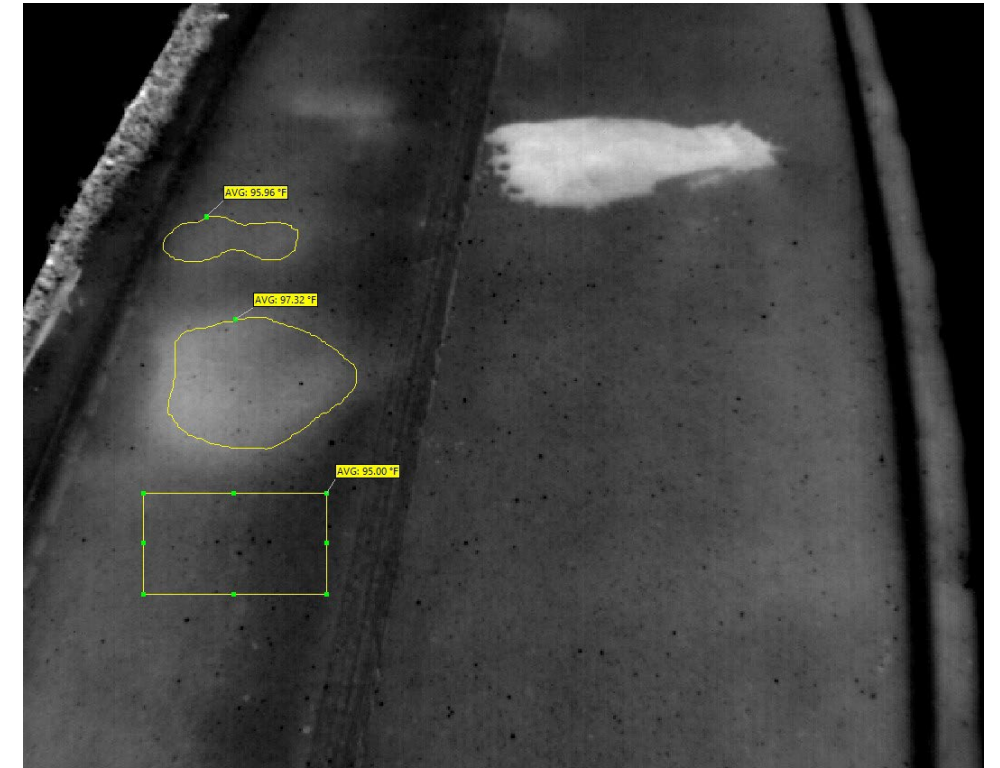
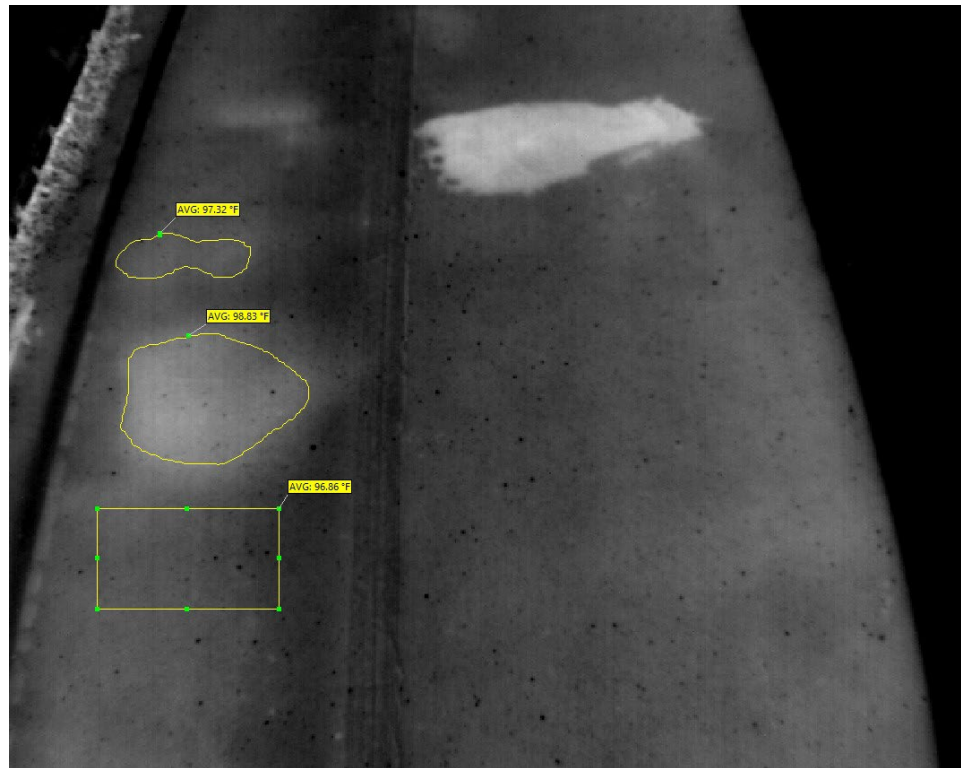
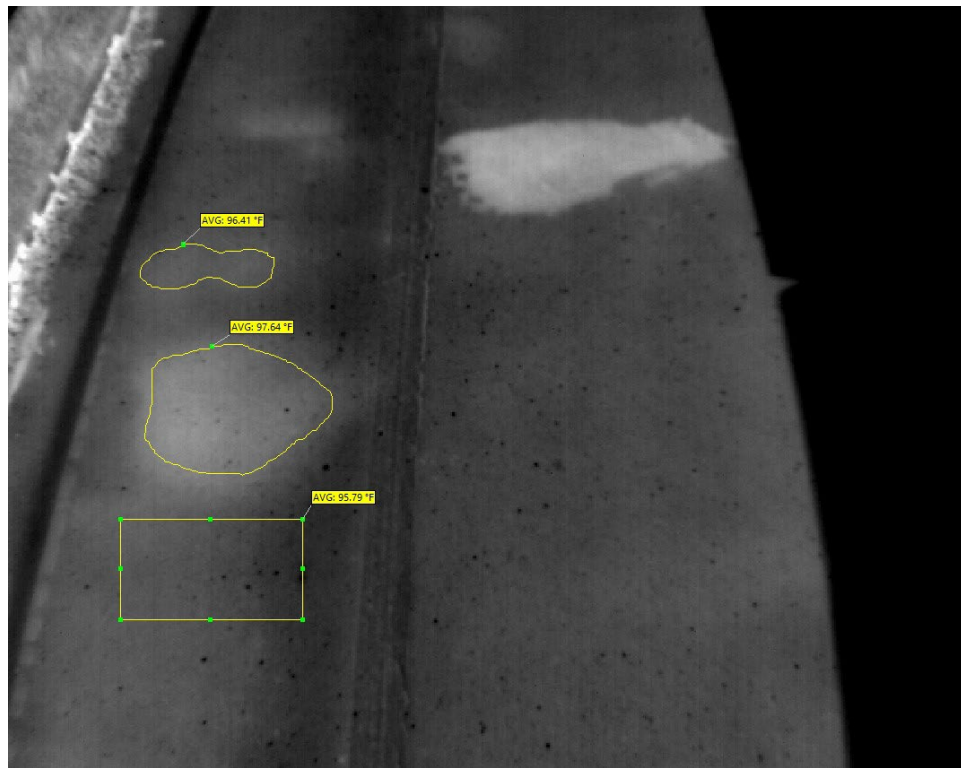
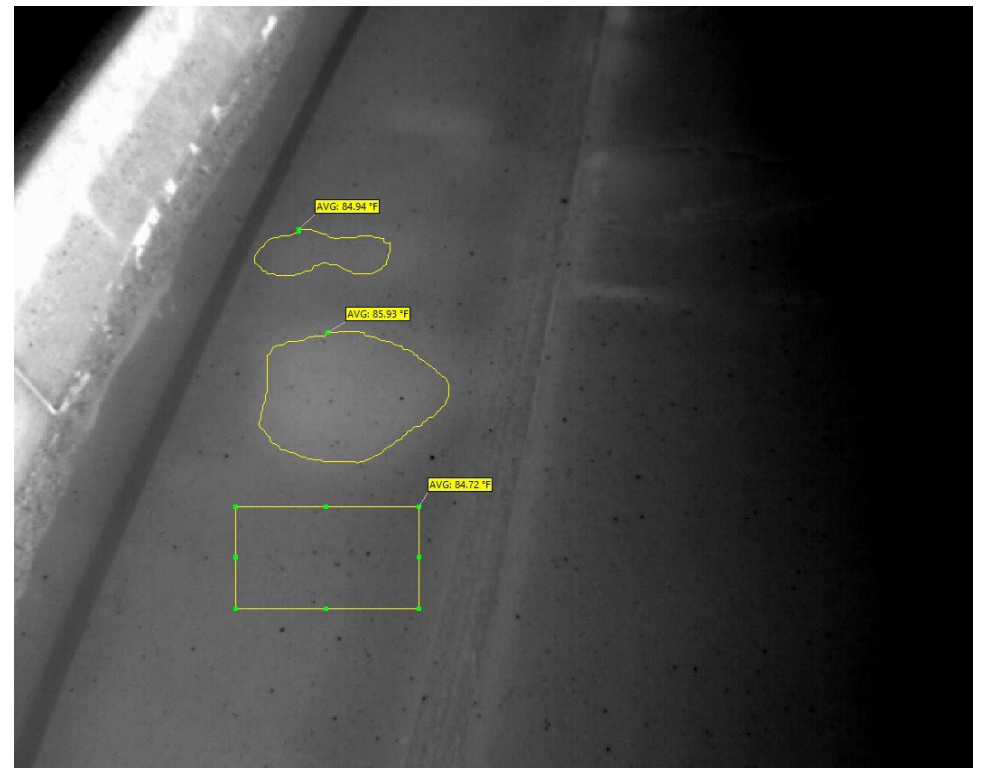
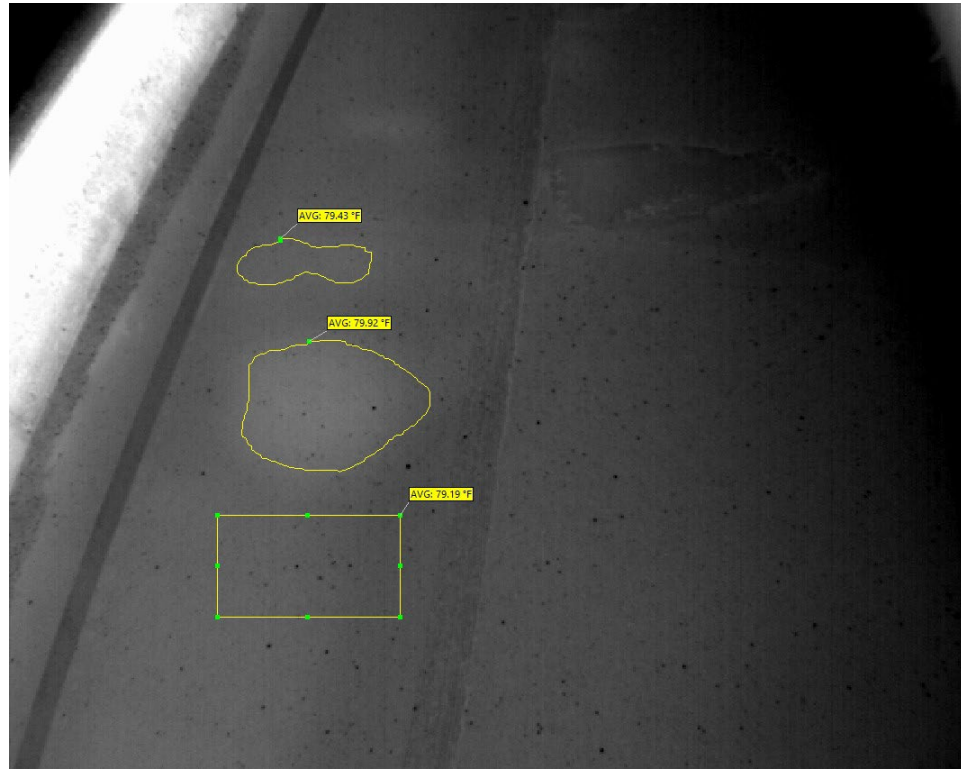
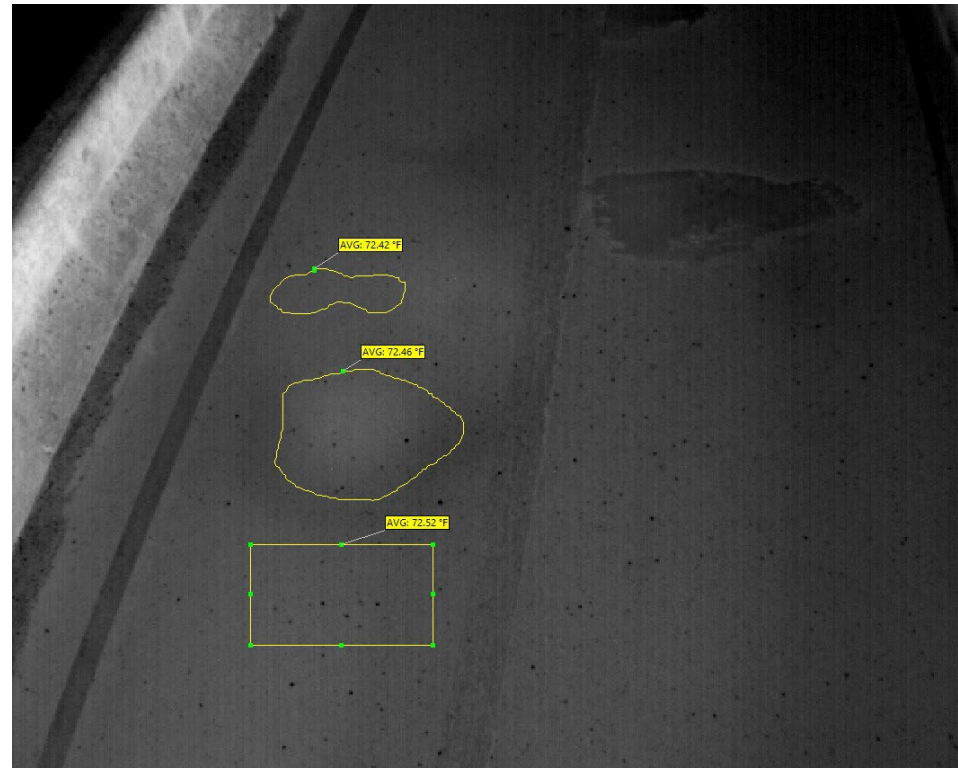
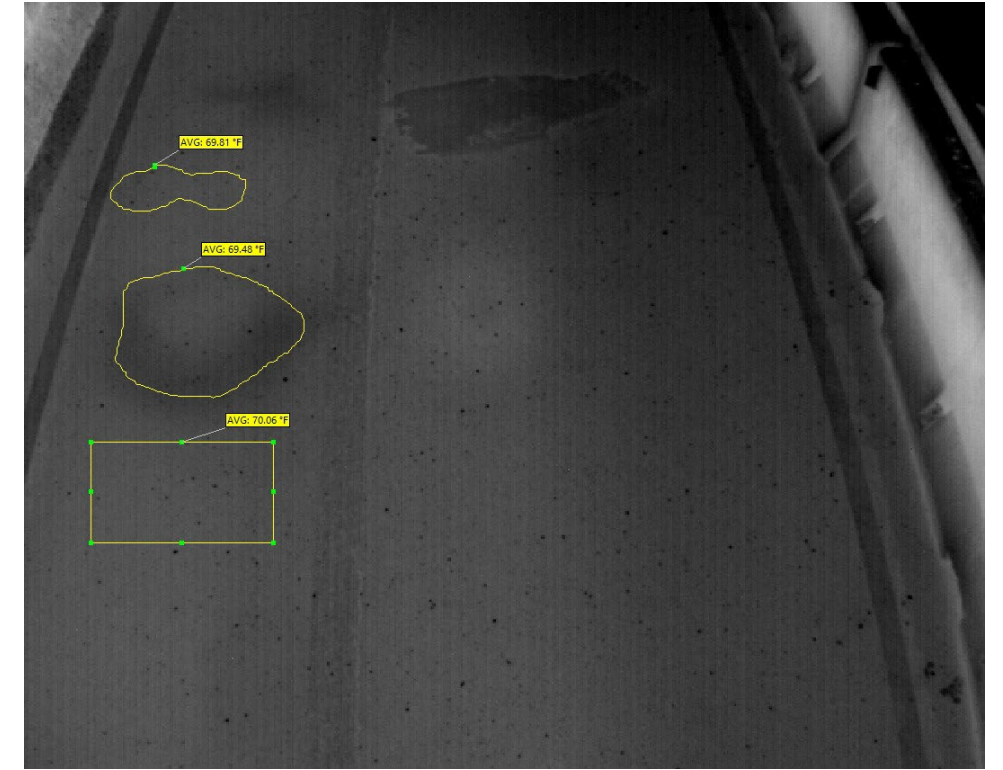
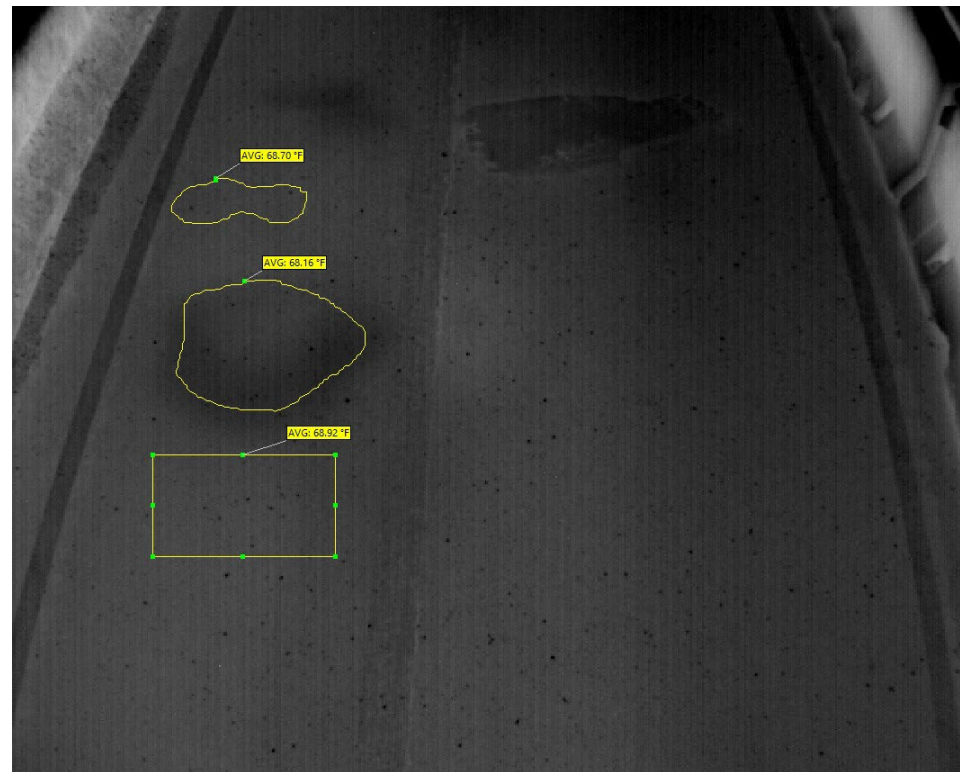
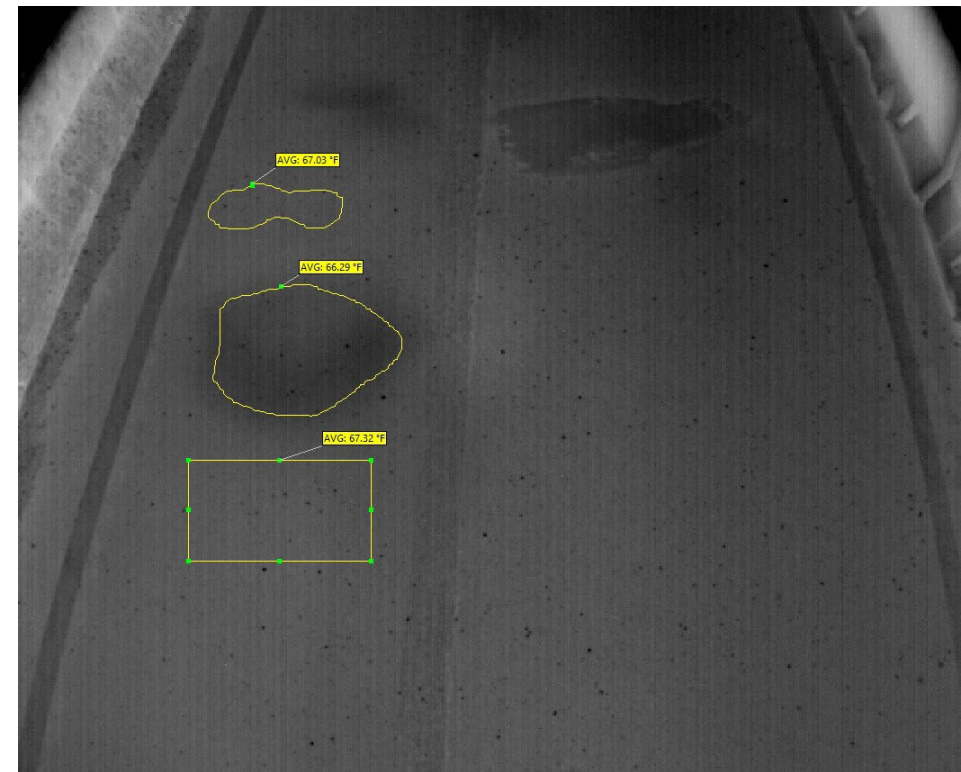
B660037 Left Lane defects 1 and 2

Bridge #	Defect #	Col. Date	Sunrise	Col. Time	Hrs after sunrise	Hrs decimal	Defect Temp. (F)	Control Temp. (F)	Temp. Difference (F) (Def-Cont)	Overlay Type	Overlay Type2
B-66-37	1	8/10/2023	5:52	14:45	8:53	8.88	97.32	96.86	0.46	97 AC / 75	AC
B-66-37	1	8/10/2023	5:52	16:05	10:13	10.22	96.41	95.79	0.62	97 AC / 75	AC
B-66-37	1	8/28/2023	6:11	17:30	11:19	11.32	84.94	84.72	0.22	97 AC / 75	AC
B-66-37	1	8/28/2023	6:11	18:30	12:19	12.32	79.43	79.19	0.24	97 AC / 75	AC
B-66-37	1	8/28/2023	6:11	20:00	13:49	13.82	72.42	72.52	-0.1	97 AC / 75	AC
B-66-37	1	8/28/2023	6:11	21:05	14:54	14.90	69.81	70.06	-0.25	97 AC / 75	AC
B-66-37	1	8/28/2023	6:11	22:00	15:49	15.82	68.70	68.92	-0.22	97 AC / 75	AC
B-66-37	1	8/28/2023	6:11	23:15	17:04	17.07	67.03	67.32	-0.29	97 AC / 75	AC
B-66-37	1	8/31/2023	6:15	0:10	17:55	17.92	57.46	57.68	-0.22	97 AC / 75	AC
B-66-37	1	8/31/2023	6:15	1:10	18:55	18.92	56.22	56.37	-0.15	97 AC / 75	AC
B-66-37	1	8/31/2023	6:15	2:15	20:00	20.00	55.22	55.41	-0.19	97 AC / 75	AC
