Bridge Deck Thermography Verification and Policy

WisDOT ID no. 0092-23-04

September 2024

TECHNICAL REPORT DOCUMENTATION PAGE

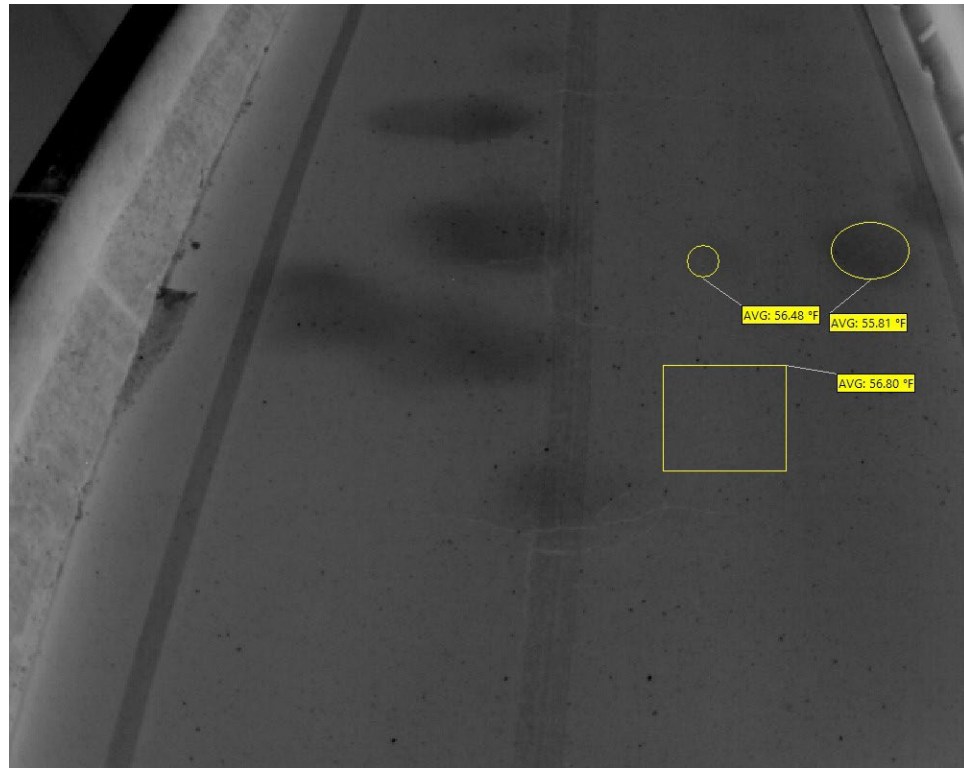
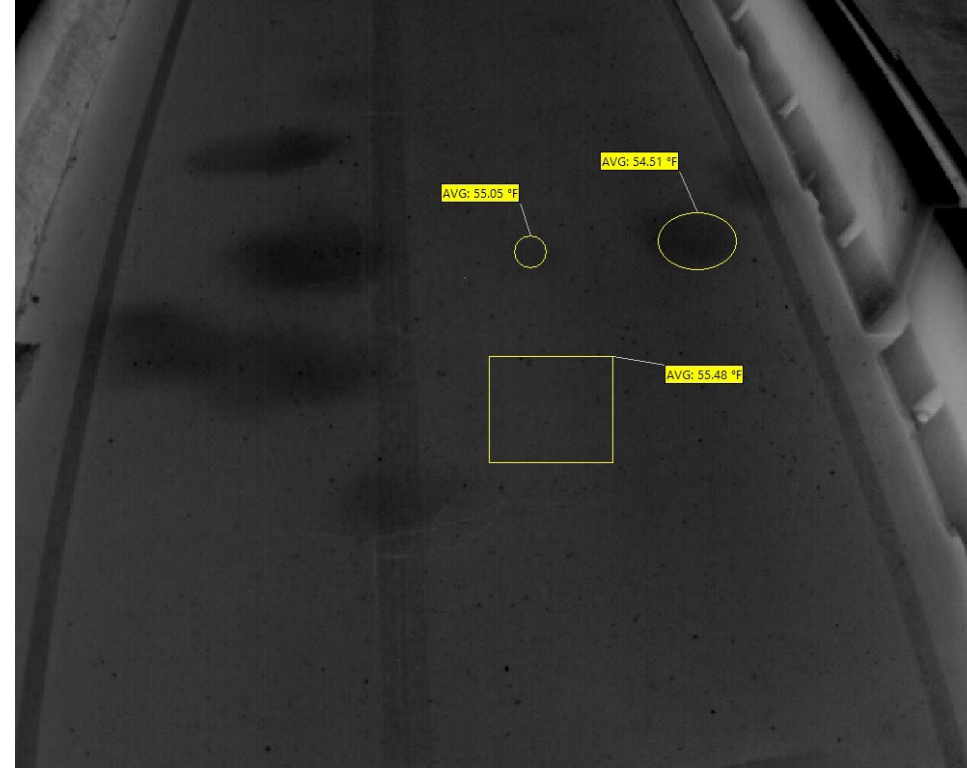
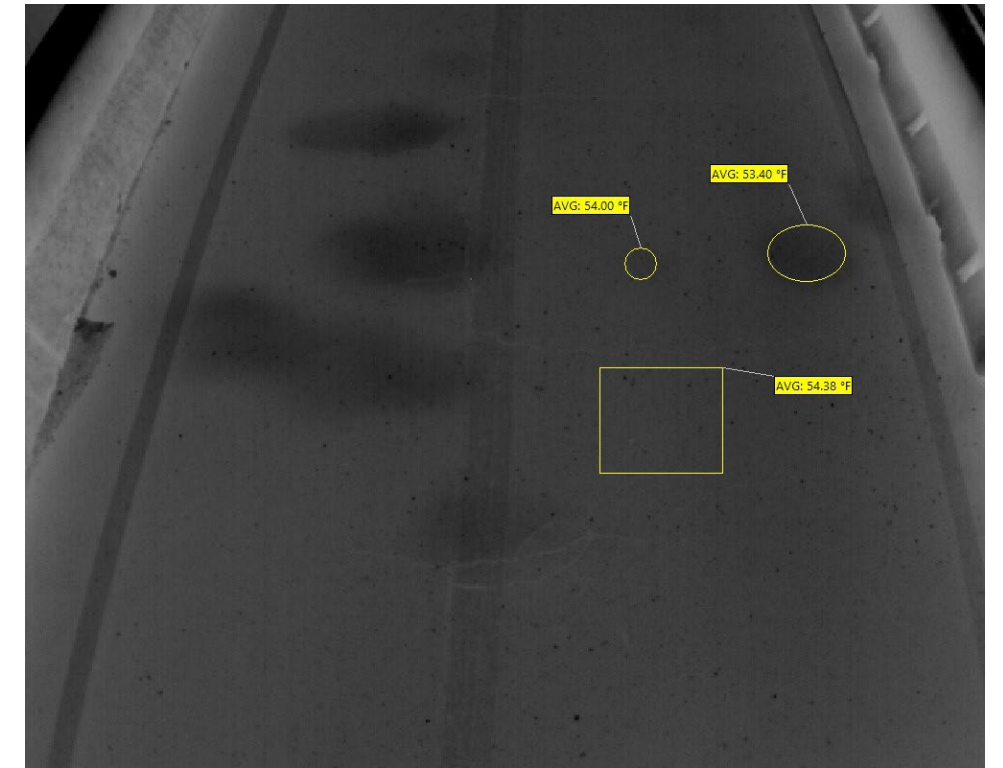
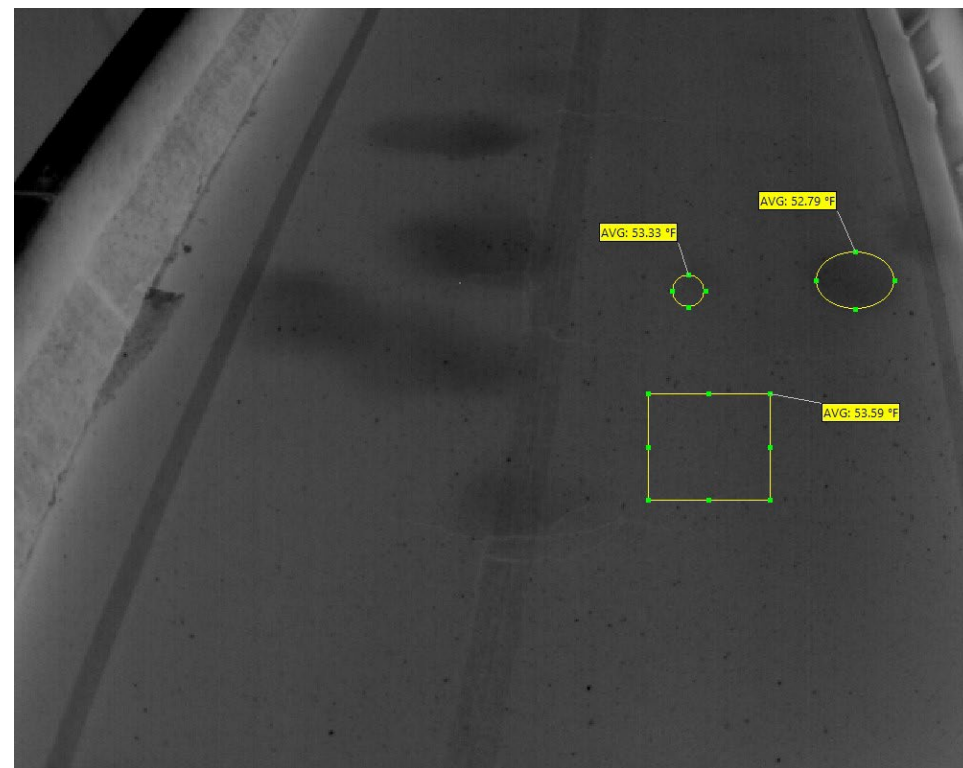
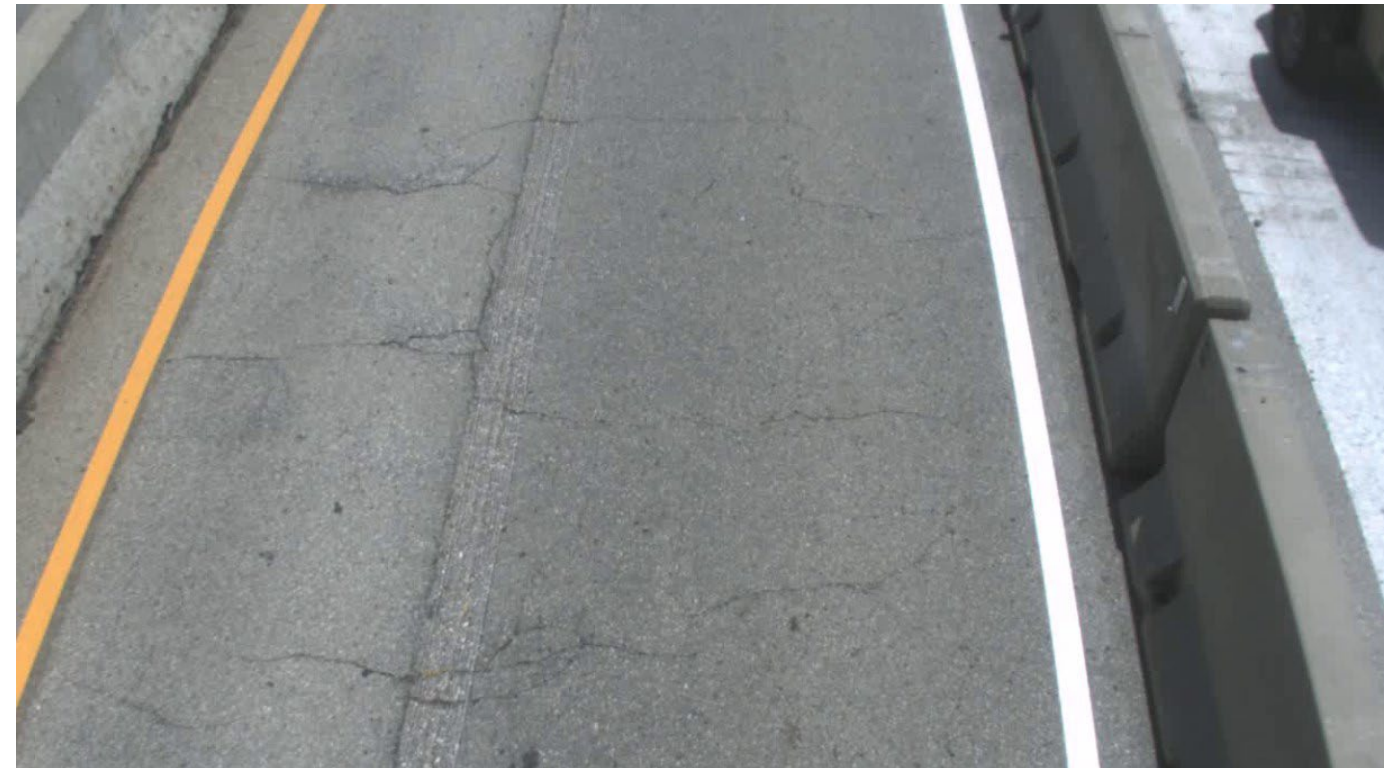
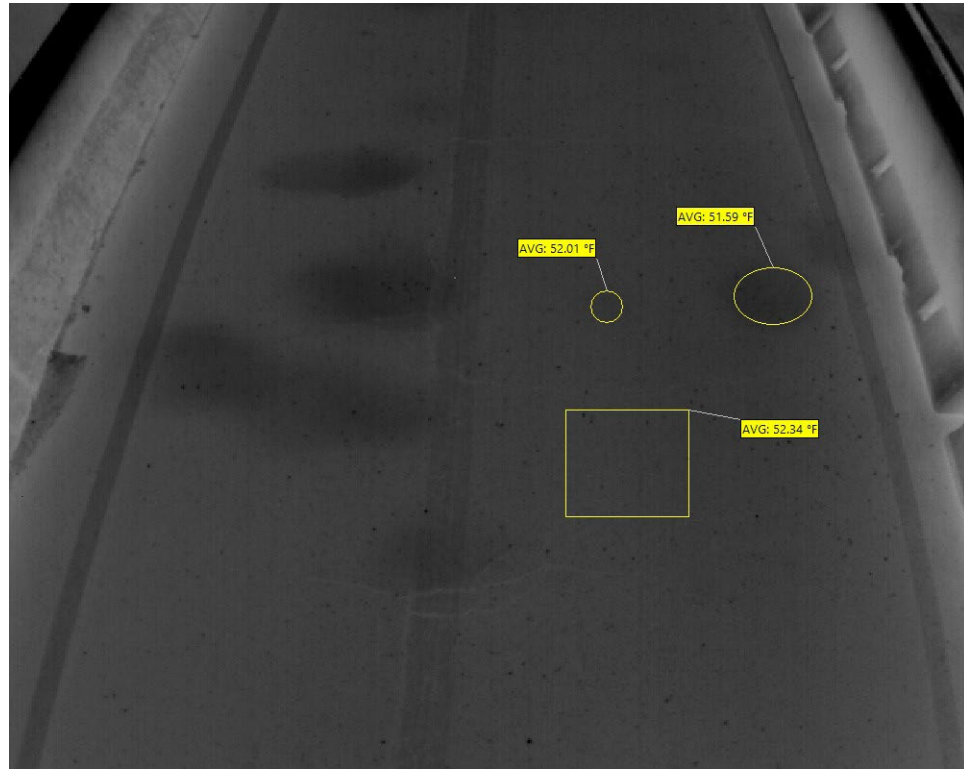
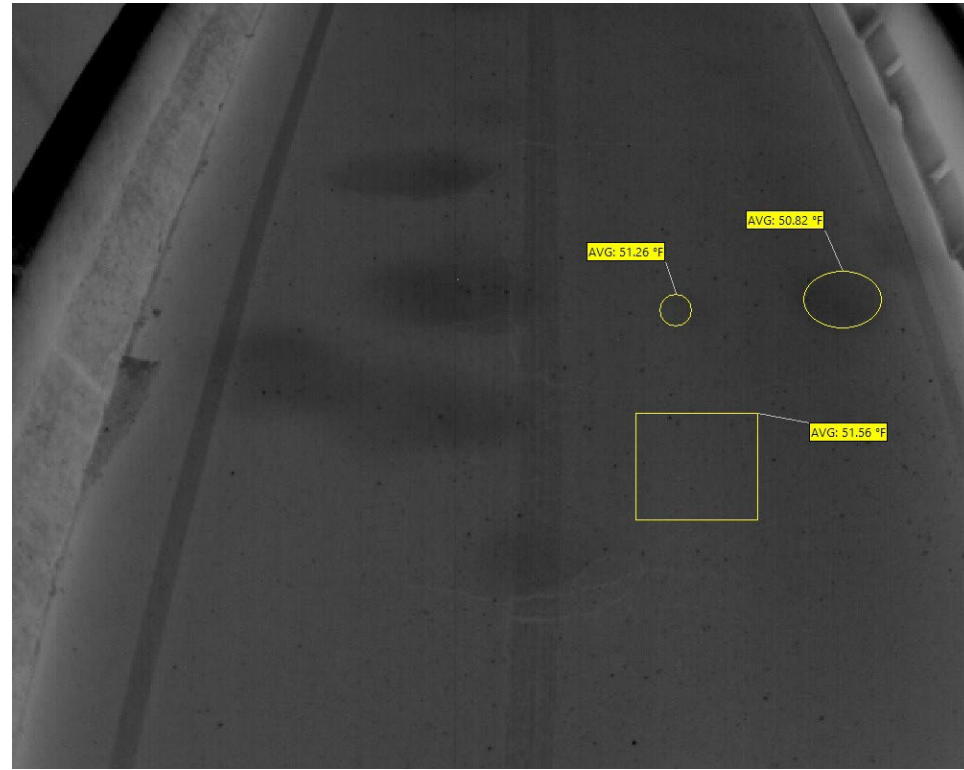
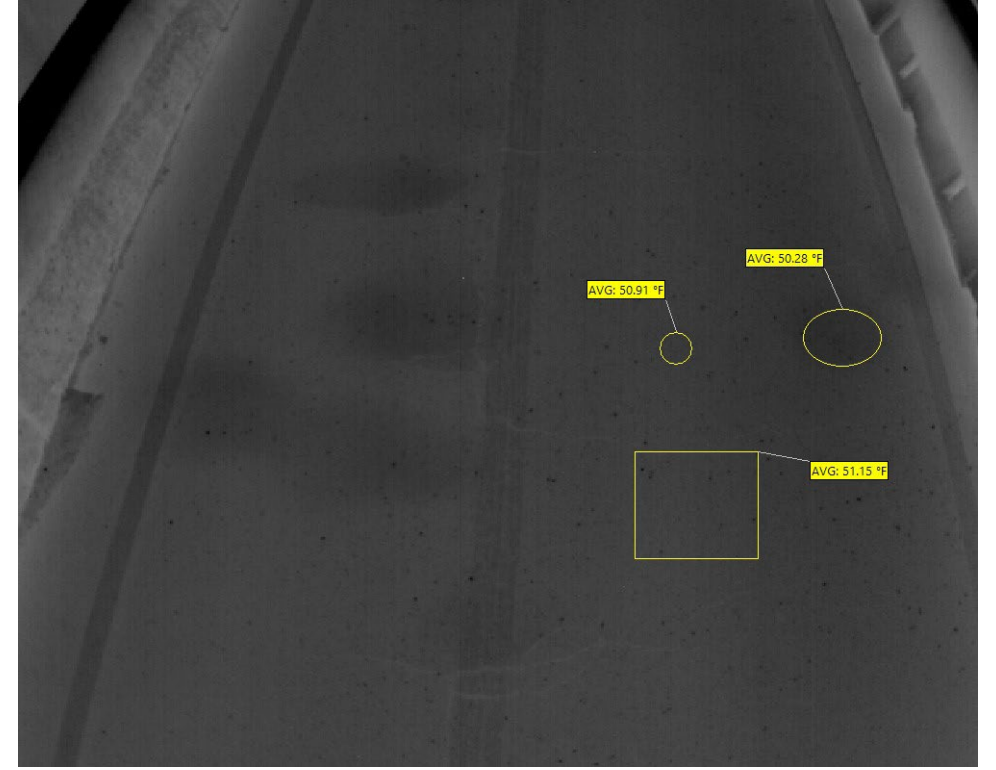
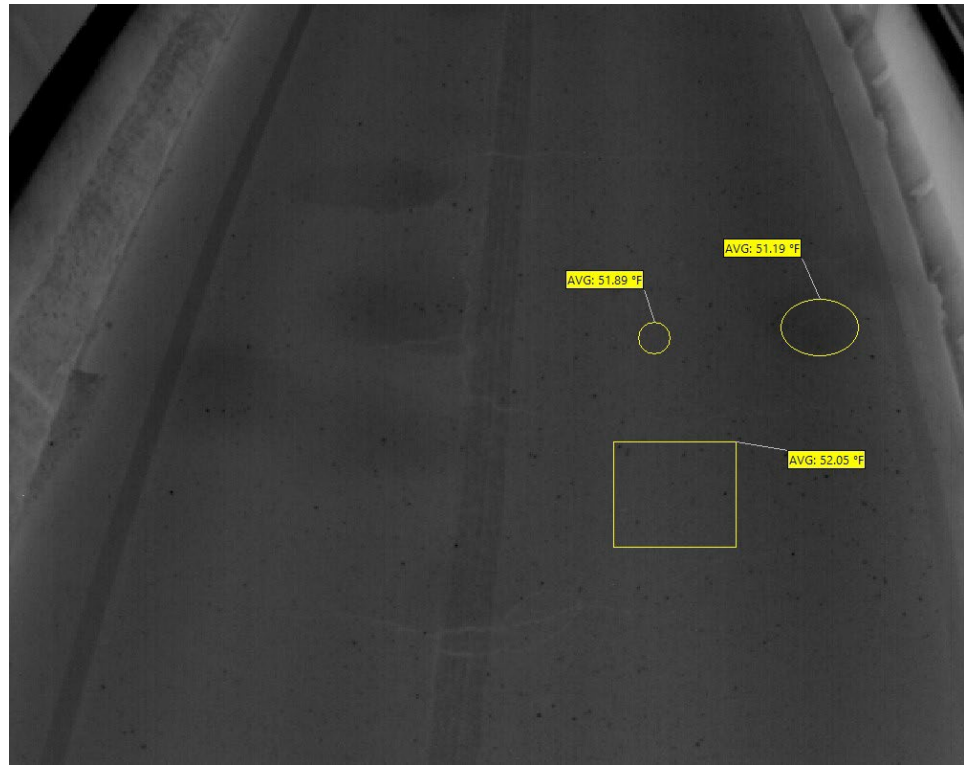
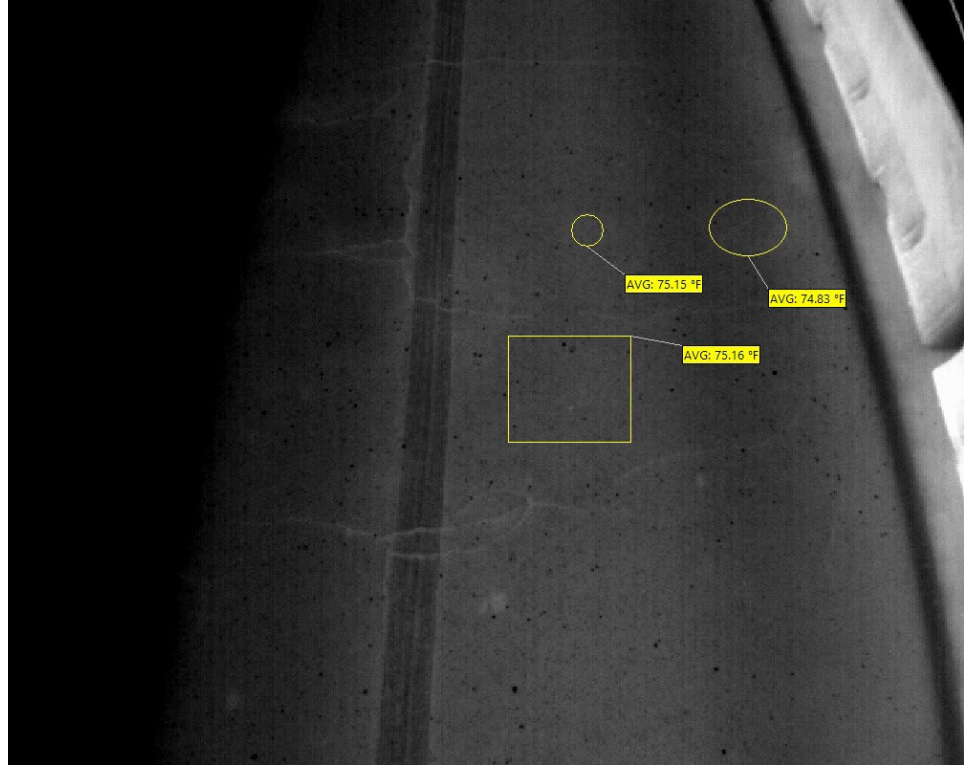
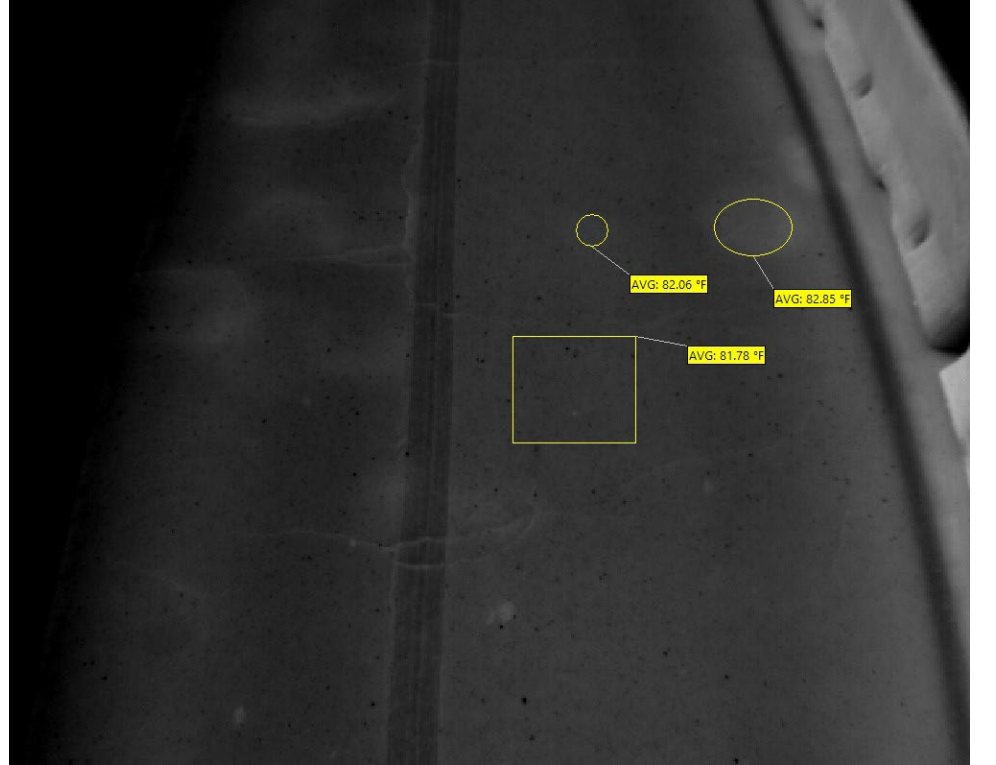
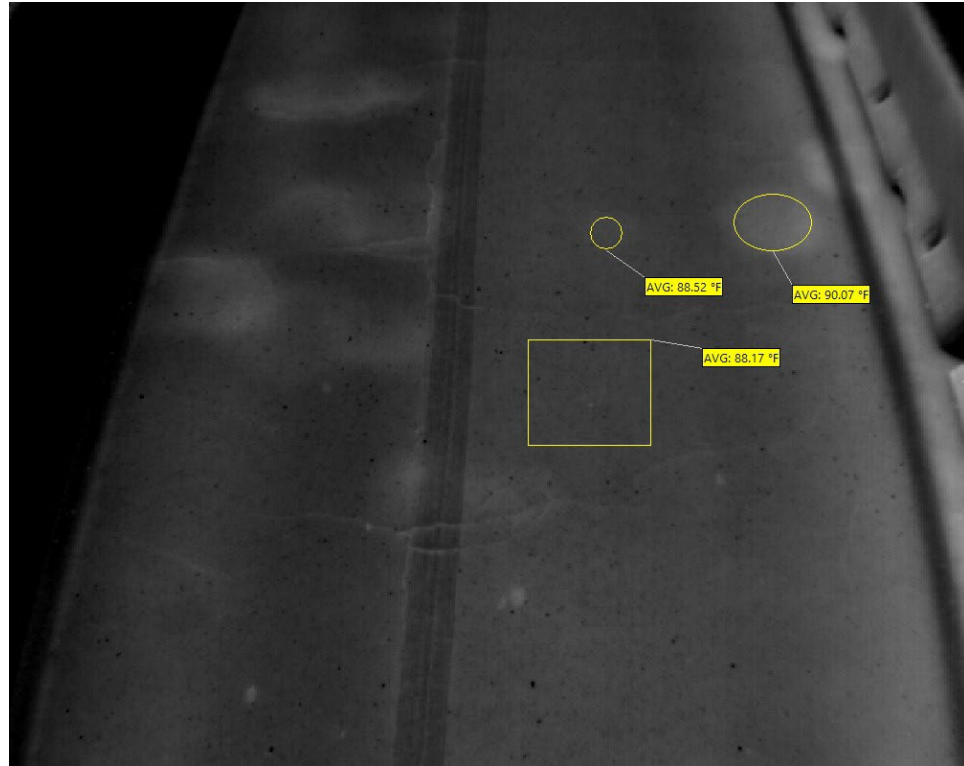
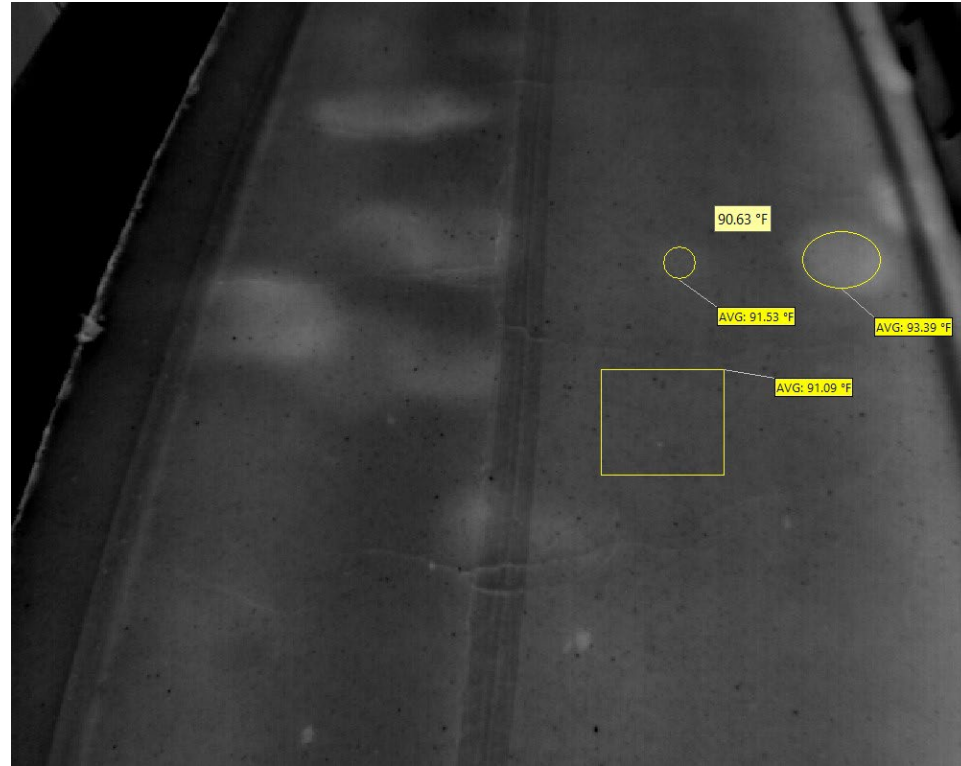
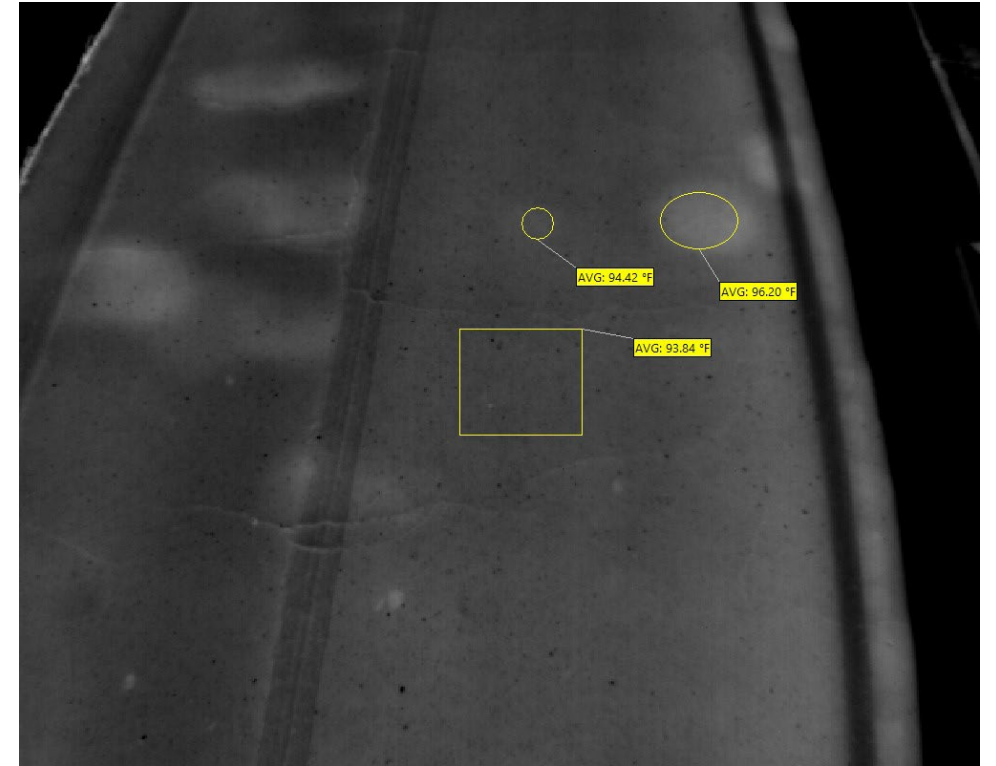
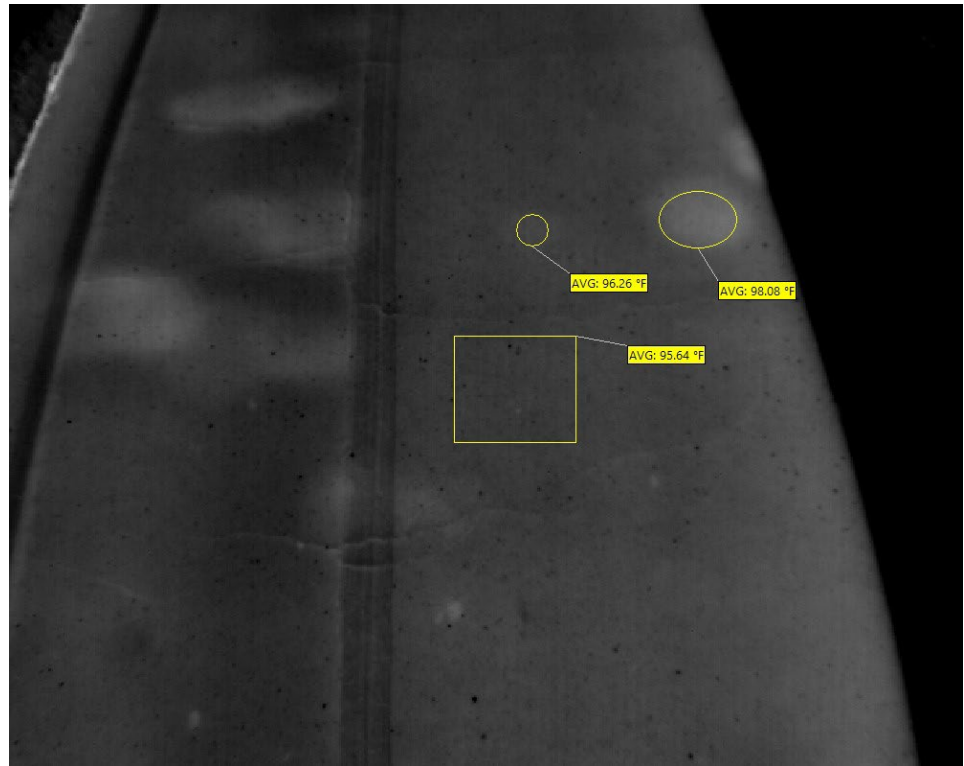
B660037 Left Lane defects 3 and 4

Bridge #	Defect #	Col. Date	Sunrise	Col. Time	Hrs after sunrise	Hrs decimal	Defect Temp. (F)	Control Temp. (F)	Temp. Difference (F) (Def-Cont)	Overlay Type	Overlay Type2
B-66-37	3	8/10/2023	5:52	16:10	10:18	10.30	94.95	94.52	0.43	97 AC / 75	AC
B-66-37	3	8/28/2023	6:11	17:30	11:19	11.32	81.47	81.40	0.07	97 AC / 75	AC
B-66-37	3	8/28/2023	6:11	18:30	12:19	12.32	77.47	77.72	-0.25	97 AC / 75	AC
B-66-37	3	8/28/2023	6:11	20:00	13:49	13.82	71.50	71.91	-0.41	97 AC / 75	AC
B-66-37	3	8/28/2023	6:11	21:00	14:49	14.82	69.24	69.69	-0.45	97 AC / 75	AC
B-66-37	3	8/28/2023	6:11	22:00	15:49	15.82	68.05	68.58	-0.53	97 AC / 75	AC
B-66-37	3	8/28/2023	6:11	23:15	17:04	17.07	66.31	66.88	-0.57	97 AC / 75	AC
B-66-37	3	8/31/2023	6:15	0:10	17:55	17.92	56.48	56.80	-0.32	97 AC / 75	AC
B-66-37	3	8/31/2023	6:15	1:10	18:55	18.92	55.05	55.48	-0.43	97 AC / 75	AC
B-66-37	3	8/31/2023	6:15	2:15	20:00	20.00	54.00	54.38	-0.38	97 AC / 75	AC

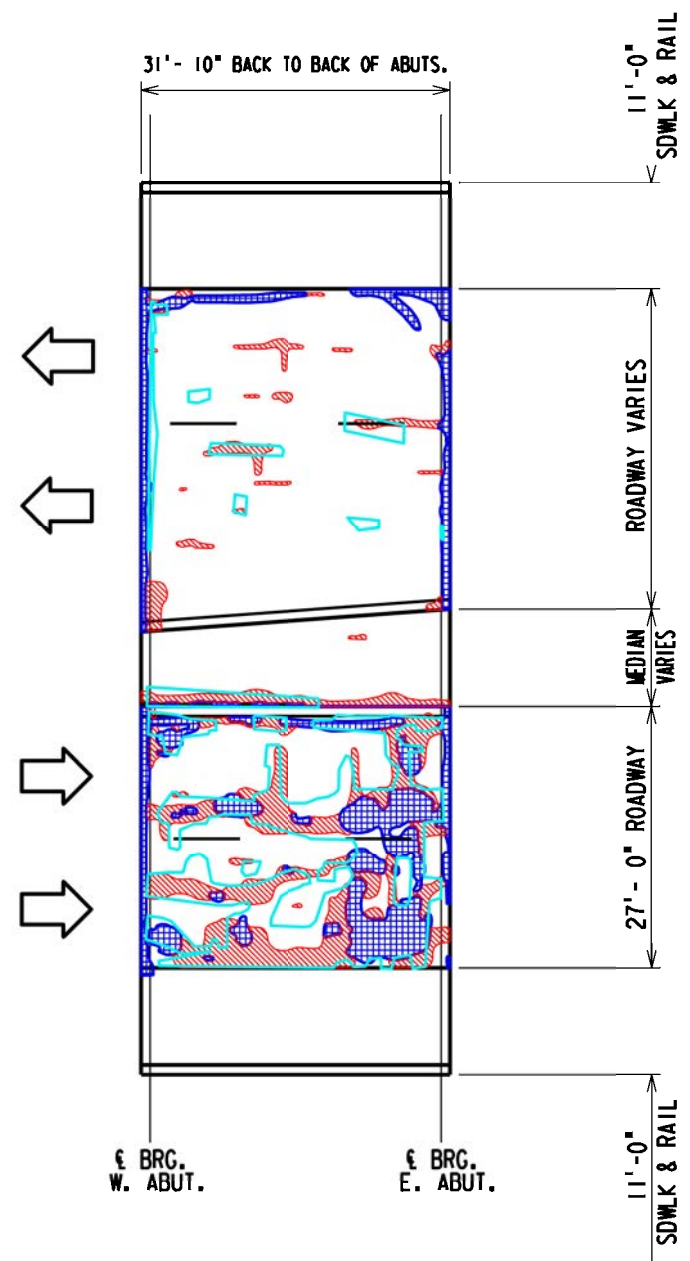
PLAN
B-5-284

DEFECT-REHAB COMPARISON	STRUCTURE NO. B-5-284		
	UNIT	QUANT.	%
TOTAL AREA	ft ²	2228	
TOTAL DEFECTS	ft ²	539	24.2
TOTAL TYPE-1 REHAB	ft ²	474	21.3
DEFECTS/REHAB OVERLAP	ft ²	323	14.5
IR FALSE POSITIVES	ft ²	216	9.7
REHAB NOT DETECTED BY IR	ft ²	151	6.8

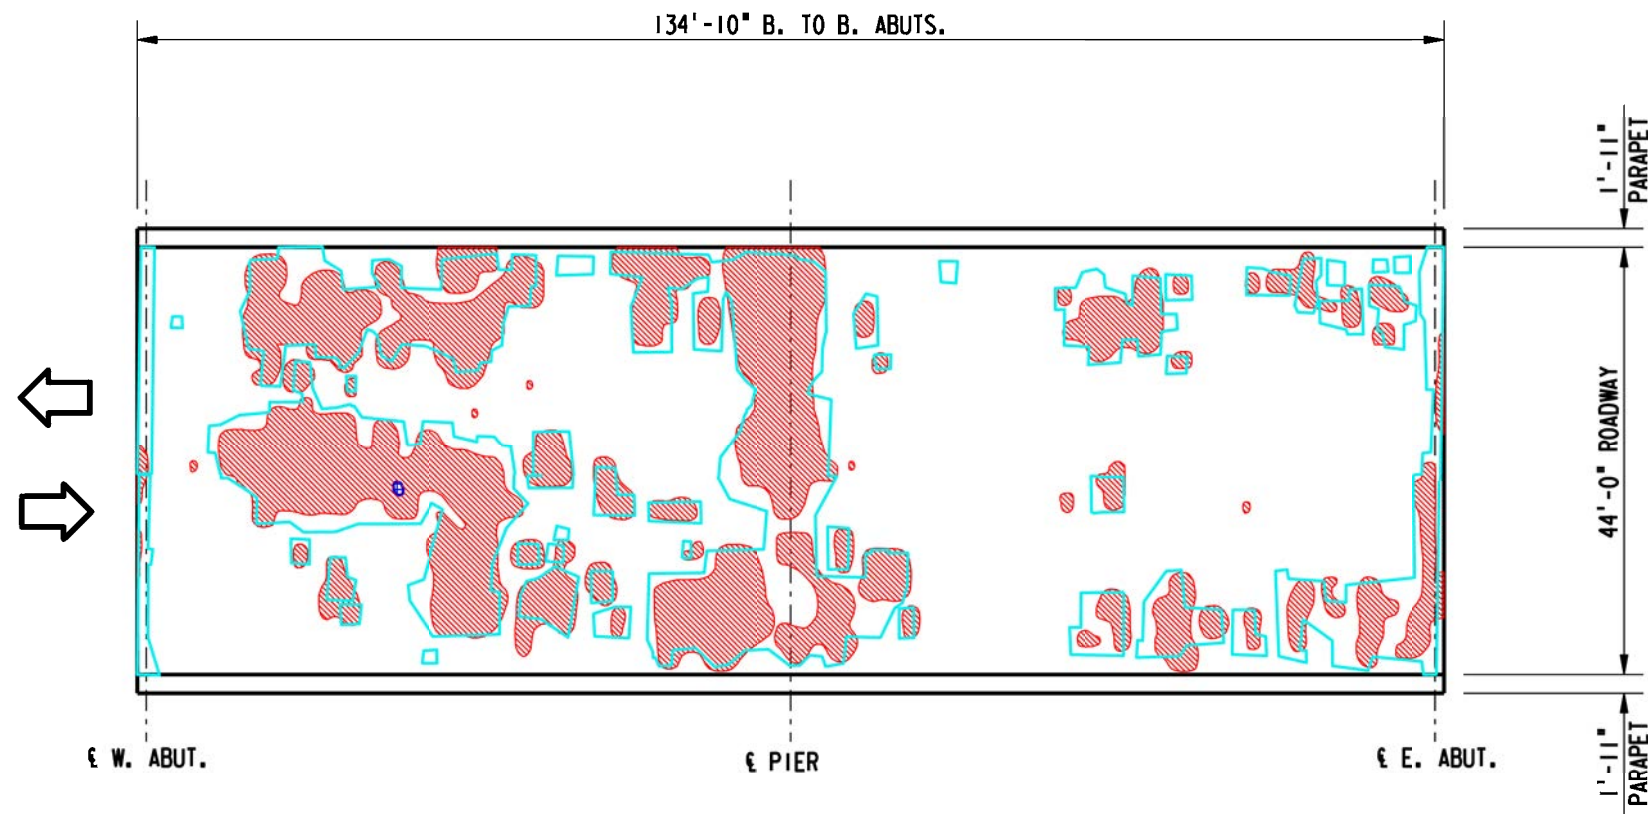
PLAN
B-20-23

DEFECT-REHAB COMPARISON		STRUCTURE NO. B-20-23	
ITEM	UNIT	QUANT.	%
TOTAL AREA	ft ²	5883	
TOTAL DEFECTS	ft ²	1517	25.8
TOTAL TYPE-1 REHAB	ft ²	1949	33.1
DEFECTS/REHAB OVERLAP	ft ²	1335	22.7
IR FALSE POSITIVES	ft ²	182	3.1
REHAB NOT DETECTED BY IR	ft ²	614	10.4

FIELD OBSERVATIONS SUMMARY		S.N. B-20-23		LEGEND	
ITEM	UNIT	QUANT.	%		
TOTAL AREA	ft ²	5883		DELAMINATION	
SHADE/DEBRIS	ft ²	0		SPALL	
DELAMINATION	ft ²	1516	25.8	DEBOND/SCALING	
SPALL	ft ²	0	0	ASPHALT PATCH	
DEBOND	ft ²	0	0	CONCRETE PATCH	
ASPHALT PATCH	ft ²	1	<0.1	SHADE/DEBRIS	
CONCRETE PATCH	ft ²	0	0	REHAB	
TYPE-1 REHAB AREA	ft ²	1949	33.1

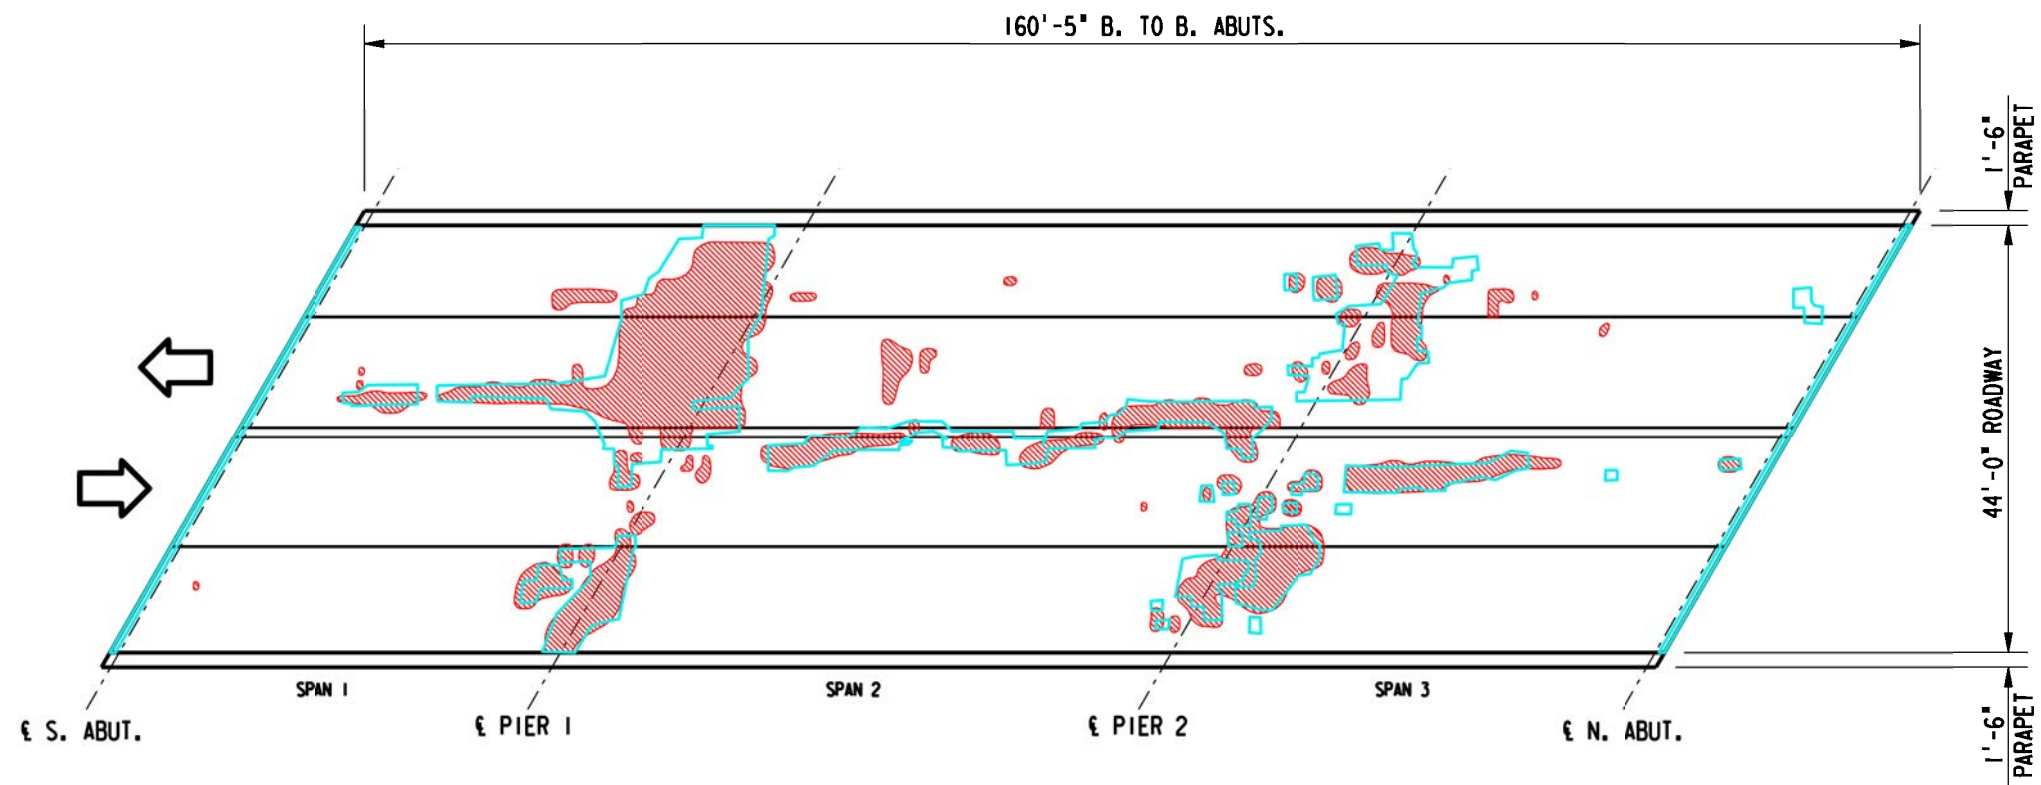
PLAN
B-31-18

DEFECT-REHAB COMPARISON		STRUCTURE NO. B-31-18	
ITEM	UNIT	QUANT.	%
TOTAL AREA	ft ²	7000	
TOTAL DEFECTS	ft ²	782	11.2
TOTAL TYPE-1 REHAB	ft ²	882	12.6
DEFECTS/REHAB OVERLAP	ft ²	608	8.7
IR FALSE POSITIVES	ft ²	173	2.5
REHAB NOT DETECTED BY IR	ft ²	274	3.9

FIELD OBSERVATIONS SUMMARY		S.N. B-31-18		LEGEND	
ITEM	UNIT	QUANT.	%		
TOTAL AREA	ft ²	7000		DELAMINATION	
SHADE/DEBRIS	ft ²	0		SPALL	
DELAMINATION	ft ²	785	11.2	DEBOND/SCALING	
SPALL	ft ²	0	0	ASPHALT PATCH	
DEBOND	ft ²	0	0	CONCRETE PATCH	
ASPHALT PATCH	ft ²	0	0	SHADE/DEBRIS	
CONCRETE PATCH	ft ²	0	0	REHAB	
TYPE-1 REHAB AREA	ft ²	882	12.6

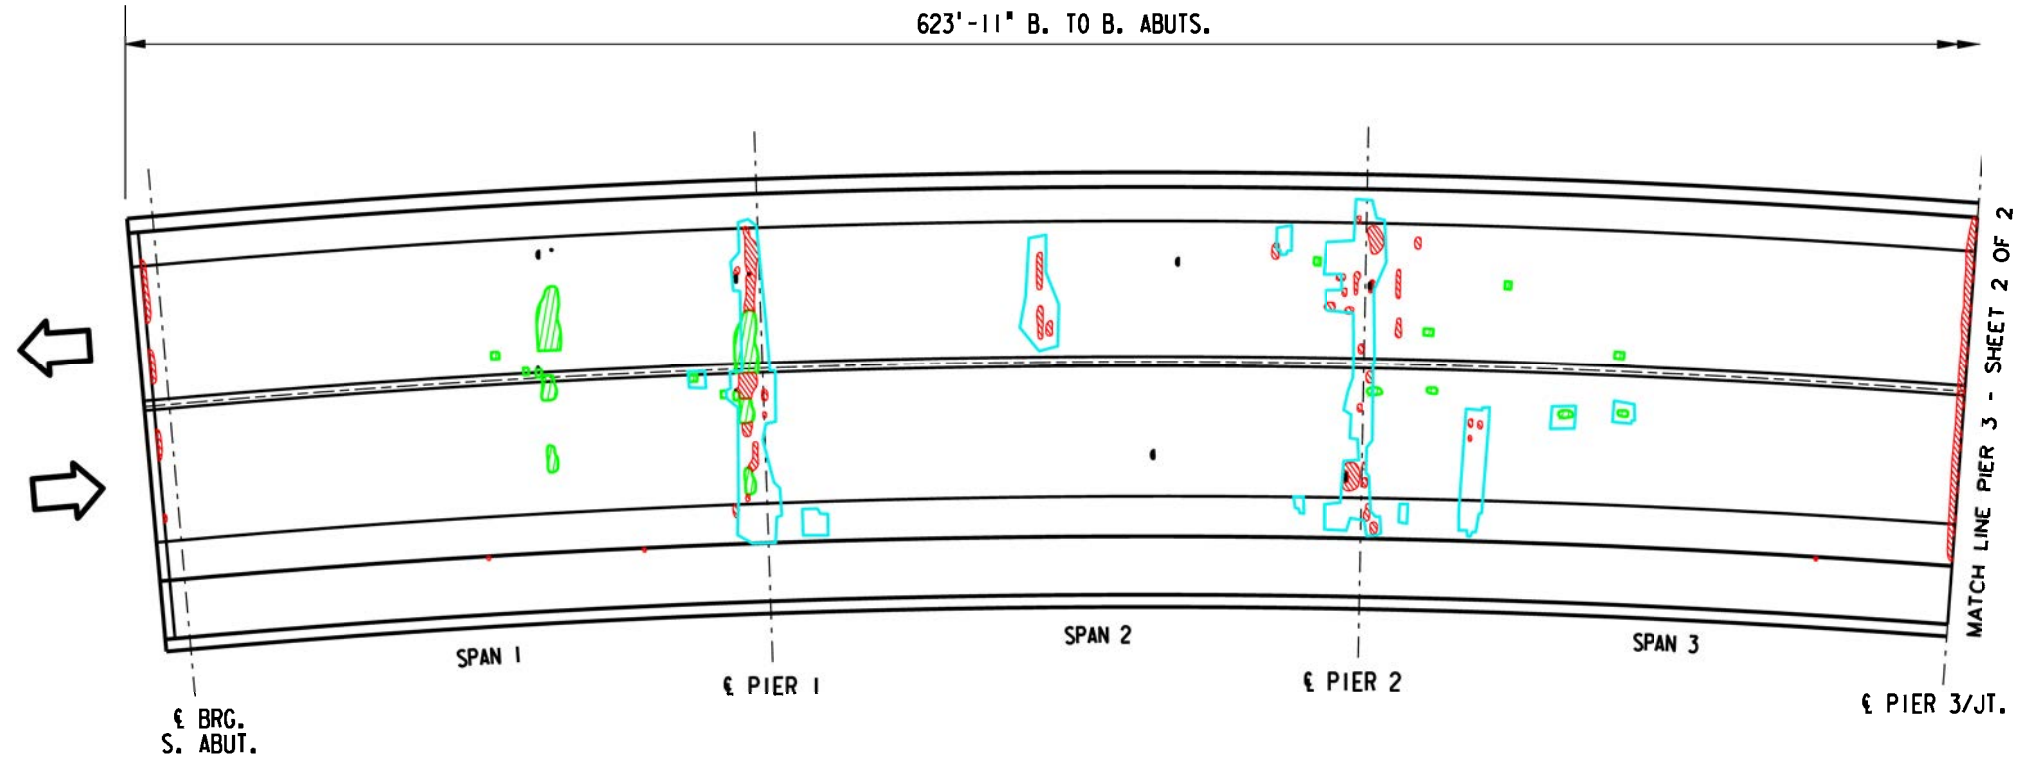
PLAN
B-31-23

DEFECT-REHAB COMPARISON		STRUCTURE NO. B-31-23	
ITEM	UNIT	QUANT.	%
TOTAL AREA	ft ²	22417	
TOTAL DEFECTS	ft ²	301	1.3
TOTAL TYPE-1 REHAB	ft ²	768	3.4
DEFECTS/REHAB OVERLAP	ft ²	155	0.7
IR FALSE POSITIVES	ft ²	146	0.7
REHAB NOT DETECTED BY IR	ft ²	613	2.7

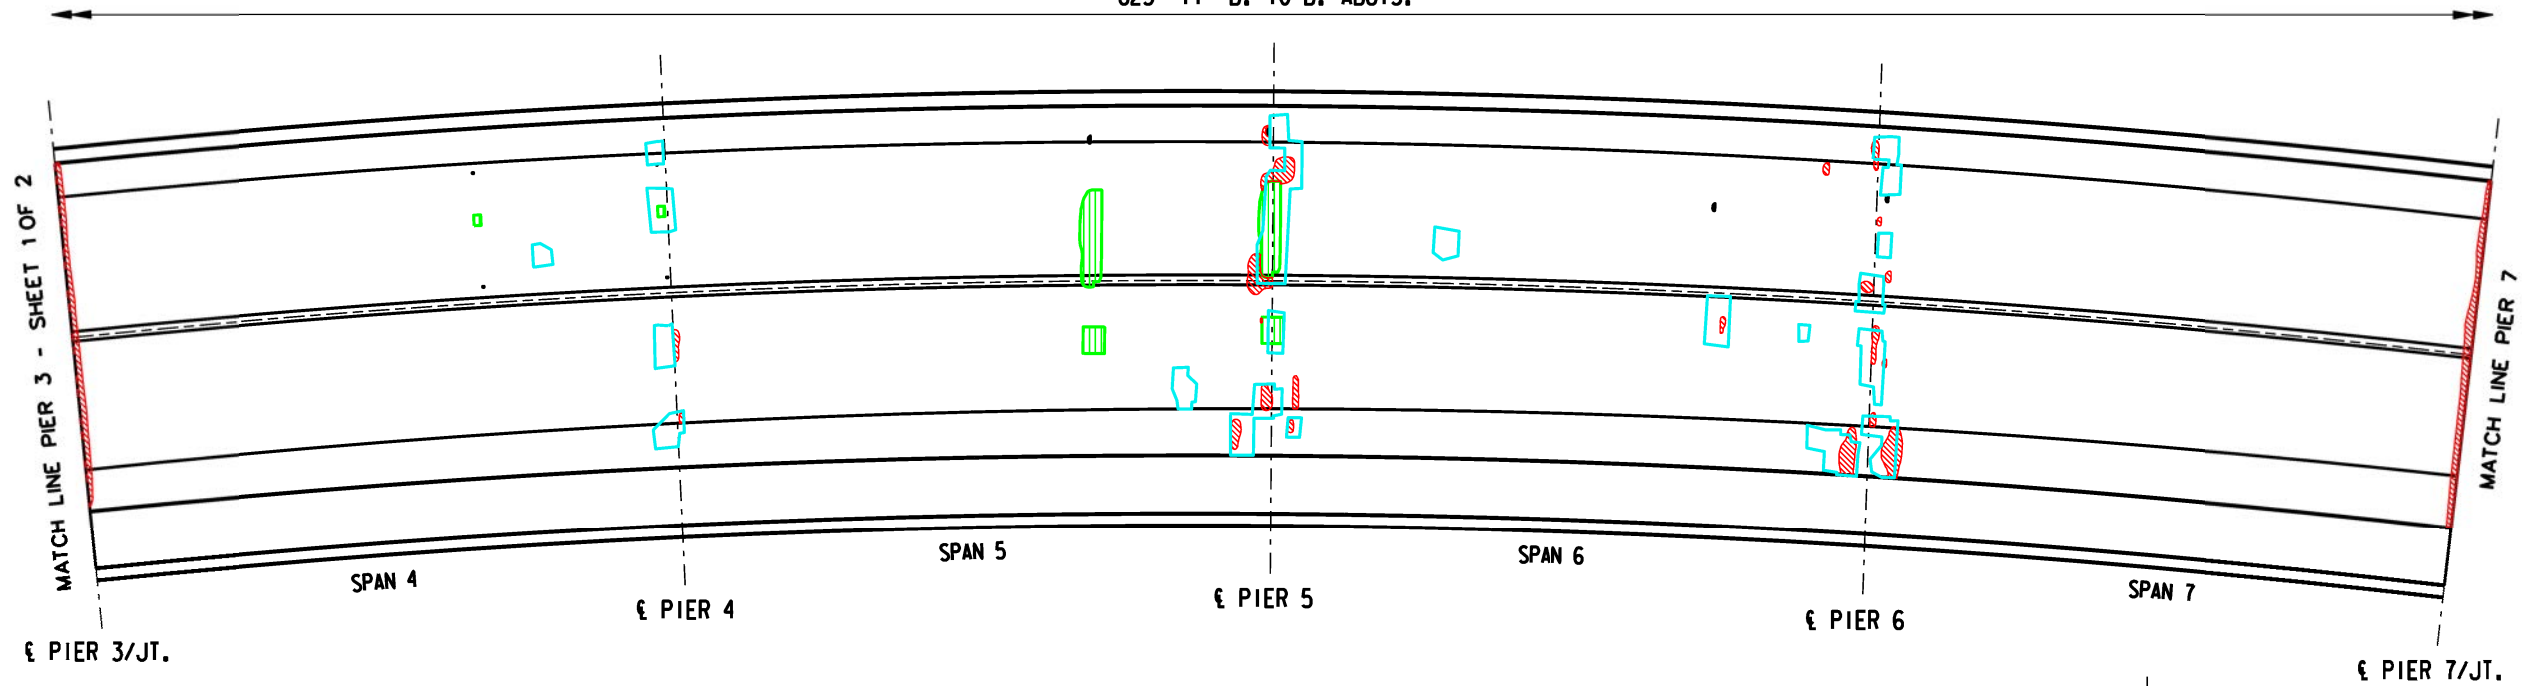
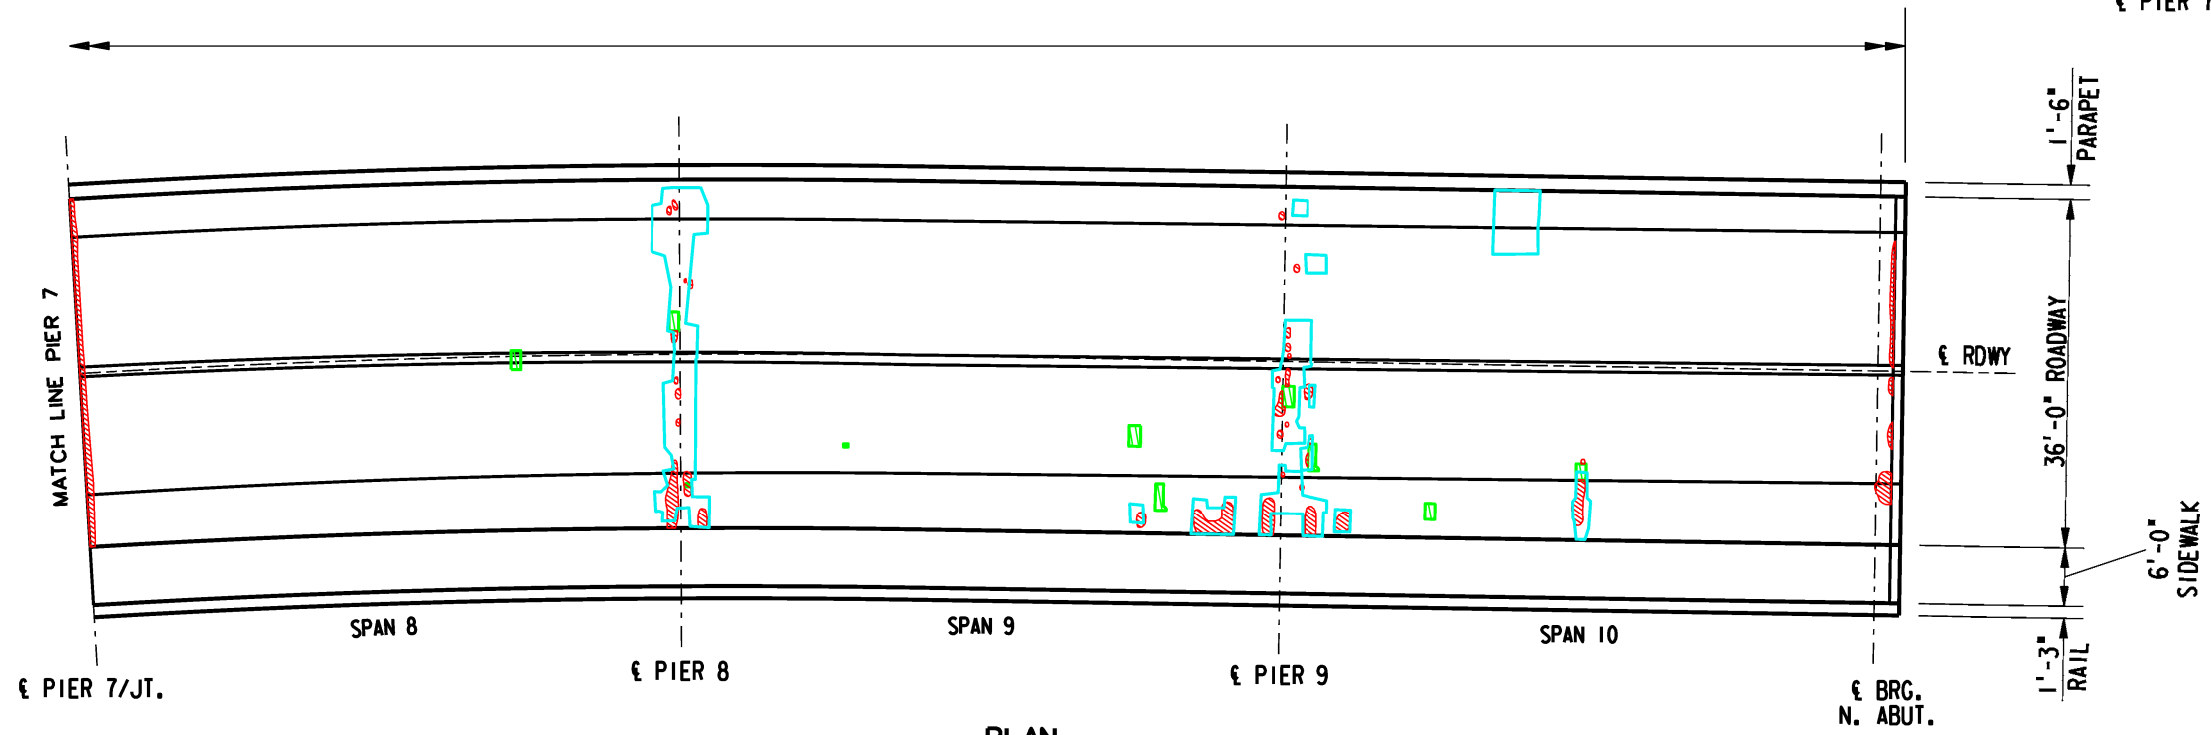
PLAN
B-31-23

SURFACE TYPE: CONCRETE - NO OVERLAY
INFRARED INSPECTION DATE: 7/27/17
