**SCHOOL OF  
CIVIL ENGINEERING  
OKLAHOMA STATE UNIVERSITY**

FATIGUE DAMAGE TO STEEL  
BRIDGE DIAPHRAGMS,

Report No. FHWA/OK 89(10)

December, 1989

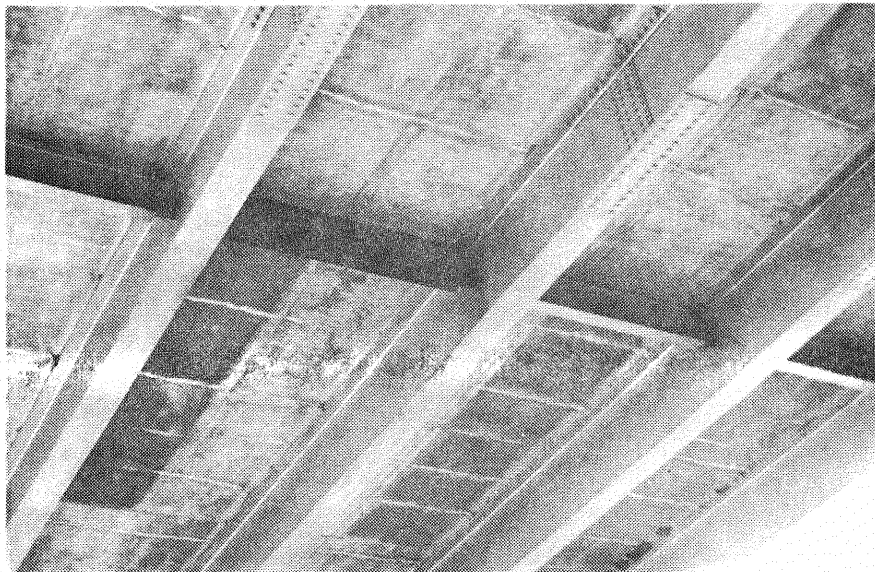
Figure 2. Position of Diaphragms

The pattern of cracked diaphragms and the location of cracks in the diaphragms indicate that diaphragms at each transverse location between the piers are acting as continuous beams. In all but one case, the cracks originate in the bottom flange cope and grow up through the web. No cracks were found at connections to exterior girders. Taken as a whole, these observations indicate that the "continuous" diaphragms are being loaded by the differential deflections of the longitudinal girders.

A truck in one of the traffic lanes will cause the interior girders to deflect more than the exterior girders. This in turn will cause the "continuous" diaphragm to deflect more at the interior of the bridge than at the exterior, inducing high positive moments at the interior region. Exterior girders are not stiff enough torsionally to induce high negative moments when the load is near the diaphragm midspan. The positive moment produces tension in the bottom flange which is magnified by the stress concentration at the cope.

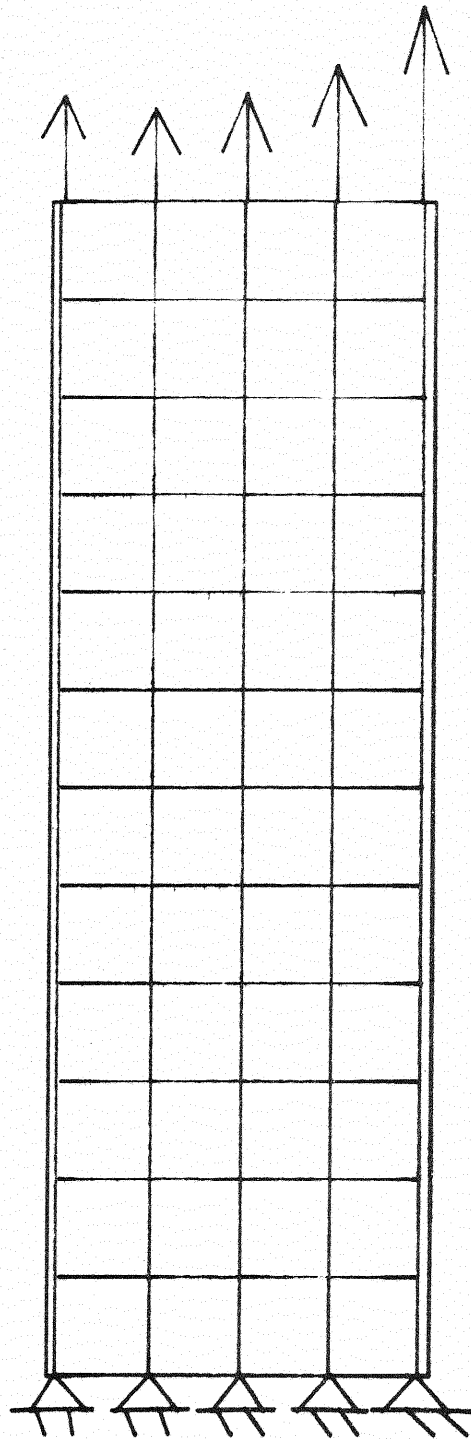
Figure 20. Uncoped Diaphragm

Three modified diaphragms were analyzed for comparison to the original diaphragm. The first modification does not have a bottom flange cope (Figure 20), the second modification has a cope tapered at a rate of 2.5 horizontal to 1 vertical (Figure 21), and the third modification calls for removing the bolts from the lower half of the diaphragm-to-girder connection. The degree of taper selected for the second modification is the same as that specified for flange transitions in the AASHTO Standard Specifications for Highway Bridges. The third modification was accomplished analytically by removing the pin supports from the bottom half of the connection. The first modification will require replacing the diaphragms while the second and third modifications can be applied to existing diaphragms.

As seen in Figure 22, all modifications succeed in reducing stress at the cope. The tapered cope provides only a slight reduction while the uncoped diaphragm and the diaphragm with bolts removed from the connection provide significant reductions. Removing the cope from the bottom flange leads to a relatively uniform stress distribution, while removing bolts from the bottom of the connection causes the peak stress to shift up away from the cope.

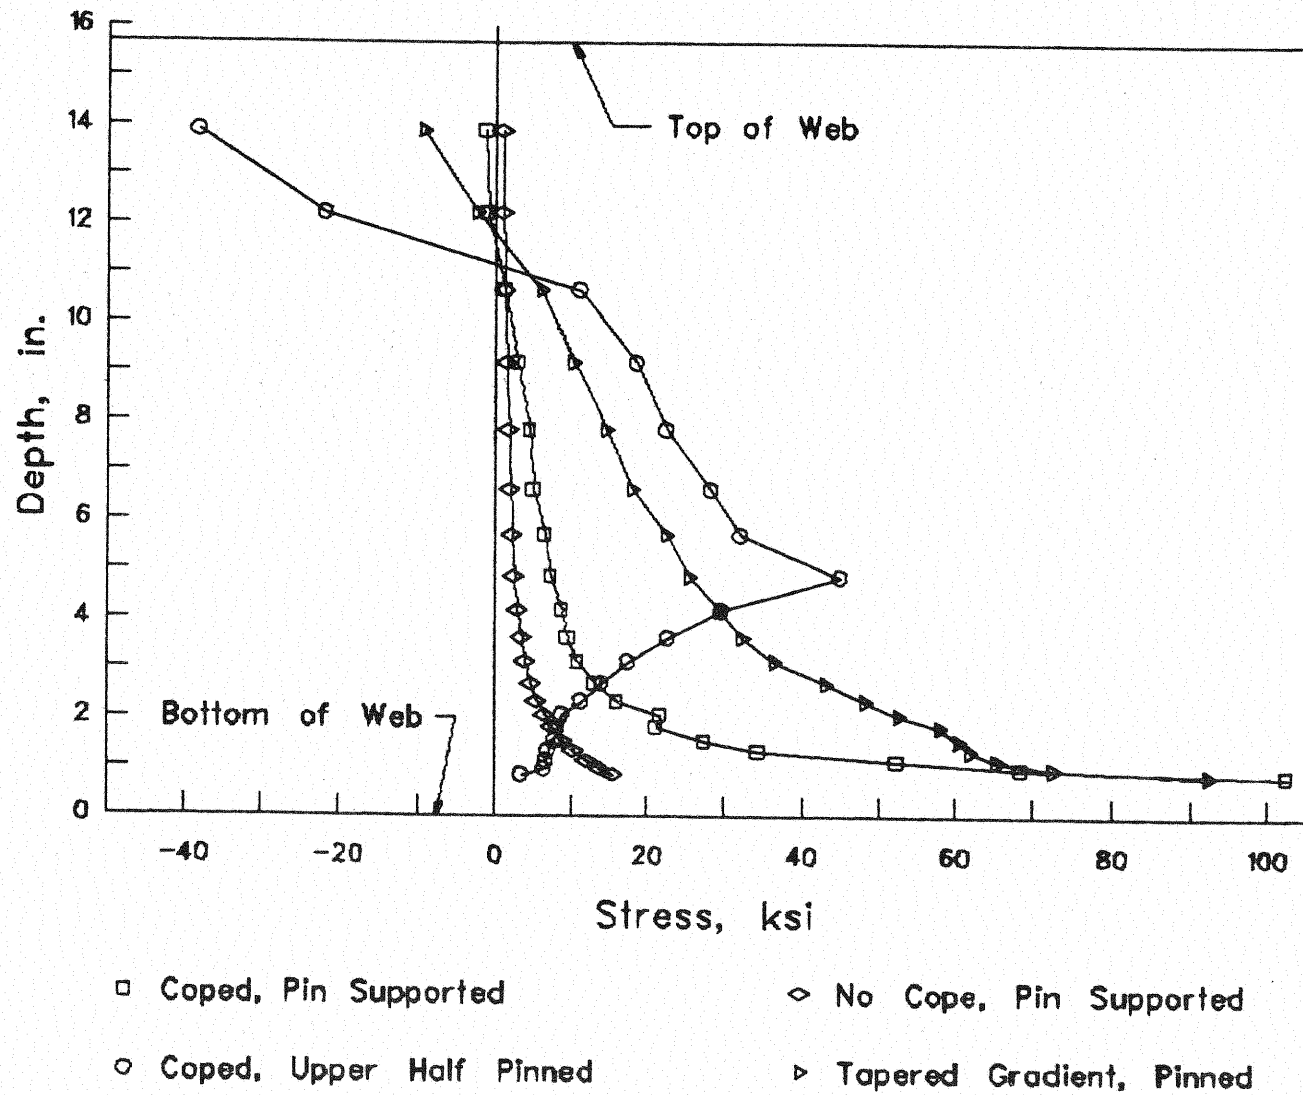
Figure 22. Stress Along Crack Line From Finite Element Analysis

Stresses calculated along the crack line for the four analytical models are shown in Figure 22. In examining this figure, recall that the moments applied to the models are ten times greater than the moments calculated from the grid analysis. Also recognize that the analysis is an elastic analysis; calculated stresses are not restricted by a plastic limit. The sole purpose of this figure is to show how the stress distribution in the vicinity of the cope changes as diaphragm modifications are applied.

The results of the analyses indicate that the most effective way of reducing stress in the diaphragm at the connection is to install an uncoped diaphragm. In the uncoped diaphragm, there are no points of high stress concentration. Removing bolts from the bottom half of the diaphragm-to-girder connection is also effective in reducing stress at the cope, but results in a high stress in the center portion of the web. Tapering the cope reduces stress at the bottom of the diaphragm, but to a much lesser degree than the other two modifications.

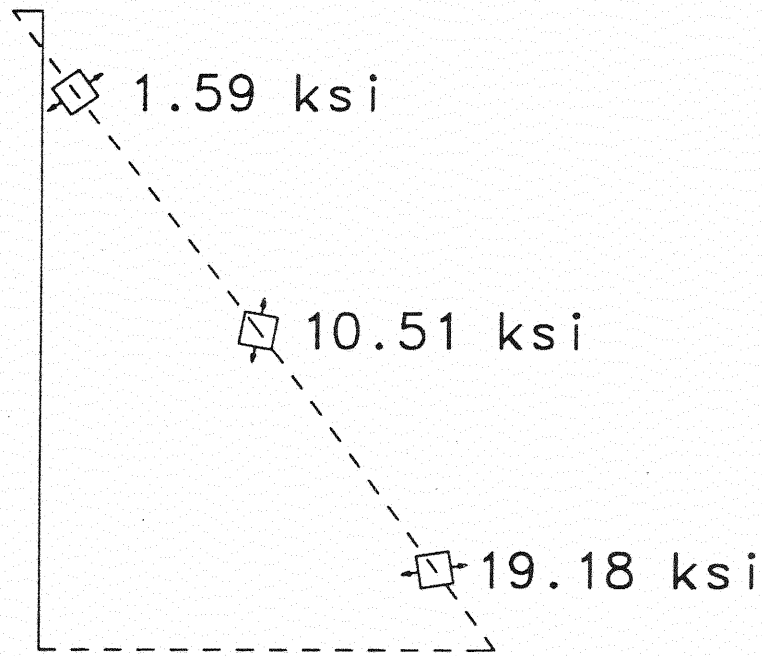
Figure 31. Principal Stresses Near Cope

The rosette data were also used to determine the magnitude and direction of principal stresses at gage locations. Principal stress elements are shown in Figure 31. The important observation to be made from this figure is that the maximum tensile stress is oriented perpendicular to the anticipated crack plane.

Failed specimens are shown in Figure 34. Specimens were considered to have failed when the crack had grown through half the web. It was found that very few cycles relative to the total number of cycles applied were necessary to propagate the crack from the web centerline through the upper half of the web. Stopping the tests when the cracks reached the web centerline was necessary to prevent the specimens from becoming so flexible that they would impact on the load frame during cycling. An important observation to be made from Figure 34 is that the crack shape is very similar to shapes observed on the bridge and that the crack plane is approximately perpendicular to the direction of the maximum principal tensile stress shown in Figure 31.

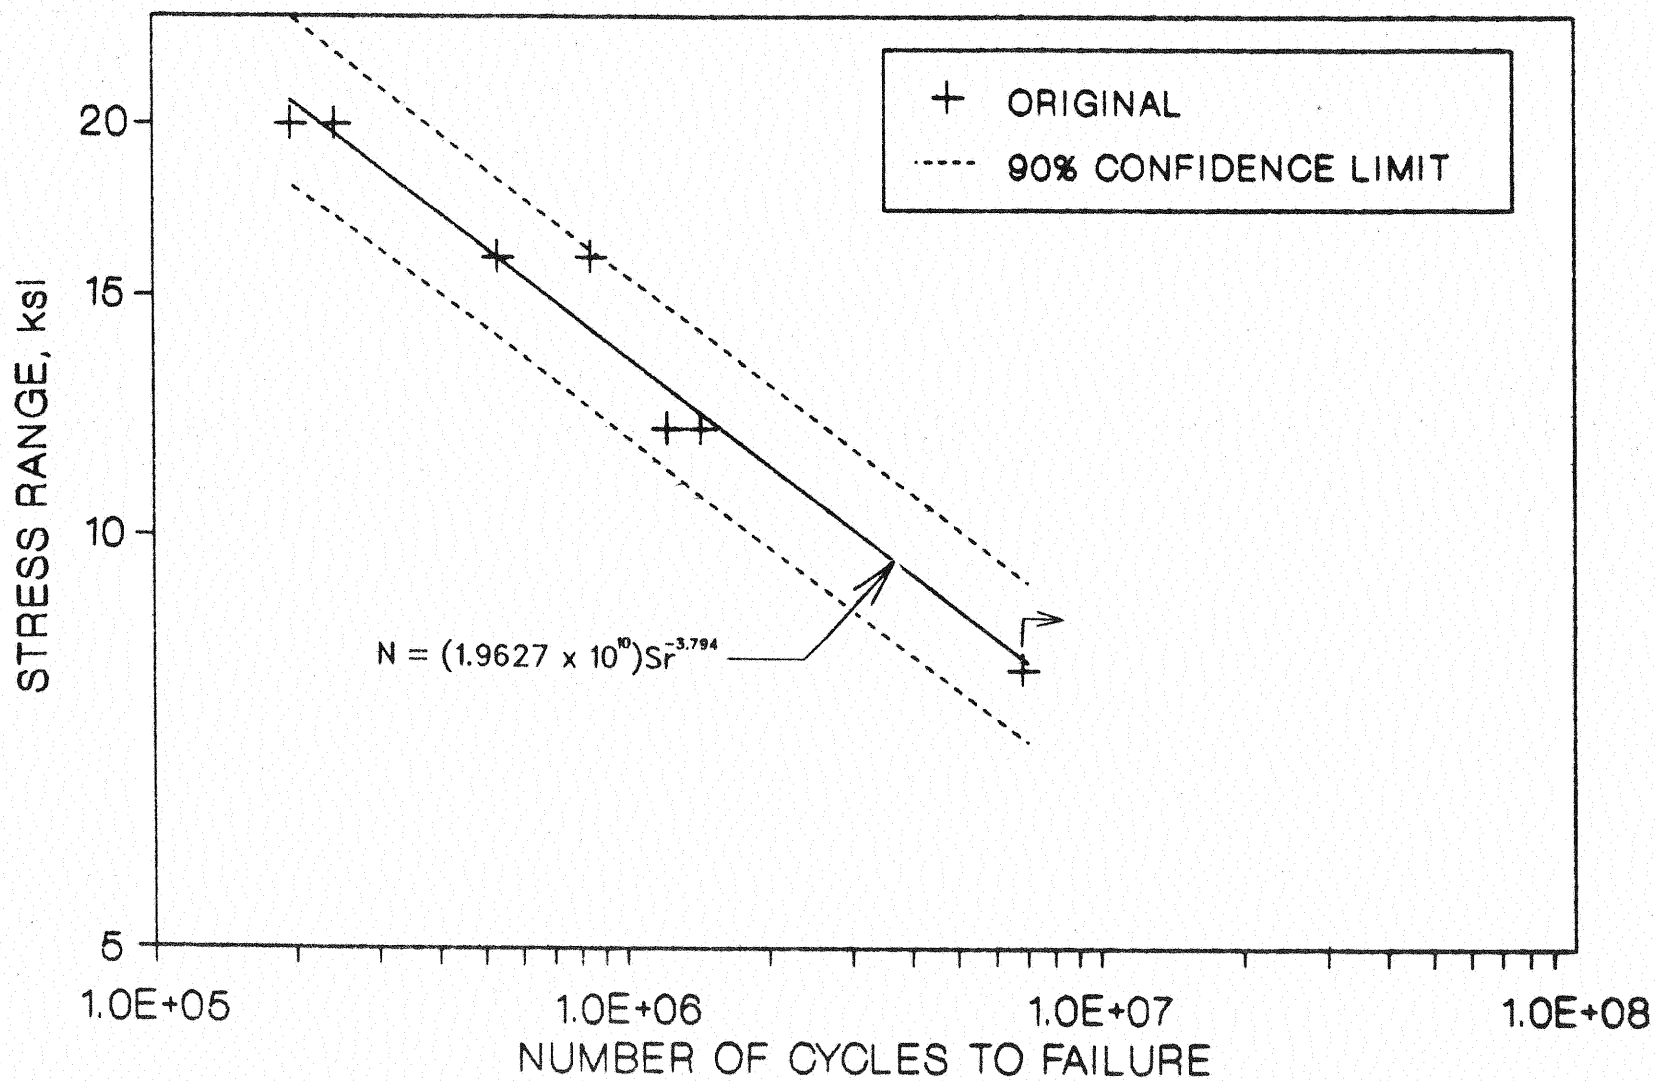
Figure 32. Fatigue Life of Original Detail

The original detail was tested under cyclic loads at a variety of stress ranges. The data obtained are shown in Table 2, and a plot is shown in Figure 32. A line fit to the data using the least squares method is also shown on the plot. Data for tests discontinued without initiating noticeable cracks are indicated by an arrow attached to the data point and are not included in the regression analysis. The 90% confidence limit lines shown on the plot indicate there is a 90% probability that future values would fall within the limits. The detail can be placed in a specific stress

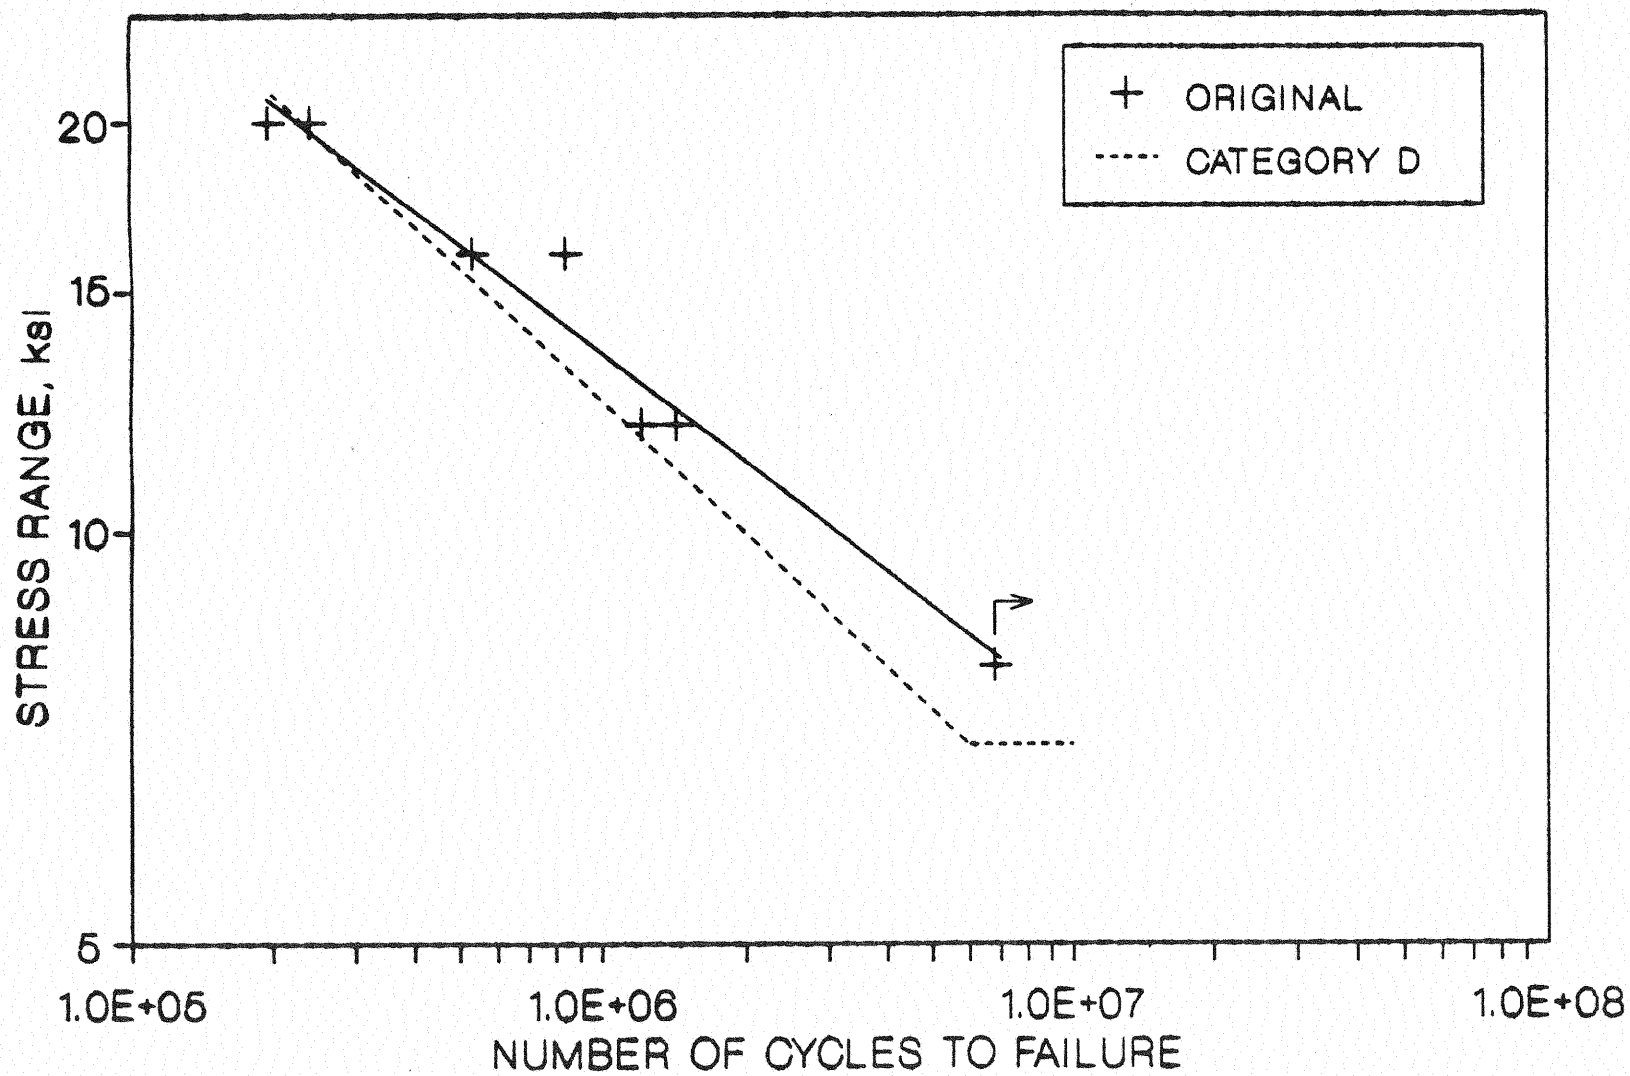
Figure 33. Fatigue Life of Original Detail Compared to a Category D Detail

category as discussed in Reference [3]. The fatigue data are replotted in Figure 33 with the corresponding stress category superimposed.

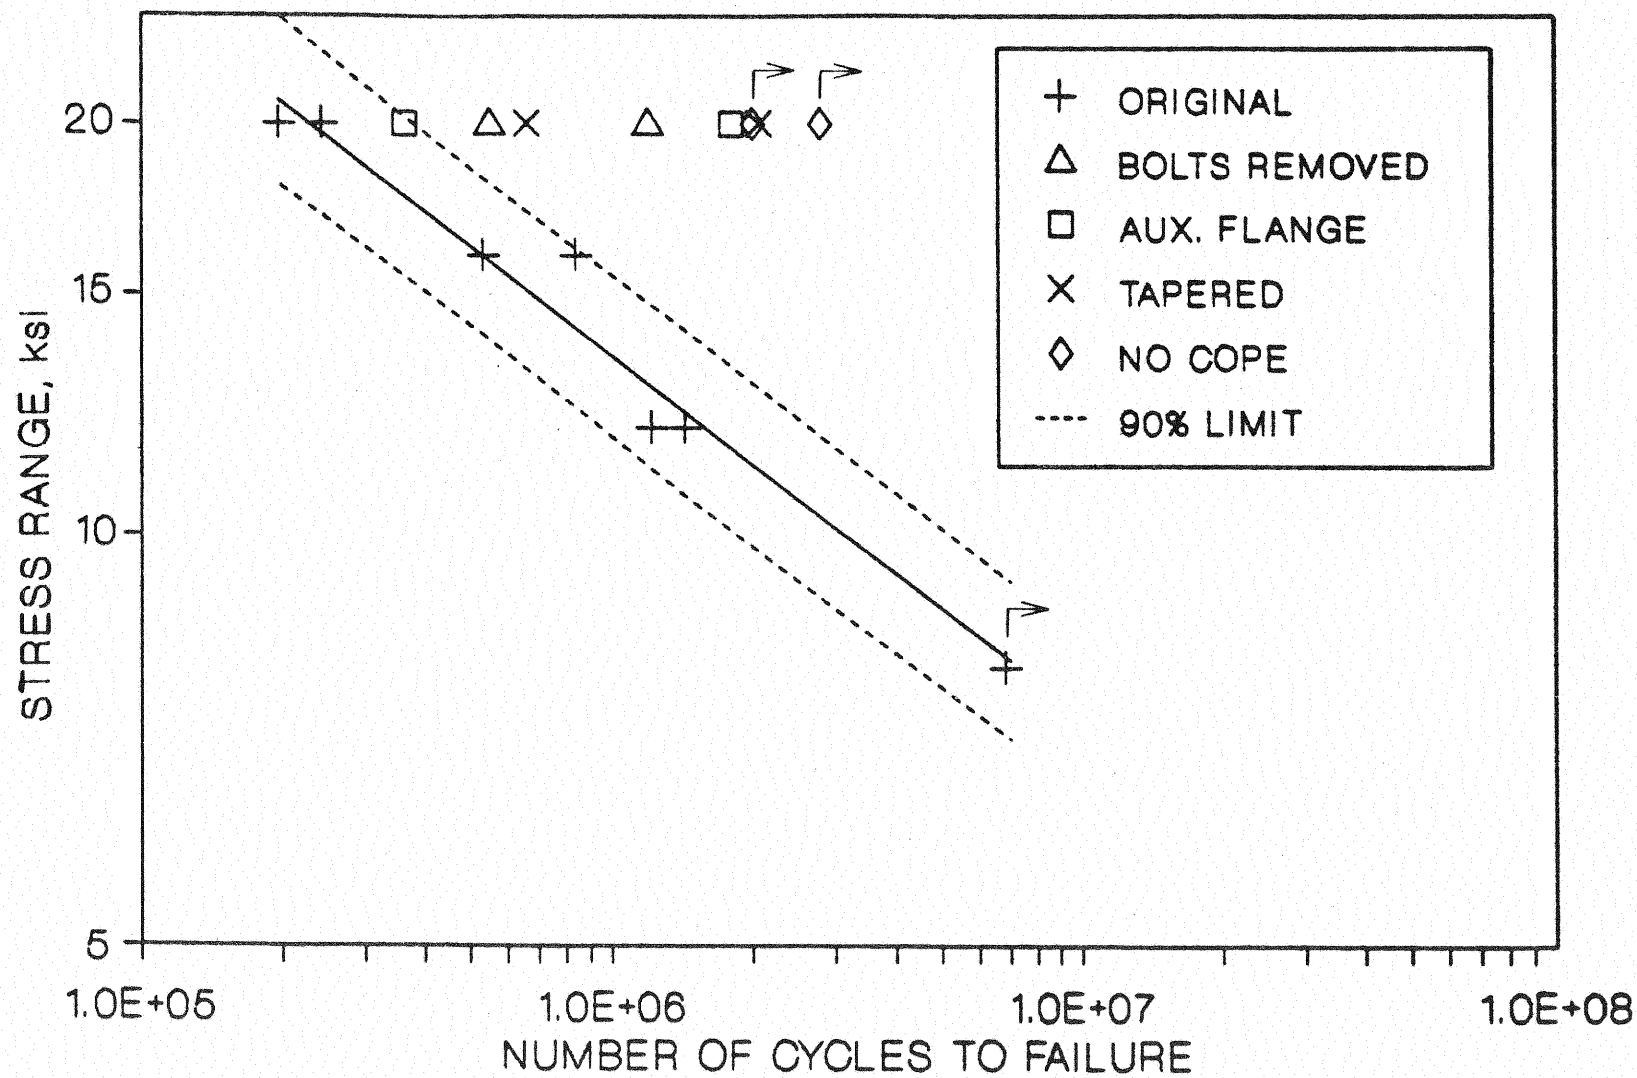
Figure 35. Fatigue Life of All Specimens

No Cope in Bottom Flange. Two specimens were tested at the 20 ksi stress range. Data are recorded in Table 2 and plotted in Figure 35. Both specimens withstood over two million load cycles with no sign of fatigue damage. The data points plot well beyond the upper 90% confidence limit for the original detail, indicating that a significant improvement in fatigue life has been achieved.

Tapered Cope. The fatigue life of the tapered cope detail was very dependent on how carefully cutting and grinding procedures were carried out. As can be seen in Table 3 and Figure 35, the two tapered cope specimens exhibited significantly different fatigue lives. One test resulted in a substantial increase over the life of the original detail while the other resulted in only a minimal increase. A failed specimen is shown in Figure 36. Cracks in these specimens originated at rough spots on the tapered surface and grew into approximately the same shape as on the original detail.

Fatigue data are recorded in Table 3 and plotted in Figure 35. Data points for the two specimens tested plot beyond the upper 90% confidence limit for the original detail, indicating the modification is effective at increasing the diaphragm fatigue life. Average fatigue life for this detail is slightly less than for the tapered cope, but scatter in the tapered cope data is greater. Neither this detail nor the tapered cope is as effective at increasing fatigue life as is the uncoped detail.

As can be seen in Table 3 and Figure 35, the modification did increase average specimen fatigue life, but there is a great deal of scatter in the data. In both tests, a short period of no growth after the modification was followed by propagation around the end of the auxiliary flange. A failed specimen is shown in Figure 39. The fact that the crack easily propagated around the auxiliary flange is an indication that the flange does not extend far enough ahead of the cope to be effective.

It is recommended that for uncracked diaphragms and for diaphragms with cracks shorter than one inch, the bottom two bolts in the diaphragm-to-girder connection be removed. This recommendation is based on the effectiveness of this modification to increase fatigue life--even for diaphragms containing small cracks--and the relative ease with which this modification can be accomplished. Diaphragms containing cracks longer than one inch should be removed and replaced with diaphragms not coped at the bottom

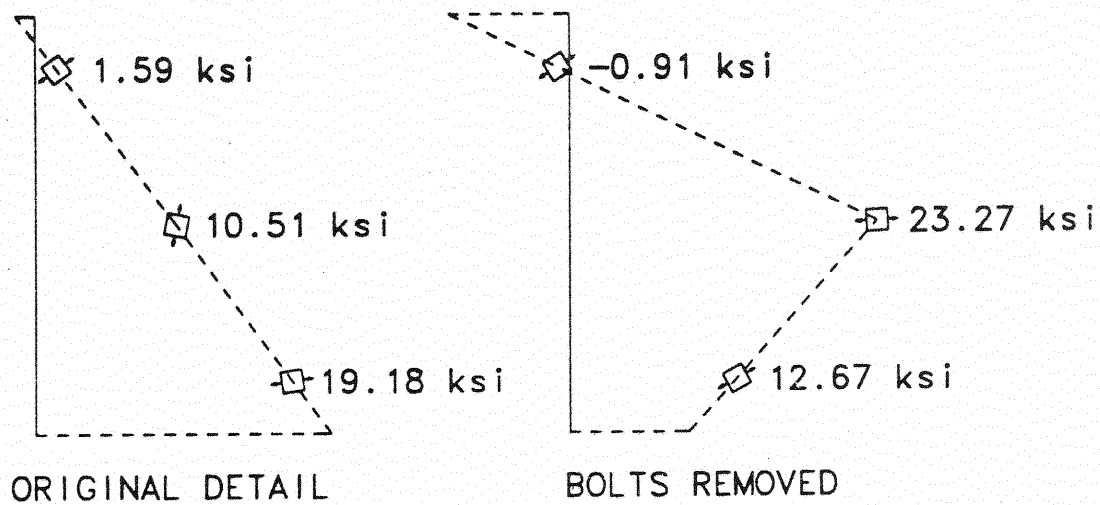
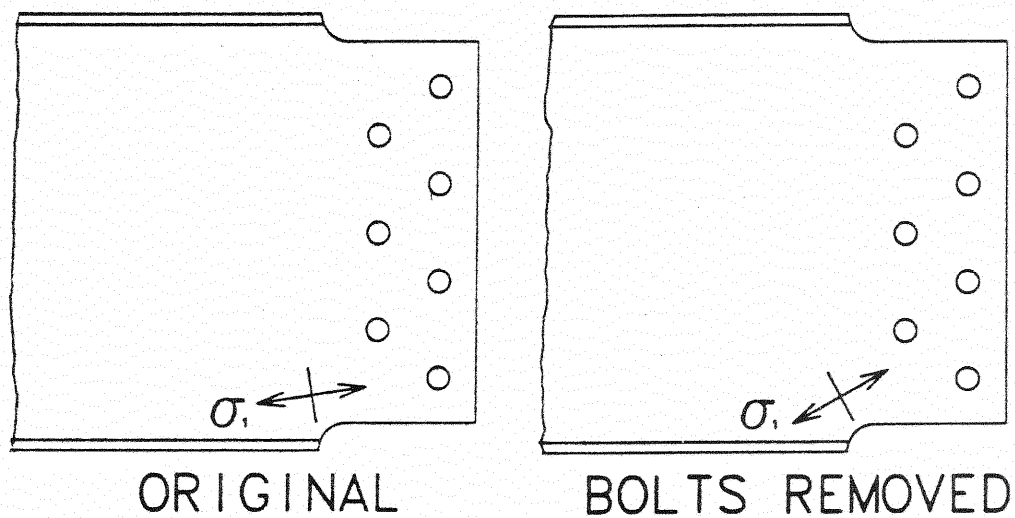
Figure 37. Comparison of Stresses in Original Detail to Stresses With Bolts Removed

Bottom Bolts Removed. Removal of the two lowest bolts relieves the stress at the lower cope, but still leaves the connection with sufficient capacity to carry the wheel loads of an HS20 truck. (Calculations are shown in Appendix B.) In Figure 37, the magnitude and direction of principal stresses in the diaphragm when all bolts are in place are compared to the stresses when the lowest two bolts are removed. Strains with bolts removed were measured using the same beam described in the discussion of the original detail. The shape of the measured stress distribution is in agreement with results of the finite element analysis shown in Figure 22.

Test results indicate that removing the bottom two bolts from the diaphragm-to-girder connection is an effective and reliable way of increasing diaphragm fatigue life. The method is effective even when small cracks are present in the diaphragm at the cope. Laboratory tests on this modification may be more severe than the detail would experience in actual service.
