USE OF FIBER-REINFORCED POLYMER COMPOSITES FOR BRIDGE REPAIRS IN MONTANA

FHWA/MT-26-001/10337

Final Report

Montana State University
Bozeman, Montana

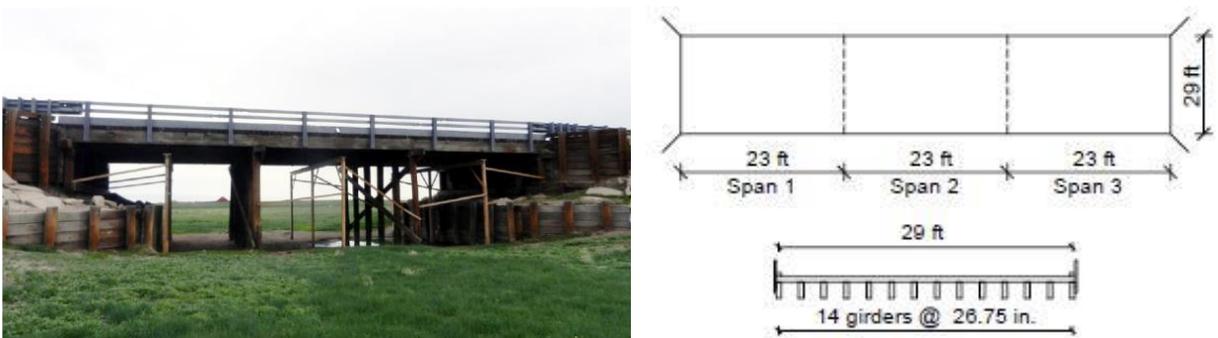
The superstructure of the F-22-V bridge, located in Washington County, Colorado, was rated 4 (Poor Condition, FHWA 1995) in 2019 due to aging and deterioration [33]. The Colorado Department of Transportation (CDOT) sponsored a program to rehabilitate the deteriorated bridge. The three-span, 83-year-old timber bridge is supported by 14 Douglas-Fir girders (Figure 5). The design load used at the time of construction was H15. This program had three major aspects: (1) laboratory testing, (2) field application and finite element model evaluation, and (3) load ratings.

Figure 5: F-22-V bridge, Washington County, Colorado [33]

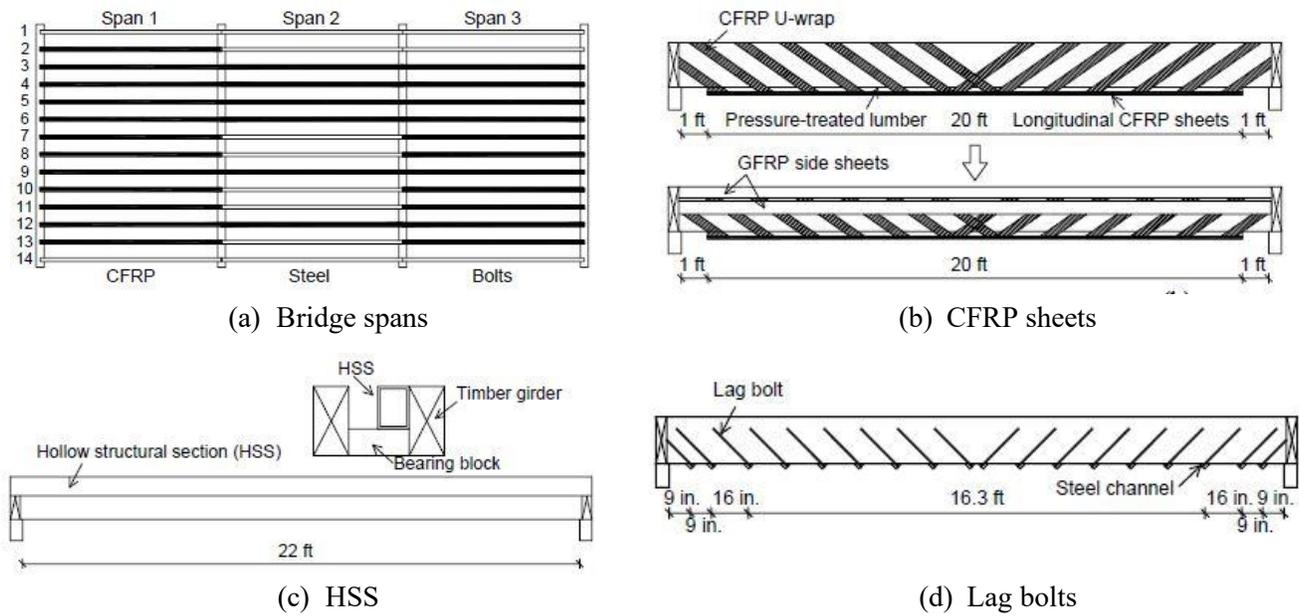
The next section of this report focused on strengthening several girders of the F-22-V bridge with CFRP sheets, lag bolts, and HSS (Figure 8). The bridge was load tested with a truck, and its responses were recorded and compared with the responses from three-dimensional finite element models. The strengthening processes were similar to those tested in the lab. Two layers of 4-in. wide unidirectional CFRP sheets were bonded with an epoxy adhesive on the bottom of the girders after cleaning and drying the girder surface. CFRP U-wrap (6 in. wide) was provided at a spacing of 20 inches. The GFRP sheet was also bonded to the sides of the girders to prevent premature debonding. ASTM A500 Grade C HSS beams (12 in. x 8 in. x 5/16 in.) were mechanically fastened with the timber at both ends and midspan using threaded rods. ASTM A354 Grade BC threaded bolts were embedded through 450 predrilled holes with an impact wrench. A Type 3 legal truck was used for the load testing, and there were two scenarios: a) unloaded truck (28 kips), and b) loaded truck (60 kips). The truckload was applied to a location near the exterior girder (the distance between the inside curb face and the rear axle outside tire was 25.4 in.) where the maximum bending moment would be generated. LVDTs were placed underneath the girders to monitor the girders' downward deflections.

Figure 8: Bridge strengthening [33]

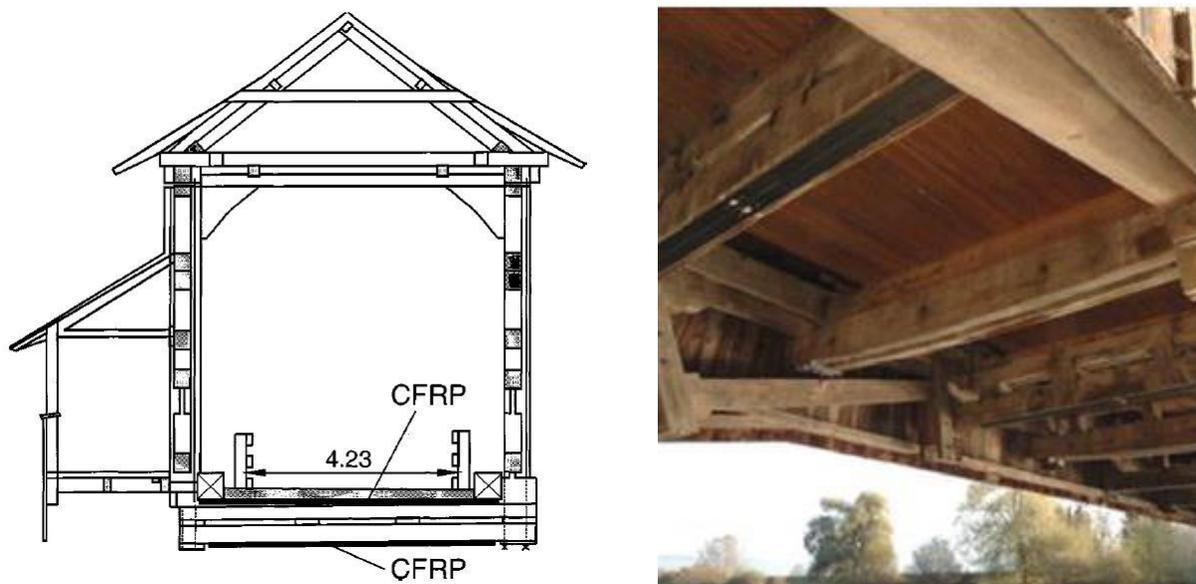
Prior to application of the strengthening technique, the surface was prepared with a portable system. Strain measurement devices were installed in selected crossbeams for post monitoring. Pulse infrared thermography was also installed to observe the bonding between the structure and the CFRP strips. Figure 10 shows pictures of the strengthened girder.

Figure 10: Strengthened girder in Sins bridge, Switzerland [35, 36]

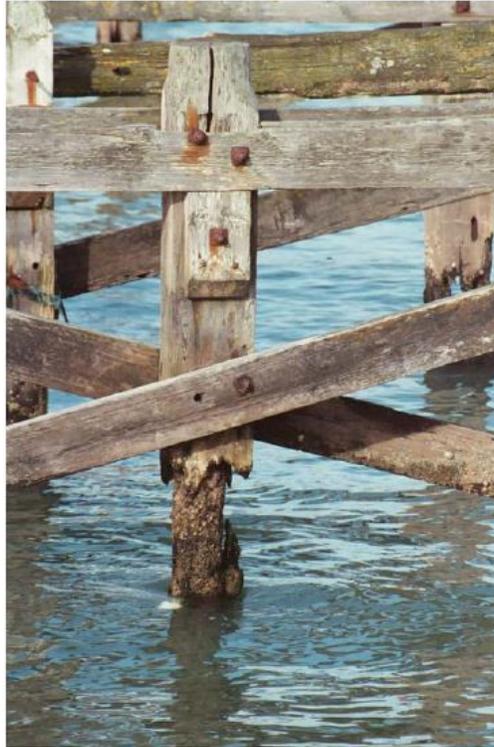
The Southern Plains Transportation Center sponsored a program to evaluate the capacity of deteriorated timber piles strengthened with FRP under concentric and eccentric loads with different deterioration configurations [39]. The timber piles of Louisiana bridges are experiencing biological degradation in the wet-dry zone. An example of a biologically degraded pile is shown in Figure 19. Since complete replacement of the piles is not economically feasible, in situ repair of the piles with FRP was explored, which eliminates the need for shoring the superstructure and road closure.

Figure 19: Biologically degraded pile [39]

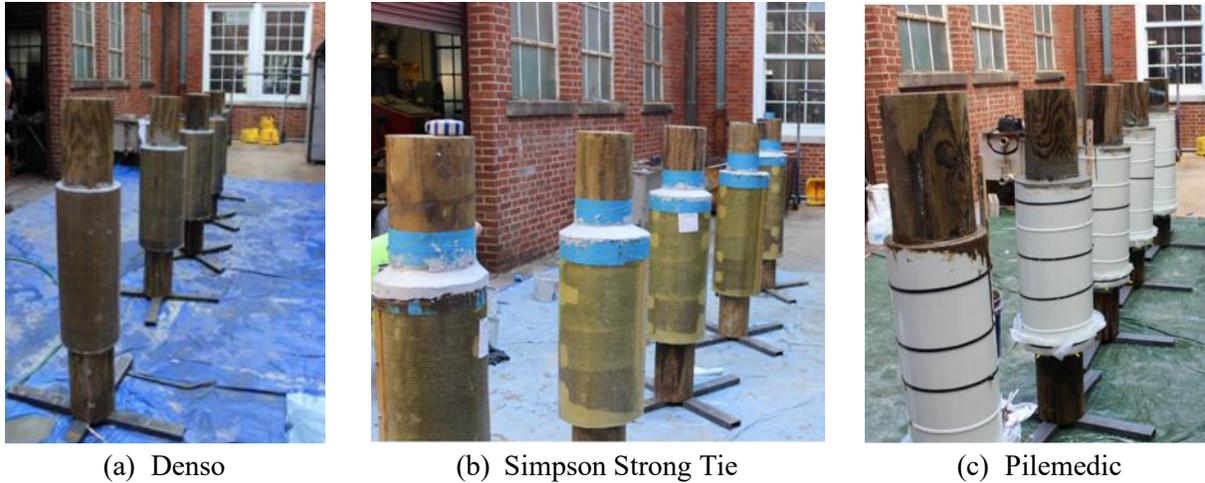
Figure 22: Repaired timber piles for Louisiana test program [39]

All repaired piles exhibited higher concentric load carrying capacities than the damaged piles and surpassed the axial capacity of the reference undamaged pile. Both the concentric and eccentric load carrying capacities of the damaged piles increased significantly after repairing them with FRP composites, regardless of the repair technique. No slip was observed at the pile-fill interface during the testing. They concluded that all investigated repair techniques are efficient and can be used to restore the capacity of damaged timber piles.

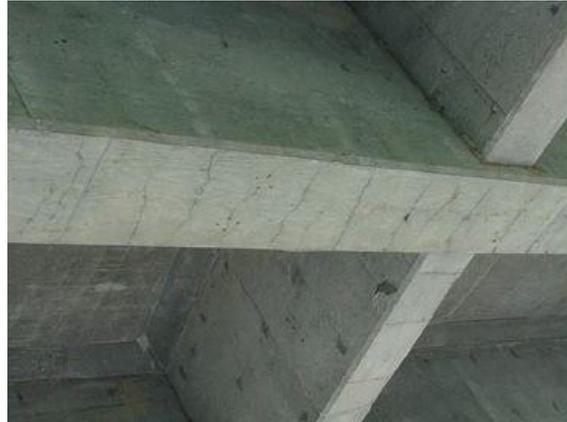
Figure 27: Cracks in Louisa Fort Gay bridge [41]

The Louisa-Fort Gay is a 12-span continuous bridge structure consisting of composite concrete deck-steel girder span and reinforced concrete middle span and is located in Lawrence County, Kentucky. Flexural cracks (Figure 27) were found in the positive bending regions of the bridge girders because of excess traffic loading that exceeded the legal weight limit specified by the American Association of State and Highway Transportation Officials (AASHTO) [41].

FHWA and the Kentucky Transportation Cabinet sponsored a program to repair and strengthen the bridge. CFRP laminates were selected as the strengthening material (Figure 28). Before applying the CFRP laminates, surface preparation was performed, including cleaning, and removing loose concrete particles, debris, and other contaminants. The CFRP laminate application process included applying the epoxy on the concrete surface, placing the laminates to the structure surface, pressing the laminates, and removing excess adhesives.

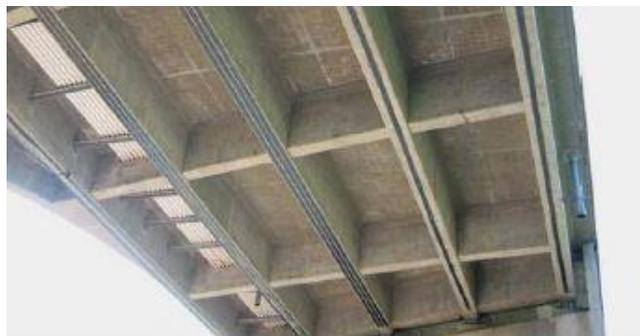
Figure 28: Repaired Louisa Fort Gay bridge girders [41]

For the post monitoring of the bridge performance, crack gauges were installed during the strengthening process. After 3 years of monitoring, no cracks were recorded.

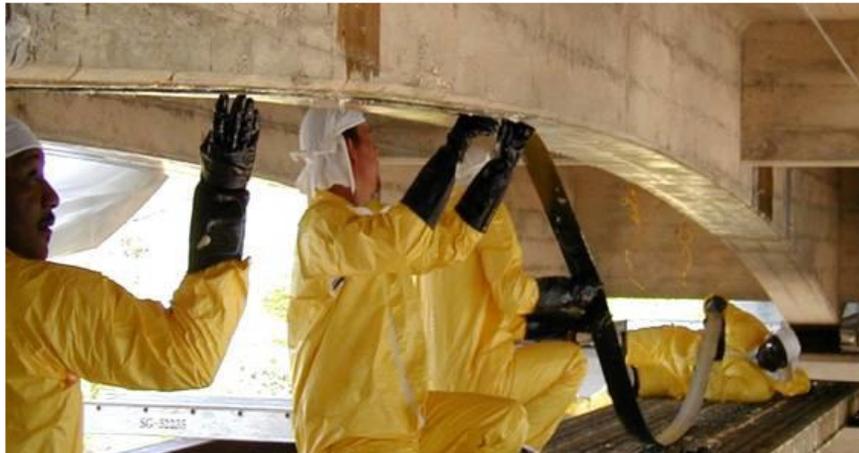
Figure 29: Application of FRP strip to the Uphapee Creek bridge girder [42]

sponsored by the Alabama Department of Transportation (ALDOT) and FHWA. The bridge was designed following the H-15 traffic loading, but the minimum design specification required AASHTO HS 20-44 for the bridges carrying heavy traffic loading. Significant flexural cracks were also identified in the positive moment regions of the bridge girders [42].

The Tyfo UC Composite Laminate Strip System from Fyfe Company, LLC was selected as the strengthening material (Table 9). Tyfo TC epoxy was used as the adhesive, primed with Tyfo S Epoxy. The strengthening process included surface preparation, epoxy injection to the cracks, epoxy application to the structure surface, and placing the FRP to the surface (Figure 29). Figure 30 shows the strengthened girders.

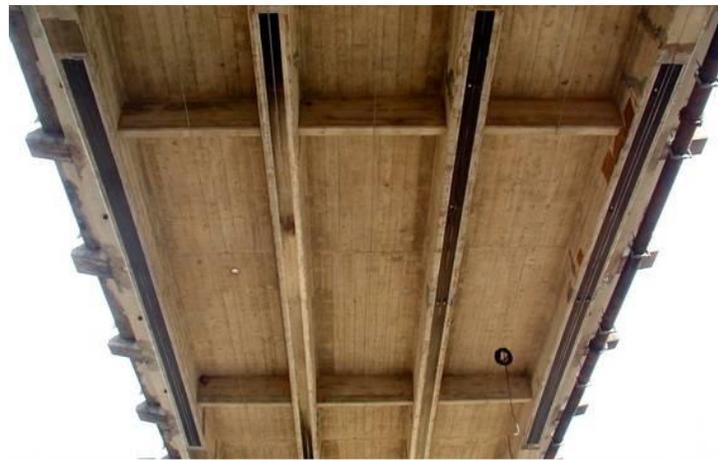
Figure 30: FRP-strengthened Uphapee Creek bridge girders [42]

In conclusion, the strengthened girders performed as predicted. No major problems were found in post monitoring after 6 months. A tap test was also performed, and no delamination was found in the FRP bond. It was also mentioned that road closures were not required while applying the externally bonded FRP strengthening techniques.

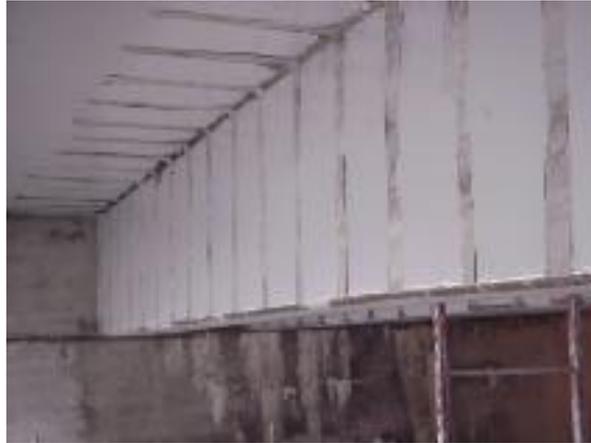
Figure 32: FRP-strengthened girder of State Route 378 bridge, New York [43]

A 40-ft (12.19 m) long bridge carries State Route 378, located in the City of South Troy, Rensselaer County, New York. During a routine inspection, freeze-thaw cracking, concrete delamination, and efflorescence were found at several locations of the bridge beams [43]. The New York State Department of Transportation (NYSDOT) decided to repair the bridge with FRP laminates. Replark 30 unidirectional carbon fiber was selected as the strengthening material, which was manufactured by Mitsubishi Chemical Corporation in Japan. The surface was cleaned, and the loose concrete was removed. Cement-based grout material was injected into the cracks, and then the surface was smoothed by sandblasting. The laminates were placed on the structure surface after applying epoxy. After drying, the structure was repainted to match the original structure (Figure 32). Load testing was done before and after strengthening the bridge girder with a 44-kip

The load distribution to bridge beam was improved with the girder repairing. It was also discussed that the rehabilitation process was cost effective since road closure was minimal.

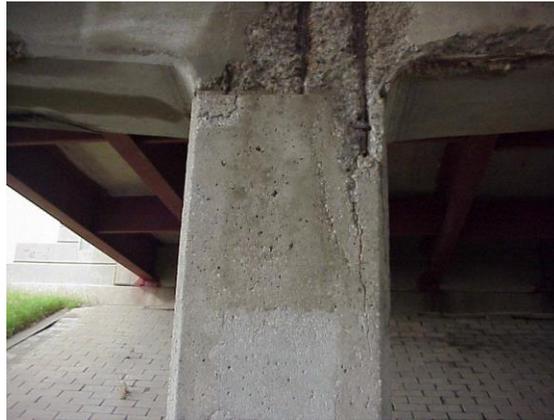
Figure 34: Deteriorated column of I-96 overpass bridge, Michigan [44]

Chloride contamination has significantly damaged numerous bridge columns in Michigan, such as corrosion of the steel reinforcement and swelling and spalling of the concrete [44]. The Michigan Department of Transportation (MDOT) sponsored a program to investigate the effectiveness of FRP wrap to address the problem. Michigan State University (MSU) conducted several tests to explore freeze-thaw durability of FRP-wrapped specimen subjected to an internal expansive force, the effect of wrapping on the rate of corrosion, the impact resistance of FRP, and the effect of elevated temperature on wraps. MSU fabricated a 4-ply composite Tyfo-S fiber glass/epoxy sheet and a 2-ply Tonen carbon/epoxy sheet which

The next phase of the program was the field application of the strengthening technique. Six columns were selected for this program which were located under the I-96 overpass, Lansing, Michigan. The columns had surface spalling and exposed rebar at several locations (Figure 34). The strengthening configurations were: two reference columns, two columns wrapped with two layers of carbon fiber, and two columns wrapped with three layers of glass fiber. Figure 35 shows one of the repaired columns.

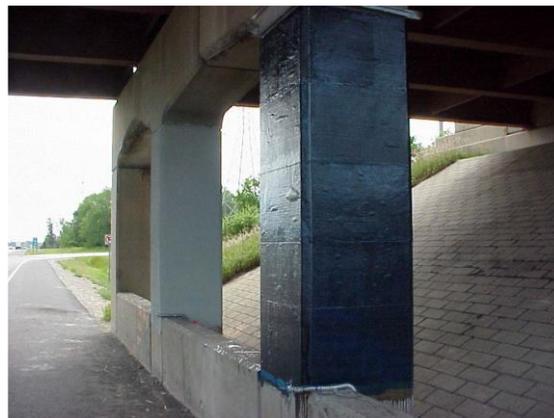
Figure 35: Repaired I-96 overpass bridge columns [44]

The repaired columns were monitored twice a month for 10 months. There were some drifts in the post monitoring readings, but no significant problems were found.

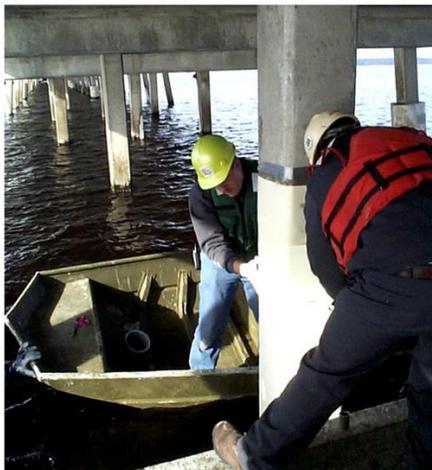
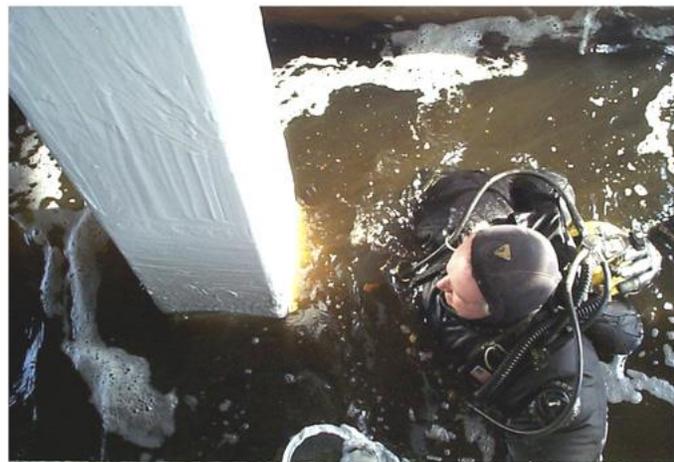
Figure 36: FRP wrapping of Friendship trail bridge pile [45]

High concentrations of chloride ions in seawater causes severe corrosion damage to the submerged concrete piles [45]. Additionally, the wet/dry cycles and high humidity can deteriorate concrete structures rapidly. To address this problem, this project investigated FRP repairing techniques for several corrosion-damaged

underwater concrete piles. The 2.6-mile-long Friendship trail bridge is located in Tampa Bay, Florida, and was selected for the project. Two types of FRP strengthening systems were introduced in the study: 1) Aquawrap, a uni-directional/bi-directional carbon FRP repair system with water-activated urethane resin, and 2) Tyfo SEH-51, a weave, uni-directional glass fabric with Tyfo-S underwater epoxy. A total of eight piles were selected for the study (Table 10). A pressure washer was used to remove all the dust and loose concrete from the pile surface above the water. A quick-setting hydraulic cement was injected into the cracks and any discontinuities. Four piles were wrapped following the wet lay-up process, and the other four piles were wrapped following the prepreg system. A boat was used to wrap the piles above water, and divers wrapped the piles under water, shown in Figure 36. A scaffolding system was also introduced to have easy access to the pile.

It was concluded that the prepreg system was more convenient than the wet lay-up process. However, the wet lay-up system performed better. Bond tests were also performed after two years of repair. The repaired piles performed as intended during the post-monitoring.

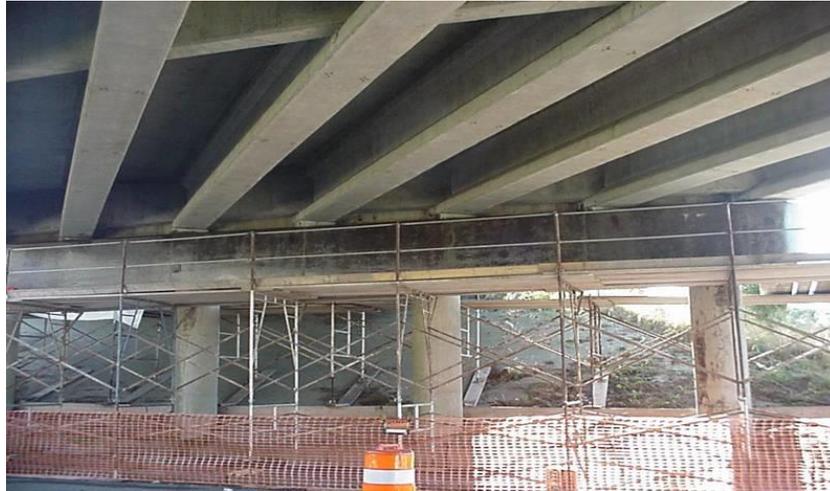
Figure 38: Scaffolding and safety measures for repairing the Salt Pond Road Bridge [46]

The Rhode Island Department of Transportation sponsored a program to repair the deteriorating RC pier cap of the Salt Pond Road bridge in South Kingstown, Rhode Island. The pier caps showed severe spalling and cracking, and the reinforcements were exposed at several locations [46] (Figure 37). The bridge is located near the ocean, and the constant exposure to contaminated water flowing over the pier caps was identified as the cause of the severe deterioration.

The faculty and students at Rutgers University and the University of Rhode Island carried out the field application with the help of professional staff. Scaffolding and surface preparation were complete before the actual application (Figure 38). E-glass fabric with Sikadur Hex 300 resin was selected as the strengthening material for field application. After the concrete surface was completely dry, the FRP composite was placed. The vacuum bagging process (Figure 39) began after 16 hours of placing the FRP.

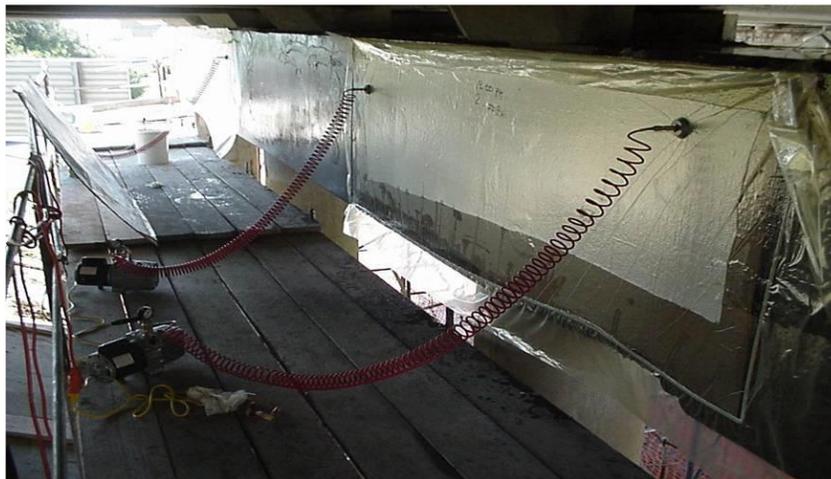
Figure 39: Vacuum bagging system adopted in repairing the Salt Pond Road Bridge [46]

The post-monitoring of the repaired bridge included visual inspection, chloride level tests, and compressive strength tests of the repaired pier cap. The repaired area performed as intended, and the compressive strengths were higher than the design strength.

The vacuum-assisted impregnation technique, commonly known as "vacuum bagging" in the aerospace industry, was employed to fabricate a composite jacket for repairing the pier caps and prevent further deterioration. E-glass fiber from the Saint Gobain Company was chosen for the strengthening material. This specific fabric was selected due to its lightweight and high tensile and flexural strength properties. A low-viscosity resin was necessary for this application technique to flow better. Pot life was also critical since this process required time to vacuum. Three epoxy resins were selected: Tyfo S, Sikadur Hex 300, and Sikadur 35. A rotary vane high vacuum pump with a 0.5 horsepower capacity was selected, which ran at a speed of 1725 RPM with a frequency of 60 Hz.

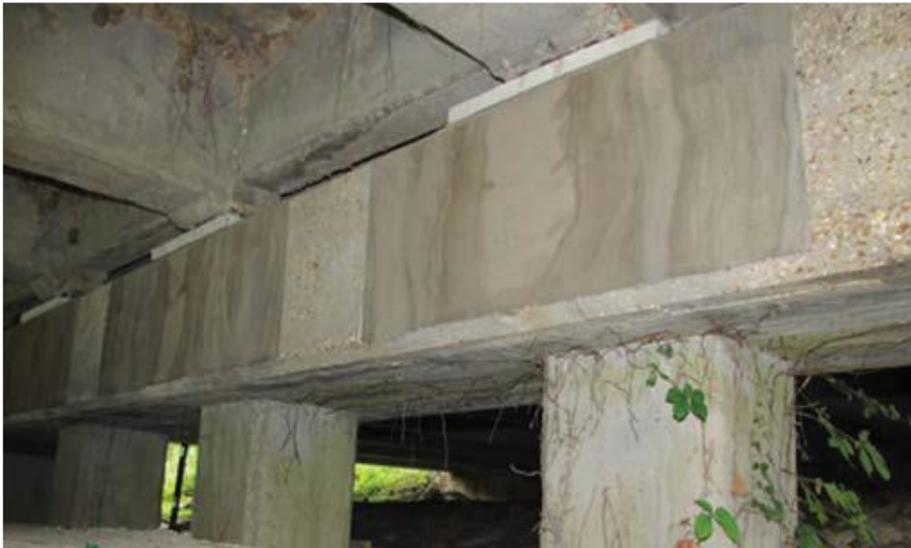
Figure 41: Repaired pile cap of the Morganza Spillway bridge, Louisiana [47]

The pile cap of the Morganza Spillway bridge in Louisiana needed repairing, as the previous repair method of patching the damaged area with structural grade high-adhesive material epoxy concrete was ineffective and resulted in delamination (Figure 40) [47]. The Louisiana Department of Transportation and

No significant problems were found during the two years of monitoring and the repair zone of the pile cap performed as intended.

Development sponsored a program to repair the damaged pile cap and Louisiana State University conducted the project. CFRP was used as the strengthening material, with Young's modulus of 90 million psi. After placing the FRP on the concrete surface, the bent surface was coated with an inorganic polymer coating reinforced with short carbon fiber (Figure 41). The coating formulation, originally developed for use in aircraft structures, was used to prevent deterioration and provide UV-protection, and had self-cleaning properties.

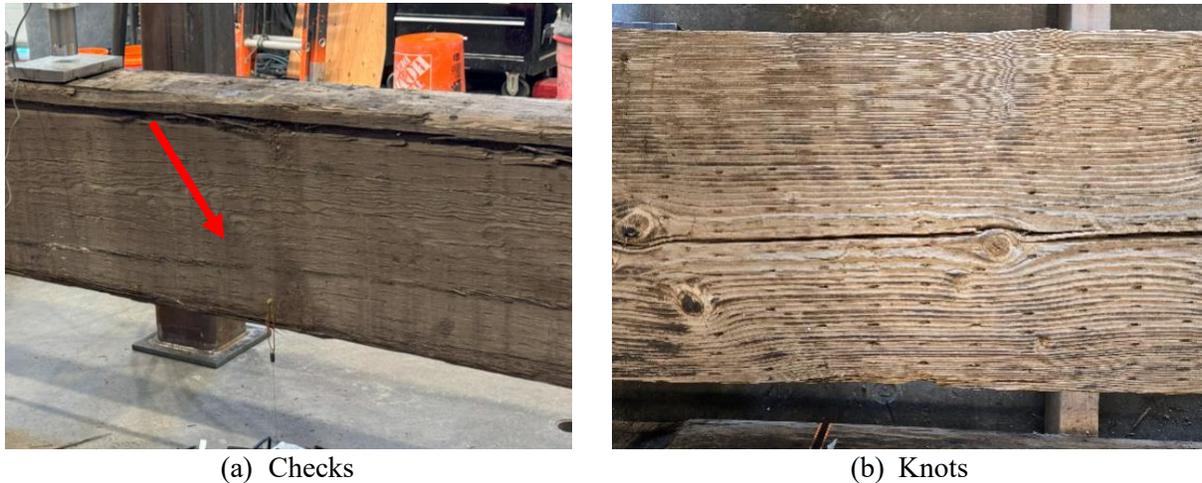
Figure 46: Examples of checks and knots

Timber beams often have natural imperfections that can impact their performance. These imperfections, such as knots, checks, waning, and grain deviations, are not classified as damage. However, if they are significant enough, they can contribute to premature failure. Figure 46 shows a couple of examples of natural imperfections.

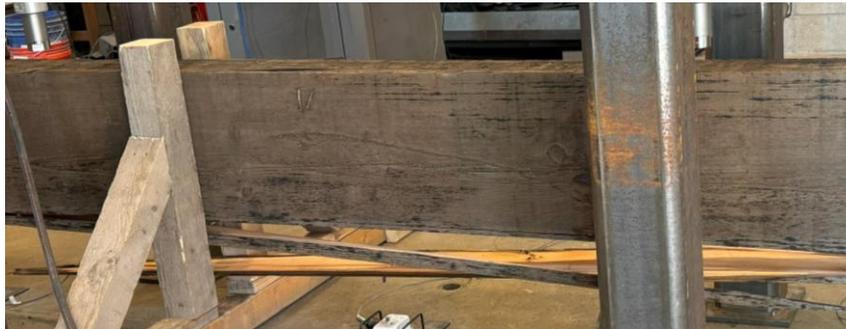
Figure 47: Example of a tension crack failure

Tension cracks are commonly formed due to flexure-induced stresses on the tension face of the beam, and extend at an angle through the member, generally along the grain of the wood (as shown in Figure 47). They often begin near mid-span (where tension stresses are greatest) and initiate at imperfections such as knots or checks, or at the site of impact or handling damage.

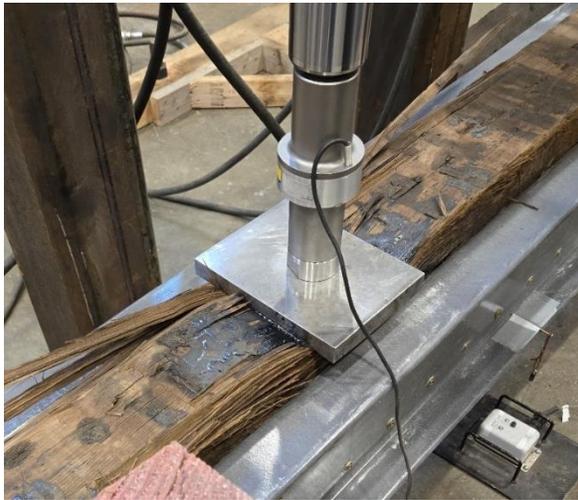
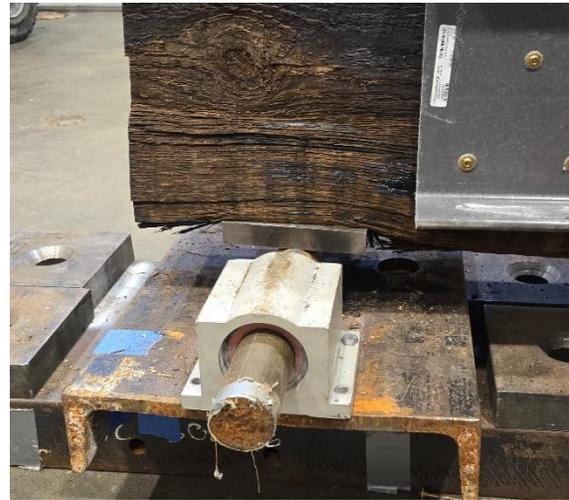
Figure 50: Examples of bearing failure

Bearing failure (crushing of the wood perpendicular to the grain) is another form of damage that can occur in timber beams. In the beams tested in this research this failure mechanism was observed under the applied loads (Figure 50-a) and at the supports (Figure 50-b).

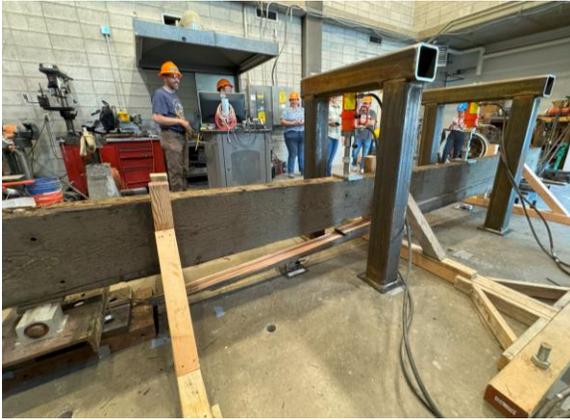
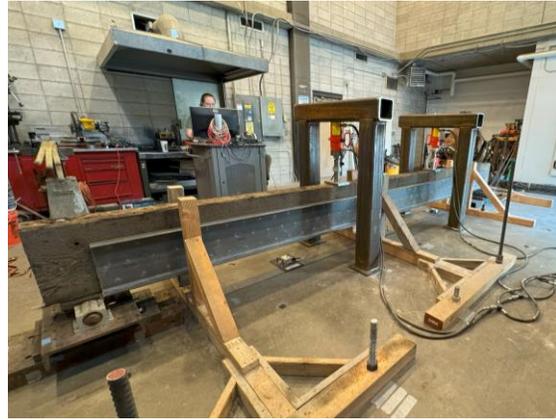
Figure 65 shows a flexure-controlled beam that failed due to a large tension crack that was repaired with the FRP channel and strip method discussed above. Figure 66 shows another beam that failed due to a tension crack that was repaired with FRP strips alone. Figure 67 shows a shear-controlled beam that failed due to a shear split and repaired with FRP channels. Finally, Figure 68 shows a beam that had an existing shear split, that was repaired with FRP channels and a strip.

(a) After initial failure, before repair

(b) After repair, before re-testing

Figure 65: An example of a tension-crack repair with FRP channels and strips

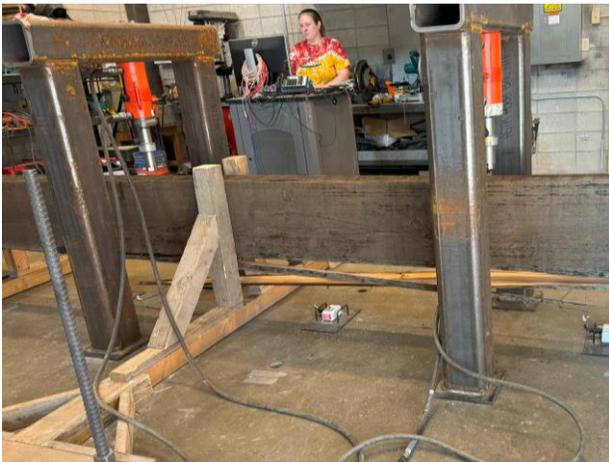
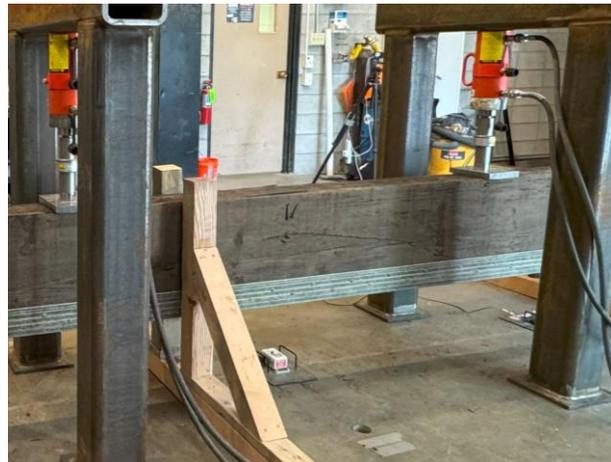
(a) After initial failure, before repair

(b) After repair, before re-testing

Figure 66: An example of a tension-crack repair with FRP strips alone

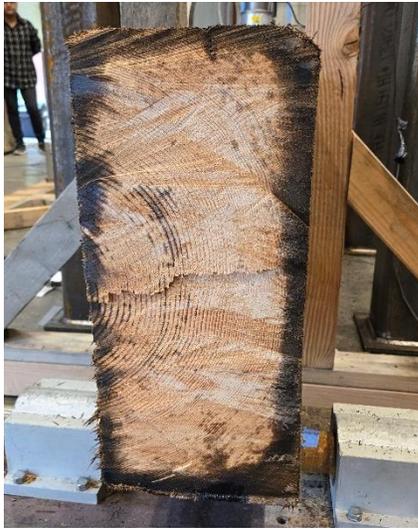
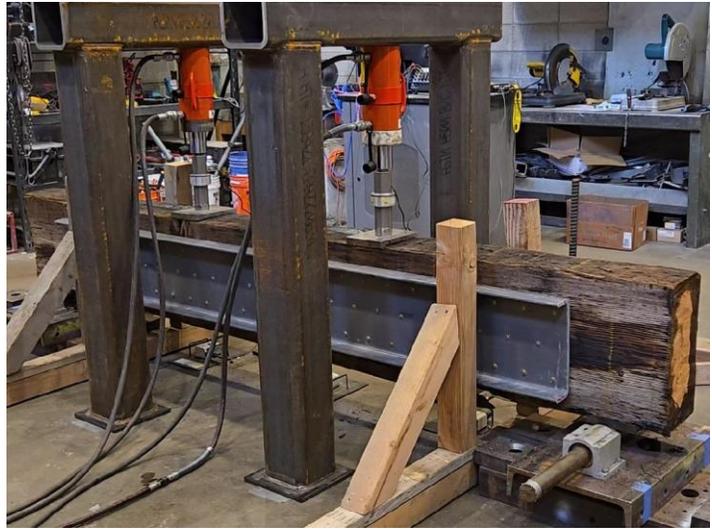
(a) After initial failure, before repair

(b) After repair, before re-testing

Figure 67: An example of the shear-split repair with FRP channels

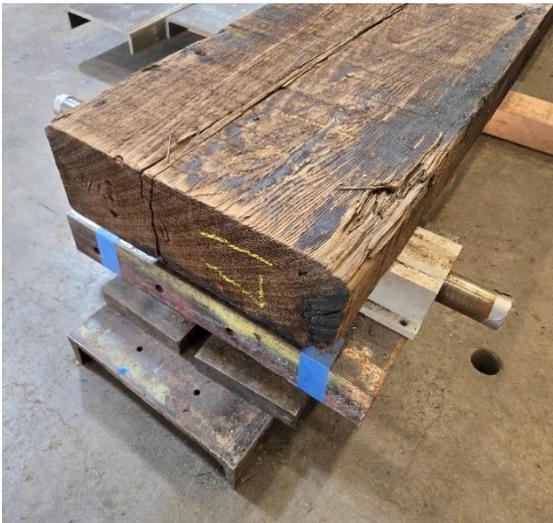
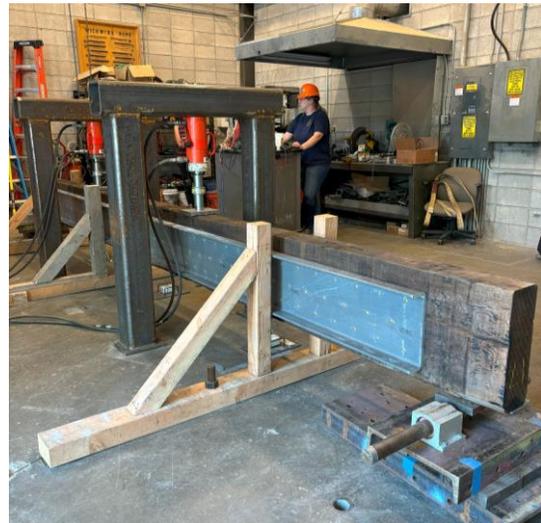
(a) Existing split, before repair

(b) After repair, before testing

Figure 68: An example of an existing shear-split repair with channels and strip

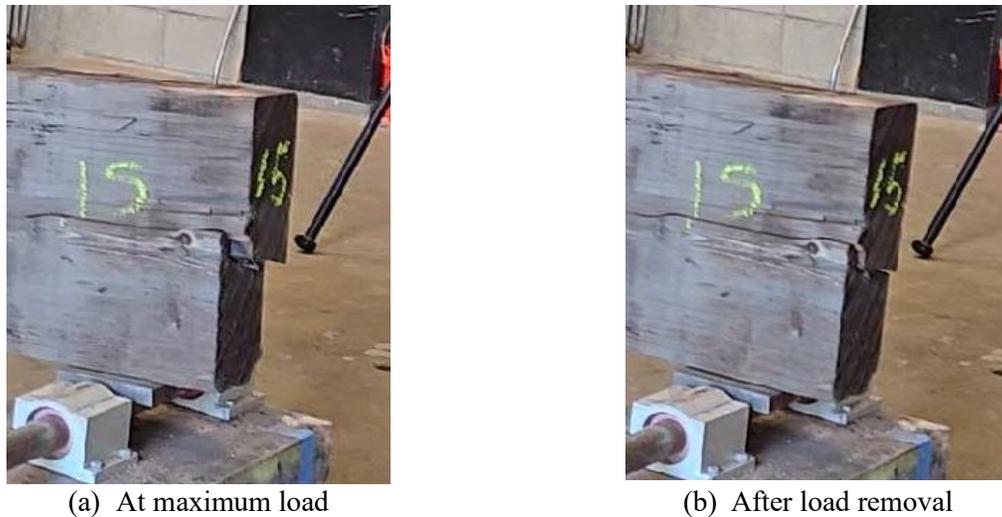
Figure 73: An example of a split closing after load removal

The surface of each beam to be repaired/strengthened with the FRP methods discussed previously was first cleaned off with a broom. When applicable, existing or induced damage was repaired prior to installation. Specifically, beams with existing or induced flexure-cracks were turned upside down and secured with ratchet straps (Figure 71). The tension cracks were then closed using #12 x 6-3/8" R4-GRK screws. There was no specific screw pattern for closing the cracks, as the crack formation was different for each beam. However, care was given to avoid overlapping screws between FRP strip screws and repair screws (Figure 72). In contrast, no additional fasteners (beyond those required for the channels) were needed for the beams with existing or induced shear splits, as these beams would return to the undamaged configuration after the load was removed (shown in Figure 73).

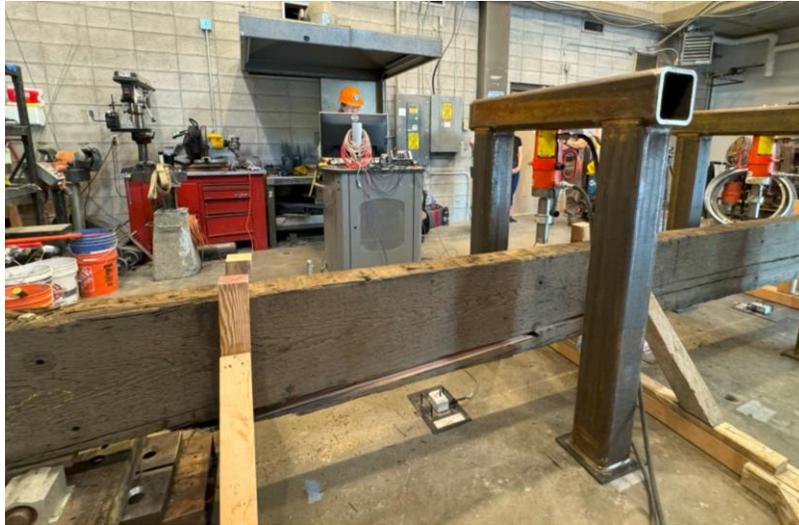
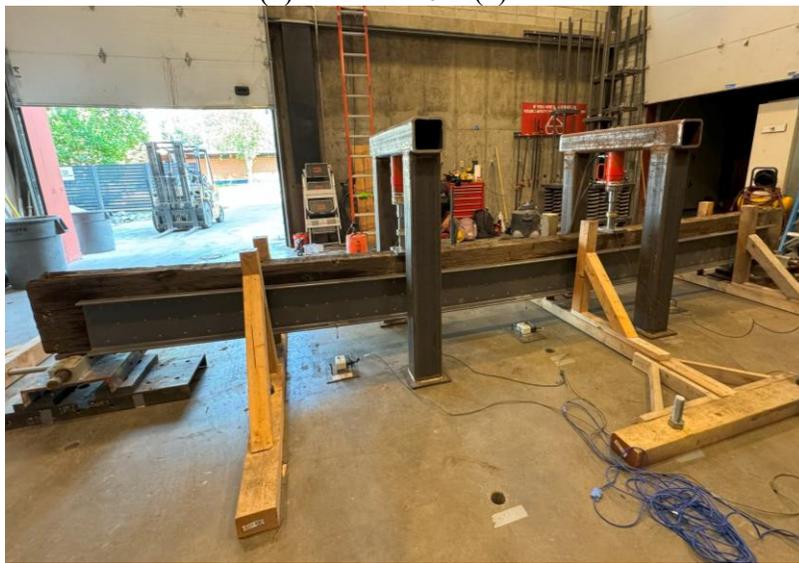
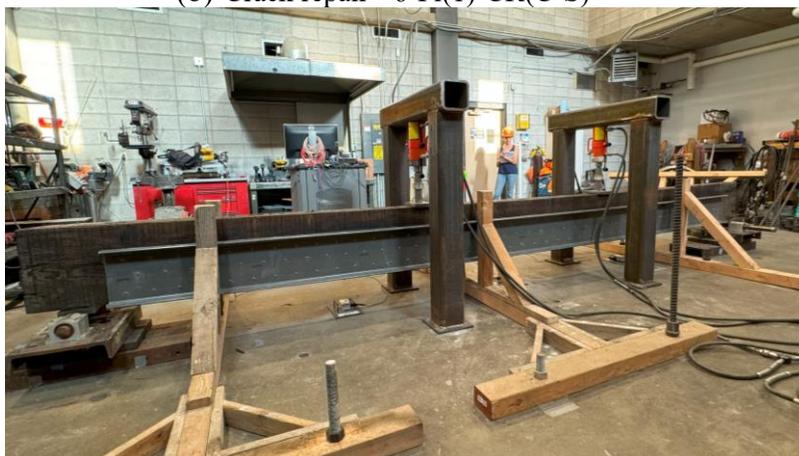
Figure 83 and Figure 84 show the three tested configurations of 6"x18" and 8"x18" timber beams, respectively: control, crack repair with C-S, and strengthened with C-S. The control beam displays the damage from testing. The repair beam is the same beam retrofitted with C-S combination, while the strengthened beam is an intact beam reinforced with C-S combination.

(a) Control – 6-FI(1)

(b) Crack repair - 6-FI(1)-CR(C-S)

(c) Strengthened - 6-FI-St(C-S)

Figure 83: Control, crack-repair and strengthened 6"x18" beams with C-S combination

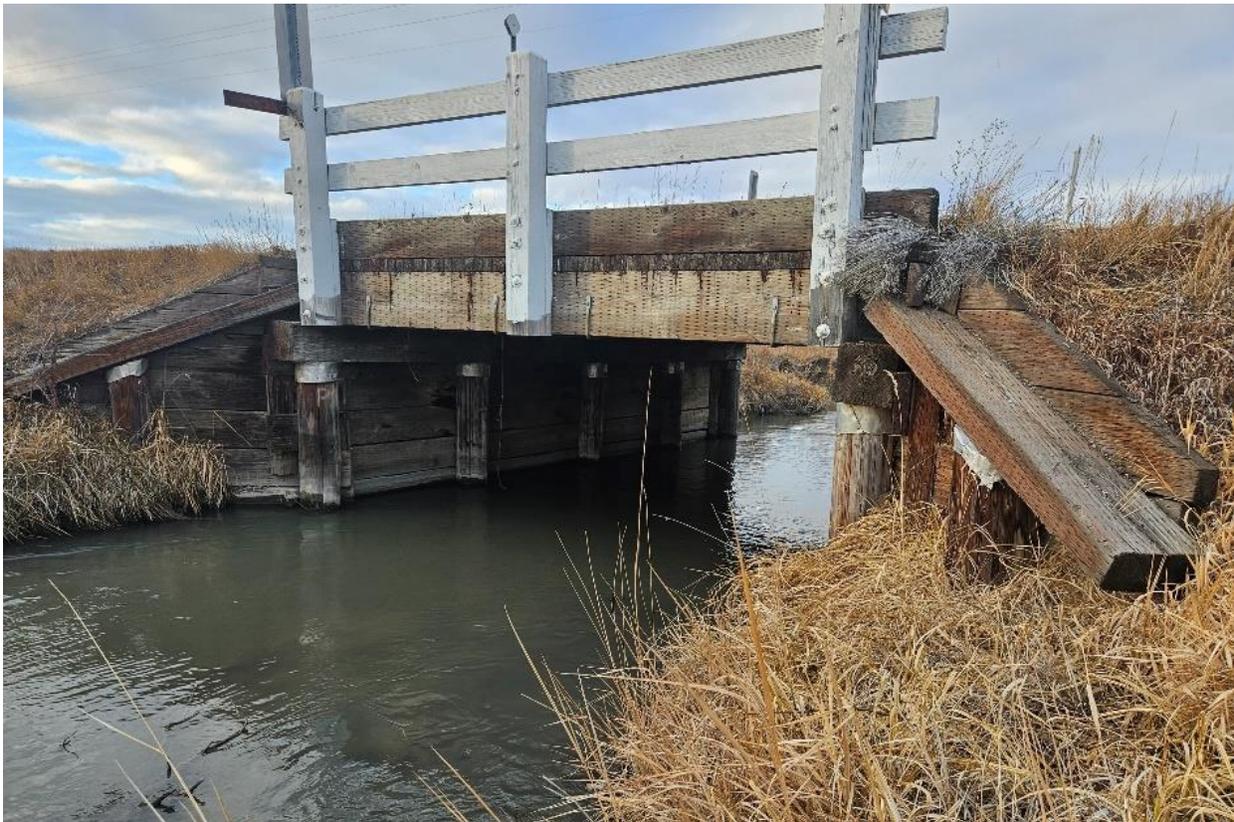
Figure 103: Bridge #06581

Bridge #06581 is a 15' single-span timber bridge constructed in 1948 and is located two miles west of Toston, Montana [48]. The bridge consists of 13 larch/fir timber girders. The cross section of the girders is 6"x15.5", which are supported by pile bents. This bridge is an essential crossing over Crow Creek along State Route S285. The superstructure includes a 5.61" timber deck with a bituminous wearing surface. There is no additional membrane or deck protection. Figure 103 shows an image of the bridge, highlighting its structural configuration and surroundings.

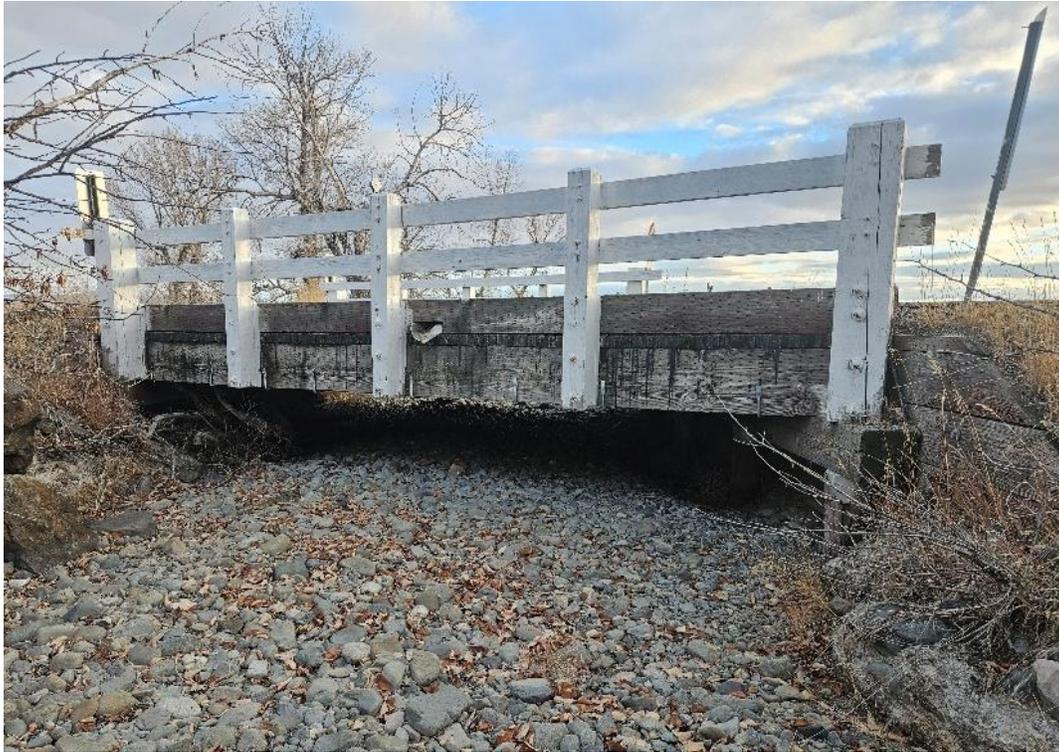
Figure 105: Bridge #06583

Bridge #06583 is a 25' single-span timber bridge constructed in 1948 and is located six miles west of Toston, Montana [48]. The bridge consists of 13 larch/fir timber girders. The cross-section of the girders consists of a 17.5" height and the widths vary from 7.5" to 7.75". The bridge has a 24' roadway width and a 1.5" thick timber deck with a 7" thick asphalt overlay. Figure 105 provides an image of Bridge #06583, showing its structural configuration and surroundings.

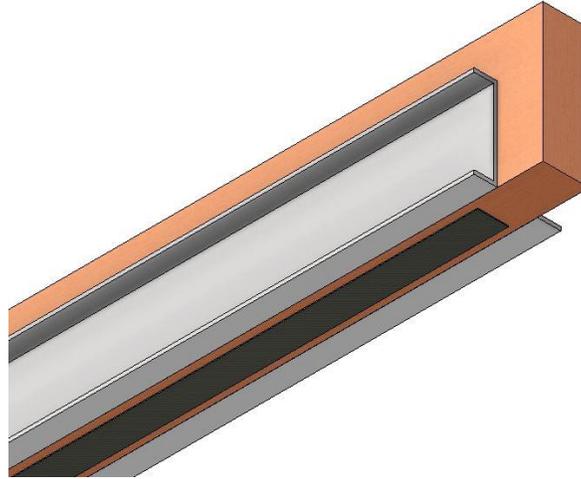
Figure 108: FRP channel-strip combination repair technique

The FRP channel and strip (C-S) combination, shown in Figure 108, was selected as the repair method for the broken girder G9 of Bridge #06581. This decision was based on the nature of the crack observed in the girder, which closely resembles the severity of the tension cracks studied in laboratory testing. As shown in Figure 104, the crack in girder G9 originates on the tension face of the beam and propagates at an angle along the wood grain, a pattern commonly associated with flexural failure in timber structures. The C-S combination was chosen due to its proven effectiveness in laboratory testing for addressing this type of failure. The FRP bottom strip enhances flexural strength through reinforcement of the tension zone, whereas the side channels provide supplemental flexural resistance and overall confinement, mitigating crack widening and increasing structural stiffness. This integrated approach ensures better load distribution, mitigates stress concentrations, and enhances the girder's durability.

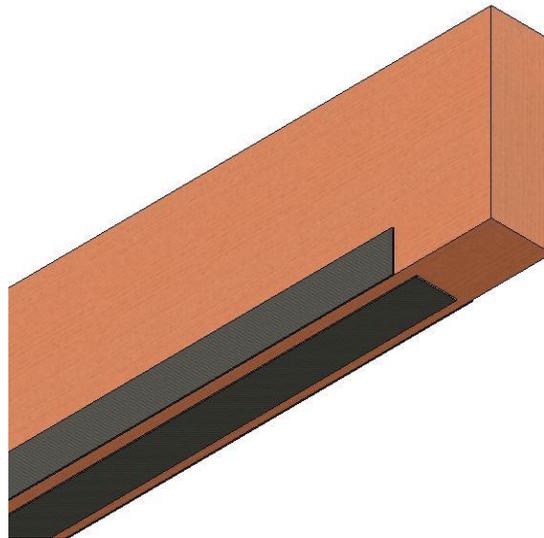
Figure 109: FRP strip-only repair technique

The FRP strip (S-only) technique, shown in Figure 109, was selected as the repair method for girder G3 on Bridge #06583 due to the minor crack currently controlling the load rating. The crack, located on the tension face, indicates early-stage flexural distress, and most likely initiated due to the knot in the timber. Laboratory testing showed that for undamaged or slightly damaged beams, the S-only technique is an effective repair solution. Unlike severely damaged girders, which require additional confinement by the FRP channels, applying the FRP strips significantly improves tensile capacity while minimizing material use and installation complexity. To restore strength and prevent further crack propagation, FRP strips were applied to both the bottom and sides of the girder, reinforcing the tension zone while maintaining the girder's structural integrity.

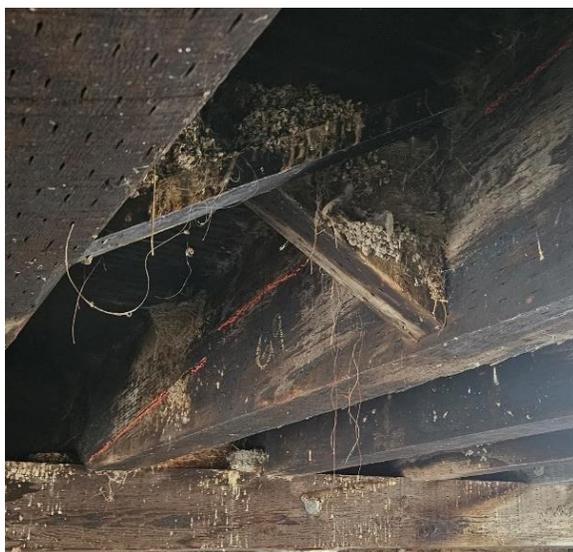
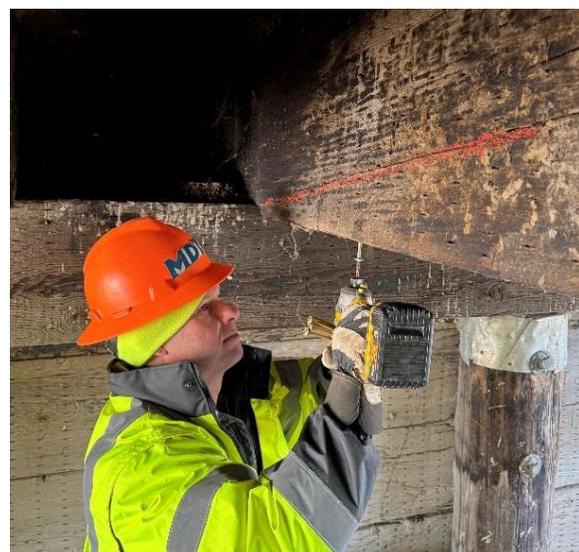
Figure 117: Surface preparation of girder G9 on Bridge #06581

The beam surface was cleaned, and the dirt, debris, and loose material were removed. Cross bracing, nests, and other obstructions were also removed to ensure a clear working area for the FRP installation. Following this, the crack in the broken beam was closed using long GRK connectors. Figure 117 shows the surface preparation of the beam and installation of screws to close the gap and secure the crack.

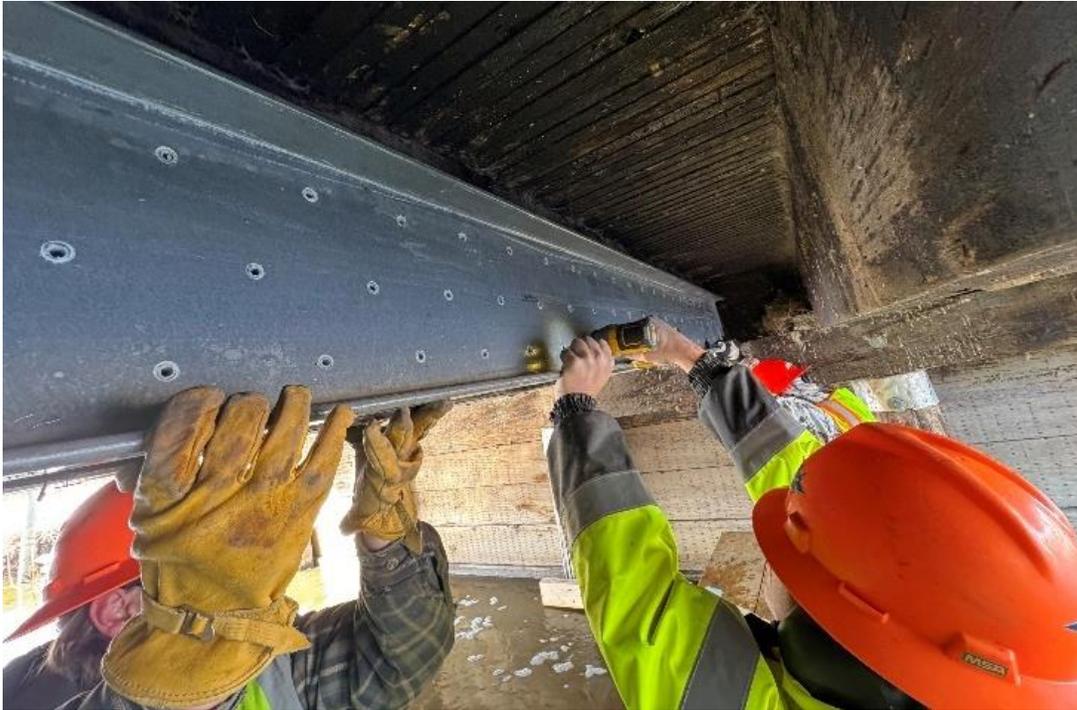
Figure 119: Attaching side channel on girder G9, Bridge #06581

Subsequently, the channels were installed on both sides of the girder. Each channel was manually positioned and stabilized as initial connectors were fastened to maintain proper alignment. The remaining connectors were then installed along the full length of each channel. Installation of each channel required approximately 15 minutes, using three impact drivers. The attachment of the strip and channel are shown in Figure 118 and Figure 119, respectively. The complete repair of girder G9 on Bridge #06581 is shown in Figure 120.

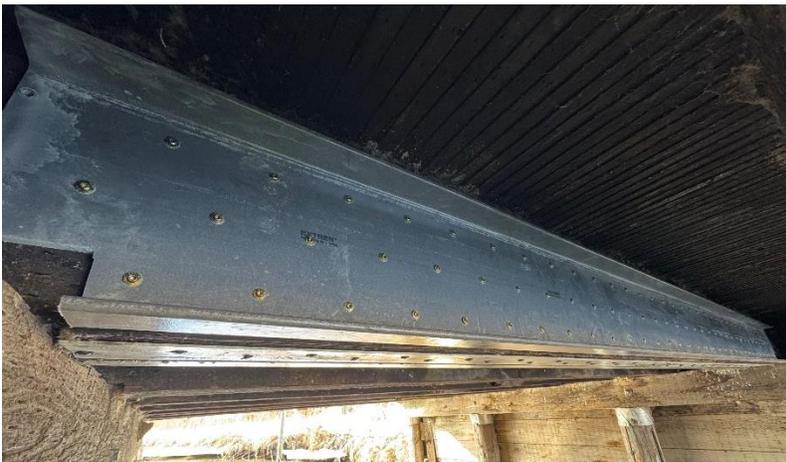
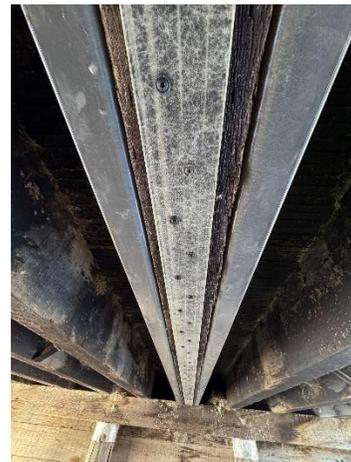
Figure 120: Repaired girder G9 on Bridge #06581
