USE OF FIBER-REINFORCED POLYMER COMPOSITES FOR BRIDGE REPAIRS IN MONTANA

FHWA/MT-26-001/10337

Final Report

Montana State University
Bozeman, Montana

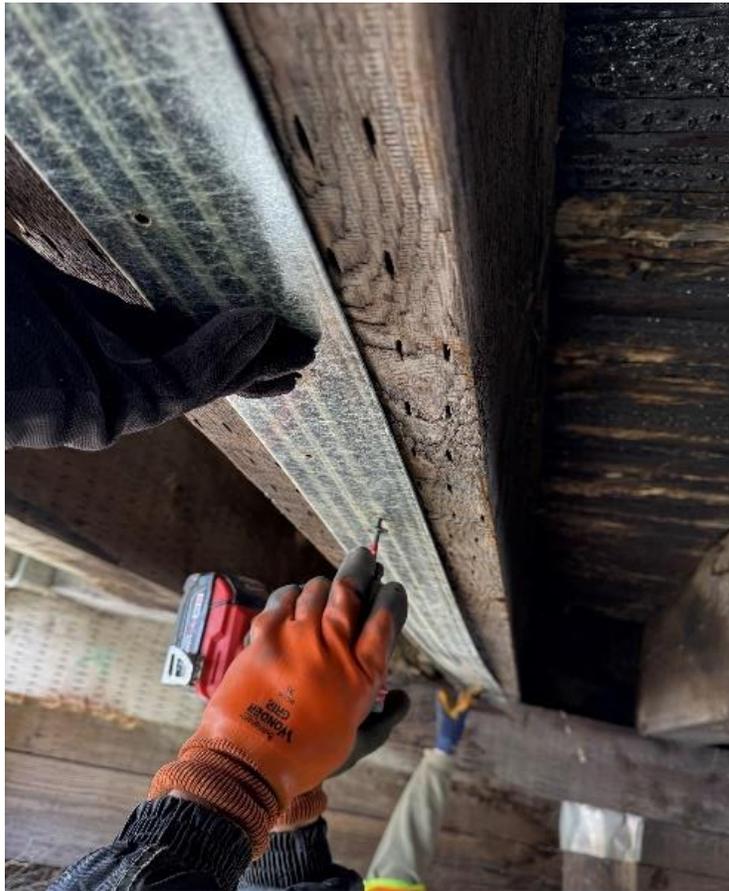
Figure 122: Attaching the bottom strip

The FRP strips were installed along the bottom and sides of the timber girder. The bottom strip was centered and held in place while initial connectors were secured at midspan (Figure 122). Once aligned, the remaining connectors were installed outward from the center to each end, ensuring the strip remained taut.

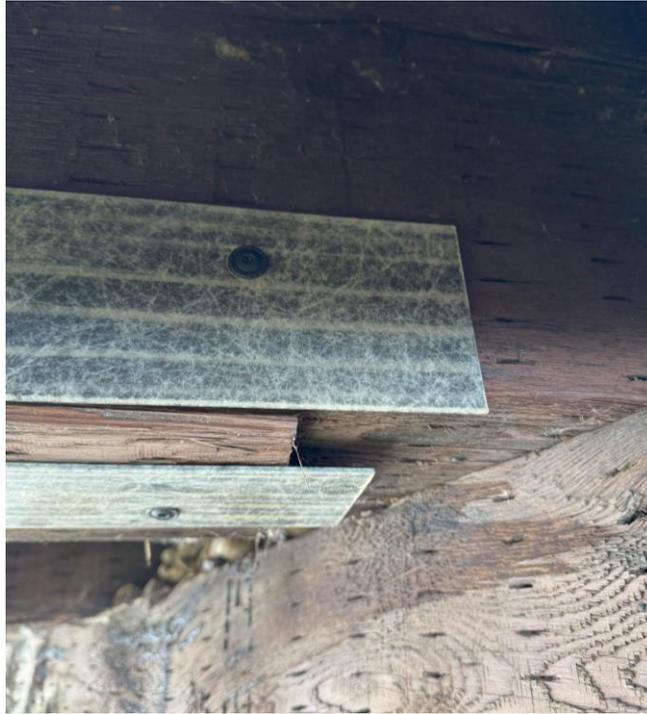
Figure 123: End of the bottom and side strips

The side strips were installed with an approximate 1" offset on each side to avoid screw overlap. Figure 123 shows the end of the bottom and side strips. The strips were installed to be flush with the bottom of the girder; however, a slight offset of approximately 0.25" was observed at midspan due to the pre-existing dead load deflection of the timber beam (Figure 124) and the strip being initially straight. This process took approximately five minutes per strip using three impact drivers. The complete repair of girder G3 on Bridge #06583 is shown in Figure 125.

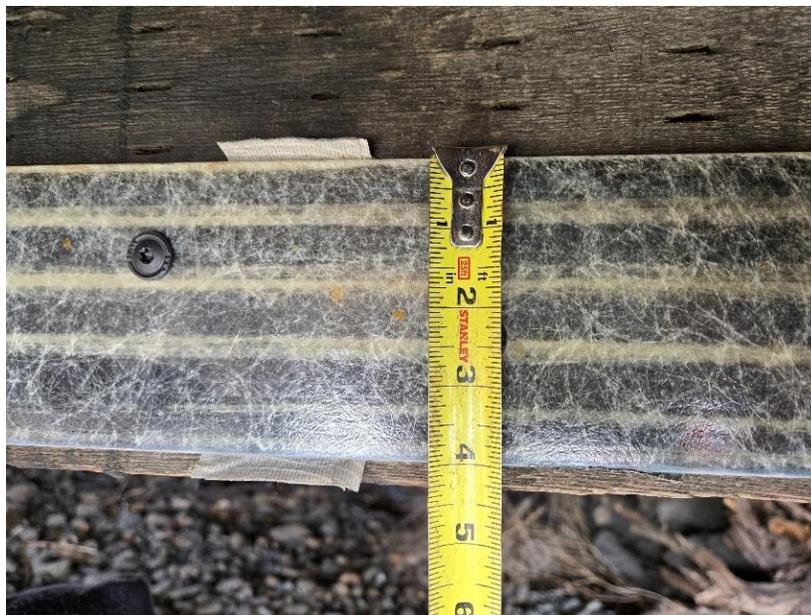
Figure 124: Approximately 0.25" FRP offset at midspan

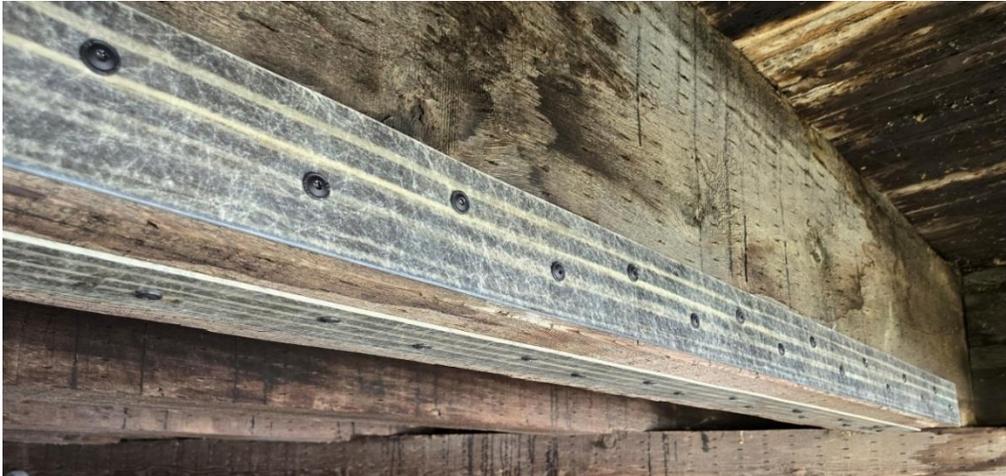
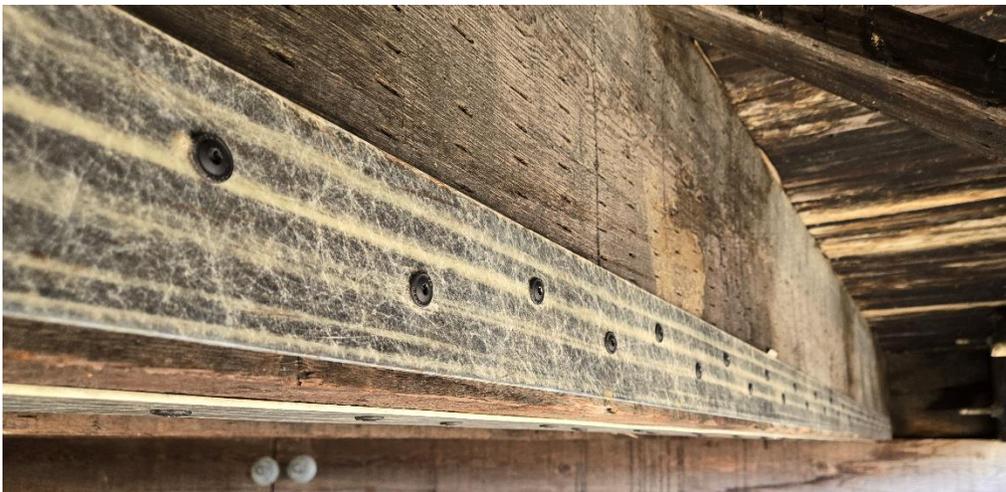
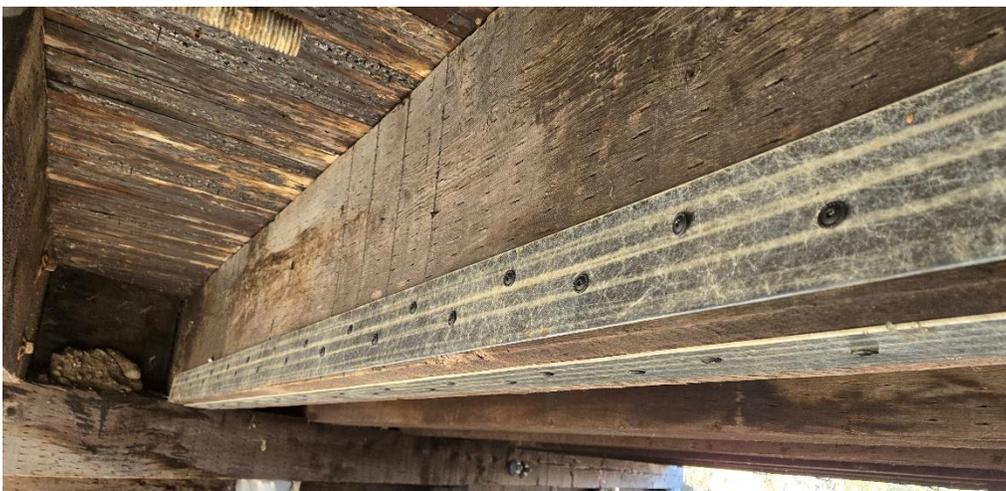
The FRP-repaired bridges west of Toston, MT were inspected on October 7th, 2025, approximately seven months after installation. Each bridge had one cracked or broken girder that was repaired using pultruded FRP sections, and both were evaluated for overall condition and signs of deterioration. As seen in the following photographs (Figure 126 and Figure 127), no major issues were observed, and the FRP materials appeared mostly unchanged from the day they were installed, with no evidence of cracking, delamination, or fastener location deterioration. Additionally, in a few select locations, fasteners were removed to inspect the fastener holes and confirm there were no signs of cracking or deterioration around the fastener locations or to the fasteners themselves. These checks verified that the FRP and fasteners remained intact and undamaged (Figure 128, Figure 129, and Figure 130), with no evidence of moisture intrusion or material degradation at the connection points. All fasteners were replaced after the photographs were taken. The only noted condition during the inspection was the accumulation of bird droppings on the flanges of both channels on Bridge #06581 (Figure 131), where birds have been roosting. Otherwise, the FRP systems and surrounding timber remained in excellent condition, indicating good performance of the repair under field conditions. However, it should be noted that this inspection took place only seven months after installation, prior to the materials experiencing a full winter season.

Figure 127: Before and after photographs of repaired girder G3 on Bridge #06583

Future inspections of the FRP-repairs should focus on locations most susceptible to environmental exposure and localized damage, particularly fastener locations and cut ends of the FRP members. For the pultruded channels, inspections should include checks for exposed fibers due to any new severe surface abrasion. For the strengthening strips, inspectors should look for signs of splitting, delamination, or surface damage. The fastener holes and termination locations represent potential pathways for moisture ingress and therefore should receive particular attention during routine bridge inspections. If minor surface damage or fiber exposure is observed, sealing the affected area with a thin polyurethane coating or comparable protective sealant is recommended by the manufacturer to prevent moisture penetration and limit further deterioration. For future applications including external girders exposed to frequent wetting and drying cycles, additional protection may be provided by sealing fastener holes and cut ends after pre-drilling, but before installation. Incorporating these inspection and maintenance practices into routine bridge inspection protocols will support the long-term durability of the FRP repair systems.

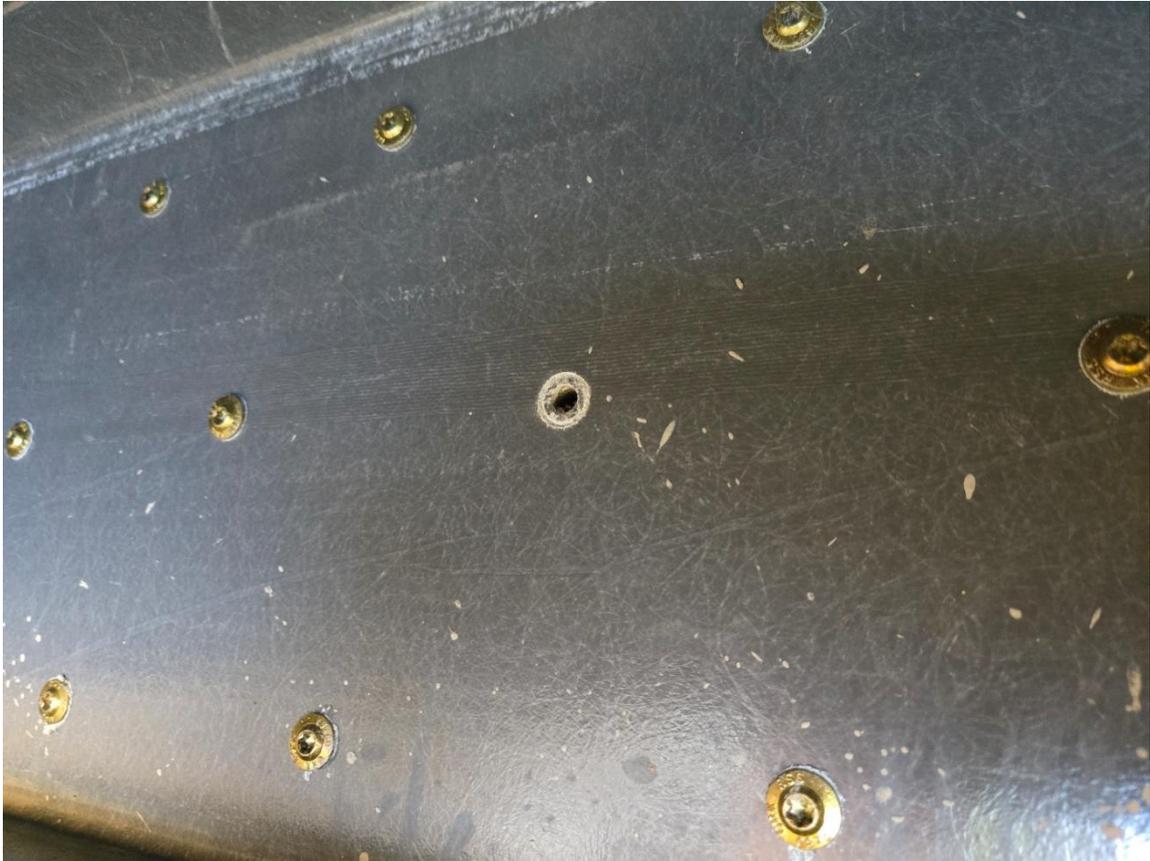
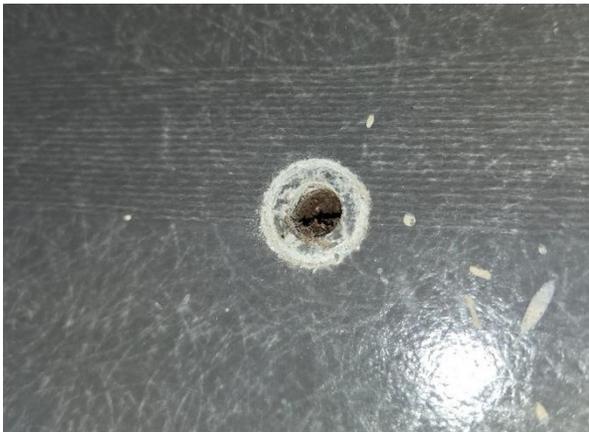
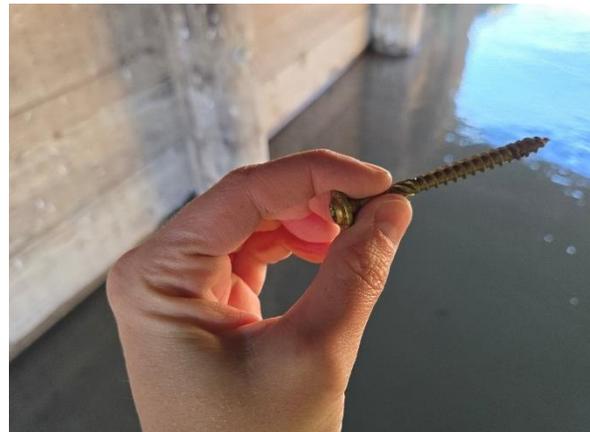
(a) Removed fastener location on channel

(b) Close-up view of fastener hole

Figure 128: Removed channel fastener on Bridge #06581

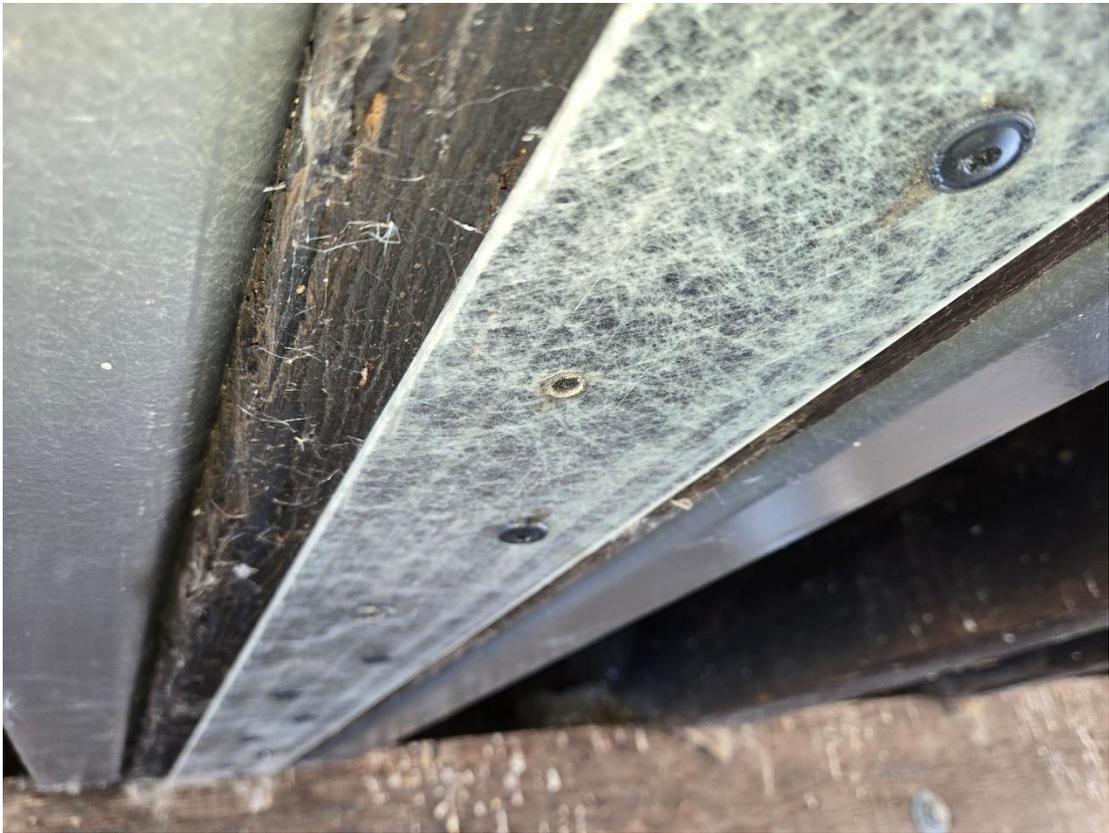
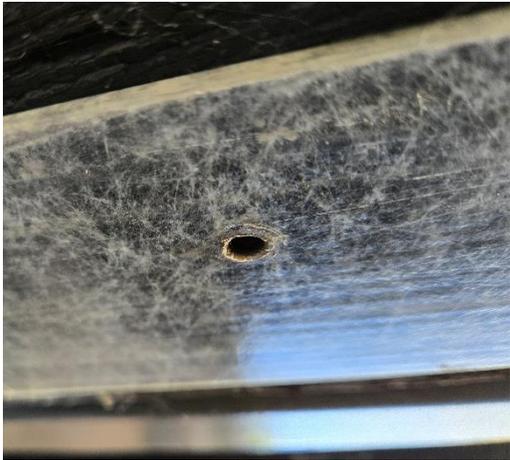
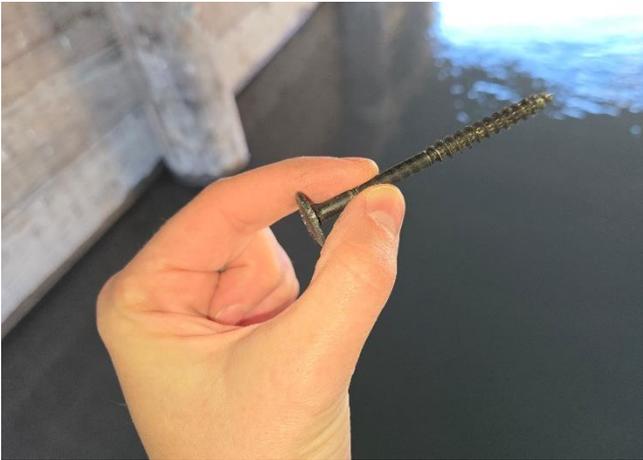
(a) Removed fastener location on strip

(b) Close-up view of fastener hole

Figure 129: Removed strip fastener on Bridge #06581

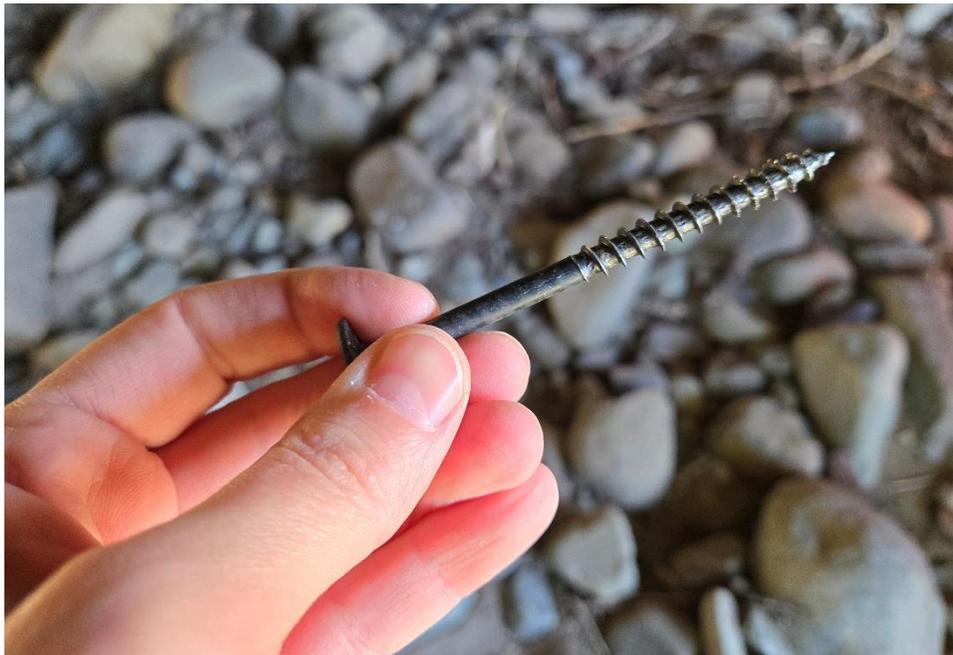
Figure 130: Removed strip fastener on Bridge #06583

(a) Close-up view of fastener hole

(b) Fastener

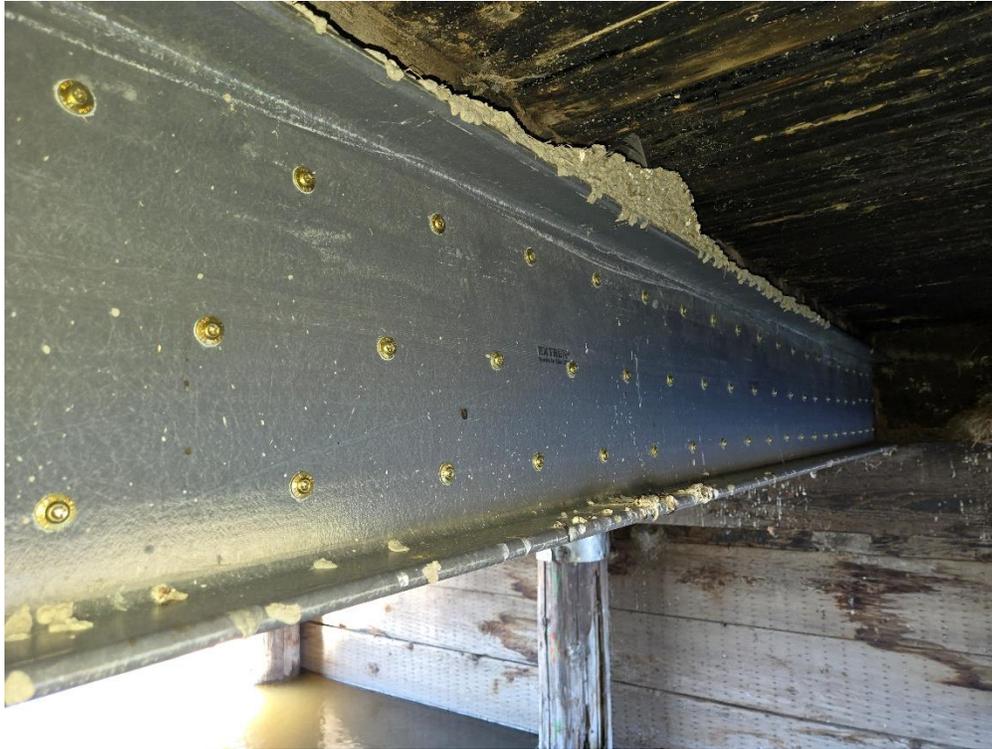
Figure 131: Bird droppings accumulated on FRP channel on Bridge #06581

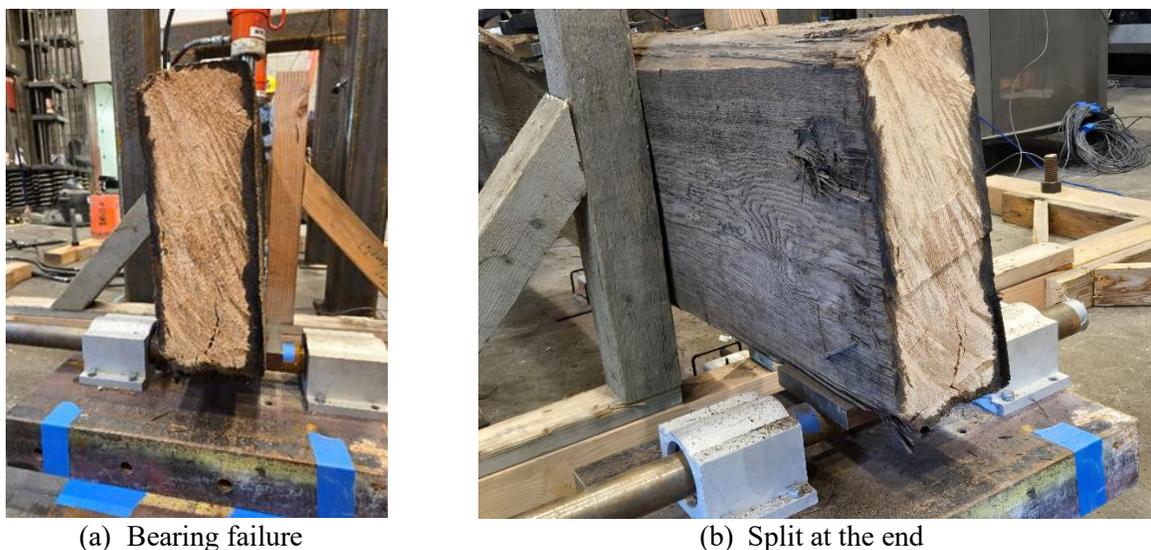
The beam had some minor checks and wane-type defects and some other minor handling impact damage on the top. Its actual dimensions were 5.75" x 17" and 10' 1" long. The beam was cut in half for the shear test setup. The span length of the test beam was 9 ft, with a 6.48" overhang on each side. The shear vs. deflection graph is shown in Figure 143. The bearing failure at the load-bearing blocks started at around 22.0 kips. A split started forming at the end of the beam (which was originally the middle of the beam) as the load progressed. The beam failed by splitting on the end of the beam (Figure 144-b) through a knot. The ultimate shear carried by the beam was 27.0 kips when the midspan deflection was 0.89".

Figure 144: Failure propagation of 6-Sh(1)

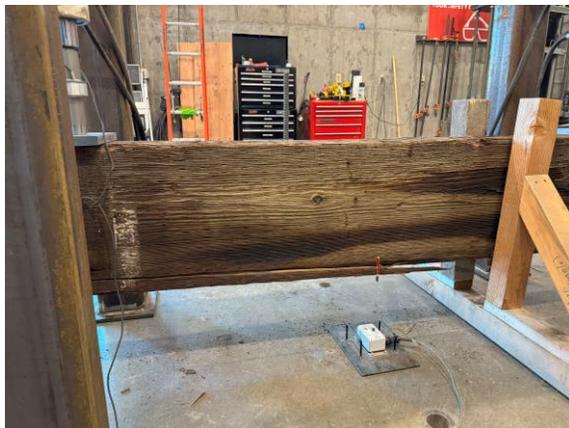
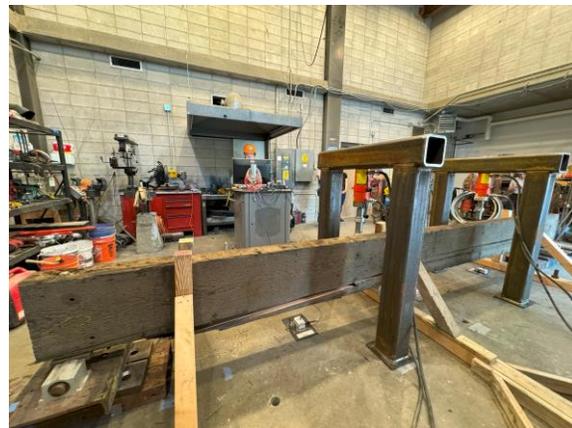
Figure 146: Failure propagation of 6-FI(1)

The beam was shorter, with an 18.5' span (19' 6" beam), and the supports needed to be adjusted to be 3" closer. The actual cross-section of the beam was 5.75" x 17". There were holes and bolts on the ends. Some holes were found near D2 and D3. Upon inspection, it was confirmed that this was an exterior beam, and core drilling confirmed no rot. The moment vs. deflection graph is shown in Figure 145. Creaking started at around 110.5 kip-ft. A flexural crack (Figure 146) formed near D1 at around 130.0 kip-ft. The ultimate moment carried by the beam was 145.6 kip-ft when the deflection was 2.53". The beam failed with a large pop as a flexural crack formed laterally with a diagonal run across the beam.

(a) Crack near D1

(b) Flexure crack across the beam

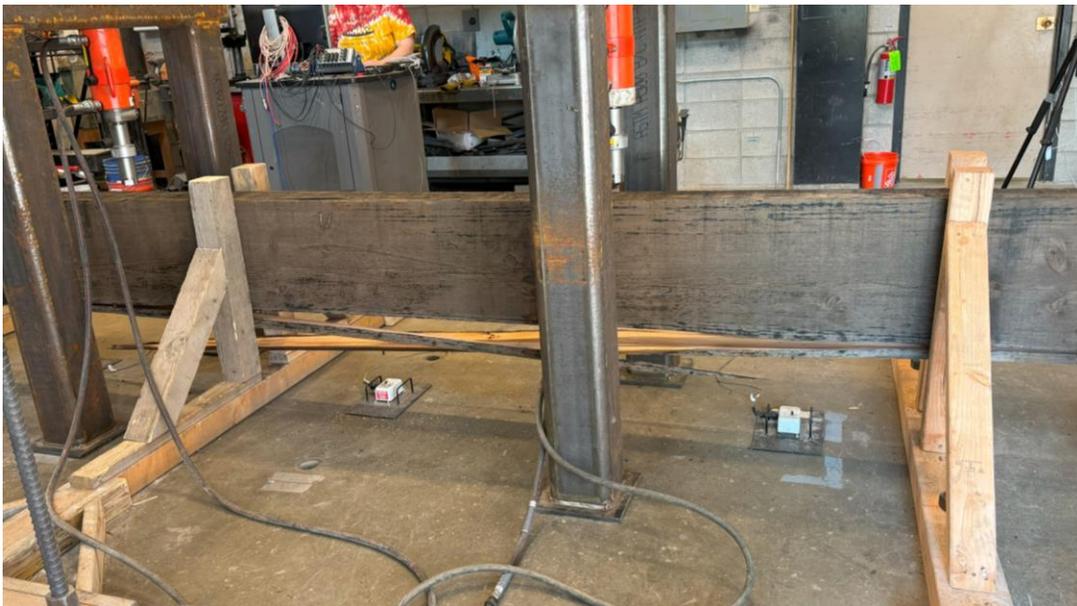
The beam's dimensions were 5.75" x 17" and 20' 0.75" in length. The beam had some minor checking. Figure 147 presents the moment vs deflection graph of the beam. The first creaking started at around 107.3 kip-ft. The beam failed due to a sudden flexure crack (Figure 148). The ultimate moment carried by the beam was 126.1 kip-ft at a deflection of 1.96".

Figure 148: Failure propagation of 6-F1(2)

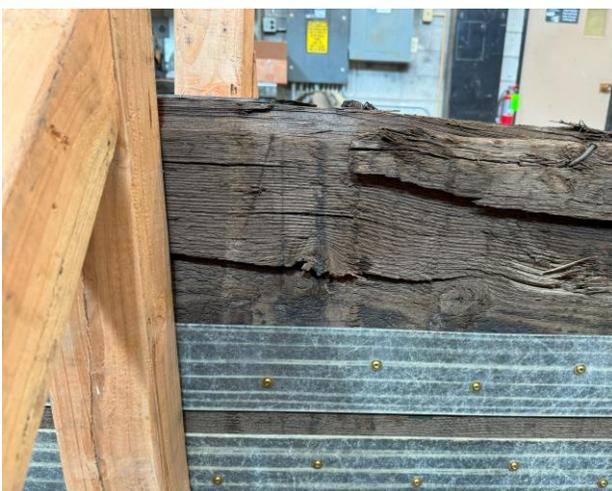
This was the Flexure Control 2 (8-FI(2)) beam with crack repairs. Four strips were attached to the sides, and one was attached to the bottom. The detailed repair method is discussed in chapter three. The string potentiometers were anchored in the middle of two strips on the side. The moment vs deflection graph is shown in Figure 176. Cracking started in the midspan at around 104.0 kip-ft and continued with higher moment. At 160.0 kip-ft, a crack was opening up at the top middle through a knot (Figure 177-a), leading to a drop in the moment to 156.8 kip-ft. At 183.2 kip-ft, a poof of dust emerged from the top middle of the beam. When the moment reached 184.0 kip-ft, the beam started contacting the two lateral bracings. The loading was paused to take pictures at around 188 kip-ft. The beam cracked a lot while holding the load and eventually failed compression through a knot at the top face middle (Figure 177-b). The ultimate moment carried by the beam was 188.8 kip-ft when the mid-span deflection was 5.08”.

(a) Crack at mid-span through a knot

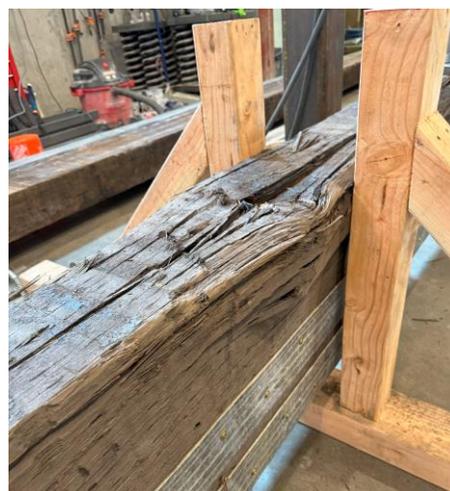
(b) Failure in compression

Figure 177: Failure propagation of 8-FI(2)-CR(S)

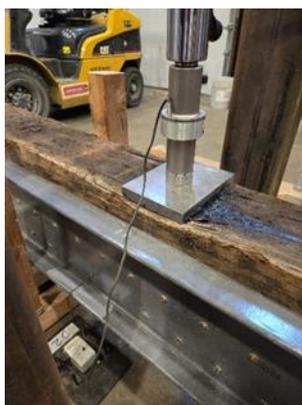
This was the split-repair beam of shear control 1 (8-Sh(1)), which was repaired following the steps outlined in chapter three, including attaching channels on the sides. There is an existing split on the end from the control test. The shear vs deflection graph is presented in Figure 178. Bearing failure began under the load block and support at approximately 26.0 kips. The beam started making contact with lateral bracings at around 36.0 kips. The existing split shifted at 36.8 kips. At 38.9 kips, a crack at the bottom midspan occurred, causing the shear to drop to 36.4 kips, with a screw on the channel shearing off. The load continued to increase, and shear failure was controlled on the end. The failure propagation of the beam is presented in Figure 179. The ultimate shear carried by the beam was 42.3 kips when the deflection was 1.58”.

(a) Bearing failure

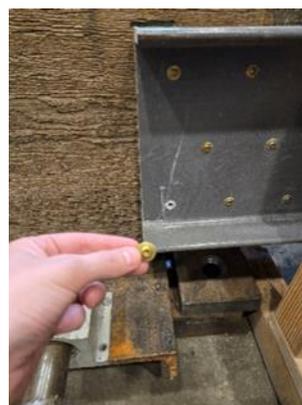
(b) Screw sheared off

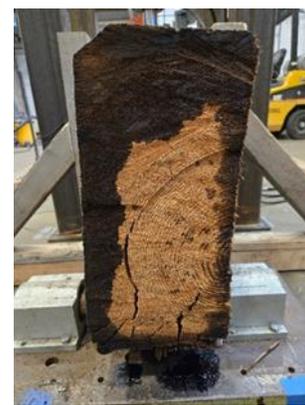
(c) Split at the end

Figure 179: Failure propagation of 8-Sh(1)-SR(C)

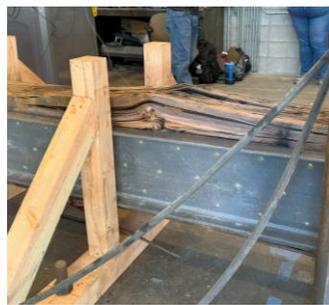
The beam's actual dimensions were 7.5" x 17" with a length of 26' 0.75". It had moderate checking along its length and was a split repaired beam with channels on the sides and a strip on the bottom. The beam had tapered ends and a through bolt was removed from one end. Figure 180 presents the moment vs deflection graphs. The first creaking occurred at around 94.4 kip-ft, and a small pop happened at around 112.0 kip-ft. A crack started forming in the bottom middle at around 133.6 kip-ft. Creaking continued with higher loading, and at a moment of 163.2 kip-ft, a crack formed under the channel, approximately 2" from the bottom on the east side, with a loud pop. As the moment increased to 175.2 kip-ft, a compression crack began to form near the top in the center of the beam. At 184.8 kip-ft, another loud pop was heard as the top middle of the beam buckled at the compression crack, causing the moment to drop to 143.2 kip-ft and then rebuild. At 167.2 kip-ft, a crack formation started near the D2 string potentiometer, about 12" from the load frame, followed by another crack at the bottom-mid, causing a slight load drop. As the moment reached 184.8 kip-ft, the beginning of a compression crack was observed near the center. At 187.2 kip-ft with 4.4" of deflection, a crack near the center began to open up. Finally, at 188.8 kip-ft with 4.7" of deflection, the bottom crack between the D1 and D2 string potentiometers started to widen, and a large crack formed near the D3 string potentiometer with a loud pop. The test was stopped after reaching the maximum stroke of the load cell. Figure 181 shows the failure propagation of the beam. The ultimate moment carried by the beam was 198.4 kip-ft at a mid-span deflection of 5.22".

(b) Beam buckled at top middle

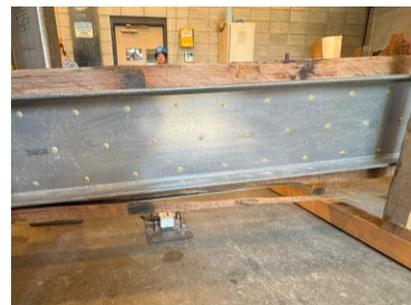
(c) Flexure crack at bottom middle

Figure 181: Failure propagation of 8-FI-SR(C-S)

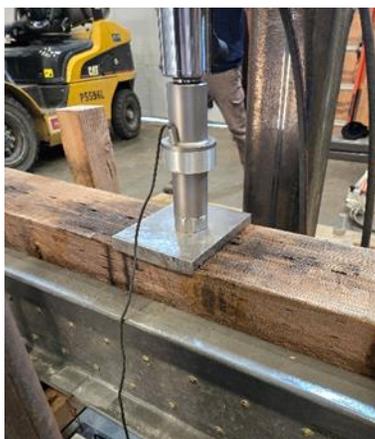
The actual dimensions of the beam were 7.5" x 17.5" with a length of 10'. It was a shear-strengthened beam cut into 10' section for the shear test setup. The strengthening process involved attaching channels on the sides, and more detailed information on the strengthening can be found in chapter three. String potentiometers were attached to the bottom flange of the channel. The bottom surface of the beam was not flat, so it was necessary to hold the beam in place before starting the loading. Figure 182 shows the shear vs deflection graph of the beam. The first creaking noise was heard at around 35.0 kips, and bearing failure occurred at both supports at around 43.0 kips (Figure 183-a). Creaking continued with higher loading, and a tension crack occurred at the bottom midspan at 52.5 kips, causing a slight load drop. The beam was continuously loaded and ultimately failed due to shear at one end, which caused split propagation and a shift (Figure 183-b). The ultimate shear carried by the beam was 56.3 kips at a mid-span deflection of 1.45".

(a) Bearing failure at load block

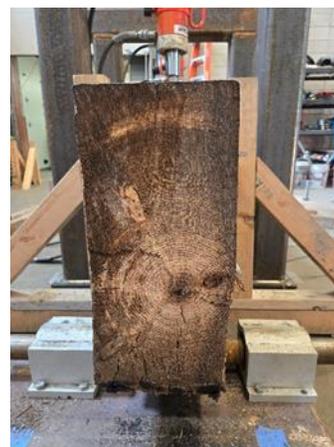
(b) Split at the end

Figure 183: Failure propagation of 8-Sh-St(C)

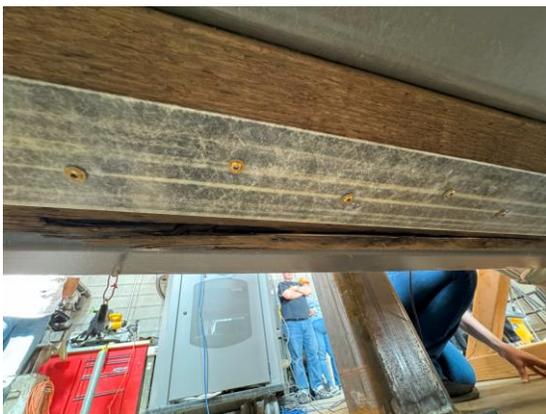
The beam was a strengthened beam with channels on the sides and a strip on the bottom. Its dimensions were 7.5" x 17" with a length of 26' 1.5". The moment vs deflection graph is shown in Figure 184. The first creaking noise was heard at around 128.0 kip-ft. At 144.0 kip-ft, there was a creak and a small pop from one end. As the moment increased to 172 kip-ft, crackling sounds accompanied by a small pop were heard from the end. When the moment reached 228.0 kip-ft, a loud pop was heard as a large compression crack began to form, causing a change in slope. At around 232.0 kip-ft, with a 4" mid-span deflection, the beam cracked just below the D2 string potentiometer with a loud pop (Figure 185-a), although the strip remained intact. At 252 kip-ft, with 5" of deflection, flange buckling was observed. Finally, at 255.2 kip-ft and 5.36" of deflection, a loud pop was heard as a small fragment flew off. The beam ultimately carried a moment of 255.2 kip-ft at a mid-span deflection of 5.32".

(a) Crack at the bottom

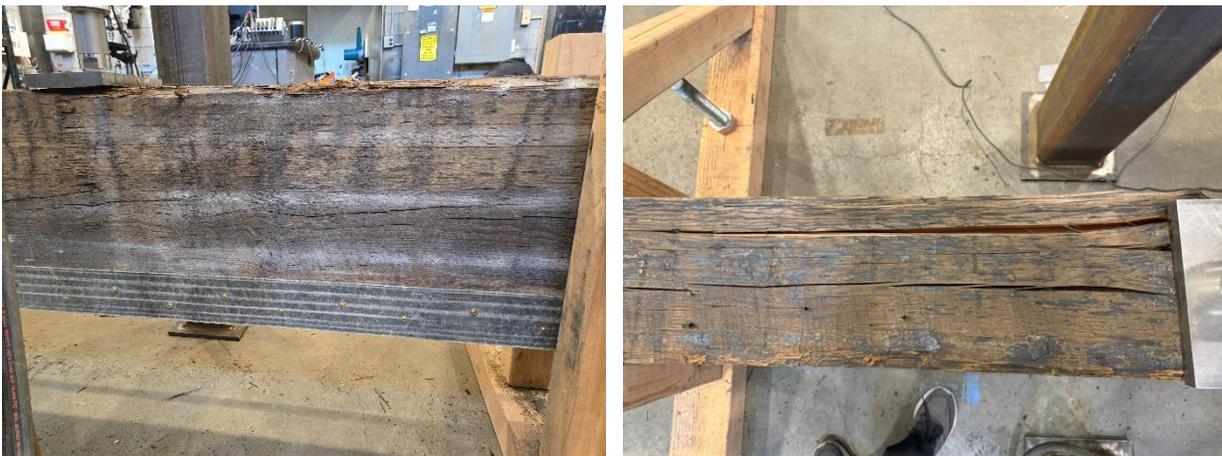
This was a beam reinforced with strips, with three strips attached to the sides and bottom. The beam's actual dimensions were 7.75" x 17.5" with a length of 26' 6.75". There was some significant checking and a large notch on one end, causing the strips to hang over. The string potentiometers were anchored above the strip on the side. The moment vs deflection is shown in Figure 186. Creaking began at around 112.0 kip-ft throughout the beam and continued with higher loading. Loud pops were heard at 168.0 kip-ft and 181.6 kip-ft with no significant drop in load. A crack (Figure 187-a) began propagating at 230.4 kip-ft on the bottom through a knot with a loud pop, causing the moment to drop to 214.4 kip-ft. The beam started touching the middle lateral bracing. Ultimately, the beam failed with a crack propagating to the midspan and compression failure under the load block (Figure 187-b) at around 200.0 kip-ft with a loud pop. The ultimate moment carried by the beam was 230.4 kip-ft when the deflection was 3.76".

(a) Crack starting

(b) Compression at top

Figure 187: Failure propagation of 8-FI-St(S)
