# Evaluation of Wind-Loading on Airport Signs

DOT/FAA/AR-TN00/32

*technical note*

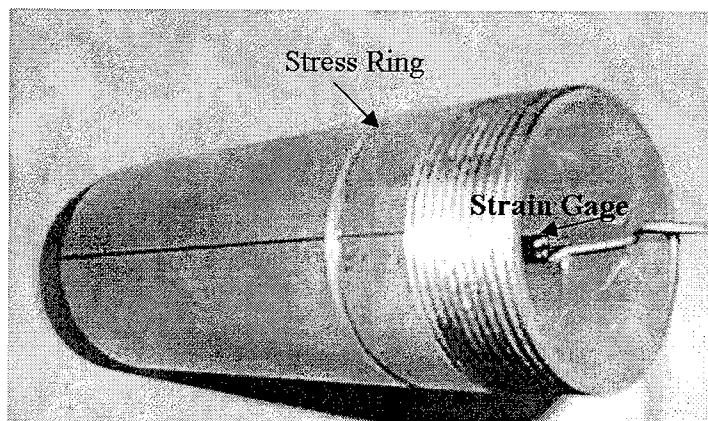
FIGURE 2. SIZE-2 FRANGIBLE COUPLING

Further investigation of events prior to the total failure of the frangible couplings showed loads that exceeded the elastic limits of the couplings, causing permanent deformation of the couplings and actual failure (cracking) of the couplings well before the sign broke completely free of the couplings.

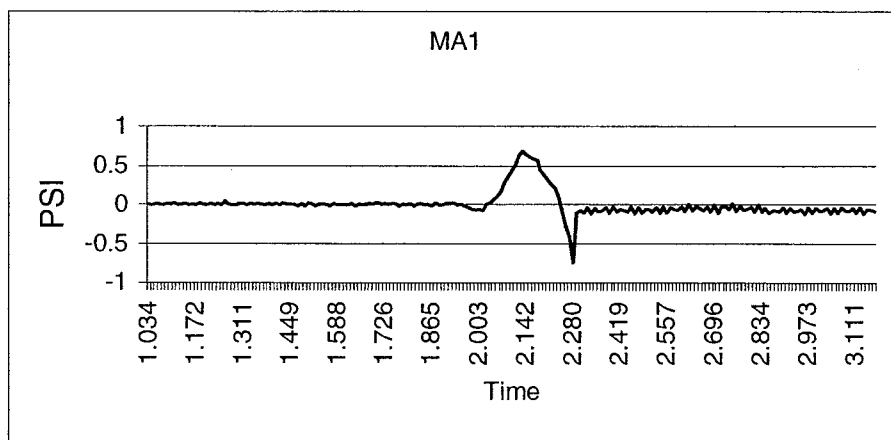
FIGURE 13. PRESSURE GAUGE ON SIGN FACE, MA1

The data also showed that the sign failed at the frangible point (couplings) under a load of only approximately 0.62 psi; which is less than the minimum frangibility requirements of the Advisory Circular. Moreover, the failure appeared to occur within the elastic limits of the laboratory tested couplings. It should be noted that the loading was applied to the sign over a time frame of less than 0.05 second, almost 200 times faster than in the laboratory tests. Although the measured wind speed was only 14.95 and 19.43 mph respectively, the data are considered to be unreliable since it was measured with a mechanical device that is not capable of providing accurate measurements over such a short period of time.
