# **Modification of Visual Approach Slope Indicator Baffles at Pearson Field Airpark, Vancouver, WA**

June 2007

DOT/FAA/AR-TN07/12

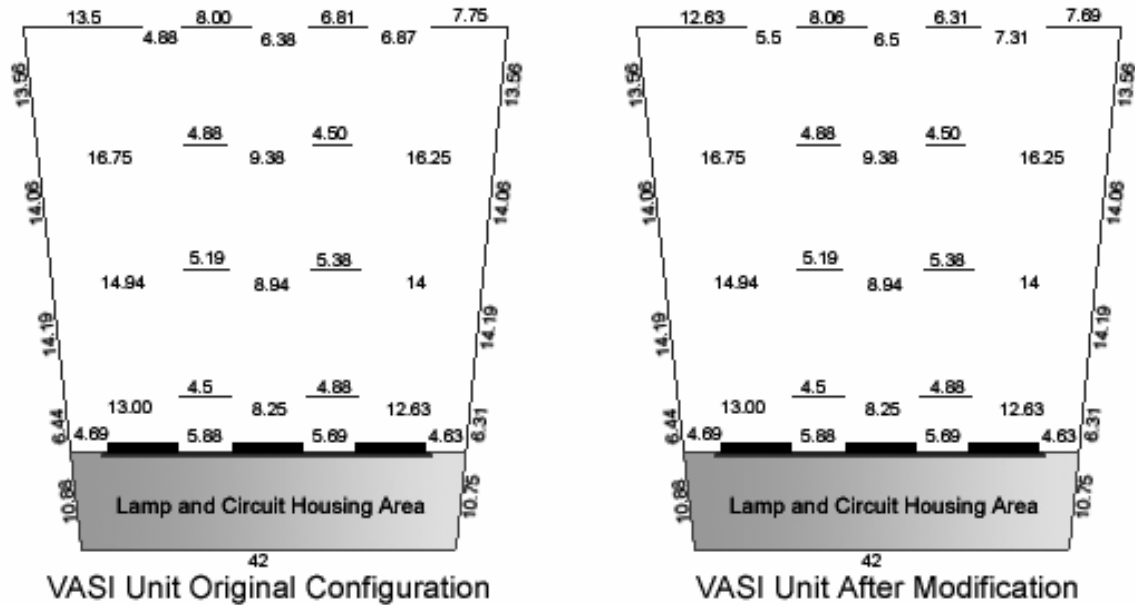
Figure A-1. The VASI Unit 1 Measurements

offset distances between the baffles varied with each unit. Furthermore, the inner baffles were attached using rivets to the sectional supports of the ceiling of the boxes, and were left in a hanging position without any support on the bottom. The inner baffles were constructed of 1/16-in.-thick aluminum. Over time, this type of material does have a tendency to warp and twist, and can contribute to the problem with the light being visible beyond the obstruction. It was determined, however, that the twisting and nonsymmetrical positioning of the baffles was not the cause of the problem at Pearson.

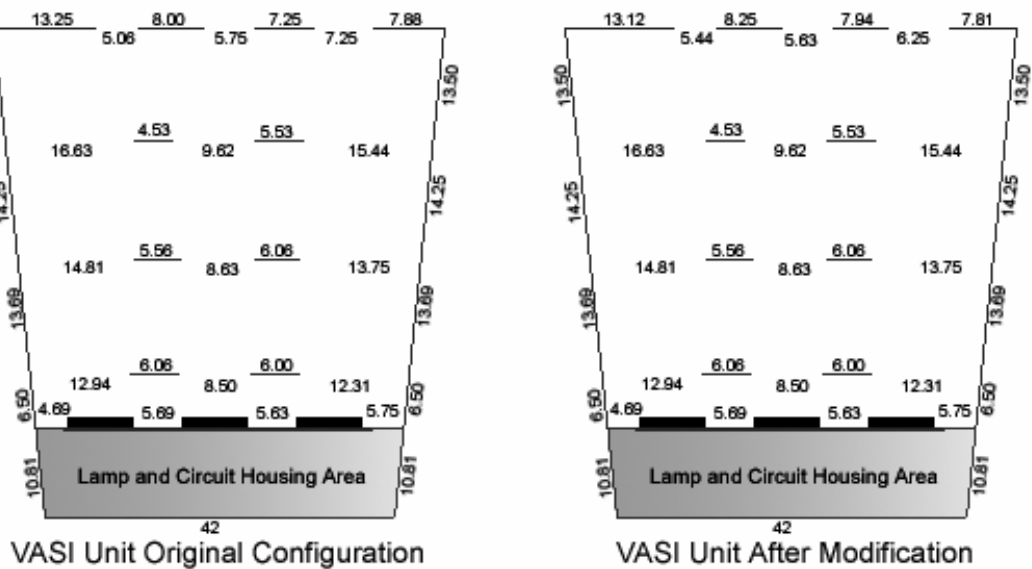
Figure A-2. The VASI Unit 2 Measurements

All measurements recorded in inches, taken to within +/- .07 in., figures are drawn to scale.  
 Measurements are recorded with respect to a horizontal cross section, top down perspective  
 with diagonal walls running along the inner wall next to the horizontal support beam.  
 Each lens housing assembly was 7.88 inches diameter.

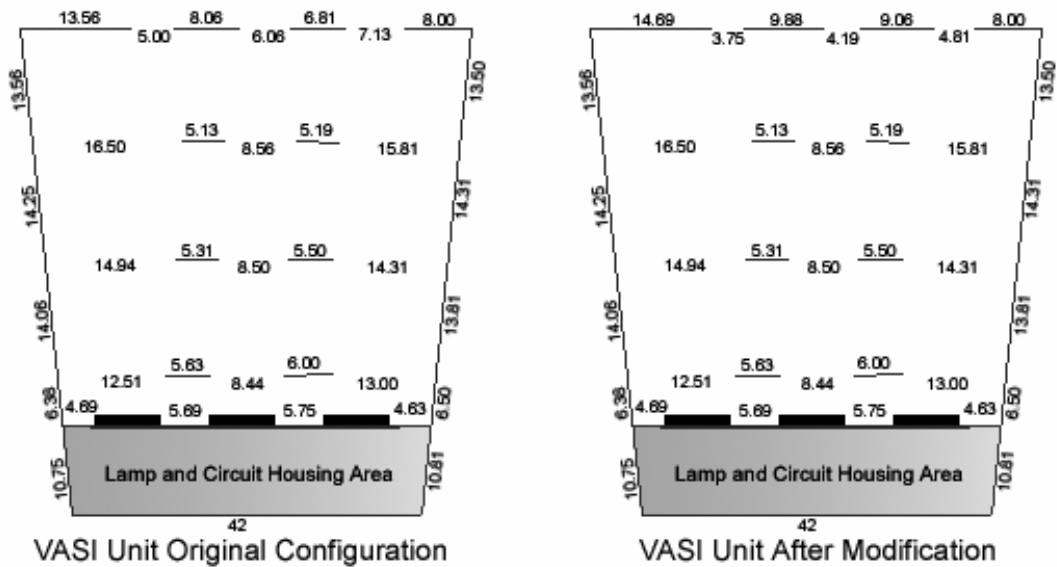
Figure A-4. The VASI Unit 4 Measurements

All measurements recorded in inches, taken to within +/- .07 in., figures are drawn to scale.  
 Measurements are recorded with respect to a horizontal cross section, top down perspective with diagonal walls running along the inner wall next to the horizontal support beam.  
 Each lens housing assembly was 7.88 inches diameter.

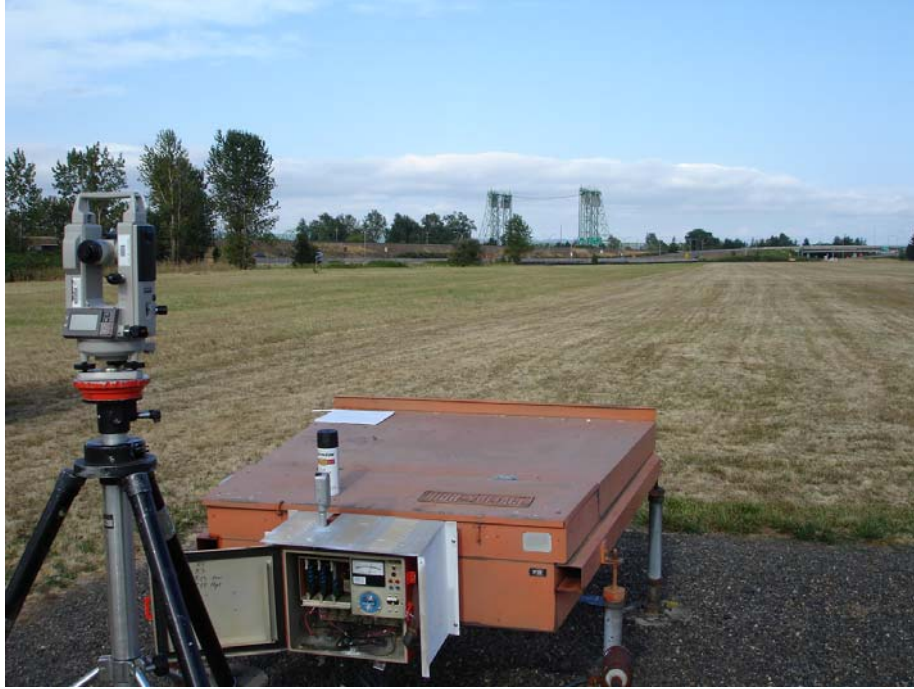
Figure B-3. Aiming and Positioning of the Theodolite

To obtain the angles that defined the toward obstruction line, baffled line, and the transition start line, two Team members walked outward along the VASI unit centerline approximately 1000 ft (as far as was feasibly permitted by ground conditions) and maintained radio contact with Team members manning the theodolite at the respective VASI unit. Upon instruction from the Team member at the theodolite, the other two Team members placed a reference marker at a point that was in line with the obstruction and the theodolite, which represented the toward obstruction line.

The Team walked back towards the runway centerline and placed two additional reference markers on it. The first marker was placed at a point where the Team determined that no visible light should be observed by the pilot. This path is referred to as the baffled line and is shown in figures 1 and 2. The Team determined that this angle was to be 2 degrees less than the angle to the obstruction, which would provide sufficient separation between the aircraft and the obstruction should the pilot attempt to use the edge of the signal of the baffled VASI. The second marker was placed at a location where the Team determined that the light from the VASI units would begin decreasing in intensity. This path is referred to as the transition start line, also shown in figures 1 and 2. The distance between the transition start line and the baffled line is determined by the physical geometry of the VASI unit and the baffles. Typically, this angle is approximately 1°, 30' wide.
