# Identification Techniques to Reduce Confusion Between Taxiways and Adjacent Runways

September 2007

DOT/FAA/AR-TN07/54

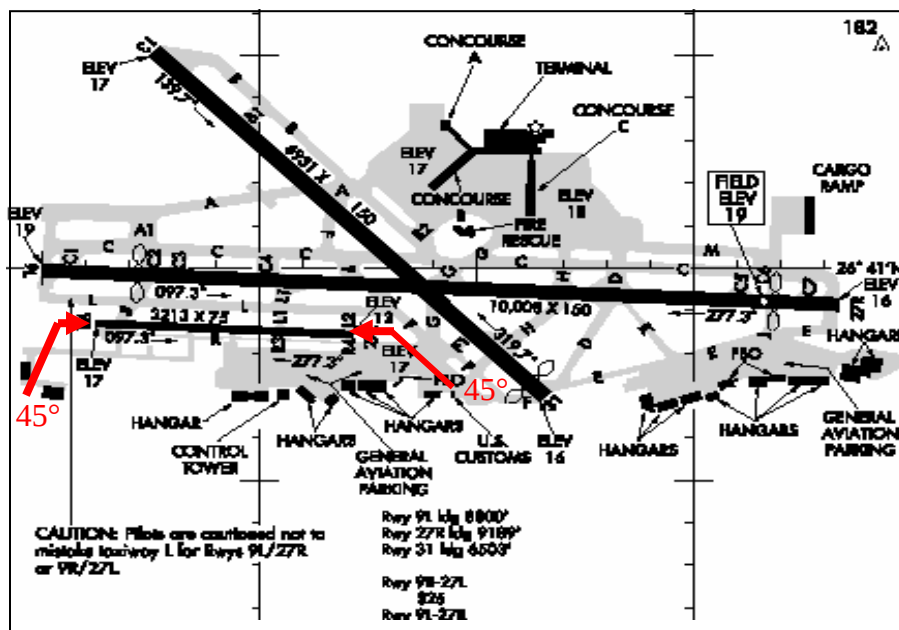
Figure 2. Airport Diagram of PBI

Of the 110 airports cited as having this particular problem, PBI is number one on the list, with approximately 36 reported incidents to date. The incidents occur in both directions on taxiway Lima, typically by general aviation pilots. ATC personnel will request that aircraft operating on 9R/27L approach or depart on a 45-degree-angle base leg or crosswind leg to increase the separation between the smaller general aviation aircraft and the air carrier jets (figure 2). This is done for two reasons: it creates an operational safety buffer, and it reduces the likelihood of potential wake turbulence encounters. The airport authority and ATC manager indicated that they did not believe that this practice contributed in any way to the inadvertent taxiway landings.

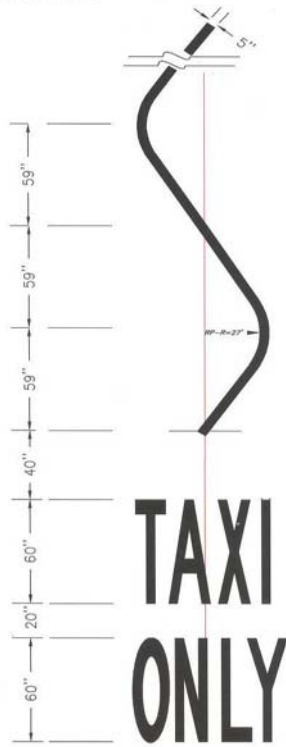
Figure A-15. Dimensions of Markings on Taxiway Alpha (LNK)

- Removal of the boxed A painted designation is recommended, since it looks too much like a displaced threshold chevron. This paint marking may be making the situation worse, since the character A with its arrow-like resemblance, potentially draws the pilot's attention to the hold line that is just beyond it on the taxiway, creating a visual illusion that it is a runway.

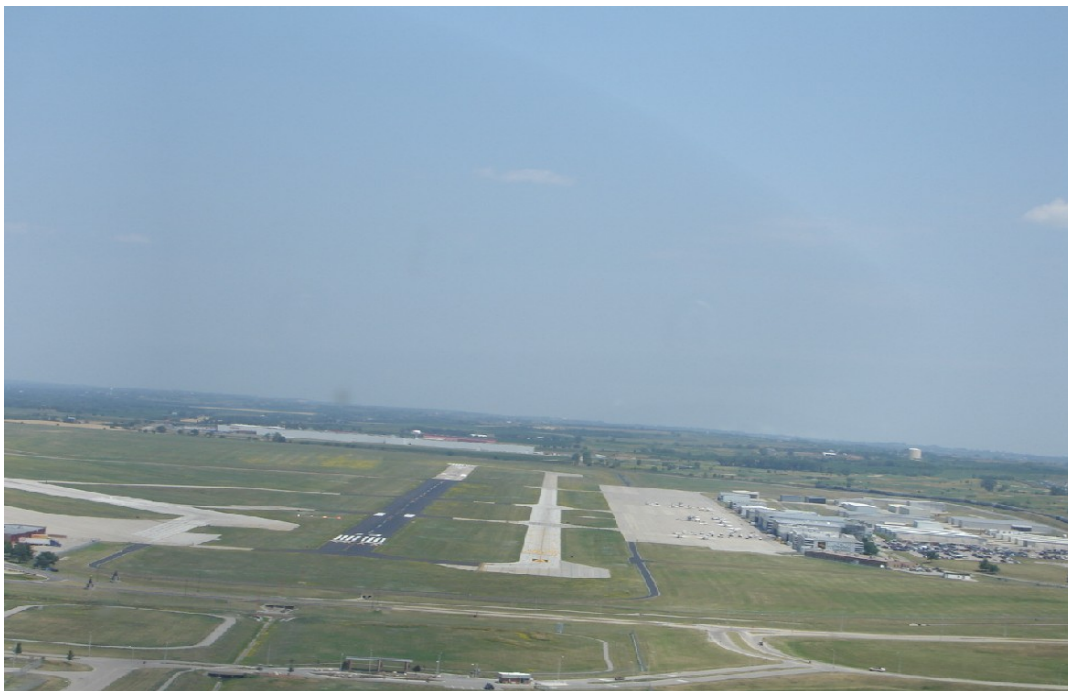
Figure A-27. Straight-In Approach to Runway 35 With Taxiway Alpha on the Right (LNK)

- The geometrical design of taxiway Alpha at the southernmost end may be the single-most contributor to the inadvertent landing problem. The run-up pavement area ideally should be differentiated from the taxi area pavement, since it visually makes the taxiway look like a runway landing surface. As shown in figures 2 and 3, the large area of pavement, along with the way its edges slope in to join the edges of taxiway Alpha, make it look

almost identical to the way the taxiways lead into runway 35. Research has shown that the most common factor contributing to taxiway landings is the squared-off threshold (typically done in anticipation of future expansion and construction). One possible solution for this situation at LNK would be to seal coat the taxiway surface up to the curved taxiway edge line, and then possibly a year later, seal coat the run-up area. This would make the two pavement surfaces vary in color. The Team recommended that removing the run-up area would be ideal, but realized that this would not be acceptable to the airport authority.
