PRESSURE RELIEF AND OTHER JOINT REHABILITATION TECHNIQUES

FINAL REPORT

February, 1987

7. Author(s) K. D. Smith, M. B. Snyder, M. I. Darter, M. J. Reiter, K. T. Hall	8. Performing Organization Report No.	
9. Performing Organization Name and Address ERES Consultants, Inc. P. O. Box 1003 Champaign, IL 61820	10. Work Unit No. (TRAIS)	11. Contract or Grant No. DTFH61-83-C-00111

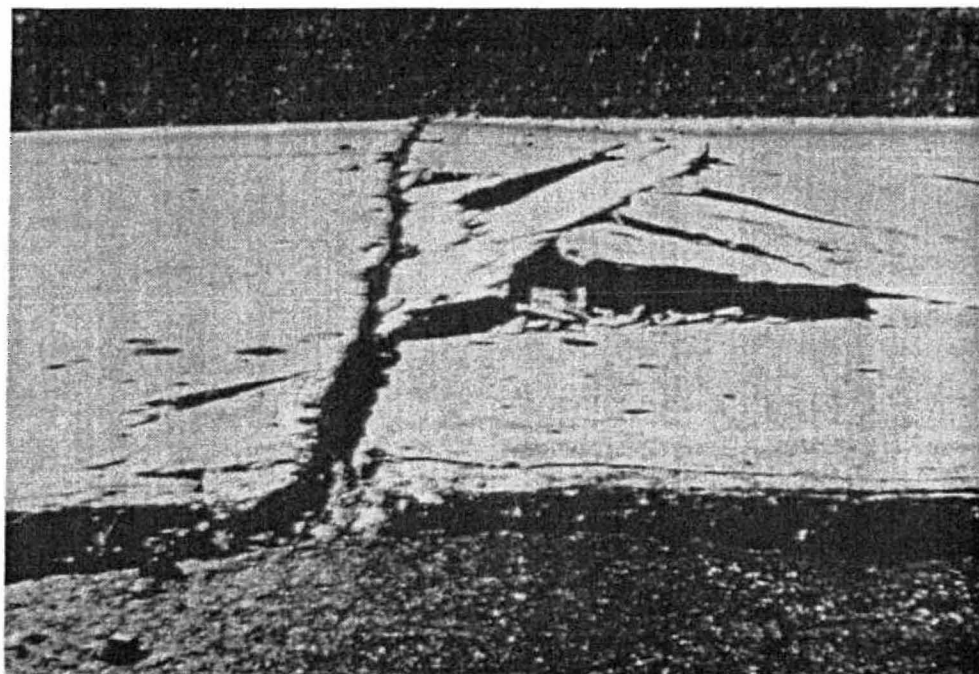
Blowups are areas of localized upward movement (see Figure 5) or shattering of the pavement (see Figure 6) due to excessive compressive forces in the slab. They often occur in hot weather at a joint or crack which is closed or filled with incompressibles and will not allow expansion of the concrete slab.

Low-severity blowups produce minor buckling or shattering of the slab, but create little discomfort to the occupants of passing vehicles. Medium-severity blowups cause some discomfort, while high-severity blowups cause substantial discomfort, pose a safety hazard, and may require passing vehicles to reduce their speed. (29, 117)

Figure 6. Photo of Blowup (Shattered Pavement).

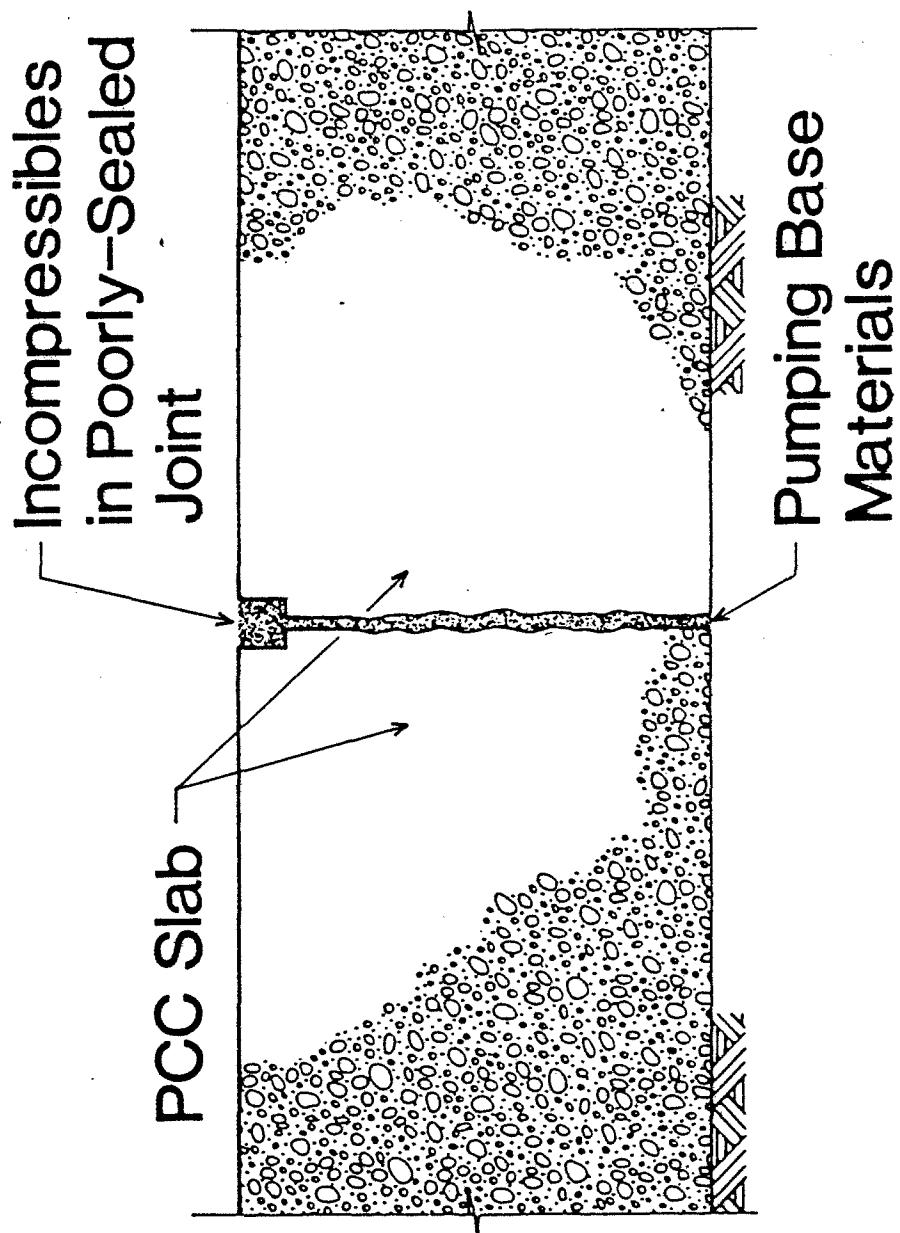
Intrusion can also occur from below the slab when vertical movements at the joints and cracks cause pumping. Water and base material particles are forced upward into the joints and cracks. In time, incompressibles can buildup (see Figure 8) which prevents the joint from functioning properly.

Figure 8. Intrusion of Incompressibles into Joint Area Through Poorly-Sealed Joint and Pumping of Base. (25)

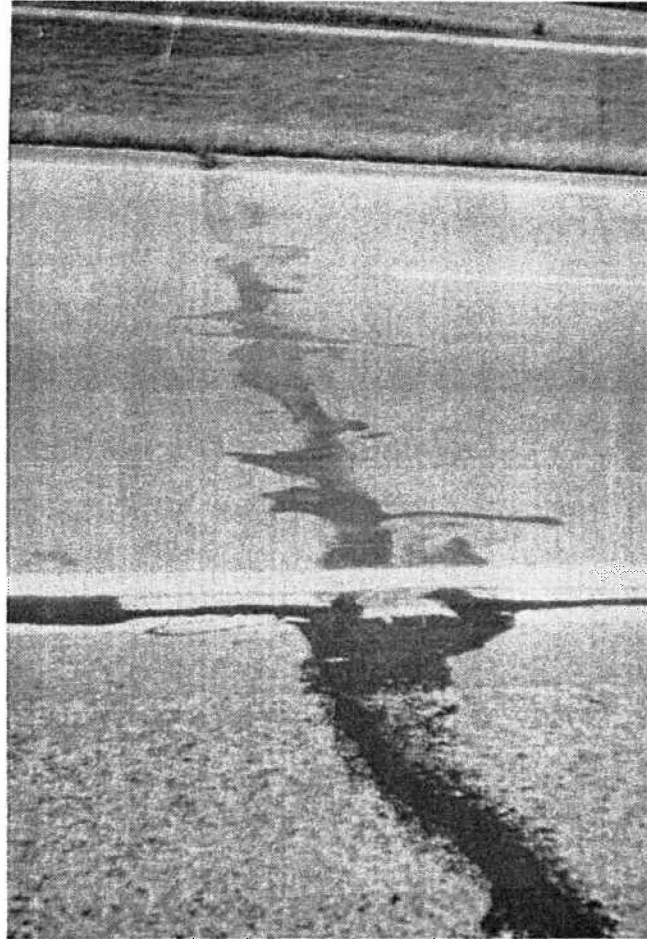
The pressure relief joints have reflected through the overlay, have been sealed and are not spalled (see Figures 30 and 31). The overlay is not "humped" above the relief joints and the flexible repairs have not reflected through the overlay and have not caused "humping."

Figure 30. Photo of Sealed Crack Over Pressure Relief Joint on OH070066.

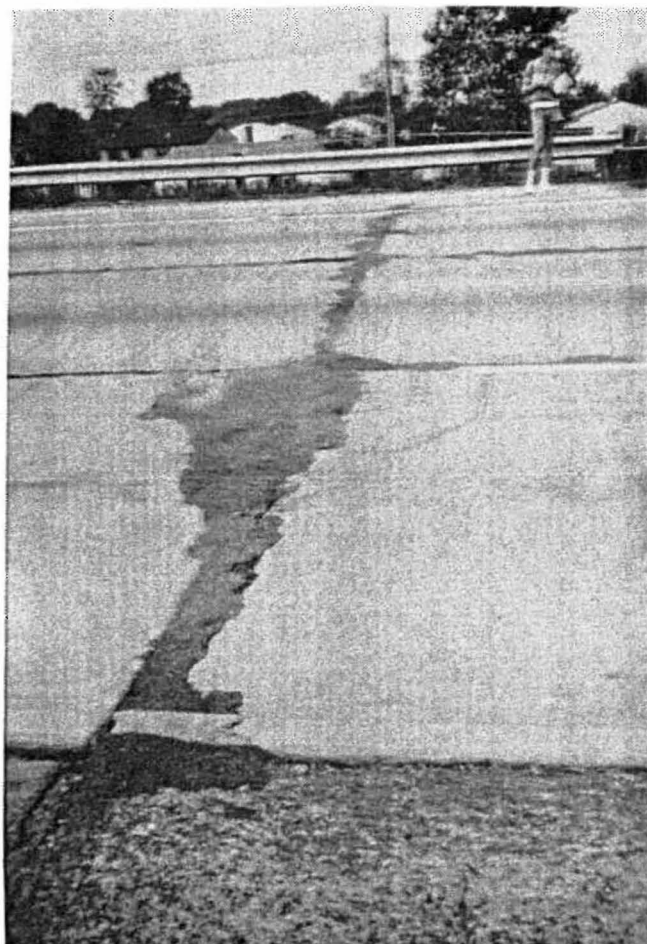
The pressure relief joints are exhibiting medium-severity joint and corner spalling. In addition, transverse cracks adjacent to the pressure relief joints have deteriorated from tight, nonworking cracks (typical of a CRC pavement) to spalled, working cracks (see Figures 34 and 35). Punchouts were more frequently located near the pressure relief joints.

Figure 34. Photo of Pressure Relief Joint on OH270031.

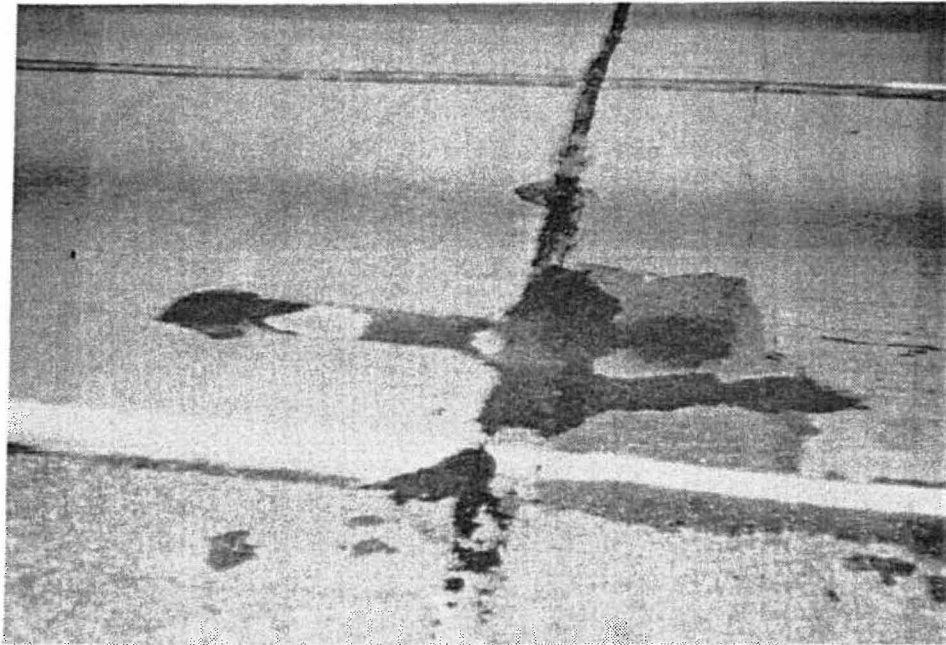
Figure 35. Photo of Pressure Relief Joint on OH270031.

Installation of pressure relief joints on this project was inappropriate because the compressive stresses in areas that had suffered blowups in the past were probably sufficiently relieved by the blowups. Further, the interruption of the continuous reinforcing steel resulted in premature deterioration of adjacent transverse cracks. A better approach might have been to remove pavement sections for the placement of traditional CRC repairs and leave these areas open for 24-72 hours to allow for pressure relief. A properly constructed repair could then have been installed by carrying the steel through the repair to keep the cracks tight. This would have reduced the possibility of loss of support caused by allowing water to enter a wide relief joint.

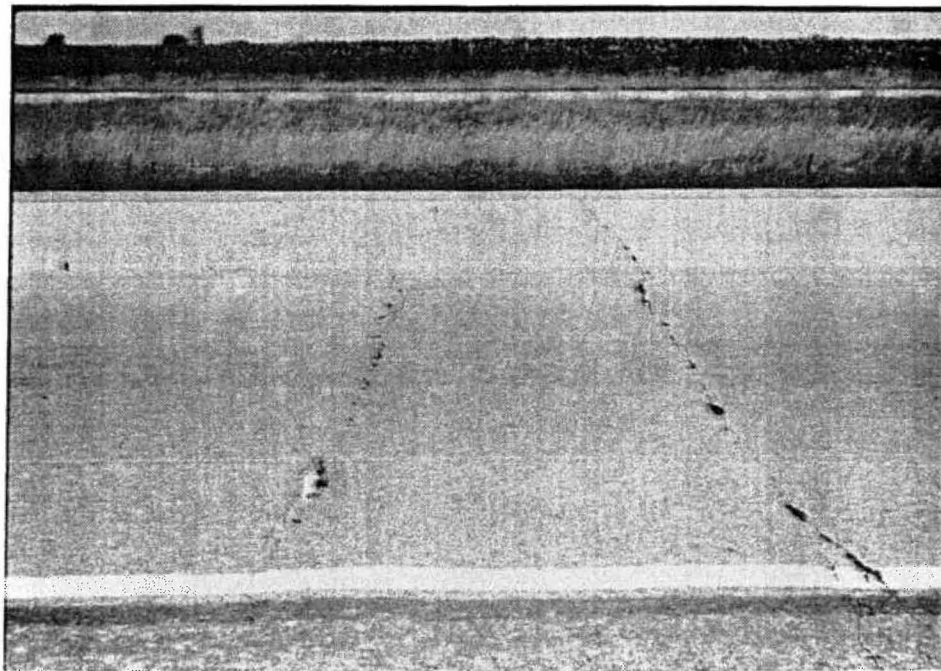
Figure 37. Photo of AC Overlay Above Pressure Relief Joint in Sample Unit 4 (Station 3+75) of IL072067.

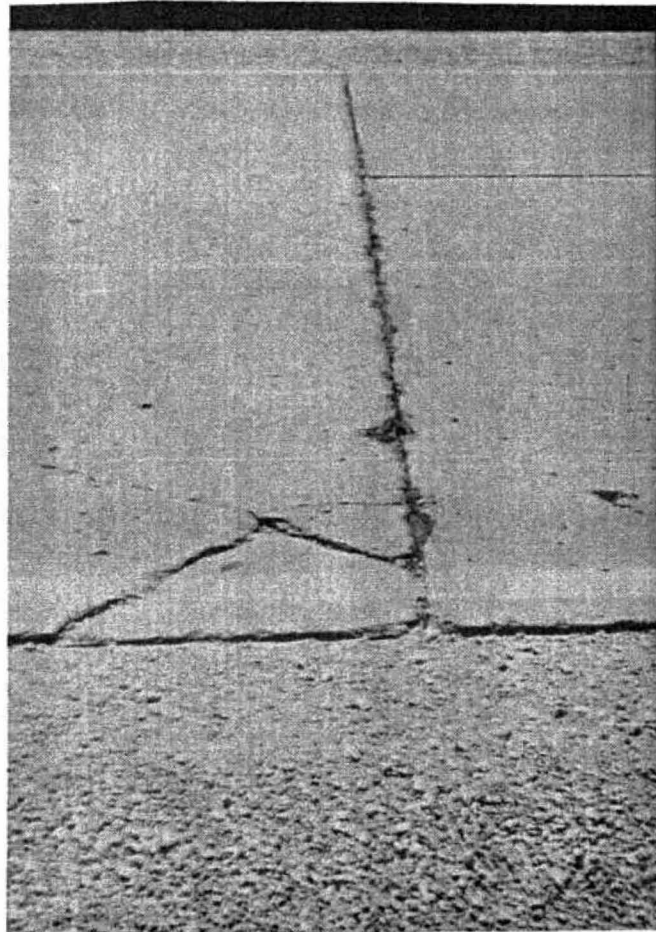
The pressure relief joints (excluding those located near bridges) have closed to an average width of 0.54 in [14 mm], which is about the same width as the resealed joints. The relief joints have faulted an average of 0.16 in [4.1 mm] after only 0.6 million ESALs, which compares with 0.11 in [2.8 mm] and 2.2 million ESALs for the original contraction joints. Half of the surveyed relief joints had no filler present and incompressibles were observed in all of the surveyed relief joints. Several of the relief joints also exhibited medium-severity transverse joint spalling (see Figures 39 and 40).

Figure 39. Photo of Typical Pressure Relief Joint
in Sample Unit 2 (Station 8+60) on IA030156.

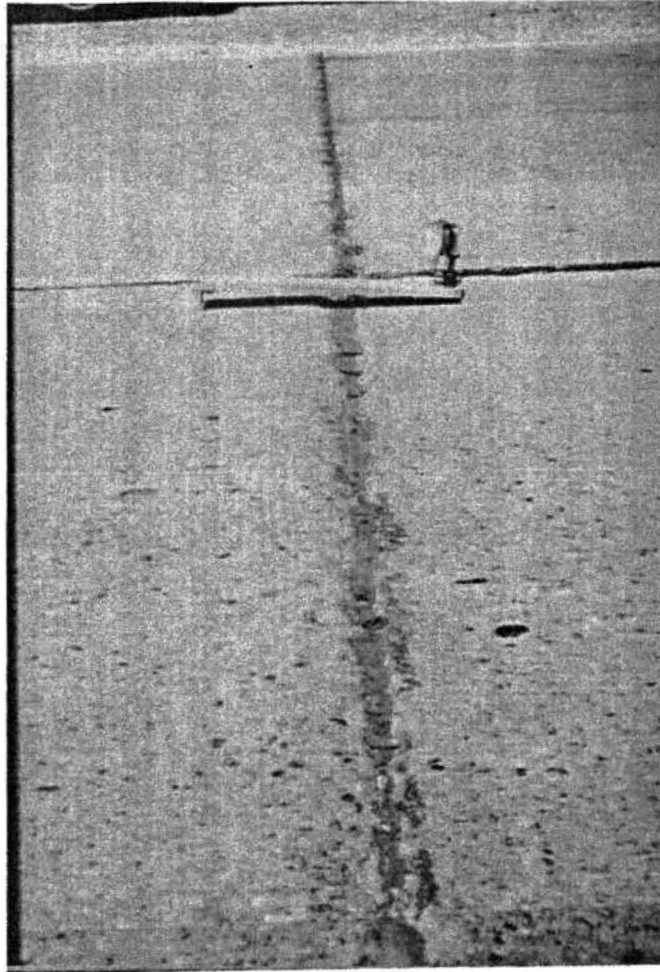
Figure 40. Photo of Typical Pressure Relief Joint in Sample Unit 1
(Station 11+40) on IA030156.

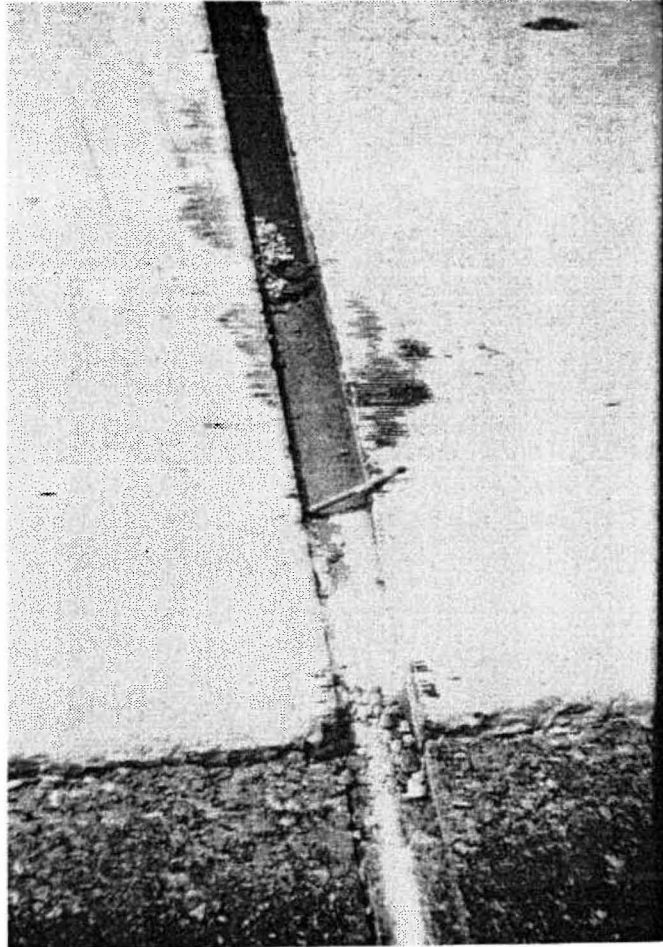
The pressure relief joints that were installed in 1984 had closed to an average width of 3.5 in [89 mm] and had faulted an average of 0.16 in [4.0 mm] in 1985 (twice the faulting of the original contraction joints). The filler was absent from two of the three relief joints surveyed and these joints contained incompressibles (see Figures 45 and 46). The third relief joint was located in the joint resealing project and it showed no

Figure 45. Photo of Typical Pressure Relief Joint in Sample Unit 1
(Station 2+40) of IL080105.

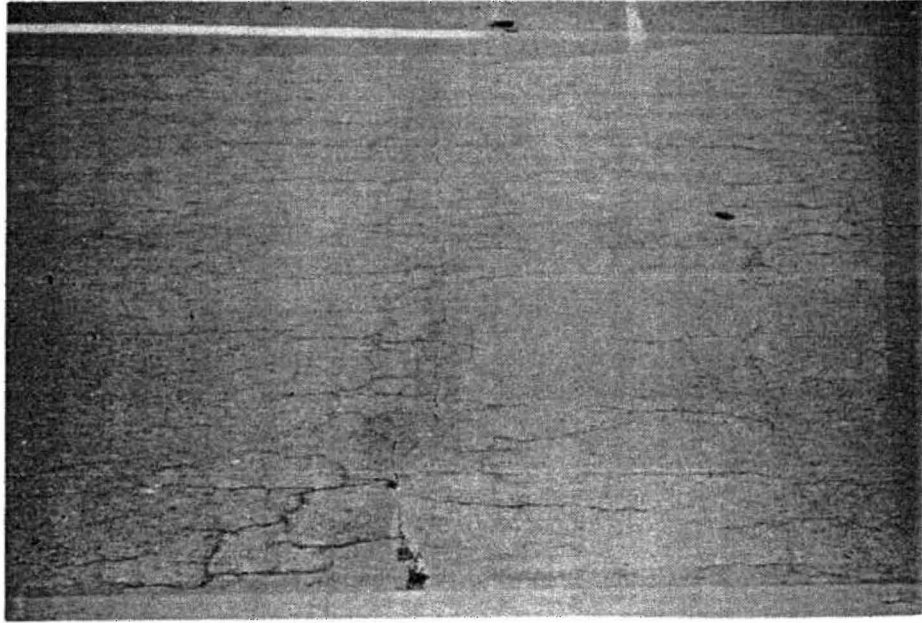
The condition surveys conducted in 1985 showed reactive aggregate distress (see Figure 53), low- and some medium-severity transverse cracking, transverse joints with extruded sealant and incompressibles in some joints, medium-severity transverse joint and corner spalling (mostly in the outer lane) and localized areas of scaling. The remaining transverse contraction joints were faulted an average of 0.02 in [0.5 mm] and were open an average of 0.3 in [7 mm]. An average Roughness Index of 120 (good) was obtained with a Mays Ride Meter in 1985. A skid number of 44 (good) was obtained with a locked wheel skid trailer in 1984.

Figure 53. Photo of Reactive Aggregate Distress Observed on
NE080189.

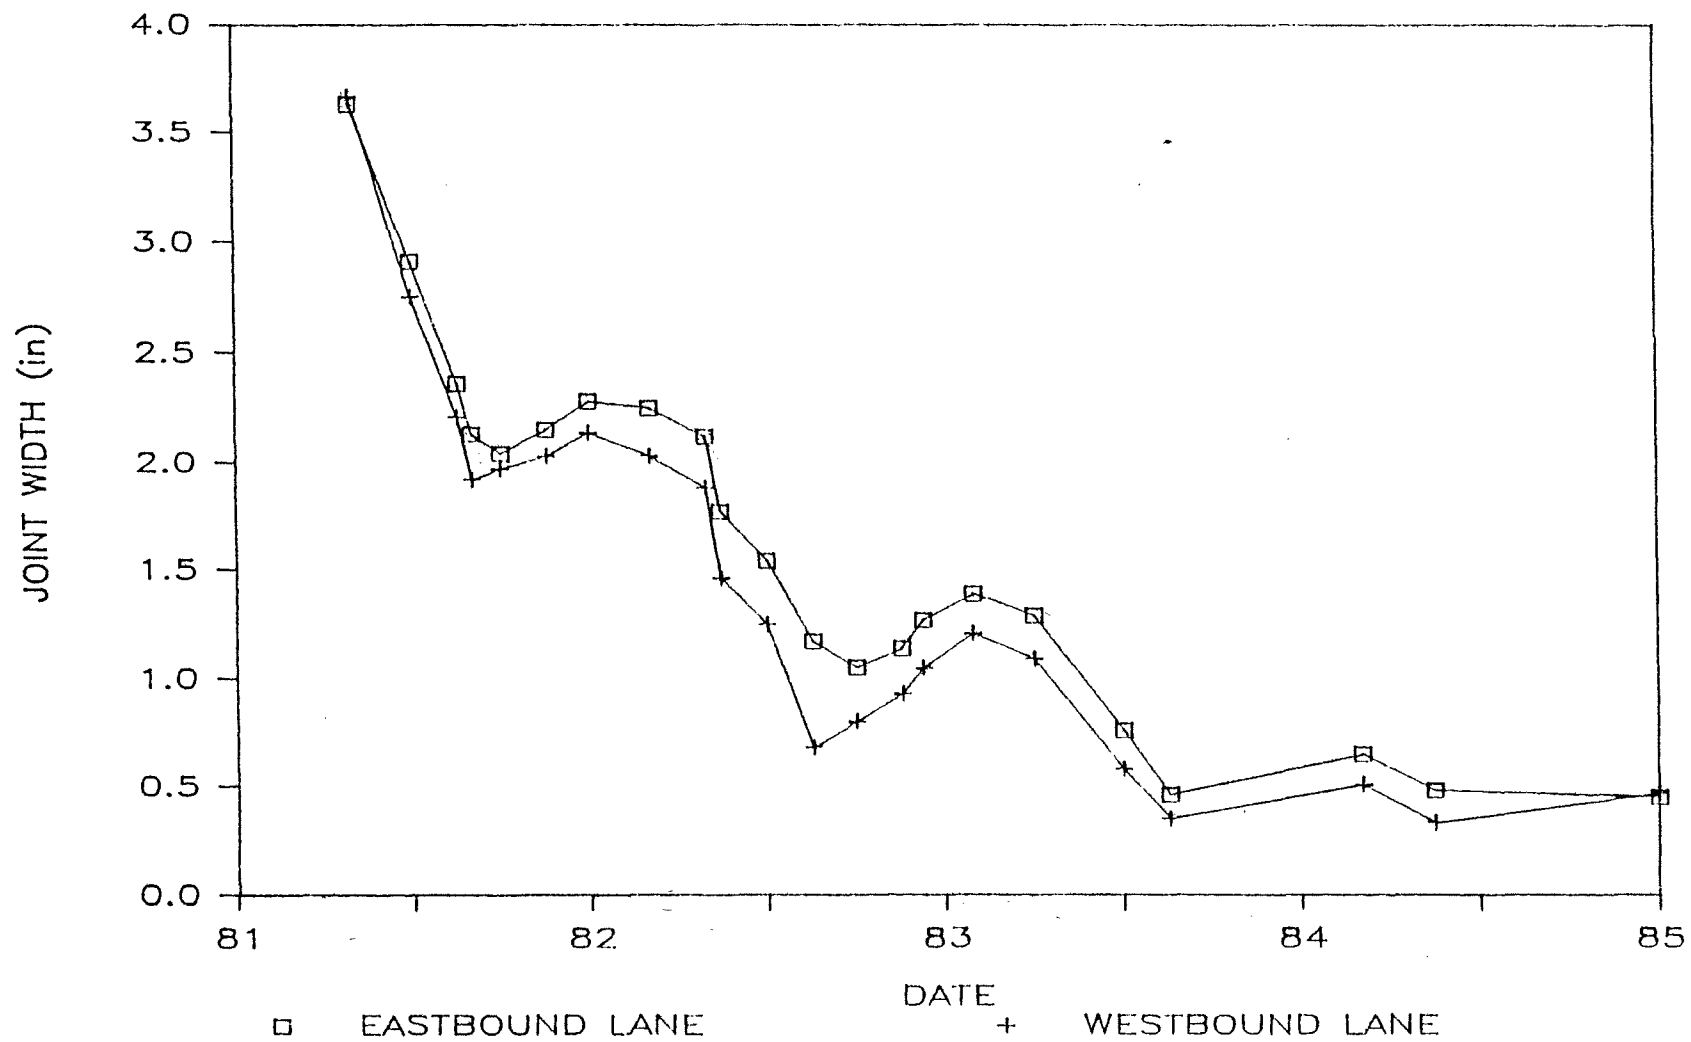
Figure 54. Pressure Relief Joint Closure Over Time on NE080189
[1 in = 25.4 mm].

The pressure relief joints that were installed in 1980 have closed from 4.5 in [114 mm] width to an average width of 0.9 in [23 mm] and have faulted an average of 0.17 in [4.3 mm]. Table 6 presents a summary of the closure of the pressure relief joints for the entire project, as measured by the Nebraska Department of Roads. Figure 55 illustrates the relief joint closure over time. The filler is still intact in most of the relief joints and is keeping incompressibles from infiltrating. Spalling was typically of low severity at the relief joints, but in a few cases medium-severity spalling was present.

The pressure relief joints were an appropriate measure taken on this project to combat the expansion caused by the reactive aggregate and evidenced by the amount of closure of the relief joints (average amount of closure 4.0 in [102 mm]) without significant opening or faulting of adjacent contraction joints. However, the full-depth repairs placed in 1979 are believed to have relieved any built-up pressure.

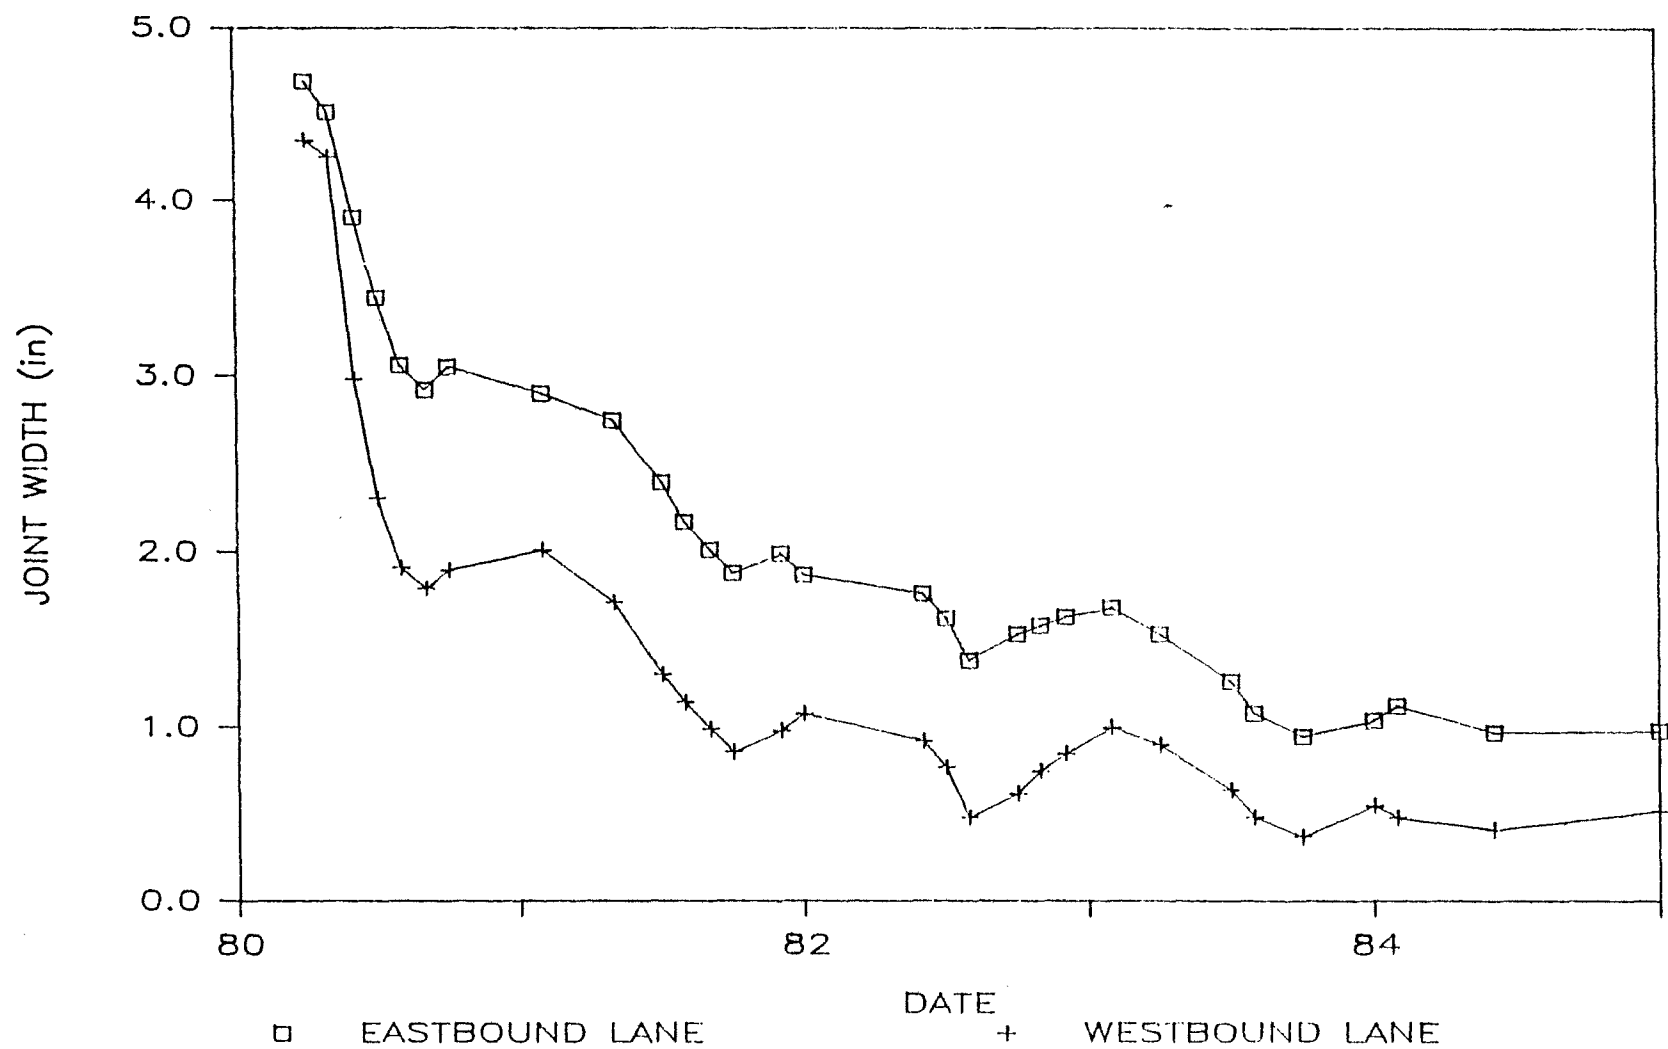
Less closure and lower rates of closure were found in the relief joints on this project (as determined by the Nebraska Department of Roads) than the preceding one (NE080189). This can probably be attributed to the placement of full-depth repairs before the installation of the relief joints on this project. The full-depth repairs allowed for some of the pressure to be relieved, but the relief joints were still necessary to allow for the expansion of the pavement caused by reactive aggregate problems.

Figure 55. Pressure Relief Joint Closure Over Time on NE080210
[1 in = 25.4 mm].

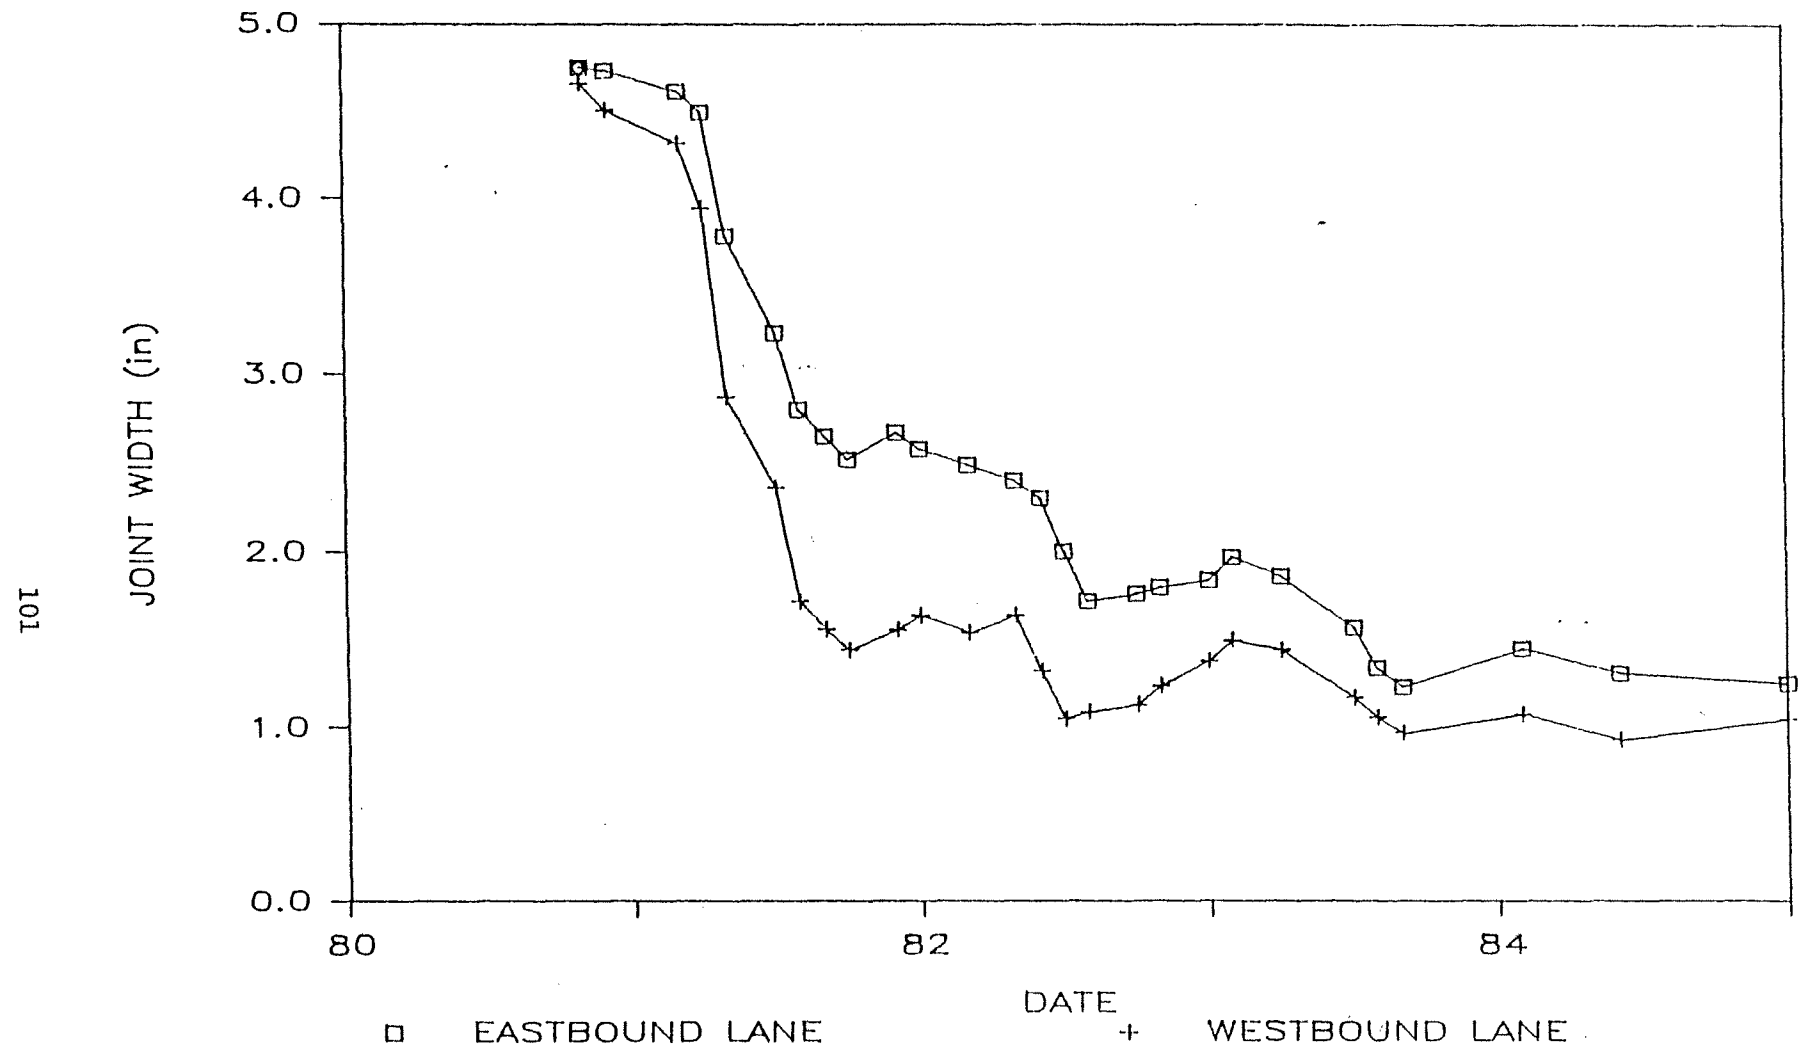
The pressure relief joints that were installed in 1980 have closed from 4.5 in [114 mm] width to an average width of 0.86 in [22 mm] and have faulted an average of 0.18 in [4.6 mm]. Table 7 presents a summary of the closure of the pressure relief joints for the entire project, as measured by the Nebraska Department of Roads. Figure 56 illustrates the relief joint closure over time. The filler is still intact in most of the relief joints and is keeping incompressibles from infiltrating. Spalling was generally of medium severity.

The pressure relief joints placed in 1980 were an appropriate measure taken on this project to combat the expansion caused by the reactive aggregate, although the placement of the full-depth repairs in 1980 probably aided in relieving any built-up pressure.

Figure 56. Pressure Relief Joint Closure Over Time on NE080256 [1 in = 25.4 mm].

The performance of the pressure relief joints has been satisfactory for this project and the two preceding it (NEO80189 and NEO80210). It is observed that the rate of closure and the amount of closure is less for this project (NEO80256) where full-depth repairs and pressure relief joints were installed the same year. However, the relief joints were apparently still necessary to allow for the expansion of the pavement caused by reactive aggregate.

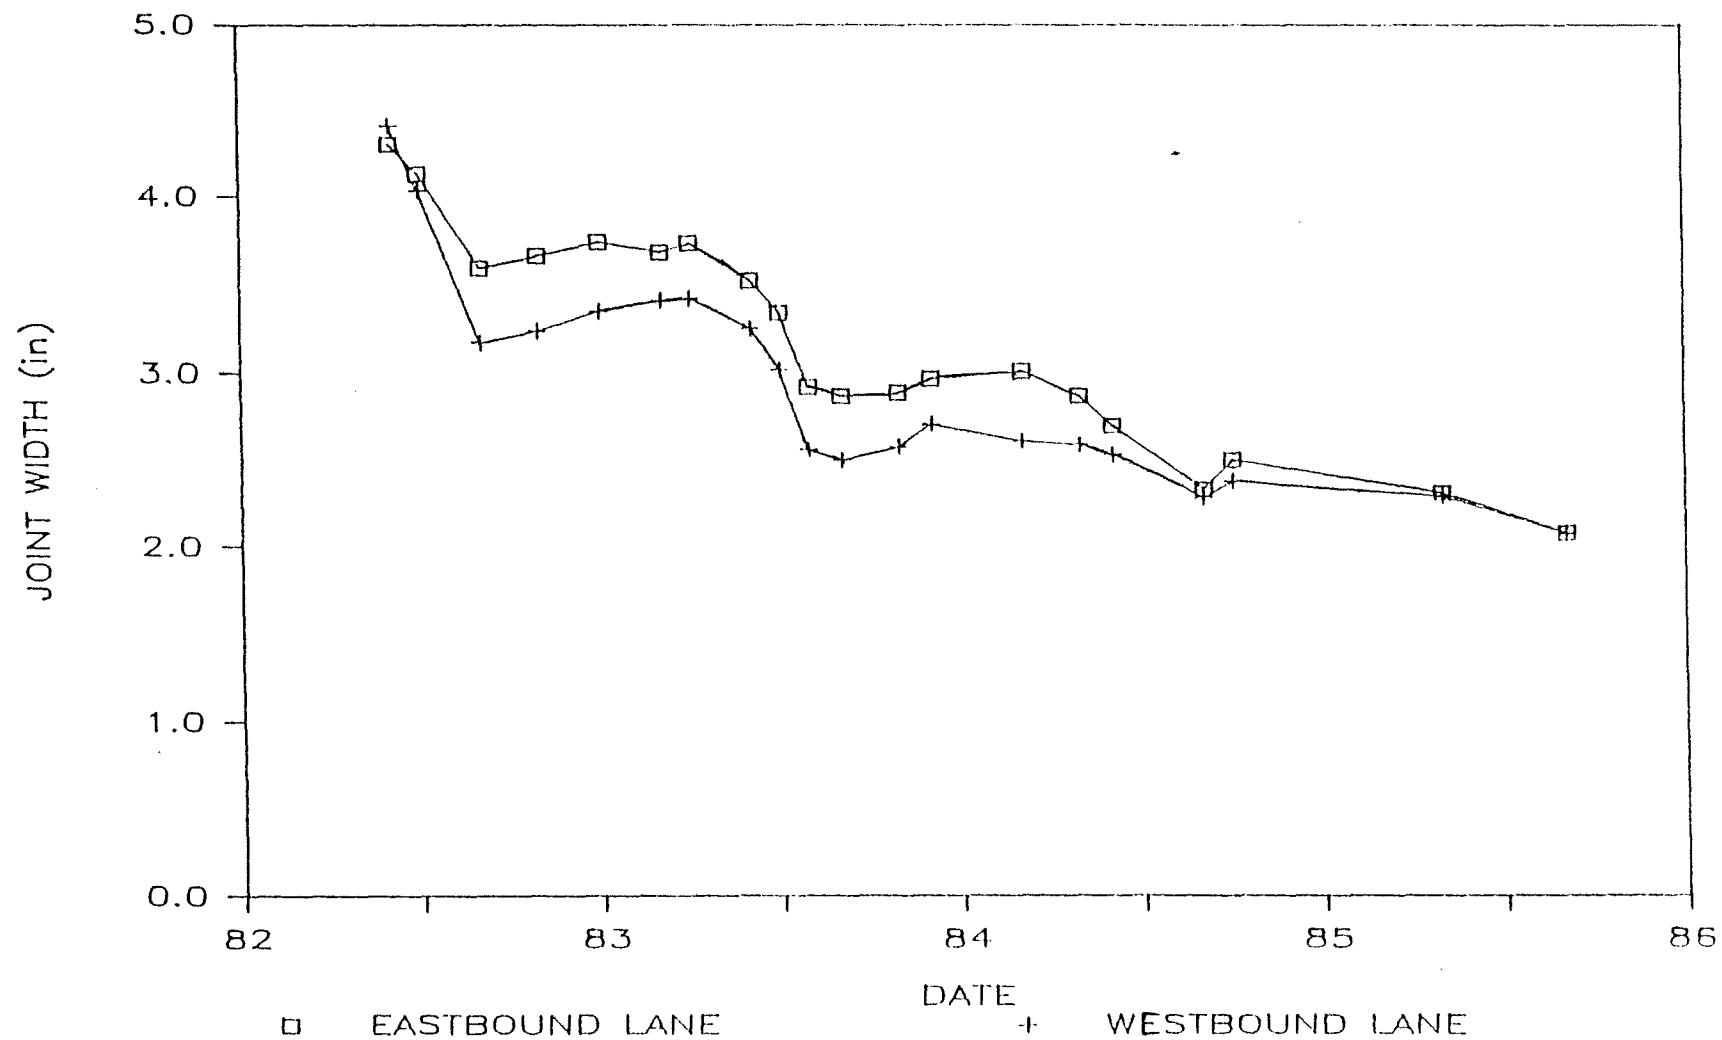
Table 10 provides a summary of the closure of all the relief joints on this project, as measured by the Nebraska Department of Roads. Figure 57 presents a plot of the relief joint closure over time.

Figure 57. Pressure Relief Joint Closure Over Time on NE080382 [1 in = 25.4 mm].

Although the use of relief joints on this project may be questionable, their presence has apparently not adversely affected the project, because the faulting and opening of adjacent contraction joints is about average and nearby slabs exhibit typical types and amounts of distress. The faulting of the relief joints might have been reduced slightly if a load transfer system (e.g., dowels or a sleeper slab) had been provided.

While the original pavement has several years of serviceable life remaining, the full-depth repairs placed in 1982 should be replaced immediately. The joints will require resealing within the next few years and a longer-life sealant is recommended.

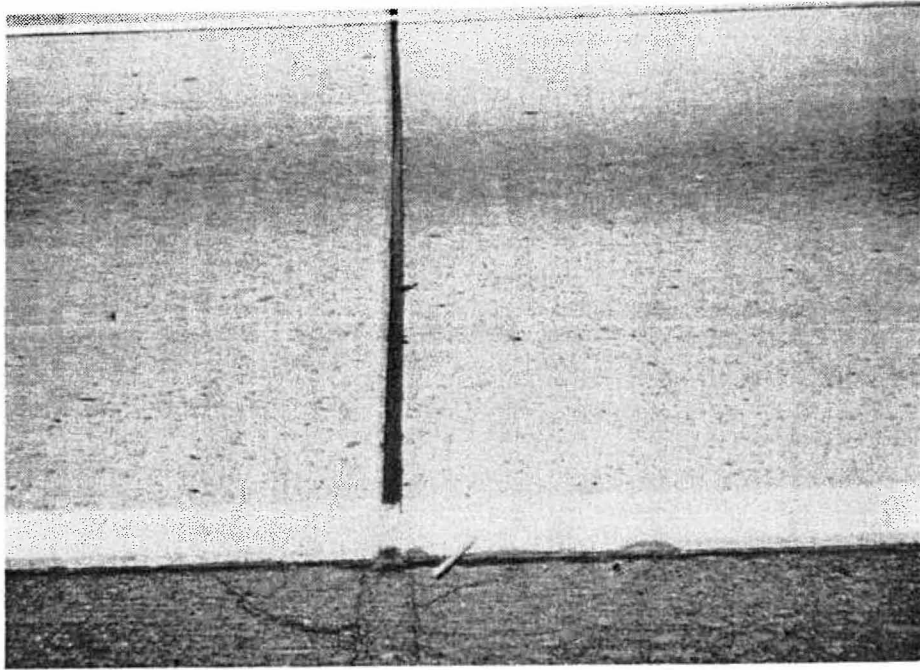
Figure 58. Photo of Pressure Relief Joint in Sample Unit 2 (Station 5+86) of VA064279 (Diamond-Ground Direction).

Suggestions for improvements include the incorporation of load transfer devices in future full-depth repairs, installation of subdrains along the entire project, cement grout undersealing at least in the vicinity of the repairs and known voids, and regrounding the pavement when roughness becomes unacceptable. Removal of the relief joints could also be considered.

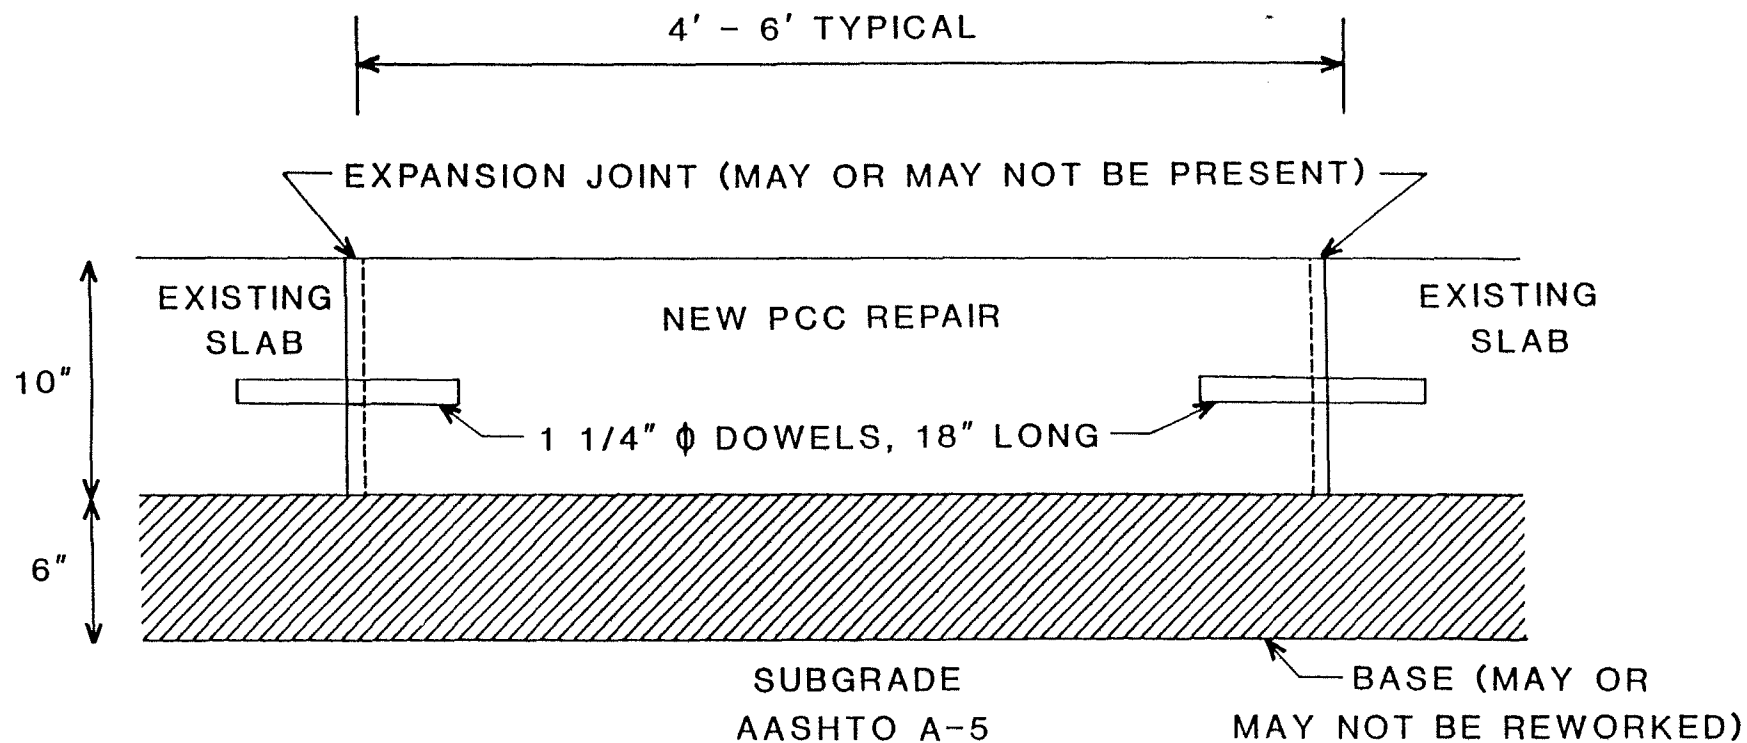
IL055098 - The original pavement was a 10-in [254 mm] JRCP with 100-ft [30.5 m] contraction joints and was constructed and opened to traffic in 1963. Full-depth repairs were placed at most joints in 1983 to address a moderate to severe "D" cracking problem. However, the following winter many of the repairs developed deep spalling and pumping due to loss of load transfer, and approximately 50% of the 1983 repairs were replaced in 1984. The 1983 repairs were typically 4 ft [1.2 m] wide and used a 3-2 dowel configuration (3 dowels in the outer wheelpath and 2 in the inner wheelpath). Dowel bars were 1.25 in [32 mm] in diameter and 18 in [457 mm] long. Several of the 1983 repairs were partial lane width. The 1984 repairs were typically 6 ft [1.8 m] wide and contained the same dowel bars and configuration as the 1983 repairs. Some 1984 repairs also incorporated a 2-in [51 mm] wide preformed cellular plastic joint filler on both the approach and leave sides of the repair. Other rehabilitation techniques applied to the pavement include pressure relief joints, cement grout undersealing, and longitudinal underdrains. The design of the full-depth repairs is shown in Figure 65.

Figure 65. Illustration of Full-Depth Repair Design Used on IL055098
[1 in = 25.4 mm].

Both sets of repairs do not always meet the acceptance criteria for smoothness, which is somewhat surprising for the short period for which they have been down. This large faulting may be due to poor load transfer at the repair joints. The loss of load transfer may be attributed to heavy truck traffic, poor support of the dowels due to a relatively large annular gap around the dowels, and inadequate grouting techniques. No difference in faulting is detected between the 1983 and 1984 repairs.

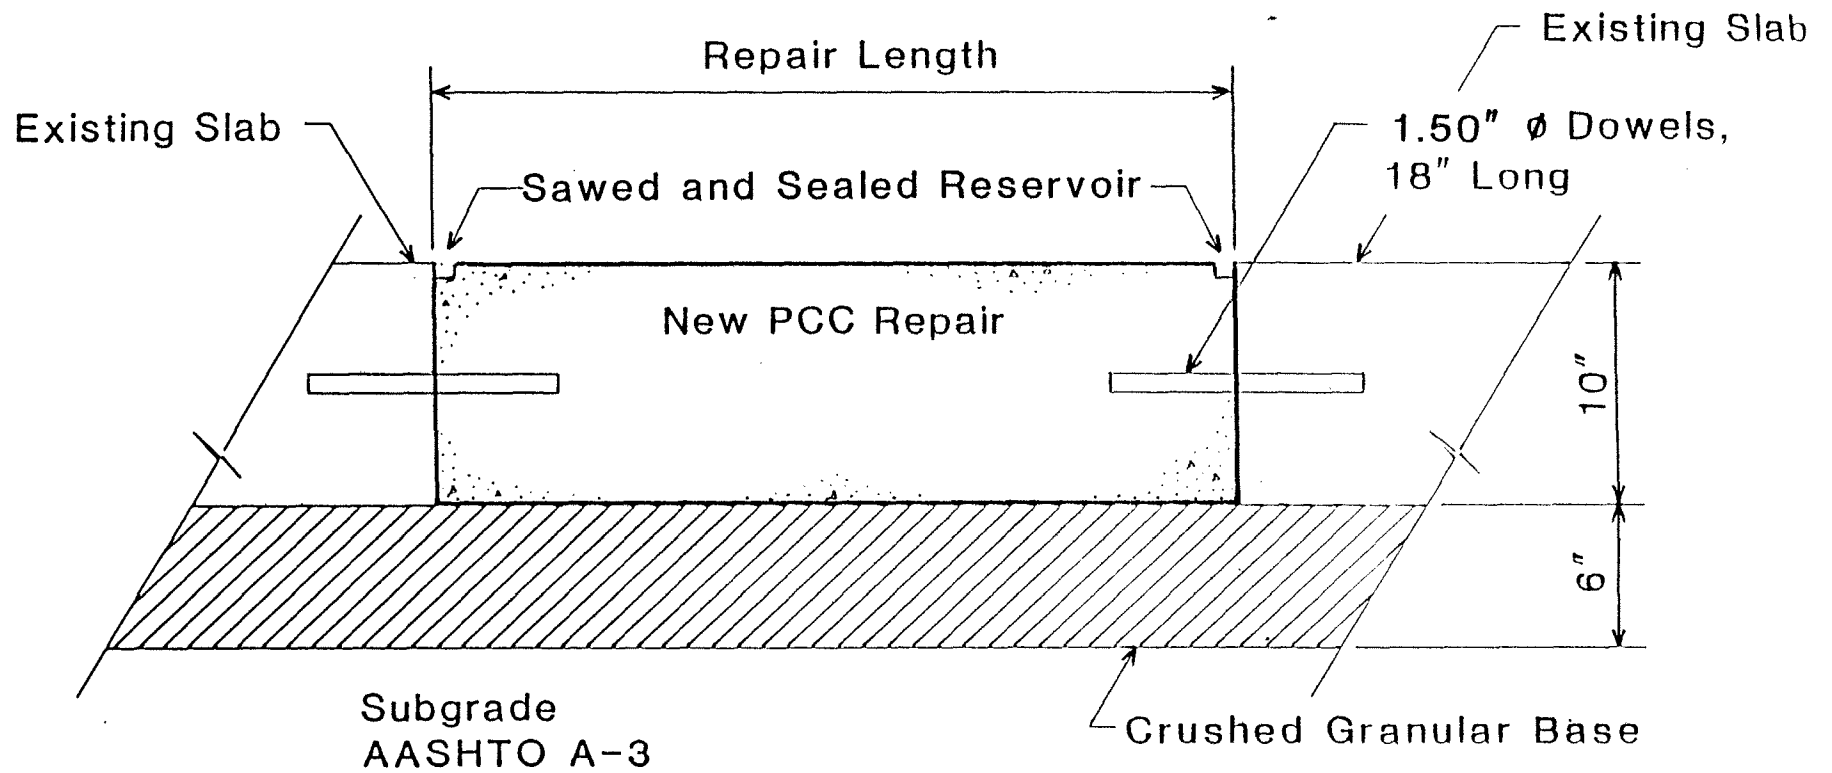
Figure 67. Illustration of Full-Depth Repair Design Used on IL280-74
[1 in = 25.4 mm].

Faulting of the repair joints was not a problem. All of the repair joints were in the smooth ride range of -0.20 in to 0.20 in [-5.1 mm to 5.1 mm], which can be attributed to diamond grinding. Repair joint faults are generally not much greater than faults at the original contraction joints, although one repair leave joint fault measured 0.14 in [3.6 mm]. Repair leave joints were commonly faulted more than repair approach joints, and the repair joints on I-280 were faulted slightly more than those on I-74 (due to there being more traffic on I-280). Although the faults are still very small, there is clearly a tendency towards tilted (approach end low) repairs, which typically accompanies pumping.

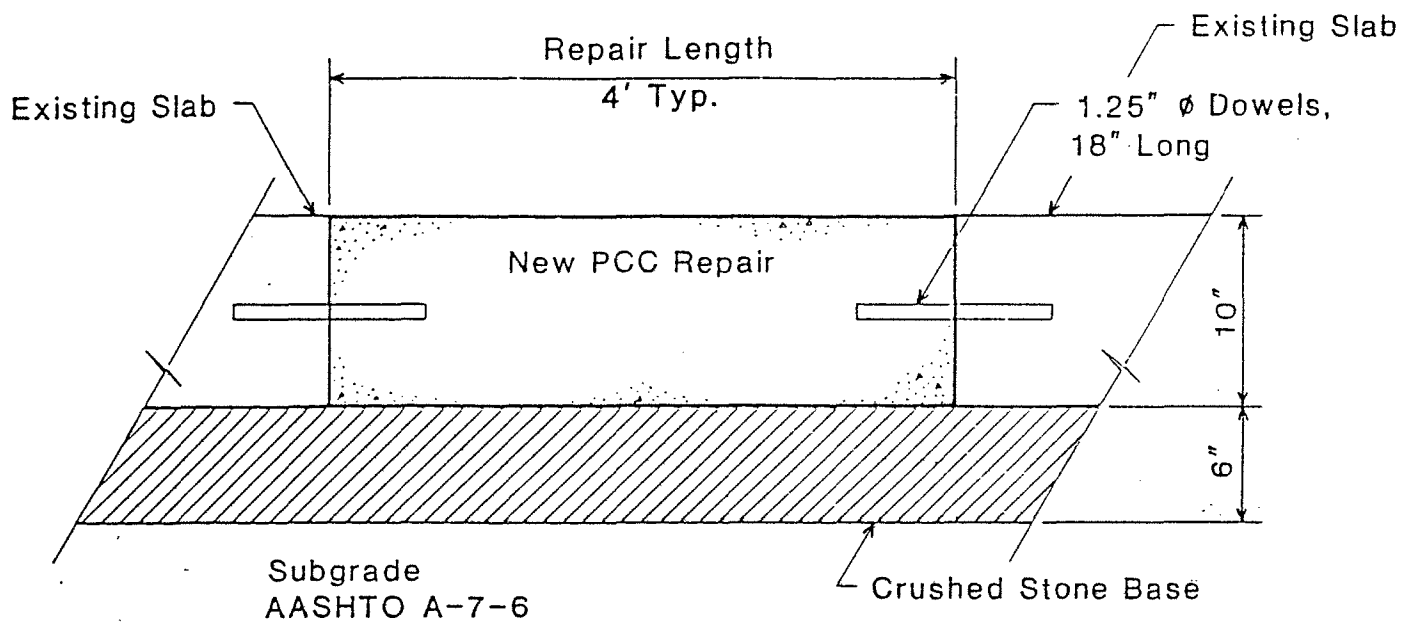
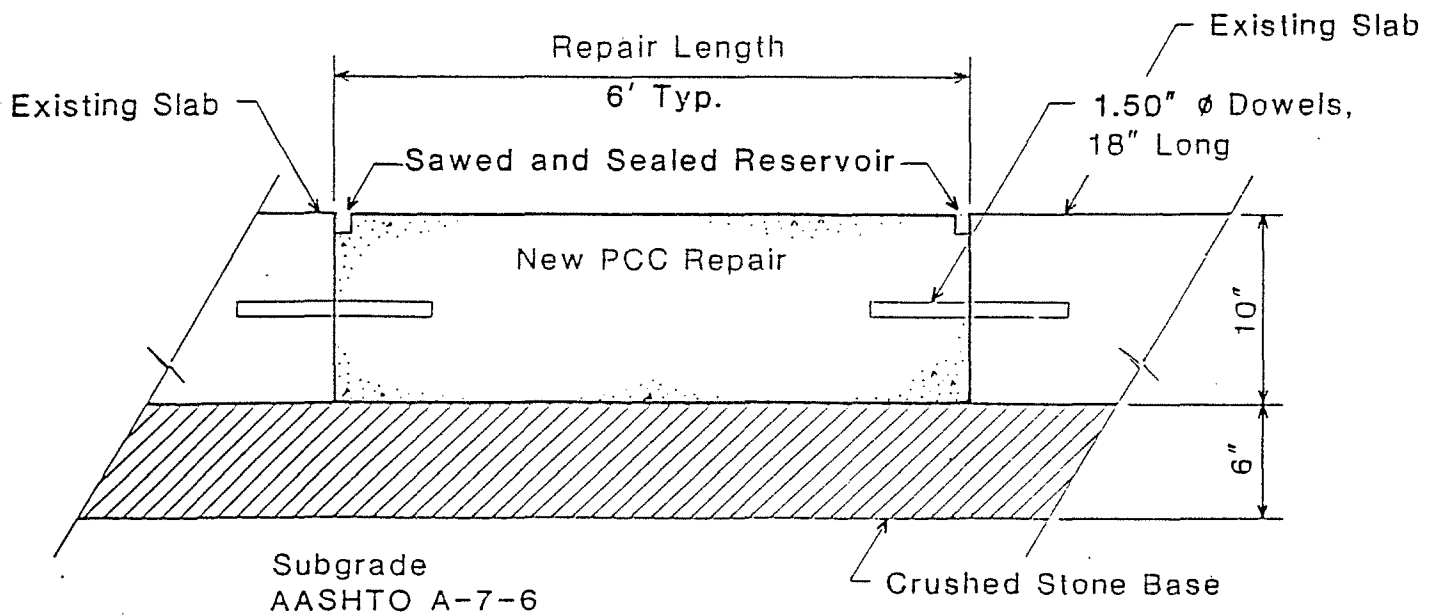
It is observed that faulting of both sets of repairs was generally within the smooth ride range, but one 1985 repair displayed an unusually high leave fault (0.46 in [12 mm]). This is an unexpected fault for such a new repair which not only contains 10 dowel bars, but dowels of 1.5 in [38 mm] diameter.

The faulting of both sets of repair joints did not seem to indicate any consistent pattern in the vertical orientation of the repair. This is probably due to the fact that the 1985 repairs have only been in place for one year and have not started to show "true" faults (from pumping). The faulting that the 1985 repairs are displaying now may have been built in during construction. The faulting of the 1985 repairs is comparable to that of the 1983 repair (which had been diamond ground).

Figure 69. Illustration of Full-Depth Repair Designs Used on IL080105
[1 in = 25.4 mm].

The 1985 repair joints had all been resawed and resealed after their placement. However, the 1983 repair had not been sealed, and both repair joints contained incompressibles and, subsequently, is spalling on the repair side of each joint. In addition, the joints were tight on this repair, as compared to an average width of 0.7 in [18 mm] for both the approach and leave joints of the 1985 repairs.
