PRESSURE RELIEF AND OTHER JOINT REHABILITATION TECHNIQUES

FINAL REPORT

February, 1987

7. Author(s) K. D. Smith, M. B. Snyder, M. I. Darter, M. J. Reiter, K. T. Hall	8. Performing Organization Report No.	
9. Performing Organization Name and Address ERES Consultants, Inc. P. O. Box 1003 Champaign, IL 61820	10. Work Unit No. (TRAIS)	11. Contract or Grant No. DTFH61-83-C-00111

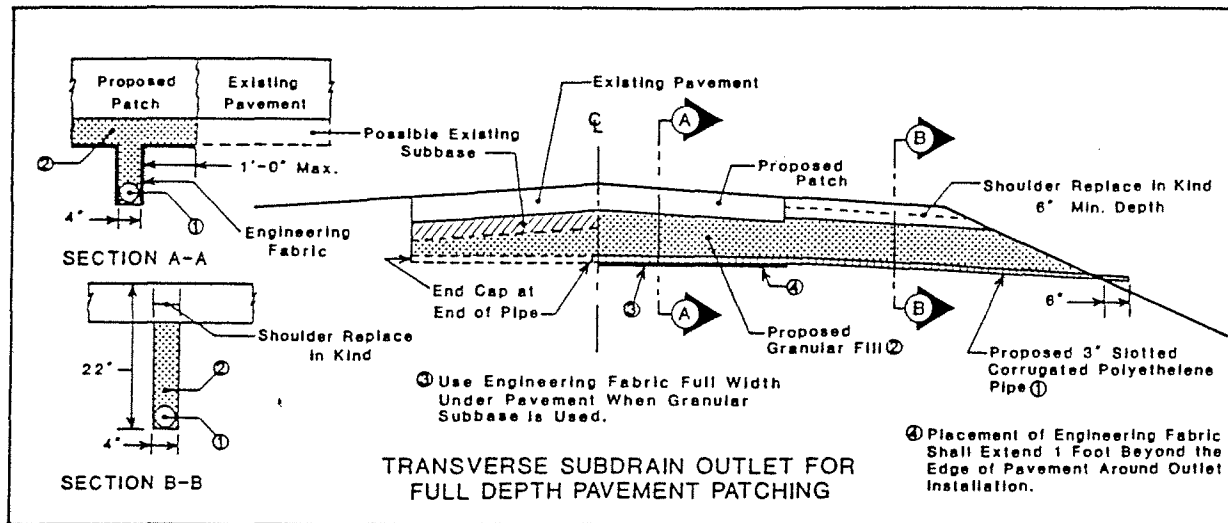
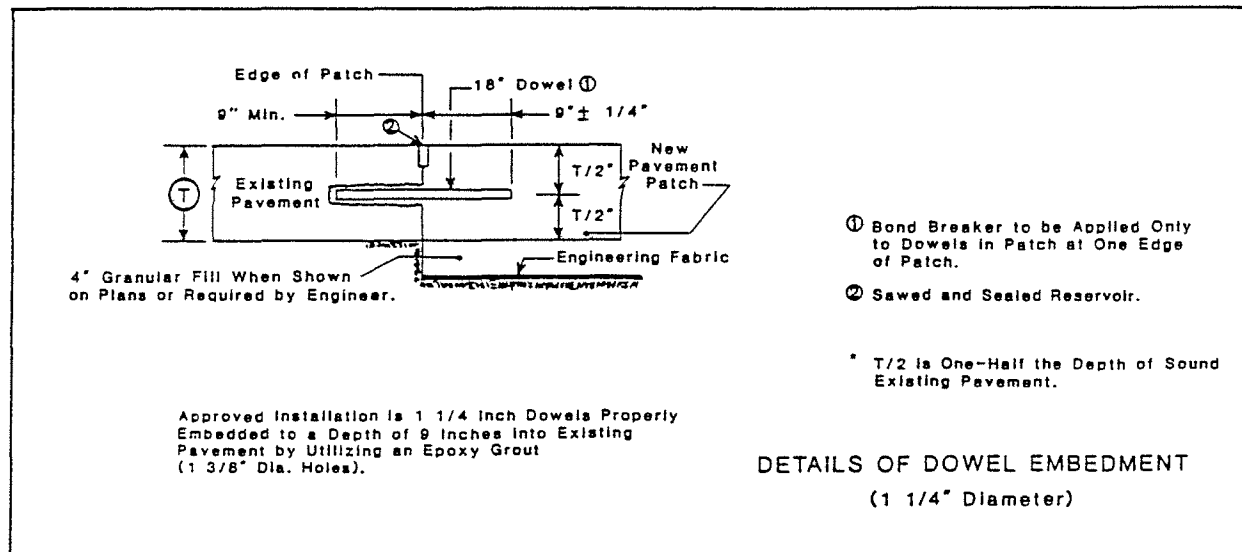
IA080288 - The original pavement was a 10-in [254 mm] JRCP with 76.5-ft [23.3 m] contraction joints and was constructed and opened to traffic in 1959. Full-depth repairs were placed in 1984, along with cement grout undersealing and diamond grinding. Only two full-depth repairs were surveyed. They contained 1.25-in [32 mm] diameter, 18-in [457 mm] long dowels (placed on 12-in [305 mm] centers), a fabric interlayer, transverse underdrains, and a drainable granular base. The joint was sawed and sealed after concrete placement. The repair design is shown in Figure 70.

Figure 70. Illustration of Full-Depth Repair Design Used on IA080288
[1 in = 25.4 mm].

Faulting of the repairs is not a problem, as all measurements are well within acceptable limits. However, repair joint faulting is nearly double that of the original contraction joints after grinding. This particular project has historically exhibited a large degree of pumping.

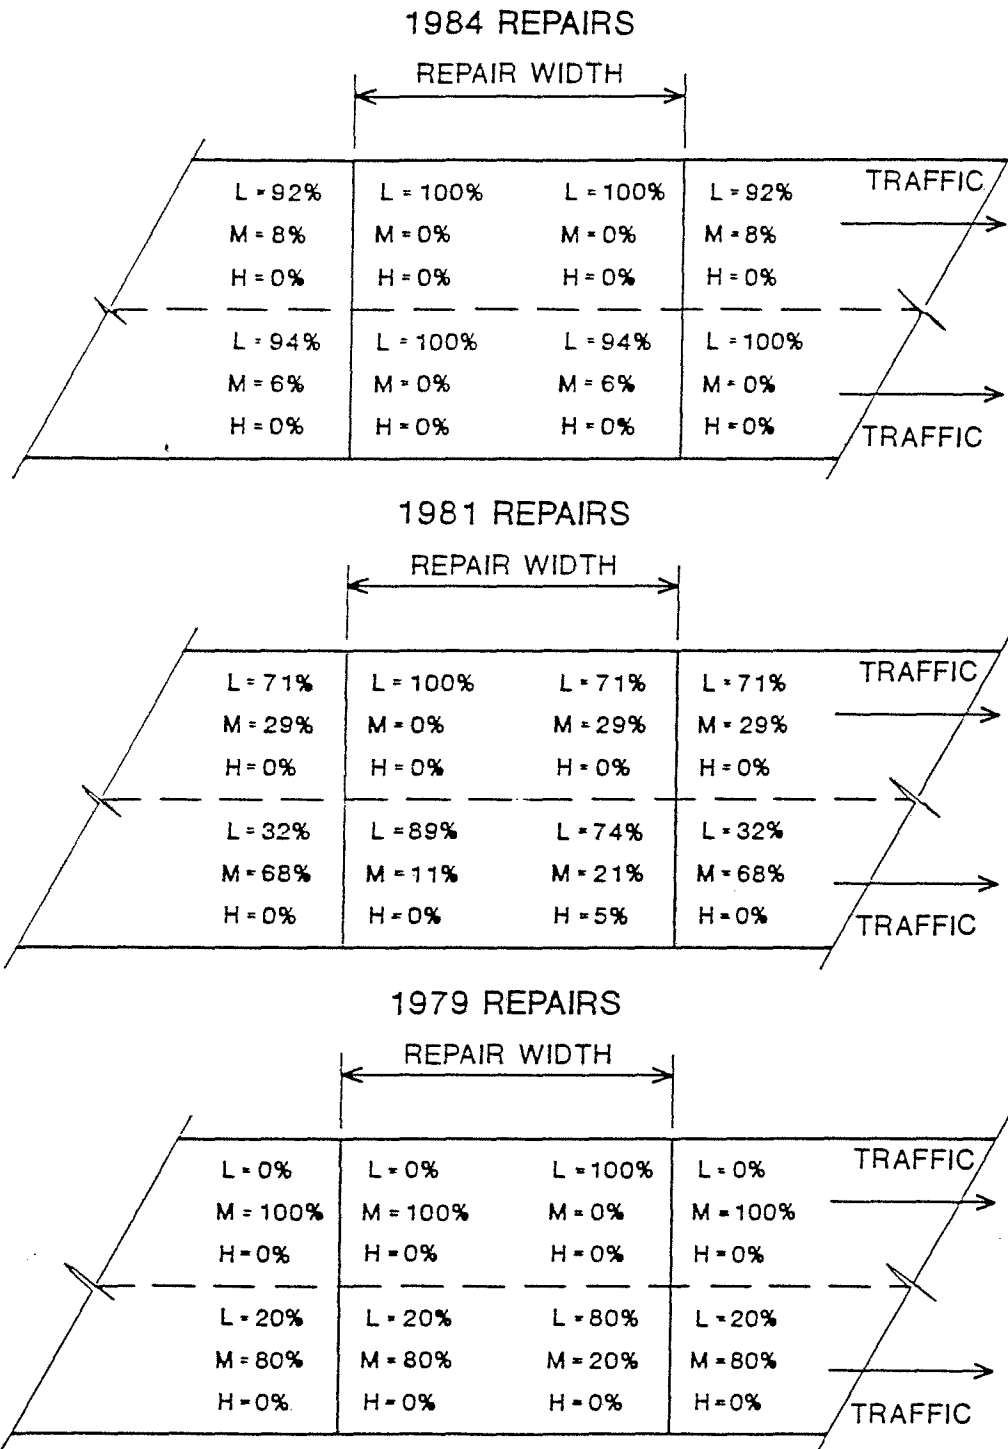
NOTE: All undamaged joints and all joints with low severity spalling were rated as low severity.

Figure 71. Summary of Spalling at Repair Locations on IA035086.

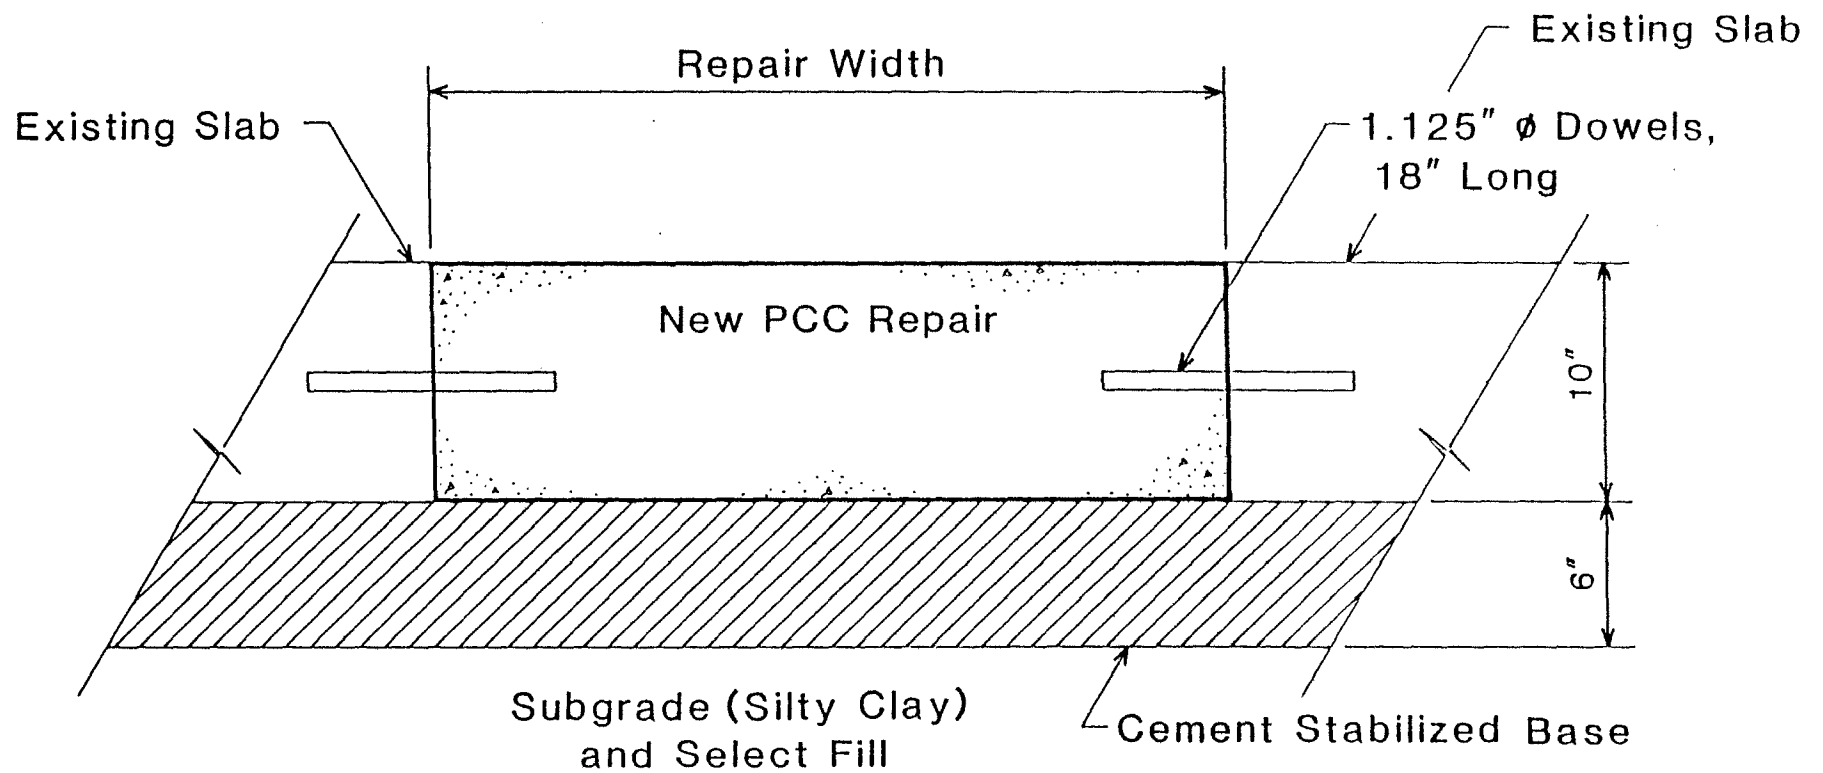
Faulting of repair joints where the dowels were epoxyed is similar to that of the regular contraction joints that were ground in 1984. However, the faulting of the one repair without epoxyed dowels was larger than the others. The full-depth repair with the "unconventional" dowel spacing and epoxyed dowels exhibited the same magnitude of faulting as those with the conventional 12 in [305 mm] dowel spacing. It is interesting that the conventionally spaced, epoxyed dowel repairs displayed visible signs of pumping, while the repair with the highest observed faults (conventional unepoxyed) did not.

Most of the full-depth repair joints are performing well. Joint widths ranged from 0.6 in to 1.0 in [15 mm to 25 mm]. The sealant was still intact and no incompressibles were present in the joint. Where spalling was observed it was generally of low severity.

Figure 72. Illustration of Full-Depth Repair Design Used on LA010151
[1 in = 25.4 mm].

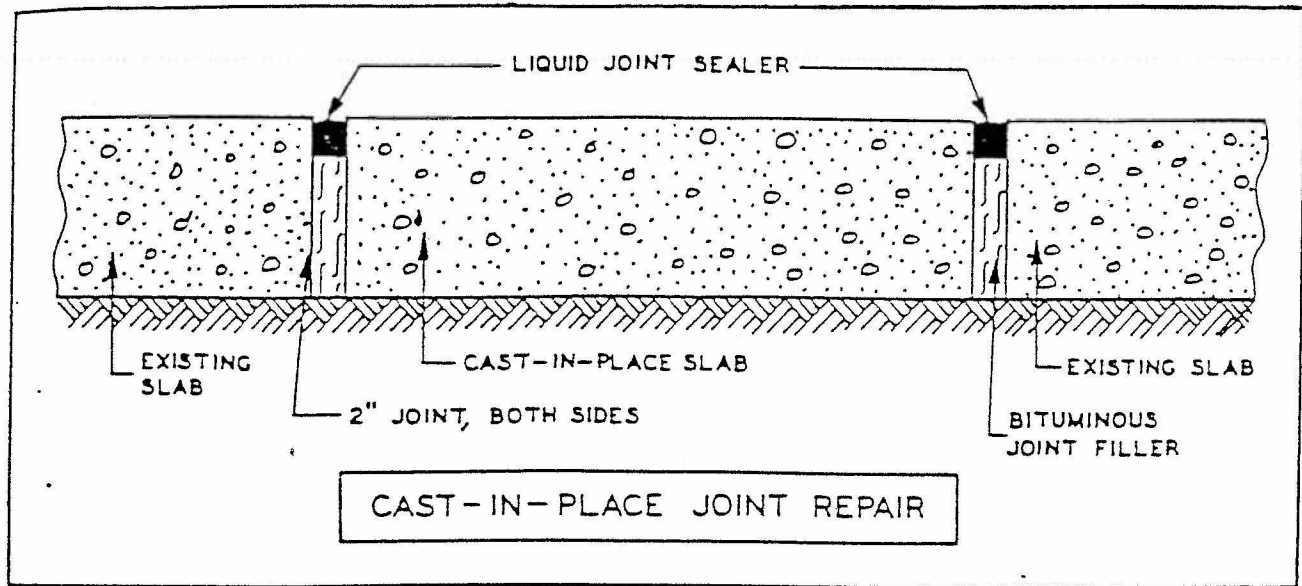
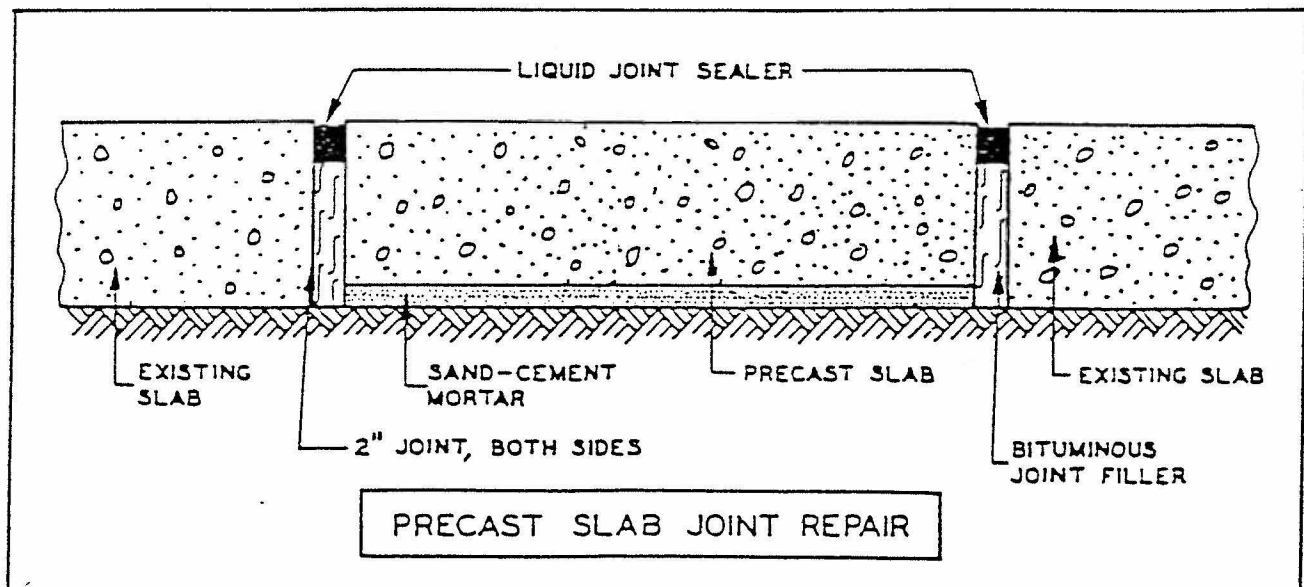
Figure 74. Illustration of Full-Depth Repair Designs
Used on MI127 (115) [1 in = 25.4 mm].

Only three full-depth repairs were surveyed: two cast-in-place repairs constructed in 1972 and one constructed in 1979. All of the surveyed repairs (and most of the other repairs observed) are structurally adequate but severely faulted, especially across the leave joint. The average

measured repair faulting in the outer lane was 0.20 in [5.0 mm] for the approach joint and 0.51 in [13 mm] for the leave joint. Medium-severity pumping was also observed at the 1979 repair. No significant difference in repair performance (i.e., faulting, spalling and slab cracking) was detected between the 1972 and 1979 repairs.

Excessive faulting of the repair joints remains the major problem of the repairs. It is apparent that a considerable amount water is entering the pavement through the deteriorated cracks, granular shoulder and unsealed transverse joints. There are no drains to remove this water and the fine-grained subgrade retains the moisture well enough to produce substantial pumping under relatively low traffic levels. The use of dowels or other mechanical load transfer devices together with the installation of drains to remove the moisture from the sand subbase would almost certainly have improved the performance of these repairs.

It is also likely that the use of repair expansion joints in the vicinity of the pressure relief joints contributed to excessive opening and deterioration of the transverse cracks in the adjacent slabs. Since compressive stress was probably relieved to some extent by the construction of the repairs, it is likely that the relief joints were not necessary.

Suggested improvements to the repair and relief joint designs include:

1. Provision of load transfer across all joints.
2. narrower expansion joints to prevent excessive movement of adjacent joints and cracks.
3. Greater separation between relief joints and concurrently placed full-depth repairs.

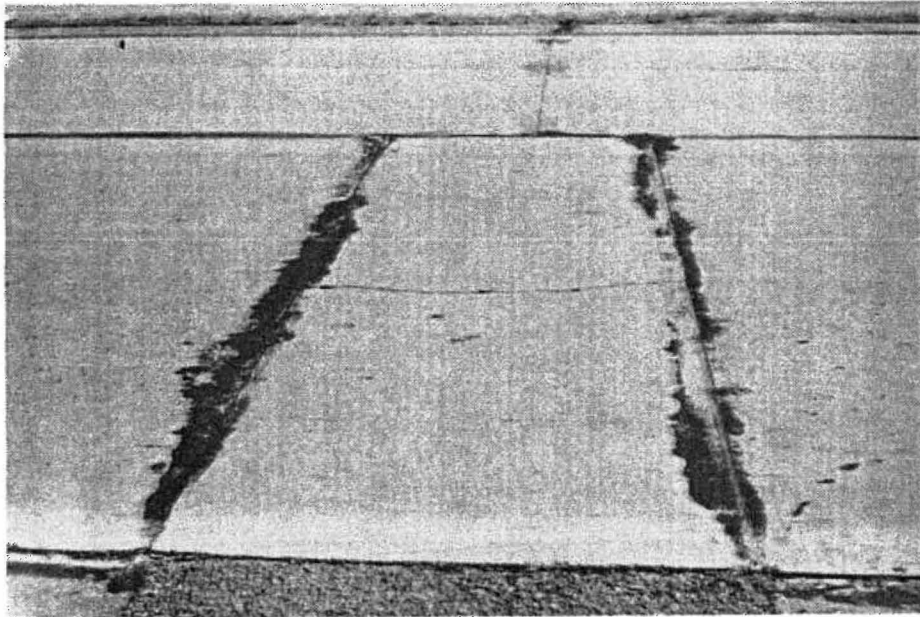
Figure 76. Photo of Typical Full-Depth Repair on NE080189.

Thirty percent of the repairs exhibited low-severity longitudinal slab cracking (see Figure 76). This may be due to either a mechanism similar to the edge punchout in CRCP, or to placement of the repairs in the morning, after which the heat of the afternoon causes the original pavement slabs to expand and crush the new repair. Longer repairs lengths, coupled with late afternoon placement, might eliminate this problem.

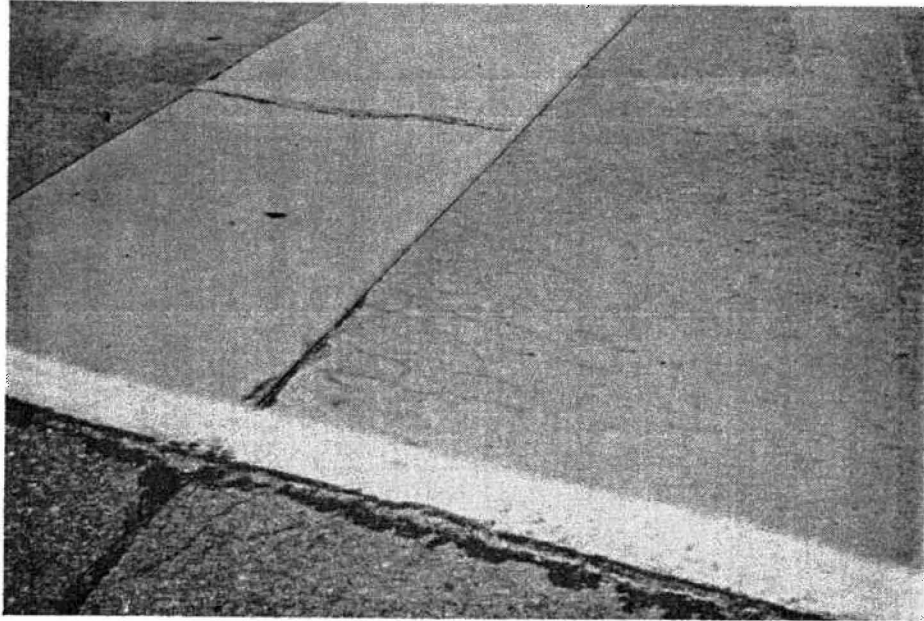
Figure 77. Photo of Full-Depth Repair and Reactive Aggregate Distress on NE080210.

Nearly half of the repairs surveyed exhibited low- and medium-severity longitudinal cracking (see Figure 77). These cracks nearly always occurred at the center of the lane and may be caused either by a mechanism similar to the development of edge punchouts in CRCP, or placement of the repairs in the morning such that the heat of the afternoon caused the original concrete slabs to expand and crush the newly placed repair. Longer repair lengths, coupled with late afternoon placement, may eliminate this problem.

The major problem with this pavement is the expansion of reactive aggregate, which is the primary cause for the joint spalling. There is little that can be done now to deal with this problem directly, other than full-depth repairs when needed.

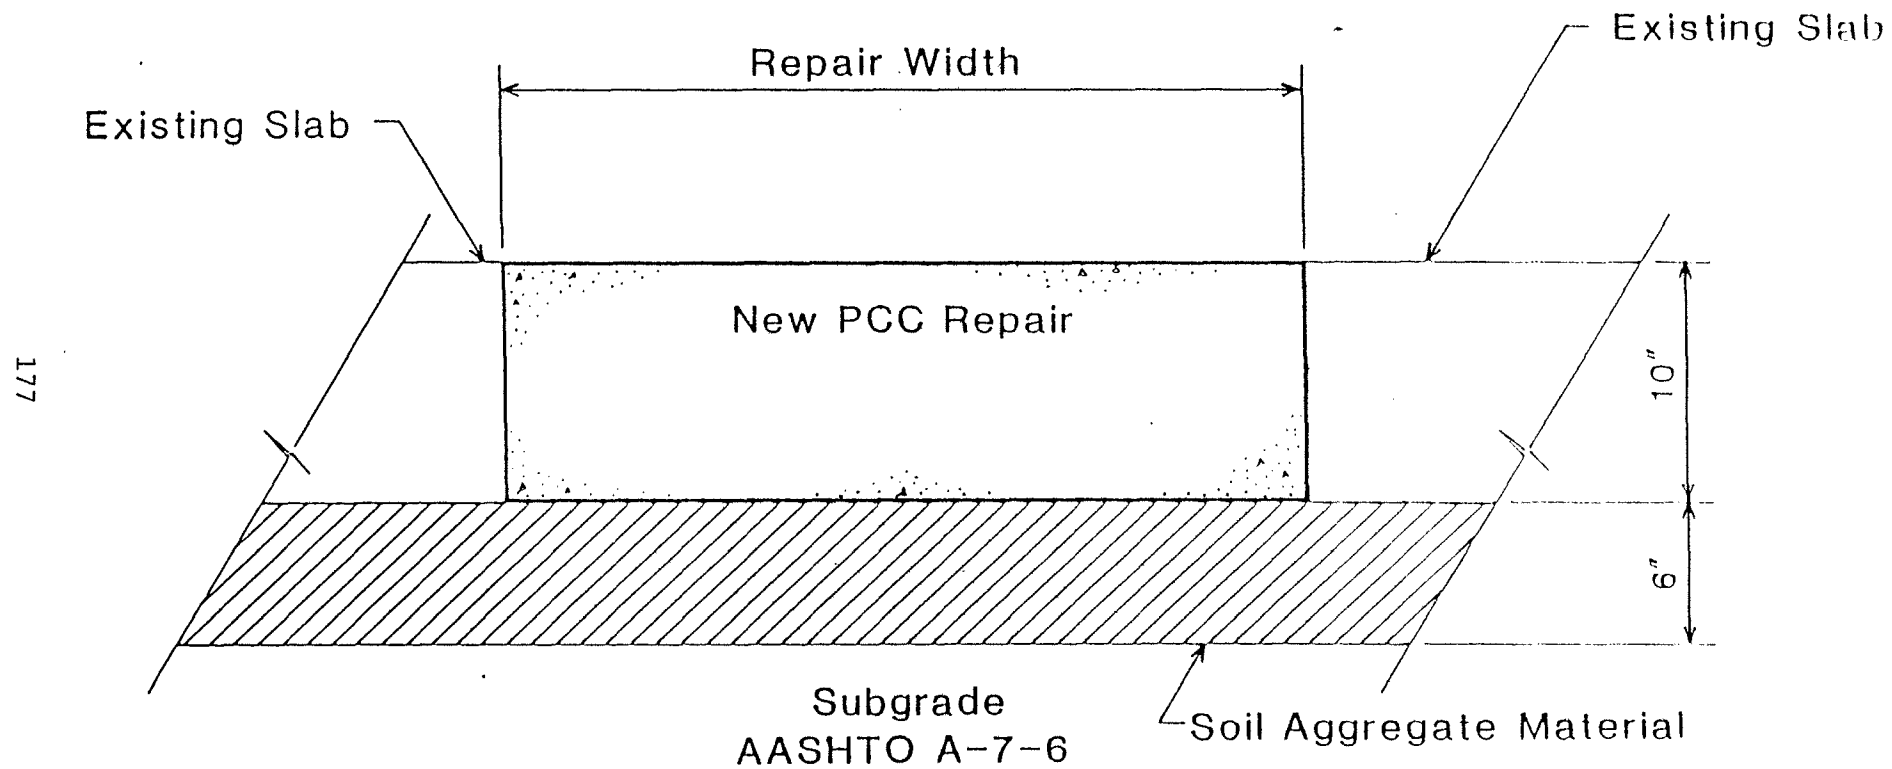
Figure 81. Illustration of Full-Depth Repair Design Used on NE080404
[1 in = 25.4 mm].

The original contraction joints have faulted significantly under heavy traffic and the repair joints are also displaying very high faults (despite having been in service only one year). This large repair joint faulting may be attributed to the lack of dowel bars in the full-depth repair design and the fine-grained subgrade present. Additionally, the repair leave joints consistently display higher faults than the repair approach joints.

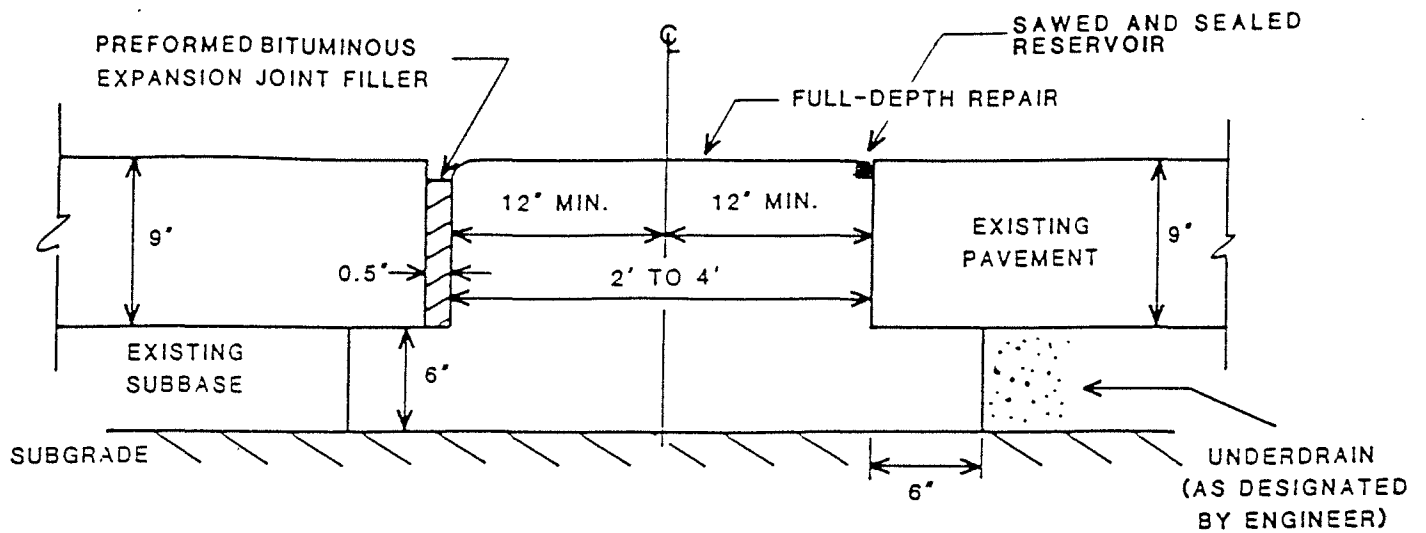
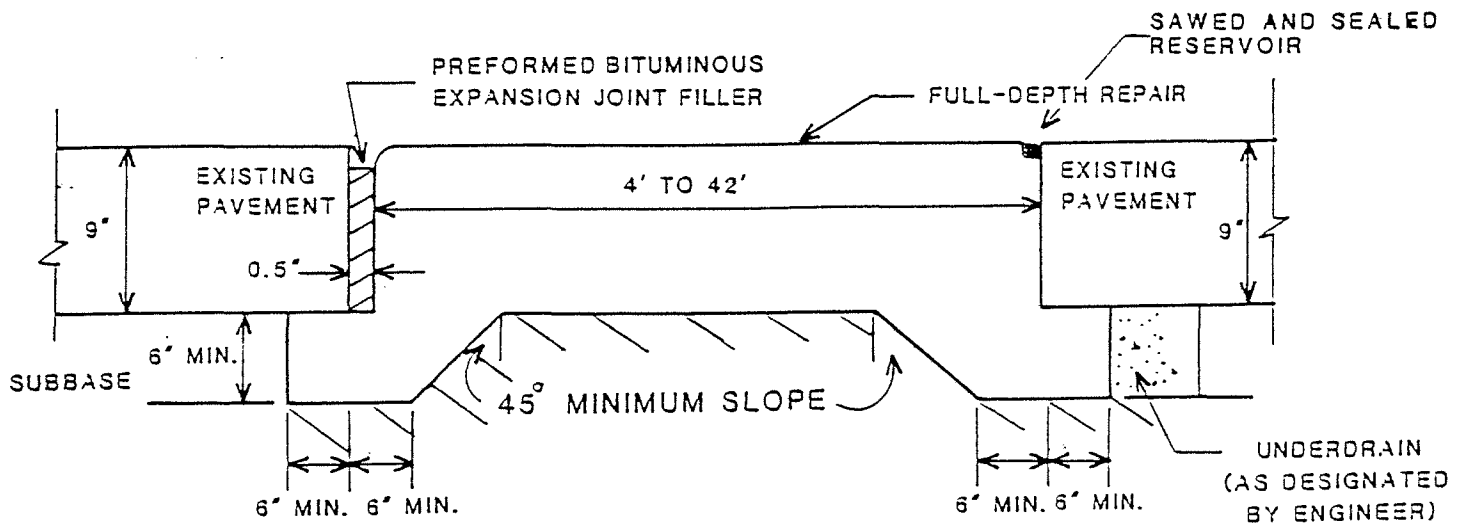
Figure 90. Illustration of Full-Depth Repair Designs Used on VA081147 [1 in = 25.4 mm].

There appear to be nearly equal numbers of raised and approach-end-low repairs, but even the raised repairs are faulted more at the leave joint, which implies that pumping is taking place in spite of the undersealing that was performed in the vicinity of the repairs. Faulting measurements for the repair joints were always within acceptable limits and did not vary appreciably with repair load transfer design. The repair leave joints display particularly high faults, considering that they have only been in service for 1 year (sustaining 0.8 and 0.2 million ESALs in the outer and inner lanes, respectively), probably due to the absence of dowels in most of the repairs.

The shear devices used in one repair have failed in shear and tension along the bond between the matrix and the existing slab. The dowels in slots appear to be intact.

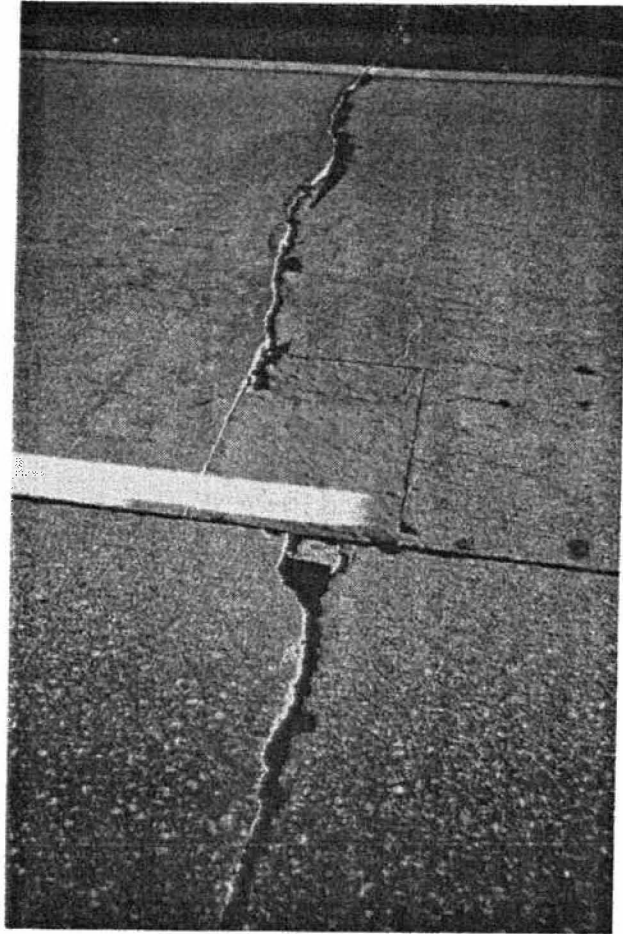
Figure 95. Photo of Partial-Depth Repair at Major Crack on NE080279.

Full-depth repairs would probably have been more appropriate for working cracks on this project (see Figure 95). Replacement of the partial-depth repairs with full-depth repairs could be performed in conjunction with other rehabilitation work which is required on this pavement in the near future.
