DOT/FAA/CT-82-118

Crash Injury Protection In Survivable Air Transport Accidents-U.S. Civil Aircraft Experience From 1970 To 1978

March 1983

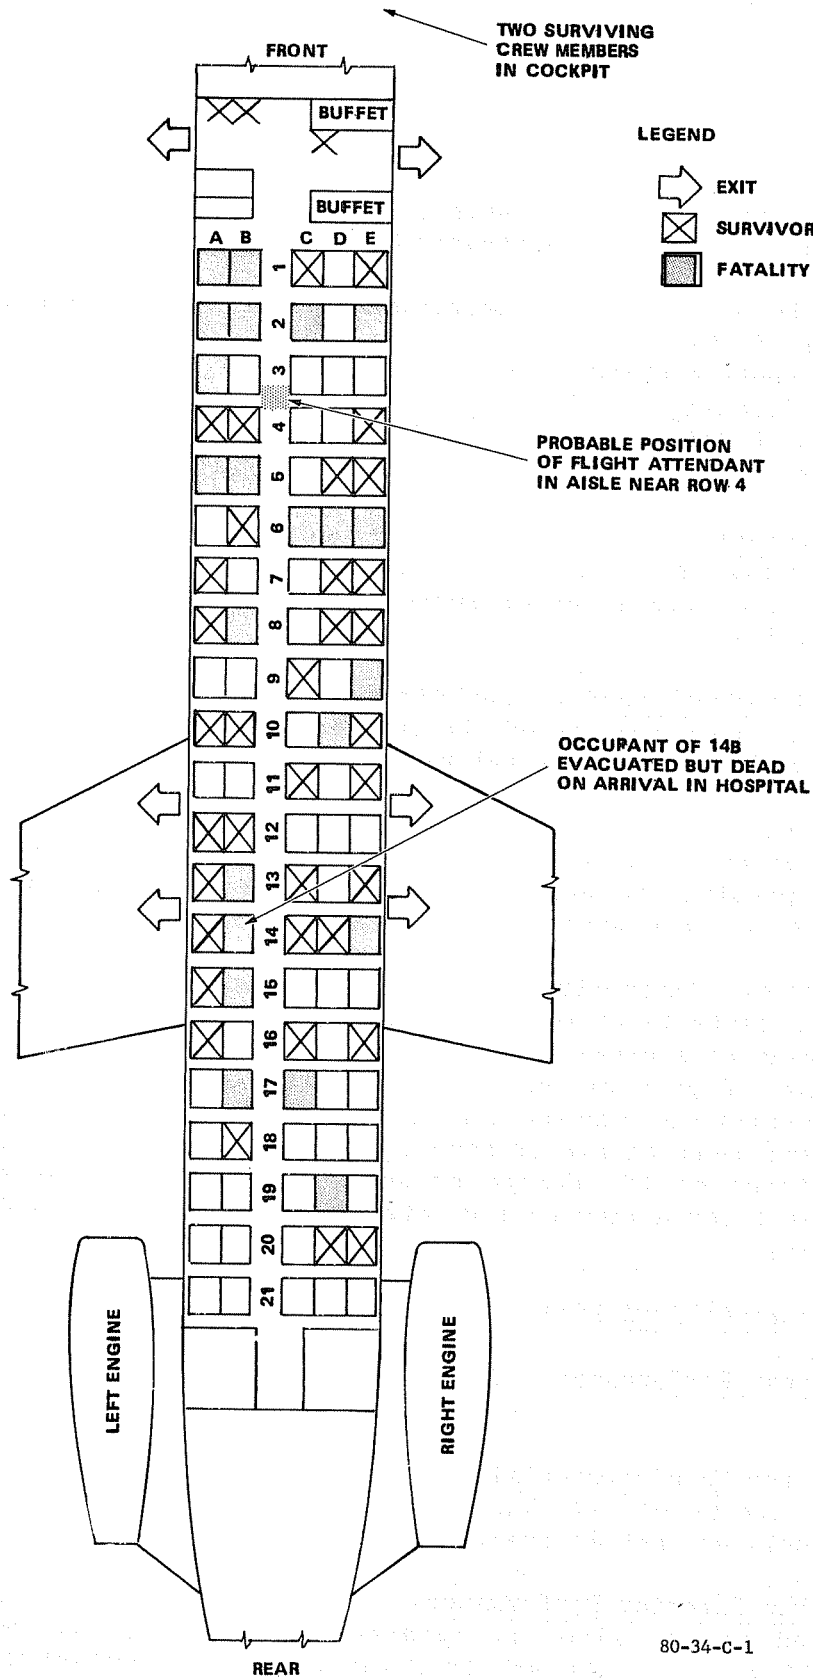
FIGURE C-1. ANTILLIAANSE LUCHTVAART MATT SCHAPPIJ DC-9-33, N935F SEATING DIAGRAM, INCLUDING SEAT LOCATIONS OF INJURED/FATALITIES AND EVACUATION ROUTES

Pax Restraint System Performance. Seven instances of seatbelt failures were reported.

Miscellaneous Cabin Interior Performance. Contents of the forward-facing galley unit were spilled on the floor at impact. This galley had been secured, and according to NTSB reports, the spillage was due to failure of the locking mechanisms. The cockpit door jammed.

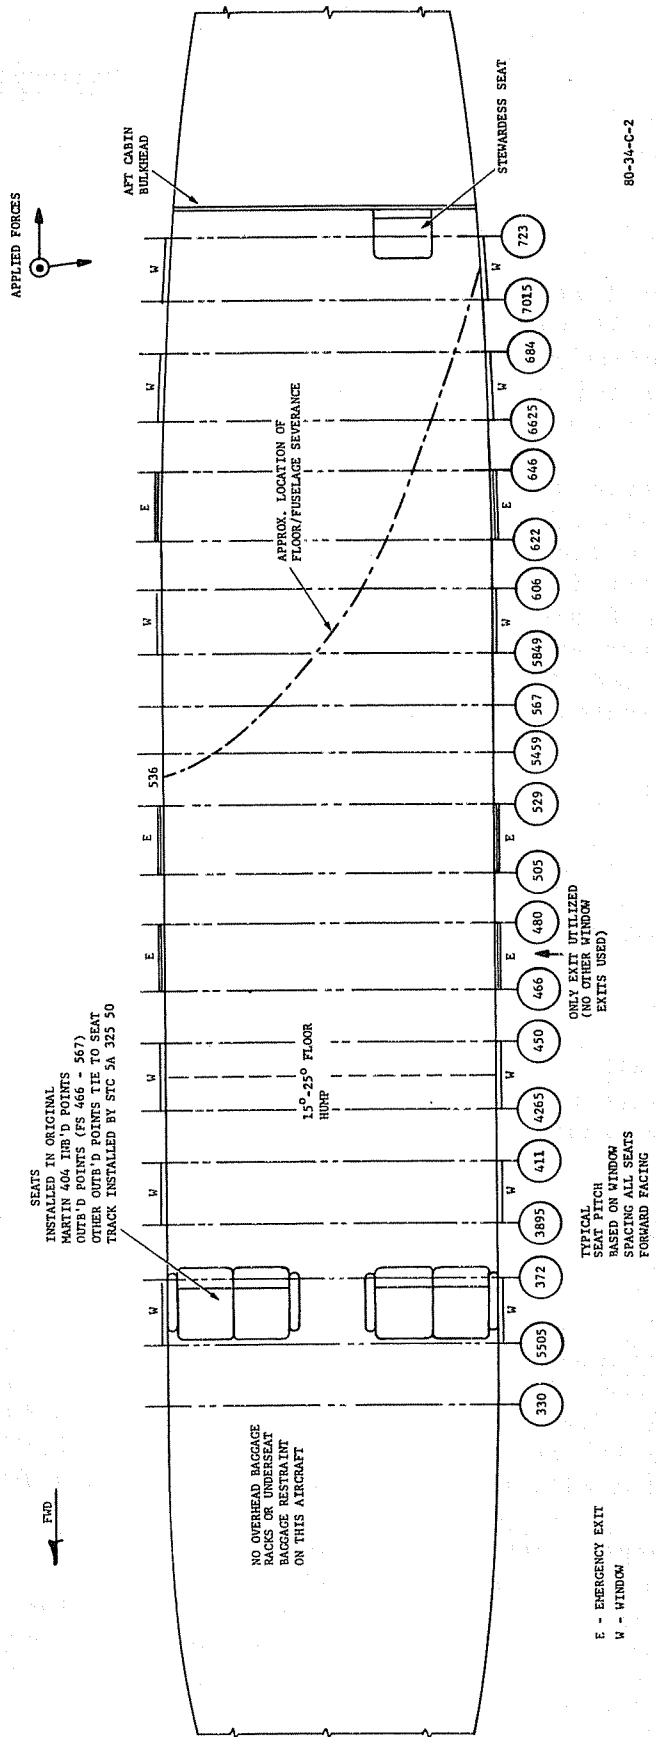
FIGURE C-2. LEHIGH ACRES DEVELOPMENT, INC., MARTIN 404, N40412 AIRFRAME DAMAGE (SCHEMATIC VIEW)

Airframe Deformation/Crash Loads. The fuselage was separated on a diagonal between fuselage stations (FS) 536 and 701. (The fuselage is presented schematically in figure C-2 and pictorially in figure C-3.) In addition, the fuselage was deformed vertically at an approximate 15° angle in the vicinity of FS 430. The major forces to the aircraft occurred in the aft, up, and from the right direction.

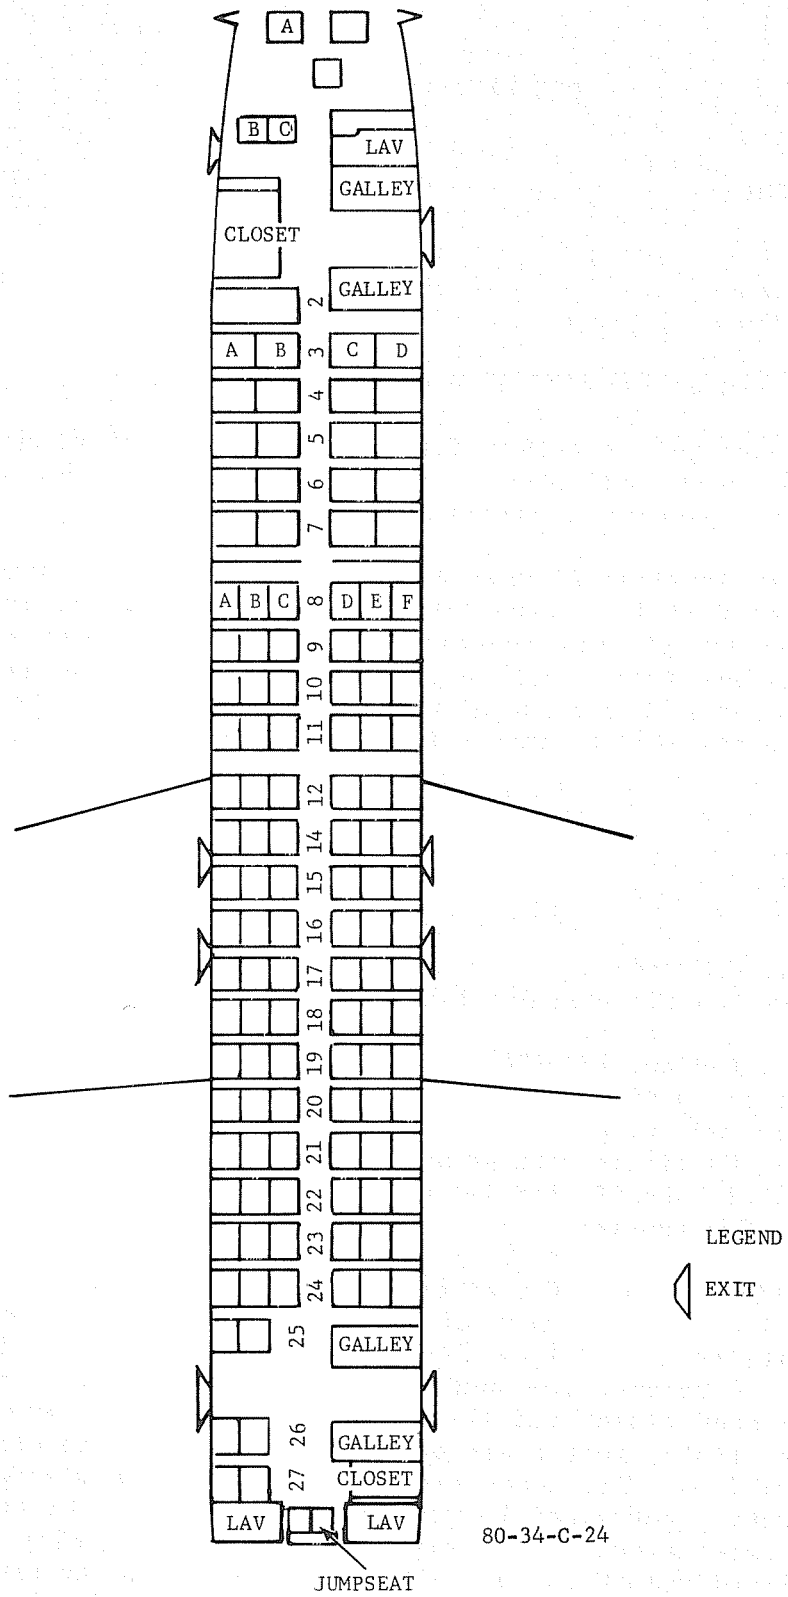
FIGURE C-25. CONTINENTAL AIRLINES, INC., BOEING 727-224, N88777 SEATING CONFIGURATION

Airframe Deformation/Crash Loads. The aircraft fuselage split at approximately FS 279 on the right side and just aft of the production joint at approximately FS 390 on the left side. This portion of the fuselage structure from FS 178 aft to FS 360

sustained severe ground impact damage in a generally aft direction. The fuselage was also split open from the crown area to the external lower portion of the fuselage near FS 390. Numerous wrinkles were in evidence. The cabin floor section in the immediate area of FS 380 had buckled and caved in at the coat closet front attachment joints. The cabin floor tracks were fractured at a point about 14 inches aft of the coat closet rear attachment points. The forward galley remained intact and attached to the floor structure. However, this section of the cabin floor had collapsed toward the center aisle. The floor beams from FS 360 to FS 460 were severely damaged. The fuselage was also separated at about FS 1050 on the right side around to FS 1100 on the left side (figure C-26). The floor beams at FS 950 were fractured (figure C-27).

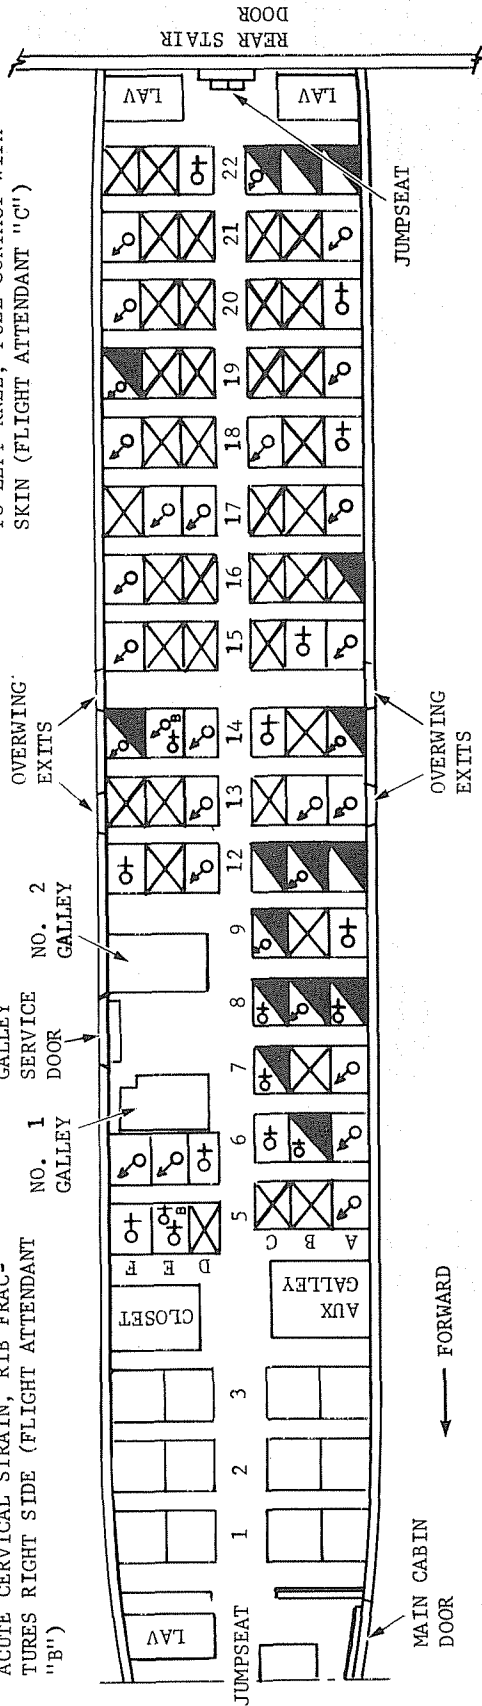
FIGURE C-34. N124AS SEAT FAILURE AND INJURY DATA

Pax Seat Performance. Although fire consumed most of the seats, passenger and flight attendant reports indicated that 16 seats failed, 9 of which were on the left side — rows 6 through 9 (figure C-34). Some passenger seat legs showed evidence of compressive buckling, indicating loads primarily in the downward direction with minimal forward deceleration.

NOTE: Passenger injuries included spinal, leg, and rib fractures, lacerations, contusions, and abrasions. The fatally injured passenger died of impact trauma. Description of injuries are included in figure C-34.

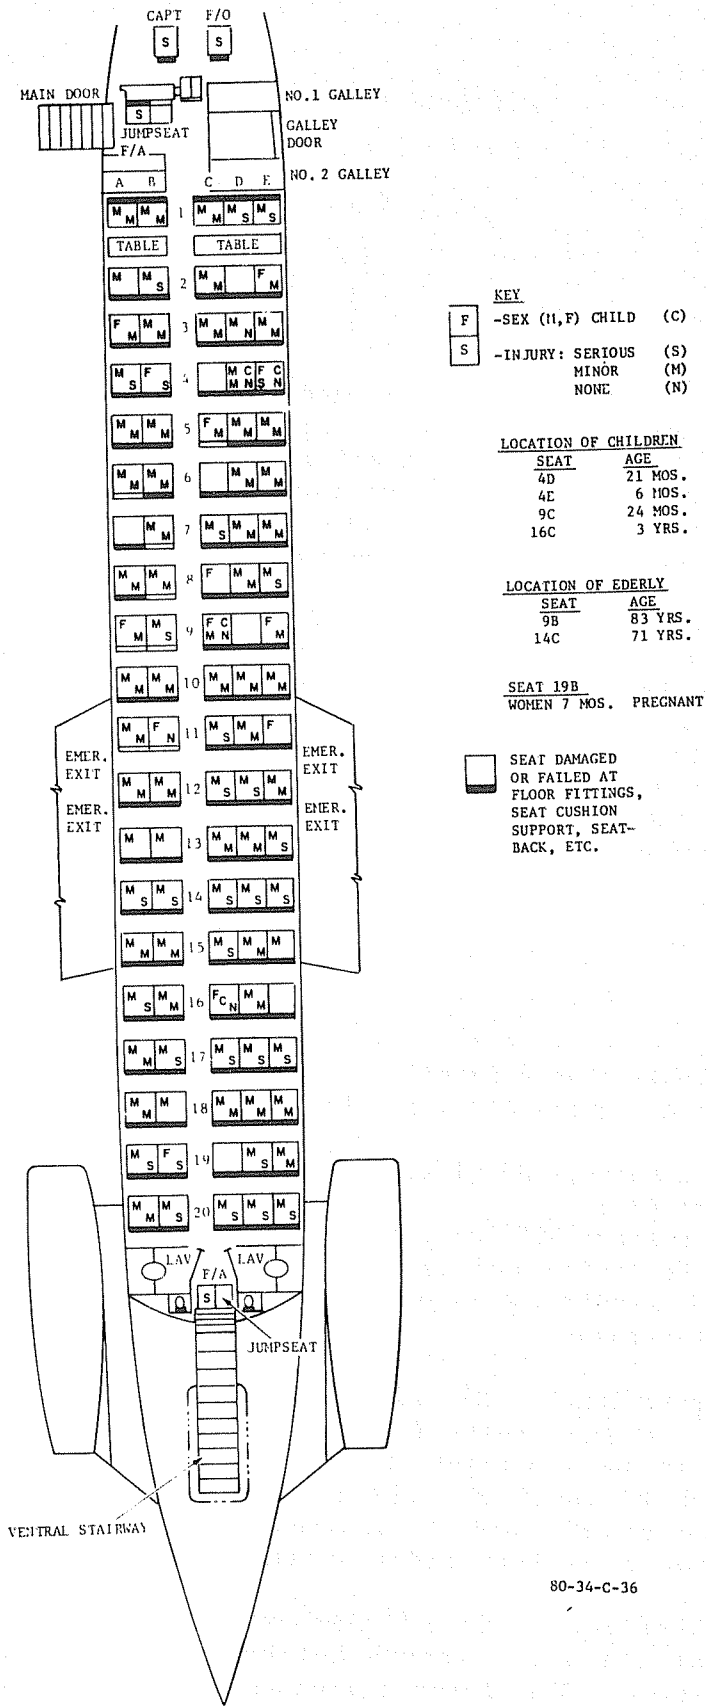
FIGURE C-38. ALLEGHENY AIRLINES, INC., DC-9-31, N994VJ SEATING DIAGRAM INCLUDING INJURIES AND SEAT FAILURES

Pax Seat Performance. At impact most seats failed, which caused passengers to be thrown into adjacent seats and pinned some passengers between seats, between the floor and seats, and between seats and side walls. Only 8 of 100 passenger seats were undamaged. Typical damage included compression buckling of seat legs, separated floor fittings, separated lateral support tubes, and torn and separated seatbottom fabric supports. Each passenger seat was examined and the damage describe as follows:
