***Optimum Locations for the Benefits of Green  
Infrastructure (GI) on the NMDOT Transportation  
System  
May 2025***

*Prepared for:  
New Mexico Department of Transportation  
Albuquerque, NM*

*Prepared by:  
GeoSystems Analysis, Inc.  
8601 Paseo Alameda NE; Suite B  
Albuquerque, NM 87113*

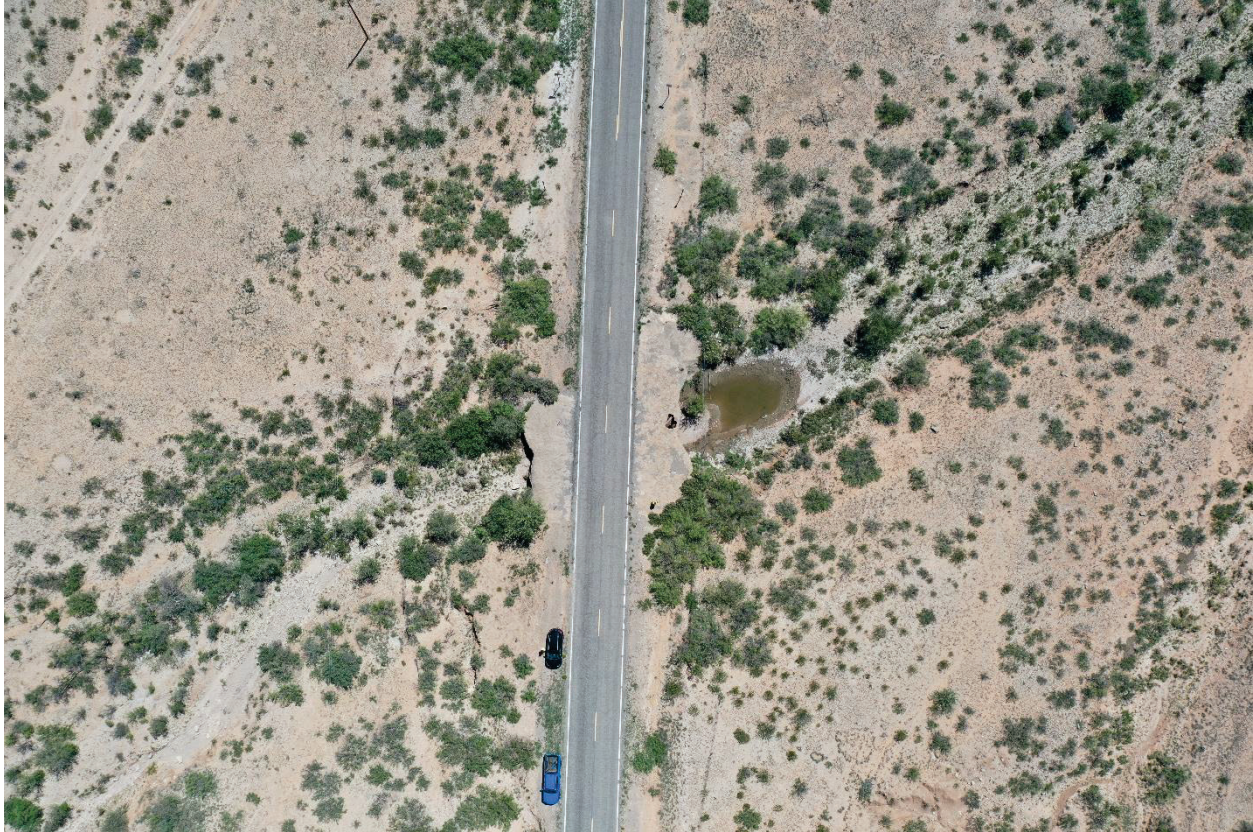
*Figure 4 - An example of the utility of drone photography in site characterization.*

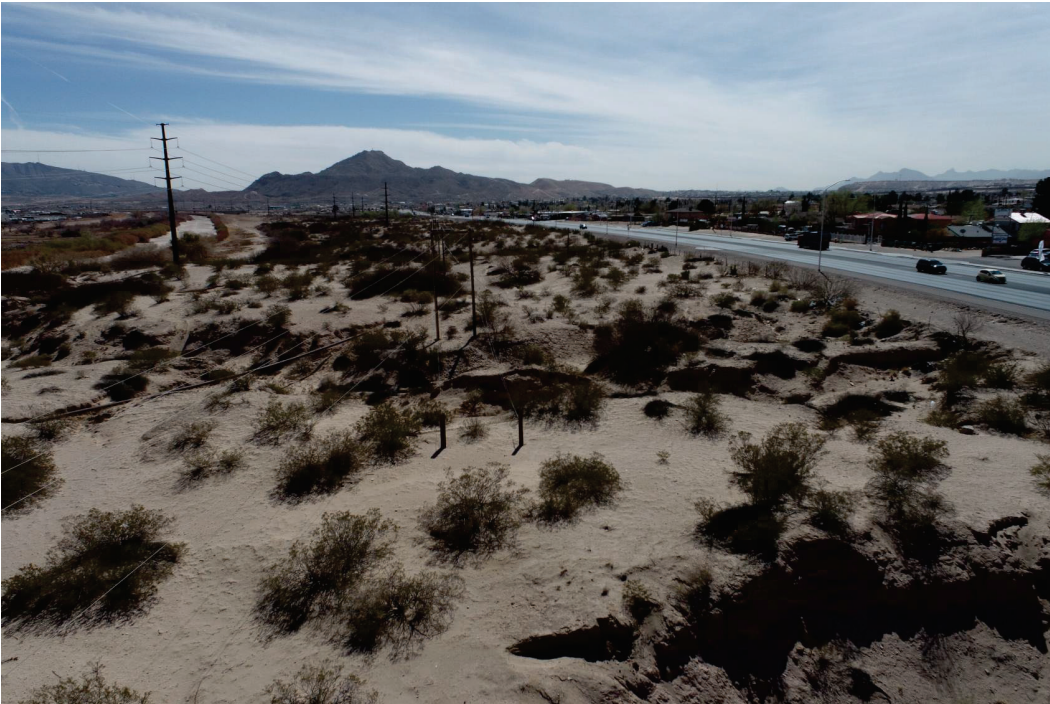
Observation ID: S1\_Ob1

This site, assessed at two observation points, exhibits significant erosion driven by inadequate drainage infrastructure and lack of flow control measures. Comprehensive erosion control and drainage improvements are needed to stabilize this area and prevent continued degradation. Severe surface erosion at this site is likely due to insufficient culvert capacity and absence of energy dissipation structures. Existing basin may be undersized to effectively capture runoff. Additionally, fencing is broken or missing, though no immediate wildlife presence was observed.

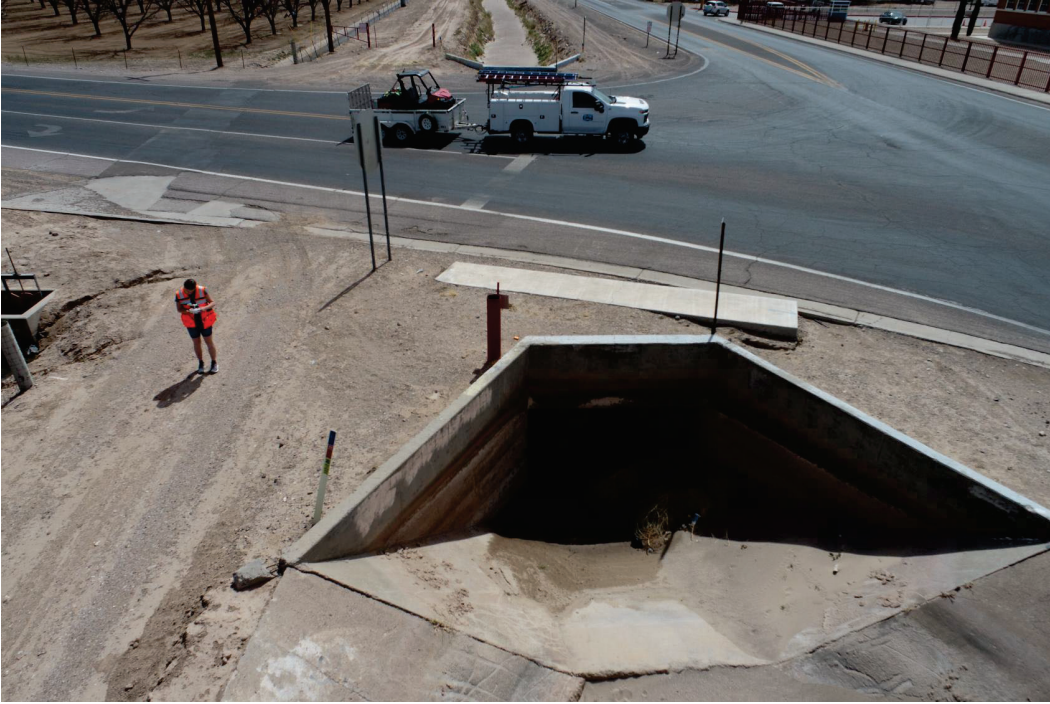
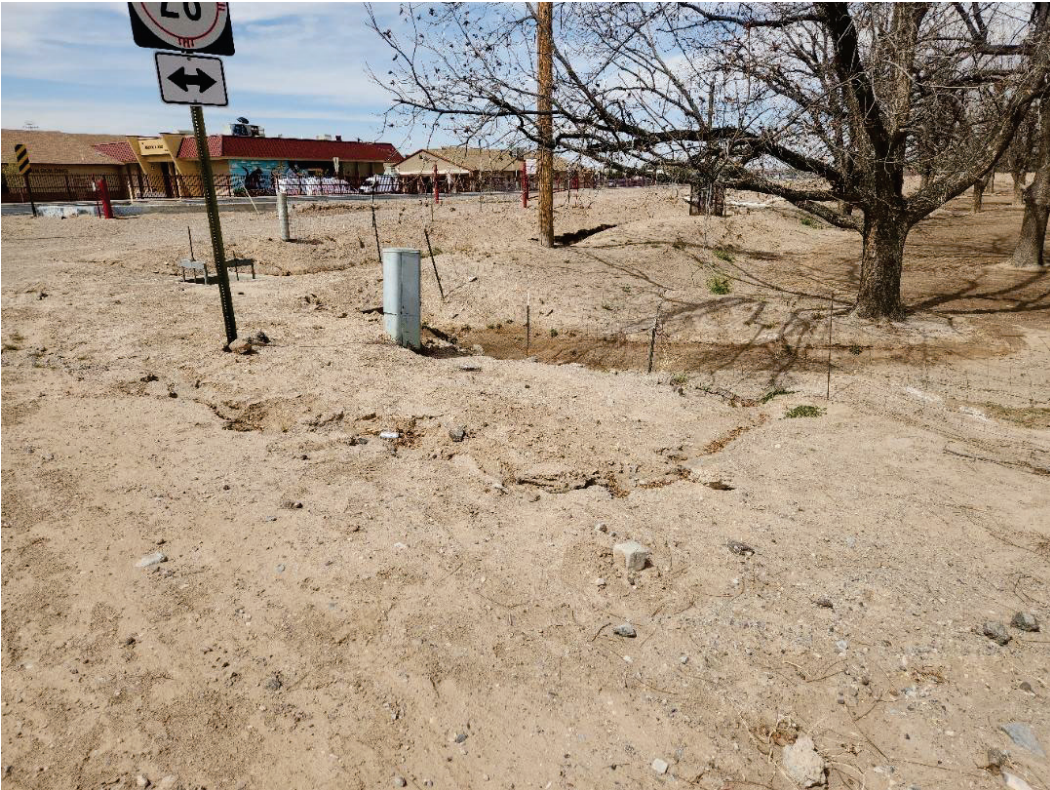
Observation ID: S2\_Ob1

At this site, drainage beneath the roadway is obstructed by tumbleweeds, leading to minor rill formation and ponding due to slope-driven flow accumulation. Targeted drainage improvements and strategic vegetation could mitigate ponding, reduce erosion, and enhance long-term site resilience. At this site, clogged drainage structures reduce flow capacity and contribute to surface water buildup while water flows toward and alongside the roadway, increasing the risk of surface degradation. Minor rill erosion is developing, indicating early-stage surface instability.

- Perform earthwork between the levee road and main roadway to construct a functional ditch and redirect flow.
- Implement bioswales, curb treatments, and culvert/outfall improvements to manage and convey runoff.
- Establish vegetation on levee slopes and along the road to enhance stability and provide erosion resistance, particularly if site conditions degrade further.

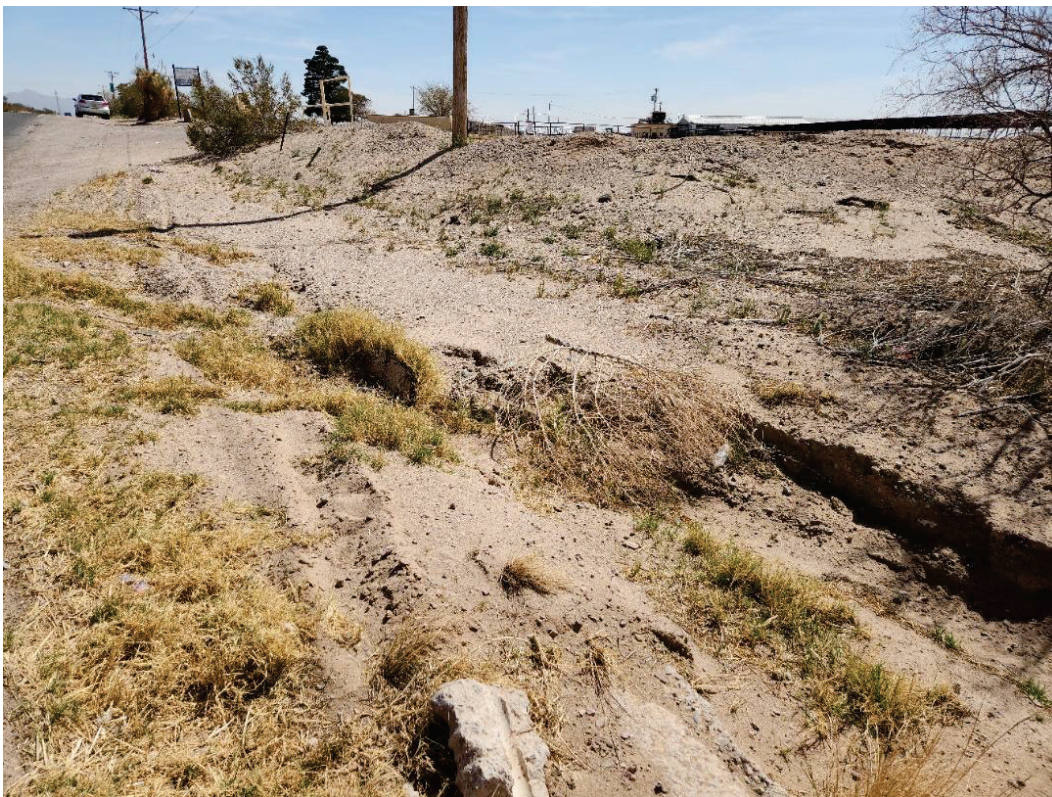
Observation ID: S5\_Ob2

Across four observation points along the frontage roads, recurring drainage and erosion concerns were documented, largely due to underperforming culverts and inadequate swale function. Routine drainage maintenance combined with targeted green infrastructure improvements will enhance system performance and reduce sediment-related roadway impacts. Key Issues observed include blocked culverts with sediment, tumbleweeds, and trash which reduce drainage capacity and contribute to roadway erosion and flood-related sand deposition. Swales are present but require maintenance and potential reshaping to effectively manage flow into culvert inlets. Localized erosion and exposed subgrade materials (e.g., metal netting) were observed, particularly in areas lacking sufficient vegetative cover.

- Maintain existing culverts to ensure proper flow conveyance and prevent blockages.
- Install or enhance bioswales at culvert inlets to slow runoff, promote infiltration, and filter sediment.
- Conduct limited earthwork and revegetation in erosion-prone or exposed areas.

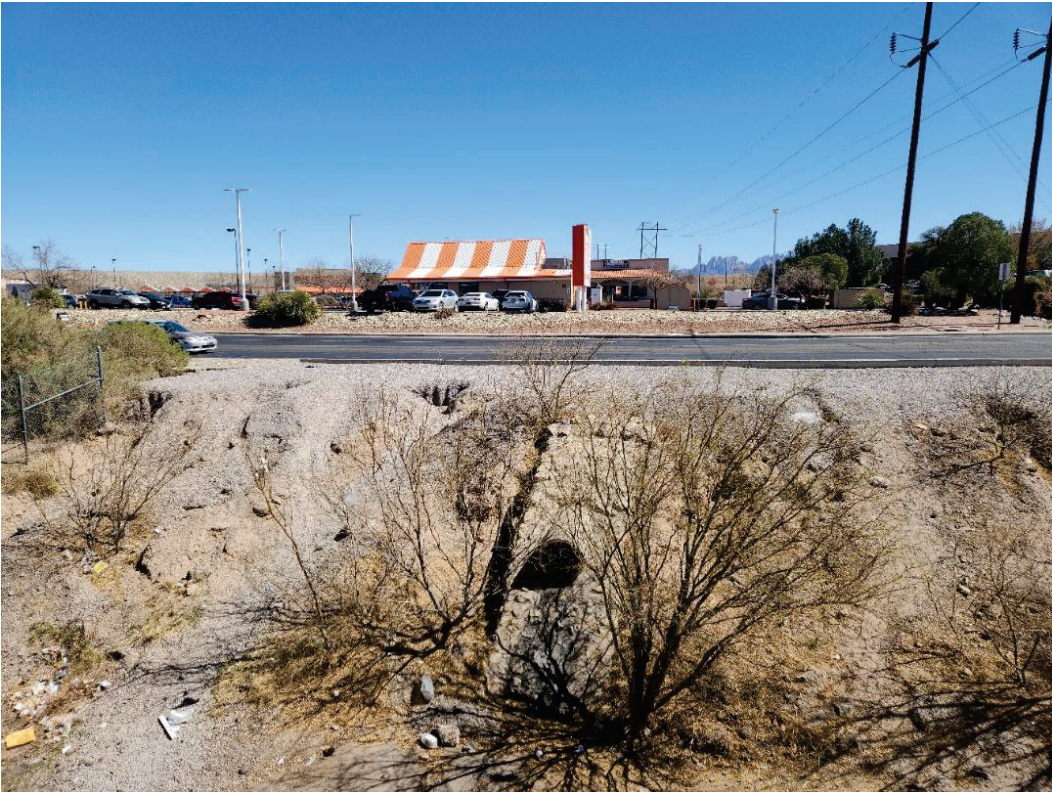
Observation ID: S6\_Ob3

Generally functional drainage infrastructure with targeted deficiencies are contributing to localized erosion and sedimentation issues. Existing swales, basins, and culverts are in place and partially effective, though culvert clearing and debris removal (e.g., tumbleweeds, trash) are needed to restore full function. Sheet and rill erosion is occurring in several locations, despite riprap protections; check dams could further mitigate erosion in these areas. One arroyo crossing lacks a culvert, leading to sediment deposition and road surface scouring. A new culvert installation is advised. A gully is forming within the right-of-way, indicating inadequate drainage and requiring stabilization. Targeted improvements to drainage connectivity and erosion control will enhance the site's stormwater management and reduce risk to infrastructure.

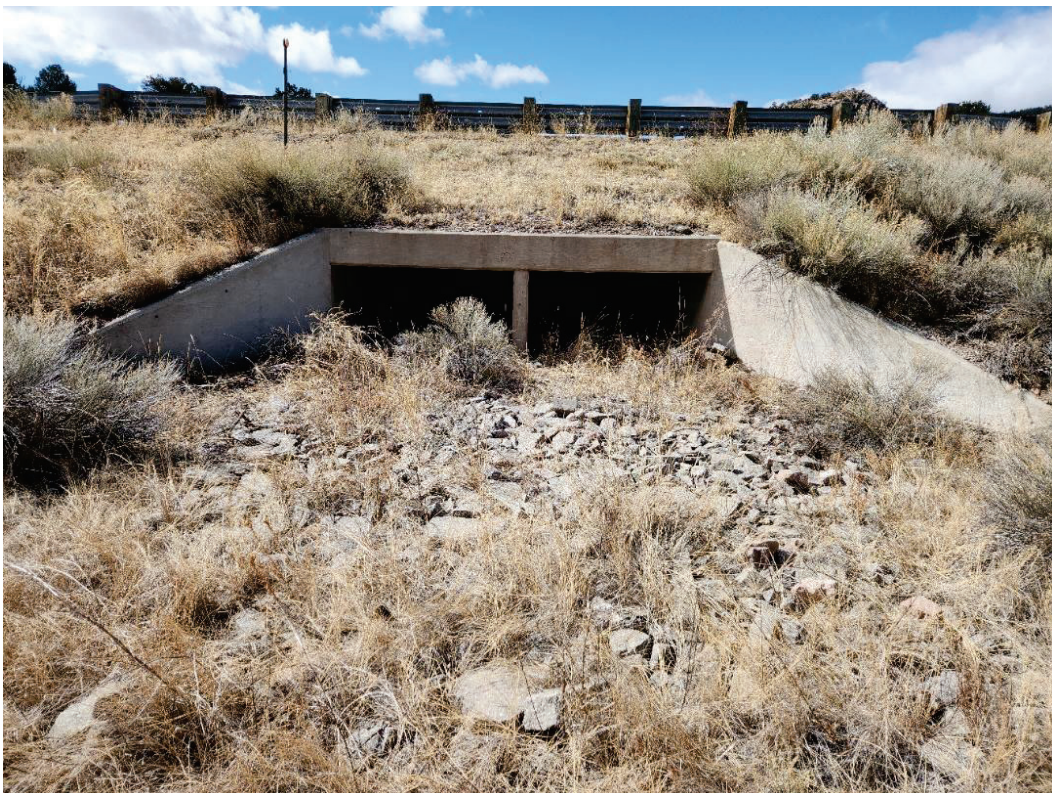
Observation ID: S24\_Ob2

This site includes a large arroyo beneath the roadway and is generally stable, though minor issues remain. Fencing surrounds much of the arroyo area and is largely intact, but could benefit from reinforcement to guide wildlife crossings and reduce damage during flooding. Some sediment accumulation is visible at culvert inlets and outlets, and vegetation is beginning to encroach near the culvert entrance. These factors do not currently appear to restrict flow but may do so over time without maintenance.

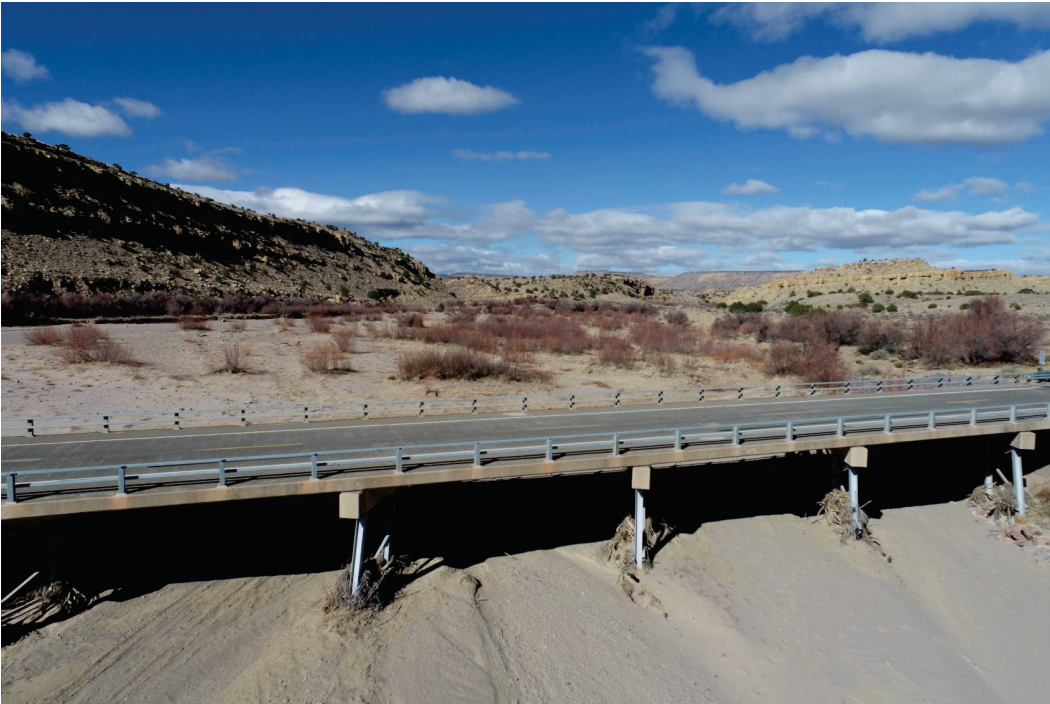
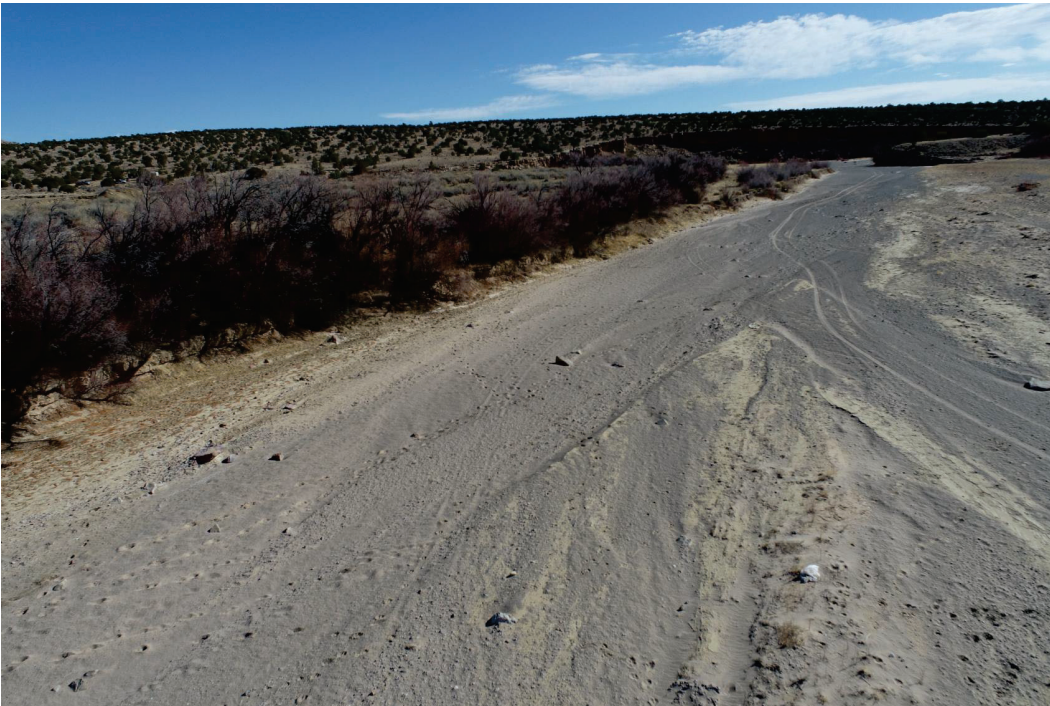
Observation ID: S25\_Ob1

This site, observed at a single location, includes a small, shallow basin roughly 3 feet deep, likely intended to manage localized runoff. While the feature is not immediately visible, it appears to provide some benefit in reducing ponding within the right-of-way. No damage to the roadway was observed, and drainage concerns at this site are relatively minor. However, small-scale green infrastructure improvements could enhance infiltration and reduce long-term surface water accumulation.

- Install bioswales to help direct and filter surface runoff.
- Consider soil sponges or shallow depressions to improve infiltration in ponding-prone areas.
- Monitor basin performance over time to ensure continued function.

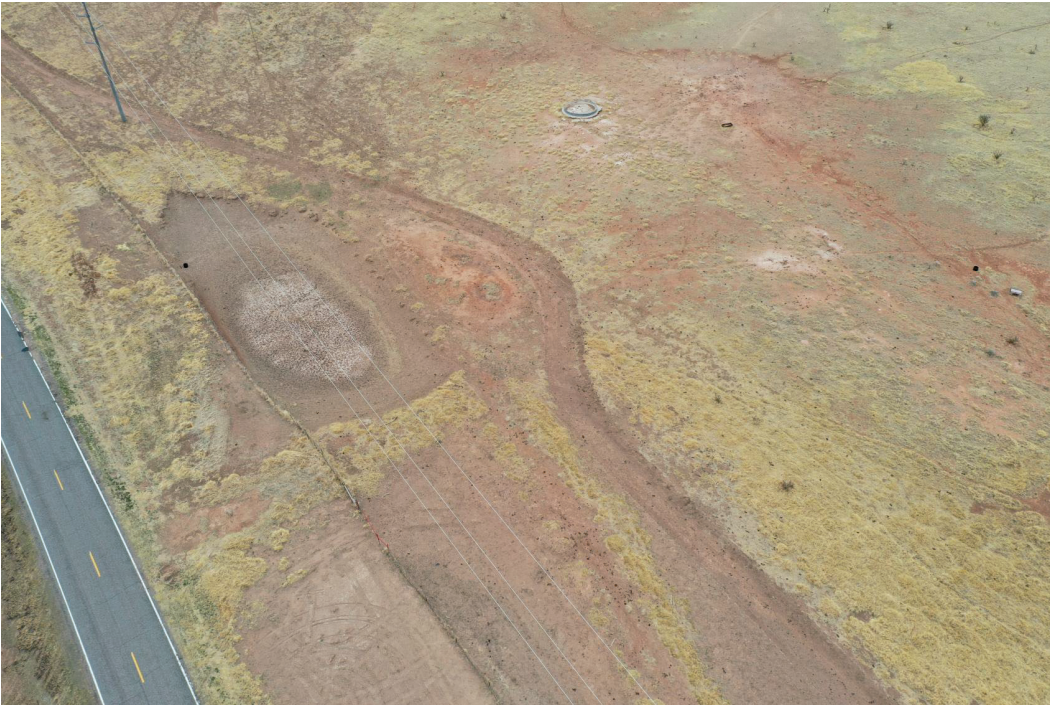
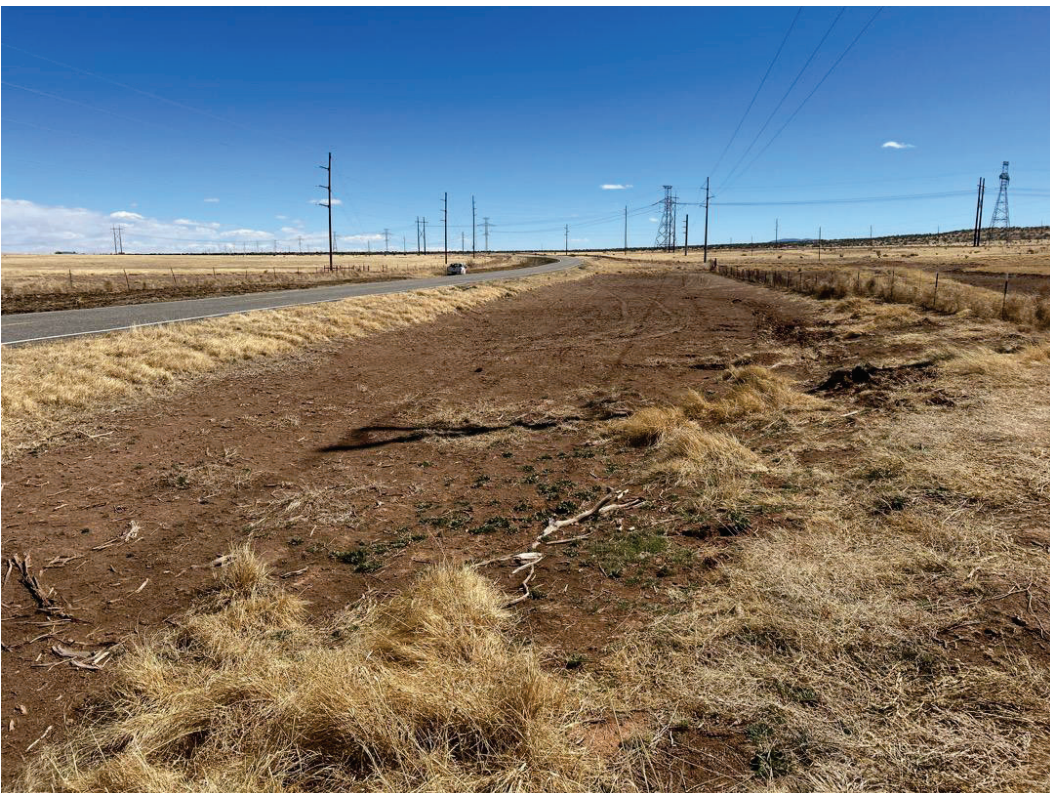
Observation ID: S26\_Ob1

This site includes a large gully extending along and across the right-of-way, contributing to ongoing erosion and active roadway damage. The gully appears to channel surface runoff during storm events, with no effective flow control measures currently in place. The severity of erosion and proximity to infrastructure indicate an urgent need for stabilization and improved runoff management.

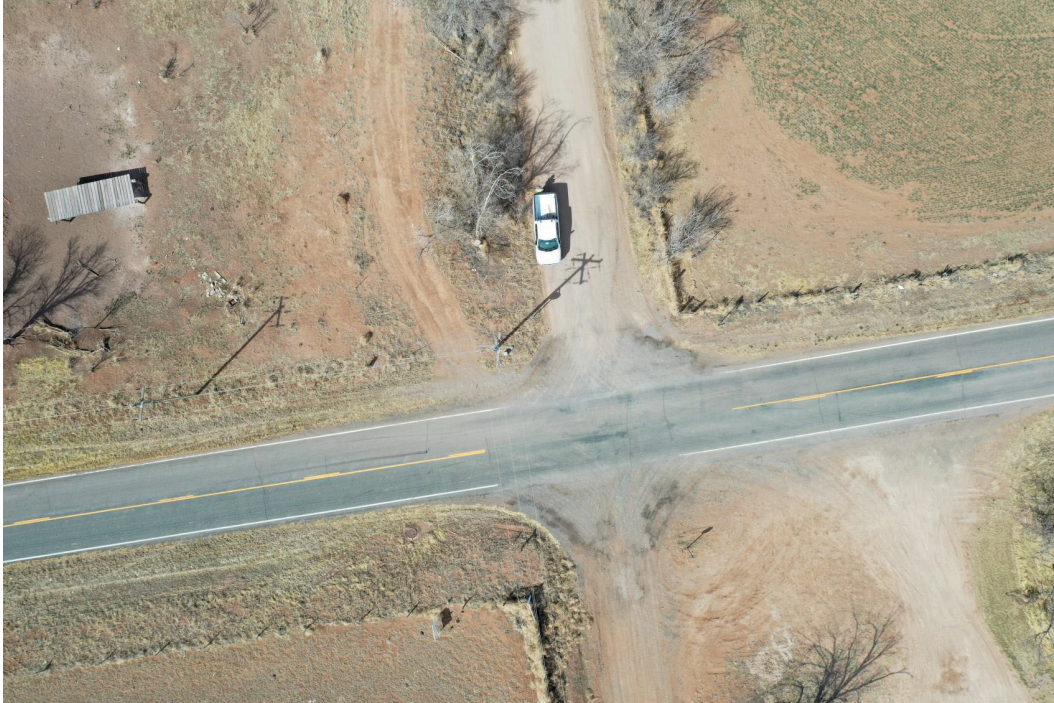
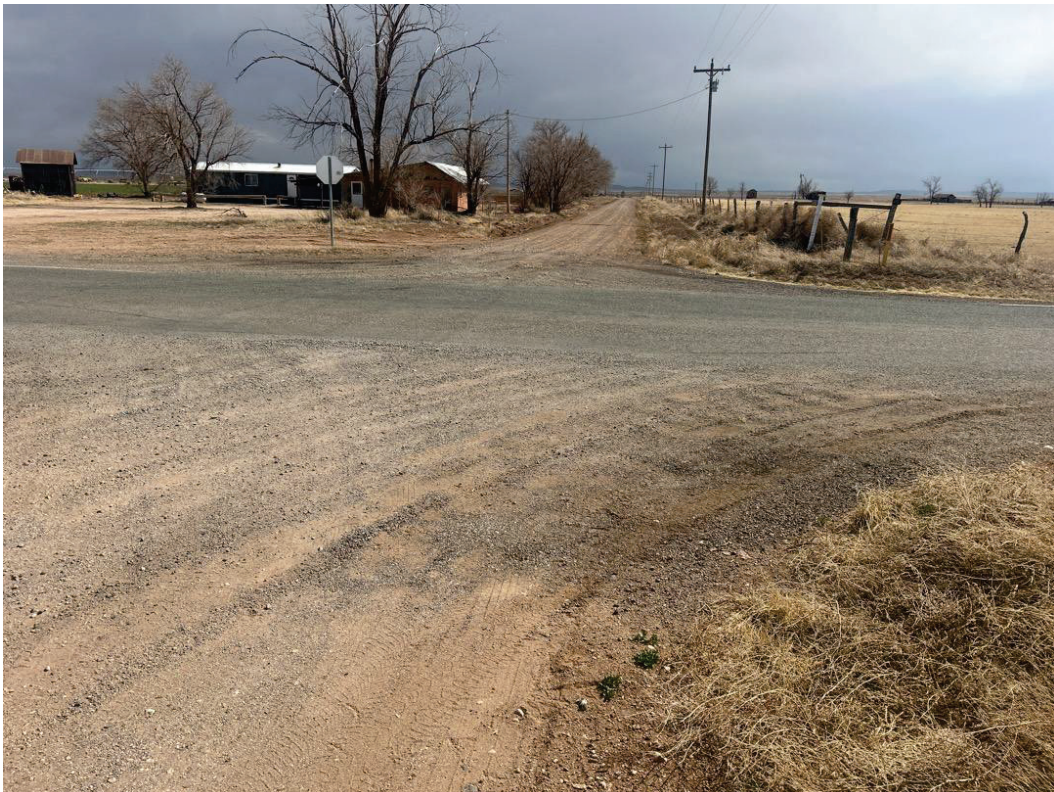
Observation ID: S28\_Ob1

This site, observed at a single location, has a history of reported ponding on the roadway, although no active ponding was observed during the field visit. The area lies within the right-of-way and does not currently show signs of roadway damage. The issue appears to be minor but recurring, likely due to inadequate drainage capacity or surface grading. Simple green infrastructure could help manage runoff more effectively and prevent future accumulation.

- Install a bioswale to intercept and redirect surface runoff.
- Monitor the site during wet conditions to assess drainage performance and confirm effectiveness of improvements.

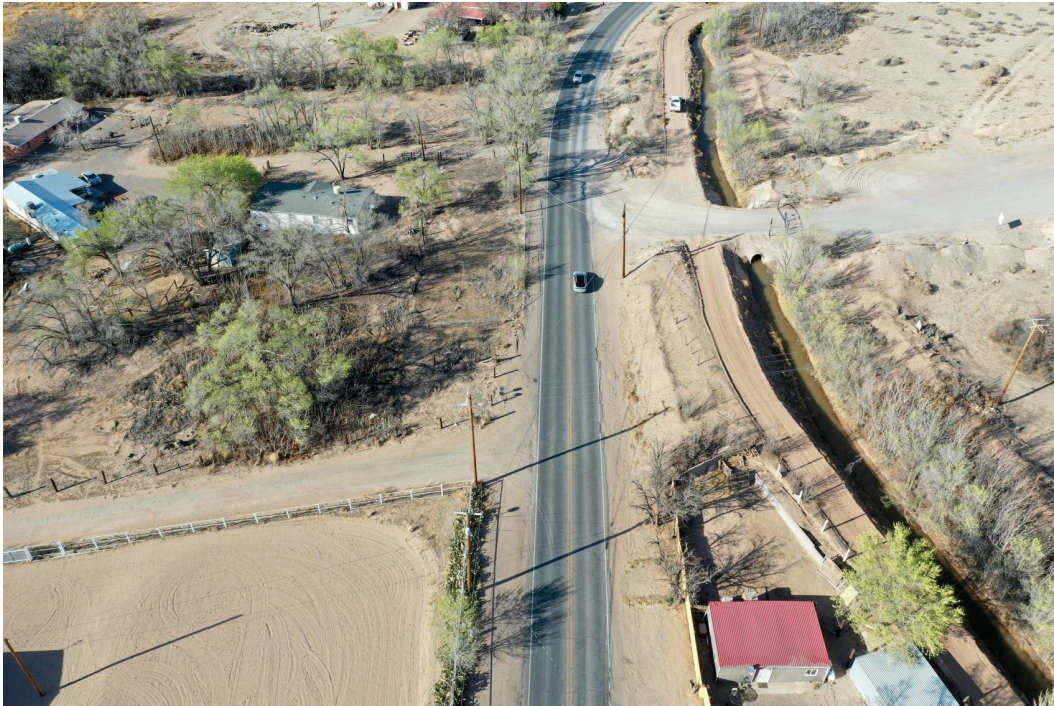
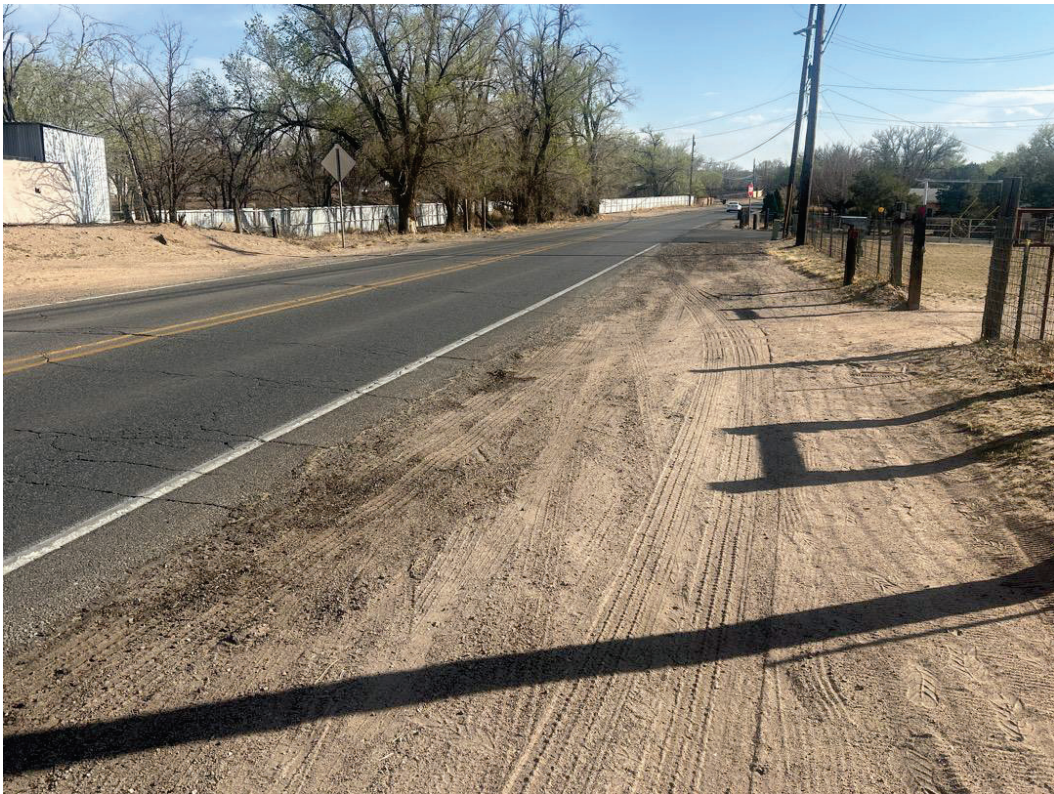
Observation ID: S29\_Ob1

This site shows minimal visible damage, though a slight depression off the shoulder may be contributing to minor ponding or erosion during storm events. The drainage issue was not clearly evident at the time of the visit but may become more apparent under wet conditions. The observation extends outside the right-of-way, and no roadway damage was observed. Modest infrastructure improvements could help manage runoff and prevent future issues.

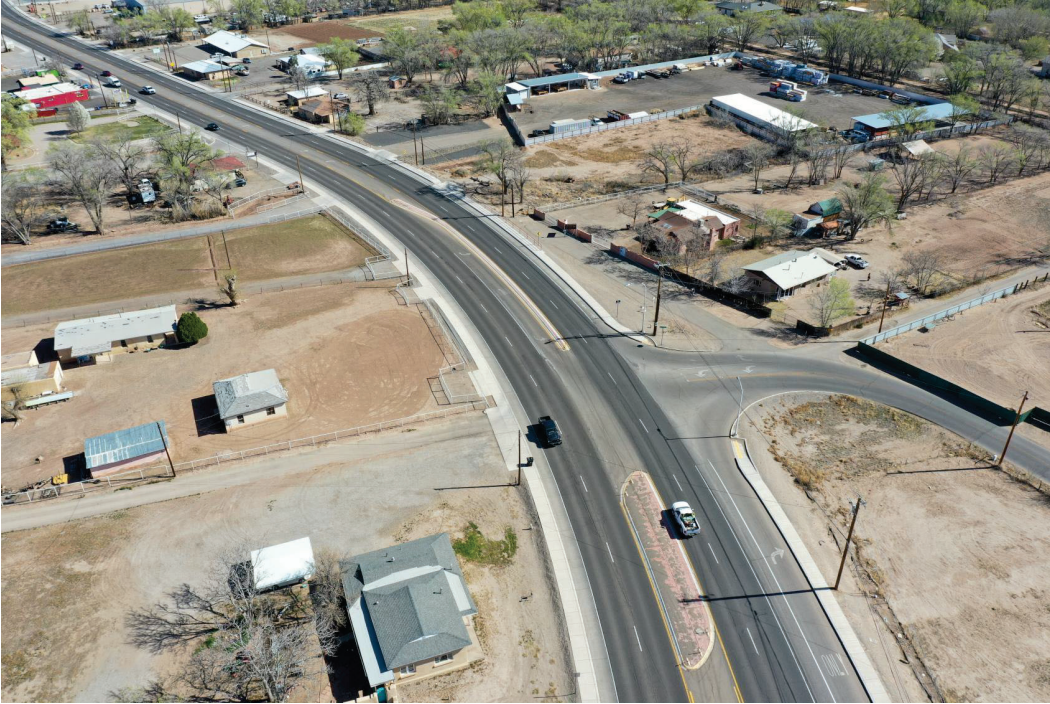
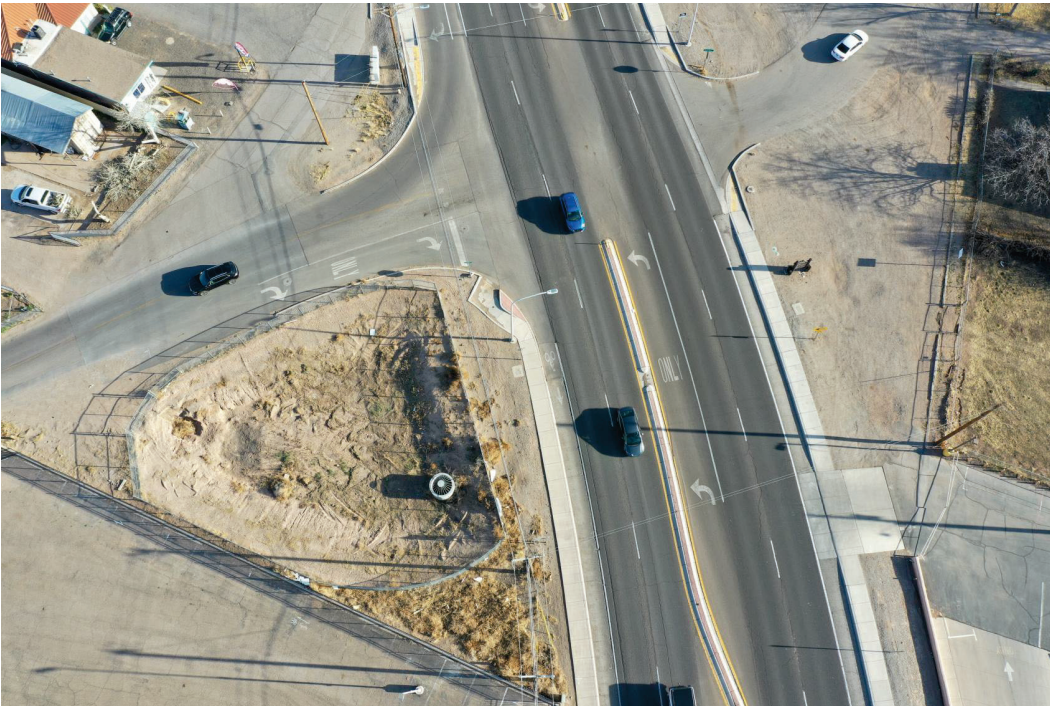
Observation ID: S30\_Ob1

This site lies along a drainage corridor with multiple culverts in need of maintenance. One damaged culvert is functioning below capacity, while another—recently installed—is already half-filled due to bi-directional flow. Ponding and minor flooding are present, with surface water contributing to overflow near a protruding pipe. Fencing across the site is degraded, allowing for frequent wildlife crossings; improvements and designated passage features are advised. The San Jose drainage feature exceeds the capacity of the existing culvert and bridge. While rock gabions have been installed to redirect overtopping, long-term solutions may require raising the bridge or constructing off-ROW retention basins in coordination with adjacent landowners.

- Maintain and repair existing culverts to restore capacity.
- Install bioswales, basins, and Zuni bowls to manage runoff and reduce flooding.
- Repair fencing and explore wildlife-friendly crossing solutions.

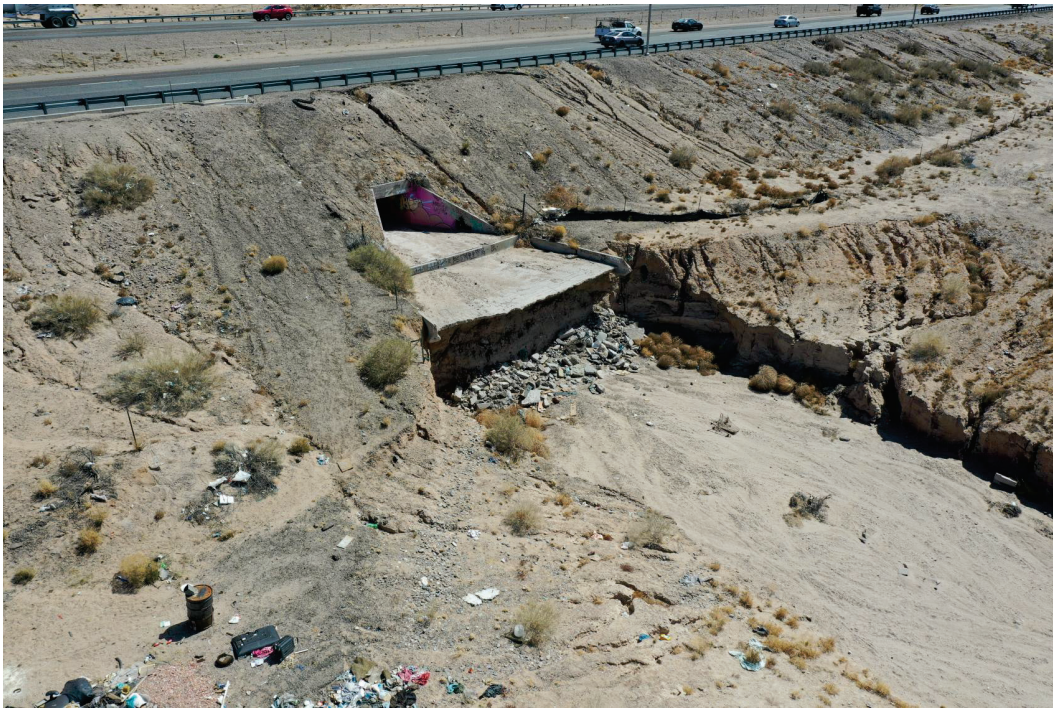
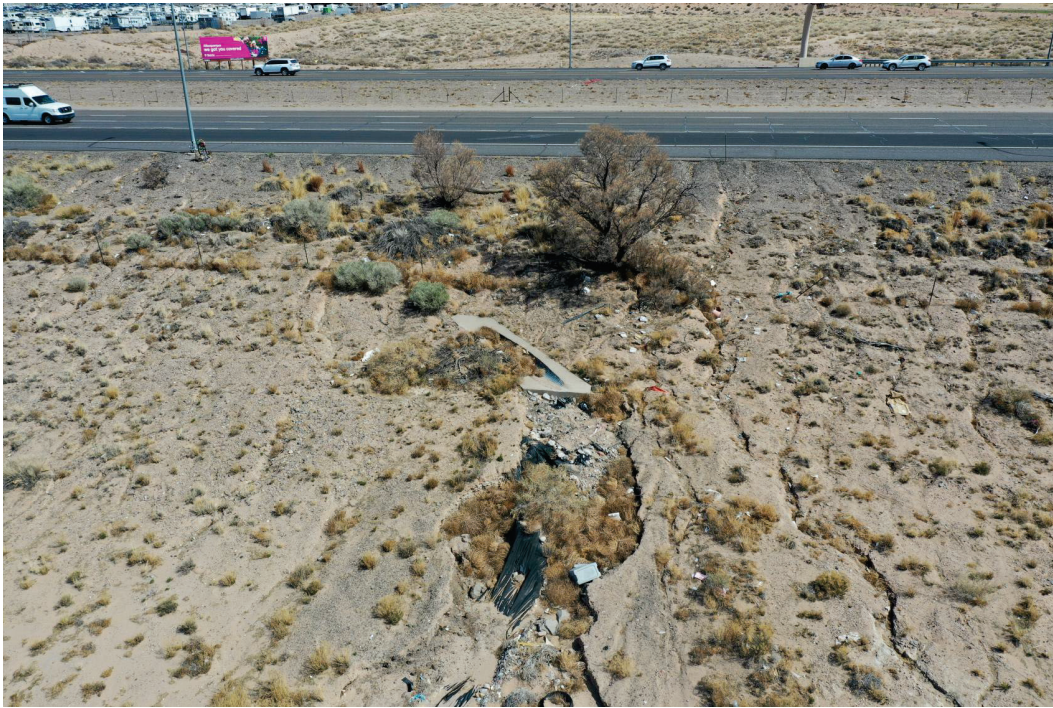
Observation ID: S32\_Ob1

This site includes two observation points documenting significant erosion, sedimentation, and roadway damage linked to undersized or poorly functioning culverts. At one location, asphalt is actively eroding where it meets a concrete headwall, and downstream channels are unstable. At the second location, the culvert may require full redesign, potentially including road elevation changes to better manage flow. Both sites experience flooding, ponding, and sediment accumulation, indicating that existing infrastructure is inadequate for stormwater volumes. Additional earthwork and flow control measures are needed to prevent continued degradation and protect adjacent roadways.

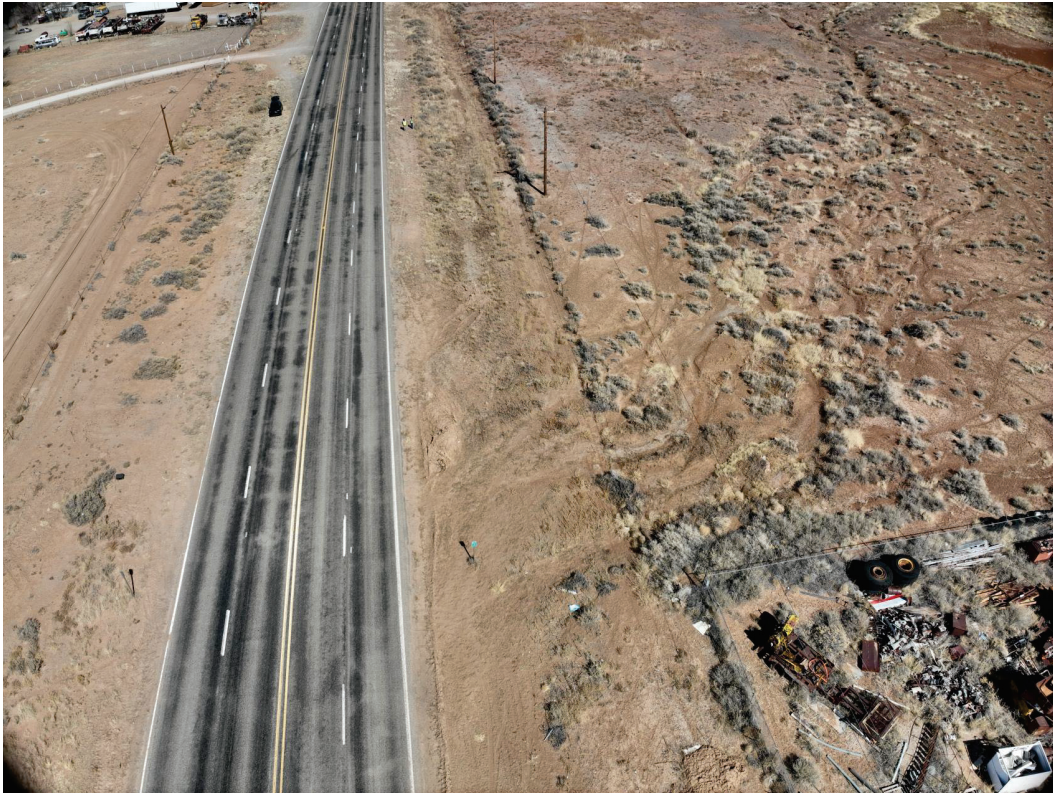
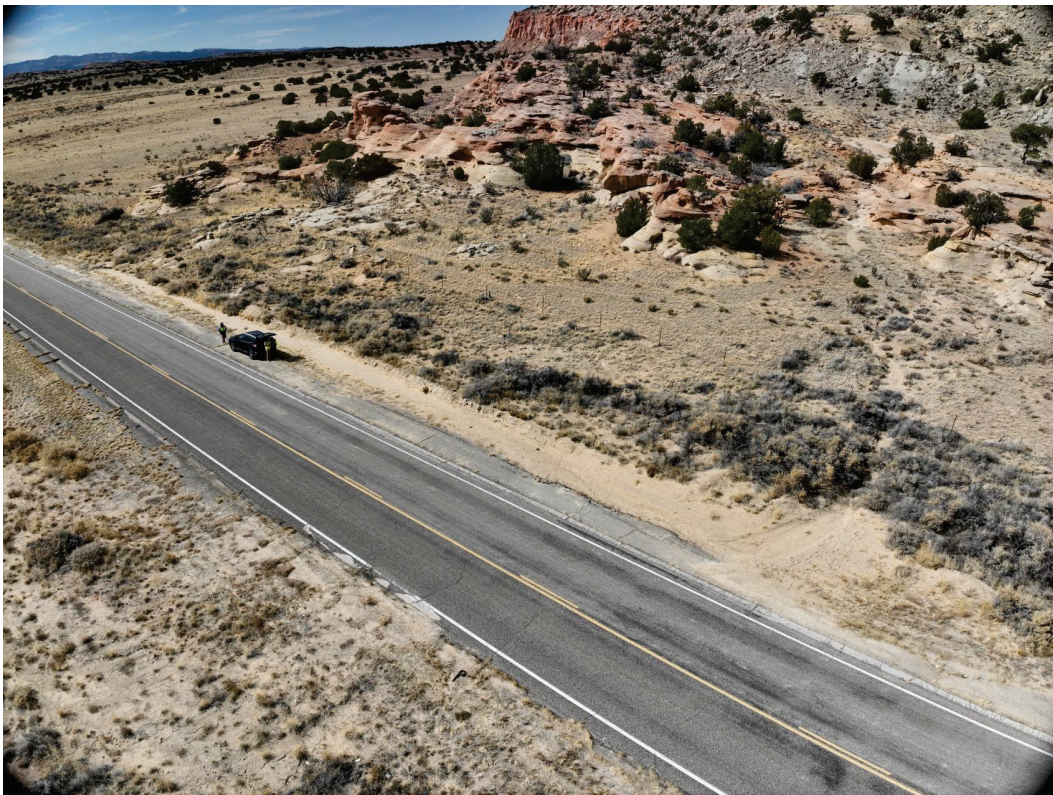
Observation ID: S36\_Ob1

Site 37 includes several erosion-prone areas along NM14, primarily between Golden and Los Cerrillos, with one outlier near the NM14/I25 interchange in Santa Fe. The region's erosive geology, road cuts, and hillsides contribute to widespread surface degradation, with varying severity across observations. Located in the highlands east of the Sandia Mountains, the site's elevation and hydrologic sensitivity contribute to a higher environmental priority. Enhancing water retention and conveyance capacity through green infrastructure would help stabilize the corridor and benefit the many small communities and travelers that rely on this route.

- Install culverts at multiple points to improve drainage and reduce roadway erosion.
- Construct bioswales, check dams, and Zuni bowls where needed to manage flow and control sediment.
- Apply mulching and soil sponges to stabilize slopes and improve infiltration.
- Implement curb treatments where runoff enters paved surfaces to reduce edge erosion.

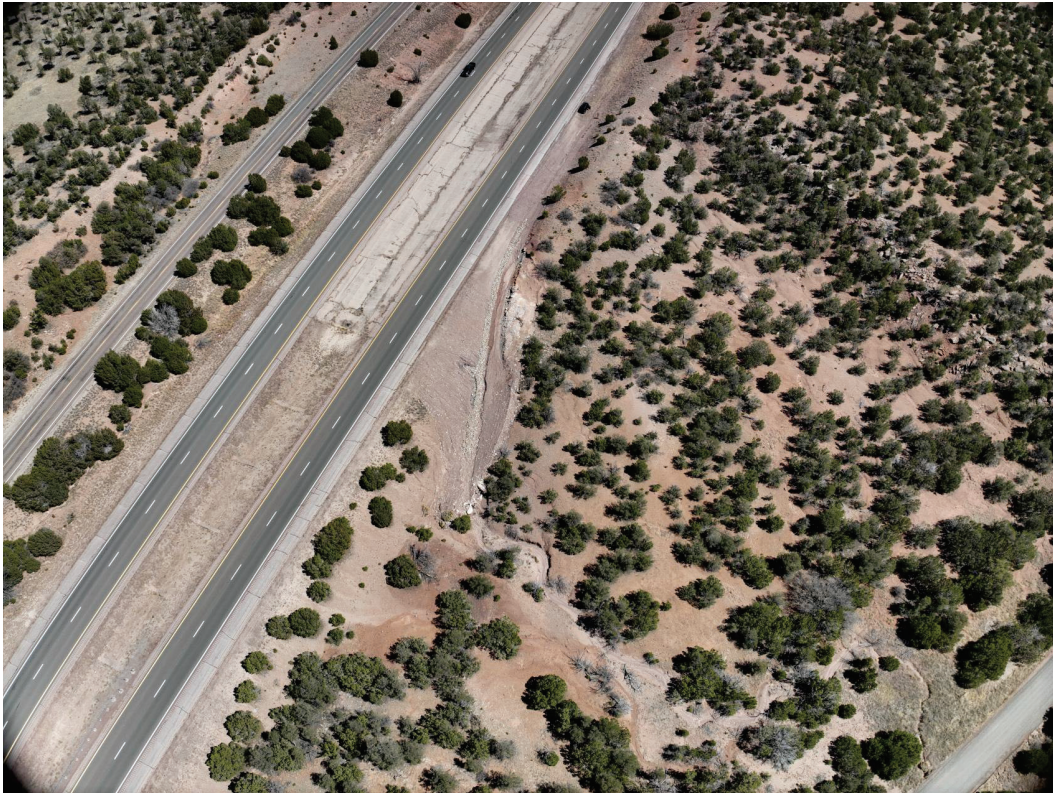
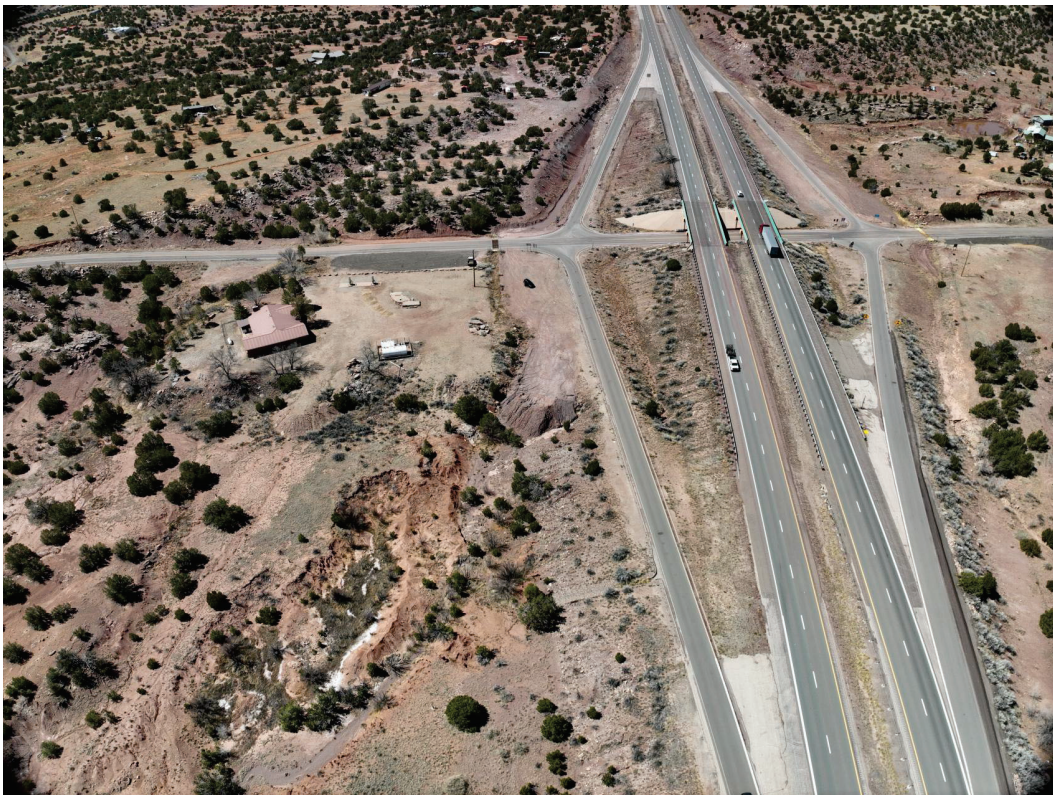
Observation ID: S39\_Ob2

At Site 40, runoff issues are affecting the I25 northbound exit ramp area. Along the ramp, water visibly flows off the asphalt, eroding the adjacent shoulder and forming rills. Downhill, sheet flow crosses the road and enters a culvert that passes under I25, which may be undersized or inadequately protected. Rock mulch has been placed near the culvert inlet to slow erosion, but more comprehensive stabilization is needed to protect the roadway margin and manage runoff effectively.

- Construct bioswales and check dams along the roadside to reduce flow velocity and manage runoff.
- Evaluate and, if needed, upgrade the culvert to accommodate flow and prevent road degradation.
- Build a large basin to retain stormwater and reduce peak discharge.
- Implement revegetation or armoring along the shoulder to improve slope stability.
