***Optimum Locations for the Benefits of Green  
Infrastructure (GI) on the NMDOT Transportation  
System  
May 2025***

*Prepared for:  
New Mexico Department of Transportation  
Albuquerque, NM*

*Prepared by:  
GeoSystems Analysis, Inc.  
8601 Paseo Alameda NE; Suite B  
Albuquerque, NM 87113*

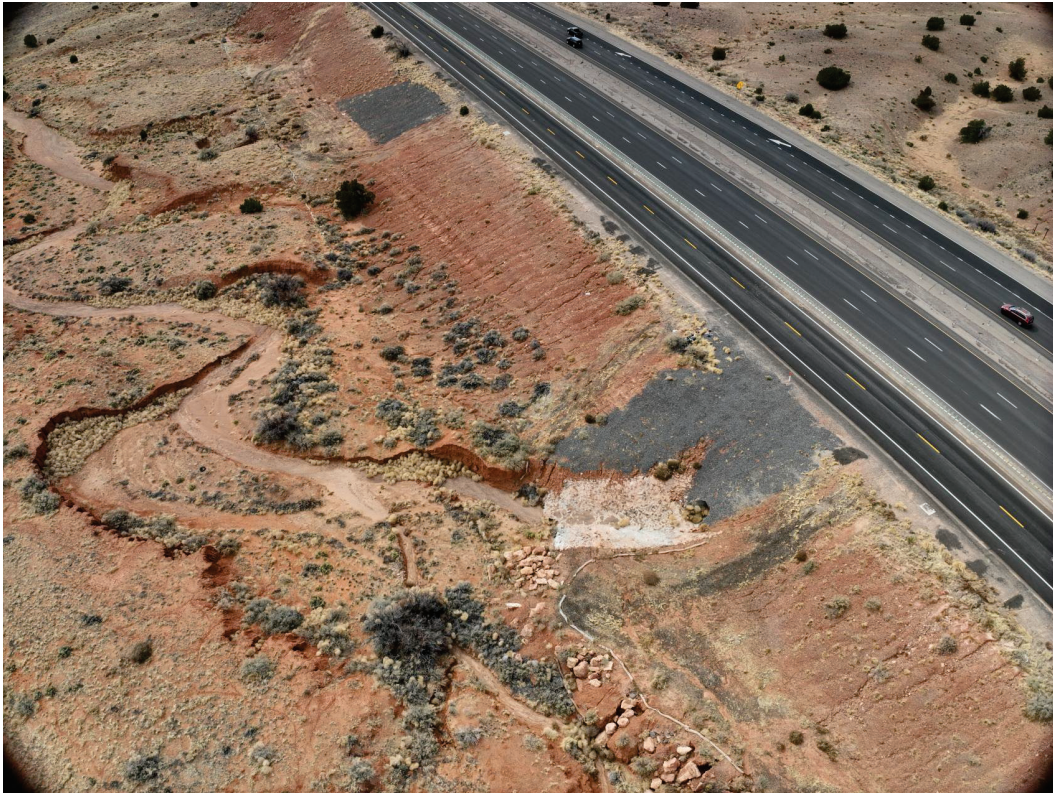
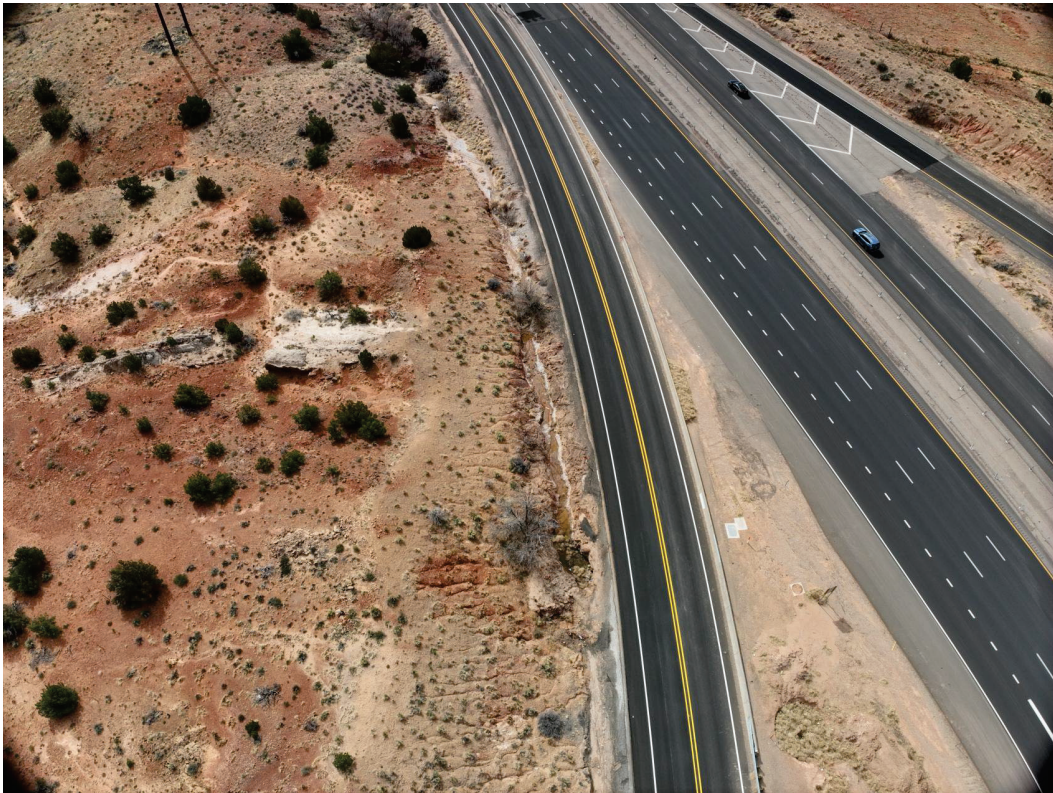
Observation ID: S40\_Ob1

Site 41 includes two observation points along a developed corridor where drainage and erosion issues are affecting both roadside infrastructure and adjacent properties. One location features a culvert so overgrown and sediment-filled that it was nearly unidentifiable, with visible ponding and sedimentation suggesting poor conveyance and potential blockage. The second location includes rill formation progressing toward gully development, likely caused by runoff from nearby developed areas. While no roadway damage was observed, both points require improvements to manage flow and prevent further degradation.

- Replace or reconstruct the compromised culvert to restore drainage function.
- Apply mulching and revegetation to stabilize rill-prone areas and reduce erosion.
- Maintain sediment-prone zones and monitor for future ponding.

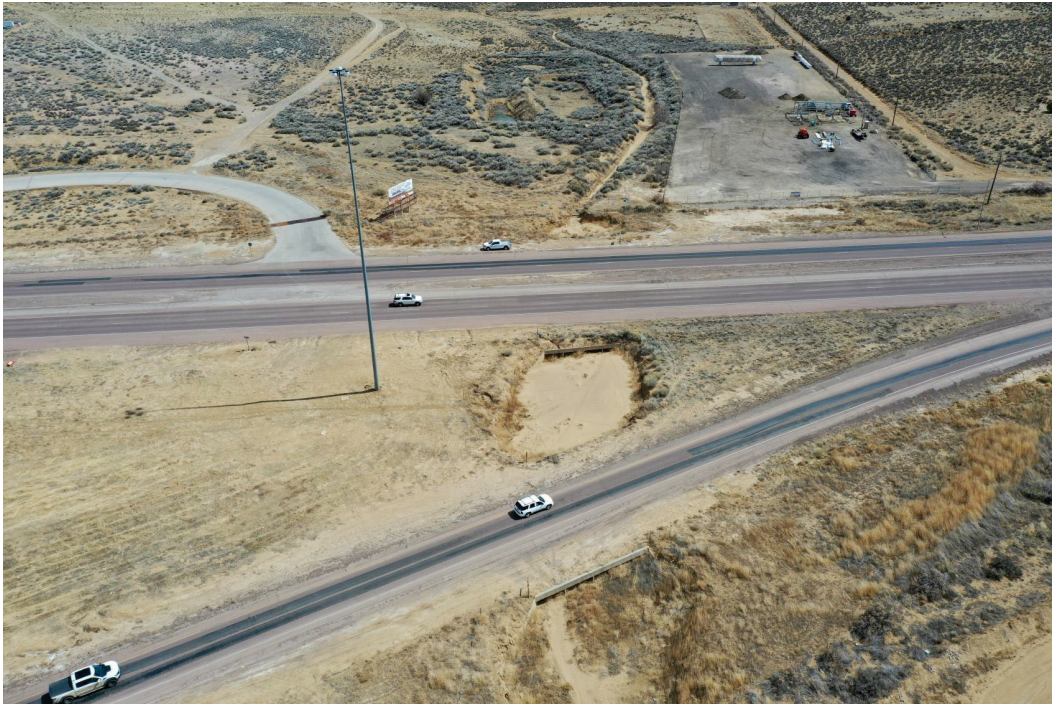
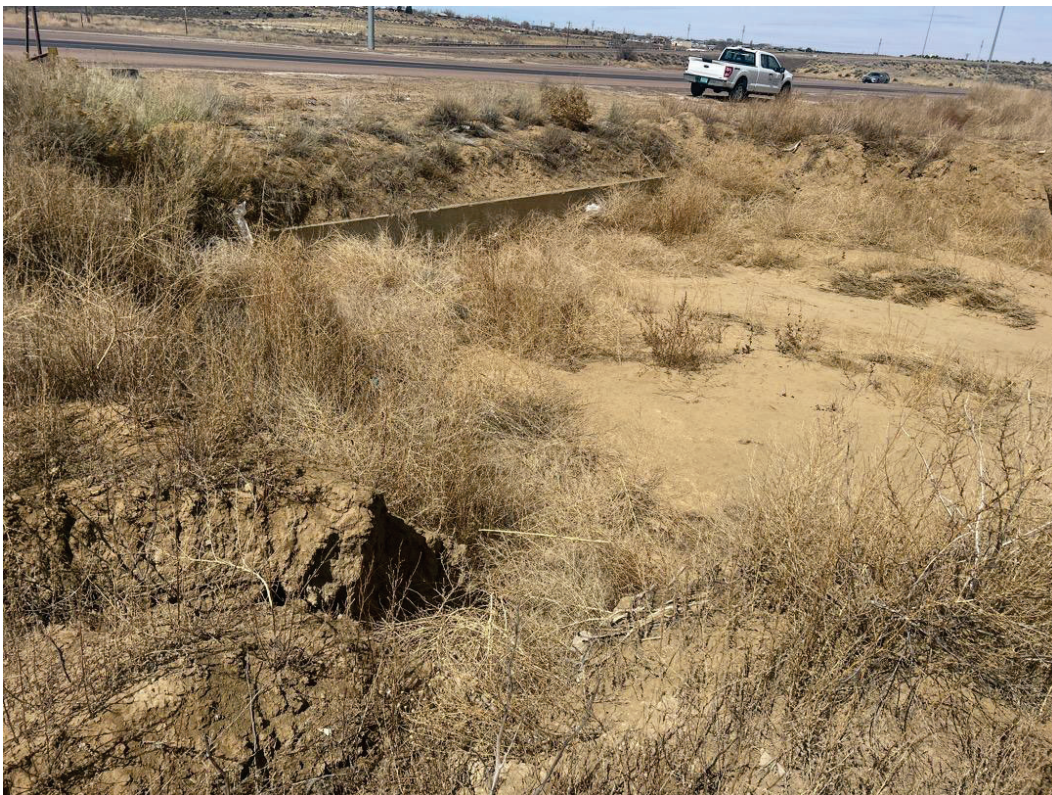
Observation ID: S45\_Ob1

Site 45 includes a single observation point where a culvert is nearly blocked, contributing to ponding and poor drainage performance within the right-of-way. Water appears to pool near the roadway during storm events, and without intervention, localized flooding or erosion could occur. No roadway damage was observed, but sediment accumulation and inadequate conveyance suggest a need for maintenance and added flow control to manage stormwater more effectively.

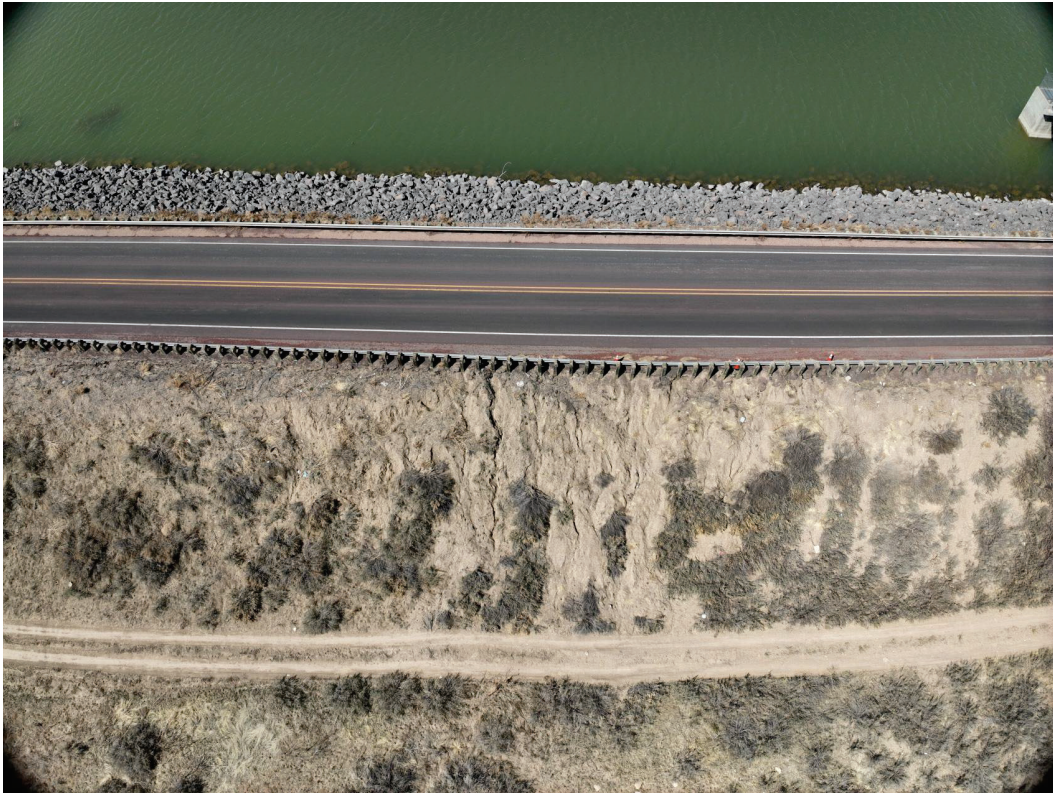
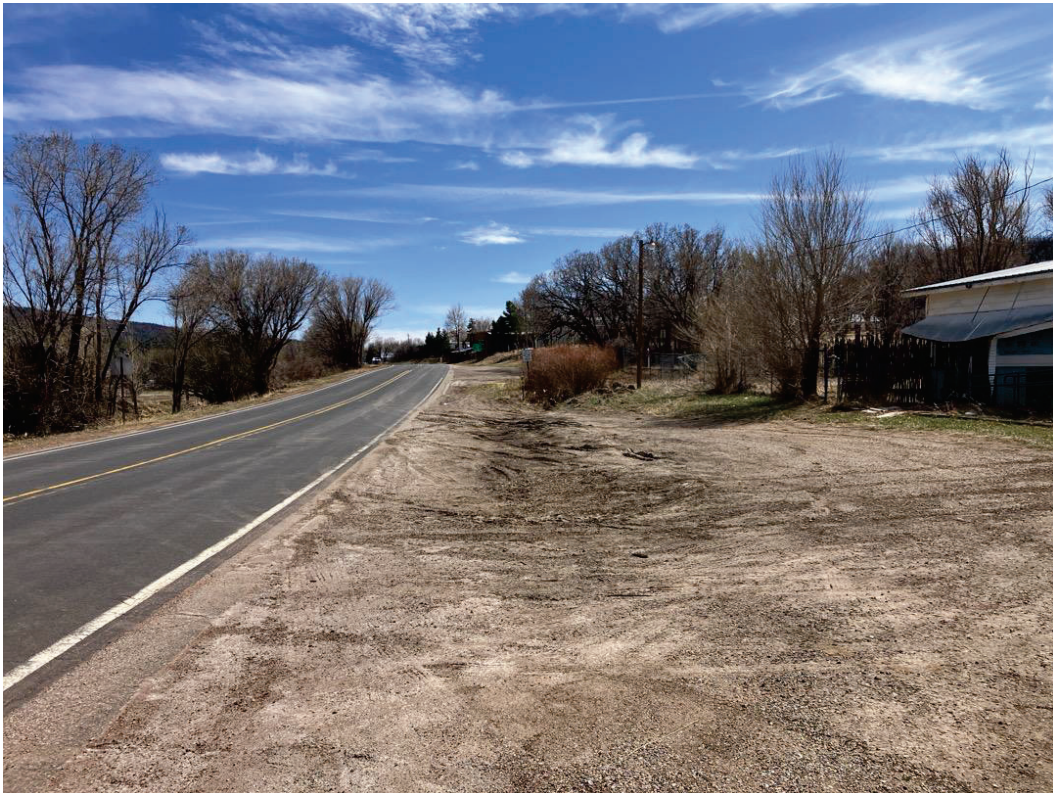
Observation ID: S46\_Ob1

Site 46 includes several distinct problem areas related to runoff and slope instability. In the northern portion of the site, a large section of right-of-way is experiencing post-fire flooding in the village of Holman. While some drainage infrastructure is present, flow paths appear unregulated, and vegetation is sparse or degraded in areas, contributing to surface erosion and poor infiltration. Just south of this area, ponding occurs frequently within the ROW, and the topography suggests that water flows across the road surface during large storm events, posing a risk to road safety. Further south along the roadway that forms the dam for Lake Storrie, an eroding hillside shows signs of slope instability, with modest vegetative cover proving insufficient to control rill formation.

- Stabilize slopes with revegetation, mulching, and erosion control measures.
- Construct swales to redirect and slow stormwater runoff.
- Improve or expand drainage infrastructure to prevent overtopping and roadway damage.
- Monitor post-fire flood-prone areas for further erosion and sediment buildup.

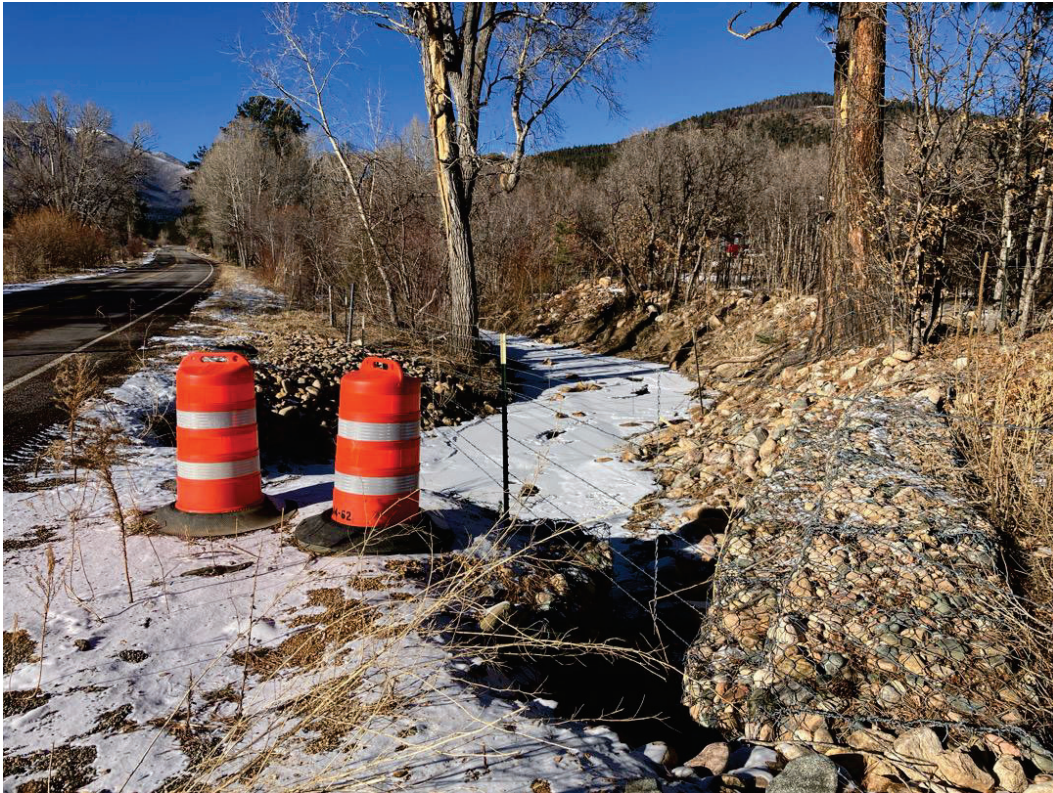
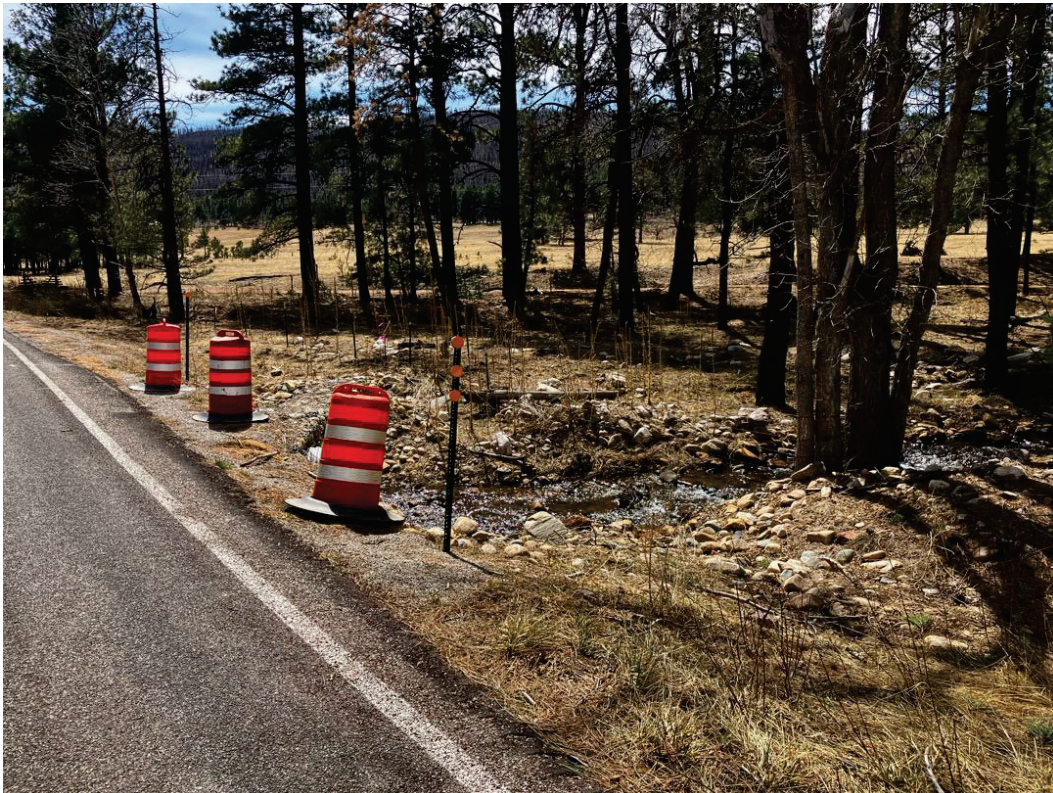
Observation ID: S47\_Ob2

Site 47 consists of three stream crossings along the same general corridor, all of which appear vulnerable to overtopping during high-flow events. At each location, streams pass beneath the roadway through culverts that may be undersized or poorly aligned with natural flow paths. Observations indicate that water regularly overtops the road surface, suggesting that the existing conveyance capacity is insufficient. This area lies near the Hermits Peak/Calf Canyon Fire burn scar, and elevated runoff from the burned watershed is likely contributing to higher peak flows that exceed culvert design limits.

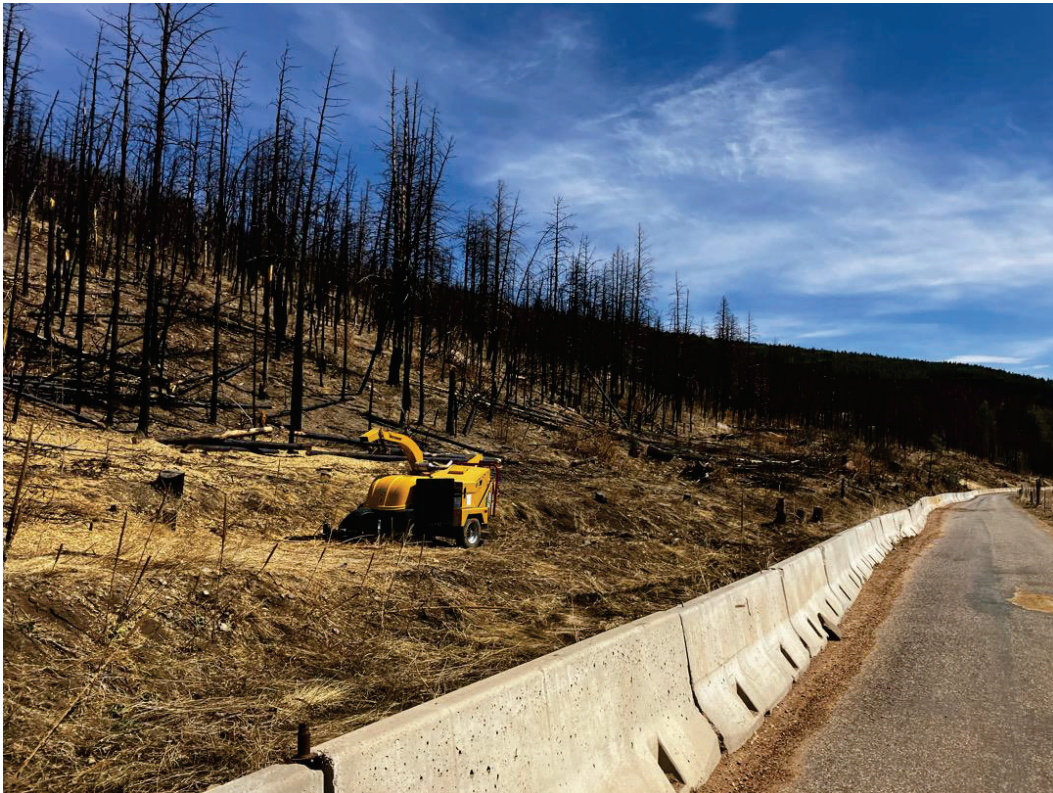
Observation ID: S48\_Ob1

Site 48 encompasses several miles of roadway with extensive damage from post-fire flooding. Located within the Hermits Peak/Calf Canyon Fire burn scar, the corridor shows signs of widespread erosion, debris deposition, and repeated overtopping, indicating that stormwater volumes have consistently exceeded the capacity of existing drainage infrastructure. The scale of the damage points to a systemic issue driven by the altered hydrology of the burned watershed. A corridor-scale response is recommended to improve resiliency, but a true long-term solution will likely require a large, landscape-scale watershed restoration effort beyond the scope of NMDOT alone.

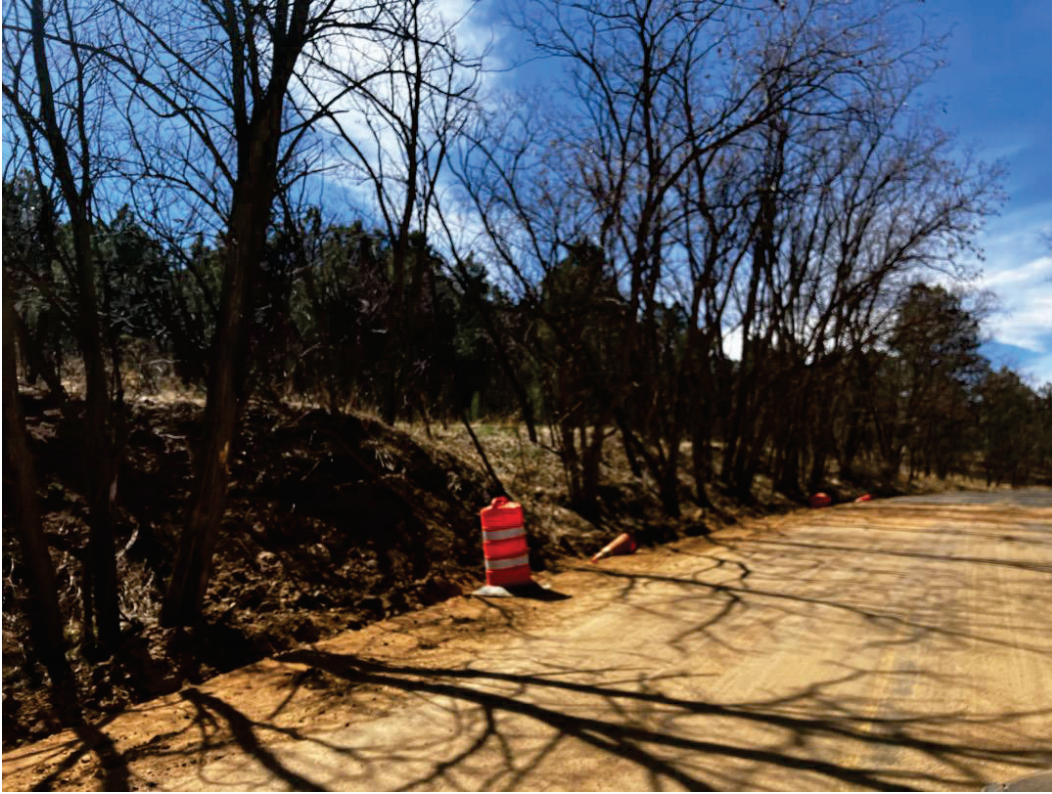
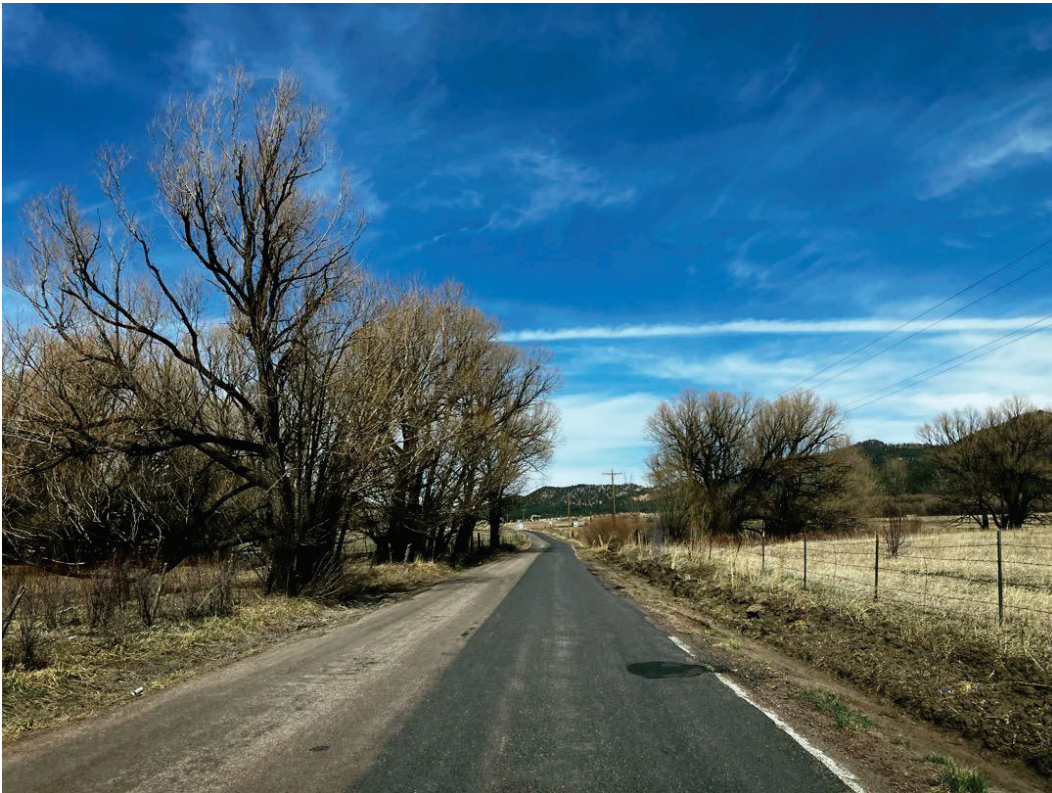
Observation ID: S49\_Ob1

Site 49 features a stream crossing where high flows are causing damage to the roadway and adjacent infrastructure. In addition to flows overtopping or bypassing the culvert, water is also running parallel to the roadway for a stretch, leading to incision and bank erosion along the road shoulder. These conditions suggest that both concentrated and distributed runoff are contributing to hydrologic stress in the area, likely exacerbated by increased flows from nearby burned terrain. Modest interventions may be effective in reducing further degradation.

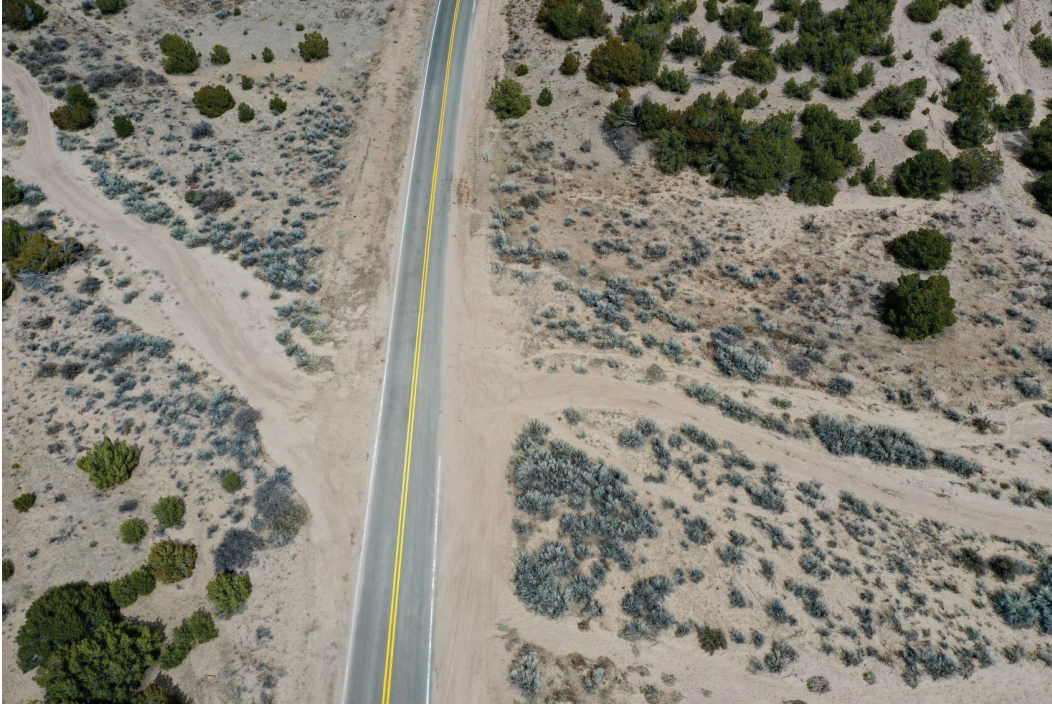
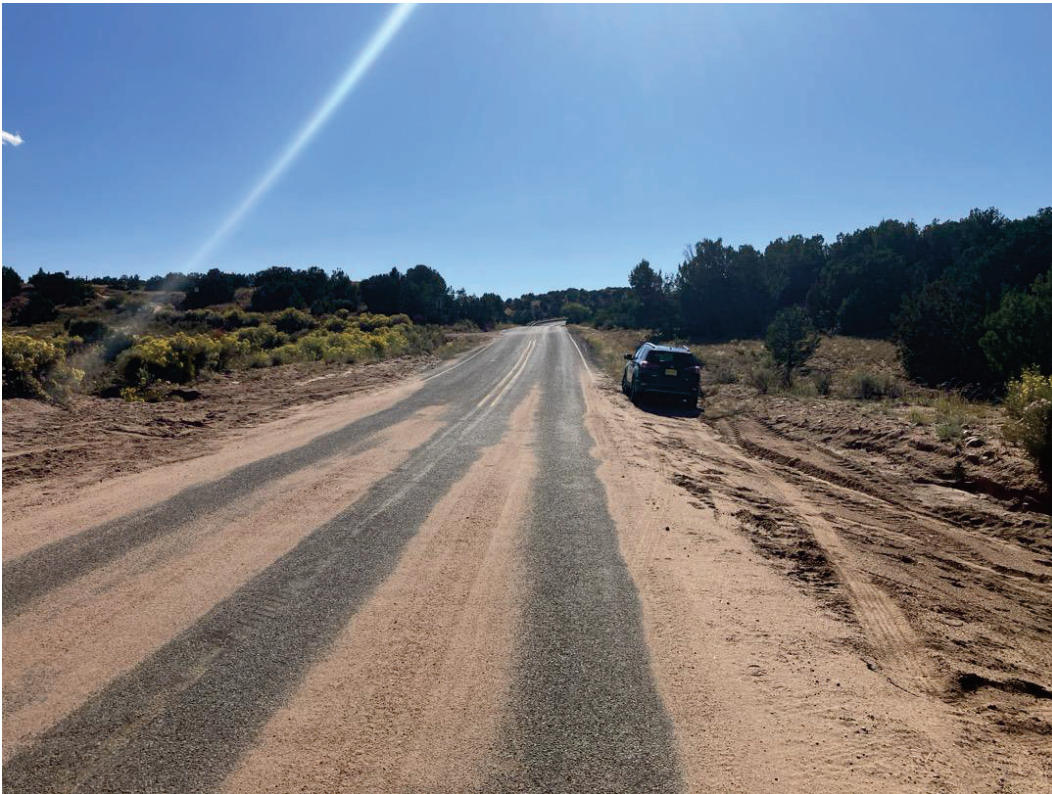
Observation ID: S51\_Ob1

A large arroyo intersects the roadway at this location with no existing culvert infrastructure. Evidence suggests periodic ponding and sediment deposition on the road surface and within the right-of-way due to insufficient drainage conveyance. A culvert installation is recommended to improve hydrologic connectivity and reduce surface water accumulation. Erosion and flooding are actively affecting the site, and adjacent arroyo flow remains unmanaged.

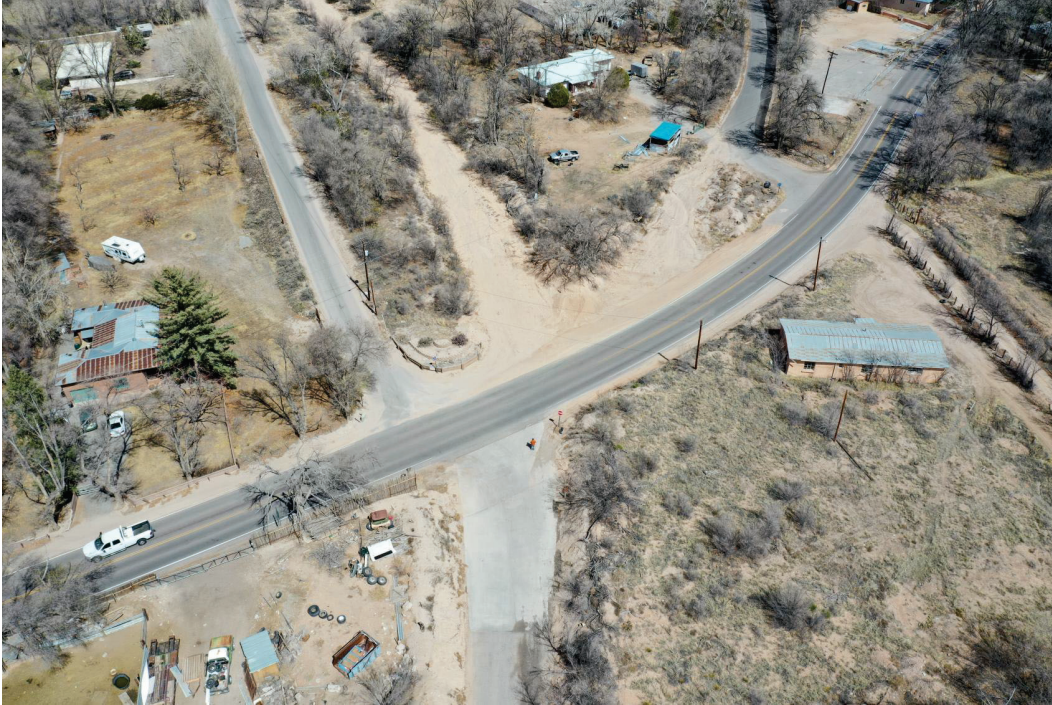
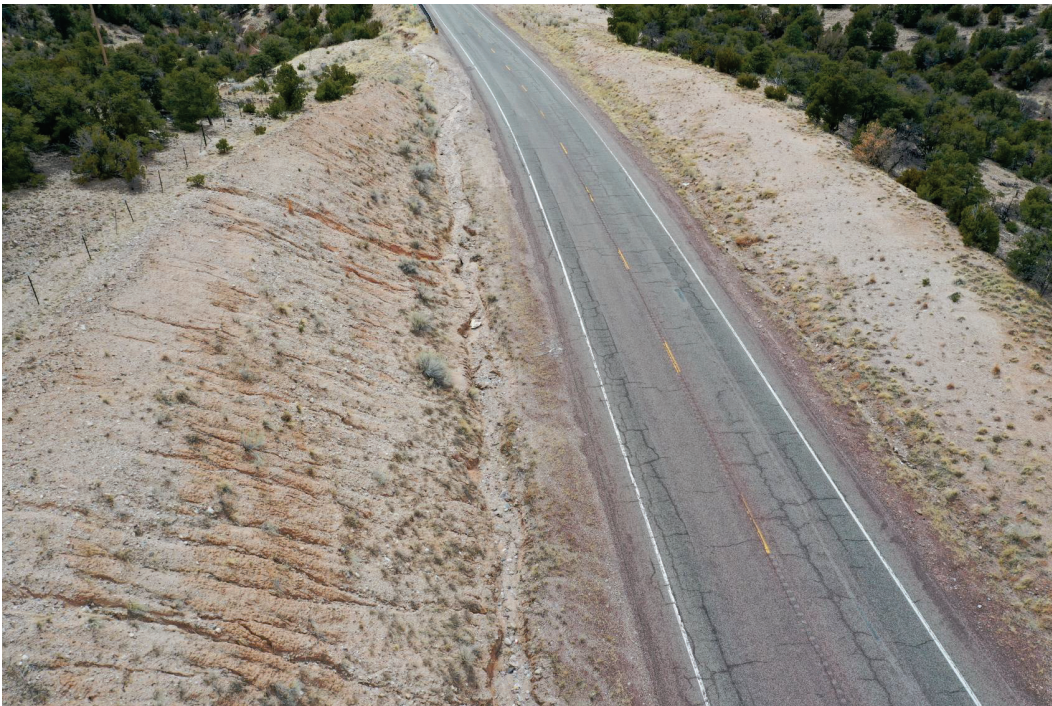
Observation ID: S52\_Ob2

This roadway segment exhibits recurring drainage and sedimentation issues due to concentrated runoff from surrounding slopes. Surface water primarily sheds from steep hillslopes to the west and northwest, with additional contributions from east-facing slopes in certain areas. Multiple low-lying sections along the roadway experience prolonged ponding, likely due to inadequate drainage infrastructure and sediment accumulation. An arroyo crossing from the northwest contributes to sediment deposition and water ponding at one location, while gully formation has initiated along the east side of the road, exacerbated by runoff flowing parallel to the roadway within the right-of-way.

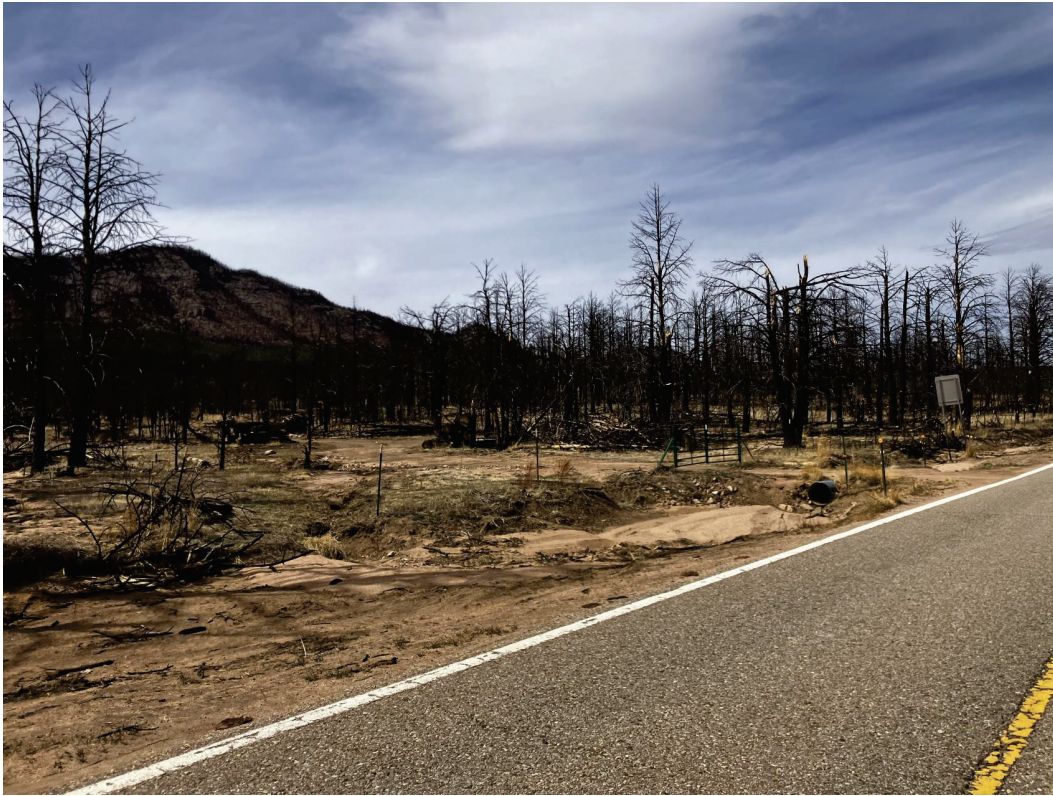
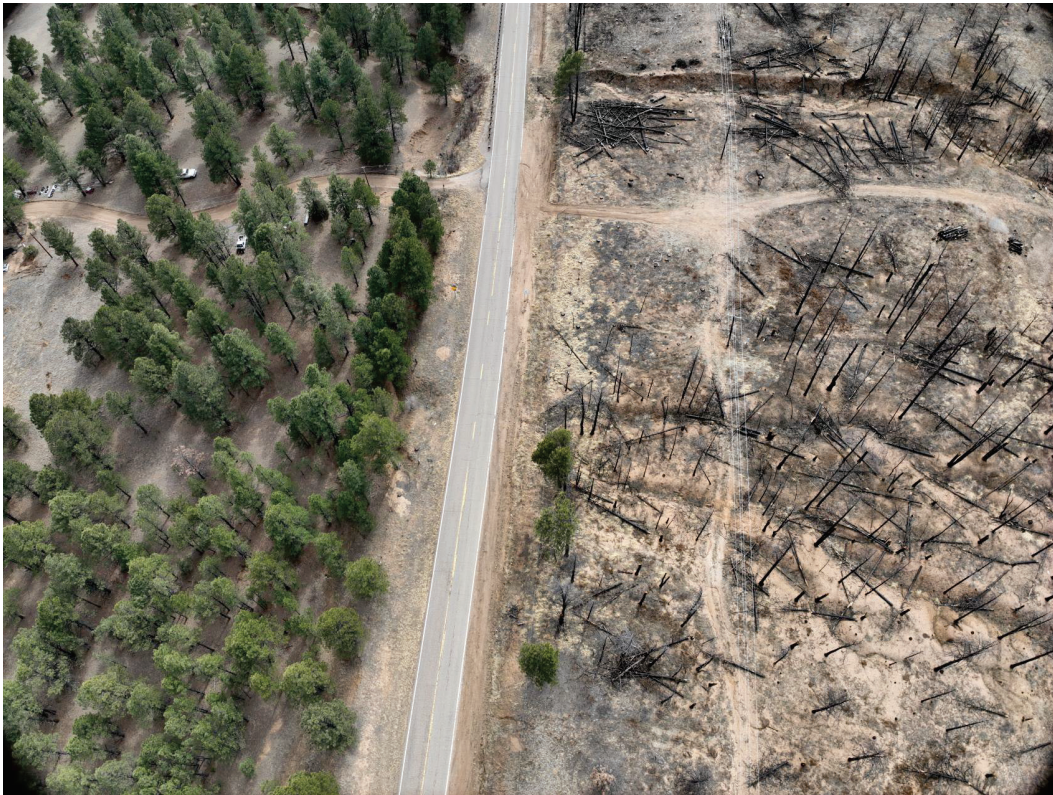
Observation ID: S53\_Ob5

This site is comprised of several problem areas along NM434 where post-fire erosion and flooding from the 2022 Calf Canyon/Hermits Peak Fire have affected the roadway. Each observation covers a relatively large area of apparent flooding and erosion, much of which extends beyond the right-of-way. While green infrastructure along the roadside would support long-term roadway stability, fully addressing the root causes of these issues will require broader upland watershed restoration outside NMDOT jurisdiction.

- Install bioswales along the ROW to manage runoff and reduce erosion.
- Construct check dams and culvert outfalls to control concentrated flow.
- Apply mulching and soil sponges to stabilize burned and erodible surfaces.
- Evaluate the feasibility of large basins in areas with higher flow volumes.

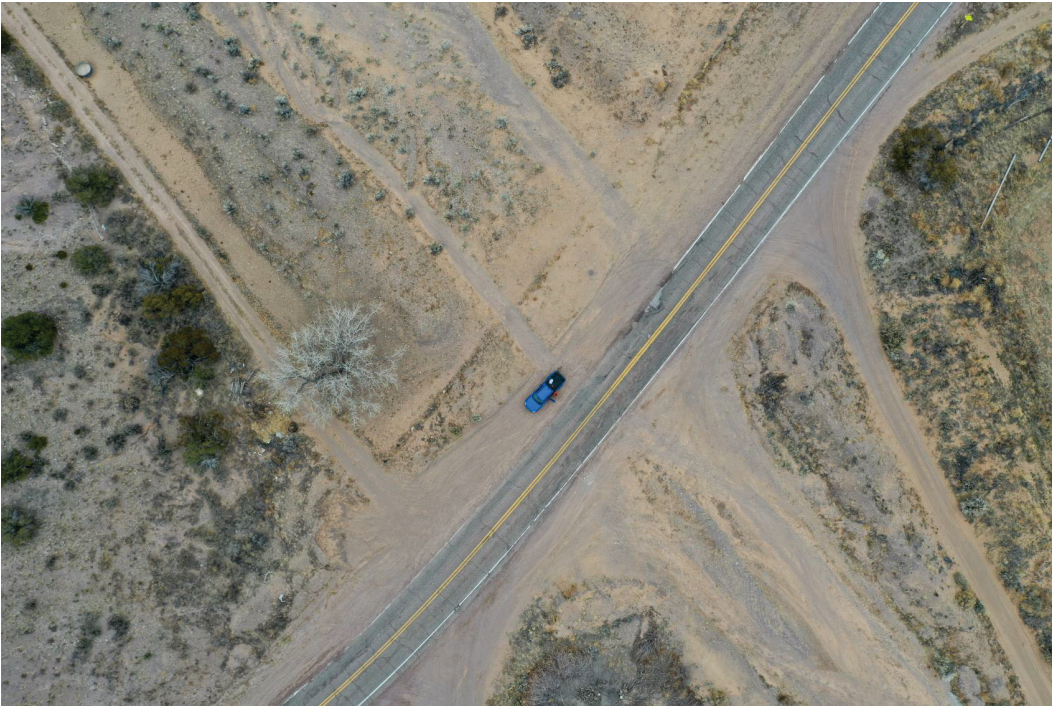
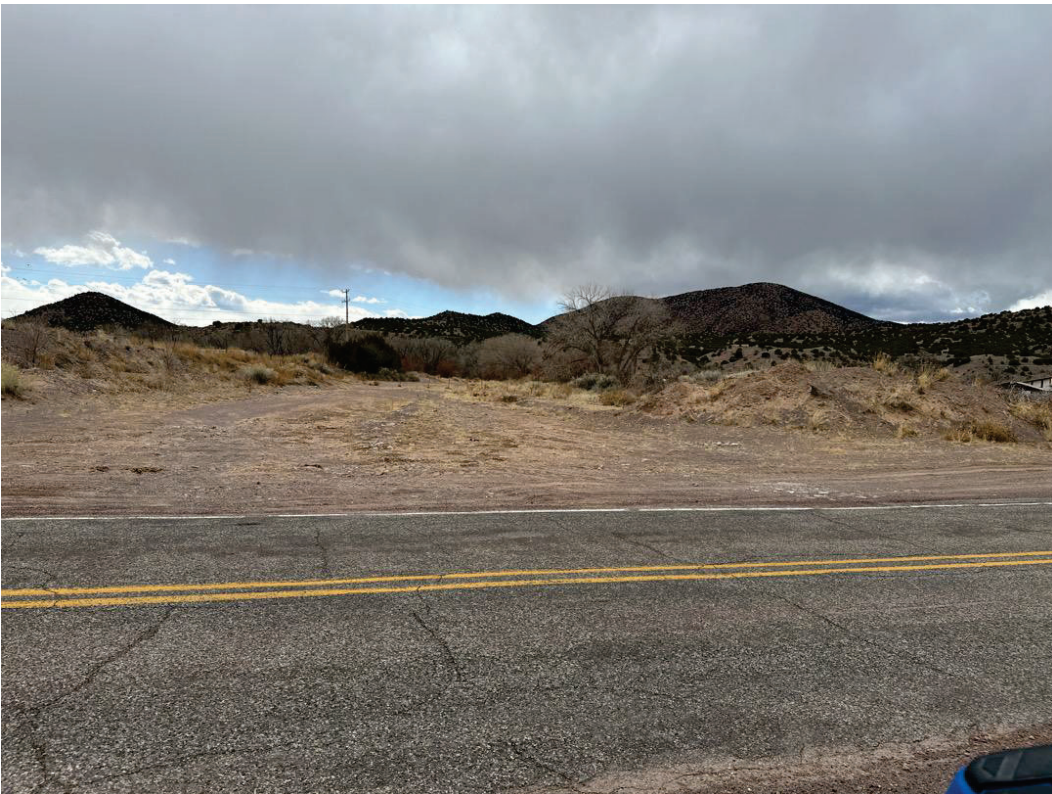
Observation ID: S55\_Ob1

At Site 55, an arroyo crosses the roadway and has deposited large amounts of sediment on and around the road surface, indicating significant flow during past storm events. The sediment piles suggest that existing drainage capacity is insufficient to handle peak discharge, and without intervention, future events may result in flooding or further roadway damage. Targeted infrastructure and green infrastructure improvements are recommended to manage runoff and sediment transport.

- Install a culvert and outfall to convey arroyo flow beneath the roadway.
- Construct a large basin to retain runoff and capture sediment.
- Add check dams and bioswales to reduce flow velocity and promote infiltration.

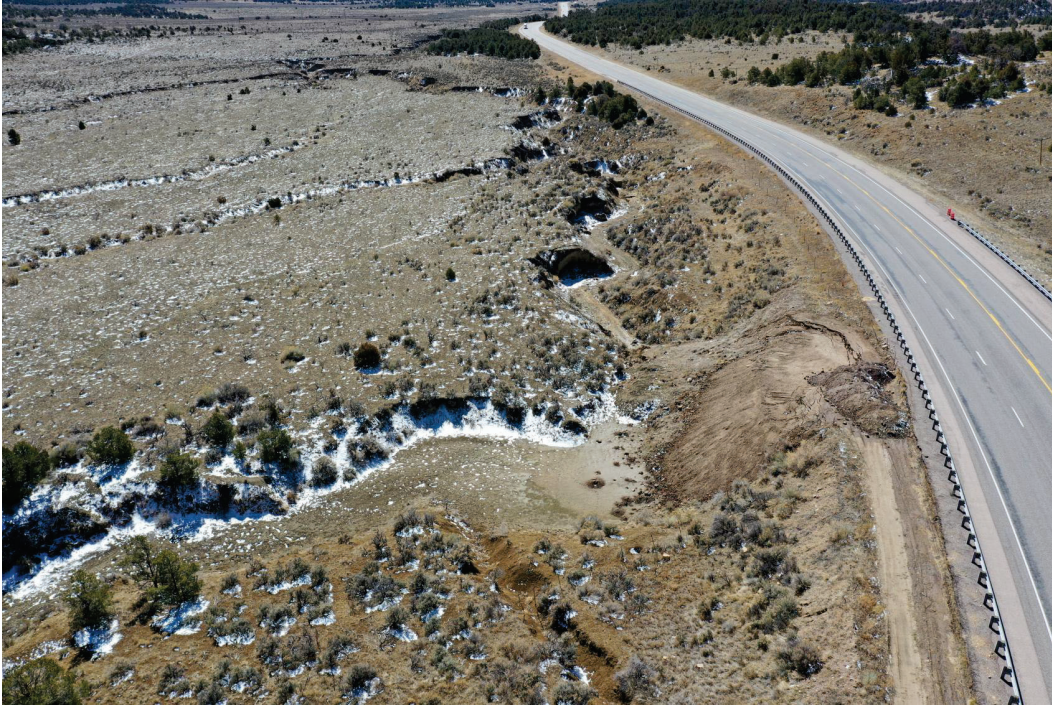
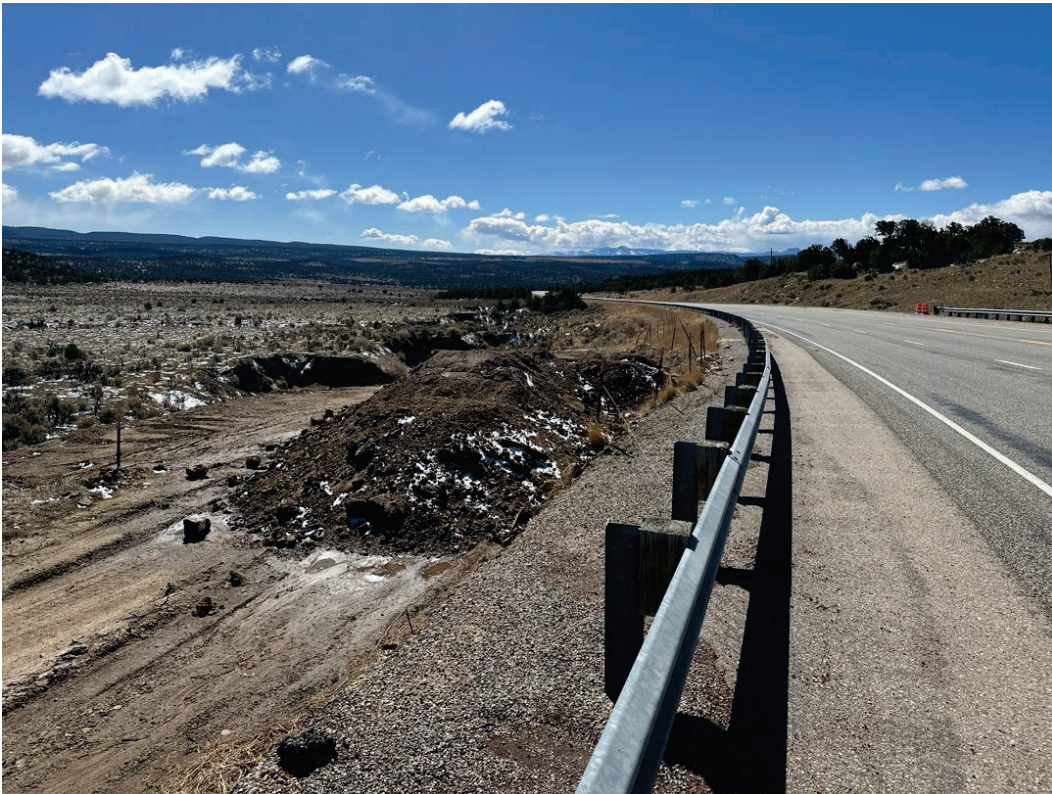
Observation ID: S56\_Ob1

Active gully erosion is occurring within an arroyo on the east side of the highway, exacerbated by slow drainage and runoff accumulation from the adjacent roadway. The combined flow from the arroyo and road surface shedding is contributing to severe soil loss and channel incision. Evidence suggests that fill material is currently being imported to the site, possibly for stabilization or grade restoration. This location presents a strong opportunity for a multi-tiered erosion control strategy to prevent continued degradation and support long-term stability.

- Implement erosion control structures, including check dams, Zuni bowls, and strategically placed rock armoring, to reduce flow velocity and minimize further incision.
- Construct bioswales to intercept and disperse road runoff before it enters the arroyo.
- Integrate green infrastructure solutions to promote infiltration and stabilize disturbed areas.

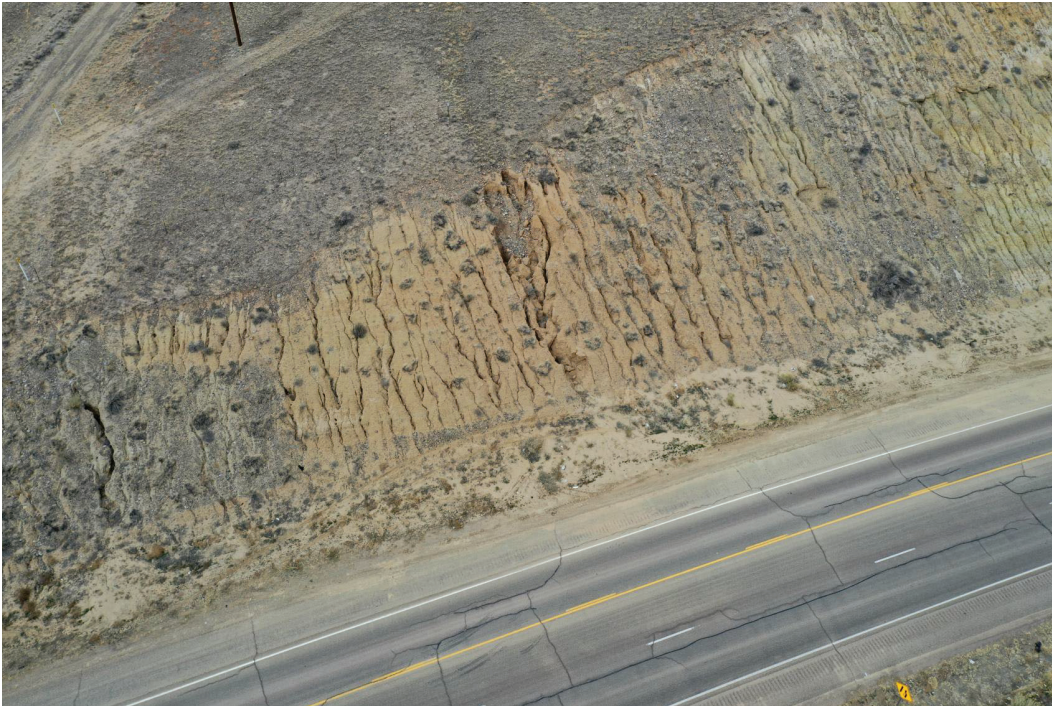
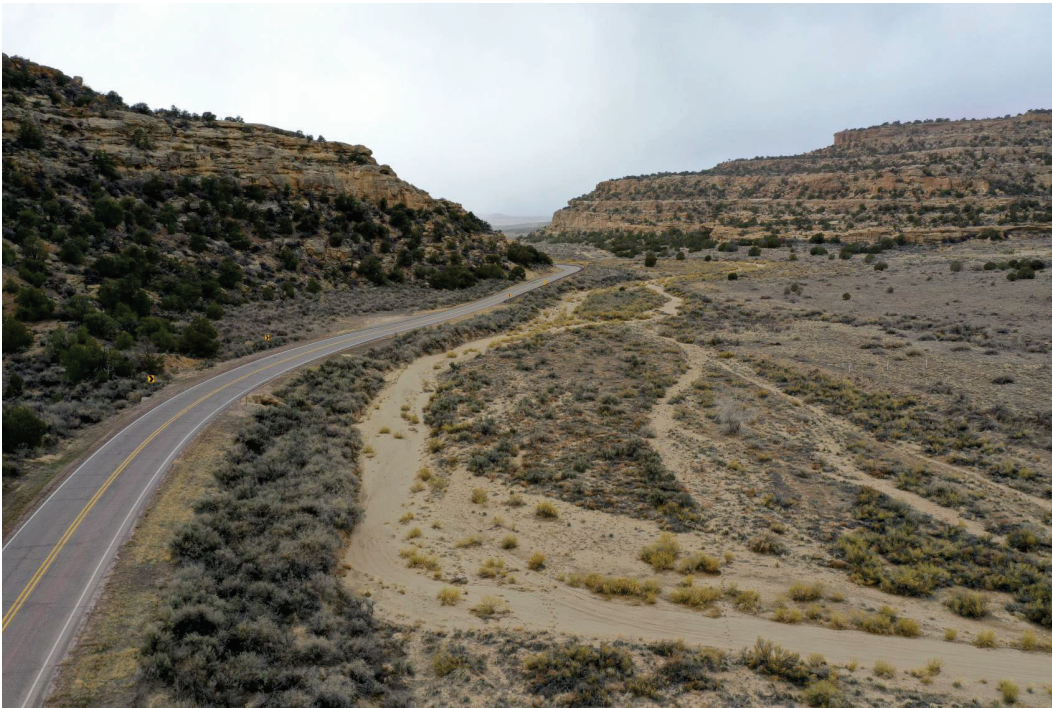
Observation ID: S57\_Ob3

Multiple issues were observed along this segment of highway, including subsidence, surface saturation, hillslope erosion, and arroyo encroachment into the right-of-way. District 5 maintenance and engineering staff noted that portions of the highway are sinking, which was supported by field observations showing saturated conditions adjacent to the roadway. Steep, bare hillslopes exhibit rilling and sediment mobilization, while active arroyo incision threatens to undermine the roadway in multiple locations.

- Construct excavated treatment wetlands and large basins to manage excess subsurface moisture.
- Install bioswales within the ROW to intercept surface runoff and reduce erosion.
- Apply mulching and revegetation on steep slopes to stabilize soils and minimize rill formation.
- Implement rock armoring and Zuni bowls to protect roadway infrastructure where arroyos are actively eroding the ROW.
- Consider channel realignment where feasible to redirect arroyo flow away from critical road segments.

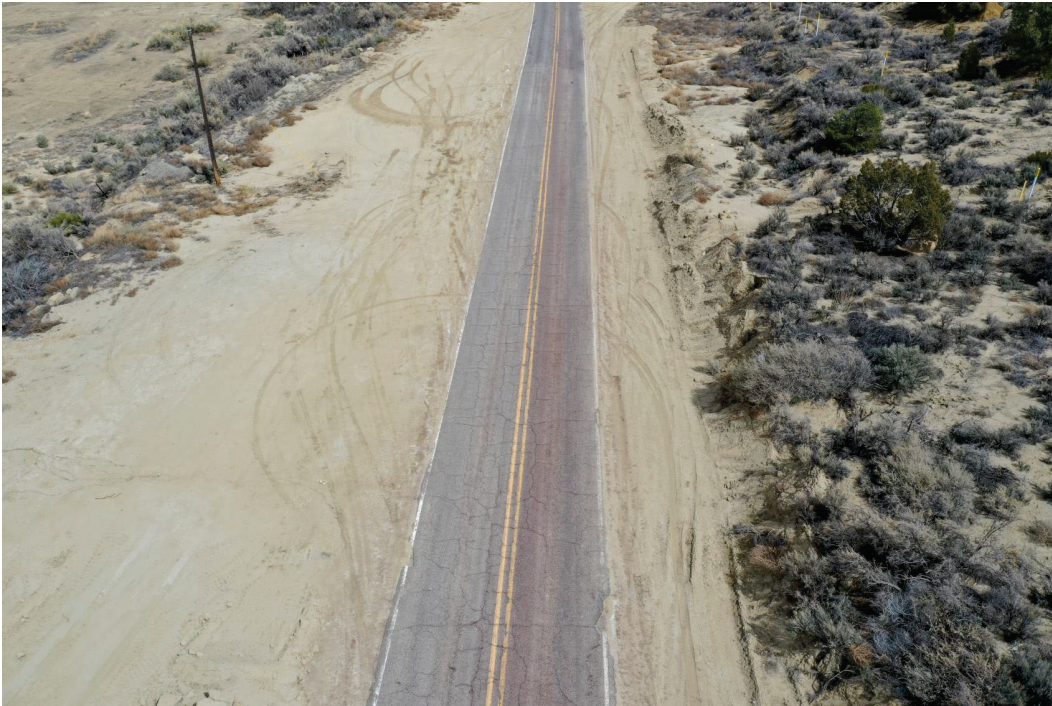
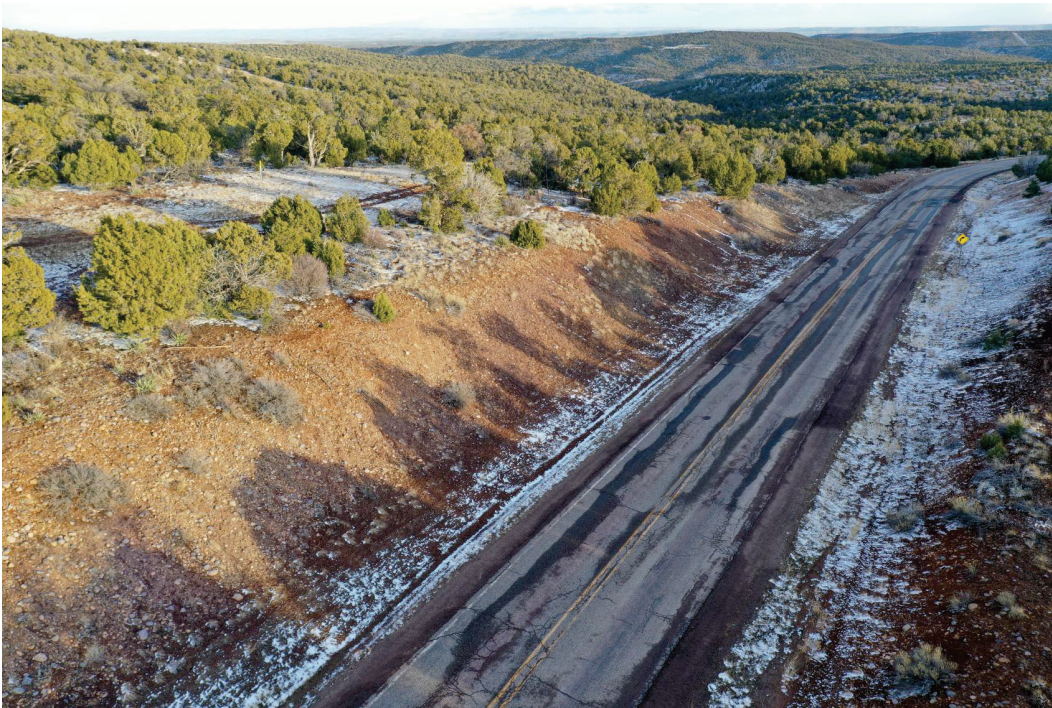
Observation ID: S59\_Ob2

This site spans multiple observation points and shows extensive erosion, sediment transport, and runoff impacts caused by steep slopes and arroyo crossings. Sediment buildup, gully formation, and localized roadway settling indicate inadequate drainage and recurring stormwater stress. A targeted set of interventions is needed to reduce maintenance and improve long-term roadway resilience.
