***Optimum Locations for the Benefits of Green  
Infrastructure (GI) on the NMDOT Transportation  
System  
May 2025***

*Prepared for:  
New Mexico Department of Transportation  
Albuquerque, NM*

*Prepared by:  
GeoSystems Analysis, Inc.  
8601 Paseo Alameda NE; Suite B  
Albuquerque, NM 87113*

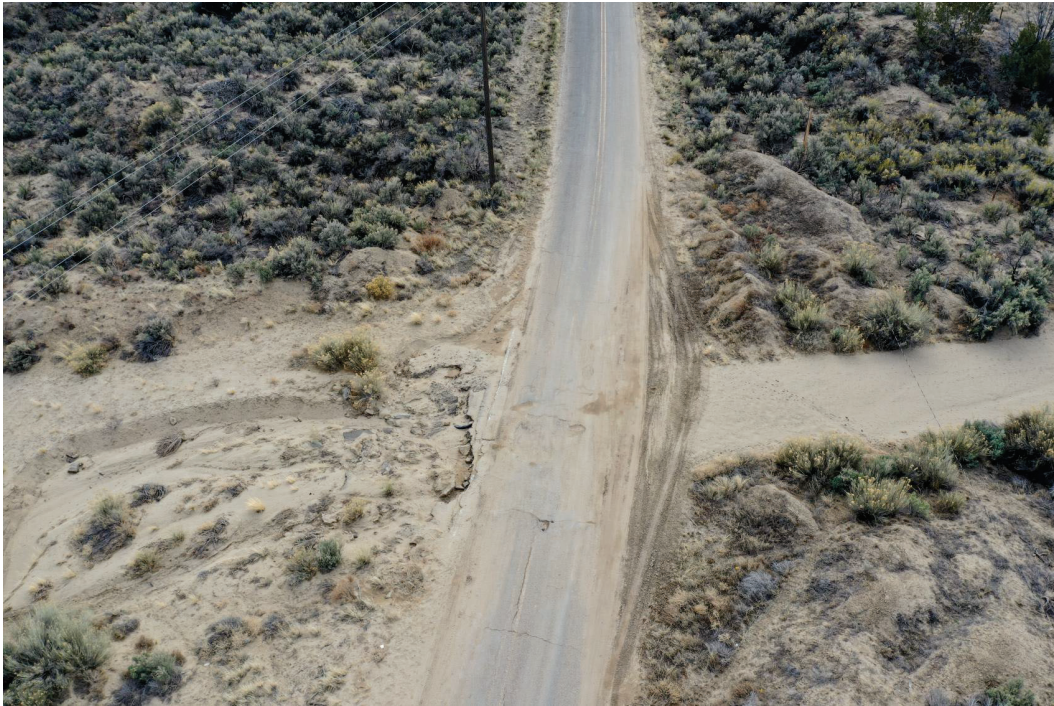
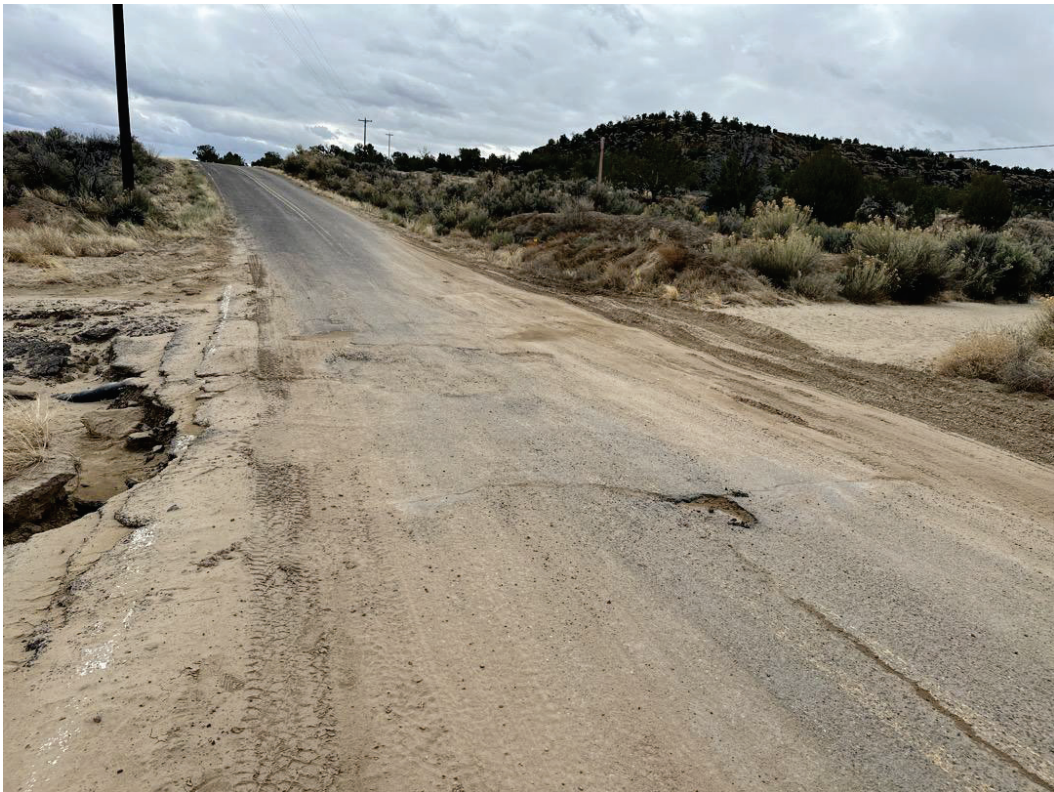
Observation ID: S60\_Ob1

Site 60 includes a single arroyo crossing where no culvert infrastructure is present. Sediment deposits on the road surface and evidence of surface runoff indicate that flow frequently overtops the roadway. Without intervention, continued erosion and debris accumulation may affect road safety and drainage performance. Green and structural infrastructure improvements are recommended to manage flow and reduce sediment transport.

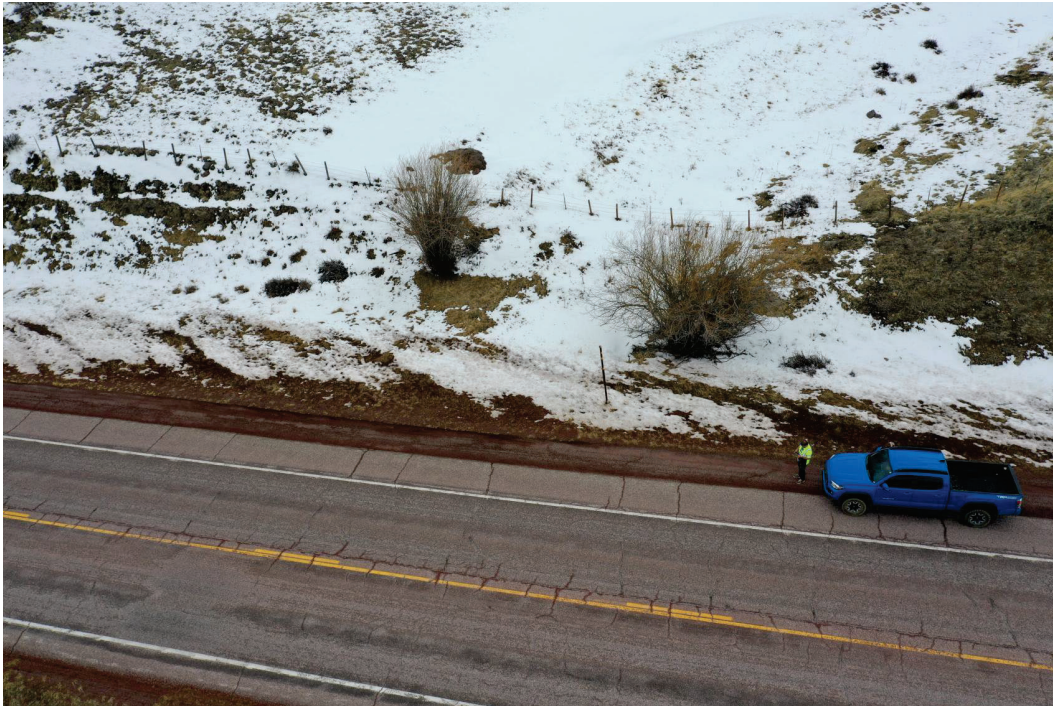
Observation ID: S65\_Ob1

Along a one-mile-long segment of NM17, water ponds persistently on the west side, likely saturating the base coarse and contributing to roadway settlement and cracking. Multiple small drainages descend from hills to the west, concentrating flow toward the road. Field observations confirm extensive cracking, including areas of recent repair.

- Install drainage basins to intercept and detain runoff from the west-facing slopes.
- Improve subsurface drainage infrastructure beneath the roadway to reduce base coarse saturation and prevent further settling.
- Conduct geotechnical assessment to evaluate subsurface conditions and guide stabilization design.
- Drainage improvements are critical to protecting roadway integrity and minimizing future maintenance needs.
