Comparing Resistivity and Conductivity in Metal Culverts

Final Report

Agua del Sol Consultants, LLC
PO Box 92797
Albuquerque, NM 87199

Report R924020

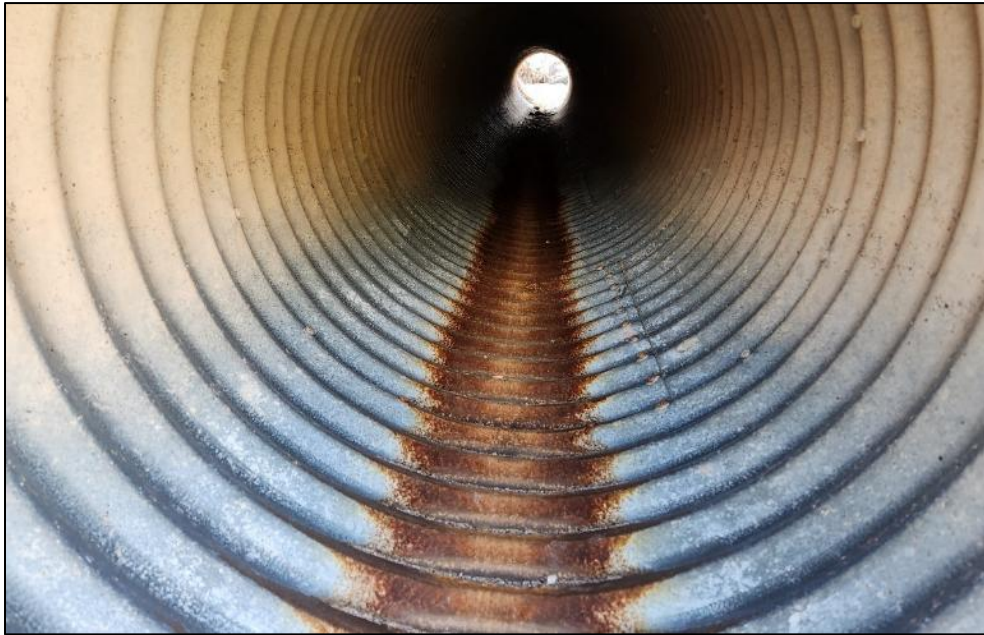
This culvert was visited on 11/05/2025 and is located on northbound (NB) I-25. This culvert had visible corrosion on the bottom inside and slight corrosion on the top outside when in contact with the surrounding soils as seen in **FIGURE 5**, **FIGURE 6**, and **FIGURE 7** below.

FIGURE 6: Inside of the outlet side of the culvert on I-25 (NB) MP 107.86.

This location had visible corrosion on the outside of the culvert only in locations close to the surrounding soils, as seen in **FIGURE 7** above. Additionally, corrosion was present on the inside bottom of the culvert, as seen in **FIGURE 5** and **FIGURE 6**, above. The slightly greater than 7.3 pH indicated that corrosion on the soil side will govern in this location. With the soil's resistivity being greater than 2000 ohm-cm at this location, the corrosion potential due to the soil's resistance values is negligible, with the corrosion on the inside bottom of the culvert likely a result of runoff from the interstate.

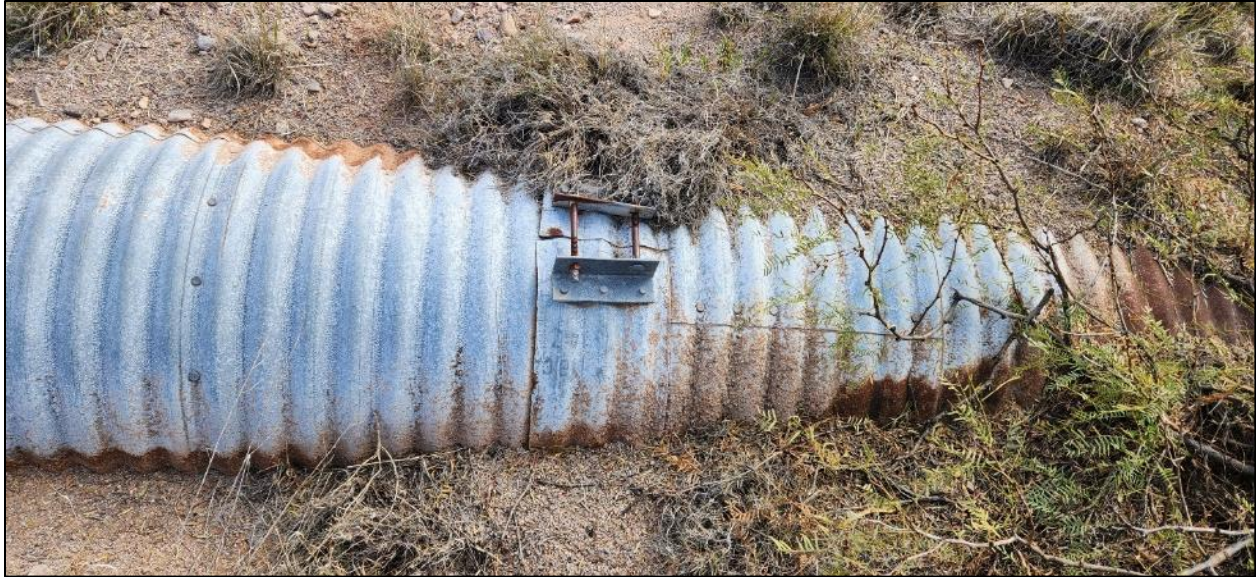
FIGURE 7: Outside of the outlet side of the culvert on I-25 (NB) MP 107.86.

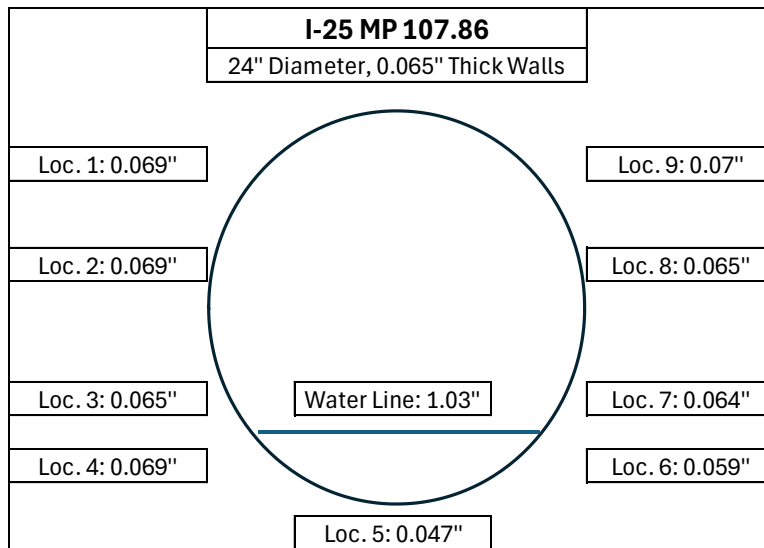
Using a micrometer on uncorroded locations of the culvert, a thickness of 0.0650”, 0.0658”, and 0.0659” was measured at three different locations, for an average of 0.0656”. The closest gage thickness to this value is 16, with a galvanized thickness of 0.064”. The ultrasonic measurements showed a thickness between 0.047” and 0.070”, with the thinnest measurements taken on the bottom.

FIGURE 8: Diagram of wall thickness measurements taken at I-25 (NB) MP 107.86 culvert.

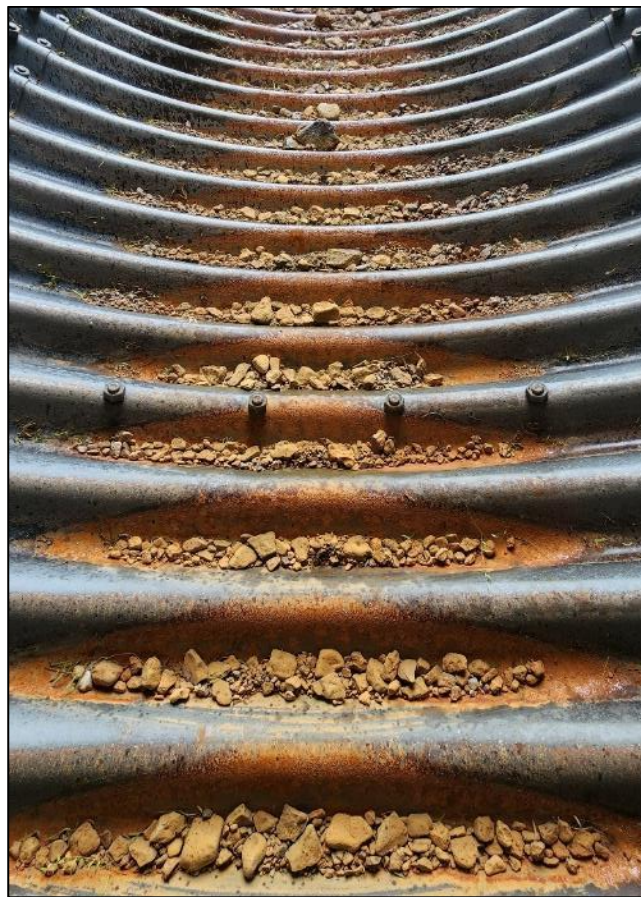
This culvert was visited on 11/05/2025. This culvert had visible corrosion on the bottom inside (**FIGURE 10**) and pitting from outside-in corrosion present in multiple locations throughout the culvert, but concentrated near the inlet and outlet areas, as seen in **FIGURE 11** below.

FIGURE 10: Inside of the outlet side of the culvert on I-25 MP 113.04.

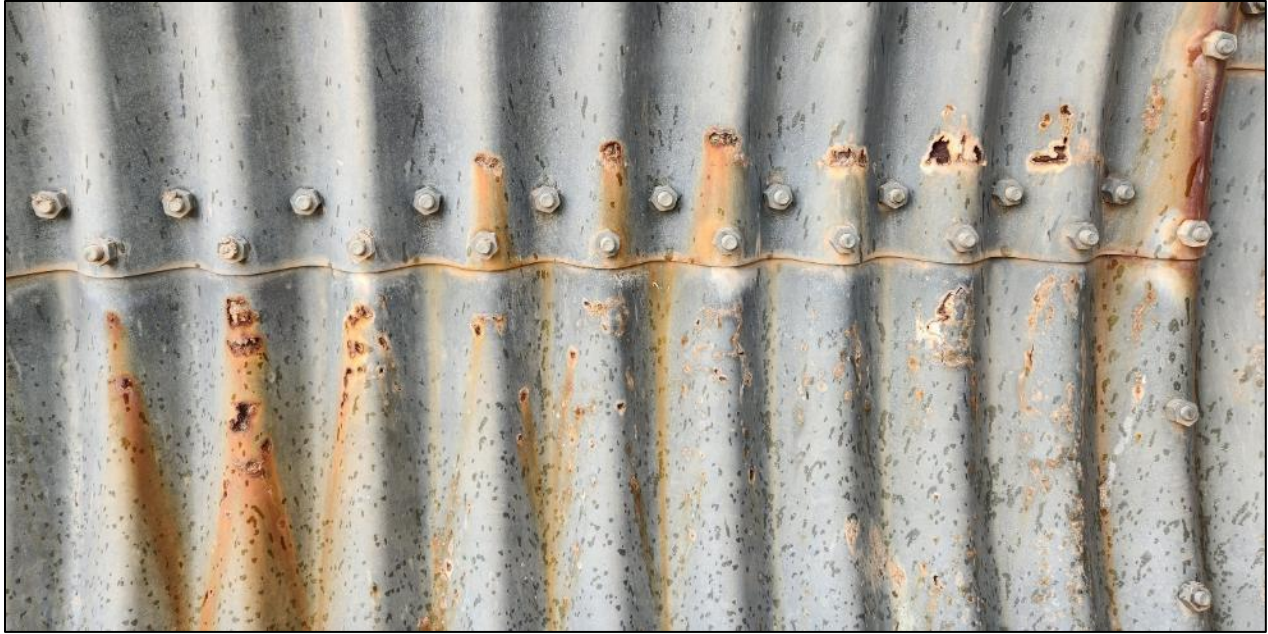
FIGURE 11: Inside wall of the outlet side of the culvert on I-25 MP 113.04.

No visual inspection of the outside of this culvert was available, due to it being encased in concrete, but the presence of corrosion on the outside was seen by the pitting corrosion throughout the culvert caused by outside-in corrosion, concentrated near the inlet and outlet, as seen in **FIGURE 11** above. The slightly greater than 7.3 pH indicated that corrosion on the soil side will govern in this location. With the soil's resistivity being greater than 2000 ohm-cm at this location, the corrosion potential due to the soil's resistance values is negligible.

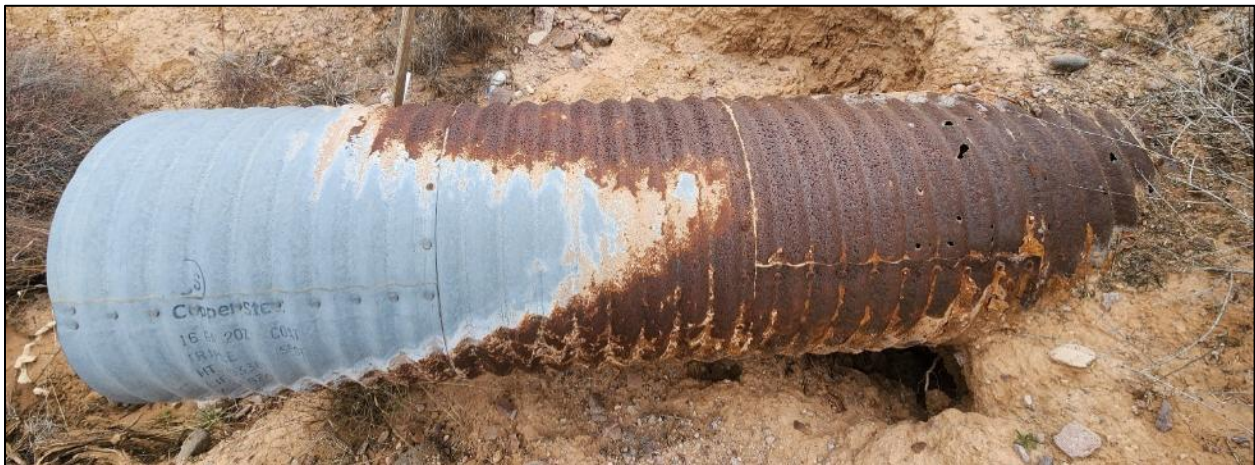
This culvert was visited on 11/05/2025. This culvert had significant visible corrosion on the outside, **FIGURE 12** and **FIGURE 13**. There was no corrosion present on the inside portion of the outlet that was not in contact with the soil, **FIGURE 12** and **FIGURE 14**, but further in, there is significant corrosion throughout the inside where the culvert is in contact with the surrounding soils (**FIGURE 15**). The pitting corrosion is clearly seen in **FIGURE 13** and **FIGURE 15** below.

FIGURE 13: Culvert on I-25 (NB) MP 142.49, outlet side.

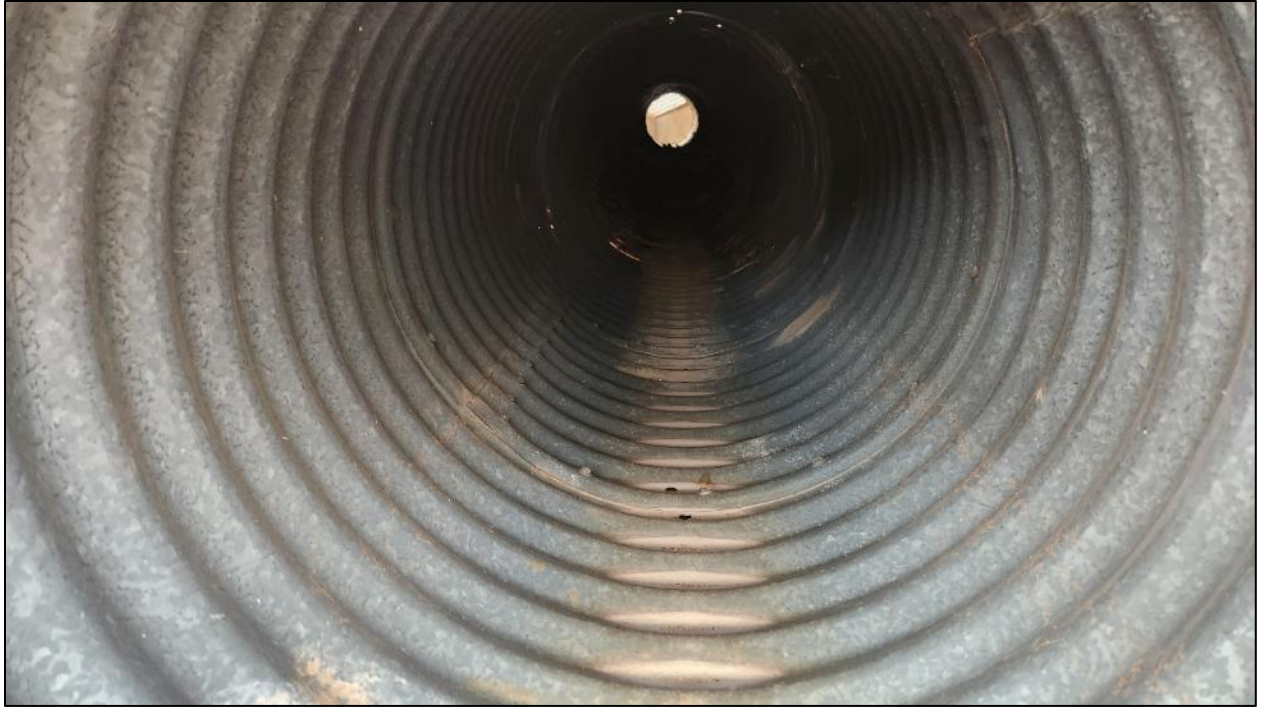
FIGURE 14: Culvert on I-25 (NB) MP 142.49, inside view near outlet side.

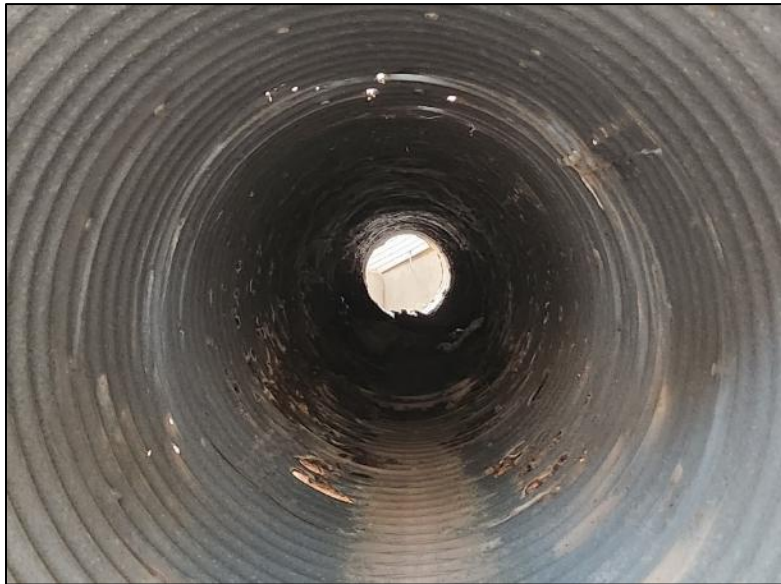
FIGURE 15: Culvert on I-25 (NB) MP 142.49.

This location had significant corrosion in locations that used to be covered by the surrounding soil and locations in current contact with the surrounding soil. The presence of soils with greater than 7.3 pH indicated that corrosion on the soil side will govern in this location, as seen in **FIGURE 12** and **FIGURE 13** above. With the soil’s resistivity being greater than 2000 ohm-cm at this location and no visible inside-out corrosion on this culvert, the corrosion potential due to the soil’s resistance values is negligible.

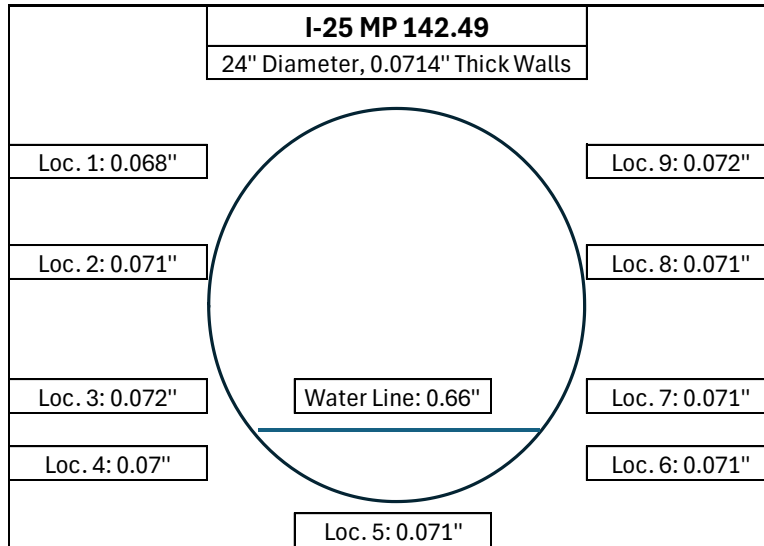
Using a micrometer on uncorroded locations of the culvert, a thickness of 0.0712", 0.0721", and 0.0710" was measured at three different locations, for an average of 0.0714". The closest gage thickness to this value is 14, with a galvanized thickness of 0.079". The ultrasonic measurements showed a thickness between 0.068" and 0.072", with the thinnest measurements taken on the bottom.

FIGURE 16: Diagram of wall thickness measurements taken on I-25 (NB) MP 142.49 culvert.

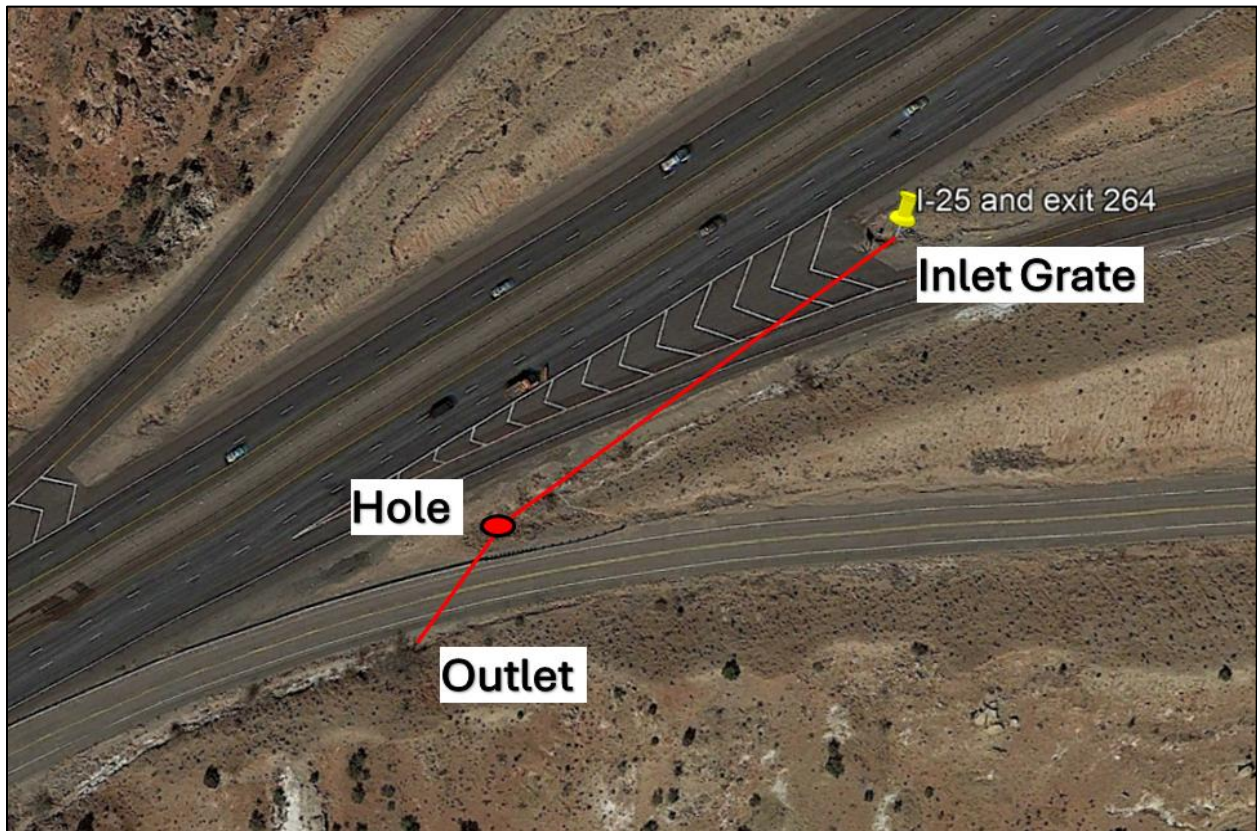
This location consists of two separate culverts (unverified and assumed based on field observations) as displayed in **FIGURE 17**, with the first culvert connecting “Inlet Grate” to “Hole” and the second culvert connecting “Hole” to “Outlet.” The first culvert drains the area between NB I-25 and exit 264’s off ramp with a metal grate at the intake, **FIGURE 18**. The outlet of this first culvert is assumed to be in the

FIGURE 17: Location of “Inlet Grate,” tumbleweed-filled “Hole,” and “Outlet” of the 2 separate 24” culverts near NB I-25 and exit 264. The red line is an estimated location of both culverts.

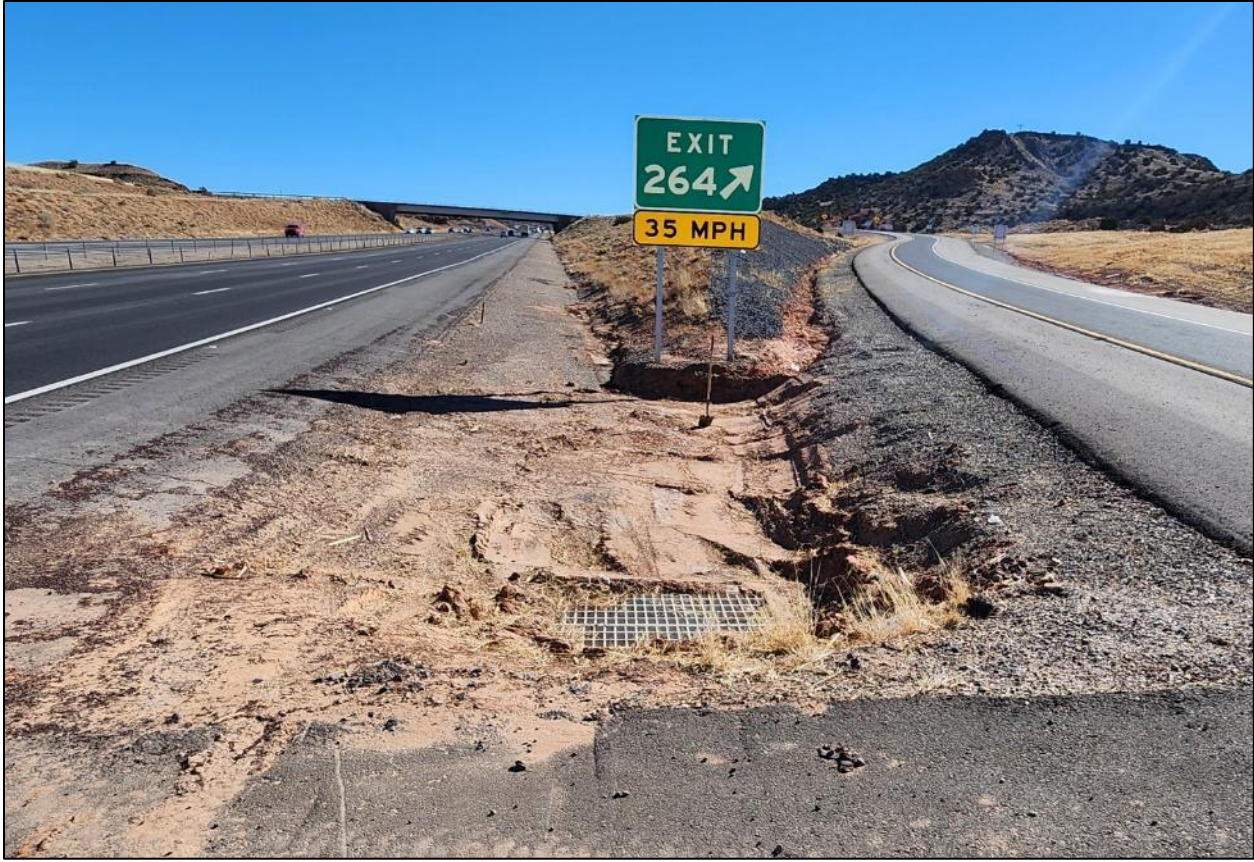
FIGURE 18: Image of “Inlet Grate” between NB I-25 and the offramp for exit 264.

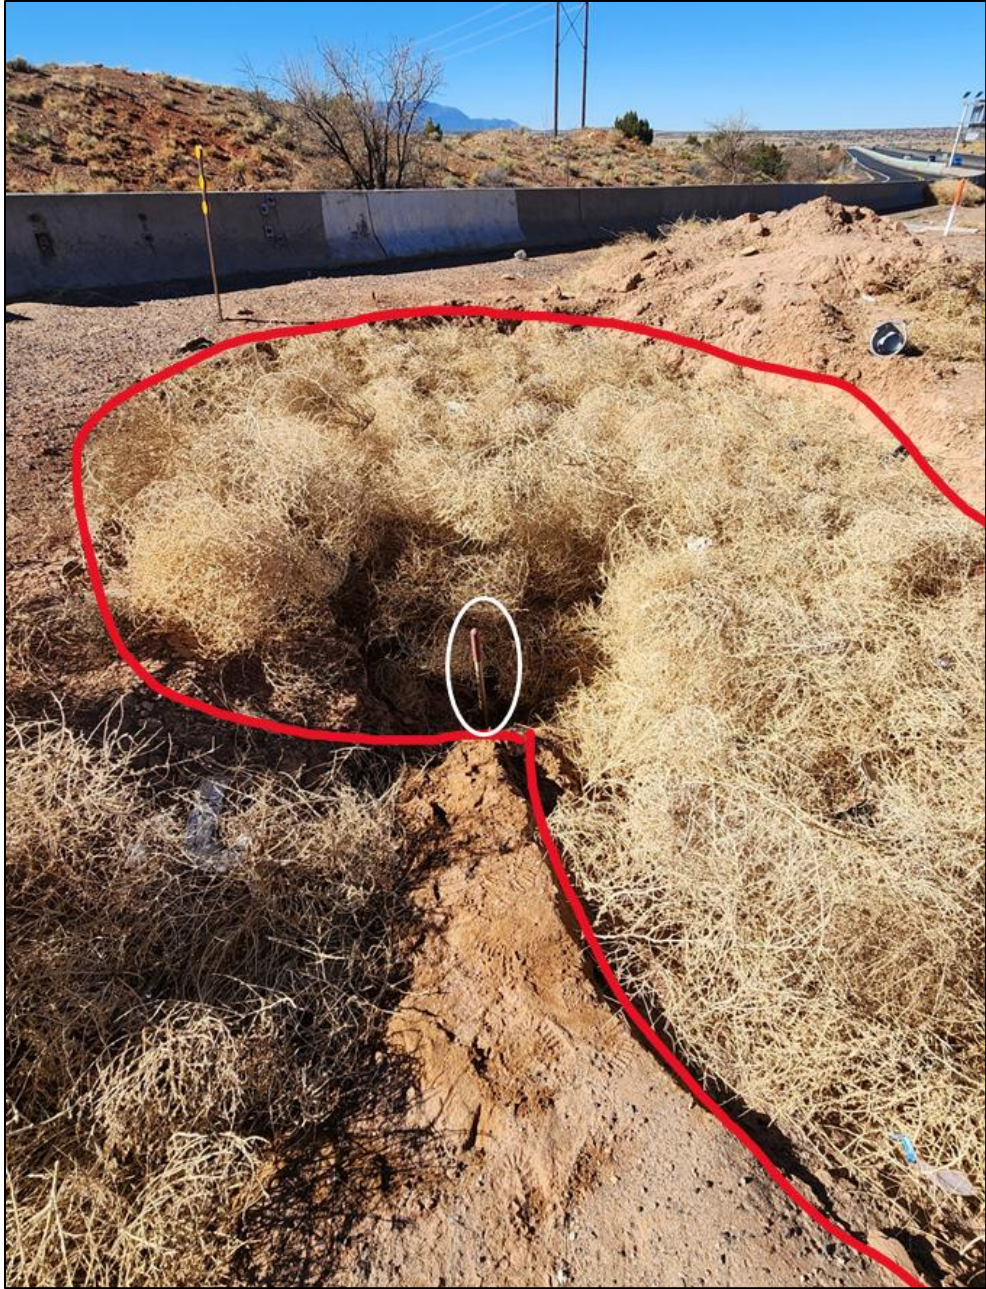
tumbleweed-filled “Hole,” but this was unable to be unverified. The second culvert is assumed to start in the tumbleweed-filled “Hole,” **FIGURE 19**, with the outlet shown in **FIGURE 20**. The inlet of this second culvert was inaccessible due to being buried below 6-10 feet of tumbleweeds, with the bottom of the “Hole” having a few inches of standing water. The outlet of the second culvert was also inaccessible and unsafe for measurement, as it was almost fully corroded away with only small portions of the original metal remaining and was located 4 feet below an actively collapsing trench wall. A close-up image of the outlet culvert’s remaining metal is shown in **FIGURE 21**. Only the area near the “Inlet Grate” was accessible for in-situ tests and soil sample collection, with the data presented in **TABLE 4**.

FIGURE 19: Image of the tumbleweed-filled “Hole,” outlined in red, and a 5’ 6” long shovel outlined in white from culvert between Exit 264 offramp and I-25.

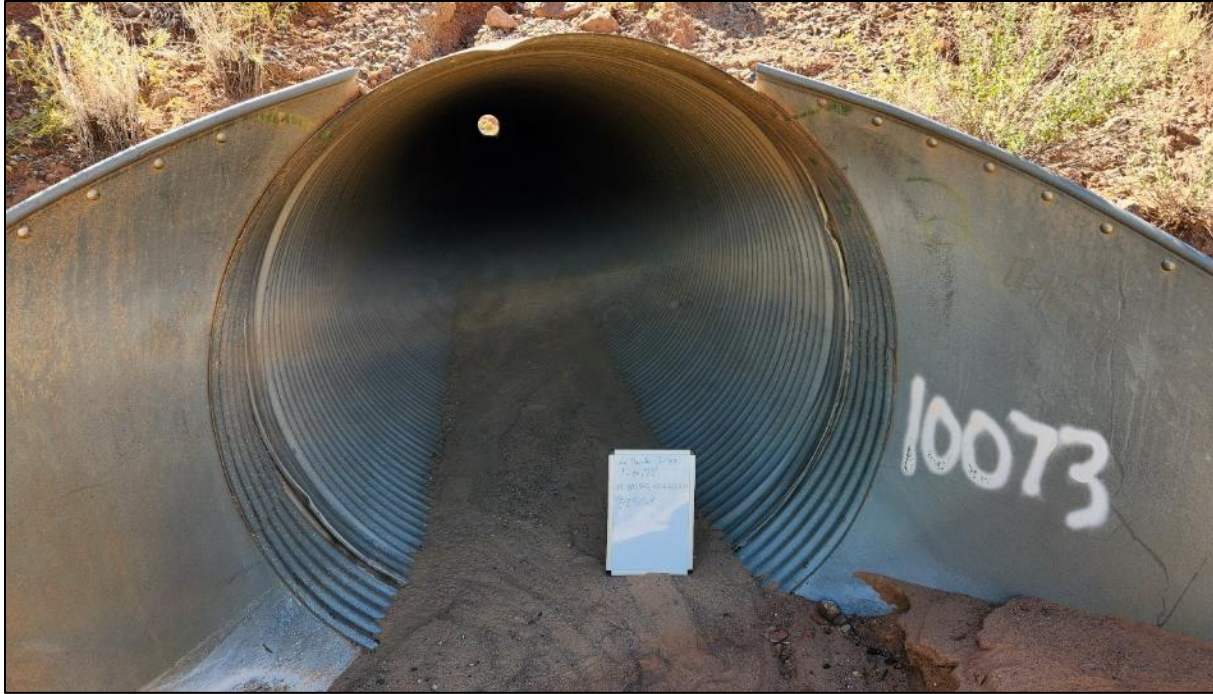
The 78" culvert south of the Cochiti exit that goes under the frontage road east of I-25 and under both lanes of I-25 was visited on 9/25/2024 and then again on 3/25/25. Approximately the first foot of the culvert is 12-gage, 0.1046" thick and the remaining length of the culvert is 16-gage, 0.064" thick. The image below, **FIGURE 22**, is looking into the inlet (west side of I-25). The only location where the outside of the culvert was accessible was at the outlet, which was completely corroded over, but no pitting or holes was observed, **FIGURE 24** below. There was approximately 9 inches of sandy soil on the bottom of the culvert on the inlet side. The culvert had minimal corrosion on the bottom, mostly appearing as scale buildup, **FIGURE 23**.

FIGURE 22: 72" culvert under I-25 at 264.2, inlet.

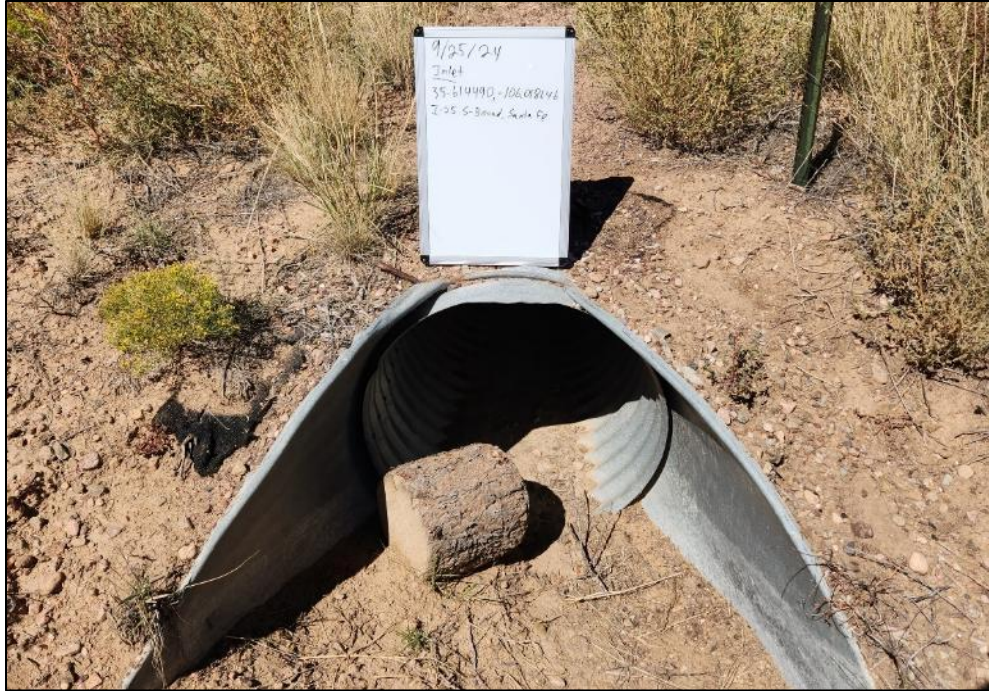
This 24" culvert under the southbound lane of I-25 is located east of Cerrillos road overpass by 1.2 miles and was visited on 9/25/2024. The image below, **FIGURE 27**, is looking into the inlet (facing north between the south bound and north bound lanes of I-25). There was approximately 2 inches of loamy soil on the bottom of the culvert on the inlet side. The culvert had no corrosion present on the inside, as seen in **FIGURE 28**.

FIGURE 27: Culvert at I-25 (SB) MP 278.7, inlet side facing North.

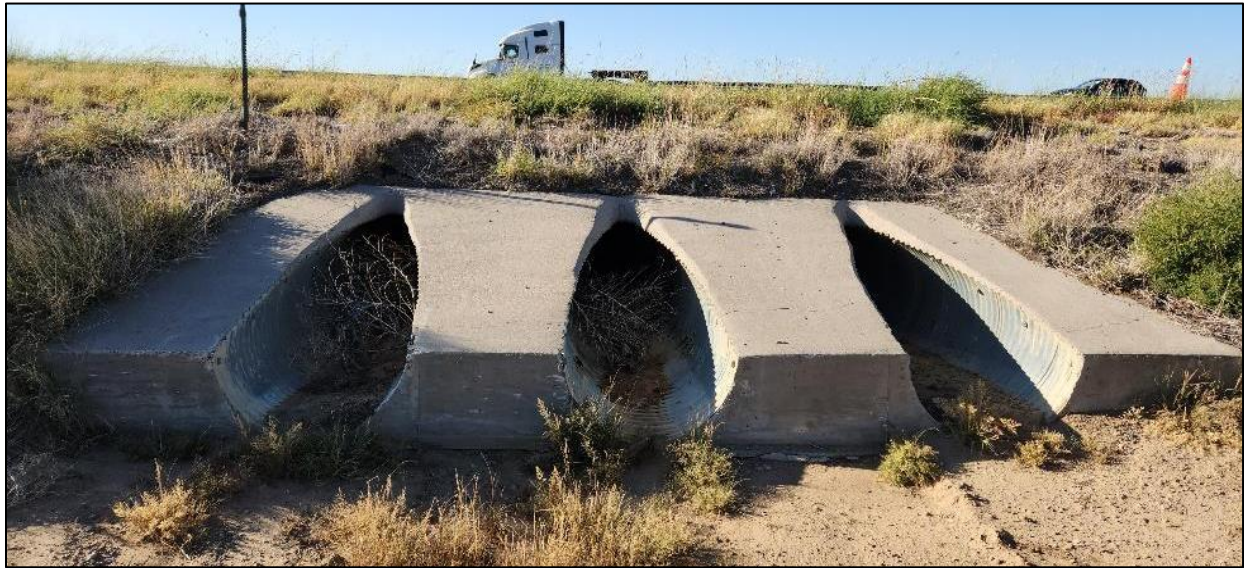
The three adjacent 36” culverts (**FIGURE 30**) were visited on 9/26/24.

FIGURE 30: 3-36" CMP I-40 MP 121.0, inlet side, westbound I-40 (facing south).

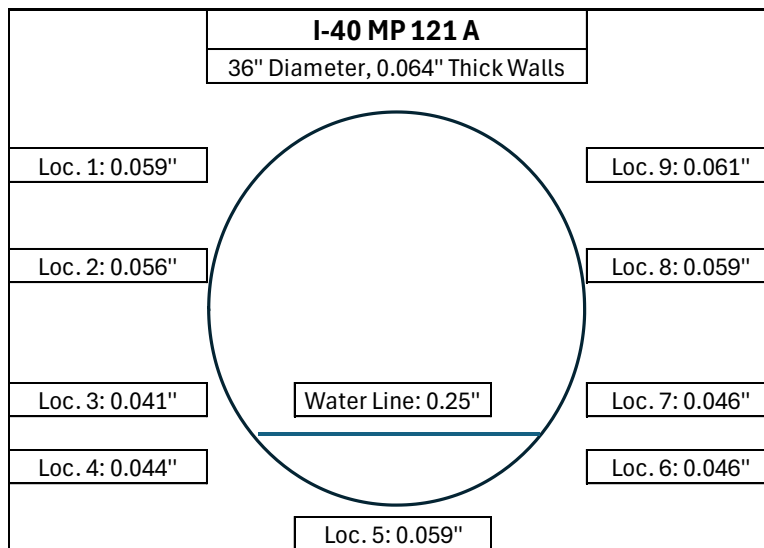
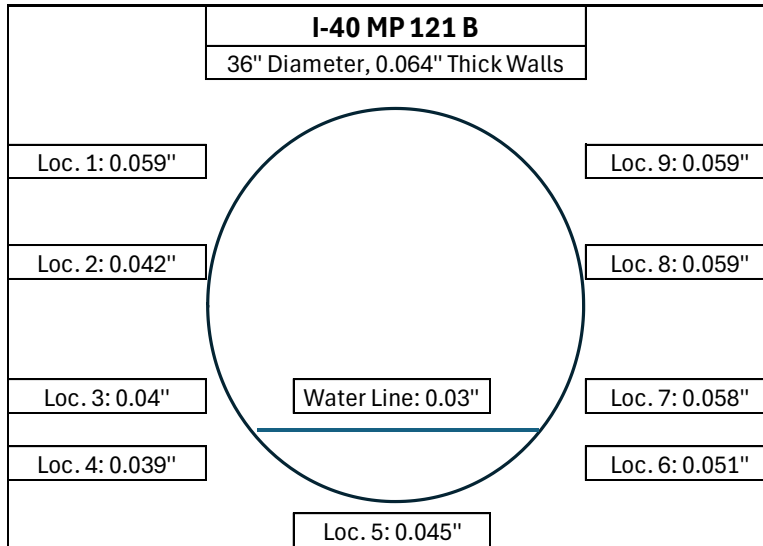
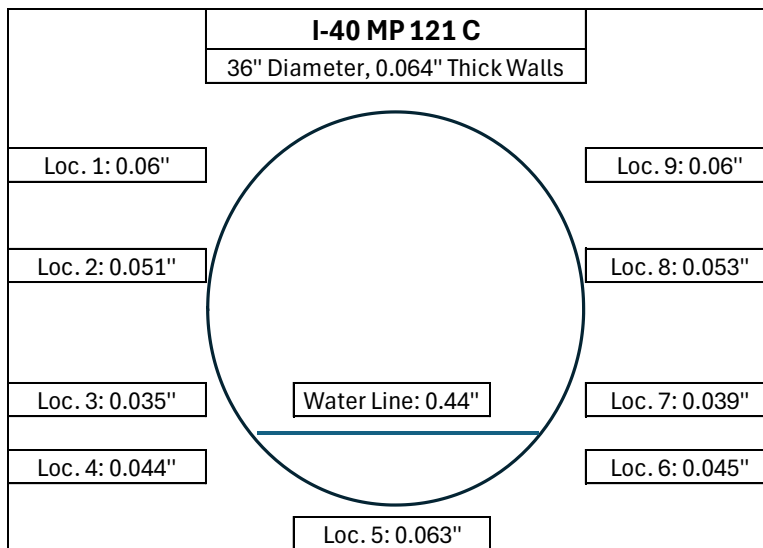
The three figures below (**FIGURE 31**, **FIGURE 32**, and **FIGURE 33**) show the wall thickness values for all three culverts for each measurement location. The rib where the wall thickness was measured for each culvert A, B, and C was 5', 3', and 4', respectively, from the end of the culvert with these locations chosen randomly.

FIGURE 31: Diagram of wall thickness measurements taken at I-40 MP 121 A culvert.

FIGURE 32: Diagram of wall thickness measurements taken at I-40 MP 121 B culvert.

FIGURE 33: Diagram of wall thickness measurements taken at I-40 MP 121 C culvert.

Locations 3 and 4 and locations 6 and 7 showed, on average, the most metal loss due to corrosion, with these regions having the most perforations on all three culverts, as shown in **FIGURE 34** and **FIGURE 35** below for Culverts A and B. In all occurrences of observed corrosion, the corrosion began on the outside of the culvert, with little to no corrosion on the inside of the culvert.

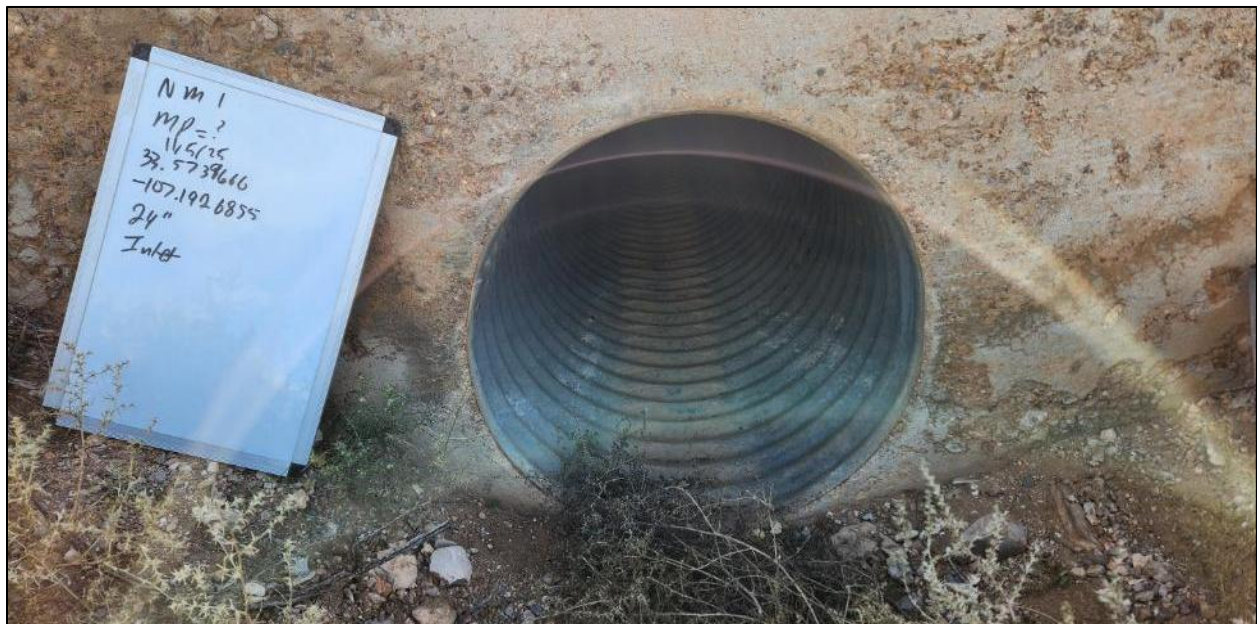
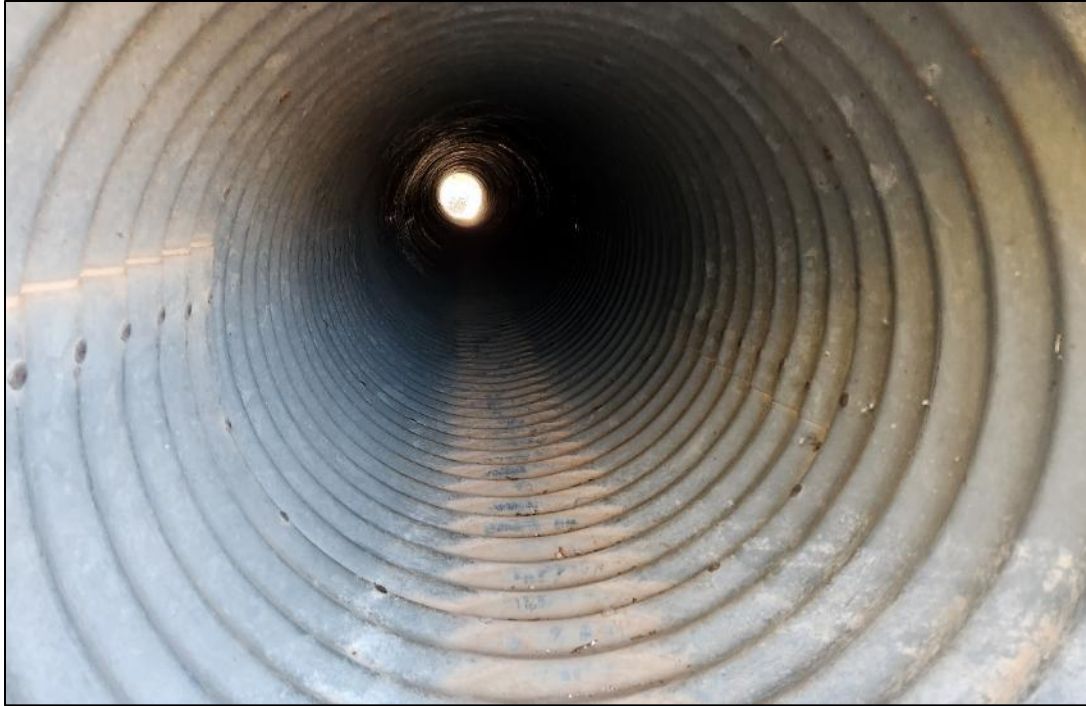
This culvert was visited on 11/05/2025. This culvert had no visible corrosion on the inside as seen in **FIGURE 36** and **FIGURE 37** below. The culvert’s inlet and outlet were encased in concrete, preventing observation of the outside of the culvert.

FIGURE 36: Culvert on NM 1 MP 19.24, inlet side.

FIGURE 37: Inside of the inlet side of the culvert on NM 1 MP 19.24.

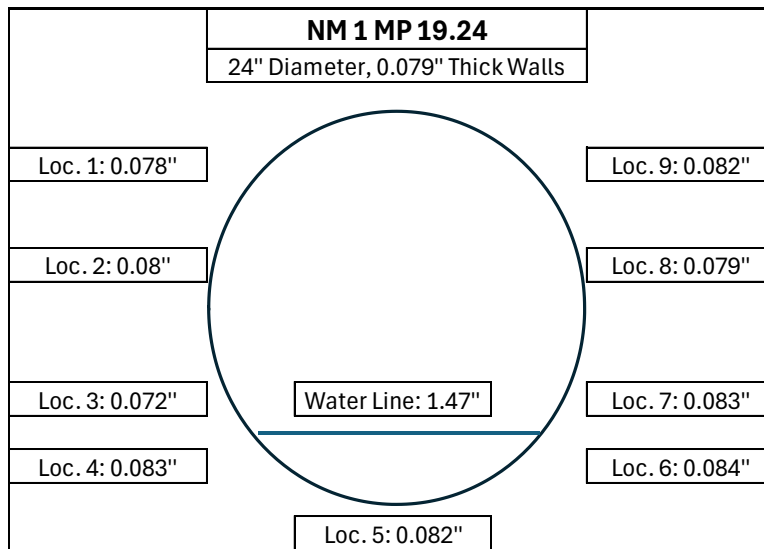
Micrometer measurements were unable to be collected on this culvert due to it being encased in concrete, but the average thickness of ultrasonic measurements was 0.0803". This average thickness closely matches a 14-gage culvert's thickness of 0.079". The ultrasonic measurements showed a thickness between 0.072" and 0.084", indicating the potential presence of corrosion on the outside of the culvert, with some scaling buildup.

FIGURE 38: Diagram of wall thickness measurements taken at NM 1 MP 19.24 culvert.

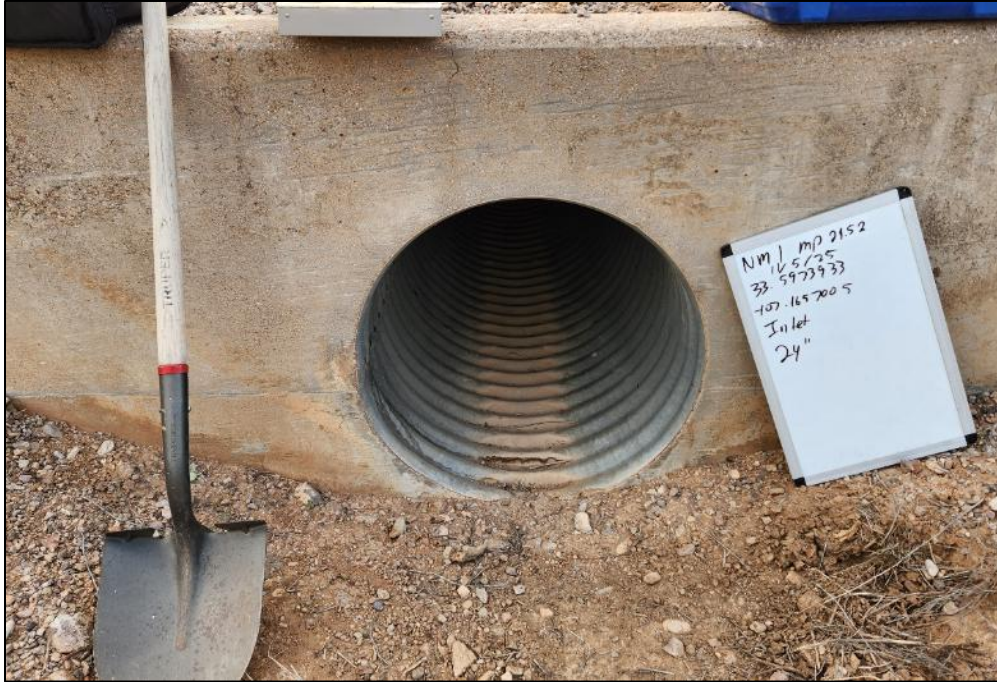
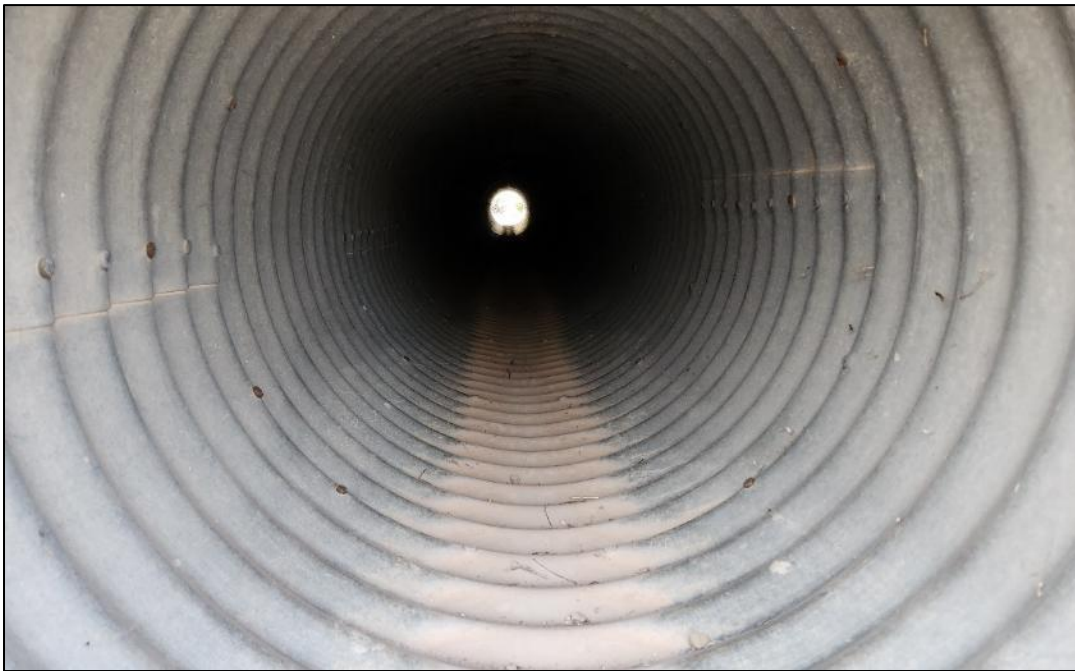
This culvert was visited on 11/05/2025. This culvert had no visible corrosion on the inside as seen in **FIGURE 41** and **FIGURE 42** below. The culvert's inlet and outlet were encased in concrete, preventing observation of the outside of the culvert.

FIGURE 41: Culvert on NM 1 MP 21.52, inlet side.

FIGURE 42: Inside of the inlet side of the culvert on NM 1 MP 21.52.

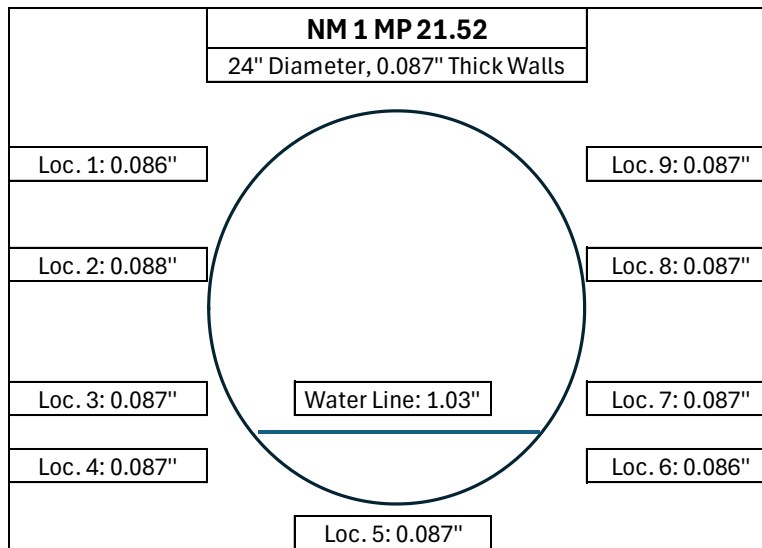
Micrometer measurements were unable to be collected on this culvert due to it being encased in concrete, but the average thickness of ultrasonic measurements was 0.087". This average thickness is 0.0078" larger than the closest matching standard culvert thickness of 14-gage with a culvert's thickness of 0.079". The ultrasonic measurements showed a thickness between 0.086" and 0.088", indicating the potential presence of corrosion on the outside of the culvert, with some scaling buildup.

FIGURE 43: Diagram of wall thickness measurements taken at NM 1 MP 21.52 culvert.

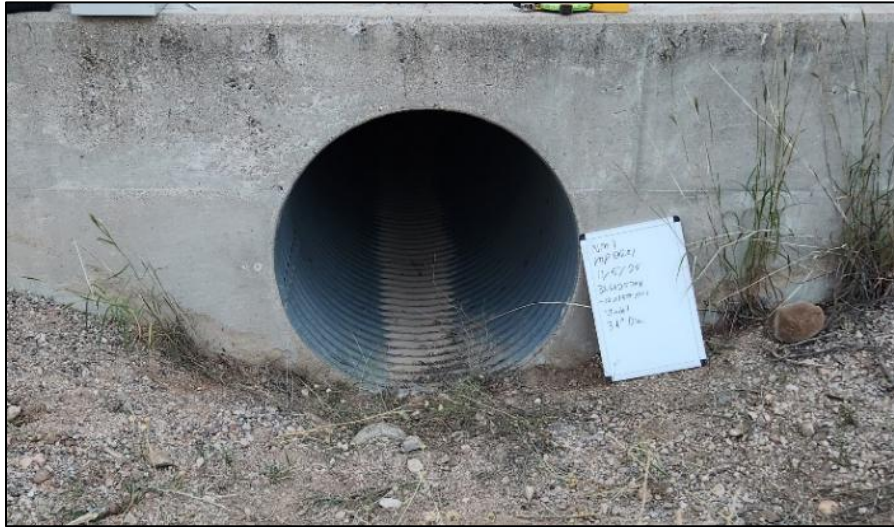
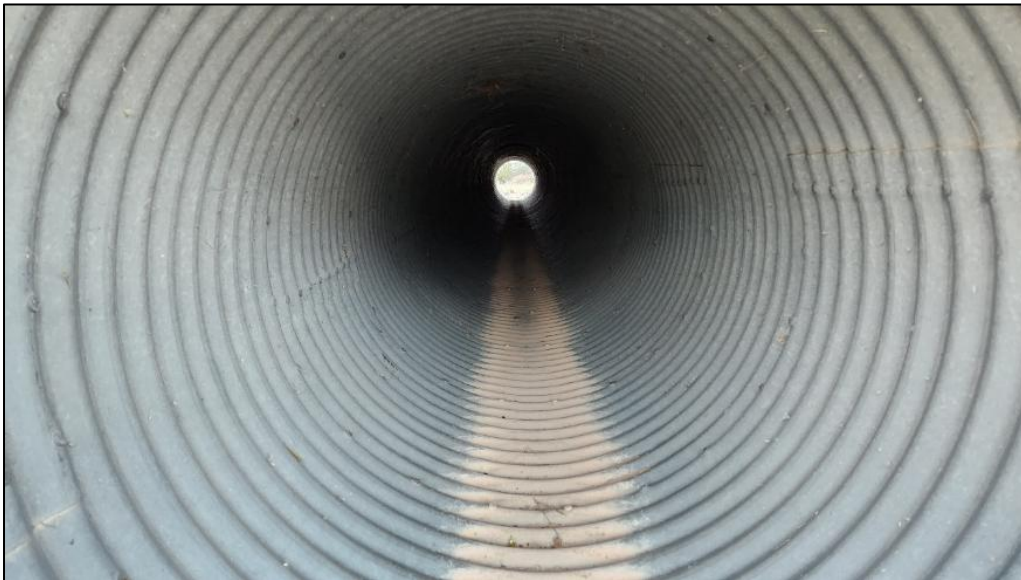
This culvert was visited on 11/05/2025. This culvert had no visible corrosion on the inside as seen in **FIGURE 44** and **FIGURE 45** below. The culvert’s inlet and outlet were encased in concrete, preventing observation of the outside of the culvert.

FIGURE 44: Culvert on NM 1 MP 22.01, inlet side.

FIGURE 45: Inside of the inlet side of the culvert on NM 1 MP 22.01.

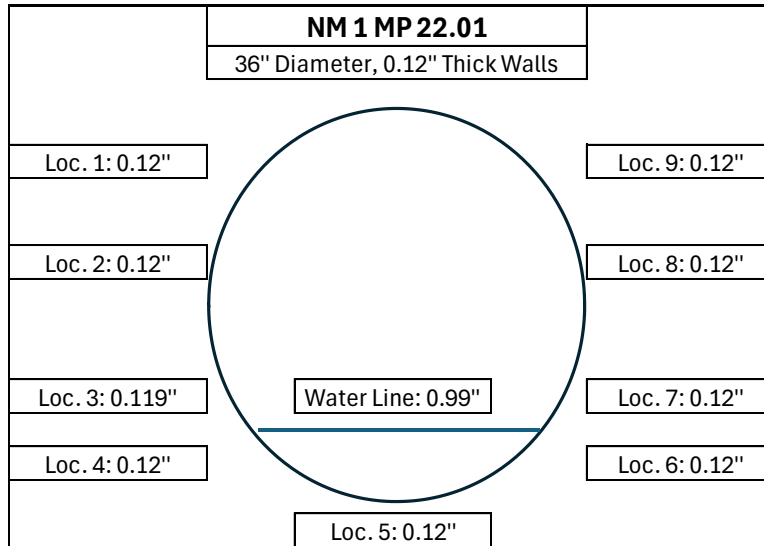
Micrometer measurements were unable to be collected on this culvert, due to it being encased in concrete, but the average thickness of ultrasonic measurements was 0.12". This average thickness is 0.009" larger than the closest matching standard culvert thickness of 12-gage with a culvert's thickness of 0.111" for galvanized structural plate. The ultrasonic measurements showed a thickness between 0.119" and 0.12", indicating little to no corrosion on the outside of the culvert.

FIGURE 46: Diagram of wall thickness measurements taken at NM 1 MP 22.01 culvert.

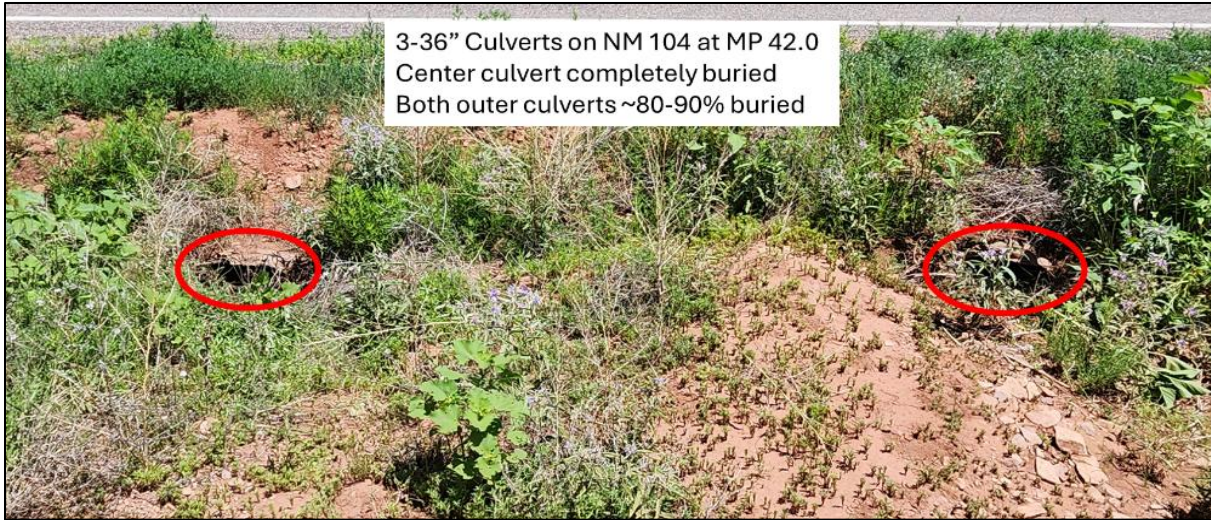
Three 36" culverts on NM 104 MP 42.0 were nearly completely silted over (**FIGURE 47** below), with the middle culvert completely silted over.

FIGURE 47: 3-36" culverts on NM 104 MP 42.0, with outer two culverts circled in red for identification and middle culvert completely silted over.

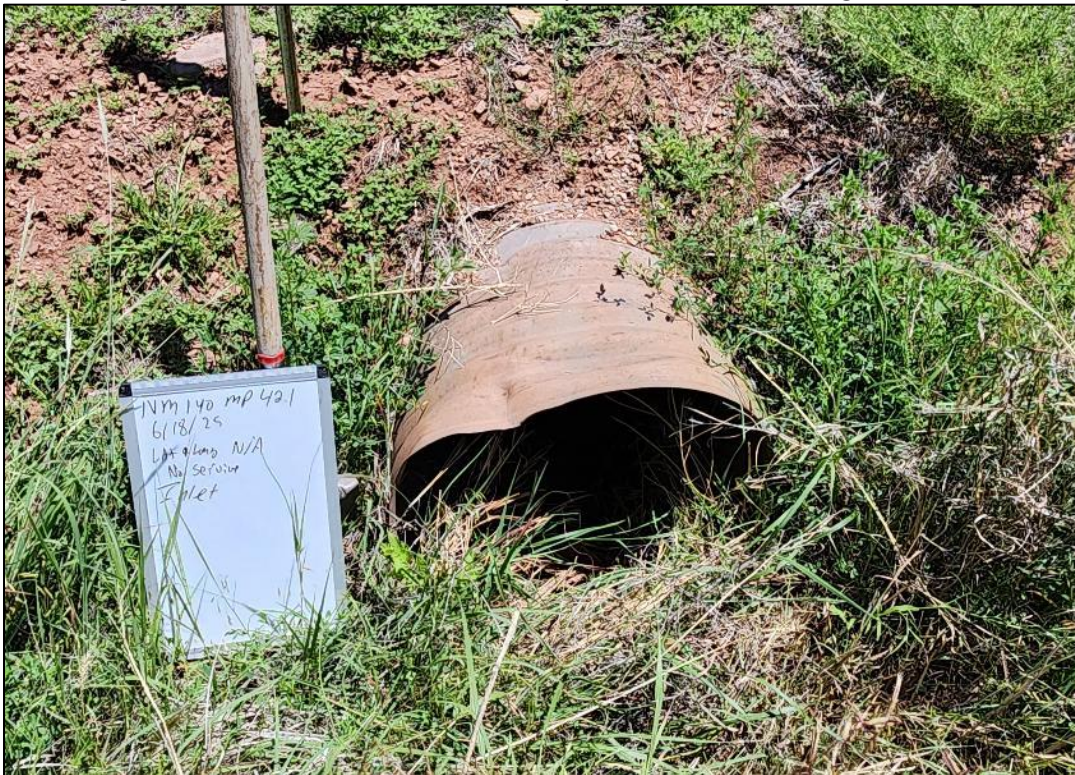
This culvert was visited on 6/18/2025. This culvert had little to no corrosion on the inside and outside. The rust coloring on the culvert is due to the red clay soil located in the region and is not rust.

FIGURE 48: Culvert on NM 104 MP 42.1, inlet side.
