Comparing Resistivity and Conductivity in Metal Culverts

Final Report

Agua del Sol Consultants, LLC
PO Box 92797
Albuquerque, NM 87199

Report R924020

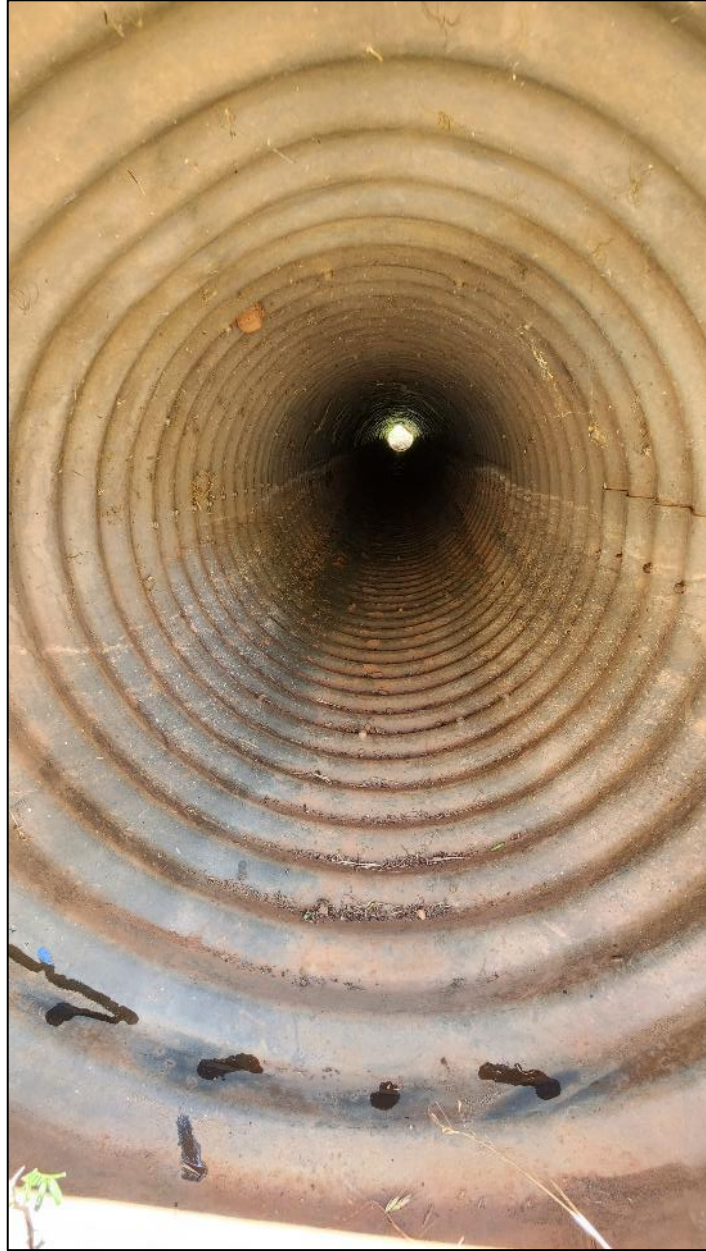
This culvert was visited on 6/18/2025. This culvert had little to no corrosion on the inside and outside. The rust coloring on the culvert is due to the red clay soil located in the region and is not rust.

FIGURE 49: Culvert on NM 104 MP 42.1 inlet side looking in.

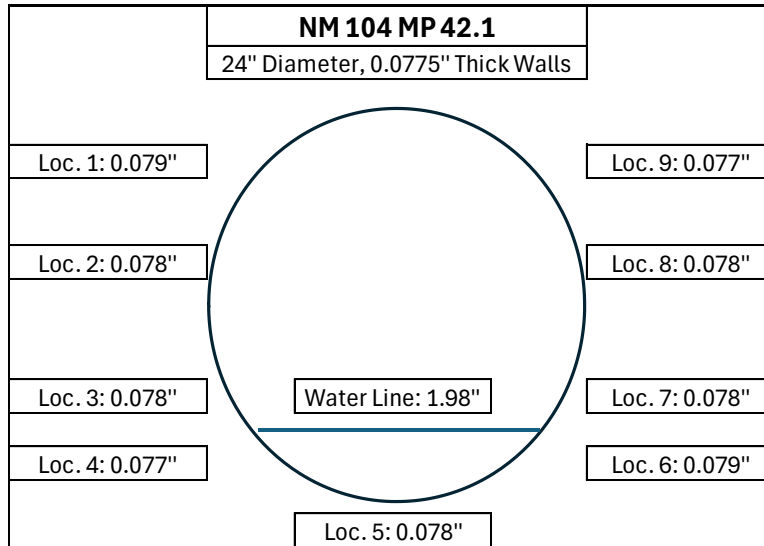
At uncorroded locations three micrometer measurements were taken, 0.0770", 0.0780", and 0.0775", for an average of 0.0775". This thickness corresponds approximately to a 14-gage culvert with a galvanized thickness of 0.079". The ultrasonic measurements showed a thickness between 0.078" and 0.079", indicating no corrosion on the outside of the culvert where it was buried.

FIGURE 50: Diagram of inlet wall thickness measurements taken on NM 140 MP 42.1 culvert.

This location had no visible corrosion on the outside and inside of the culvert, and the ultrasonic thickness measurements indicated no corrosion on the outside of the culvert where it was buried. The presence of soil pH values less than 8 and resistivity values far greater than 2000 ohm-cm contribute to this location having negligible corrosive soils.

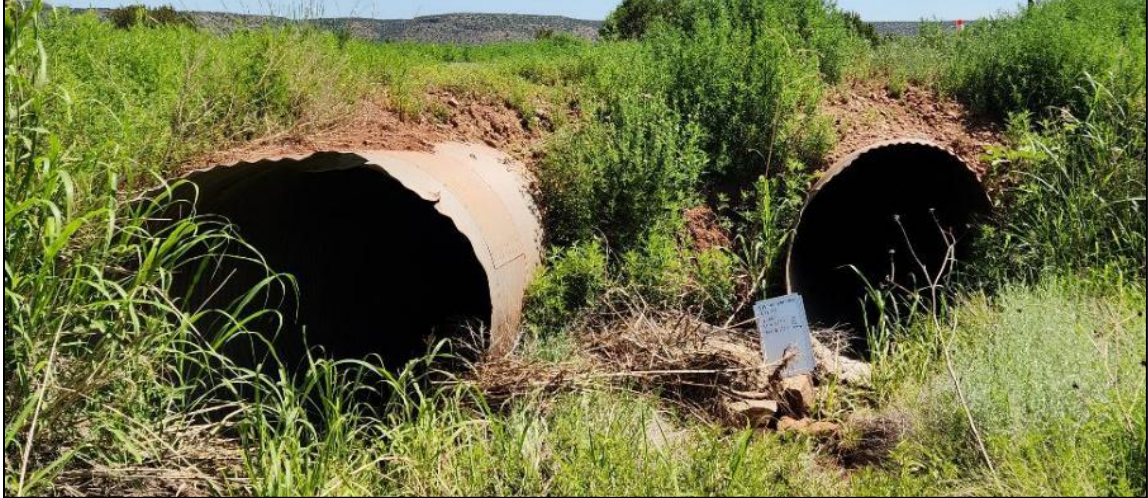
These two culverts were visited on 6/18/2025. There was no corrosion visible on either culvert, with any discoloration of the metal caused by the red clay soil.

FIGURE 51: Two 60” culverts on NM 104 MP 43, inlet side.

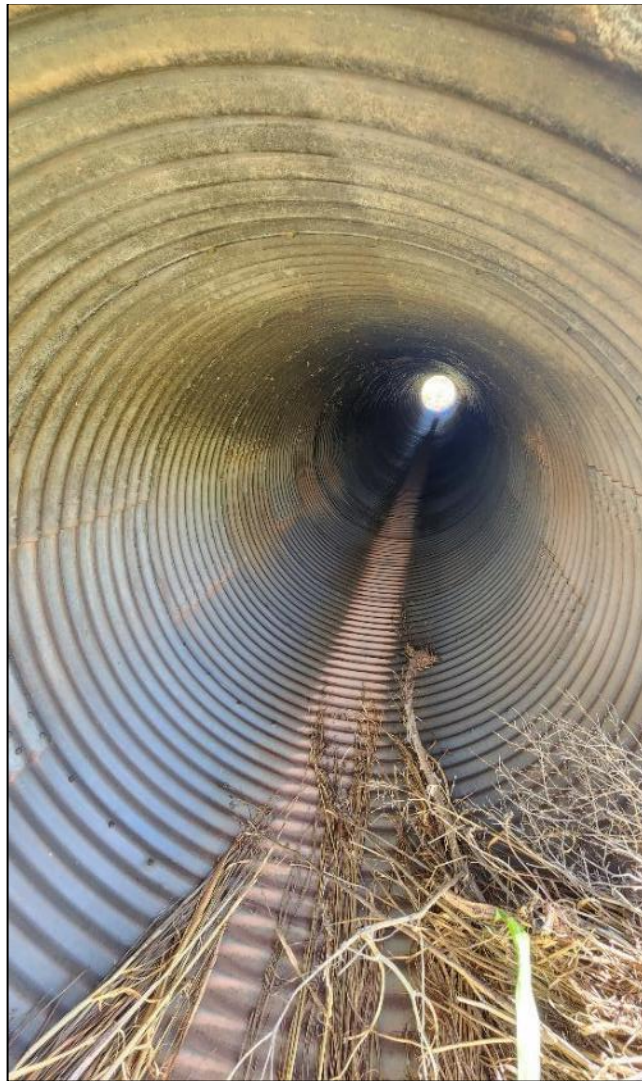
FIGURE 52: Western 60” culvert on NM 104 MP 43, inlet side looking in.

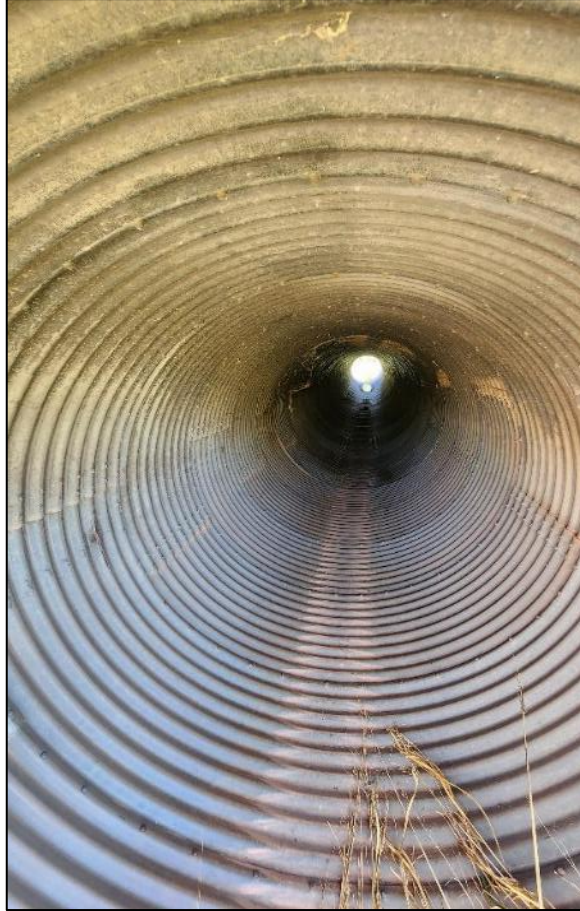
FIGURE 53: Eastern 60” culvert on NM 104 MP 43, inlet side looking in.

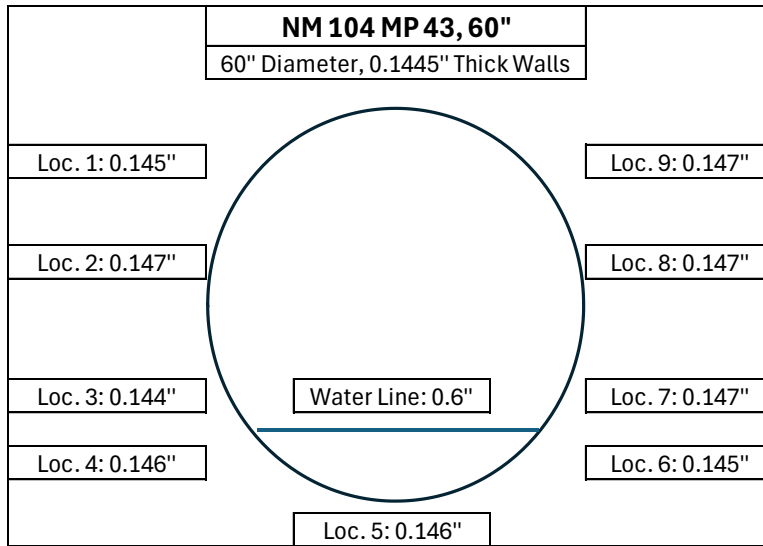
Western Culvert: At an uncorroded location, three micrometer measurements were taken, 0.1450”, 0.1440”, and 0.1444”, for an average of 0.1445”. This thickness corresponds approximately to a 10-gage culvert with a galvanized structural plate thickness of 0.140”. The ultrasonic measurements showed a thickness between 0.144” and 0.147”, indicating no corrosion on the outside of the culvert where it was buried.

FIGURE 54: Western culvert diagram of inlet wall thickness measurements taken from the NM 104 MP 43 culvert.

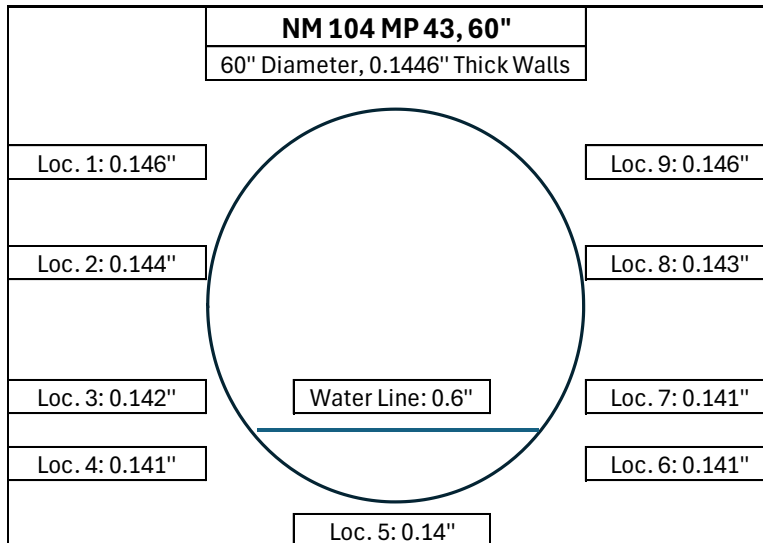
Eastern Culvert: At an uncorroded location, three micrometer measurements were taken, 0.1450”, 0.1440”, and 0.1448”, for an average of 0.1446”. This thickness corresponds approximately to a 10-gage culvert with a galvanized structural plate thickness of 0.140”. The ultrasonic measurements showed a thickness between 0.140” and 0.146”, indicating very slight corrosion on the outside of the culvert where it was buried.

FIGURE 55: Eastern culvert diagram of inlet wall thickness measurements taken from the NM 104 MP 43 culvert.

This location had no visible corrosion on the outside and inside of the culvert, and the ultrasonic thickness measurements indicated no corrosion on the western culvert and very minimal corrosion on the outside of the eastern culvert where it was buried. The presence of soil pH values only slightly above 7.3 and resistivity values at or greater than 2000 ohm-cm contribute to this location having negligible corrosive soils.

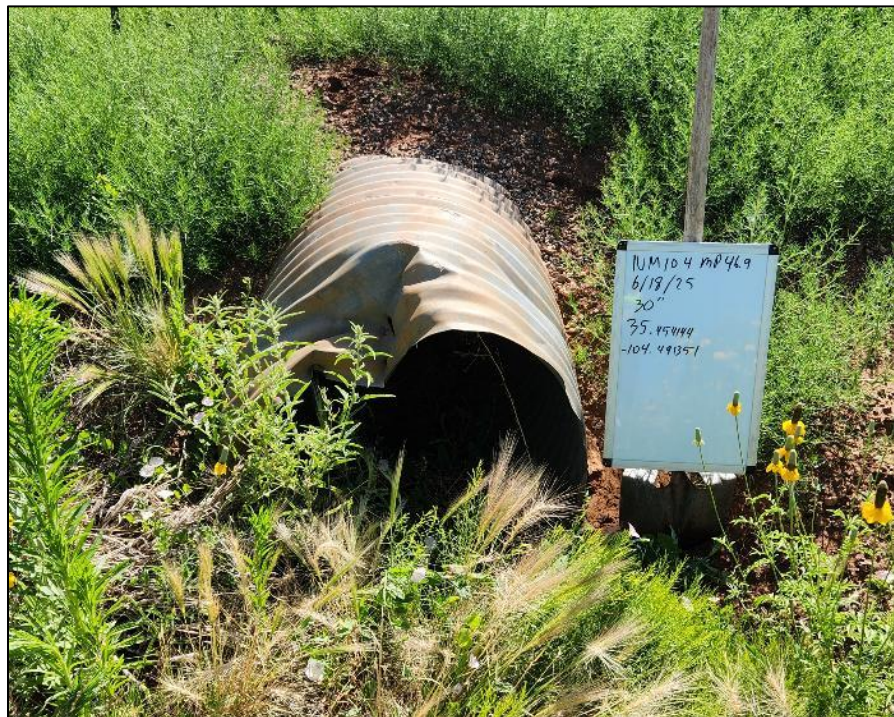
This culvert was visited on 6/18/2025. No corrosion was visible on the outside and inside of this culvert. Any discoloration of the metal is due to the red clay soil in this region.

FIGURE 56: Culvert on NM 104 MP 46.9, inlet side.

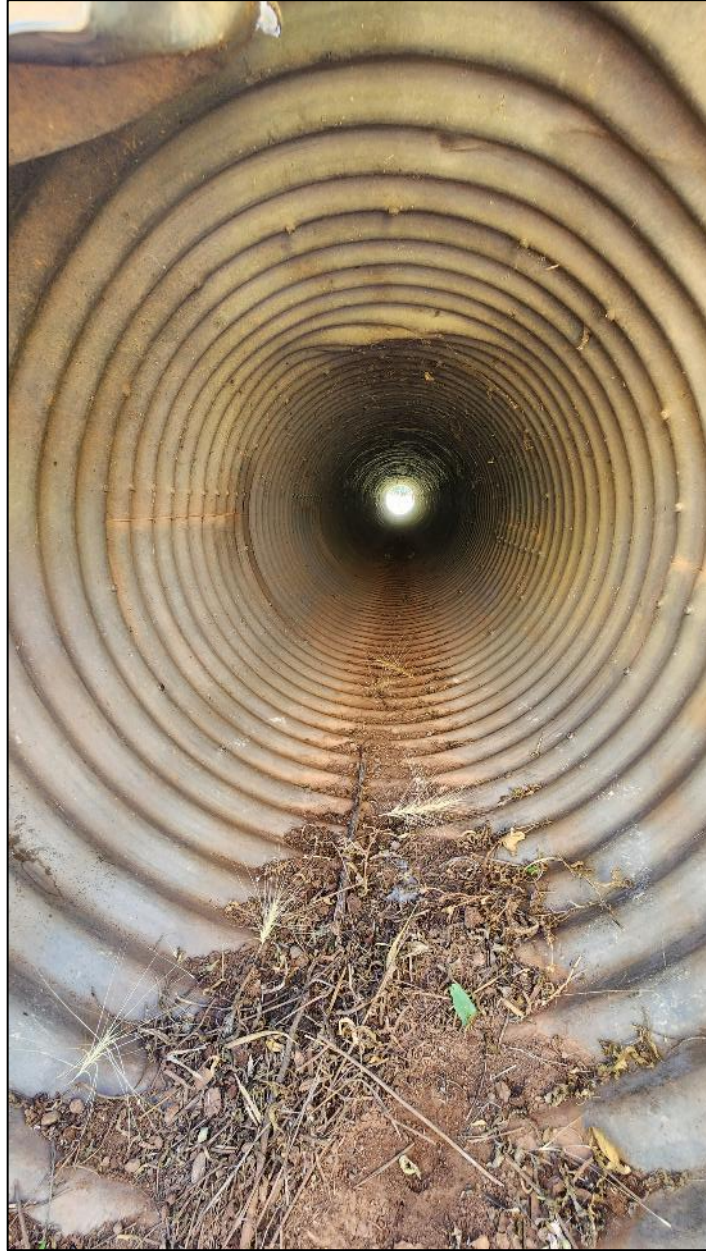
FIGURE 57: Culvert on NM 104 MP 46.9, inlet side looking in.

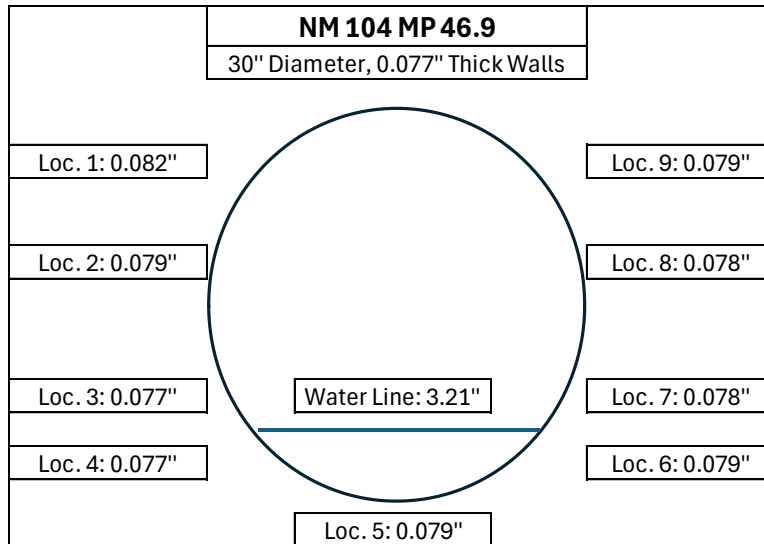
At the uncorroded location, three micrometer measurements were taken, 0.0768", 0.0780", and 0.0763", for an average of 0.077". This thickness corresponds approximately to a 14-gage culvert with a galvanized thickness of 0.079". The ultrasonic measurements showed a thickness between 0.077" and 0.082", indicating no corrosion on the outside of the culvert where it was buried.

FIGURE 58: Diagram of inlet wall thickness measurements taken from the NM 104 MP 46.9 culvert.

This location had no visible corrosion on the outside and inside of the culvert, and the ultrasonic thickness measurements indicated no corrosion on the outside of the culvert where it was buried. The presence of soil pH values less than 8 and resistivity values at or greater than 2000 ohm-cm contribute to this location having negligible corrosive soils.

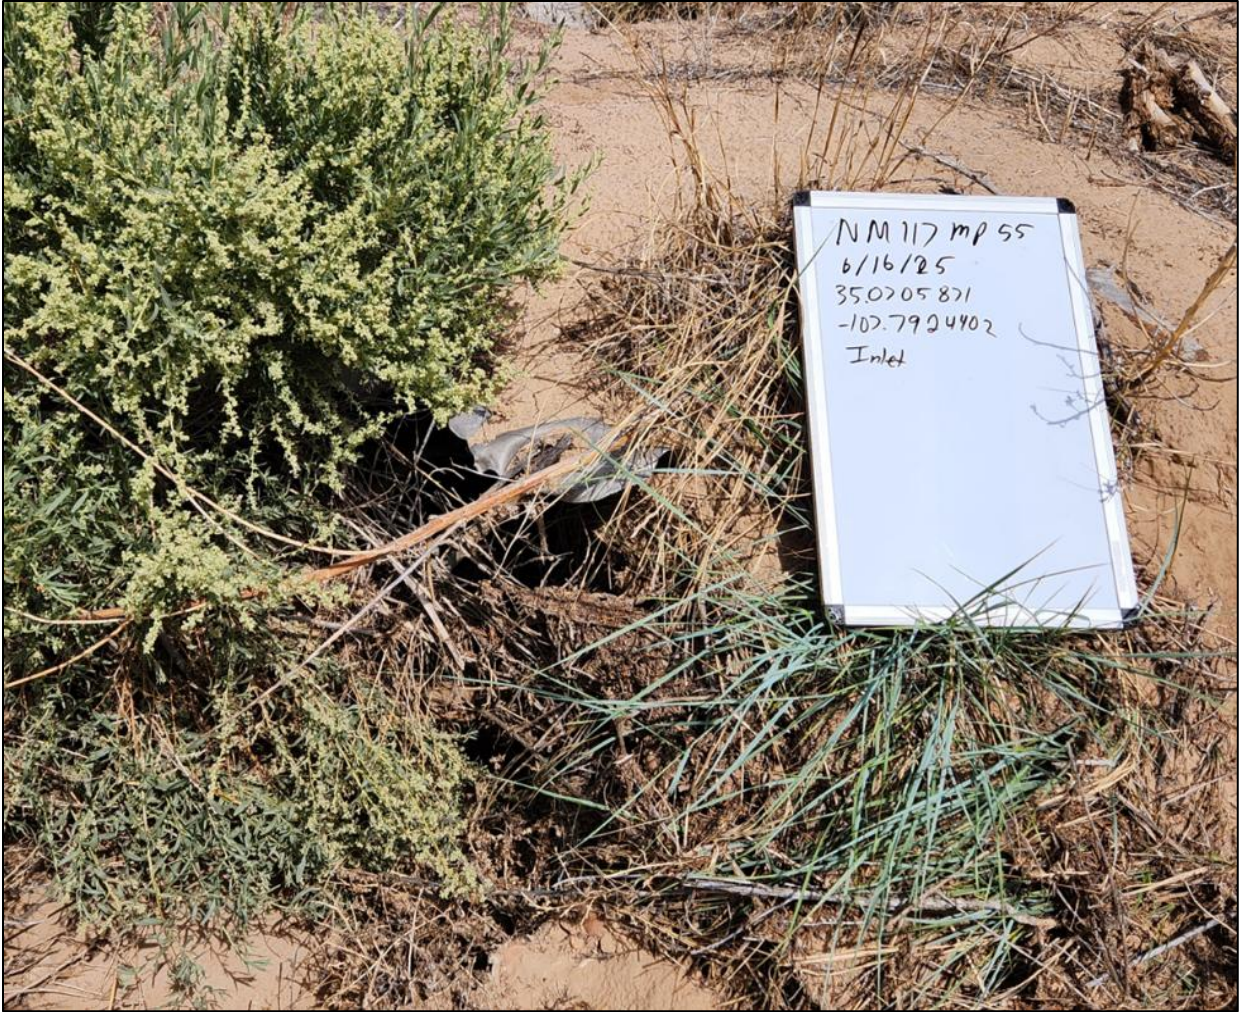
This culvert was visited on 6/16/2025. The inlet of the culvert was clogged with brush and debris (**FIGURE 59**), which had to be removed to conduct field tests (**FIGURE 60**). There was a section of the culvert that collapsed around 6 feet from the inlet (**FIGURE 61**). This culvert showed zero corrosion on the inside or outside. The inlet side of the culvert has experienced significant damage (**FIGURE 60**), likely due to the removal of sedimentation with heavy equipment.

FIGURE 59: Culvert on NM 117 MP 55 inlet before removal of brush.

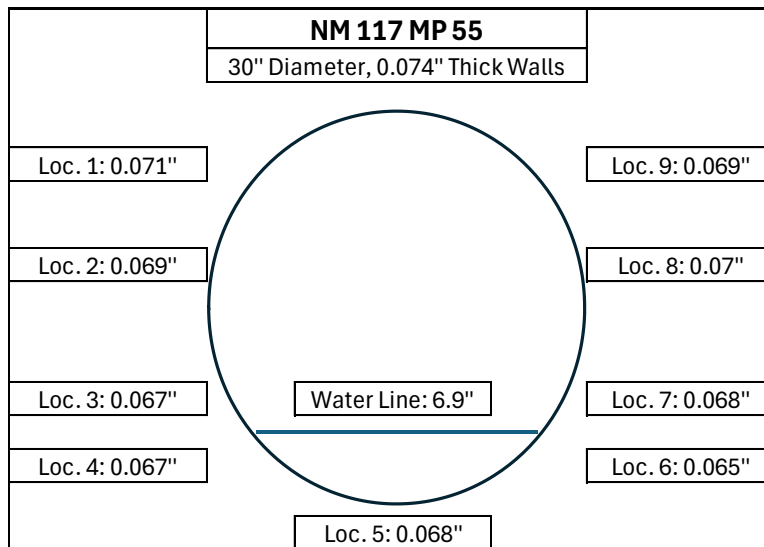
Using a micrometer on uncorroded locations of the culvert, a thickness of 0.073", 0.075", and 0.074" was measured at three different locations, for an average of 0.075". The closest gage thickness to this value is 14, with a galvanized thickness of 0.079". **FIGURE 63** below shows the location where ultrasonic thickness measurements were taken after the removal of around 6" of sand from the bottom of the culvert. As seen below, there are no signs of corrosion on the inside of the culvert. The ultrasonic measurements showed a thickness between 0.065" and 0.071", indicating some slight corrosion on the outside of the culvert where it was buried.

FIGURE 63: Diagram of inlet wall thickness measurements taken on the NM 117 MP 55 culvert.

This location had no visible corrosion on the outside and inside of the culvert, and the ultrasonic thickness measurements indicated very minimal corrosion on the outside of the culvert where it was buried. The presence of soil pH values less than 8 and resistivity values far greater than 2000 ohm-cm contribute to this location having negligible corrosive soils.

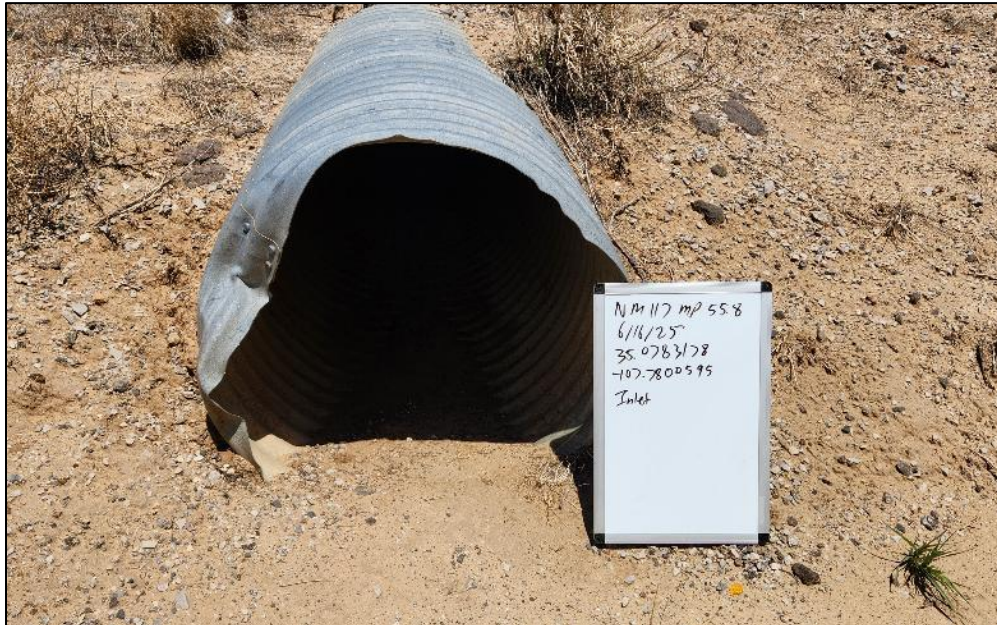
This culvert was visited on 6/16/2025. The exposed outside of the culvert had little to no corrosion present, as seen in **FIGURE 64** below. **FIGURE 65** below shows some slight corrosion on the inside bottom of the culvert. The outlet of this culvert had a collapsed section, as seen in **FIGURE 66** below.

FIGURE 64: Culvert on NM 117 MP 55.8, inlet side.

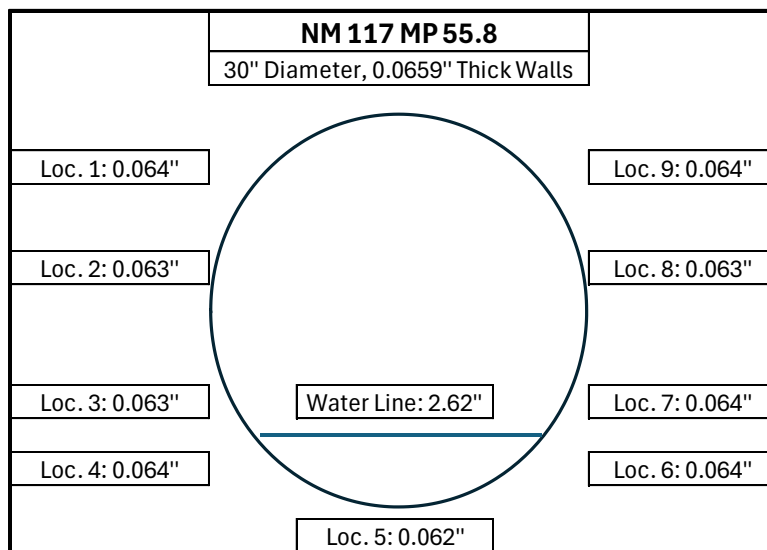
At uncorroded locations, three micrometer measurements were taken, 0.0669”, 0.0652”, and 0.0658”, for an average of 0.0659”. This thickness corresponds approximately to a 16-gage culvert with a galvanized thickness of 0.064”. The ultrasonic measurements showed a thickness between 0.062” and 0.064”, indicating some slight corrosion on the outside of the culvert where it was buried and the most corrosion on the bottom of the culvert.

FIGURE 67: Diagram of inlet wall thickness measurements taken on NM 117 MP 55.8 culvert.

This location had no visible corrosion on the outside and very minor corrosion inside the bottom of the culvert, and the ultrasonic thickness measurements indicated very minimal corrosion on the outside of the culvert where it was buried. The presence of soil pH values less than 8 and resistivity values far greater than 2000 ohm-cm contribute to this location having negligible corrosive soils.

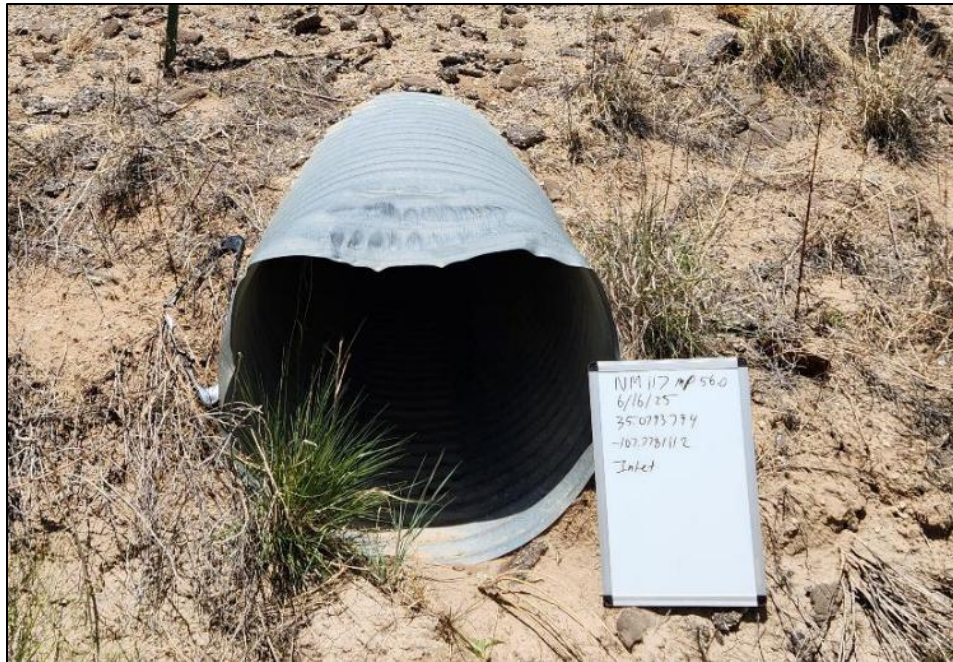
This culvert was visited on 6/16/2025. The exposed outside of the culvert had little to no corrosion present, as seen in **FIGURE 68** below. **FIGURE 69** below shows no corrosion on the inside of the culvert.

FIGURE 68: Culvert on NM 117 MP 56, inlet side.

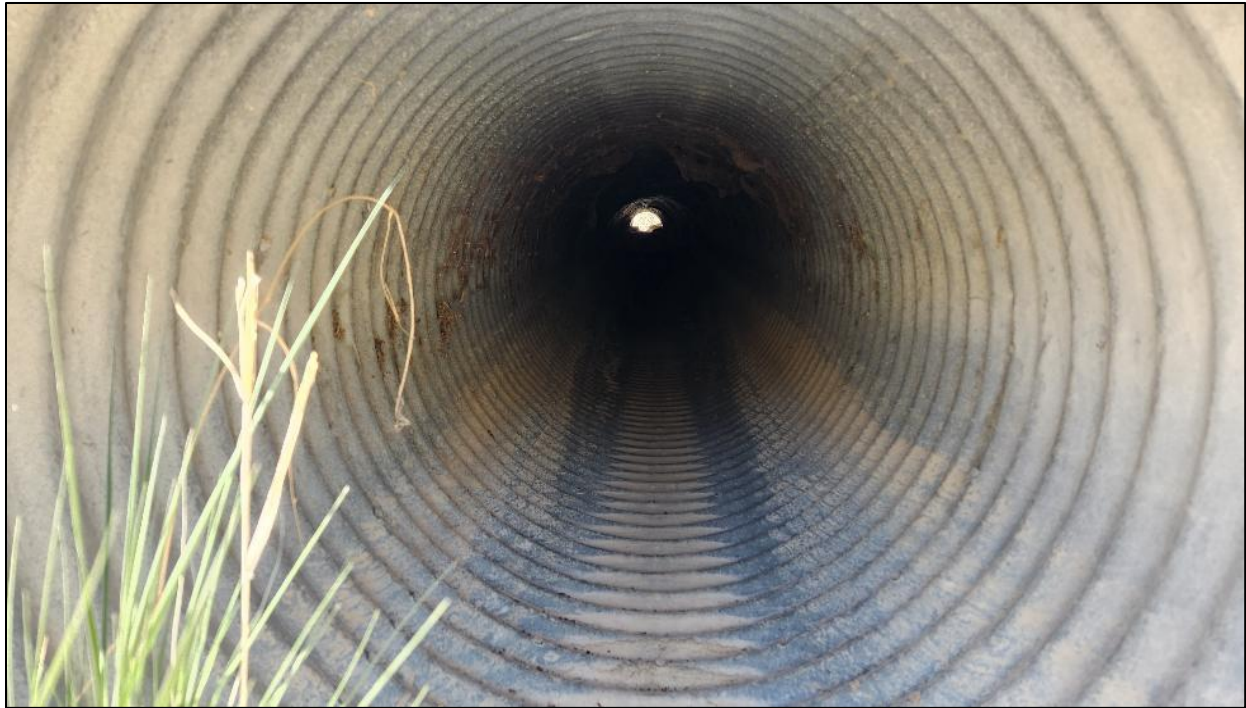
FIGURE 69: Culvert on NM 117 MP 56, close-up of inside on inlet side.

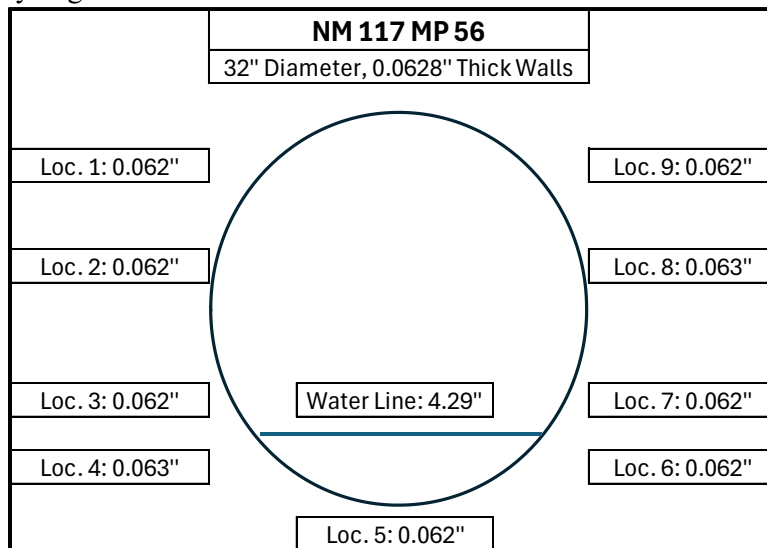
At uncorroded locations, three micrometer measurements were taken, 0.0624", 0.0633", and 0.0626", for an average of 0.0628". This thickness corresponds approximately to a 16-gage culvert with a galvanized thickness of 0.064". The ultrasonic measurements showed a thickness between 0.062" and 0.063", indicating some very slight corrosion on the outside of the culvert where it was buried.

FIGURE 70: Diagram of Inlet wall thickness measurements taken on NM 117 MP 56 culvert.

This location had no visible corrosion on the outside and inside of the culvert, and the ultrasonic thickness measurements indicated very minimal corrosion on the outside of the culvert where it was buried. The presence of soil pH values less than 8 and resistivity values greater than 2000 ohm-cm contributes to this location having negligible corrosive soils.

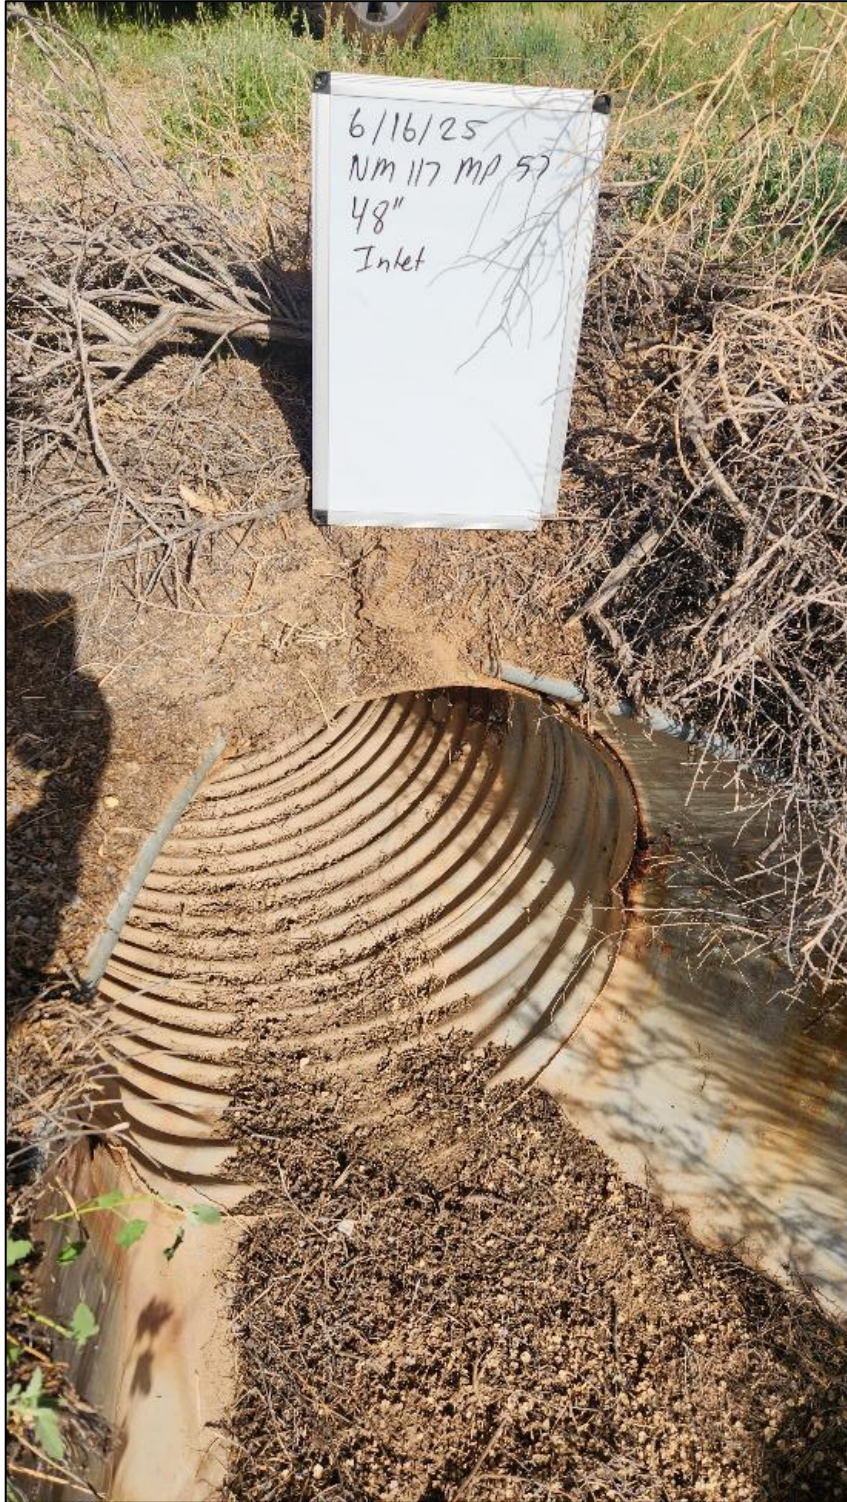
This culvert was visited on 6/16/2025. Significant corrosion was visible on the outside of the culvert, as seen in **FIGURE 71** below. Very significant corrosion on the upper half of the inside of the culvert was present, with multiple locations where there were large holes in the culvert where the metal had all but corroded away, as seen in **FIGURE 72** below. Most of the corrosion was located on the upper half of the culvert, with little to no corrosion on the bottom inside.

FIGURE 71: Culvert on NM 117 MP 57, inlet side.

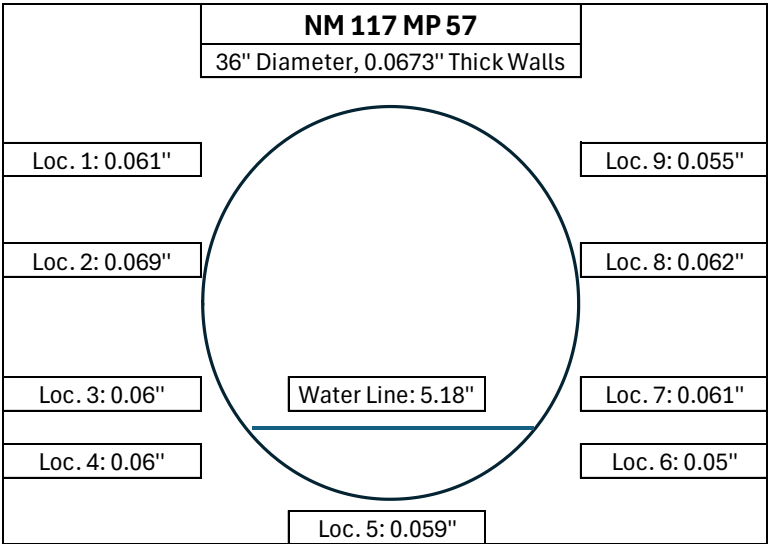
At the least corroded location three micrometer measurements were taken, 0.0690”, 0.0660”, and 0.0670”, for an average of 0.0673”. This thickness falls between a 16 (0.064”) and 14 (0.079”) gage. The ultrasonic measurements showed a thickness between 0.050” and 0.069”, indicating some very slight corrosion on the outside of the culvert where it was buried.

FIGURE 73: Diagram of inlet wall thickness measurements taken on NM 117 MP 57 culvert.

This location had significant corrosion with up to 3-4” diameter holes in the upper half of the culvert, where all the metal had corroded away. The higher pH values, especially in the samples collected from behind the culvert (B.C.), is the main contributing factor for the corrosion present. The greater than 2000 ohm-cm resistivity values indicate that natural soils are not contributing to the corrosion. The significantly lower resistivity values and higher pH values from the soil sample collected from behind the culvert might be due to deicing/salting of the road in the winter.

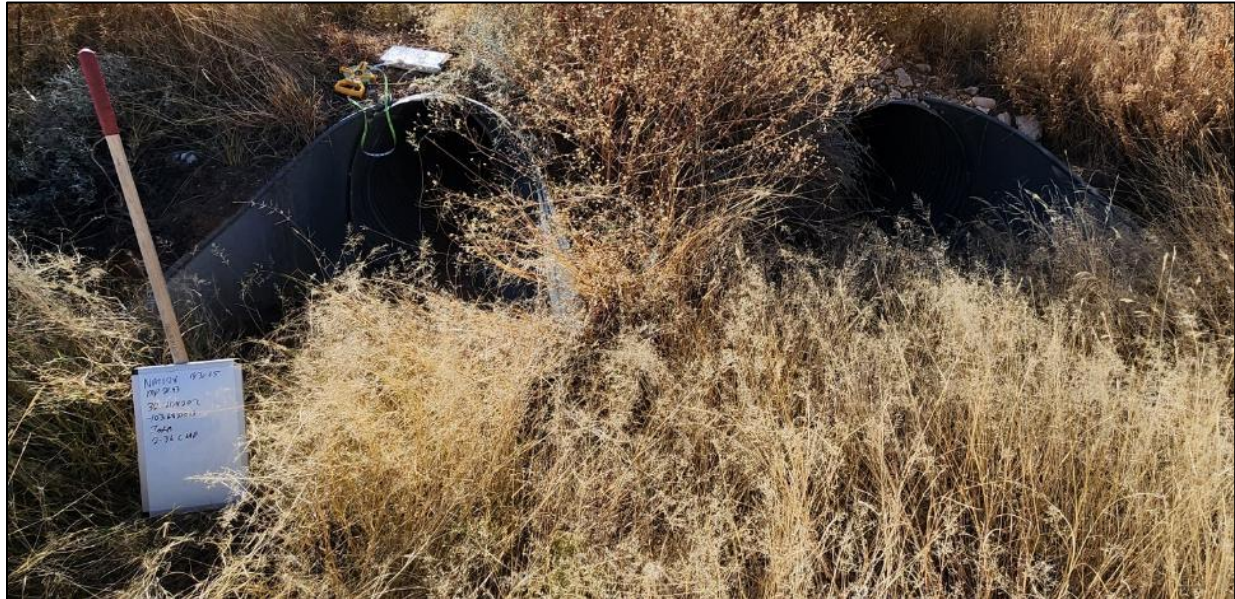
FIGURE 75: 2-36" culverts on NM 128 MP 21.93, facing south, inlet side (eastern culvert on left and western on right)

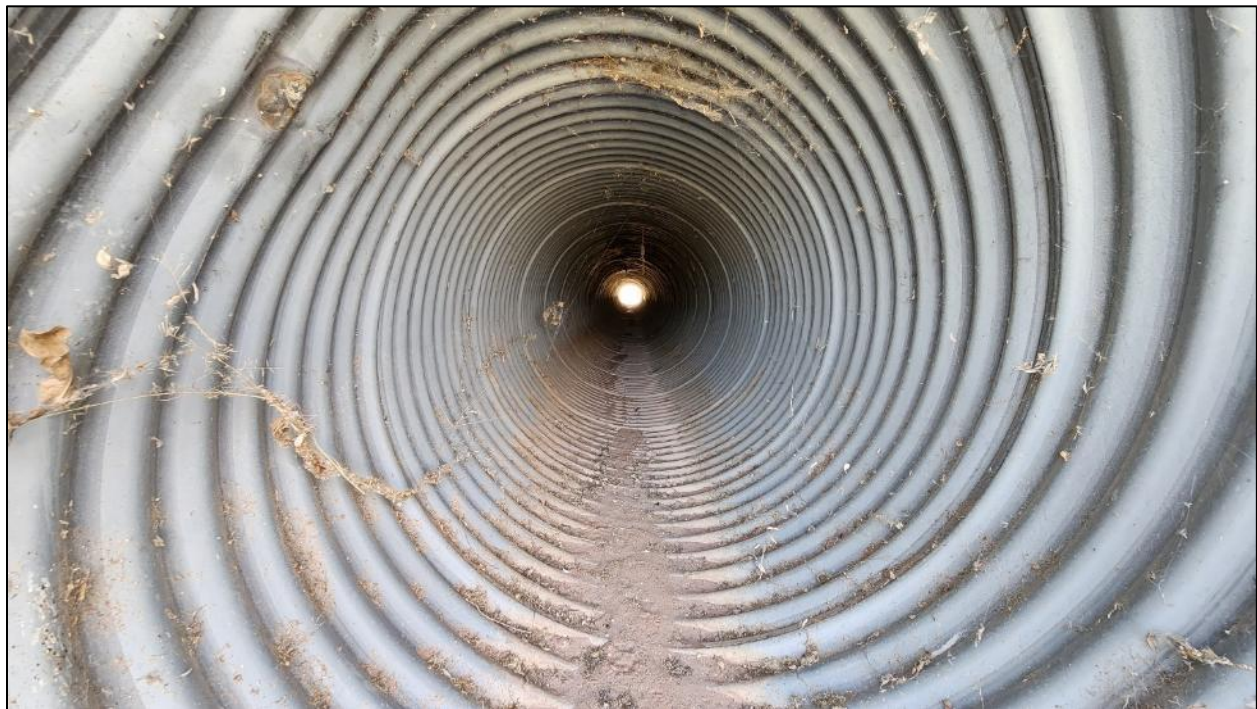
This culvert was visited on 11/3/2025. This location had 2-36" culverts that had no corrosion present in either culvert, as seen in **FIGURE 76** and **FIGURE 77** below.

FIGURE 76: Eastern 36" culvert on NM 128 MP 21.93 facing south at inlet.

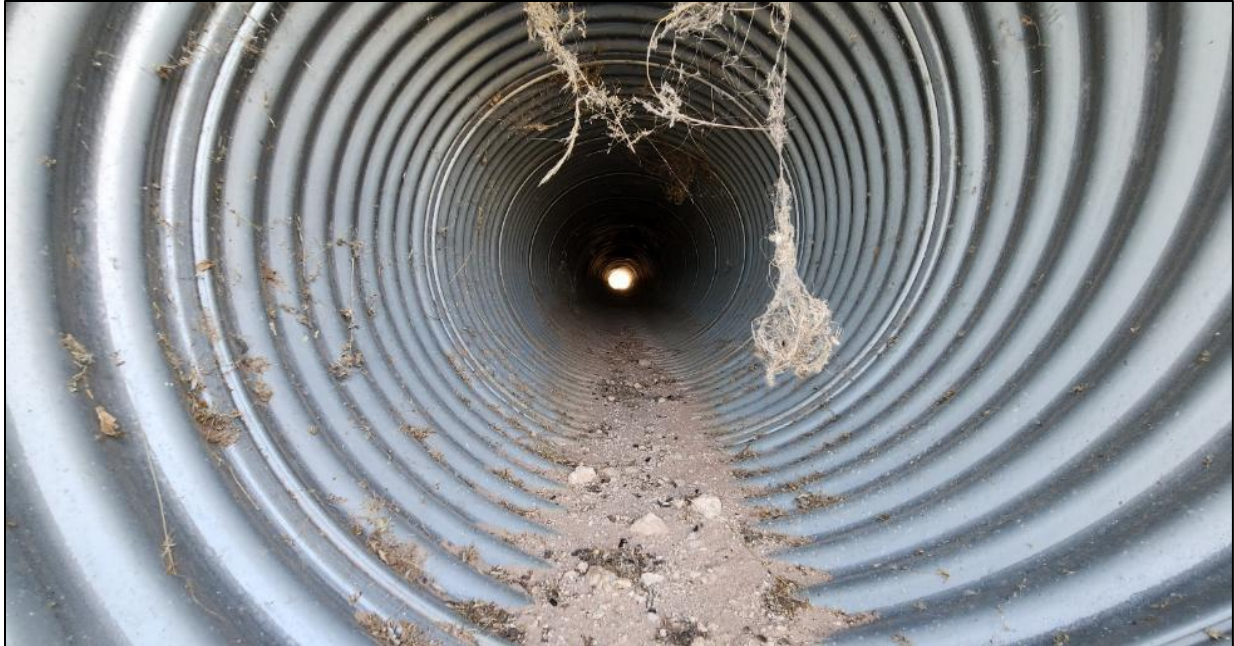
FIGURE 77: Western 36" culvert on NM 128 MP 21.93 facing south at inlet.

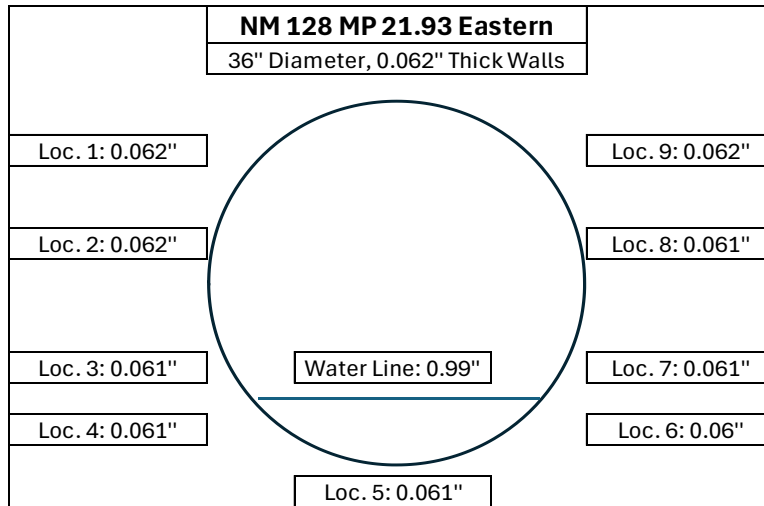
Eastern: Using a micrometer on uncorroded locations of the culvert, a thickness of 0.0625", 0.0612", and 0.0619" was measured at three different locations, for an average of 0.062". The closest gage thickness to this value is 16, with a galvanized thickness of 0.064". The ultrasonic measurements were taken 18" from the inlet and showed a thickness between 0.060" and 0.062", indicating no corrosion present on the unseen outside of the culvert.

FIGURE 78: Diagram of wall thickness measurements taken at NM 128 MP 21.93 Eastern culvert.

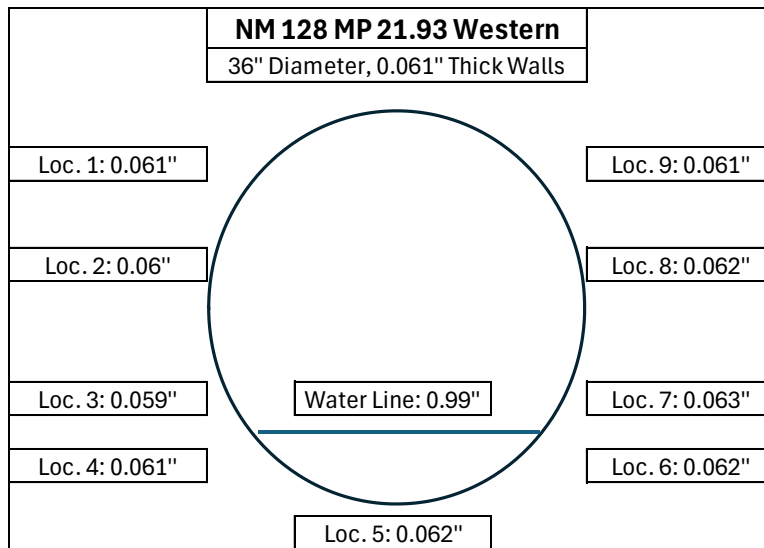
Western: Using a micrometer on uncorroded locations of the culvert, a thickness of 0.0624", 0.0605", and 0.0611" was measured at three different locations, for an average of 0.061". The closest gage thickness to this value is 16, with a galvanized thickness of 0.064". The ultrasonic measurements were taken 18" from the inlet and showed a thickness between 0.059" and 0.063", indicating no corrosion present on the unseen outside of the culvert.

FIGURE 79: Diagram of wall thickness measurements taken at NM 128 MP 21.93 Western culvert.

This location had no visible corrosion on the outside or inside of the culvert, and the ultrasonic thickness measurements confirm this. The presence of soil pH slightly greater than 7.3 and resistivity values far greater than 2000 ohm-cm contribute to this location having negligible corrosive soils.

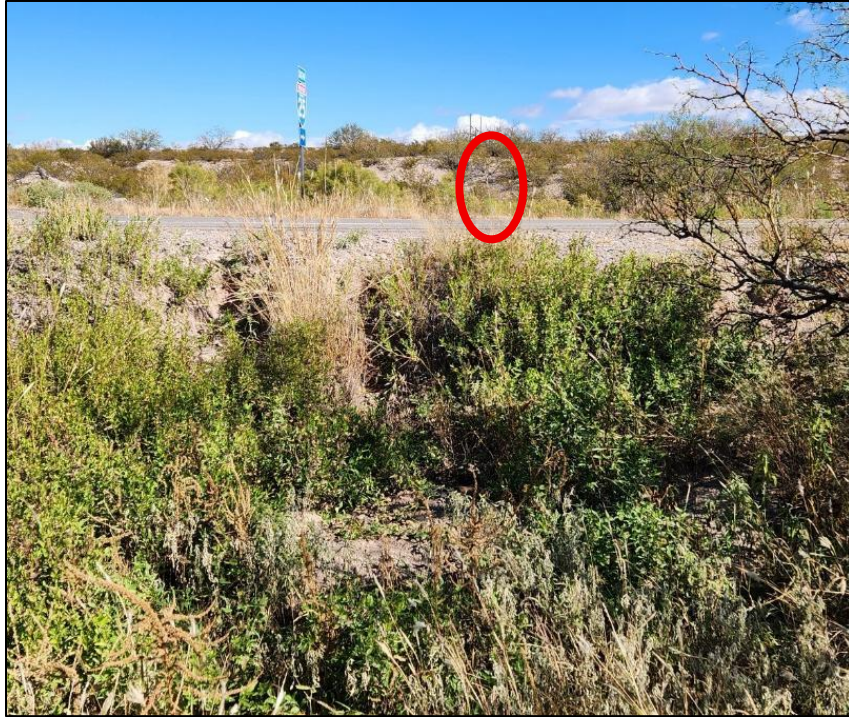
This culvert was visited on 11/05/2025, but could not be located. The warning post indicating a culvert as seen in the red-circled area in **FIGURE 80** below indicated the location of a culvert, but it was completely buried on the inlet side, and it also could not be located on the outlet due to very dense brush.

FIGURE 80: Approximate inlet side of culvert on NM 181 MP 5.48, buried in dirt. Culvert road warning marker circled in red.

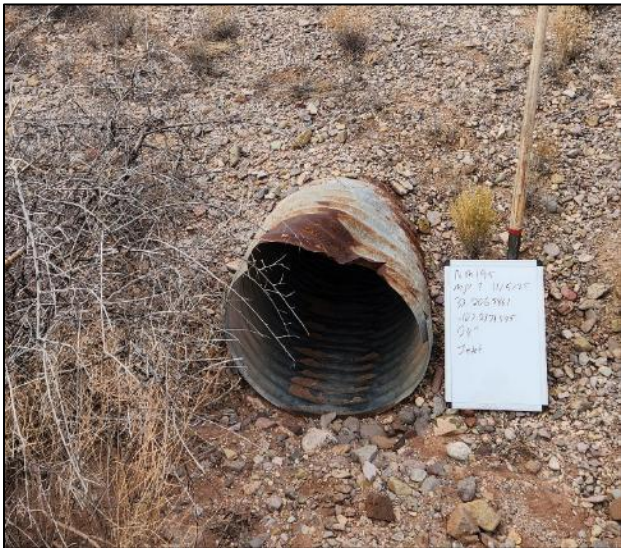
This culvert was visited on 11/05/2025. The exposed outside of the culvert had a significant amount of corrosion present, as seen in **FIGURE 81** below. **FIGURE 82** below shows the presence of corrosion only on the upper inside portion of the culvert.

FIGURE 81: Culvert on NM 195 MP 1.51, inlet side.

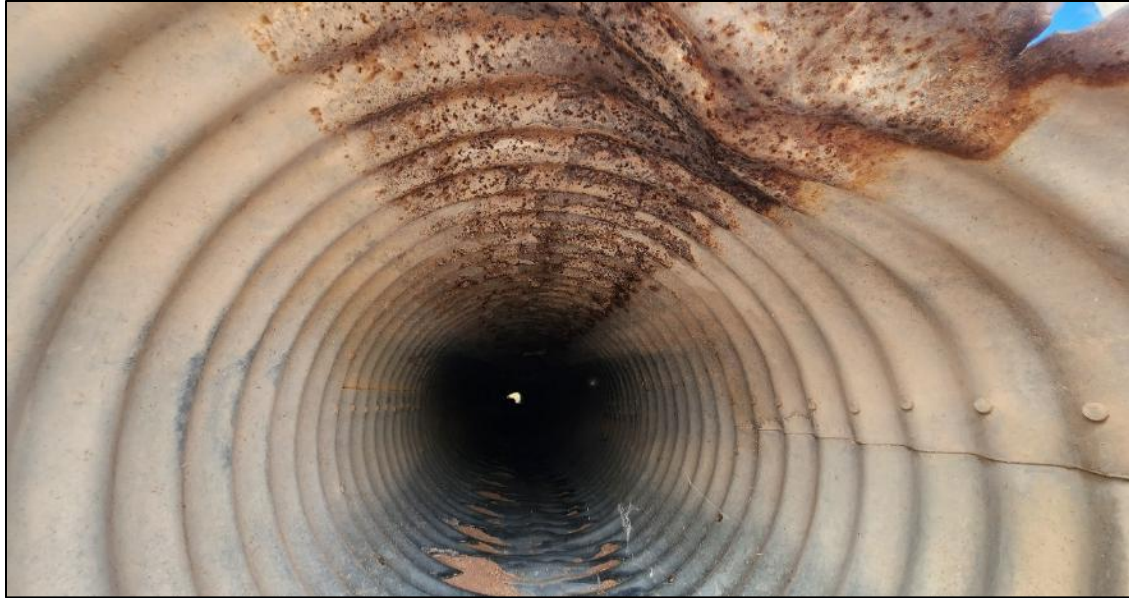
FIGURE 82: Inside of the inlet side of the culvert on NM 195 MP 1.51.

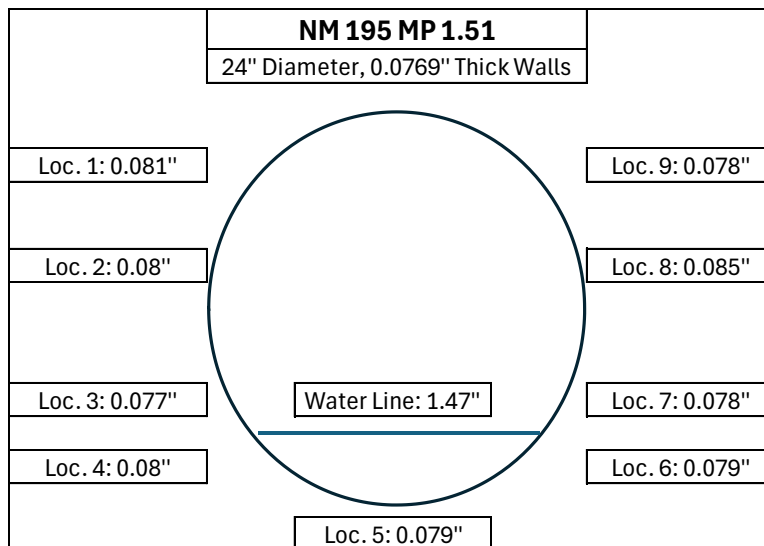
At uncorroded locations, three micrometer measurements were taken, 0.0778”, 0.0759”, and 0.0771”, for an average of 0.0769”. This thickness corresponds approximately to a 14-gage culvert with a galvanized thickness of 0.079”. The ultrasonic measurements showed a thickness between 0.077” and 0.085”, indicating the presence of corrosion on the outside of the culvert, with some scaling buildup.

FIGURE 83: Diagram of wall thickness measurements taken at NM 195 MP 1.51 culvert.

This location had considerable corrosion on the outside, specifically in locations in contact with surrounding soils and on the upper inside portions of the culvert. Due to the small size of the culvert, ultrasonic measurement samples were unable to be collected on the inside of the culvert where it was buried and were instead collected 8 inches from the culvert’s opening. The presence of soils with greater than 7.3 pH indicated that corrosion on the soil side will govern in this location. This corrosion is easily seen in **FIGURE 81** and **FIGURE 82** above. The soil’s resistivity being below 2000 ohm-cm indicated that some of the corrosion was also caused by this lower resistivity value.

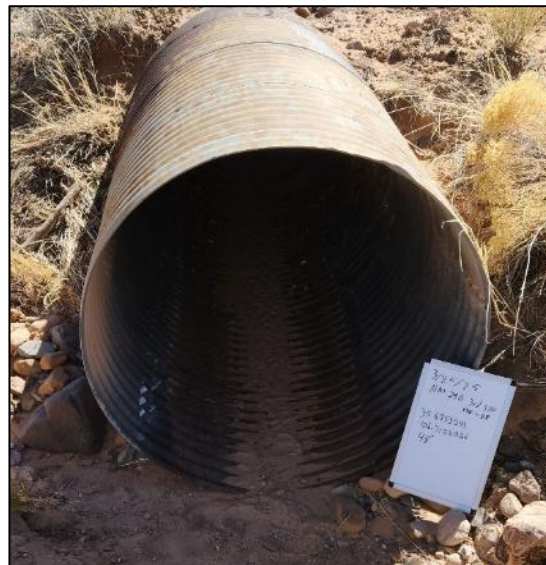
The third culvert investigated on NM 290 was located at MP 0.65. This culvert is a 48” culvert made from galvanized structural plate. This culvert had extreme corrosion, with multiple areas where the undermining of the culvert’s backfill occurred during the last time water flowed through it. The following images show the extreme amount of the corrosion present on this culvert, with multiple large holes present near the inlet and outlet. There are potentially additional large holes in the culvert’s walls in the middle section, but it was not deemed safe to venture further in to investigate.

FIGURE 84: Culvert on NM 290 MP 0.65, inlet side.

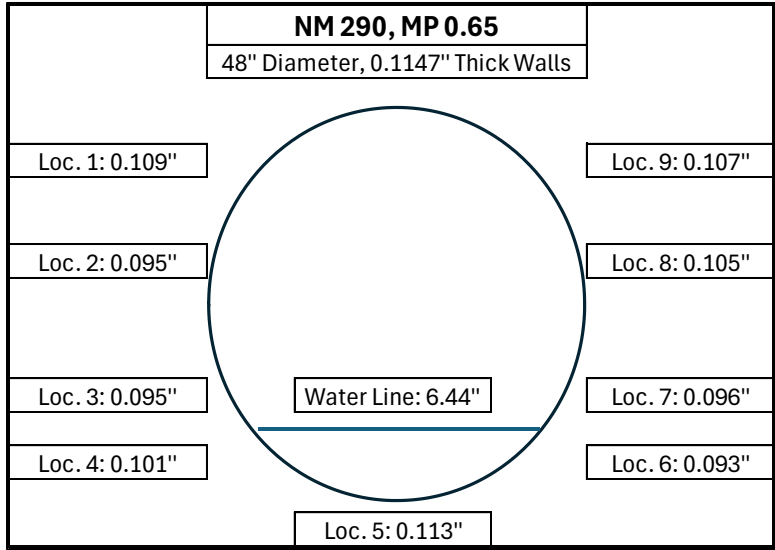
A value of 0.1147" was measured on an uncorroded exposed location with a micrometer; the closest gage thickness is 12 for galvanized structural plate. Based on the ultrasonic thickness measurements taken 6 feet in from the end of the culvert, on the inlet side, there is a considerable amount of surface corrosion and scaling on the inside and outside of the culvert, especially above and below the corroded waterline.

FIGURE 88: Diagram of inlet wall thickness measurements taken on NM 290 MP 0.65 culvert.

The higher pH values at this location indicate that soil-side corrosion will govern, which is verified by the thickness measurements being less than the original thickness, especially above and below the waterline. The soil conductivity of the sample from behind the culvert shows a significant difference than the others collected at this site and from nearby sites. This extremely small resistivity value is potentially explained by deicing sprays and salt used in this mountainous location, greatly increasing the conductivity of the soil and therefore substantially decreasing the soil's resistance.
