Comparing Resistivity and Conductivity in Metal Culverts

Final Report

Agua del Sol Consultants, LLC
PO Box 92797
Albuquerque, NM 87199

Report R924020

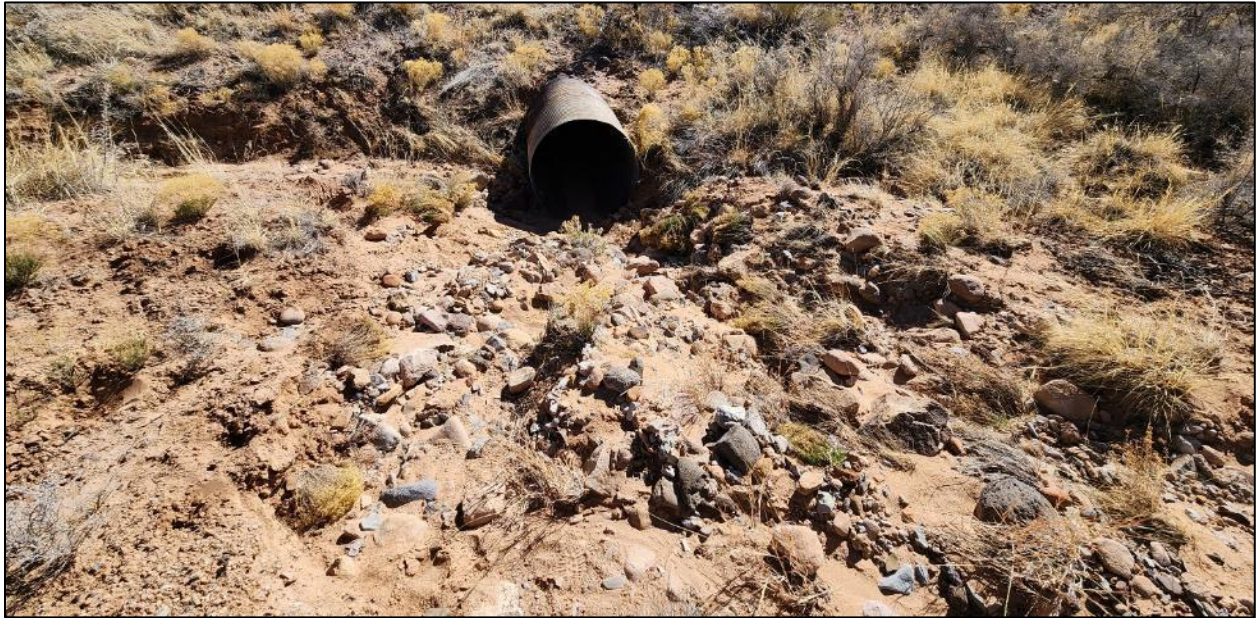
No in-situ 4-pole resistivity tests were conducted at this location due to a rocky terrain preventing the resistivity test probes from being driven into the ground, as seen in **FIGURE 89** below. Soil samples were collected at 0m, 1m, 2m, 3m, and from behind the culvert in the large hole midway up, shown in **FIGURE 87**. The results of the laboratory tests are in **TABLE 21** below.

FIGURE 89: Culvert on NM 290 MP 0.65, inlet side. Image of the rocky ground around the inlet of the culvert.

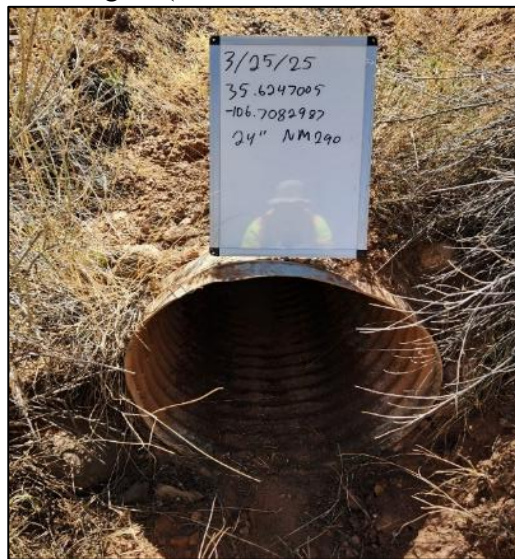
This is the second culvert investigated along NM 290, within 0.5 miles of the culvert that was visited on 12/4/24 at MP 1.0. The culvert at MP 1.0 was recently replaced, as the existing culvert was completely corroded out. Investigating additional culverts in the vicinity of the one at MP 1.0 was requested by NMDOT. A suitable culvert to investigate (accessible at inlet and outlet) was located at MP 0.91.

FIGURE 90: Inlet of culvert on NM 290 MP 0.91.

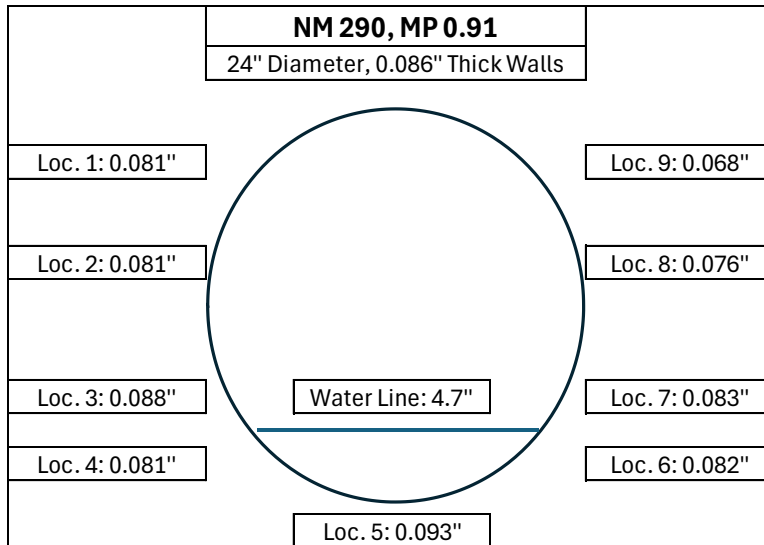
A thickness of 0.086 inches was measured on an uncorroded exposed location with a micrometer, with the closest gage thickness being 14-gage that has a standard galvanized thickness of 0.079". Ultrasonic thickness measurements were taken 1 foot in for the end of the culvert on the inlet side, with the results displayed in **FIGURE 93** below.

FIGURE 93: Diagram of inlet wall thickness measurements taken on NM 290 MP 0.91 culvert.

The majority of the measurements were less than the uncorroded thickness of 0.086", indicating outside corrosion, as there was minimal corrosion on the inside above the waterline level.

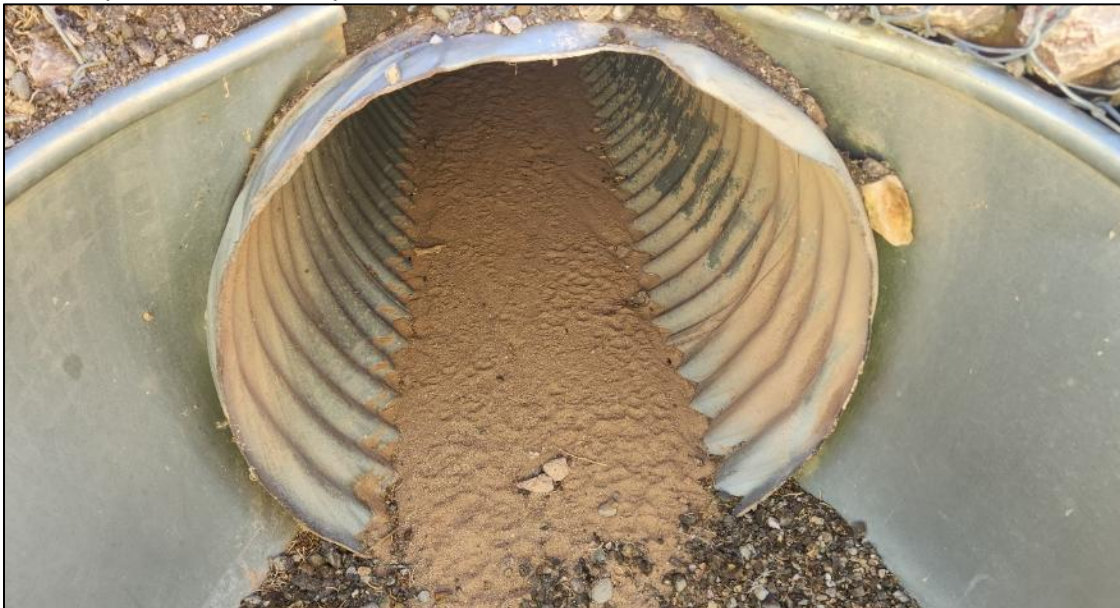
This 24” culvert is located northeast Jemez Pueblo on NM 290 and was visited on 12/4/24. This culvert was recently replaced due to the prior culvert being completely corroded out. The image below, **FIGURE 94**, is looking into the inlet (facing south). As this culvert was recently replaced, there was zero corrosion present on the inside or outside, as seen in **FIGURE 94 and FIGURE 95** below. There was approximately 4 inches of sandy soil on the inside of the culvert.

FIGURE 94: 24” culvert under NM 290, MP 1.0, inlet side facing south.

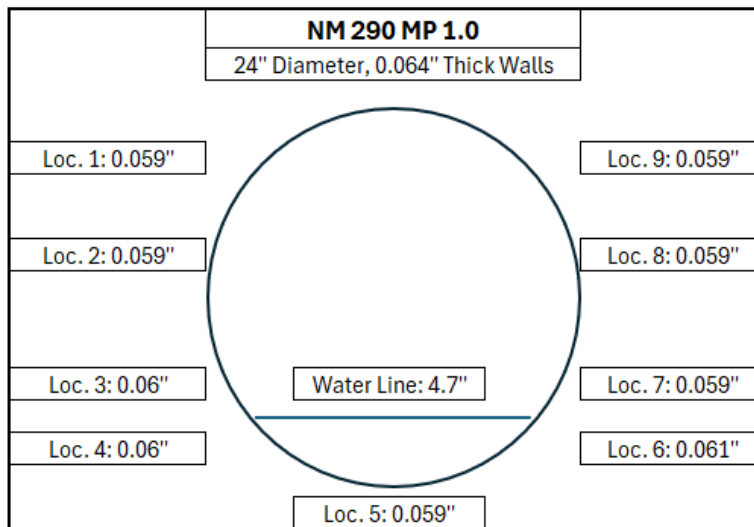
A value of 0.0615 – 0.0618 inches was measured on an uncorroded exposed location with a micrometer; the closest gage thickness is 16 with a standard galvanized thickness of 0.064 inch. Based on the ultrasonic thickness measurements taken 1' 7" in from the end of the culvert, there was no corrosion on the inside and outside of the culvert, see **FIGURE 96** below.

FIGURE 96: Diagram of inlet wall thickness measurements taken on NM 290 MP 1.0 culvert.

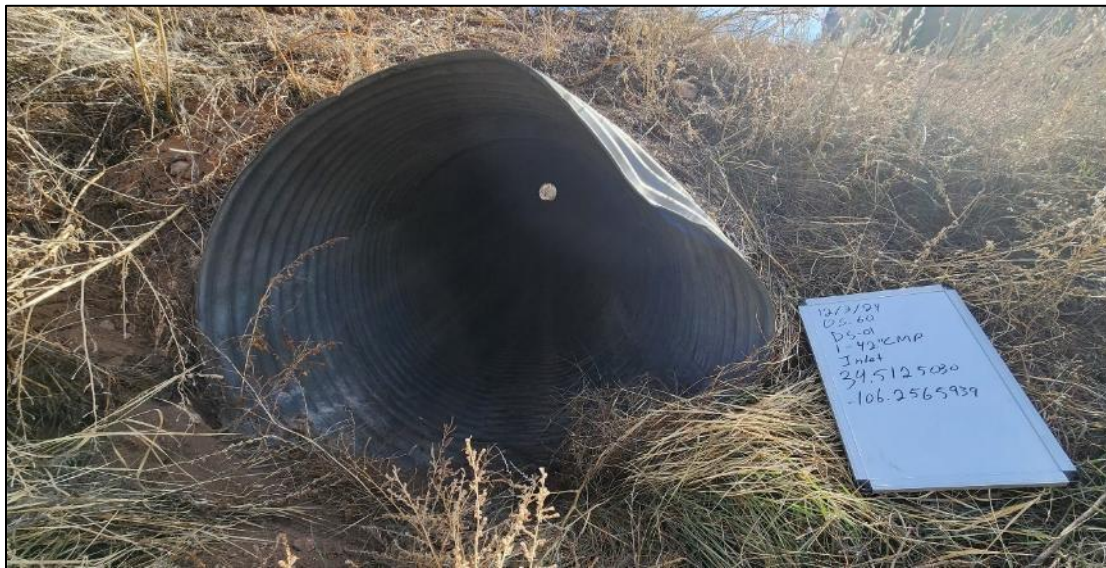
This 42” culvert under US 60 is located southwest of Mountainair and was visited on 12/3/24. This culvert was identified as DS-01 in the Preliminary Drainage Report, US 60 Roadway Improvements, CN 5101350. The image below, **FIGURE 97**, is looking into the inlet (facing south). There was no soil on the bottom inside of the culvert, but there was evidence of a waterline approximately 8 inches up from the bottom. The culvert had no corrosion present on the inside or outside, as seen in **FIGURE 98**.

FIGURE 97: 42” culvert under US 60 MP 203.41, inlet side facing south.

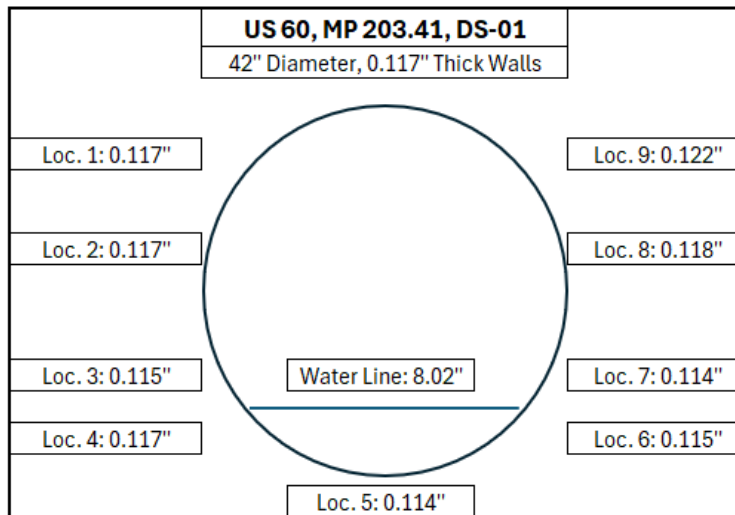
A value of 0.117 inches was measured on an uncorroded exposed location with a micrometer; the closest gage thickness is 12 with a standard galvanized thickness of 0.111 inch when in galvanized structural plate form. Based on the ultrasonic thickness measurements taken 1 foot in from the end of the culvert, there appears to be very little corrosion on the outside of the culvert, **FIGURE 99** below.

FIGURE 99: Diagram of inlet wall thickness measurements taken on US 60 MP 203.41 culvert.

The slightly higher pH values at this location suggest that soil-side corrosion will govern, which is indicated by 4 of 5 ultrasonics measurements at and below the waterline being less than the original thickness.

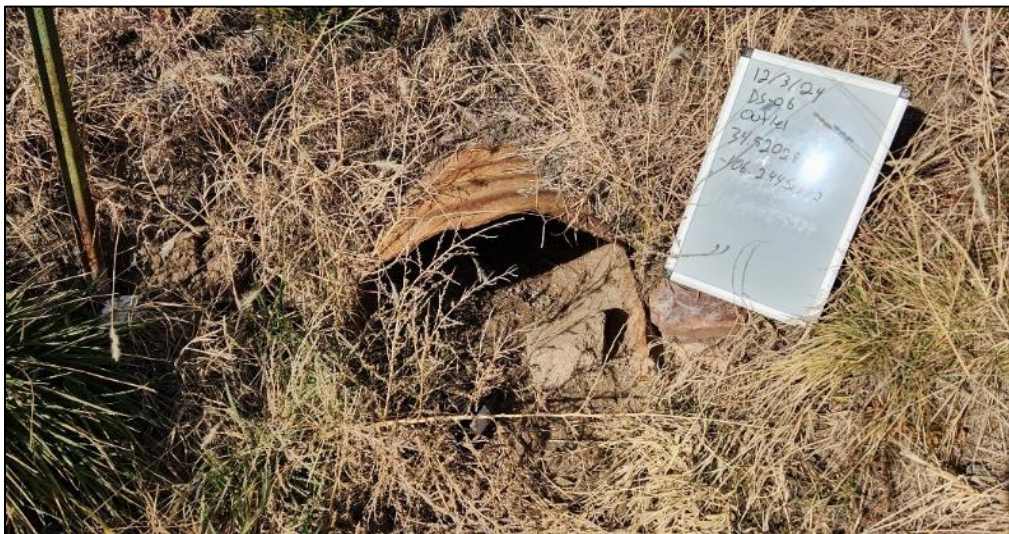
This 24” culvert is located west of the intersection of US 60 and Sunset Ave in Mountainair and was visited on 12/3/24. This culvert was identified as DS-06 in the Preliminary Drainage Report, US 60 Roadway Improvements, CN 5101350. The image below, **FIGURE 100**, is looking into the outlet (facing north). The inlet of this culvert was adjacent to a parking lot, making in-situ resistivity test at that location impossible, so the tests were conducted near the outlet instead. A considerable amount of corrosion was present on the outside, **FIGURE 100**, and on the inside, **FIGURE 101**, of this culvert. There was approximately 10 inches of soil on the inside of the culvert.

FIGURE 100: 24” culvert under US 60 MP 204.33, outlet side facing north.

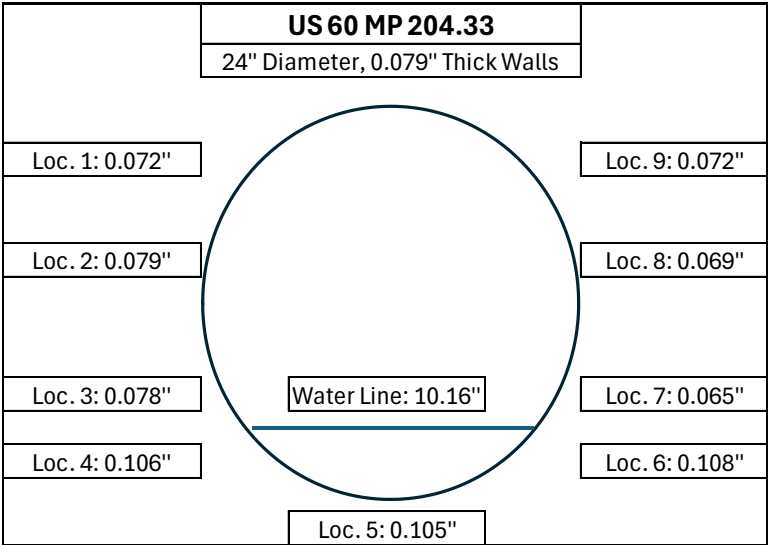
A value of 0.078 – 0.080 inches was measured on the least corroded exposed location with a micrometer; the closest gage thickness is 14 with a standard galvanized thickness of 0.079 inch. Based on the ultrasonic thickness measurements taken 1 foot in from the end of the culvert, there was a considerable amount of surface corrosion and scaling on the inside and outside of the culvert, **FIGURE 102** below. There was some pitting, but no holes observed in the culvert.

FIGURE 102: Diagram of outlet wall thickness measurements taken on US 60 MP 204.33 culvert.

The slightly higher pH values at this location suggest that soil-side corrosion will govern, which is indicated by 4 of 6 ultrasonics measurements above the waterline being less than the original thickness. The measurements below the waterline all had significant scale buildups.
