## Field Evaluation of Lightweight Noise Barriers and Development of Noise Barrier Inspection and Asset Management Program

**Final Report VTRC 26-R47**

**FIELD EVALUATION OF LIGHTWEIGHT NOISE BARRIERS AND DEVELOPMENT  
OF NOISE BARRIER INSPECTION AND ASSET MANAGEMENT PROGRAM**

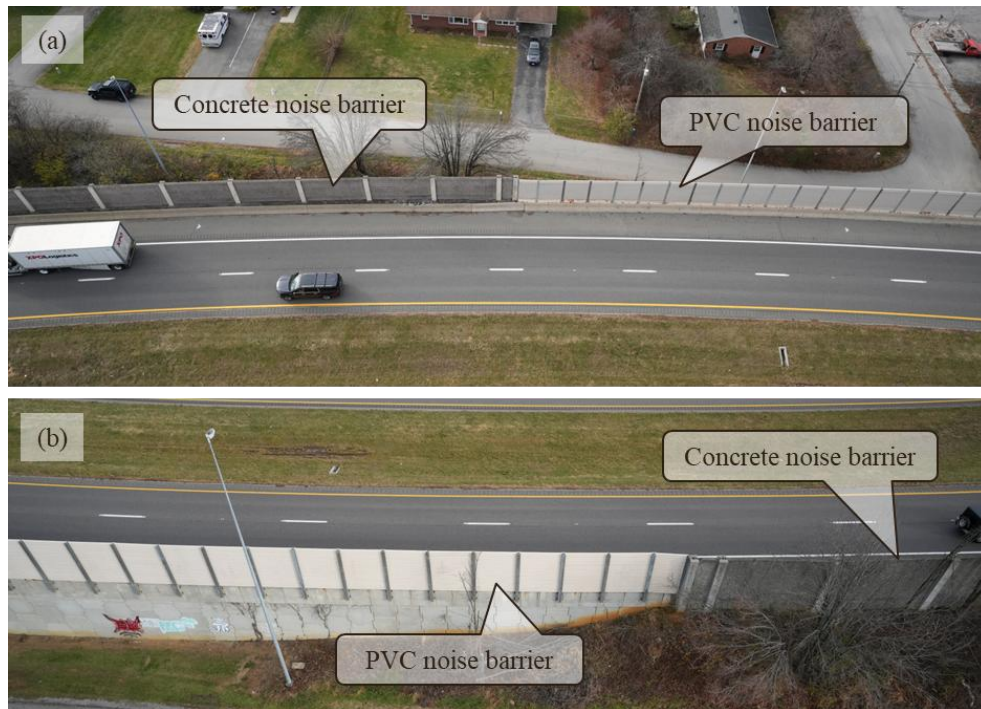
The UAS trial inspections were successful at capturing condition data of both sides of all three noise barriers at both sites. Figure 18 shows some of the individual oblique-angle photos captured during the UAS flights over the PVC and concrete noise barriers at the Christiansburg site. Figure 18 includes photos from both the front and back sides of the noise barriers. Figure 19 shows an orthomosaic “top of wall” photo where the PVC and concrete noise barriers join.

**Figure 18. Oblique Imagery of PVC and Concrete Noise Barriers at Christiansburg Site: (a) Front Side of Noise Barriers; (b) Back Side of Noise Barriers. PVC = polyvinyl chloride.**

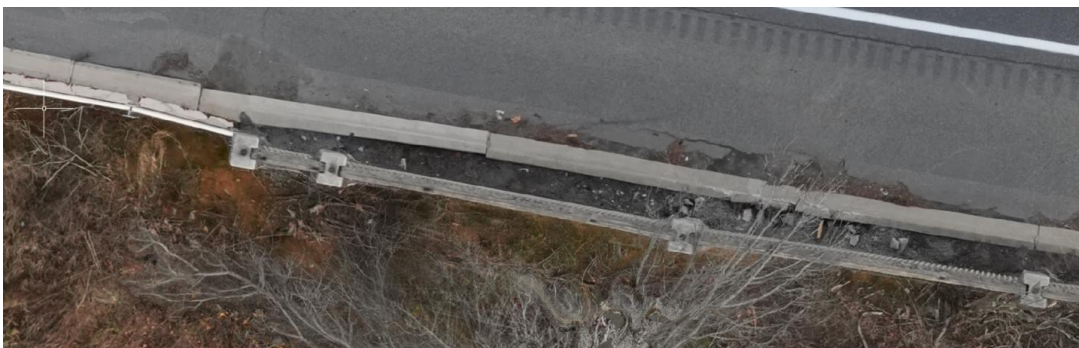
**Figure 19. Orthomosaic “Top of Wall” Photo Where the Polyvinyl Chloride and Concrete Noise Barriers Join at Christiansburg Site**

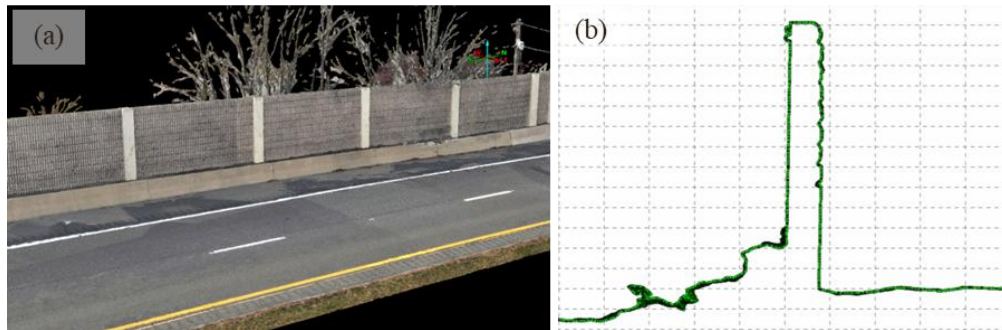
Figure 22 shows example screenshots of the LiDAR collected from the concrete noise barrier at the Christiansburg site. Figure 22b shows that the LiDAR data model can be used to view cross sections of the object. These data could be used to evaluate if a noise barrier was out of alignment. Additional data collected from future inspections could also be used to conduct a change analysis on the vertical alignment of the noise barrier to identify damage. One benefit of LiDAR is that it can travel through vegetation, so vegetation does not need to be cleared to develop an accurate LiDAR model.

**Figure 22. Screenshots of LiDAR Data from Concrete Noise Barrier at the Christiansburg Site: (a) Point Cloud Data; (b) Cross-Section Scan**

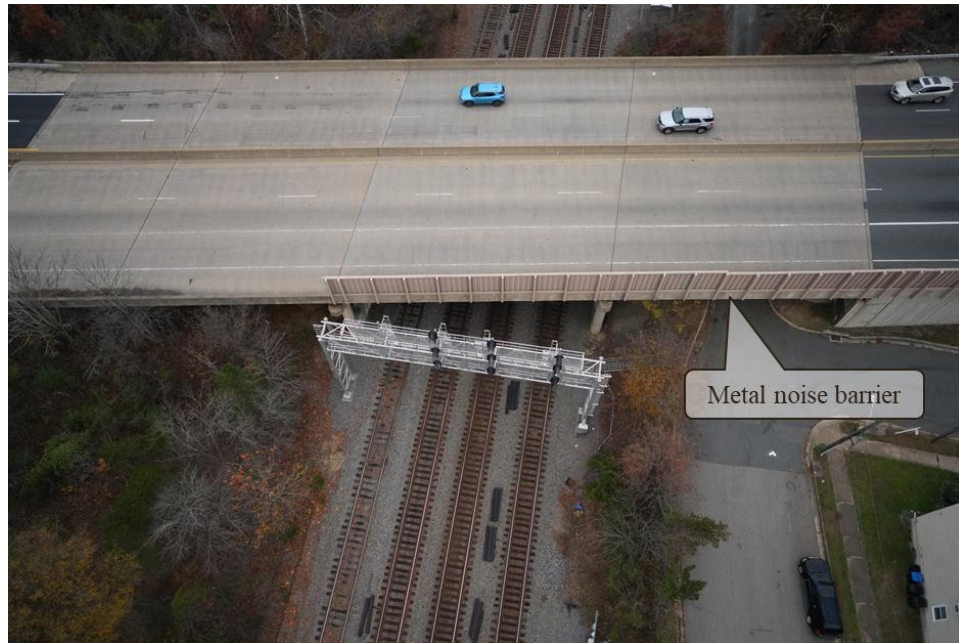
Similar data were gathered from the metal noise barrier at the Fredericksburg site. As stated previously, the noise barrier was mounted to a bridge crossing over railroad tracks. A truss structure also crossed over the railroad tracks just south of the bridge. Figure 23 shows an oblique-angle image recorded from the UAS during the trial inspection. This site served as a likely use case for UAS inspection due to access difficulties associated with the railroad tracks. Access by other inspection tools, such as a bucket truck, would require additional railroad coordination and permits, in addition to a traffic lane closure to inspect the back side of the noise barrier without a UAS. All this effort would contribute to increased inspection delays and additional costs in equipment and resources.

**Figure 23. Oblique Imagery from the Fredericksburg Site Showing Metal Noise Barrier, Railroad Tracks, and Truss Structure over Railroad Tracks**

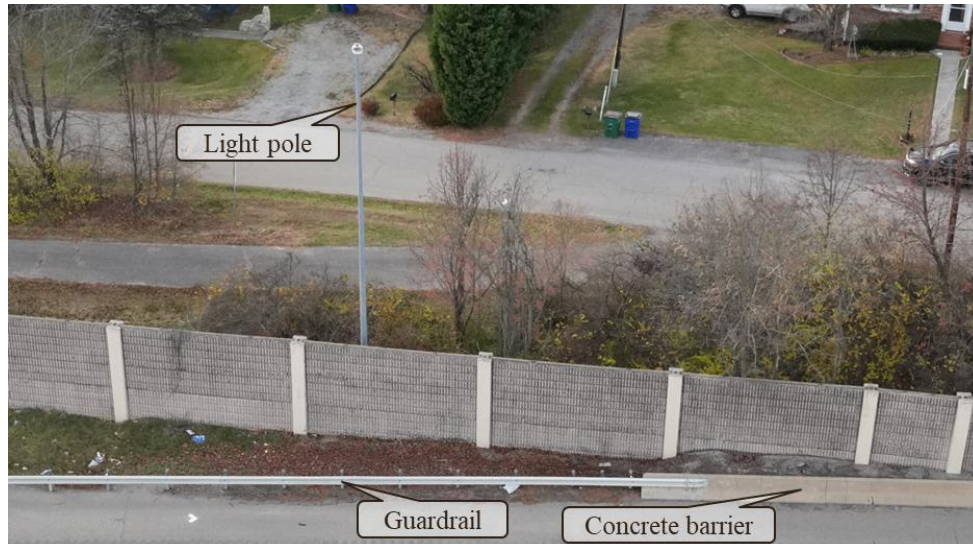
Figure 26 shows some of the other VDOT assets that UASs captured during the trial inspections, including light poles, guardrails, and concrete barriers. A single UAS flight could collect data on multiple assets for future analysis. This capability could present a significant opportunity to minimize field site visits while maximizing the number of assets on which data were collected. This achievement would be possible if UAS performance and collection standards were developed and the data collection process were centralized.

**Figure 26. Other VDOT Assets Observed During Unmanned Aerial System Trial Inspections**
