DOT/FAA/CT-83/42  
NASA-TM-85654

# Structural Response of Transport Airplanes in Crash Situations

November 1983

Final Report

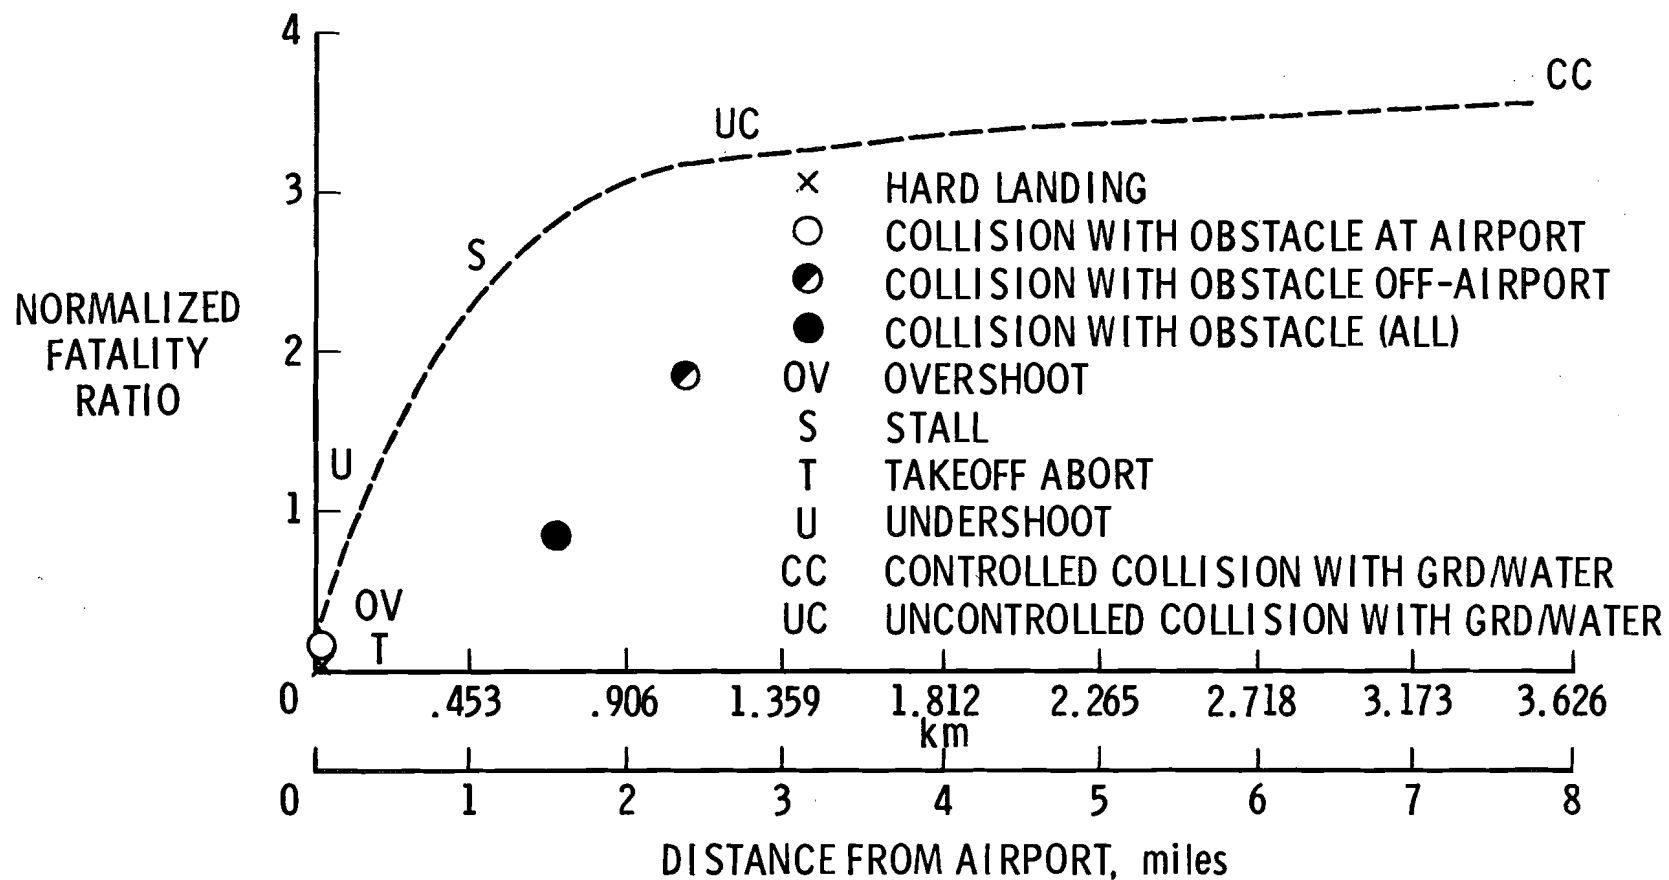
FIGURE 4. - NORMALIZED FATALITY RATIO AS A FUNCTION OF DISTANCE FROM AIRPORT FOR CRASH SCENARIOS

The average distance from the airport that the various accident types occur is shown in table 5. In figure 4 a normalized fatality ratio (ref. 21) is plotted as a function of distance from the airport in miles. The Fatality Ratio (FR) is the ratio of number of fatalities/total number of passengers onboard and a normalized fatality ratio is obtained by dividing by the average fatality ratio, based on the total number of reports and briefs considered. This average fatality ratio was 0.1917 (ref. 21), and an "average" accident would have a normalized fatality ratio equal to one. Normalized ratios above one and below one are more and less severe, respectively, than the 'average'. The fatality ratio is related to the distance from airports at which aircraft accidents occur. Accidents around airports such as "Hard Landings", "Takeoff Aborts", and "Overshoots" are relatively fatality free. Under-shoots which occur at approach velocities but involve terrain with some degree of roughness and contour unpredictability at an average distance of approximately 900 feet shy of the runway, are moderately severe, but less than the average. Stalls, which occur on an average about 1.2 miles from the airport, are severe accidents. The airplane's uncontrolled attitude at impact during a stall contributes to this severity. Collision with Obstacles at or near the airport are relatively mild. Usually they involve wires and approach lights which damage the airplane but do not inhibit the pilot from making a safe landing. Injuries that result from this type of accident often occur during the evacuation from the airplane. Collisions with Obstacles, generally trees and buildings, are more fatal than the average. This type of accident occurs on an average 2.3 miles from the airport and has a fatality ratio equal to 1.86. Uncontrolled Ground/Water Collisions occur on an average 2.7 miles from the airport and have a fatality ratio of 3.26. The Uncontrolled Ground/Water Collision accident type occurs

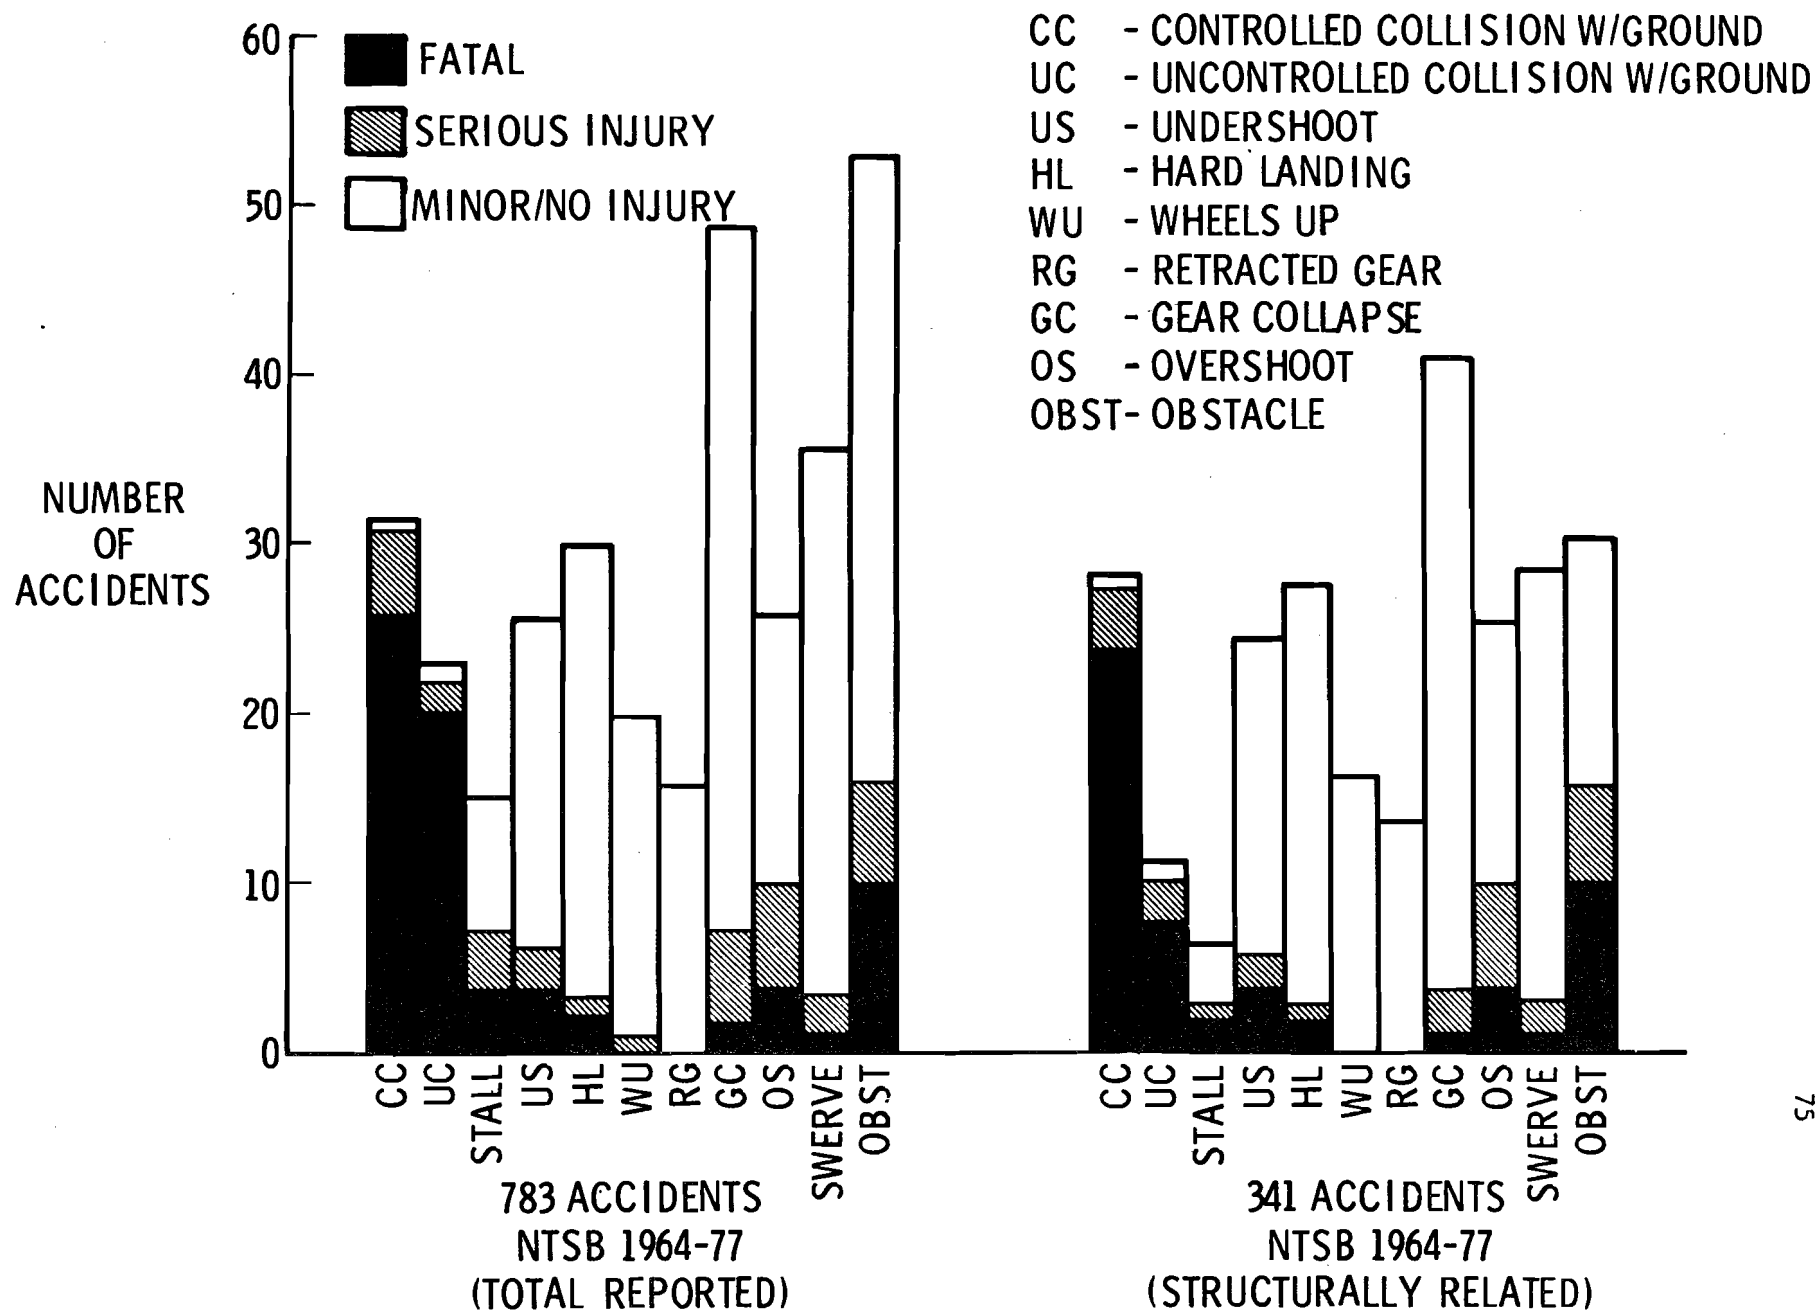
FIGURE 5. - COMPARISON OF NTSB SUMMARIES

The NTSB accident data was used as a basis for formulating accident scenarios primarily because it provided the most details about accidents. The NTSB data represents less than 29 percent of the total accidents in the world during the period 1964-77. During this period of time the NTSB summaries include 783 accidents compared to 2707 worldwide accidents (reference 24). Figure 5 (ref. 21) shows a comparison of the number of occurrences of fatal, serious injury and minor/noninjurious accidents for both the original set of data (783) and the reduced (structural-related) set (341) as a function of primary accident types. The distribution and severity of injury exhibited by both sets of data are similar.

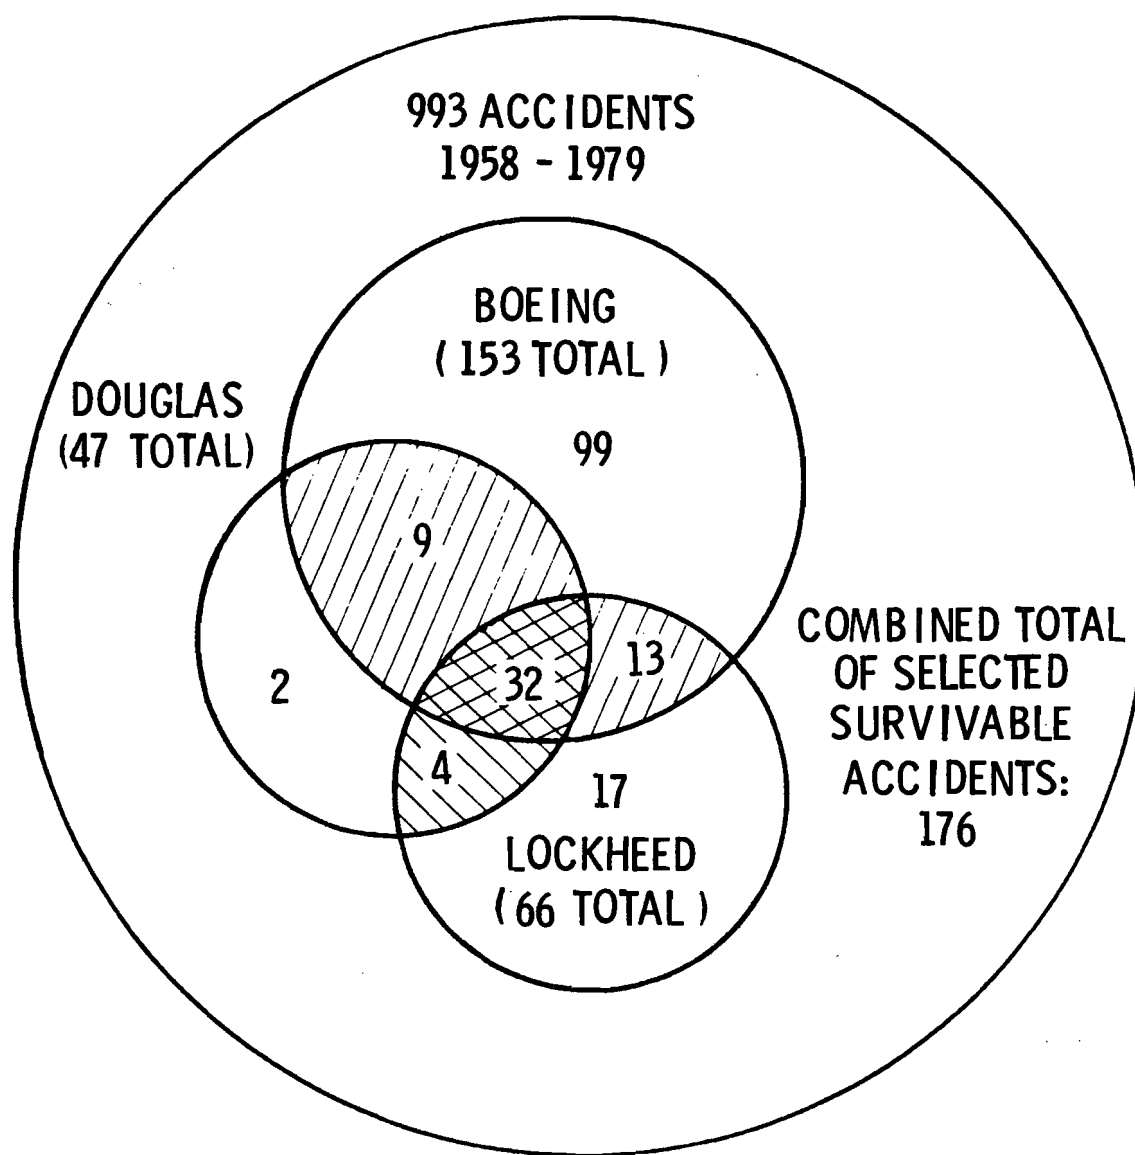
FIGURE 6. - SELECTED ACCIDENT STUDY DATA BASE

The purpose of the selected accident study data base was to review the historical accident data to identify and define aircraft behavior and structural break-up and the associated injury causing mechanisms or factors. In an objective, but somewhat unavoidably subjective manner, a combined total of 176 fairly-well documented survivable accidents were chosen to form a data base from the total (341) examined in references 19, 20, and 21. A listing of these 176 accidents are given in Table 8. This data base was then used to study and assess the pertinent structural behavior of both the total airplane and selected subsystems. In a few isolated cases the one survivor condition for survivability was waived when it was felt that trauma forces were within human tolerance levels, but a fire hazard existed. The distribution of accident data between the three contractors (refs. 19, 20, and 21) is illustrated in figure 6. The three transport manufacturers generally examined different accidents, but some accidents were examined by all three manufacturers as indicated in the figure by the cross-hatched area, some by two of the three as indicated by the hatched areas, and other accidents solely by one manufacturer (primarily the accidents involving

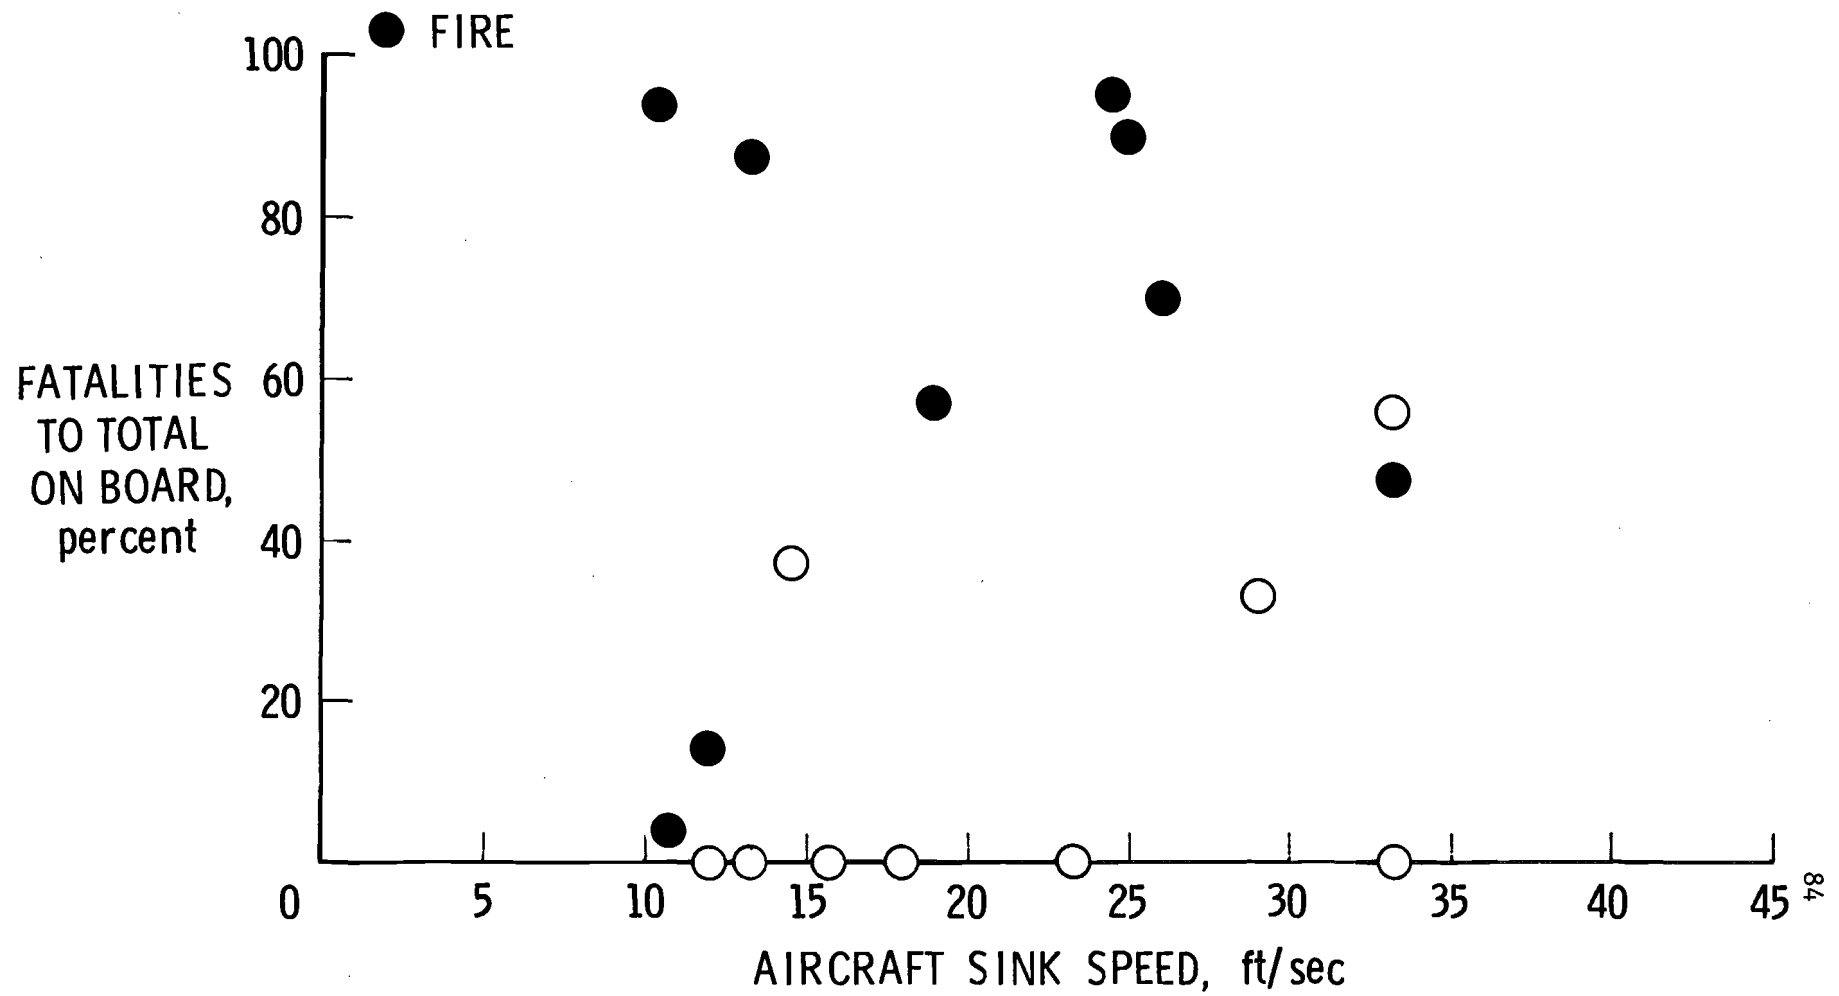
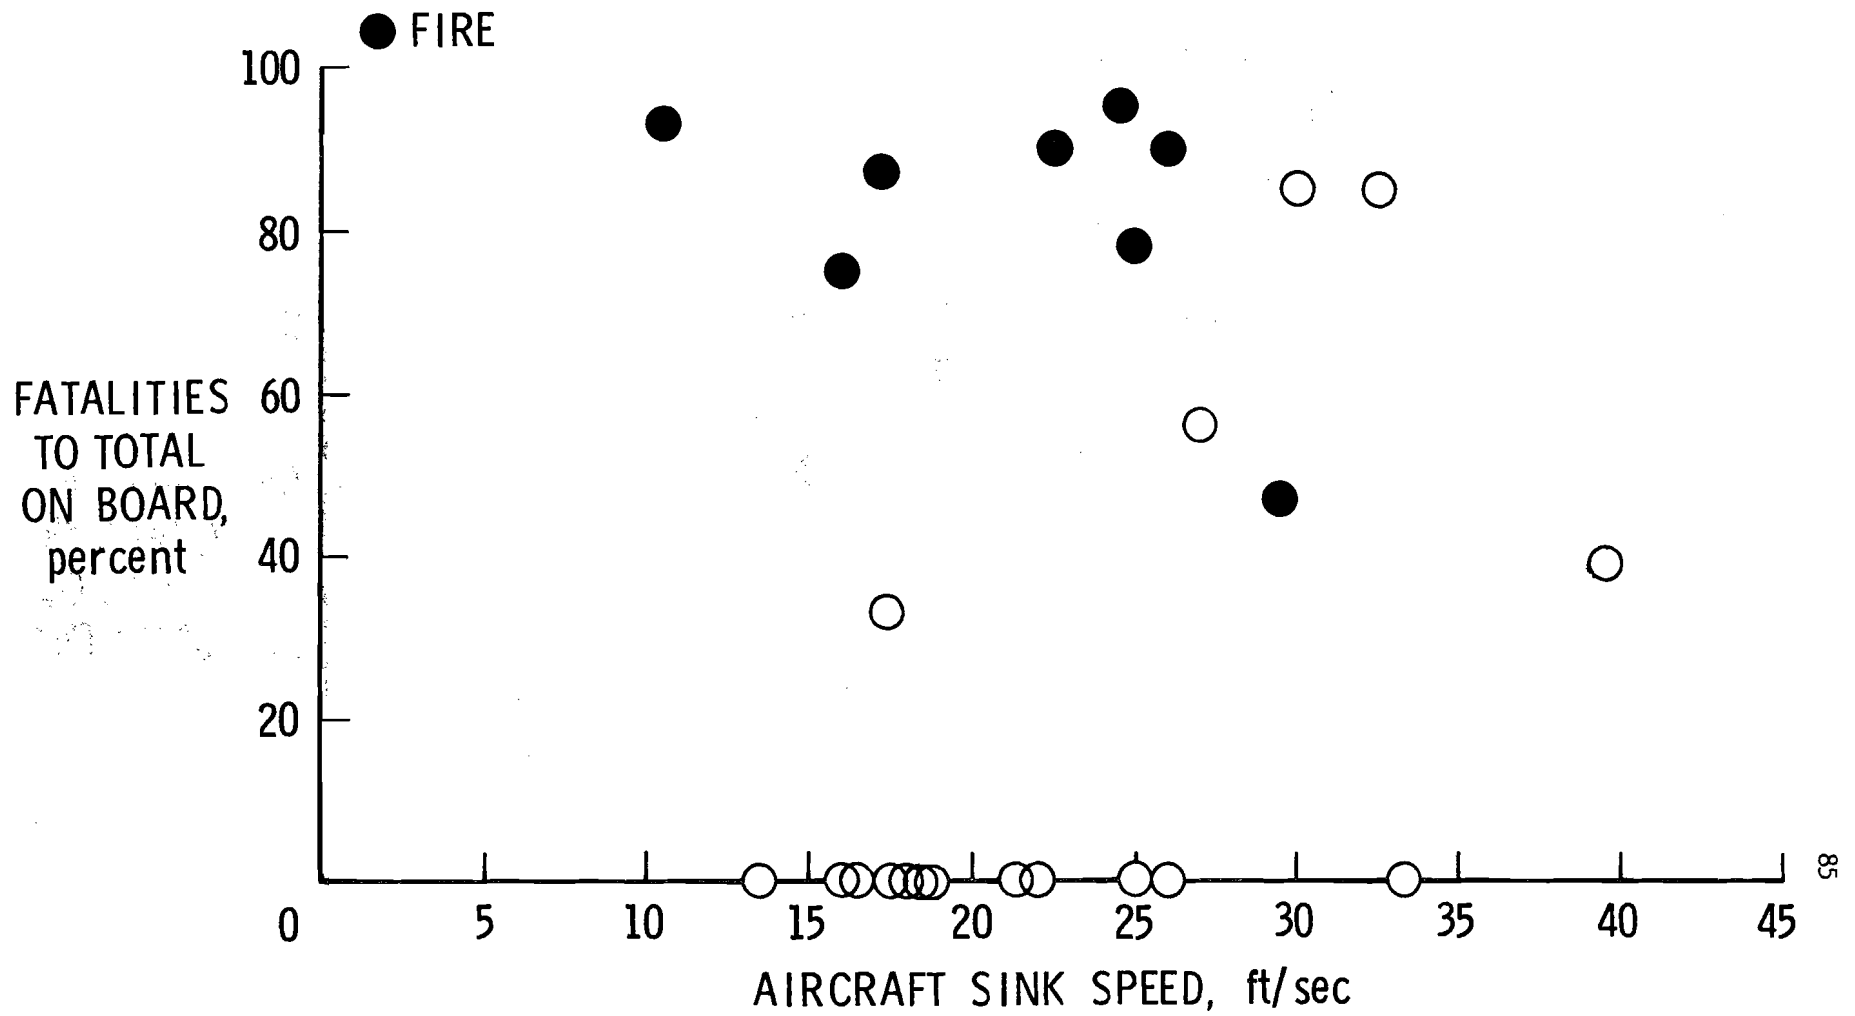
To further explore the effect of rate of descent on fatalities a graph of fatalities as a percentage of total onboard for air-to-surface approach accidents, as a function of sink rate, is plotted in figure 11. In figure 11(a) the data from ref. 19 is presented, in 11(b) the data from ref. 20, and in figure 11(c) the data from ref. 21. Recognizing the fact that following initial impact, subsequent hazards may be encountered such as impact into columns, ditches or other obstructions the data plotted in figure 11 should only be viewed as indicating a trend. Furthermore, the accidents in which a large percentage of the fatalities are fire related are shown as solid symbols. Reviewing the solid and open symbol data for all three data bases indicates a general increase in trauma-related fatalities occurring at aircraft sink speeds of approximately 25 fps and above. This trend shows an inherent structural capability of the airframe to provide a good measure of load attenuation in the vertical direction. In figure 12(a), (b), (c) the percent injury to total onboard is plotted as a function of sink rate for the same air-to-surface approach accidents as in figure 11. Again, the accidents involving a high percentage of fire-related fatalities are shown as solid symbols. The data exhibit no apparent trend indicating that injury-causing mechanisms may be more local in nature than global. The accident data does show injuries occurring at a sink speed of 10 fps and above which coincidentally is approximately the landing gear design sink speed.

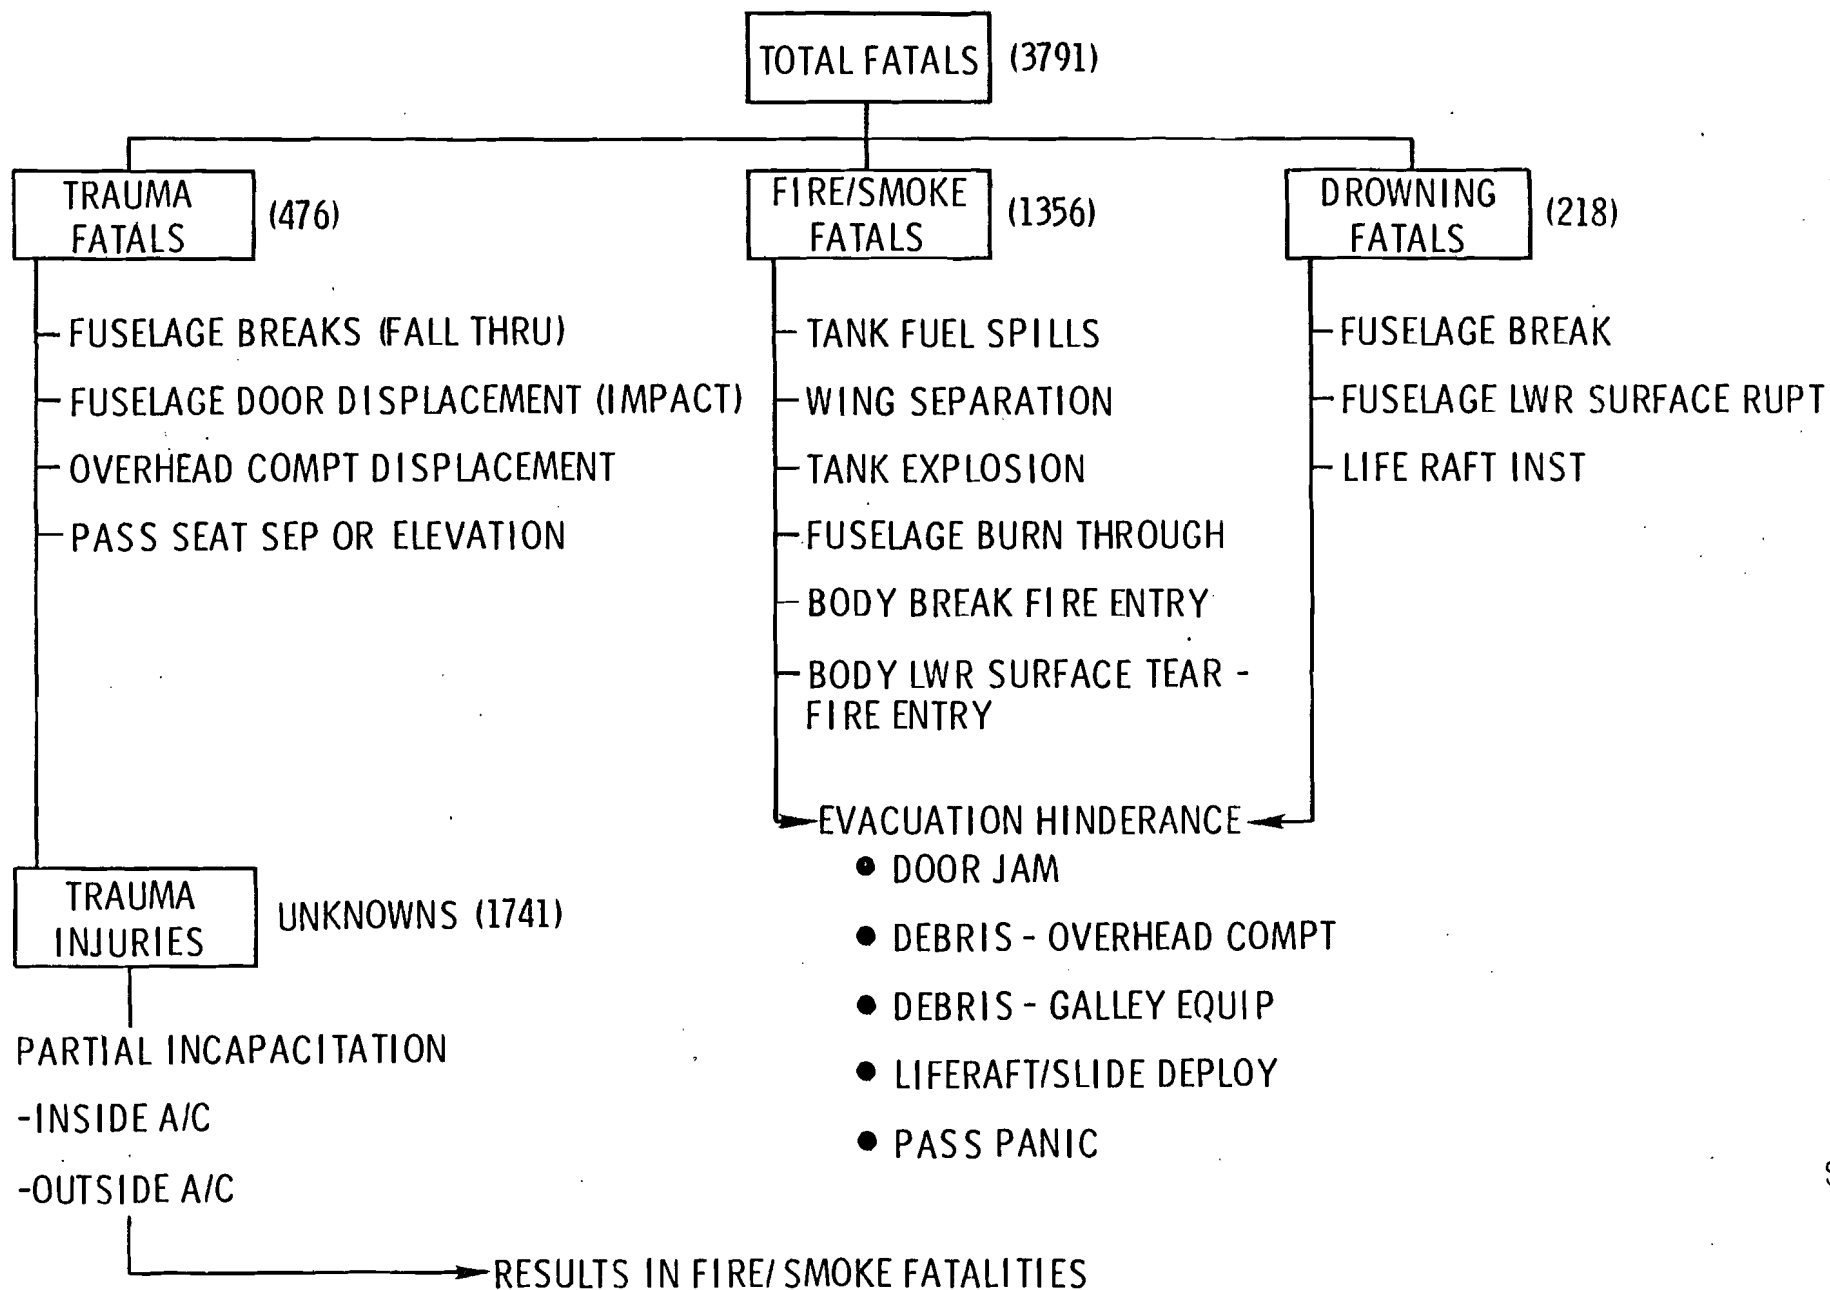
FIGURE 13. - STRUCTURAL FACTORS IN FATALITIES

The participation of structural factors in fatalities is shown in figure 13 (the number of fatalities coming from Table 12. The major factor in fatalities is fire/smoke, the unknowns representing a combination of trauma and fire. The role of trauma injuries in fire fatalities is undefined. An assessment of the interaction and role of these structural components in a crash environment is presented in Appendix A. A more thorough assessment is presented in references (19), (20), and (21).
