DOT/FAA/CT-85/25

# **Seat Experiment Results Full-Scale Transport Aircraft Controlled Impact Demonstration**

Mark R. Cannon  
Richard E. Zimmermann

July 1986

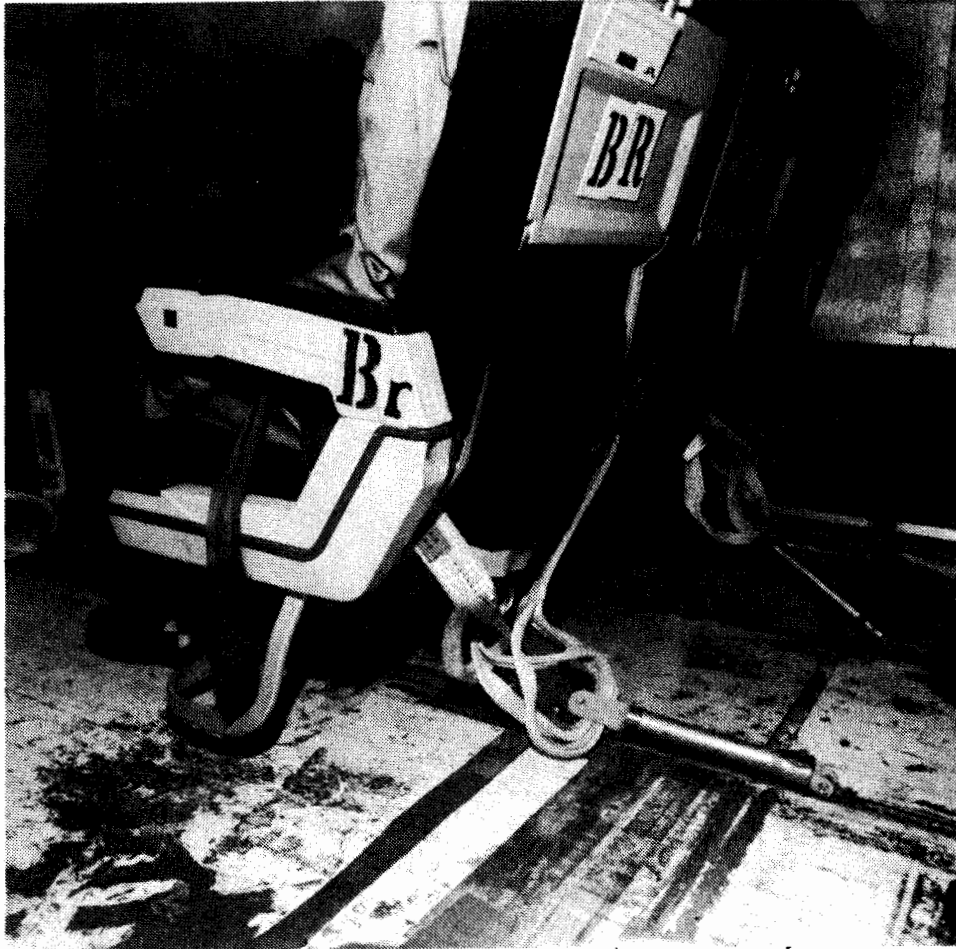
Figure 29. Secondary restraint system.

The system was tied to the dummies, because this appeared to be the most reliable means of restraining both the seat and dummy should the seat fail. The installation shown in figure 29 is typical of the restraint system used on the various seat configurations.

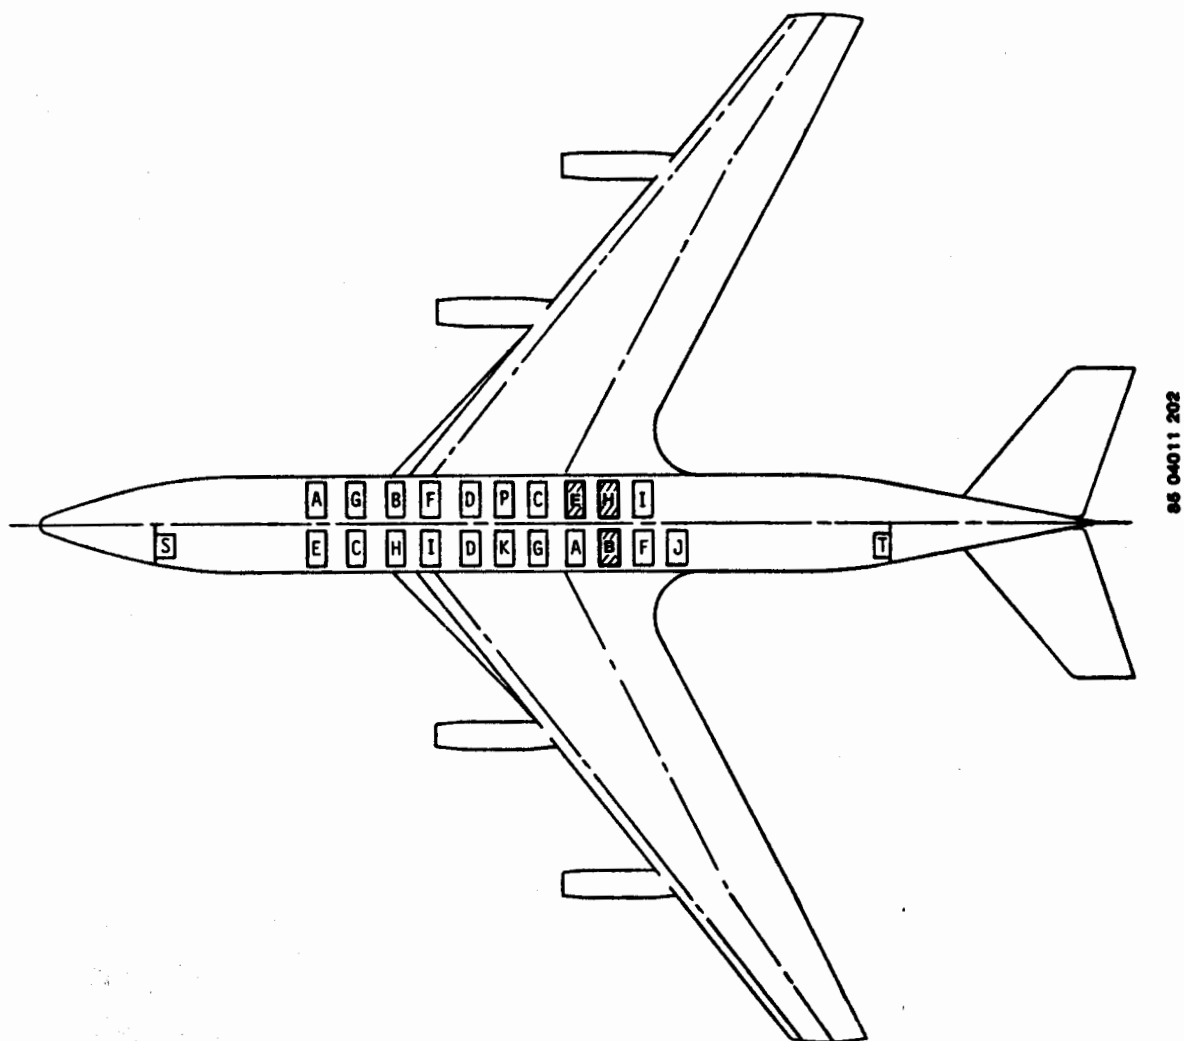
Figure 53. Locations of seats with seat pan deformation.

A common occurrence found on three seats was the deformation of the right side of the center seat pan. Figure 53 shows the locations of these seats and figures 54-56 show the seat pans. Onboard films showed the dummies in these seats leaning to the right and bouncing during the obstacle impact and slideout. The accelerometers from seats H/R and B/L indicated peak vertical accelerations of 40 G with 10-msec durations.

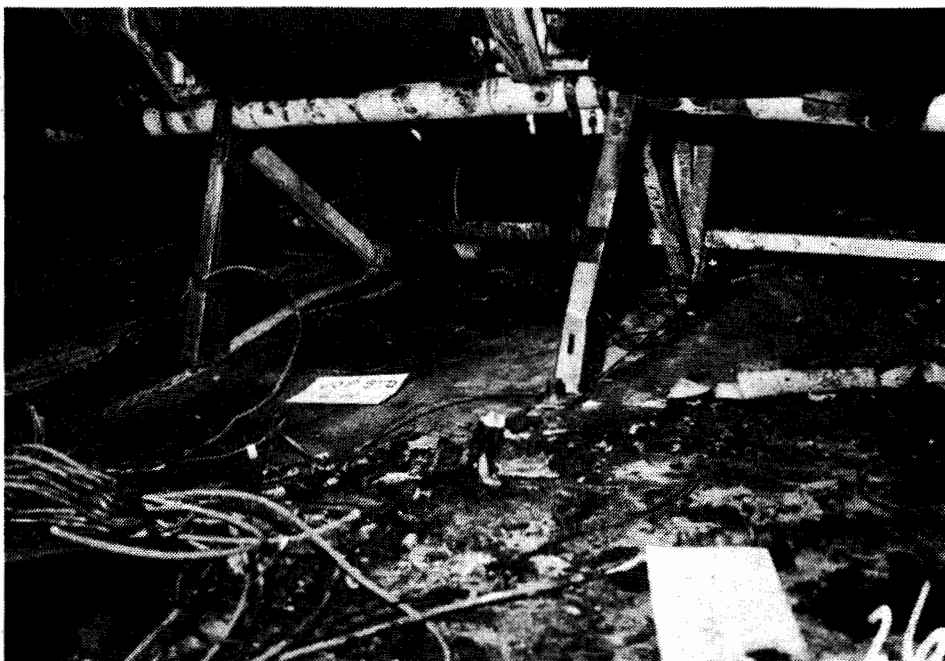
Figure 76. Deformation of floor due to gear hub impact.

SEAT B/L. During the obstacle impact, a landing gear hub struck the underside of the floor structure directly beneath the outboard track cover bar that connects the front and rear seat legs. The floor broke and assumed the shape of an inverted V. Since the track cover bar was lying flush over the floor track, it also assumed the same shape (figure 75). The deformation of the floor also caused the outboard front track fitting to come loose from the floor track (figure 76), leaving the seat supported by three legs.

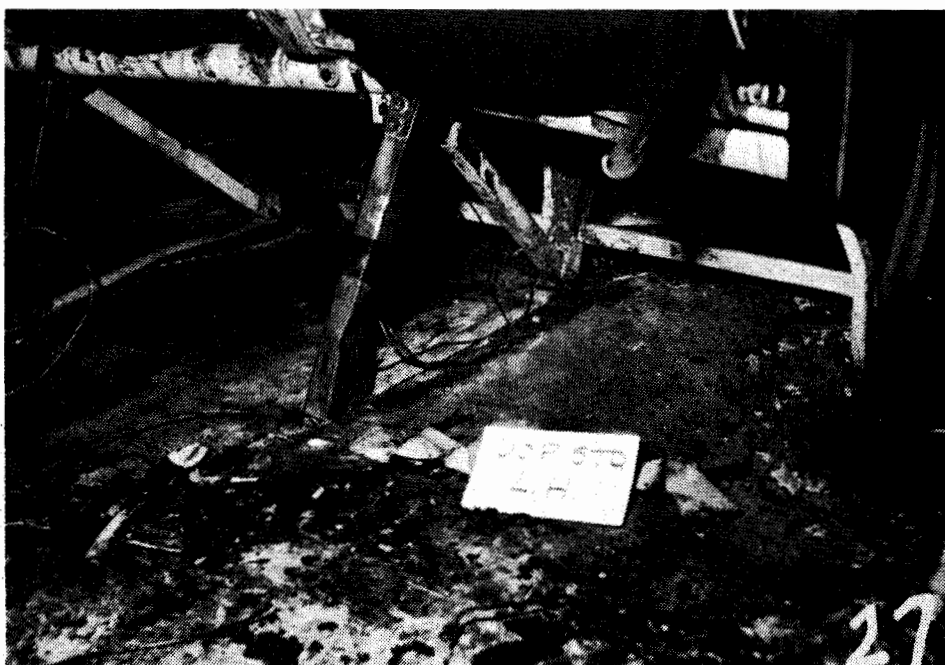
Figure 77. Buckled inboard rear leg of seat B/L.

Lateral loading caused the inboard rear leg to buckle (figure 77) and the outboard rear leg to bend slightly. It is not possible to show conclusively whether the seat was supported by three or four legs when the leg buckling occurred. The vertical and lateral seat accelerations (figure 78) indicate the vertical impact which dislodged the front outboard track fitting could have occurred before the lateral pulse which bent the legs. On the other hand, seat J/L, a seat two rows to the rear with a similar leg construction, failed due to the lateral accelerations. All the other adjacent seats were modifications built to withstand at least 6 G, twice the strength of seats B/L and J/L. The modified seats did not experience any deformation.

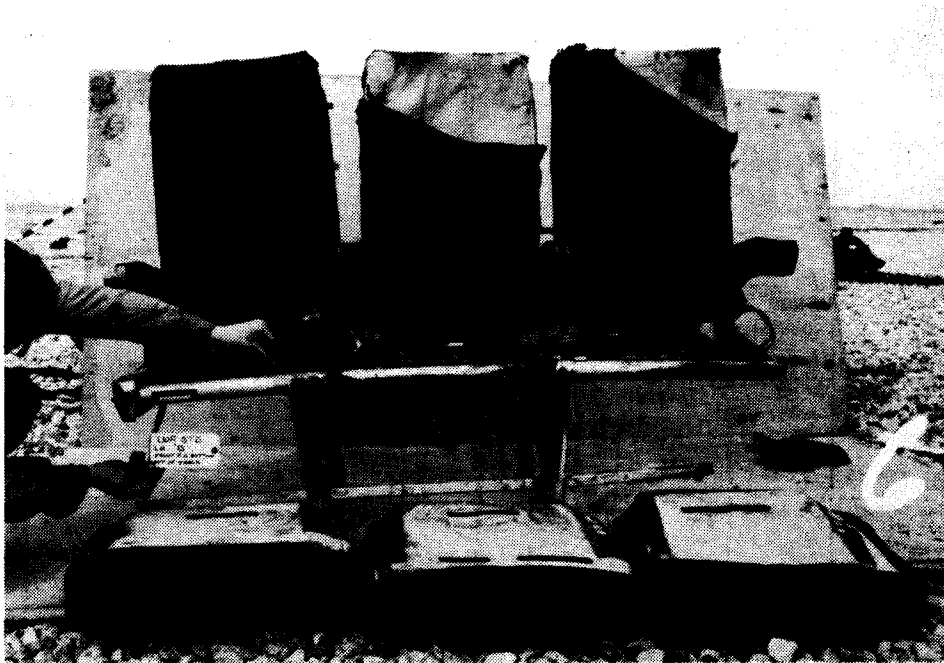
Figure 79. Deformed front seat pan tube of seat B/L.

The front seat pan tube was deformed downward at both window and aisle seat positions (figure 79) and the rear seat pan tube was similarly deformed at the aisle seat position (figure 80). Since the fire had discolored the tubes at these locations, the deformations can be attributed to the heat softening the metal.

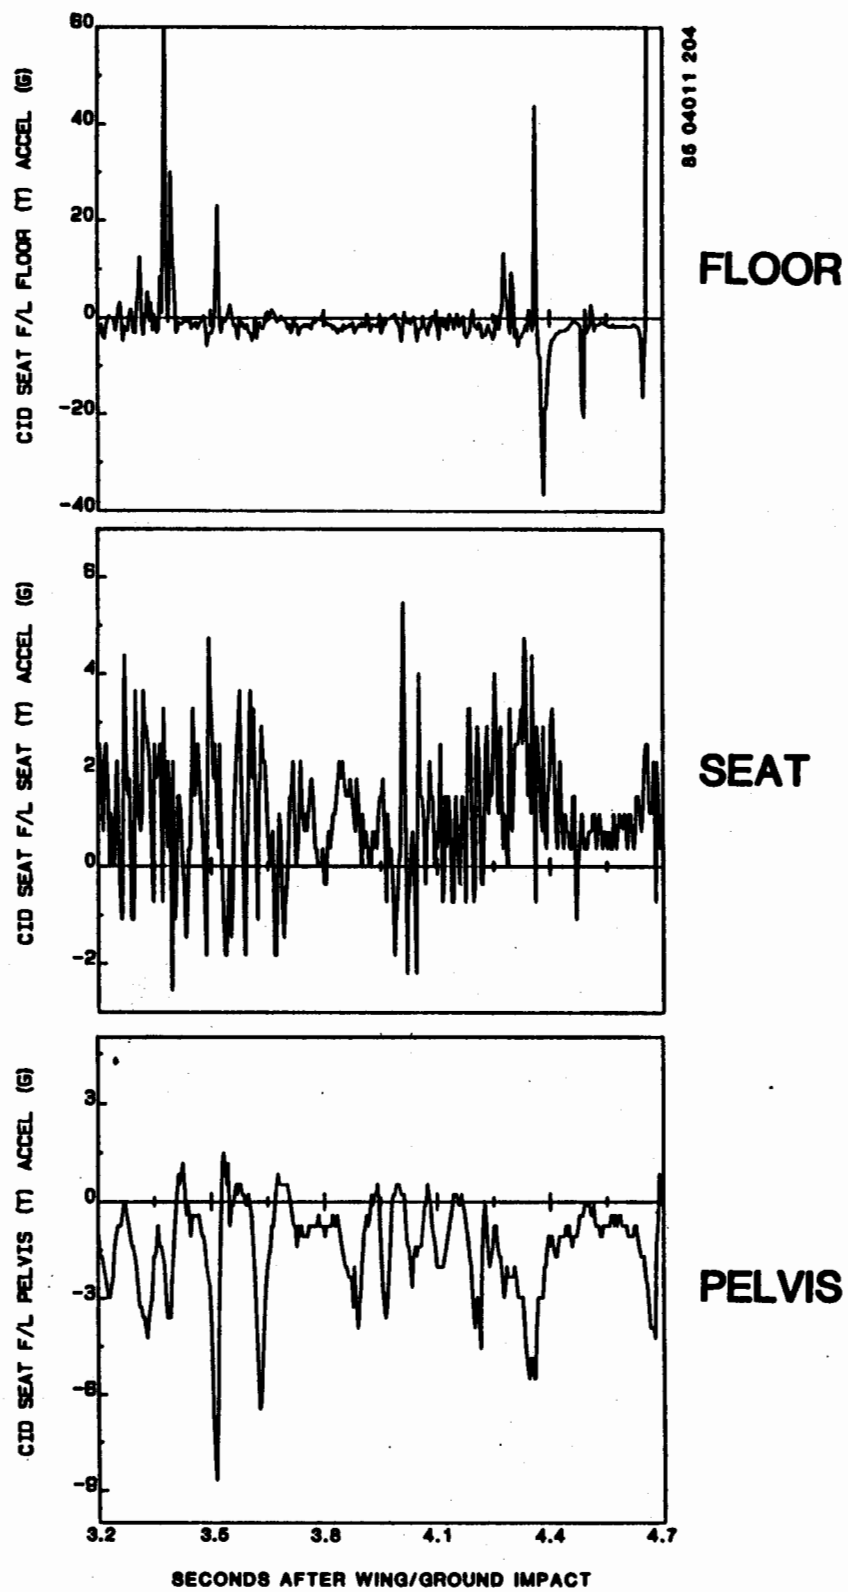
Figure 84. Seat F/L - lateral accelerations after obstacle impact.

This seat did not have any instrumentation, and the closest accelerometers were those on seat F/L immediately in front. The lateral accelerations from seat F/L after the obstacle impact are shown in figure 84.

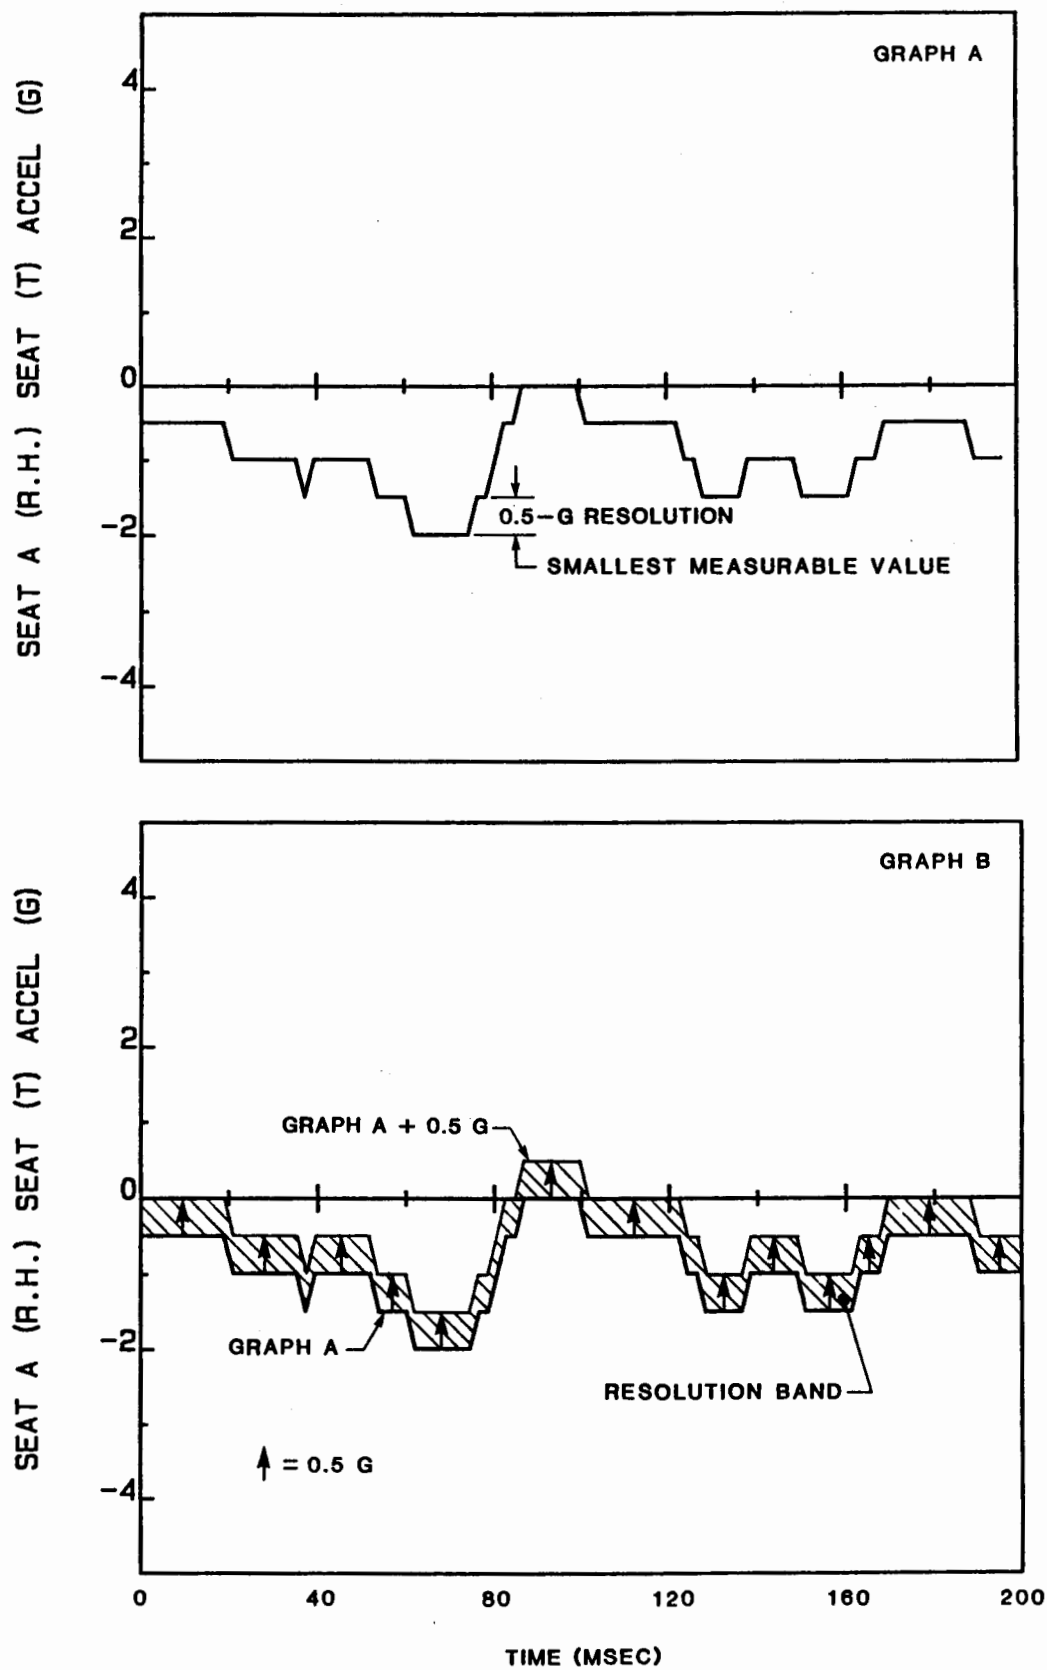
Figure 87. Illustration of CID data resolution.

Graph A of figure 87 is a typical acceleration trace. Measuring the smallest distance from one level to another shows that the resolution of this particular data channel is 0.5 G. Since the analog signal always defaults to the lower digital value, this trace is actually a plot of minimum acceleration values. Thus, every acceleration that was actually output by the accelerometer lies between the value shown on graph A and 0.5 G above that value. This is illustrated in graph B, where every value from graph A has been increased 0.5 G and the area between the two traces has been shaded. The shaded area is the resolution band, and the actual acceleration trace lies somewhere in that band.

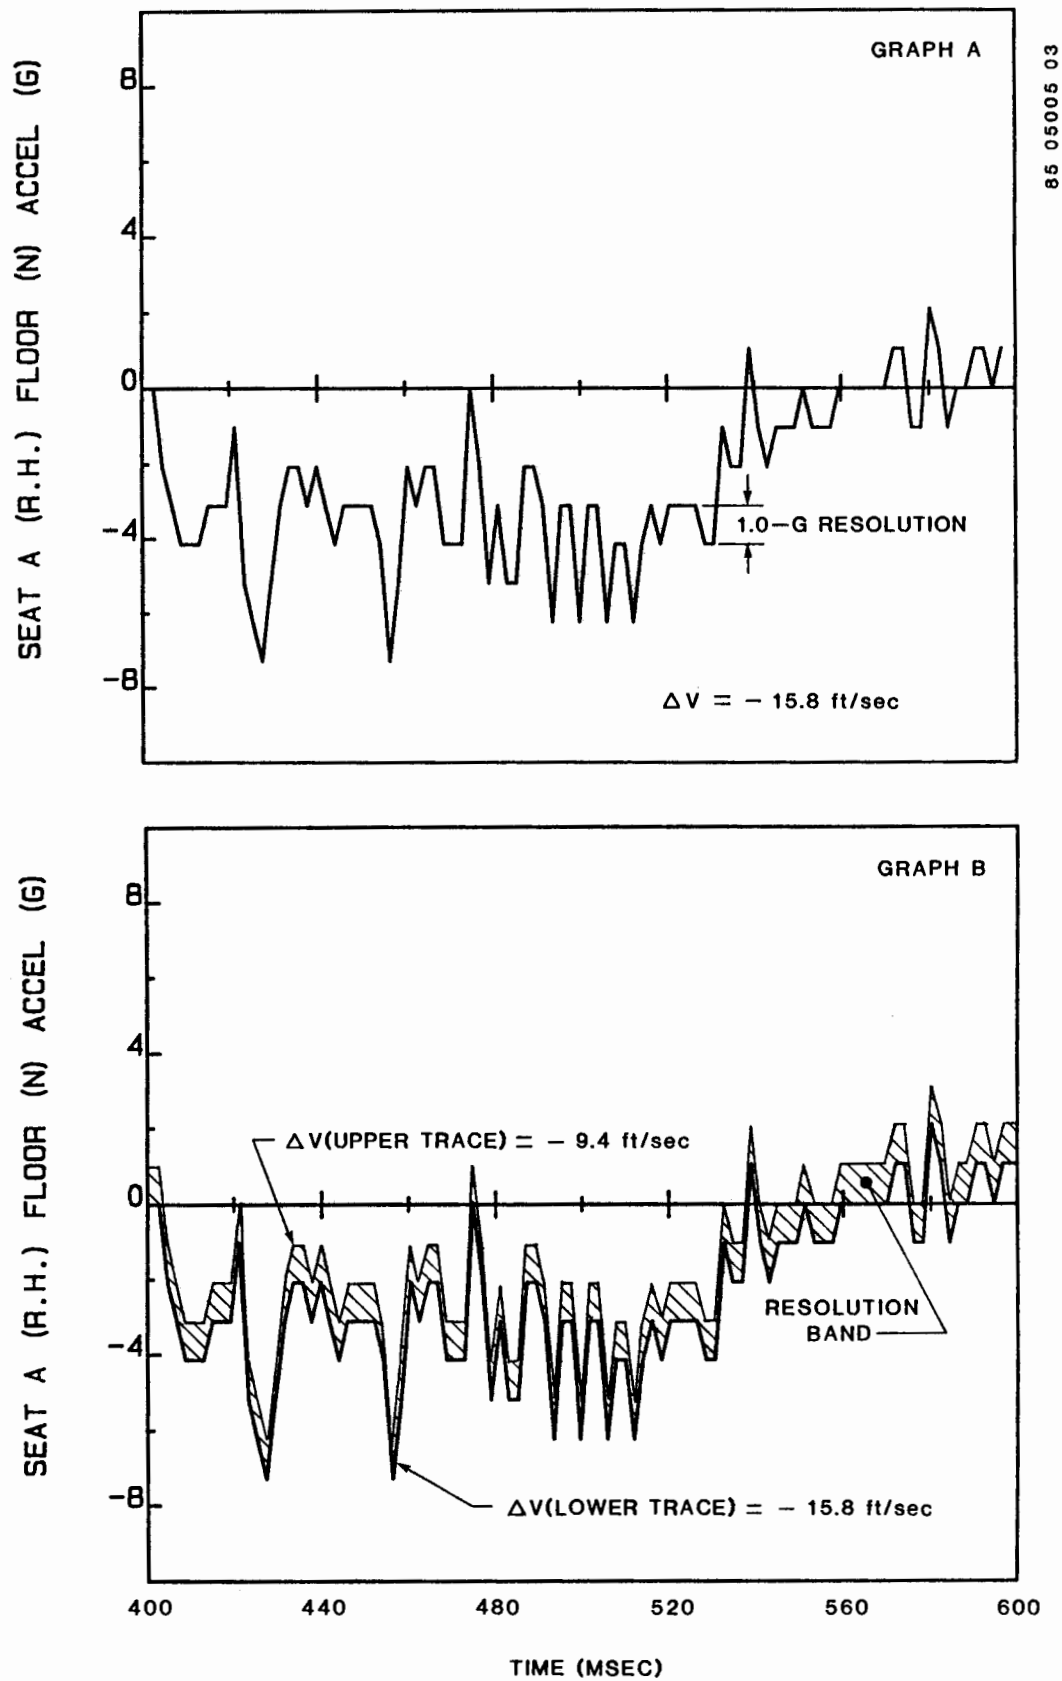
Figure 88. Example of velocity change uncertainty.

Data resolution becomes especially significant when determining velocity changes. As an example, the velocity change calculated from the acceleration trace in graph A of figure 88 is approximately -15.8 ft/sec. (Velocity change is defined as the difference in areas above and below the abscissa circumscribed by an acceleration-versus-time curve.) If the resolution band is drawn in as shown in graph B, and the upper trace used, the new velocity change is -9.4 ft/sec. Thus, the actual velocity change over the 200 milliseconds shown is between -15.8 and -9.4 ft/sec.

If velocity changes are to be calculated from any of the acceleration-versus-time curves from the CID data, it must be remembered that the velocity change uncertainty is proportional to the product of the resolution and the time interval. In the example from figure 88, the data channel has a resolution of 1.0 G. This, multiplied by the duration (.200 sec) and a conversion factor (32.2 ft/sec<sup>2</sup> per G), yields an uncertainty of 6.4 ft/sec.

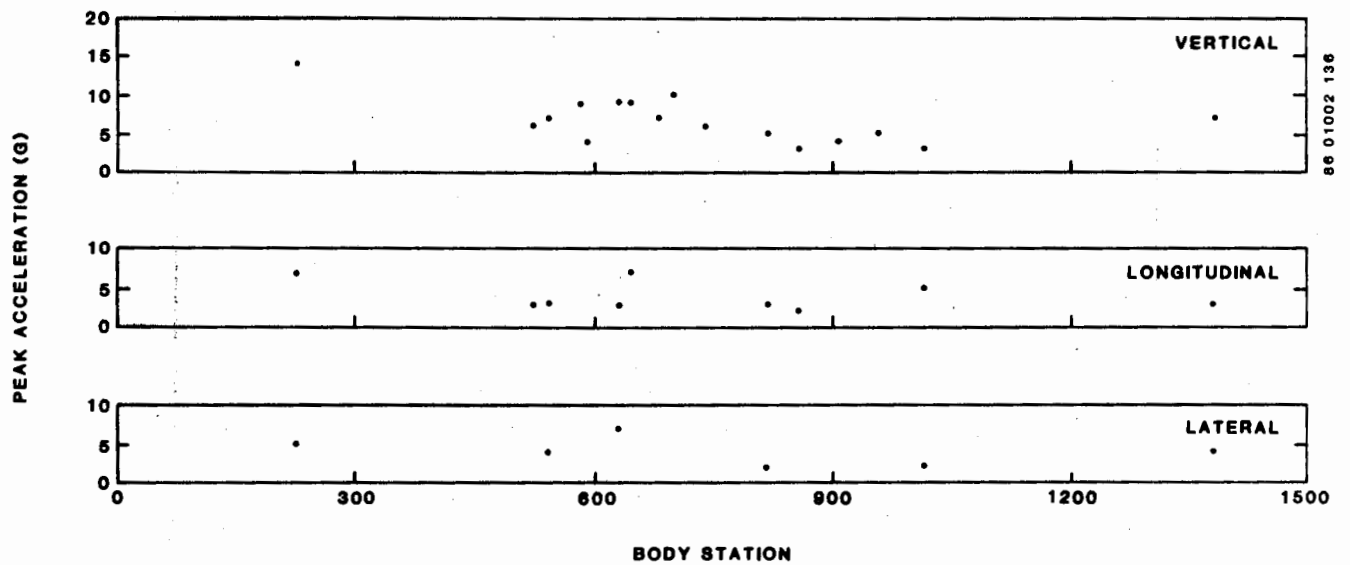
Figure 89. Plot distribution of vertical, longitudinal, and lateral floor accelerations.

A plot distribution of the peak accelerations measured at instrumented seat/floor locations is provided in figure 89. The peak vertical cabin floor accelerations were measured in the 2 to 10 G range with levels as high as 14 G recorded at the pilot cockpit floor area. The peak floor accelerations recorded in the lateral/longitudinal directions were in the 2 to 8 G range.

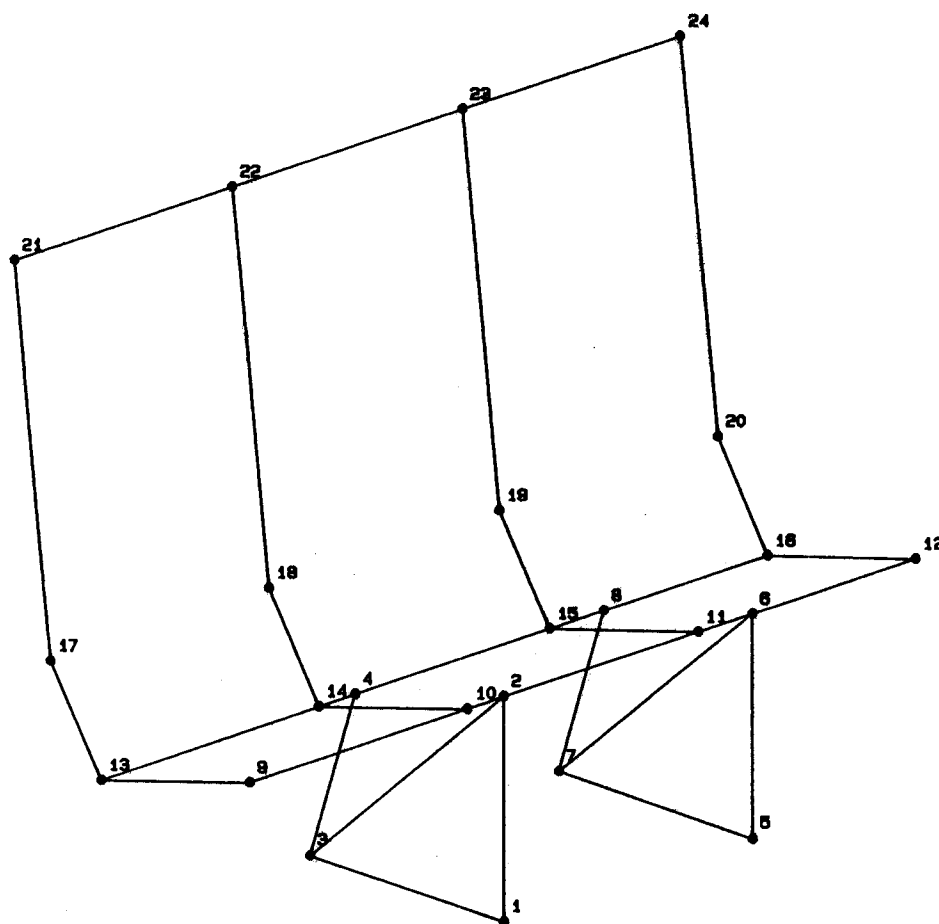
Figure F-7. Weberlite 4000 seat (A/R) finite element model.

Program SOM-TA simulations of the Weberlite 4000 seat (A/R) indicate that the impact did not produce any significant seat deformations. The internal loads predicted for the beam elements used to model the seat structure were all below those that will cause structural failures.

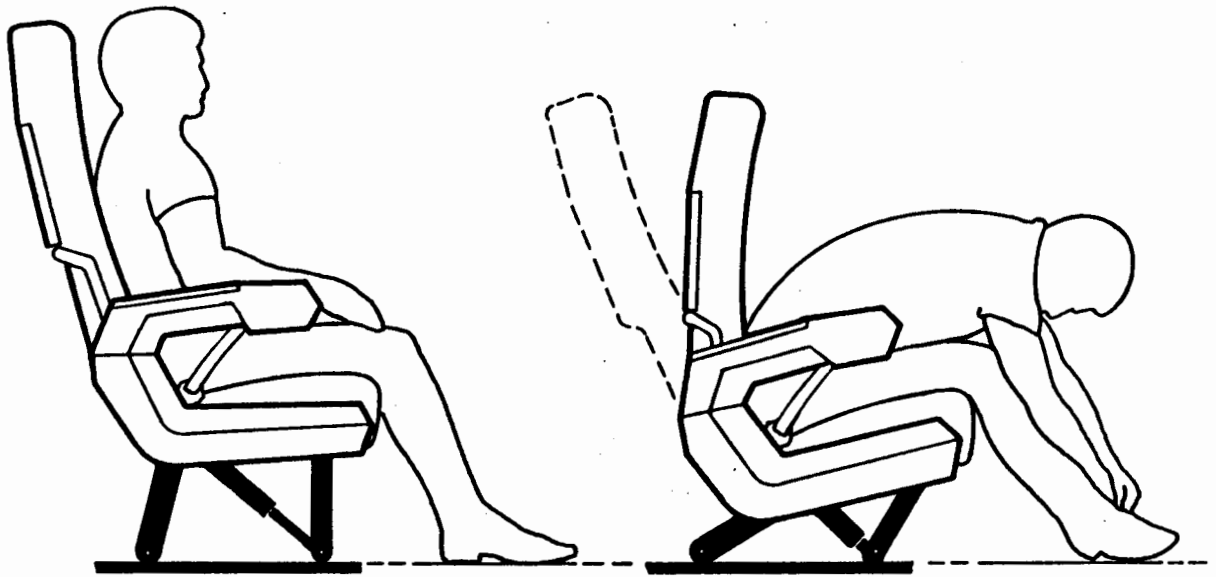
Figure F-8. Modified UOP 901 seat (F/L) before and after stroking of the diagonal compressive energy absorbers.

The UOP 901 seat modeled was a modified version of the standard production design. The production design was modified to include a compressive energy absorber as shown in figure F-8. The seat track fittings were also replaced by track fittings of Simula Inc. design (figure F-9). These fittings were locked in both the front and rear legs and also provided moment release about the pitch and roll axes.

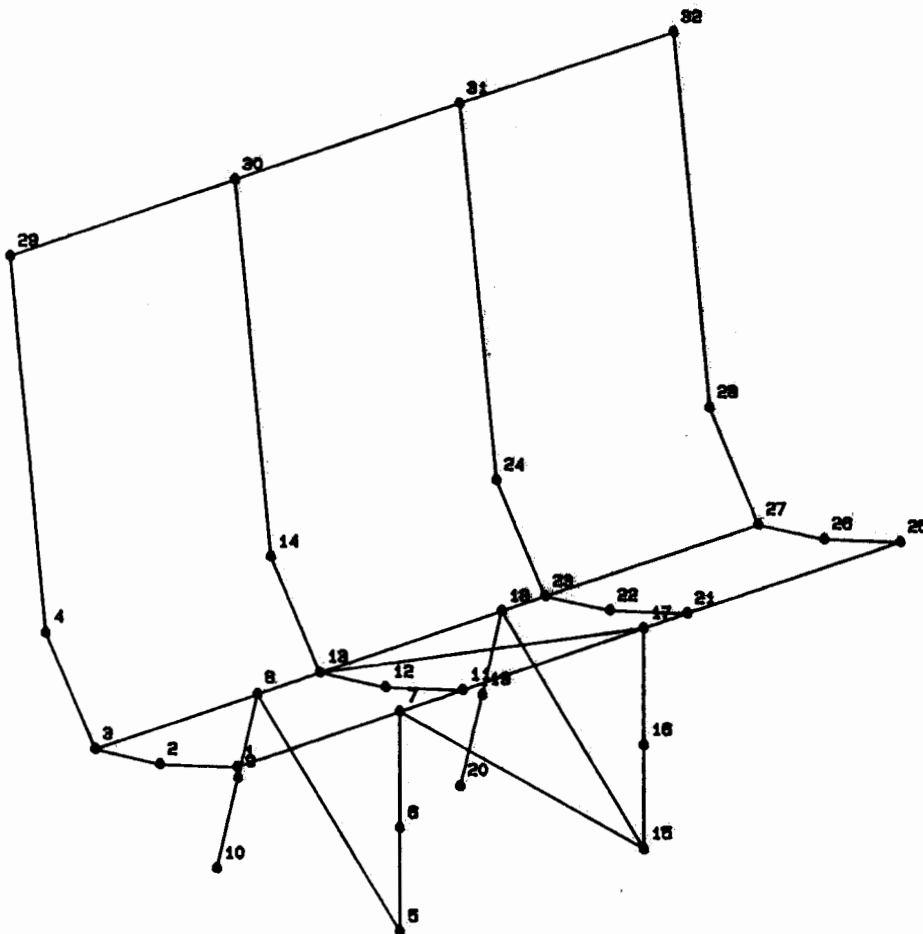
Figure F-10. Modified UOP 901 seat (F/L) finite element model.

Program SOM-TA simulations of the modified UOP 901 seat (F/C) and the CID test data indicate that the impact did not produce any significant seat deformations. The internal loads for the beam elements used to model the seat structure were all below those that will cause any structural failures.
