DOT/FAA/CT-85/33

# **Galley and Overhead Compartment Experiment Results - Full-Scale Transport Controlled Impact Demonstration**

Roger M. Lloyd  
RMS Technologies, Incorporated  
Trevose, Pennsylvania

December 1985

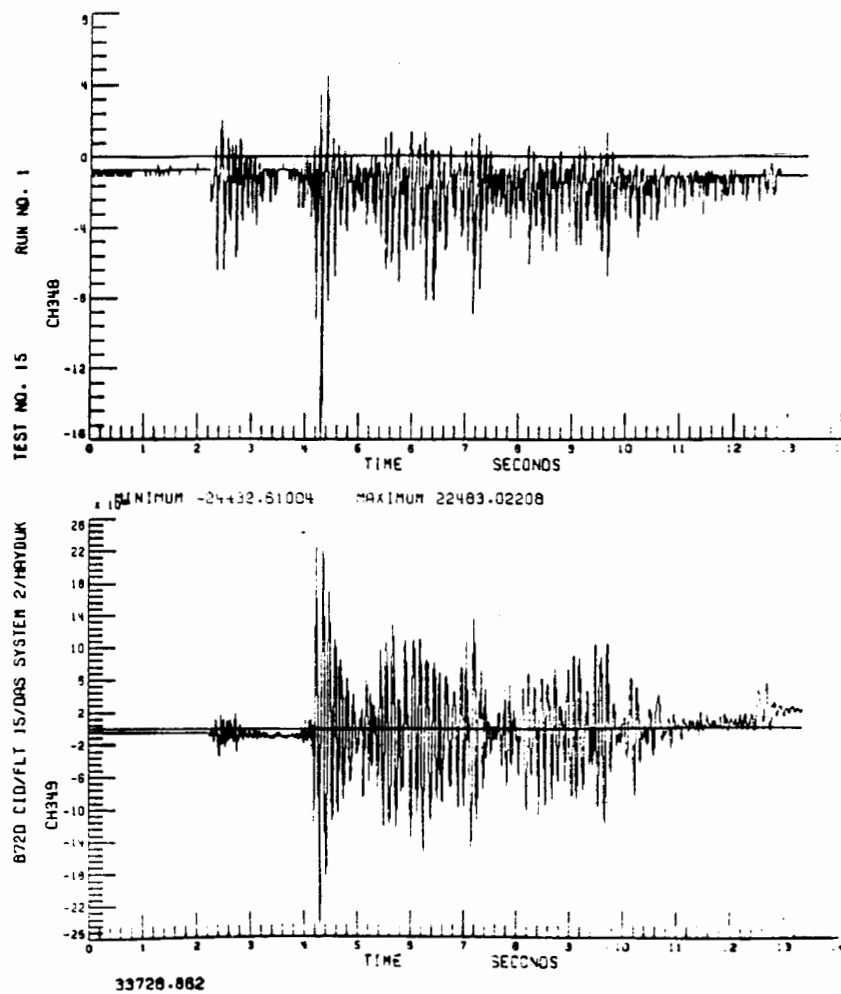
FIGURE 33. SUPPORT LINK DATA WITH EXPANDED TIME SCALE

In figure 33, an identification of the pre and post-impact loads across the upper (channel 348) and the lower (channel 349) instrumented support links are shown. Notwithstanding that the identified loads in the lower link are undetermined due to a drift in the data (cause unknown), the relative variation of loads in the upper link after the crash is about 60 percent greater than before the crash. It is believed that this increase in load as carried by the upper link could have been contributed by failures of one or more of the other support links. (NOTE: Due to a scaling factor error under figure 25 (channels 348 and 349), the exact magnitude of peak loads are not correctly identified. The qualitative assessment of upper link performance was therefore, based upon the relative change in load.) Another indication of possible link failure may be seen by comparing the general forms of the compartment mass accelerations and link load data in figures 34 through 38. In figures 34 through 37, the range of the accelerations or loads are roughly the same before and after the implanted obstacle impact at about 4000 milliseconds. In figure 38, the range is much larger after impact than it was prior to impact. Again, either some links broke or the instrumentation on the lower support links failed at that time. Unfortunately, the fire devastated the area and made absolute determinations impossible.

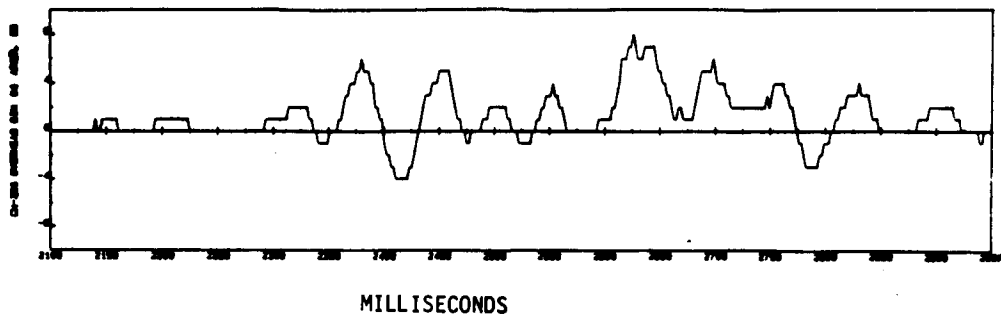
FIGURE 39. NORMAL ACCELERATIONS DURING GROUND IMPACT

The peak accelerations obtained from the restrained compartment mass item during both the initial ground impact and subsequent obstacle impact are shown in figures 33 through 38. Figures 39 and 40 depict vertical accelerations during the initial and obstacle impact which peaked at approximately 5 and 9 G's respectively, with each having a duration of 30 - 40 milliseconds. The appropriate longitudinal accelerations are shown in figures 41 and 42 at values of approximately 5 to 6 G's with durations of 60 - 75 milliseconds. Figures 43 and 44 provide transverse accelerations of 9 to 10 G's with duration in

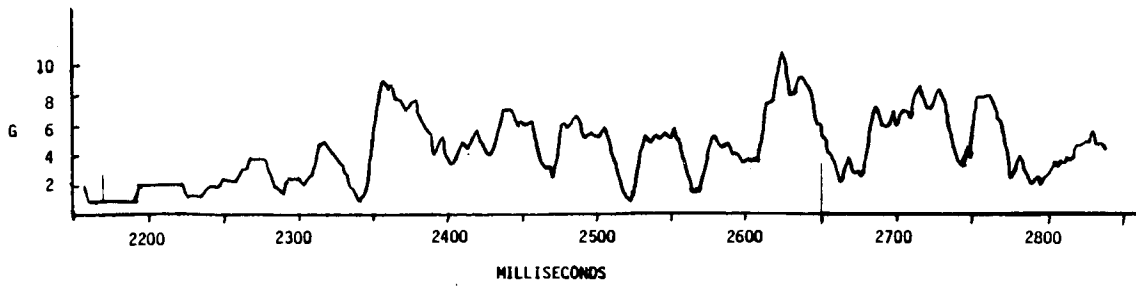
FIGURE 45. RESULTANT ACCELERATIONS ON OVERHEAD COMPARTMENT

the 50 milliseconds range. Figures 45 and 46 identify the resultant compartment mass accelerations which were analytically derived from the individual accelerometer data. The maximum resultant G measured in the compartment was approximately 11.0 G during the ground impact stage, 10.5 at the implanted obstacle impact and 13.7 G during the slide out over the railroad bed rock.

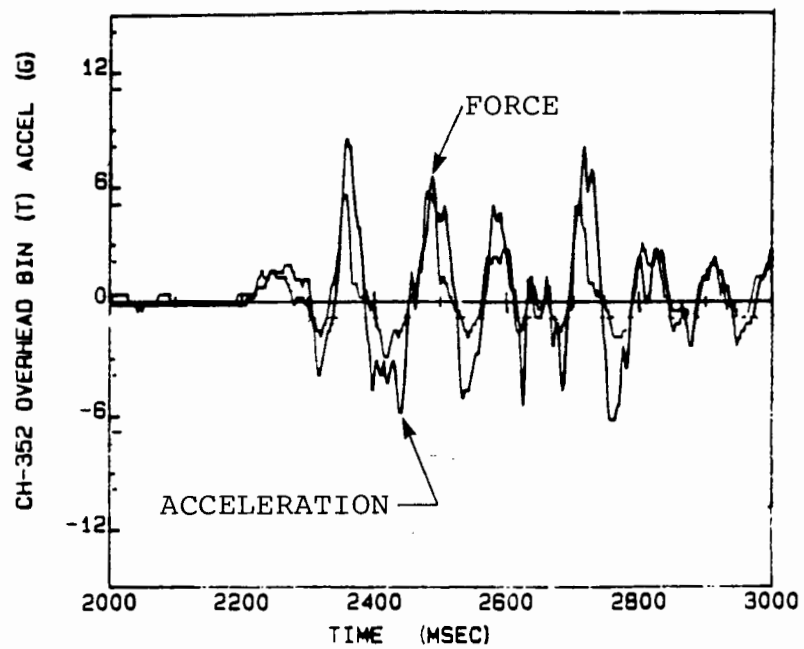
FIGURE 47. LOWER SUPPORT LINK FORCE COMPARISON  
WITH TRANSVERSE ACCELERATION

The stress in the lower support link was almost completely due to transverse accelerations of the overhead compartment. Figure 47 shows the overhead compartment transverse accelerations with the lower support link forces with reverse polarity superimposed. They are an almost perfect match. The upper support link stresses were due to a combination of accelerations and did not display any such direct similarities.

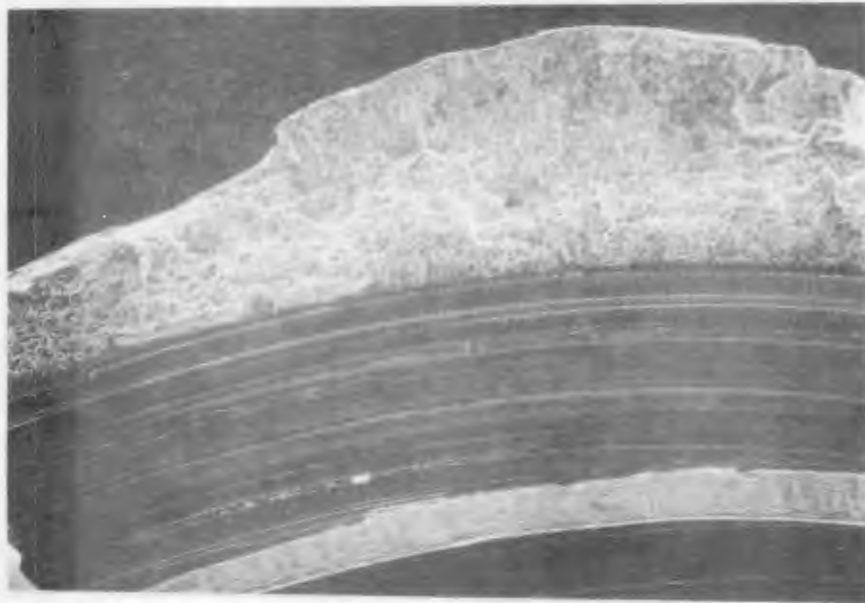
prominent shear lips as shown in Figure 8. The elongated dimple rupture as shown in Figure 8 indicates that the material failed in a ductile manner at room temperature. The elevated temperature failure was flat and intergranular as shown in Figure 9. Comparison of the test program failure with the crash failures revealed that the crash fractures have characteristics that were most similar to the elevated temperature failures, as shown in Figure 6.

FIGURE A-8A. SURFACE AFTER FRACTURE AT ROOM TEMPERATURE SHOWING SHEAR LIPS

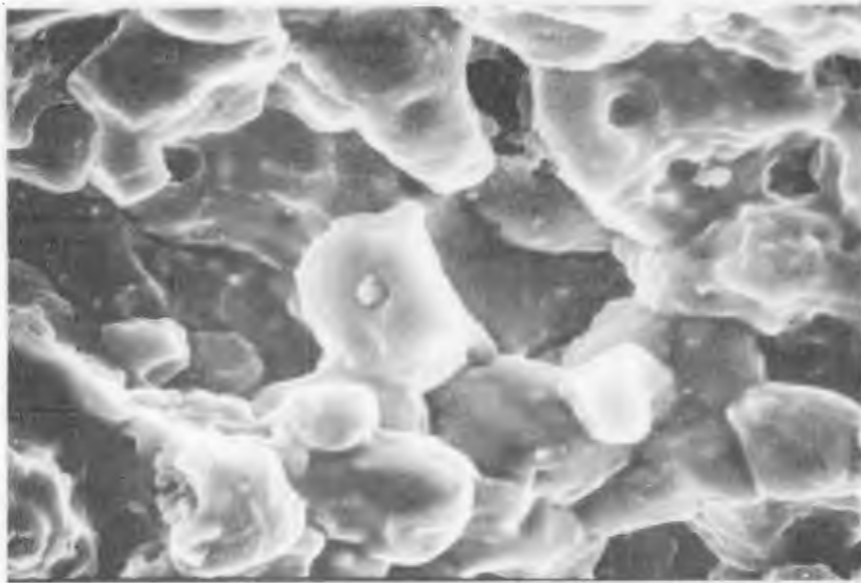
FIGURE A-9. SURFACE AFTER FRACTURE AT ELEVATED TEMPERATURE  
SHOWING INTERGRANULAR FAILURE
