Report No. DOT/FAA/TC-26/13

**Assessment of Emerging Metallic Structures  
Technologies through Test and Analysis of Fuselage  
Structure: Test Panel 3**

July 2026

Final report

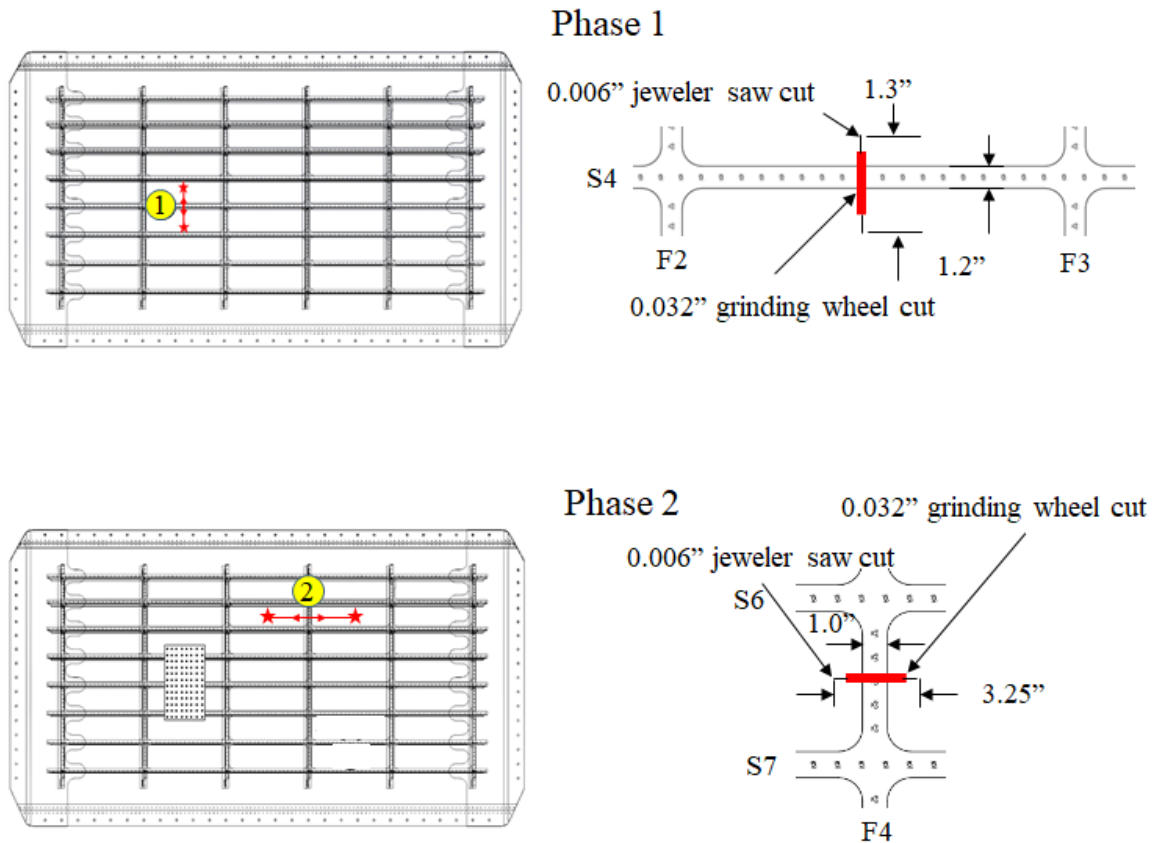
Figure 4. Initial damage scenarios used in the two test phases

**Phase 1:** Initial damage consisted of a crack-like notch having a length of 1.3 in. in the circumferential direction spanning two skin bays between frames F2 and F3, with the central stringer S4 severed (see Figure 4, Phase 1). The panel was fatigue tested under loads representing pressure, flight maneuver and gust accelerations, and landing loads in the forward crown section of a single-aisle aircraft. Fatigue testing was conducted until the crack extended to a final total length of 11.3 in. Afterwards, a limit load test was conducted, during which the panel was subjected to approximately 2.5 g axial load while holding the pressure constant under operational conditions. The panel was then repaired for follow-on phase 2 (Appendix B).

**Phase 2:** Initial damage consisted of a two-bay longitudinal crack-like notch between stringers S6 and S7, with the central frame/shear tie F4 severed, as shown in Figure 4, Phase 2. A 3.25 in. long notch was inserted with the underneath frame severed. Initial strain surveys and finite element analysis (FEA) were conducted to ensure proper load introduction and to verify no effects from the repairs made in Phase 1. The panel was then fatigue tested, simulating pressure-only operational conditions, until the crack extended to a final length of approximately 12.5 in. The 12.5 in. crack was extended manually to 40 in. A residual strength test was finally conducted to failure, measuring the load-carrying capacity of the panel.

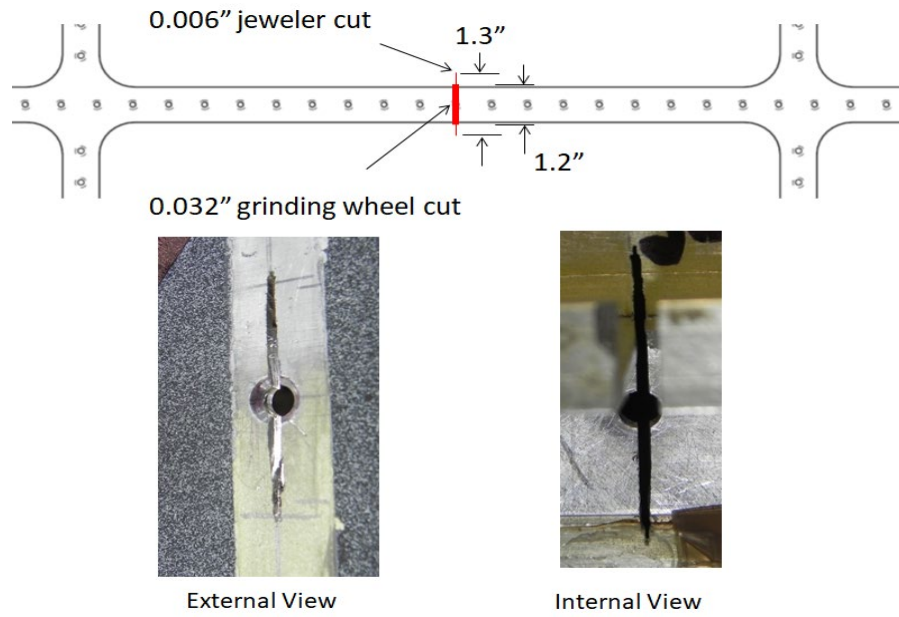
Figure 9. Configure of Phase 1 damage scenario

A central crack-like notch was machined in the skin above the severed stringer S4, which is 1.30 in. long and 0.032 in. wide. The notch was centered about the removed fastener; the geometry is shown in Figure 9. Initial strain surveys were conducted to verify proper load introduction to the baseline panel and validate the FEA model.

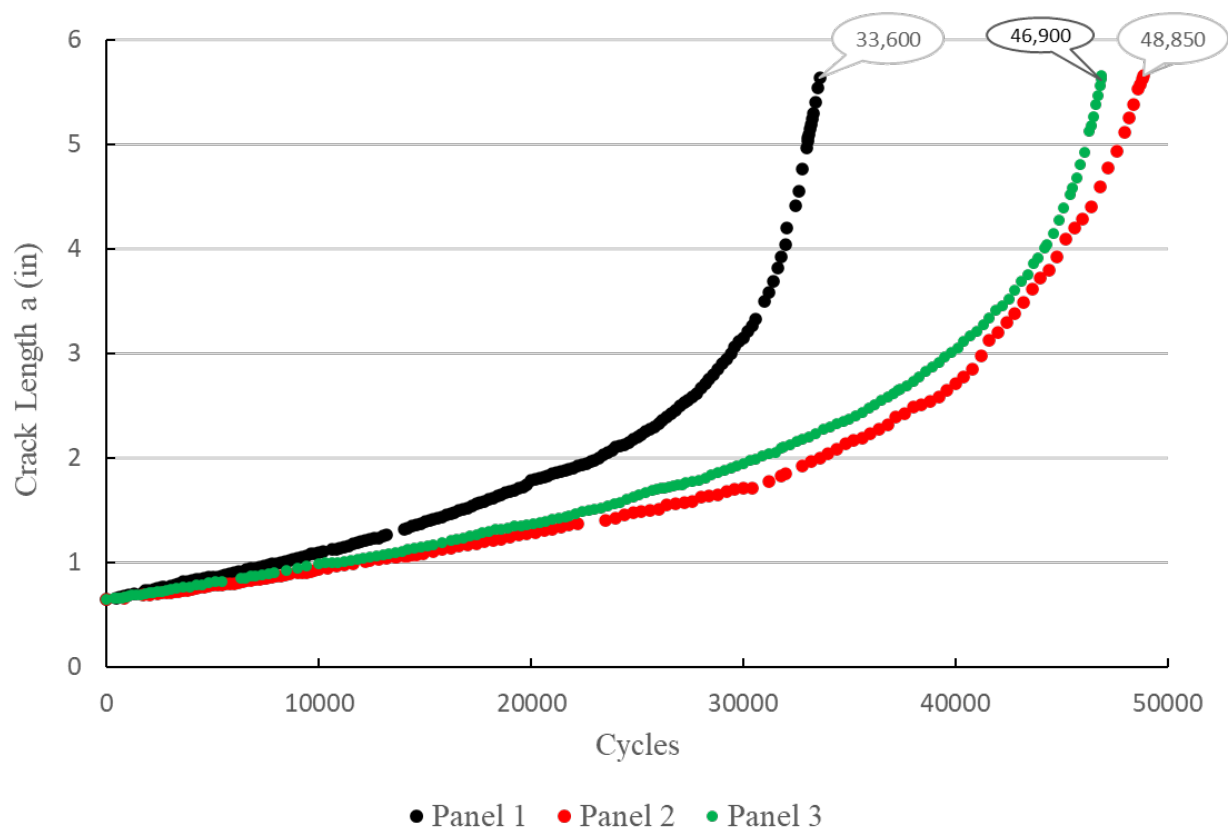
Figure 13. Circumferential crack growth comparison between panels 1, 2, and 3

As shown in Figure 13, panel 3 exhibited better fatigue crack growth performance compared to panel 1. Crack extension occurred across two stringer bays to a final length of about 11 inches after 33,600, 48,850 and 46900 fatigue cycles in panel 1, 2 and 3, respectively.

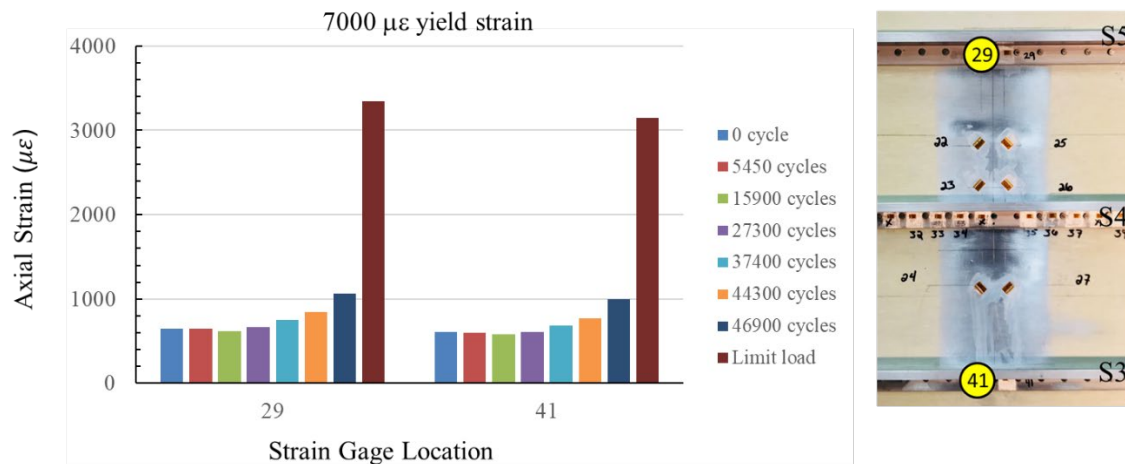
Figure 17. The result of stringer gages during the circumferential direction limit load test

Strain gages located on the inner and outer flanges of the stringer ahead of the fatigue crack revealed that the stresses were below the yield strength of the stringer material (see Figure 17). The intact stringers ahead of the crack were effective in containing the damage. In addition, limited stable-tearing extension and crack tip plasticity were observed from each crack tip, as shown in Figure 18 using DIC measurements.

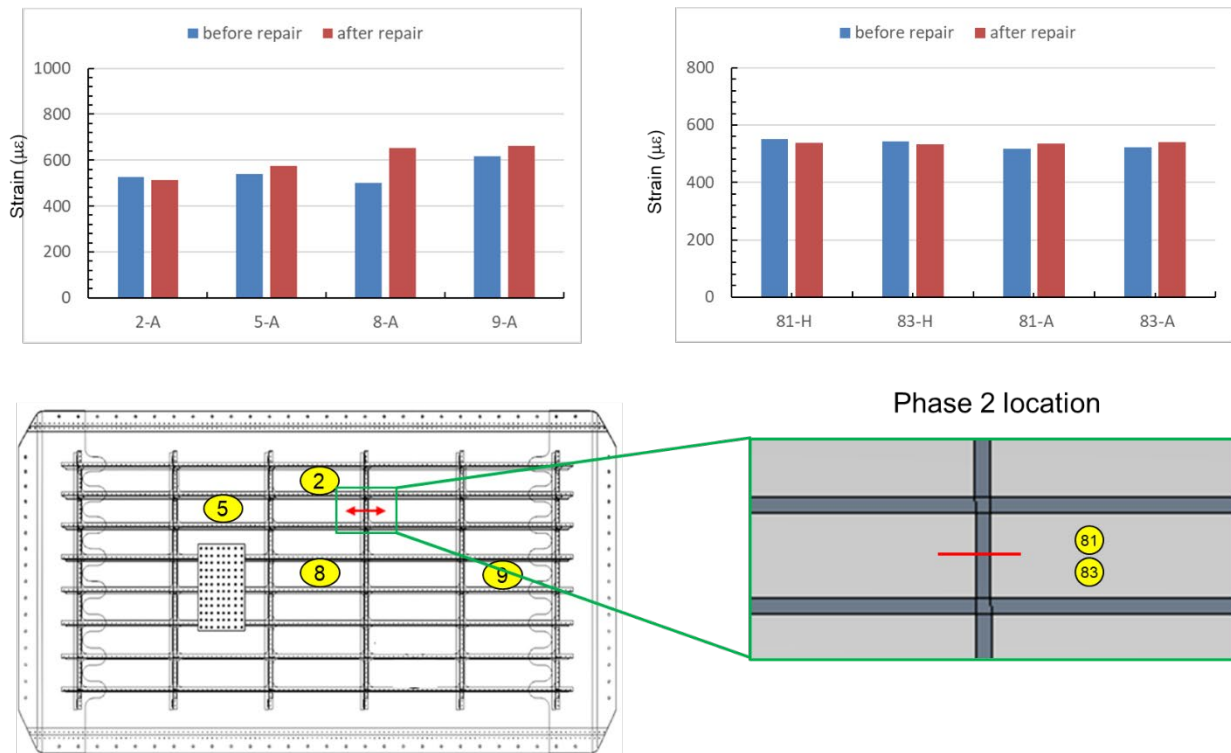
Figure 19. Strain survey after Phase 1 crack repair

The panel was then repaired for follow-on phases, as shown in Appendix B. The strain survey was conducted to ensure there was no effect of repair on Phase 2 test bay, as shown in Figure 19.

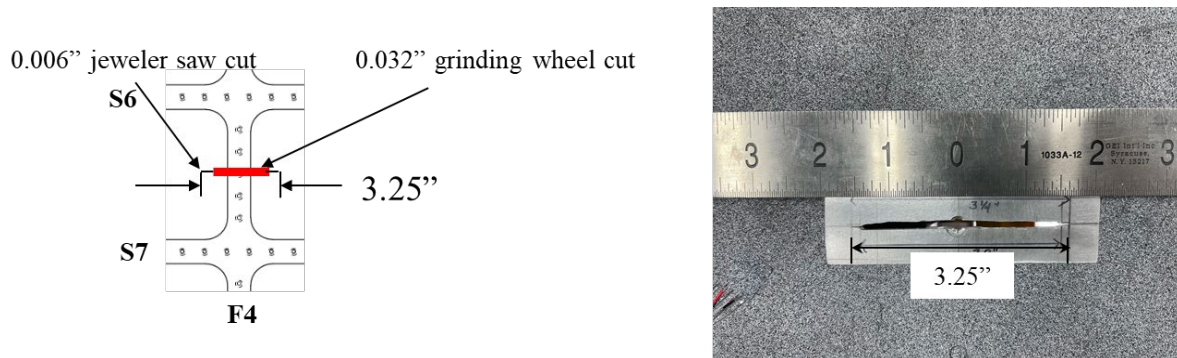
Figure 20. Configuration of Phase 2 damage scenario

The longitudinal damage scenario for Phase 2 is shown in Figure 20. The frame F4 rivet at the mid-frame location between stringers S6 and S7 was removed, and frame F4 was severed at this location. Damage was simulated by cutting a 3.25-in. long notch in the skin above the severed F4 frame.

For this phase, the panel was fatigue tested under pressure load conditions for 42,000 cycles, during which the skin crack extended across two frame bays to a final total length of approximately 12.5 in. The crack growth was slow in the initial stages of fatigue testing, and one side (right) was significantly slower than the other side (left) due to the crack binding, as shown in Figure 21. Consequently, the notch on the right side was extended using cutting wire to remove the binding portion of the crack front at around 9,000 cycles. After the removal of the crack binding, the fatigue crack growth was stable and continuous. The fatigue crack growth comparison among panels 1, 2, and 3 is shown in Figure 23. For an apples-to-apples comparison between the panels without the crack binding effect, the crack growth data for all three panels were shifted to the same crack length  $2a = 3.85$  in., as shown in Figure 24. Panel 3 still demonstrates similar damage tolerance performance to panel 2, and better than the baseline panel 1.

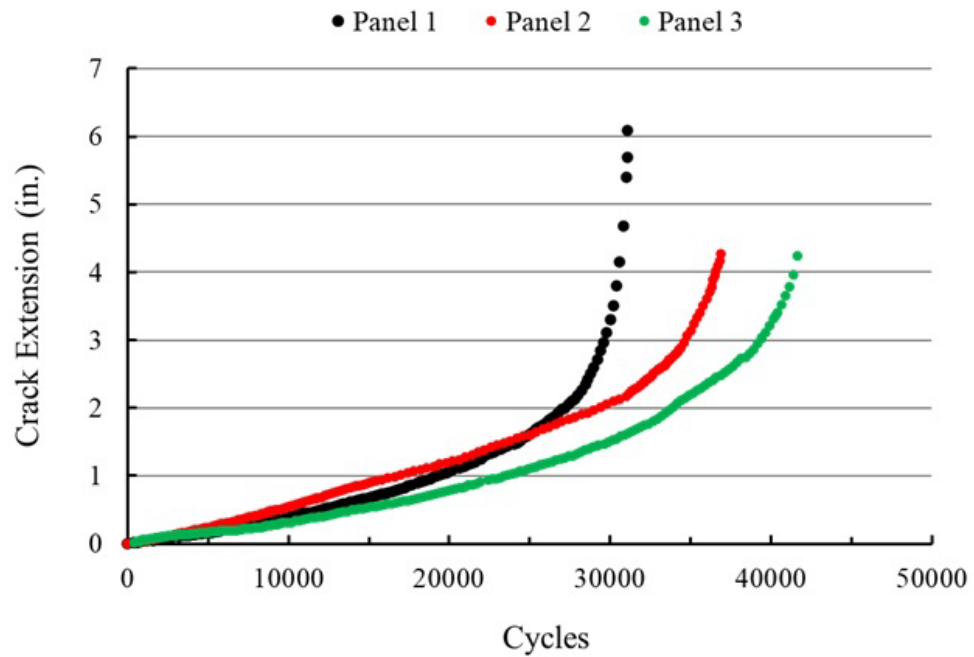
Figure 23. Average longitudinal crack growth comparison between panel 1, 2, and 3

However, the right-side crack growth is still slower than the other side. Post-residual strength test investigation revealed that the asymmetrical crack growth was due to the transition of crack surface morphology resulting in crack growth-rate changes as observed during Phase 1 fatigue test, as shown in Figure 12. The left-side crack had slanted crack surface throughout the whole fatigue testing. However, the right-side crack transition from slant to V or less slant crack surface during the fatigue from approximately 18,000 to 28,000 shifted cycles (27,000 to 37,000 total cycles), as shown in Figure 22, which led to the slower crack grow. However, panel 3 exhibited

better average crack growth performance compared to panel 1, as shown in Figure 23 and Figure 24.
