**Report No. CDOT-DTD-R-2006-8**  
**Final Report**

**PRECAST CONCRETE PAVING PANELS:  
THE COLORADO DEPARTMENT OF  
TRANSPORTATION REGION 4 EXPERIENCE,  
2000 TO 2006**

**Gary L. DeWitt, P.E.**

**August 2006**

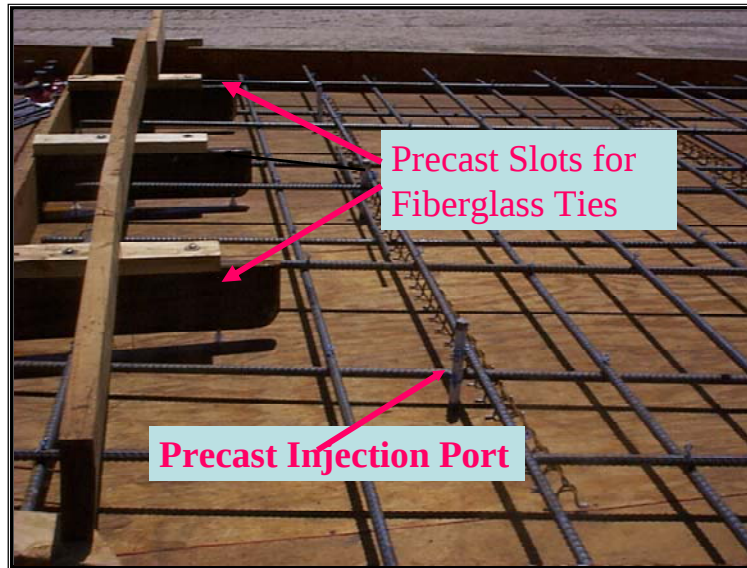
**FIGURE 6**  
**PRECASTING: REBAR PLACEMENT**

The worst condition was determined to be **Uniform loading with point supports**. As a result 2 mats of rebar were identified for negative or positive moment resistance.

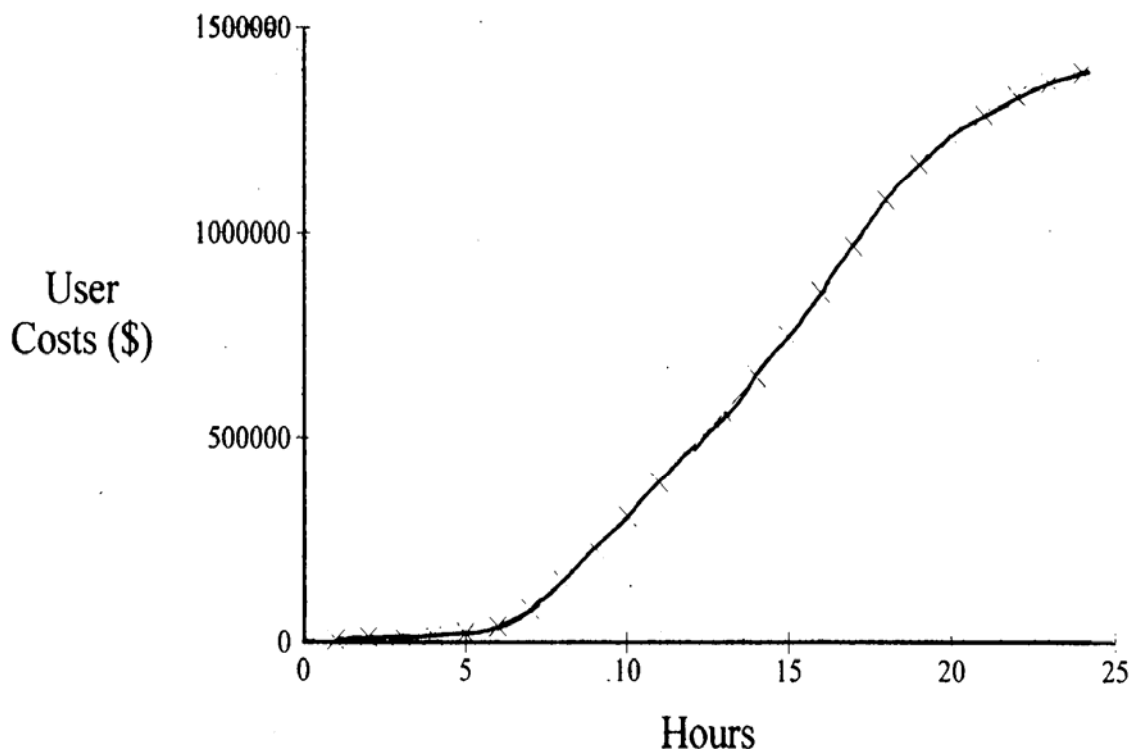
**FIGURE 8**  
**REMOVAL OF CONCRETE (Cost vs time)**

The results of the Workzone program suggest a cost of \$63,673,596 for a 4 day shut down of one lane during a conventional concrete removal program whereas a normal user cost of \$71,482 would exist if the construction work wasn't being conducted. From Figure 6 User costs vs. hours the user cost is approximately \$25,000 for an 8 hour shut down of a lane for concrete removal and correspondingly \$145,000 for a 24 hour shut down.
