**Report No. CDOT-DTD-R-2006-2**  
**Final Report**

**FLOWFILL AND MSE BRIDGE APPROACHES:  
PERFORMANCE, COST, AND RECOMMENDATIONS  
FOR IMPROVEMENTS**

**February 2006**

**COLORADO DEPARTMENT OF TRANSPORTATION RESEARCH  
BRANCH**

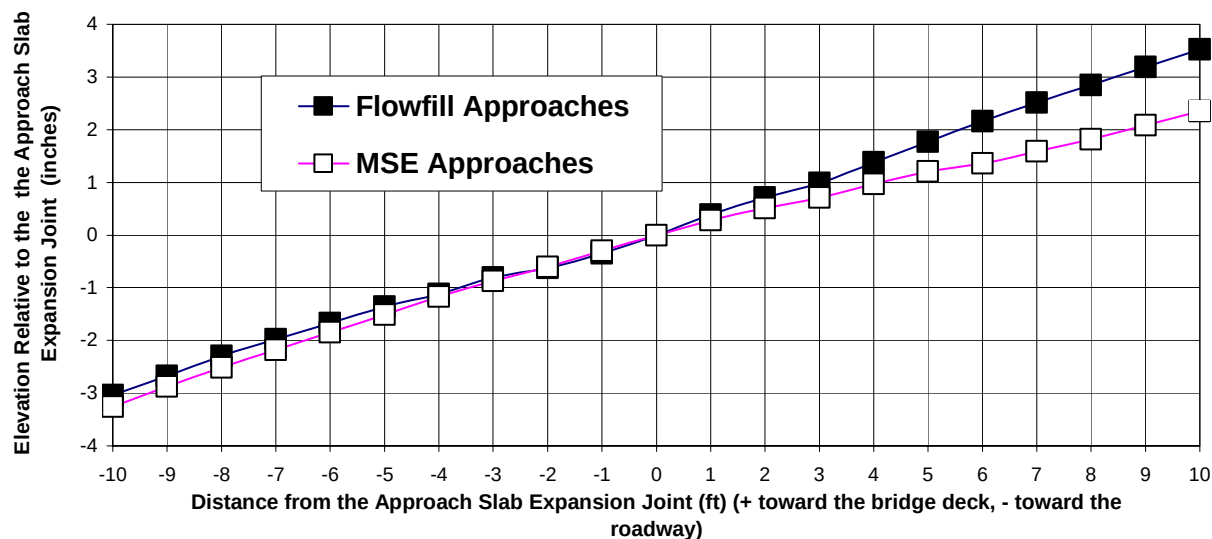
The visual observations and the results shown in Figure 4.1 suggest that the transition between the bridge and approaching roadway after almost two years in service is smooth and shows no signs of developing a bridge bump problem. Thus, we can conclude that the two systems of abutment backfill are performing well so far with comparable performance.

**Figure 4.1. Measured Elevation Profiles for Structure C-15-U Where Side by Side Flowfill and MSE Approaches Were Constructed.**

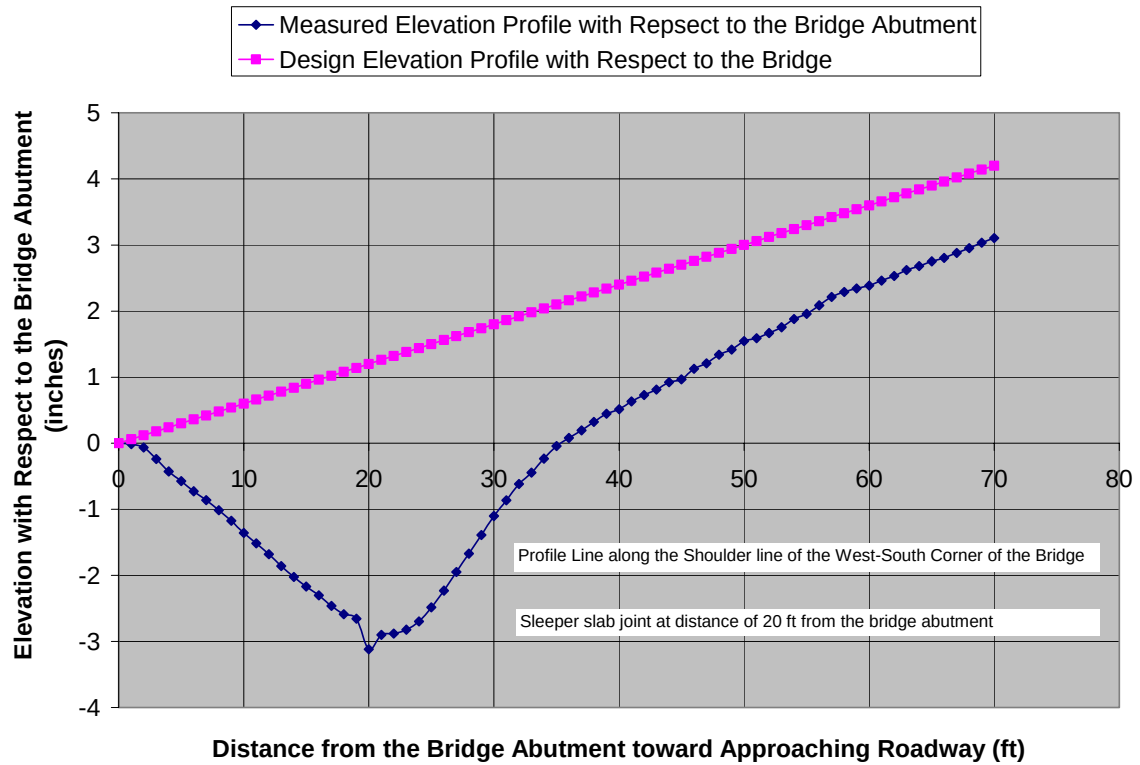
A digital road profiler was used to draw elevation profiles of the transition section from the bridge deck to the approaching roadway (see Abu-Hejleh et. al., 2001 for more on this technique). The measured and design elevation profiles along the shoulder line of the southwest corner of the bridge-roadway zone are shown in Figure 5.3. The construction plans indicate that the final design elevation of the top surface of the pavement in that zone drops at a rate of 0.06 inch/ft in the direction going west to east. Based on the measured and design elevation profiles, the settlement profile along the bridge approach was developed (Figure 5.4). At the sleeper slab, the settlement was estimated at 4.32 inches. Across the bridge, the design slope was 0.02 ft/ft. The measured average slope was 0.029 ft/ft. Assuming that the median did not settle, this suggests a settlement of around 4.5 inches at the sleeper slab by the shoulder line. This is close to the settlement estimated from the longitudinal elevation profile.

**Figure 5.3. An Elevation Profile of the Bridge Approach along the Shoulder Line of the SW Corner of the Salt Creek Bridge Approaches.**

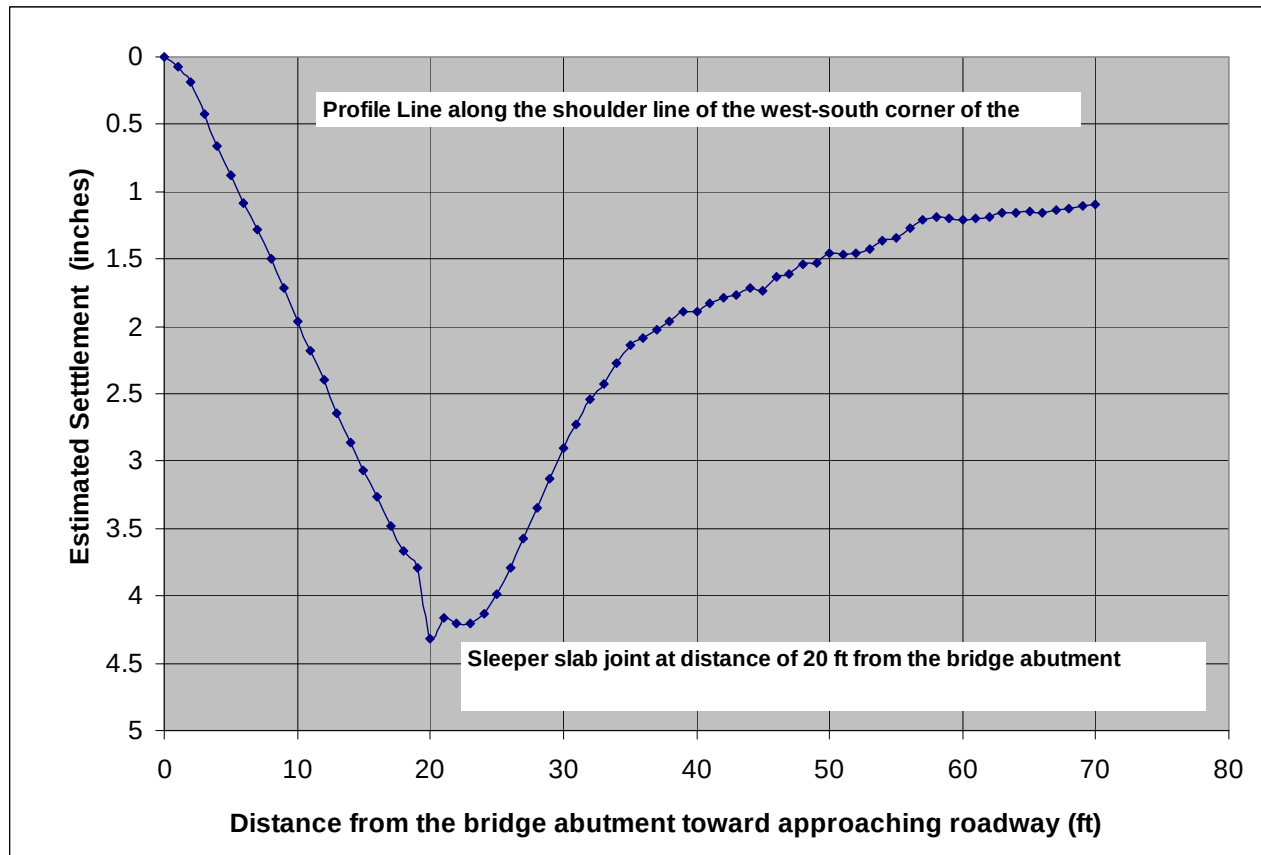
**Figure 5.4. A Settlement Profile of the Bridge Approach along the Shoulder Line of the SW Corner of the Salt Creek Bridge Approaches.**

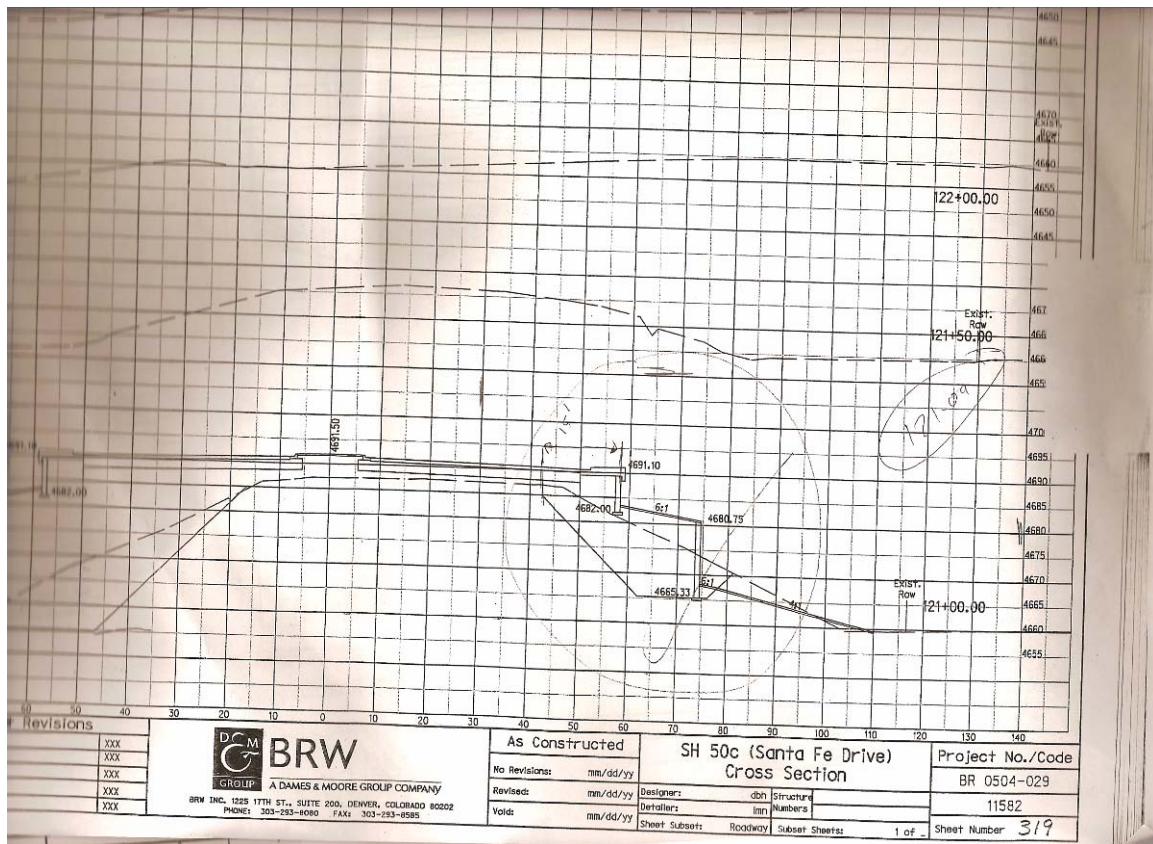
Review of the construction plans revealed that the new bridge and approaching roadways with side MSE walls replaced an older bridge with side sloped embankments. The new bridge and roadway structures were only extended on the sides. The boundaries of the old and new bridges at the SW corner of the bridge are illustrated in Figure 5.5. A granular fill was used for construction of the front, lower and upper MSE walls as shown in Figures 5.1 and 5.2. Part of this fill was to replace old embankment soil that was removed and additional fill was placed above the original ground level mainly for the lower and upper MSE wall (beneath the sidewalk and part of the shoulder, see Figure 5.5).

**Figure 5.5. Elevation Profiles across the SW Corners of the Old (dashed line) and New (solid line) Bridge Approaches of the Salt Creek Bridge.**

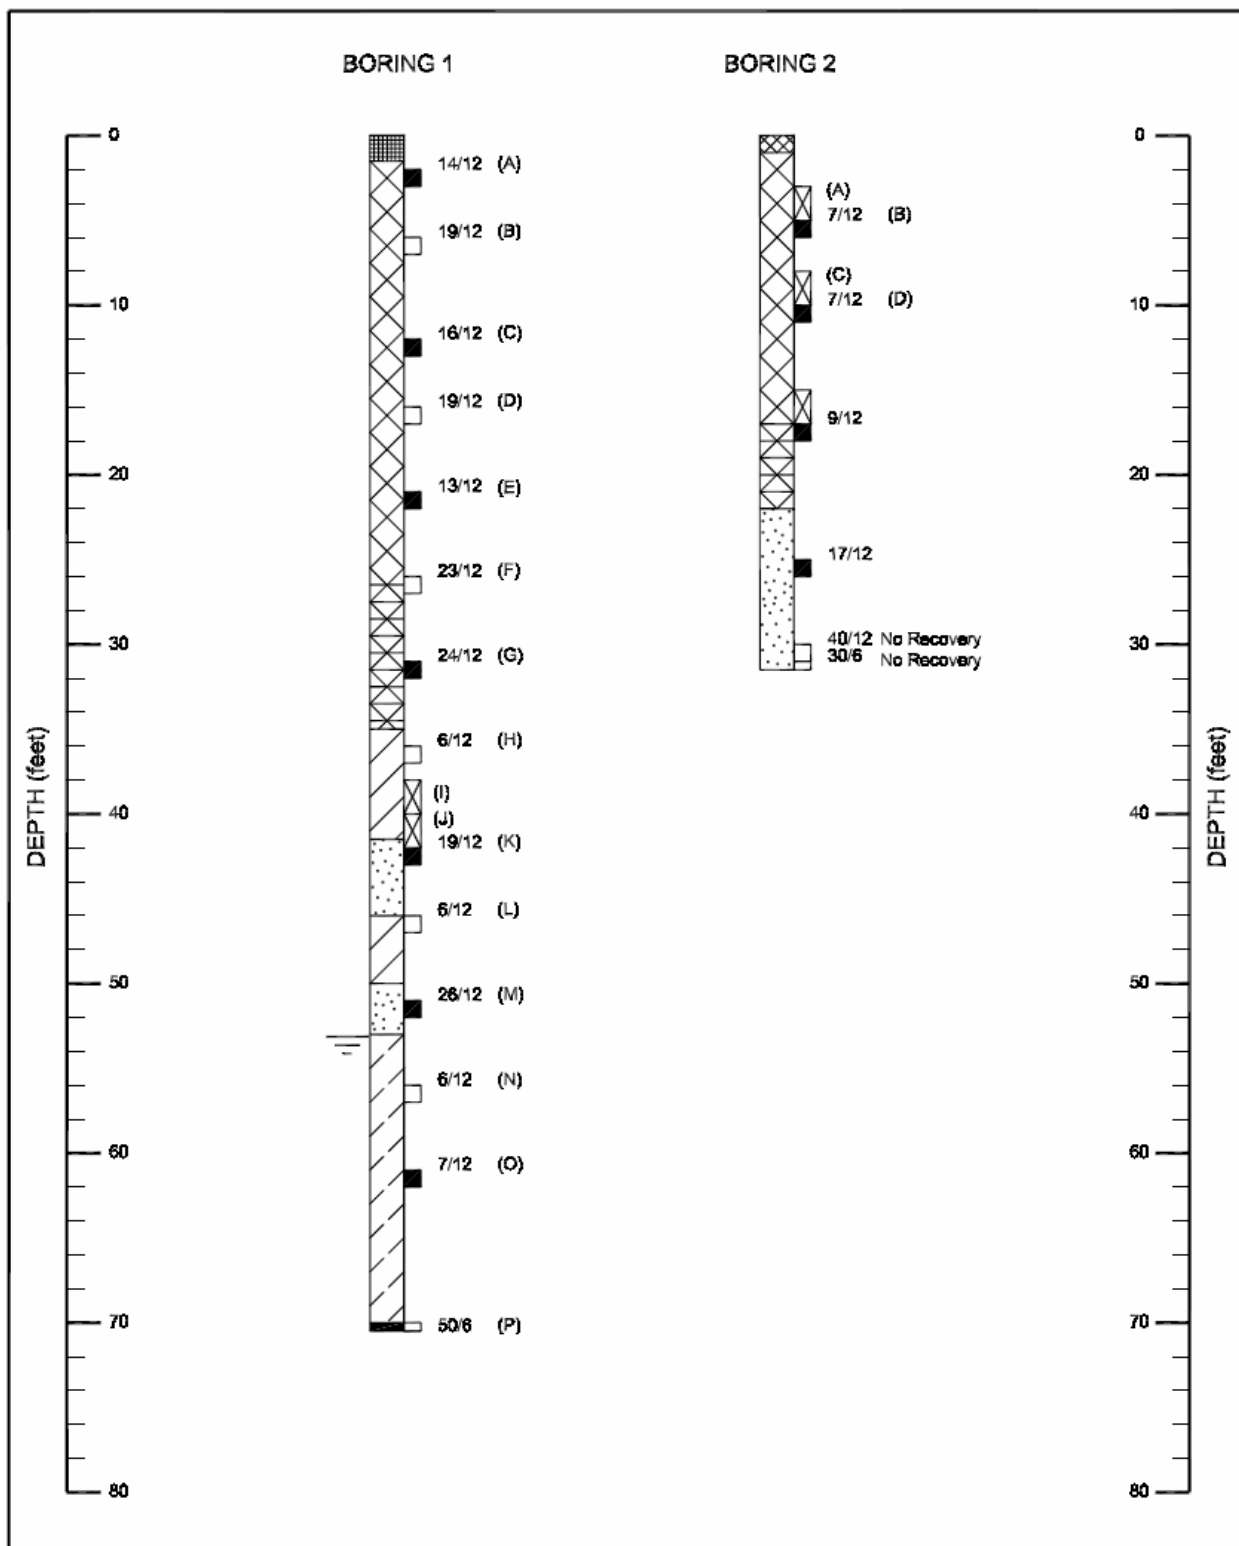
Two borings were drilled. Boring 1 was located in the approach slab, about 6' from the bridge abutment and 6' from edge of the sidewalk. Boring 2 was located 3.5 ft from the sleeper slab joint toward the roadway and 3.5 ft from edge of the sidewalk. For these borings, Figure 5.6 shows a log of subsurface materials encountered, driving test results in term of N-values collected from the SPT and California Samplers, and locations and types of all collected soil samples. According to Boring 1, the depth of the abutment and embankment fill materials is around 35 ft and the thickness of the foundation soil layer is 35 ft. Rock was encountered at a depth of 70 ft. The log results suggest that the N-values obtained from SPT and the California Sampler are comparable.

Table 5.1 and Figure 5.6 list all the laboratory and field test results on the abutment and embankment fill materials. The granular backfill is described as medium dense in Boring 1 (N-values from 13 to 14), and loose in Boring 2 (around the sleeper slab). The tabulated results suggest that the backfill materials of Boring 1 nearly met the requirements for gradation, compaction, and Atterberg limits (measured PI of 8 is close to the required value of 6) for Class 1 structure backfill. However, the compaction requirements were not met for the backfill placed in Boring 2 (Table 5.1) for a depth that extends up to 20 ft. Both the field and laboratory test results

**Figure 5.6. Boring Logs for the Salt Creek Bridge Approaches**

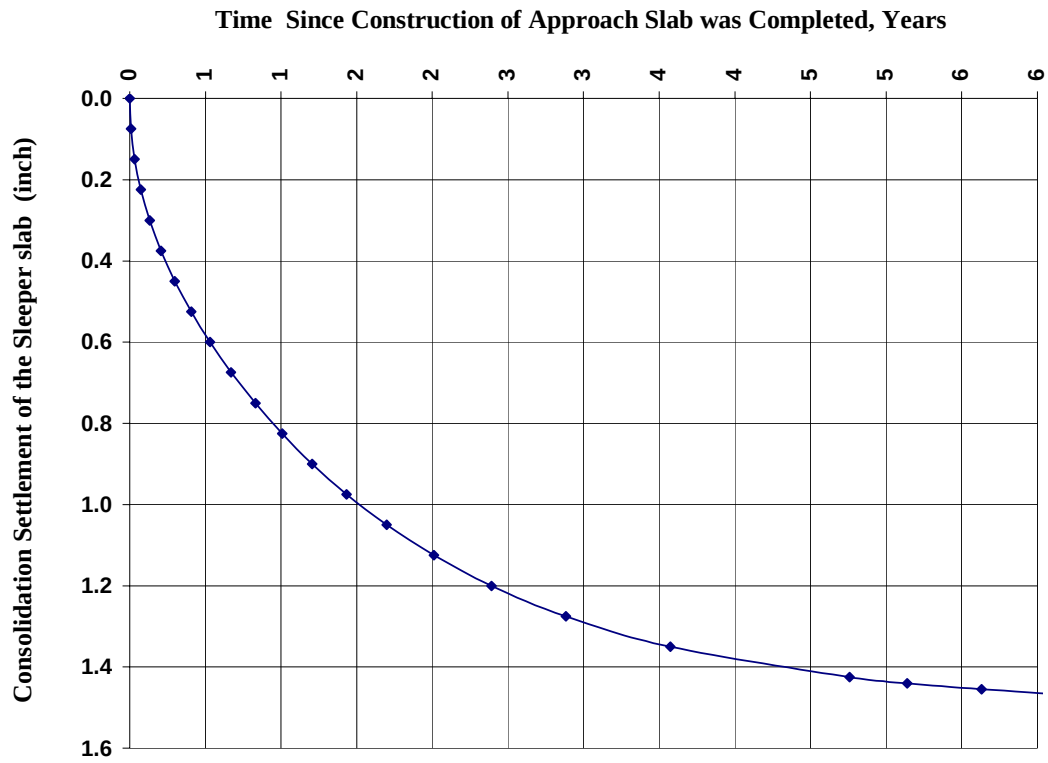
**Figure 5.9. Predicted Settlements of the Sleeper Slab Due to Consolidation of the Foundation Clay Layer (Salt Creek Bridge Approaches).**

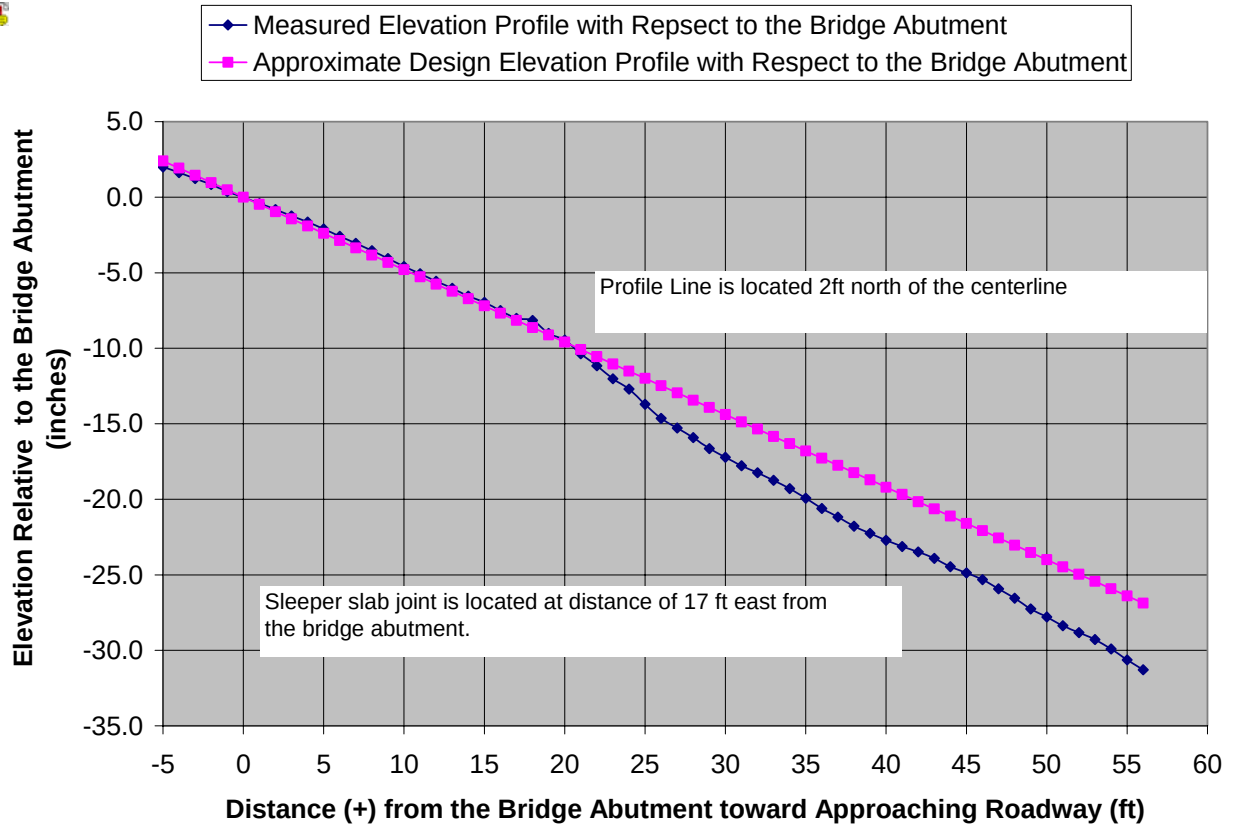
**Figure 5.12. Elevation Profiles of the Eastern Approaches to the I-70/I-225 Structure.**

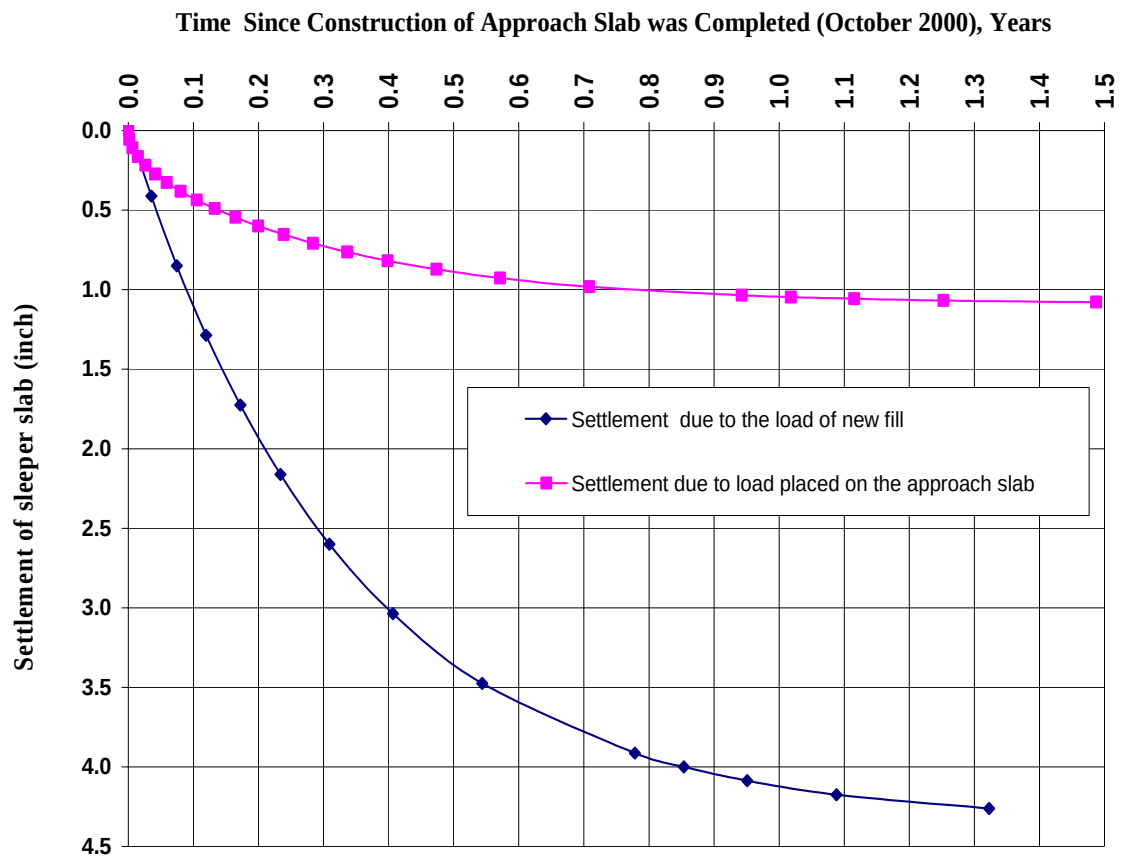
*consolidation of the foundation clay layer. The measured preconsolidation pressure,  $\sigma'_c$ , is very close to the vertical earth pressure calculated under normally consolidated conditions. This is strong evidence that most, if not all, the consolidation settlements have occurred.*

**Figure 5.16. Predicted Settlement with Time at the Sleeper Slab of the SH 287 Bridge.**

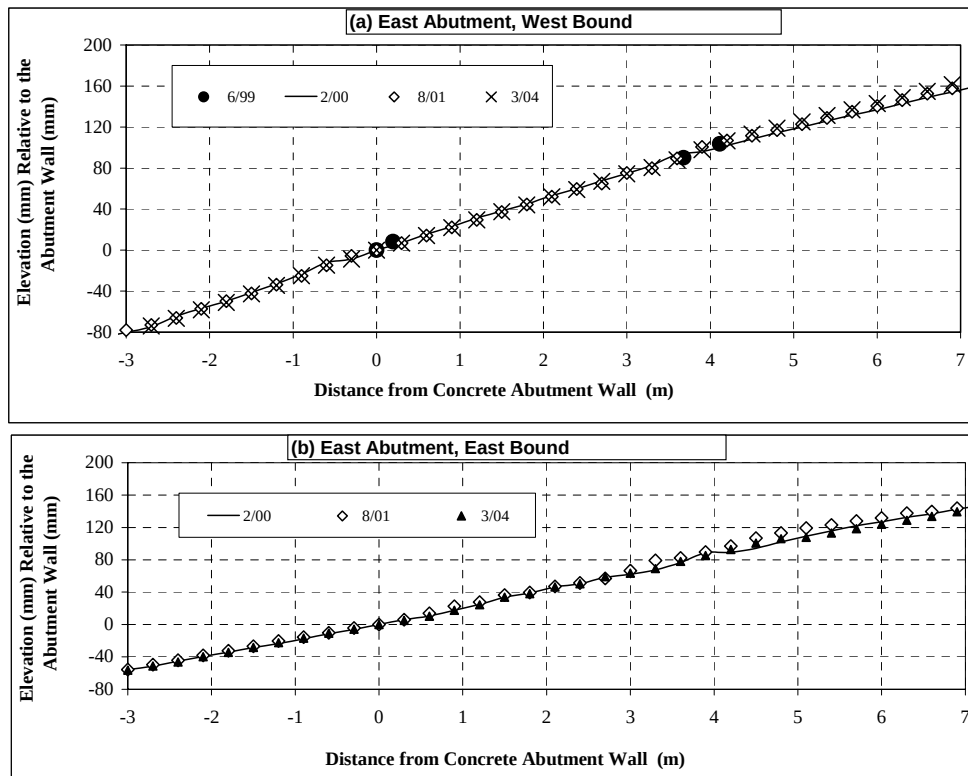
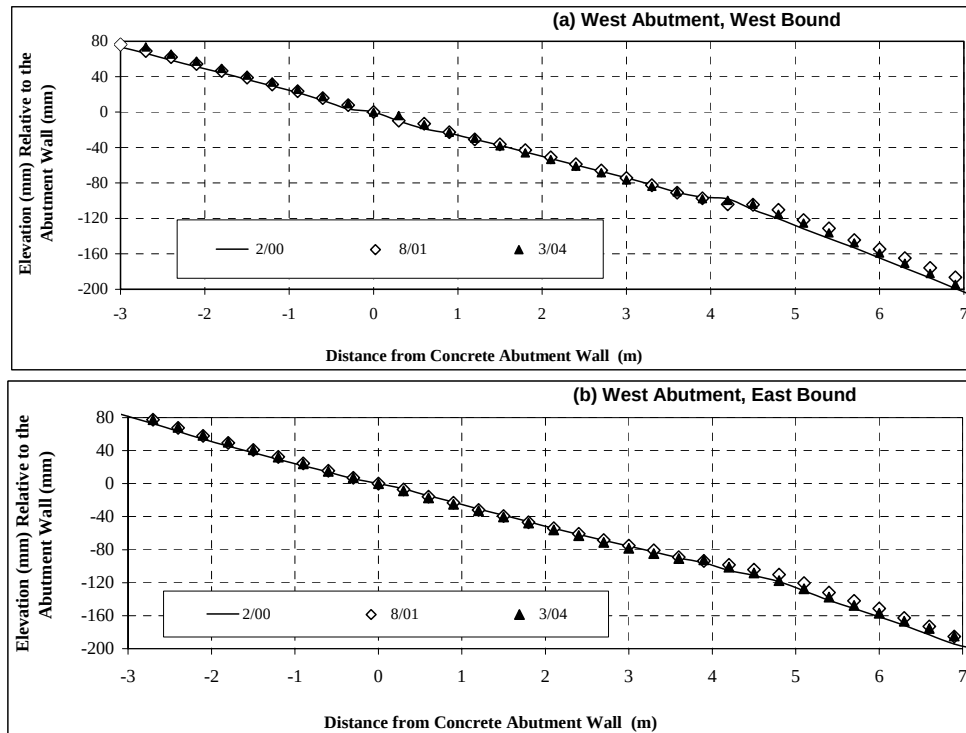
The results shown in Figures 6.4 and 6.5 indicate that the transition between the bridge and approaching roadway after five years in service is smooth and shows no signs of developing differential settlements between the bridge abutment and the approaching roadway (i.e. “bump at the bridge” problem). *The elevation profiles collected at different times essentially match each other, suggesting that settlements of the bridge superstructure and approaching roadway have been uniform.* That is, no evidence of differential settlement has been observed between the bridge superstructure and approaching roadway. *Thus, it could be concluded that the overall short- and long-term performance of the approaches of the Founders/Meadows structure is excellent because there is no evidence of the “bump at the bridge” problem after five years in service and even with no signs of structural distress to the approach slab and the bridge expansion device.*

**Figure 6.4: Measured Elevation Profiles Relative to the Bridge Abutment for Two Lines over the East Abutment along the Traffic Direction (Note: Distance from bridge abutment is + towards the approach slab and is - towards the bridge deck).**

**Figure 6.5: Measured Elevation Profiles Relative to the Bridge Abutment for Two Lines over the West Abutment along the Traffic Direction (Note: Distance from bridge abutment is + towards the approach slab and is - towards the bridge deck).**

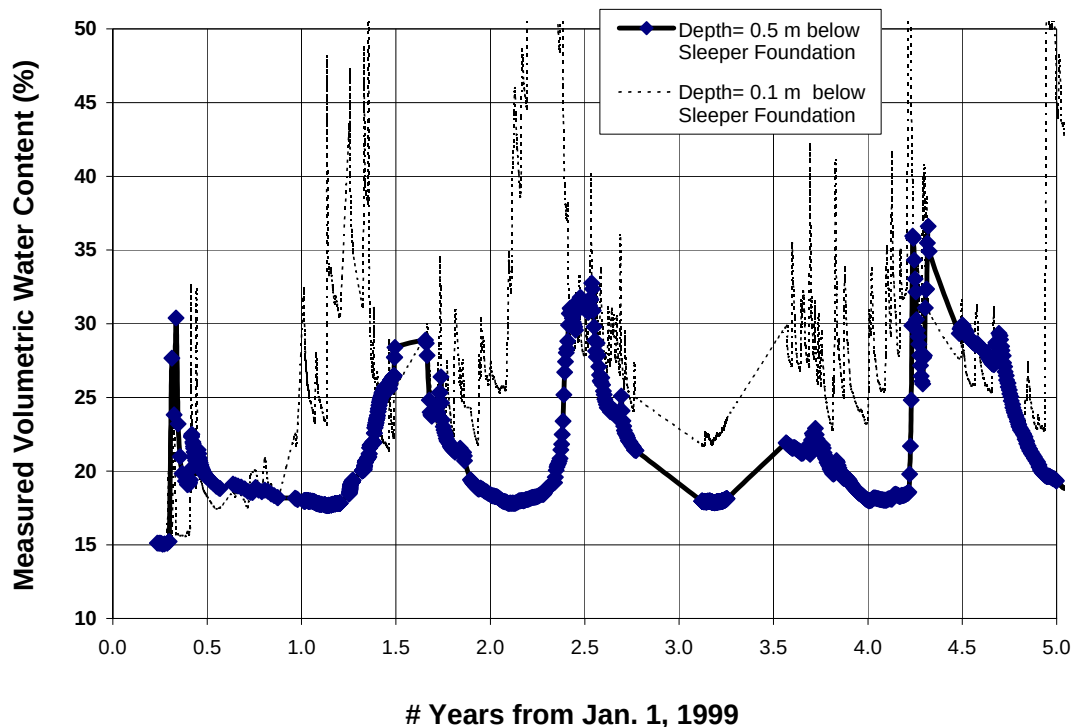
- ❑ Install temporary drainage protection measures during the construction stage before placement of the permanent drainage protection system.
- ❑ *The placed drainage protection system **was not** fully effective in preventing the surface water from reaching deep inside the reinforced soil mass. The backfill beneath the sleeper slab becomes fully saturated during late June of each year and should be designed for these conditions. Signs of gradual softening of the backfill placed beneath the sleeper slab with time due to increase of retained water by soil every year are noticed. This will lead to gradual backfill settlement with time.*
- ❑ The impervious membrane was placed just beneath the approach slab and was not extended to protect the soil beneath the sleeper slab where a joint is placed. This membrane should be extended to protect the backfill beneath sleeper slab.

**Figure 6.6. Measured Changes in Soil Moisture Before and After Placement of the Drainage Protection System.**

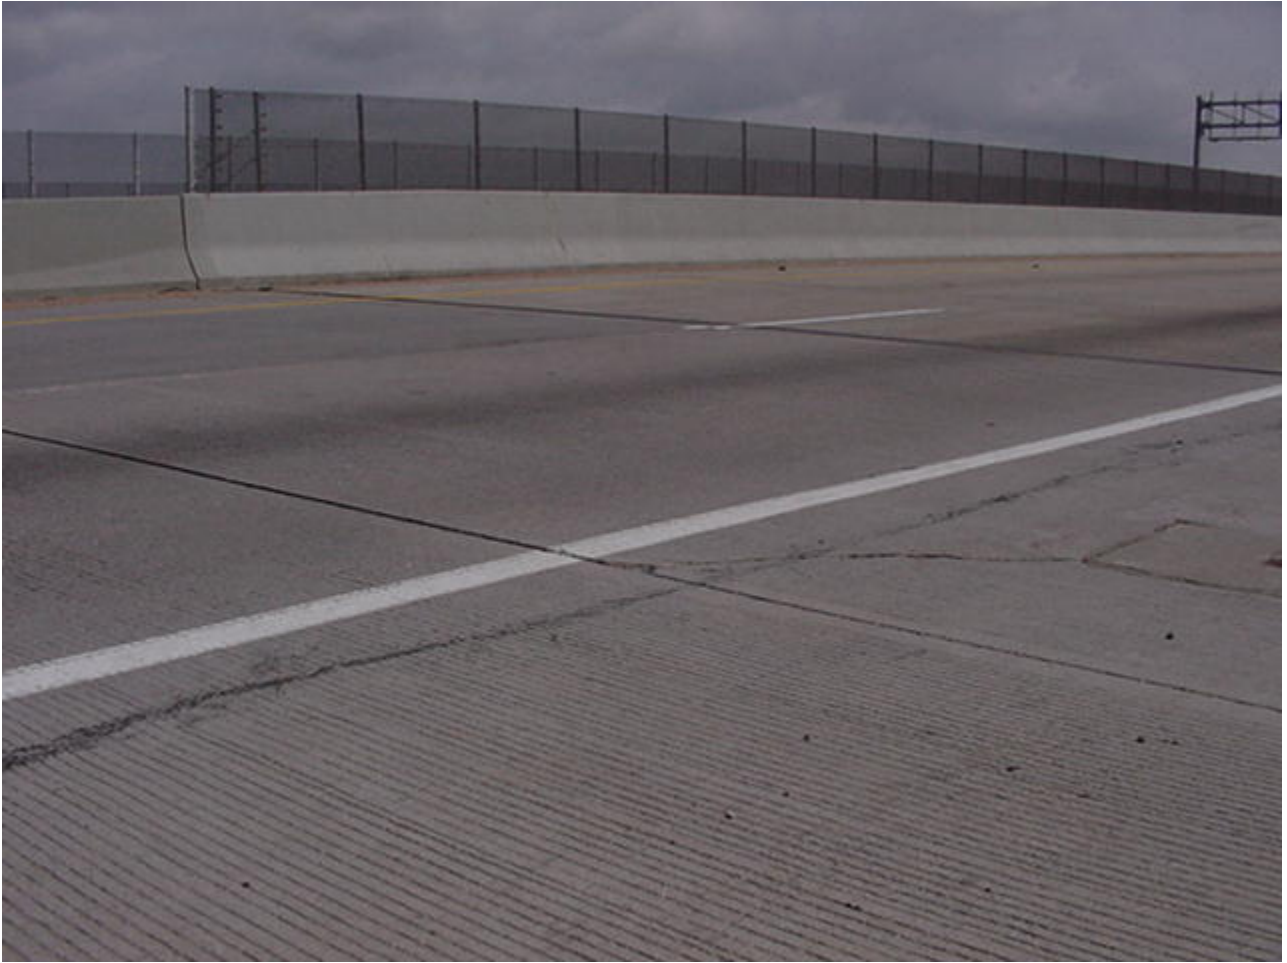
**Figure C.9. Photo of Structure E-17-PS in Region 6**

| Rating based on Approach Settlement | | Bridge Information | | | | Rating Based on Staff Bridge Inspection Records | | | | |
|---|---|---|---|---|---|---|---|---|---|---|
| 1 | Settlement around 1", voids were noticed | E-17-PS | 76 | 20.87 | 1994 | 2 | 0 | 0 | 2 | Many light longit. cracks in both. |

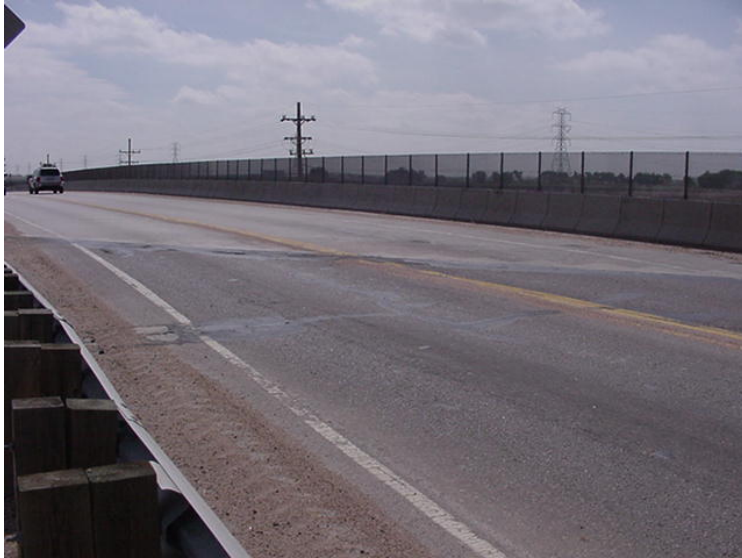
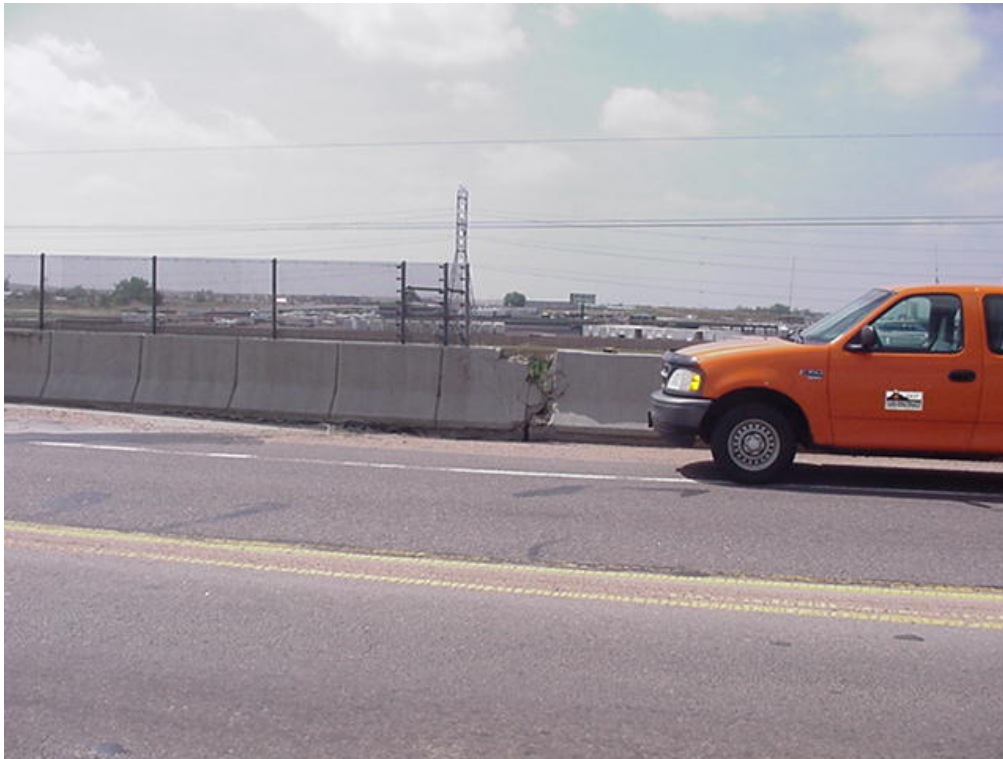
**Figure C.10. Photos of Structure E-17-VR in Region 6**

| 2 | Settlement of 1" East side, 2" west side, approaching roadway settled significantly around 3", short approach slab of 6' to 8' making the problem worsen, Asphalt meet concrete, rated 2 because of low SL | E-17-VR | 44 | 1.075 | 1996 | 2 | 0 | 0 | 2 | Same elevation as deck. Several diagonal cracks. |

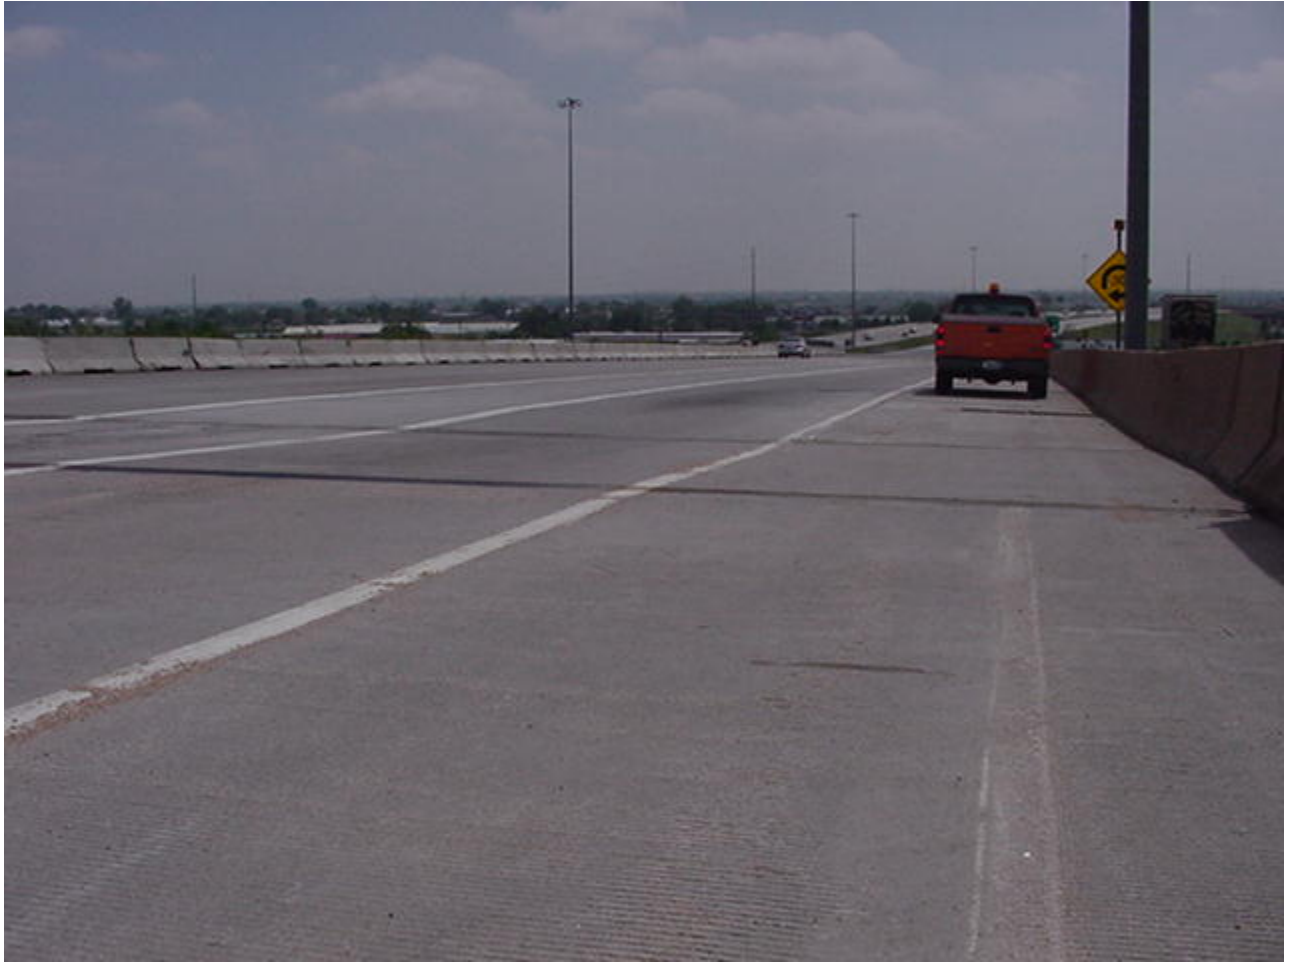
**Figure C.11. Photo of Structure E-17-QA in Region 6**

| Rating based on Approach Settlement | | Bridge Information | | | | Rating Based on Staff Bridge Inspection Records | | | | |
|---|---|---|---|---|---|---|---|---|---|---|
| 2 | East: Sleeper slab drops of around 2", concrete is bust around exapnsion joint | E-17-QA | 270 | 0.01 | 1994 | 2 | 0 | 0 | 2 | Asph. covered on right lane only @ A6. Few lite longit. cracks in both. No problems. |
