## **DURAFLEX CURB**

**COLORADO DEPARTMENT OF TRANSPORTATION  
RESEARCH BRANCH**

Report No. CDOT-2007-3

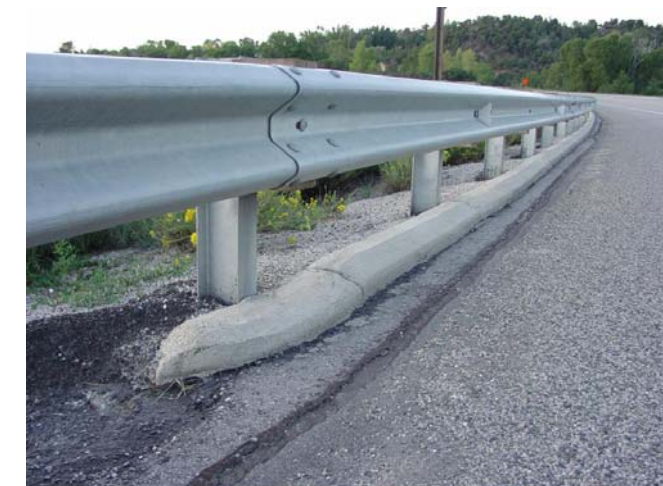
In the past, most of Colorado’s rural highway curbs were either extruded from pavement material or pressure treated lumber. Extruded curbs can be made by passing concrete or asphalt through specially designed slip form machines. Extruded curbs (**Figure 2**) are very

effective, and are not easily damaged by traffic or normal maintenance operations such as snow removal. However, they are expensive. Repairs are difficult and installation of new extruded

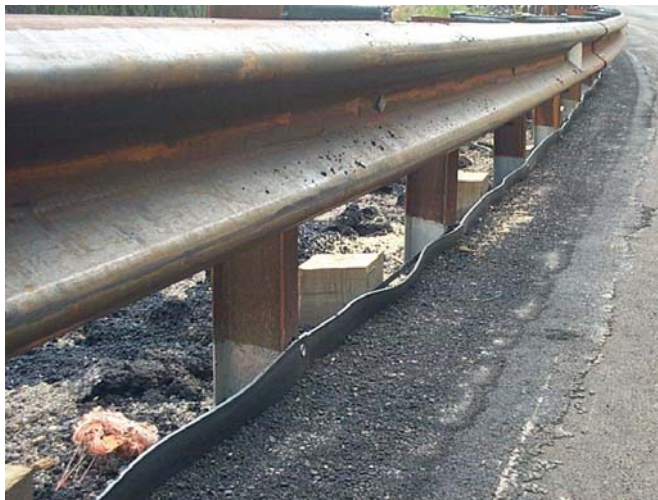
**Figure 6. The edge of the pavement was placed and compacted by hand.**

At both sites, most of the new guardrail was installed before the final mat was laid; as the old guardrail was removed new guardrail was placed immediately so that all areas were protected at all times. Unfortunately, having the block-outs and guardrail already in place prevented the paver and rollers from operating close to the guardrail posts, so the asphalt for about two feet out in front of the curb had to be placed and compacted by hand (**Figure 6**). This resulted in lower density, hence, lower strength in the mat next to the curb.

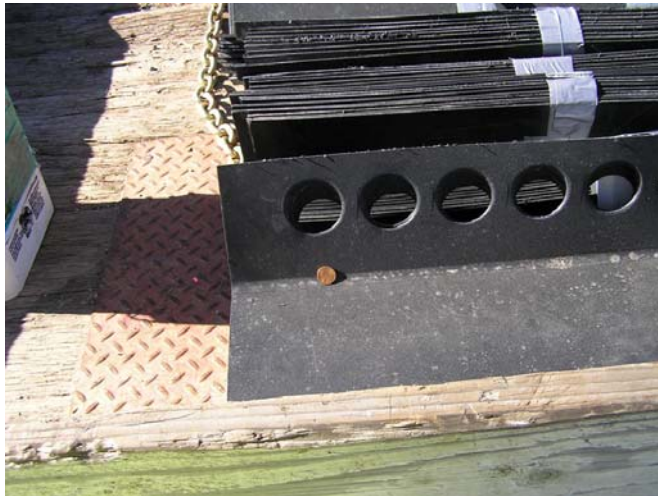
**Figure 8. Holes in the horizontal leg of the DFC help the layers of asphalt bond together to strengthen the curb.**

Colorado Springs, Colorado. It is made of High Density Polyethylene plastic (HDPE) – the plastic used to make milk and laundry detergent jugs. The original DFC installed on USW-24 was HDPE sheets formed into L-shaped sections with a row of holes punched along one leg (**Figure 8**). The curb was extensively re-designed between the two projects to address some issues encountered on US-24.

As **Figure 8** shows on the previous page, the HDPE had a memory; it tried to return to its original flat shape rather than maintain a 90° bend. Because the curb material had partially flattened out, it was difficult for the installers to push it tight against both the bottoms of the guardrail posts and the surface of the asphalt at the same time. They used shovels to hold the curb in place while it was nailed to the pavement along the edge of the horizontal leg (**Figure 10**). (The DFC was not nailed to the guardrail posts on US-24.)

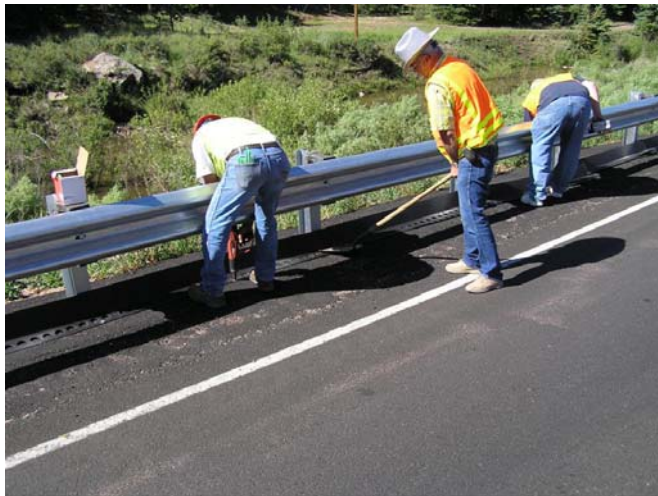
**Figure 10. Holding DFC tight against the post base and the pavement with a shovel.**

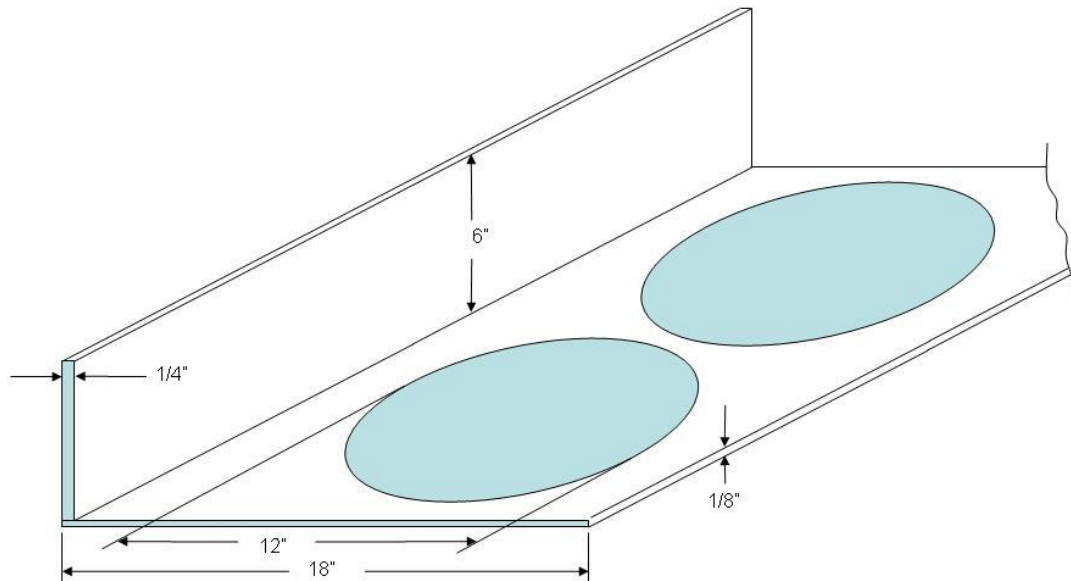
Before the Monarch Pass project, the DuraFlex Curb was extensively redesigned. The new curb is extruded with the 90° L-shape rather than a formed sheet. The curb has a 6-inch vertical leg – doubled in thickness to  $\frac{1}{4}$  inch, and is anchored into the asphalt by an 18-inch horizontal leg.

**Figure 16. Drawing of the modified DuraFlex Curb used on US-50.**

The horizontal leg is  $\frac{1}{8}$  inch thick and has a row of 12 inch diameter holes spaced one inch apart along its length. When the asphalt is laid over the curb, the larger diameter the holes provide more area to improve the bond between the asphalt lifts and help make the curb become a part of the pavement. The curb sections are light and easy to transport and handle - the entire quantity of  $\pm 2000$  feet for the project was delivered on a 15 foot goose neck trailer.

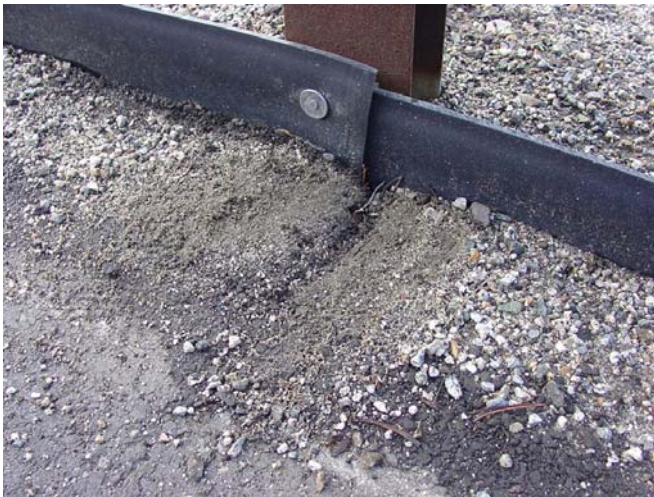
**Figure 17. DFC nailed to a guardrail post on US-50.**

the downhill one. For the Monarch project, the curb was nailed to the guardrail posts near the top of the curb (**Figure 17**).

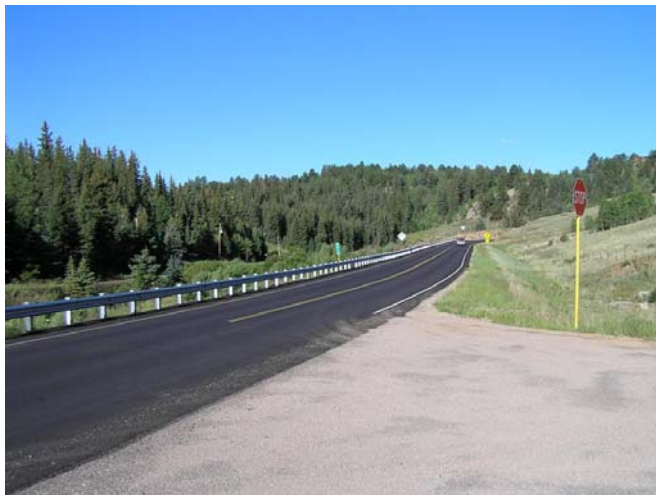
**Figure 25. US-24 on Ute Pass.**

roadway. US-24 near Divide **Figure 25** is such a location: a narrow, gently sloping, two-lane road, crowned in the center, with gently sloping shoulders. Water carried by the curb in this kind of location will have little energy to cause problems even if it does find a gap in the curb.
