DOT/FAA/CT-90/10

# Fuselage Burnthrough from Large Exterior Fuel Fires

July 1994

Final Report

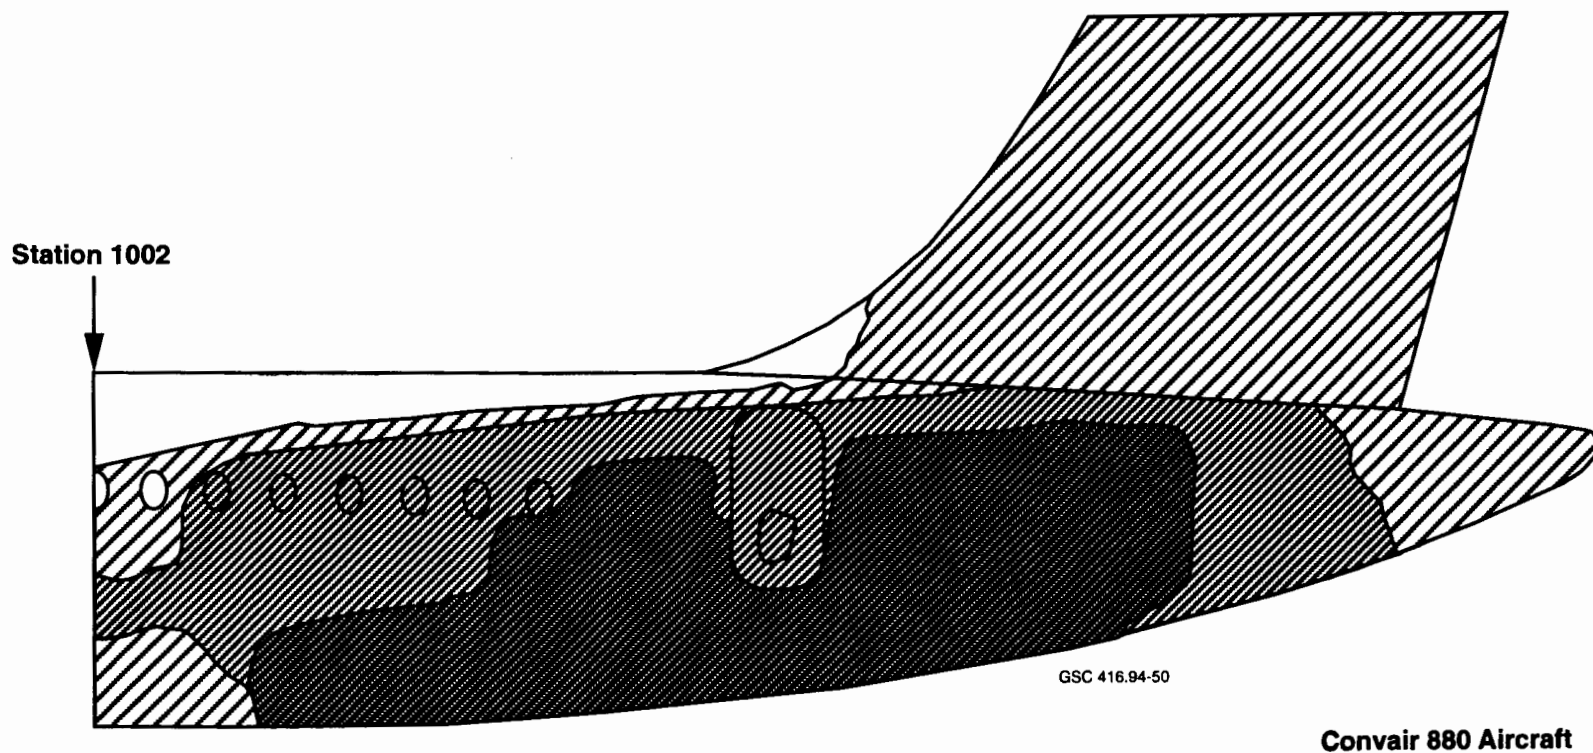
FIGURE D-16. TEST 4 EXTERIOR FIRE DAMAGE, AFT SECTION FUSELAGE PORT SIDE

Paint Burned Off and Some Heat Buckling of Skin Panel
-

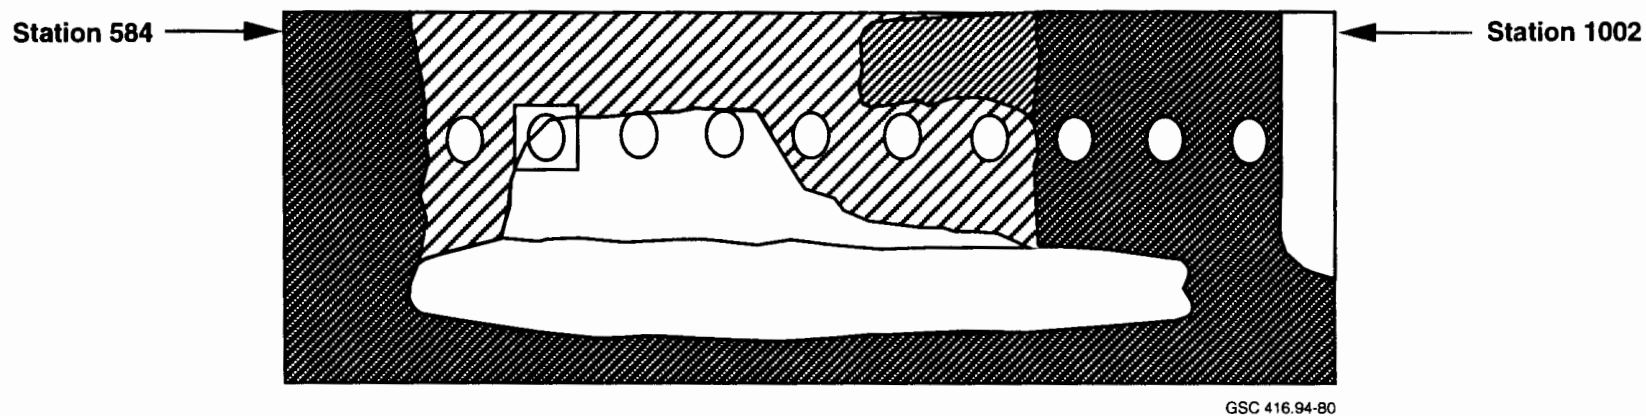
FIGURE F-7. TEST 6 EXTERIOR FIRE DAMAGE, CENTER SECTION FUSELAGE PORT SIDE

Paint Burned Off and Some Heat Buckling of Skin Panel
-

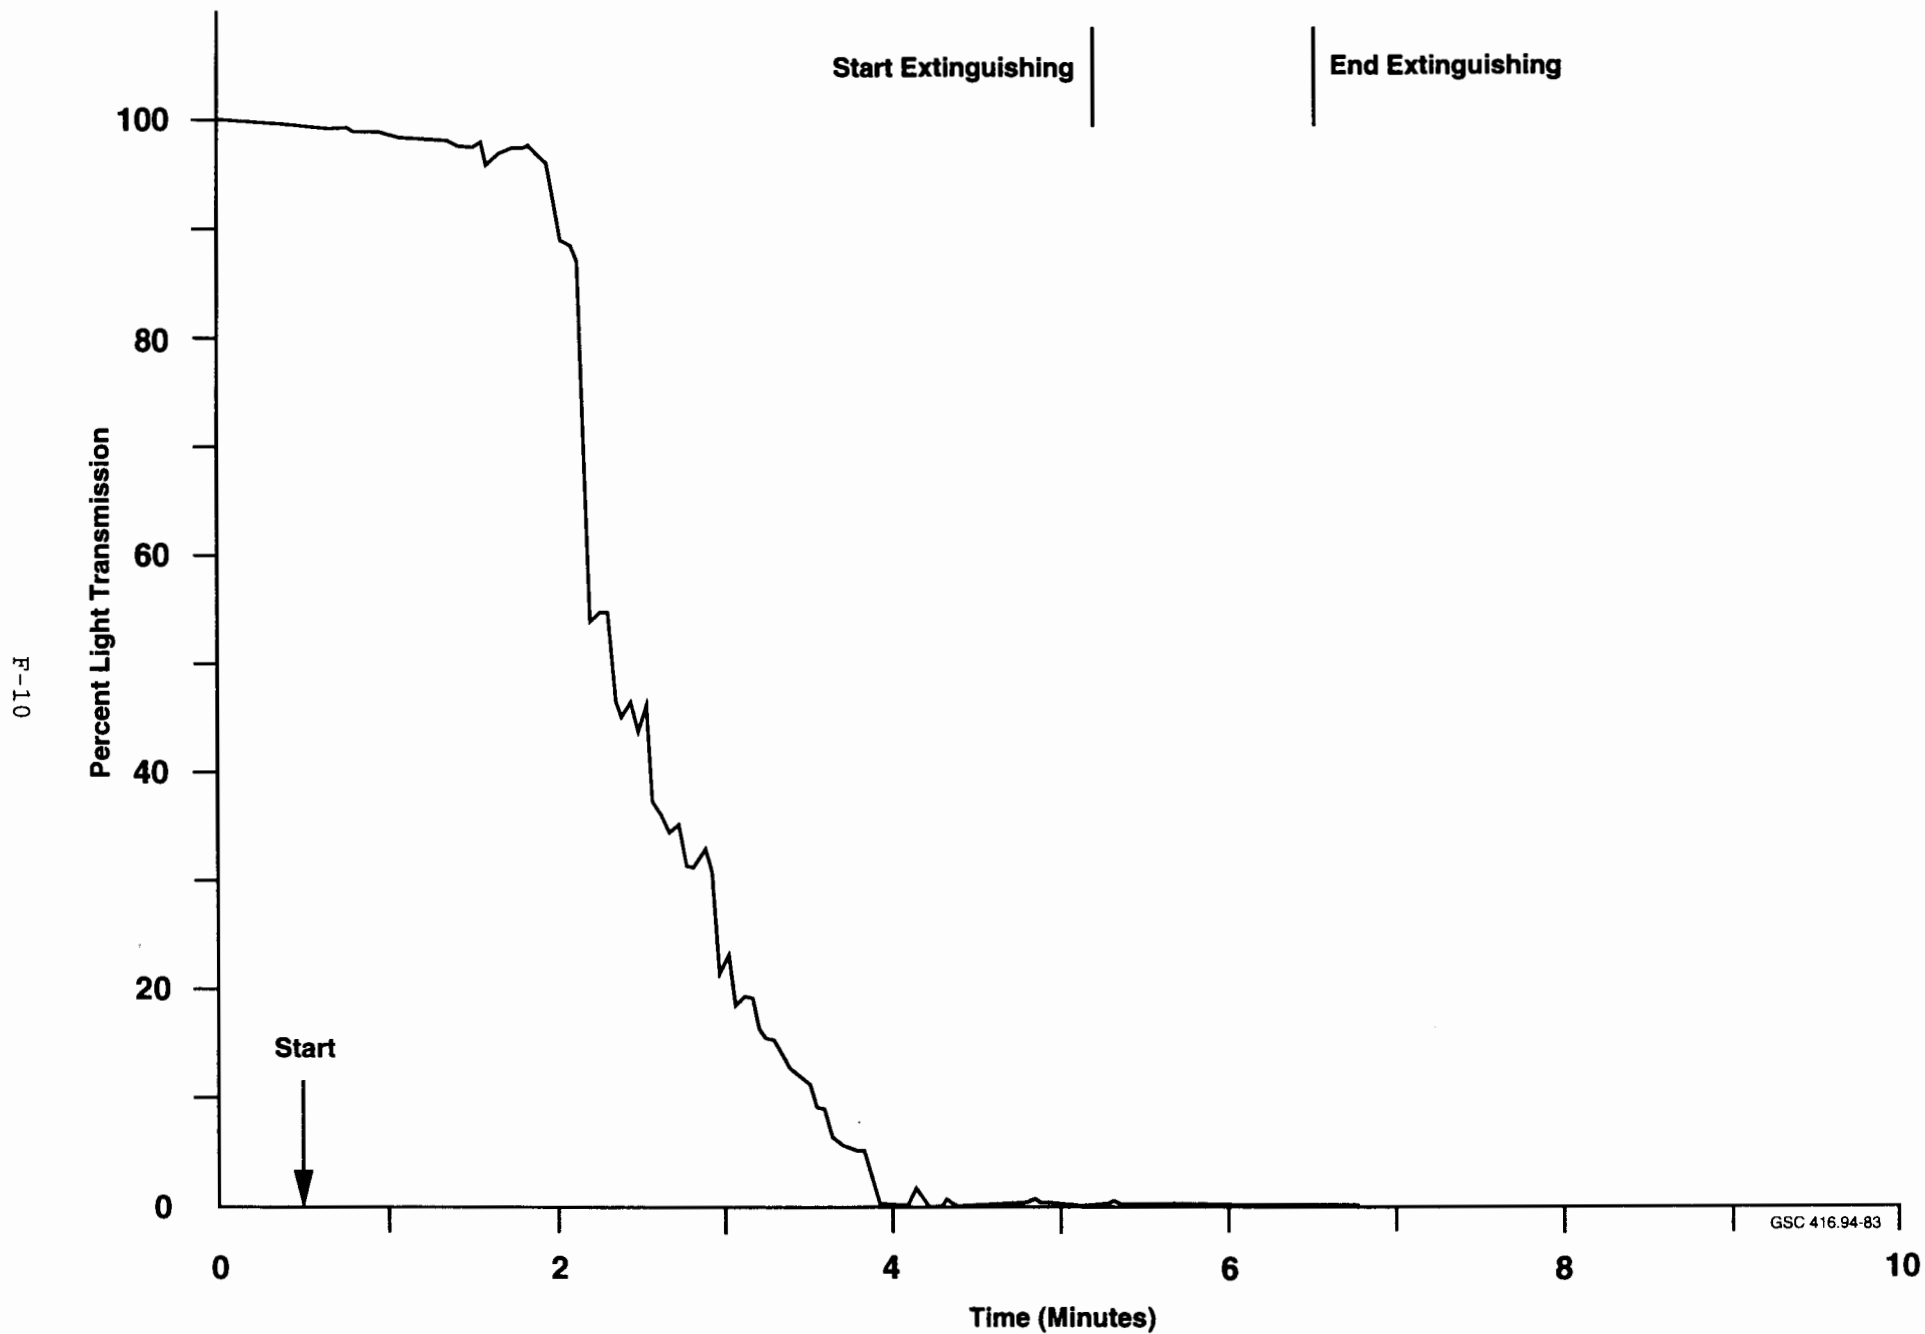
FIGURE F-10. TEST 6 SMOKE DENSITY 48" ABOVE THE FLOOR AT STATION 788

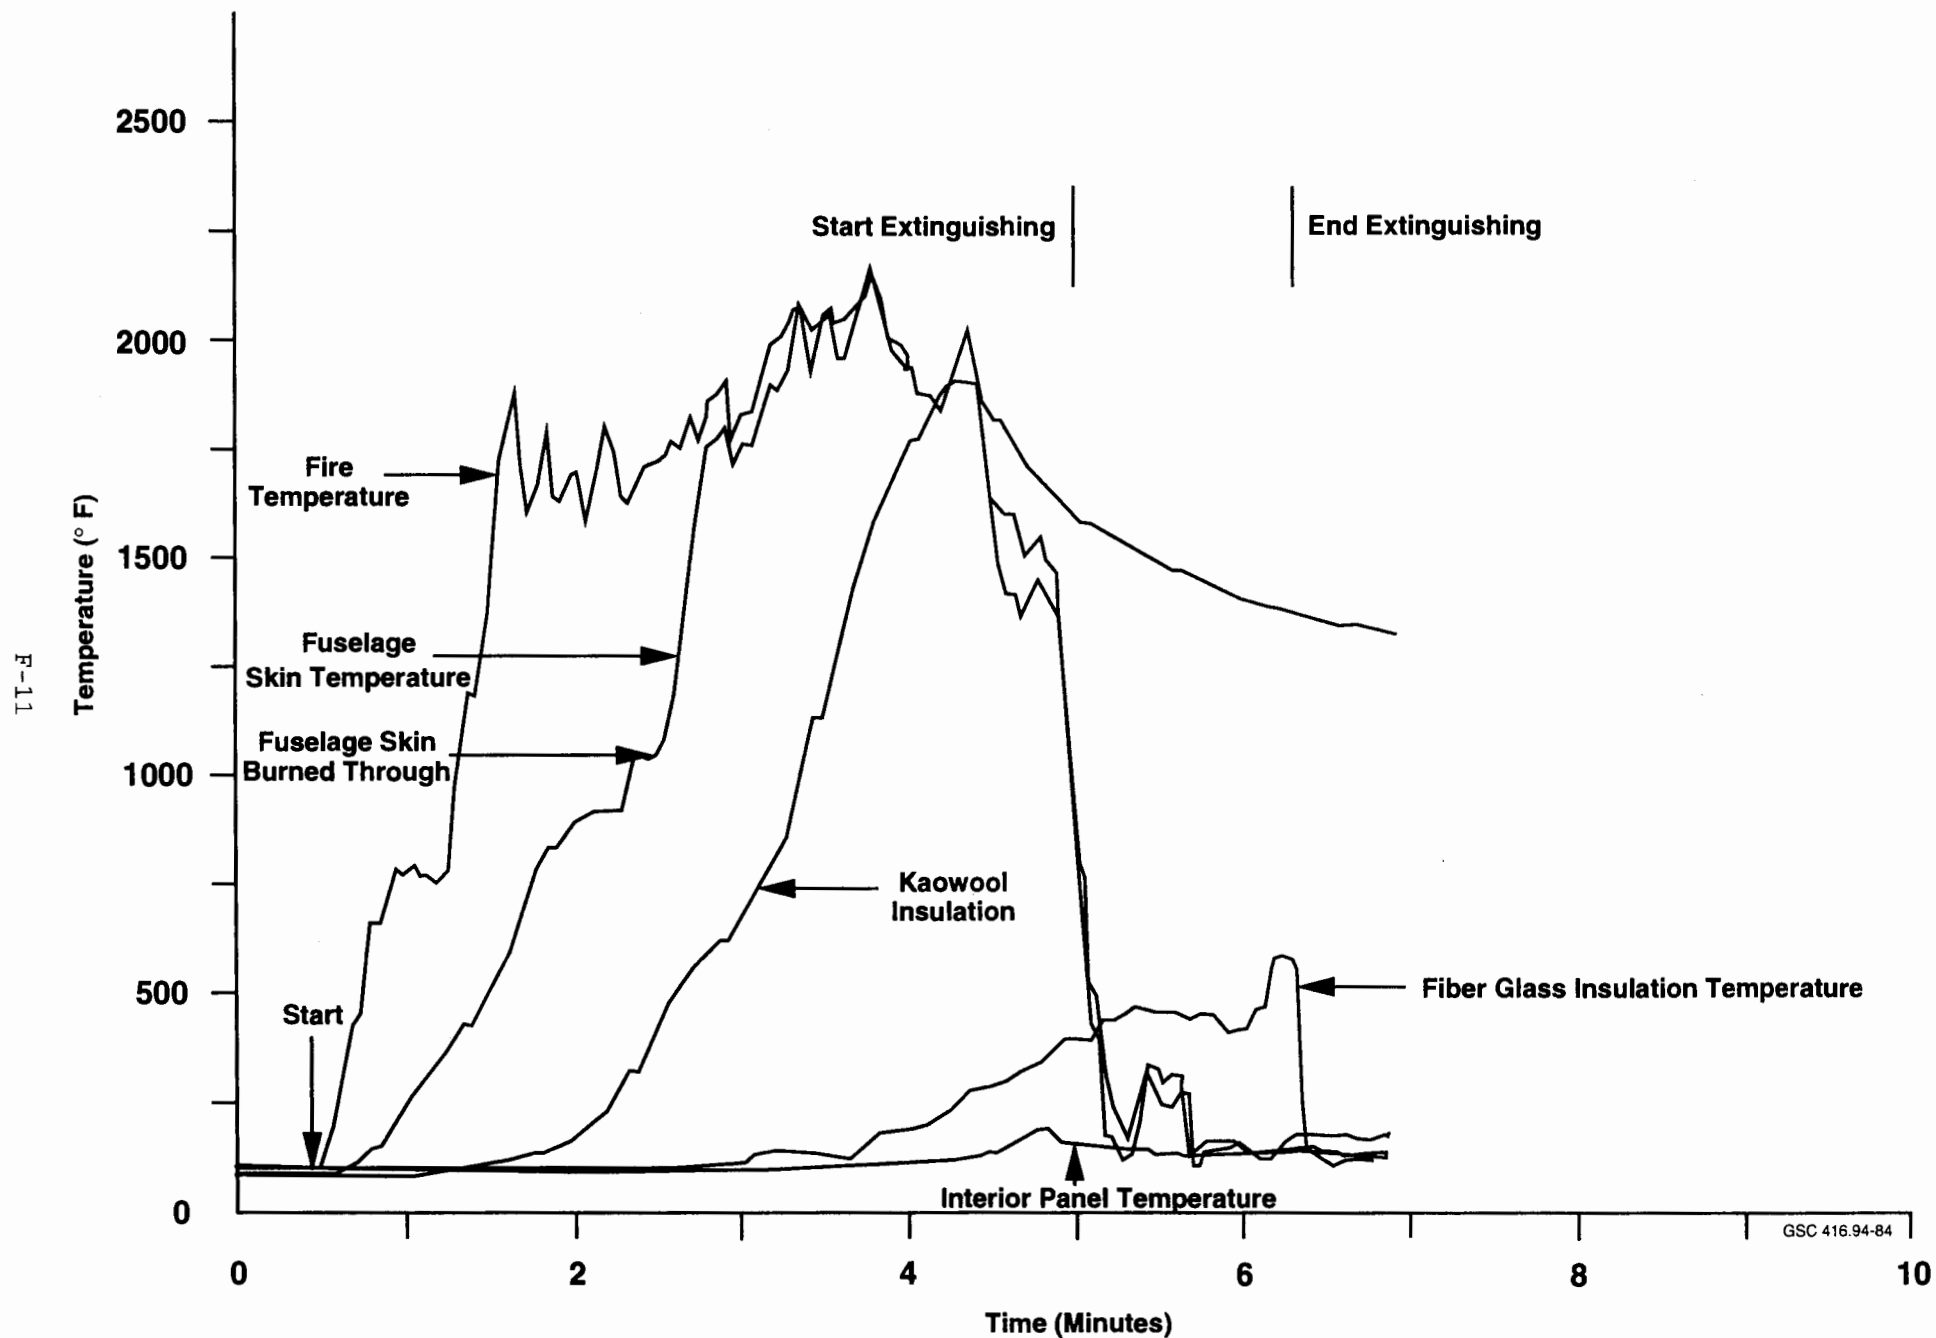
FIGURE F-11. TEST 6 FIRE, FUSELAGE SKIN, FIBER GLASS INSULATION, KAOWOOL INSULATION, AND INTERIOR PANEL TEMPERATURES, STARBOARD SIDE AT STATION 955

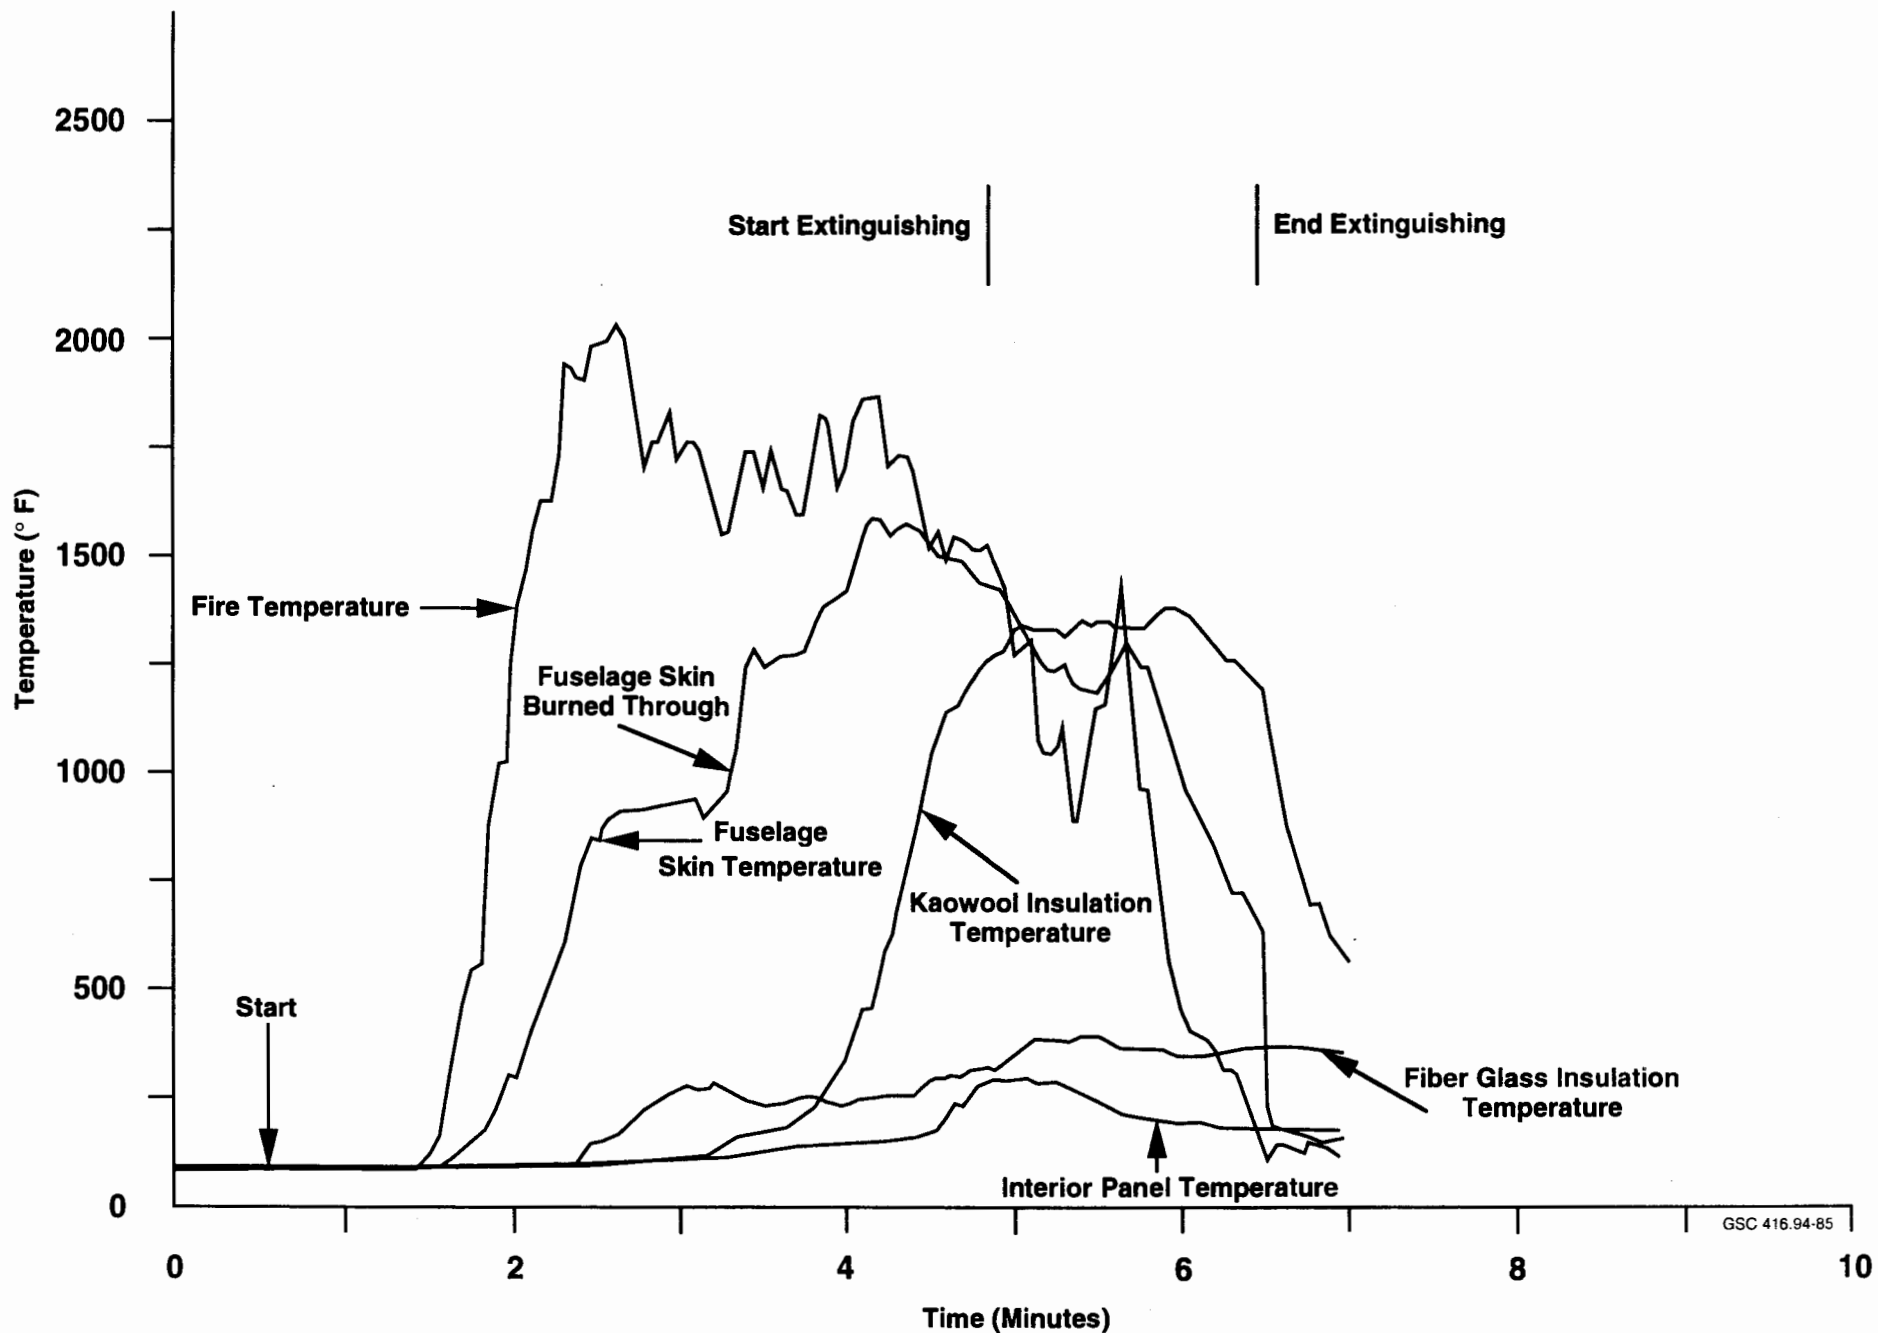
FIGURE F-12. TEST 6 FIRE, FUSELAGE SKIN, FIBER GLASS INSULATION, KAOWOOL INSULATION, AND INTERIOR PANEL TEMPERATURES PORT SIDE AT STATION 955
