## **Final Report**

Evaluation of Concrete Specimens Prepared with Corrosion Resistant  
Reinforcement after Long Term, Greater than 15 years, Outdoor and  
Laboratory Exposures

Contract Number – FDOT (BED27-977-04)  
FAU (AWD003253)

Submitted to  
Florida Department of Transportation  
Research Center  
605 Suwannee Street  
Tallahassee, Florida 32399

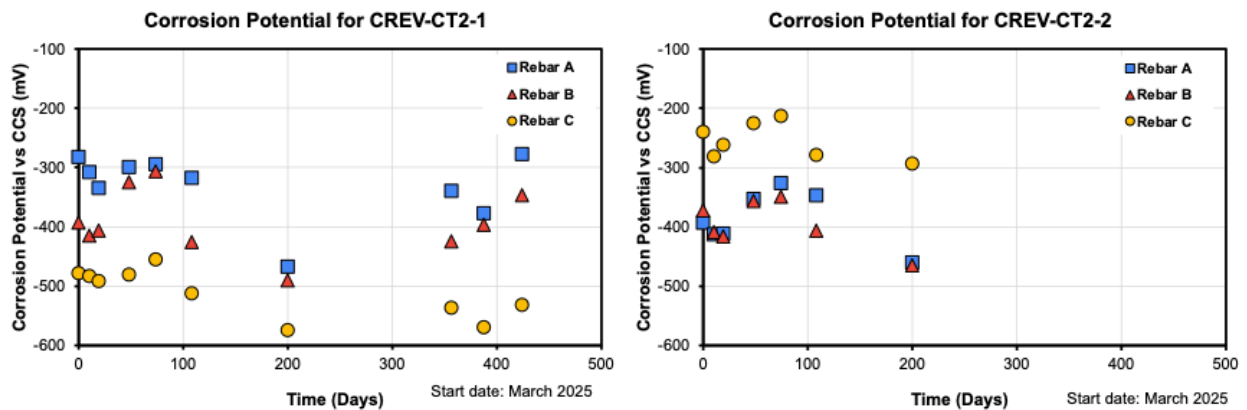
For samples with high corrosion activity, plots showing the corrosion potentials measured with the Gecor 8 are shown in Figure 3-1 through Figure 3-5. Plots of samples that were terminated are presented next to their non-terminated counterpart. Corroding samples generally showed potentials more negative than  $-350 \text{ mV}_{\text{CSE}}$ , though some samples showed a wide range of variability between individual rebars. For example, rebar C of terminated BCCD-CT2-1 (Figure 3-3) measured potentials in the range that would suggest no active corrosion, while rebar A of the same sample measured significantly more negative potentials.

Figure 3-2. Potential vs. time for terminated CREV-CT2-2 and non-terminated companion CREV-CT2-1.

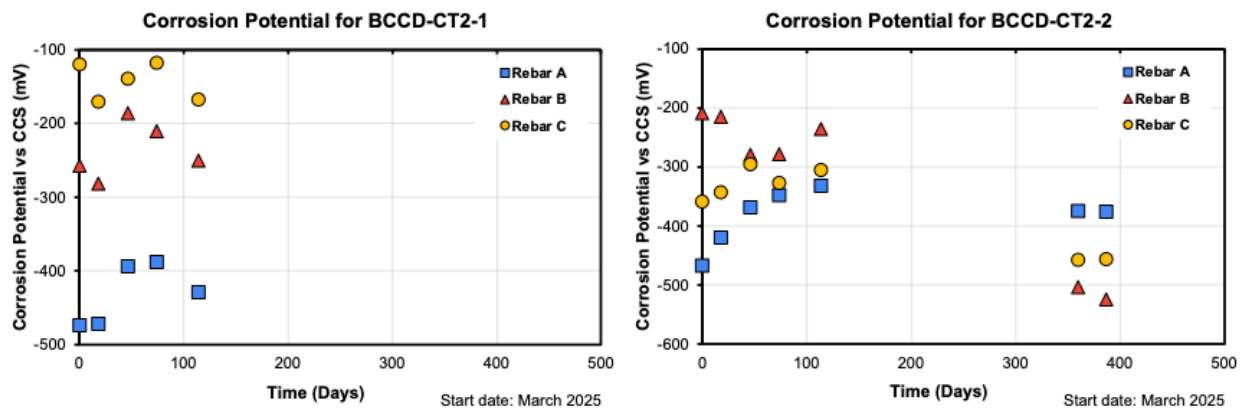
Figure 3-3. Potential vs. time for terminated BCCD-CT2-1 and non-terminated companion BCCD-CT2-2.

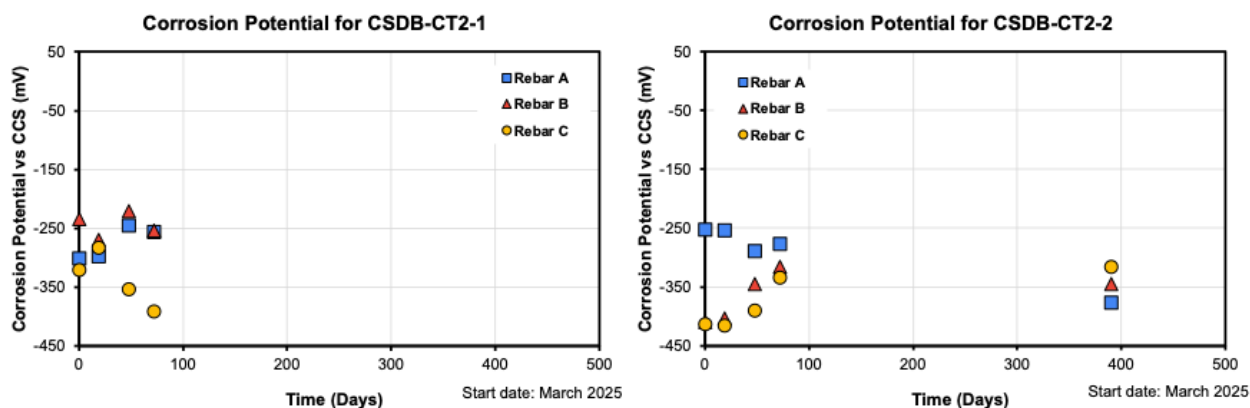
Figure 3-4. Potential vs. time for terminated CSDB-CT2-1 and non-terminated companion CSDB-CT2-2.

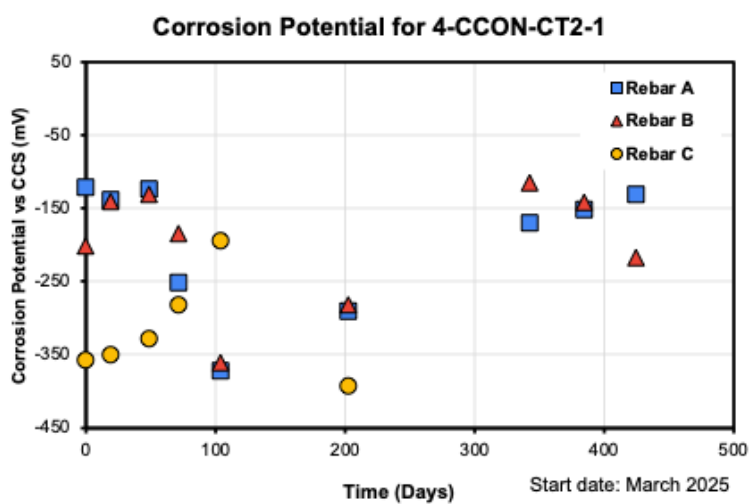
Figure 3-5. Potential vs. time for 4-CCON-CT2-1. Rebar C was terminated.

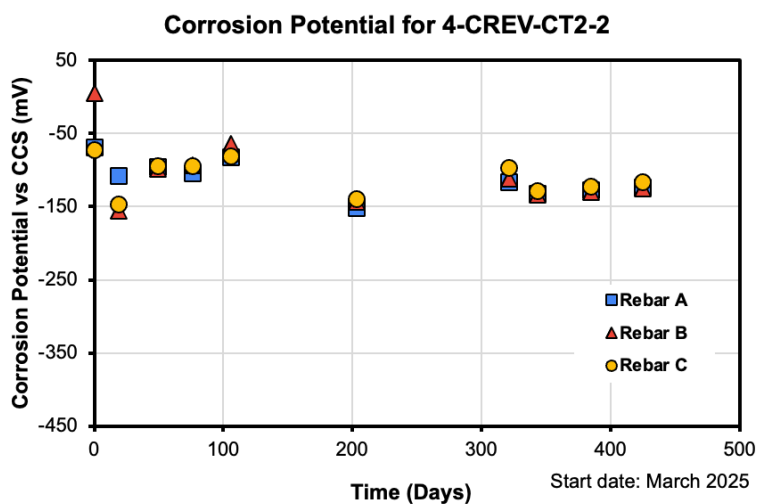
Plots of corrosion potential over time for selected samples with all rebars showing moderate corrosion activity are shown in Figure 3-6 through Figure 3-8. With the exception of rebar B of sample 6-CREV-304-1 (Figure 3-6), potentials for each rebar from the selected samples measured more positive than  $-250 \text{ mV}_{\text{CSE}}$  on average. Rebar B of 6-CREV-304-1 had an average potential of approximately  $-410 \text{ mV}_{\text{CSE}}$  over the monitoring period, indicating a high likelihood of active corrosion. Upon visual examination of this sample, a concrete crack in the reservoir directly above rebar B was observed.

Figure 3-7. Potential vs. time for 4-CREV-CT2-2.

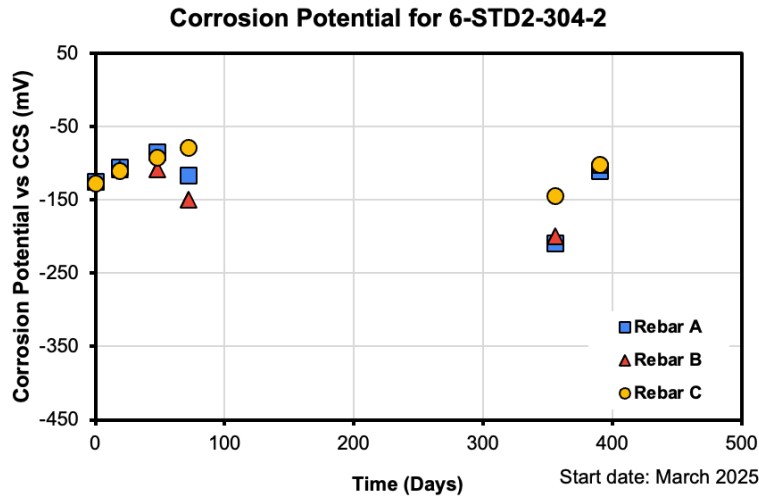
Figure 3-8. Potential vs. time for 6-STD2-304-2.

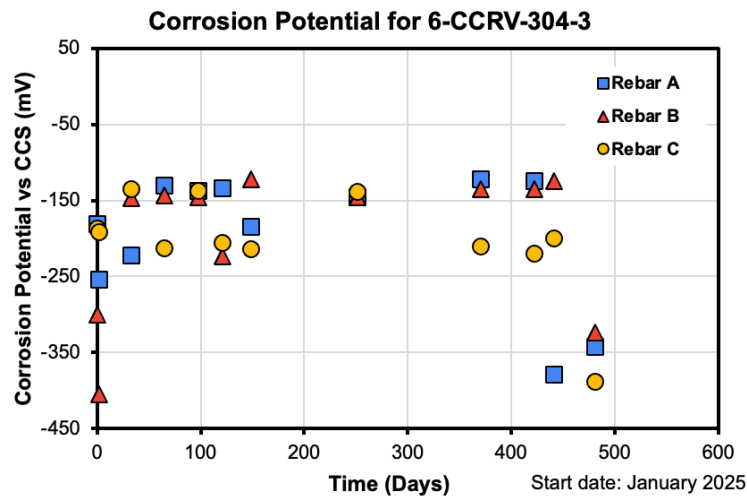
Figure 3-9. Potential vs. time for 6-CCRV-304-3.

Plots of corrosion potential over time for indoor samples with little to no corrosion activity are shown in Figure 3-9 through Figure 3-13. Potentials for the samples measured more positive than  $-250 \text{ mV}_{\text{CSE}}$ , with some excursions to more negative values. Sample 6-CCRV-304 (Figure 3-9) had a significant negative potential shift towards the end of the monitoring period; however, isolated corrosion rates suggest the sample did not become active. The CT1 sample with undamaged cladding (Figure 3-11) measured potentials in the same range as the sample with solid 316 rebar (Figure 3-10). The samples with 2304 rebars (Figure 3-12 and Figure 3-13) presented similar potential measurements, generally oscillating between  $-150 \text{ mV}_{\text{CSE}}$  and  $-250 \text{ mV}_{\text{CSE}}$ , despite their differing concrete mix types.

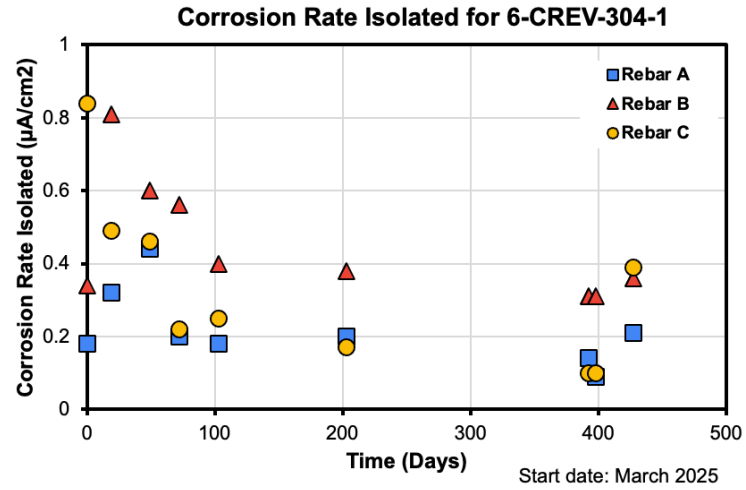
Figure 3-19. Isolated corrosion rates for 6-CREV-304-1.

Plots of isolated corrosion rates over time for selected samples showing moderate corrosion activity in each rebar are shown in Figure 3-19 through Figure 3-21. The average isolated corrosion rates for each rebar in the selected samples ranged between  $0.4 \mu\text{A}/\text{cm}^2$  and  $1 \mu\text{A}/\text{cm}^2$  except for rebars A and C of 6-CREV-304-1 (Figure 3-19), which had average rates below  $0.4 \mu\text{A}/\text{cm}^2$ .

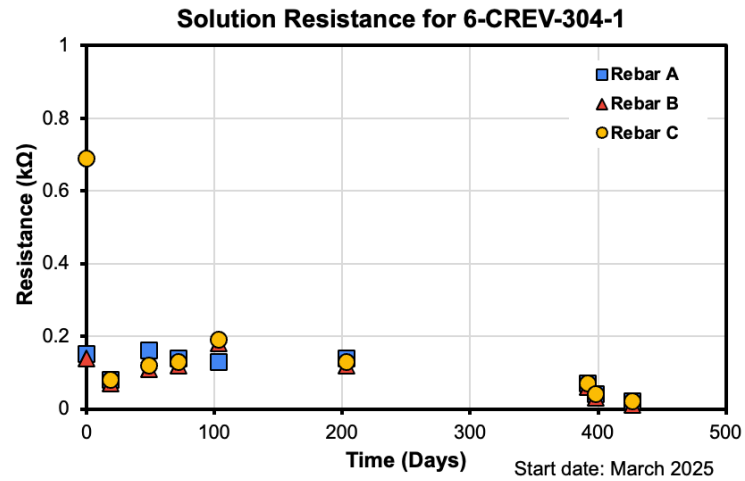
Figure 3-32. Solution resistance vs. time for 6-CREV-304-1.

Plots of solution resistance over time for selected samples showing moderate corrosion activity in each rebar are shown in Figure 3-32 through Figure 3-34. Sample 6-CREV-304-1 (Figure 3-32) had low solution resistance values that averaged below 0.2 kΩ. The concrete crack in the reservoir above rebar B of this sample likely facilitated an easier path for chlorides to penetrate. Samples 4-CREV-CT2-2 (Figure 3-33) and 6-STD2-304-2 (Figure 3-34) had solution resistances that averaged above 0.2 kΩ and less than 0.6 kΩ, which may be evidence of slightly less chloride penetration than in samples with lower solution resistances and higher corrosion activity. Although STD2 concrete has a lower w/c ratio and is of a higher quality than STD1 (as in 4-CREV-CT2-2), solution resistances between the two types are comparable after corrosion has initiated.

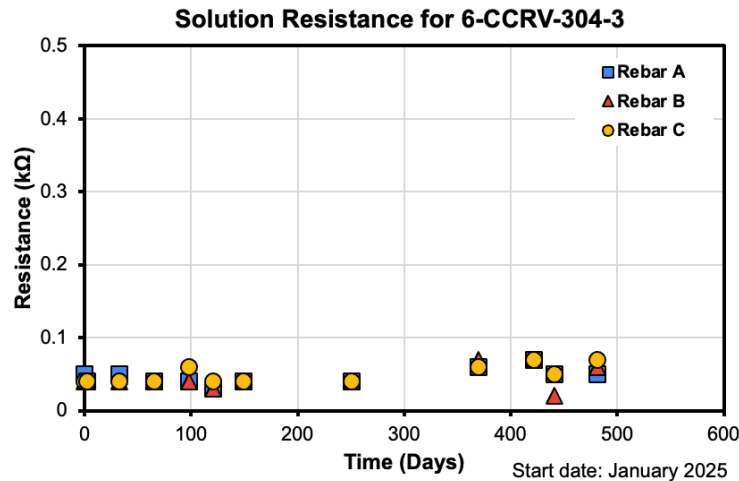
Figure 3-35: Solution resistance vs. time for 6-CCRV-304-3.

Plots of solution resistance over time for indoor samples with little to no corrosion activity are shown in Figure 3-35 through Figure 3-39. Except for STD3-2304-1, each sample measured relatively low solution resistances. Samples 6-CCRV-304-3 (Figure 3-35), 1-STD1-316-2 (Figure 3-36), and 1-STD1-CT1-1 (Figure 3-37) generally measured solution resistances below 0.2 kΩ, as they were stored in the same closed tank which maintained a high relative humidity throughout the duration of the monitoring period. It was often necessary to leave the tank open for a couple days and allow the samples to partially dry and prevent sensor errors while measuring.

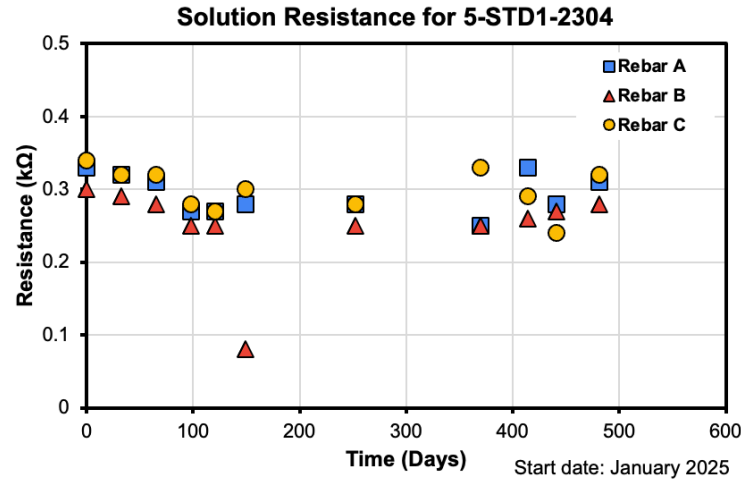
Figure 3-38. Solution resistance vs. time for 5-STD1-2304.

Sample 5-STD1-2304 (Figure 3-38) measured somewhat higher solution resistances, ranging between 0.2 kΩ and 0.4 kΩ. The tank in which this sample was stored was not as airtight, and therefore the relative humidity to which it was exposed was lower. Sample STD3-2304-1 (Figure 3-39) measured significantly higher solution resistances, ranging between 1 kΩ and 2 kΩ. Recall that the STD3 concrete mix included 10% fly ash F; the higher solution resistances presented by this sample resulted from the higher quality concrete mix.

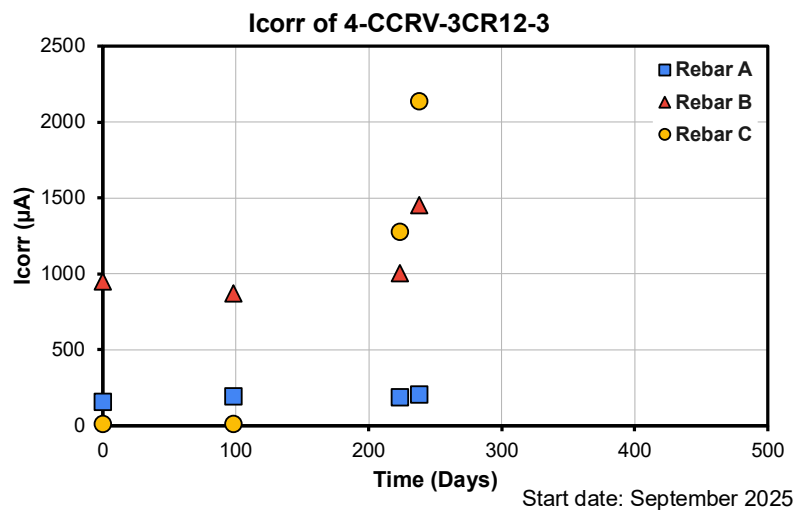
Figure 3-40. Corrosion current vs. time for non-terminated sample 4-CCRV-3CR12-3.

For samples with high corrosion activity ( $I_{\text{corr}} > 20 \mu\text{A}$ ), plots showing the corrosion currents are shown in Figure 3-40 through Figure 3-45. Plots of samples that were not terminated are presented next to their terminated counterpart where available. The companion of sample 4-CCRV-3CR12-3 was terminated before GP measurements commenced on outdoor samples. Corroding samples generally showed corrosion currents higher than 50  $\mu\text{A}$ , though some samples showed a wide range of variability between individual rebars. For example, rebars B and C of 4-CCRV-3CR12-3 (Figure 3-40) had corrosion currents that reached above 1000  $\mu\text{A}$ , while rebar A stayed well below 500  $\mu\text{A}$ . The terminated rebar C of 4-CCON-CT2-1 (Figure 3-44) had corrosion currents consistently measuring above 50  $\mu\text{A}$  while non-terminated rebars A and B of the same sample showed lower corrosion currents, ranging below 20  $\mu\text{A}$ . Not pictured are the non-terminated companion samples of 4-CCON-CT2-1, which yielded more moderate  $I_{\text{corr}}$  values but still showed signs of corrosion. Rebar B of 6-CREV-304-1 (Figure 3-45) displayed corrosion currents between 20  $\mu\text{A}$  and 40  $\mu\text{A}$ , while the corrosion currents of rebars A and B of the same sample remained below 10  $\mu\text{A}$ . The concrete crack above rebar B of 6-CREV-304-1 likely allowed more chlorides to reach this rebar, increasing corrosion and leading to higher corrosion current values.

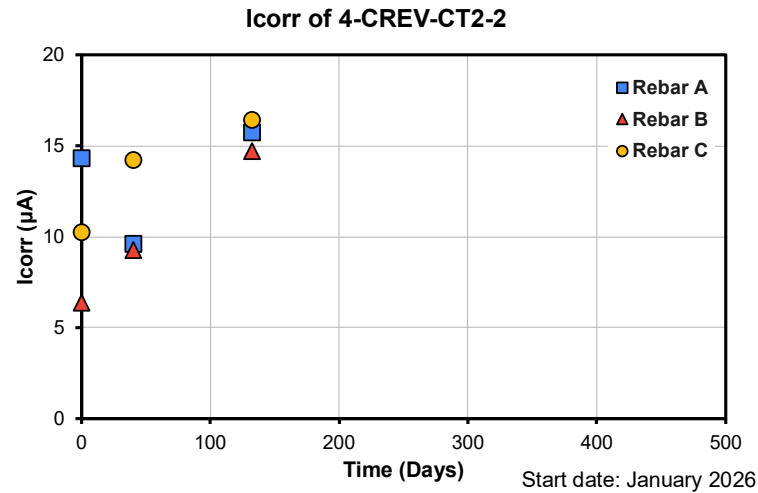
Figure 3-46. Corrosion current vs. time for 4-CREV-CT2-2.

For samples with moderate corrosion activity ( $12 \mu\text{A} < I_{\text{corr}} < 20 \mu\text{A}$ ), plots showing the corrosion currents are shown in Figure 3-46 and Figure 3-47. Corrosion currents of rebars A and C of 4-CREV-CT2-2 (Figure 3-46) each averaged between  $13 \mu\text{A}$  and  $14 \mu\text{A}$ . Corrosion currents of 6-STD2-304-2 (Figure 3-47) averaged between  $14 \mu\text{A}$  and  $17 \mu\text{A}$ .

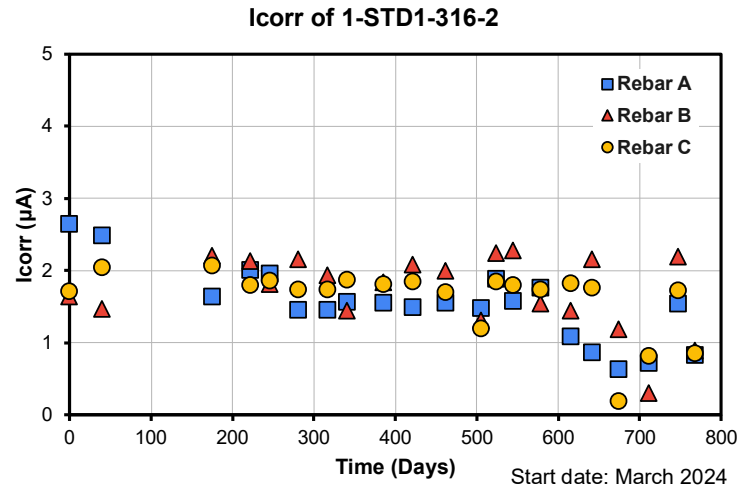
Plots of corrosion current vs. time for indoor samples with little to no corrosion activity are shown in Figure 3-48 through Figure 3-52. Corrosion currents for these samples generally remained stable, measuring less than 10  $\mu\text{A}$  throughout the study. Out of this group, the highest corrosion currents were experienced by the sample with clad rebars, 1-STD1-CT1-1 (Figure 3-50). The samples with the most corrosion resistant alloys and no intentional damage displayed the lowest corrosion currents, i.e. below 3  $\mu\text{A}$  for each rebar. These included 1-STD1-316-2, 5-STD1-2304, and STD3-2304-1 (Figure 3-49, Figure 3-51, and Figure 3-52, respectively).

Figure 3-49. Corrosion current vs. time for 1-STD1-316-2.

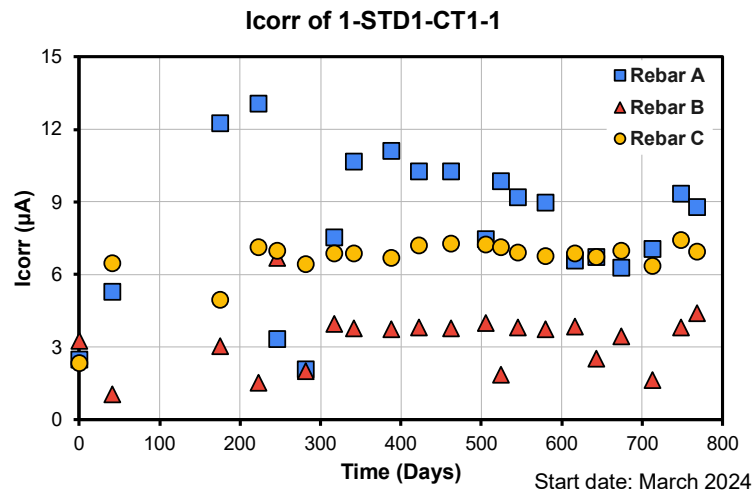
Figure 3-50. Corrosion current vs. time for 1-STD1-CT1-1.

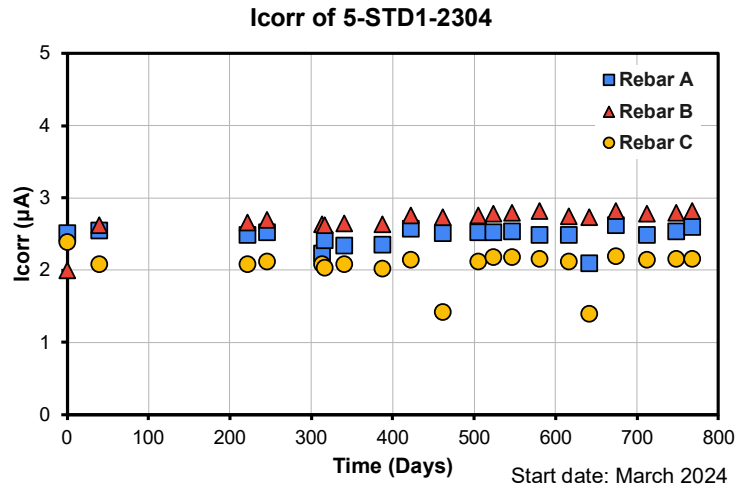
Figure 3-51. Corrosion current vs. time for 5-STD1-2304.

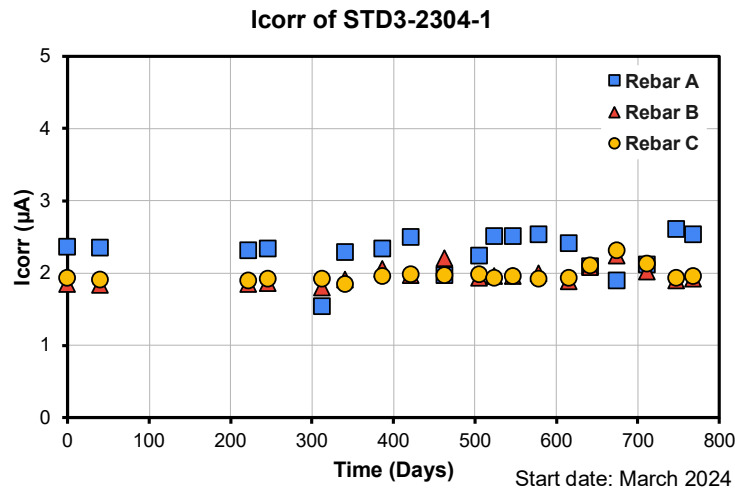
Figure 3-52. Corrosion current vs. time for STD3-2304-1.

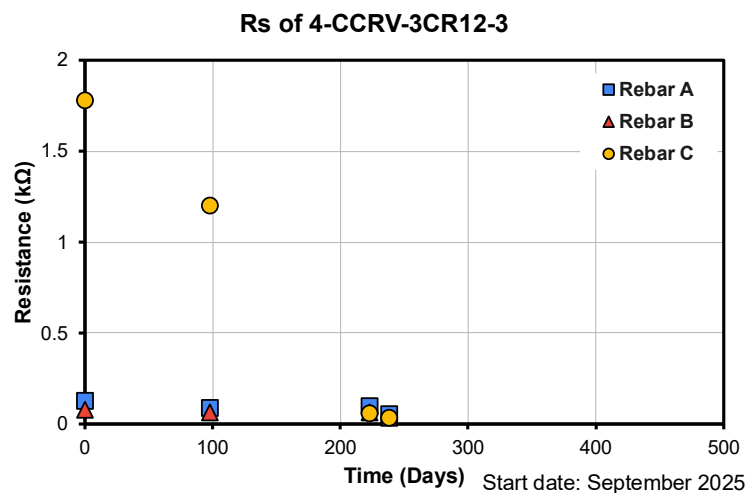
Due to bad electrical contact on rebar C of 4-CCRV-3CR12-3 (Figure 3-53), solution resistance was higher on this rebar compared to A and B until the rebar was sanded. After good contact was made, solution resistance values lowered and were comparable to the other rebars in the

Figure 3-53. Solution resistance vs. time for non-terminated 4-CCRV-3CR12-3.

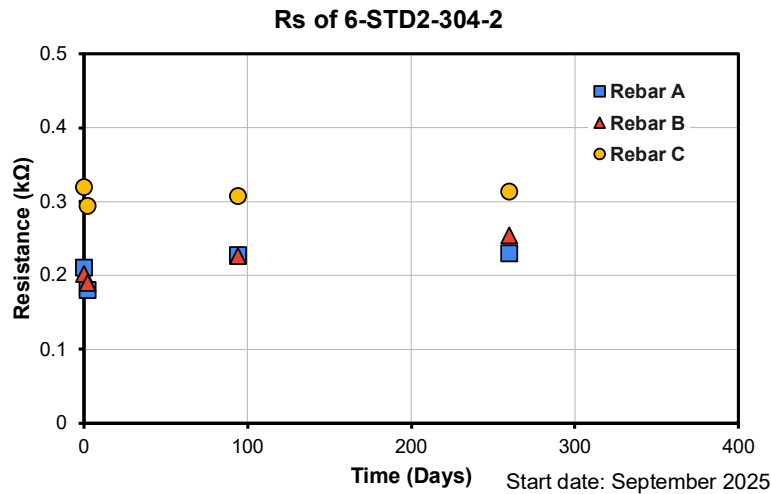
Plots of solution resistance over time for selected samples showing moderate  $I_{corr}$  values are shown Figure 3-59 and Figure 3-60. Samples 4-CREV-CT2-2 (Figure 3-59) and 6-STD2-304-2 (Figure 3-60) had solution resistances that averaged between 0.1 kΩ and 0.6 kΩ, which is comparable to the values measured with the Gecor 8. Although the concrete quality of 6-STD2-304-2 was higher than that of 4-CREV-CT2-2 (which was composed of STD1 concrete), solution resistances calculated for the STD2 sample were slightly lower on average than those calculated for 4-CREV-CT2-2.

Figure 3-60. Solution resistance vs. time for 6-STD2-304-2.

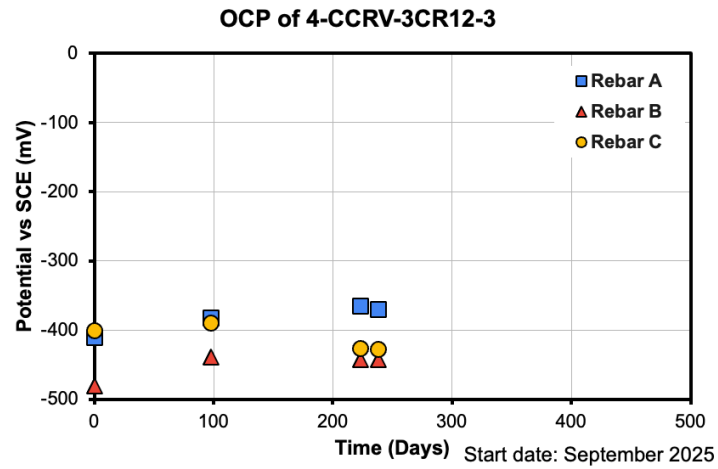
Two examples of open circuit potentials (i.e. corrosion potentials) vs. time as measured by the GP method are shown in Figure 3-66 and Figure 3-67. Sample 4-CCRV-3CR12-3 is presented first, demonstrating active corrosion with open circuit potentials averaging more negative than  $-380 \text{ mV}_{\text{SCE}}$  ( $-453 \text{ mV}_{\text{CSE}}$ ). Sample 6-STD2-304-2 is presented next, with open circuit potentials ranging between about  $-120 \text{ mV}_{\text{SCE}}$  ( $-193 \text{ mV}_{\text{CSE}}$ ) and  $-10 \text{ mV}_{\text{SCE}}$  ( $-83 \text{ mV}_{\text{CSE}}$ ). The open circuit potentials of most samples as measured with the GP method are comparable to their corrosion potentials as measured with the Gecor 8, after converting SCE to CSE.

Figure 3-66. Open circuit potential vs. time for 4-CCRV-3CR12-3.

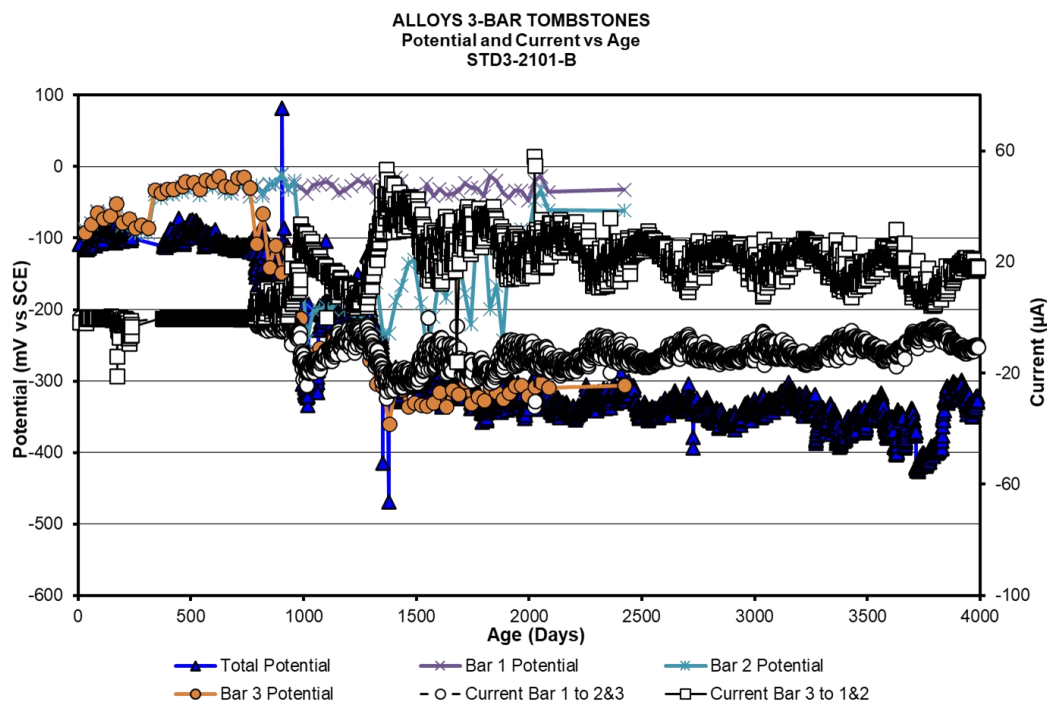
All new set Tombstone samples with 2101LDX rebar have total average rebar potential more negative than  $-350 \text{ mV}_{\text{SCE}}$ . For the new set of Tombstone samples with 2101LDX rebars, the total potential transitioned to  $-300 \text{ mV}_{\text{SCE}}$  (total/interconnected) or more negative between 1000 and 1400 days for samples A, B and E. The rebars in sample 2101-C transitioned to  $\sim -300 \text{ mV}_{\text{SCE}}$  after 3000 days and rebars in sample D transitioned to active values at around 200 days. All samples have reached total rebar potential of around  $-400 \text{ mV}_{\text{SCE}}$ . The measured macro-cell current values are less than  $50 \text{ } \mu\text{A}$  for most rebars (except sample E rebar 3 to 1&2 with a value of  $-70 \text{ } \mu\text{A}$ ). Figure 4-8 shows the total rebar potential and current measured on sample STD3-2101-B. In this sample, Bar 3 is the rebar that seems to drive the total potential value after Bar 3 transitioned to more negative rebar potential values. Before all rebars contributed to the total potential value (i.e., all rebars had similar noble potential), Rebar 3 activated first for samples A and B, Rebar 2 activated first for samples C and D and Rebar 1 for sample E (but Rebar 2 became active soon after). Sample STD3-2101-B was the sample selected for termination.

Figure 4-8. Potential and current vs. Age measured on Tombstone sample STD3-2101-B.

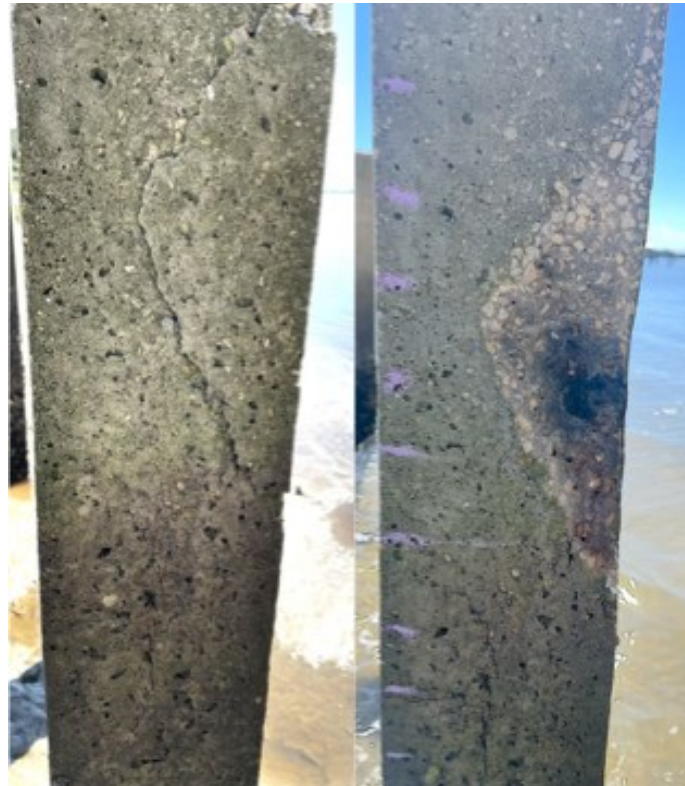
Column 2101-C north face experienced spalling due to corrosion of the reinforcement between the October 2024 and September 2025 visits. A large crack was visible in October 2024, as shown in Figure 5-10 on the left. By September 2025, the concrete had spalled in the same location, exposing corrosion products from the embedded rebar, as seen in Figure 5-10 on the right.

Figure 5-10. Picture showing north face of 2101-C in October 2024 (left) and September 2025 (right).

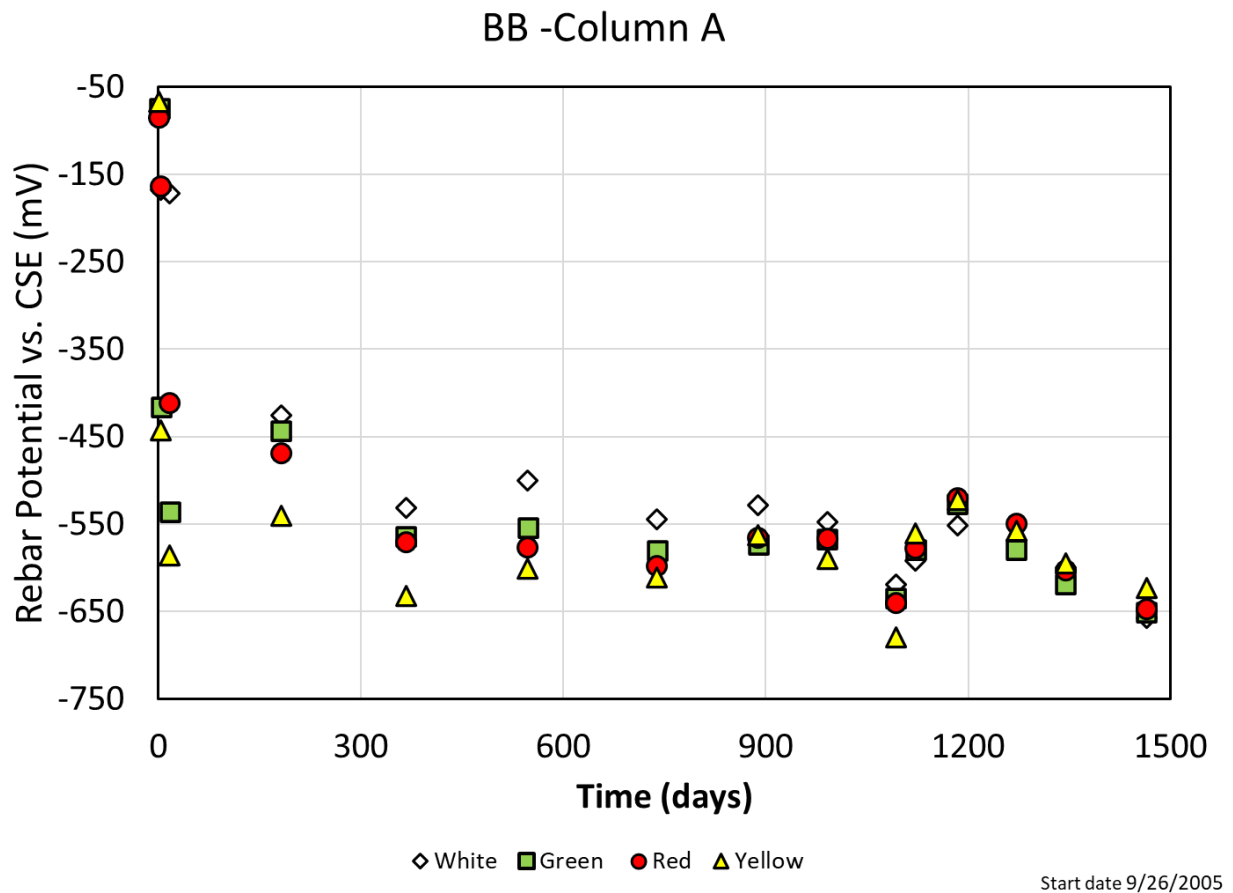
This section presents rebar potential vs. time for selected columns. The plots were prepared from the data provided by FDOT-SMO. Figure 5-11 shows column BB-A, with conventional black rebar. All rebars show potential values more negative than  $-400 \text{ mV}_{\text{CSE}}$ , this in part could be due to the low oxygen availability for the section on the ground that likely is wet most of the time. Figure 5-12 shows the rebar potential evolution for column MMFX-Column A. Similar transition to values more negative than  $-400 \text{ mV}_{\text{CSE}}$  are also observed. Figure 5-13 shows how the 2101 rebar potential evolved, in this case the transition to values more negative than  $-400 \text{ mV}_{\text{CSE}}$  were observed after 500 days. Figure 5-14 shows how the 3CR12 rebars embedded in column C evolved with time. The rebar potential reach values as negative as  $-500 \text{ mV}_{\text{CSE}}$  within a short period of time. LPR measurements not included in here indicated that the corrosion rate was moderate during the period shown. Figure 5-15 shows column A with 304 rebars, the rebar potential in this column ranged between  $-200 \text{ mV}_{\text{CSE}}$  and  $-100 \text{ mV}_{\text{CSE}}$ . Figure 5-16 (Column A)

Figure 5-11. Plot showing the potential evolution for black bars embedded in BB column A.

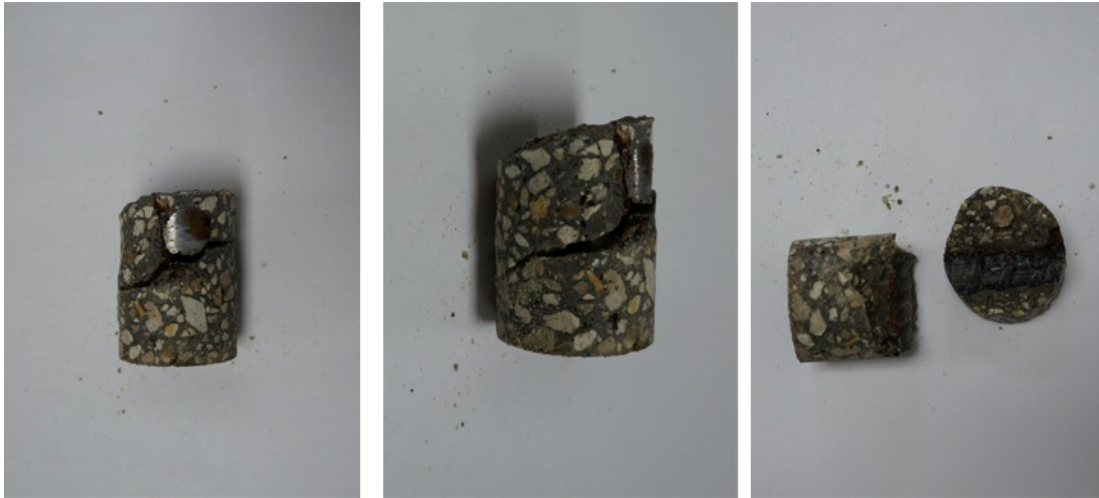
Selected columns with 3CR12, MMFX and 2101 rebars were cored. Cores were obtained from columns MMFX-A (Figure 5-29), 2101-A with the core obtained ~ 20 inches above the water line, (see Figure 5-30), 2101-B with the core obtained ~6 inches below the water line (Figure 5-31). These three cores had rebar segments that were later cleaned to assess corrosion extent.

Figure 5-29. Images show the core obtained from column MMFX-1. It included a rebar segment.

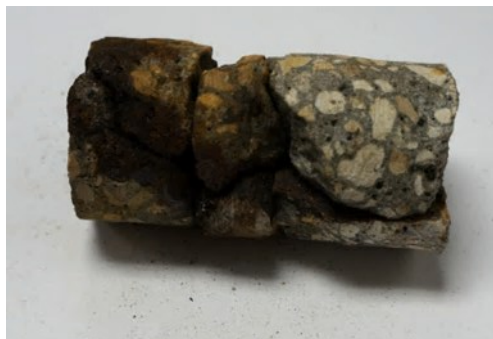
Figure 5-30. Image shows the core obtained from column 2101-A (~20 inches above WL).

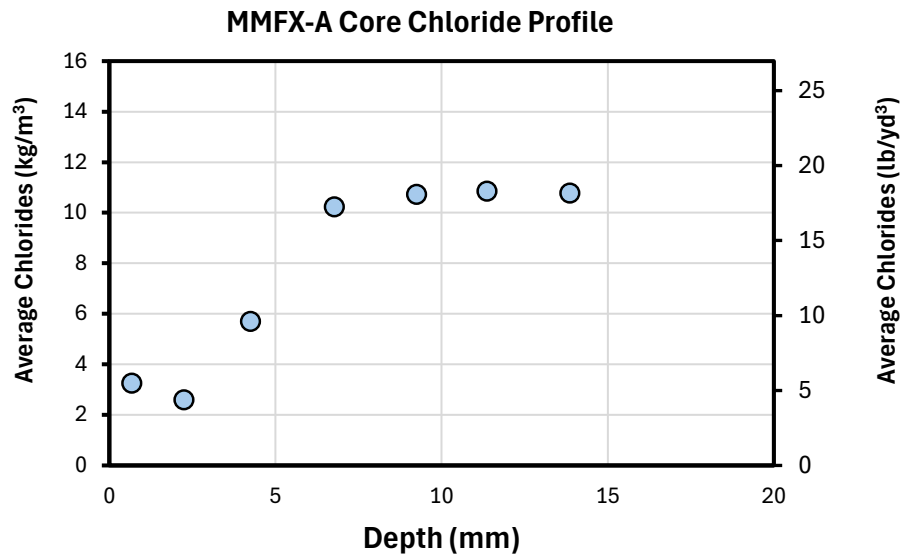
Figure 5-34. MMFX-A Core Chloride Profile.

Figure 5-34 and Figure 5-35 depict chloride profiles for one of the MMFX columns. Both profiles correspond to millings obtained from a concrete core. Figure 5-34 shows the profile from the column surface, whereas Figure 5-35 shows how the chloride evolved behind the rebar (rebar trace). Note that the chloride concentration at the rebar depth is two to three times the  $C_T$  reported by Trejo [15].

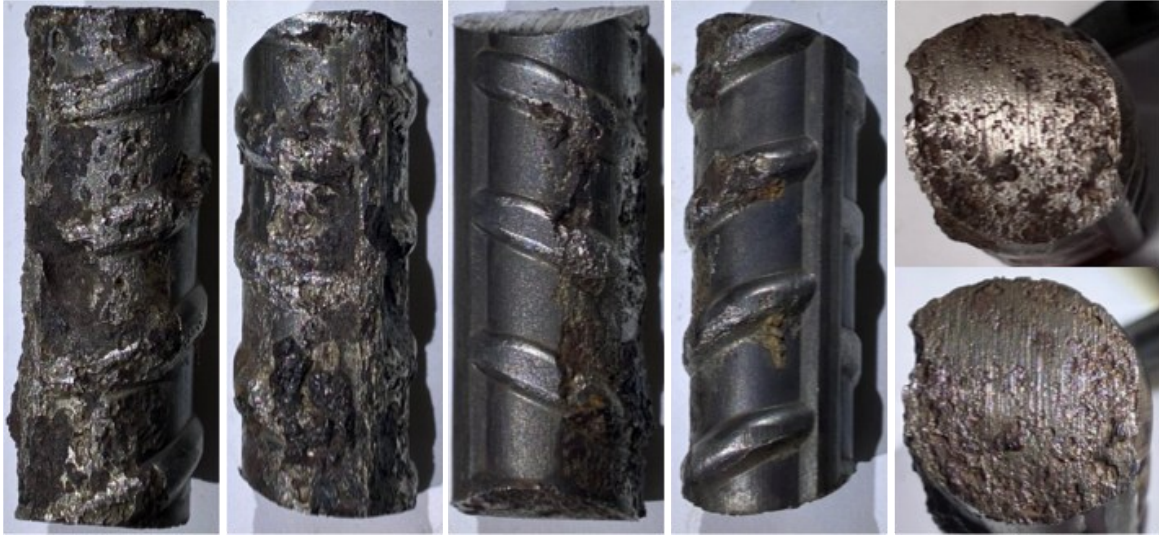
Deliverable 3 included images of the rebars segments before and after cleaning. Figure 5-45, Figure 5-47, and Figure 5-49 show images of the MMFX rebar section, the 2101 Column A rebar section, and the 2101 Column B rebar section, respectively, after additional immersion time in the cleaning solution. Figure 5-46, Figure 5-48, and Figure 5-50 show close-up image(s) of the MMFX rebar section, the 2101 Column A rebar section, and the 2101 Column B rebar section, respectively, for the areas with more significant cross section loss.

Figure 5-45. MMFX rebar section after additional immersion in cleaning solution.

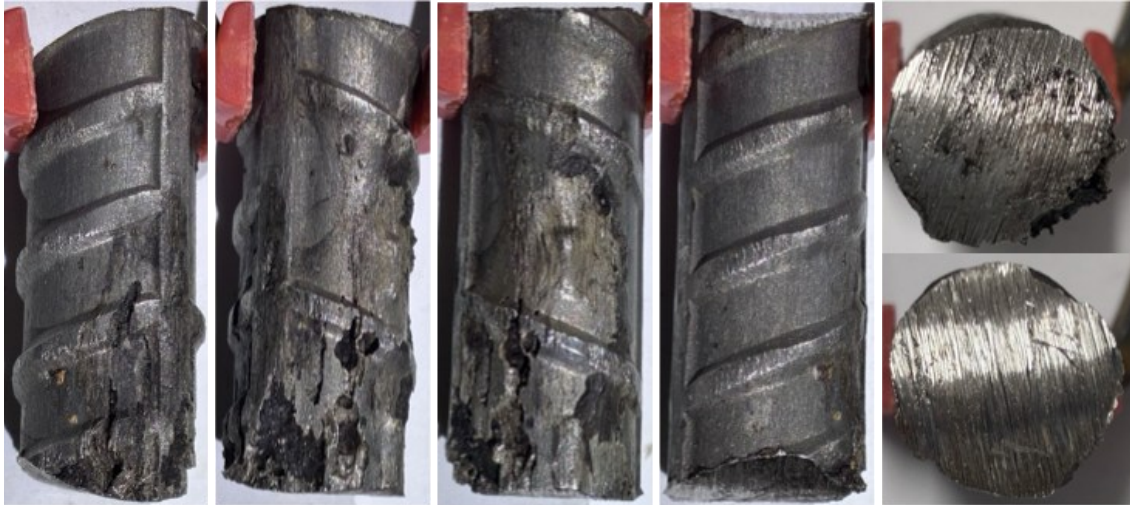
Figure 5-47. 2101 rebar section (Column A) after additional immersion in cleaning solution.

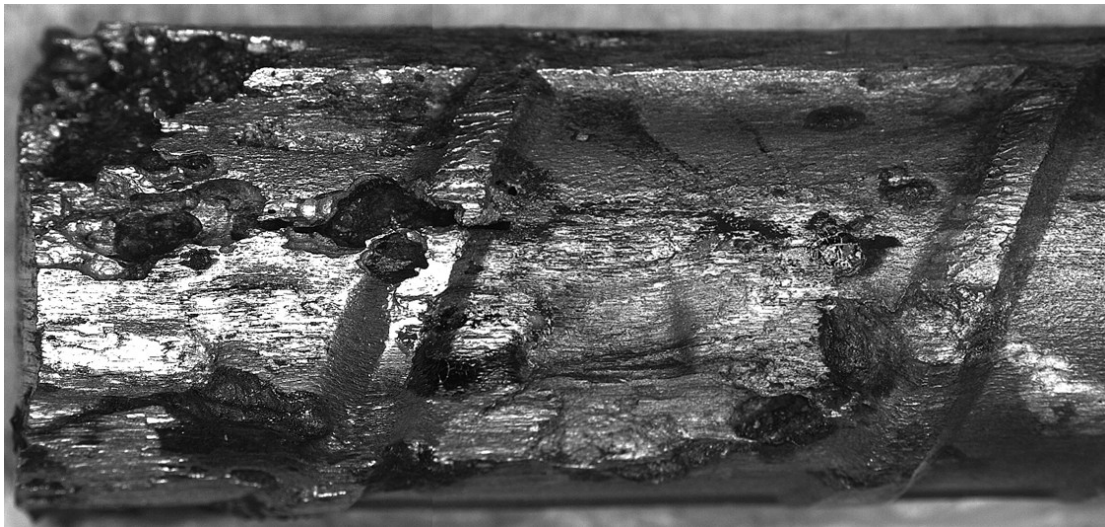
Figure 5-48. 2101 (Column A) rebar section close-up of the region with most corrosion.

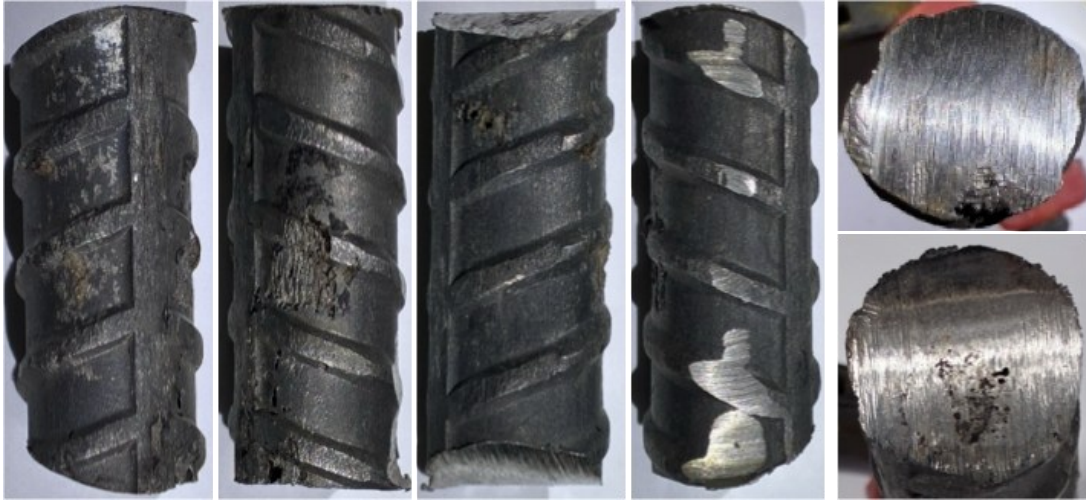
Figure 5-49. 2101 rebar section (Column B) after additional immersion in cleaning solution.

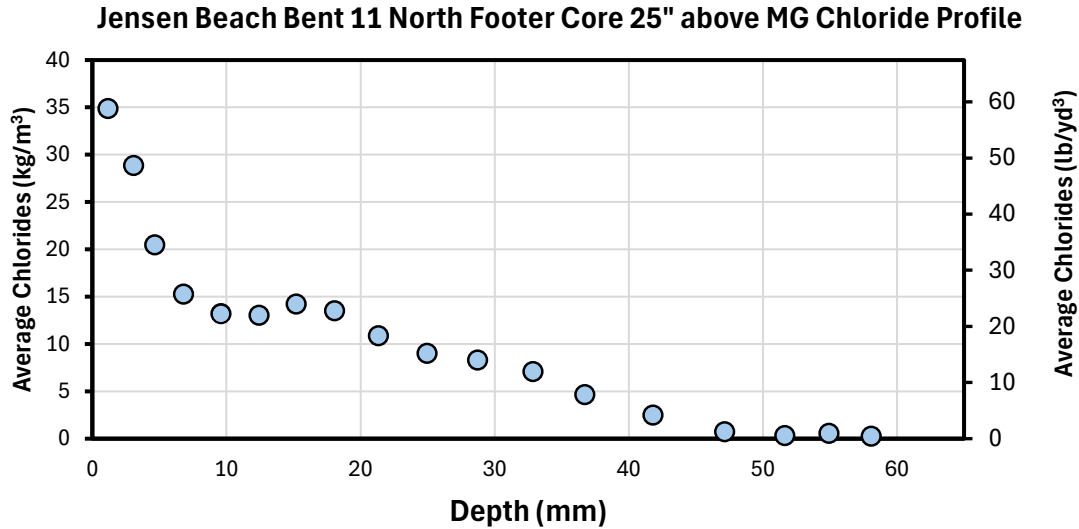
Figure 6-16. Chloride profile of Jensen Beach bent 11 north footer core (25" above marine growth).

Figure 6-16 and Figure 6-17 reveal that the chloride concentration decreased significantly faster with depth for the north footer core 25 inches above the marine growth compared to the core from the same footer 5 inches above the marine growth. As Figure 6-17 demonstrates, the chloride concentration for the core 5 inches above the marine growth hovers consistently near 30 kg/m<sup>3</sup> for the first 10 mm. This is likely because the area closer to the marine growth remains submerged or wet for longer periods of time, resulting in a higher chloride surface concentration that then appears to have penetrated about 10 mm. On the other hand, because the area at the

higher elevation experiences more wetting and drying cycles, the chloride surface concentration is higher, and thus Figure 6-16 shows that the concentration decreases by over half in the same depth range of 0 mm to 10 mm. There appears to be a local maximum at 15 mm depth.

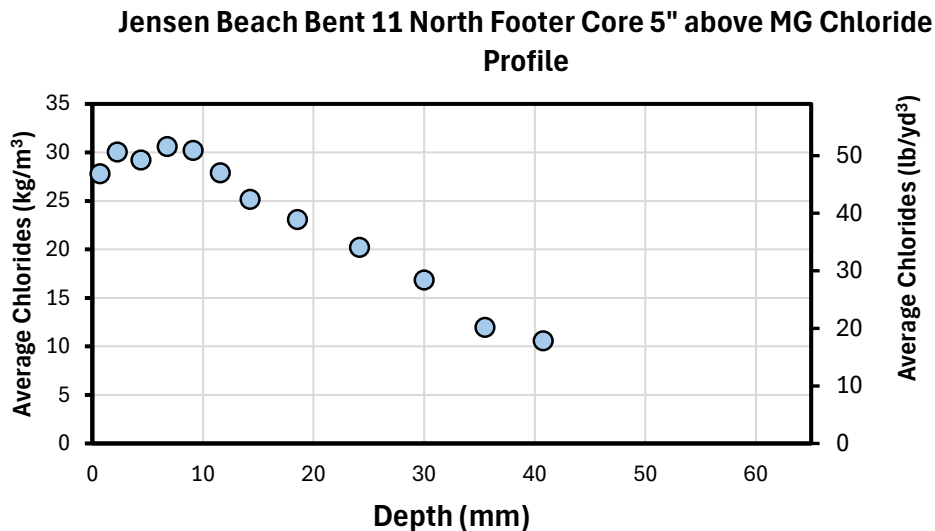
Figure 6-17. Chloride profile - Jensen Beach bent 11 north footer core (5" above marine growth).

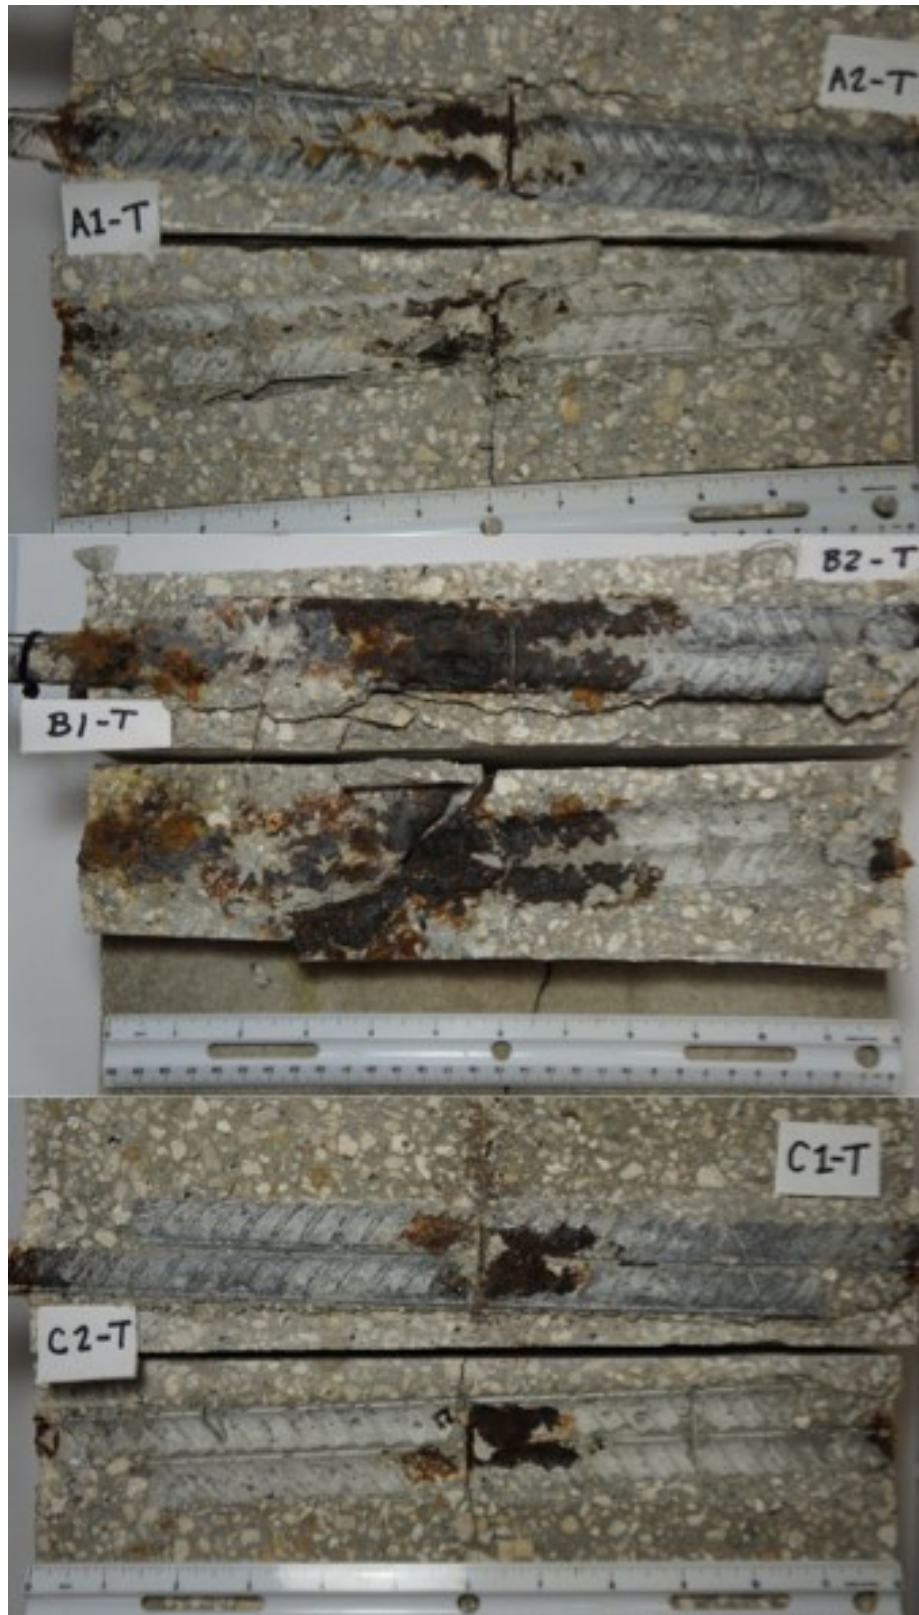
This section presents photos of sample 4-CCRV-3CR12-2 immediately after termination, including each rebar and its rebar trace in the concrete. Figure 7-1 presents the top-facing side of the top row of rebars while Figure 7-2 shows the bottom-facing side of the top row. Because this sample had a simulated crevice, there are 6 rebars in the top row instead of 3. The top-facing side displayed the most severe corrosion, concentrated near the midpoint of the rebars. This is because the sample also had a simulated crack, which helped facilitate the initial chloride ingress. Red rust stains appear on both the concrete and the rebars. Extensive pitting and cross-section loss is present on the top-facing side of all the rebars in the top row, with rebars B1 and B2 having the most severe pits. As Figure 7-1 shows, the corrosion products that accumulated on rebars B1 and B2 caused a large crack inside the concrete. Figure 7-2 shows that no or very little corrosion is apparent on the bottom-facing sides of the rebars. As expected, corrosion was present at the exposed ends of each rebar (outside the concrete) in both the top and bottom rows.

Figure 7-1. 4-CCRV-3CR12-2 top row, top-facing rebars and concrete rebar traces.

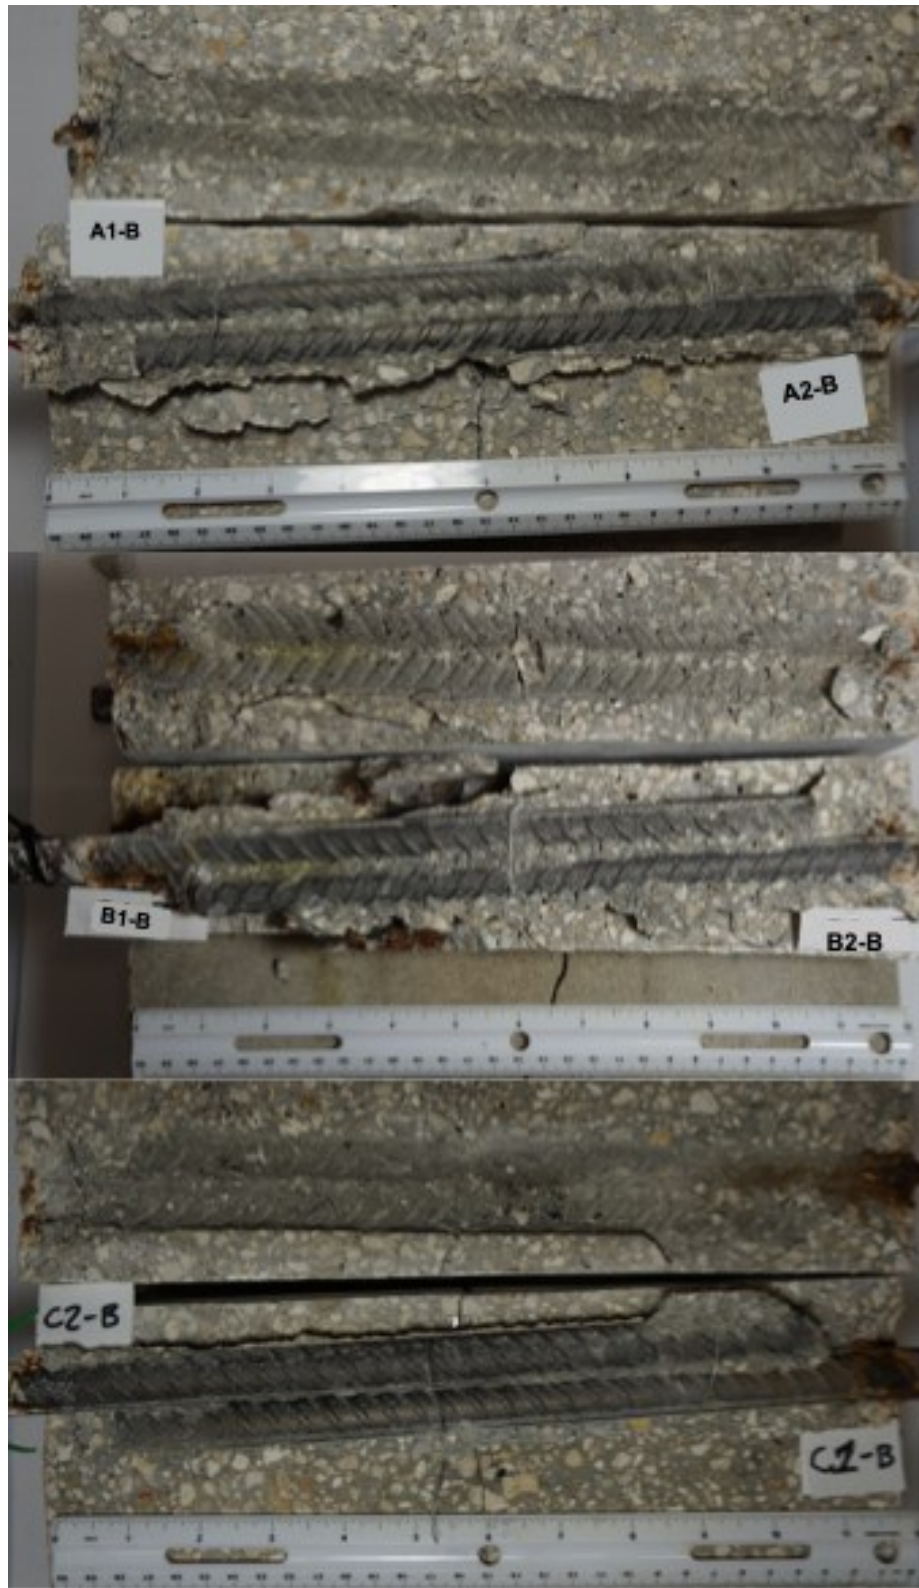
Figure 7-2. 4-CCRV-3CR12-2 top row, bottom-facing rebars and concrete rebar traces.
