## **Final Report**

Evaluation of Concrete Specimens Prepared with Corrosion Resistant  
Reinforcement after Long Term, Greater than 15 years, Outdoor and  
Laboratory Exposures

Contract Number – FDOT (BED27-977-04)  
FAU (AWD003253)

Submitted to  
Florida Department of Transportation  
Research Center  
605 Suwannee Street  
Tallahassee, Florida 32399

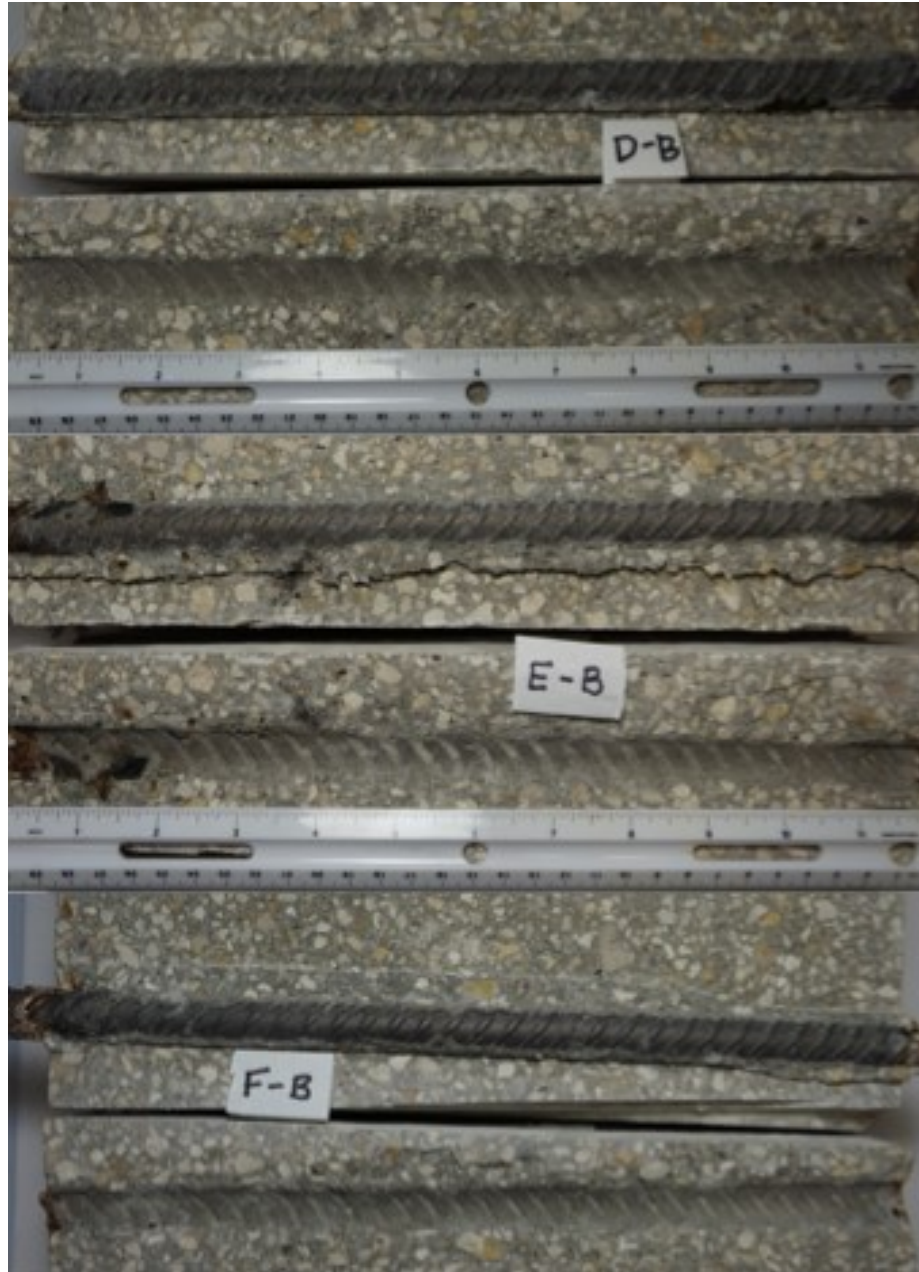
Figure 7-4. 4-CCRV-3CR12-2 bottom row, bottom-facing rebars and concrete rebar traces.

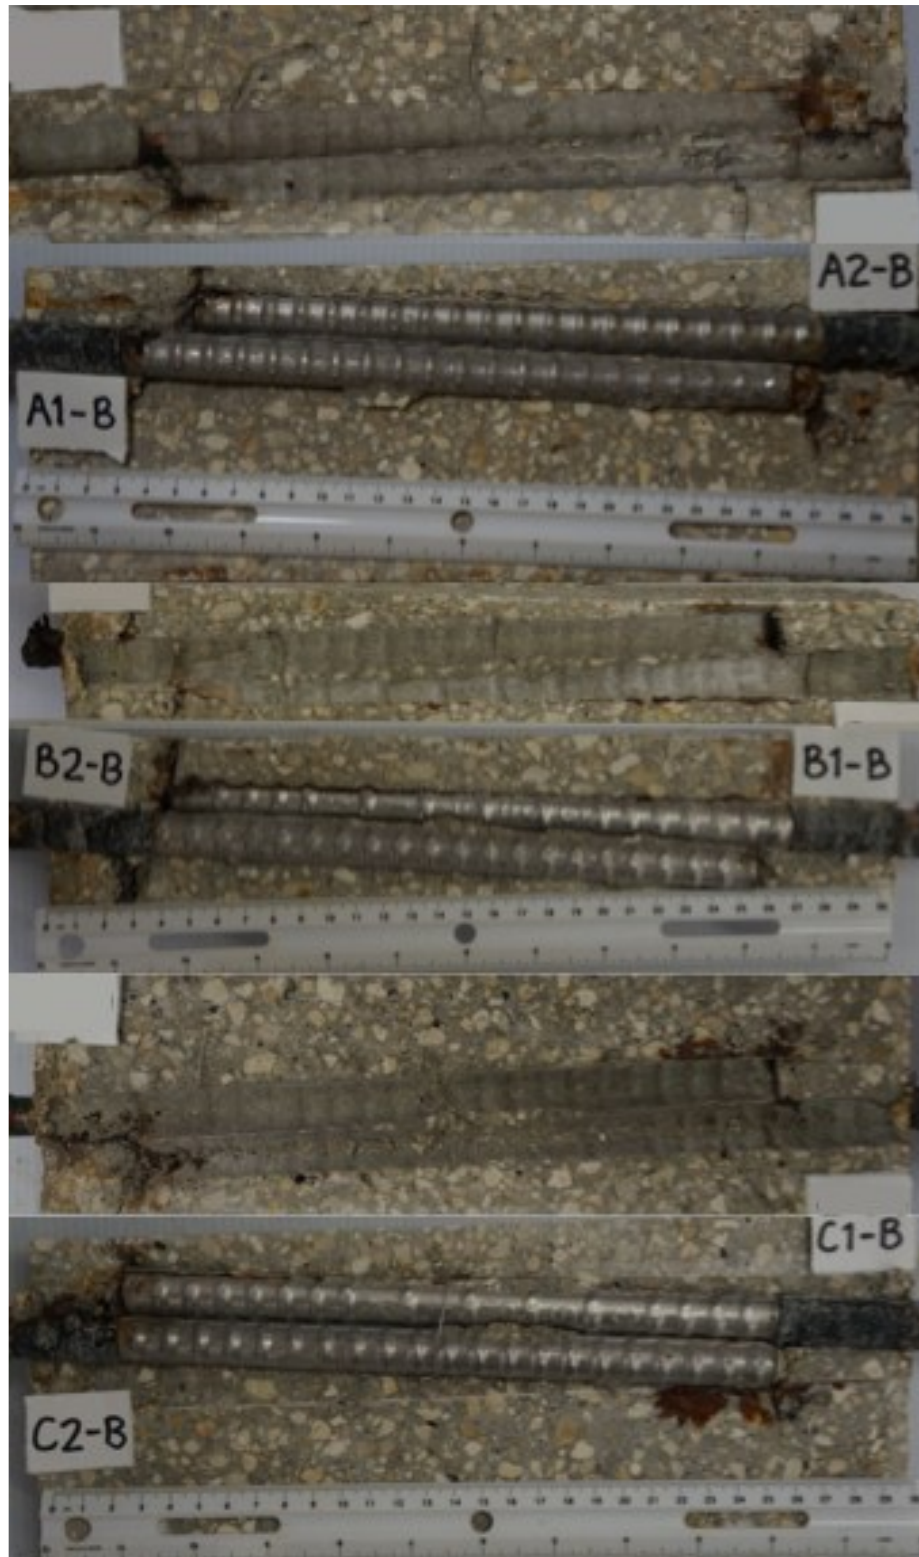
Figure 7-6. CREV-CT2-2 top row, bottom-facing rebars and concrete rebar traces.

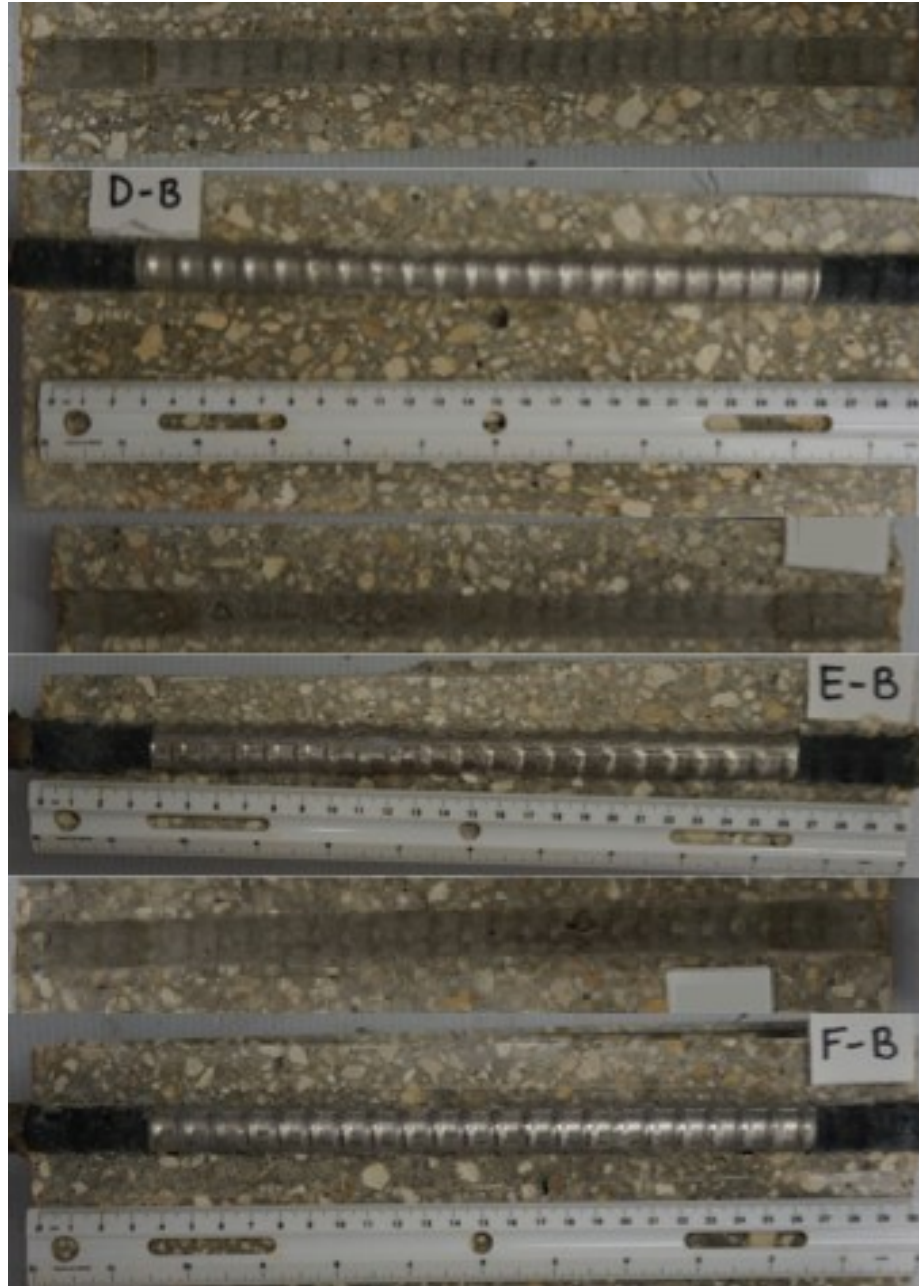
Figure 7-8. CREV-CT2-2 bottom row, bottom-facing rebars and concrete rebar traces.

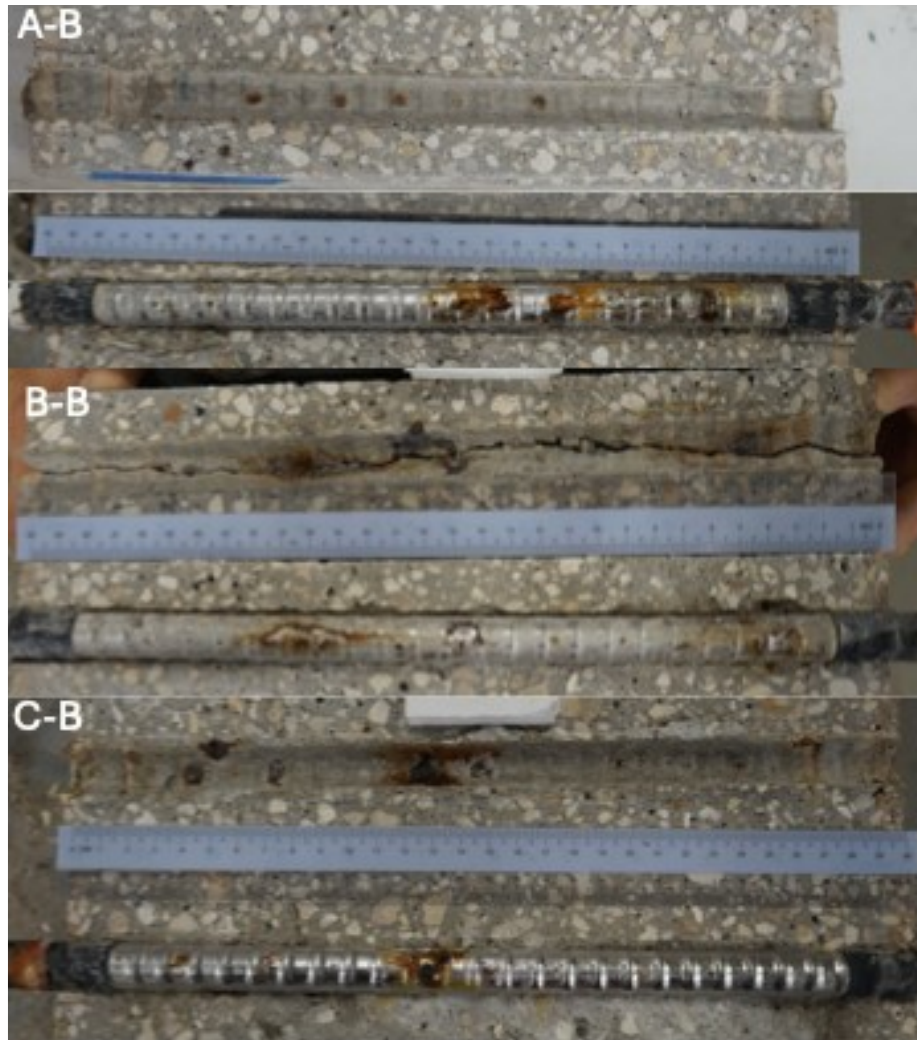
Figure 7-12. BCCD-CT2-1 bottom-facing, top rebars and concrete rebar traces.

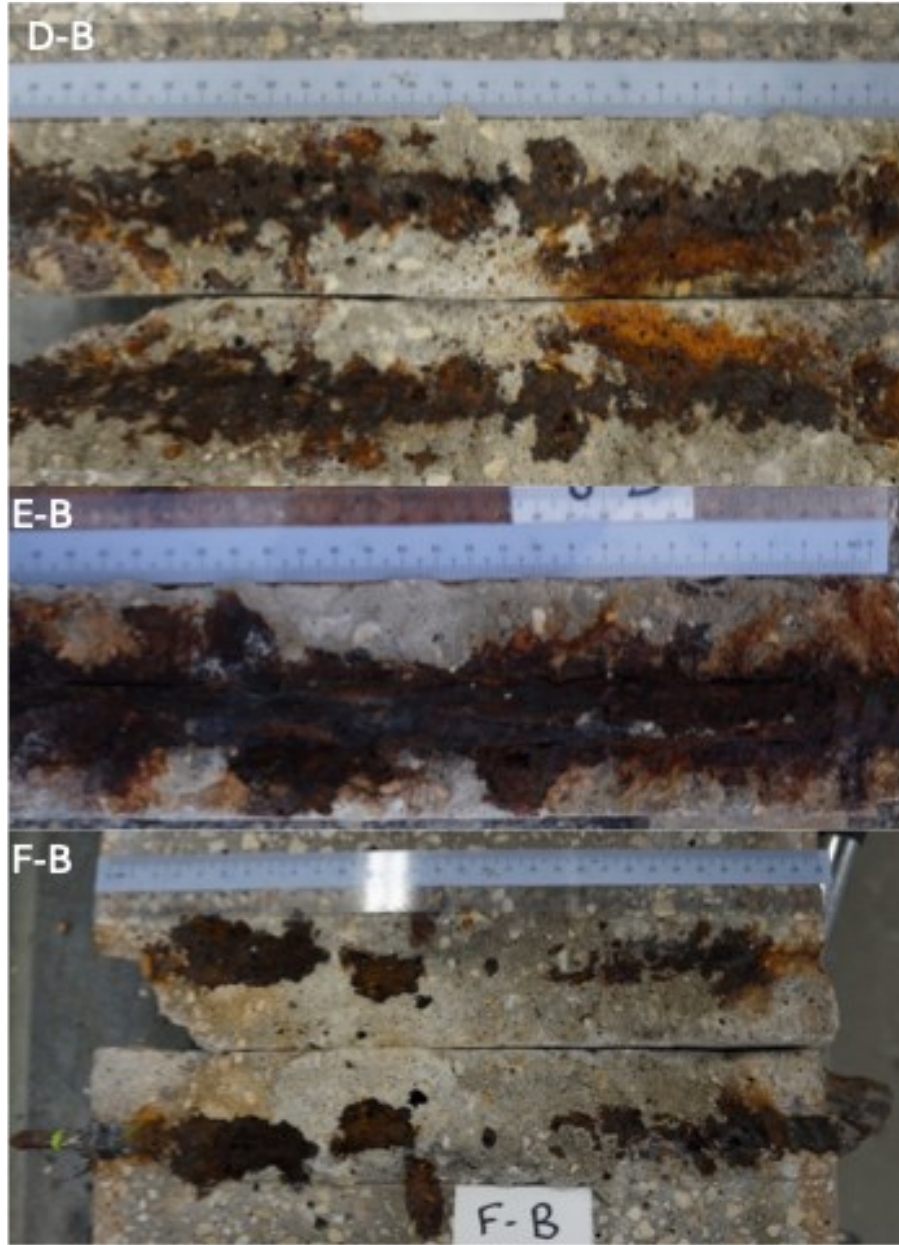
Figure 7-14. BCCD-CT2-1 bottom-facing, bottom rebars and concrete rebar traces.

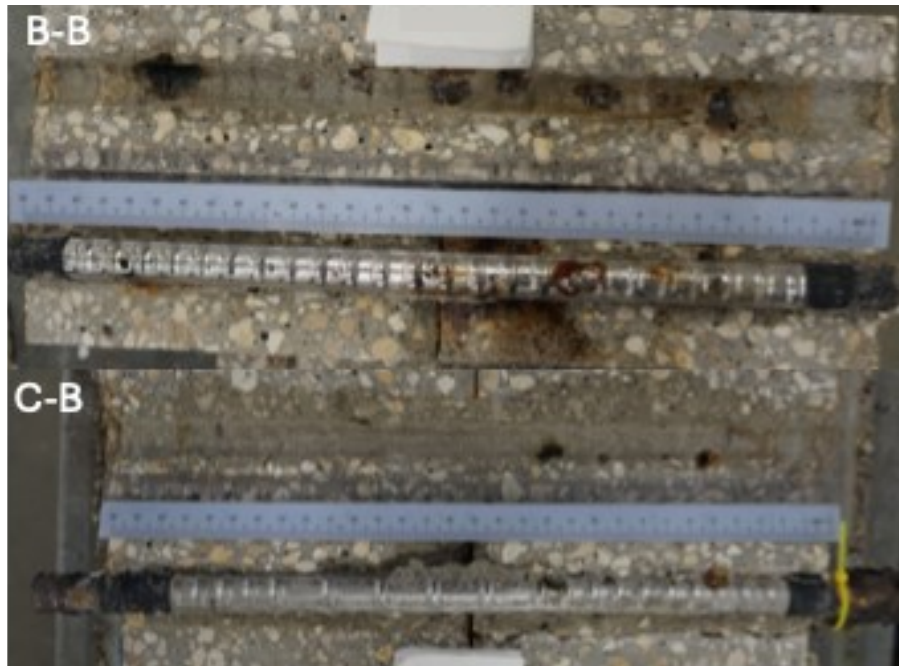
Figure 7-16. CSDB-CT2-1 bottom-facing, top rebars (excluding rebar A) and concrete rebar traces.

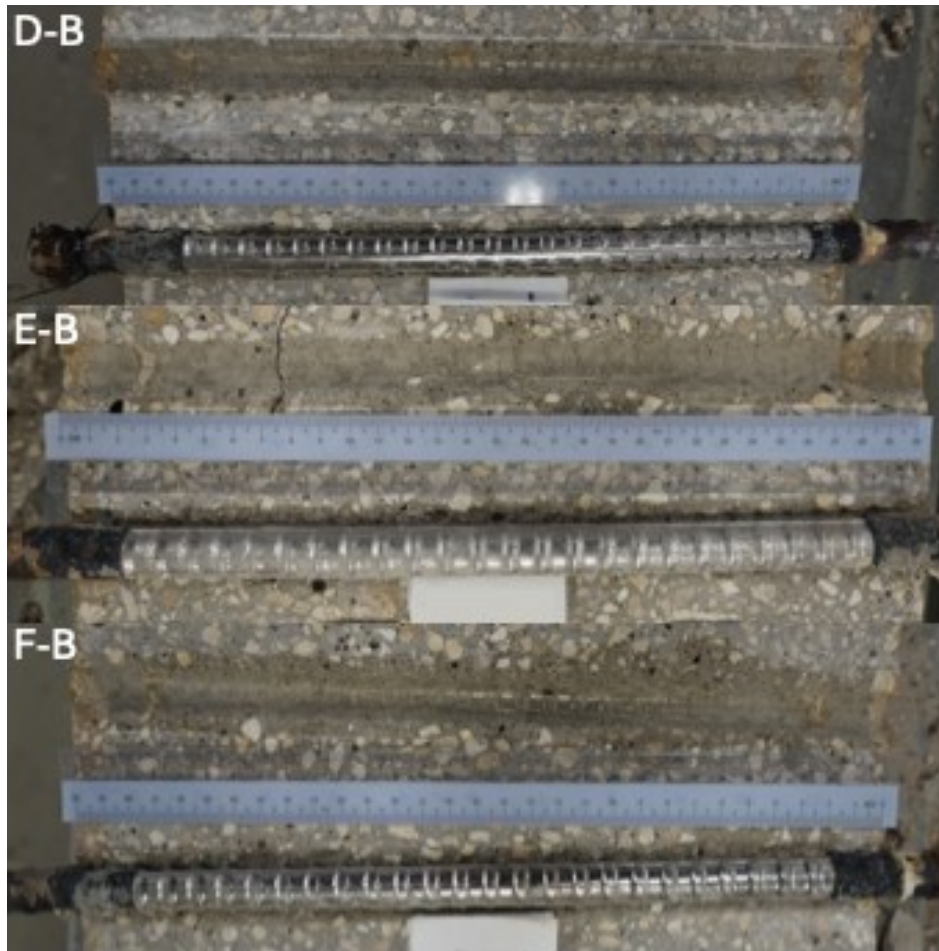
Figure 7-18. CSDB-CT2-1 bottom-facing, bottom rebars and concrete rebar traces.

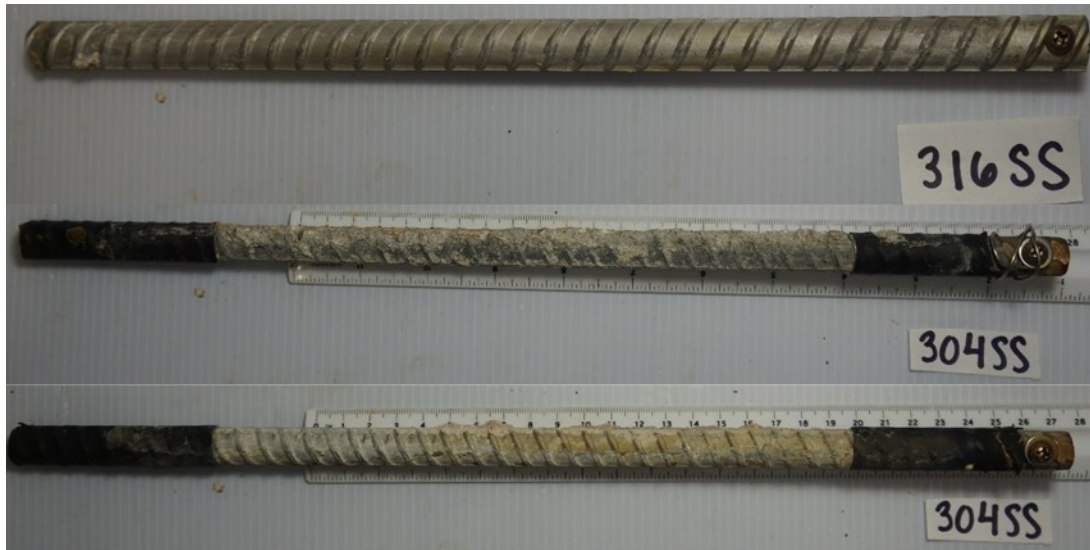
In addition, one 316 rebar and two 304 rebars were obtained from samples not described above. The 304 and 316 rebars were obtained from SDS samples that had black carbon steel rebars in the second row and that caused the concrete to crack in the upward direction, allowing these rebars to be removed. Images documenting the corrosion extent in the 316, and 304 rebars are included in this section. Figure 7-19 shows one 316 rebar and two 304 rebars. The 316 rebar showed no corrosion and the two 304 rebars still had some concrete paste attached to them. The images are of the top side. Figure 7-20 shows an image of the bottom side for one of the 304 rebars. Figure 7-21 shows a close-up of the only red rust (pit) observed on the 316 rebar. It is possible that the pits developed after the concrete surrounding them had cracked. Figure 7-22 shows close-ups for the 304 rebars; there were a few small pits that might have formed after the concrete had completely separated due to the crack caused by the bottom carbon steel rebars.

Figure 7-19. Images of one 316 SS rebar and two 304 SS rebars before cleaning.

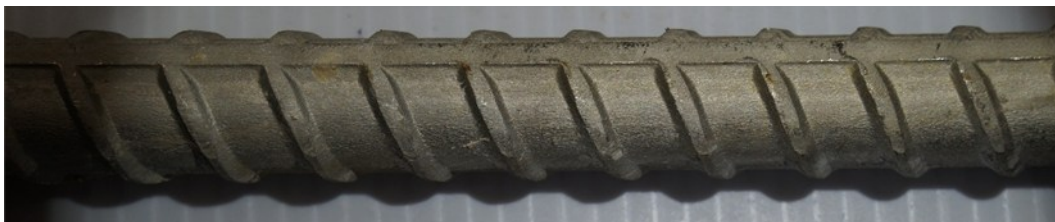
Figure 7-21. Closeups of pitting corrosion on 316SS rebar.

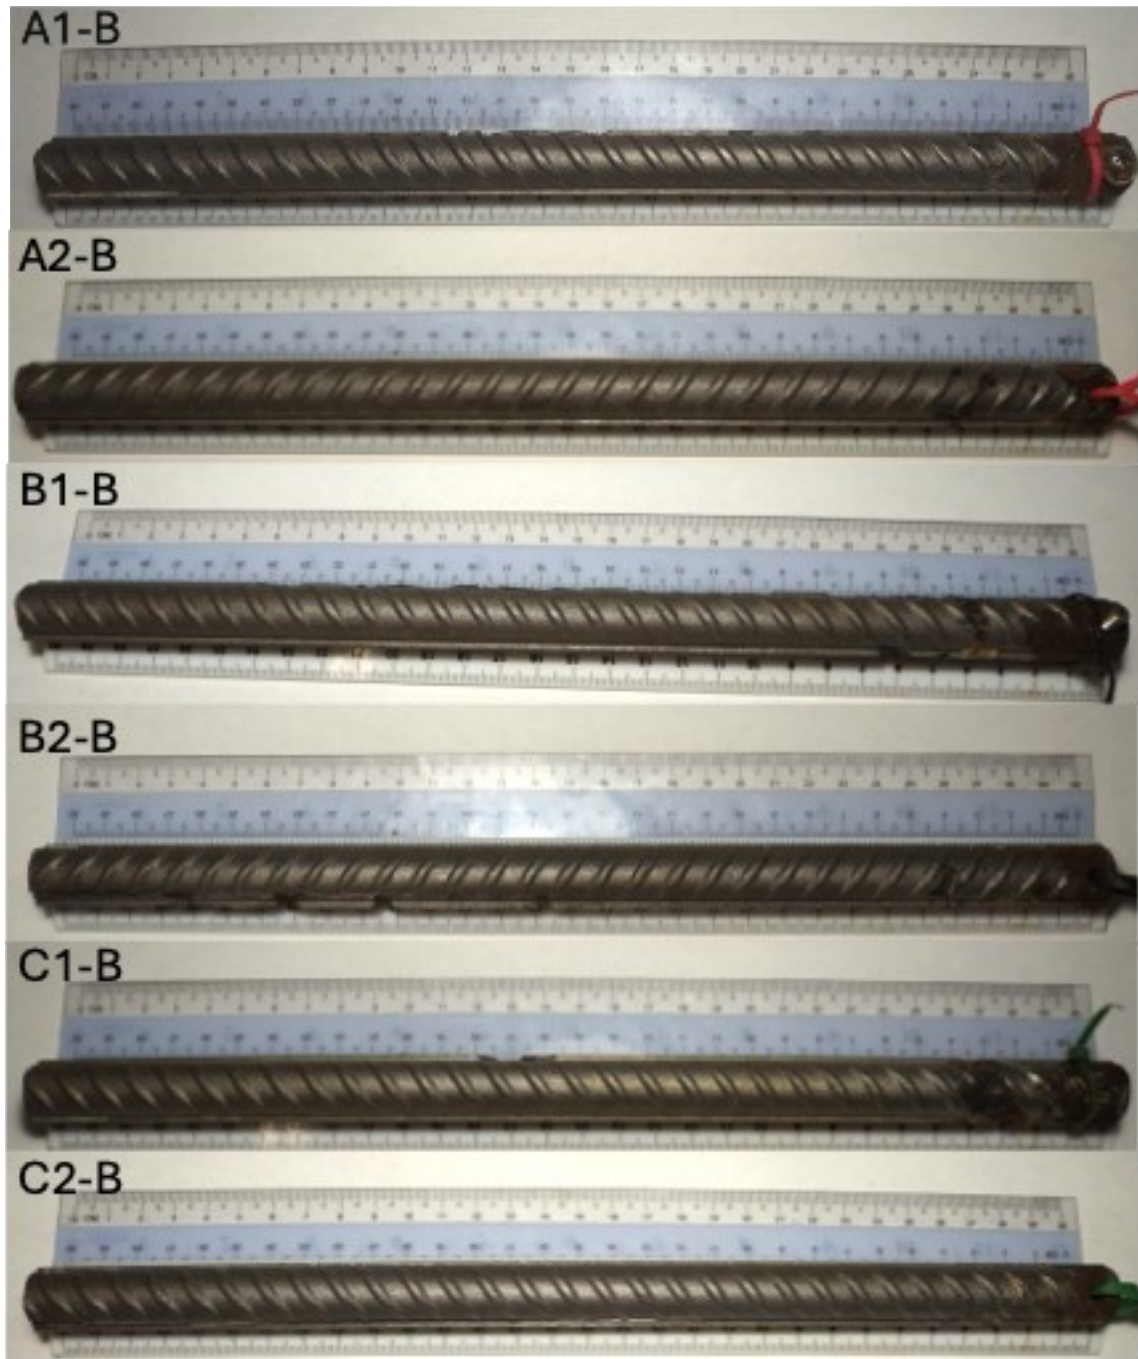
Figure 7-24. 4-CCRV-3CR12-2 top row, bottom-facing rebars after cleaning.

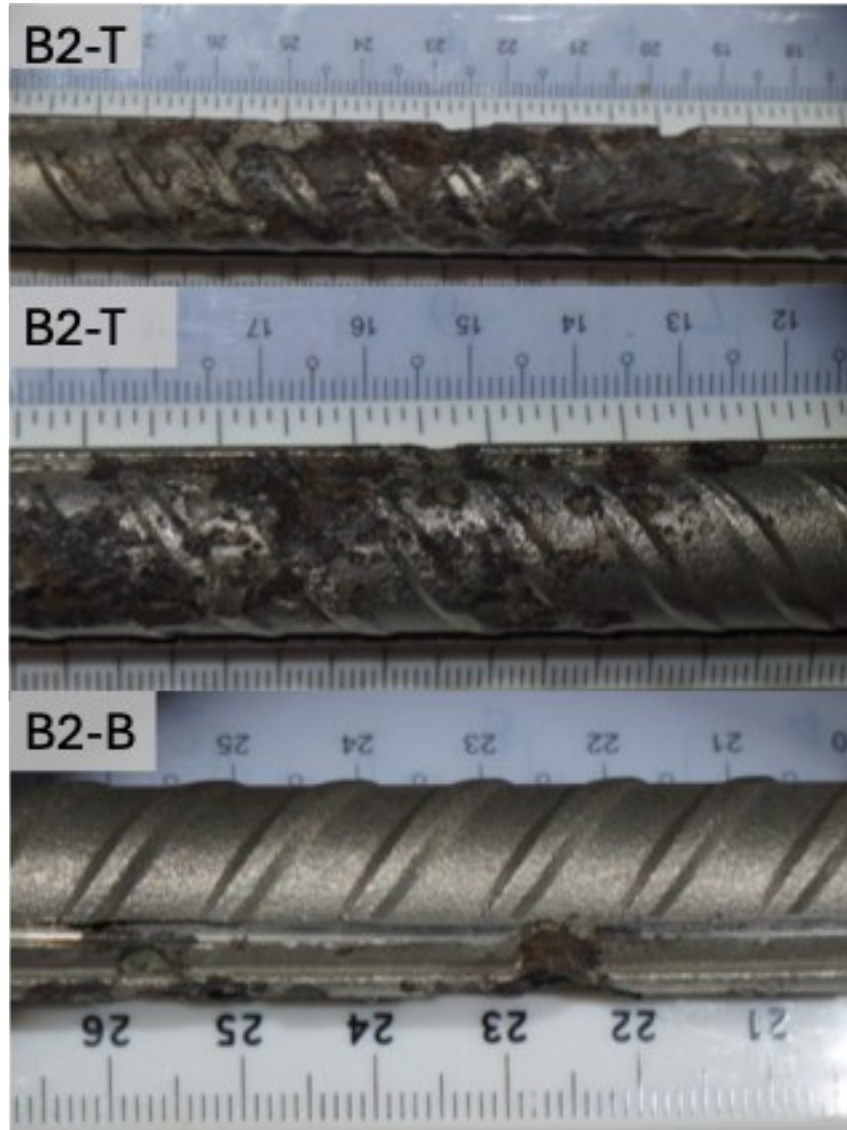
Figure 7-29. Rebar B2 closeups (top and bottom).

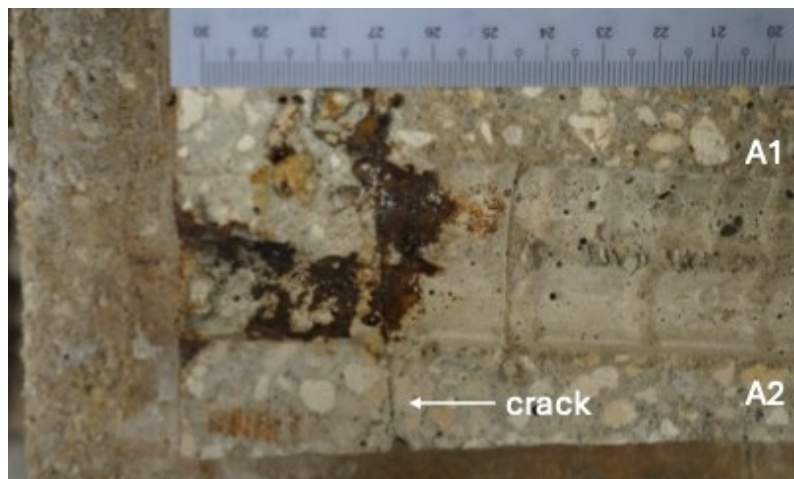
Figure 7-33. Concrete crack near rebar A2, likely caused by corrosion from rebar B1.

Figure 7-35 and Figure 7-36 show closeups of the rebar ends, after cleaning, that caused the cracks. Figure 7-35 shows the embedded, unclad end of rebar B1 which caused the crack shown in Figure 7-32 and likely caused the crack near rebar A2 in Figure 7-33. The loss of cross section due to corrosion at the end of rebar B1 extended 6 mm deep, as noted in Table 11-12. Figure 7-36 shows the embedded, unclad end of rebar C1 which caused the crack shown in Figure 7-35. The loss of cross section due to corrosion at the end of rebar C1 was less extensive than that of B1; the penetration depth was approximately 3.5 mm, as noted in Table 11-12.

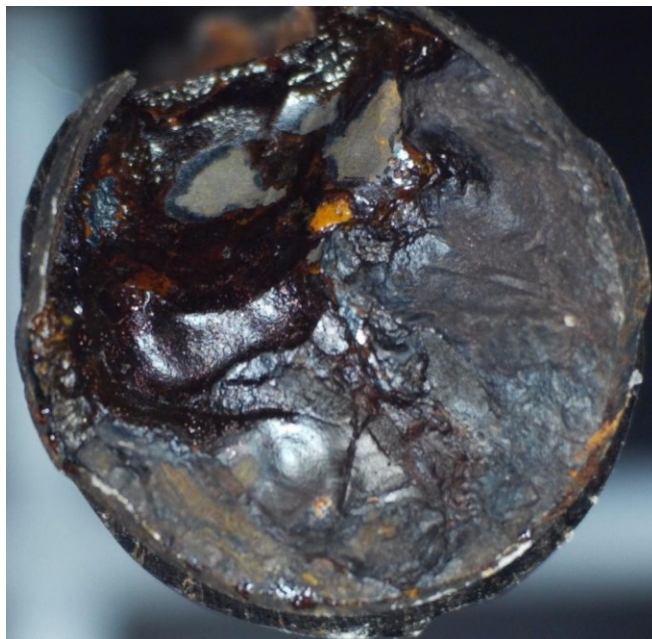
Figure 7-35. Corrosion of unclad, embedded rebar end of rebar B1 after cleaning.

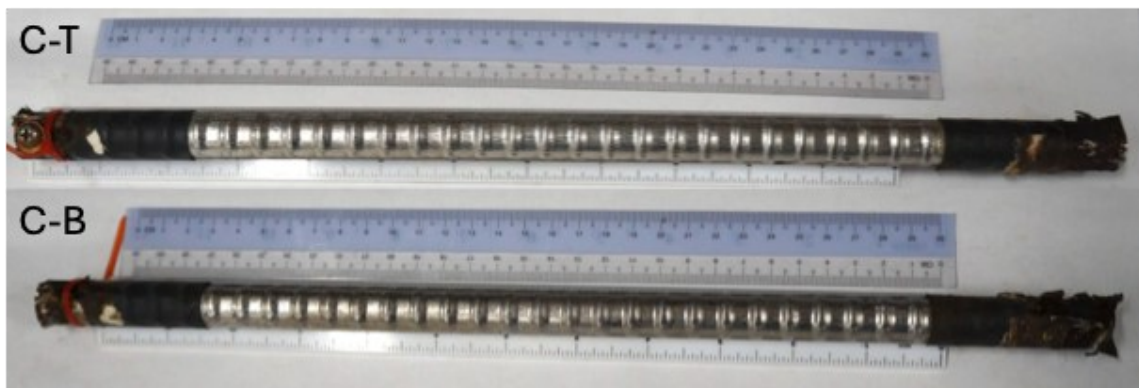
This section presents photos of rebar C from sample 4-CCON-CT2-1 after cleaning. The rebars (rebar F not shown) were cleaned using the same way explained in the methodology. Figure 7-37 presents both sides of rebar C while Figure 7-38 depicts a closeup photo of several shallow red rust pits in the cladding in top face of rebar C. The original damage to the rebar likely occurred during the preparation of the rebar when the cladding was being clamped on around the carbon steel core of the rebar. It is likely there was a small holiday. Residual stresses from this process likely resulted in weak spots in the cladding, possibly facilitating the mild corrosion depicted in Figure 7-38 during the sample's exposure period. The damage extends about 1.5 cm along the length of the rebar, with a maximum diameter loss of approximately 0.19 mm.

Figure 7-37. Both sides of 4-CCON-CT2-1 rebar C.

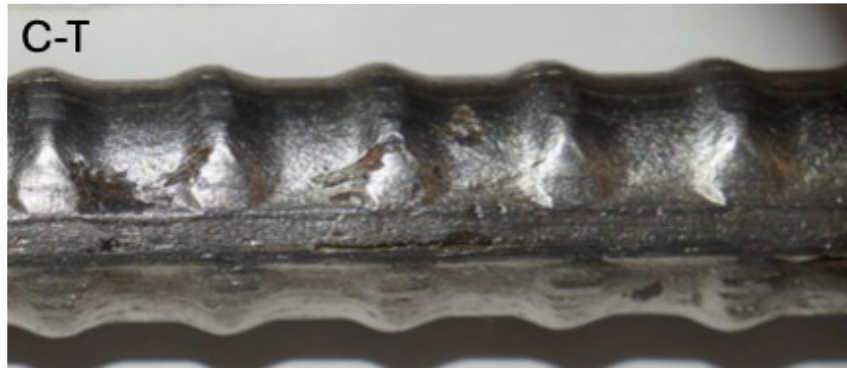
Figure 7-38. Closeup of pits on cladding, top face of 4-CCON-CT2-1 rebar C.

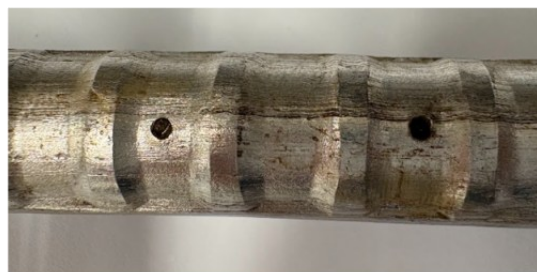
The top sides of rebars A, B, and C were examined first. Rebar A, shown in Figure 7-39, did not show significant signs of corrosion along the top side after cleaning. The two deepest holes on the top side of rebar A were holes 1 at 3 millimeters and hole 9 at 5.2 millimeters, which are shown in Figure 7-40 and Figure 7-41. Hole 9 shows an initial smaller diameter closer to the surface, and it becomes larger towards the bottom of the hole, while hole 1 was uniform in diameter throughout.

Figure 7-39. Top side of rebar A and select segments of sample BCCD-CT2-1.

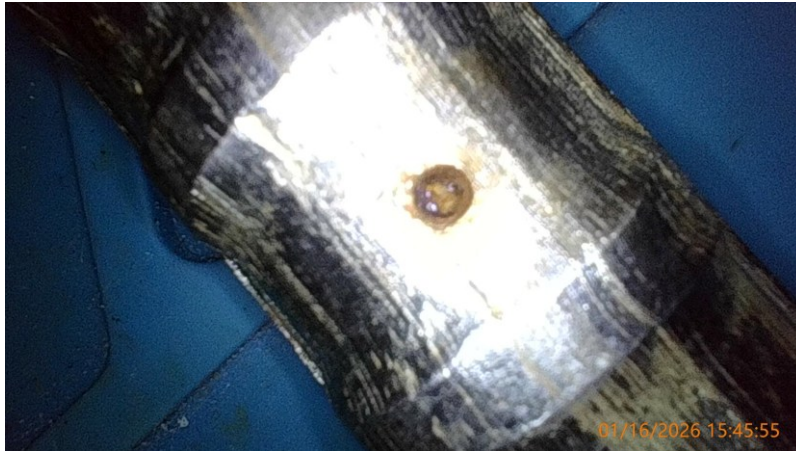
Figure 7-41. Hole 9 on top side of rebar A of sample BCCD-CT2-1.

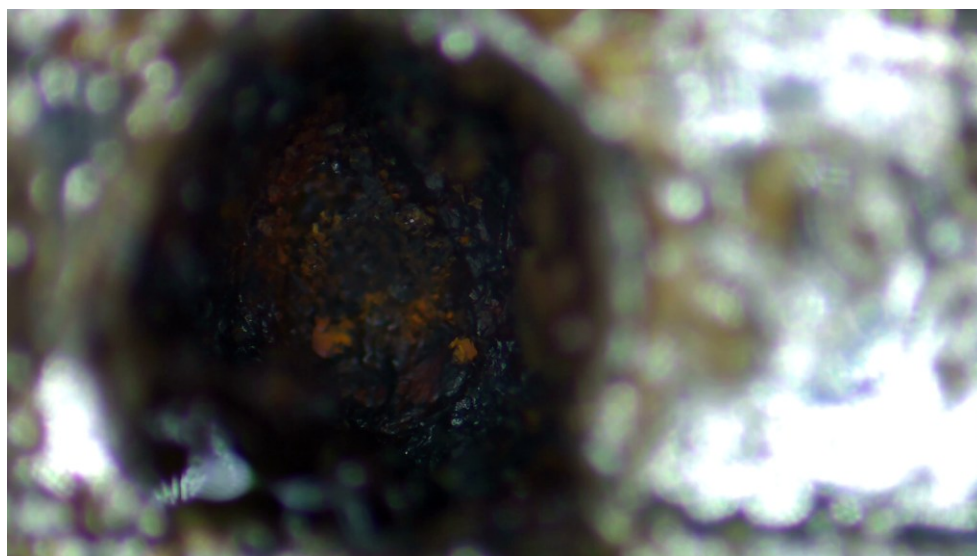
Figure 7-45 shows the top side of rebar C. There was some corrosion throughout the middle of the surface from holes 1 to 7. Holes 1 and 2 were also slightly deformed. The holes on the top side of rebar C did not have large depths, and the largest one was hole 2 at 1.2 millimeters, which is shown in Figure 7-46. This side had several bumps with cracks in them along the holes. Hole 3 is an example shown in Figure 7-47.

Figure 7-46. Hole 2 on top side of rebar C of sample BCCD-CT2-1.

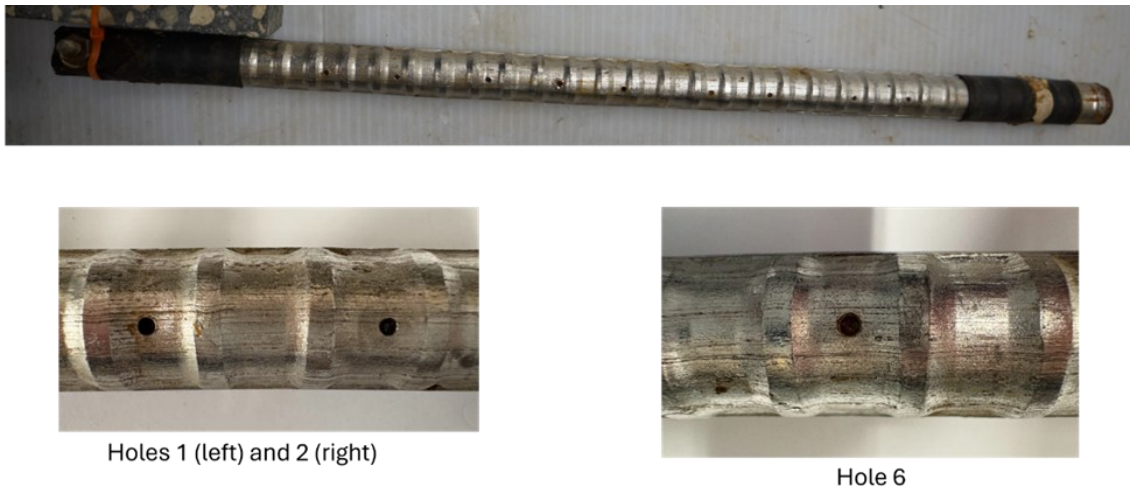
The bottom sides of each top rebar in sample BCCD-CT2-1 are analyzed in the following section. Overall, the amount of corrosion products on these sides was less than the top sides after cleaning. The bottom side of rebar A in Figure 7-48 did not show major signs of corrosion after it was cleaned, with only some spots left over. The only hole that had a major depth was hole 5 at 3.3 millimeters, which is shown in Figure 7-49. It is important to note that this hole had a relatively uniform diameter throughout, unlike some other rebars. Hole 9 had a slight bump beneath the hole as well, which is visible in Figure 7-48.

Figure 7-48. Bottom side of rebar A and select segments of sample BCCD-CT2-1.

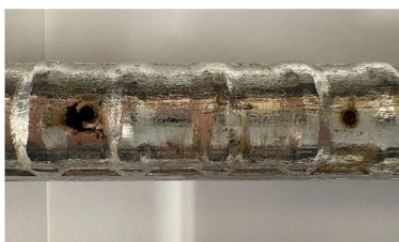
The bottom side of rebar C in Figure 7-52 had a hole deformation that occurred on hole 6 and slightly on hole 7. This side also had relatively shallow holes. The two deepest holes were 4 and 6 both at 2.2 millimeters. Figure 7-53 and Figure 7-54 show that holes 4 and 6 could also be subject to pitting corrosion, as the hole shape is irregular and changes at different depths. There were slight bumps beneath a few holes, and remnants of a bump around hole 6, which seemed to have broken from corrosion that occurred inside of it.

Figure 7-52. Bottom side of rebar C and select segments of sample BCCD-CT2-1.

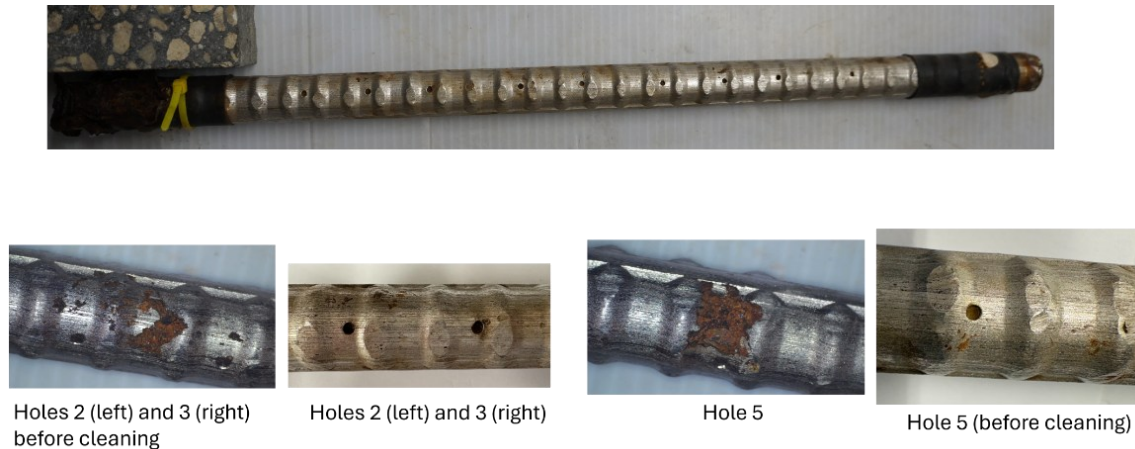
Figure 7-59 shows the top part of rebar C, which did not have signs of significant corrosion after cleaning. Some spots were visible around holes 2, 3, and 5 after initial cleanings, but they were removed after. After all the cleanings were done, this side of the rebar did not show significant signs of corrosion and showed much less compared to the top sides of rebar A and B of this sample. The only hole on the top side of rebar C that had a relatively large depth was hole 8 at 2.5 millimeters, which is depicted in Figure 7-60. This hole also shows changes in shape at different depths.

Figure 7-59. Top side of rebar C and select segments of sample CSDB-CT2-1.

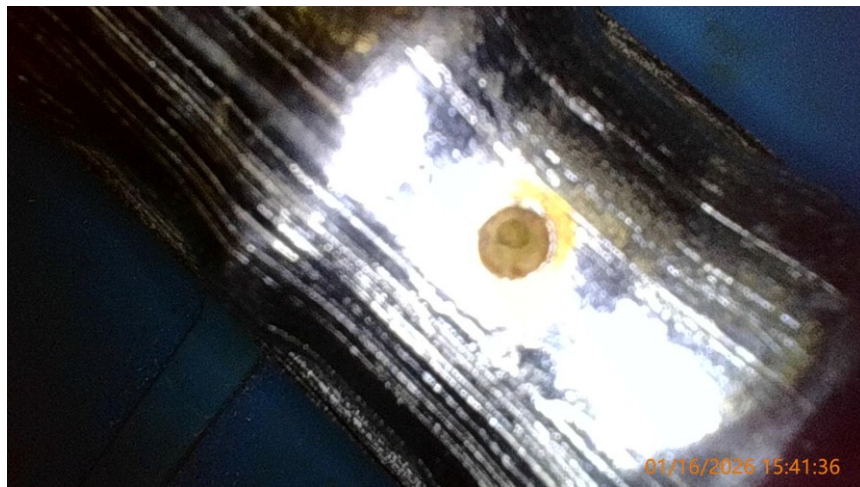
The next set of figures shows the bottom sides of each top rebar in sample CSDB-CT2-1. Figure 7-61 shows the bottom side of rebar A. This rebar did have notable hole depths of 3.5 millimeters for hole 1 and 2 millimeters for hole 7. Both also showed a change in diameter at varying hole depths. This can be seen with the outer, darker ring of corrosion product in the photo that surrounds the deeper, more illuminated section at the bottom. This suggests evidence of pitting corrosion. These holes are depicted in Figure 7-62 and Figure 7-63.

Figure 7-62. Hole 1 on bottom side of rebar A of sample CSDB-CT2-1.

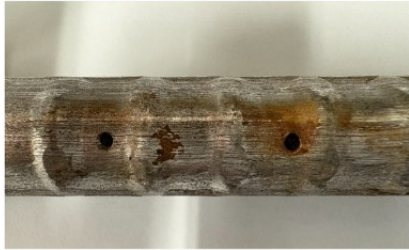
Figure 7-68 shows the bottom side of rebar C. This side also had stains after the rebar was fully cleaned with trace amounts of corrosion product as seen around holes 1 and 2 in the figure. This side of the rebar also had multiple holes of significant depth. Hole 3 was 3 millimeters deep, Hole 5 was 2 millimeters deep, Hole 6 was 2.8 millimeters, hole 8 was 4.5 millimeters, and hole 9 was 3.6 millimeters deep. Figure 7-69, Figure 7-70, and Figure 7-71 show holes 3, 8, and 9, which were the three deepest ones. They all showed varying hole diameters along the hole depth.

Figure 7-68. Hole 3 on bottom side of rebar C of sample CSDB-CT2-1.

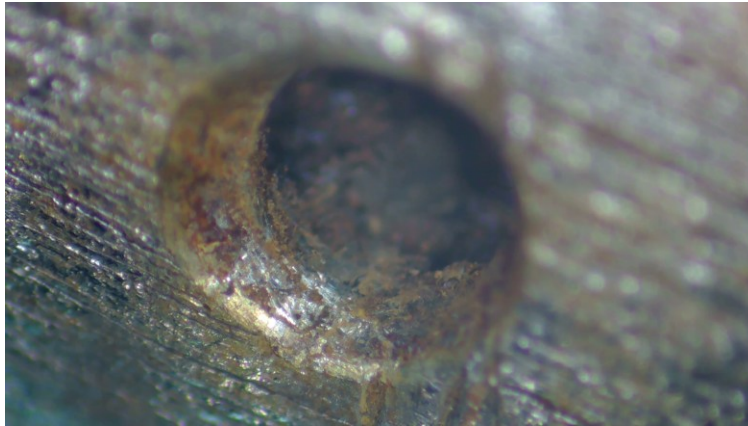
Figure 7-69. Hole 3 on bottom side of rebar C of sample CSDB-CT2-1.

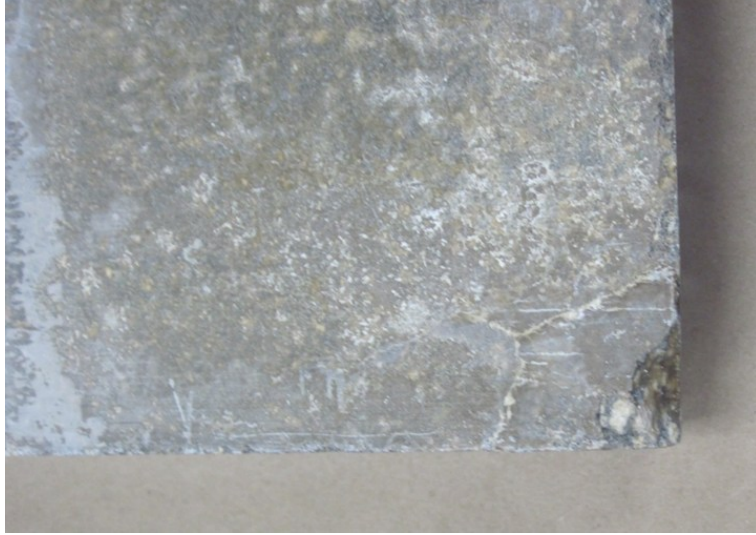
Figure 8-8 shows the front and back of sample STD3-3CR12-E. There was a crack with white bleed out on the bottom left corner of the front side below the waterline extending to the left face, which is shown in Figure 8-9. There was no corrosion in this crack.

Figure 8-9. Back side crack of sample STD3-3CR12-E before termination.

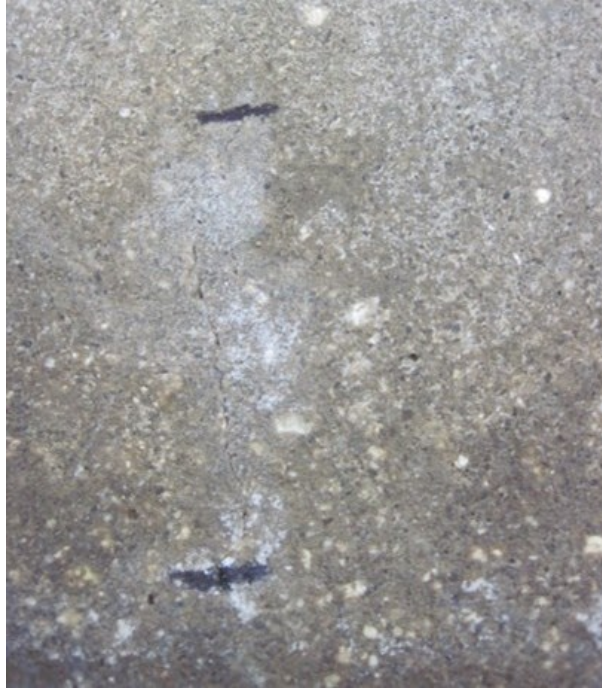
Figure 8-10 shows the front side and back side of sample STD3-MMFX-B. Figure 8-11 shows a close-up of the crack that was observed on the front face.

Figure 8-11. Crack observed on the front side of sample STD3-MMFX-B before termination.

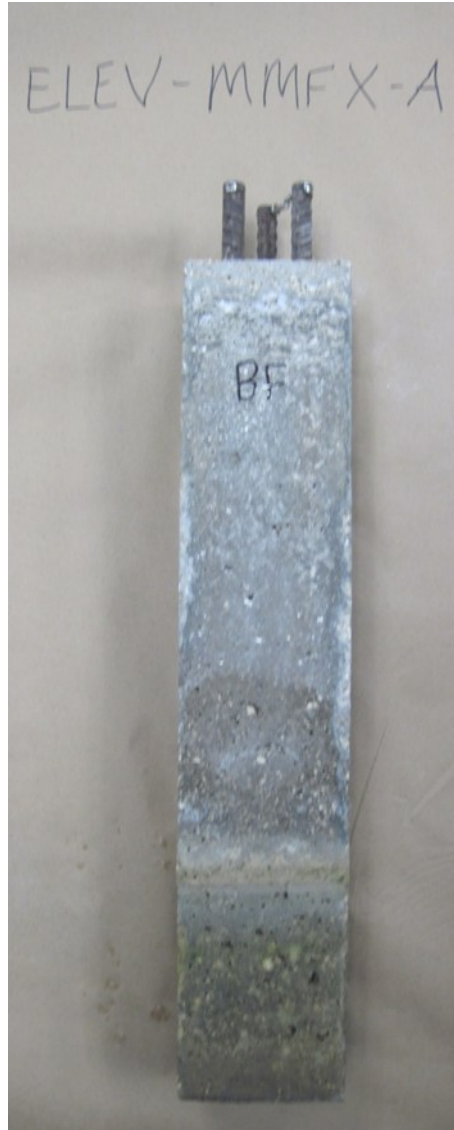
Figure 8-12 shows the front side of sample ELEV-MMFX-A with a bleed out evident on the bottom area. Figure 8-13 shows the back side. No noticeable corrosion took place, and there were no visible cracks.

Figure 8-13. Back side of sample ELEV-MMFX-A before termination.

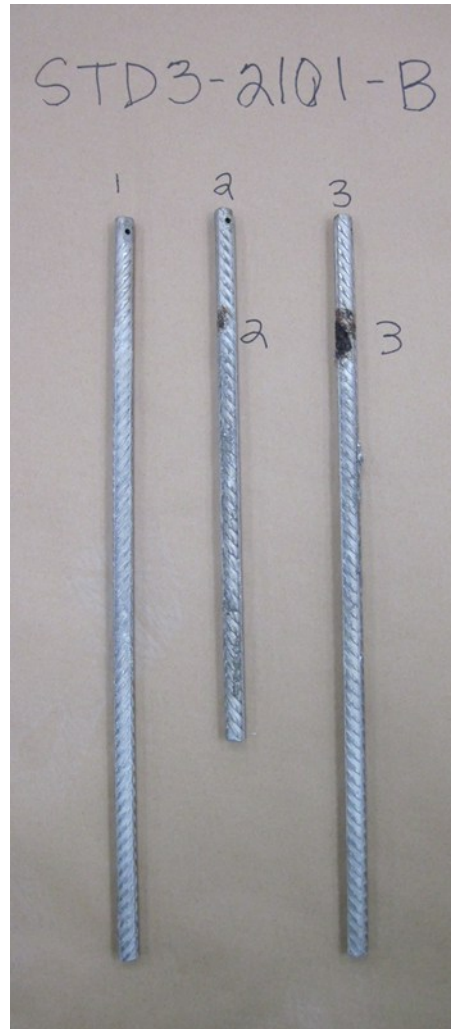
Figure 8-16 shows all the rebars from sample STD3-2101-B. There were notable signs of corrosion on rebars 2 and 3, while rebar 1 had no corrosion. Figure 8-17 and Figure 8-18 show corrosion spots from multiple angles on rebars 2 and 3, respectively. Rebar 2 and 3 had corrosion where the bar exits the concrete. There was no corrosion on the bar at, above, or below the waterline on the bar.

Figure 8-16. All rebars of sample STD3-2101-B.

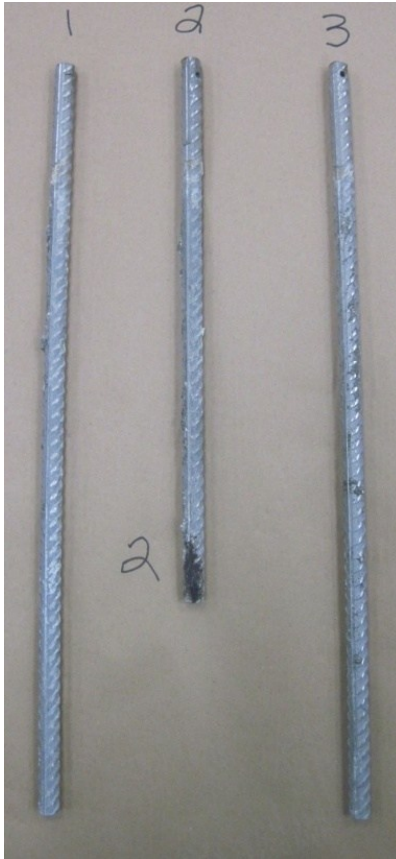
Figure 8-19 shows all the rebars from sample STD3-2304-B. Rebar 2, shown in Figure 8-20, had notable corrosion at the bottom of the bar extending 2" up from the bottom of the bar and the spot itself is about 1/2" wide. Rebars 1 and 3 had no corrosion.

Figure 8-19. All rebars of sample STD-2304-B.

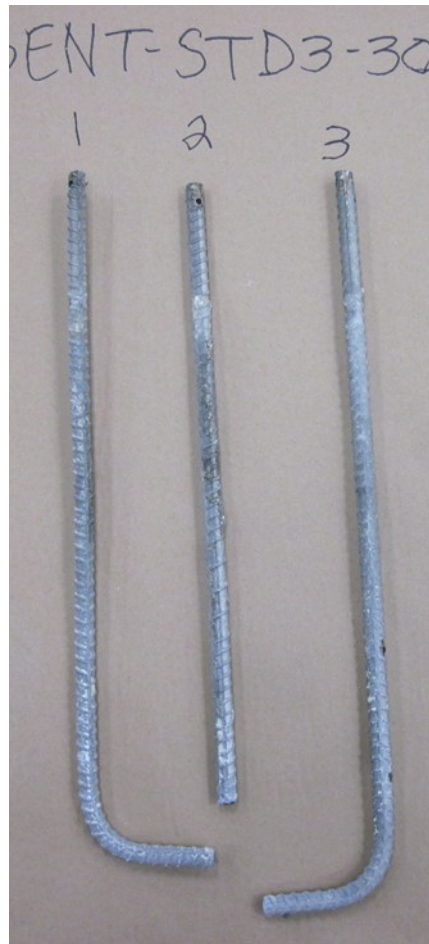
Figure 8-21 shows all the rebars of sample BENT-STD3-304-C. Rebar 1 had corrosion near the top of the bar where the bar exits the concrete, which is shown in Figure 8-22. There was a corrosion spot on the bar at about 3" above the bend that had a length of 0.25", and a width of about 0.25".

Figure 8-21. All rebars of sample BENT-STD3-304-C.

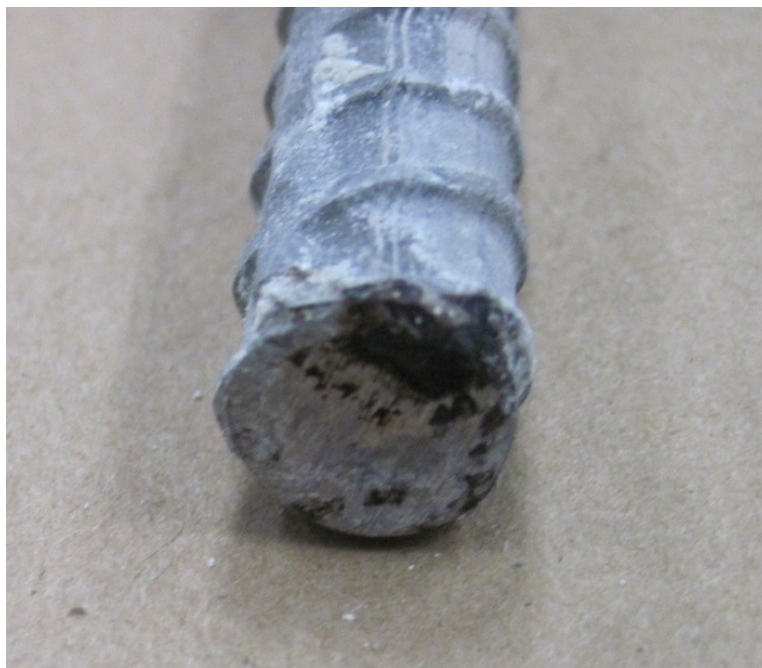
Rebar 2, shown in Figure 8-23, had corrosion on the bottom of the bar that covers about 1/3 of the bottom; there was no other corrosion on the bar. Rebar 3, shown in Figure 8-24 had two spots of corrosion on the bar; one at approximately the waterline and one below the waterline; the topmost spot was about 13.5" down from the top of the bar; the bottom most spot was about 17 and 1/8" down from the top of the bar.

Figure 8-23. Close up corrosion spot on end of rebar 2 of sample BENT-STD3-304-C.

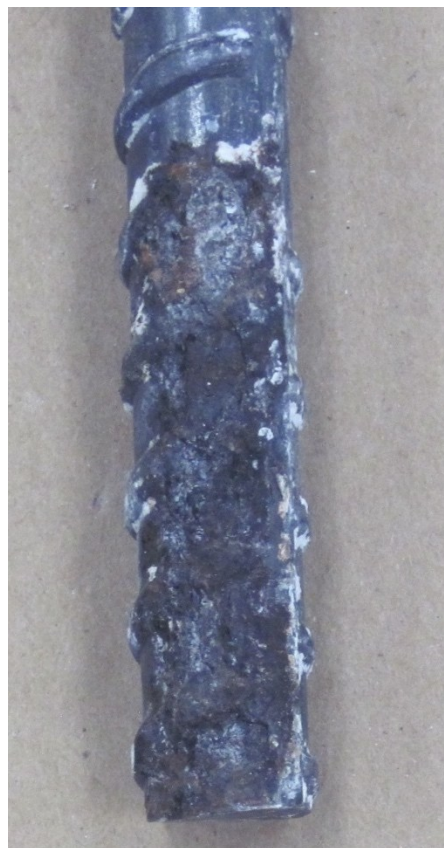
Figure 8-29 shows all rebars of sample STD3-MMFX-B. Figure 8-30 shows corrosion spots on rebars 1, Figure 8-31 shows the corrosion spots observed on rebar 2 (bottom of the rebar), and. Figure 8-32 shows the corrosion spots observed on rebar 3.

Figure 8-31. Corrosion spots observed on rebar 2 of sample STD3-MMFX-B.

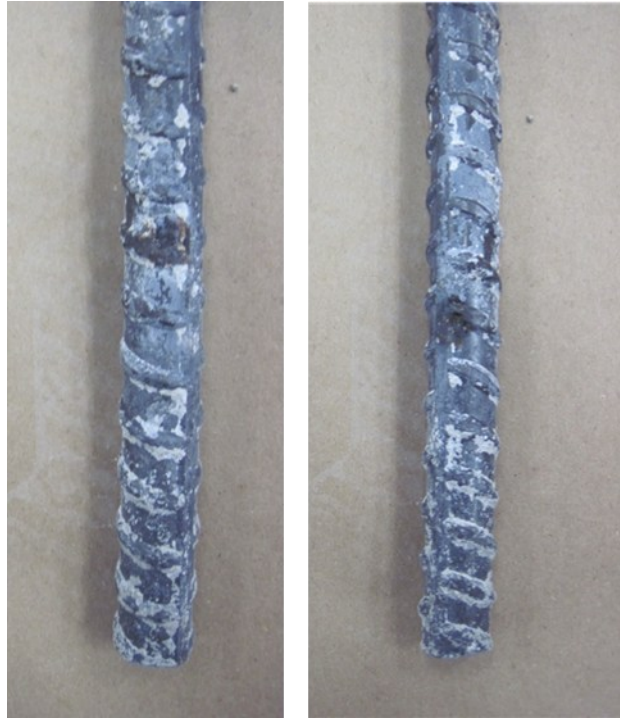
Figure 8-33 shows the rebars from sample ELEV-MMFX-A. Each rebar in this sample had corrosion. Figure 8-34 shows corrosion on rebar 1. There was corrosion on the bar about 3.25" up from the bottom of the bar which extended to  $\frac{3}{8}$ " up from the bottom with a width of  $\frac{1}{2}$ ". Figure 8-35 shows the corrosion on rebar 2. There was corrosion on the bar about 3.5" up from the bottom of the bar extending to about  $\frac{2}{3}$ " around the bar at that location. Figure 8-36 shows the corrosion spots on rebar 3, which was about  $\frac{1}{8}$ " up from the bottom extending to approximately  $\frac{3}{4}$ " and 1" up from the bottom. There was also a spot of corrosion about 3.5" up from the bottom of the bar extending 1" up on the bar. Corrosion covered approximately  $\frac{3}{4}$  of the bar at that location.

Figure 8-34. Corrosion spots on rebar 1 of sample ELEV-MMFX-A.

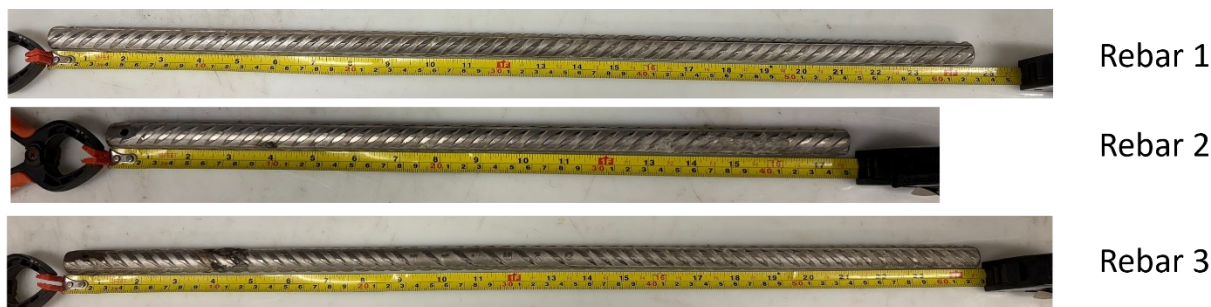
Figure 8-39 shows all three rebars of sample STD3-2101-B as an example of the rebars after cleaning has taken place.

Figure 8-39. All rebars of sample STD3-2101-B after cleaning.
