## **Final Report**

Evaluation of Concrete Specimens Prepared with Corrosion Resistant  
Reinforcement after Long Term, Greater than 15 years, Outdoor and  
Laboratory Exposures

Contract Number – FDOT (BED27-977-04)  
FAU (AWD003253)

Submitted to  
Florida Department of Transportation  
Research Center  
605 Suwannee Street  
Tallahassee, Florida 32399

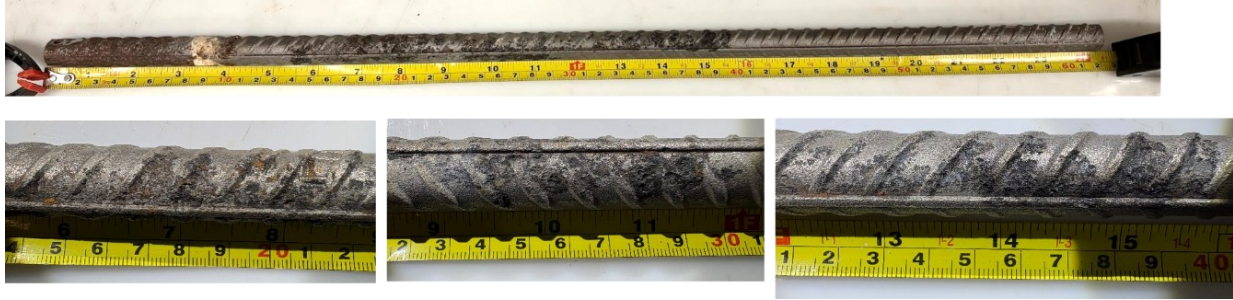
Figure 8-49 shows rebar 3, which had major damage along a large section of the rebar. The damage spanned from about 5.5 inches to about 15.7 inches on the length scale. Although the damage covered a large surface area, the corroding sites after cleaning were not very deep.

Figure 8-49. STD3-3CR12-E - full length of rebar 3 and notable areas of corrosion damage.

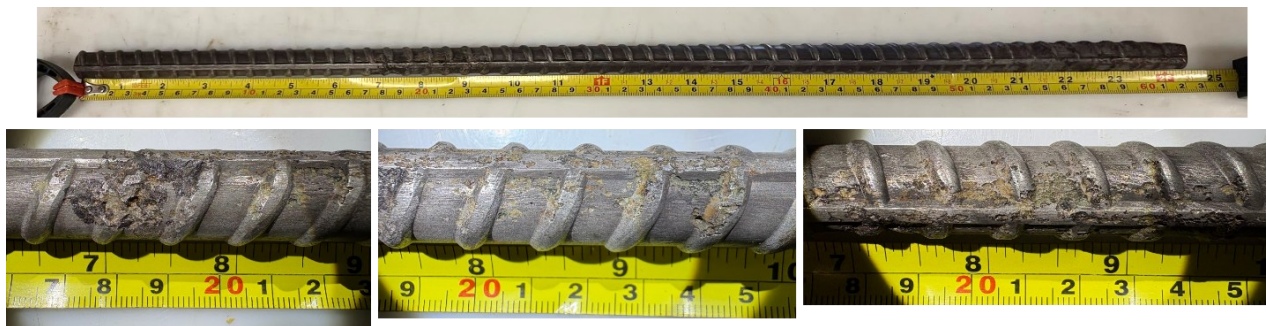
Figure 8-52 shows rebar 3, which had one large section with corrosion damage, located 19 inches from the side with the drilled hole. The corrosion site extended about two inches in length. The damaged area was somewhat deep as can be observed on the close-up. It cover most of the rebar circumference.

Figure 8-52. STD3-MMFX-B - full length of rebar 3 and notable areas of corrosion damage.

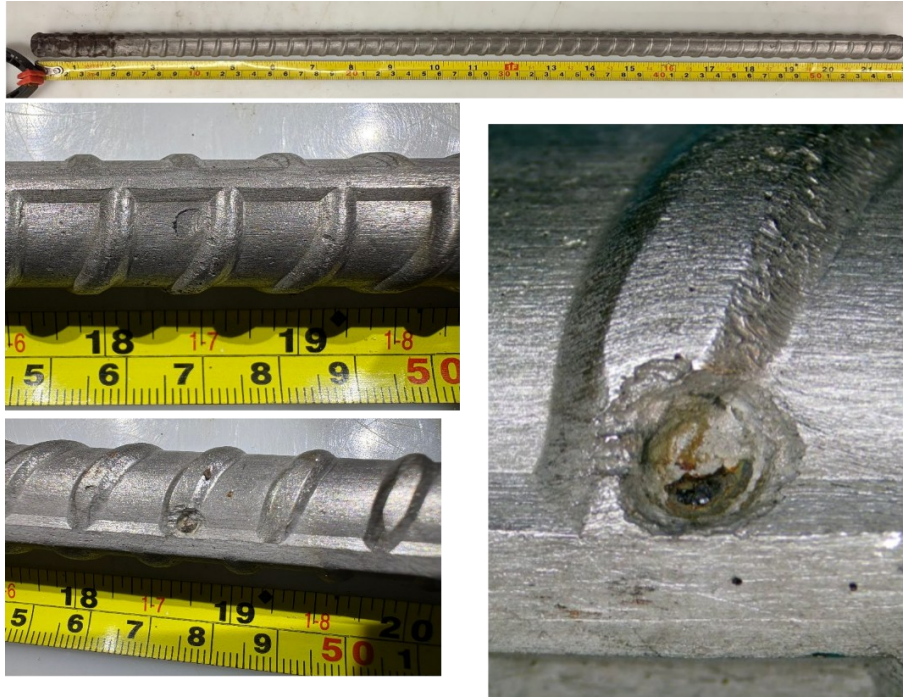
The following rebar images after cleaning the rebar removed from ELEV-MMFX-A 3-Bar Square sample. Each of the three rebars of this sample had some corrosion damage. Figure 8-53 shows rebar 1, which had very little damage, and only contained one small corrosion site, a deep pit occurred at around 18.8 inches on the length scale.

Figure 8-53. ELEV-MMFX-A - full length of rebar 1 and notable areas of corrosion damage.
