WL-TR-91-4032  
DOT/FAA/CT-91/23  
VOL II, Part 3

COMPOSITE FAILURE ANALYSIS HANDBOOK  
VOLUME II - TECHNICAL HANDBOOK  
PART 3 - CASE HISTORIES

R.J. Kar  
Northrop Corporation  
One Northrop Avenue  
Hawthorne, California 90250-3277

February 1992

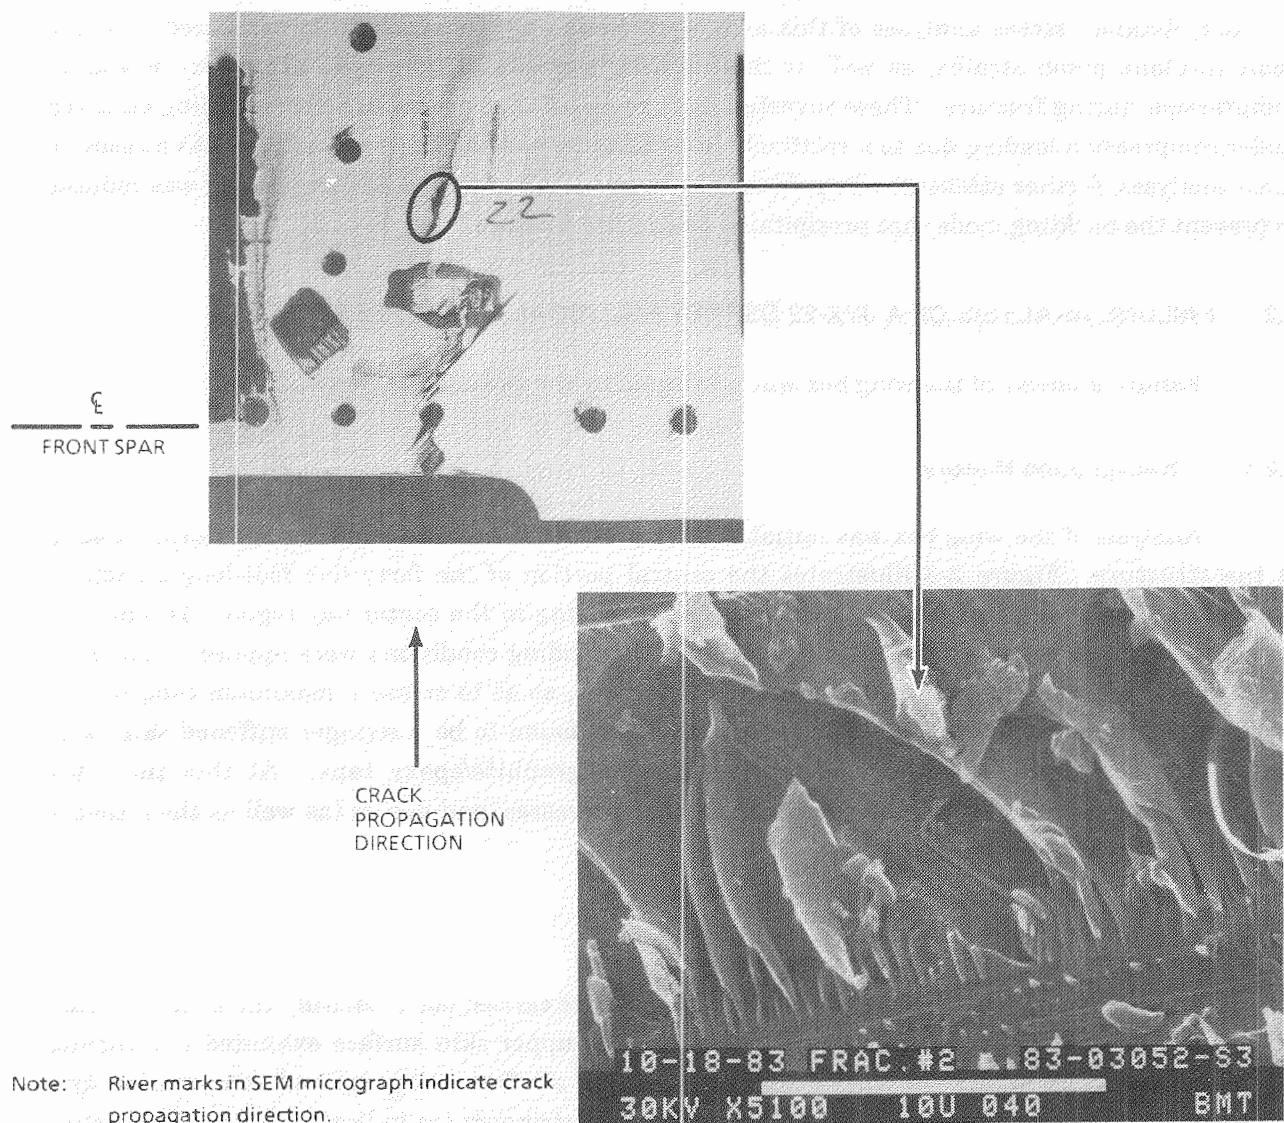
Figure 2-2. 737-300 Elevator Static Test Fracture Directions

Note: River marks in SEM micrograph indicate crack propagation direction.

By reconstructing the fracture process through the interlaminar crack mapping process, it was discovered that crack initiation occurred at the periphery of a fastener hole located at the front spar. Subsequent propagation occurred in a chordwise direction across the compression loaded skin panel. See Figure 2-2 for the arrow across the skin panel illustrating the direction of the delamination process, particularly related to the fastener hole and the translaminar crack near the hole. No microscopic anomalies were identified at the origin region, and therefore no contamination analyses such as surface chemical tests were required.

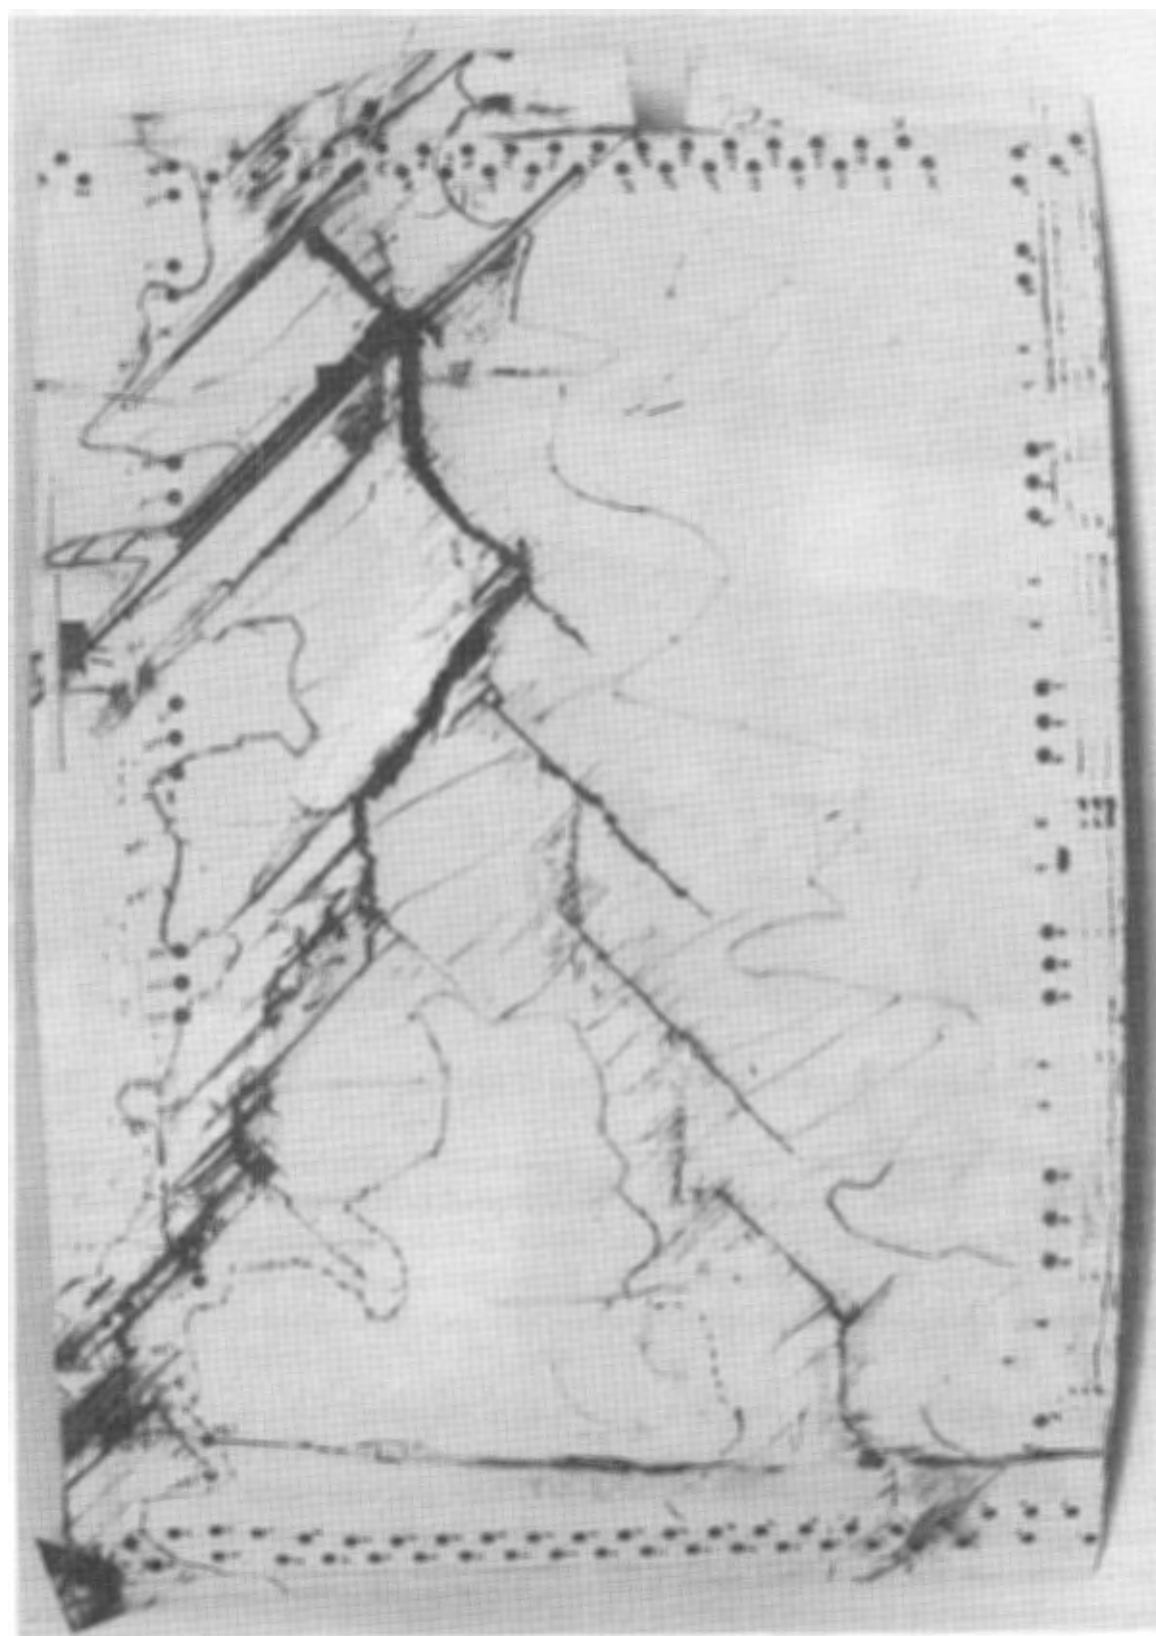
Figure 2-4a. JXX Wing Test Box Upper Skin Surface

Initial visual inspections of the damage region were carried out to identify the areas of visible fracture or deformation. As shown in Figure 2-4a, the upper skin surface exhibited a branching translaminar crack across the entire surface (severing all five stringers) and compression type translaminar fracture morphology for both the skin and stringers (as indicated by the flat fracture appearance). This macroscopic translaminar branching most likely indicated the gross overall fracture direction, such that the cracking progressed across the skin from the rear spar region in a chordwise direction toward the front spar. The translaminar cracking intersected the trailing edge of the skin at a radius for a runout of an overhanging tab. Extensive delamination was evident on each side of the translaminar cracking, often wedged open from mating fracture surface overrun during compression loading. Figure 2-4b presents the underside of the upper skin surface, at the trailing edge tab region, illustrating the type and extent of damage.

Nondestructive examinations were then performed to determine the extent of nonvisible damage. While still intact as a complete structure, the entire wing box was subjected to hand-held pulse echo inspection. This allowed determination of the extent of delamination surrounding the translaminar fracture as well as checking the remaining structure for any other damage that may have either contributed to, or occurred during, the failure. The outline of the delaminations surrounding the translaminar fractures as indicated by pulse echo are visible in Figures 2-4, 2-5 and 2-6.

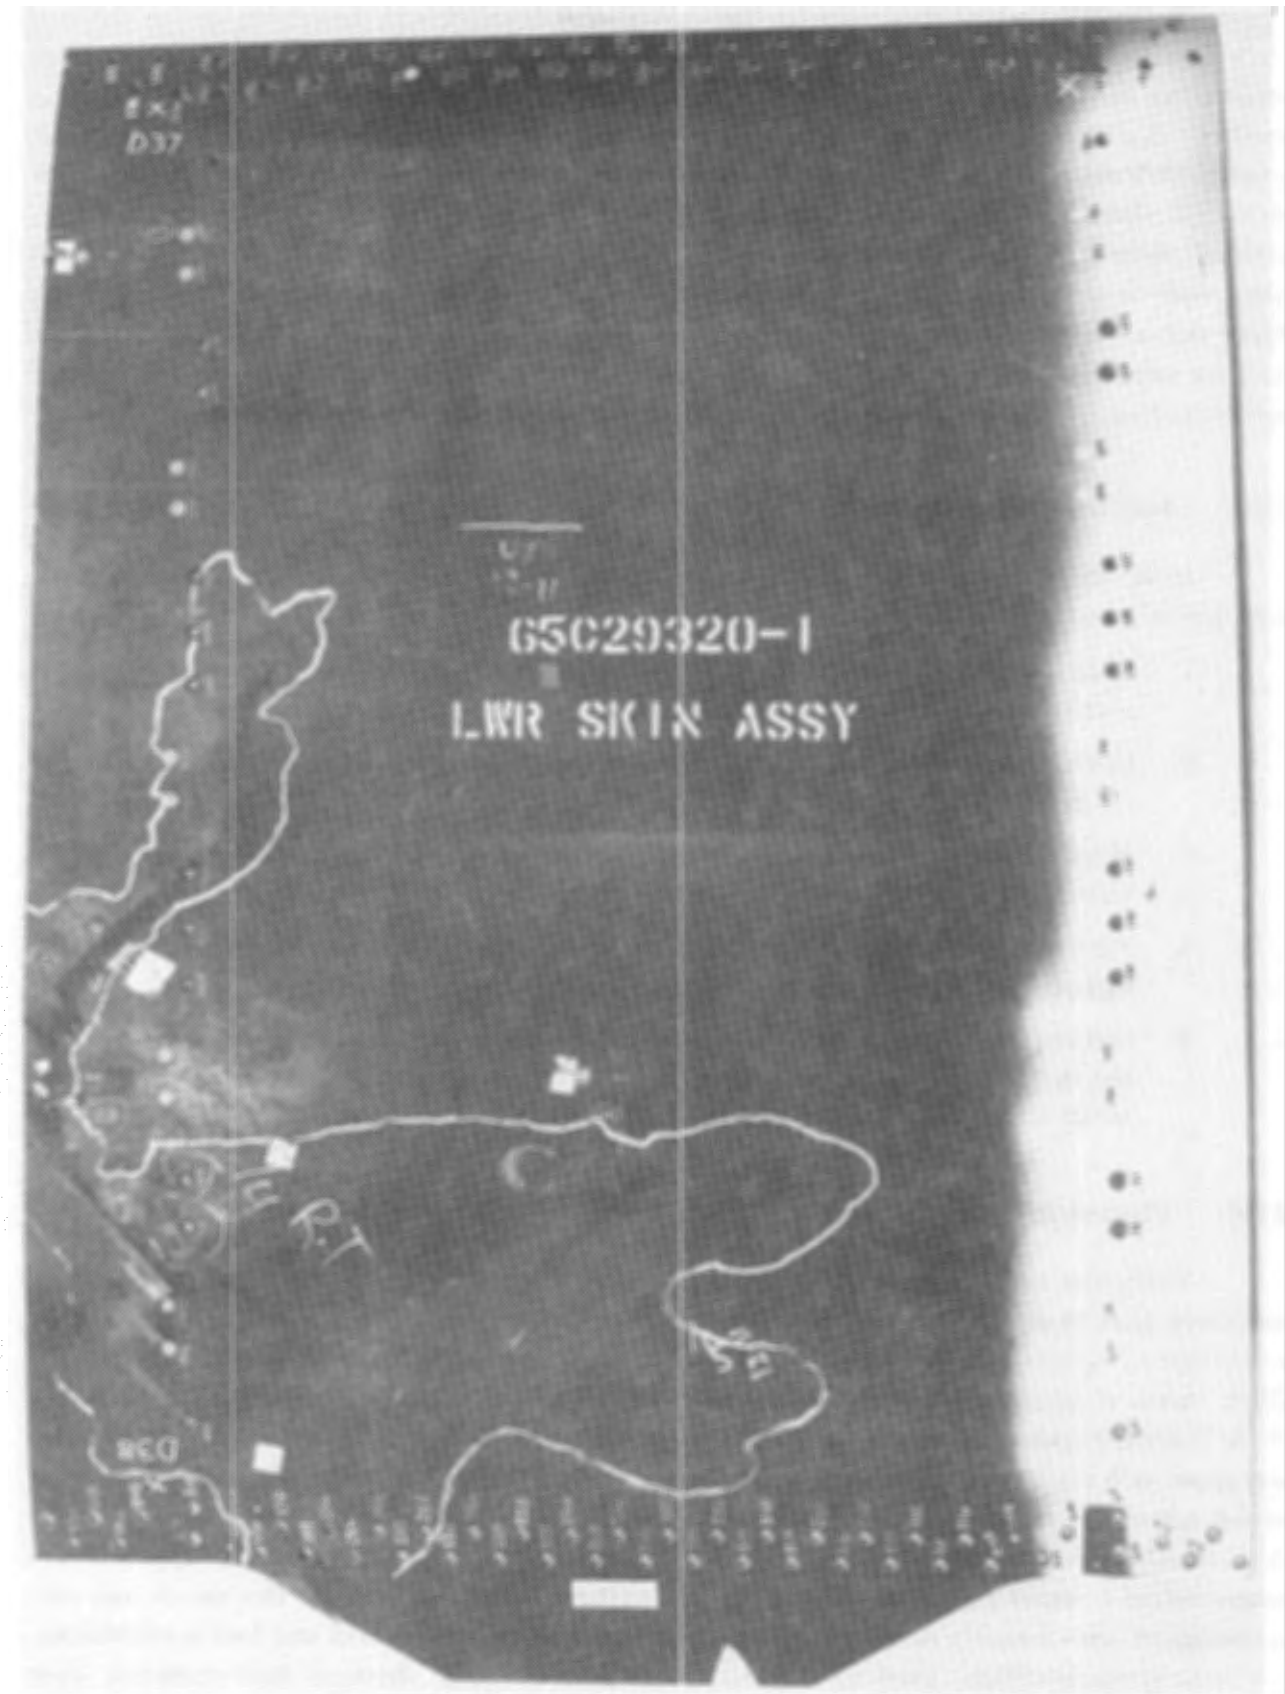
Figure 2-6. J VX Wing Test Box Lower Skin Surface

The lower skin surface, shown in Figure 2-6, was damaged in a similar manner to the upper skin, although to a lesser extent. The skin buckling also indicated a compressive loading. Since the stress prior to fracture was supposed to be tensile, the neutral axis between tension and compression must have shifted to below the lower skin surface during the failure process. As a result of these visual observations, it appeared that damage in the upper skin and spars occurred prior to cracking in the lower skin.

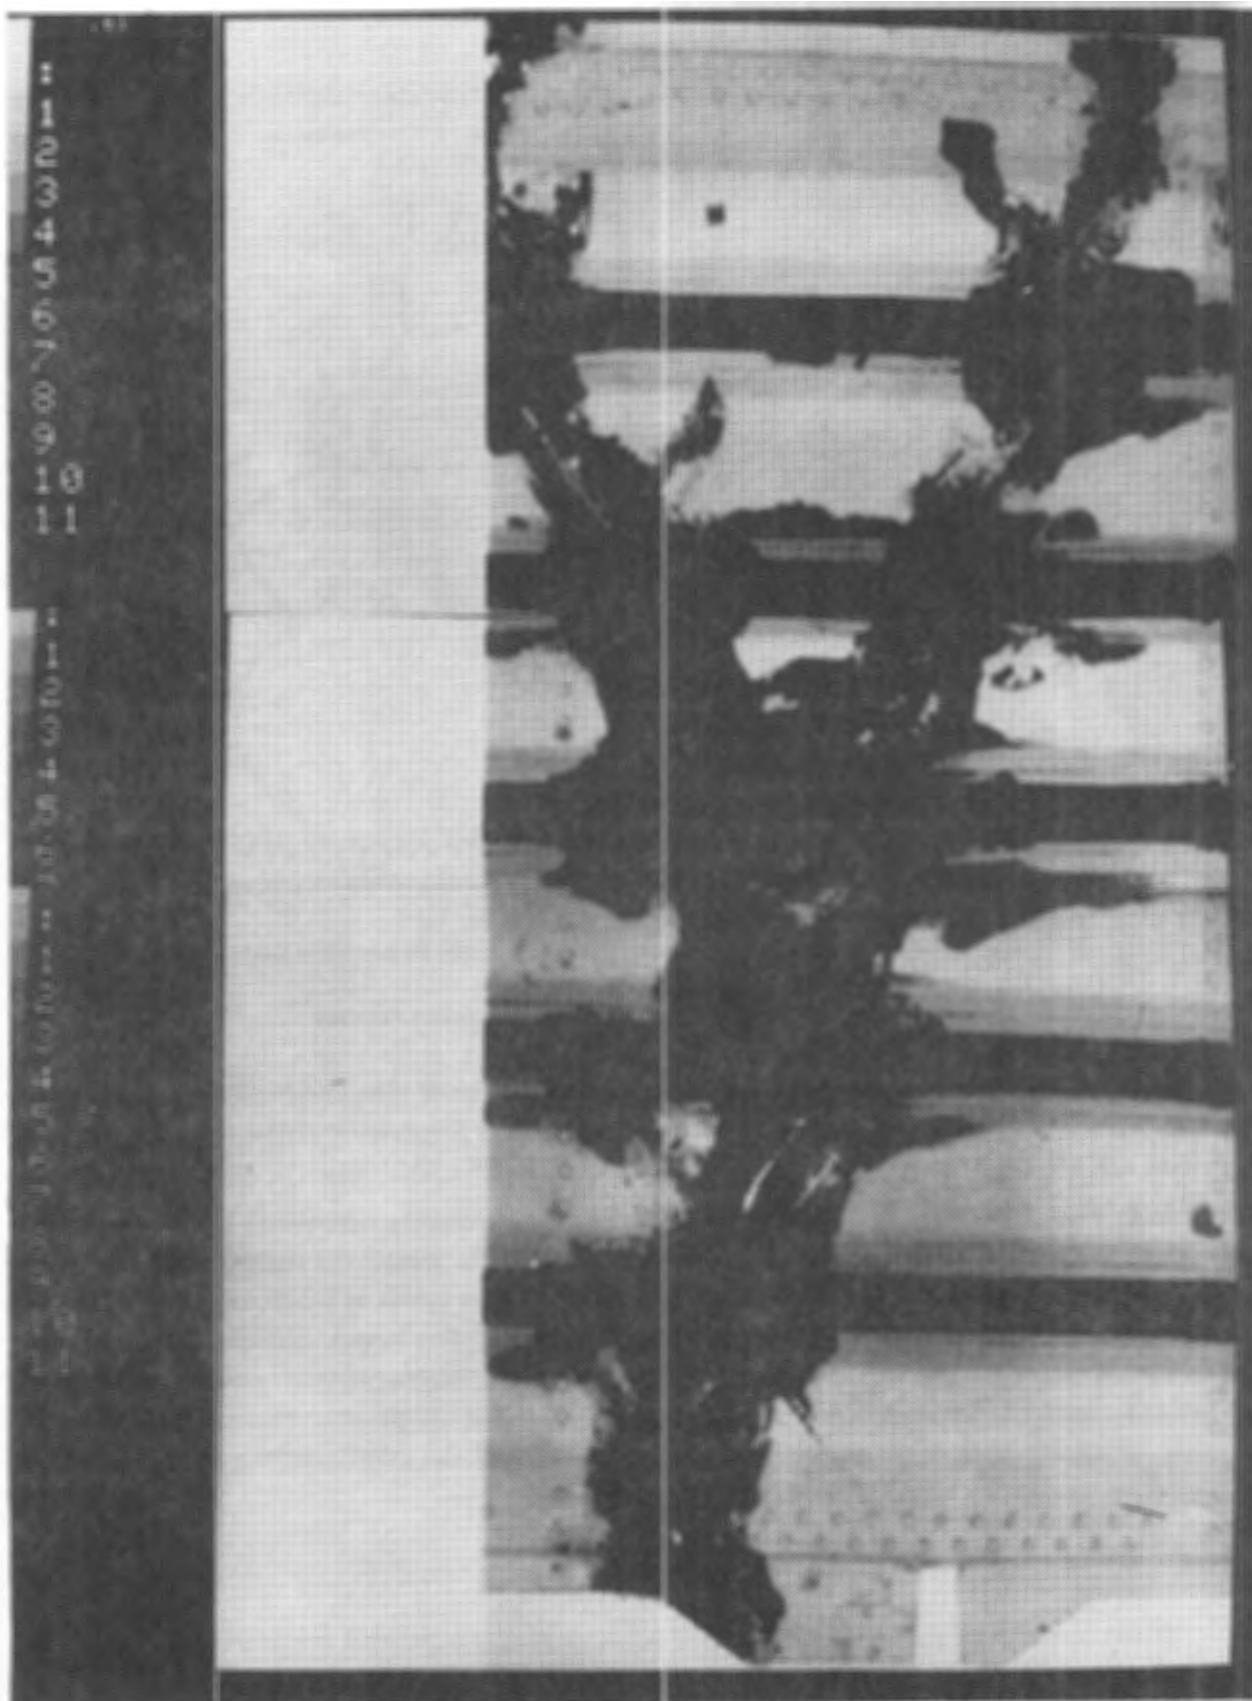
Figure 2-7. Ultrasonic C-Scan of Upper Skin Surface

Using the outline of the delamination generated by NDE, the fractures were abrasively sectioned open to minimize artifacts. Detailed crack mapping of the delamination surfaces was performed by optical microscopy, with documentation of the fracture morphologies obtained by the SEM. Areas of delamination were found to be principally Mode I tension dominated, with localized Mode II shear regions. The overall crack growth directions, as well as the fracture origin regions for the upper skin surface and the rear spar are shown in Figure 2-8. These analyses revealed cracking of the upper skin initiated by compression buckling fracture mode at the trailing edge tab radius with resultant fracture propagating toward the leading edge. Similarly, the rear spar fracture originated in a region adjacent to the upper skin surface. Crack mapping in this region was very inconsistent, with a nearly random variation in the microscopic river marks and hackle orientation. No anomalous conditions such as porosity, resin starvation, or chemical contamination were identified in the origin regions.

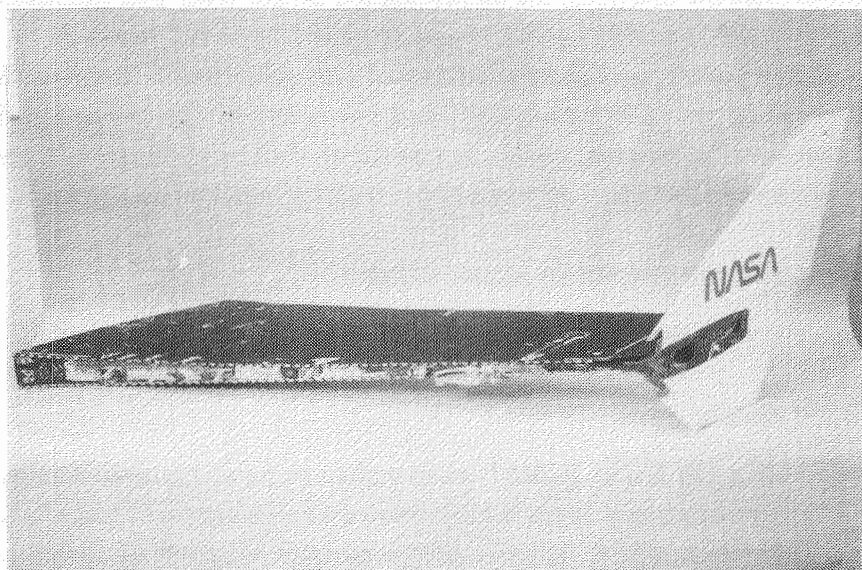
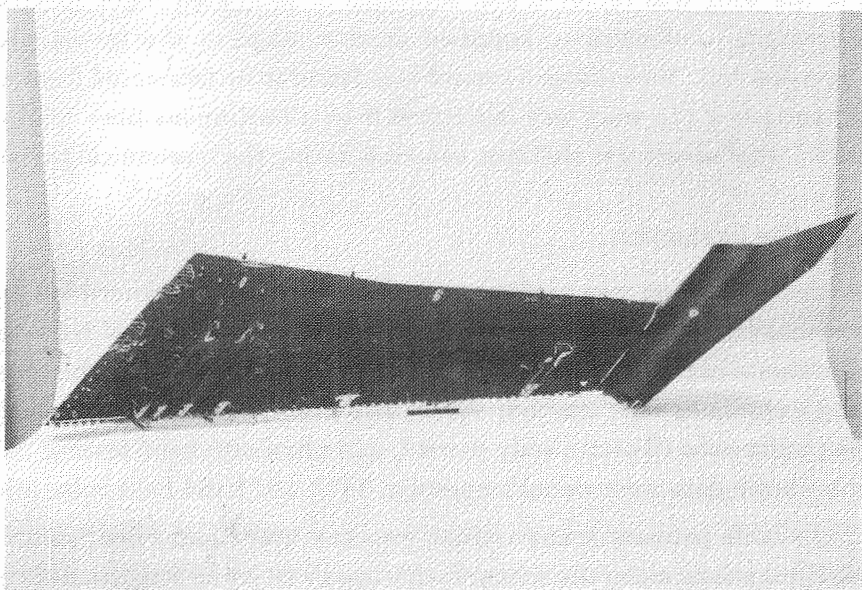
**Figure 2-9. NASA HiMAT Test Wing in the As-Received Condition**

Figure 2-9 presents the NASA HIMAT wing section in its as-received condition. This wing was built by Rockwell International for a highly maneuverable research vehicle to study future designs for the next generation of U.S. fighters. The composite wing is a 44 percent scale model, to lower overall program cost and risk. Following numerous unmanned test flights, the outboard sweeping section of the wing was removed and subjected to simulated flight spectrum mechanical testing in the laboratory. Information supplied at this stage in the investigation regarding construction was very limited; the outboard canard was found to be fabricated from aluminum alloy and the remaining portion of the wing was fabricated from a continuous fiber reinforced laminate. Failure, denoted as a loss of structural stiffness, occurred during the mechanical testing.

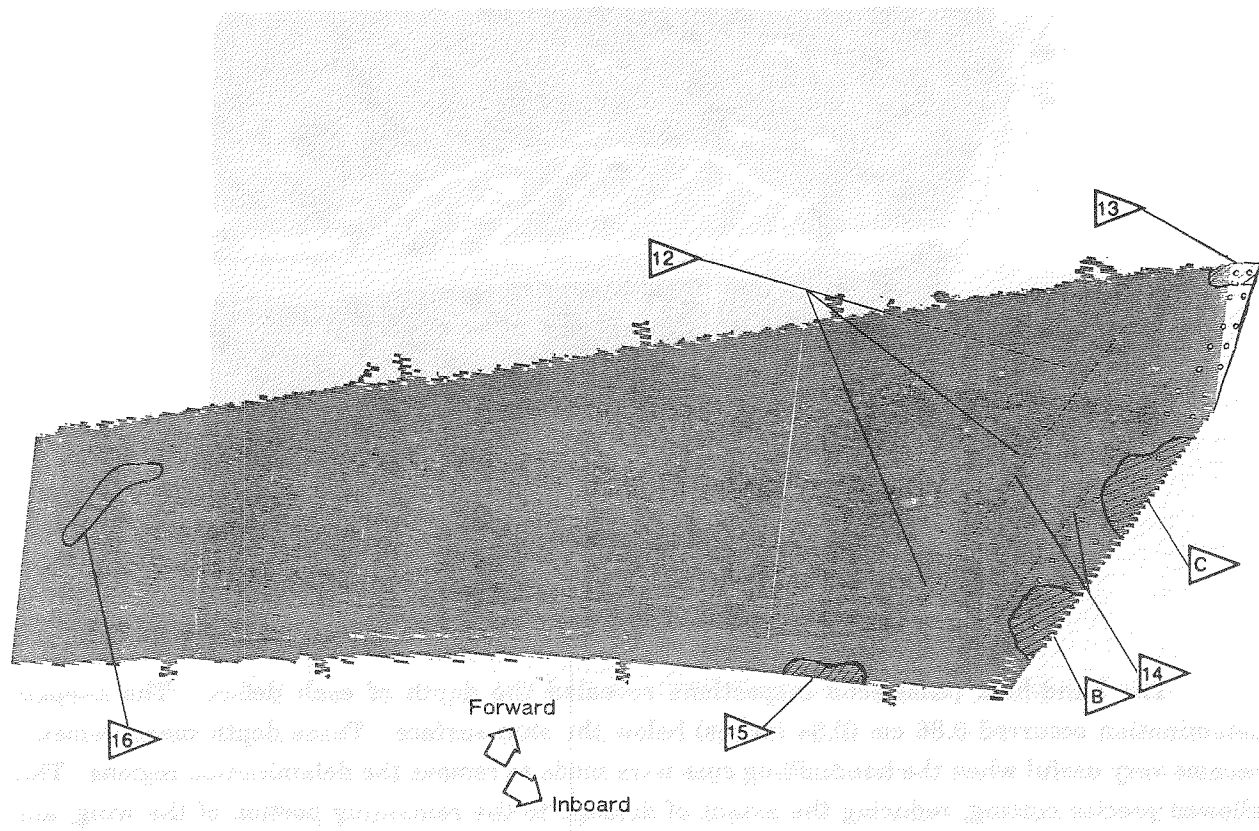
Figure 2-12. NDE Results of the Upper Surface

TTU analysis provided a through scan of the discontinuities along the upper and lower skins. The major delaminations and disbonds occurred along the inboard edge of the wing, with the exception of one donut-shaped delamination at the center of the wing. Figures 2-11 and 2-12 show

the TTU hard copy printout. The areas indicated by alphabetical flagnotes were delaminations or disbonds which were crack mapped during subsequent fractographic examinations. However, the areas shown with numerical flagnotes were defects indicated by X-ray, such as core to skin disbonds, core crush, and water in the core cells.

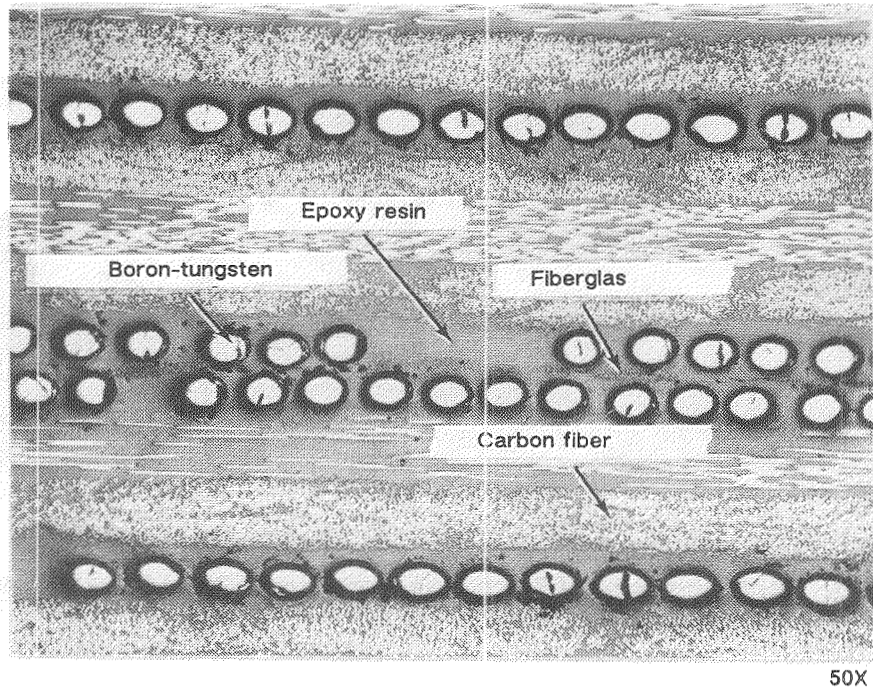
Figure 2-14. Photomicrograph of Zone B Cross-Section

The materials used to construct the wing were found to be carbon, boron-tungsten, and fiberglass fibers in an epoxy resin. These material constituents were identified by the following techniques: scanning electron microscopy, optical microscopy, electron probe microanalysis, and electron scattering for chemical analysis (ESCA). The fibers were identified by SEM, ESCA (Figure 2-13), and optical microscopy (Figure 2-14). The novalac based epoxy resin was identified by infrared spectroscopy.

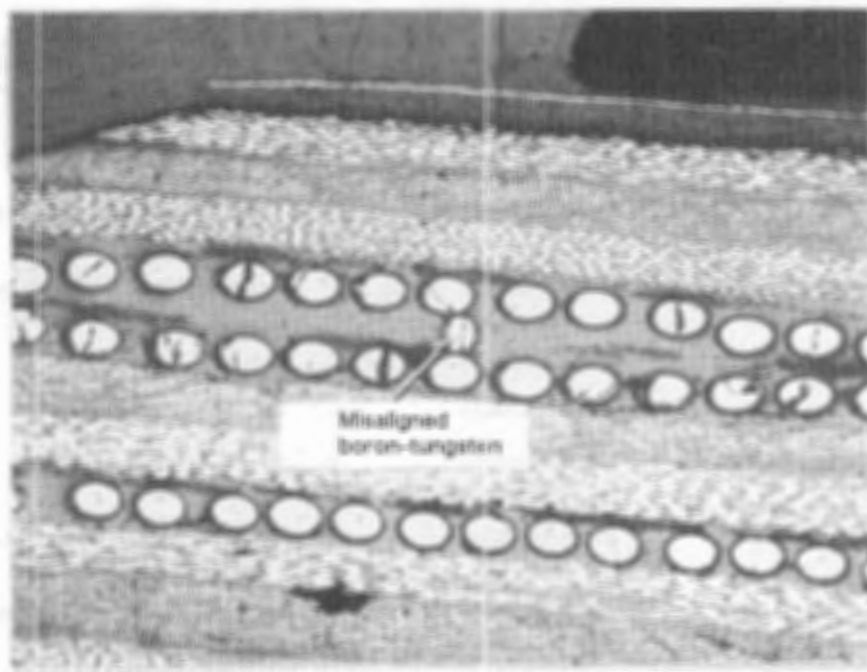
Figure 2-15. Cross-Section Illustrating Boron Fiber Misalignment Resulting in Resin-Rich Adjacent Regions

The ply orientation and number of plies were found to be consistent with engineering drawing specifications. Localized discontinuities such as resin-rich and resin-starved regions (Figure 2-15) were usually caused by misalignments of the extremely large boron fibers. A small amount of porosity was seen in the graphite/epoxy plies between the 0 and 90 degree plies. These discontinuities were not found to be associated with the delamination regions and therefore were not considered as contributory factors to the cause of part failure.

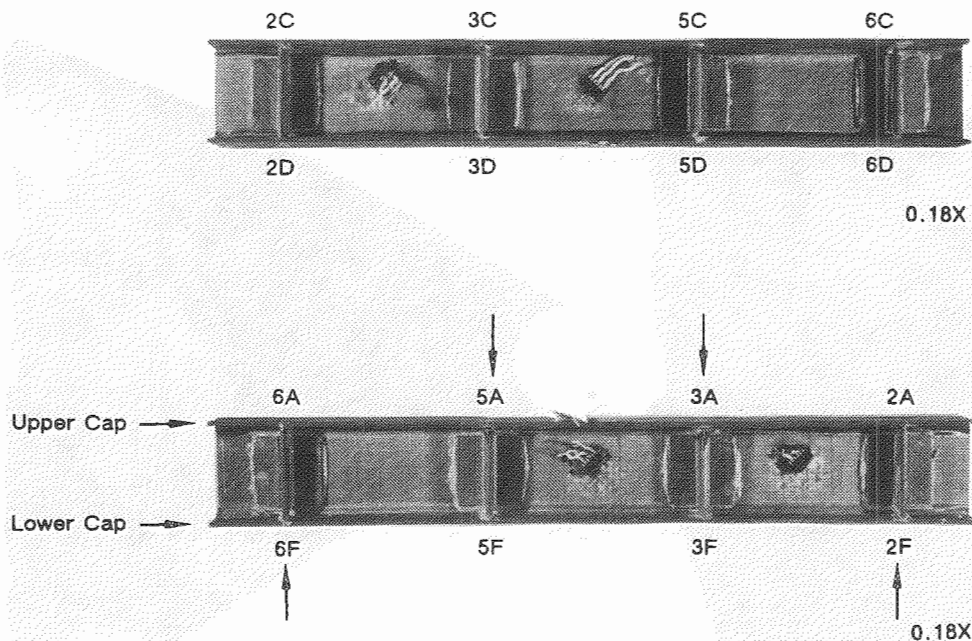
Figure 2-18. CFRP I-Beam in the As-Received Condition

Figure 2-18 shows the I-beam in its as-received condition. This component was fabricated by the personnel at the Air Force Wright Patterson Aeronautical Laboratories (AFWAL). Information regarding the component's layup, material composition, resin content, and cure temperature was provided by AFWAL. The component was tested in a four point bend test. The I-beam consisted of a tape laminate with vertical web and two horizontal caps, similar to stringers used to stiffen skins on aircraft wing construction. Small vertical stiffeners were secondarily bonded at several locations along the length to provide support of the cap flanges during loading. Efforts were aimed at determining the cause of failure with the quickest and lowest cost methods available. As a result, examinations such as fractography were performed without an SEM, relying on macroscopic and optical means of identifying the sequence and origin of fracture.

NDE was performed on the I-beam to determine areas of damage or defects caused from testing or manufacturing. Visual inspection of the beam revealed bearing damage on the caps indicative of the loading points during mechanical testing. This allowed determination of the types of stress, (that is, compression, tension or shear) imparted on the various regions of the beam. For continuity throughout this discussion, the upper cap was compressively loaded and the lower cap was in tension during flexural loading. Delaminations were found at two locations in the upper cap, with remaining damage limited to brooming (localized buckling) of the small vertical stiffeners immediately below the two center loading points, most likely due to the compressive loading. These damage conditions are presented in Figures 2-19 and 2-20. TTU inspection required three scans to evaluate the entire beam. First, the vertical web section was inspected. Since no delaminations were identified, the beam was cut longitudinally along the web to allow the upper compression cap to be inspected. The upper cap was found to be delaminated in the identical regions which were visually identifiable (Figure 2-21). The upper cap was free of delaminations in the central region between the two loading points (an area of pure compression loading and no shear stress in the laminate plane).

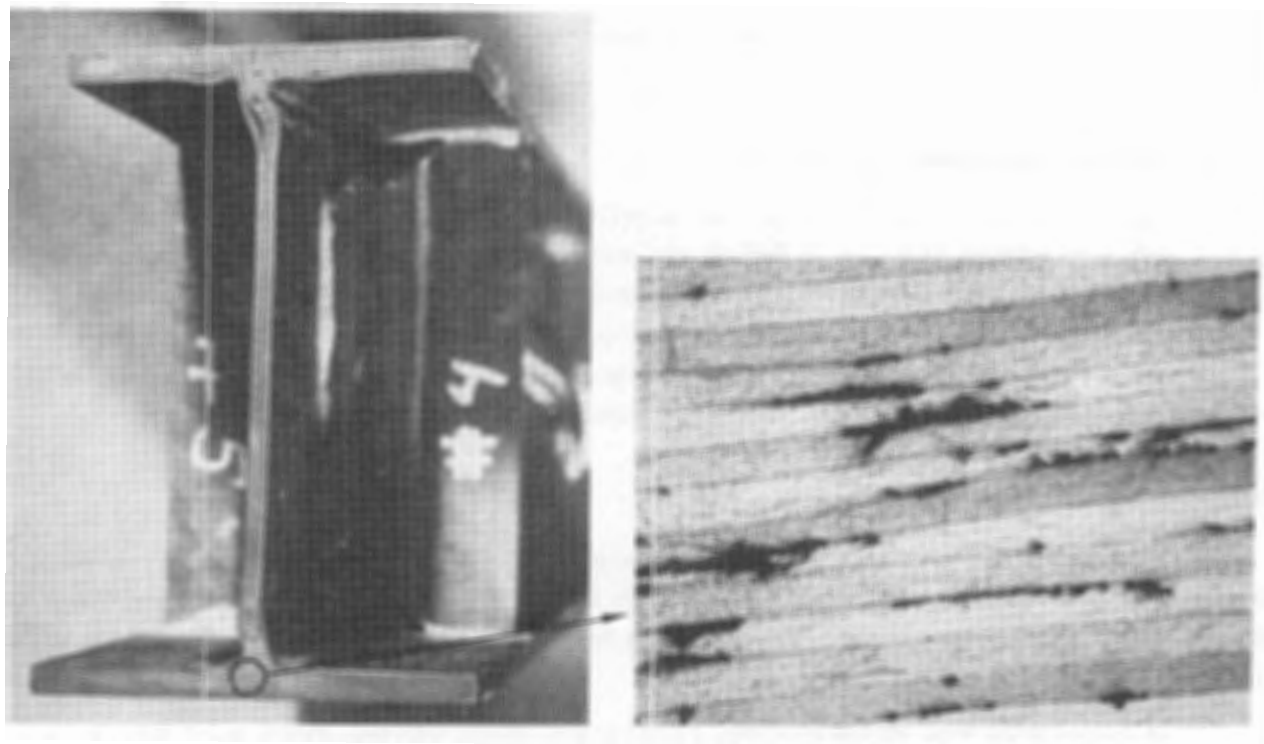
**Figure 2-22. Extensive Porosity and Laminate Deformity in the Web-to-Cap Junction**

Cross-sections were performed on the ends of the beam to evaluate the laminate quality and construction. Ply counts indicated that the beam was fabricated with the correct number and orientation of plies. The overall part quality was found to be poor; extensive porosity was located at the web-to-cap junction and lack of adequate tooling constraint during cure allowed deformation of the entire laminate thickness (Figure 2-22).

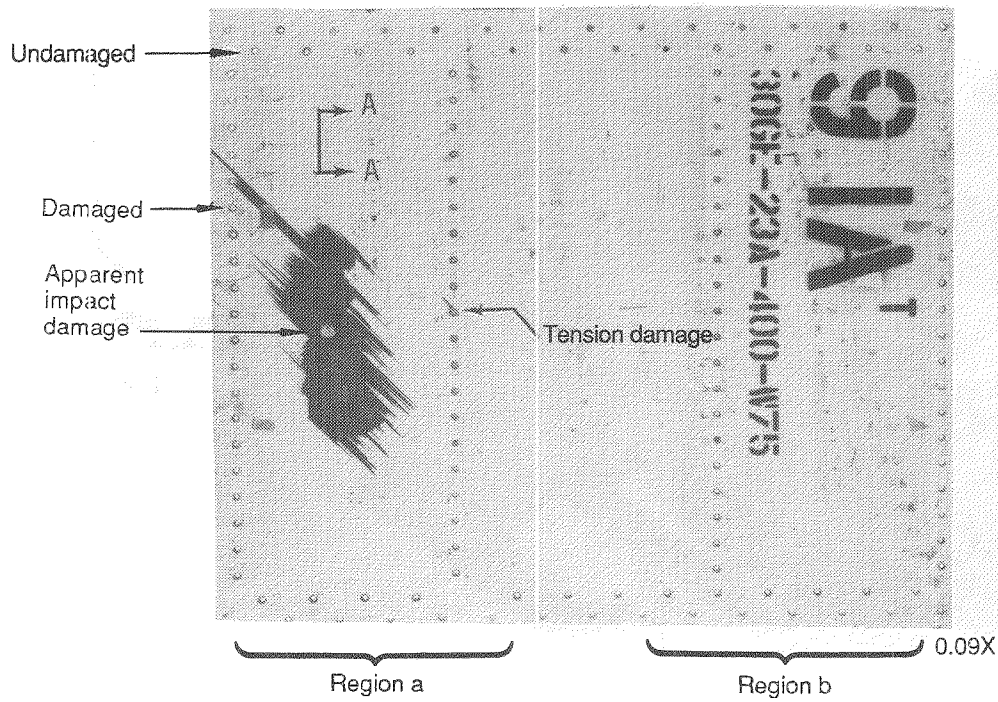
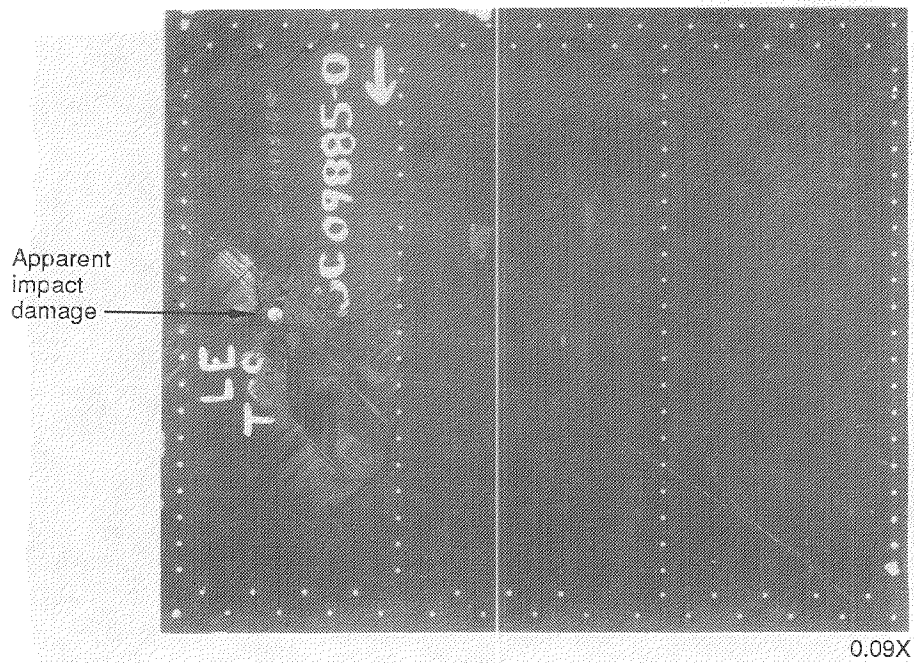
Figure 2-24. Photomacrographs of the Component As-Received

Figure 2-24 shows the fractured test panel in its as-received condition. The rectangular panel, with a dimension of 43 by 36 inches, appeared to have been fastened to one or more fixed structures during testing. Due to limited background information, the emphasis was placed on the visual examination. At the time of the part's receipt, it was speculated that the part had been fractured via impact loading. This speculation was made due to the appearance of the damage which was typical of that observed in impact loaded structures.

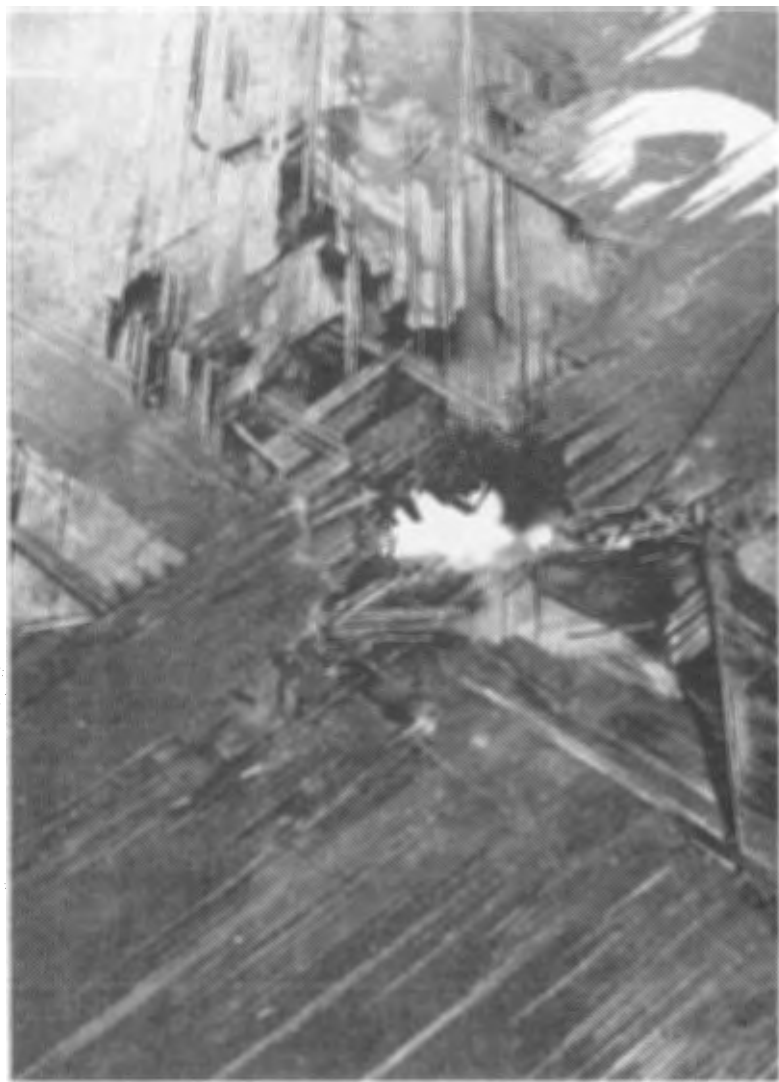
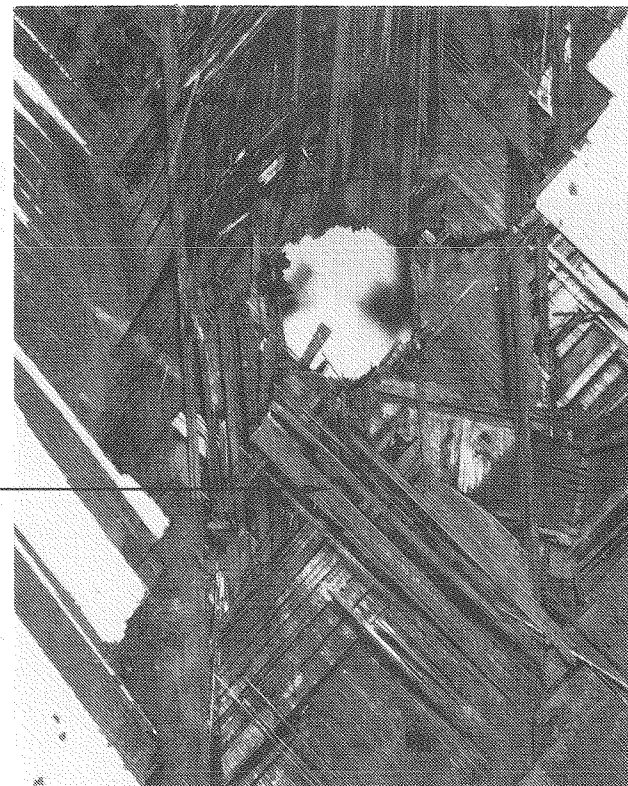
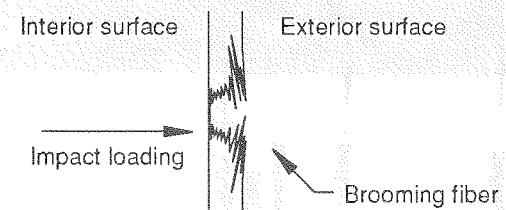
Figure 2-25. Apparent Impact Damage

As shown in Figure 2-25, the damage appeared to have been caused by an object penetrating through the panel from the interior surface (Figure 2-25a), as evidenced by the brooming fibers on the exterior surface (Figure 2-25b). These damage features are commonly observed in an impacted specimen.

(a) Damage on the interior surface

Note the depression  
at the impact site  
which indicates the  
direction of the  
penetration

Brooming fiber

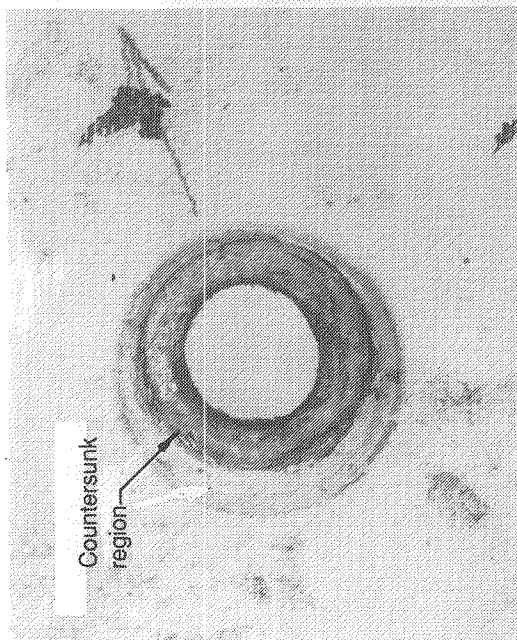
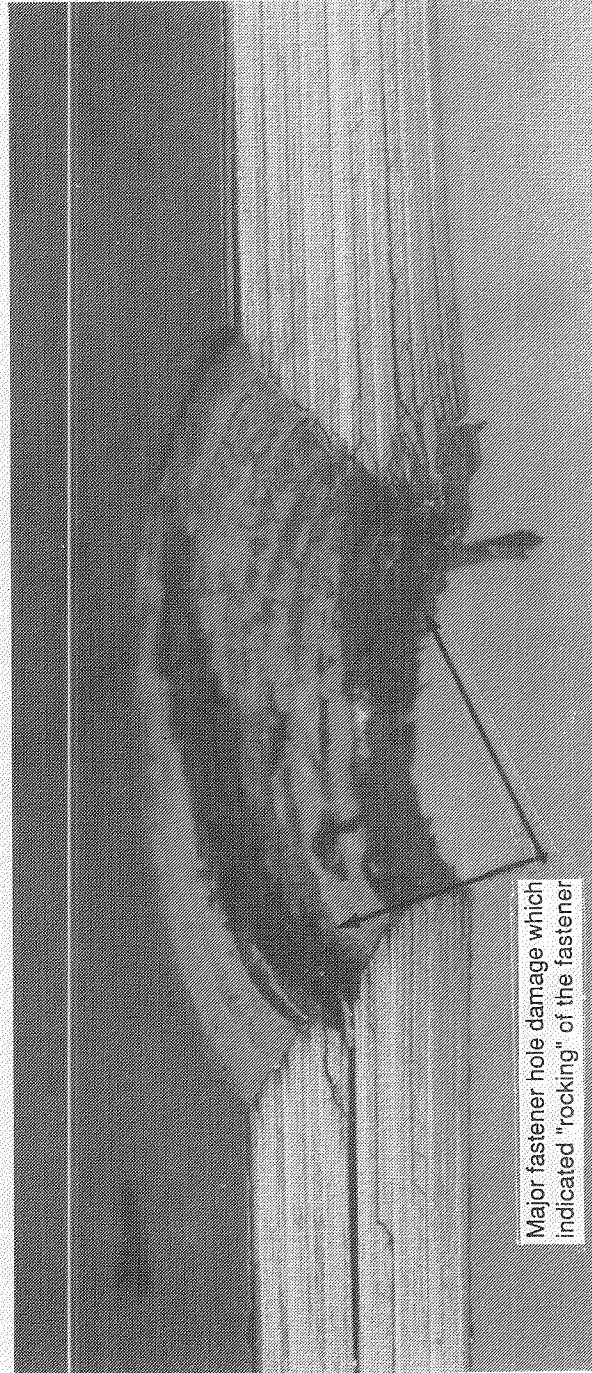
*Figure 2-26. Damage in Fastener Hole Loaded Under Shear*

In conjunction with stress analysis, visual examination was performed using fastener hole damage as evidence to determine the loading condition experienced by the panel during the test. The key evidence was the depth and elongation of the hole. In general, hole elongation indicates shear-type loading in which the head and the shank of the fastener tilt at an angle to the hole. Figure 2-26 illustrates the damage of a typical shear loaded fastener hole. The damage seen in the countersunk region of the fastener hole was created by the fastener head which dug into the laminate due to the test load. In contrast, tension loaded fastener holes did not show any sign of elongation, retaining their circular shape (Figure 2-27). The fastener head dug beyond the countersunk region causing severe delamination near the inner edge of the hole. Figure 2-28 shows the mapping of the fastener hole damage. From the mapping, it was determined that Region A of the panel was loaded under tension and shear. However, Region B seemed to have been securely fastened to a fixed structure as evidenced by the lack of fastener hole damage in that portion of the panel.

experienced a substantial amount of shear loading compared to the rest of the panel. The recommendation would be to examine the hole damage and make appropriate changes in the fasteners (i.e., change to shear or tension) to accommodate the load conditions experienced during the initial testing. Due to the fact that the mechanical test was unknown, recommendation for design improvement is difficult.

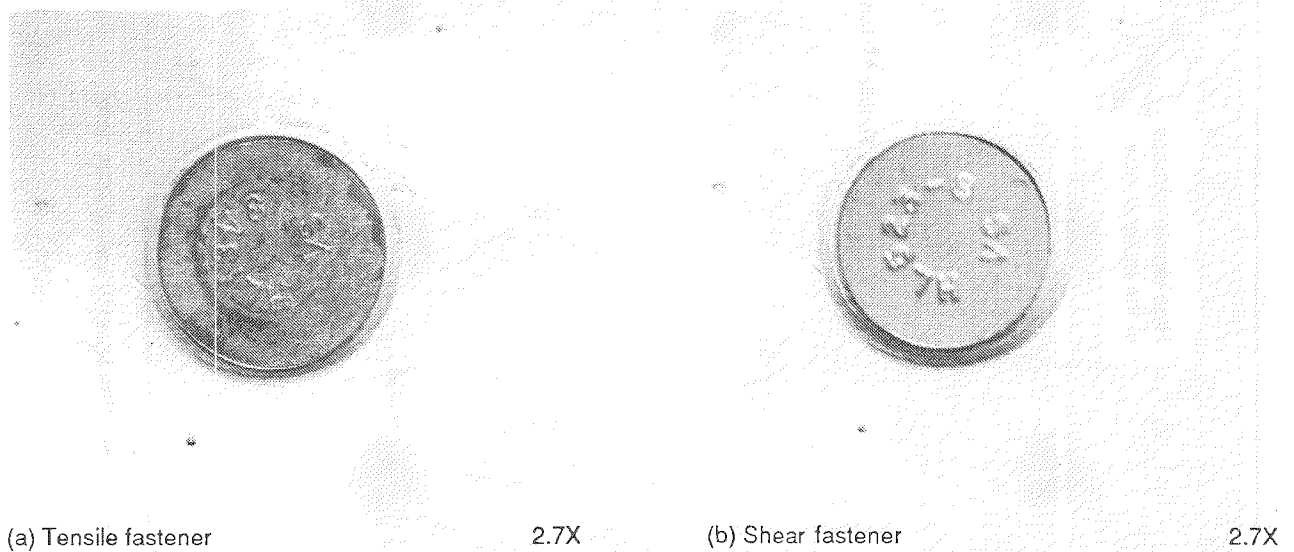
Figure 2-29. Difference in Fastener Fit in the Undamaged Fastener Hole

The fastener hole damage also provided information to verify the proper use of the fasteners or the fastener holes for the particular load conditions applied. Two commonly used fasteners were placed into an undamaged fastener hole to determine which had been used (Figure 2-29). The tensile fastener, which has a slightly larger head diameter than the (intermediate) shear fastener, fitted flush into the undamaged hole. However, when the fasteners were placed into one of the fastener holes damaged from tensile loading (Figure 2-30) it was evident that the shear fastener was used. The tensile fastener head was too large for this particular fastener hole damage, but the shear fastener fitted almost perfectly into the damaged hole. The above macroscopic analysis suggests that the tensile fasteners were used for Region B and shear fasteners were used for Region A.

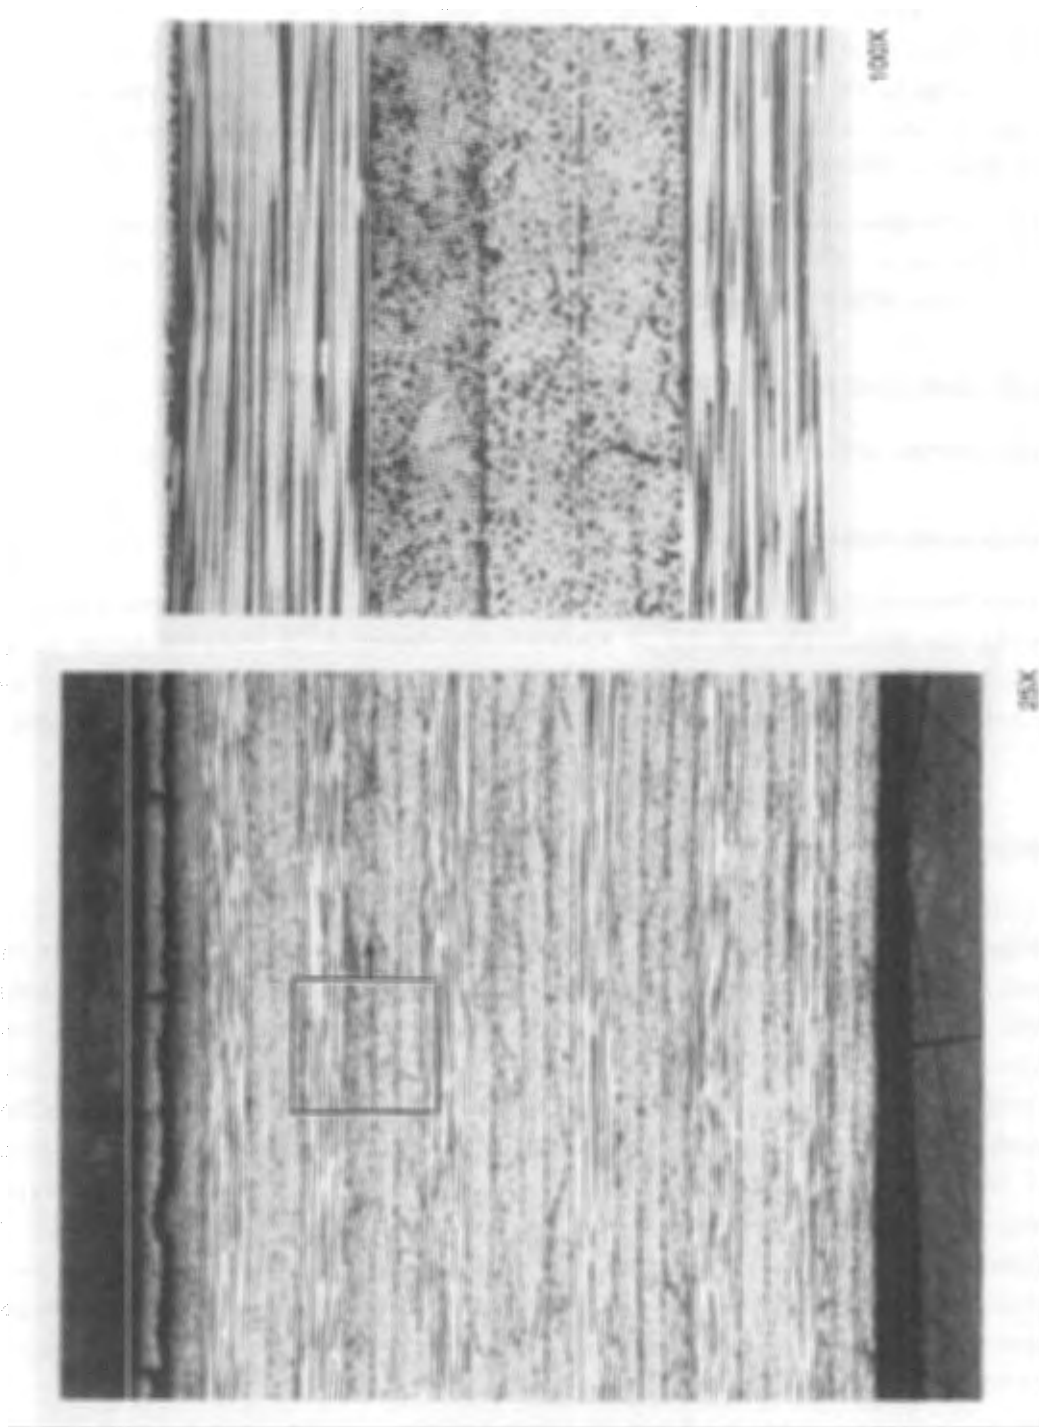
Figure 2-37. Cross-Sectional View of the Panel

Evaluation of an area away from the fracture showed that the quality of the laminate was good (with little porosity) and the ply stacking sequence was symmetrical (Figure 2-37). Due to the severity of the fiber damage near the apparent impact site, it was impossible to perform an evaluation of the cross-section.
