WL-TR-91-4032  
DOT/FAA/CT-91/23  
VOL II, Part 3

COMPOSITE FAILURE ANALYSIS HANDBOOK  
VOLUME II - TECHNICAL HANDBOOK  
PART 3 - CASE HISTORIES

R.J. Kar  
Northrop Corporation  
One Northrop Avenue  
Hawthorne, California 90250-3277

February 1992

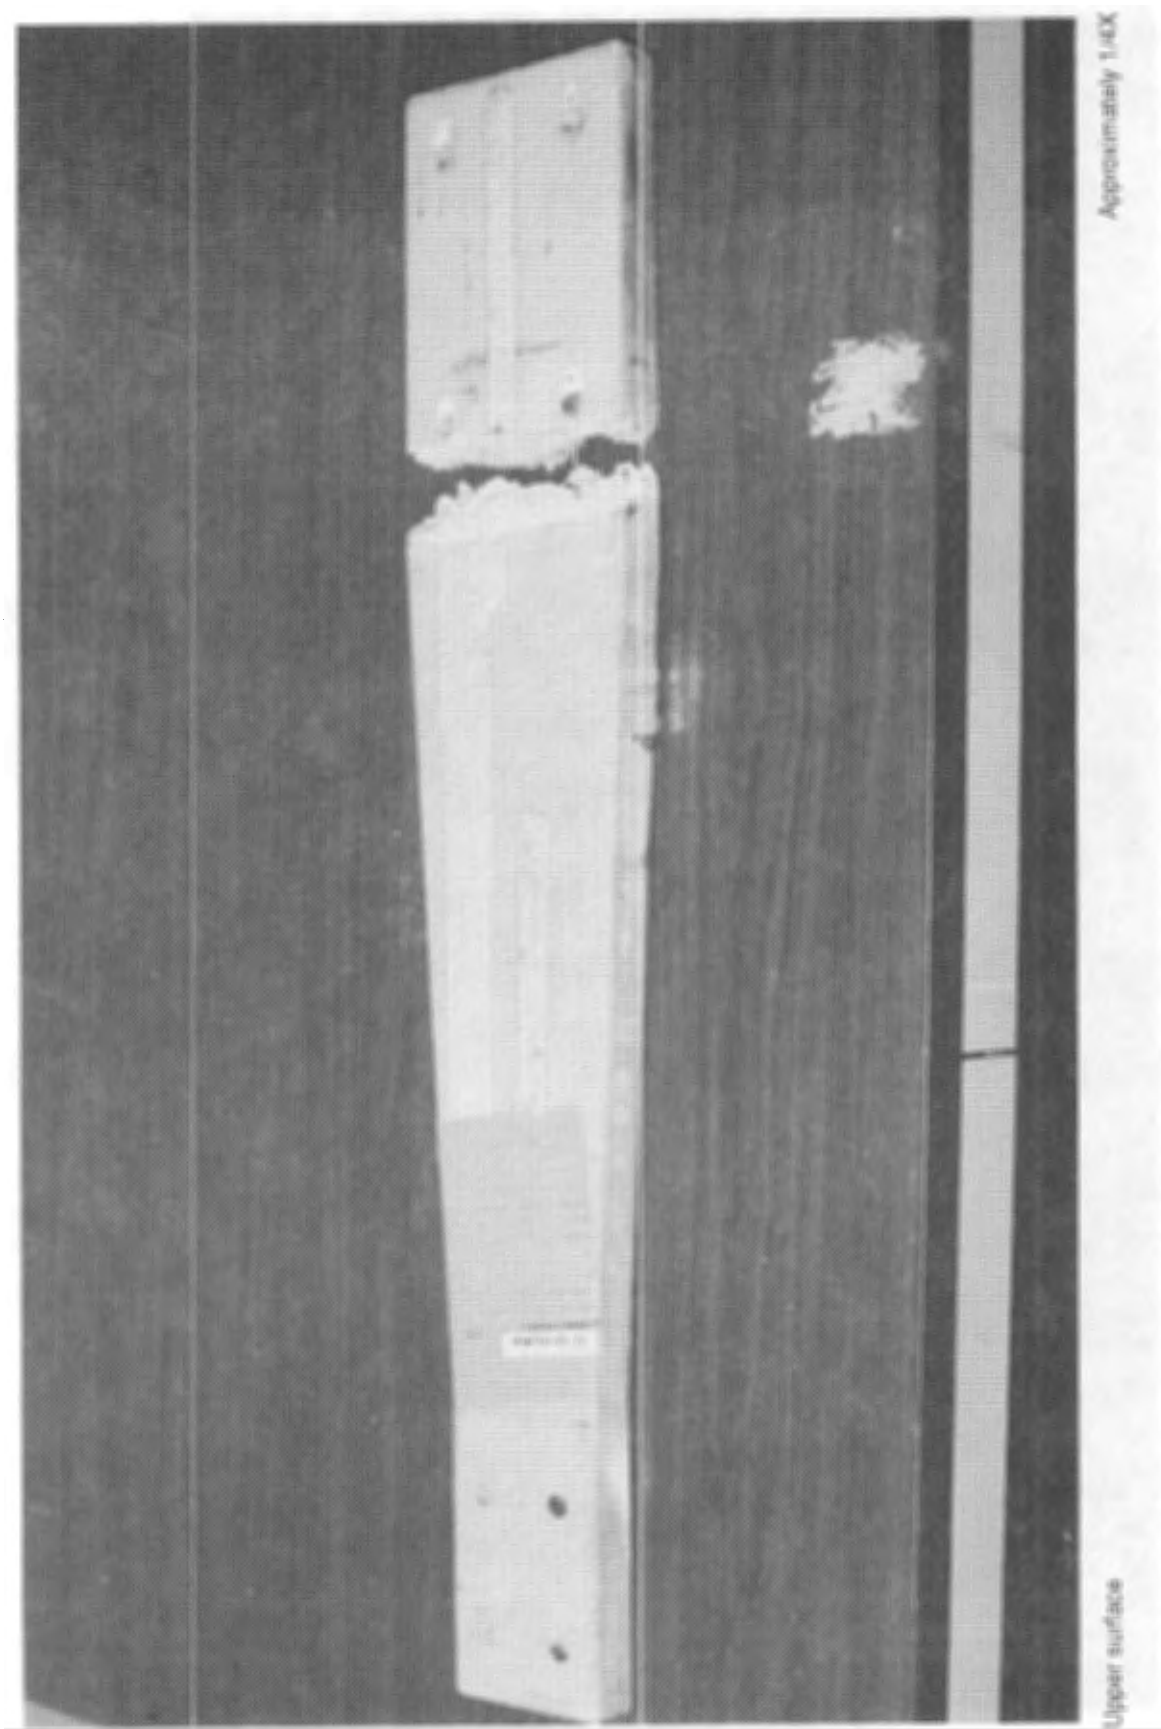
Figure 2-38. Macro photograph of the Upper Surface of the Landing Strut As-Received

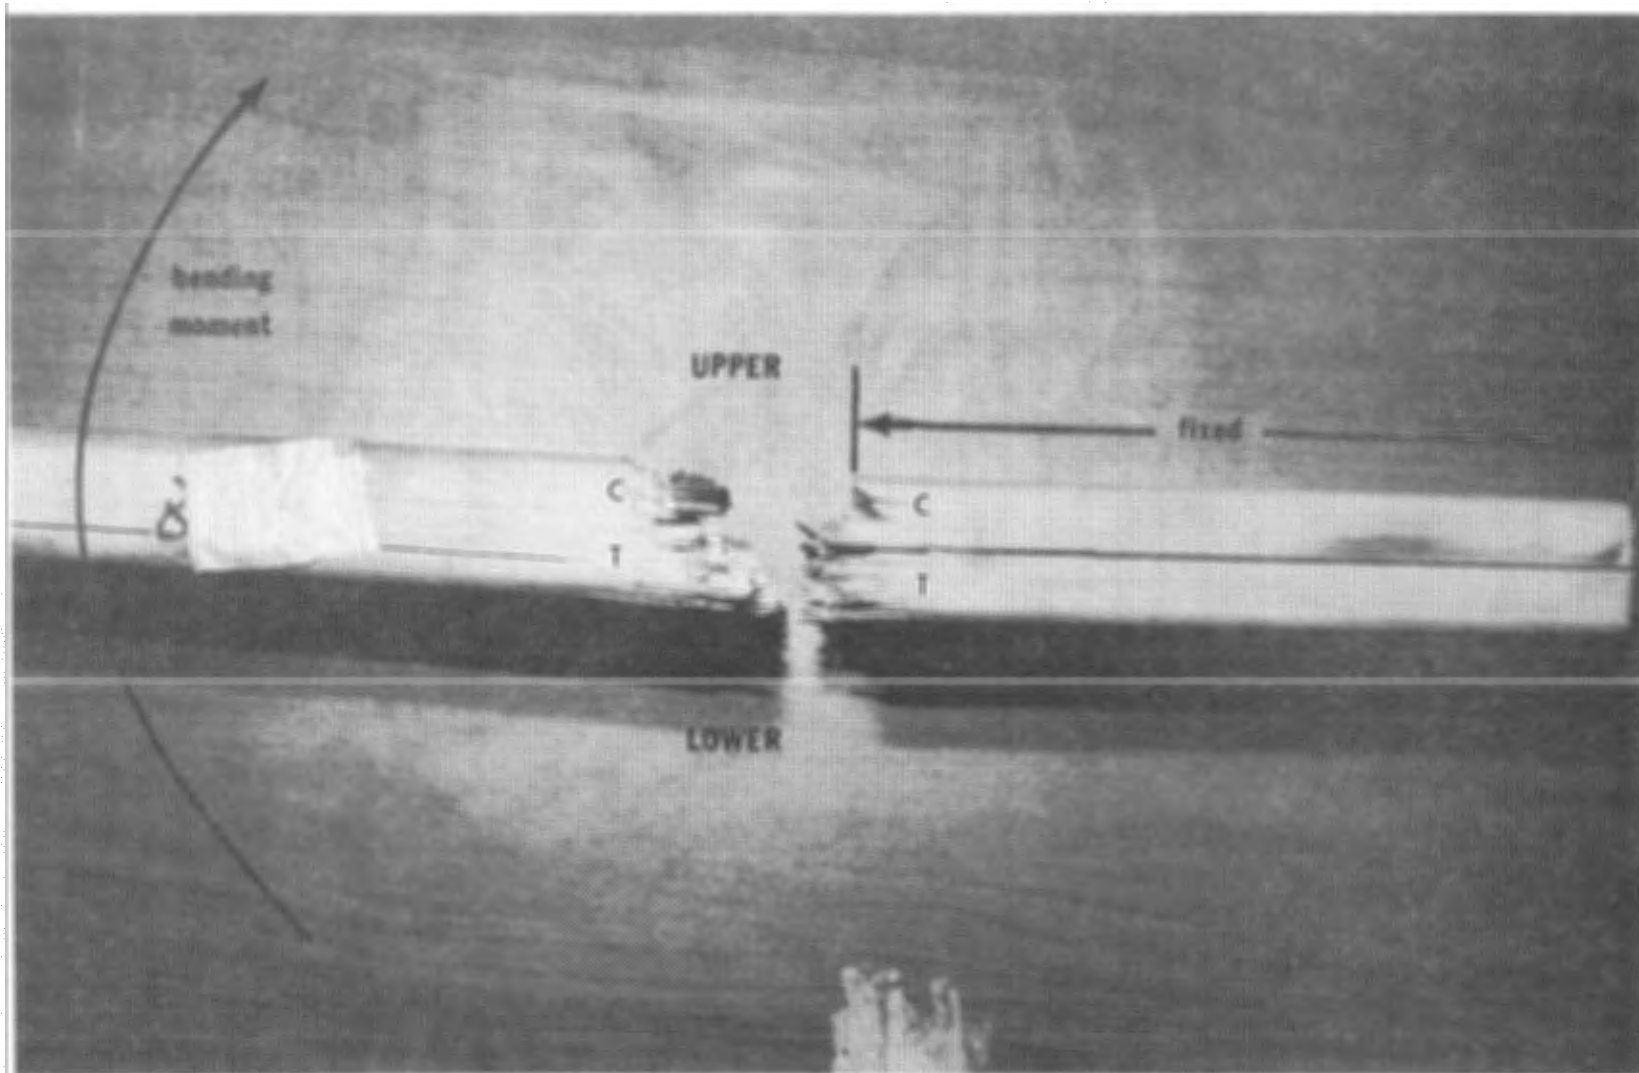
Side view—delaminations

Neither portion of this strut was completely separated by delaminations. The figure shows the apparent loading conditions which led to failure. The bending moment was the greatest at the edge of the fixed portion of the strut, the failure location. As anticipated from this loading condition, the upper surface failed in compression (C) and the lower surface failed in tension (T).

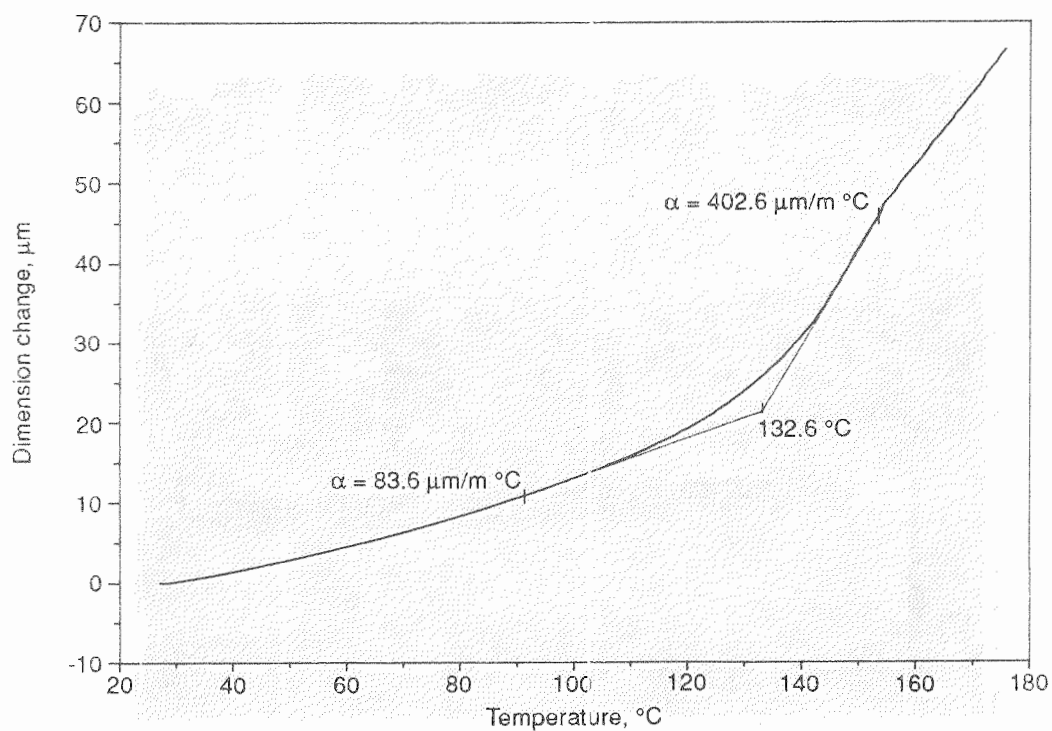
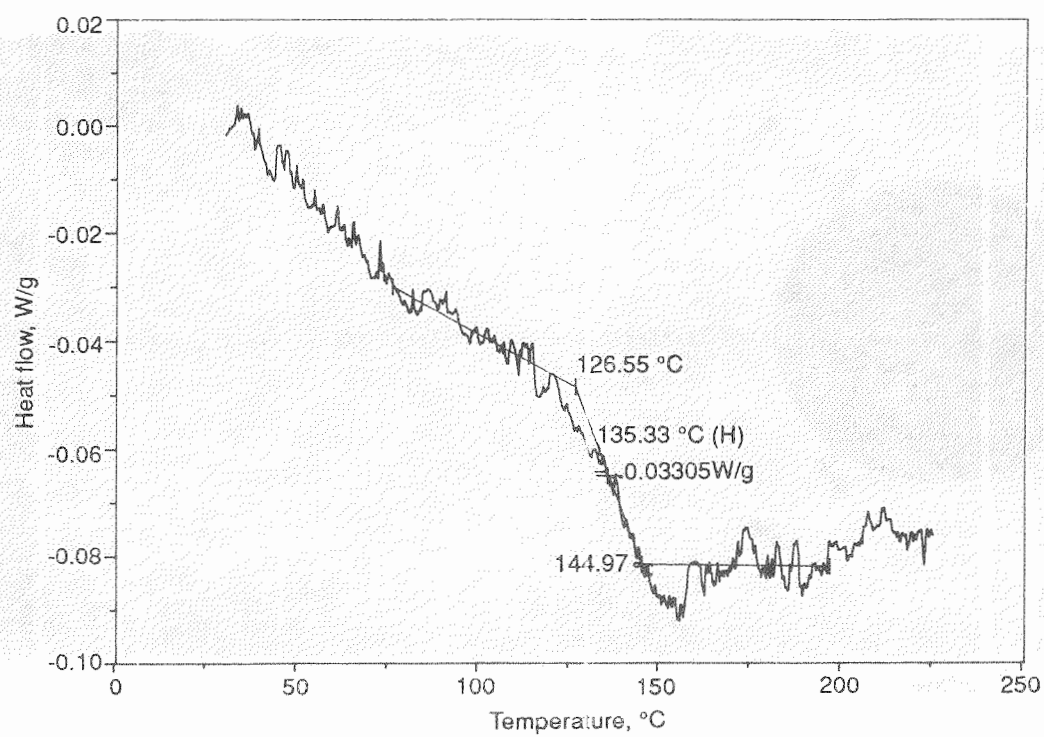
Figure 2-43. TMA and DSC Thermograms of Strut

Nearly identical results were obtained from the glass transition temperature measurements by TMA and DSC (see Figure 2-43). These values were 133°C (271°F) and 135°C (275°F), respectively. These are typical values for a 121°C (250°F) epoxy resin. A metallographic section was taken through a bulged area (see Figures 2-44 and 2-45), found adjacent to a bolthole, which was apparently the result of constraint by the bolt. This section revealed microbuckling of fibers in a crack-like formation extending from the delamination toward the lower surface. Fiber and matrix details were difficult to discern from the prepared section, but the overall condition of the laminate appeared to be good.

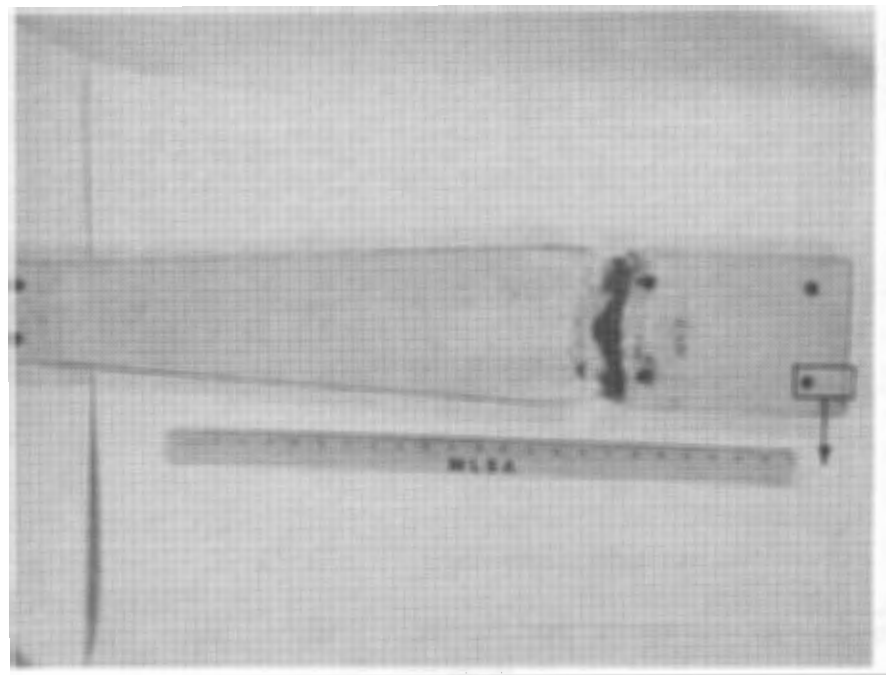
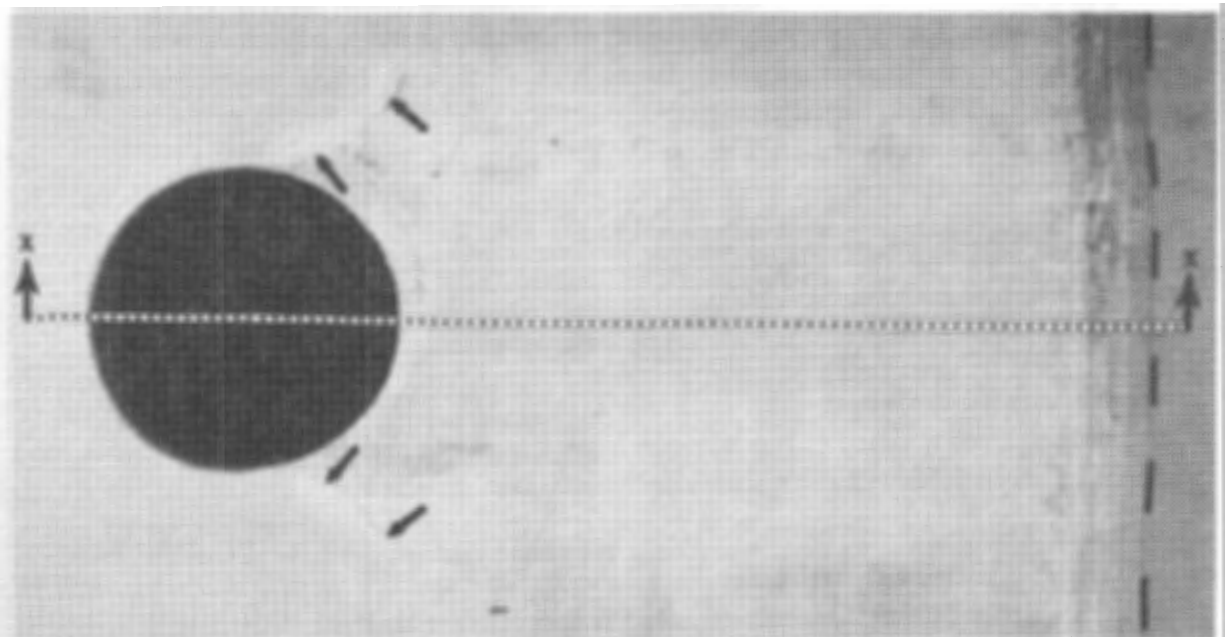
**Figure 2-44. Macrophotographs of the Lower Surface of Strut**

The figure shows the location and the orientation of section X-X, magnified in Figure 2-45. The local bulging at the end of the strut (emphasized by the segmented line) occurred as a result of a restraint from the bolt. Cracks labeled by the small arrows were also generated by this loading condition.

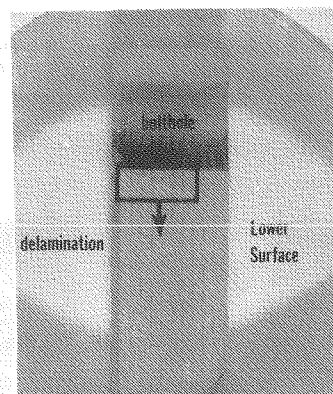
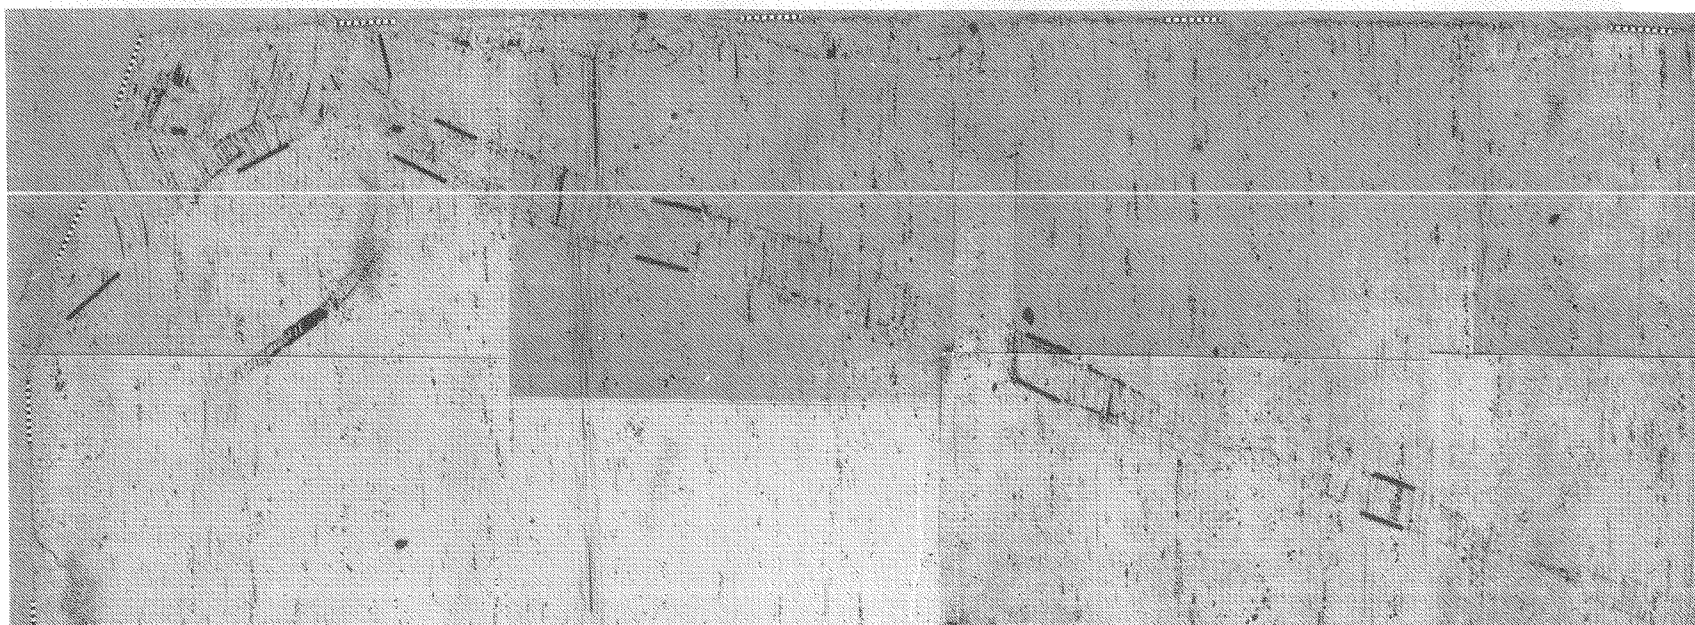
**Figure 2-45. Macro photograph (A) and Photomicrograph (B) of Section X-X Taken Through the Bolt Hole and End**

The segmented black lines outline a region of fiber microbuckling damage induced by the local restraint of the bolt on this side of the bolt hole. The delamination and bolt hole surfaces of this section are outlined by the segmented dashed lines.

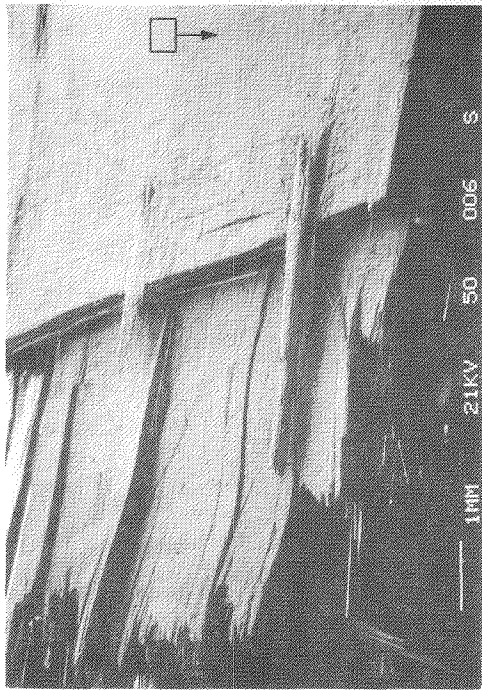
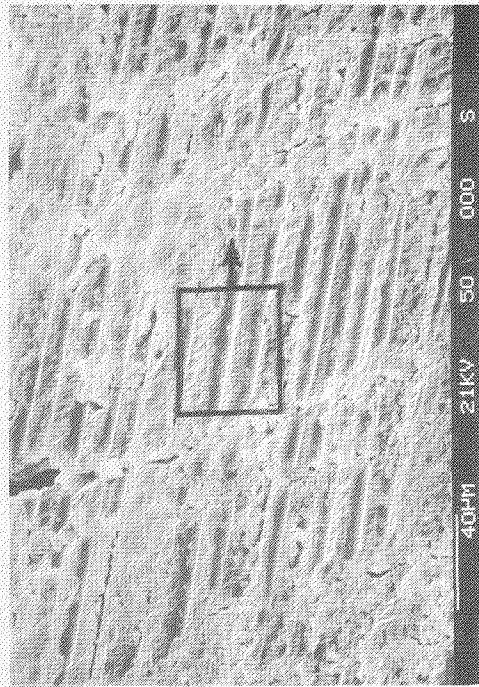
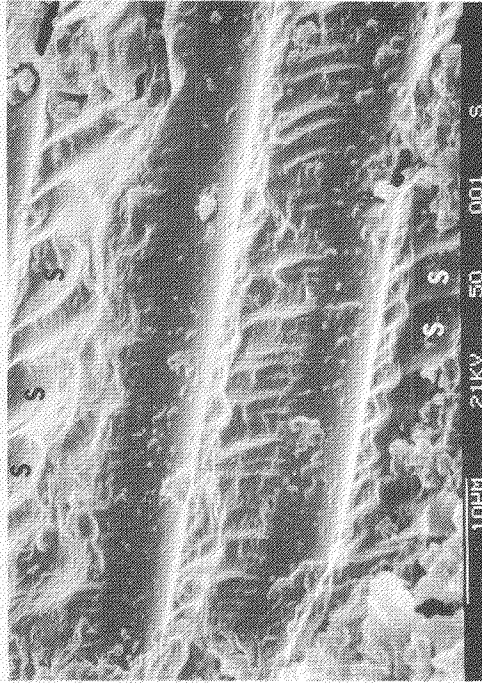
SEM examination was performed on the single delamination of the small piece. Evidence of shear fracture (scallop and hackles) was observed on the laboratory-exposed surface of this delamination (see Figures 2-46 and 2-47). The propagation direction was oriented axially along the length of the strut, but the exact direction could not be determined. Examination of the tensile half of the translaminar fracture revealed radial patterns on fiber end fractures (see Figure 2-48). The resultant direction of crack-propagation, determined by mapping the directions in which the lines radiate in the individual fiber fractures, was from the lower surface (tension) toward the delamination. Examination of the compressive half of the translaminar fracture revealed buckled fibers displaying chop marks (see Figure 2-49), typical of compressive failures. Although SEM examination of the translaminar fracture was conducted around the bolthole region, the non-conducting surfaces encountered produced images which were not of sufficient quality to include in this report. SEM examination of the translaminar fracture was difficult to perform, due to the extreme depth of this fracture. This prevented adequate application of gold (even after multiple sputter applications) to get a uniformly covered surface. Therefore, charging of uncoated areas during SEM examination made the location of suitably informative, fiber fractures difficult to perform.

**Figure 2-46. SEM Fractographs of Delamination at the Translaminal Fracture Surface of the Small Piece**  
Scallops indicate shear fracture. The orientation of these scallops indicates propagation of the delamination axially along the strut.

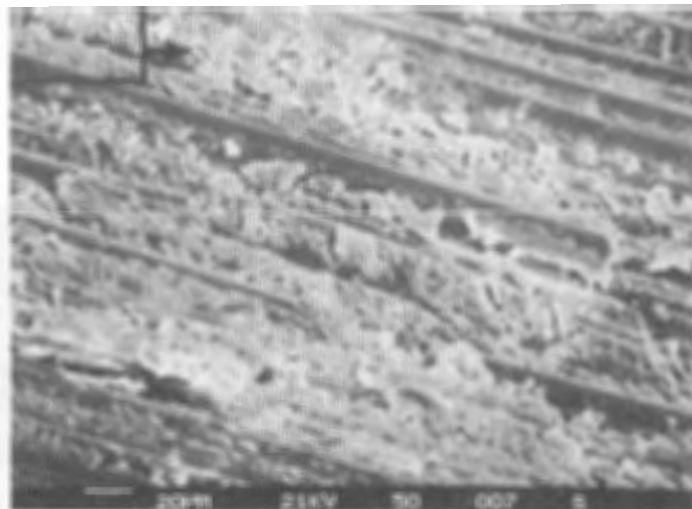
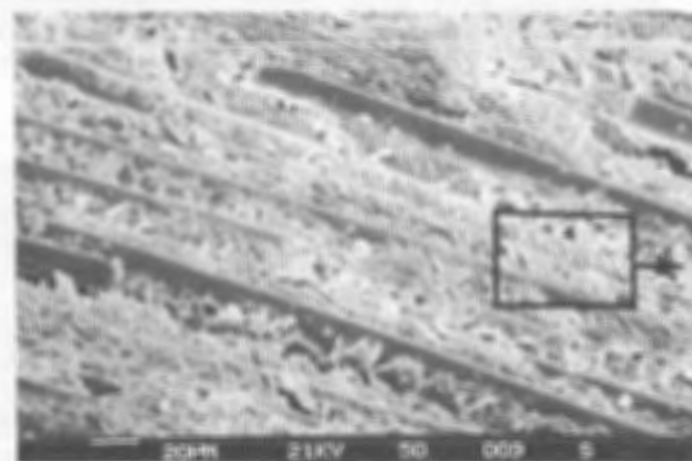
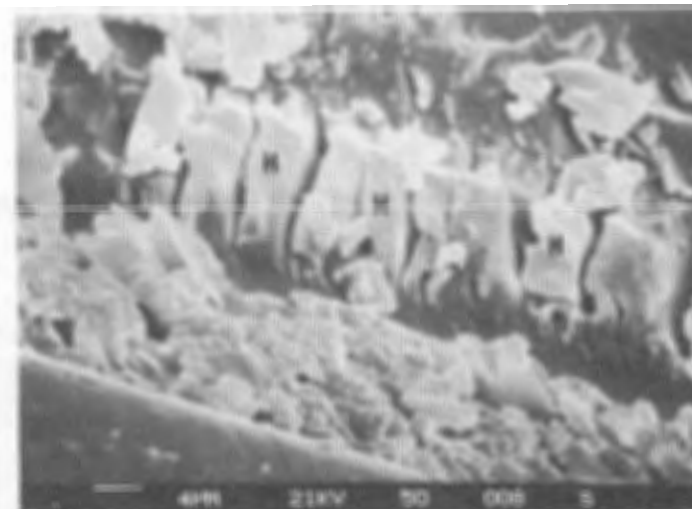
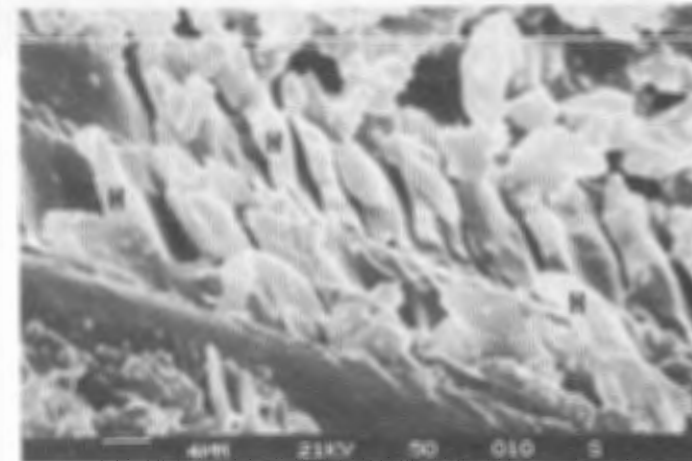
Figure 2-47. SEM Fractographs of  
Hacks indicate shear fracture

Delamination Adjacent to Translaminar Fracture  
and propagation of the delamination axially along the strut.

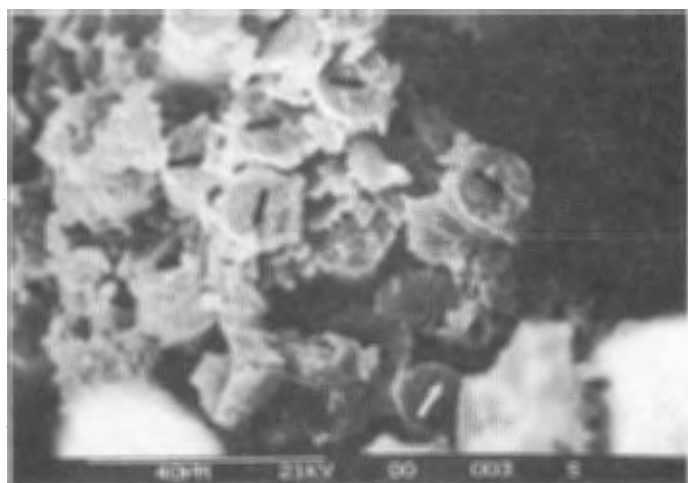
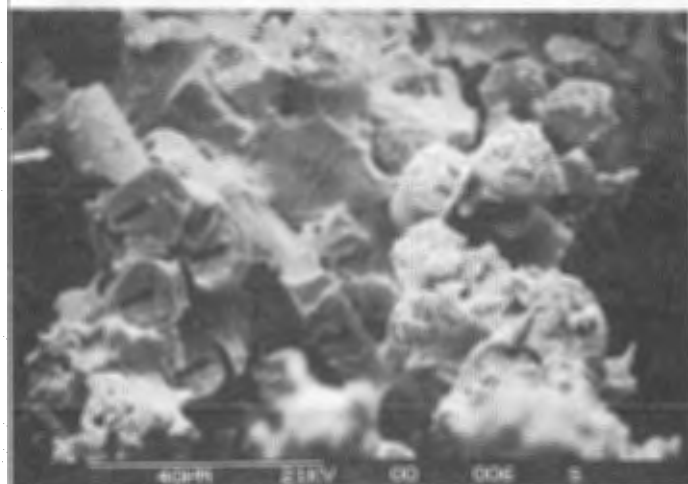
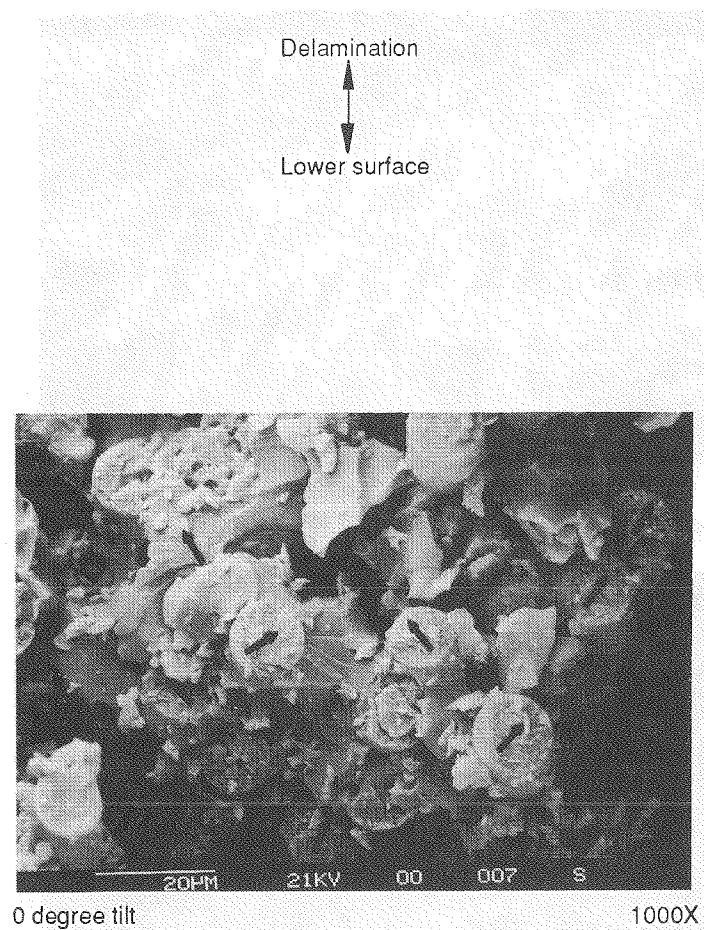
**Figure 2-48. SEM Fractographs of the Tensile Half of the Translaminar Fracture Surface**  
 Small arrows show crack propagation direction indicated by individual fiber end fractures. The overall crack propagation direction indicated by these fibers is toward the delamination from the lower (tensile) surface.

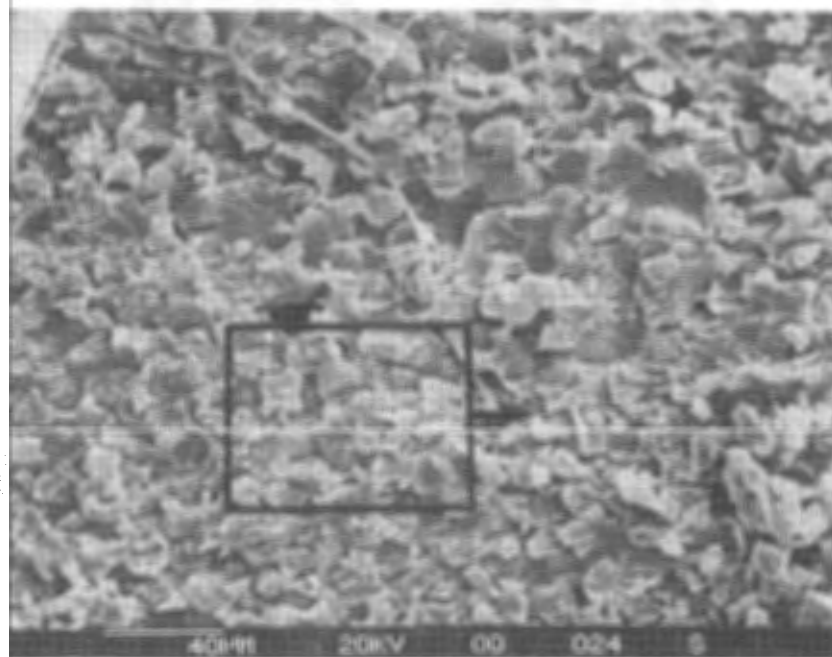
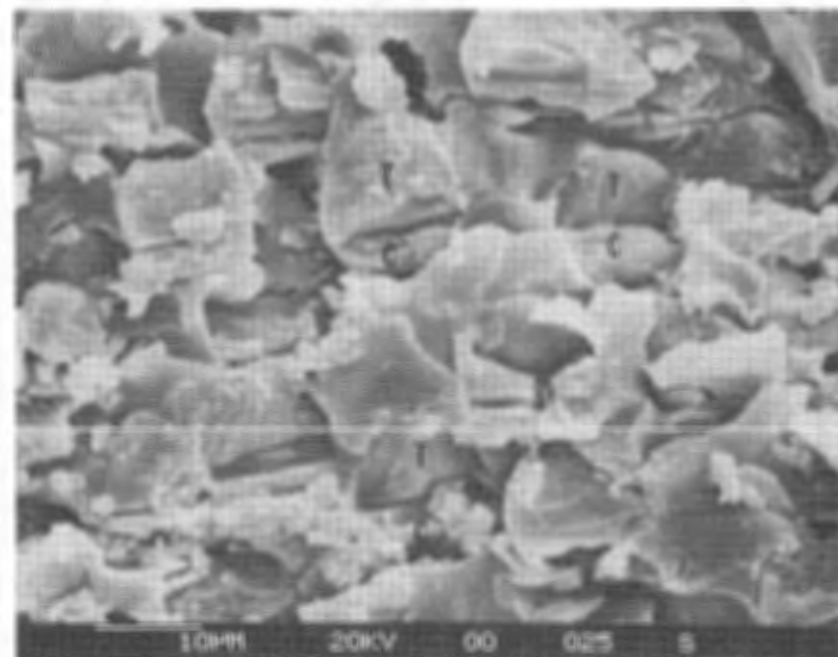
**Figure 2-49. SEM Fractographs of the Compressive Half of the Translaminar Fracture**  
These fractographs exhibit compressively loaded fiber fractures, as indicated by the presence of both tensile and compressive fracture morphology.

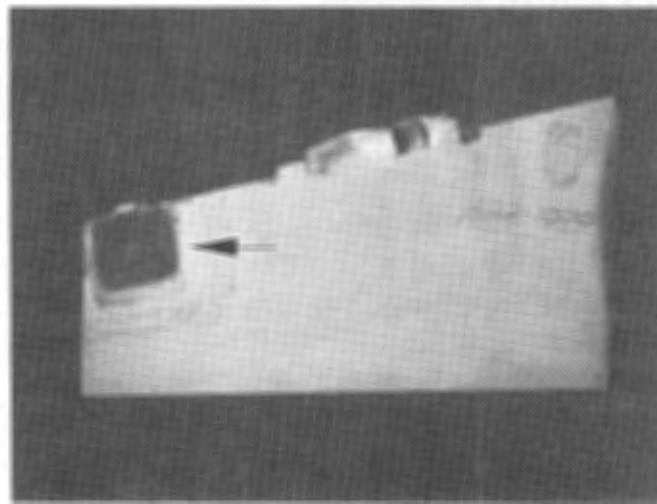
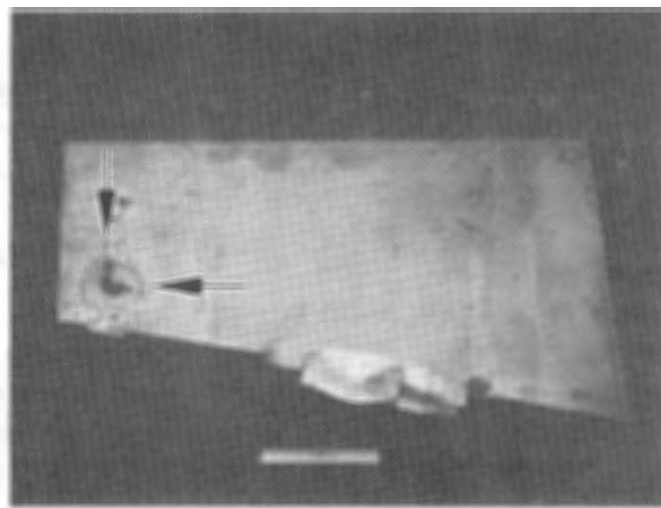
**Figure 2-51. As-Received Photographs of Rudder**

Initial examination of the parts in the as-received condition showed that the rudder labeled P/N 76301-68G240001-1003 was relatively intact, whereas P/N 68A240001-1013, A221070 was the part that had been repaired. Further testing was accordingly concentrated on the latter part. Figure 2-51 shows photographs of the repaired part in the as-received condition. As shown, one of the skins (arbitrarily labeled as the inboard side) had a repair patch close to the leading edge of the assembly. The outboard skin had a localized region of damage as determined by simple coin tap tests, in a region immediately opposite the patch.

Note damage at arrows

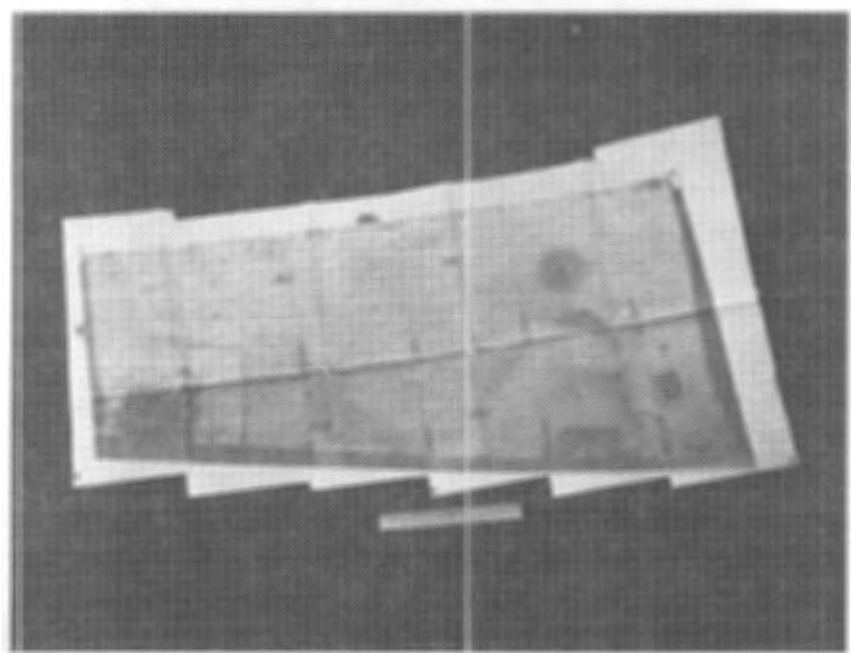
*Figure 2-52. Composite TTU Plot of Rudder*

Initial nondestructive testing of the rudder consisted of conventional through-transmission ultrasonic (TTU) testing of the assembly. Figure 2-52 is a photograph showing a composite of the TTU plot. C-scan testing revealed indications in the outboard skin close to the leading edge.

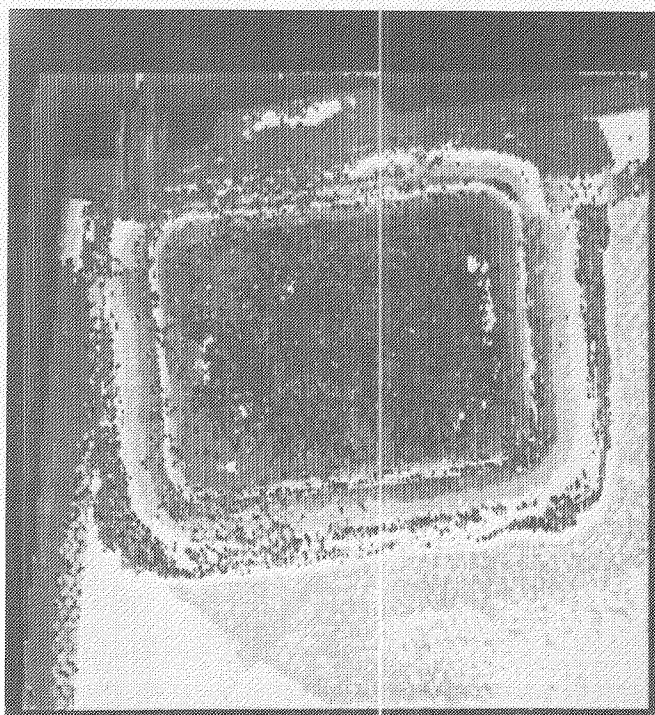
Detailed 2-D and 3-D pulse echo ultrasonic imaging was concentrated on the repair and the outboard skin in the area associated with C-scan ultrasonic indications. Figure 2-53 shows a B-scan of the repair on the inboard skin. No disbonds or delaminations could be detected in the repaired area. Figure 2-54 shows 2-D and 3-D pulse-echo images of the damaged region in the outboard skin. As shown in Figure 2-54a and 2-54b, damage in the outboard skin consisted of a large circular delamination approximately 5 inches in diameter and at a distance of  $2/3t$  ( $t$  = skin thickness) from the top surface. In addition, as shown in Figure 2-54, there were two smaller delaminations closer to the top surface, and extensive porosity in the damaged region.

*Figure 2-53. B-Scan of Repair Region on Inboard Skin*  
Note porosity in repaired area

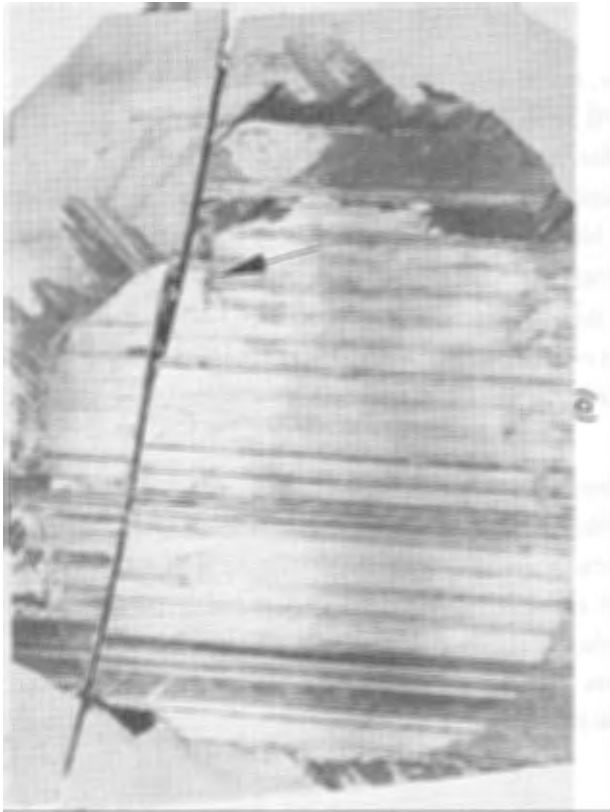
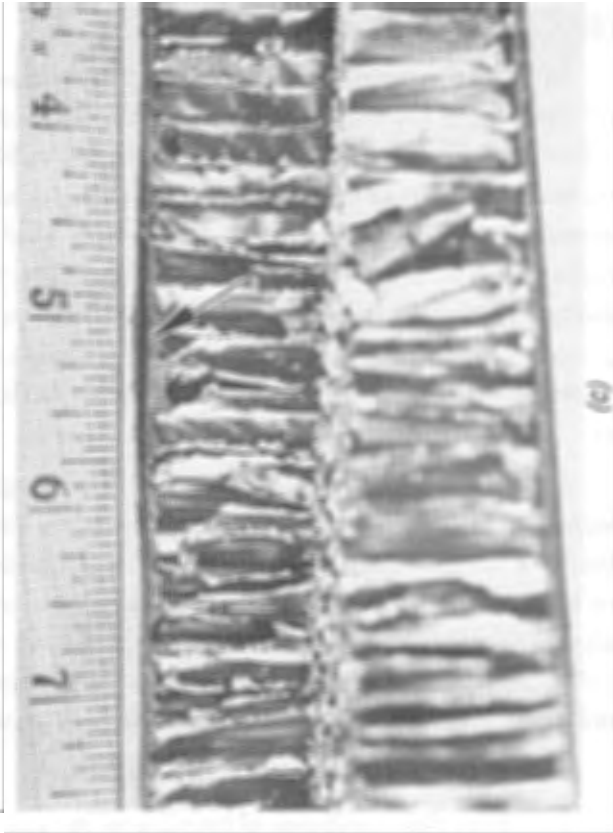
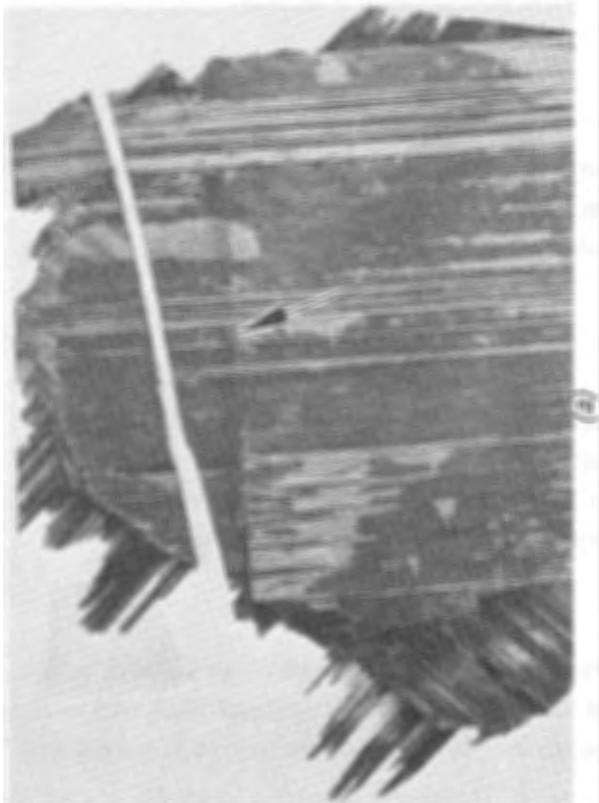
In order to perform fractographic examination, a rectangular coupon was sectioned from the rudder containing the damaged region in the outboard skin, and the repaired region in the inboard skin. The coupon was obtained by sectioning the rudder well away from the regions of interest using a flood-cooled carbide saw. The defect surface associated with the primary delamination was exposed by means of a controlled saw cut and gentle peel loads in the laboratory. Figure 2-55 shows macrophotographs of the coupon after exposing the fracture. As shown in Figure 2-55a and 2-55b, the fracture surface associated with the delamination was highly reflective and had a colored ridge of epoxy traversing the surface, approximately 3 inches away from the center of the delamination. Also of interest was the observation that the damage indications were not due to core disbond (see Figure 2-55c).

**Figure 2-55. Macrophotographs of Delamination Fracture in Coupon From Damaged Area**  
**(a) Bottom View of Top Skin**  
 Note epoxy ridge in delamination (at arrow)  
**(b) Top View of Core**  
 Note epoxy ridge in delamination (at arrow)  
**(c) Lateral View of Assembly Showing Absence of Core Disbond**  
 Note damage (at arrow)

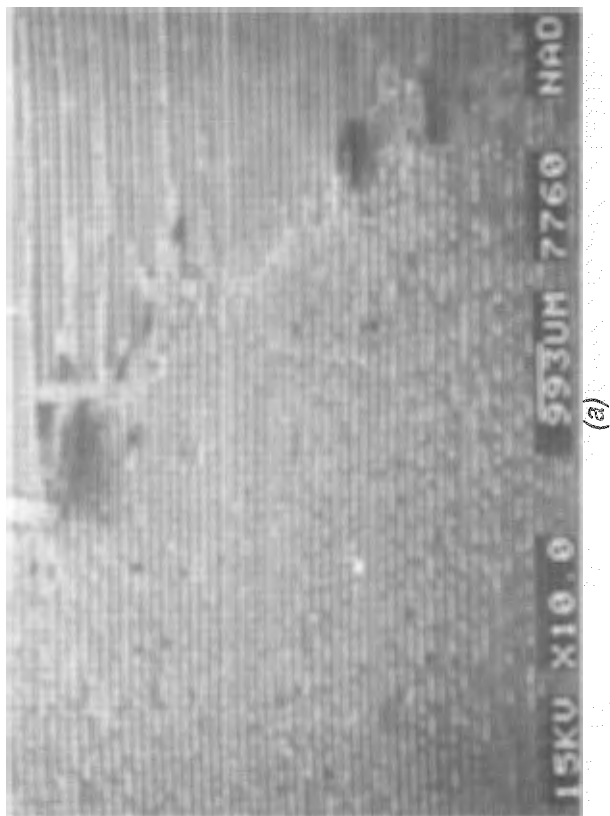
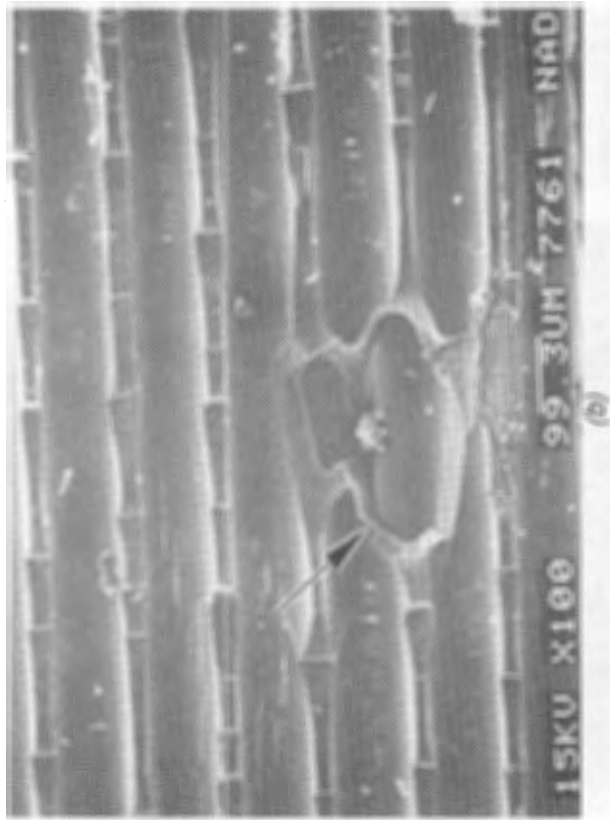
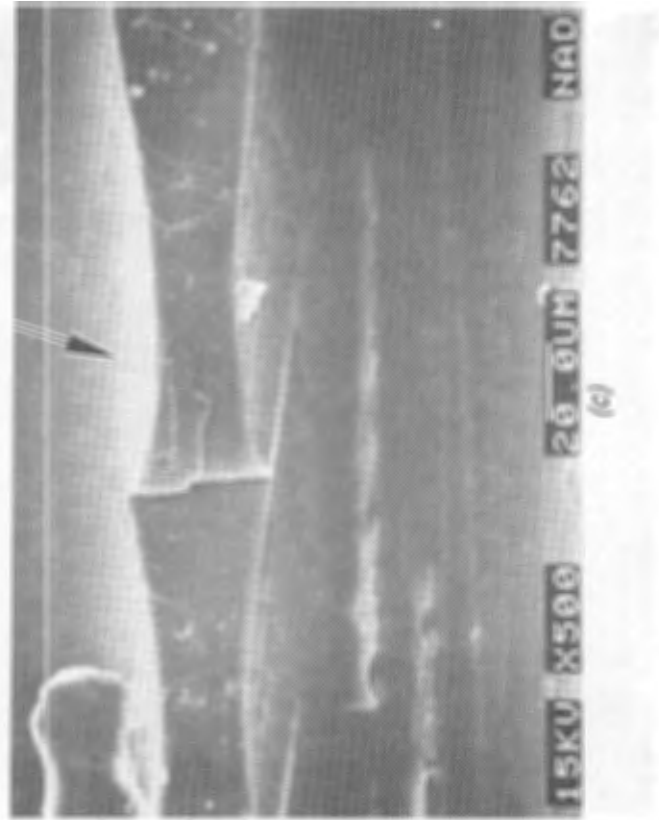
Figures 2-56 and 2-57 show SEM photographs of fracture features observed in the delamination region and in regions adjacent to the delamination. In the region of the delamination, the fracture surface exhibited a "resin-starved" condition, with very little evidence of fracture. As shown in Figure 2-56, stray hackles could be observed; however these were associated with very fine porosity. The epoxy ridge shown in Figure 2-55 was also associated with fine porosity (see Figure 2-57b). The laboratory fracture regions, in contrast, were associated with peel fracture characteristics in the form of river patterns in fractured epoxy (Figure 2-57c).

Figure 2-56. SEM Photographs of Delaminated Surface  
 (a) Low Magnification  
 (b) Intermediate Magnification Showing  
       Resin-Starved Condition (Arrow)  
 (c) High Magnification Showing Porosity (Arrow)

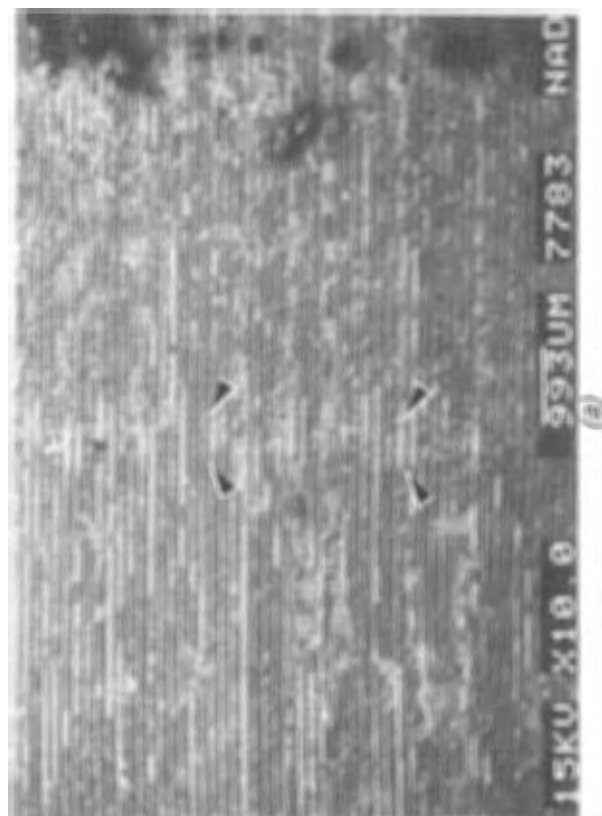
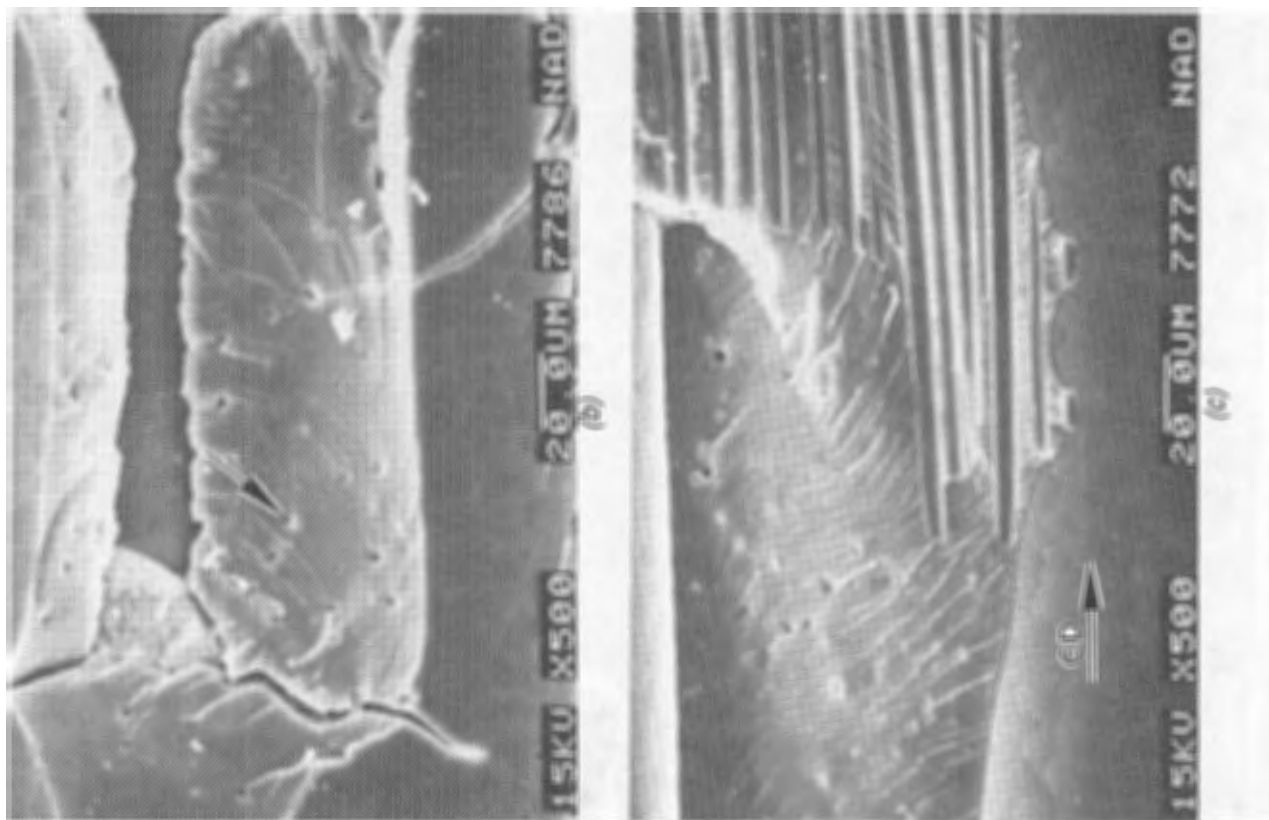
Figure 2-57. SEM Photographs Showing Fracture Details in Delamination  
 (a) Low Magnification Showing Epoxy Ridge (Arrows)  
 (b) Porosity in Epoxy Ridge (Arrow)  
 (c) Peel Fracture in Laboratory Overload Region  
 CD = Crack-propagation direction

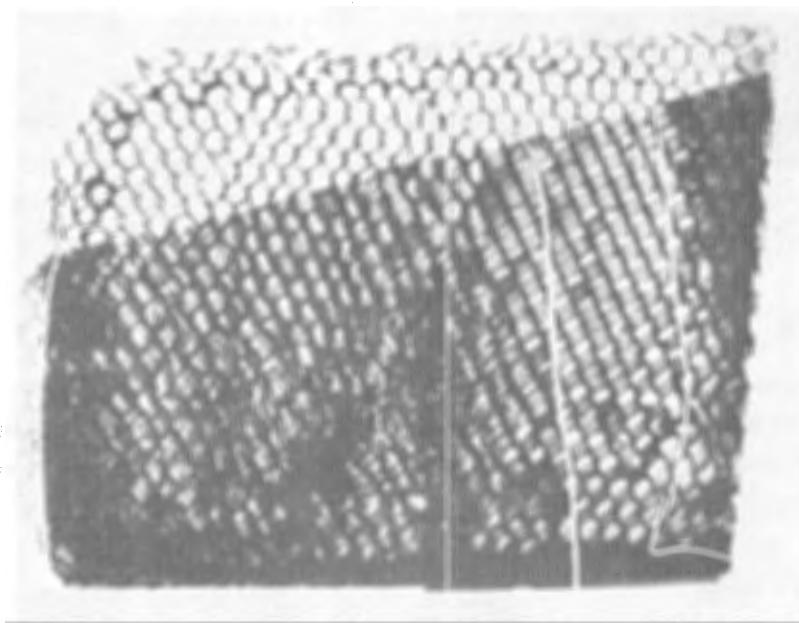
The occurrence of porosity in the defect was considered unusual and suggested that it may have occurred prior to the delamination event. Consequently, X-ray examination was carried out on the rudder assembly. Radiographic examination revealed a "blown-core" condition in the rudder as is illustrated in Figure 2-58.

The occurrence of a blown core condition indicated that moisture had played a role in the failure event. It was concluded that failure occurred when repair was attempted with wet core. During repair, the moisture turned into steam, and cause localized delaminations in the outboard skin.

**Figure 2-58. X-Ray Radiograph Shows Blown-Core in Rudder**
