WL-TR-91-4032  
DOT/FAA/CT-91/23  
VOL II, Part 3

COMPOSITE FAILURE ANALYSIS HANDBOOK  
VOLUME II - TECHNICAL HANDBOOK  
PART 3 - CASE HISTORIES

R.J. Kar  
Northrop Corporation  
One Northrop Avenue  
Hawthorne, California 90250-3277

February 1992

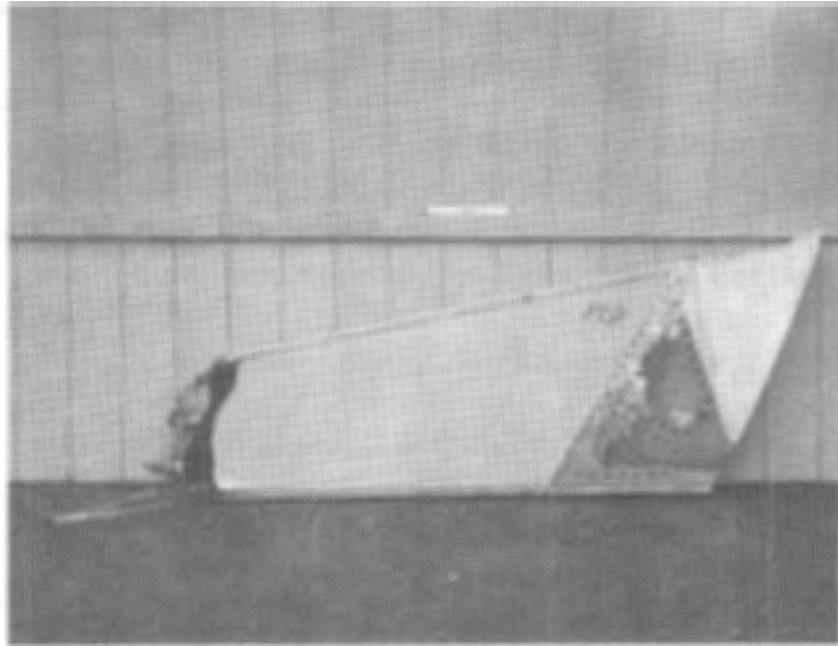
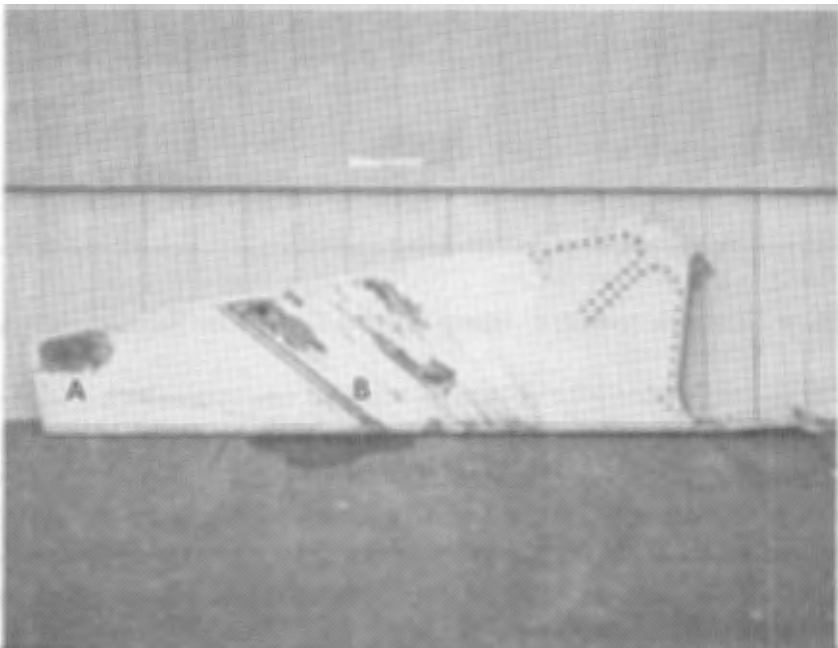
**Figure 2-61. As-Received Photographs of Horizontal Stabilizers**

Figure 2-61 shows photographs of the parts in the as-received condition. P/N 7630168A890054-2003 (hereafter referred to as stabilizer #1) had the outboard tip missing (Figure 2-61a), whereas P/N 7630168A210053-1015 (hereafter referred to as stabilizer #2) had extensive damage on the outboard flight surface (Figure 2-61b). The overall appearance of damage on stabilizer #1 suggested that the damage may have been a post-failure event. The appearance of the outboard skin damage on stabilizer #2 suggested foreign object or impact damage. Based on discussions with the Air Force, further evaluation was concentrated on stabilizer #2.

**(b) Skin Damage on Stabilizer #2, P/N 7630168A210053-1015**

Note damaged zones A and B

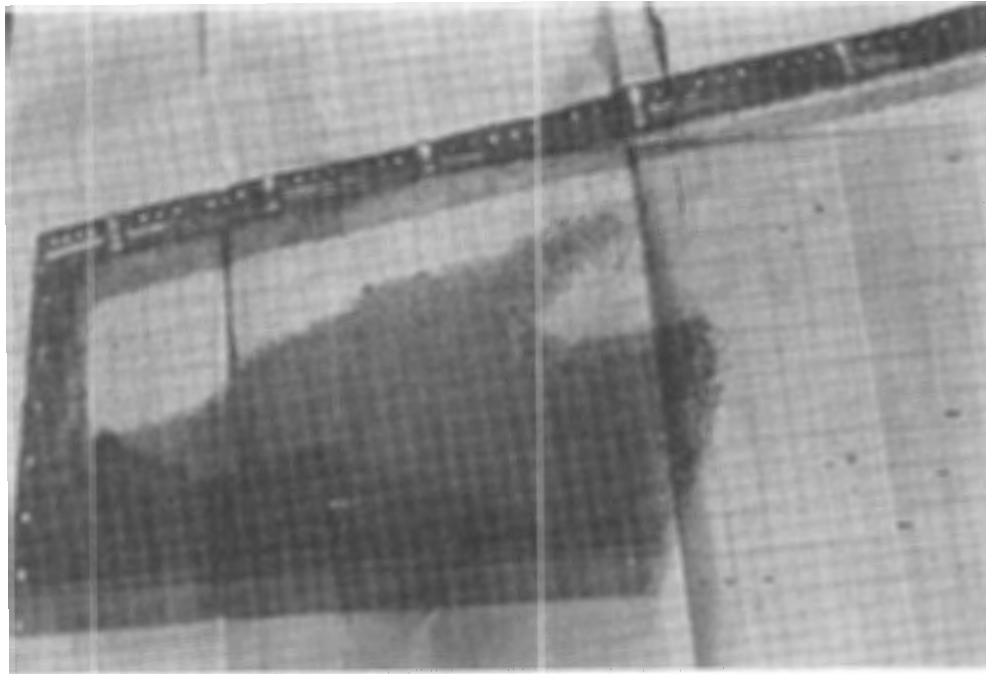
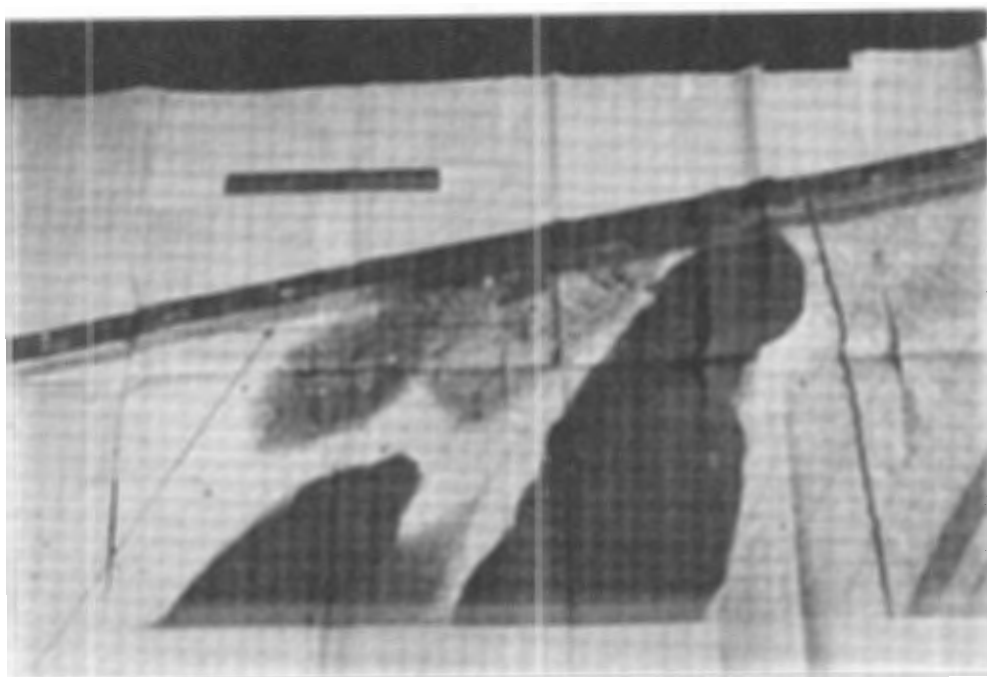
Initial nondestructive testing of the part consisted of conventional through-transmission ultrasonic (TTU) C-scan testing of the assembly. Figure 2-62 shows photographs of the C-scan plots. Damage in stabilizer #2 consisted of two zones, 1) damage at the outboard end of the stabilizer adjacent to the trailing edge (Figure 2-62a), and 2) mid-section damage extending approximately 9 inches span-wise, and approximately 10 inches chord-wise, starting from the trailing edge (Figure 2-62b).

Figure 2-62. TTU C-Scans of Horizontal Stabilizer  
 (a) Damage on Outboard Location Near Trailing Edge (Zone A in Figure 2-61b)  
 (b) Mid-Spar Damage (Zone B in Figure 2-61b)

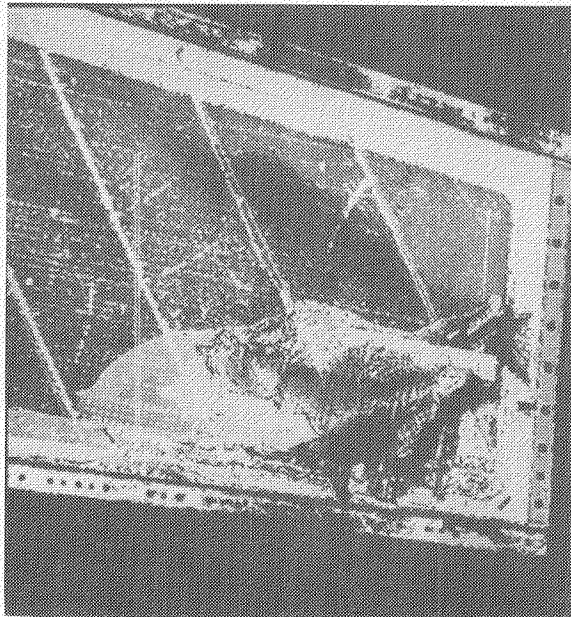
Detailed 2-D and 3-D pulse echo ultrasonic imaging was concentrated on these two zones of damage. Figure 2-63 shows pulse-echo images of the damage at the outboard end. Orthogonal cross-sections of the 2-D image (Figure 2-63a) revealed that the damage in this zone (hereafter referred to as zone A) consisted of two principal regions of delamination (Figure 2-63b) with one close to the outer skin, and the second closer to the back face of the skin. Damage in the mid-section location (hereafter referred to as zone B) started at or very close to the top face, and extended across the flight surface and into the interior (Figure 2-64).

**Figure 2-63. Pulse-Echo Images of Damage at the Outboard End of the Stabilizer (Zone A)**  
 (a) 2-D Image Showing Delamination  
 (b) Orthogonal Section Showing Two Zones of Delamination

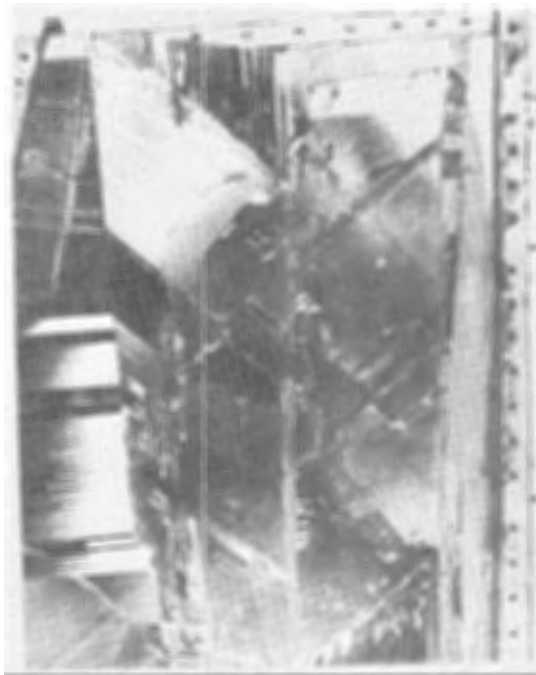
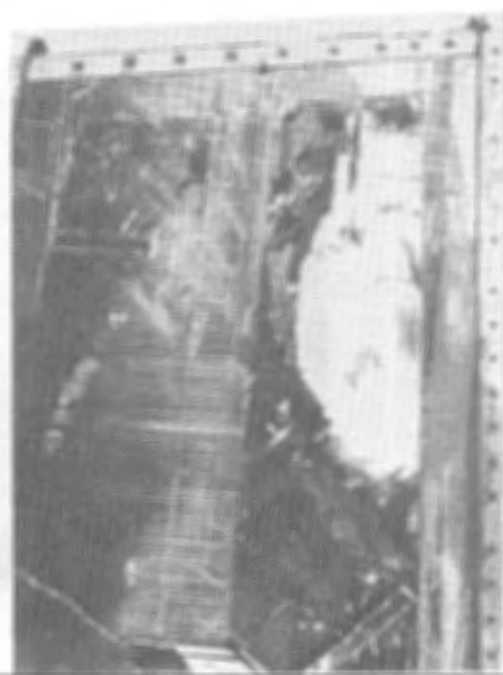
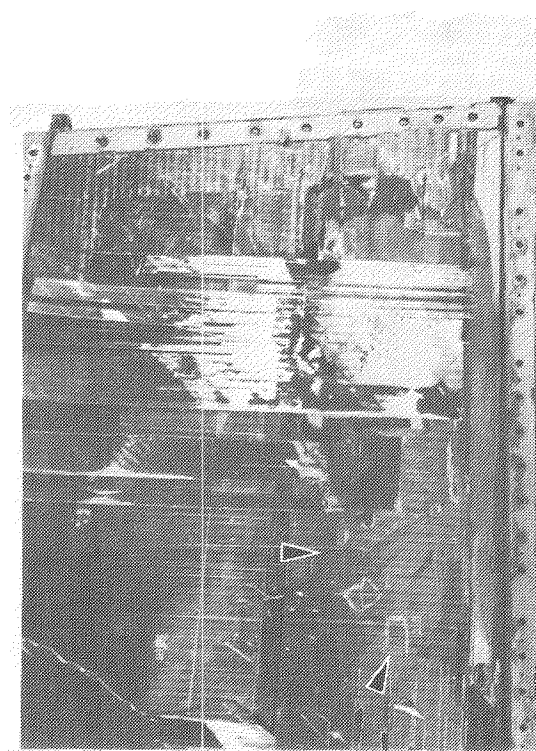
Figure 2-65 shows macrophotographs of damage in zone A. Figure 2-65a shows the fracture with the outer (top) ply of the skin removed. Several features were of interest. The overall fracture had a shiny appearance, with extensive occurrence of rubble. The laminate surface had a wrinkled appearance, and this was determined to be due to localized buckling of plies (see Figure 2-65a). Figures 2-65b and 2-65c show photographs of the defect surface with the second and third plies removed. It was determined that in each layer there was a fan-shaped region of buckled plies and extensive rubble.

Figure 2-65. Evaluation of Skin Damage in Zone A After Ply Removal

- (a) Top Layer Removed
- (b) Second Layer Removed
- (c) Third Layer Removed

Note buckled plies and wrinkling at arrows

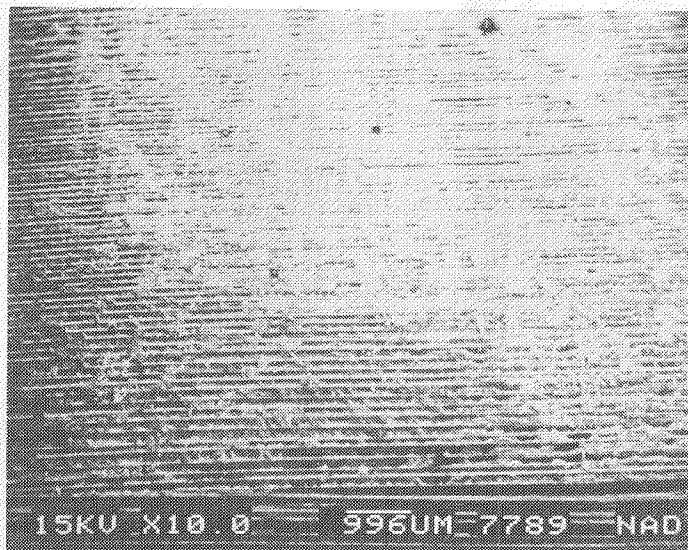
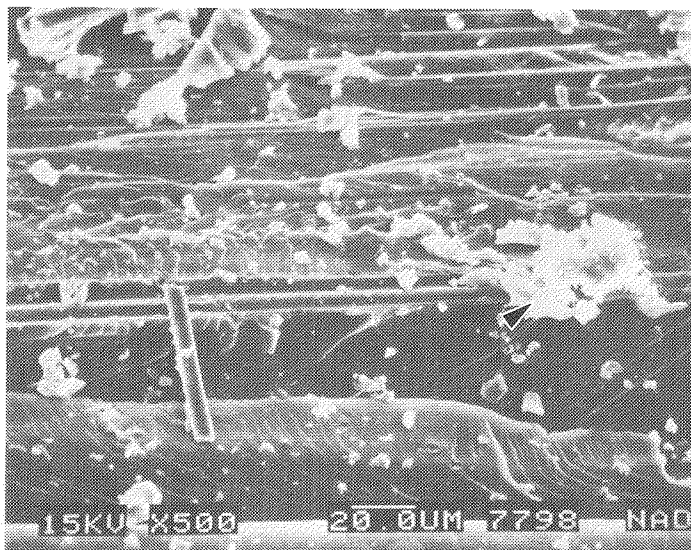
Figures 2-66 and 2-67 show SEM photographs of fracture features observed in the first and second layers of the delamination in zone A close to the outer surface. In each layer, the delaminations are associated with a central zone of compression debris (Figure 2-66a), believed to be the local point of impact. The delamination was characterized by fine river patterns in the fractured epoxy (Figure 2-66b) that propagated radially outward from the impact site, and suggested that delamination had occurred due to peel.

Figure 2-66. SEM Photographs of Delamination in Zone A (Top Layer Removed)  
 (a) Low Magnification Showing Component Debris  
 (b) High Magnification Showing Peel Characteristics in Delamination  
 Note debris at arrow

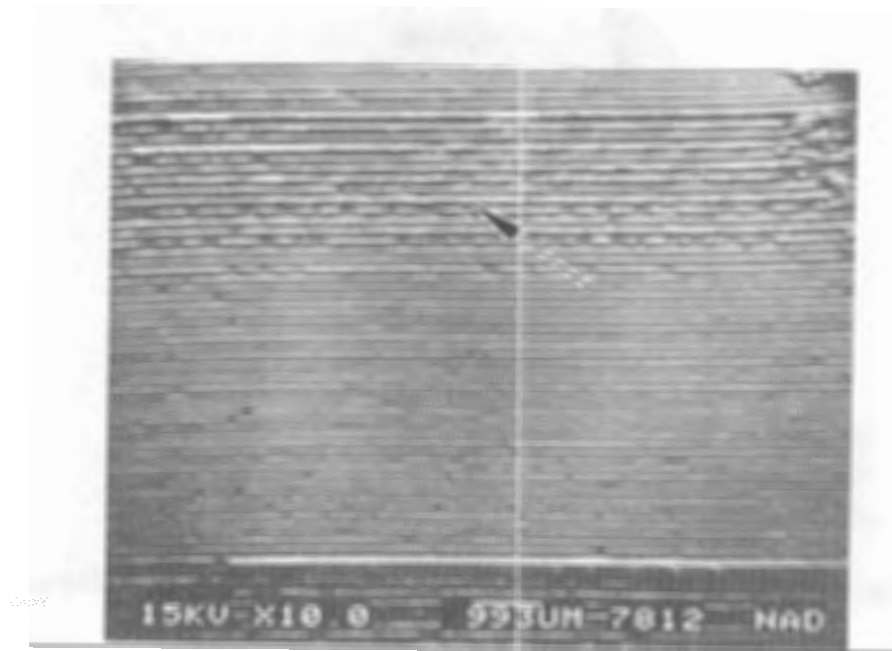
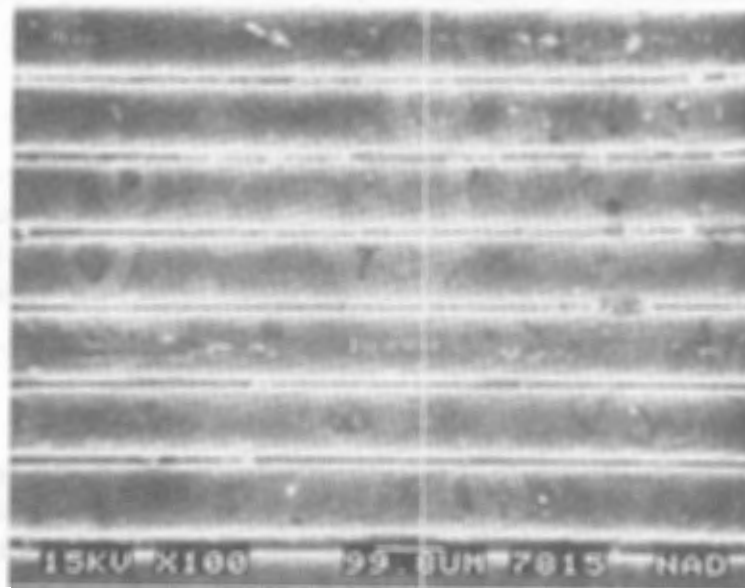
Figure 2-67 shows SEM photographs of the delamination in zone A with the second layer removed. Again peel fracture characteristics were observed. Stray regions were also associated with "bare" boron fibers (Figure 2-67a), however, it was felt that these were unrelated to the failure event.

**Figure 2-67. SEM Photographs of Delamination in Zone A (Second Layer Removed)**  
 (a) Central Region of Resin Starved Fibers (Arrow)  
 (b) High Magnification Photograph Showing Detail in Central Region

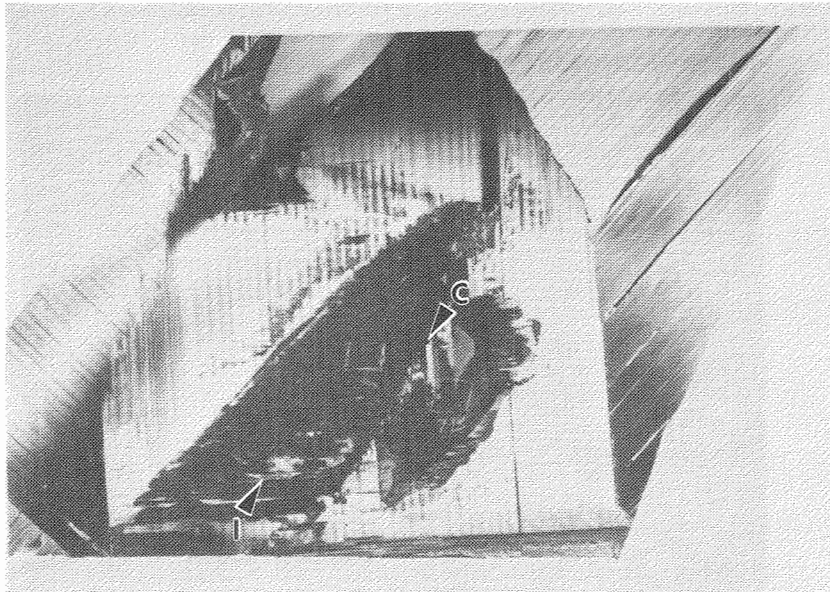
SEM examination of the damage in zone B again revealed features indicative of failure due to impact. Figure 2-68 is a macrophotograph of the section with the outer skin removed. The fracture surface was characterized by two local points of impact (only one of which is shown), cracks in cross-plyies and extensive rubble.

**Figure 2-68. Macrophotograph of Zone B Damage With Top Layer Removed**  
Note impact at I and cracks at C

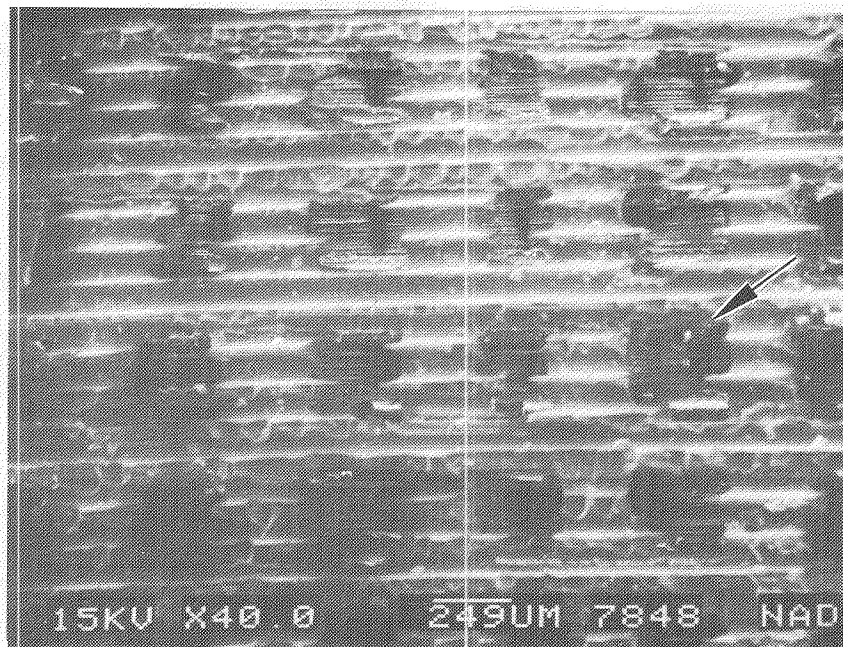
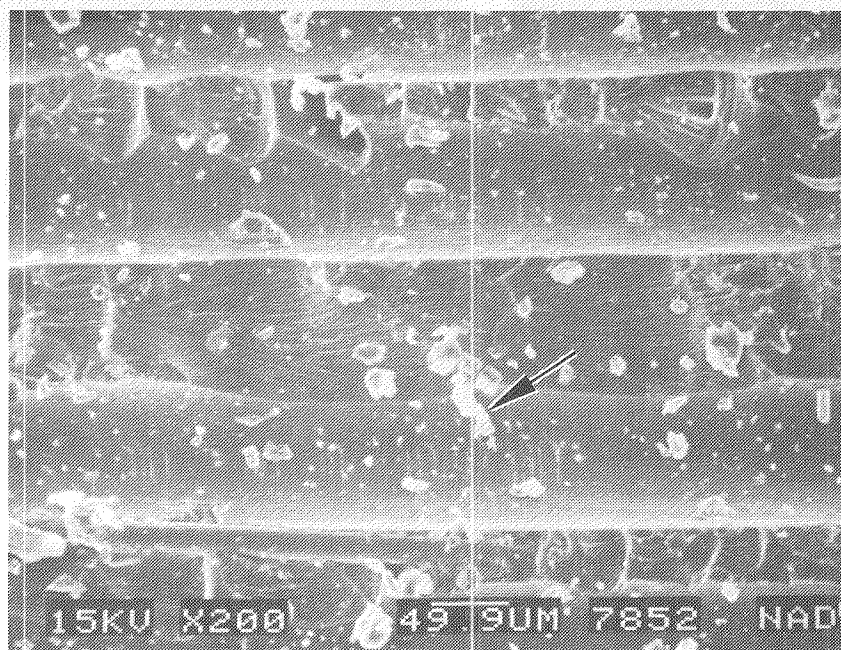
Figure 2-69 shows SEM photographs of the delaminated layer in zone B. Again mapping of the rivers indicated local fracture propagating by peel radially across the surface with key-holing (Figure 2-69a) and an abundance of compression debris.

Figure 2-69. SEM Photographs of Zone B Delamination (Top Layer Removed)  
 (a) Low Magnification Showing Key-Holing (Arrow)  
 (b) High Magnification Showing Compression Debris (Arrow)

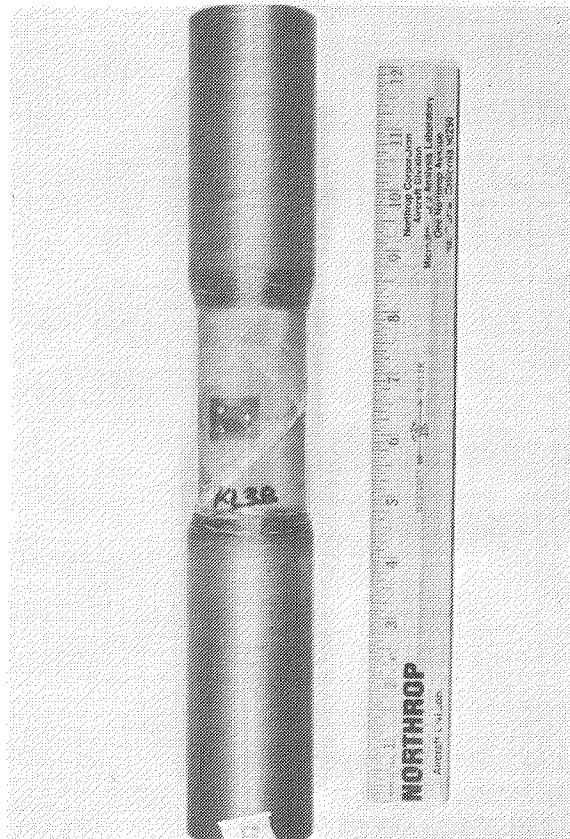
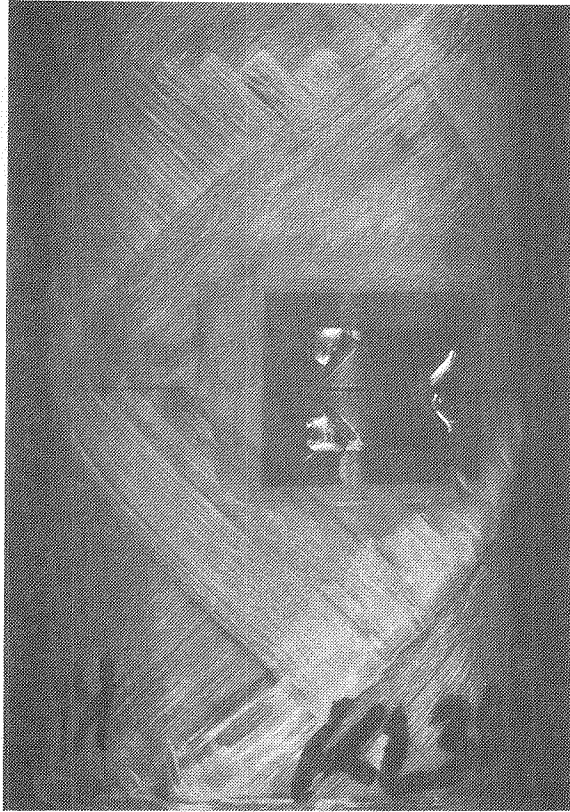
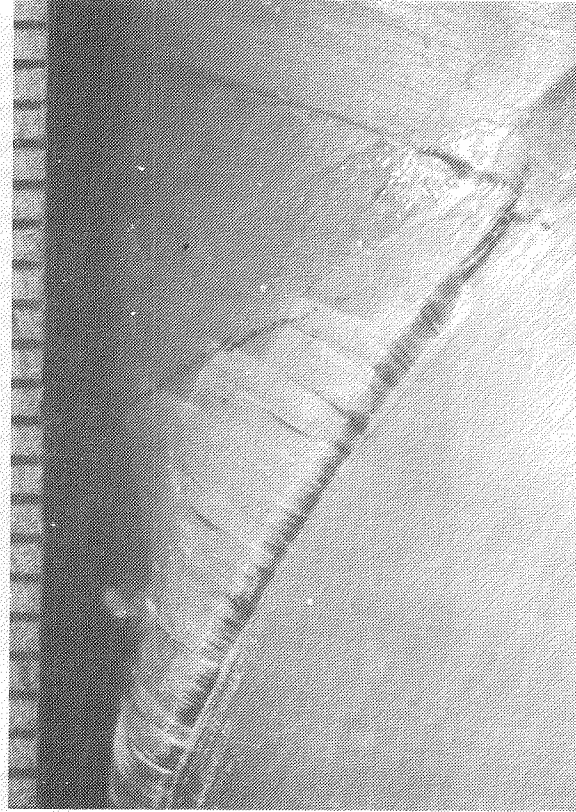
Figure 2-70a shows the component in the as-received condition. Visual examination of the component revealed that the part was filament wound and that it exhibited a surface condition in the form of a diagonal bulge (shown in Figures 2-70b and 2-70c) present around the outer periphery of the gage section of the cylinder.

Figure 2-70. As-Received Documentation of Failed Cylindrical Specimen

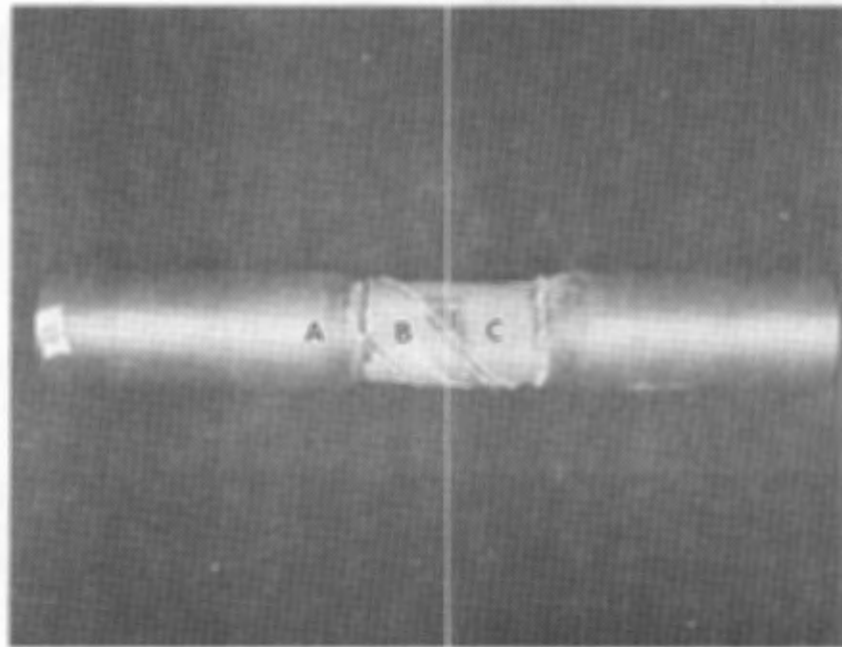
Figure 2-71 presents a photograph of the cylinder after sectioning with a diamond wheel. Sectioning was guided by the NDE and visual observations, and precautions were taken to ensure that sectioning was well away from the damage. The fragments have been arbitrarily labeled as A, B, and C, in Figure 2-71, with fragment B containing the region of damage.

Figure 2-71. Photograph of Cylindrical Specimen After Sectioning to Expose Internal Damage

Note: The fragments have been labeled as A, B, and C.

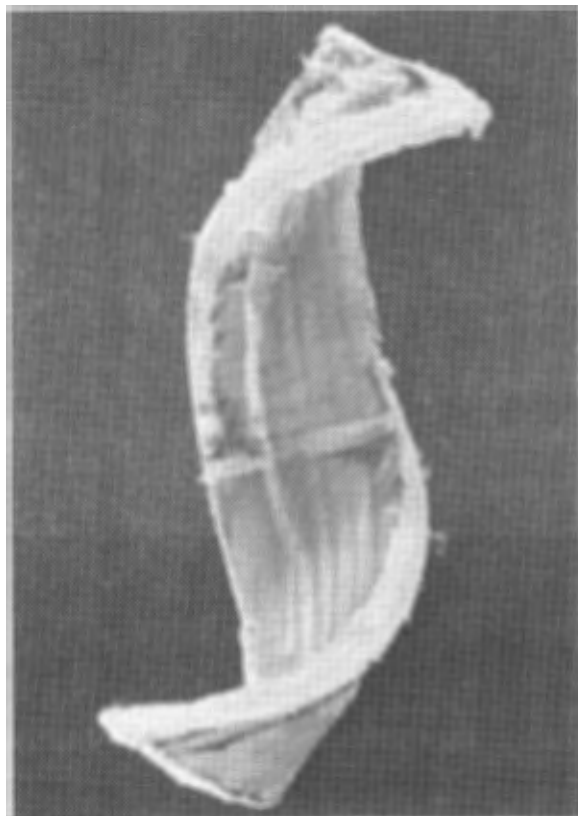
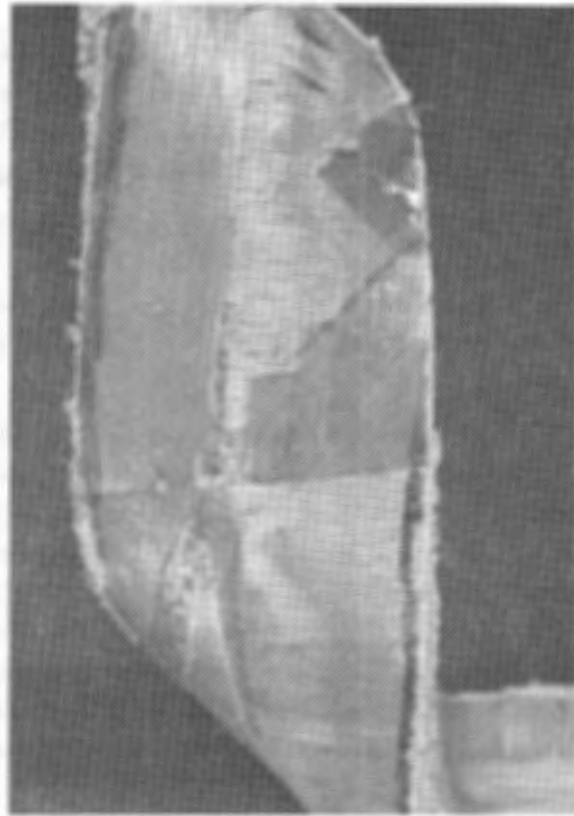
Figure 2-72 presents photographs of fragment B as viewed from various angles. Examination of the inner surface of the fragment revealed internal displacements (Figure 2-72a) which correspond to the external bulge. The contour of the interior defect was identical to that present on the exterior, indicating that these areas of damage had possibly been caused by the same load event.

**Figure 2-72 Photographs Showing Damage in Fragment B of Cylinder**  
 (a) 1X Photo Shows Interior Damage  
 (b) 2X Photo of Interior Damage (Bulge at Arrow)  
 (c) 2X Photo Showing Mating Damage on Exterior

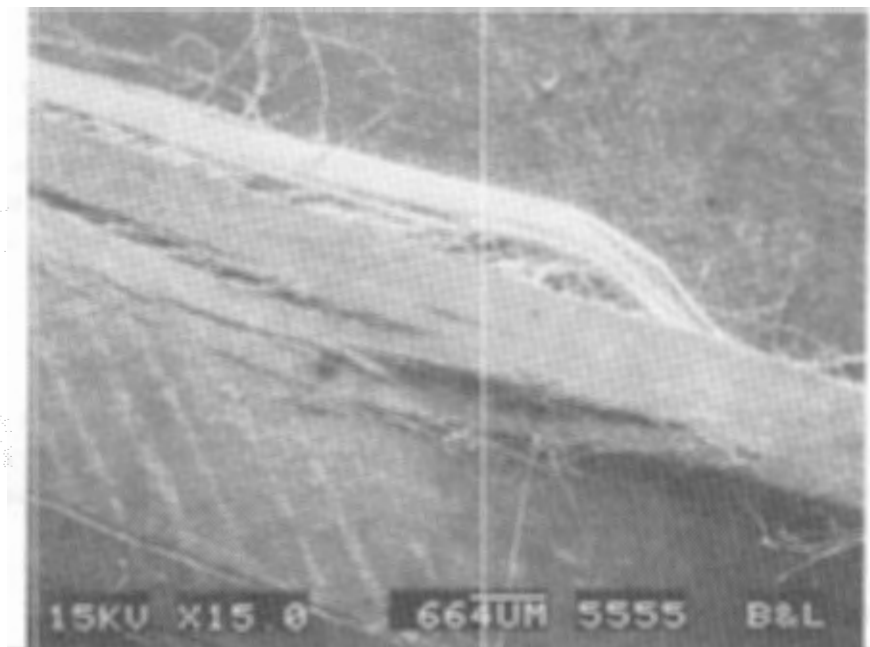
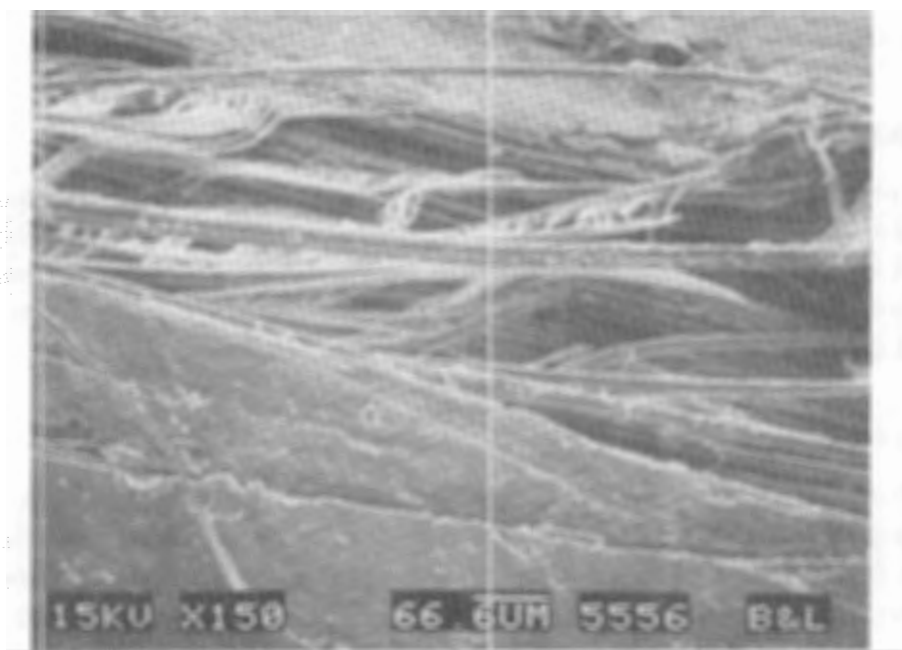
SEM examination was carried out on the outer and inner surfaces of the cylinder. Figures 2-73, 2-74, and 2-75 present SEM photographs of fracture present on the outer and inner surfaces. As shown in Figure 2-73a, the region of damage on the outer surface consisted of localized displacement of fiber bundles, splitting of fibers, and defibrillation of fiber ends. Figure 2-74 presents SEM photographs of the outer surface with the cluster of fibrils removed. As can be seen in Figure 2-74a, the fractured resin exhibited hackles, and the fibers appeared to be bending under shear loads (Figure 2-74b). Such fracture characteristics are typical of failure due to localized in-plane shear stresses caused by torsional loads. Figure 2-75 presents SEM photographs of the inner surface of the cylinder. The failure in this region was also characterized by fiber splits, and bending of fiber ends.

**Figure 2-75. SEM Photographs of Damage on Inner Surface of Cylinder**  
**(a) Low Magnification Showing Splitting**  
**(b) High Magnification Showing Splits and Bending of Fibers**

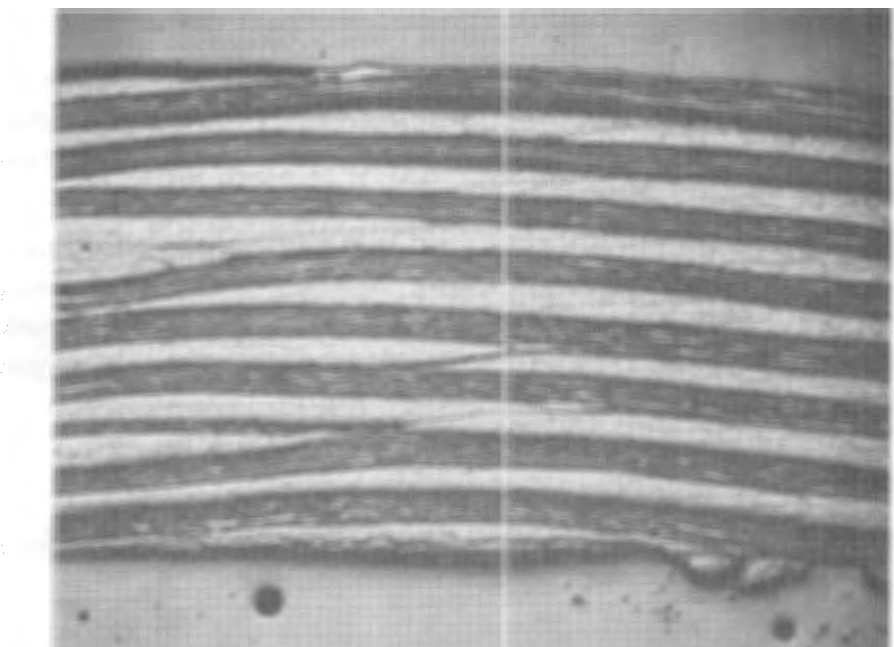
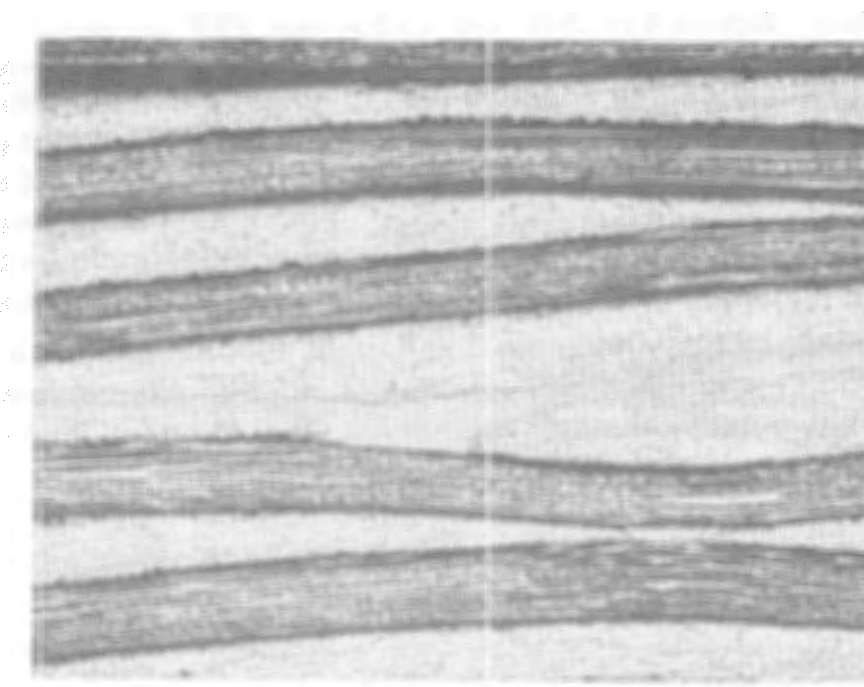
Radial sections were taken through the cylinder in the region of the defect, and the sections were oriented so that the fractures were in profile. Figure 2-76 shows optical micrographs of the cross-sections taken through the failed regions. In these areas, no material defects such as porosity or contaminants were detected. Chemical identification of the resin was not carried out due to lack of material specifications. However, the general appearance of the fracture locations and morphologies suggested that failure was not related to material discrepancies.

**Figure 2-76. Optical Photomicrographs of Cross-Section Taken Through Defects in Cylinder**

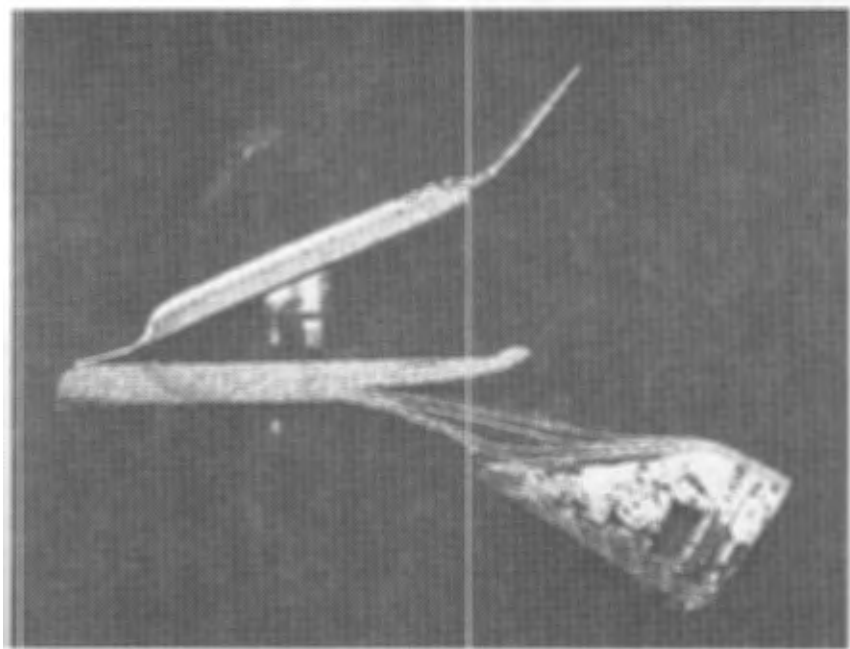
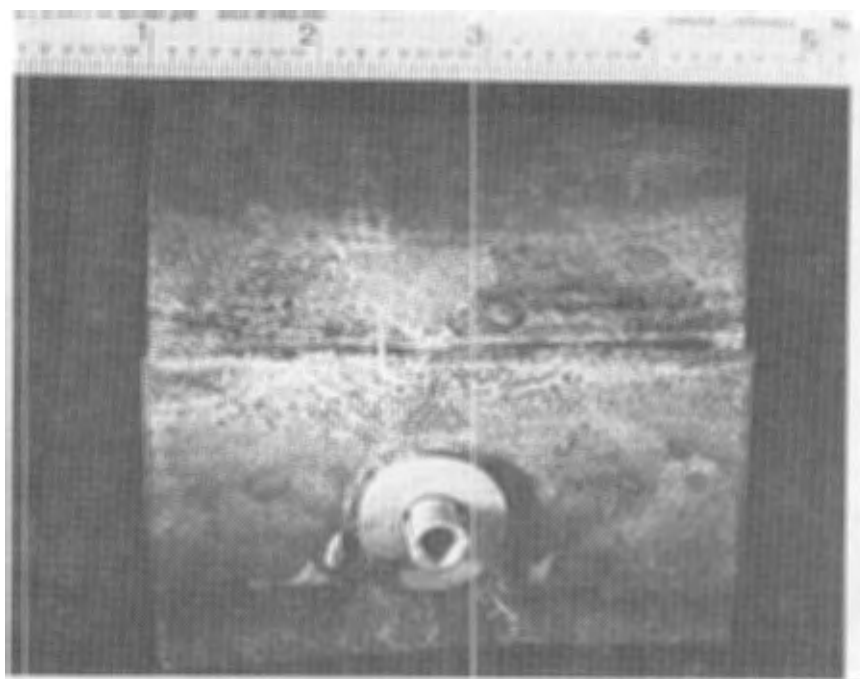
Examination of the component in the as-received condition revealed a charred or burnt odor suggesting that the part may have been heat damaged. Figure 2-77 shows photographs of the part as-received. A lateral view of the assembly is shown in Figure 2-77a and the upper surface of the plate is shown in Figure 2-77b.

**Figure 2-77. As-Received Documentation of Compound Plate and Fastener Assembly**

**(a) Lateral View of Assembly**

**(b) Top Surface of Plate**

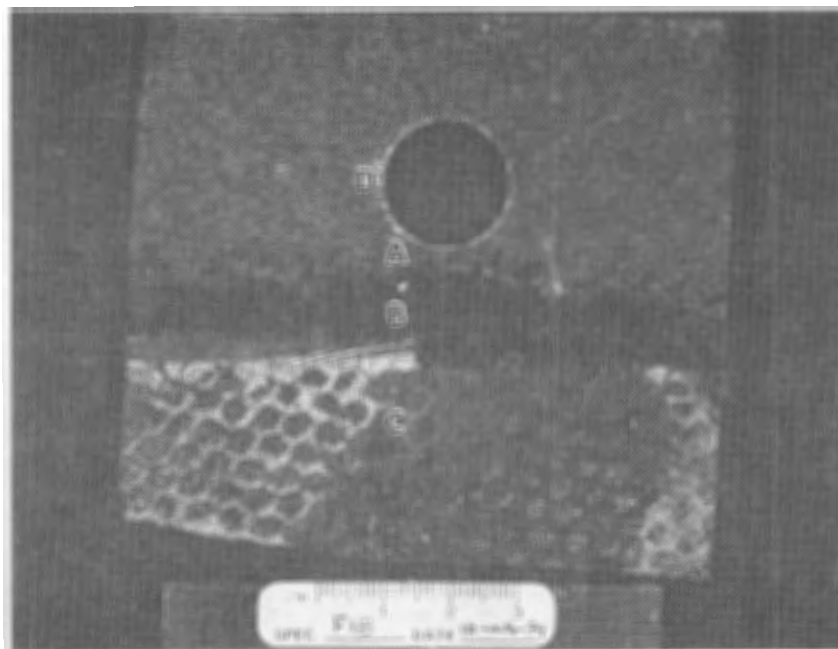
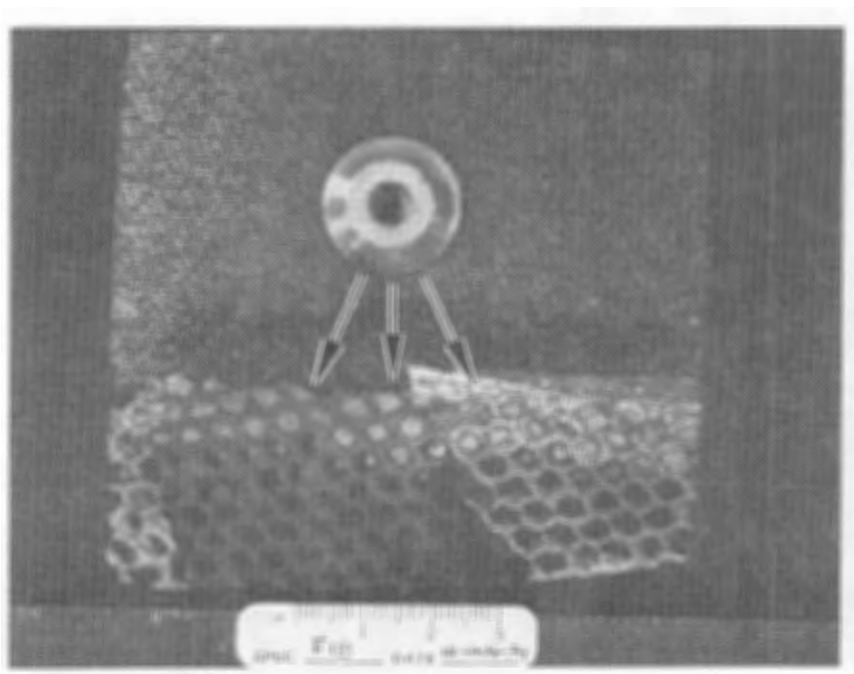
During initial examination, the lower face plate separated from the honeycomb core. The mating halves of the fragments are shown in Figures 2-77c and 2-77d. The remnants of the honeycomb can also be seen in these photographs. It was observed that the honeycomb had a dull brown color suggesting a glass honeycomb. The regions labeled A, B, C and D in Figure 2-77c are areas where detailed SEM examination was performed on the delaminated section.

**Figure 2-77. (Continued)**  
**(c), (d) Delamination in Bottom Surface of Compound Plate (Mating Halves)**  
 The regions labeled A, B, C, and D are where detailed SEM examination was carried out. The arrows indicate fracture mapping.

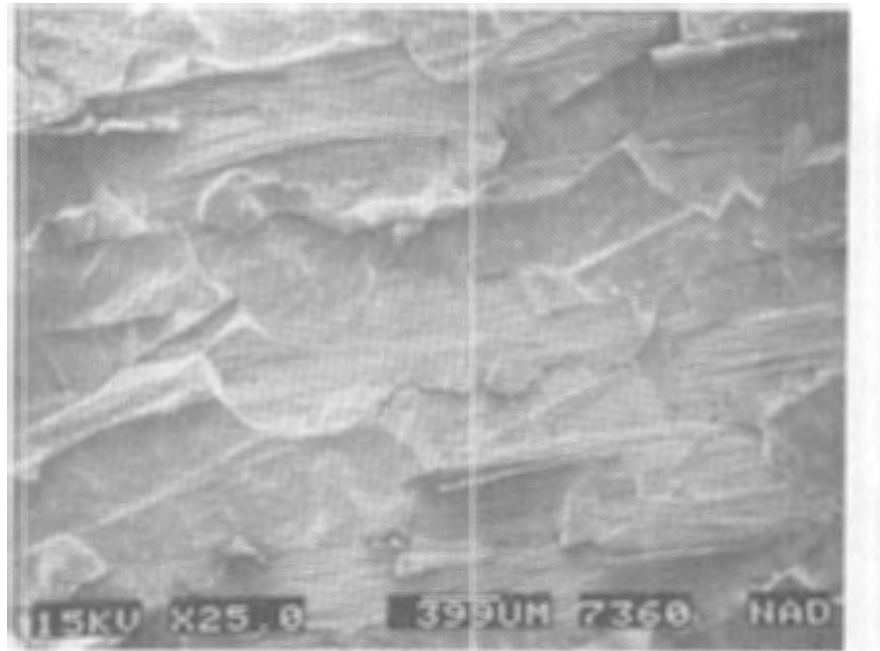
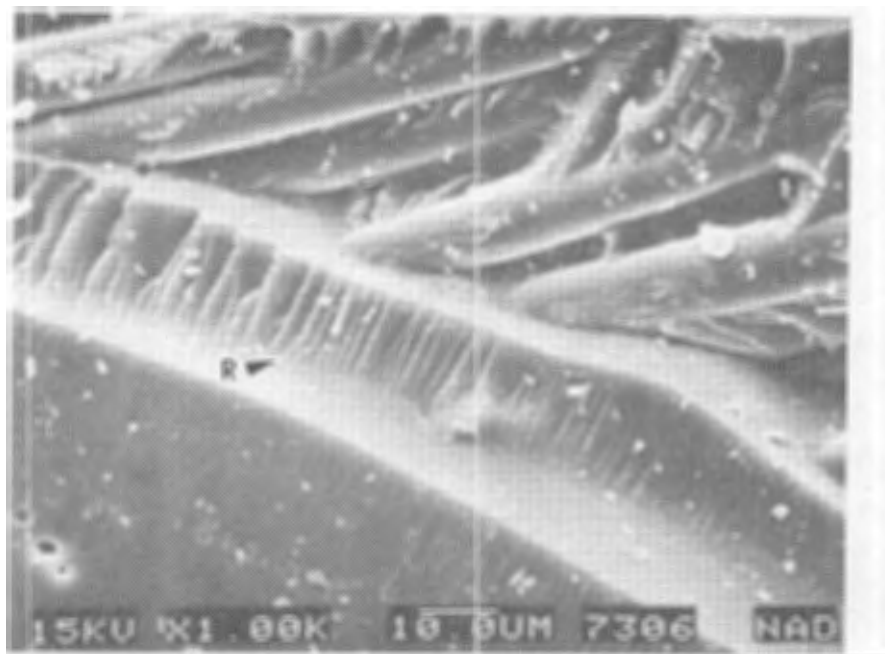
**Figure 2-78. SEM Photographs in Region A of Delamination of Bottom Surface of Compound Plate**  
**(a) Mixed Cohesive-Adhesive Failure**  
**(b) Holes and Voids in Resin**  
 Note river patterns (arrow)

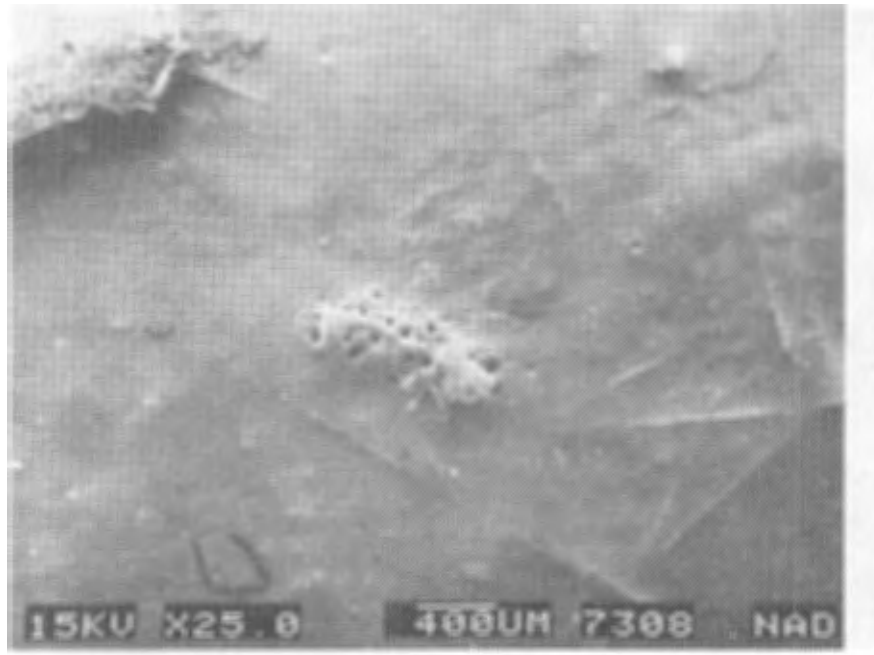
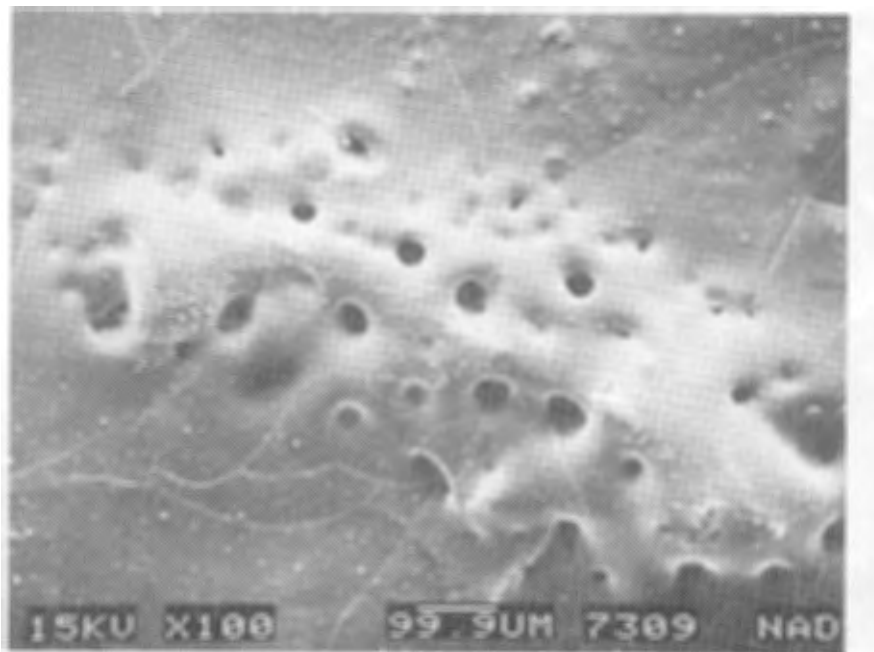
*Figure 2-79. SEM Photographs in Region B of Delamination of Bottom Surface of Compound Plate  
(a), (b) Low and High Magnifications Showing Melted Surface  
Associated With Porosity and Cracks*

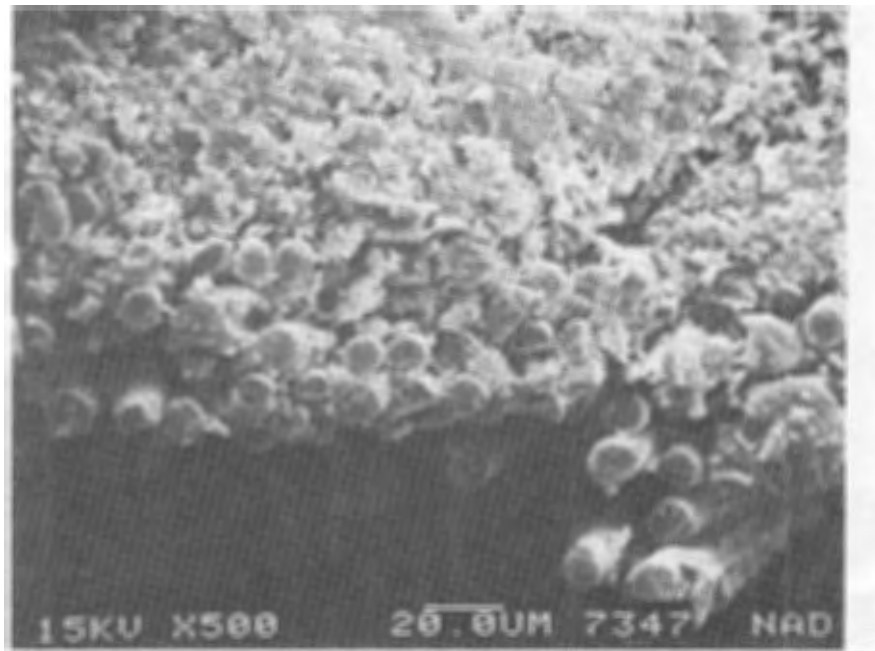
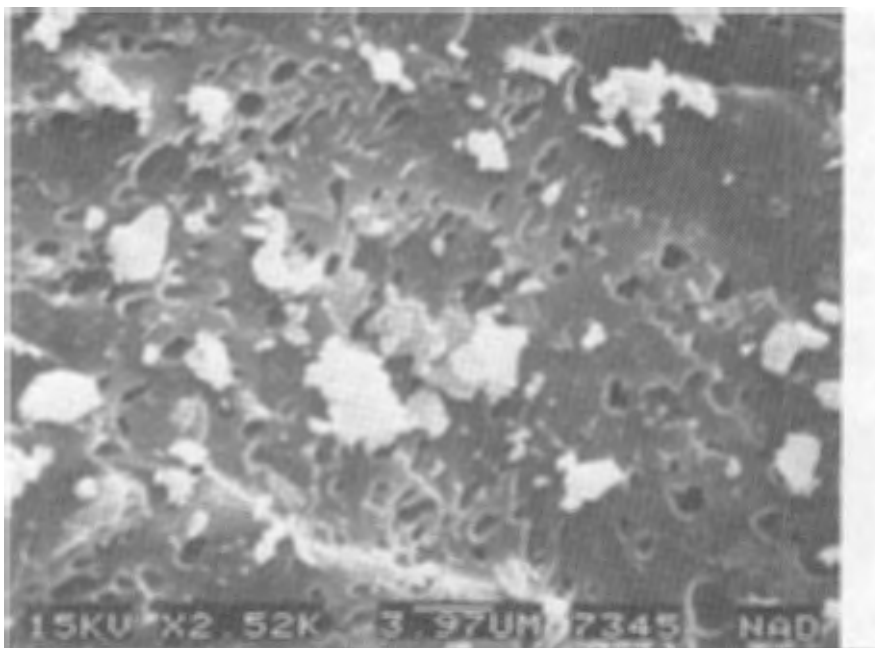
SEM examination was also carried out on a cross-section of the plate bolt-hole (Region D). The fracture features observed are shown in Figure 2-81. The cross-section revealed fracture characteristics indicative of bearing loads, namely compression of the fibers (Figure 2-81a) and debris. Also of interest was the extensive porosity present in the epoxy (Figure 2-81b).

Figure 2-81. SEM Photographs of Bolt Hole Cross-Section in Bottom Surface of Compound Plate (Region D)  
 (a) Compression Fracture of Fiber Ends  
 (b) Porosity and Debris in Resin

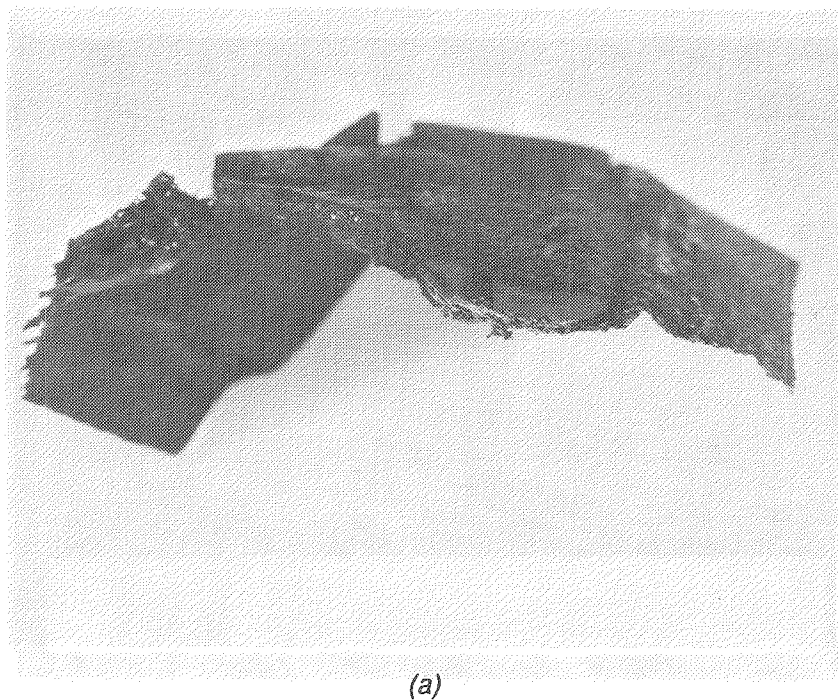
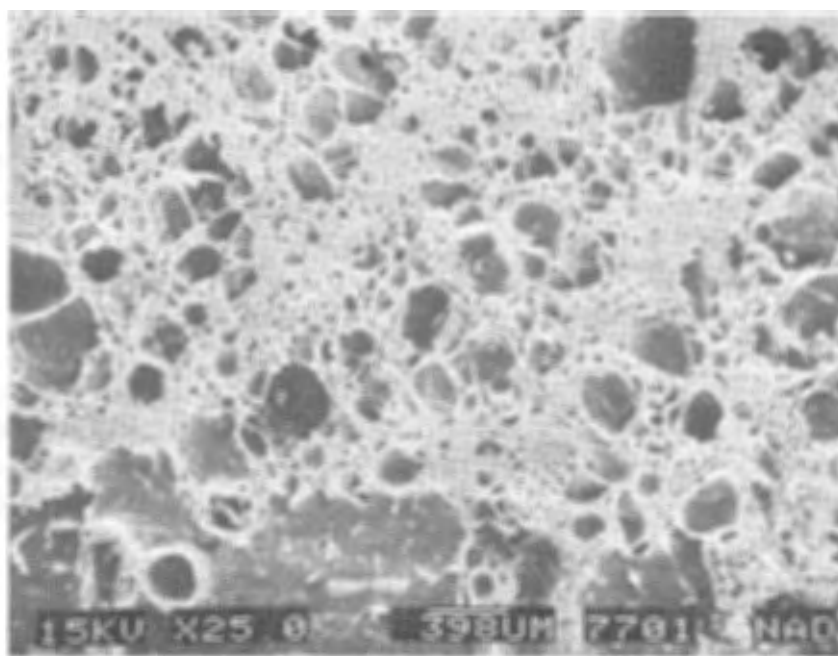
The top surface of the compound plate was also examined. The section was extremely brittle and delaminated upon gentle handling with a tweezer (Figure 2-82). Evaluation of the fragment, which appeared to be ceramic in nature, revealed evidence of overheating as suggested by the bent contour (Figure 2-83a) and voids observed during SEM examination (Figure 2-83b).

**Figure 2-83. Optical and SEM Photographs of Delaminated Fragment of Top Surface of Compound Plate**  
**(a) Oblique View Showing Bent Contour of Fragment**  
**(b) Voids on Top Surface**
