WL-TR-91-4032  
DOT/FAA/CT-91/23  
VOL II, Part 3

COMPOSITE FAILURE ANALYSIS HANDBOOK  
VOLUME II - TECHNICAL HANDBOOK  
PART 3 - CASE HISTORIES

R.J. Kar  
Northrop Corporation  
One Northrop Avenue  
Hawthorne, California 90250-3277

February 1992

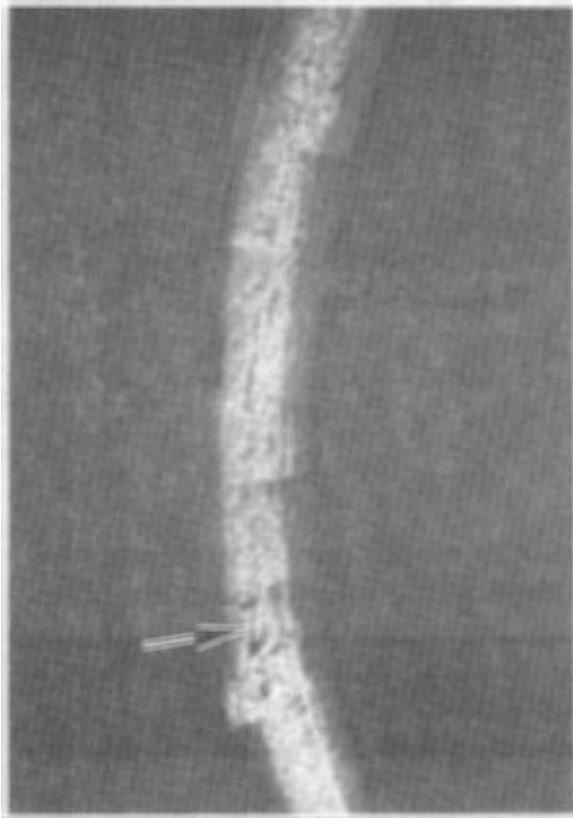
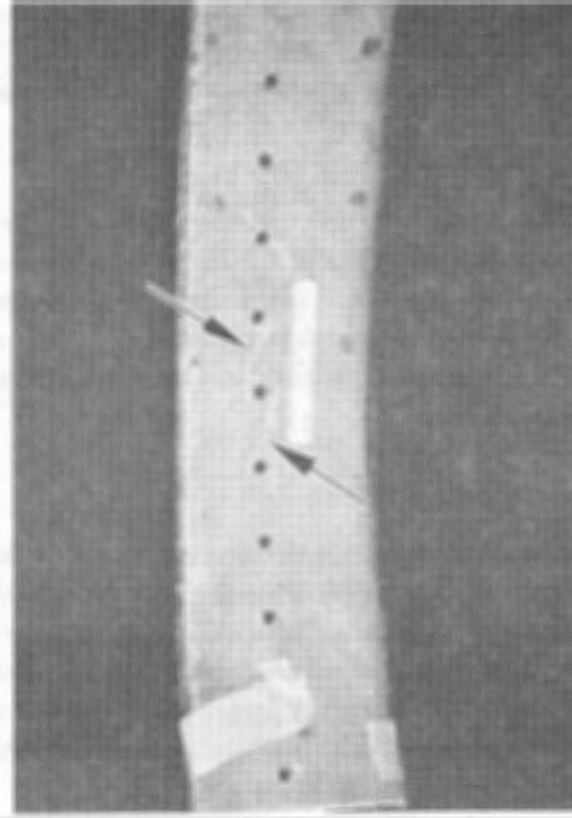
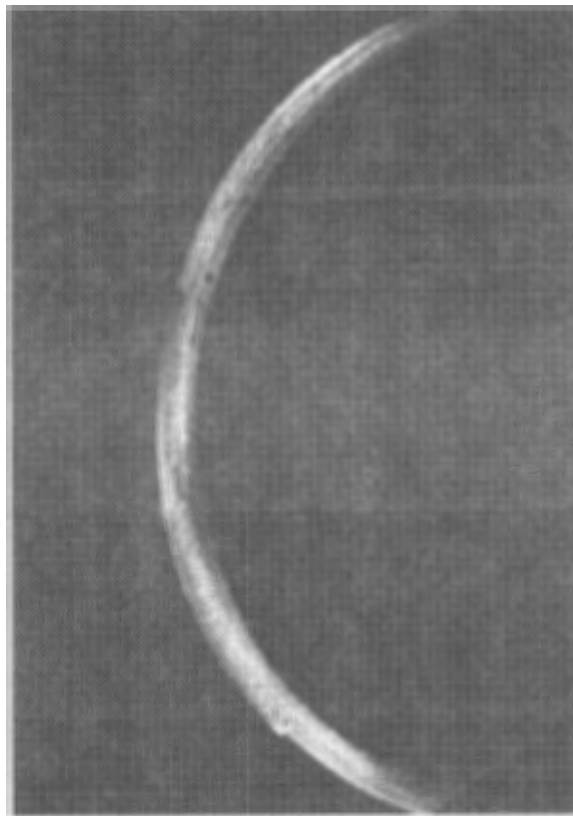
Figure 2-84 shows a collage of the part in the as-received condition. Close examination of the part indicated that the component consisted of a thin woven sheath (believed to be Kevlar/epoxy) enclosing a laminated bow (believed to be filament wound Kevlar/epoxy and glass/epoxy). The part was associated with extensive cracking all around the outer periphery (see Figure 2-84b); and along the inner diameter in mid-section regions containing fastener holes (see Figure 2-84c, and Figure 2-85a). When viewed obliquely, the sheath appeared torn in several areas (see Figure 2-85b). The entire sheath appeared loose and disbonded, and barely held in place by the ends. In addition the bow was associated with extensive delaminations (see Figure 2-85c), as determined by simple visual examination of the part.

Figure 2-84. As-Received Documentation of Composite Arch Reinforcement  
 (a) Overall View  
 (b) Cracking in Outer Periphery of Sheath (Arrow)  
 (c) Cracks in Mid-Section Fastener Holes (Arrows)

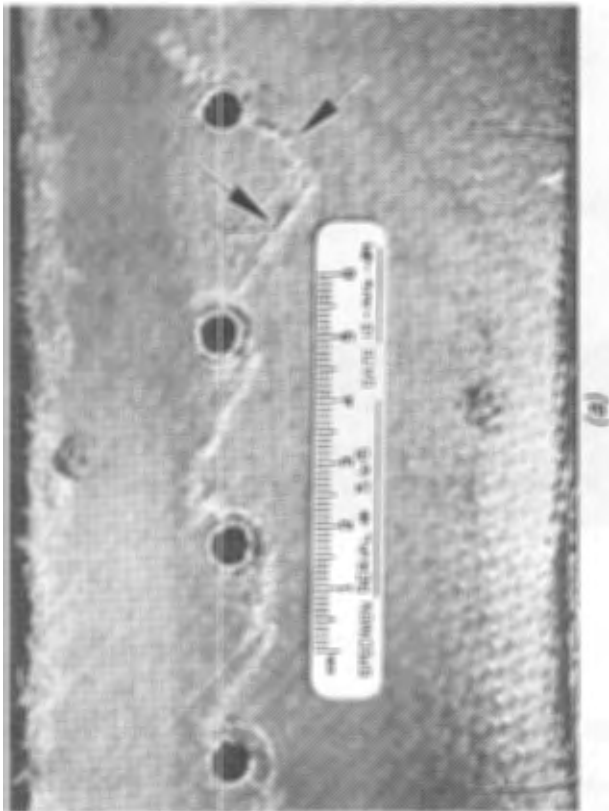
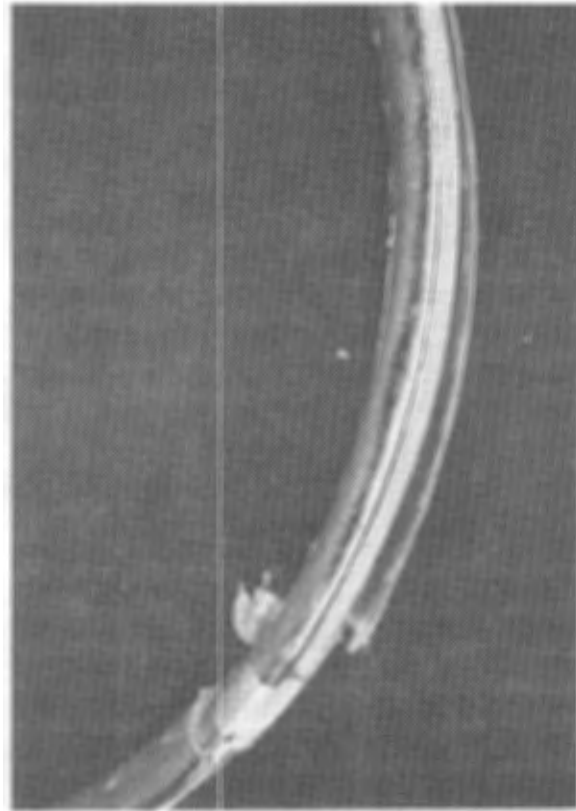
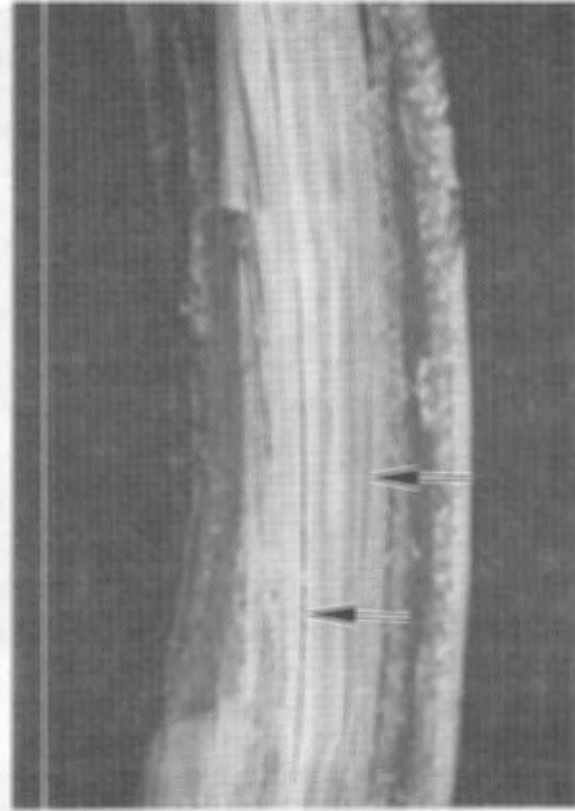
**Figure 2-85. Documentation of Cracks in Part**  
 (a) Shear Cracks in Fastener Holes (Arrows)  
 (b) Oblique View Showing Tearing of Sheath  
 (c) Delaminations in Bow Contained by Sheath (Arrows)

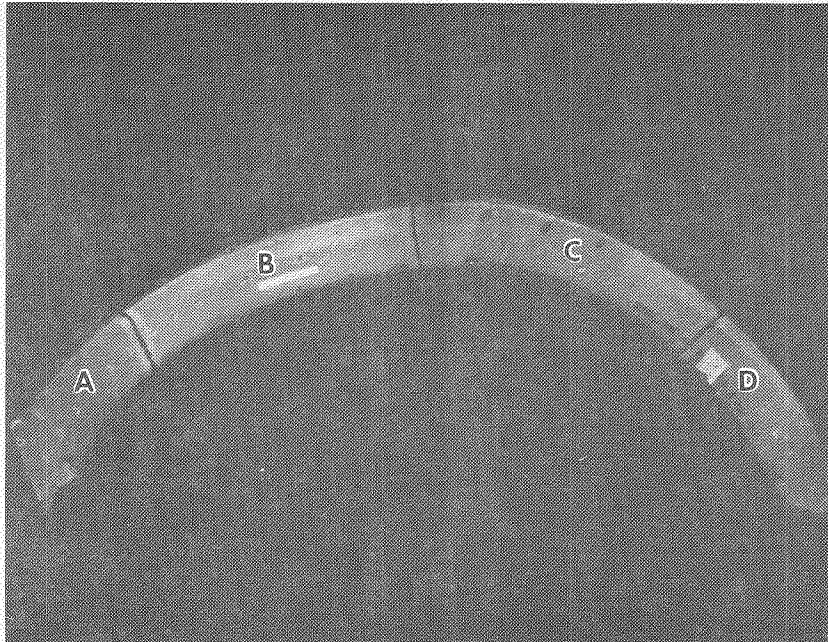
Guided by the visual and NDE tests, the part was sectioned into four sections for detailed fractographic examination. Figure 2-86a shows the part after sectioning. The sections have been

**Figure 2-86. Documentation of Ply Removal and Sectioning**

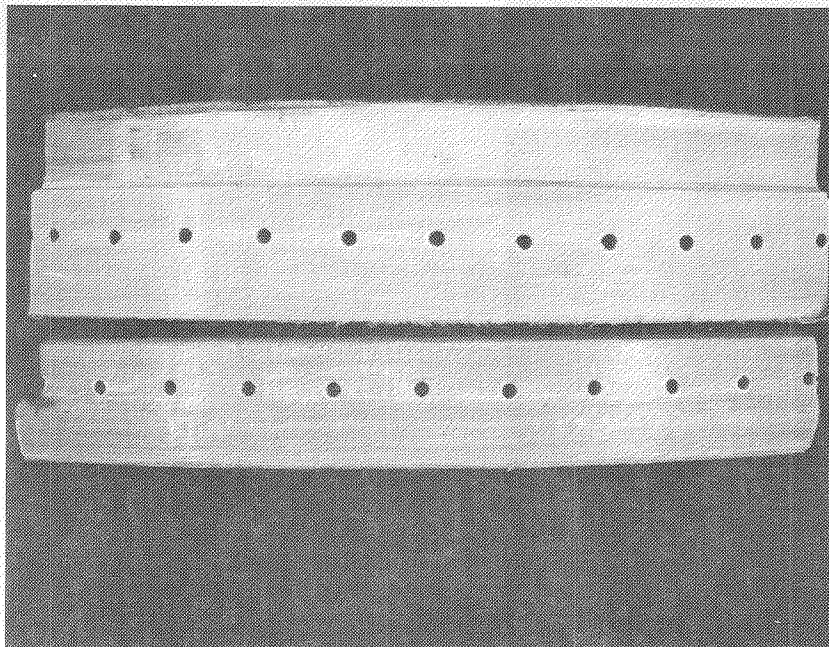
**Note:** The fragment labeled B contain fastener cracks.

arbitrarily labeled as A, B, C, and D in Figure 2-86a. Upon sectioning, the sheath totally separated from the bow in the sections labeled B, and C. In addition the bow delaminated into two fragments in the section labeled C, as is illustrated in Figure 2-86b.

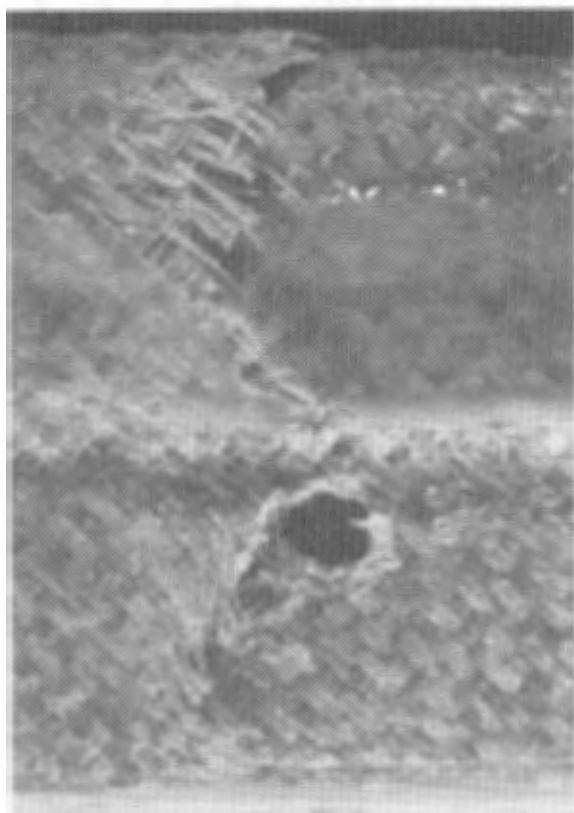
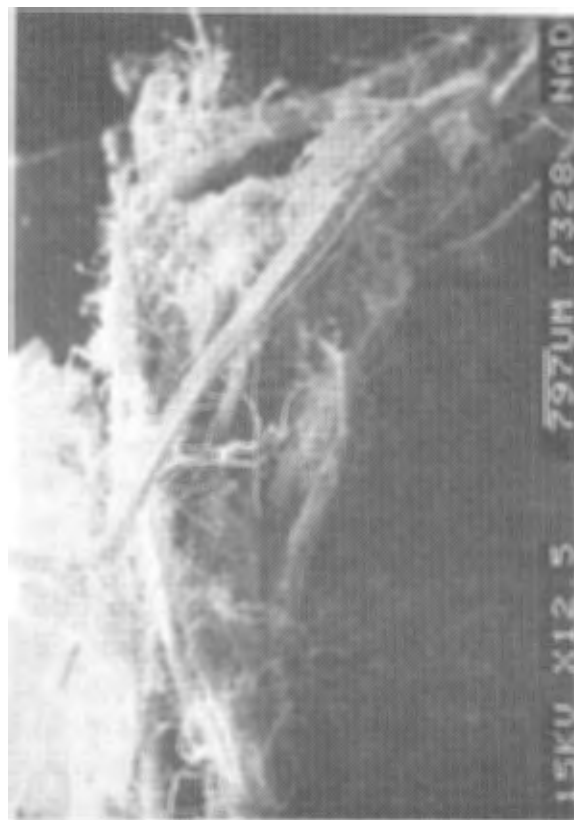
Initial examination was concentrated on the cracks observed in the sheath and bow around fastener holes (refer to Figure 2-85a). The general appearance of these cracks suggested that these were shear cracks, rather than tensile cracks. Figure 2-87 presents fracture features observed in the sheath in the region of a fastener crack. The fracture was characterized by dense tangles of fibrils (Figure 2-87b), as would be expected in translaminar failures in Kevlar/Epoxy. Examination of the regions below the fibrils revealed a delaminated surface associated with hackles, as is shown in Figure 2-87c, indicating that the fastener cracks were shear cracks. The orientation and morphology of the fibrils suggested that cracking in this region occurred under in-plane shear loads, resulting in tensile failures of the Kevlar fibers. Figure 2-88 presents a delaminated region in the bow in the vicinity of a crack. The fracture was once again characterized by shear failure characteristics, namely the occurrence of hackles in the resin (Figure 2-88a). The glass fibers, and Kevlar fibrils (Figure 2-88b) were characterized by tensile fracture characteristics.

**Figure 2-87. Optical and SEM Photographs of Shear Fracture at Fastener Hole**  
 (a) Macro photograph of Crack  
 (b) SEM Photograph Showing Kevlar Fibrils in Crack Viewed End On  
 (c) Delamination Surface Containing Hackles (Arrows)

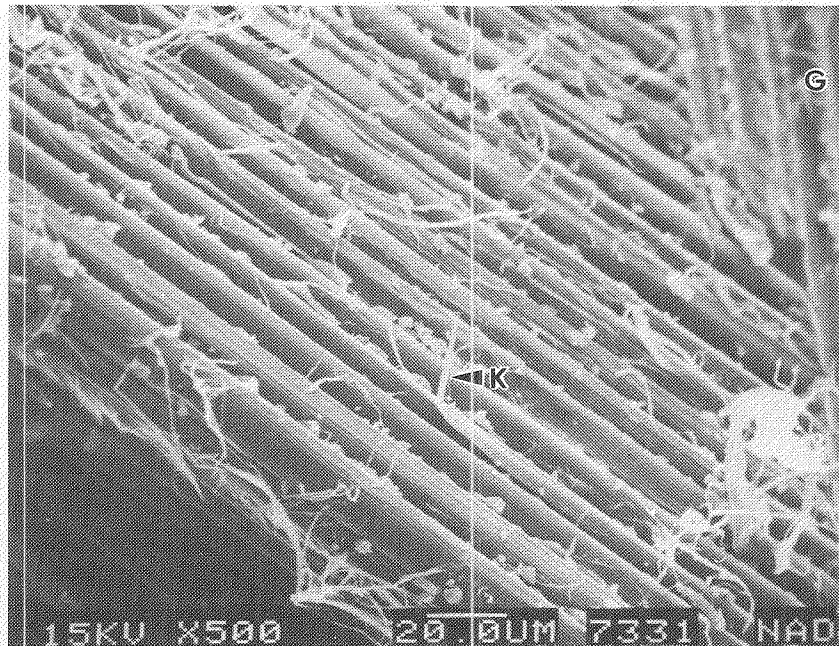
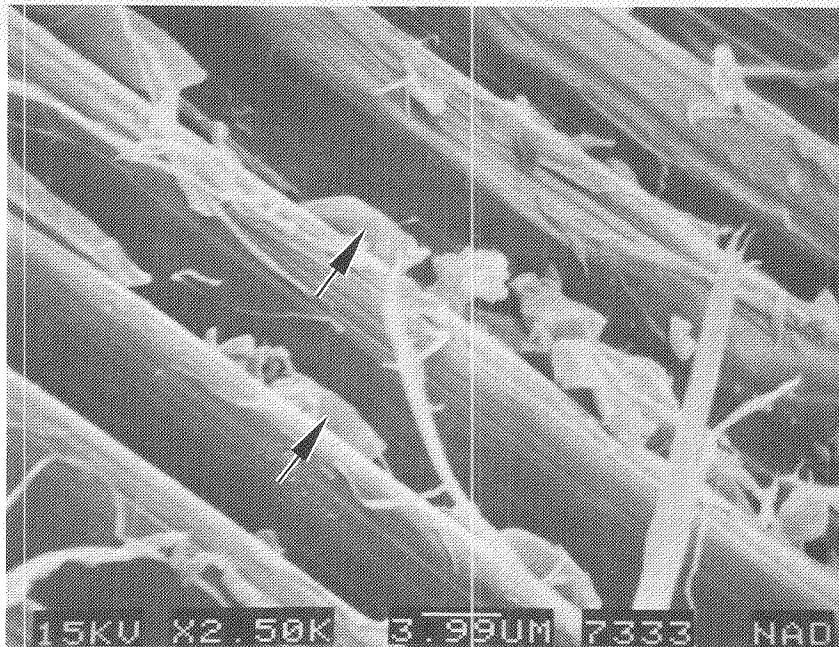
Figure 2-88. SEM Characterization of Fastener Hole Crack in Bow  
 (a) Glass (G) and Kevlar Fibrils (K)  
 (b) Hackles in Resin (Arrows)

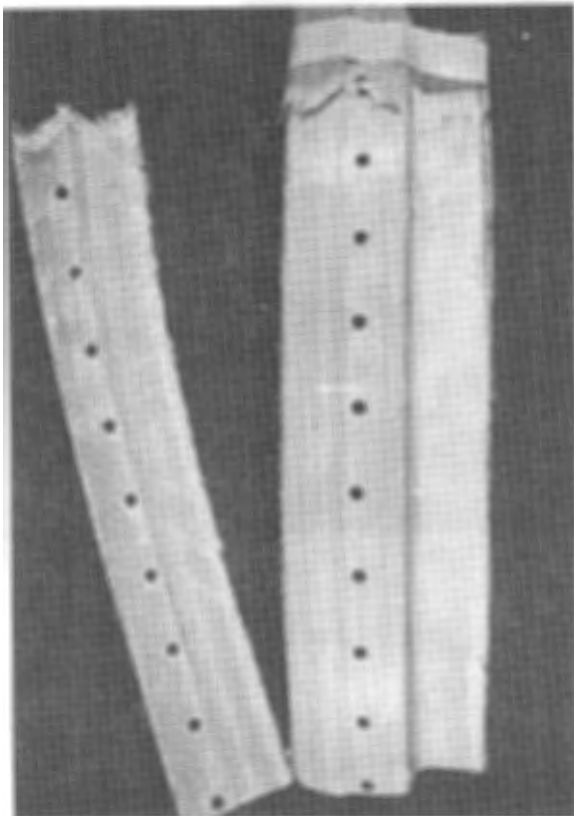
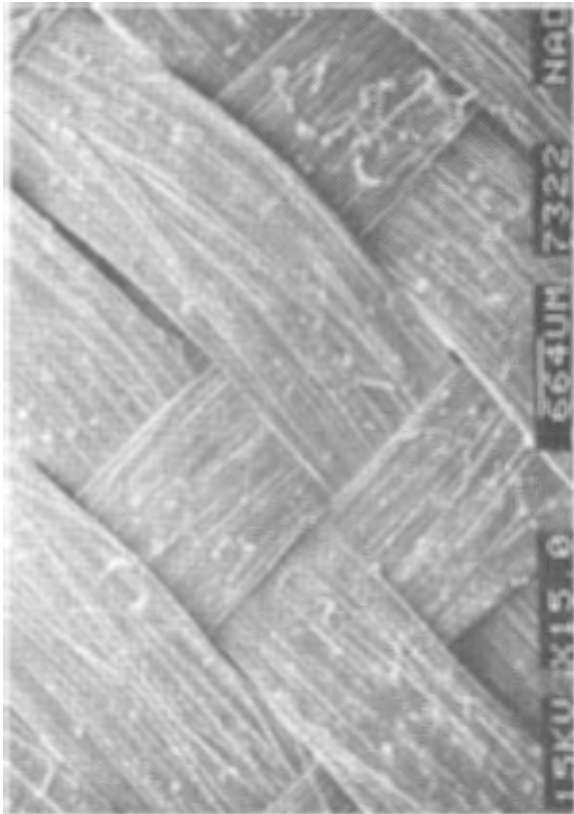
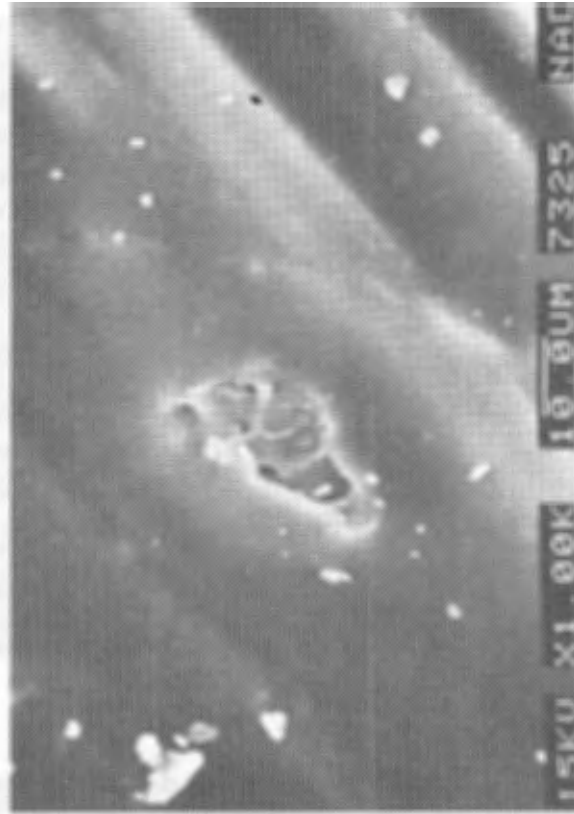
Figure 2-89 shows features observed on the bottom surface of the sheath that had separated from the bow. As can be seen in Figures 2-89b and 2-89c, there was practically no evidence of bonding of the sheath to the bow. Figure 2-90 shows optical and SEM photographs of the mating surface where the sheath should have been bonded. Again there was practically no evidence of fracture, with the surface appearing to be in the original unbonded state, and with occurrence of porosity.

Figure 2-89. Characterization of Sheath Surface  
 (a) Macro photograph showing separation from bow  
 (b) Macro photograph of sheath surface  
 (c) Absence of bonding with bow

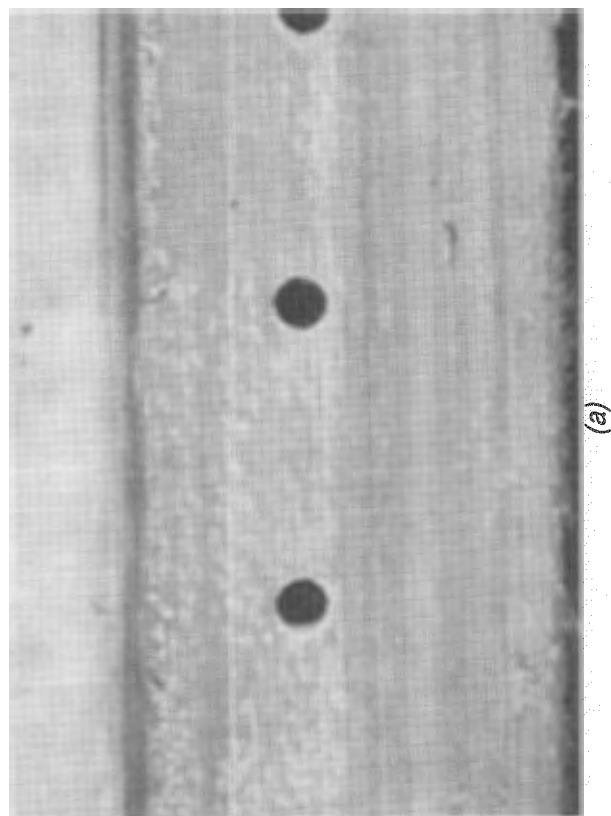
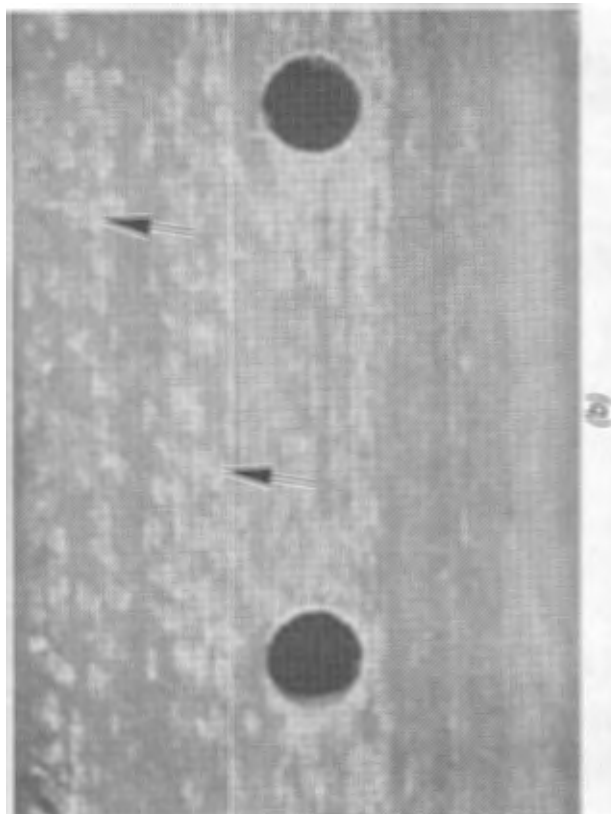
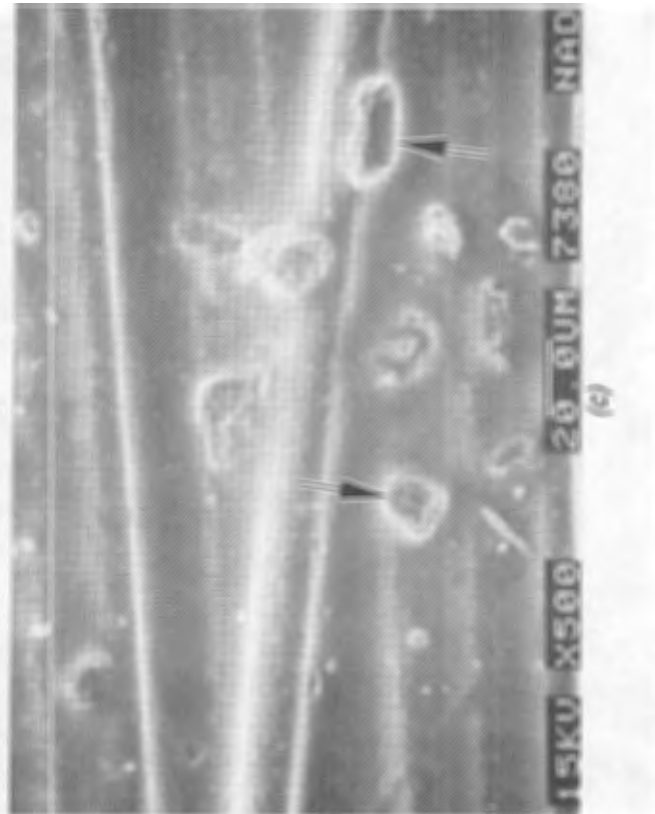
**Figure 2-90. Evaluation of Bow Surface**  
 (a) Macrophoto of Surface Where Sheath Separated  
 (b) Higher Magnification Photo Showing Traces of Glass Scrim (Arrows)  
 (c) SEM Photograph Showing Unbonded Surface With Porosity (Arrows)

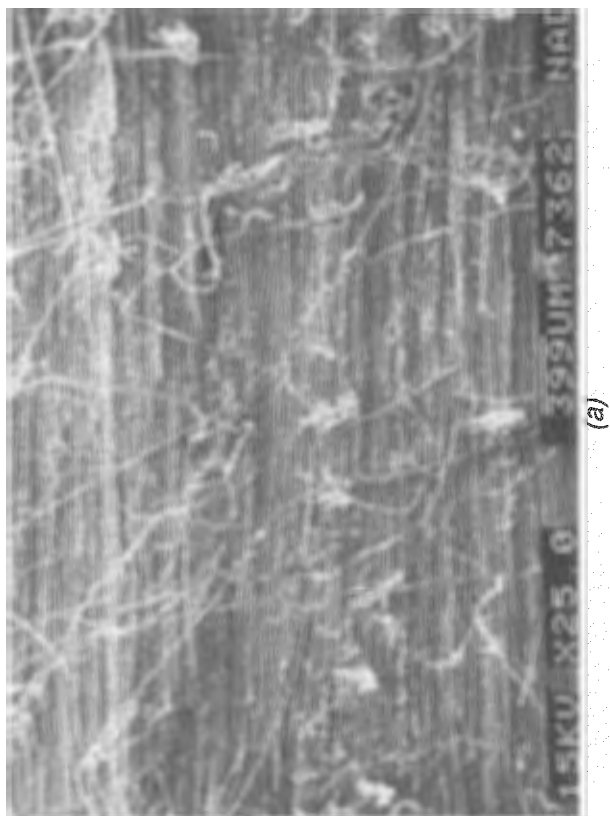
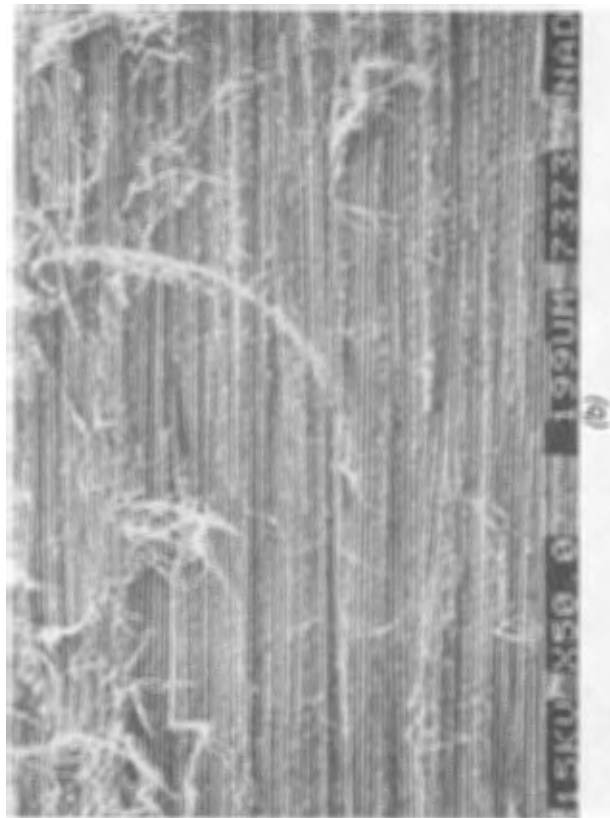
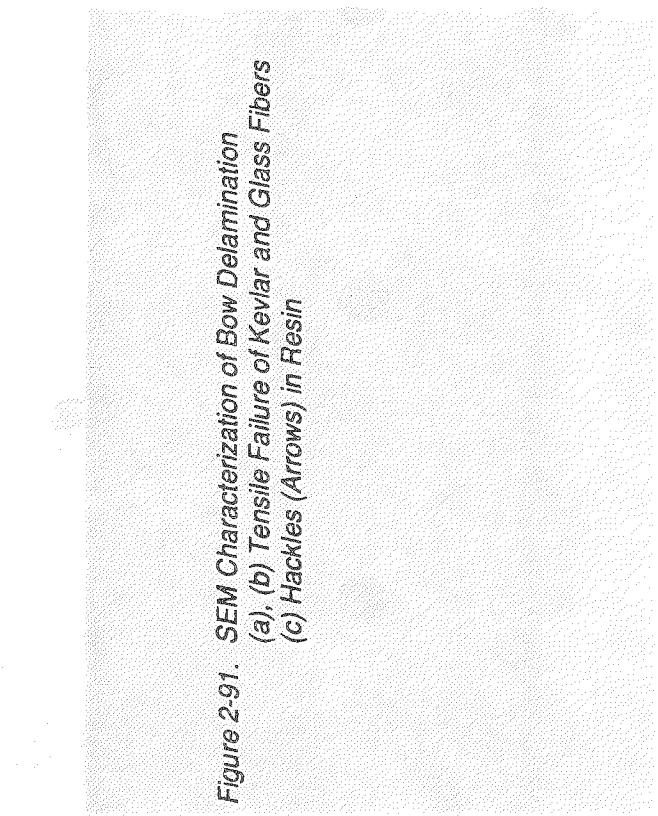
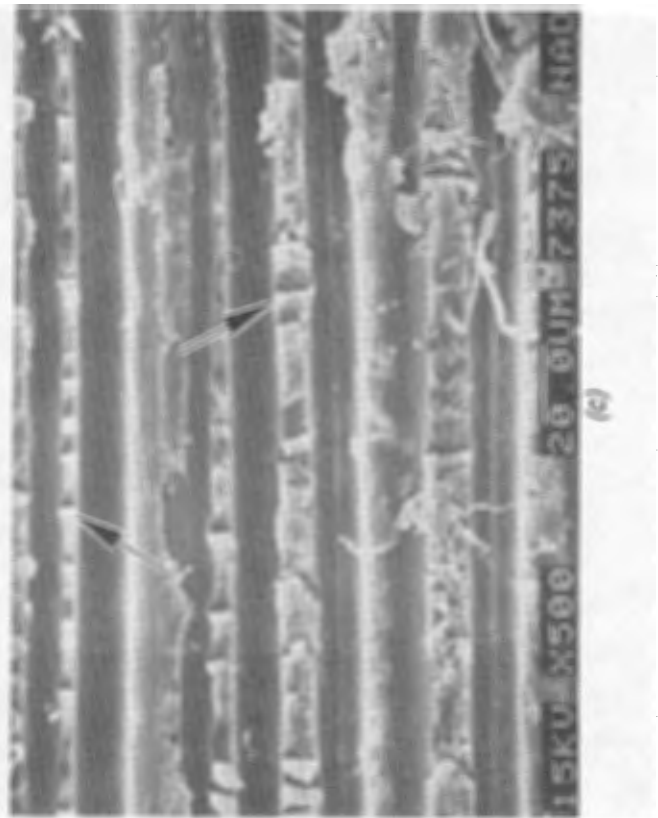
SEM examination was also carried out on the delaminations in the bow (refer to Figure 2-86b). Figure 2-91 presents optical and SEM fractographs of fracture features observed in a principal delamination in the bow mid-section. Fracture was characterized by in-plane shear failure characteristics, namely translaminar tensile fracture in the glass and Kevlar fibers (Figure 2-91b), and hackles in the fractured resin (Figure 2-91c).

Figure 2-91. SEM Characterization of Bow Delamination  
 (a), (b) Tensile Failure of Kevlar and Glass Fibers  
 (c) Hackles (Arrows) in Resin

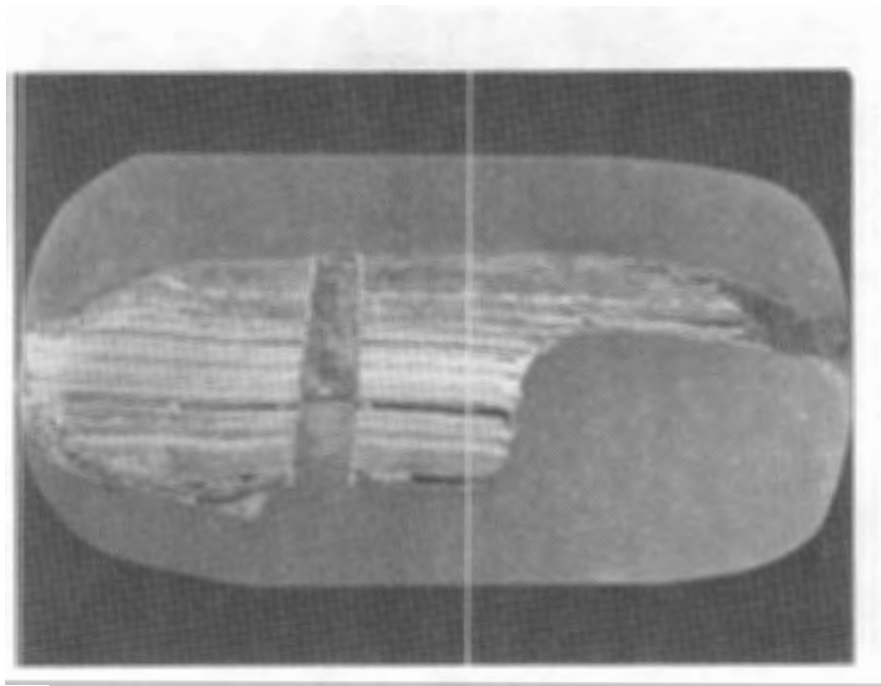
Microstructural examination was carried out on sections taken through the part in a region of fastener holes. As can be seen in Figures 2-92 and 2-93, extensive delaminations were present in the bow, with the sheath totally separated from the bow. The glass and Kevlar plies were characterized by extensive porosity, indicating that the part may have been of poor quality.

*Figure 2-92. Macrophotograph of Cross-Section Taken Through Fastener Hole*

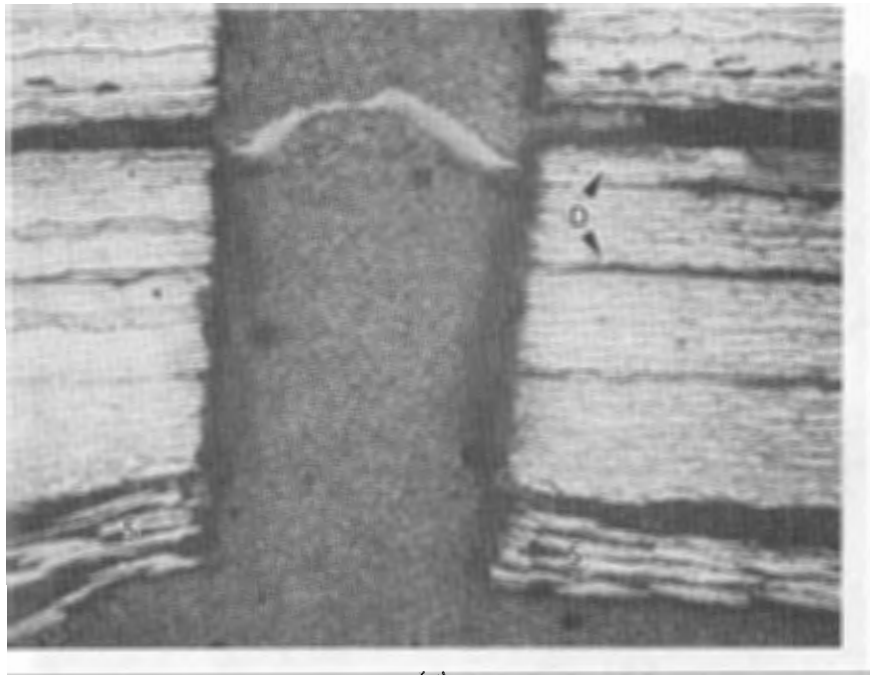
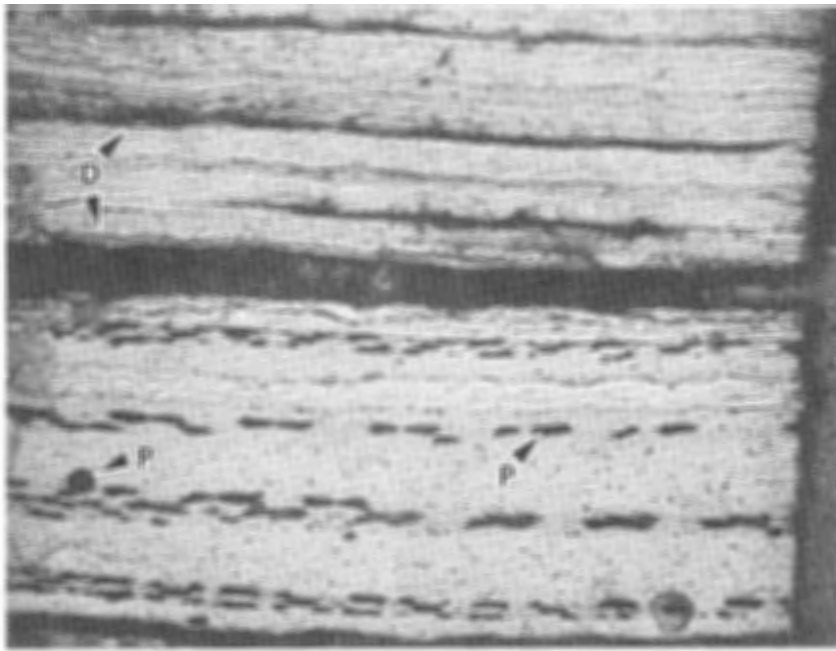
**Figure 2-93. Optical Photomicrographs of Cross-Section Through Fastener Hole**
