**DOT/FAA/CT-92/04**

# **Commuter/Air Taxi Ditchings and Water-Related Impacts that Occurred from 1979 to 1989**

July 1994

Final Report

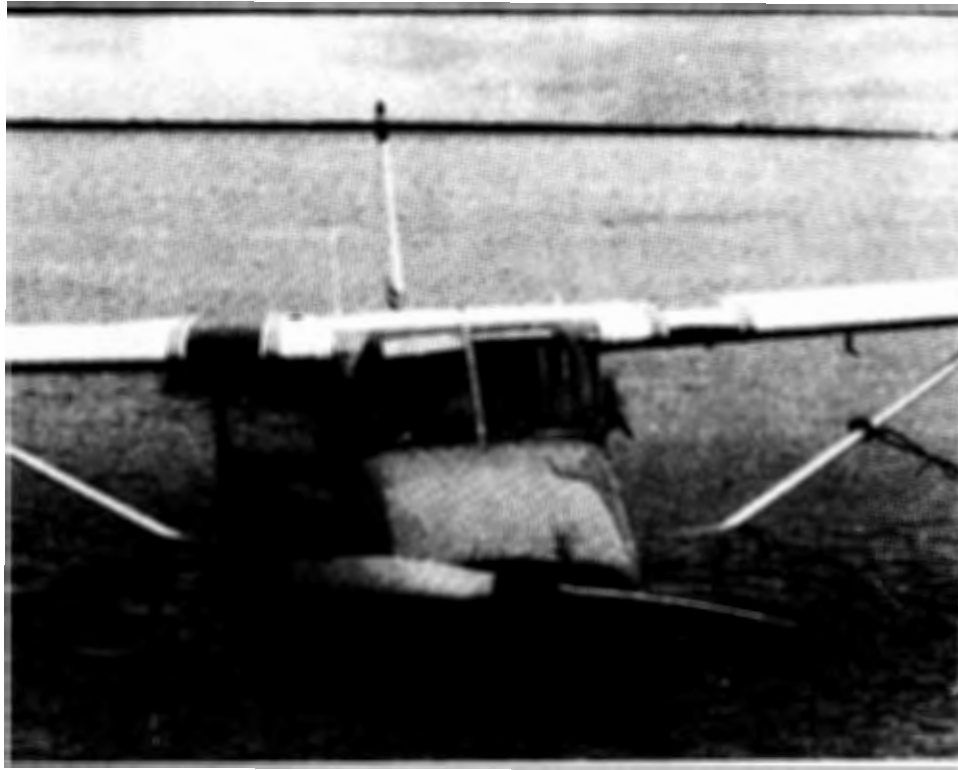
FIGURE 4.4. CASE STUDY 3, FRONT VIEW OF AIRCRAFT

This accident was a mild impact based on the lack of reported impact injuries and the pictures that showed no significant damage to the occupiable volume. No occupants expressed any difficulty in egressing from the downed aircraft. No mention was made of any difficulty posed by the water environment after leaving the aircraft. The proximity to the shoreline and the calm sea state may have contributed significantly to the post-crash survivability of this accident (figure 4.4).

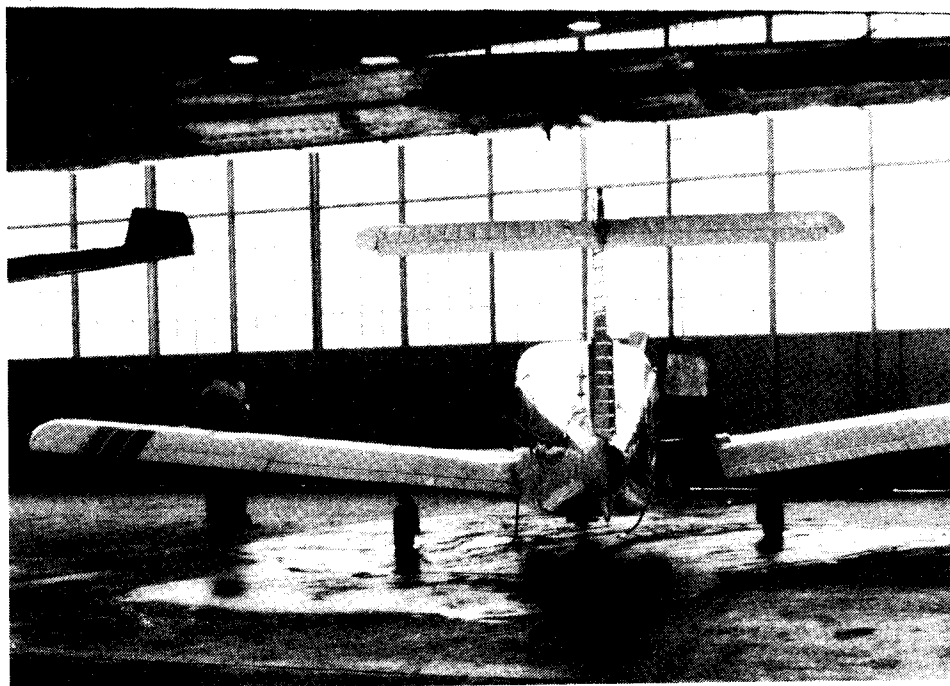
FIGURE 4.5. CASE STUDY 4, REAR VIEW OF AIRCRAFT

- a. The lower inboard ends of both wings revealed heavy water moulding.
- b. A small amount of scratching along the leading edges and wing tips.
- c. The upper inboard surface of the right wing displaced upward, enough to interfere with the right cockpit door opening (figure 4.5).
- d. Small wrinkling along both sides of the rear portion of the fuselage (figure 4.6.)
- e. Separation of the engine cowling (figure 4.7).
- f. Upper engine mount pads broken.
- g. Both propeller blades bent back (figure 4.8).

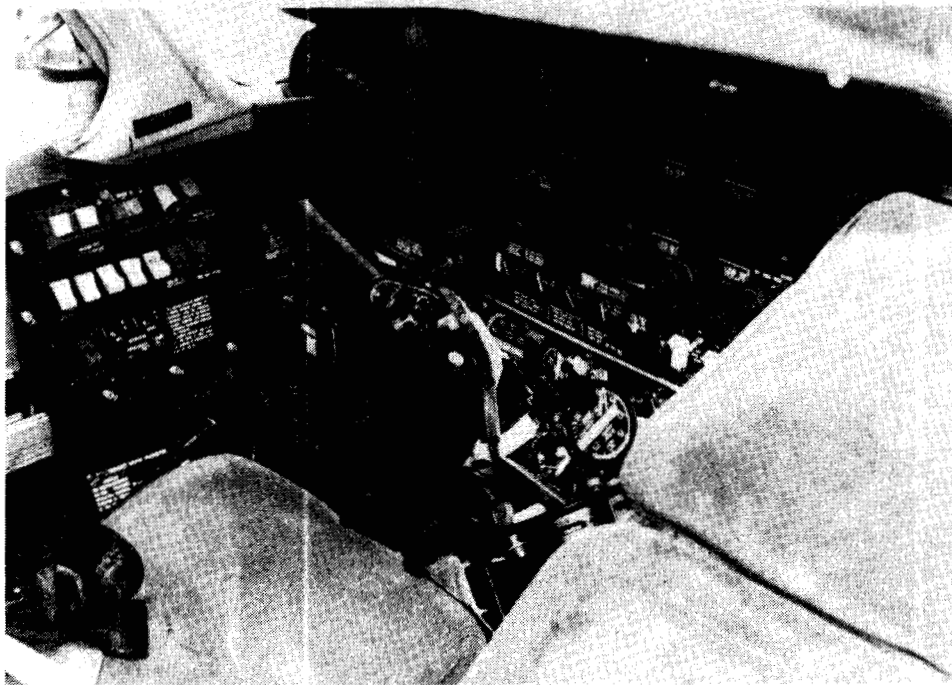
FIGURE 4.9. CASE STUDY 6, FRONT LEFT VIEW OF COCKPIT

The aircraft in this case was recovered. Two views of the cockpit interior are given in figures 4.9 and 4.10. Major aircraft damage is listed below:
