DOT/FAA/CT-92/13

# Rotorcraft Ditchings and Water-Related Impacts that Occurred from 1982 to 1989 - Phase I

October 1993

Final Report

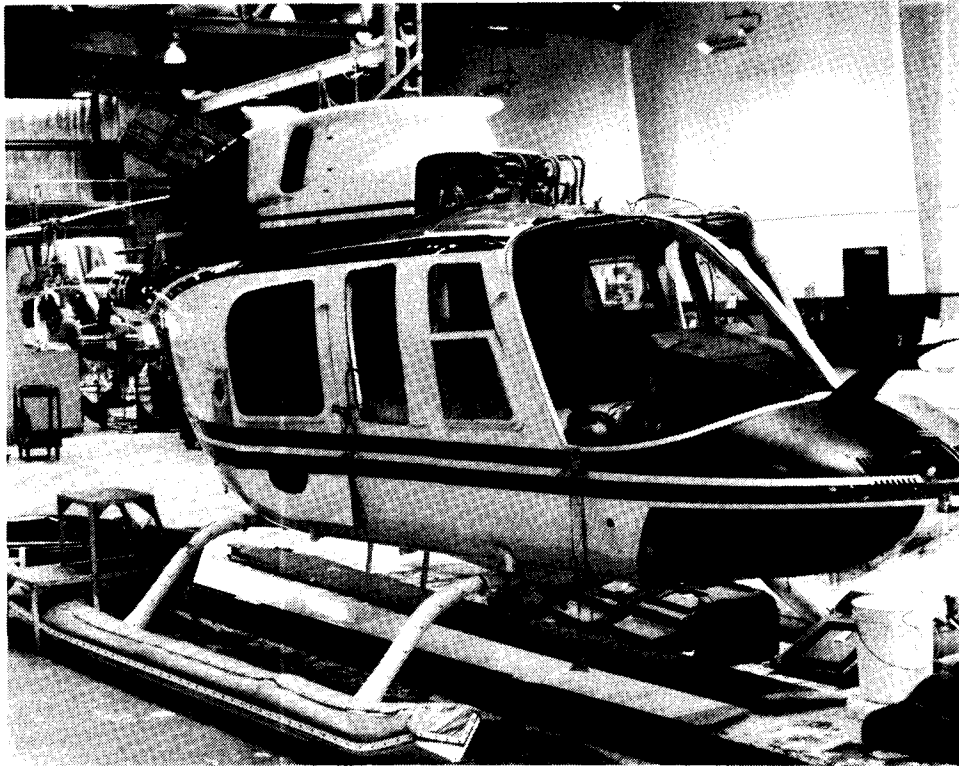
**Figure 8.1 Case Study 1, Right Side View of Aircraft**

8.1.2 Accident Characteristics. The accident initiated approximately 30 sec. after lift off from an oil platform. At approximately 150 - 200 ft. above the water surface with an airspeed of 30 - 40 kts., the engine failed for unknown reasons. The failure followed an observed 10 percent torque bounce one to two seconds earlier. The low RPM audio warning was heard by pilot and passengers immediately previous to the engine out warning.

The pilot initiated an autorotation, during which a mayday call was transmitted and the emergency floats were activated. The pilot claimed to have pulled full collective to flare the aircraft just prior to touchdown. The aircraft impacted the water hard with the

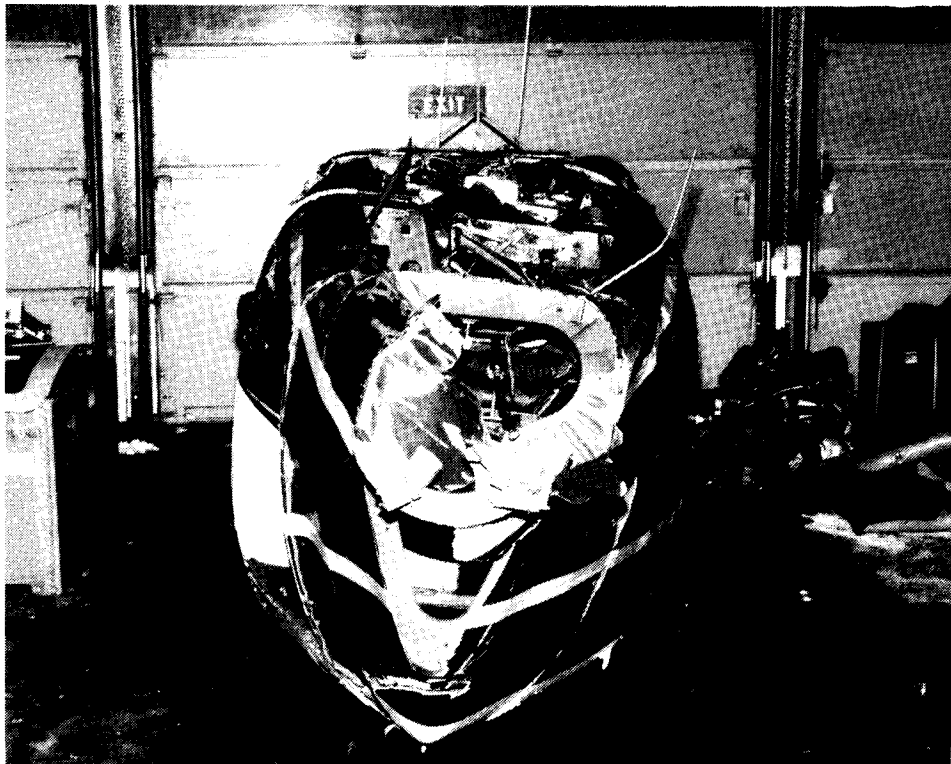
***Figure 8.6 Case Study 3, Rear View of Aircraft***

- Both front chin bubbles and windshields destroyed (figure 8.4).
- Both front doors and posts torn away (figure 8.5).
- Left front seat and pedestal ripped out (figure 8.5).
- Tail boom broken off (figure 8.6).
- Main rotor blades and head assemblage broken off (figure 8.4).
- Transmission displaced forward and partially separated (split top of fuselage) (figure 8.4).
- Extensive damage to left side of cockpit and cabin and relatively minor damage to right side (figures 8.4, 8.7).

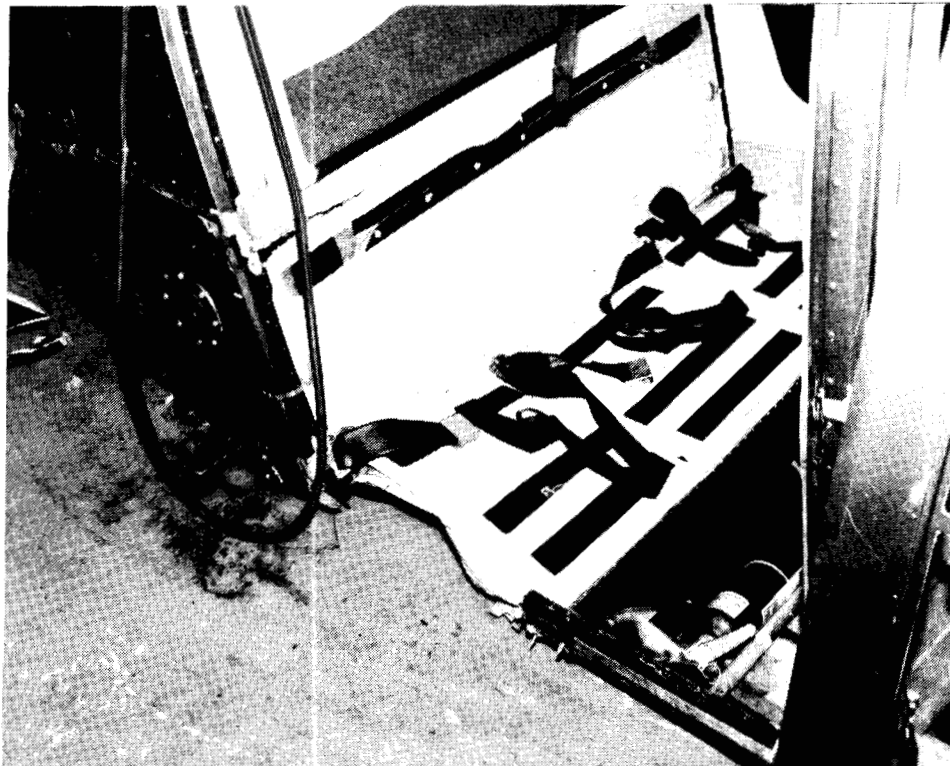
**Figure 8.9 Case Study 5, Right View of Rear Cabin Seats**

- The tail rotor and vertical fin were separated from the tail boom just aft of the horizontal stabilizer (figure 8.8).
- One rotor blade had the outer two thirds of its length broken off (figure 8.8).
- The right rear side of the fuselage aft of the right passenger door showed some crushing (figure 8.8).
- The outboard corner of the right rear bench seat exhibited some crushing downward (figure 8.9).
- The pilot's seat showed downward crushing of 1-2 inches
- The rear crosstube separated from the aircraft (figure 8.10).
- The left front door post buckled (figure 8.11).
