DOT/FAA/CT-93/1

# Vertical Drop Test of a Metro III Aircraft

June 1993

Final Report

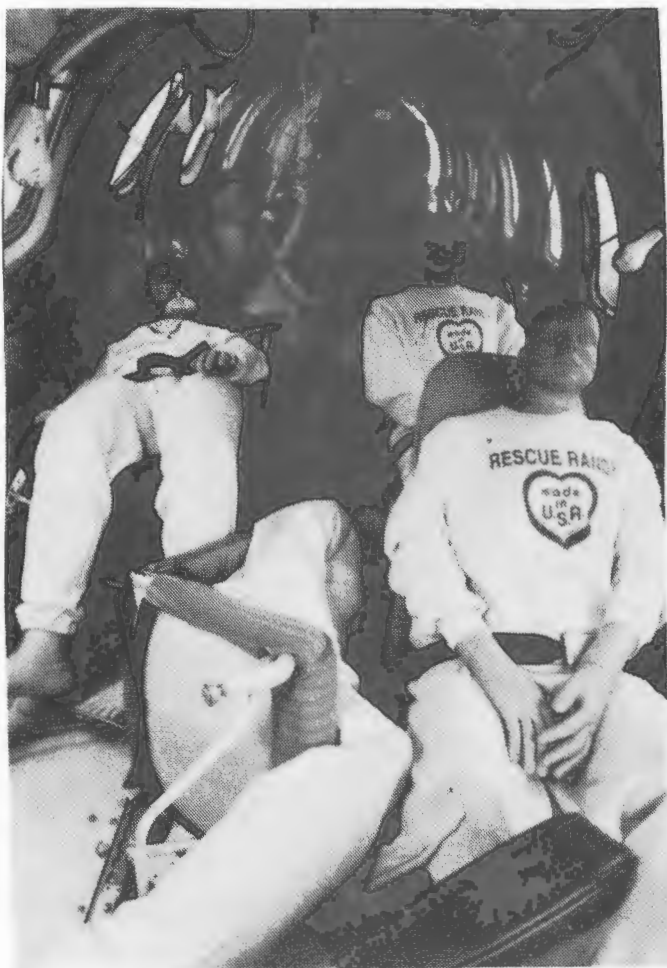
FIGURE 12. POST TEST FUSELAGE INTERIOR,  
FORWARD TO AFT - 1

Figure 12 and 13 are two forward-to-aft views of the aircraft interior after the drop.

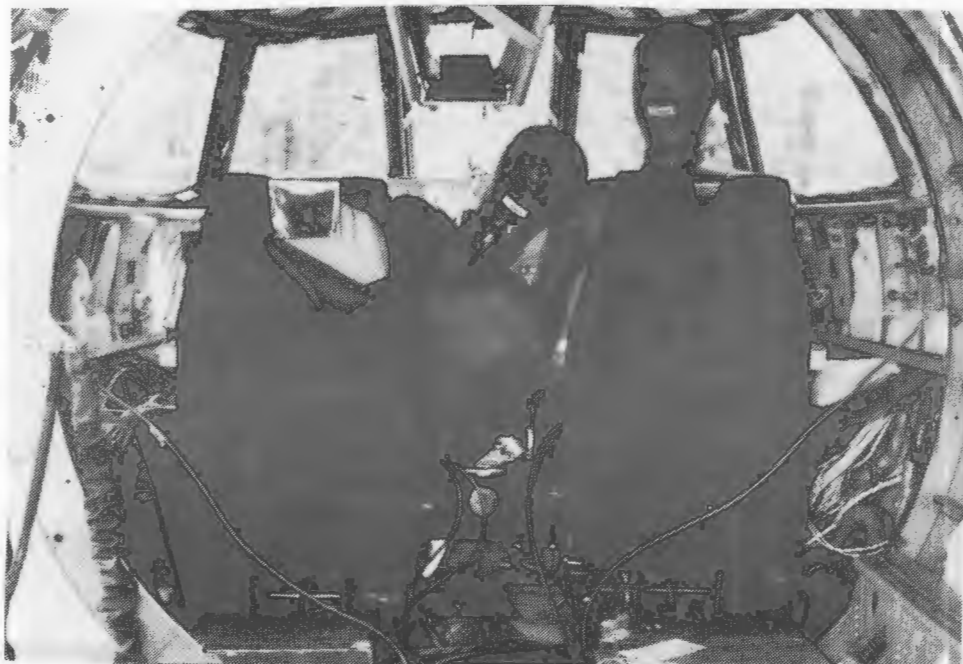
FIGURE 17. POST TEST PILOT AND COPILOT SEATS

Figure 17 is a view of the pilot and copilot seats after the test.

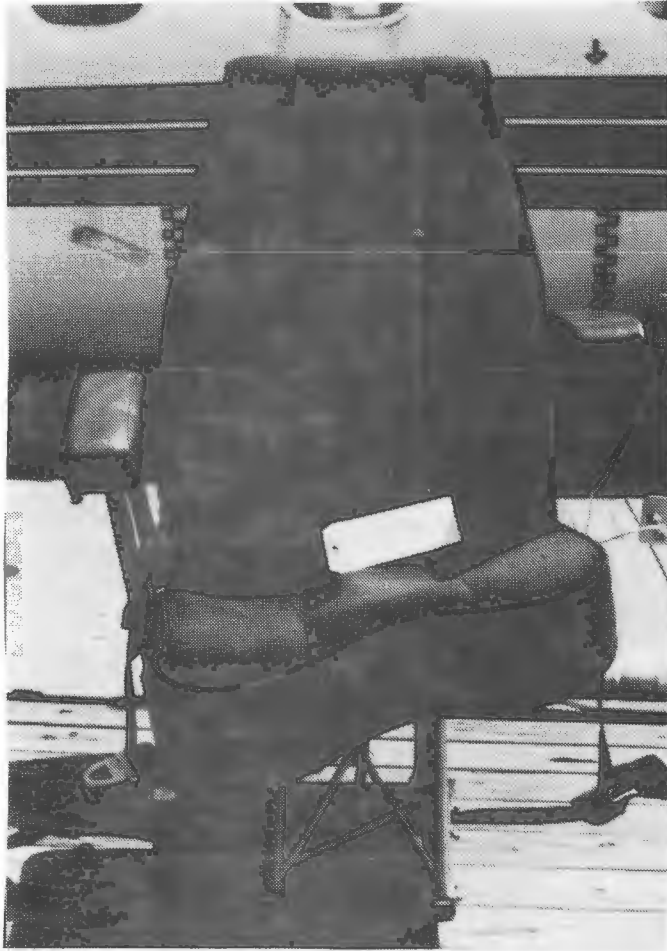
FIGURE 18. POST TEST PILOT SEAT

Figure 18 and 19 are individual pictures of the pilot and copilot seats, respectively, after the test.

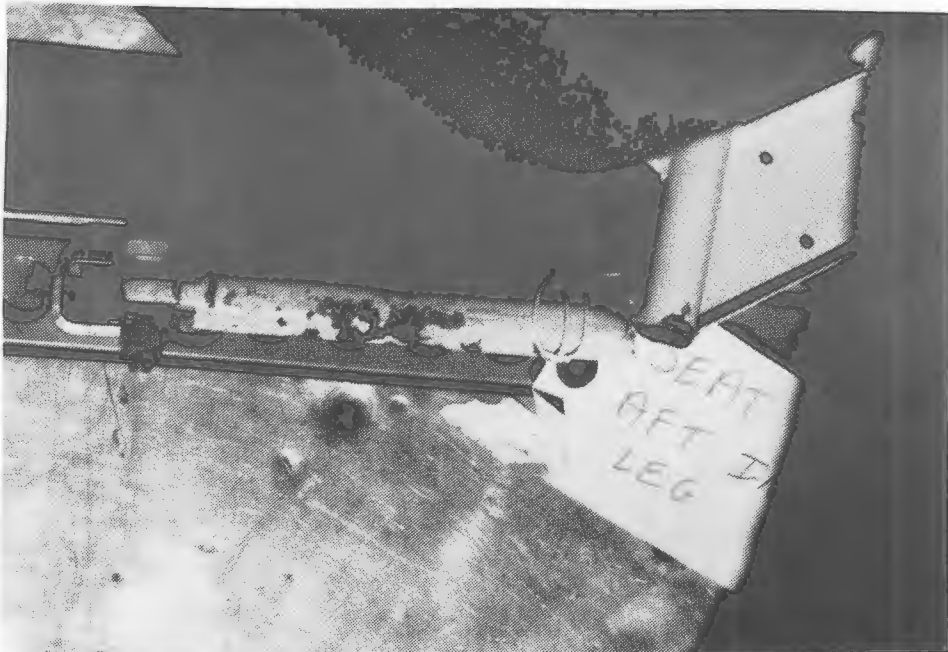
FIGURE 21. POST TEST SEAT 3, INBOARD AFT LEG

Figure 20 is a post-test view of seat 3. Figure 21 shows the damage to the inboard aft leg of seat 3, while figure 22 is a view of the seat track under seat 3.

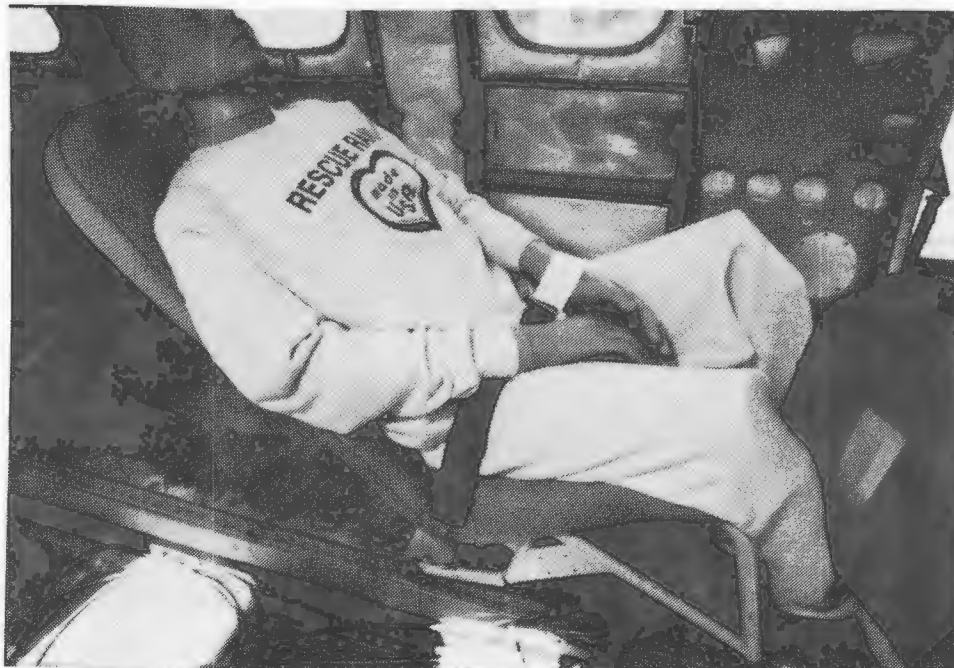
FIGURE 23. POST TEST SEAT 4

Figures 23 and 24 show an overall view and the inboard aft leg of seat number 4 after the test, while figure 25 shows the seat track.

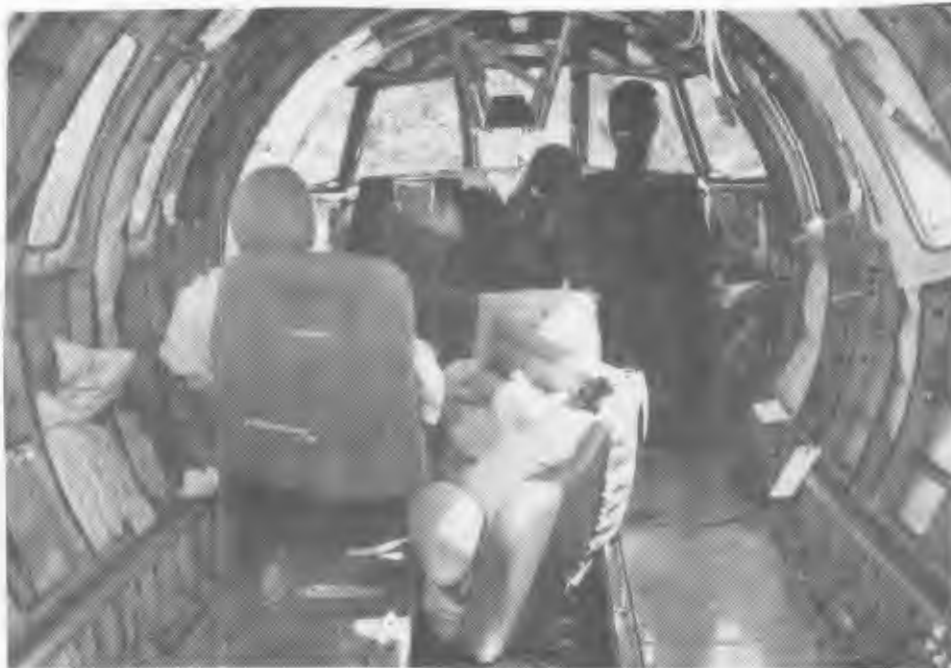
FIGURE 26. POST TEST SEAT 5

Figure 26 is a post-test view of seat 5. Figures 27 and 28 show the inboard and outboard aft legs respectively, and figure 29 shows the damage to the seat track.

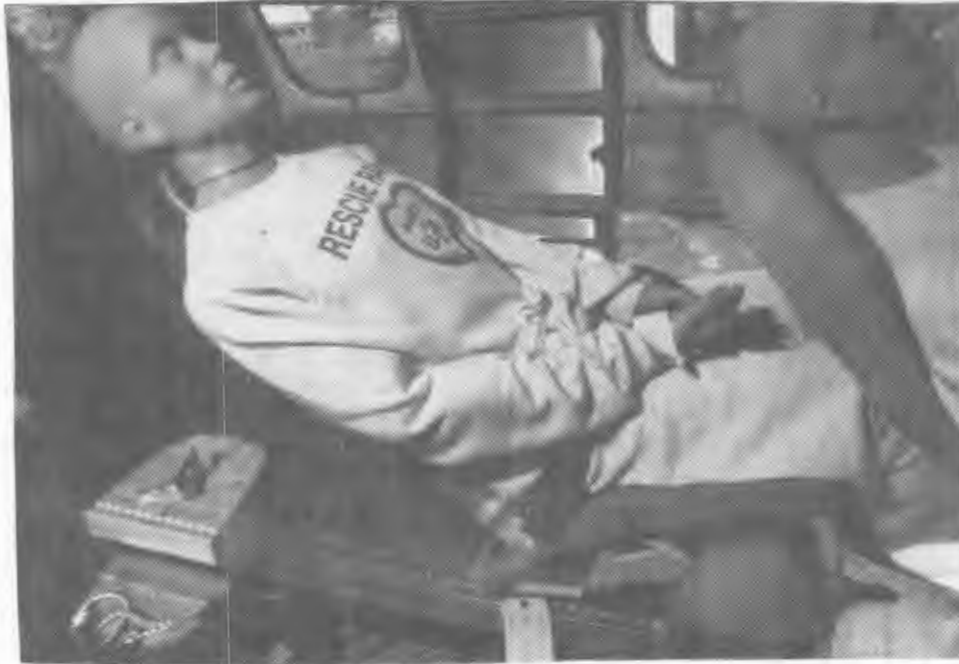
FIGURE 30. POST TEST 6

Figure 30 is a view of seat 6 after the test. Figure 31 shows the damage to the inboard aft leg, while figure 32 is a view of the seat track.

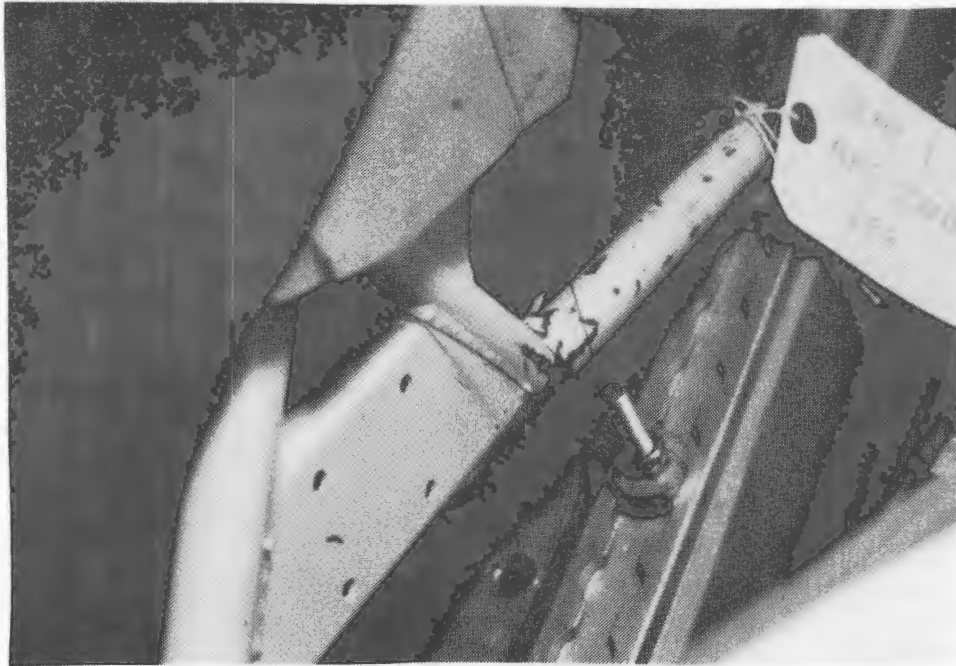
FIGURE 34. POST TEST SEAT 7, INBOARD AFT LEG

Figure 33 shows seat 6 (on the left) and seat 7. Figure 34 shows the damage to the inboard aft leg of seat 7, and figure 35 shows the damage to the seat track under seat 7.

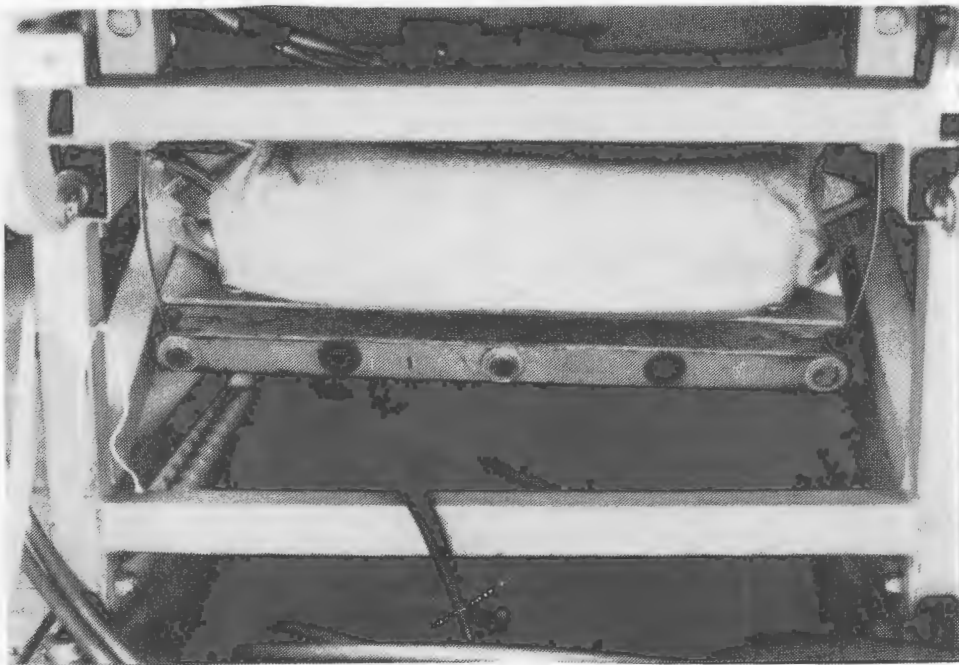
FIGURE 37. POST TEST CAMI SEAT PAN

Figure 36 is the rear view of the CAMI seat (seat 8) after the test. Figure 37 shows a closeup of the seat pan after the test; notice the deflection of the energy absorbing mechanism caused by the impact.

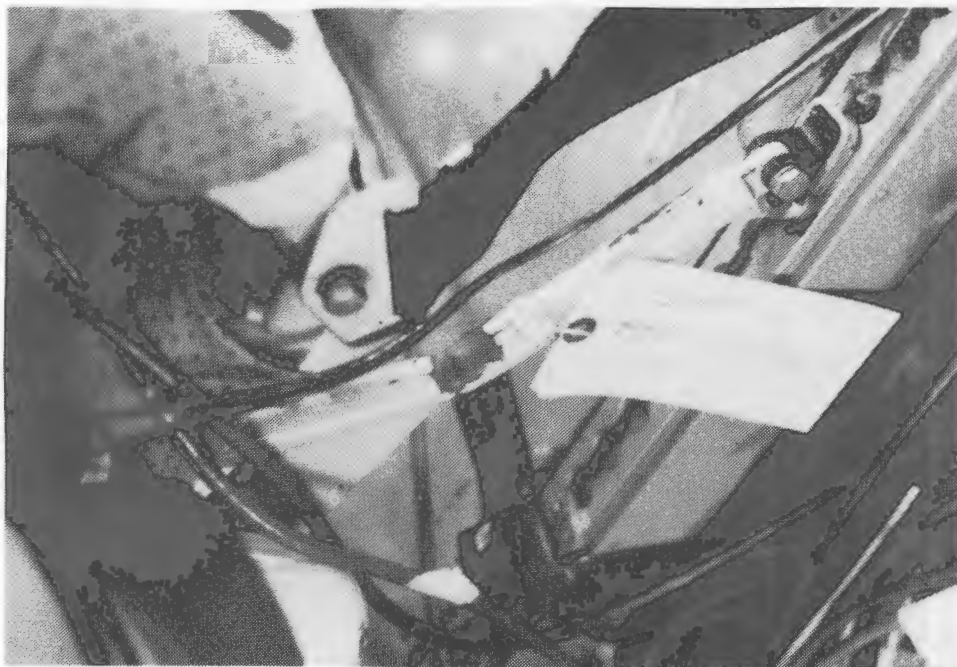
FIGURE 44. POST TEST SEAT 12, INBOARD AFT LEG

Figure 43 shows seat 12 after the test. Figure 44 shows the resulting damage on the inboard aft leg of seat 12.

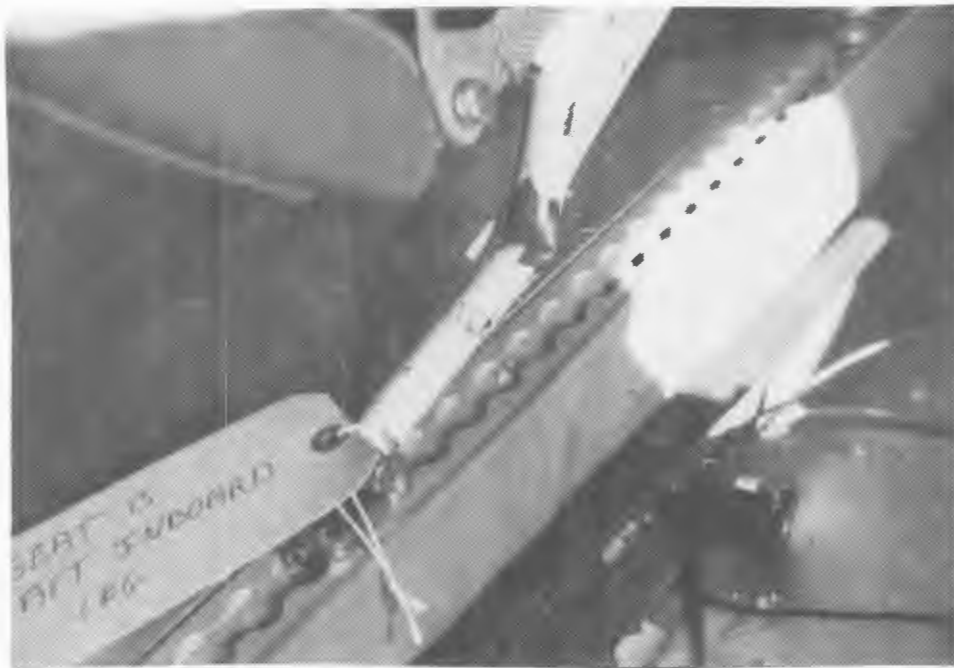
FIGURE 46. POST TEST SEAT 13, INBOARD AFT LEG

Figure 45 illustrates the damage incurred on seat 13 during the test. Figure 46 is a close-up of the inboard aft leg showing damage resulting from the impact.

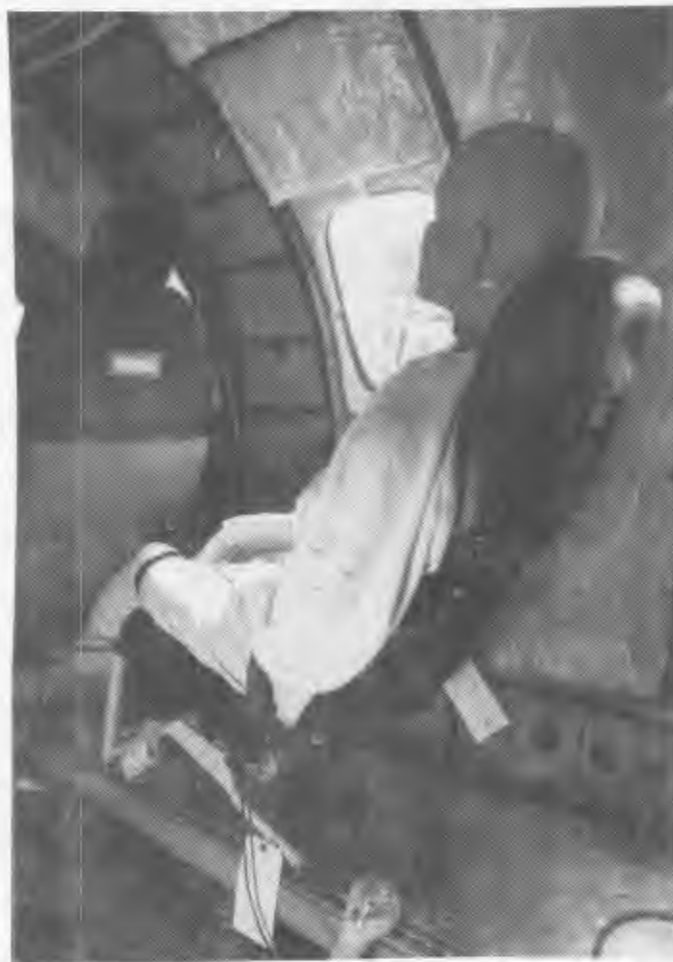
FIGURE 47. POST TEST SEAT 14

Figure 47 is a post-test rear view of seat 14, while figure 48 is a closeup of the track under seat 14.

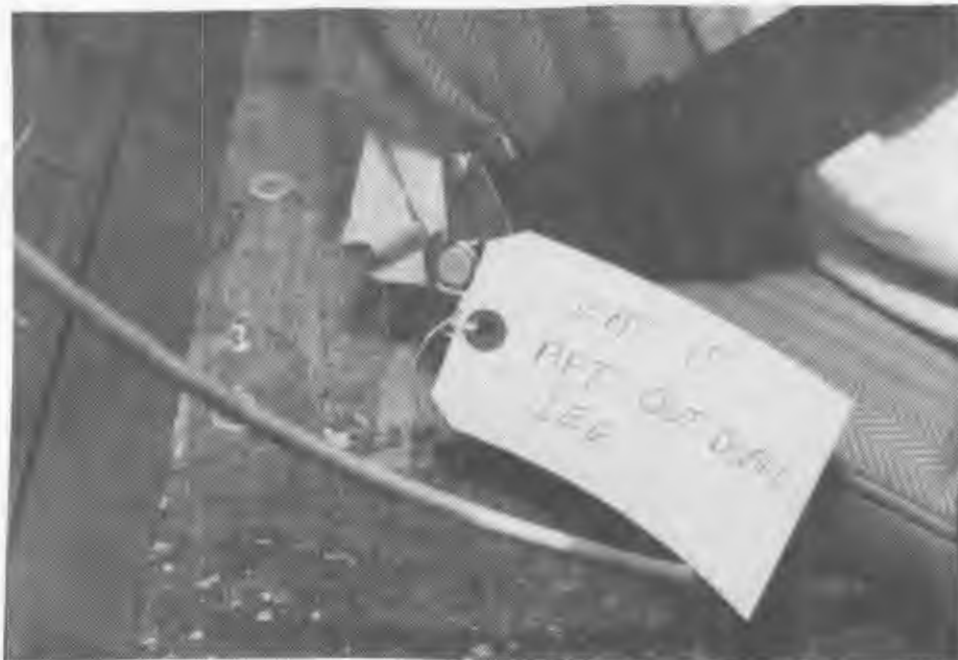
FIGURE 50. POST TEST SEAT 15 - 2

The damage to seat 15 can be seen from a variety of angles in figures 49, 50 and 51

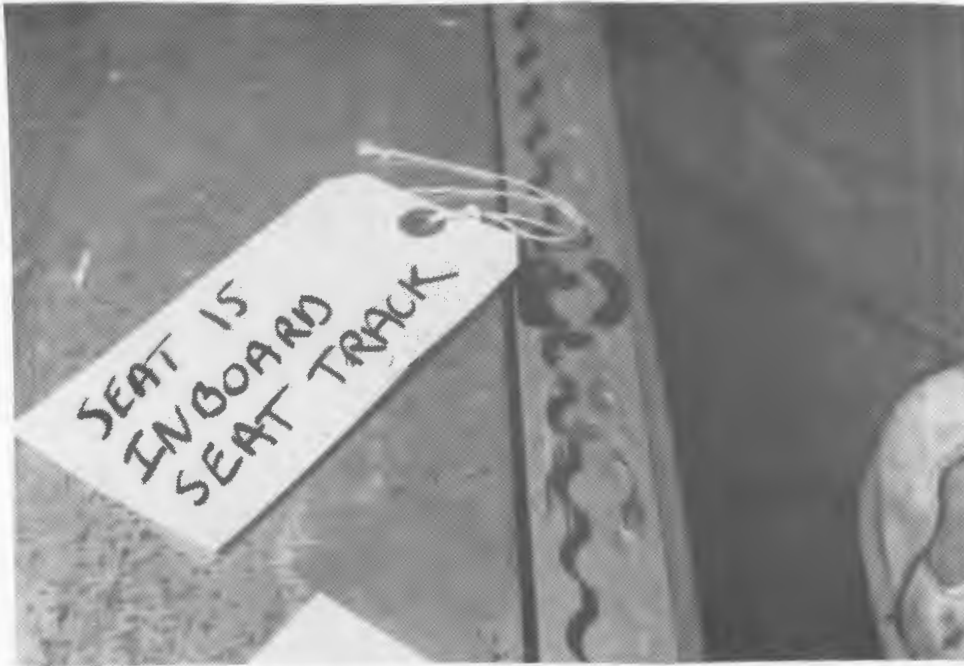
FIGURE 52. POST TEST SEAT TRACK, SEAT 15

The seat track is visible in figure 52.

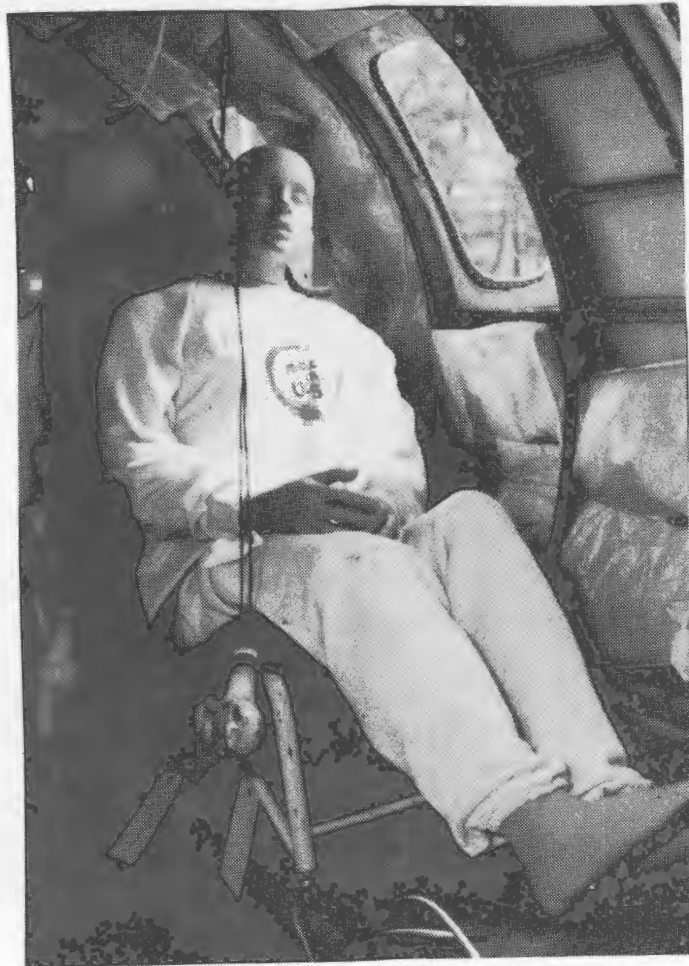
FIGURE 53. POST TEST SEAT 16

Figure 53 shows the final seat (16), which is rear facing, after the test. Figure 54 is a view of the inboard legs of seat 16, while figure 55 shows the seat track.

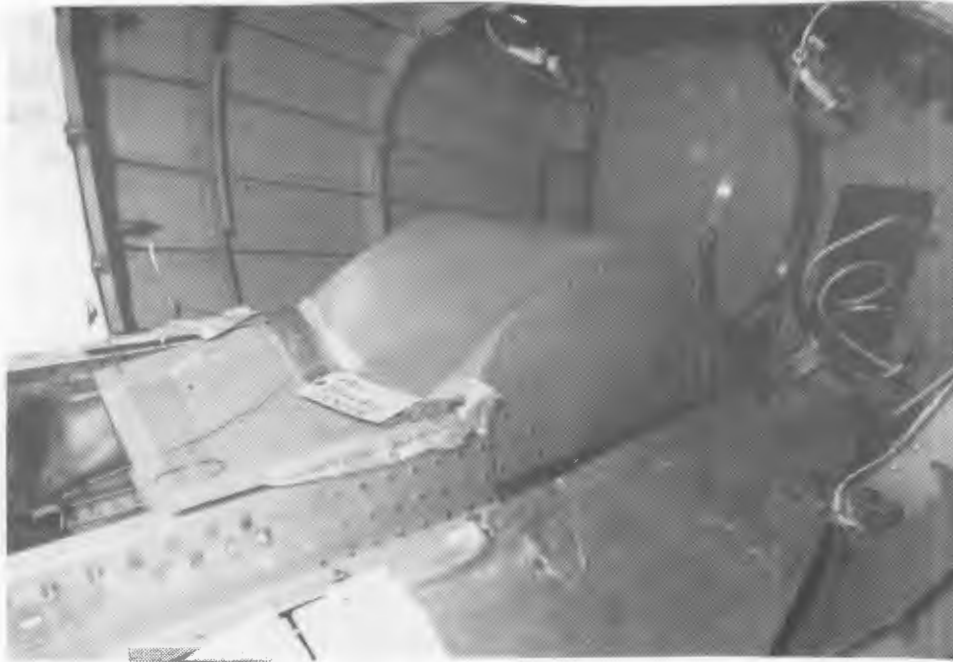
FIGURE 60. POST FORWARD BAGGAGE COMPARTMENT - 2

Figures 59, 60 and 61 view the inside of the forward baggage compartment after the test.

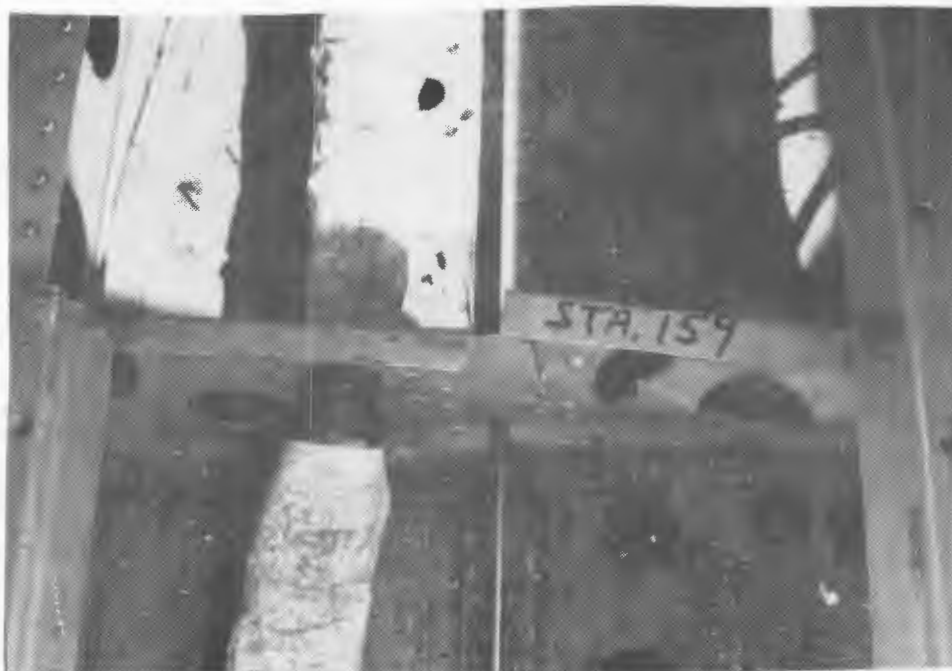
The interior of the fuselage also experienced some damage during the test. Figure 62 shows an example of such damage, occurring at body station 159. Figure 63 shows more structural damage at body station 189. Ceiling damage can be seen in figure 64, while sidewall damage is observed in figure 65.

FIGURE 62. POST TEST INTERIOR FUSELAGE, BODY STATION 159

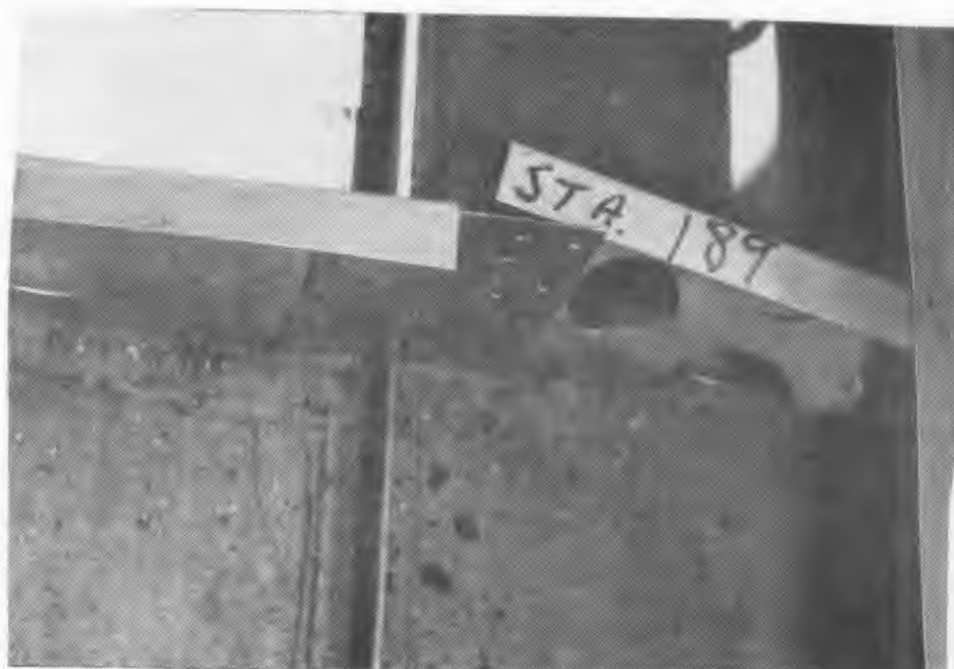
FIGURE 63. POST TEST INTERIOR FUSELAGE, BODY STATION 189

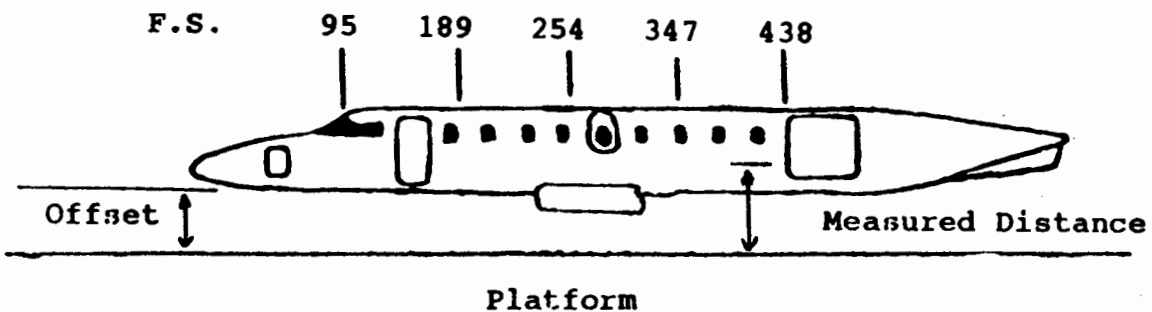
FIGURE 66. FUSELAGE CRUSH MEASUREMENT LOCATIONS

As a result of the test, the fuselage experienced a slight deformation, varying throughout its length. The deformation was calculated by measuring the distance from a set point on the aircraft to the platform, both prior to and after the test. An offset value was used to compensate for the wingbox prior to the test, and the forward lean of the aircraft about the wingbox, after the test. See table 4 and figure 66. No significant crush of the airframe could be determined by film analysis.

The above readings were measured from a set point on the outside of the aircraft to the platform. The offset value is the distance from the bottom outside of the aircraft to the platform. See diagram below.
