Testing of State Roadside Safety Systems Volume XI: Appendix J— Crash Testing and Evaluation of Existing Guardrail Systems

PUBLICATION NO. FHWA-RD-98-046

1. Report No. FHWA-RD-98-046		2. Government Accession No.	
4. Title and Subtitle TESTING OF STATE ROADSIDE SAFETY SYSTEMS VOLUME XI: APPENDIX J - CRASH TESTING AND EVALUATION OF EXISTING GUARDRAIL SYSTEMS		5. Report Date April 1999

7. Author(s) King K. Mak, Roger P. Bligh, and Wanda L. Menges		6. Performing Organization Code	
9. Performing Organization Name and Address Texas Transportation Institute The Texas A&M University System College Station, Texas 77843-3135		8. Performing Organization Report No. Research Foundation 7147-Vol. XI

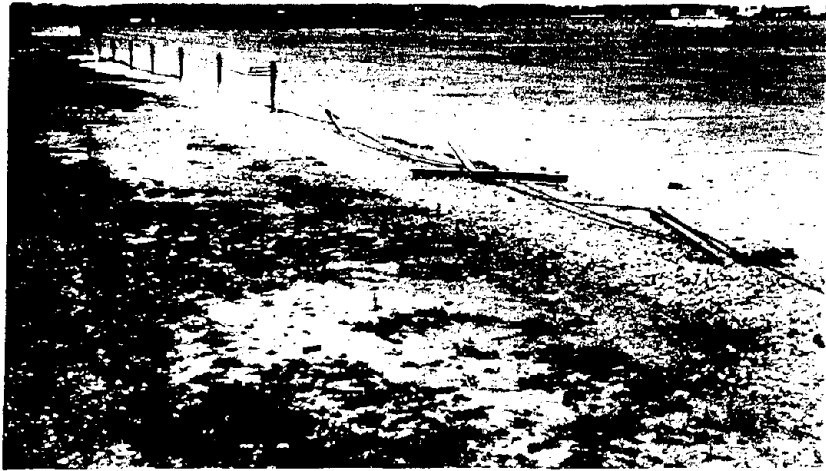
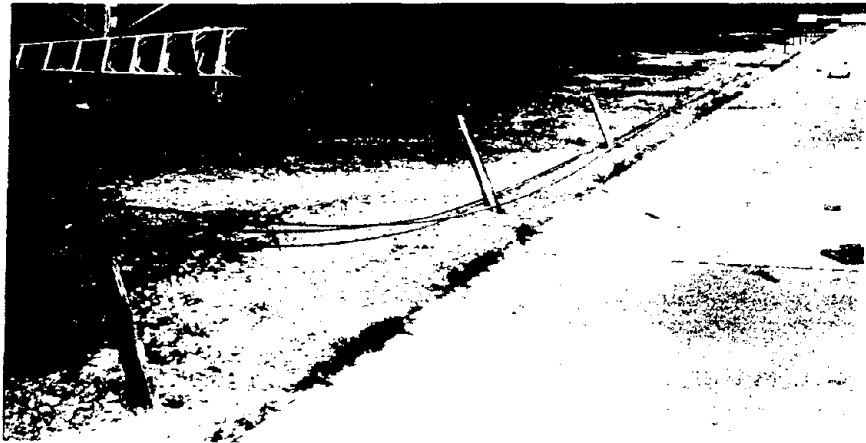
Figure 16. Cable (G1) guardrail installation after test 471470-28.

As seen in figures 16 and 17, the test installation received moderate damage. The cables were separated from the posts between posts 10 through 16. The lateral deflections recorded at posts 8 through 16 are noted in table 2.

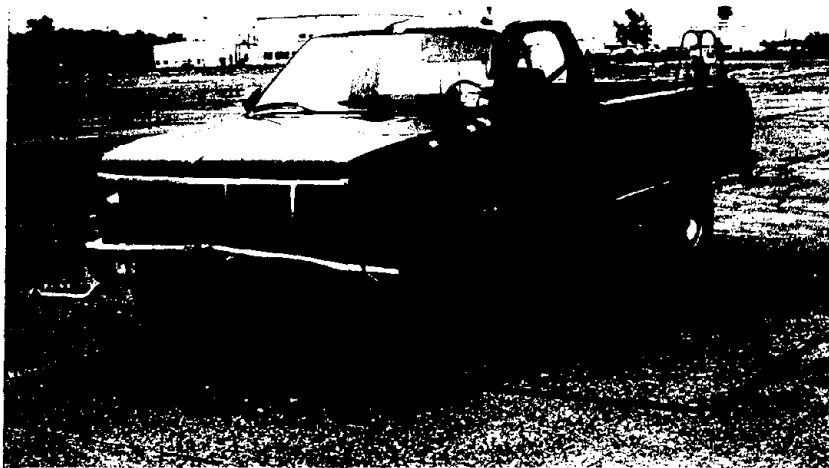
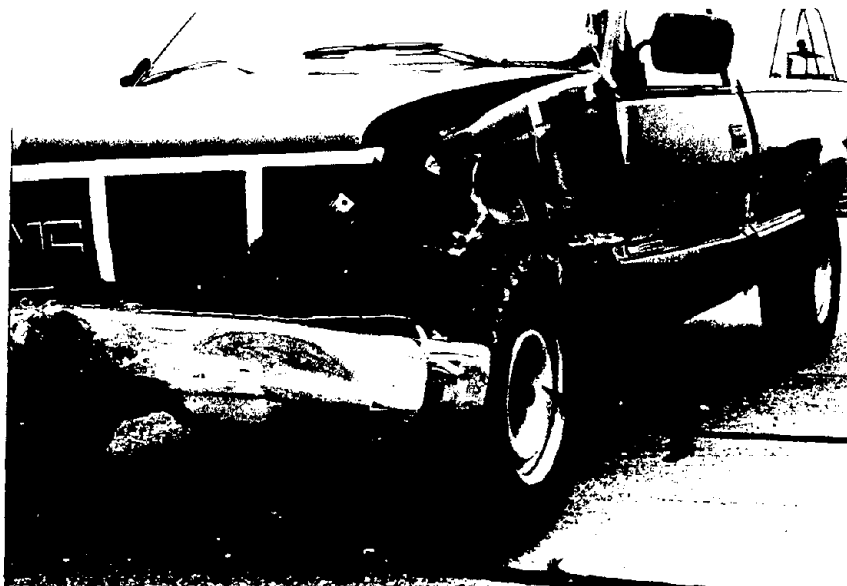
Figure 18. Vehicle after test 471470-28.

The vehicle sustained minimal damage, as shown in figure 18. The front bumper and grill were damaged, and the entire left side of the vehicle was scraped by the wire rope. Maximum exterior crush at the left front corner of the vehicle was 360 mm (14.2 in), and there was no deformation or intrusion into the occupant compartment.

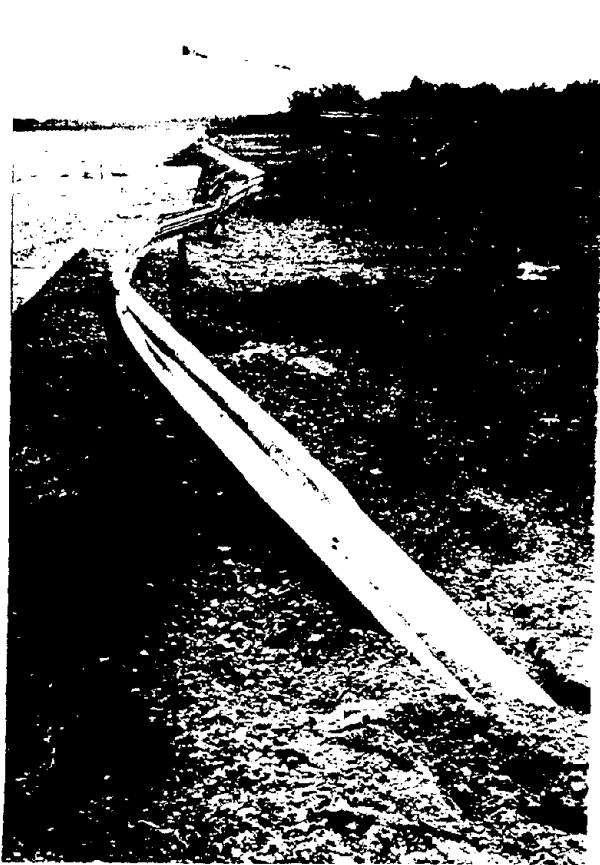
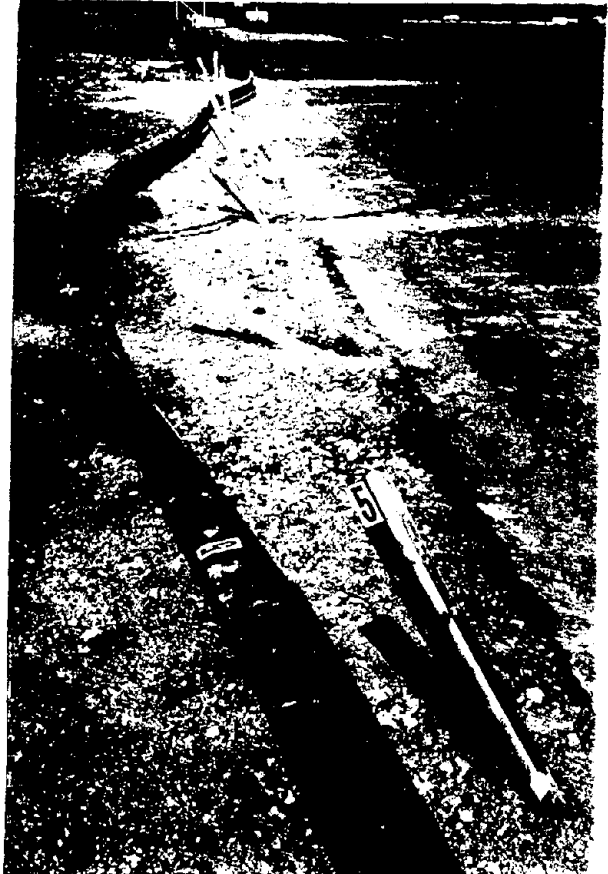
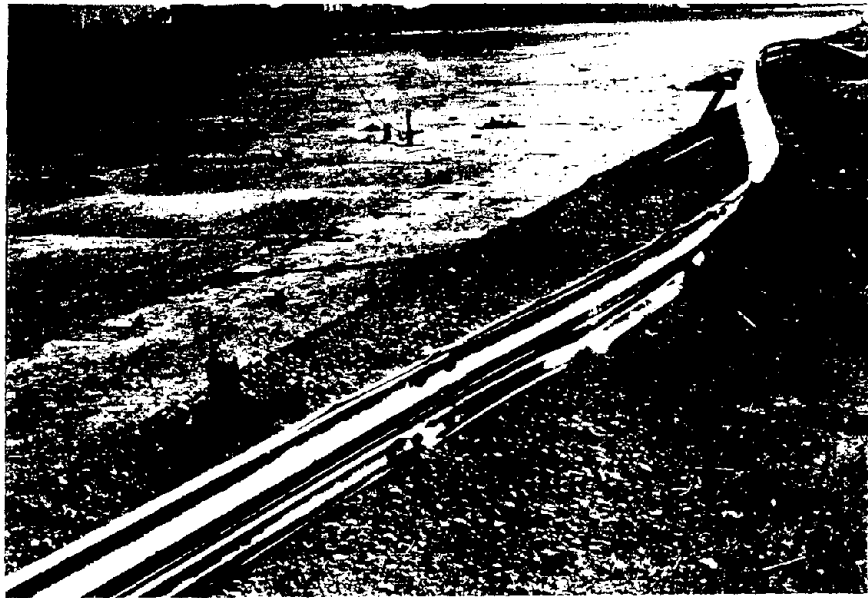
Figure 31. W-beam, weak-post (G2) guardrail after test 471470-21.

As can be seen in figure 31, the test installation received considerable damage. There was evidence of movement on all of the posts and the W-beam slipped over the tops of post 5 through 13 and the maximum permanent deformation of the W-beam was 1.8 m (5.9 ft). The vehicle was in contact with the installation from impact to the end of the guardrail.

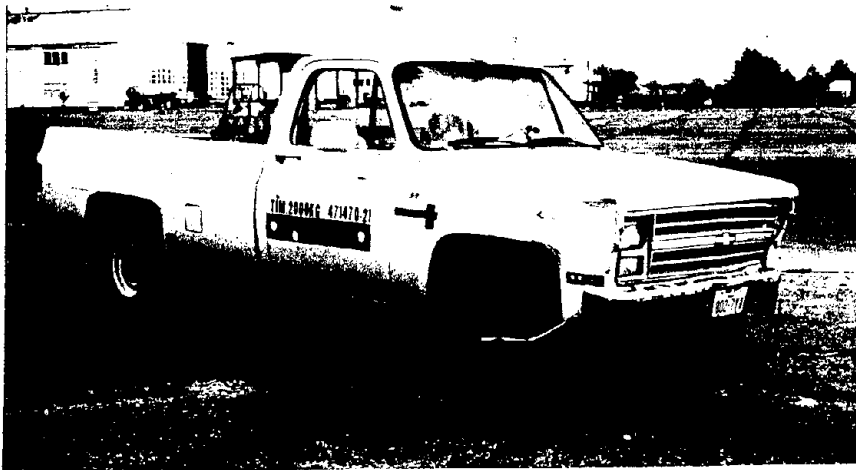
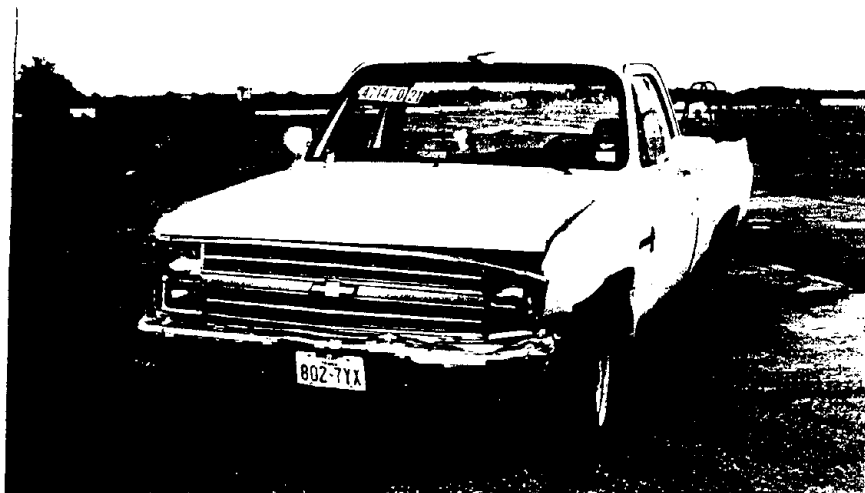
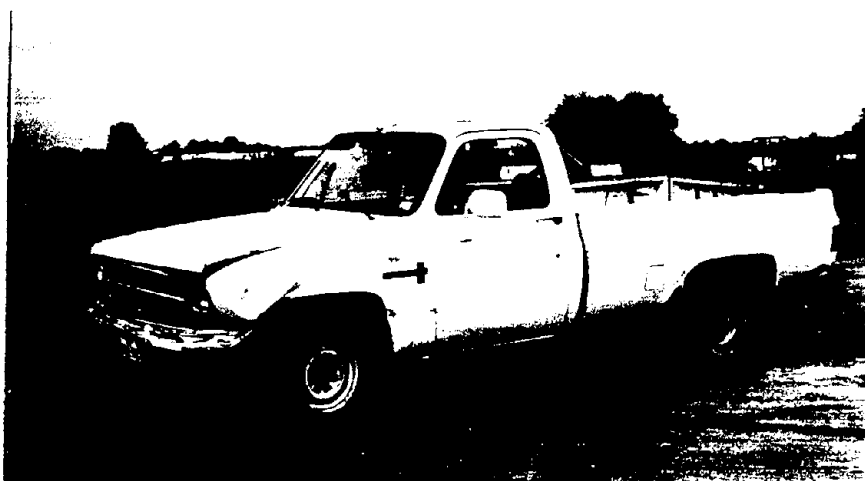
Figure 32. Vehicle after test 471470-21.

The vehicle sustained moderate damage to the left side as shown in figure 32. Maximum exterior crush at the left front corner at bumper height of the vehicle was 259 mm (10.2 in), and there was no intrusion into or deformation of the occupant compartment. Damage was sustained to the front bumper, grill, hood, and along the entire left side the body panels were dented and scraped. There was slight damage to the right front corner where the vehicle came to rest against the next installation downstream.

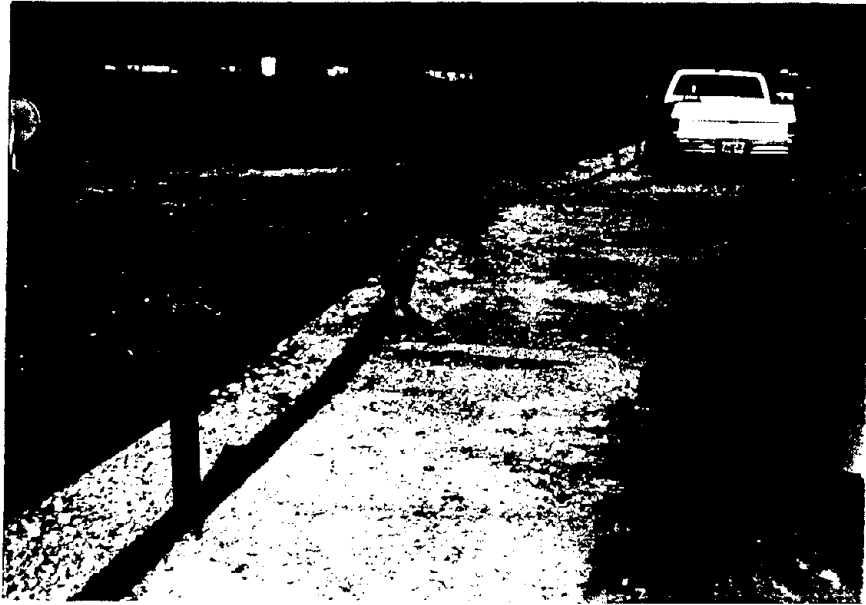
Figure 44. W-beam, weak-post (G2) guardrail after test 471470-22.

As can be seen in figures 44 and 45, the guardrail installation received considerable damage in the area of contact. There was evidence of movement on the first 9 posts. The W-beam slipped over the tops of posts 5 through 7 and the maximum permanent deformation of the W-beam was 1.3 m (4.2 ft). The vehicle was in contact with the installation for a total length of 15.7 m (51.7 ft).

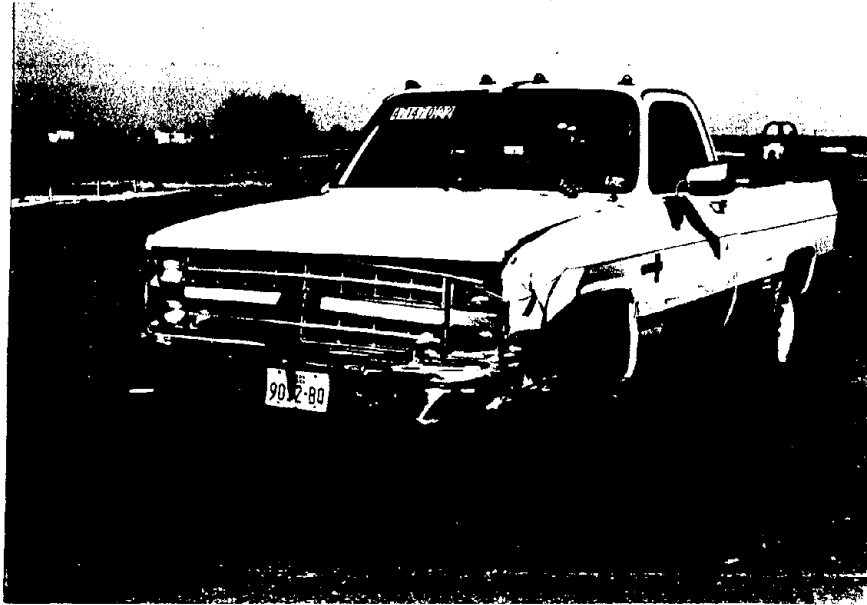
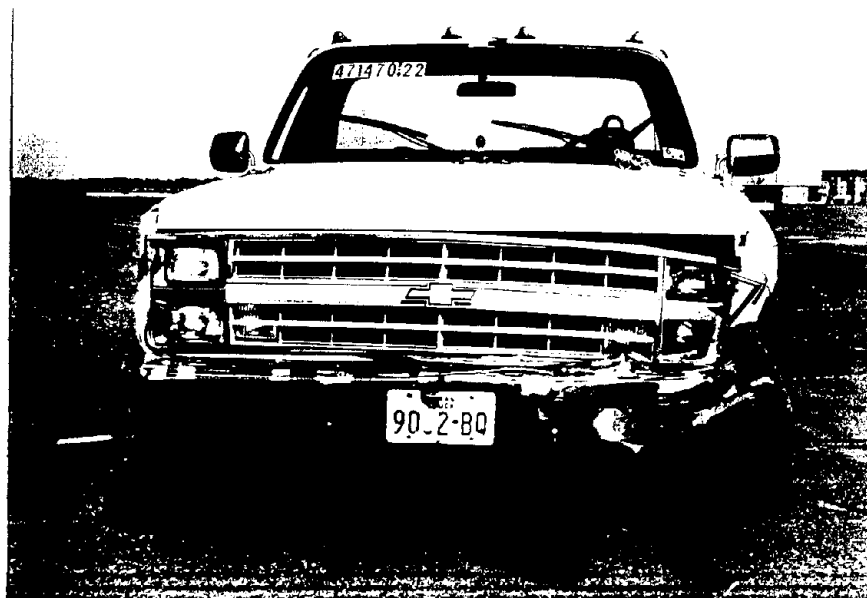
Figure 45. Vehicle after test 471470-22.

The vehicle sustained moderate damage to the left side, as shown in figure 46. Maximum exterior crush at the left front corner at bumper height of the vehicle was 231 mm (9.1 in), and there was no intrusion into or deformation of the occupant compartment. Damage was sustained to the front bumper, grill, hood, left front lower A-arm assembly, and along the left side the body panels were dented and scraped through the driver's door.

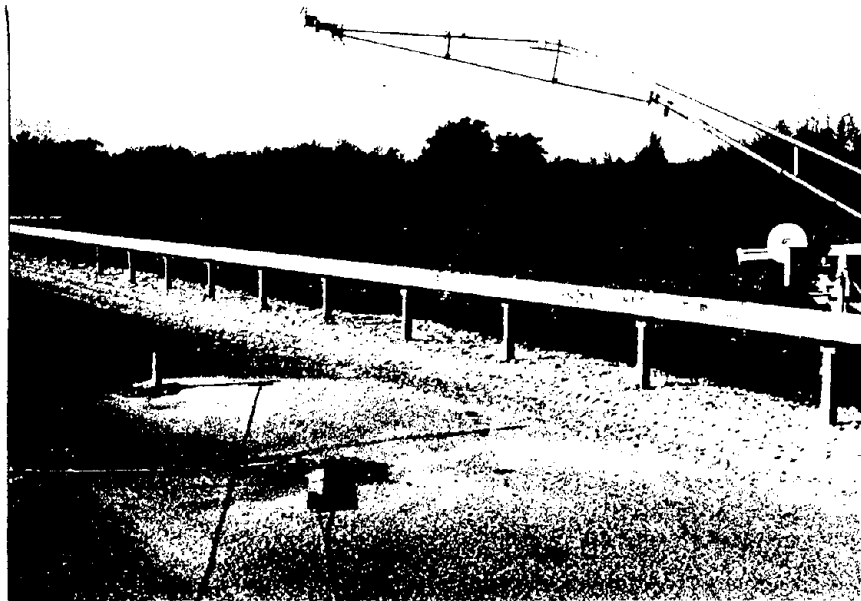
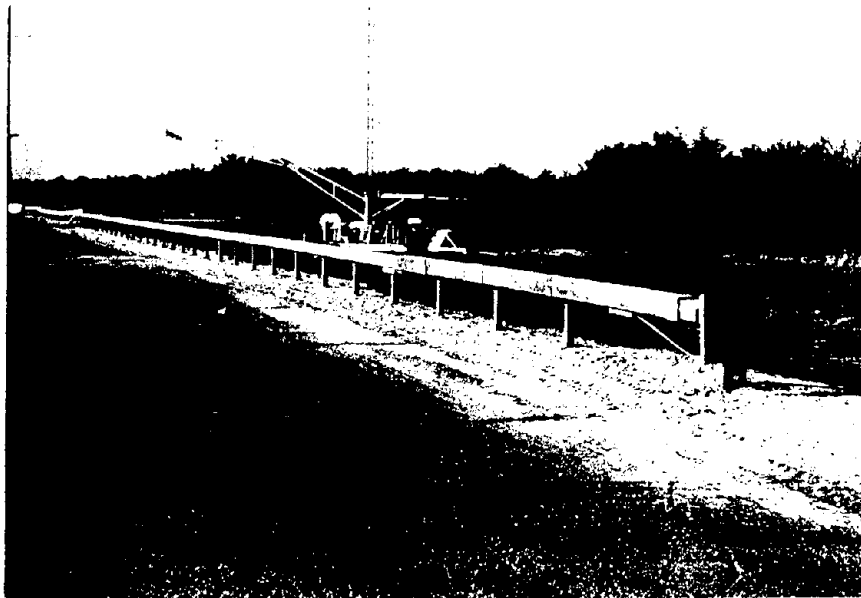
Figure 52. Box-beam (G3) guardrail installation used for test 471470-33.

The test installation consisted of a 45.7-m- (150-ft-) long section of the box-beam (G3) guardrail with a 15-m- (49.2-ft-) long telescoping tube terminal (WYBET) on the impact end and a turned-down terminal on the downstream end. The layout of the test installation is shown in figure 51. Photographs of the test installation are shown in figures 52 and 53.

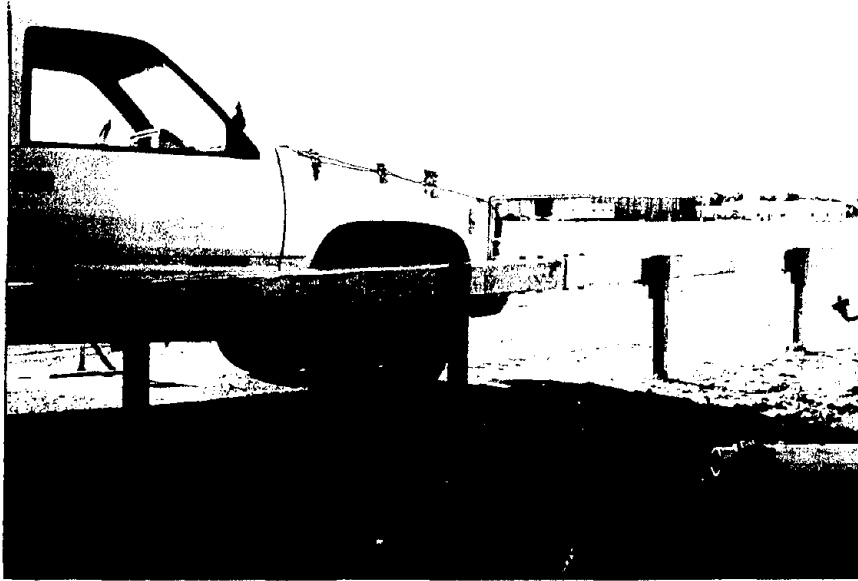
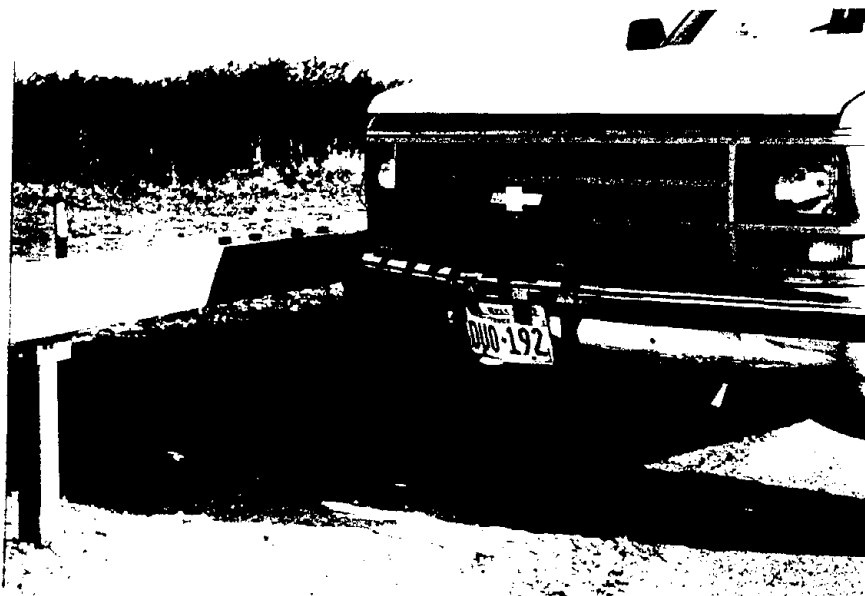
Figure 54. Vehicle/guardrail geometrics for test 471470-33.

A 1989 Chevrolet 2500 pickup (shown in figures 54 and 55) with a test inertia weight of 2000 kg (4409 lb) was used for the crash test. The gross static weight of the vehicle was 2076 kg (4573 lb) which included a restrained 50th-percentile male anthropomorphic dummy placed in the driver's position of the vehicle. The heights to the upper and lower edges of the vehicle bumper were 640 mm (25.2 in) and 415 mm (16.3 in), respectively. Additional dimensions and information on the vehicle are given in figure 56. The vehicle was directed into the installation using the cable reverse tow and guidance system, and was released to be free-wheeling and unrestrained just prior to impact.

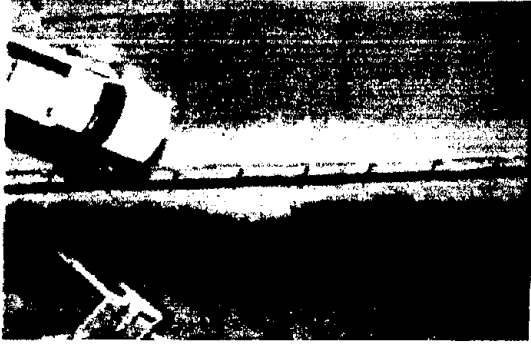
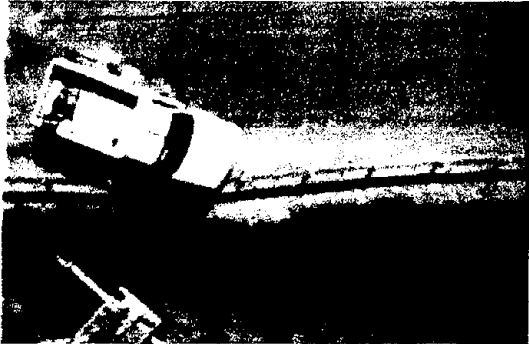
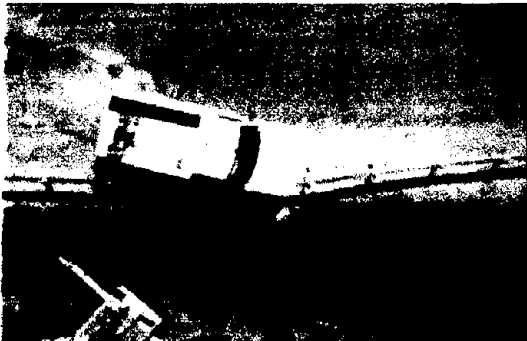
Figure 57. Sequential photographs for test 471470-33 (overhead and frontal views).

The vehicle contacted the guardrail a second time at 1.566 s and subsequently came to rest with the nose of the vehicle against the guardrail 26 m (85 ft) down from the initial point of impact. Sequential photographs are shown in figures 57 and 58.

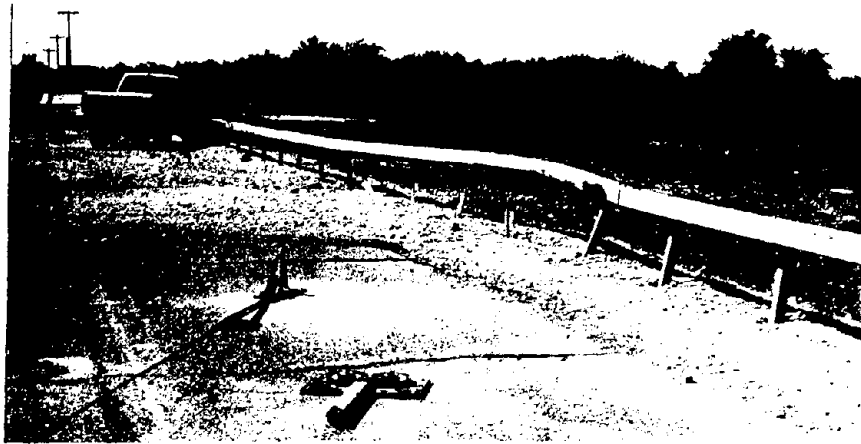
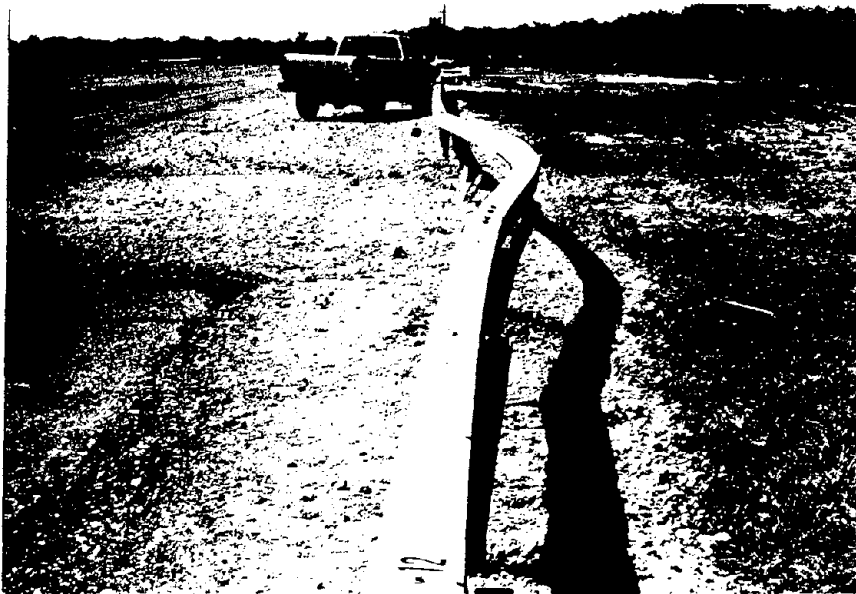
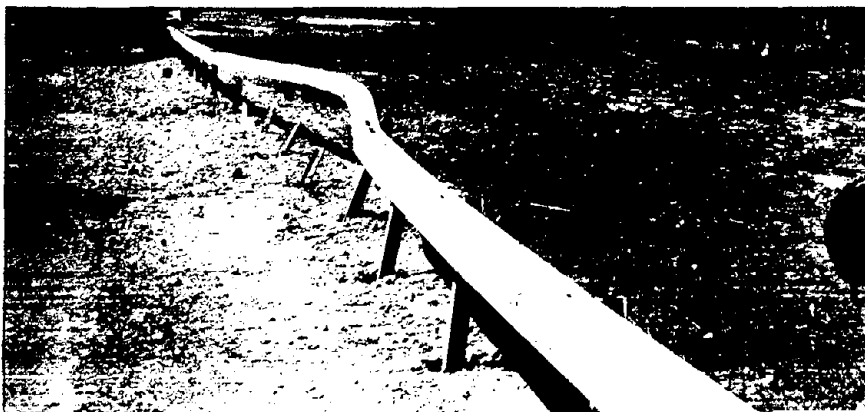
Figure 59. Box-beam (G3) guardrail after test 471470-33.

As seen in figures 59 through 61, the guardrail installation received moderate damage. There were tire marks on the face of the box-beam rail element from posts 15 through 21, and on posts 15 through 20. The box-beam rail element was separated from posts 16 through 20, and these posts were bent at ground level. The lateral deflections recorded at posts 12 through 22 are noted in table 3.

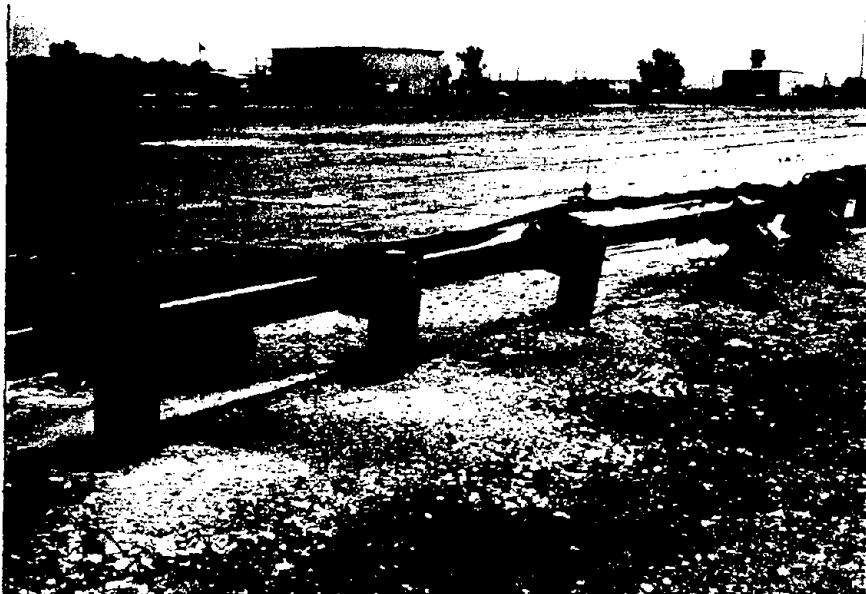
Figure 75. W-beam, wood-post (G4(2W)) guardrail installation after test 471470-26.

As can be seen in figures 75 and 76, the installation received moderate damage. The bolts were pulled out of the W-beam rail element at posts 15 and 16, and the blockout on post 16 was split. None of the posts broke off, but some posts were pushed back. The displacements of the posts are shown in table 4.

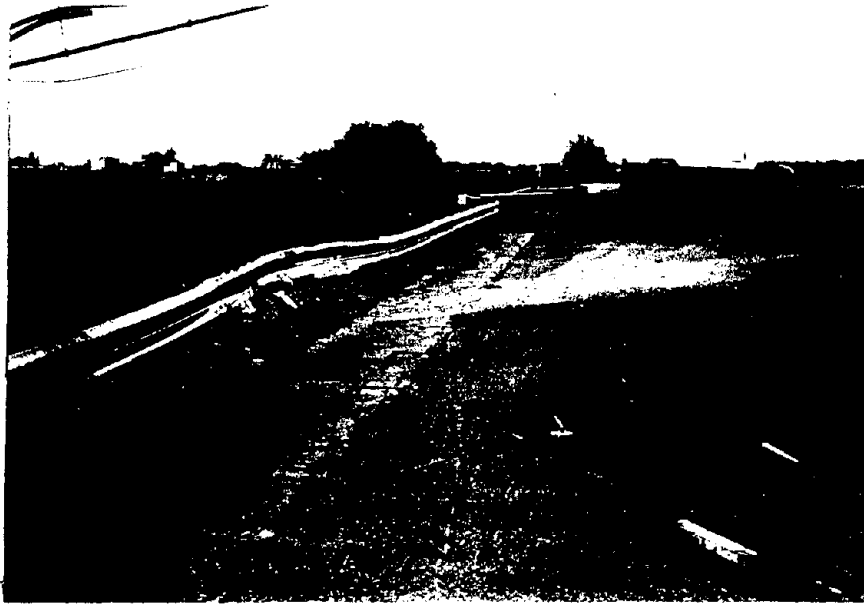
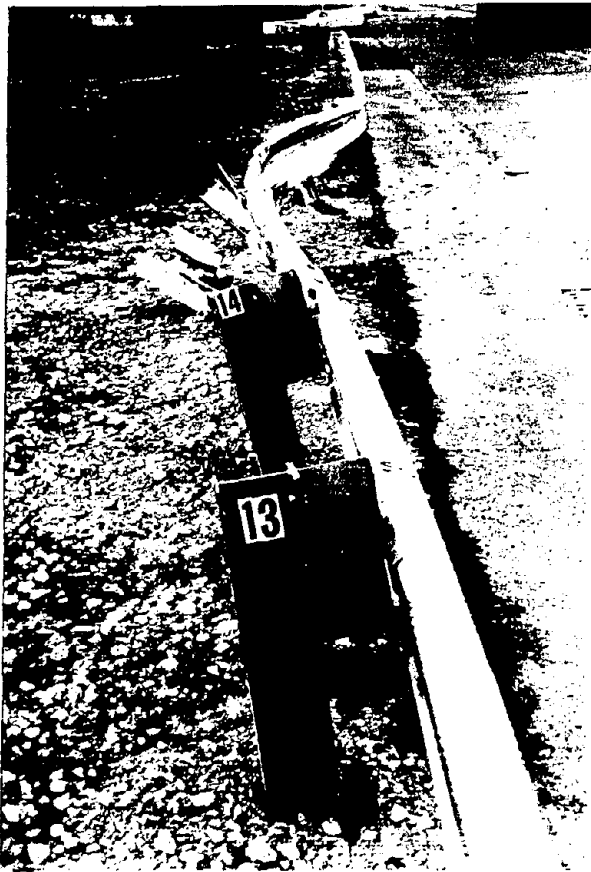
Figure 90. W-beam, steel-post (G4(1S)) guardrail installation after test 471470-27.

As can be seen in figures 90 and 91, the installation received moderate damage. The MELT anchor on the upstream end had pulled up slightly and moved laterally 44.5 mm (1.75 in). The buffered end nose was pulled off the end post (post 1). The bolts were pulled out of the W-beam rail element at posts 15, 16, and 17, and the posts and blockouts were bent. All the steel posts upstream of impact were disturbed, with measurable displacements as shown in table 5.

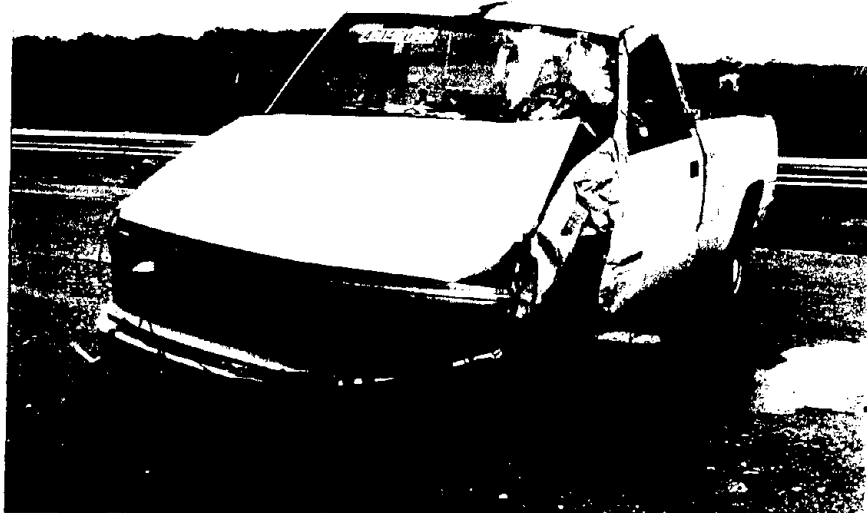
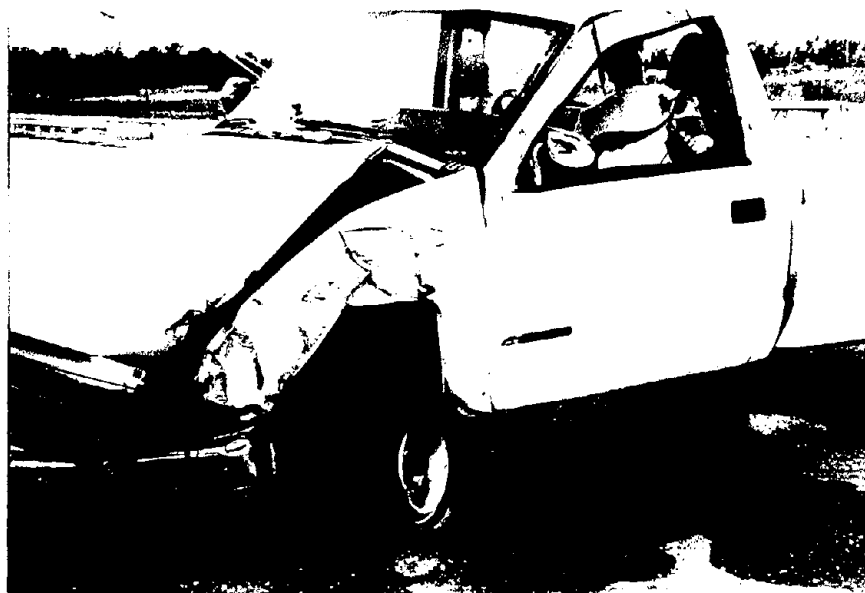
Figure 93. Vehicle after being uprighted, test 471470-27.

The vehicle sustained moderate damage, as shown in figures 92 and 93. The stabilizer bar, upper and lower A-arms, and tie rods on the left side were damaged, and the frame at the left front was bent. The left front spindle, wheel, and tire were damaged. The front bumper, grill, hood, radiator, windshield, and entire left side also were damaged. Maximum exterior crush at the left front corner of the vehicle was 570 mm (22.4 in) at bumper height. There was 53-mm (2.1-in) deformation of the occupant compartment in the floor pan area on the driver's side.

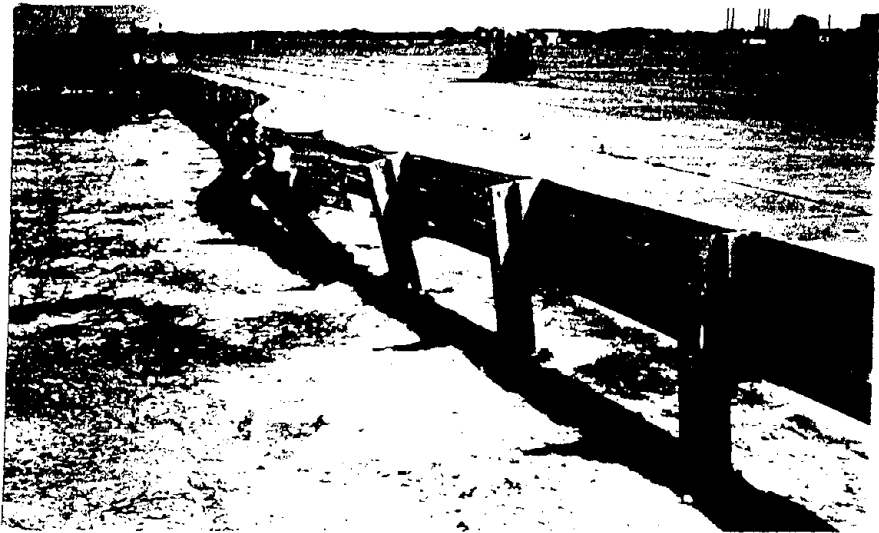
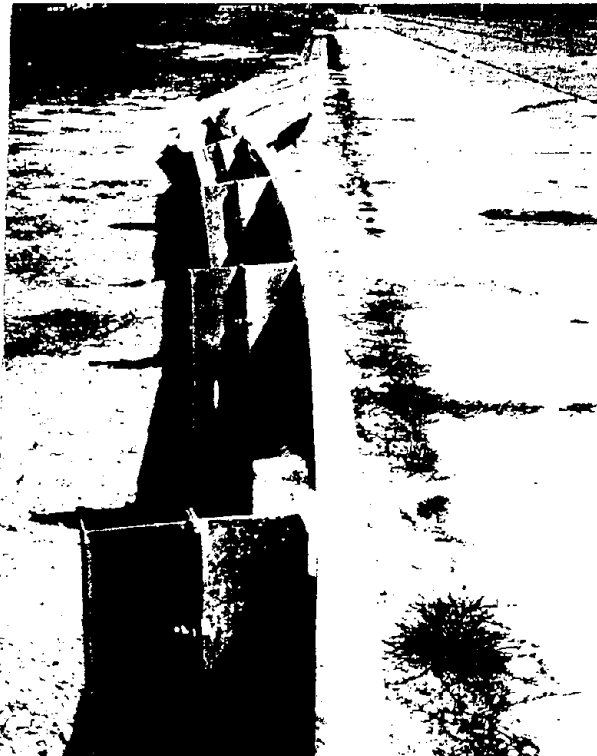
Figure 107. Three-beam guardrail after test 471470-31.

As seen in figures 107 through 109, the test installation received moderate damage. There were tire marks on the face of the thrie-beam rail element from post 15 through post 19, and on the face of posts 16 and 17. The thrie-beam rail element was separated from post 16, and the flanges on post 17 showed evidence of wheel contact. Posts 15 through 19 were twisted severely. The lateral deflections recorded at posts 13 through 20 are noted in table 6.

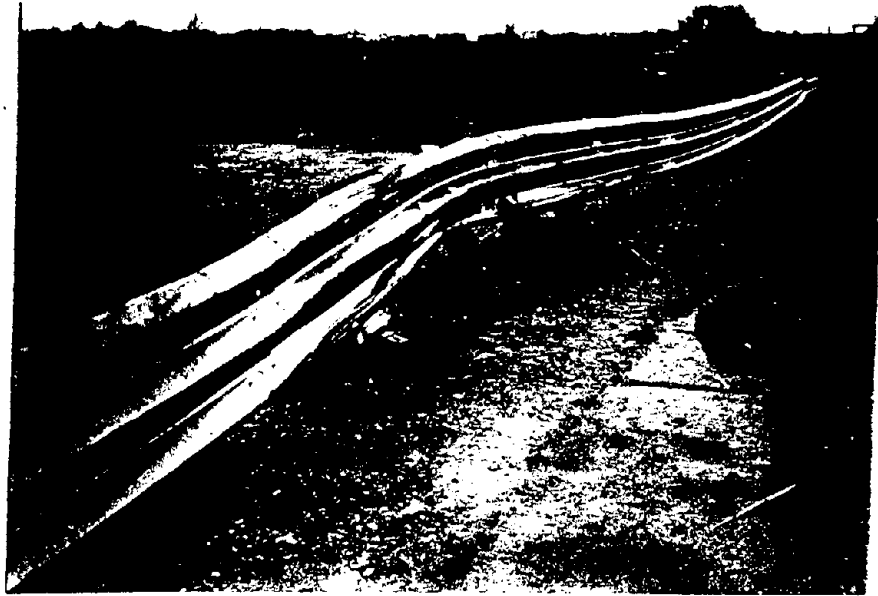
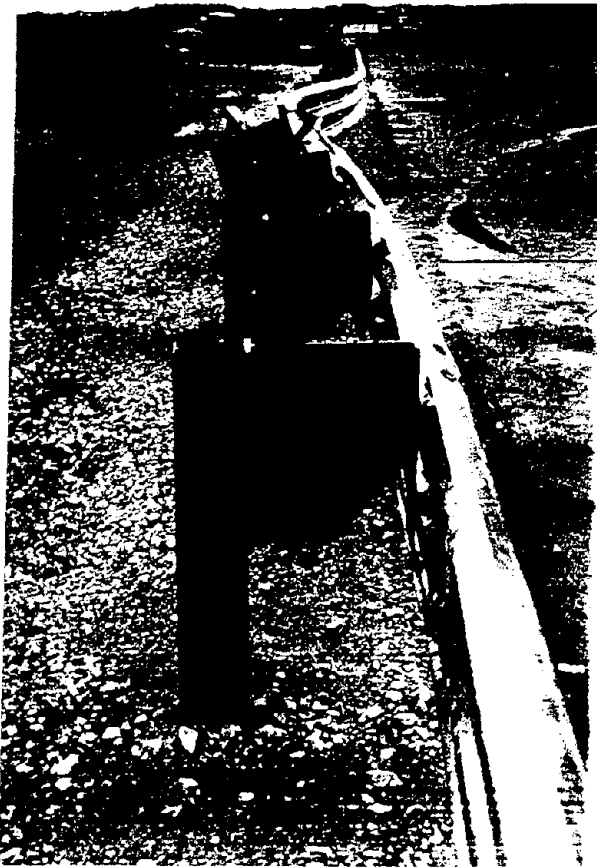
As seen in figures 124 through 128, the installation received moderate damage. There were tire marks on the face of the thrie-beam rail element from post 15 through post 19, and on

Figure 124. Modified three-beam galvanometer after test 471470-30.

the face of post 16 and the back side of post 17. The thrie-beam rail element was separated from post 17, and the flanges on post 17 showed evidence of wheel contact. Posts 16, 17, and 18 were twisted severely. The lateral deflections recorded at posts 14 through 20 are noted in table 7.

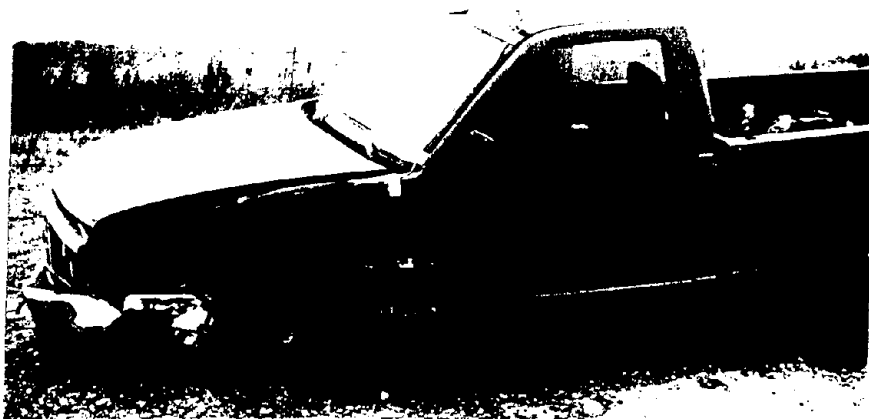
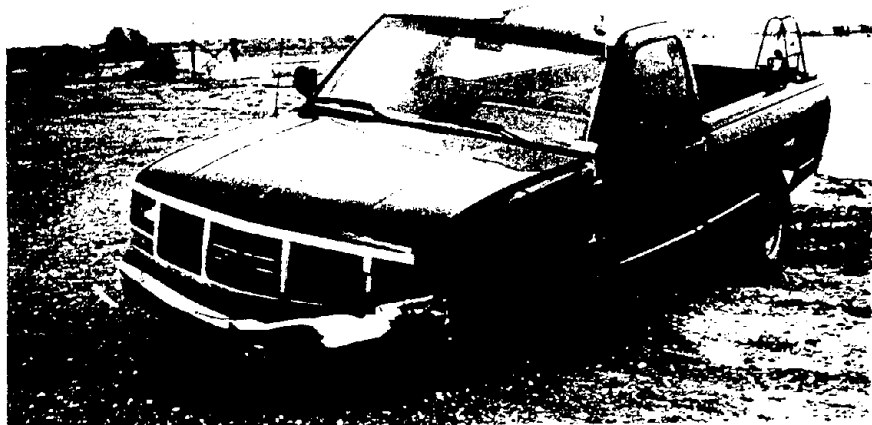
The vehicle sustained moderate damage, as shown in figure 129. The upper and lower A-arms, stabilizer bar, frame, tie rod ends, and spindle on the left side were damaged. The left front wheel assembly was torn from the vehicle's axle. The front bumper, grill, left front quarter panel, and both doors also were damaged. Maximum exterior crush at the left front corner of the vehicle was 430 mm (16.9 in) and there was deformation at the floorpan area of 16 mm (0.6 in).

Figure 129. Vehicle after test 471479-50
