Report No. CDOT-DTD-R-93-12

# **CURTAIN DRAINS**

Final Report  
December, 1993

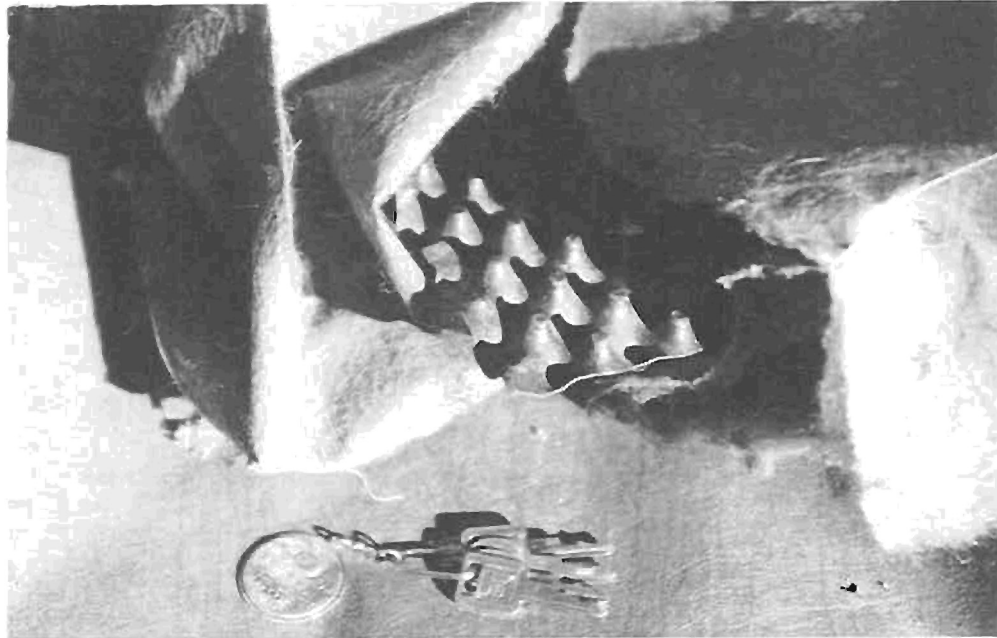
**Figure 1** This photo shows the "egg-crate" core of the curtain drain surrounded by the non-woven filter material.

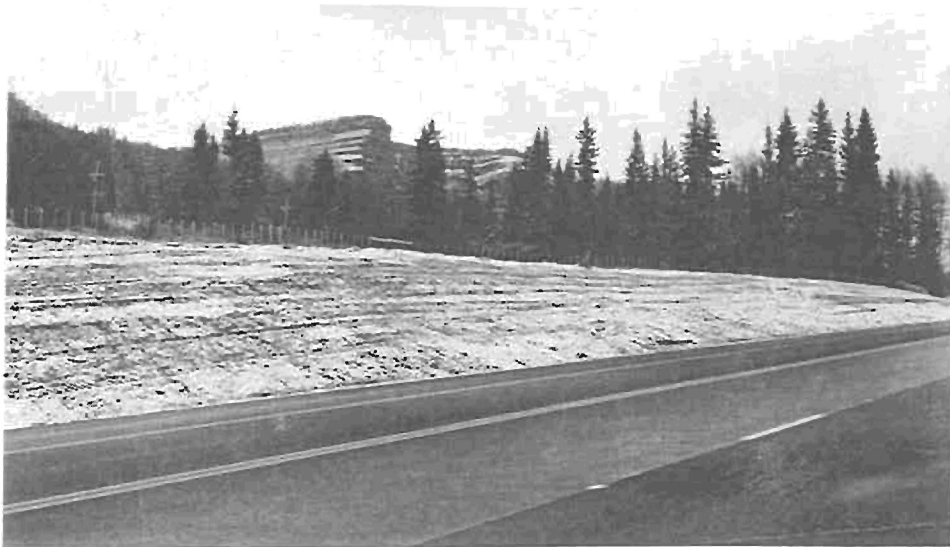
**Figure 2** The curtain drains were placed within this hill on the west side of US 550 south of the Purgatory Ski Area.

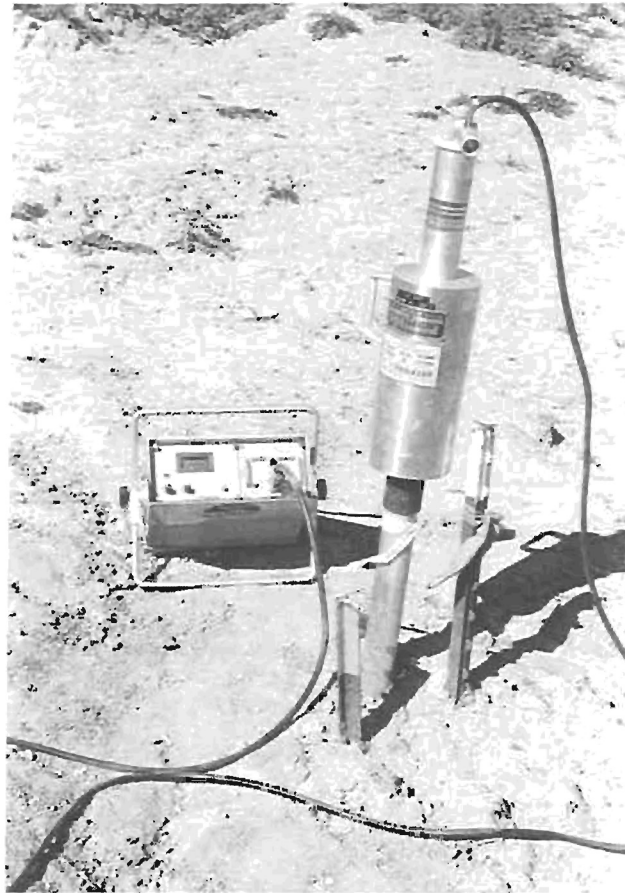
**Figure 13** This photo shows the nuclear device used to measure the moisture content of the soil. The nuclear source is in a cylinder attached to the end of the cable which can be lowered to the full 3.7 meter (twelve foot) depth of the tubes. Moisture content measurements were taken at one foot depth intervals the whole length of the tubes.

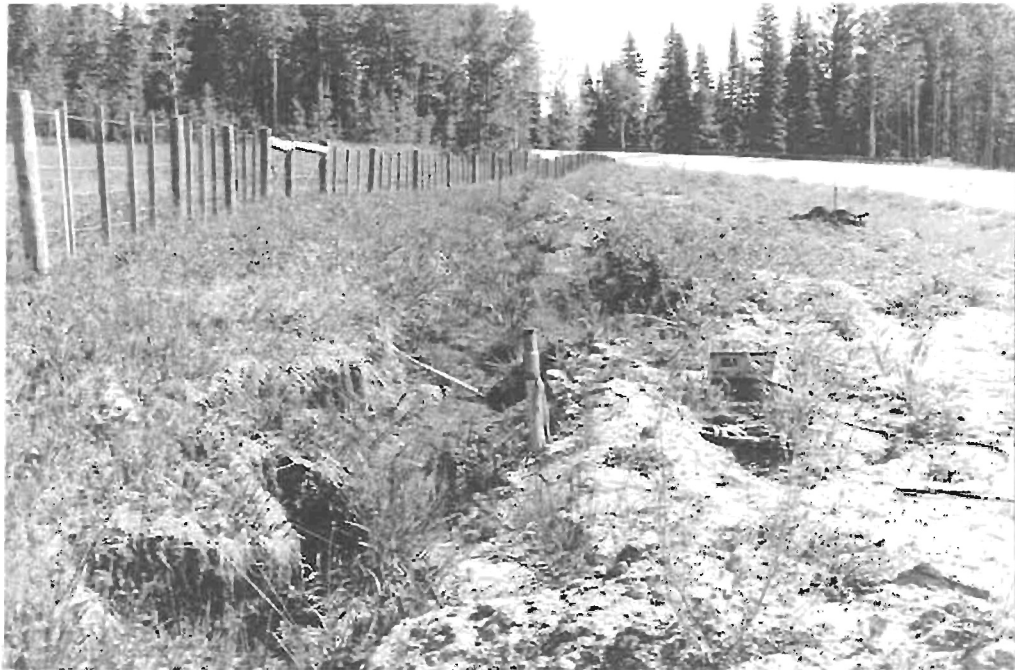
In the Spring of 1988 the tubes were repaired. After this they performed well, except that water sometimes needed to be drained before readings could be taken. In May of 1990, two of the holes needed to be drained of water before readings were taken, one of them was an uphill hole and one a downhill hole. The area around the downhill hole also had to be dug out about 0.6 meters (two feet) down to fix the pipe, which had broken apart at a coupling.

**Figure 15** This moisture tube is adjacent to the interceptor ditch on the uphill side of the curtain drain.

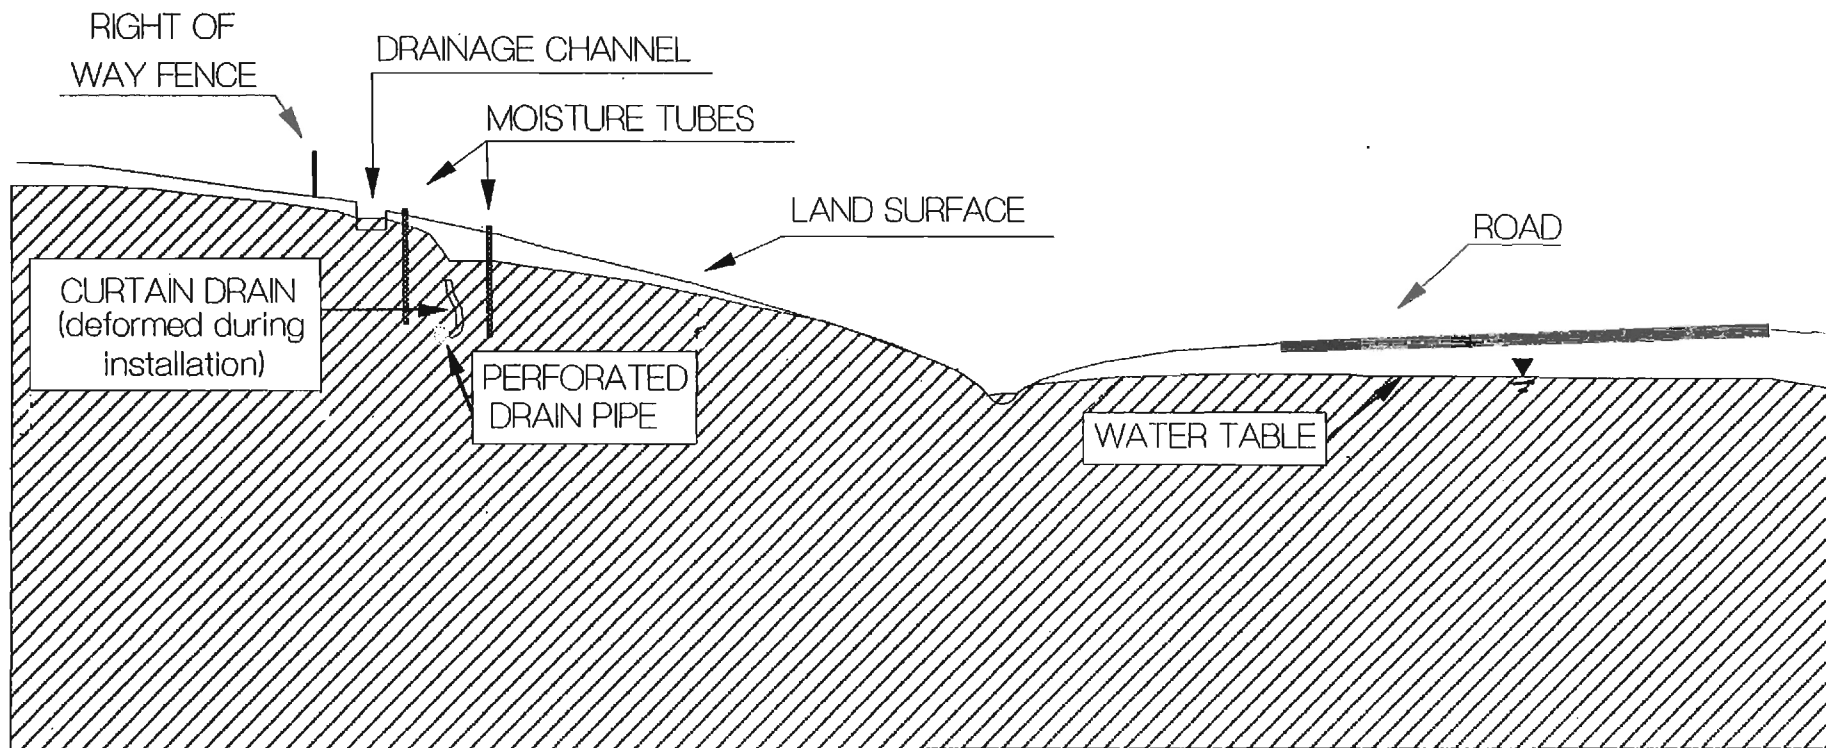
# CROSS-SECTION OF CURTAIN DRAIN STATION 434+50

Consistently throughout the testing period, the water table on the downhill side of the curtain drain was approximately 0.6 meters (two feet) lower from the ground surface than the water table above the curtain drain. Over three years of testing, the water table on either side varied by no more than one quarter to three quarters of a meter (one or two feet). The dense clay at this site makes groundwater transport very slow. Figure 17 is a cross section diagram that shows the location of moisture tubes, the curtain drain, the roadway, and representative water table at one of the two nuclear moisture tube locations.

**Figure 17** Moisture tube diagram

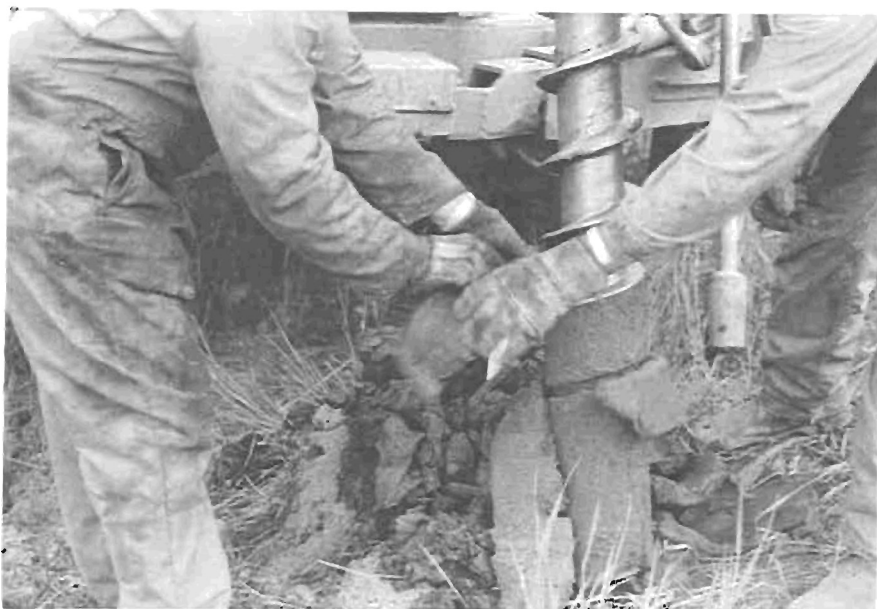
When the wells were drilled, no water was found in the bottom of the wells, although the clayey soil was wet. Small stones that were dropped into the well made a thud as they hit the bottom. This situation was temporary. Within a few days, a few meters of water had risen in the wells. This experience shows how slowly water moves through dense clayey soil.

**Figure 18** The cohesiveness of the clay was demonstrated by the way strips of mud were peeled off the auger during the installation of the monitoring wells.

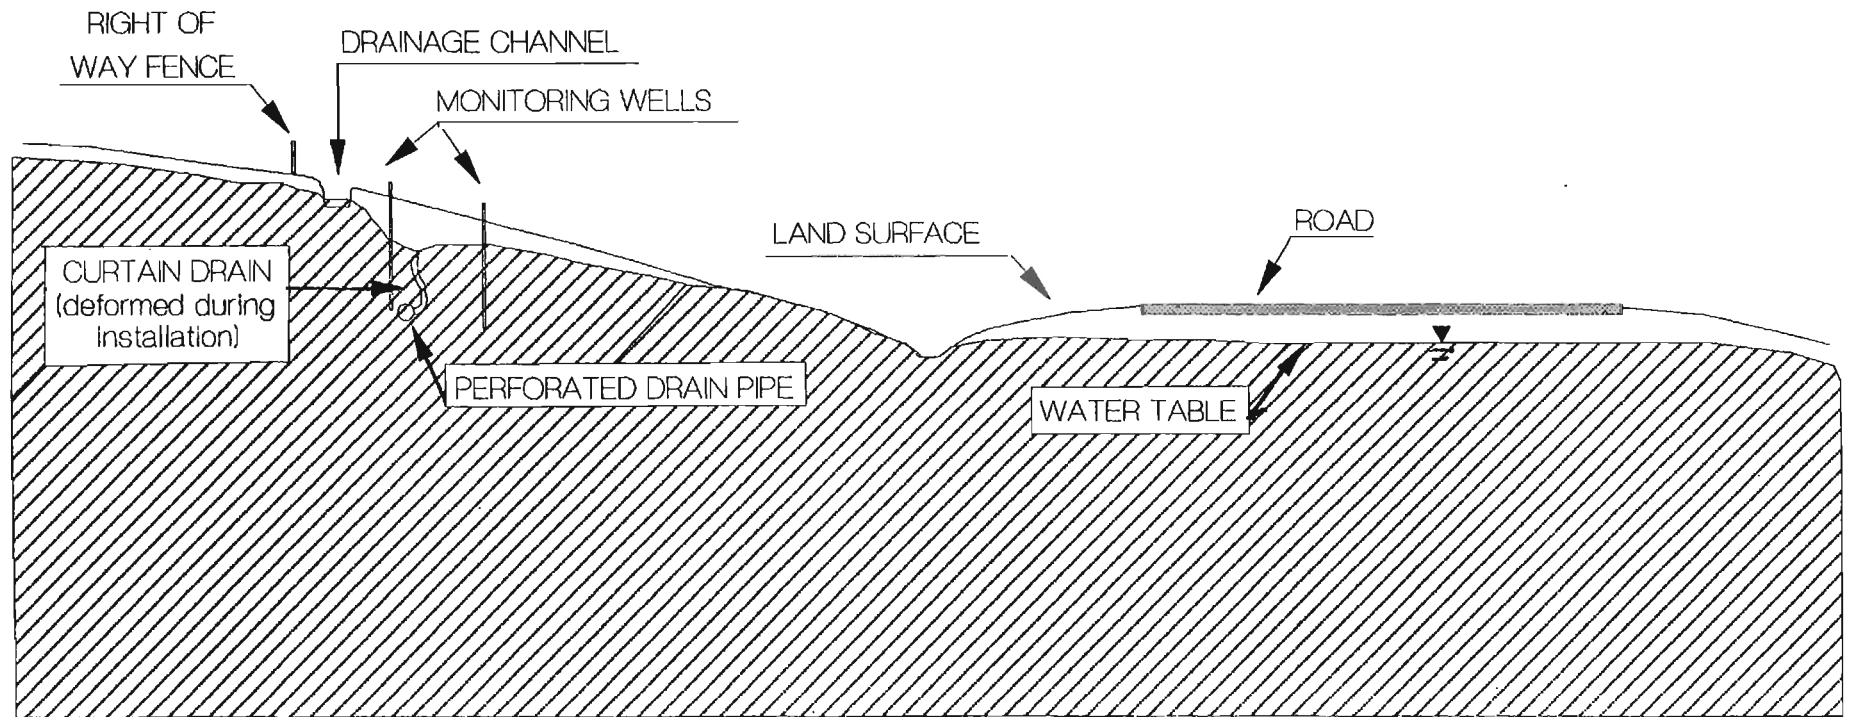
# CROSS-SECTION OF CURTAIN DRAIN STATION 433+00

As can be seen in the table, the set of wells to the south at station 433 do not exactly show the same information. The downhill hole at this location was placed further down the hill on a steeper section. The water in this hole is closer to the surface than the uphill hole. This is probably due to the groundwater coming closer to the surface due to the steepness of the slope. There are cattails and other wetland vegetation growing at the bottom of the slope where the groundwater daylights. Figure 19 shows the cross section of the roadway and roadside features at this location south of the moisture tubes.

**Figure 19.** Monitoring well diagram

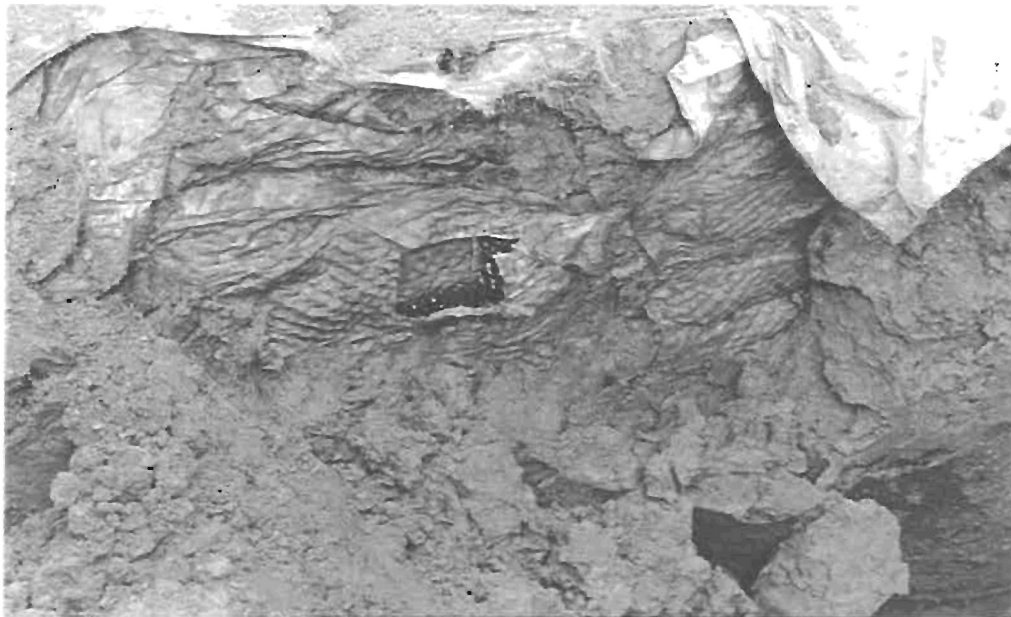
In September of 1990 a trip was made to the site to excavate a section of the curtain drain and determine if it was clogged, if it was installed properly, and if it was draining properly. The backhoe reached the top of the curtain drain at a depth of 1.8 meters (six feet) about halfway between the upper and lower moisture tubes. The downhill side of the curtain drain was excavated an additional 1.8 meters, and a 15cm (six inch) by 15cm piece of the curtain drain was cut out and examined.

**Figure 23** A piece of the curtain drain was cut out for further examination.
