DOT HS 813 841

**Special Crash Investigations:  
On-Site Child Restraint System  
Crash Investigation;  
Vehicle: 2007 Mitsubishi  
Outlander;  
Location: Indiana;  
Crash Date: January 2023**

**Special Crash Investigations**  
**On-Site Child Restraint System Crash Investigation**  
**Case Number: CR23004**  
**Vehicle: 2007 Mitsubishi Outlander**  
**Location: Indiana**  
**Crash Date: January 2023**

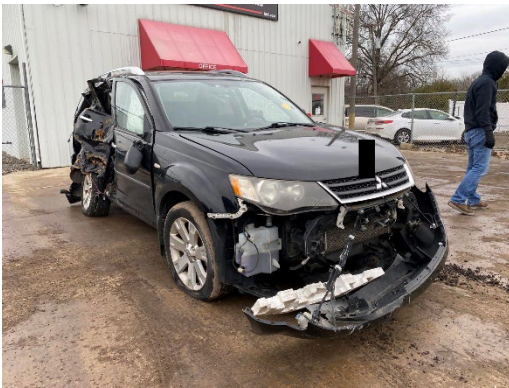
*Figure 1. Right oblique view of the 2007 Mitsubishi Outlander*

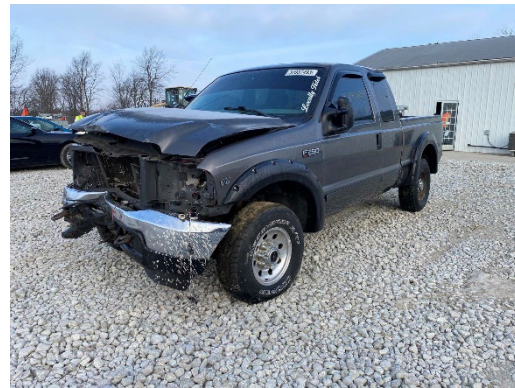
*Figure 2. Left oblique view of the 2002 Ford F-250*

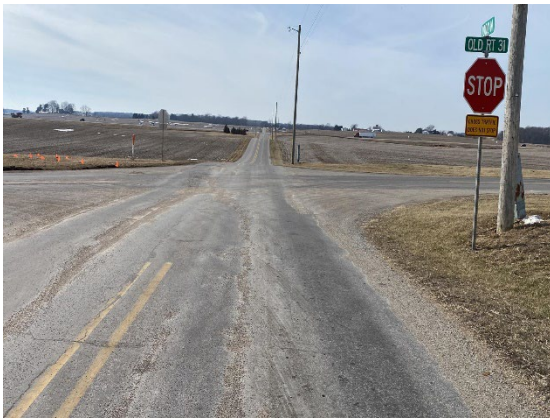
The crash occurred during the day on a two-lane, undivided county roadway at a four-leg intersection. The intersection had stop signs for the east and westbound travel lanes (Figure 3) that were upright and visible. There were no traffic controls for the north and southbound (Figure 4) lanes. The weather was cloudy skies, a temperature of -2.7 °C (27 °F), 75 percent humidity, light rain, and winds from the southeast at 10 km/h (6 mph). Travel lanes were 3 m (9.8 ft) wide and were separated by a double yellow centerline. The bituminous road surface had no paved shoulders, and the speed limit was 89 km/h (55 mph). On approach to the intersection, the westbound travel lane had a positive grade of 4 percent while the southbound travel lane had a positive grade of 3 percent. A crash diagram is included at the end of this report.

*Figure 3. Westbound view of the Mitsubishi's approach to the crash site*

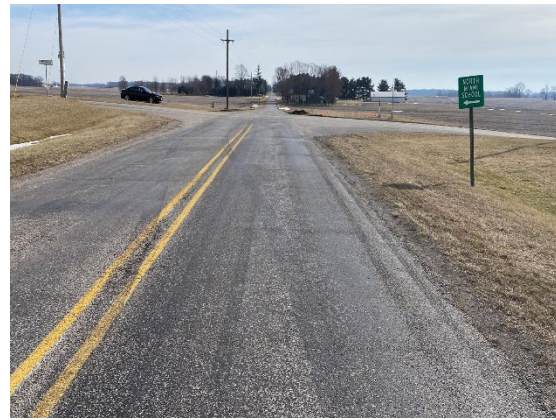
*Figure 4. Southbound view of the Ford's approach to the crash site*

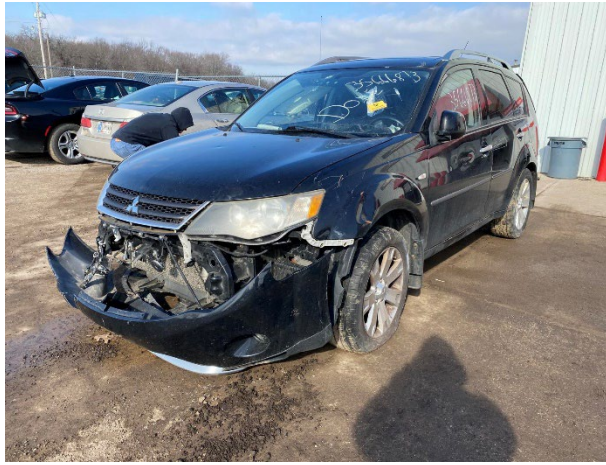
*Figure 5. Left oblique view of the 2007 Mitsubishi Outlander*

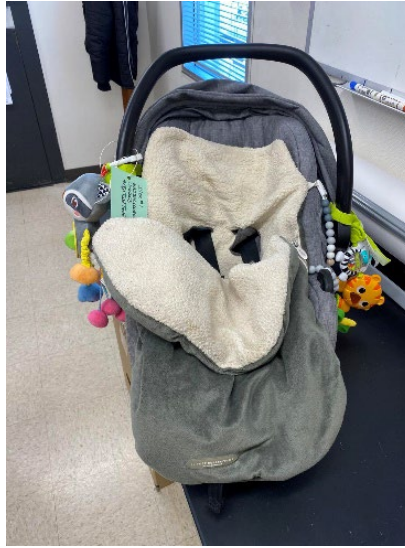
Local law enforcement had possession of the second-row right CRS as evidence and would not allow the SCI investigator to reconstruct the CRS's position at the time of the crash during the vehicle's inspection. The CRS for the second-row right passenger was an Evenflo Litemax Omni (Figure 12). The CRS was designed to be used only as rear-facing with a 5-point harness to secure the child. The harness webbing was routed through the third highest of four slots in the shell's back. In this crash, the CRS was secured within the base that was secured to the seat by the LATCH system, which was routed through the carrier base and each end was attached to the vehicle's lower anchors at the second-row right seat position. According to medical records, the infant weighed 9 kg (19 lb) and was within the manufacturer's recommended weight of 1.8 – 16

*Figure 12. CRS that was secured in the second-row right seating position of the Mitsubishi*

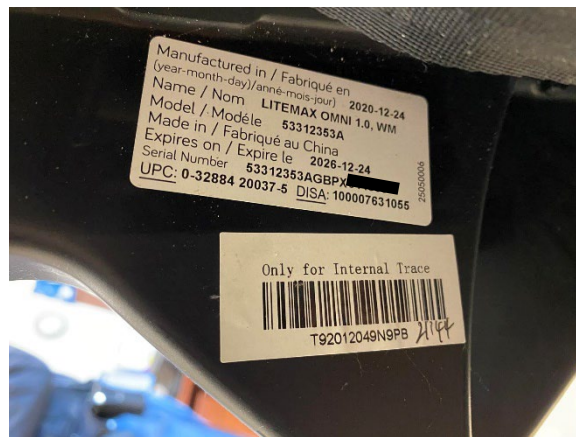
kg (4 to 35 lb) for using the CRS. The manufacturer label (Figure 13) indicated that it was produced on December 24, 2020, with an expiration date of December 24, 2026.

*Figure 13. Manufacturer label on CRS*

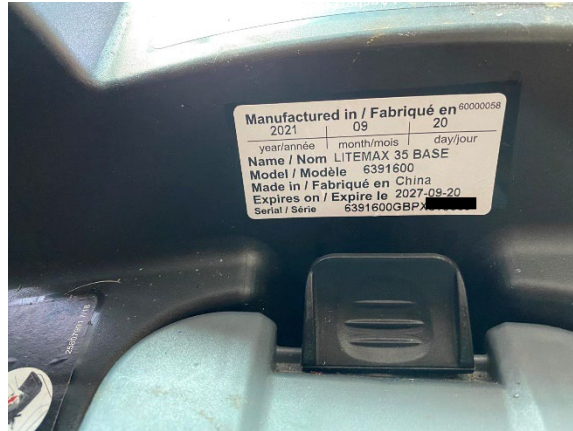
At the time of the inspection, the CRS base (Figure 18) appeared to have been secured properly to the anchor points located in the second-row right seating position. Due to the extent of the damage to the interior, it cannot be determined if the CRS base was level at the time of installation or not. The manufacturer label (Figure 19) stated that it was produced on September 20, 2021, with an expiration date of September 20, 2027.

*Figure 19. Manufacturer label on CRS base*
